## Glenorchy Area Geomorphology and Geo-hazard Assessment

**Otago Regional Council**

5 September 2007

.....  
Dr Mark Mabin  
Senior Environmental  
Scientist

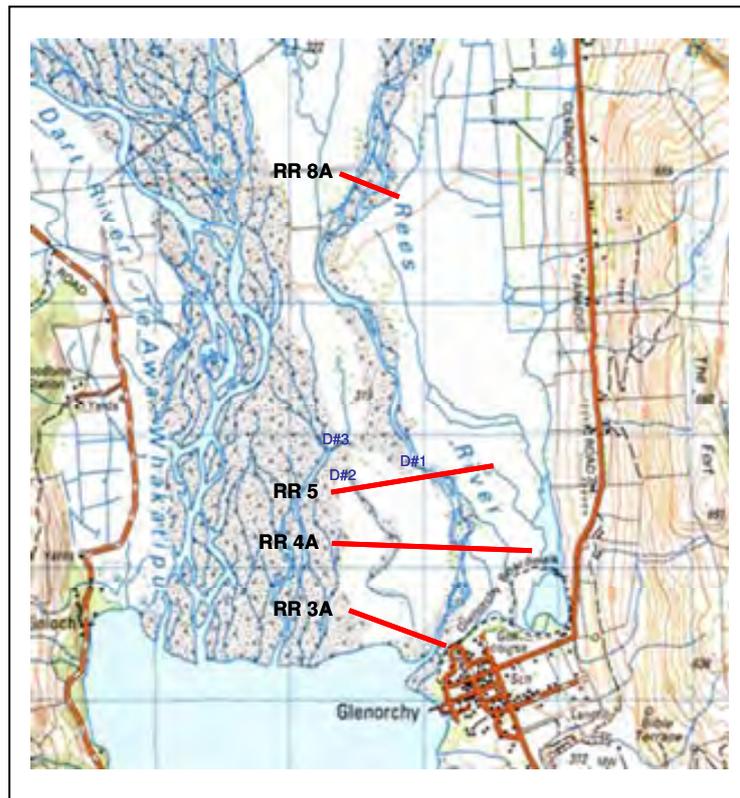
Figure 3-1 Lower Rees River floodplain (Transects labelled RR. Distributary channels D#.)

- A large quantity of gravel is situated in the fairway at the head of distributary #1. If this migrates downstream it is likely to increase the potential for the Rees River to shift its channel and flow directly into the Glenorchy Wetland/Lagoon area; and/or to cause aggradation near the mouth leading to loss of freeboard on the Rees/Glenorchy floodbank and an increased risk of flooding through the northern parts of the town.

By 1998, there had been a significant change, and the bulk of the Rees River flow now entered distributary #1 to flow to Lake Wakatipu past Glenorchy. A large tongue of gravel appears to be advancing into the head of this channel. Distributary #2 was by this time very small, and did not appear to

carry significant flow. In 2001 the gravel tongue is still in place, having not been significantly altered during the 1999 flood. Distributary # 2 was almost dry, and all Rees River flow is now passing down the eastern channel (Distributary #1) past Glenorchy.

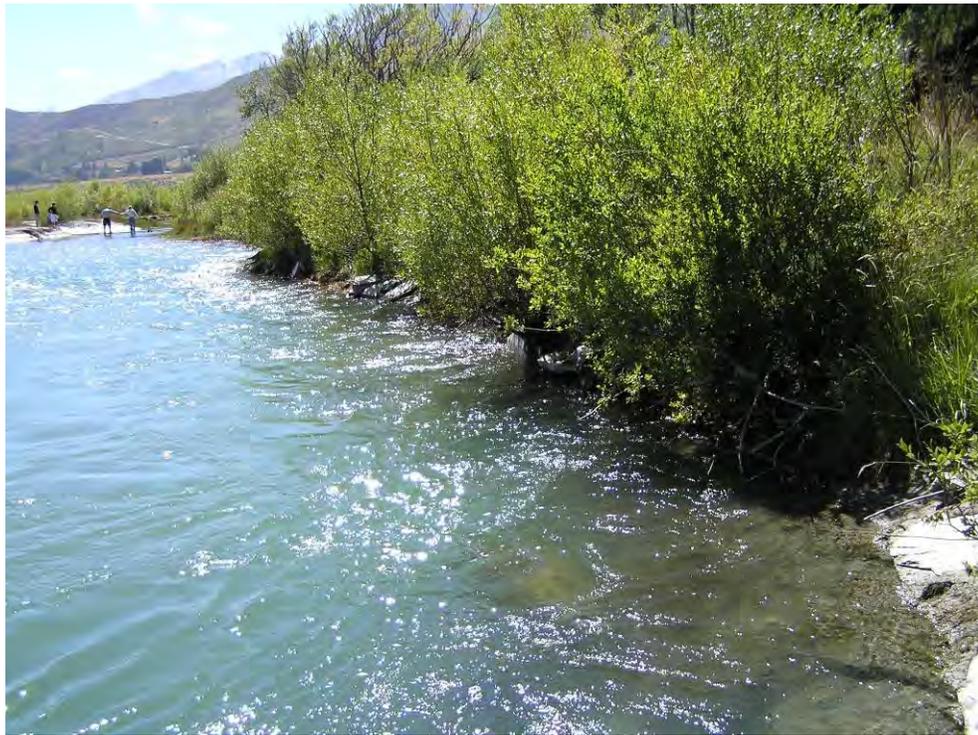
**Photograph B-1** View of Rees River flowing against western end of the Glenorchy-Rees River Floodbank. Some schist boulders can be seen offering some erosion protection. Photograph taken 13 February 2007 (photo Tim McMorran)

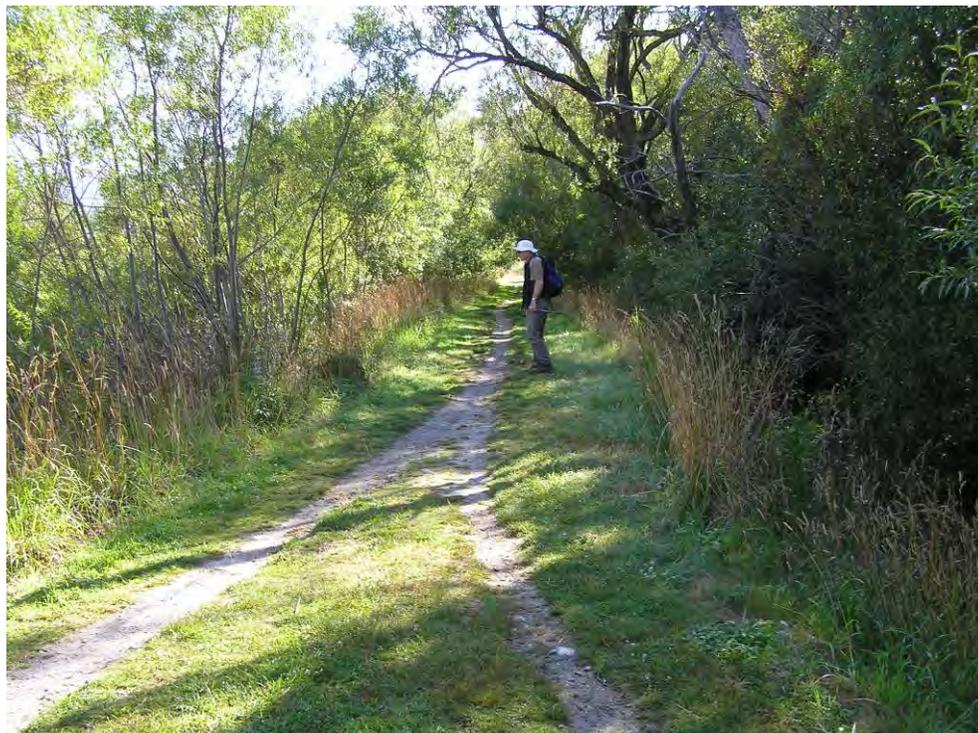
**Photograph B-2** View (to the northeast) of Glenorchy-Rees River Floodbank near the western end showing the 3 m wide, relatively level crest and significant vegetation cover. Photograph taken 13 February 2007 (photo Tim McMorran)

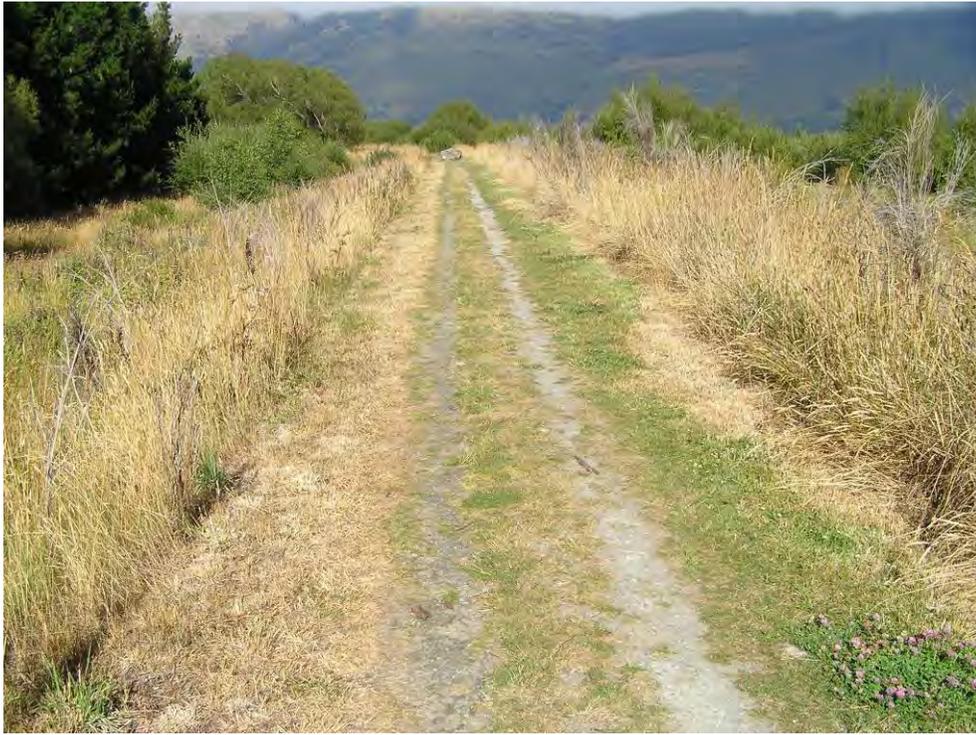
**Photograph B-3** View (to the west) of the Glenorchy-Rees River floodbank about half way along its length. Photograph taken 13 February 2007 (photo Tim McMorran)

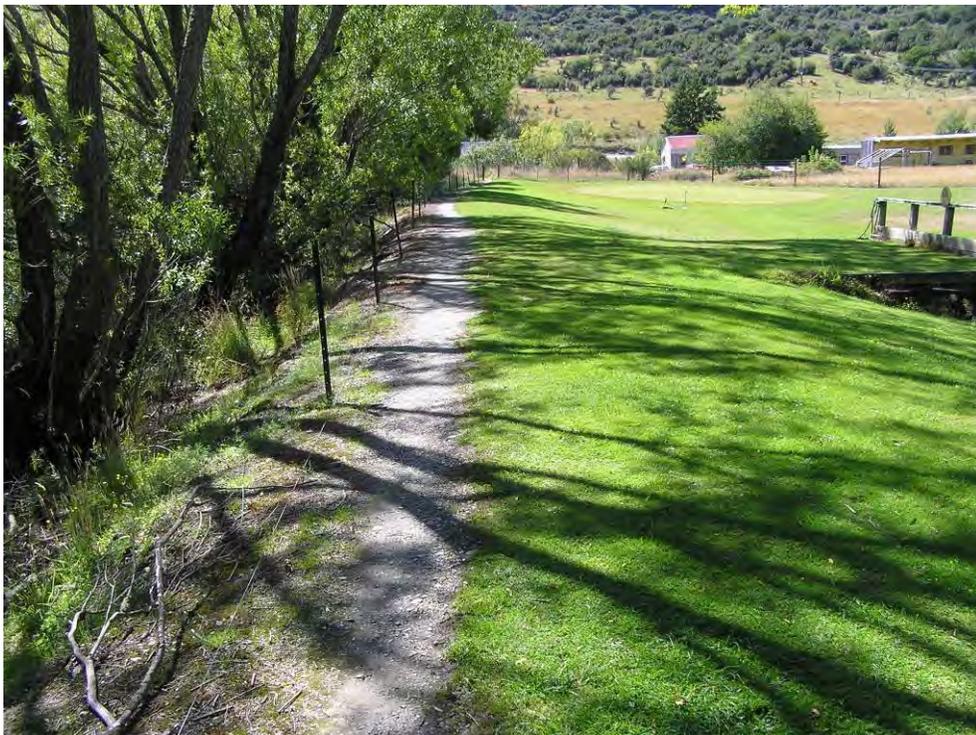
**Photograph B-4** View (to the east) of Glenorchy-Rees River Floodbank near the eastern end showing a very gentle downstream slope, relatively level crest and good grass cover of the golfcourse. Photograph taken 13 February 2007 (photo Tim McMorran)

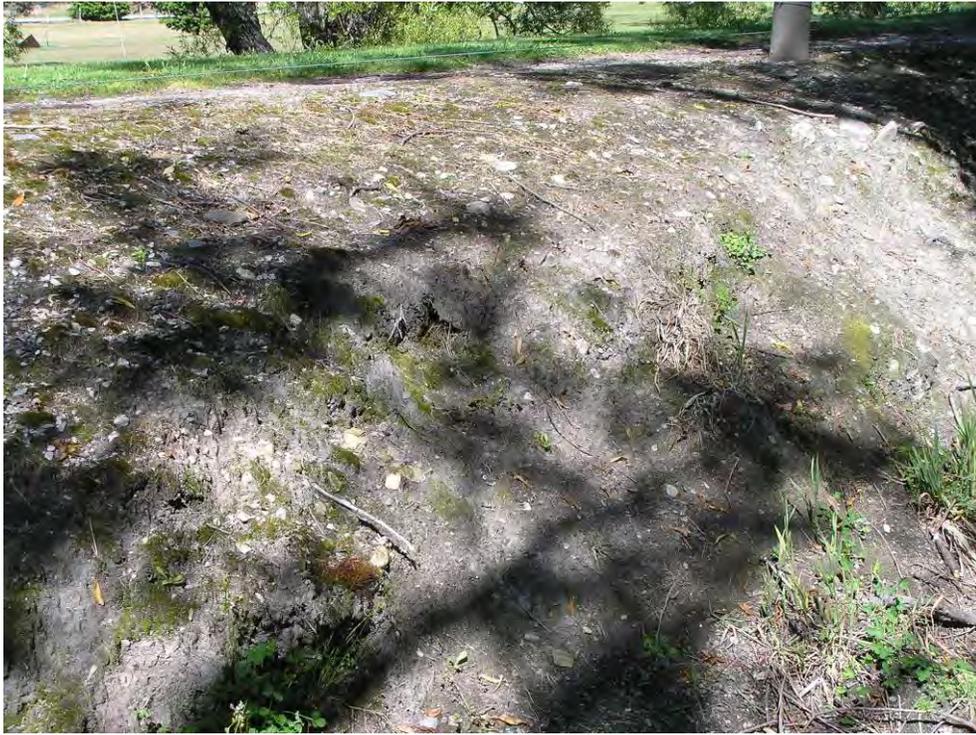
**Photograph B-5** Upstream slope of the Glenorchy-Rees River floodbank at photograph 4 location. Note steep slope, lack of vegetation and high fines content. Photograph taken 13 February 2007 (photo Tim McMorran)

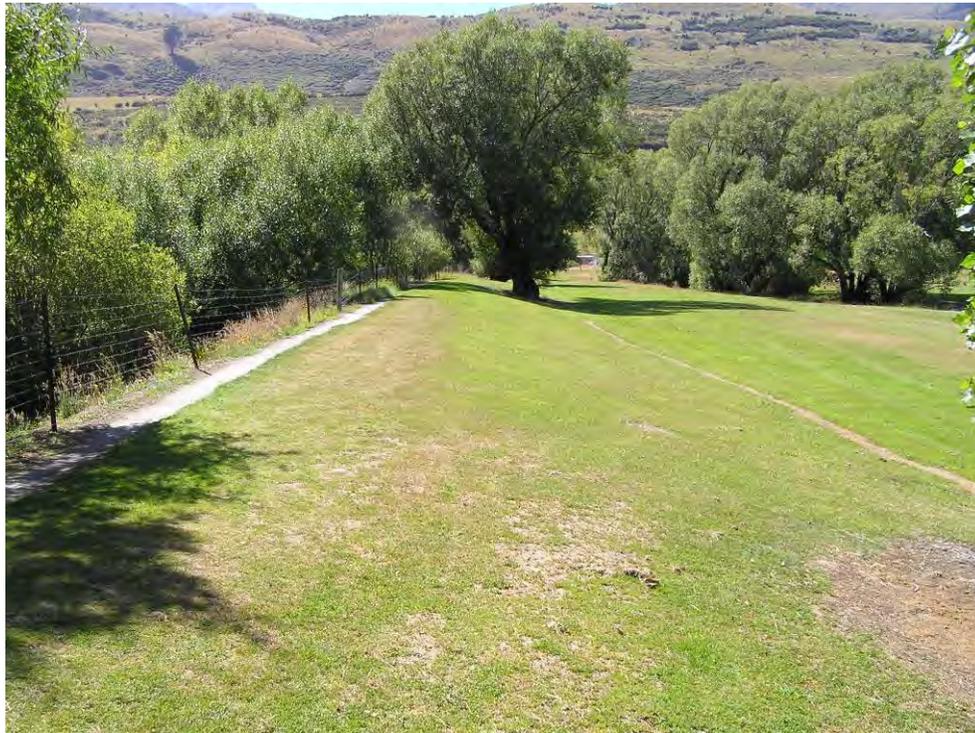
**Photograph B-6** View (to the east) of Glenorchy-Rees River Floodbank along golf course showing a very gentle downstream slope, relatively level crest and good grass cover. Photograph taken 13 February 2007 (photo Tim McMorran)

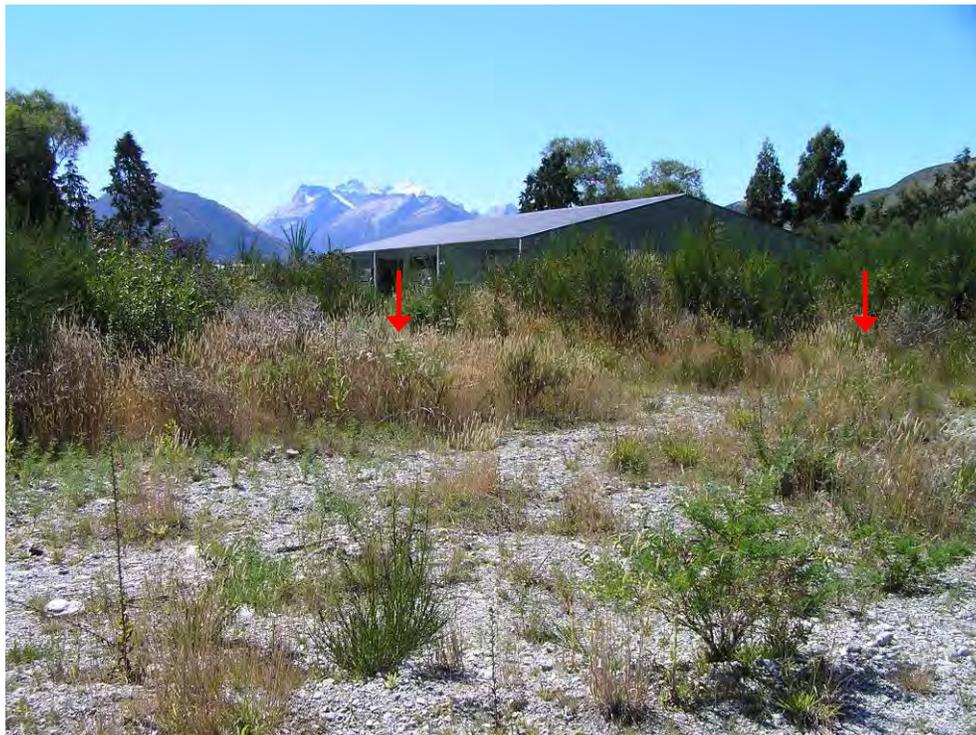
**Photograph B-7** The Glenorchy-Buckler Burn floodbank is located beneath broom bushes where arrowed. The structure is only about 0.5 m high and heavily overgrown. Photograph taken 14 February 2007 (photo Tim McMorran)

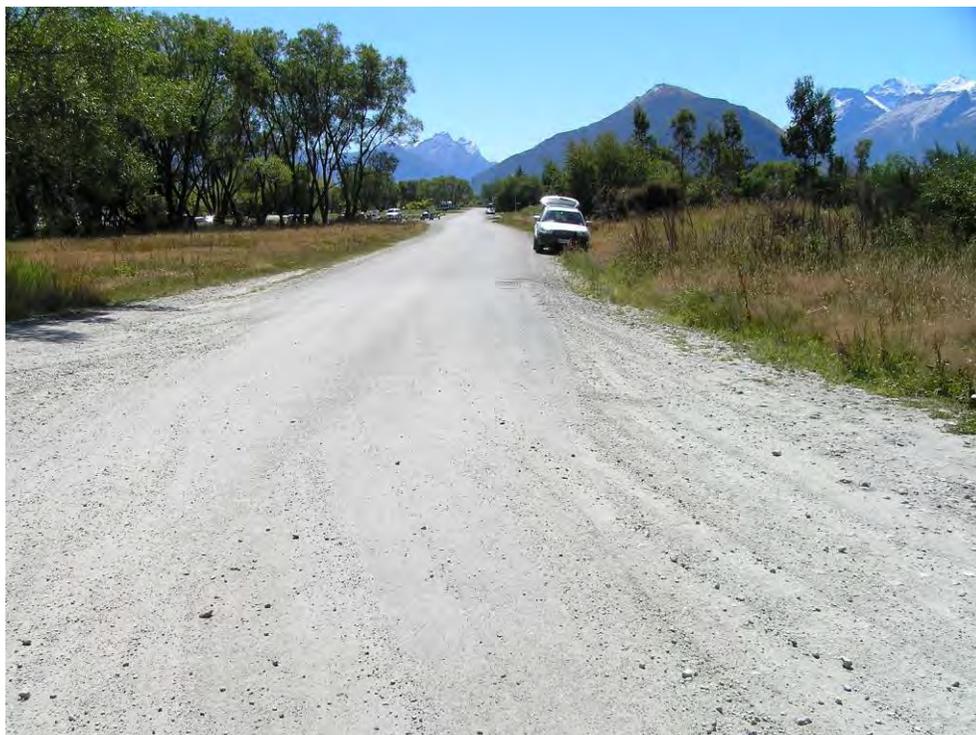
**Photograph B-8** View (to the north) along Benmore Place. The Glenorchy-Rees River Floodbank should cross the road in this area. Photograph taken 14 February 2007 (photo Tim McMorran)

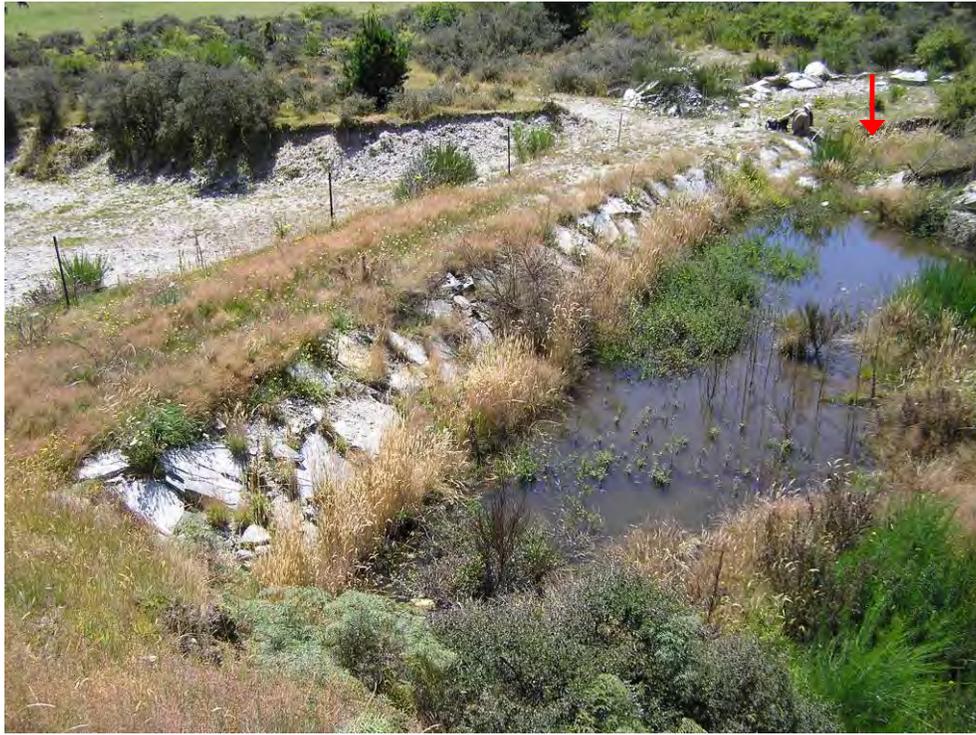
**Photograph B-9** View to northeast along embankment on Bible Terrace Stream. Note schist boulders on upstream face. Red arrow shows the location of the outlet to the diversion channel. Photograph taken 13 February 2007 (photo Tim McMorran)

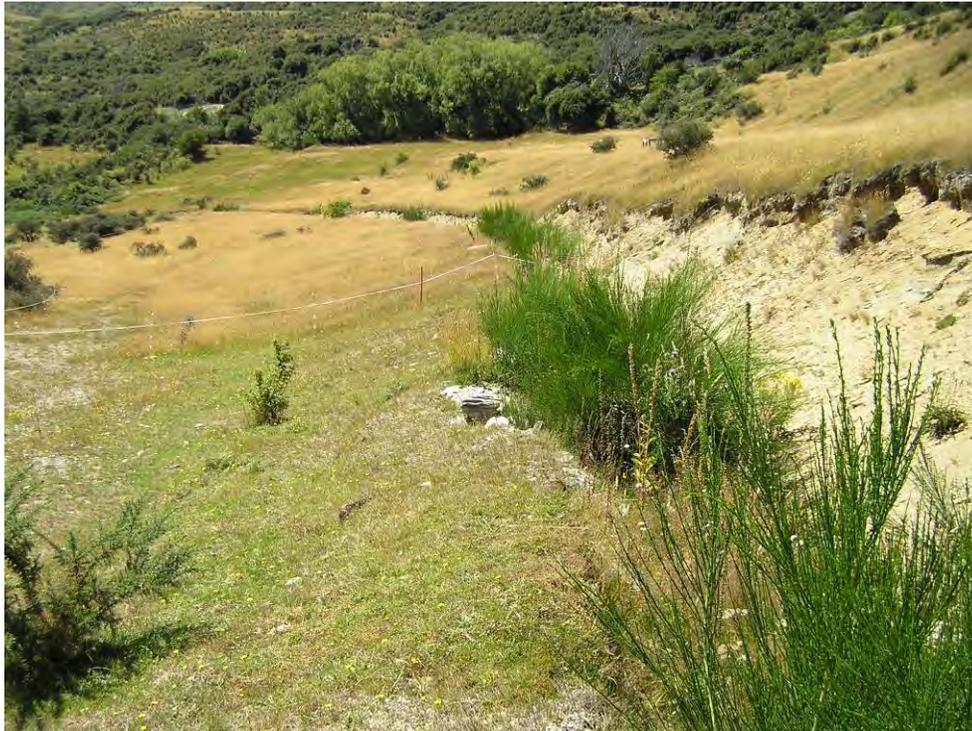
**Photograph B-10** View to northeast along the diversion channel of Bible Terrace Stream. Photograph taken 13 February 2007 (photo Tim McMorran)

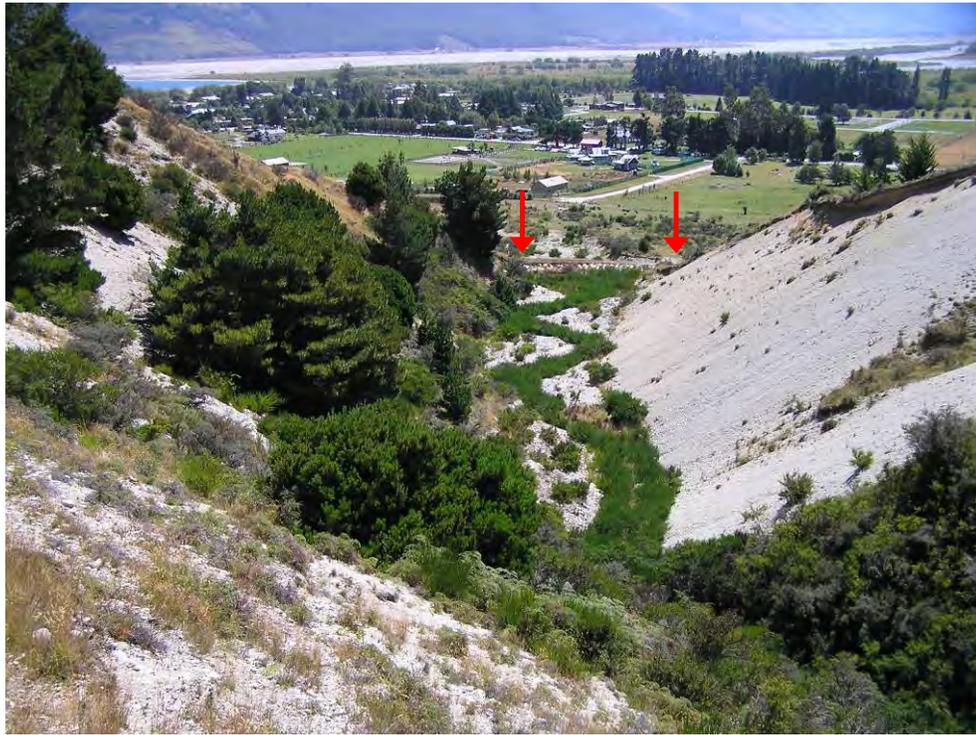
**Photograph B-11** View north along Bible Terrace Stream showing deeply incised channel cut mainly in deltaic sediments. The embankment location is arrowed. Photograph taken 13 February 2007 (photo Tim McMorran)

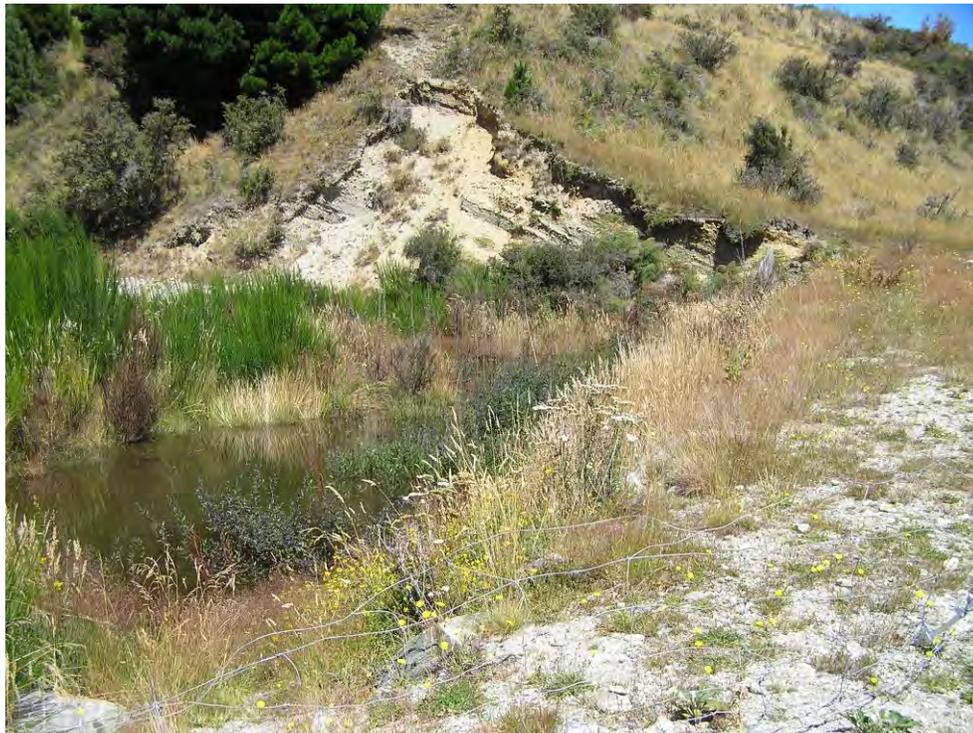
**Photograph B-12** View along the crest of the Bible Terrace Stream embankment showing deltaic sediments dipping to the northeast exposed in the abutment. Photograph taken 13 February 2007 (photo Tim McMorran)

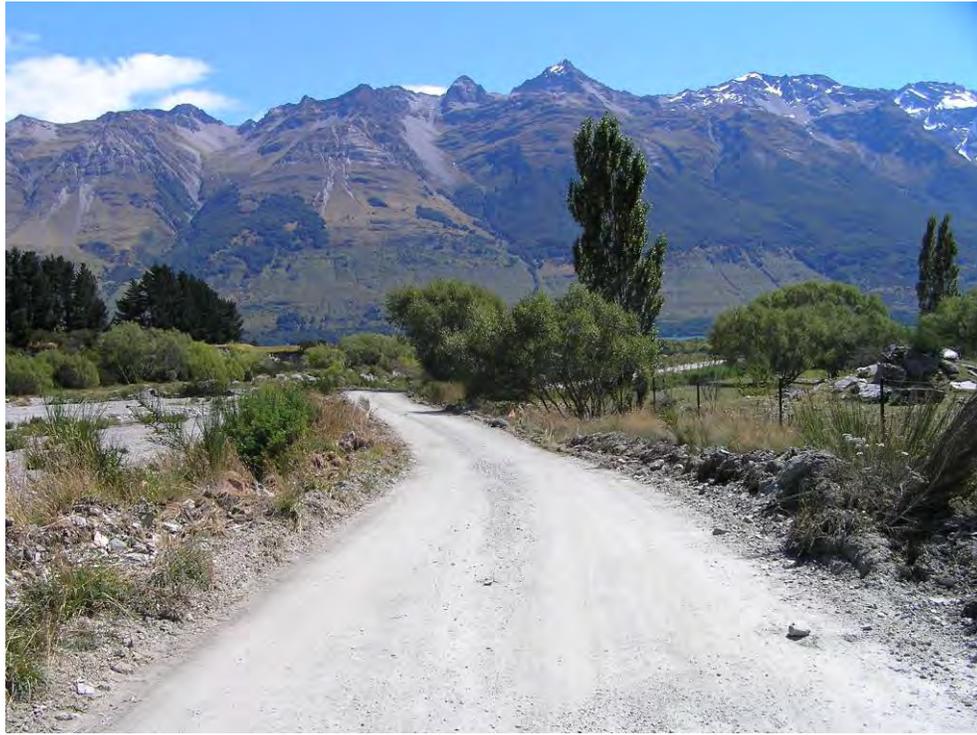
**Photograph B-13** View west along Buckler Burn Groyne showing 5 m wide crest. Buckler Burn floodplain is to the left. Photograph taken 14 February 2007 (photo Tim McMorran)

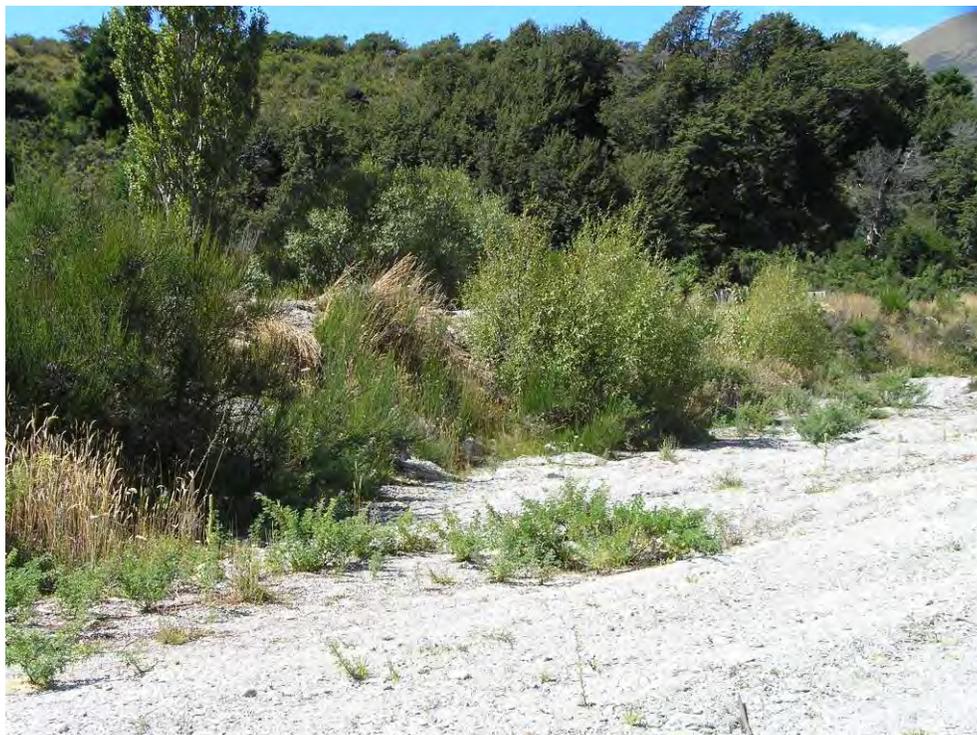
**Photograph B-14** View of upstream face of Buckler Burn Groyne. The Groyne is about 2 m high. Photograph taken 14 February 2007 (photo Tim McMorran)

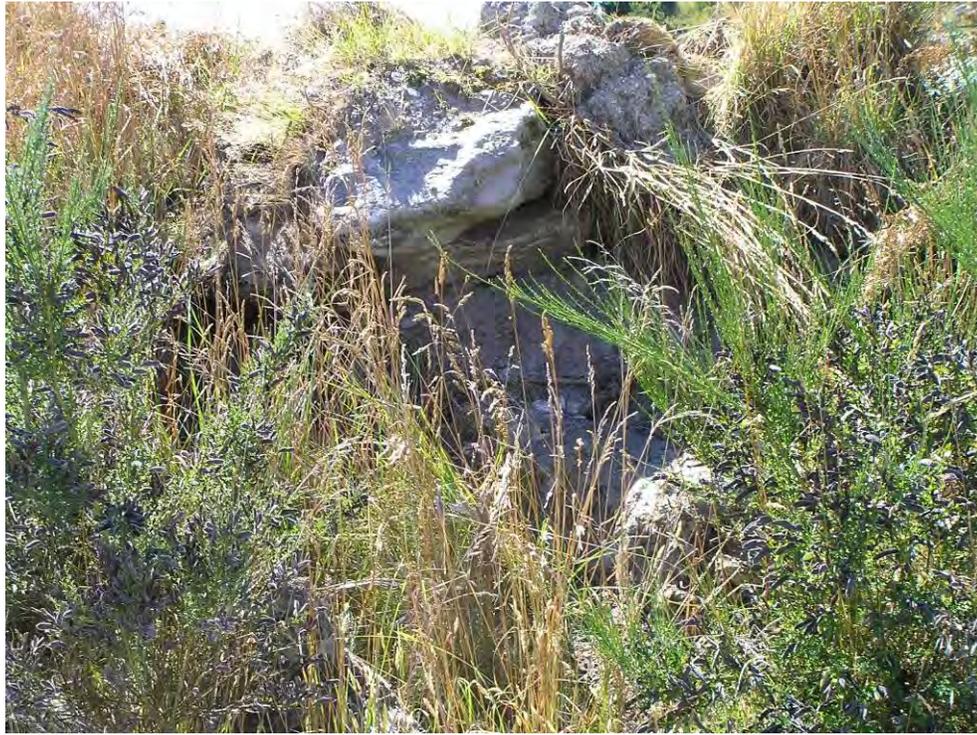
**Photograph B-15** Close up of schist blocks armoured Buckler Burn Groyne. Photograph taken 14 February 2007 (photo Tim McMorran)

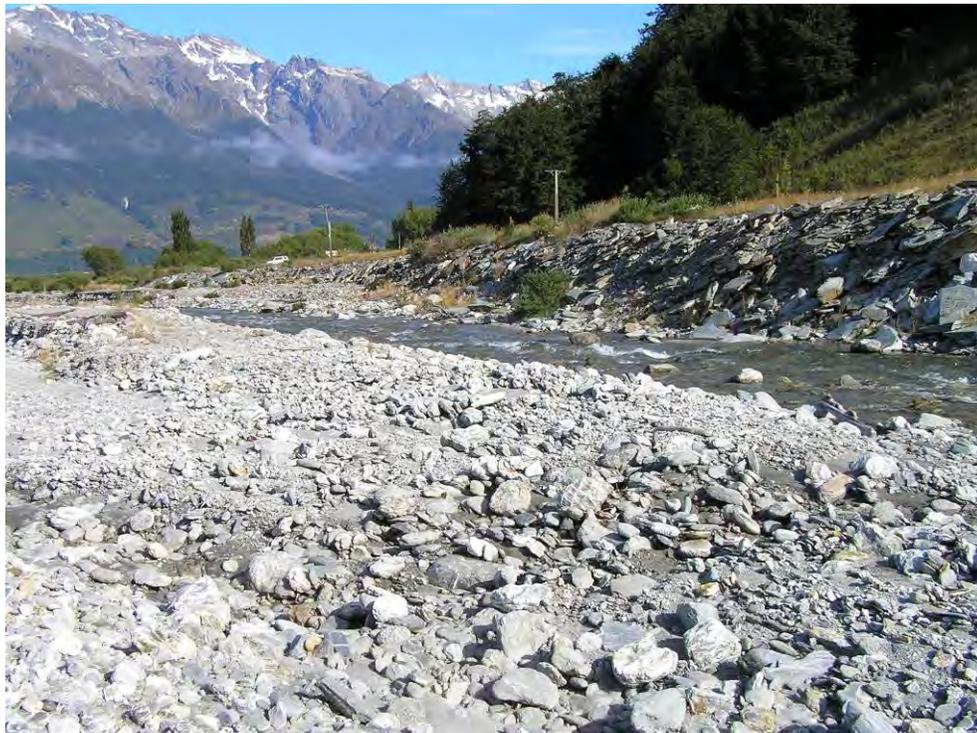
**Photograph B-16** View of rock protection between Buckler Burn and the Glenorchy-Queenstown Road. Photograph taken 14 February 2007 (photo Tim McMorran)

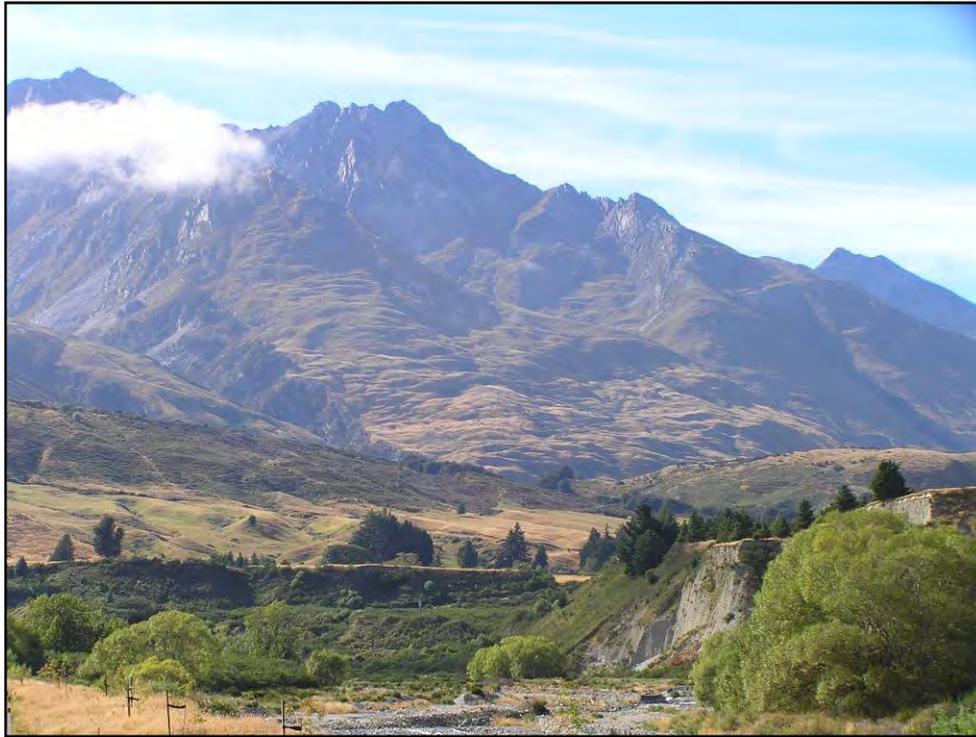
**Photograph 9-1** View of Mt Larkins across Buckler Burn. Hummocky debris in the centre of the photograph is creeping landslide debris typical of steep schist slopes. Photograph taken 14 February 2007 (photo Tim McMorran)

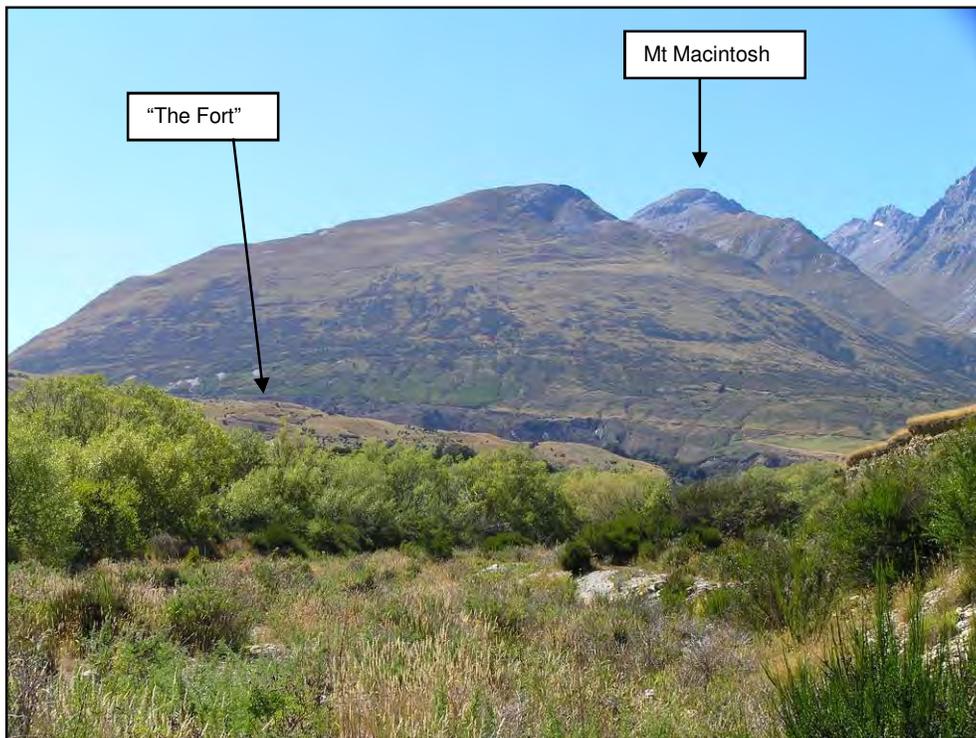
**Photograph 9-2** View of Un-named hill and Mount Macintosh (arrowed). Landslide debris covers this west-facing slope and landslide scarps are visible near the skyline. Glenorchy is protected from any landslide activity by the low ridge visible behind the willows ("The Fort"). Photograph taken 14 February 2007 (photo Tim McMorran)

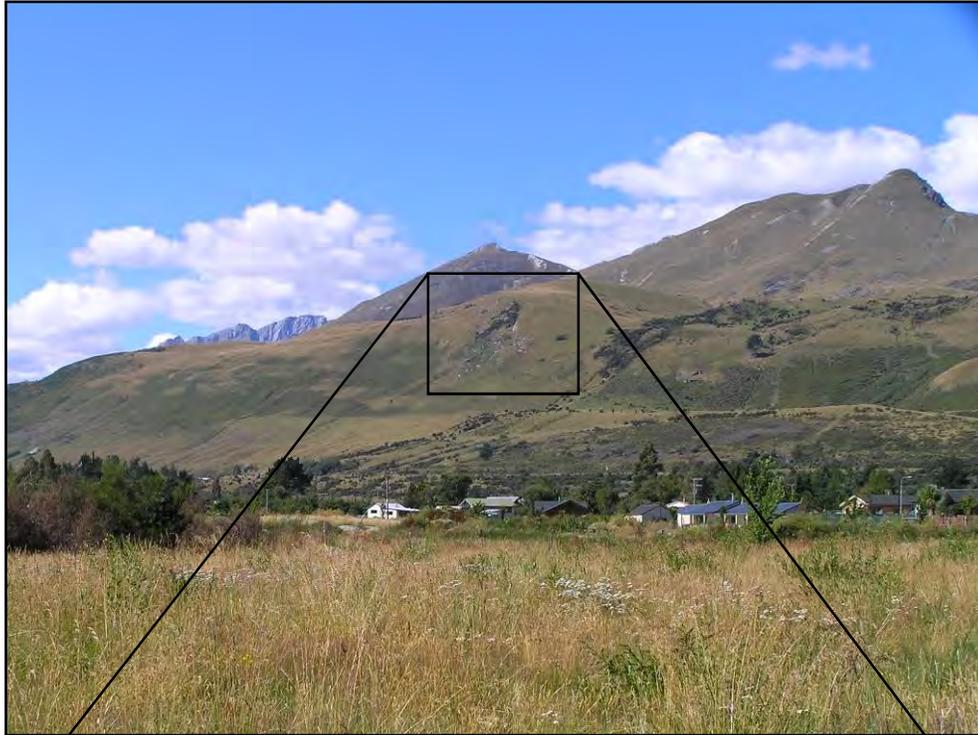
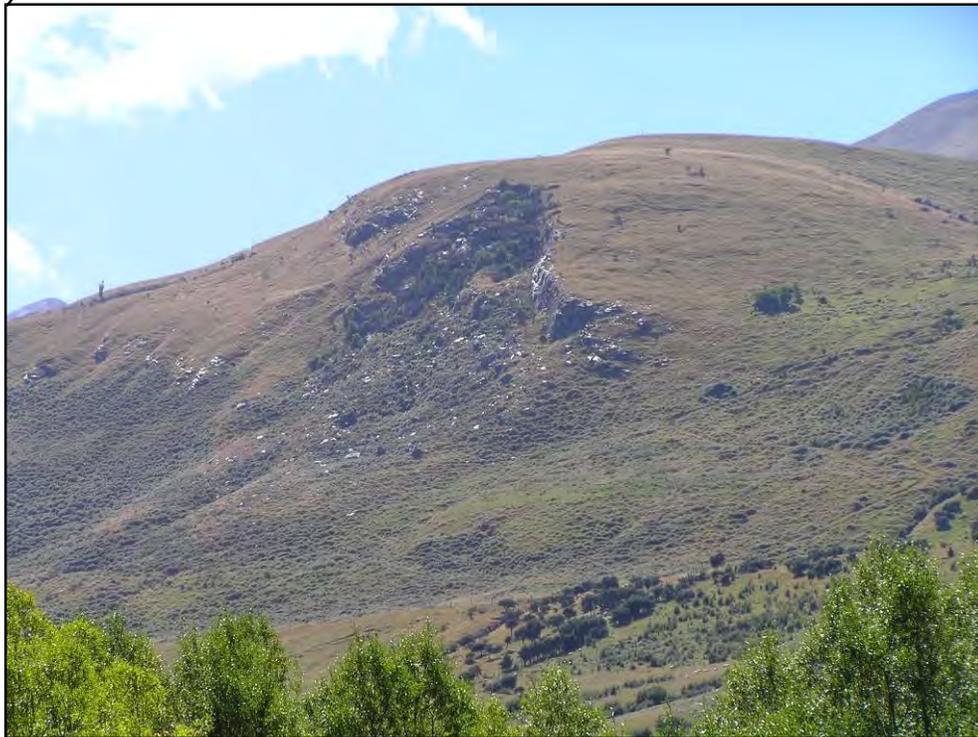
**Photographs 9-3 & 9-4** View of West facing slope of “The Fort” above the Glenorchy – Paradise Road. The steep backscarp is visible with rockfall debris scattered on the slope below. Photograph taken 14 February 2007 (photo Tim McMorran)

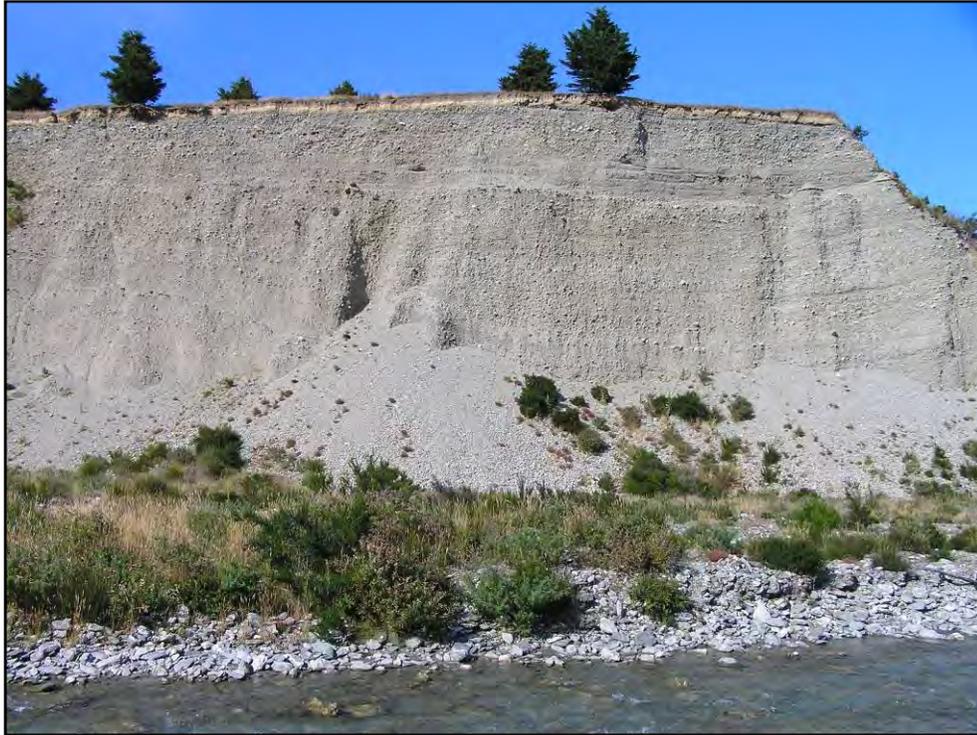
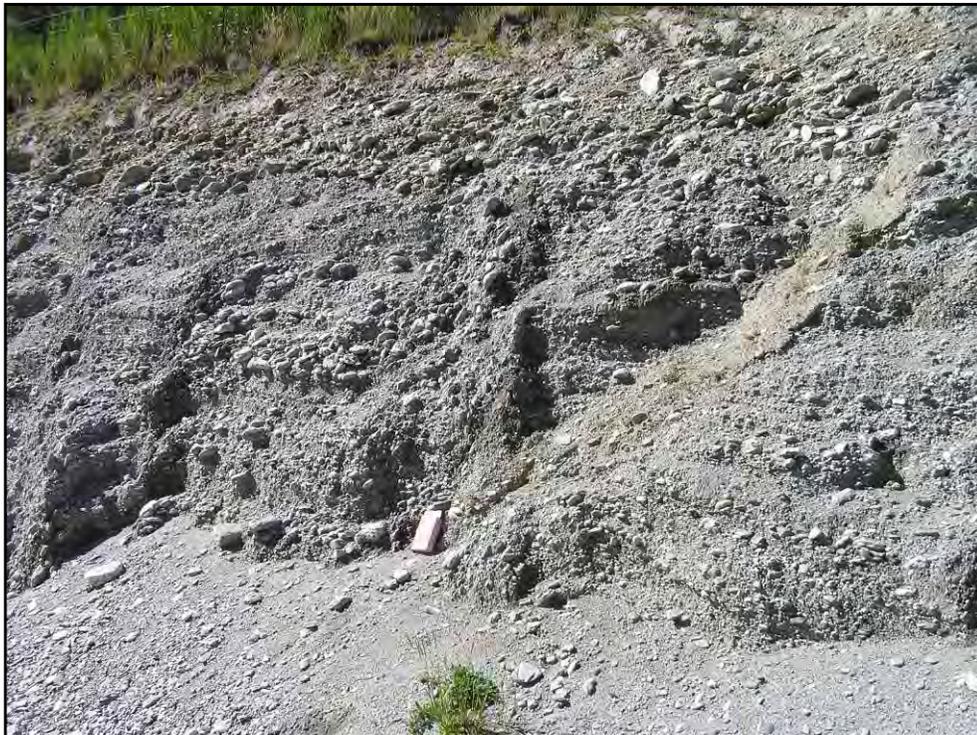
**Photographs 9-5 & 9-6** Deformation in gravels on the south bank of Buckler Burn. Photograph 5 shows irregular bedding dips in fan gravels (gentle dips toward and away from Lake Wakatipu located to the right of the photograph). Photograph 6 shows bedding in fan gravels deformed by folding and faulting. The fan alluvium is inferred to be underlain by a significant depth of deltaic sediments. Photograph taken 14 February 2007 (Photo Tim McMorran)

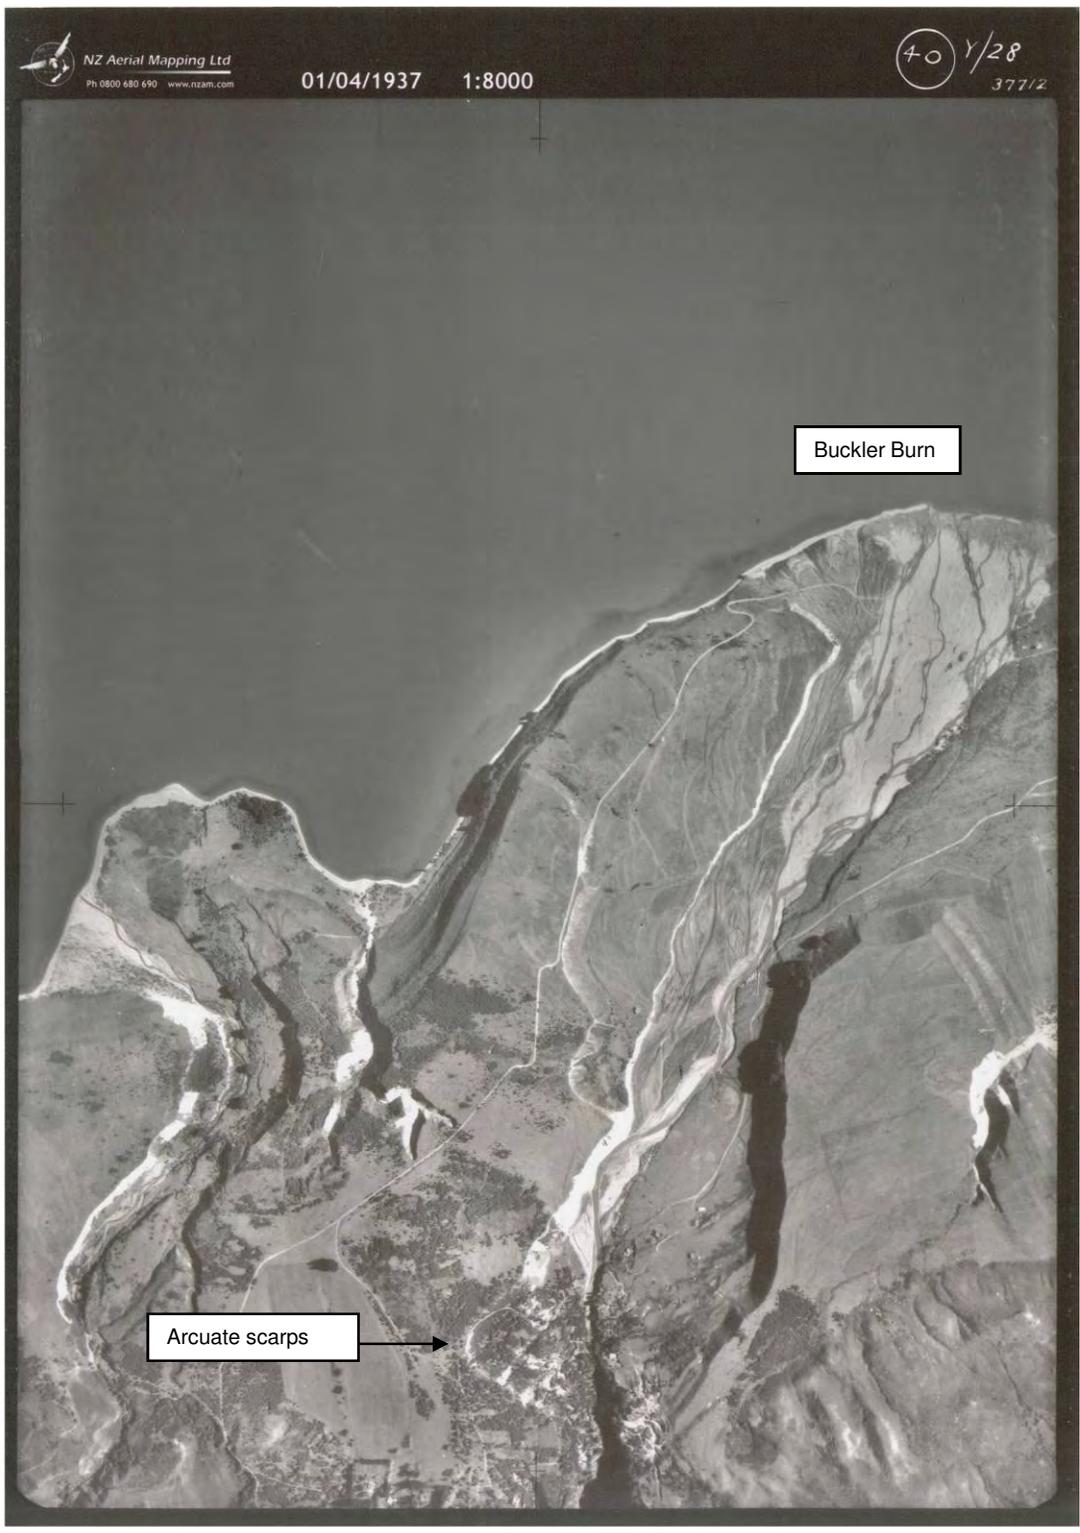
**Photograph 9-7** Vertical aerial photograph of lower Buckler Burn showing arcuate scarps that may be natural slope failures. Photograph taken 1937 NZ Aerial Mapping
