Project Number: 6-XO011.00

Glenorchy Rees Floodbank

Floodbank Assessment

3 September 2020

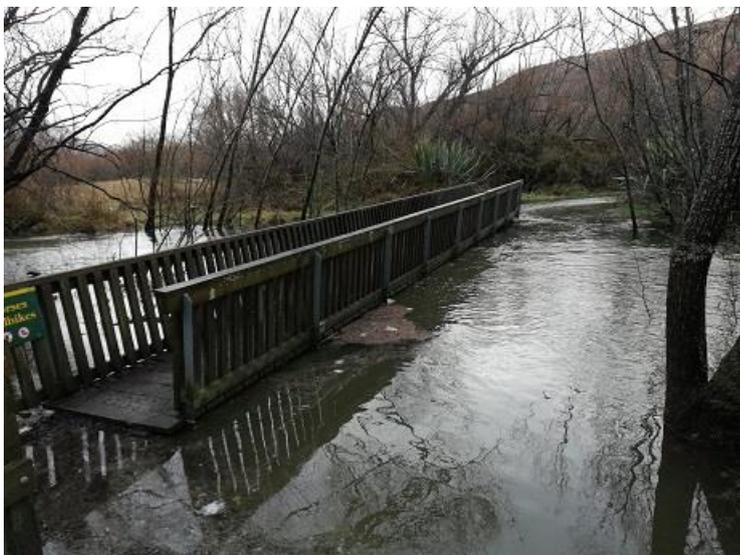
Figure 1 - Lagoon Bridge 21st June. Photograph Ingrid Temple to Ulrich Glaser

Since the initial inspection there has been a further significant rainfall which resulted in flooding of the Lagoon Creek bridge around the 21st July. This was detailed in an email from Ulrich Glaser (QLDC) showing photographs of the flooding taken by Ingrid Temple.

Remedial works were then undertaken by Otago Regional Council (ORC) at the end of July 2020 which involved clearance of the vegetation in the Lagoon stream and dredging of the riverbed to relocate the main Rees channel towards the true right bank.

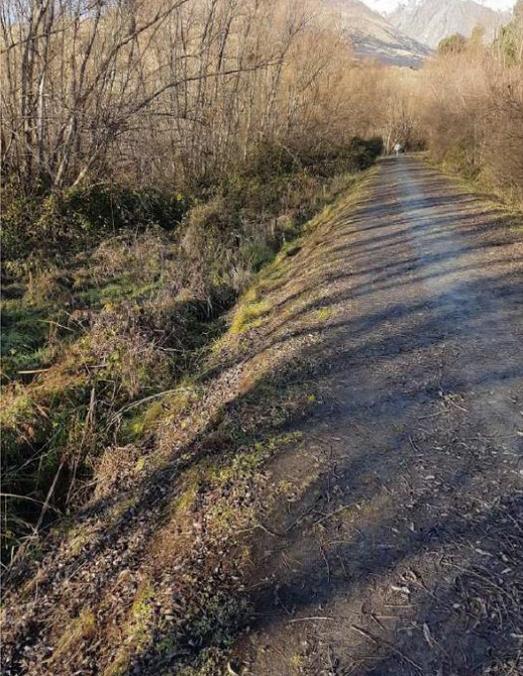
ID	Situation	Photograph
Stab.1	Lagoon stream, some oversteep areas, slope angle estimated around (30°) 1.7H:1V

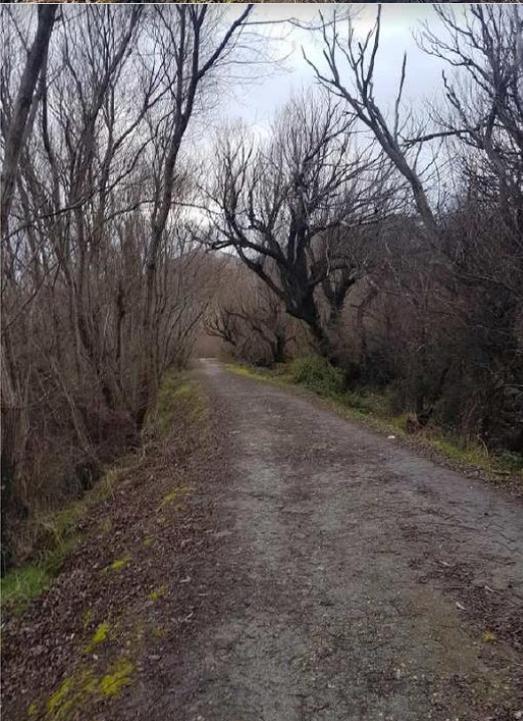
Stab.2	Lagoon stream walkway, some oversteep areas towards the centre of the photograph, potentially 1H:1V (45°)

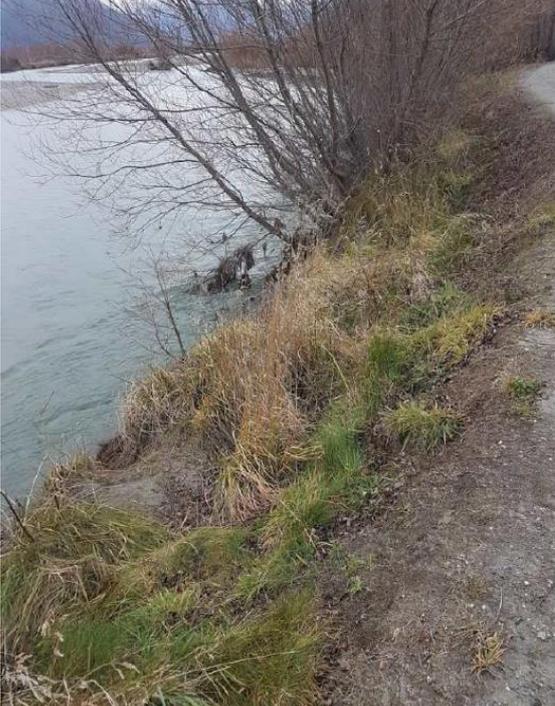
<p>Stab.3</p>	<p>Immediately downstream of the Lagoon confluence, evidence of slope failure where undercut by the Rees river, 1H:1V (45°)</p>

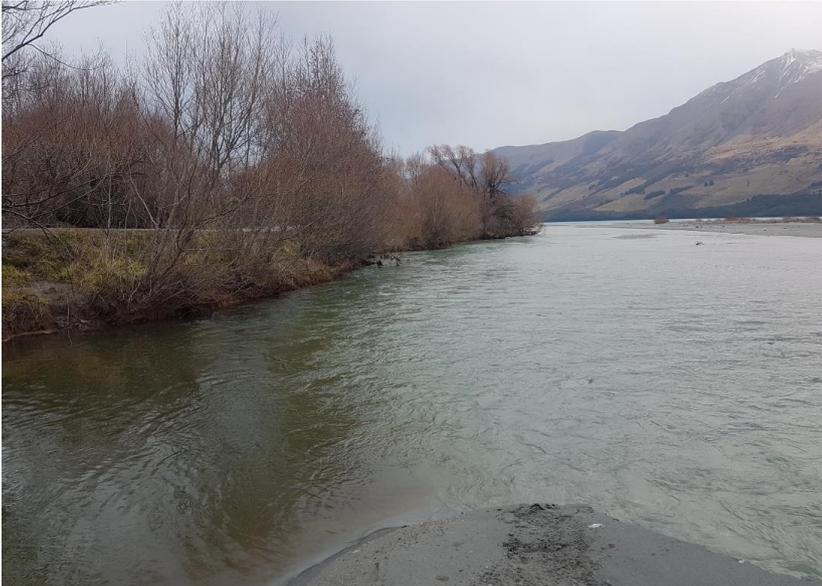
ID	Situation	Photograph
Ext.1	Section immediately downstream of Lagoon stream confluence

The confluence provides a complex hydrological situation, where, at high flows the water from the Lagoon stream is prevented from entering the Rees. Turbulence at the confluence leads to the development of eddies and downcutting of the base of the channel. Where fast flowing river water is slowed by the turbulence, a depositional environment of mobilised river sediments forms. This can change the bed profile which could lead to the undercutting of the main floodbank and the possibility of rotational failure.

- Installation of rock armouring to the 50m long section around of the Lagoon stream confluence. If additional funding is available, this rock armouring shout extend the full length of the stopbank downstream (approximately 300m total, additional 250m).
- Installation of groynes or river training upstream of the confluence
- Repair of oversteep areas and
- Vegetation maintenance

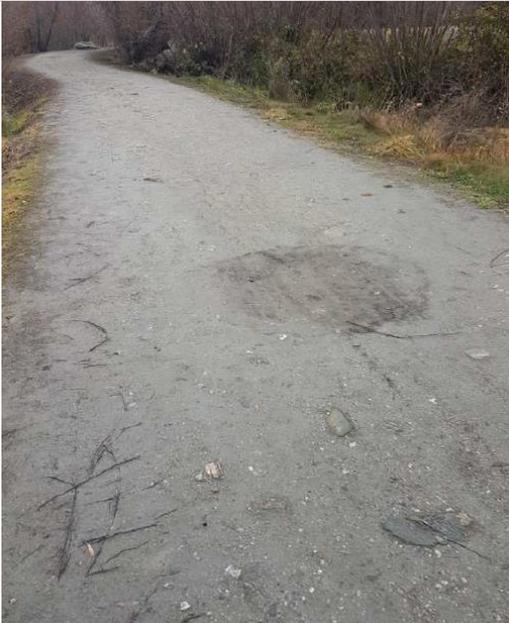
ID	Situation	Photograph
Pipe.1	Depression in the footpath

While failure through piping is considered a possibility, its assessment should be undertaken through physical investigation of the area considered to be affected, at the depression identified above. The investigation should then assess and review if the ground conditions are different here than at other parts of the stopbank.

During the physical works it would be possible to investigate the potential piping location through the digging of a trial pit in the area and assessment of the material found.

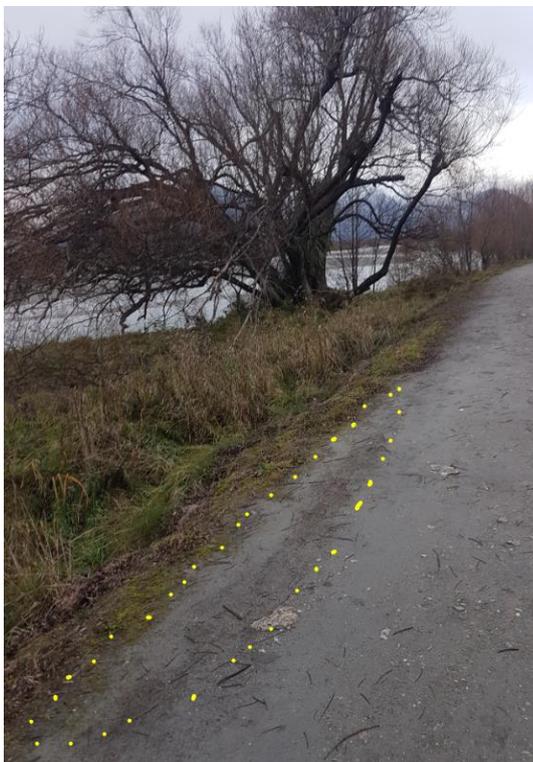
Figure 7 - Indicative surface slumping of the embankment crest

Based on the inspections completed to date key signs of a progressing failure in the embankment are considered to be associated with a reduction in the trail width, as a result of slipping of the bank. This may be manifested as:

- A localised drop in level at the edge of the track, (as seen below)
- Trees and vegetation leaning
- Buckled surface of the vegetation, indicating surface creep of the slope

It is therefore recommended that periodic inspections are completed to assess the potential for developing failures and enable early intervention lessening the potential for a catastrophic failure.
