## Memorandum

<b>To</b>	Tim van Woerden
<b>Copy</b>	
<b>From</b>	Paul Jaquin
<b>Office</b>	Queenstown
<b>Date</b>	19 June 2020
<b>File/Ref</b>	6-XO011.00 015GX
<b>Subject</b>	Glenorchy Floodbank Rees River

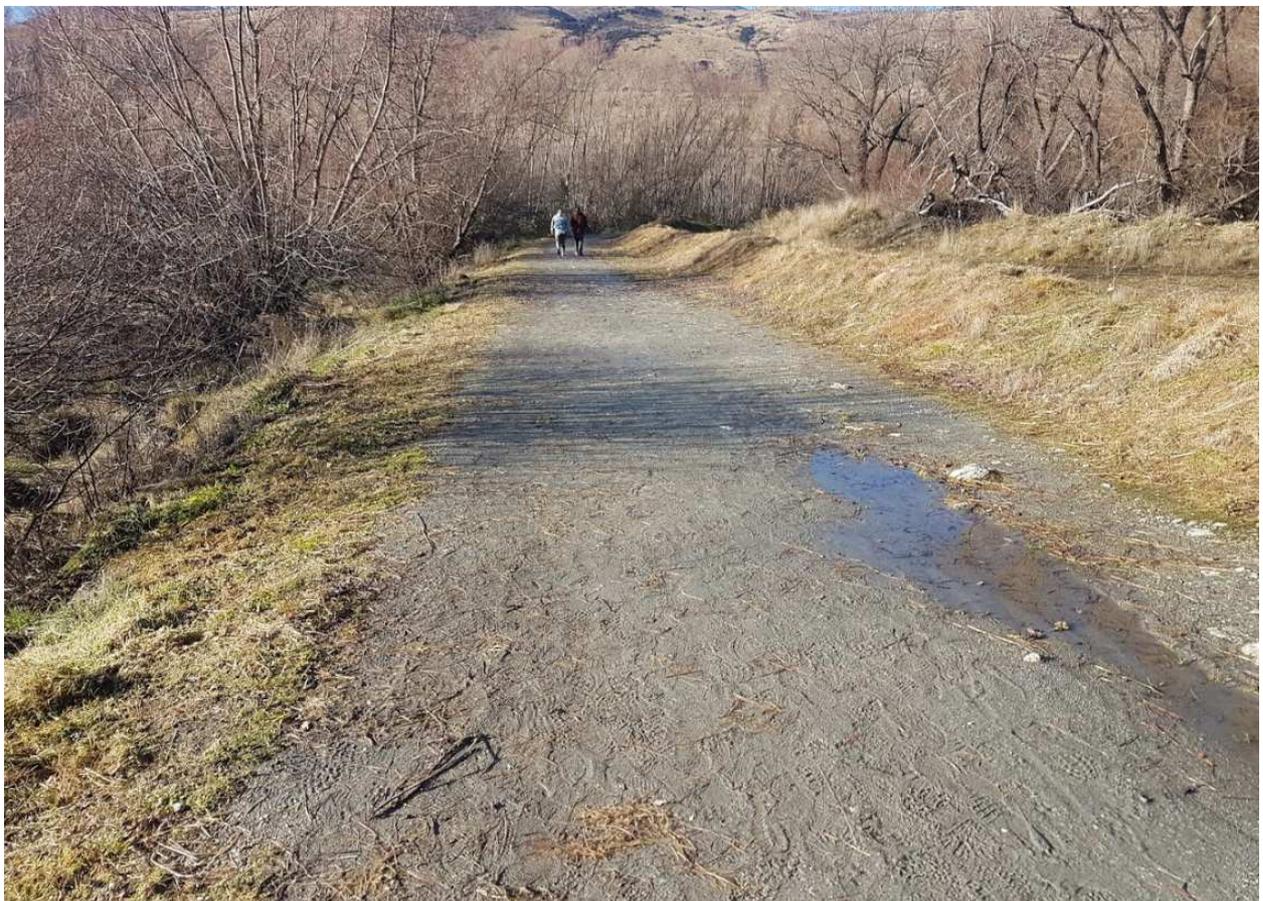
1. Areas of standing water at the head of the slope upstream of the crossing point. There appears to be dumped material on the head of the floodbank. There is some standing water on the path and behind the mounded material. This is not considered a significant issue in terms of stability of the floodbank, although significant standing water could lead to oversaturation of the floodbank, resulting in a reduction in strength. Track maintenance would allow this to drain.

Site 1. Standing water on the floodbank upstream of the bridge.

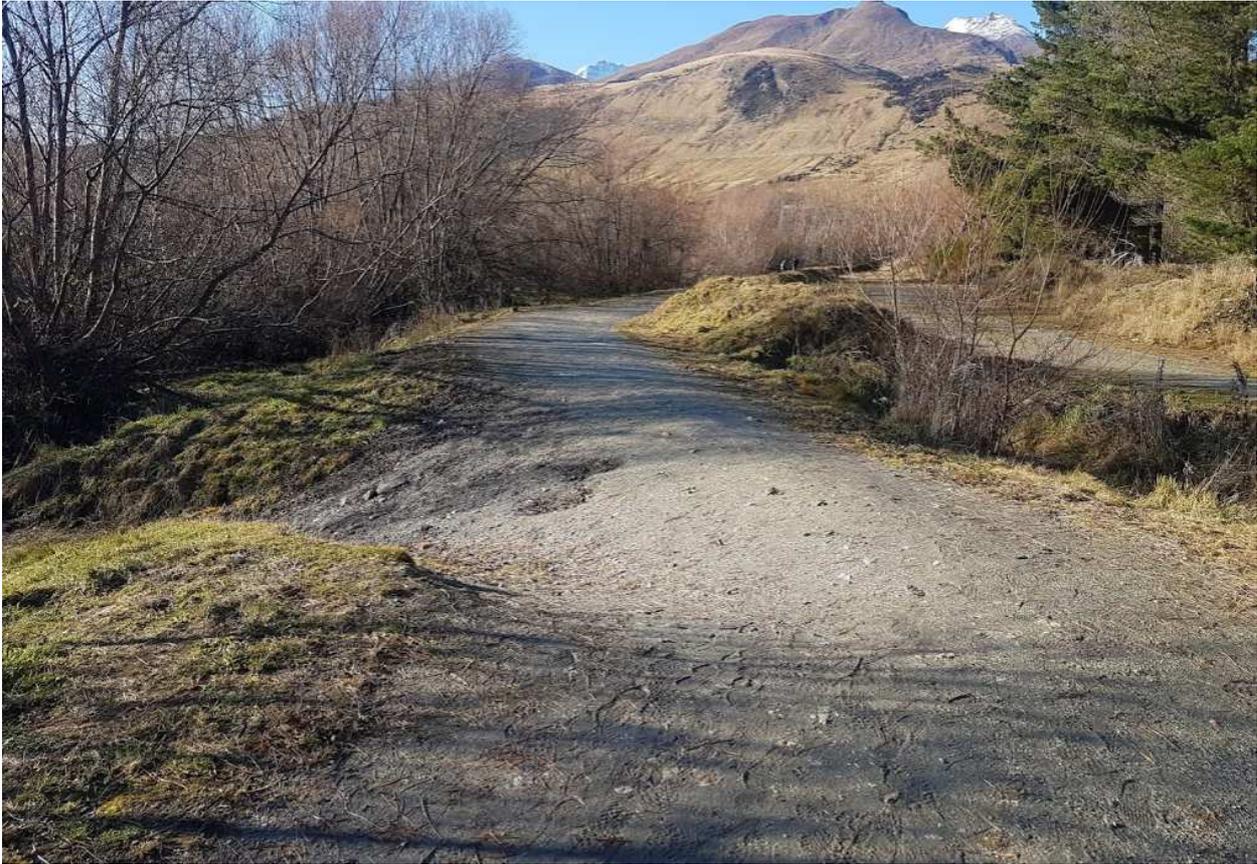
2. Some minor erosion and track damage was noted in the vicinity of the trekking / 4wd crossing point. This is not considered to be a major threat to the stability of the flood bank, but works to locally repair the track could be undertaken to prevent further damage by wheel tracks, and to locally improve the drainage.

Site 2 – 4wd crossing point

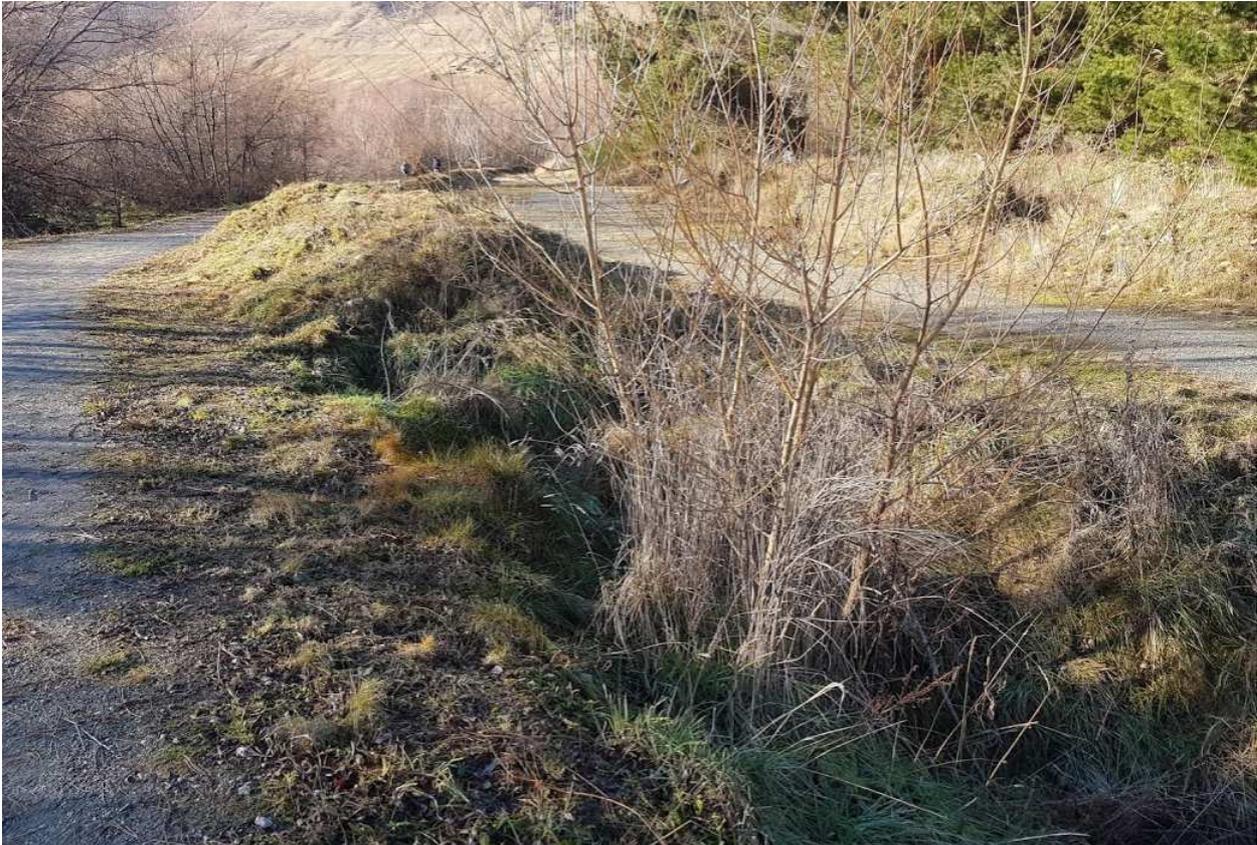
Site 2 – 4wd crossing point, with drainage channel and culvert.

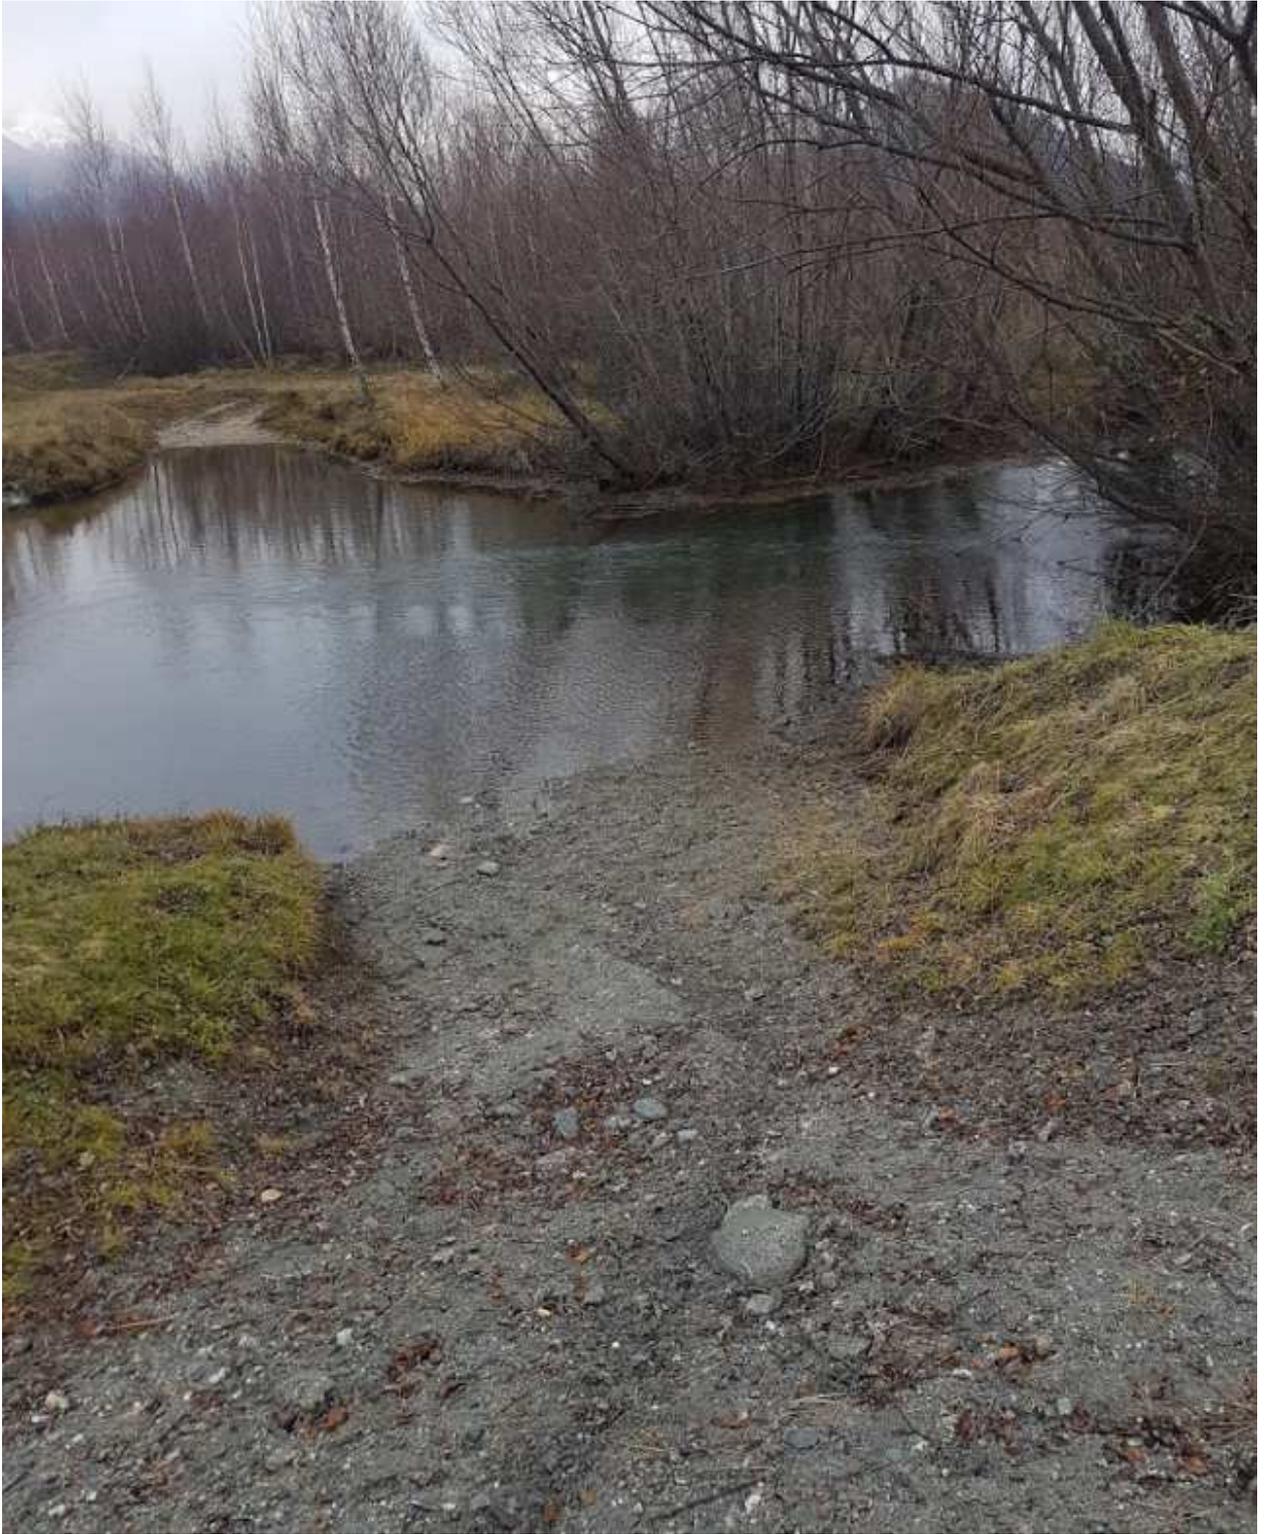
Site 2. 4wd crossing point

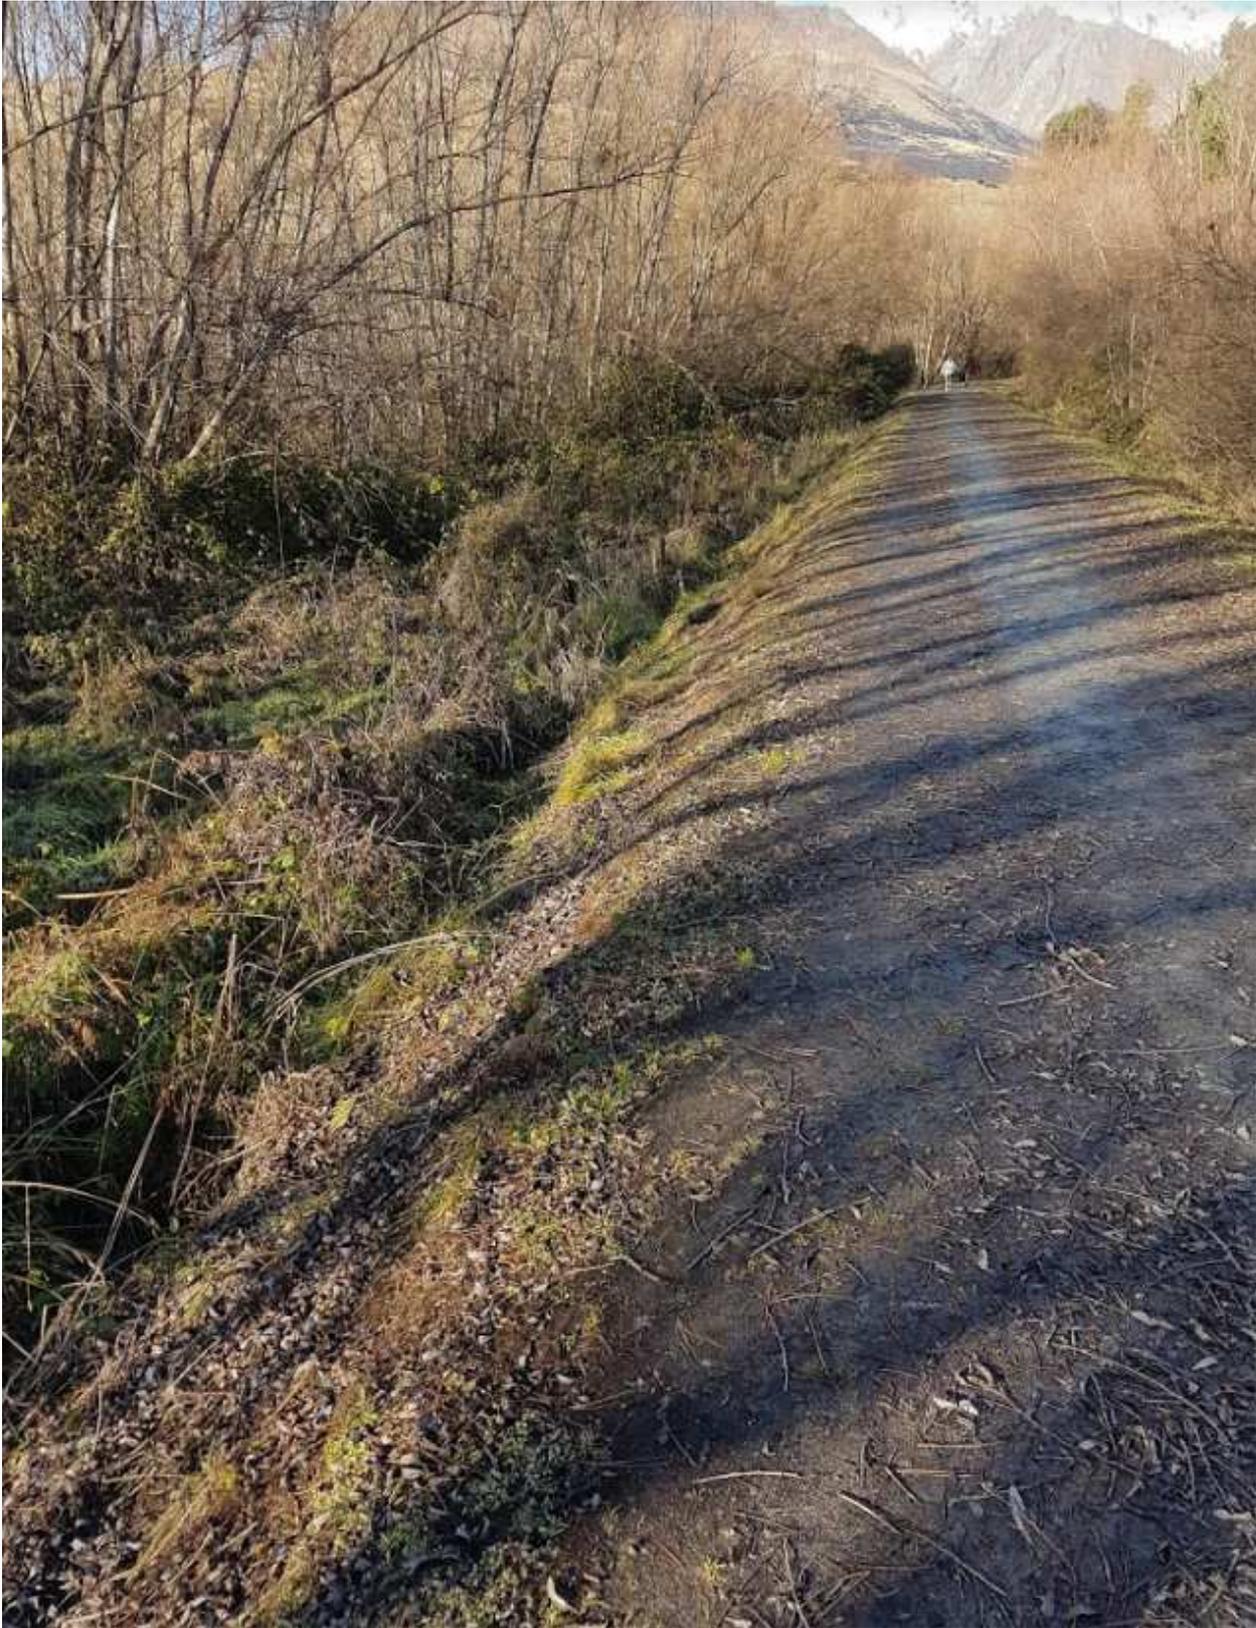
3. There are areas where the bank appears significantly over steep compared to other areas. There is little evidence of failure of the slopes in this area, and the Lagoon stream does not generally appear to be eroding the base of the bank. Vegetation maintenance and monitoring of this area is considered to be required.

The stream has scoured a deep channel at the base of the floodbank due to continued flow through low strength sediments of the lagoon.

Site 3 - Potentially oversteep bank upstream of the bridge

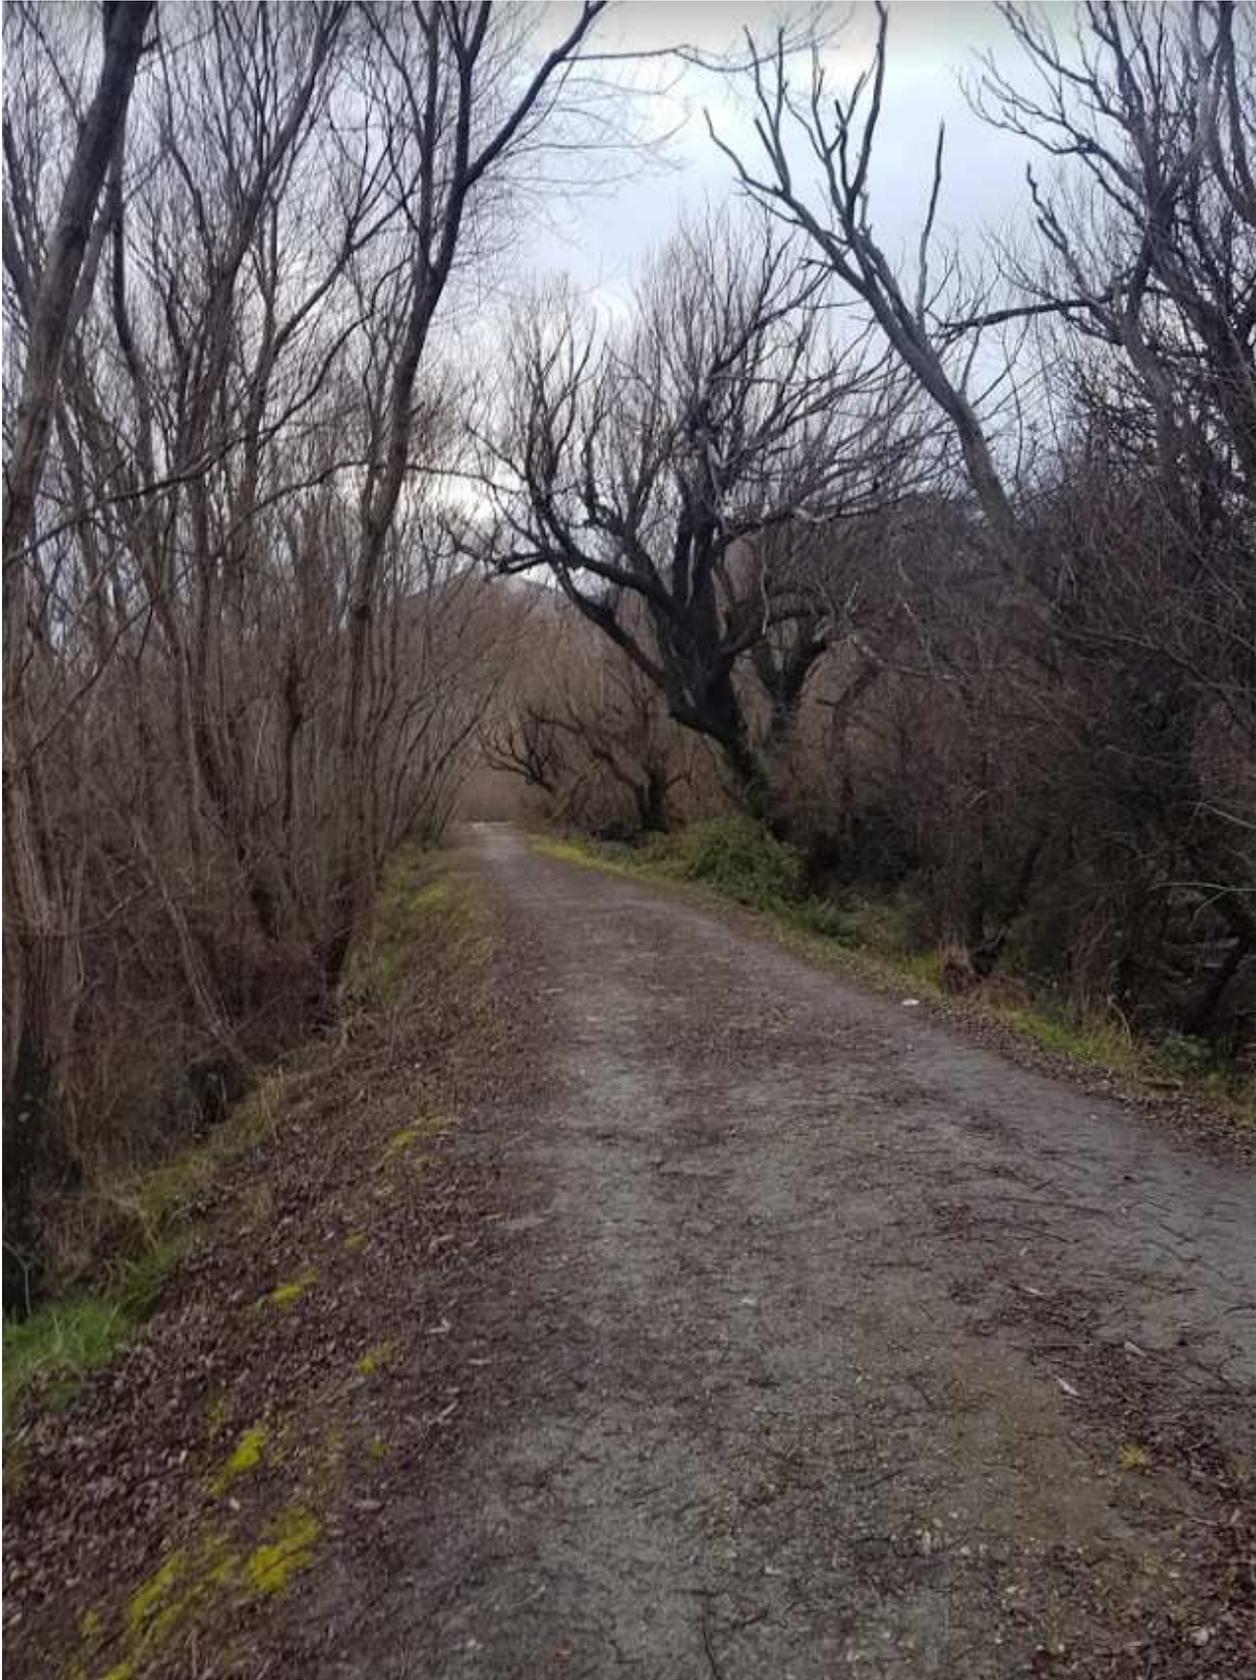
Site 3 - Floodbank at the Lagoon stream

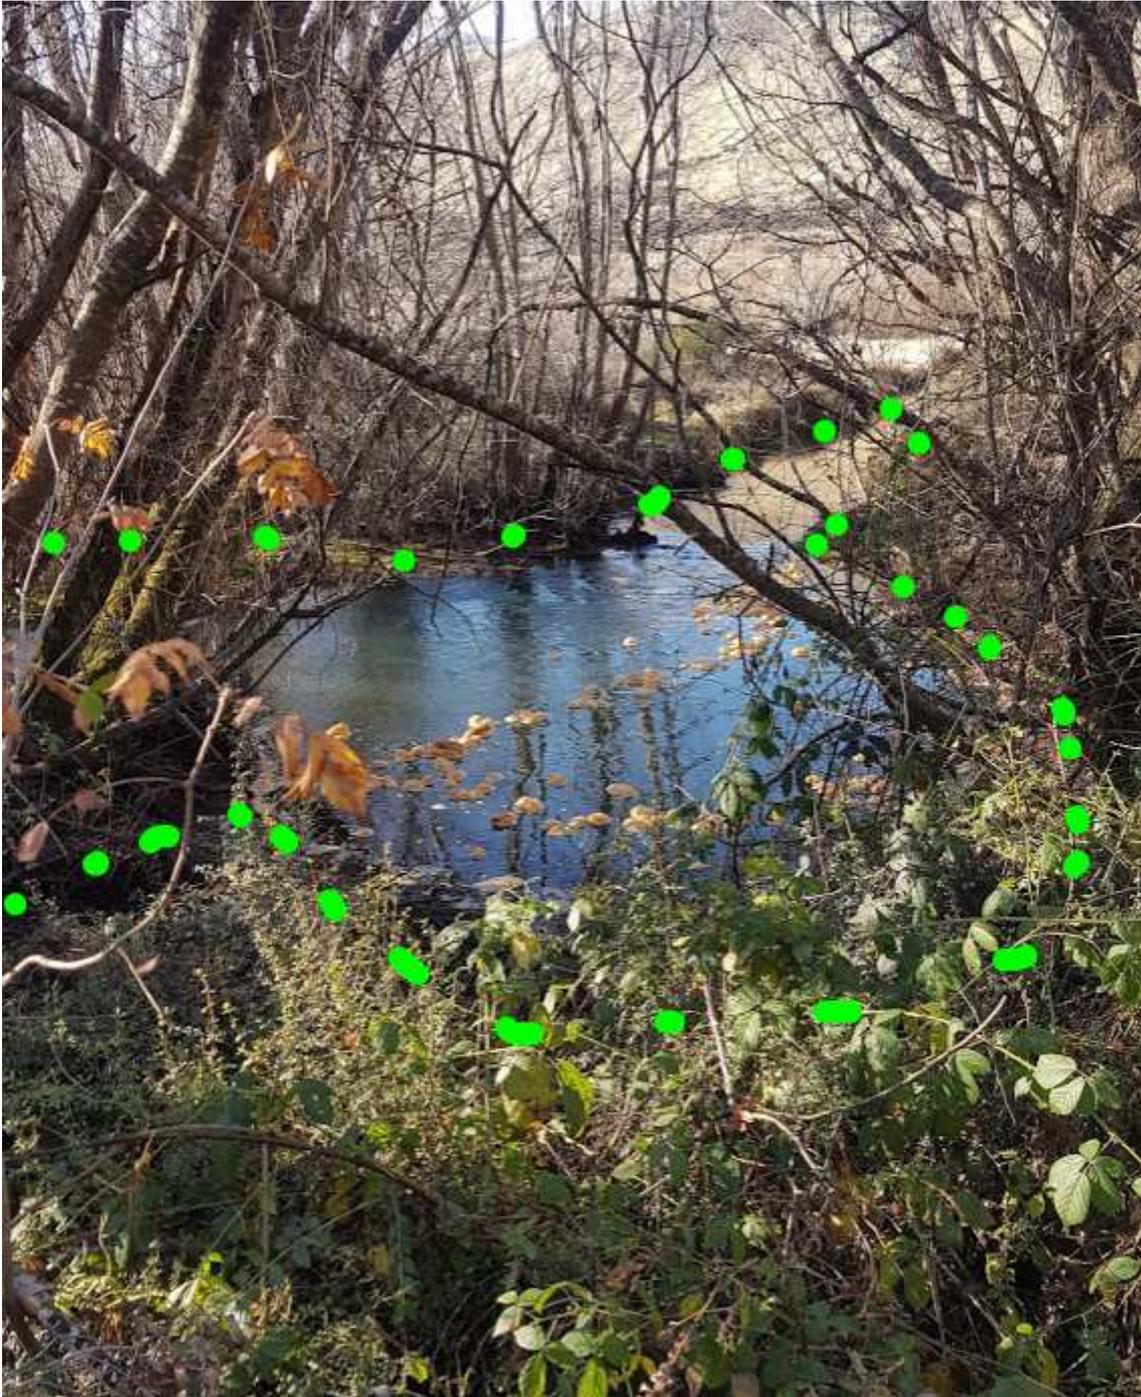
4. An eddy area has formed immediately upstream of the bridge. While flows from the lagoon are generally low velocity, vegetation maintenance may be required in this area. The site was not inspected from the water, but it is not considered that the floodbank is being undermined.

Site 4 – Eddy area upstream of the bridge

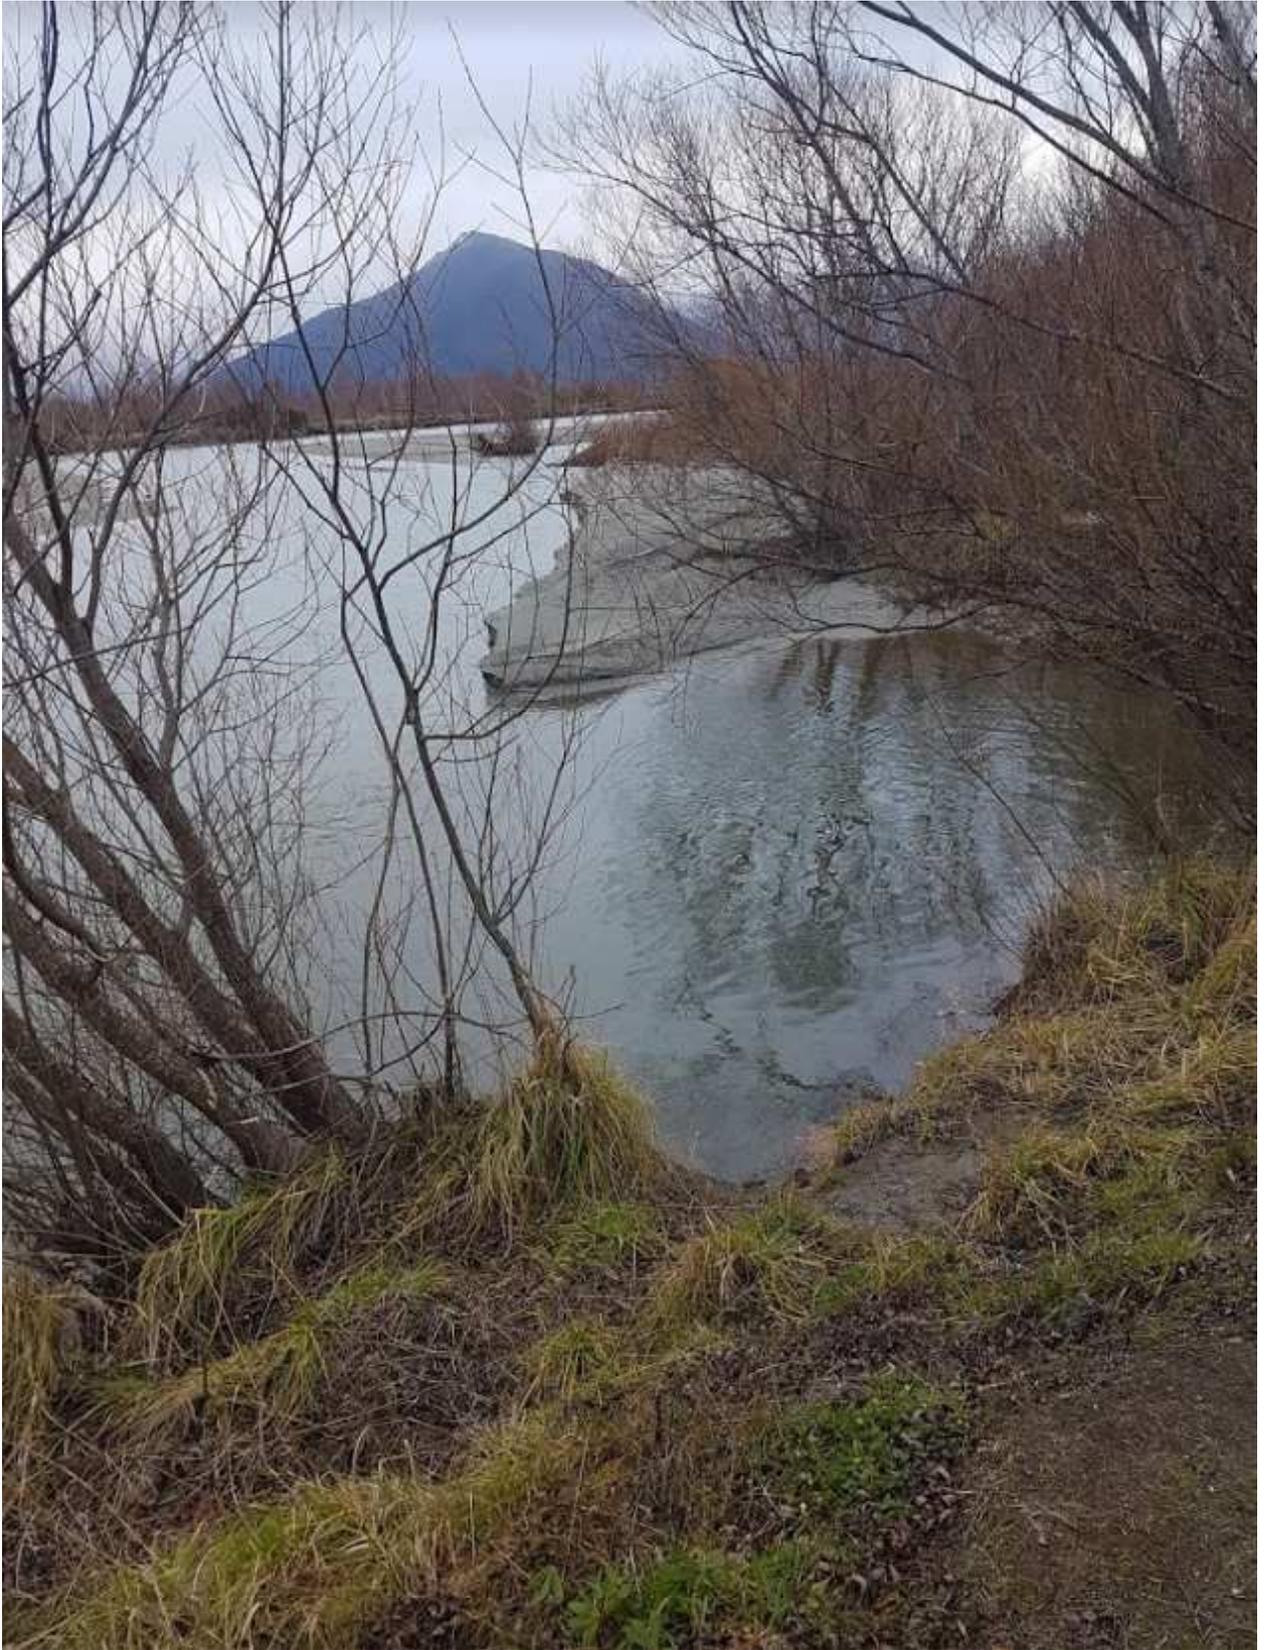
5. Upriver of the Glenorchy Lagoon Stream confluence, the scouring action of the main flow of the Rees River is causing the existing silt bar to be eroded. Erosion and removal of this floodbank would allow the Rees River to impact further up the Lagoon stream, and further damage the flood bank.

A few boulders of dimension 500mm were noted at the toe of the bank, it was unclear if these were rip rap. Other than these, there was no visible rip rap along the toe of the bank. It is however unclear if rip rap boulders have been covered in vegetation, or have been dislodged.

Site 5 - Confluence of the lagoon stream and the Rees

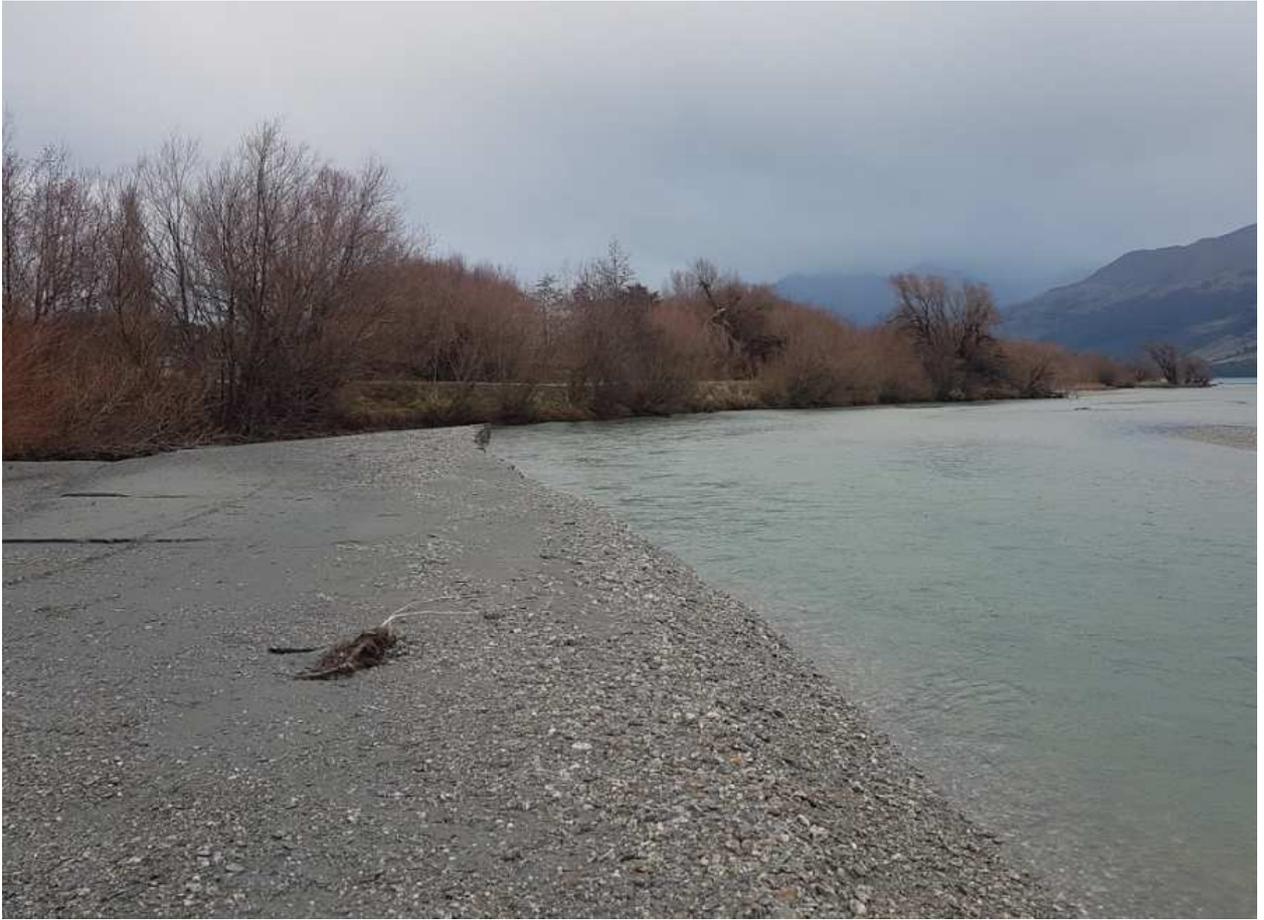
Site 5 - Lagoon stream confluence looking downstream, standing on the silt bar

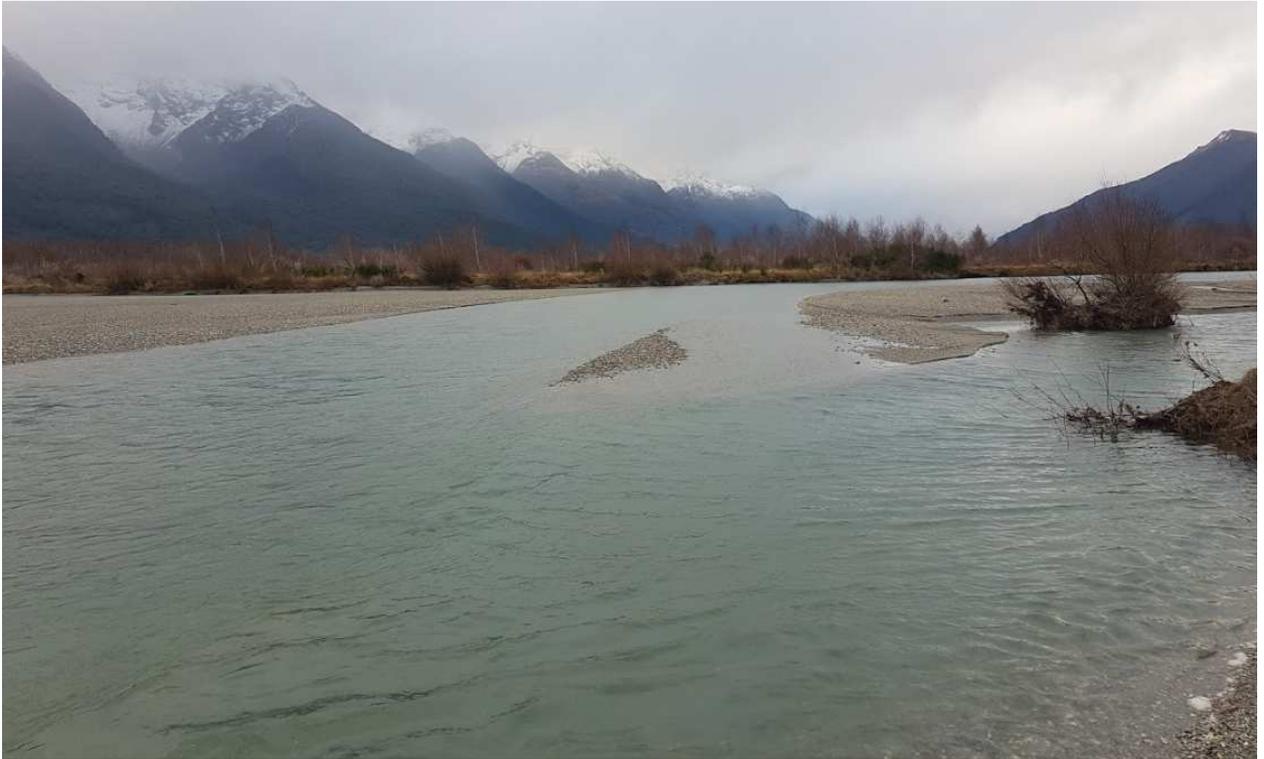
Site 5 - Lagoon stream confluence looking upstream

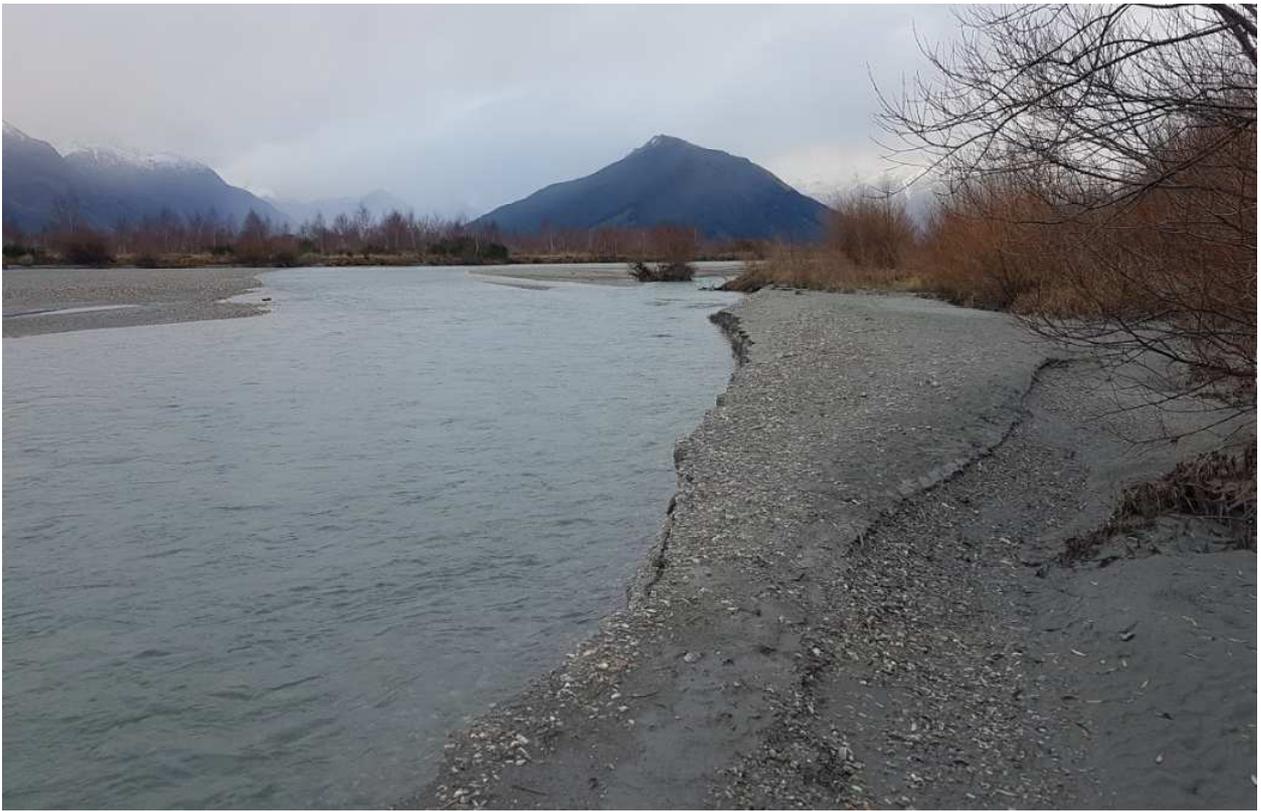
Site 5 - Lagoon stream confluence looking upstream, showing the silt bar

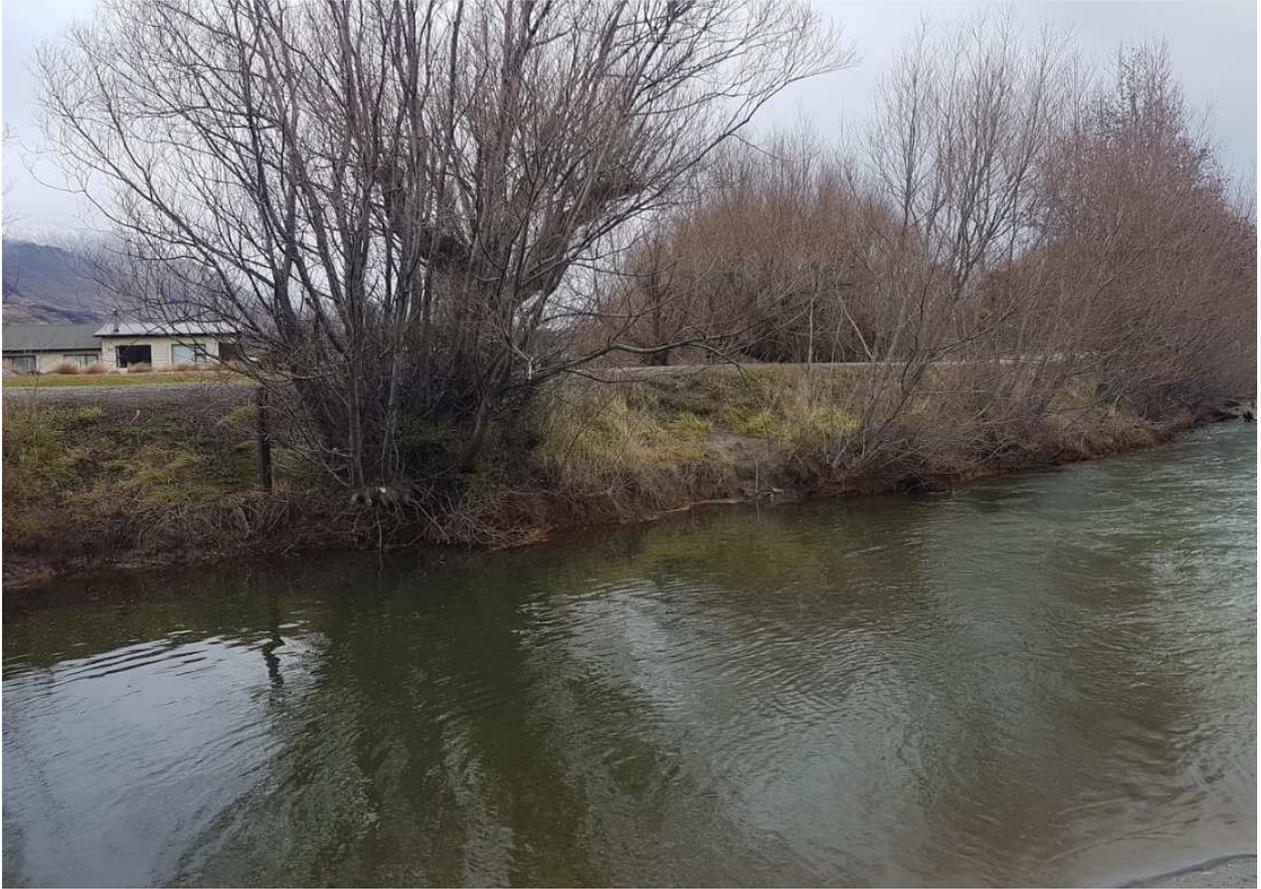
Site 5 - Floodbank at the Lagoon stream confluence

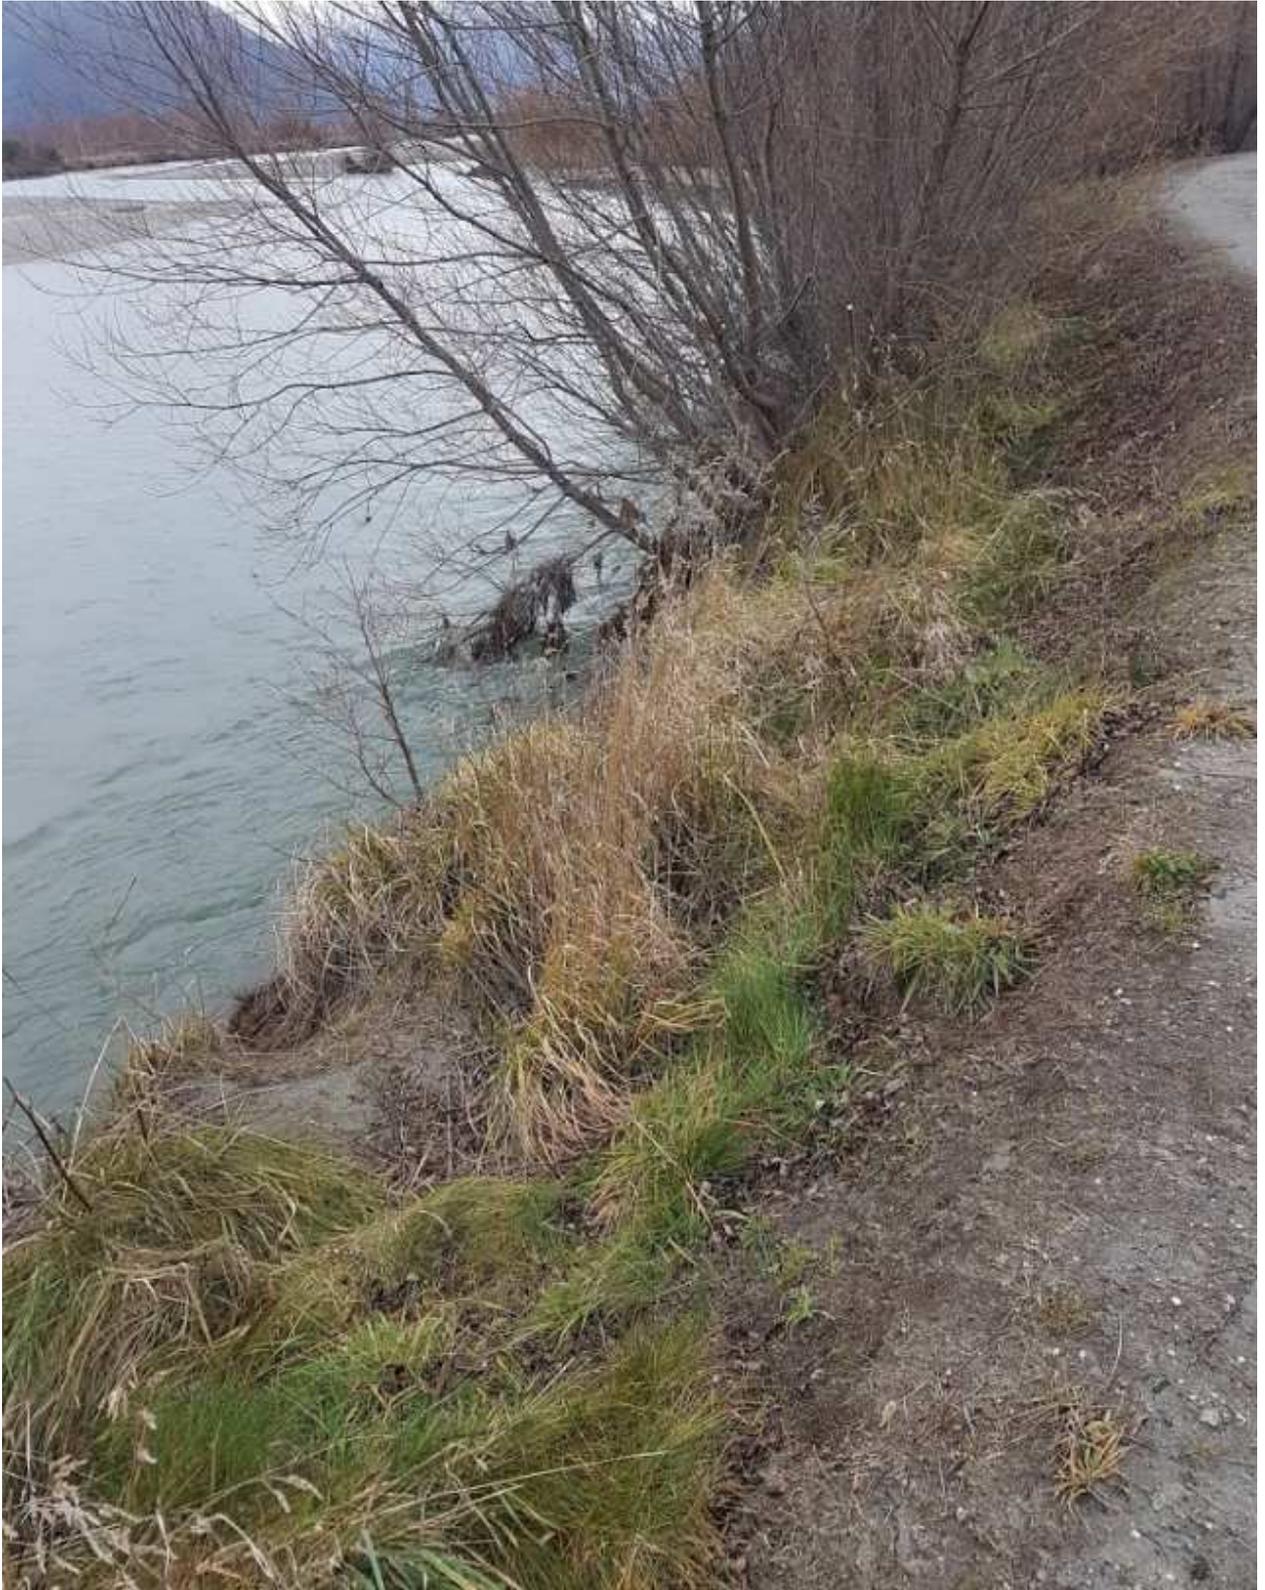
6. The current path of the main river channel is causing the full volume of the Rees River to flow into the flood bank at an almost perpendicular angle, with some over steepening, and erosion of the toe of the flood bank visible. This is an area of significant concern, and mitigation in the form of armouring should be installed to protect the floodbank.

The comparatively deep channel of the Lagoon stream at the confluence means that main flow of the Rees River will be directed into that channel and against the toe of the bank.

The undermining of some of the trees on the bank could lead to their death and collapse into the river. This has the potential to cause further collapse of the bank, leading to a reduced cross section, which would then rapidly scour.

Site 6 - Rees river running against the base of the flood bank, undermining the bank

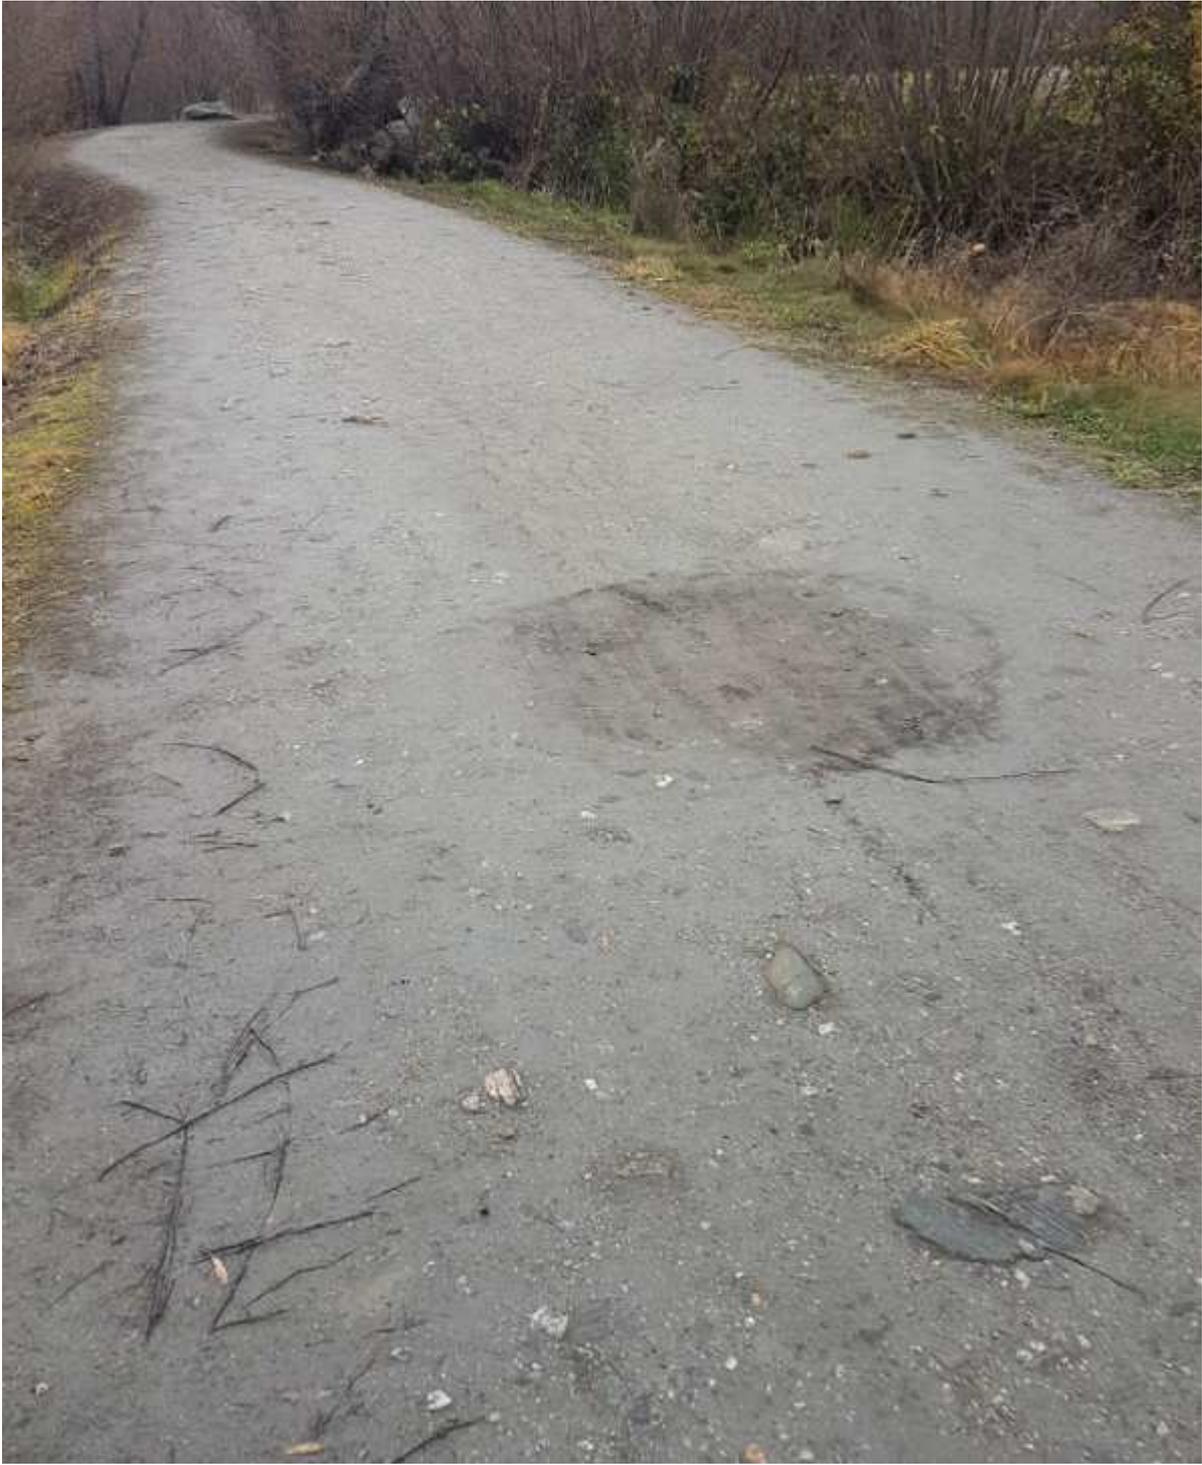
7. A large depression visible in the centre of the track is possible evidence of piping. There may be flow of water from the land side, through the bank, transporting fine material and leading to a loss of material and a depression at the surface.

Site 7 - Large circular puddle, evidence of piping
