## Memorandum

<b>To</b>	Tim van Woerden
<b>Copy</b>	
<b>From</b>	Paul Jaquin
<b>Office</b>	Queenstown
<b>Date</b>	19 June 2020
<b>File/Ref</b>	6-XO011.00 015GX
<b>Subject</b>	Glenorchy Floodbank Rees River

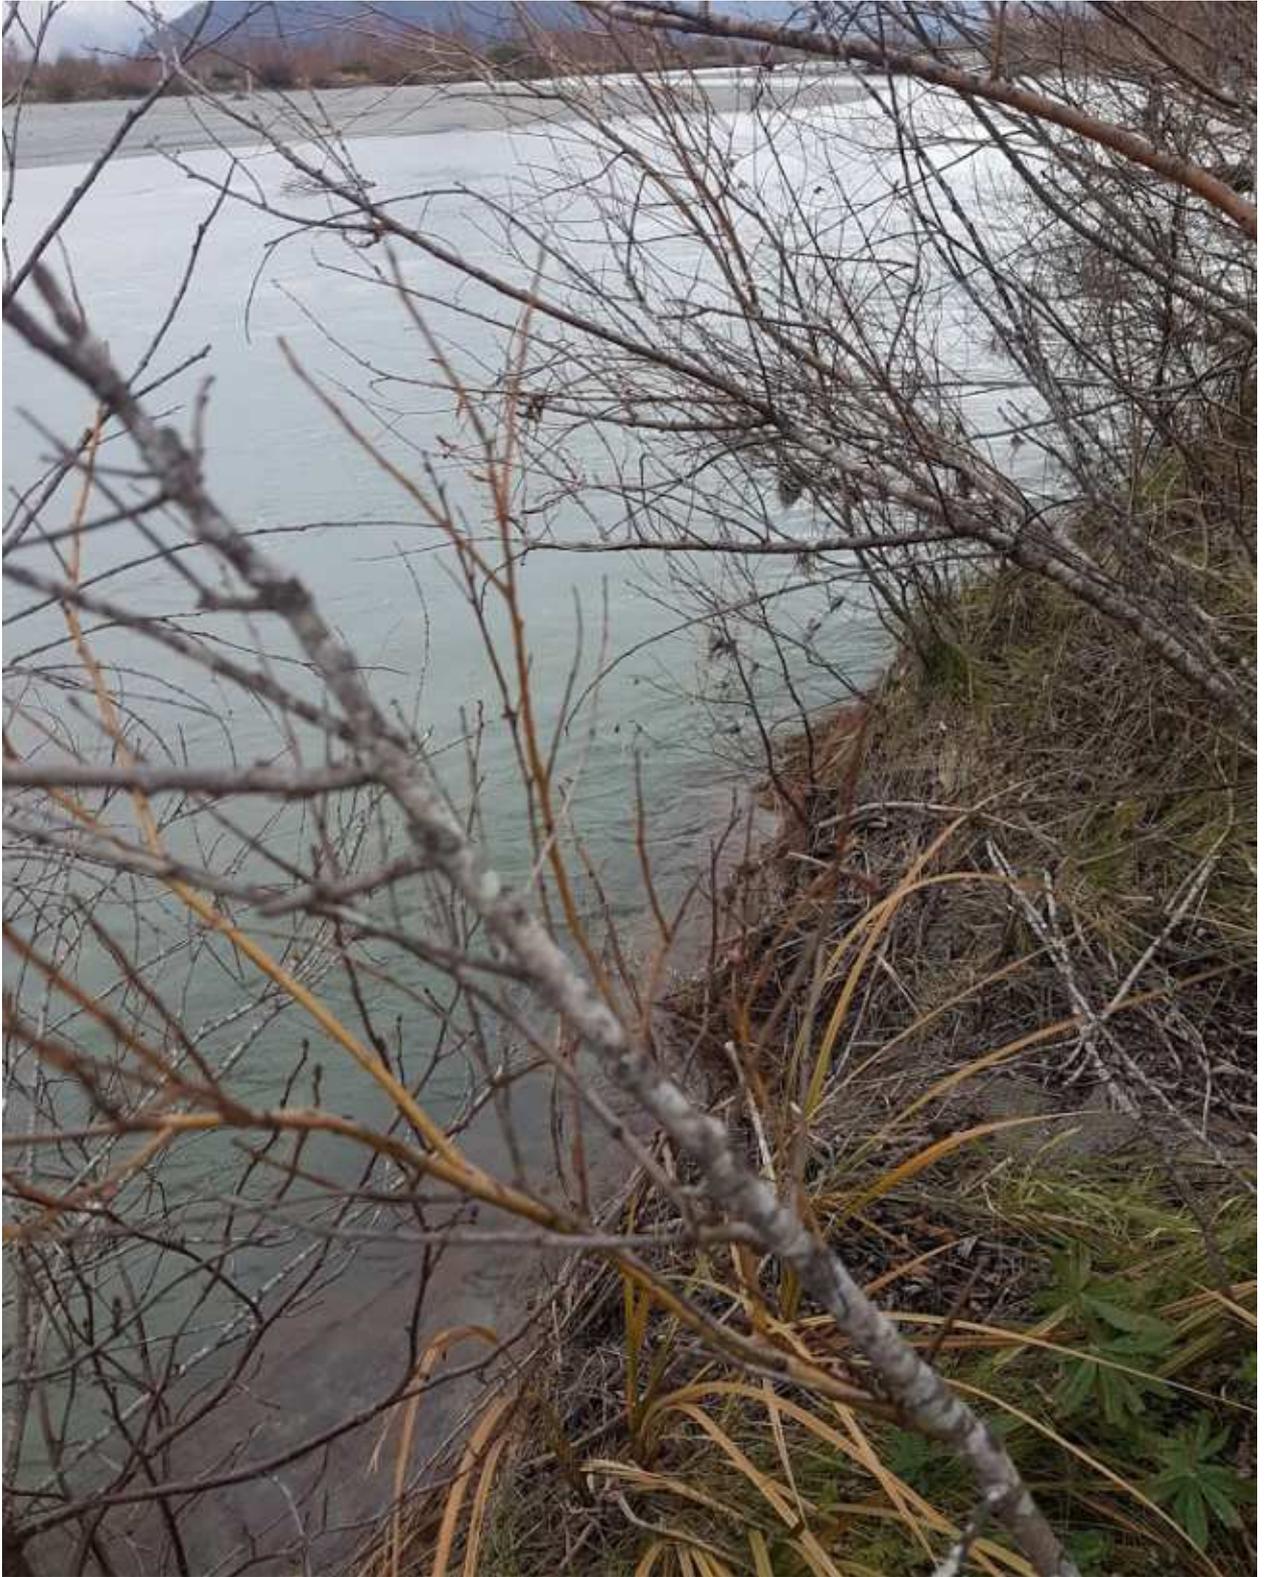
8. Headscarps appear to be forming at the river side of the bank where it is overstep and being undermined by the Rees River. The slope is reasonably well bound by the vegetation, specifically the roots of the willows, but undermining of the toe of the slope and erosion of the soil matrix is occurring.

Site 8 - Rees River against the base of the slope

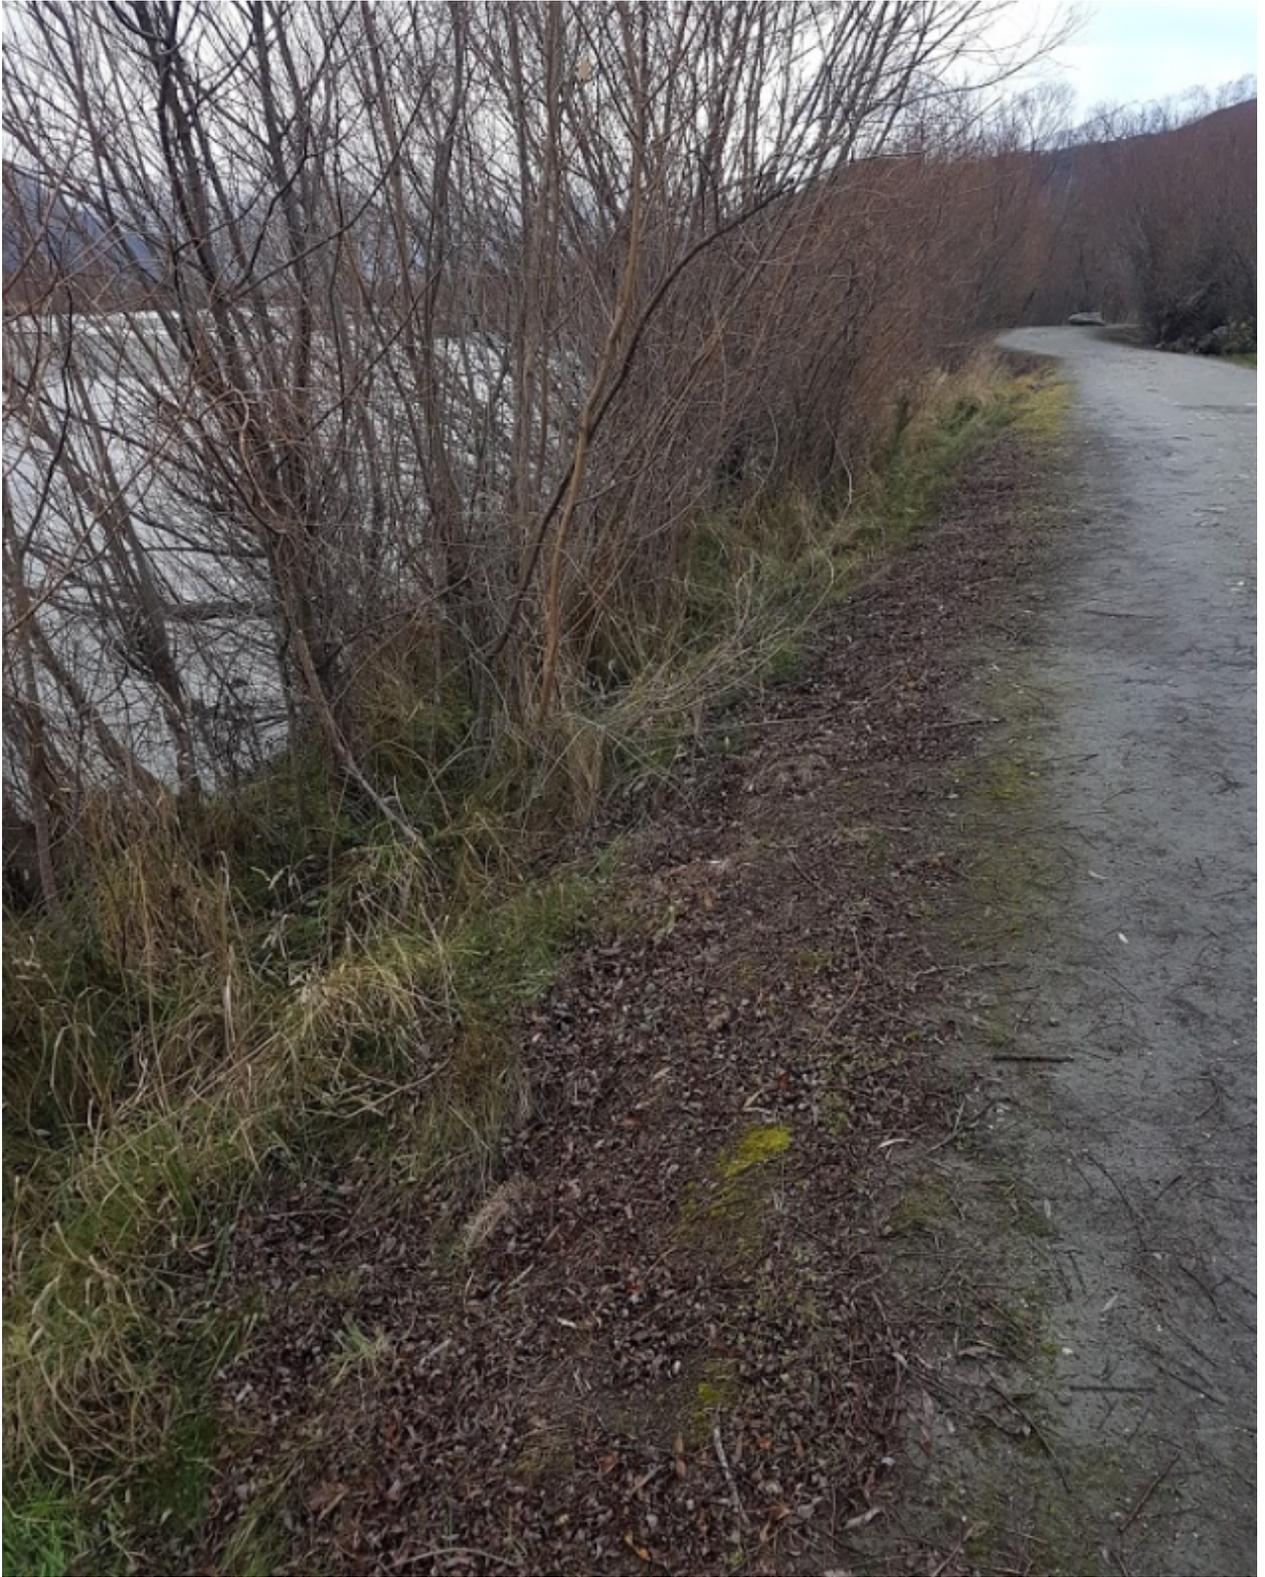
Site 8 - Rees river hard up against the bank downstream of the lagoon confluence

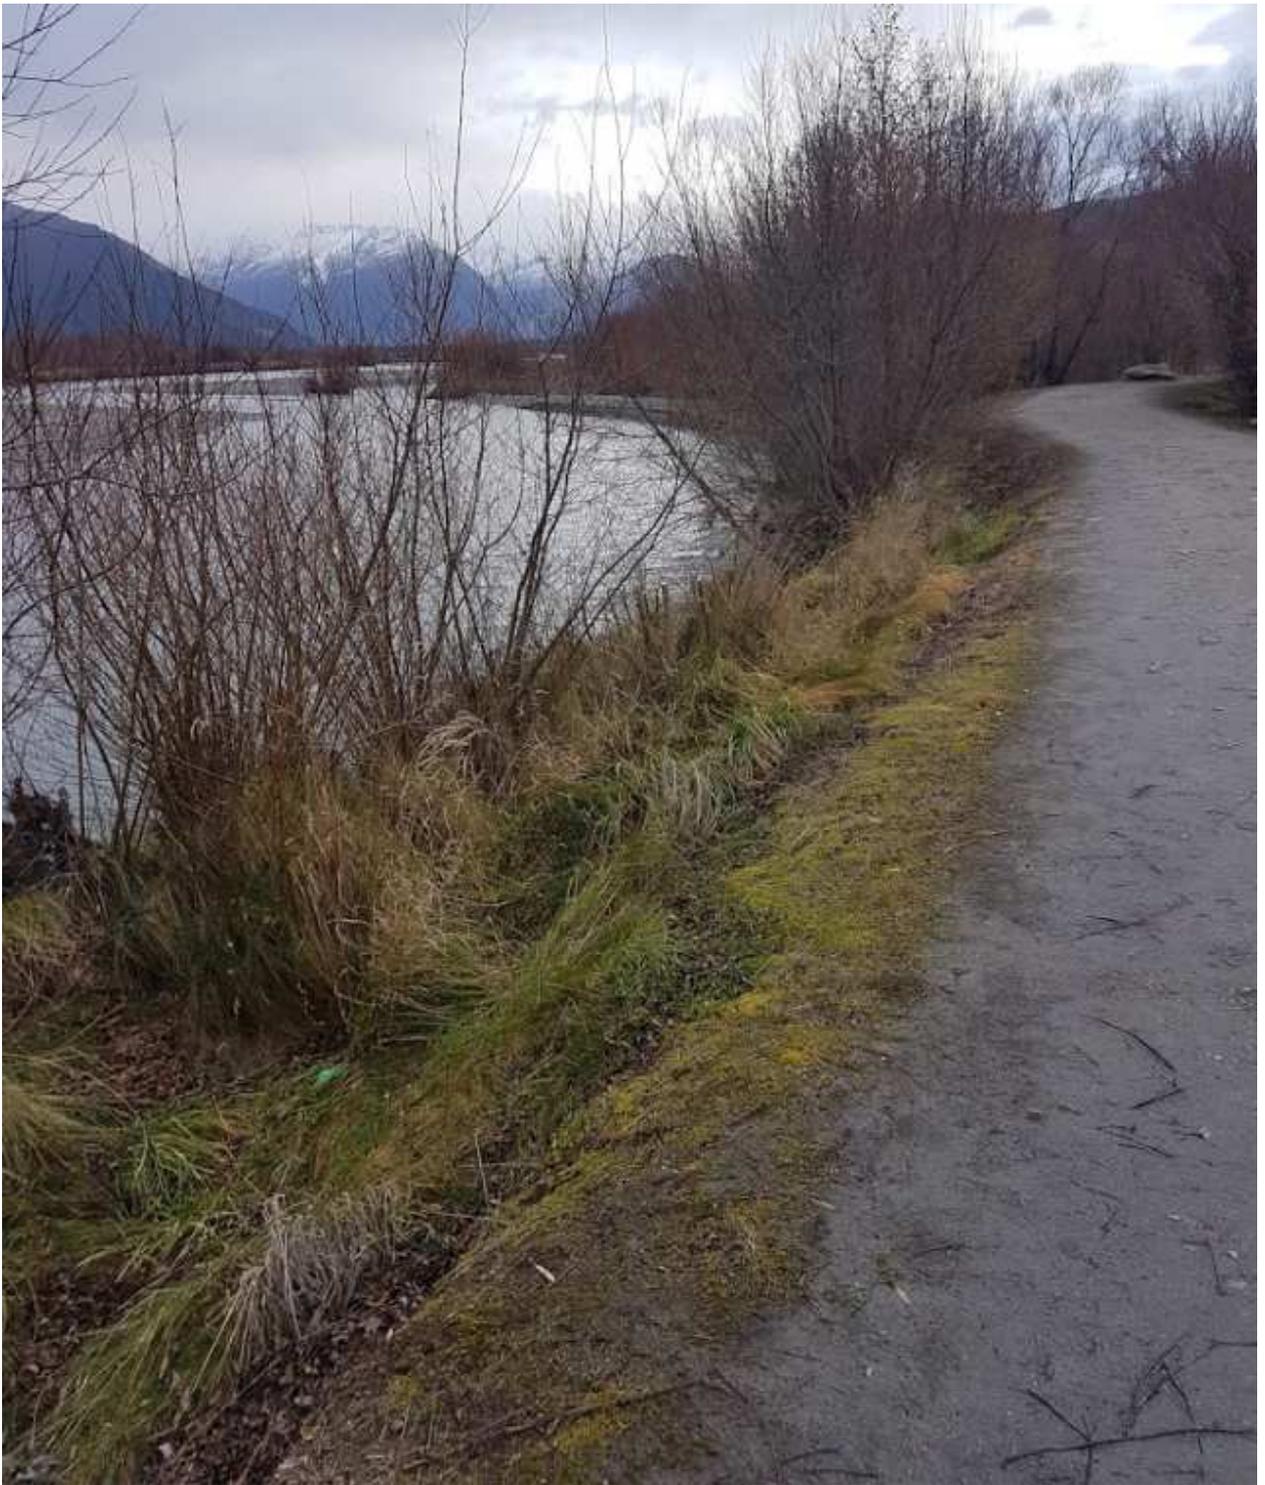
Site 8 - Headscarps forming at over steep bank downstream of the Lagoon stream confluence

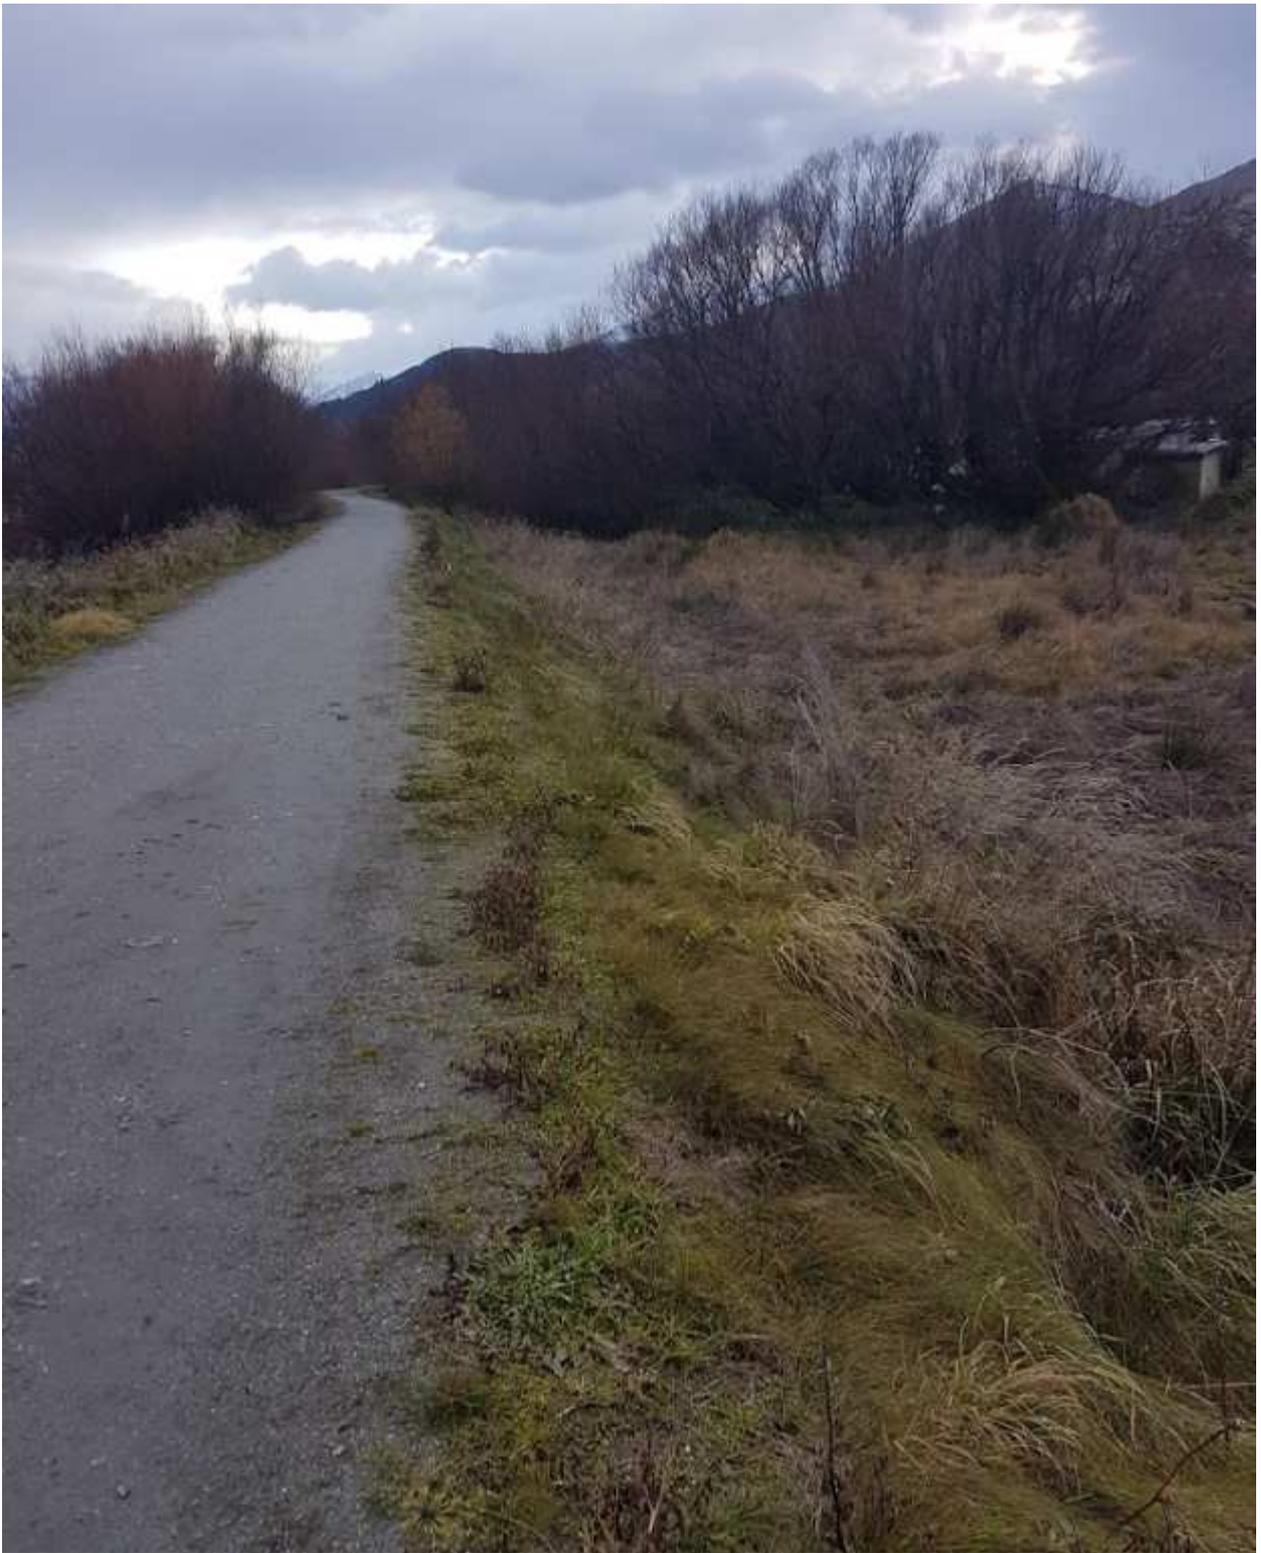
9. At site 9 we understand that fill material was dumped following remediation works to the roading network north of Glenorchy. This area appears to be poorly drained and has the potential to allow the floodbank in this area to become saturated.

Site 9 - Area of dumped fill on the right of the photograph

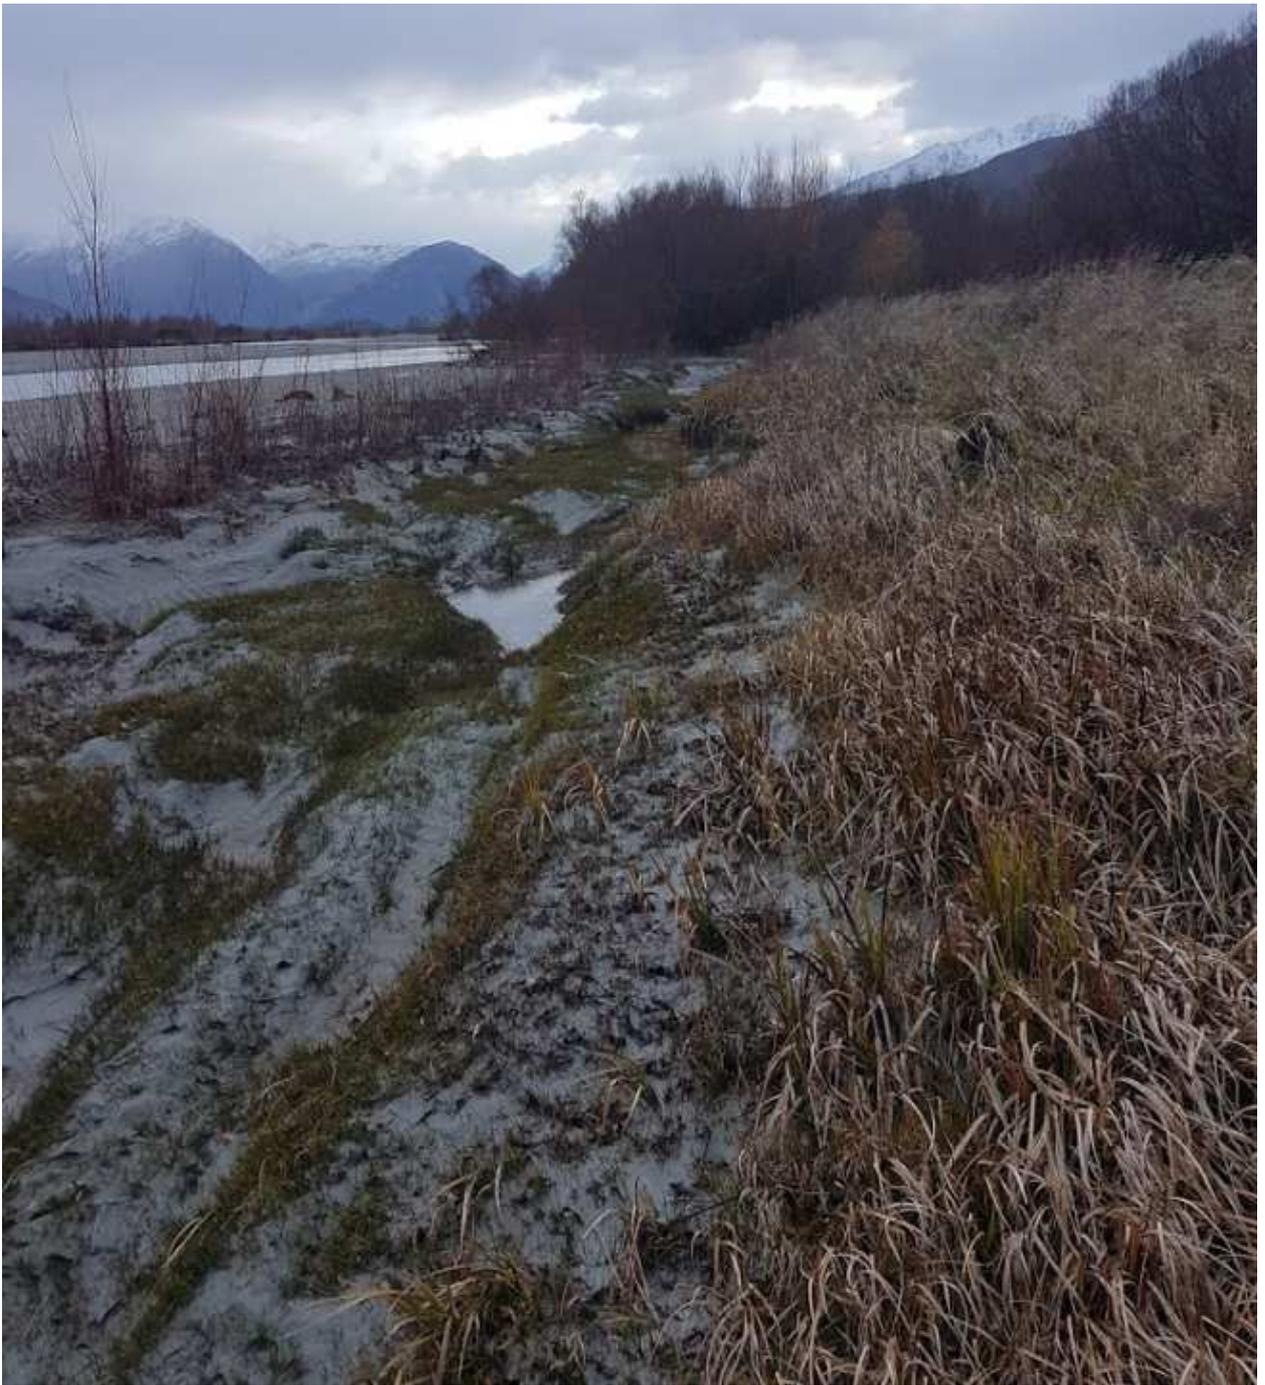
10. A minor channel of the Rees River runs against the base of the floodbank. At the time of inspection the channel did not have significant flow, but there is the potential that this could form the main channel following future flood events or sediment mobilisation. If this does become activated as the main channel this would cause significant flow of the Rees against the floodbank.

Site 10 - Channel against the base of the floodbank

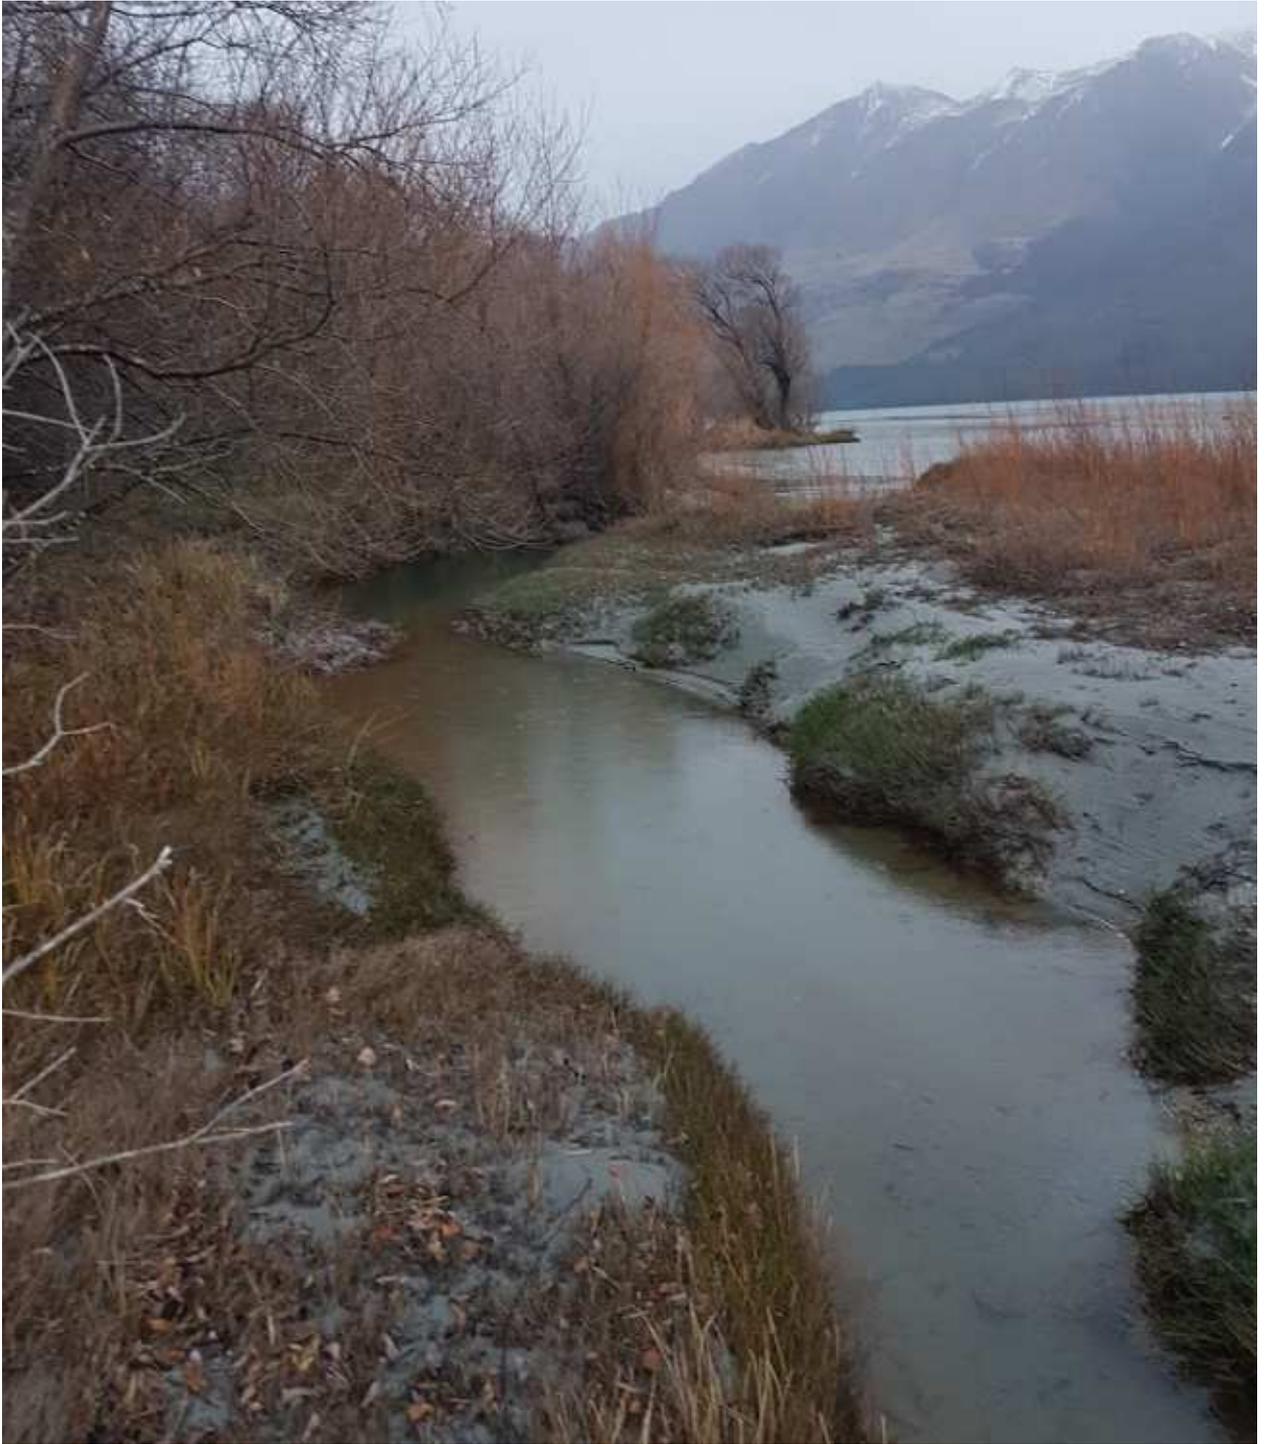
Site 10 – Minor channel against the base of the floodbank

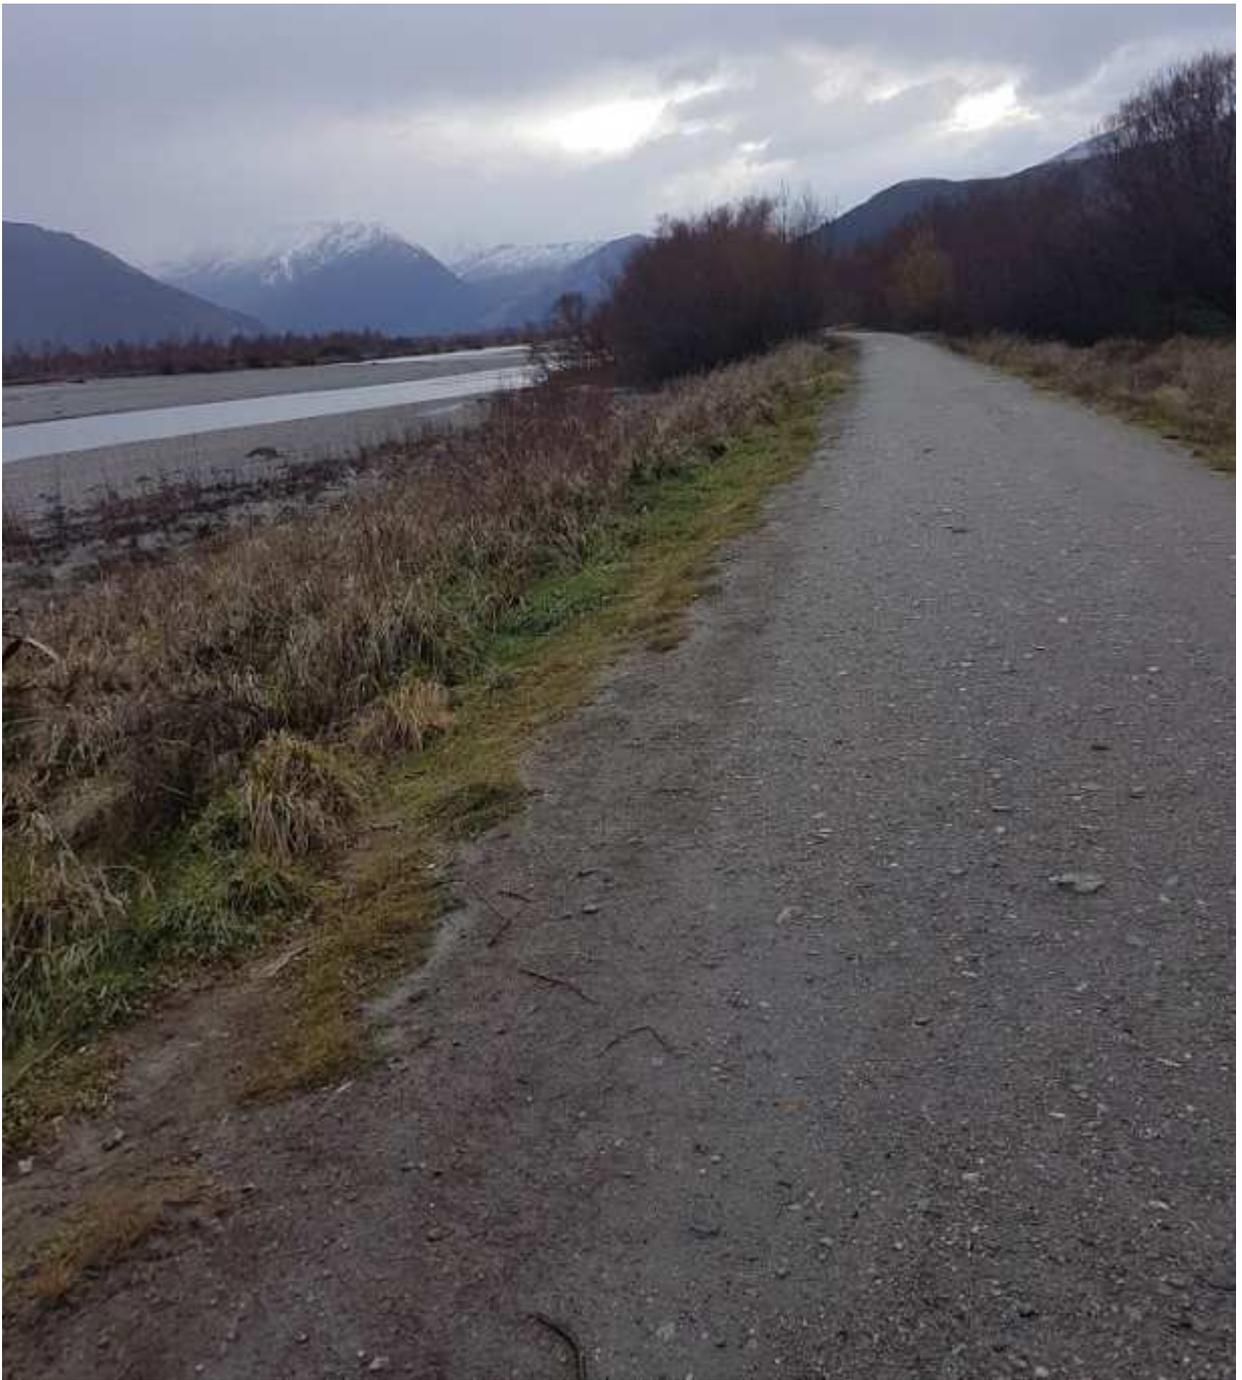
11. At Site 11 there is evidence of minor slope failure on the water side of the floodbank. This is evidenced by a drop in the ground surface and the formation of a headscarp.

Site 11 - General section of trail with a drop in trail level and the formation of a headscarp on the water side.

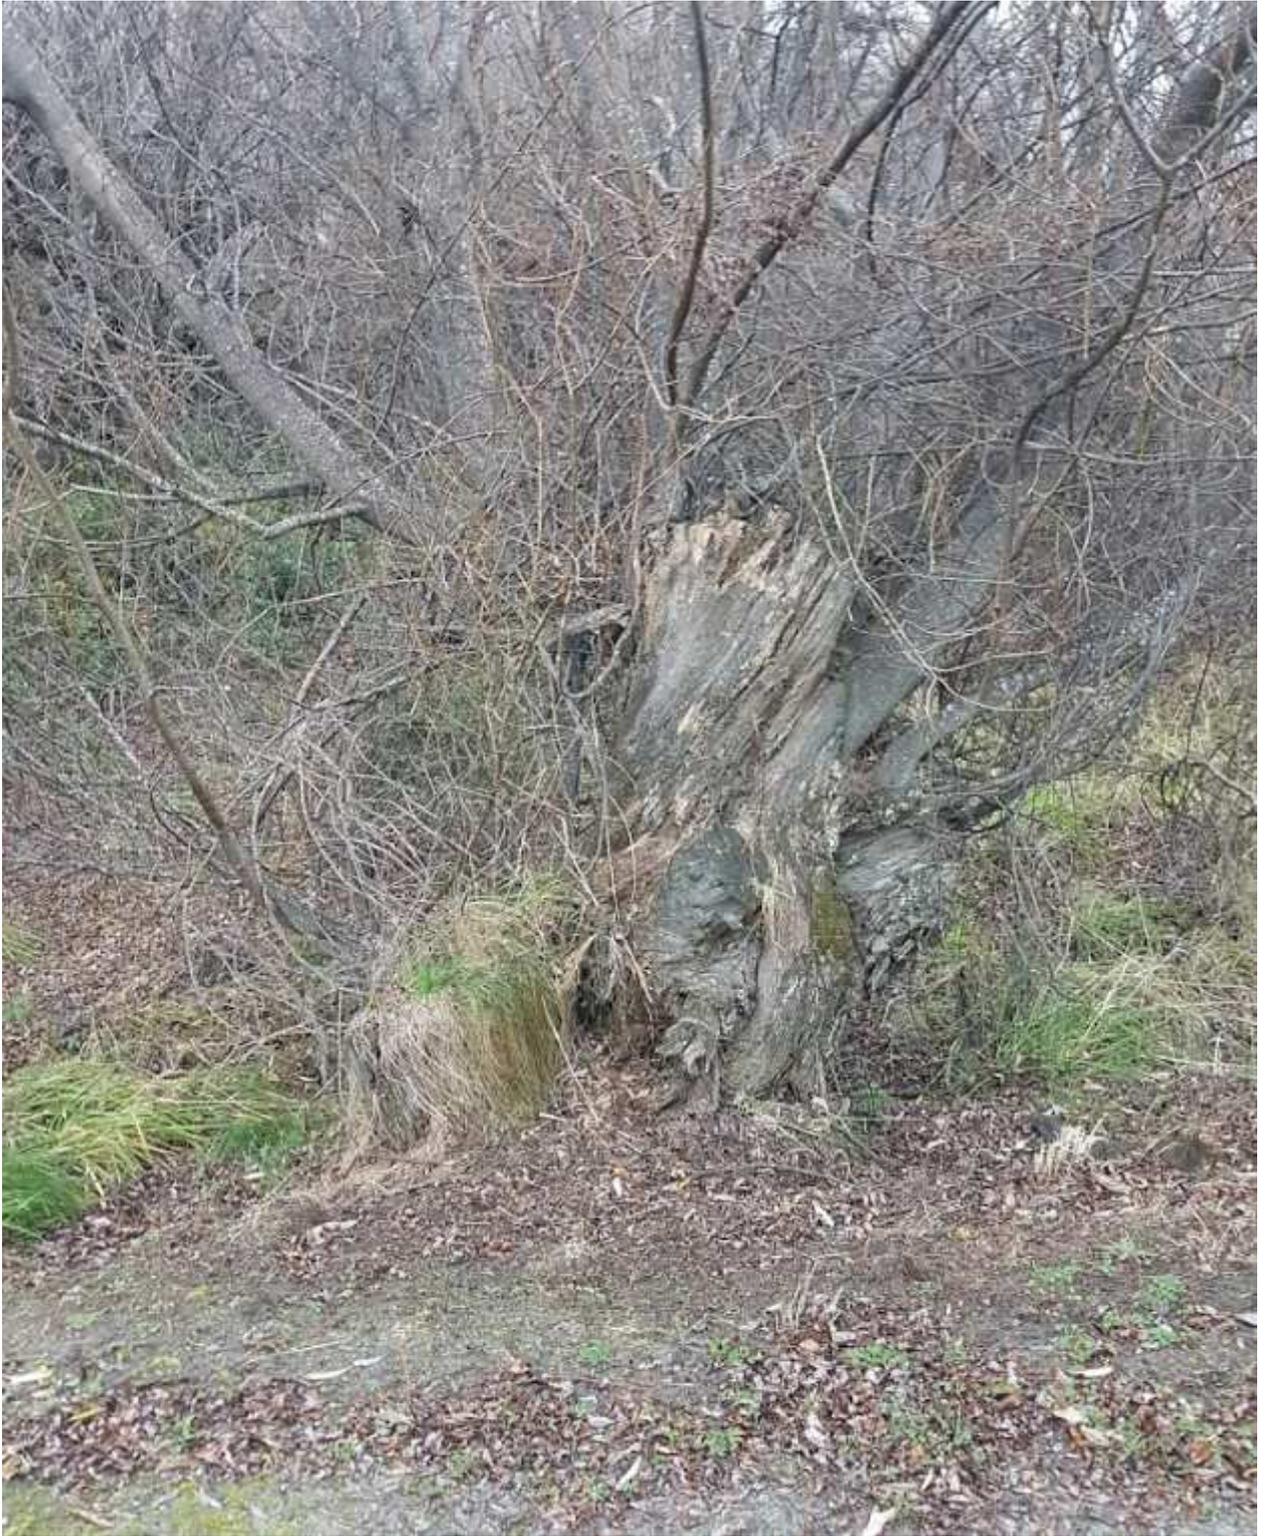
12. Around the length between Butement Road and the car park there are a number of older (than the floodbank) Crack Willow trees on the land side of the floodbank which have the potential to collapse and cause damage to the floodbank.
13. Close to the car park there is evidence of minor slope failure on the water side of the floodbank. This is evidenced by a drop in the ground surface and the formation of a headscarp. The scarps at site 13 are more pronounced than at Site 11.
14. The track between the car park and the floodbank has several large scour depressions. It is assumed that these formed as floodwater from previous events drained across and through this area.

Site 12 - Older cracked willow on the land side

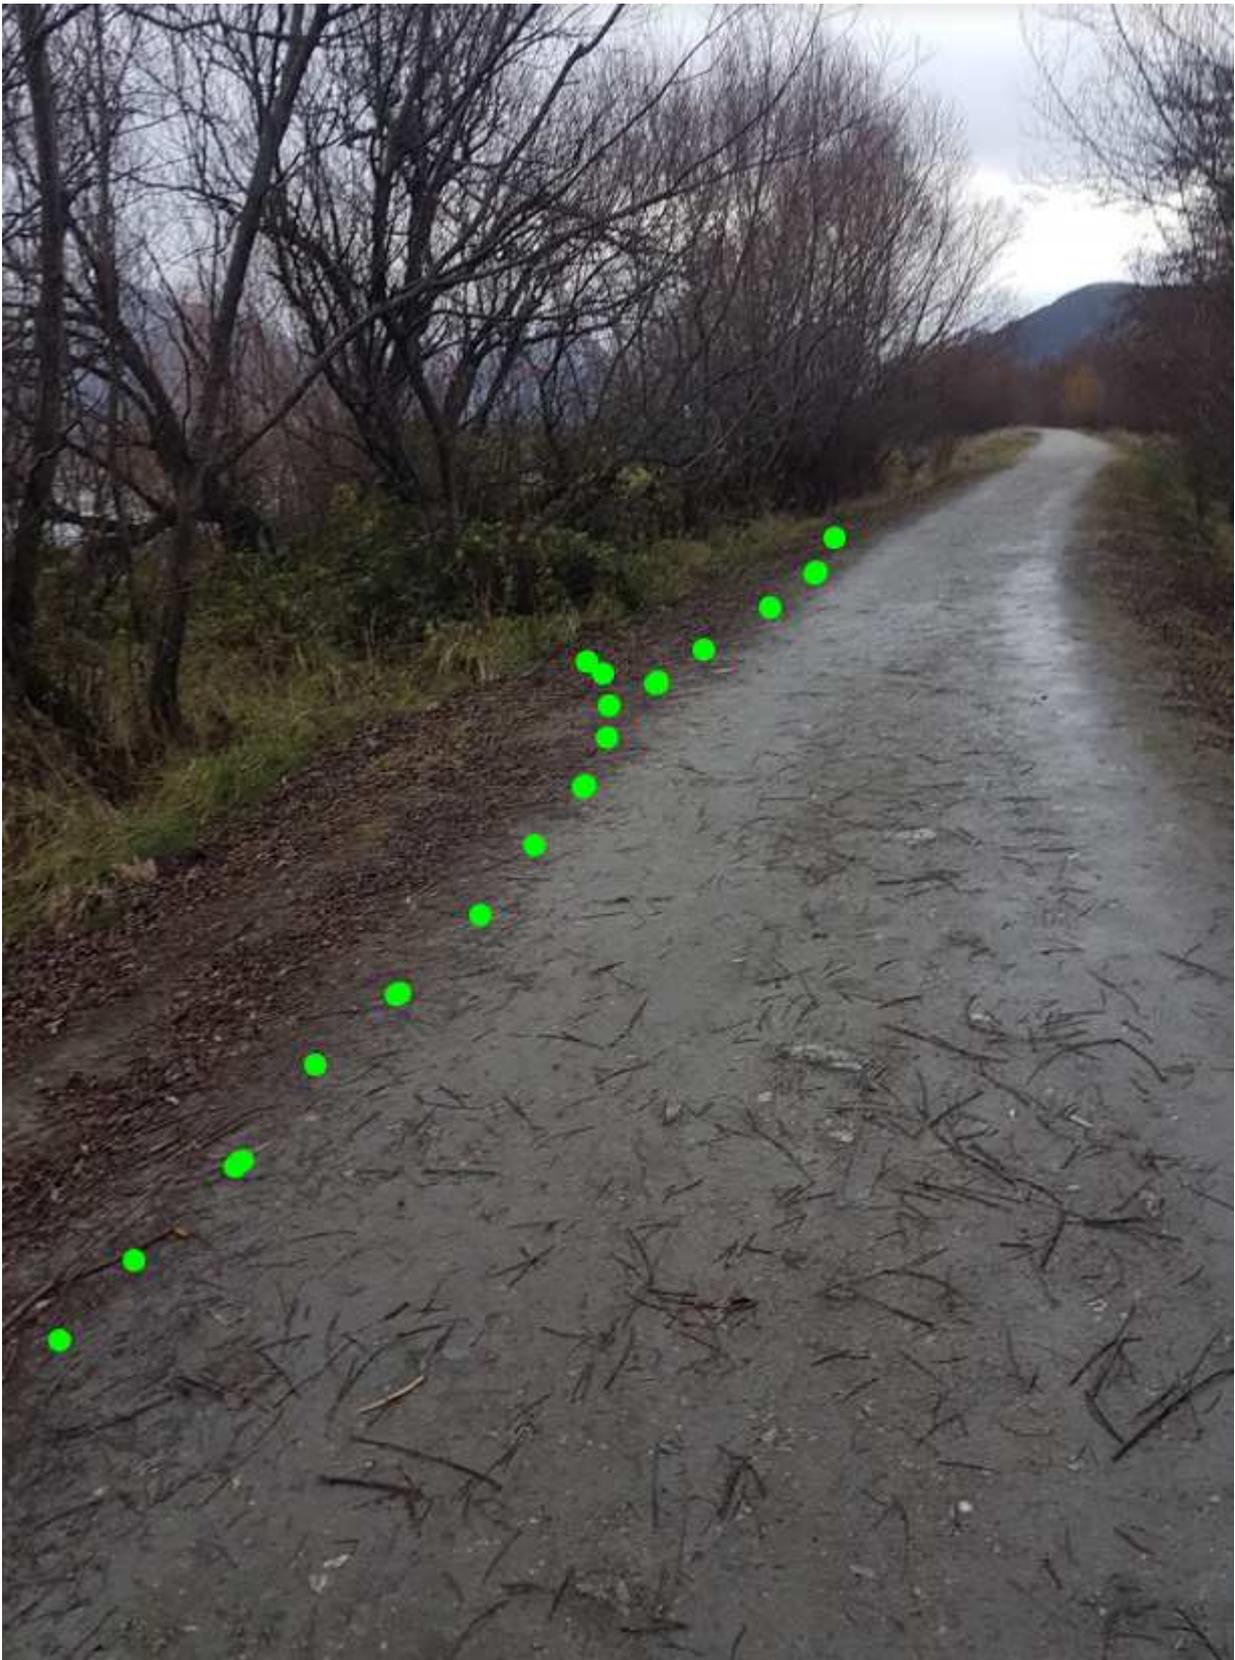
Site 13 - Headscarp forming at the delta end of the track

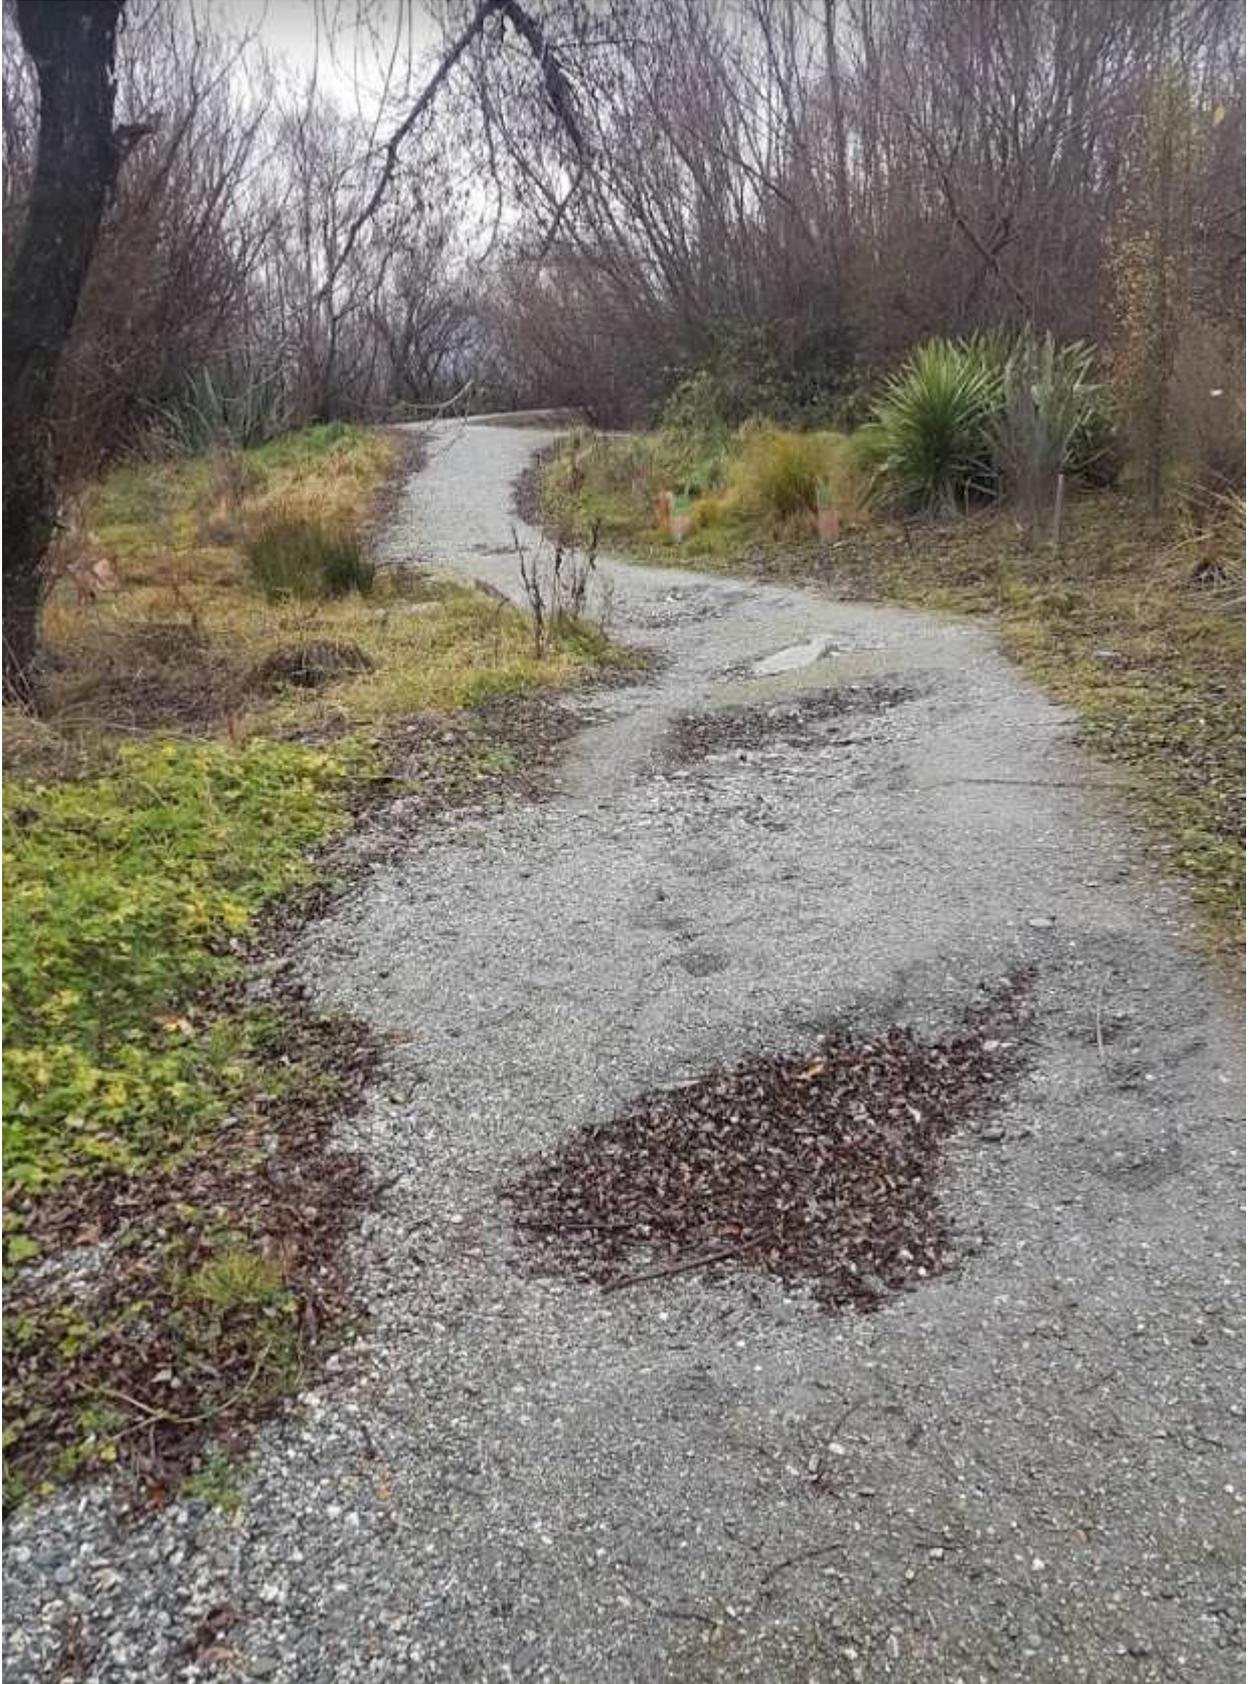
14 - Scour holes at the path between the car park and the floodbank.
