Fish passage assessment and improvement

Potential barriers to fish passage have been surveyed throughout Te Hākāpupu / Pleasant River catchment as part of the catchment restoration project. Seven of the 20 structures assessed need replacement and/or improvement. There are a variety of ways to restore passage for fish at these sites.

As part of the Toitū Te Hākāpupu / Pleasant River Restoration Project, Kāti Huirapa Rūnaka ki Puketeraki worked with the East Otago Catchment Group and local landowners to survey fish passage barriers in the catchment and recommend actions to remove these barriers. Twenty instream structures were surveyed, of which seven need replacement or improvement. All seven are in the lower part of the catchment.

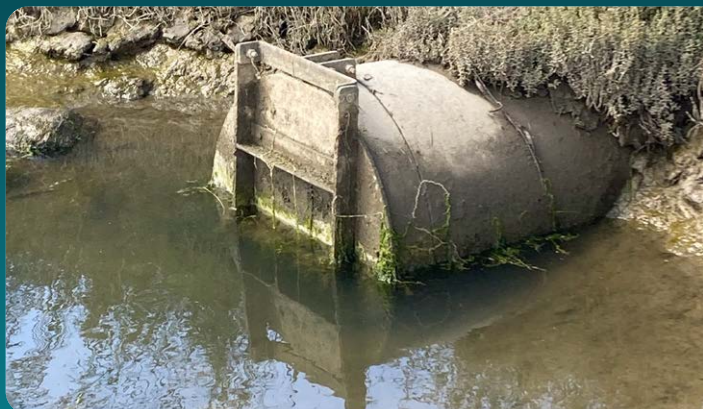
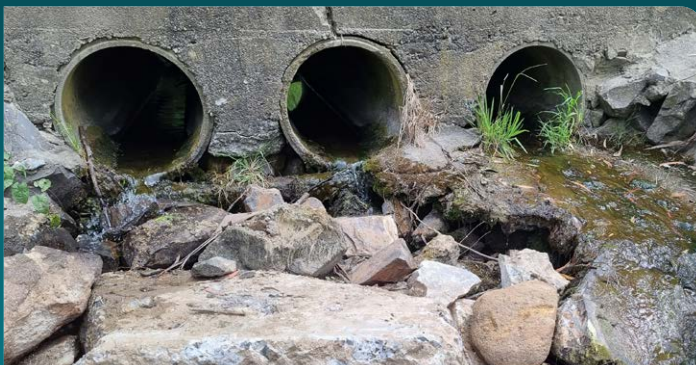
Figure 1. Examples of flap gates (left image) and culverts (right image) restricting fish passage in Te Hākāpupu / Pleasant River catchment. Photo credit: Matt Dale, Waterscape Solutions.

Many of Aotearoa's fish species, such as tuna (eel) and some whitebait species, migrate between fresh and salt water as part of their life cycle. Barriers such as culverts and flap gates (**Figure 1**) can prevent this migration between their breeding, juvenile and adult habitats.

Replacement of the seven structures is recommended; however, they may need temporary improvements while the substantial work required for full replacement is completed. Improvements could include rock ramps, spoiler baffles, and mussel spat ropes (Figure 2).

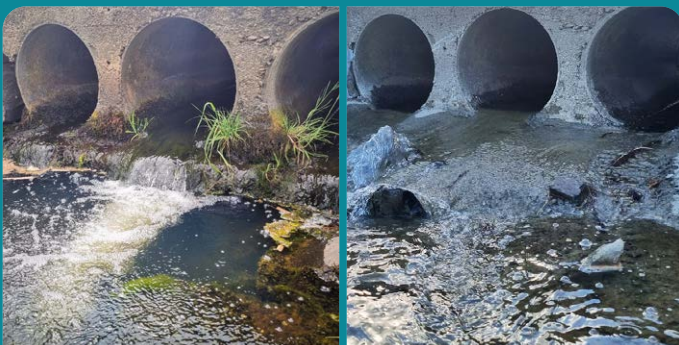
Figure 3. Before (left) and after (right) installation of a rock ramp to improve fish passage at the Patterson's Road ford.
Photo credit: Matt Dale, Waterscape Connections.

Fish passage improvements are already being made in the catchment, including rock ramps at the Patterson's Road ford and Brooklands Road ford (Figure 3).
