## 11.6. November 2017 Roxburgh Debris flow

**Prepared for:** Technical Committee  
**Activity:** Safety & Hazards - Natural Hazards  
**Prepared by:** Dr Jean-Luc Payan, Manager Natural Hazards  
Dr Ben Mackey, Natural Hazards Analyst  
**Date:** 25 January 2018

Flooding caused by the 26 November 2017 intense thunderstorm in the Roxburgh Township area resulted in extensive sedimentation in the Township. The purpose of this report is to present the observations and preliminary assessments made after the event and associated flooding. The report also describes the alluvial fan hazards for this area.

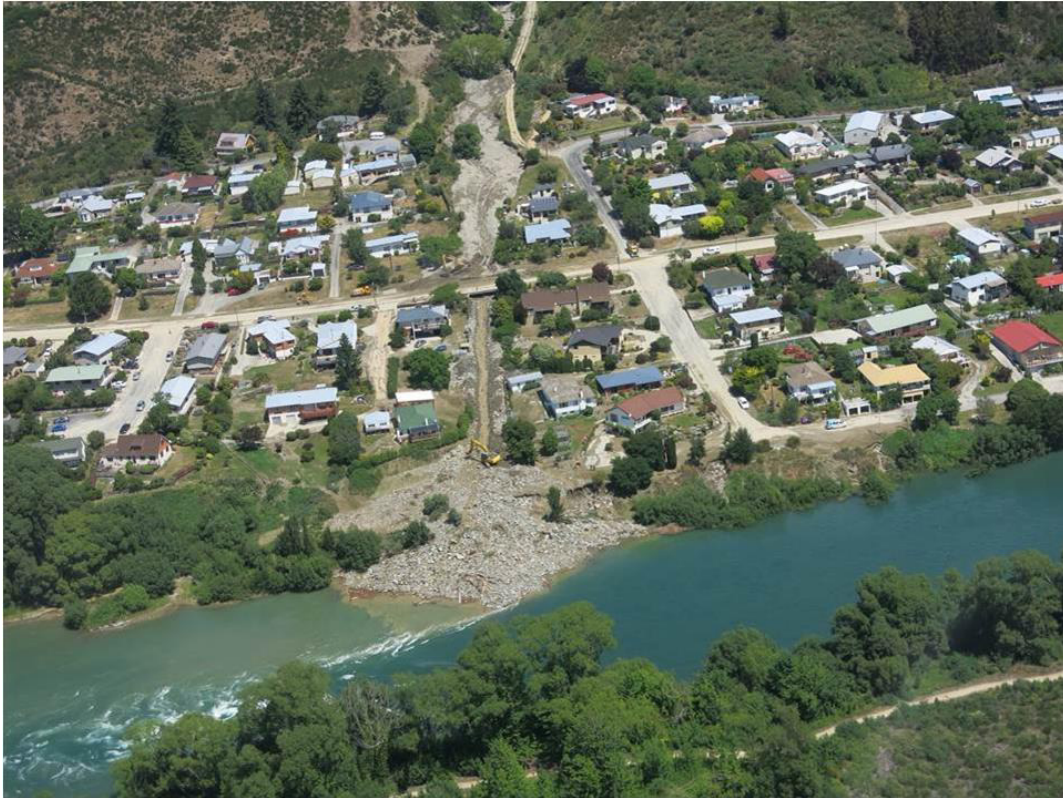
**Figure 3.** View up Reservoir Creek showing sediment and debris deposited at the confluence with the Clutha River – Photo taken by ORC staff on 27 November 2017. Excavator has cleared part of the channel in the middle of the view. Width of debris at river edge is approximately 70 m. The Clutha River flows from right to left.

On 26 November 2017, out of channel sedimentation occurred across the alluvial fan of Reservoir Creek. In the early stages of the event, the concrete lined channel contained most of the debris within the channel as designed, and deposited it in the Clutha River. Eventually the concrete channel backed up with sediment, and resulted in silt and water exiting the channel. Silt-laden floodwater escaped the channel near the top of the fan, and flowed downslope into nearby properties including the Roxburgh Area School (Figure 3 and Figure 5).

The concrete channel was filled with sediment, a volume of 2400 cubic meters. At the outlet of the channel at the Clutha River, a 70 m wide and 35 m long visible lobe of sediment accumulated, with an estimated volume of a further 5000 cubic meters. An unknown volume of sediment also accumulated on the river bed, and additional sediment likely bypassed the lobe deposit and was swept downstream. Boulders up to 1 m in diameter were visible in the lobe deposit. The Reservoir Creek sediment deposited in the bed of the Clutha River created a new rapid with standing waves in excess of 1 m in amplitude.

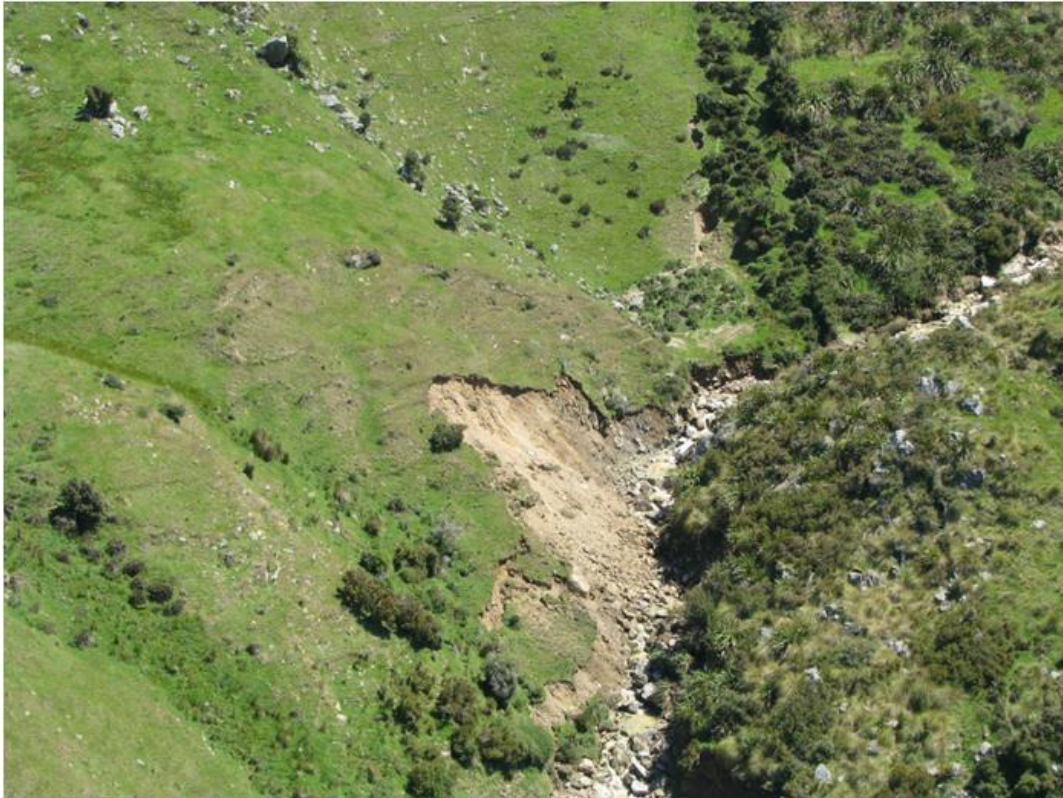
In the upper catchments, many small landslips and bank failures were observed adjacent to the channels (Figure 4). Observations suggest that sediment laden flows travelled down the channels, stripping vegetation from the channel banks, and mobilising bed sediment. Significant quantities of sediment, ranging from silt to large boulders (over 1m diameter), were deposited across alluvial fans, including in northern Roxburgh Township (on roads, streets, properties, school grounds) (Figure 5).

**Figure 4.** Example of small landslips and bank failures in the upper reaches of Black Jacks Creek – Photo taken by ORC staff on 27 November 2017.

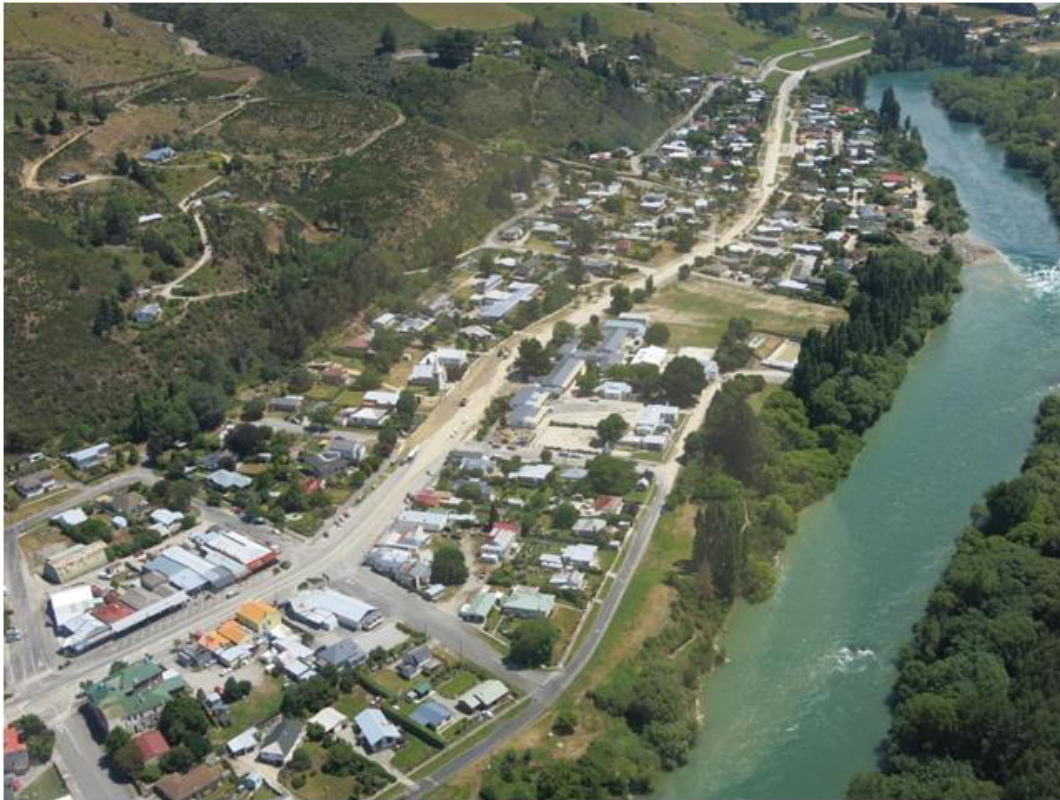
The debris deposited in the Clutha River at Reservoir Creek and Black Jacks Creek have created deposition lobes which extend tens of meters into the river. These lobes potentially reduce channel capacity, and could induce bank erosion by changing river flow patterns (Figure 5).

**Figure 5.** Sediment deposition in Roxburgh Township and in the Clutha River from Reservoir Creek – Photo taken by ORC staff on 27 November 2017. The sediment lobe from Reservoir Creek protruding into the Clutha River is visible in top right of image. Note the finer sediment deposited on SH8 in the centre of the image.

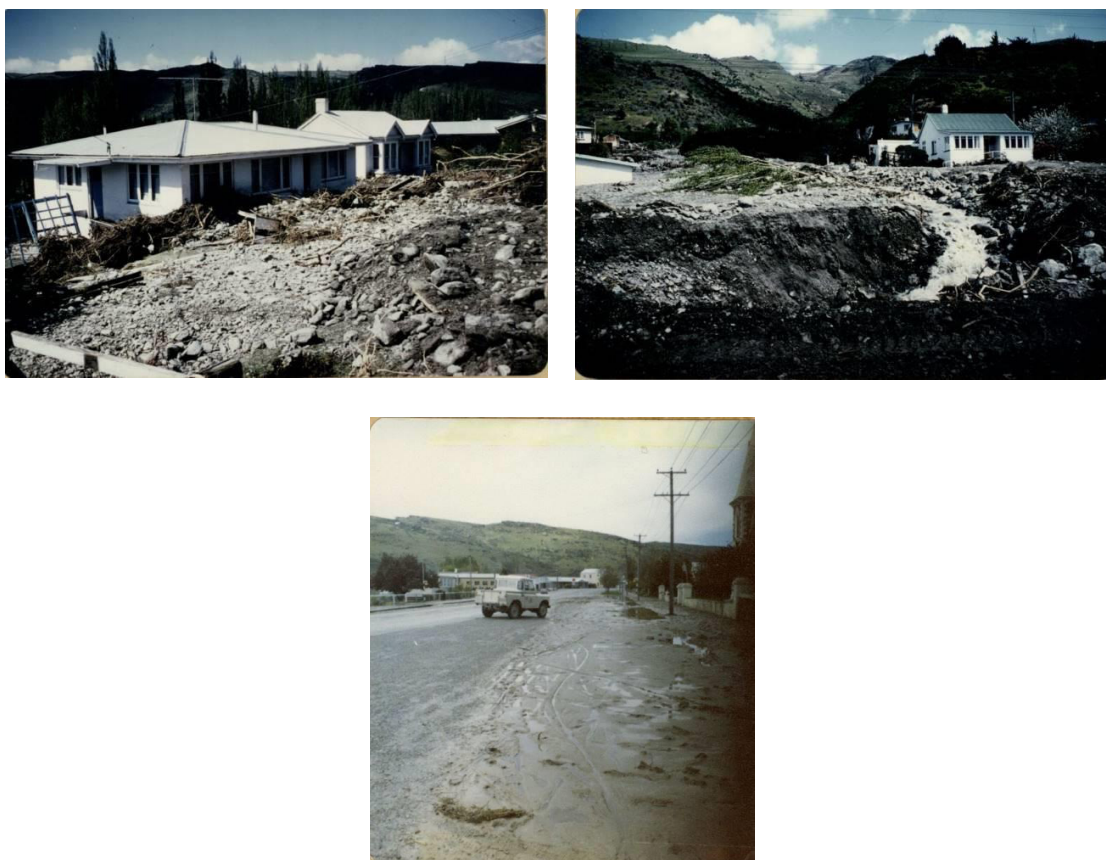
The fan has been subject to recurrent debris flow events in the past. In October 1978, debris flows overwhelmed the channel and affected residential properties on the surface of the fan above and below SH8 (Figure 8).

**Figure 8.** Sedimentation on the Reservoir Creek fan surface. Top left photo is looking downstream and top right photo is looking upstream (16 October 1978). Bottom photo is showing silt deposited on SH8 (15 October 1978) (OCB photos).

Following this 1978 event, in the early 1980's, the Otago Catchment Board (OCB) has excavated the channel and constructed a concrete lined channel in the downstream section of Reservoir Creek (from where it exits the valley). The channel structure is designed to rapidly convey floodwaters and debris across the alluvial fan and into the Clutha River (Figure 9). The concrete channel is 200 m long, 3 m wide at its base, 9 m wide at the top, and 2 m deep.

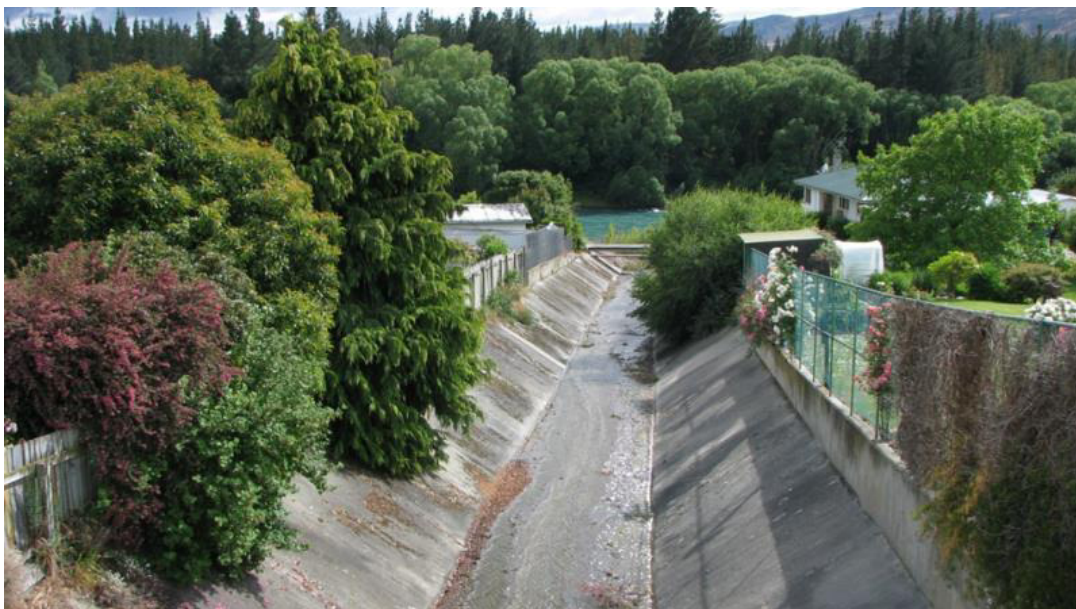
**Figure 9.** Concrete lined channel in the downstream section of Reservoir Creek (2009, ORC staff photo).

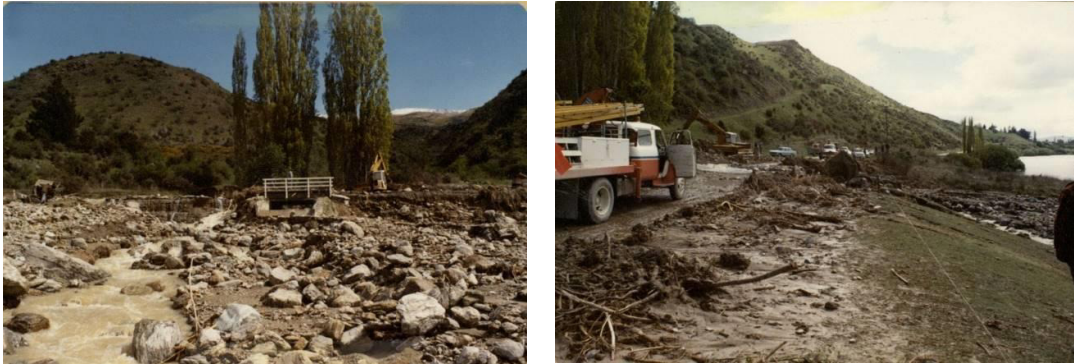
Like Reservoir Creek, the fan has been subject to recurrent debris flow events in the past. In October 1978, a debris flow overwhelmed the channel and large amounts of debris were deposited on SH8 (Figure 10). An event also occurred in 2015 closing SH1 for two days (Figure 11)<sup>3</sup>.

**Figure 10.** Sedimentation on the lower reach of Black Jacks Creek – 15 October 1978. Left photo is looking upstream to the culvert under SH8 and the right photo is looking along SH8 towards Roxburgh Township (OCB photos).

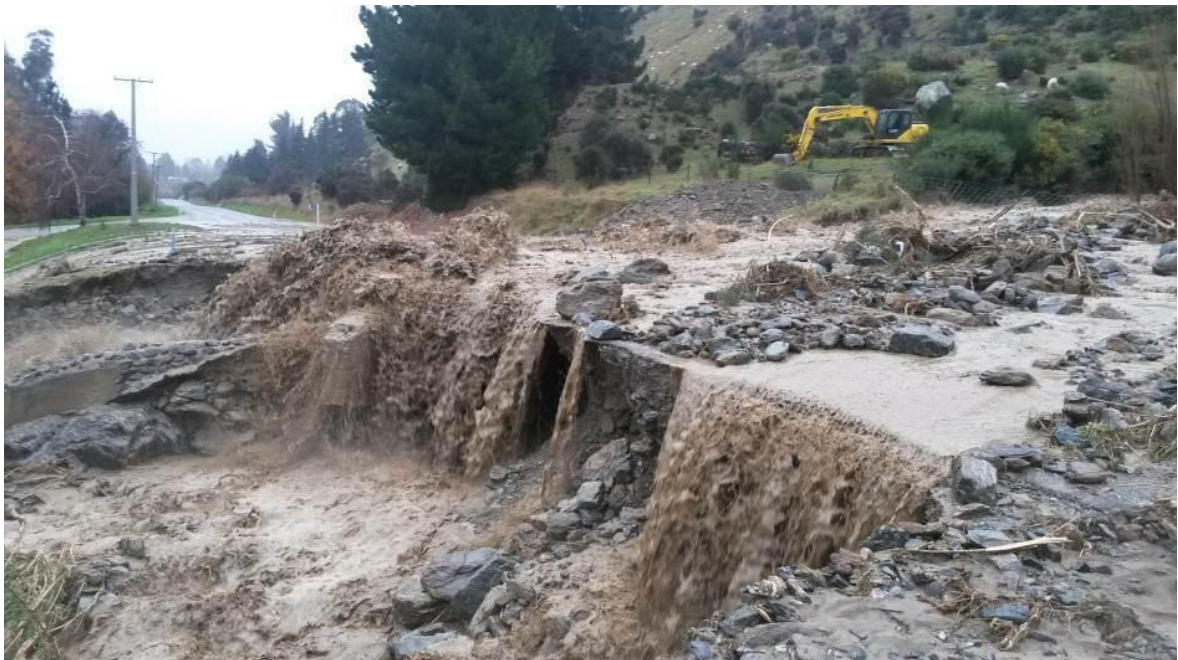
**Figure 11** Flooding at Black Jacks Creek at SH8, 3 June 2015.

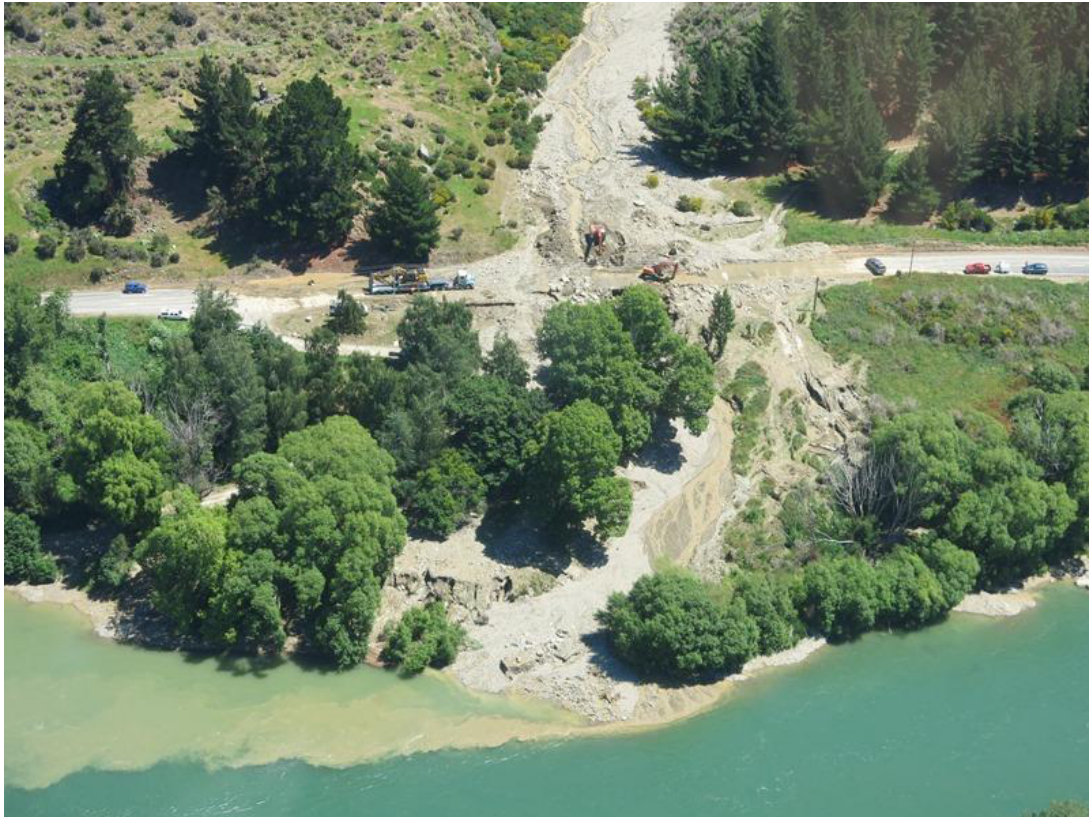
**Figure 12. Sedimentation on the lower reach of Black Jacks Creek – 27 November 2017 (ORC staff photo). Width of view along the riverbank is 150 m.**

A significant volume of sediment also needed to be removed from SH8 and from the fan surface (Figure 12) to re-establish the channel. The Black Jacks Creek alluvial fan is comparatively small, but the 120 m long and 50-100 m wide central area of the fan was covered by sediment averaging ~0.5 m in thickness, including a 70 m length of SH 8. The channel also required excavation to re-establish a flow path. These two components suggest approximately 6000 cubic meters of sediment was deposited in the lower channel and on the fan surface. Black Jacks Creek did not build a substantial lobe out into the Clutha River (compared to Reservoir Creek), but an unknown volume of sediment bypassed the alluvial fan and was deposited in the River. The sediment on the fan surface ranged from fine silt, through to boulders in excess of 1 m in diameter.

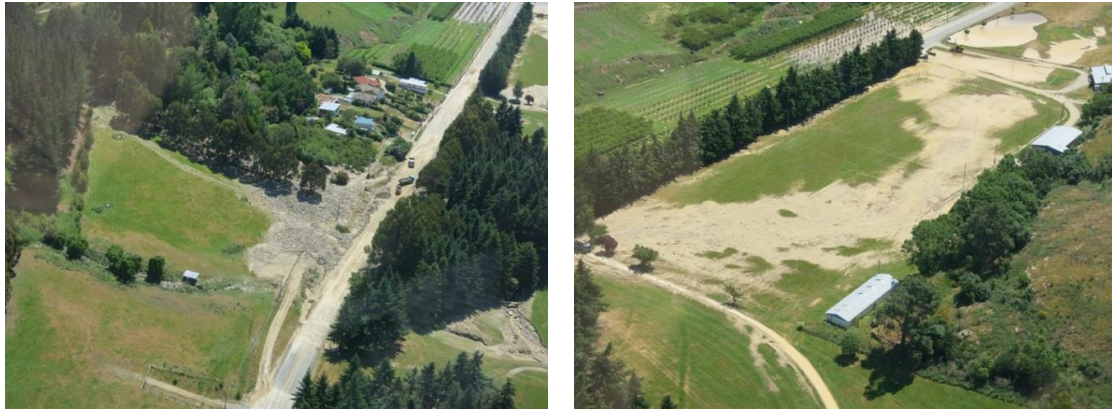
Golf Course Creek (informal name) blocked the culvert crossing SH8, and a large volume of coarse sediment (small boulders) was deposited upstream of and across the highway, inundating adjacent paddocks. Floodwaters carried fine sediment across the broader alluvial fan, with significant sediment deposited across the rugby grounds (Figure 13).

**Figure 13.** Sedimentation in the lower reaches of an unnamed creek, here referred to as Golf Course Creek– 27 November 2017 (ORC staff photos). In the left image, boulders inundated a paddock upstream of the highway. The right photo shows finer sediment (silt to small gravels) deposited across the rugby field.

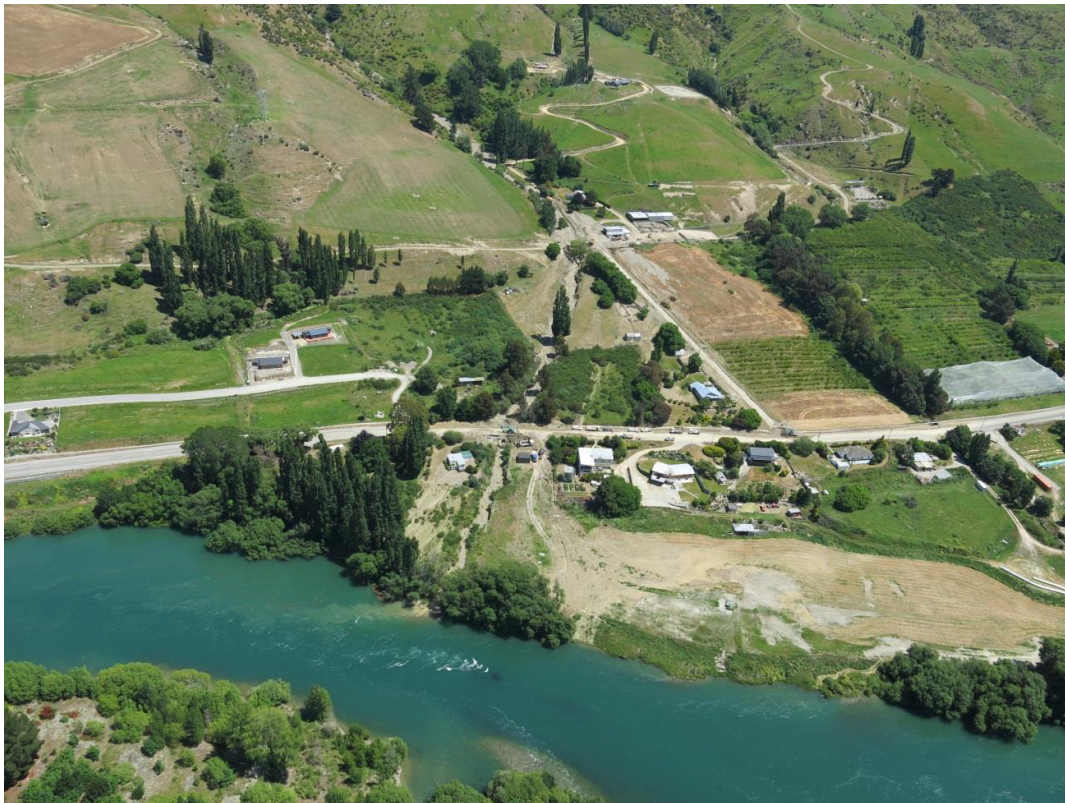
An un-named creek immediately to the north of Roxburgh (Figure 2) also had debris deposited across its alluvial fan, which blocked SH8 and resulted in sediment deposited against structures (Figure 14).

**Figure 14.** Sediment deposited across the alluvial fan of a creek north of Roxburgh (27 November 2017, ORC staff photo).
