## Key notes and observations from preliminary assessment of debris flood and flow hazard potential at Glenorchy, Otago, for Otago Regional Council

Prepared by Prof. Ian Fuller and Dr Sam McColl (Massey University).

21 December 2021

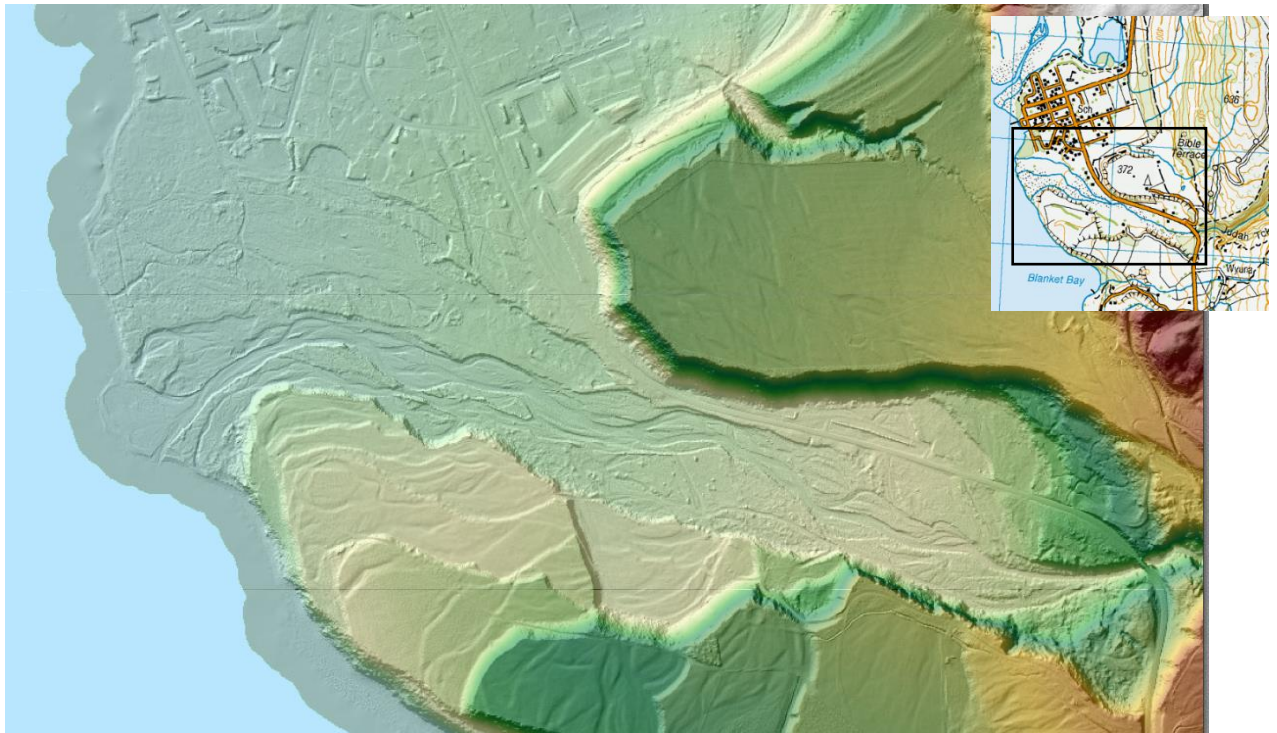
Buckler Burn, which currently enters Lake Wakatipu south of Glenorchy township, has followed a more northerly course in the recent past, indicated by both LiDAR DEM (Figure 1) and 1937 historic aerial photo (Figure 2).

Figure 1 LiDAR DEM, 2019.

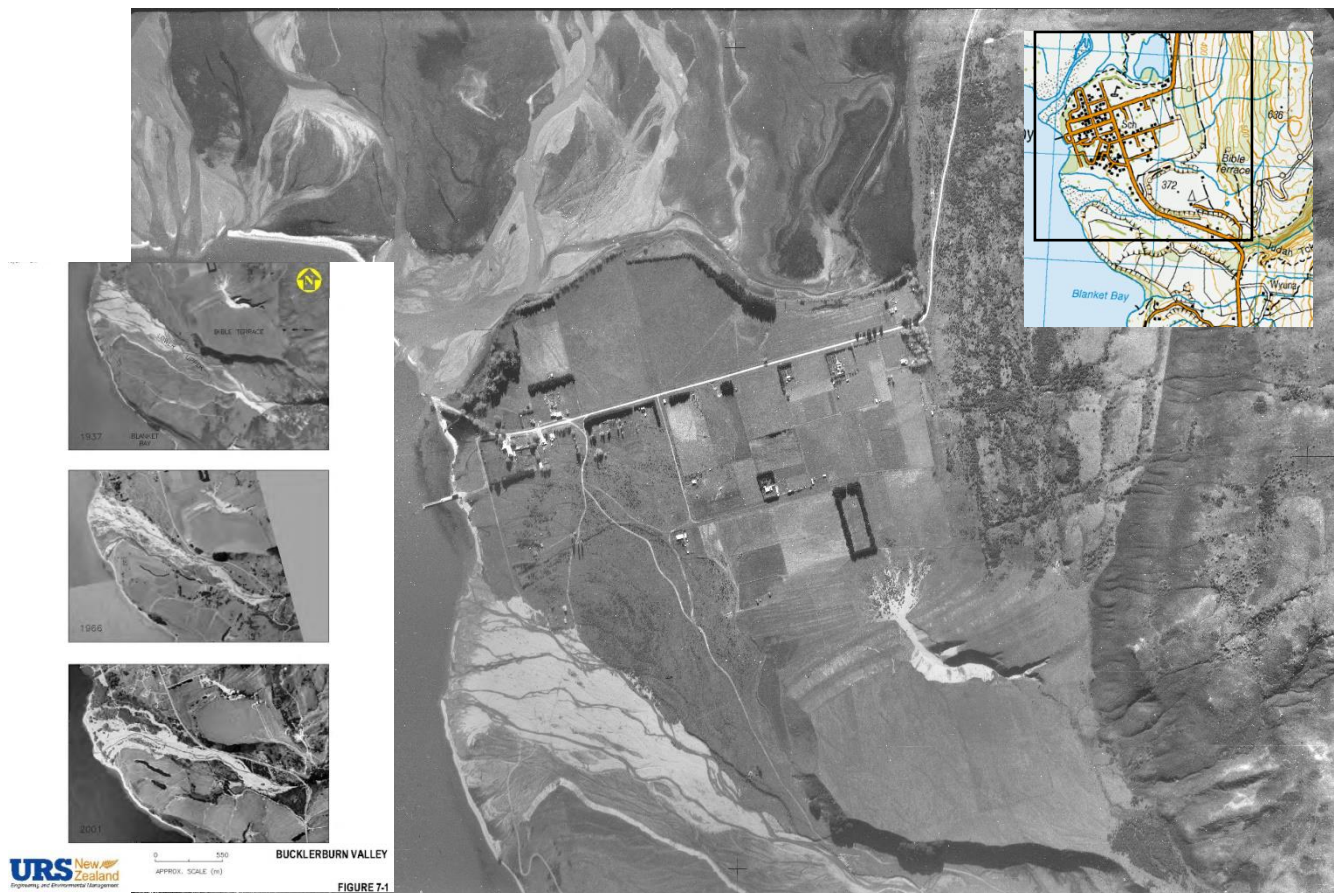
Figure 2. Main image: Aerial photograph, 1937. The active part of the Glenorchy fan is situated to the south of the township, but former channel courses are traceable on this photo between the active channel and Queenstown-Glenorchy Road. The sequence of photos from 1937, 1966 and 2001 from URS Report (2007) shows the progressive migration south of the mouth of the Buckler Burn.

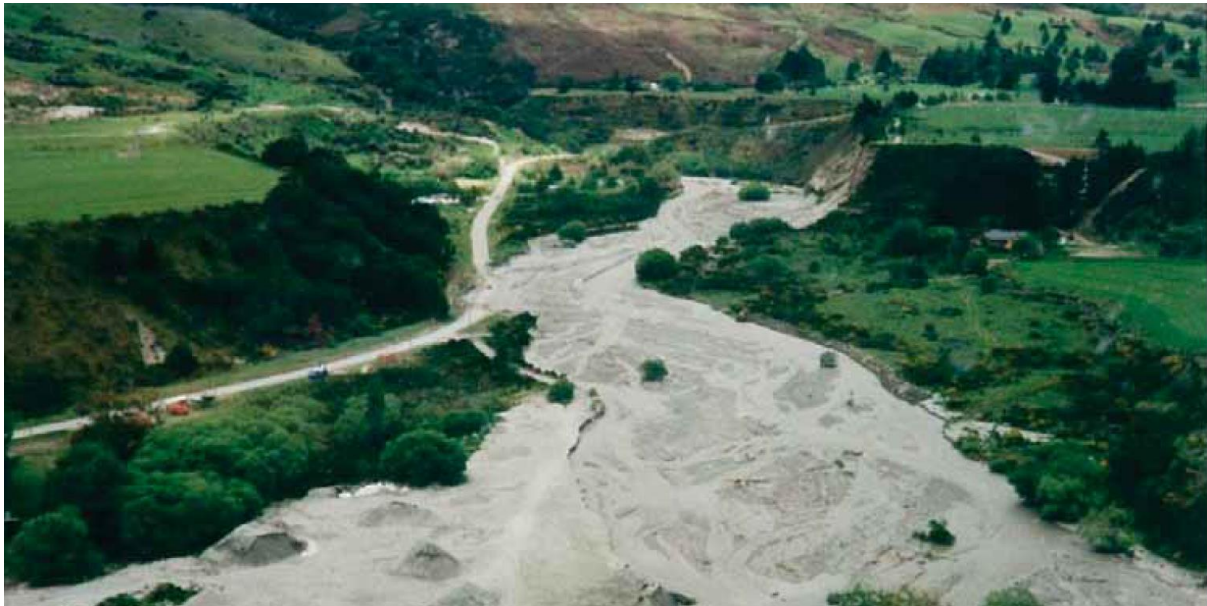
Figure 3 Lower Buckler Burn, November 1999 (Natural Hazards at Glenorchy Summary, Figure 4, 2010)

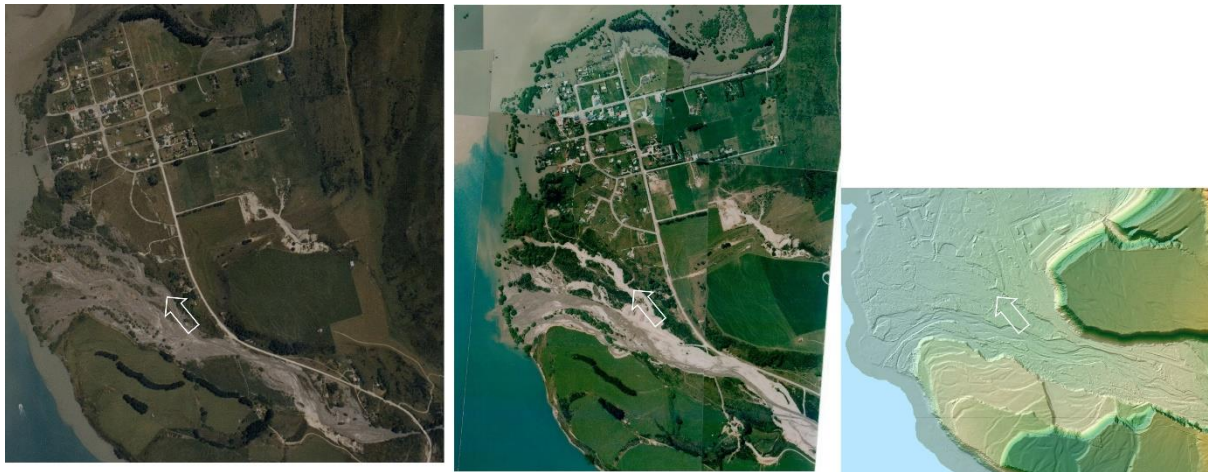
The November 1999 flood event appears to have reoccupied the primary 1994 channel of the Buckler Burn (Figure 5). This scenario takes high energy flood flows very close to properties in Glenorchy that have been built since 1999. The presence of another palaeochannel to the north of the 1994 channel, evident in the LiDAR DEM and observed in the field, runs the risk of channelling flood flows adjacent to the road and into the centre of Glenorchy. This is not out of the question, since sediments in the boreholes indicate a sequence of debris rich floods in their upper metres, likely deposited by the Buckler Burn in a previous northerly alignment.

Figure 5. 1994 aerial photo, November 1999 aerial photo and 2019 LiDAR DEM, arrow shows primary channel in 1994, indicating reoccupation during 1999 flood and morphology evident in LiDAR DEM.

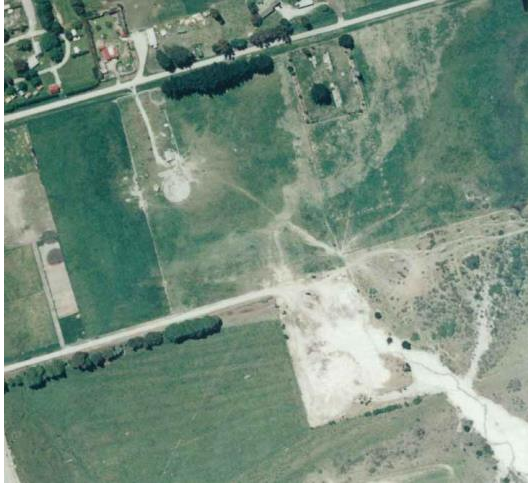
It is possible that high energy flood events have been routed down Bible Stream. This stream has incised the Bible Terrace and in a storm event there is considerable readily mobilised material in the steep gully side that is available for this stream to entrain and re-deposit in the vicinity of the cemetery and Coll Street. Sedimentation from this stream occurred in November 1999 and Figure 6 shows overland flow paths associated with this event. However, given the size of the catchment and scale and morphology of the fan, any flood energy is likely to dissipate rapidly. The Bible Stream fan should remain undeveloped. Confining the channel at any point across the fan (and particularly at the apex) risks reducing energy dissipation and worsening the impacts of floods in this small system.

Figure 6. November 1999 overland flow pathways and sedimentation emanating from Bible Stream towards Coll Street (Natural Hazards in Glenorchy, Summary Report, 2010)
