# Shotover WWTP Enforcement

Technical Assessment - Shotover WWTP  
Compliance

December 2024

Otago Regional Council  
70 Stafford St  
Dunedin 9054

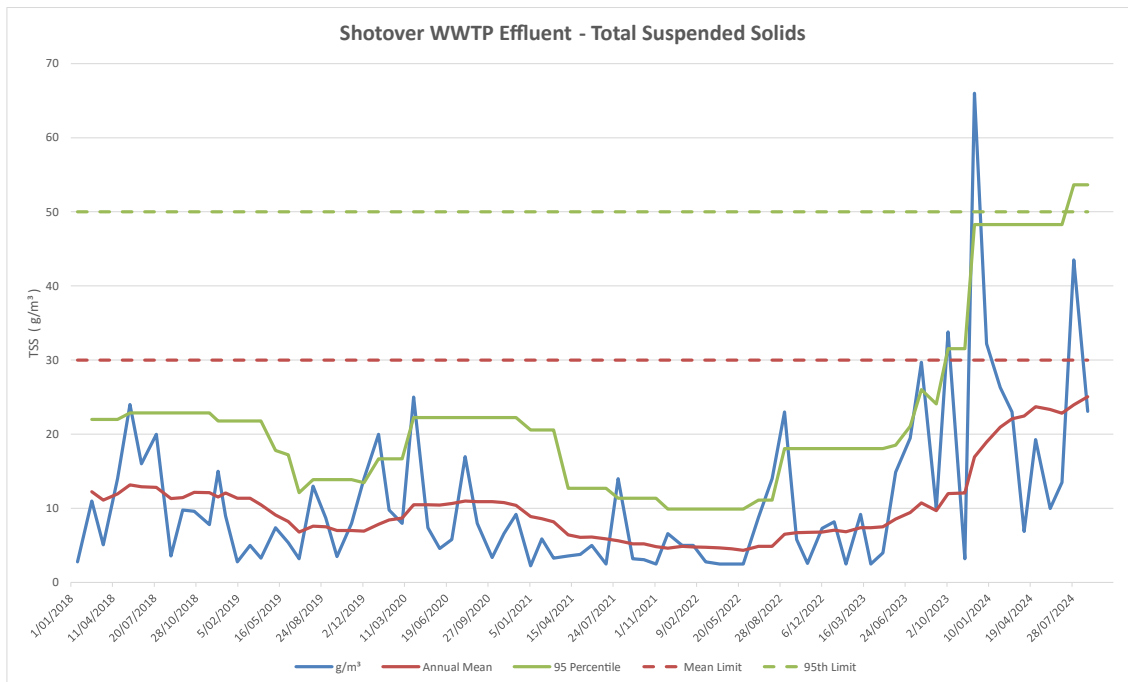
**Figure 2.1: Total Suspended Solids in Shotover WWTP Effluent**

The results show that there was a high TSS in the effluent from the plant on the 7 December 2023 and 1 August 2024, and that this correlates with the elevated cBOD<sub>5</sub>, Total Nitrogen, Total Ammoniacal-Nitrogen, and E. coli results. It seems likely that the low DO and the loss of solids from the MLE process contributed to the loss of nitrification and elevated ammonia levels seen in the December 2023 sample.

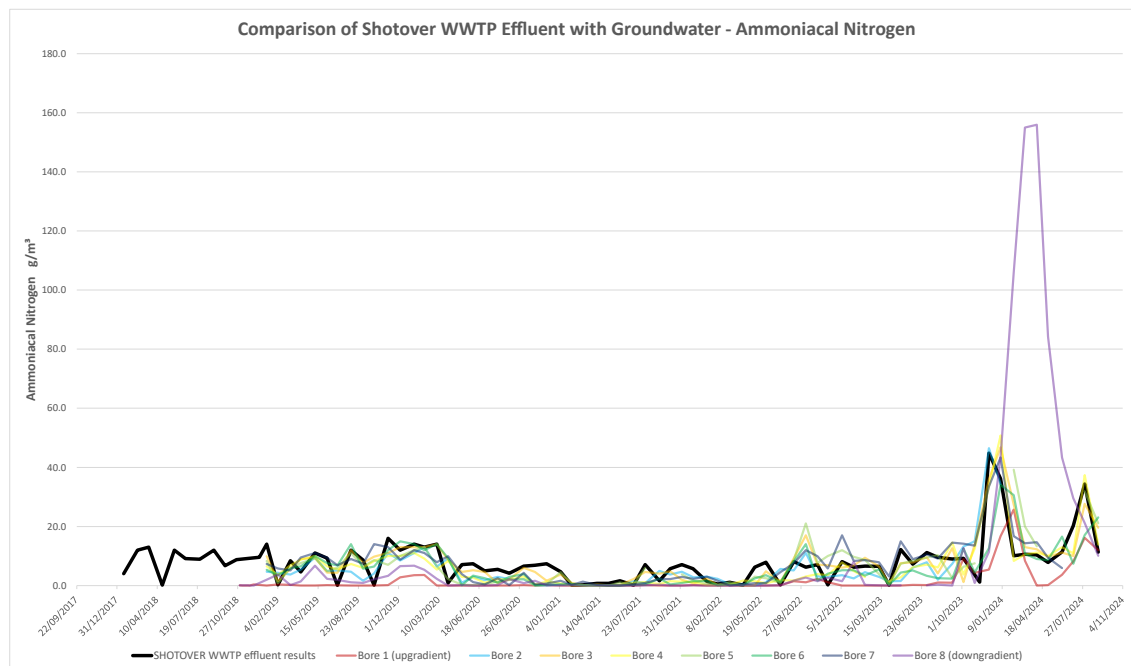
**Figure 2.7: Ammoniacal Nitrogen in Groundwater Bores and Shotover WWTP Effluent**

Generally, there is a reasonable correlation between the WWTP effluent concentrations, and the concentrations measured in the groundwater bores.

However, the down gradient bore 8 showed a disproportionate and delayed response to the effluent peak seen in December 2023.

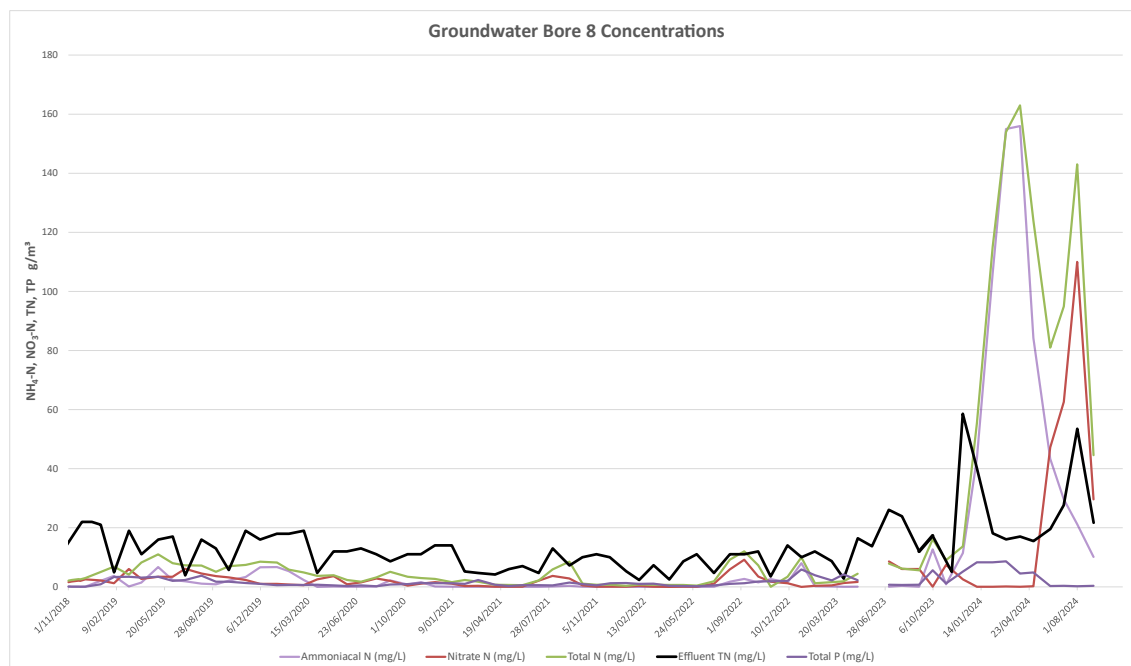
**Figure 2.8: Groundwater Bore 8 Concentrations (Effluent TN shown for comparison)**

Generally, one would not expect the total nitrogen concentration in the bore to exceed the concentration in the discharged effluent by this magnitude (it is nearly 3 times higher). Nitrogen is converted from one form to another depending on the environmental conditions (eg from ammonia to nitrate, and from nitrate to nitrogen gas) but the total nitrogen is conserved or reduced (for example if ammonia or nitrogen gas is stripped from the liquid phase). For the total nitrogen to increase like this would suggest another source is contributing significant ammonia to the groundwater.

One possible explanation is that there has been a significant discharge of organic solids (consistent with the loss of biological solids from the WWTP) deposited in the disposal field that have accumulated and then decomposed. Organic solids are broken down by microorganisms to produce ammonia. This ammonia can then be biologically converted to nitrate under aerobic conditions, which may be what we are seeing in the June sample (ammonia is decreasing whilst nitrate is increasing).

The ammonia in the bore is on a downward trend and it would appear that nitrate levels have also peaked and are now falling. It is expected that this should continue, provided there is not another breakthrough of solids from the plant.

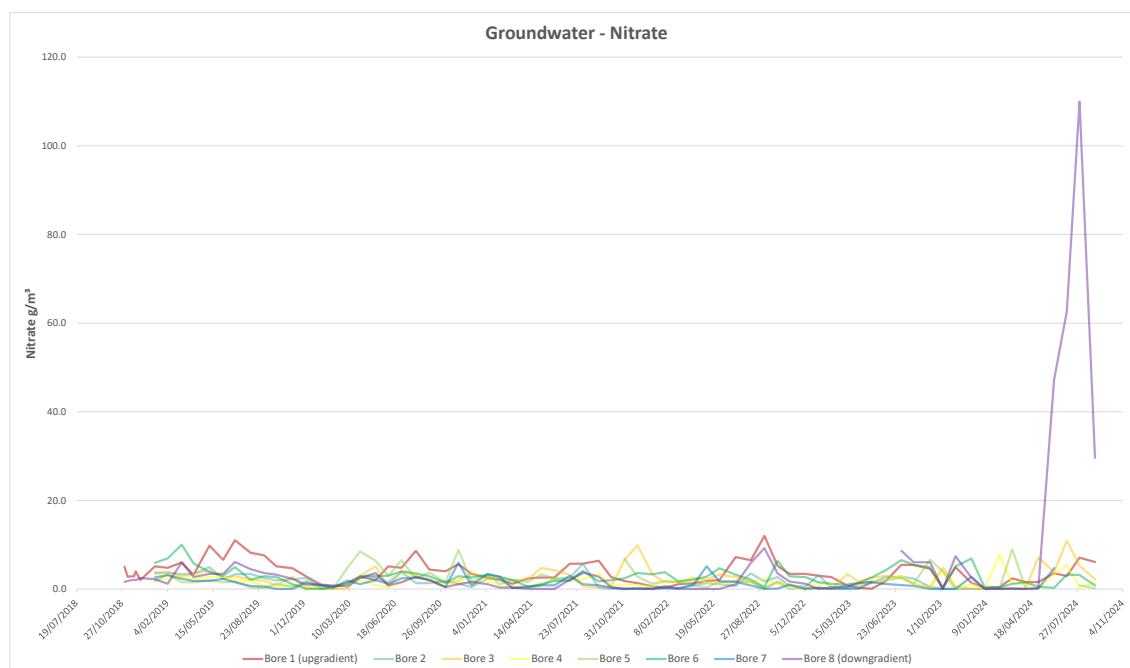
**Figure 2.9: Nitrate-Nitrogen in Groundwater Bores**

Nitrate-nitrogen levels in the groundwater bores were generally consistent, with the exception of bore 8 which showed a disproportionately high datapoint in June 2024, as discussed previously.

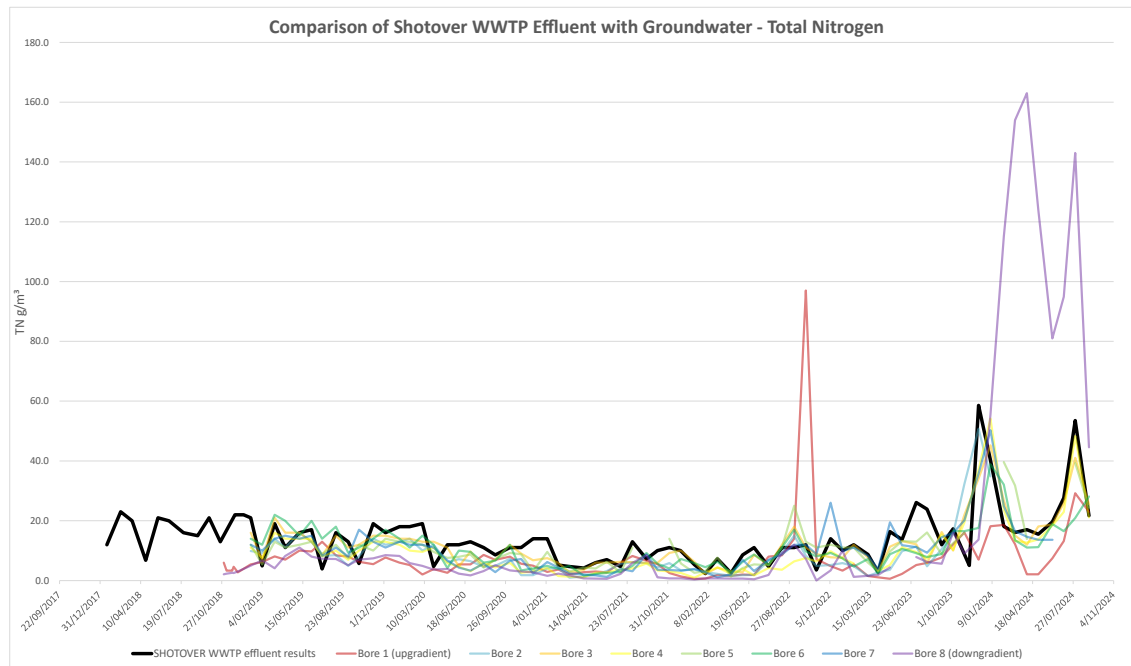
**Figure 2.10: Total Nitrogen in Groundwater Bores and Shotover WWTP Effluent**

Generally, there is a reasonable correlation between the WWTP effluent total nitrogen concentration, and the concentrations measured in the groundwater bores. As discussed previously, a disproportionately high peak was observed for bore 8 peaking in April 2024 at 163 mg-N/L.

It is noted that there was a peak in total nitrogen seen in the up gradient bore 1 in October 2022 that was not seen by the other groundwater bores. However, the ammoniacal nitrogen sample for bore 1 (Figure 2.7) did not respond in a similar fashion for the same time period, suggesting the datapoint could perhaps have been an outlier.

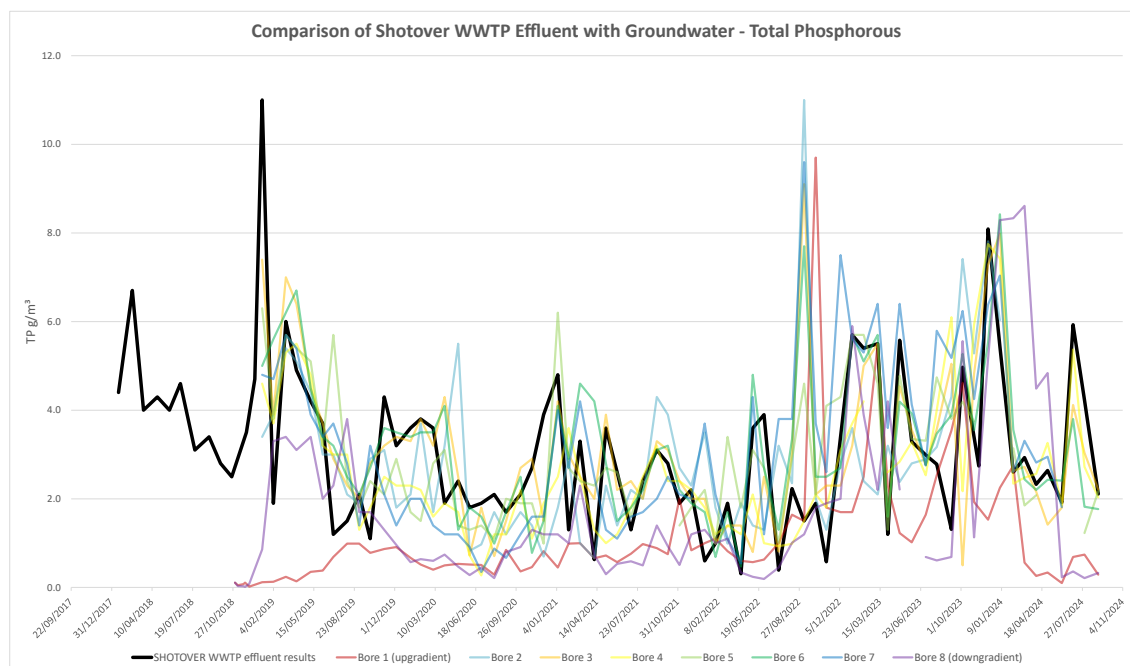
**Figure 2.11: Total Phosphorus in Groundwater Bores and Shotover WWTP Effluent**

The concentration of total phosphorus in the groundwater samples have had similar concentrations to the Shotover WWTP effluent sampling data, with high levels of variation in 2023. However, there was a disproportionately high peak of total phosphorus recorded for the groundwater samples, specifically bores 2, 3, 4, 6 and 7 in September 2022, as well as a delayed peak from bore 1 in October 2022, that were not reflected in the Shotover WWTP effluent for the same time periods. The reason for this peak is not known.

It is interesting to note that the phosphorus peak seen in bore 8 between January and March 2024 does not vary to the same magnitude as the total nitrogen.

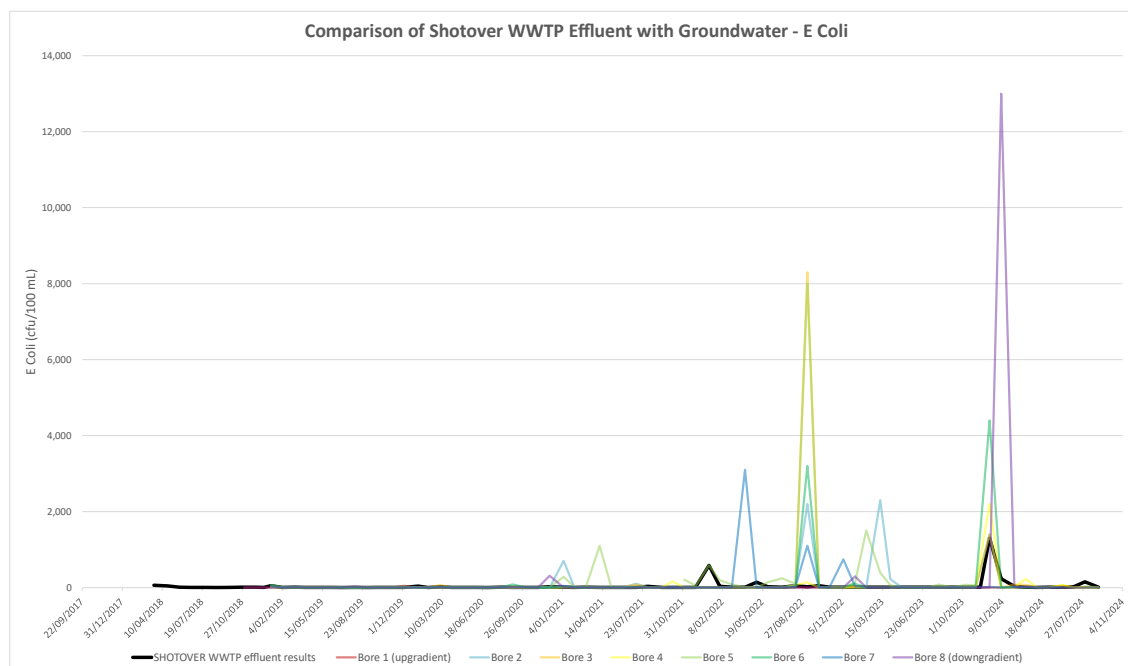
**Figure 2.12: E. coli in Groundwater Bores and Shotover WWTP Effluent**

The E. coli levels in the groundwater samples are shown to have increased variability in the latter half of the sampling period, with a large spike observed in September 2022 for bores 2, 3, 5, 6, and 7. This spike is not reflected in the E. coli level for the Shotover WWTP effluent in the same time period which was found to be 20 cfu/100mL.

It is possible that bacterial growth within the disposal field, as well as contamination by bird droppings etc, could result in levels of E. Coli higher than in the effluent.
