Project Number: 6-XO015.00

# Shepherds Hut Creek Debris Flow Hazard Report

14 September 2022

Date: September 2022 Reference: 6-XO015.00 Status: Issue 2

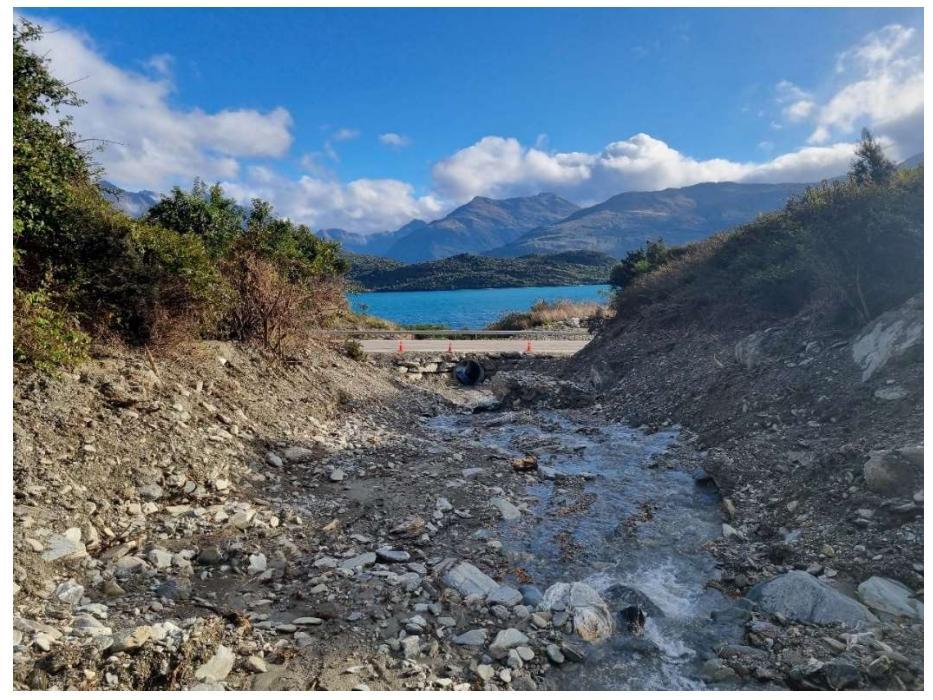
In the lower reaches of the stream the channel has been cleared and widened to a width of approximately 10 m. This section of the channel is directly upstream of the culvert and dominated by deposition of cobbles and boulders. Moderately steep banks typically 15 - 20° along the channel comprise sands, gravels, and cobbles with occasional boulders (shown in Figure 2). The channel walls are vegetated mainly with native shrubs. There is no evidence of the debris flow having overtopped the channel through this section during the most recent event.

Figure 2: Section 320 - 360 m asl - Lower reaches of Shepherds Hut Creek, looking downstream towards Glenorchy-Queenstown Road culvert and Lake Wakatipu.

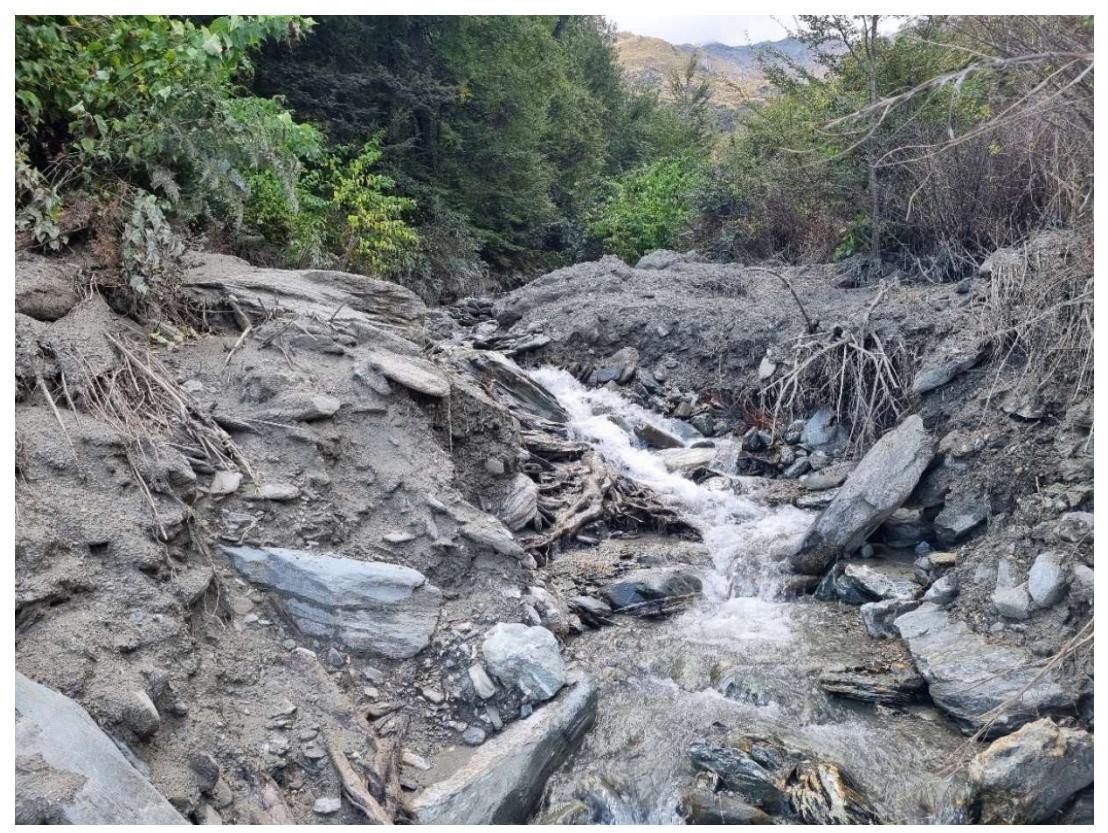
Through this section, the creek narrows and tends to step down over deposited boulder weirs (Figure 3). The stream channel is approximately 1m to 6 m wide. The bedload is dominated by boulders and cobbles. Sections of the channel are incised up to approximately 1.0 m. Silty deposits are visible on the vegetation bounding the creek channel to a depth of approximately 1 m above the existing creek level.

Figure 3: Section 360 – 380 m asl of Shepherds Hutt Creek showing incision of current stream of approx. 1m into bouldery debris fan material.

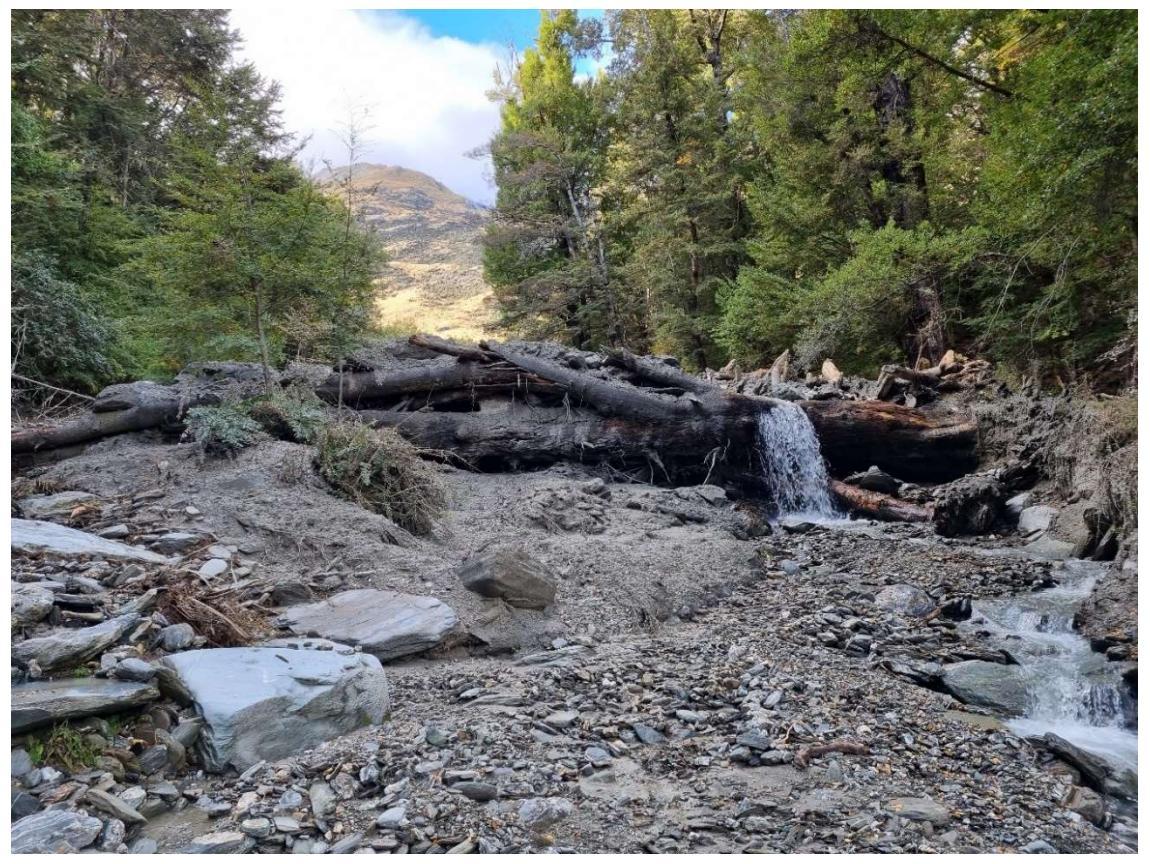
A logjam was noted approximately 300 to 500 m upstream from the culvert. It was observed that this tree had trapped a significant volume of sediment and woody debris. Whilst it is likely that this tree and sediment will slowly erode, breaching of this sediment trap under debris flow conditions has the potential to mobilise a significant volume of material. Entrainment of this material would result in a large volume of material inundating the road.

It is considered likely that following a further significant rainfall event this natural dam has the potential to breach suddenly and mobilise a significant amount of material towards the road.

Figure 4: Section 380 – 470 m asl - Large logjam damming a significant volume of debris upstream.

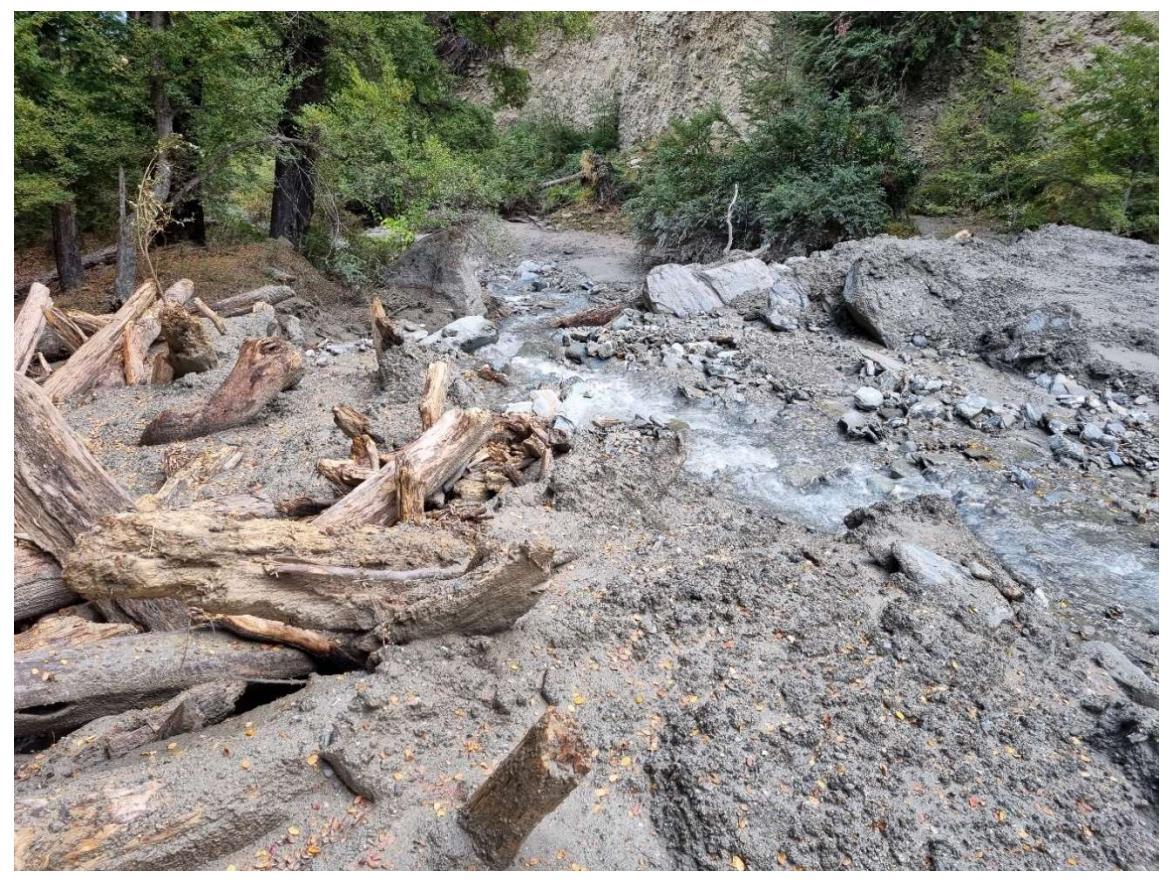
Figure 5: Section 380 - 470 m asl - View upstream of the logjam, showing a significant number of wooden debris and sediment has been deposited.

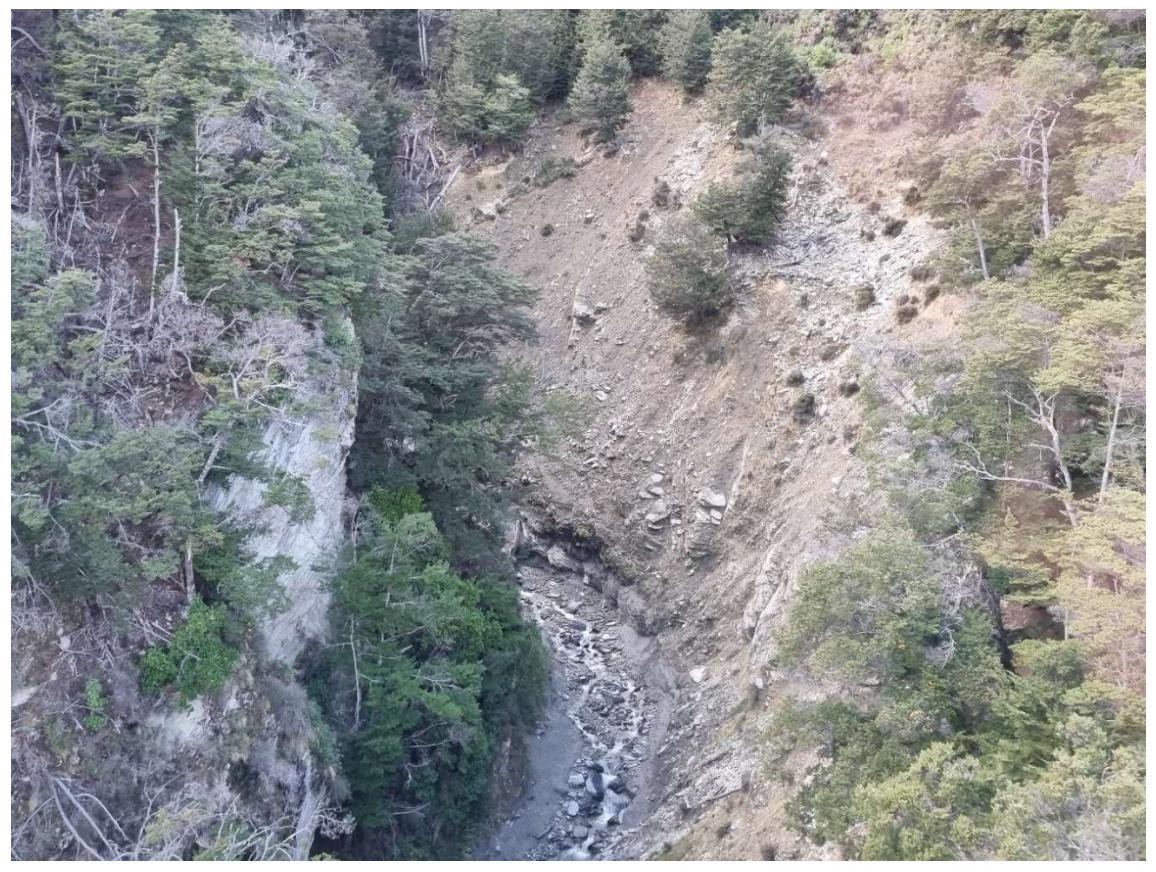
This section is bound by forest on the true right-hand side of the stream with evidence of ongoing erosion and extensive soil creep and shallow translational failures on the true left-hand bank. Both the left-hand and right-hand banks are steep through this section (e.g., 30 - 50°)

The depth of overburden soils overlying bedrock appears moderate (up to 3 – 5 m) here and capable of contributing large volumes of material in the event of a landslide occurring in the steep bare soils in the true left-hand bank (Figure 6). Beech forest is present along the channel and wooden debris has entered the creek. The forest is beginning to thin out and transition into tussock.

There is still significant bedload through this section with some exposed bedrock on the true righthand bank and the creek cutting down to bedrock in places. Some of the scarps appear quite large (>100 m in length – shown in Figure 7).

Figure 6: Section 470 – 900m asl - Exposed bedrock on right left-hand bank and steep eroding soil on true left-hand bank.

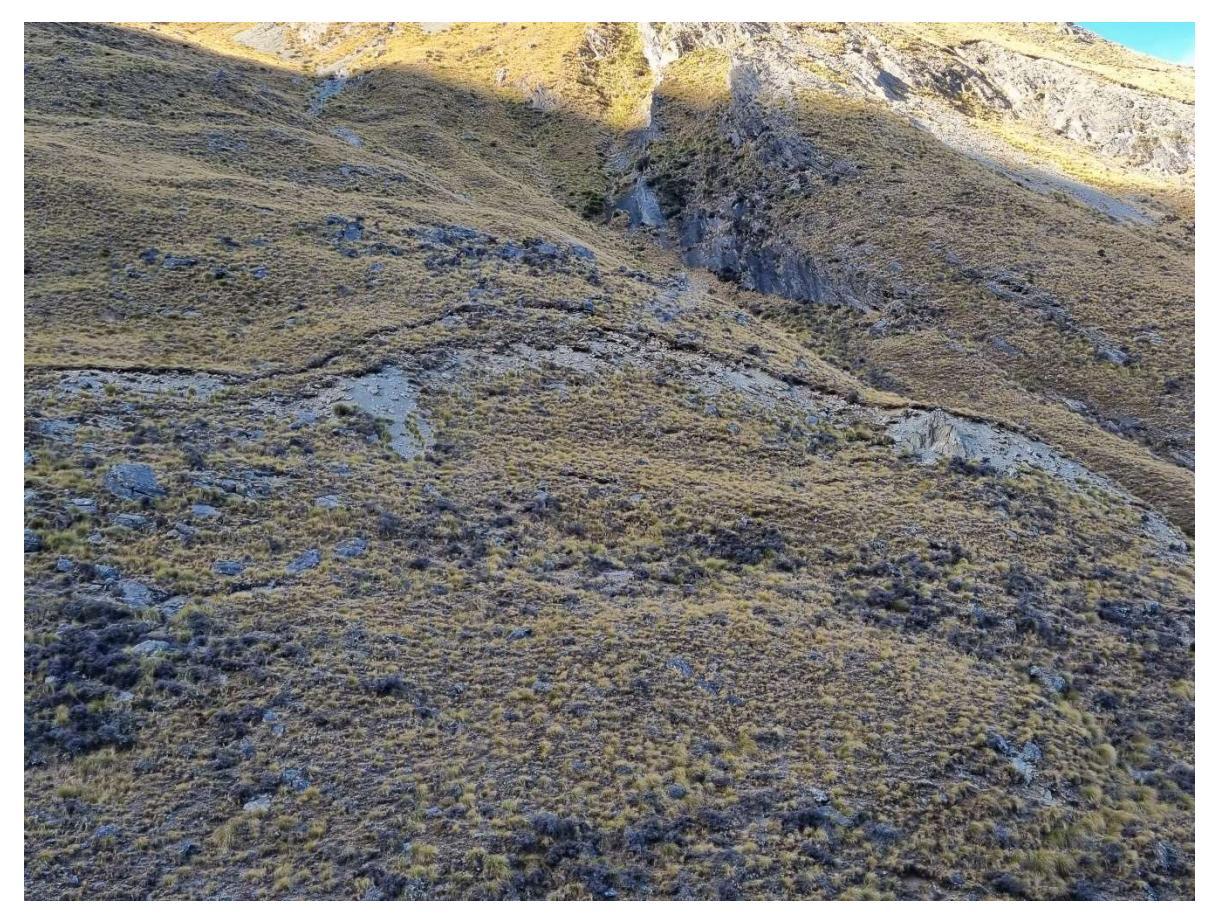
*Figure 7:* Section 900 - 1400m asl - Extensive evidence of shallow mass movements with distinct scarps on slopes along the true left-hand bank

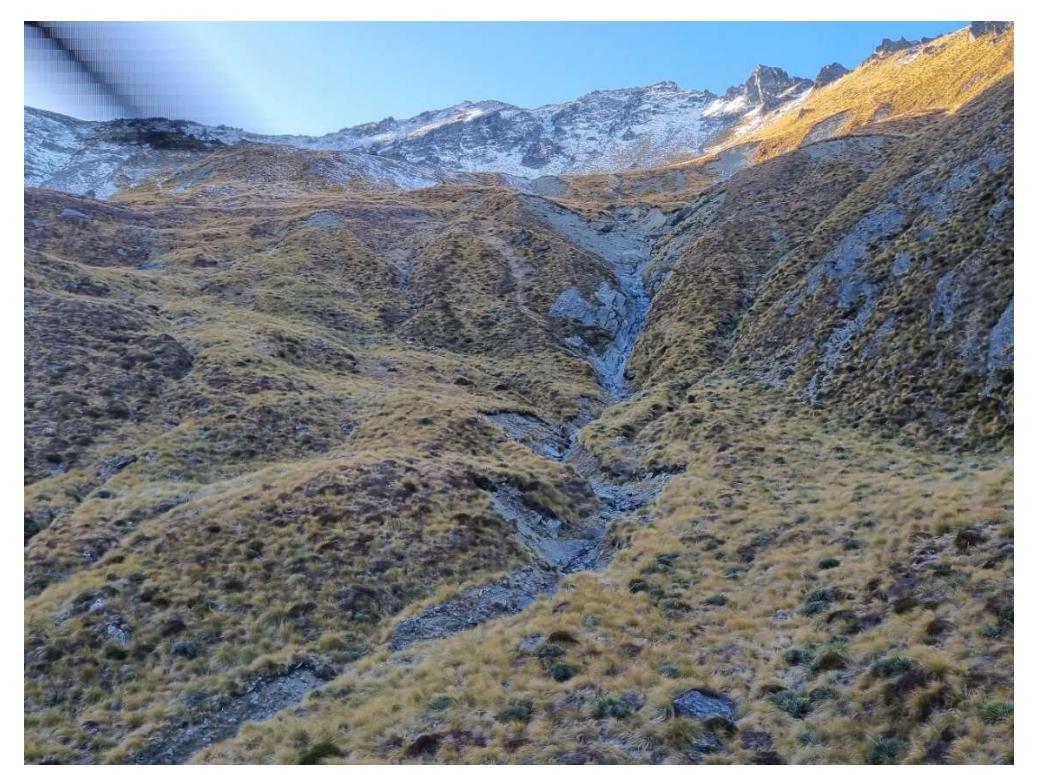
This section is steep (>30°) with the stream narrowing and incised down to bedrock. Numerous slip scarps bound the creek and add boulders to the creek channel particularly at the confluence of the main tributaries. The scarps appear shallow, approximately 1.0m deep. The vegetation through this section is dominated by alpine tussocks.

*Figure 8:* Section 900 - 1400 m asl - Widespread erosion along banks in the upper catchment and evidence of creeping mass movements.

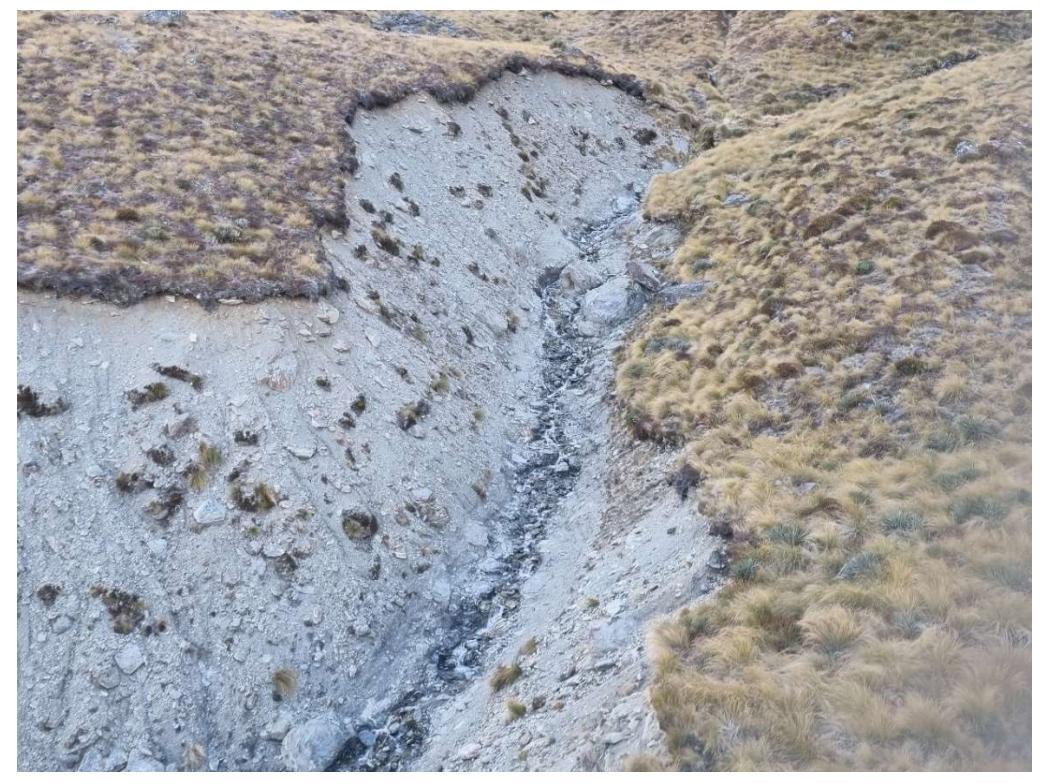
Figure 9: Section 900 - 1400 m asl - Erosion within colluvium along banks in the upper catchment.

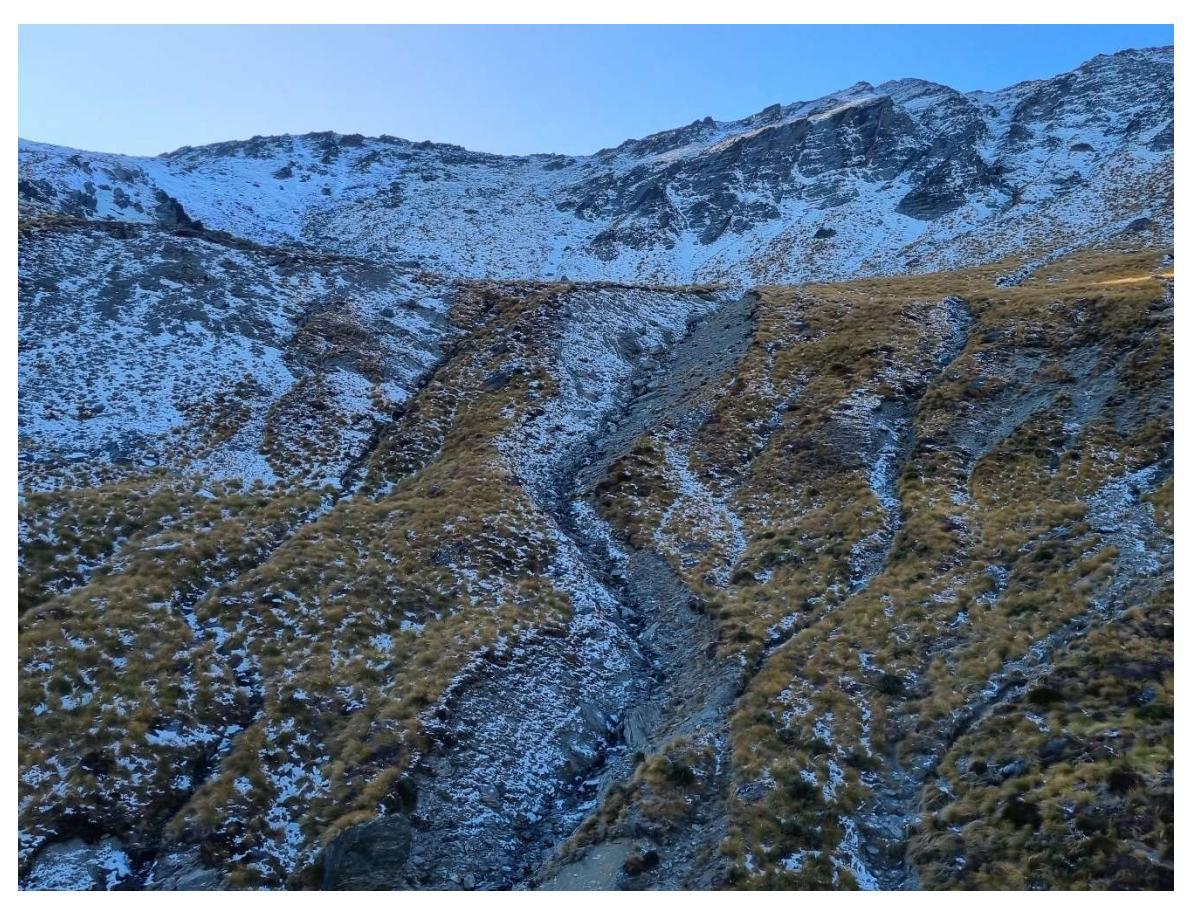
This section within the upper catchment of Shepherds Hutt Creek has minimal (approximately 1 – 2.0m of topsoil and colluvium) soil cover and predominantly displays exposed schist bedrock. It is considered this section provides little contribution of material due to relatively low degree of weathering compared to the lower reaches of the catchment, however there is still a notable amount of loose material that can be entrained during a high intensity rainfall event as shown in Figure 10.

Figure 10: 1400 – 1800 m asl - Photograph of the upper slopes with transition from tussock to exposed bedrock. Colluvium and soil cover estimated to be up to max. 1m. Evidence of active bank erosion present along channels that are incised into bedrock (low volume of erodible bedload).

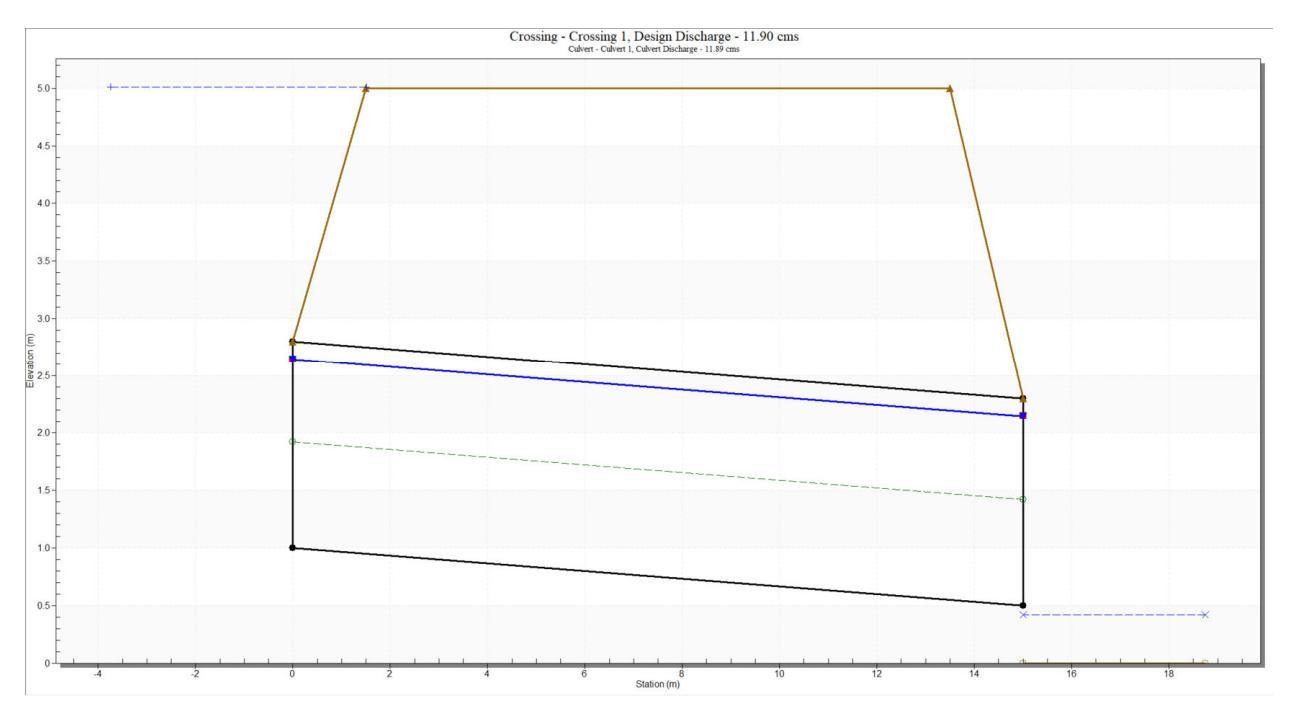
The existing culvert was predicted to overtop at a total discharge of 11.9 m<sup>3</sup>/s (Figure 4**Error! Reference source not found.**). This is approximately the lowest estimated discharge in Table 2.

Figure 4. The existing 1800% culvert overtopping at a 11.9 m<sup>3</sup>/s discharge.

The results of the above assessment indicate that the existing 1800Ø culvert is unsuitable for all estimated design discharges. By comparison, modelling determined that a new circular 2550Ø culvert would improve overall discharge capacity but, fail to satisfy the design discharge of 25 m<sup>3</sup>/s. Further modelling indicated that a new precast 3 m x 2.5 m (H x W) box culvert will satisfy the estimated design flow.

Given the known debris issue at this location we would recommend that a box culvert is installed, with an allowance for embedment below the stream bed.

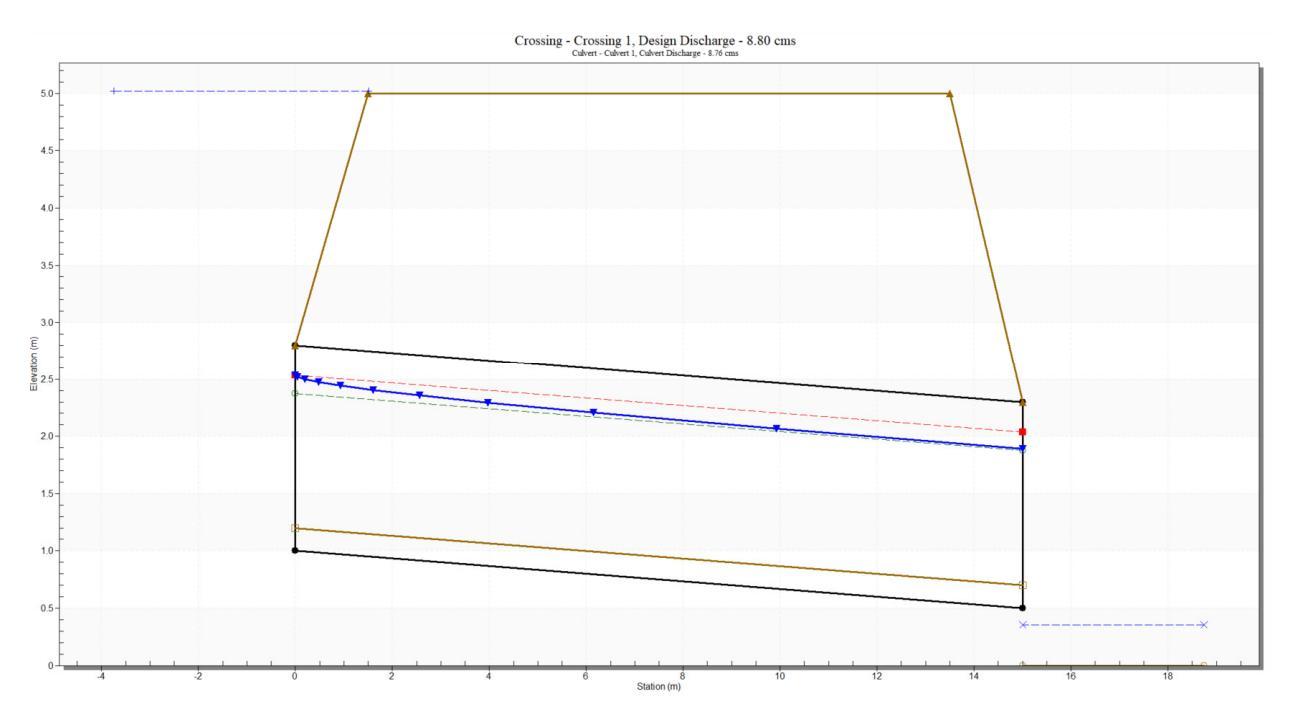
Assuming a 200 mm accumulated depth of debris material in the culvert the total discharge reduces to 8.8 m<sup>3</sup>/s (Figure 45**Error! Reference source not found.**). This is lower than all estimated flood flows in Table 2.

Figure 5. The existing 1800% culvert overtopping at a 8.8 m<sup>3</sup>/s discharge.

- 1. The downstream pavement edge and embankment slope is reinforced to prevent erosion damage.
- 2. The cover to the invert steel is increased to say 100 mm to accommodate abrasion. The box culvert is installed at an increased gradient to improve sediment transport through the culvert.
