Morphology of the Clutha River/Mata- Au between Roxburgh Dam and the Pacific Ocean

March 2017

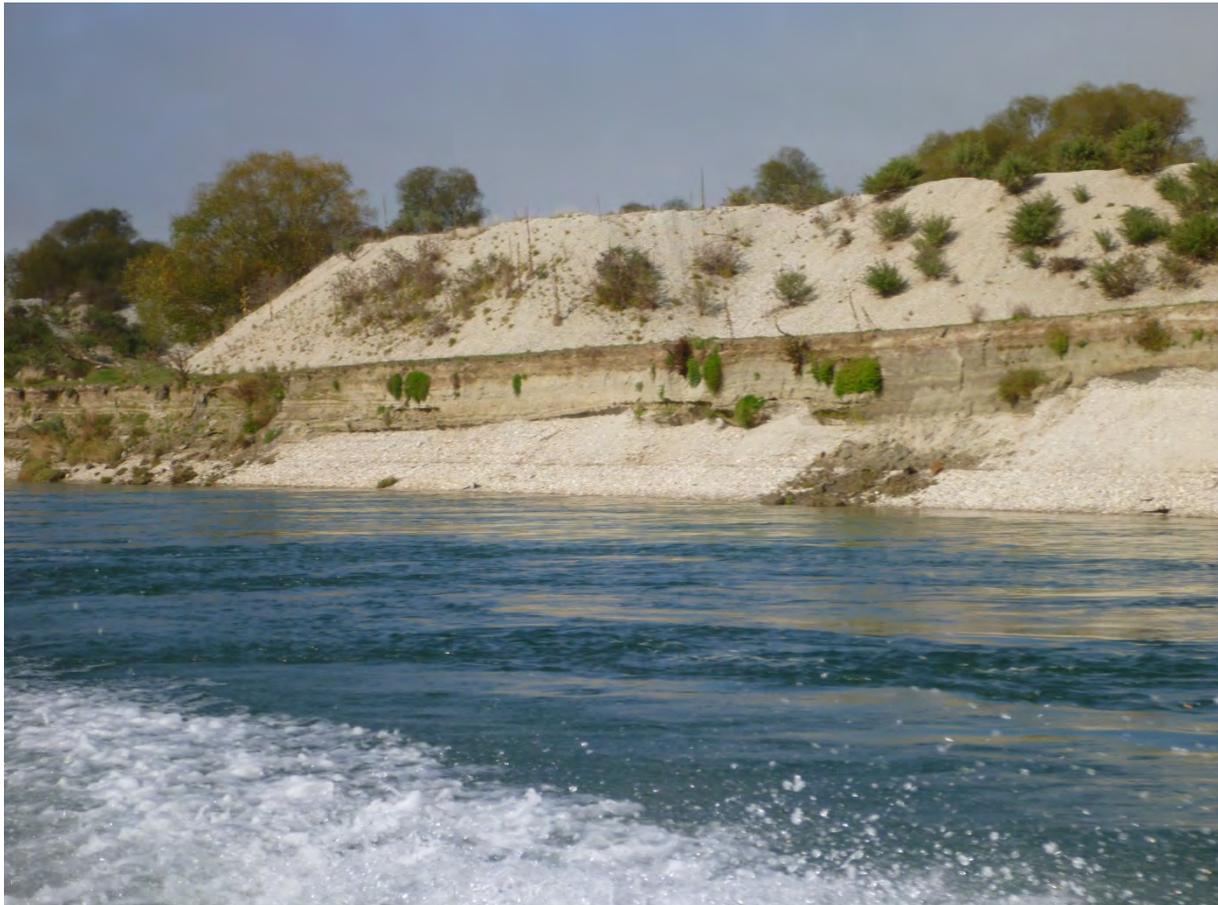
Figure 15. Evidence of erosion on the true right bank upstream of Gull Island/cross section C21 (April 2002).

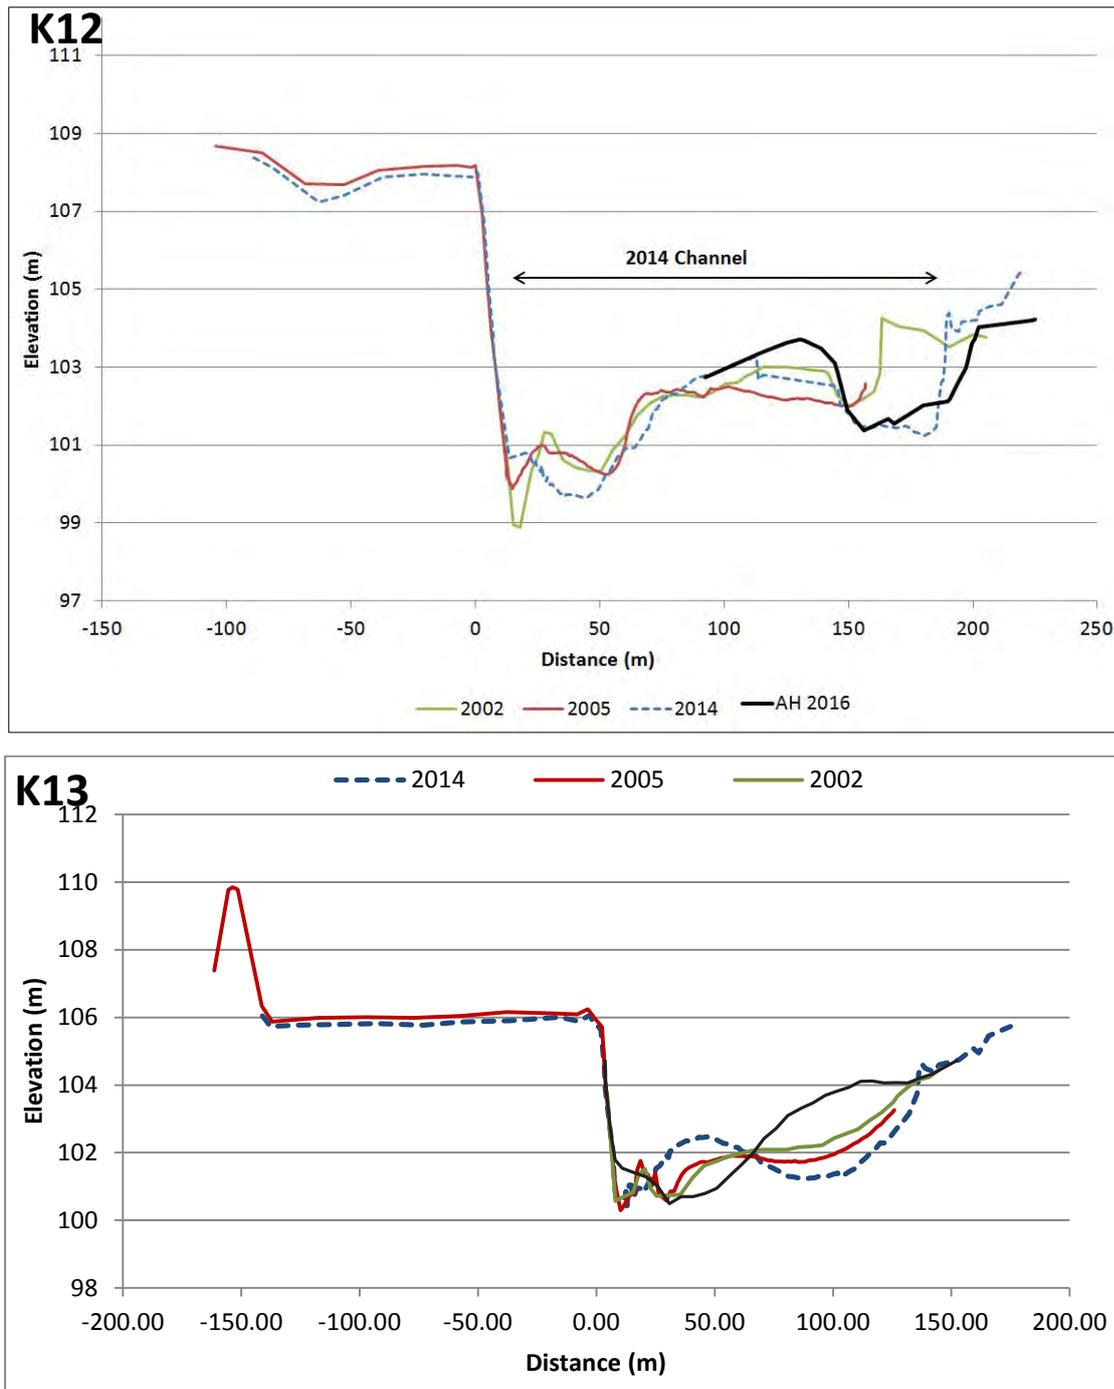
Figure 19. Changes in channel profile of cross sections K12 and K13 (looking downstream), including 2016 data collected by gravel extraction consent holder that partially covers cross section K12.

The partial cross-section K12 (Figure 19) collected in 2016 by the gravel extraction consent holder indicates there has been a build-up of the mid-channel bar and erosion of the bank, but whether the erosion can be attributed more to overall gravel stripping or gravel build-up and displacement of the channel is not clear without a complete cross section and data from up- and down-stream of the site. A full re-survey of this and surrounding cross sections is recommended before any further gravel extraction is consented in the area, given the fact

that is still unclear whether extraction has helped stop bank erosion or exacerbated it in recent years, and the overall trend of recent bed degradation in the Koau branch.

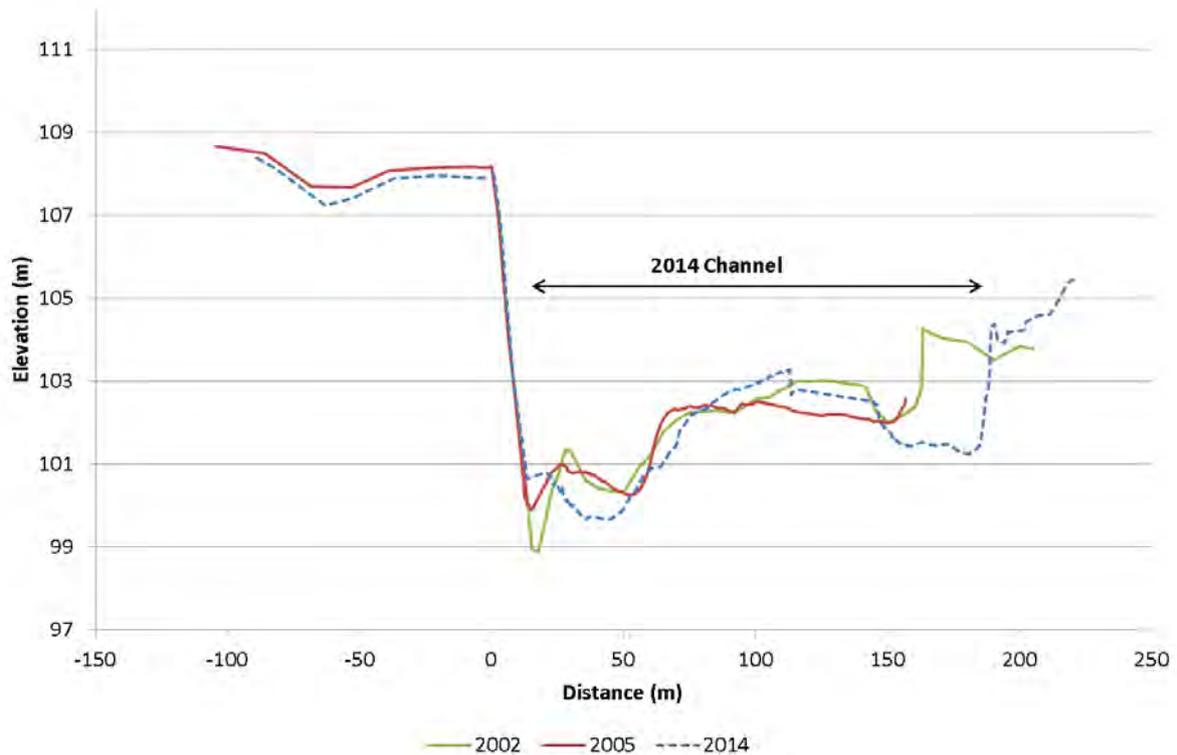
Figure 106. Clutha River/Mata-Au cross-section K12, looking downstream

Cross-section K12 is located 14.9 km upstream of the confluence of the Koau branch of the Clutha River/Mata-Au with the Pacific Ocean. Between 2005 and 2014 the main channel has experienced both aggradation and degradation on the true left bank, the centre of the channel has aggraded. The true right bank of the main channel appears to have eroded, however the 2005 survey did not extend far enough on the right bank to confirm this.

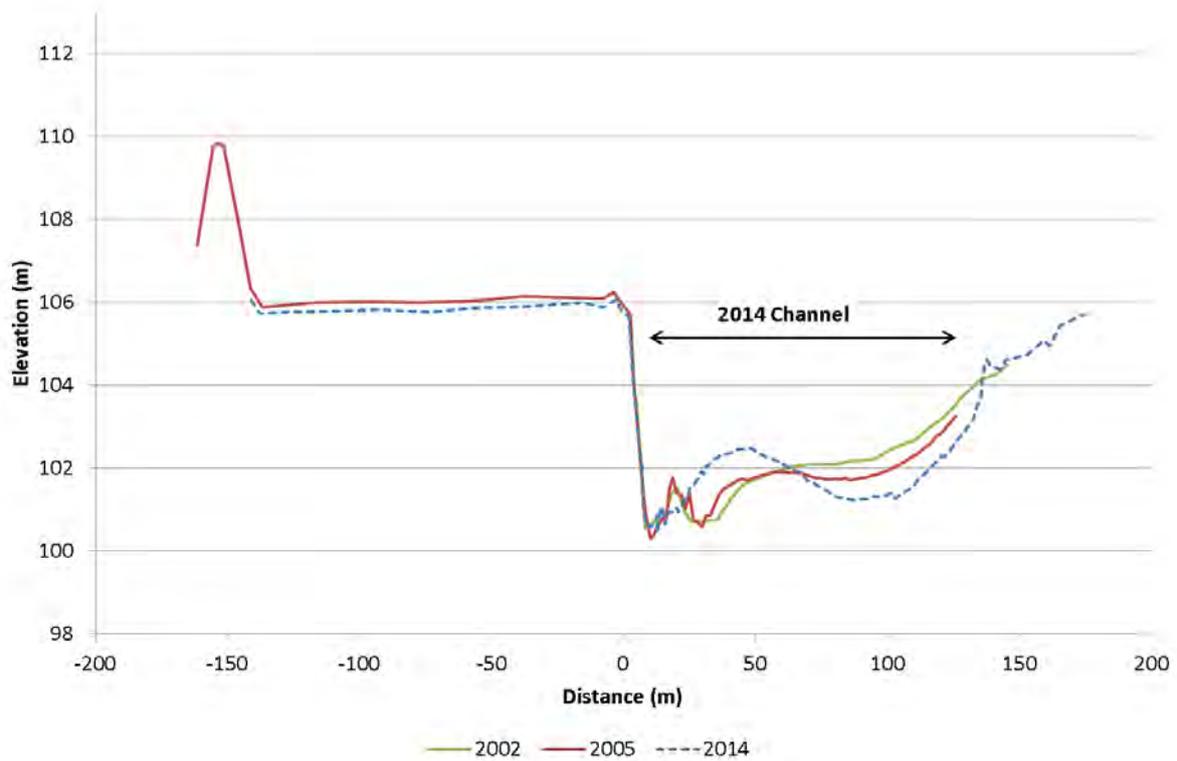
Figure 108. Clutha River/Mata-Au cross-section K13, looking downstream

Cross-section K13 is located 16 km upstream of the confluence of the Koau branch of the Clutha River/Mata-Au with the confluence of the Pacific Ocean. The true left of the main channel has remained similar between 2005 and 2014, the centre of the main channel has aggraded with degradation and bank erosion occurring on the true right of the main channel.

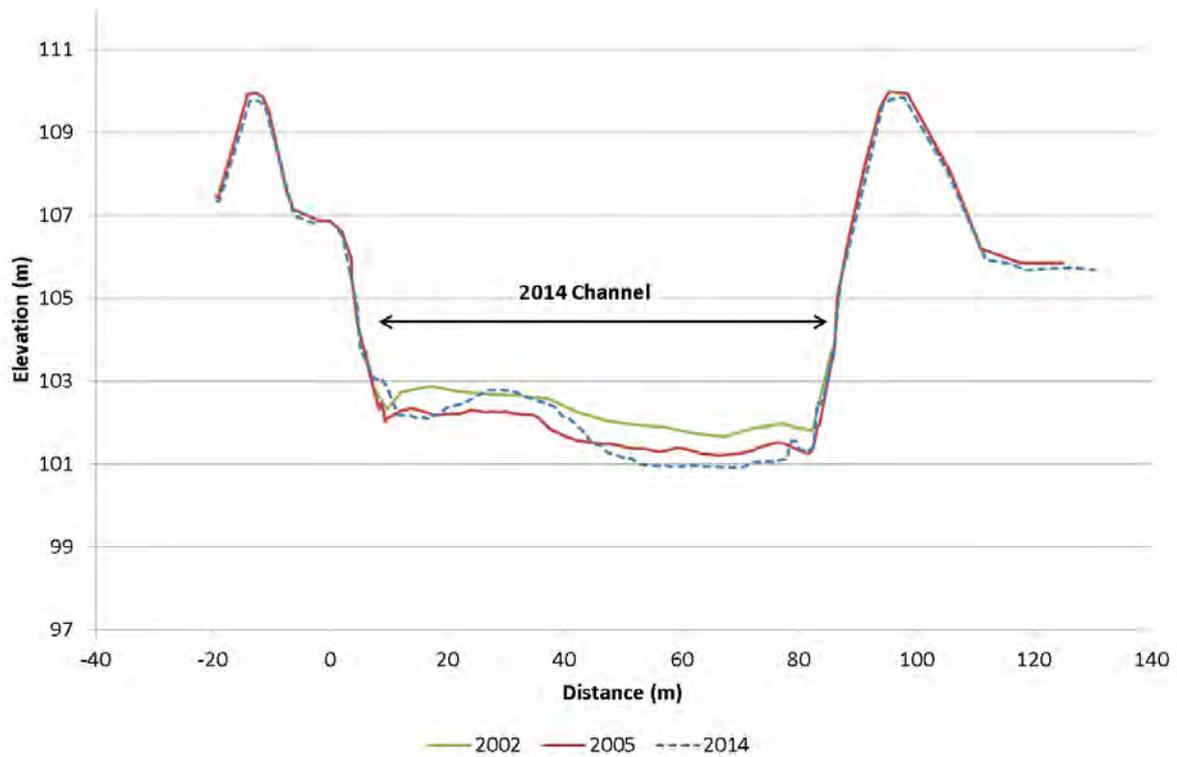
Figure 142. Clutha River/Mata-Au cross-section M12, looking downstream

Cross-section M12 is located 27 km upstream of the confluence of the Matau Branch of the Clutha River/Mata-Au with the Pacific Ocean. The true left of the channel has aggraded and the true right has degraded between 2005 and 2014 with the wider floodplain remaining similar.

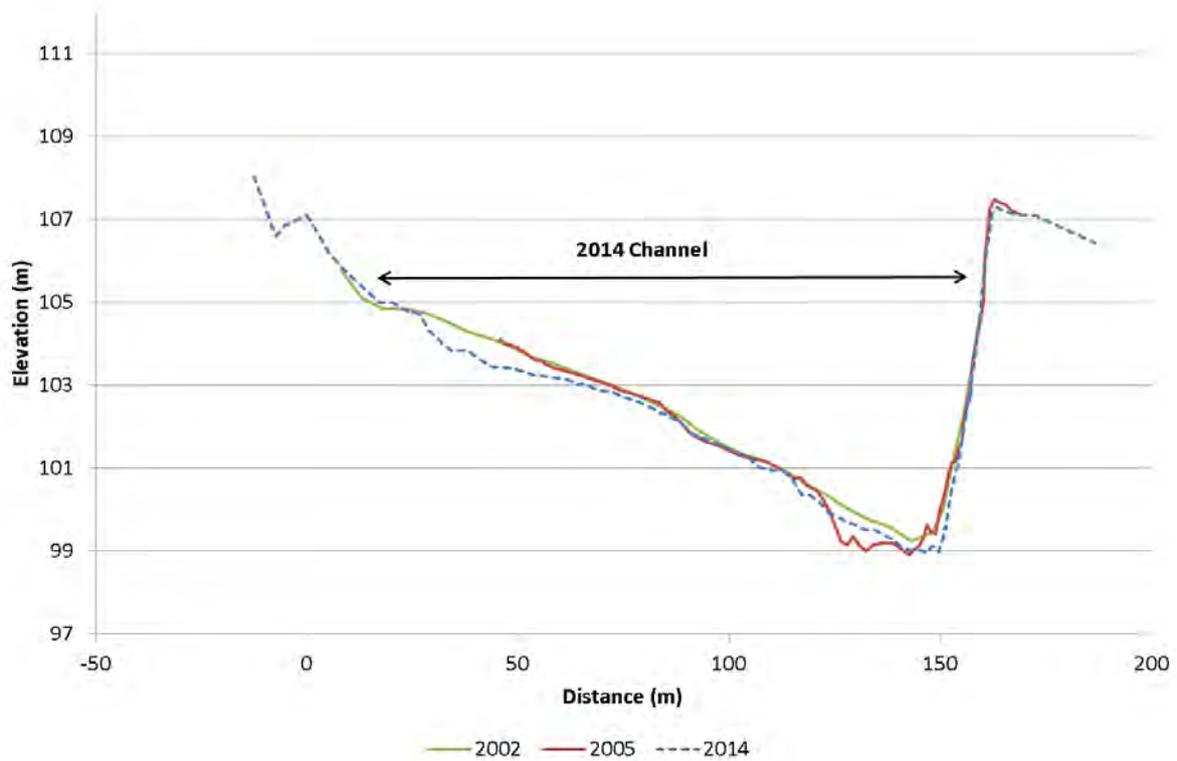
Figure 154. Clutha River/Mata-Au cross-section C7, looking downstream

Cross-section C7 is located 2.3 km upstream of the Clutha River/Mata-Au bifurcation at Balclutha, adjacent to the Balclutha Lagoon. Between 2005 and 2014 the true left of the channel has degraded with the thalweg section of the channel eroding and moving towards the right bank.

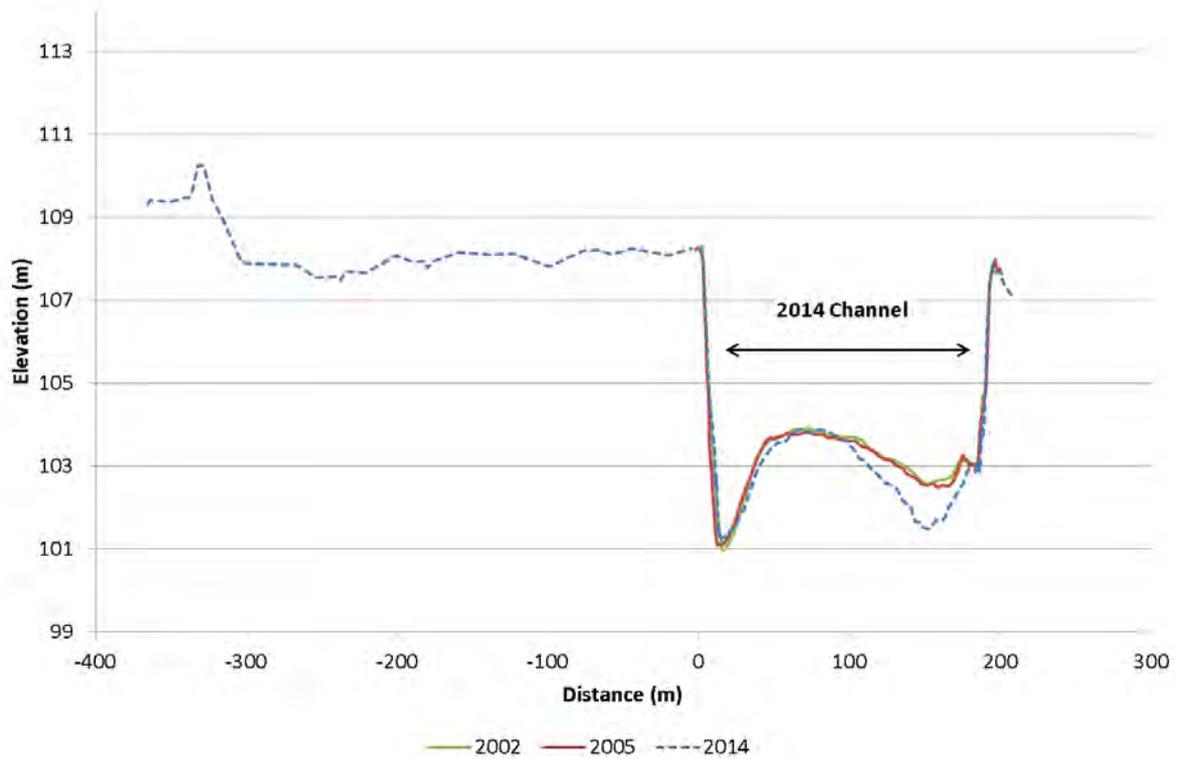
Figure 156. Clutha River/Mata-Au cross-section C8, looking downstream

Cross-section C8 is located 3.2 km upstream of the Clutha River/Mata-Au bifurcation at Balclutha. The true left of the main channel has remained similar between 2005 and 2014 with the right side of the channel degrading by 1 m at the deepest location. The 2005 survey did not extend sufficiently on the true left bank to allow a comparison to be made.

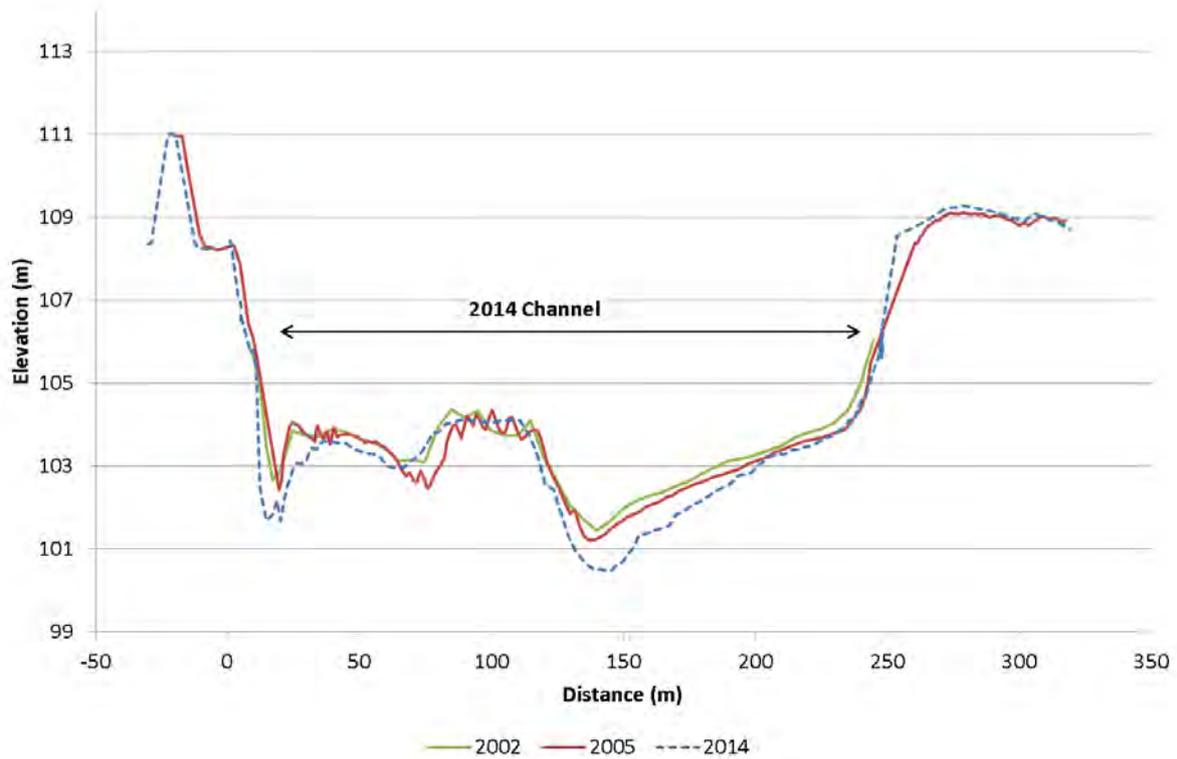
Figure 166. Clutha River/Mata-Au cross-section C13, looking downstream

Cross-section C13 is located 5.5 km upstream of the Clutha River/Mata-Au bifurcation at Balclutha. The true left of the channel has widened and degraded between 2005 and 2014 with degradation also occurring in the centre of the channel. The true right bank has aggraded between 2005 and 2014.

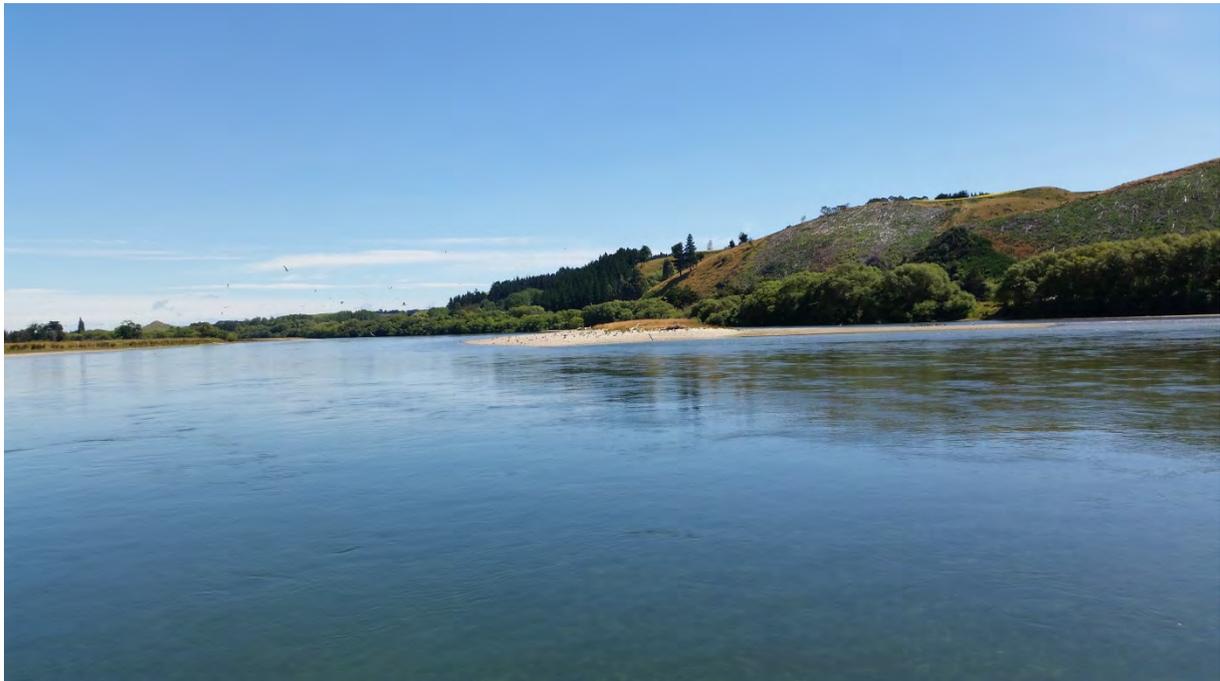
Figure 177. Clutha River/Mata-Au cross-section C18, looking upstream

Cross-section C18 is located 8.6 km upstream of the Clutha River/Mata-Au bifurcation at Balclutha. The point labelled A is a mid channel bar that becomes exposed at low flows. The true left channel has degraded by 3 m and become more confined between 2007 and 2016. The true right side of the gravel has degraded and the true right channel has remained in a similar position between 2007 and 2016.

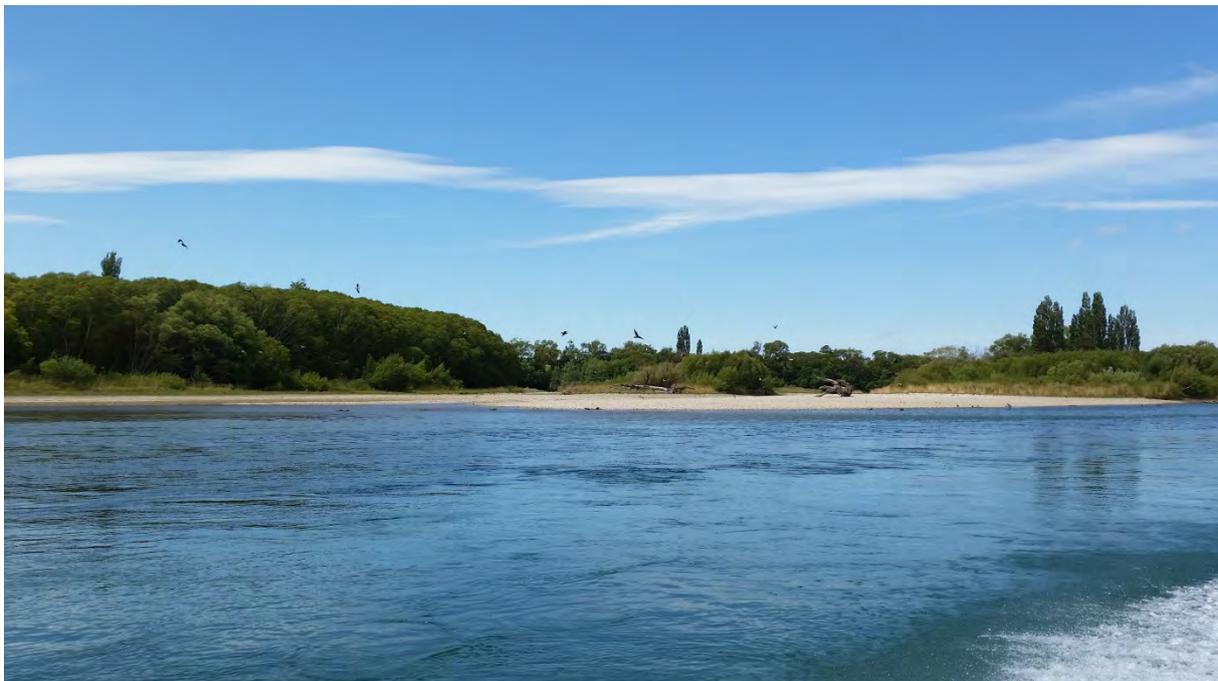
Figure 183. Clutha River/Mata-Au cross-section C21, looking downstream

Cross-section C21 is located 25.6 km upstream of the Clutha River/Mata-Au bifurcation at Balclutha and is situated on a secondary channel that flows around a gravel island just downstream of the Allangrange Road bridge in Clydevale. The channel has both aggraded and degraded with the creation of two, more defined, channels between 2007 and 2016.

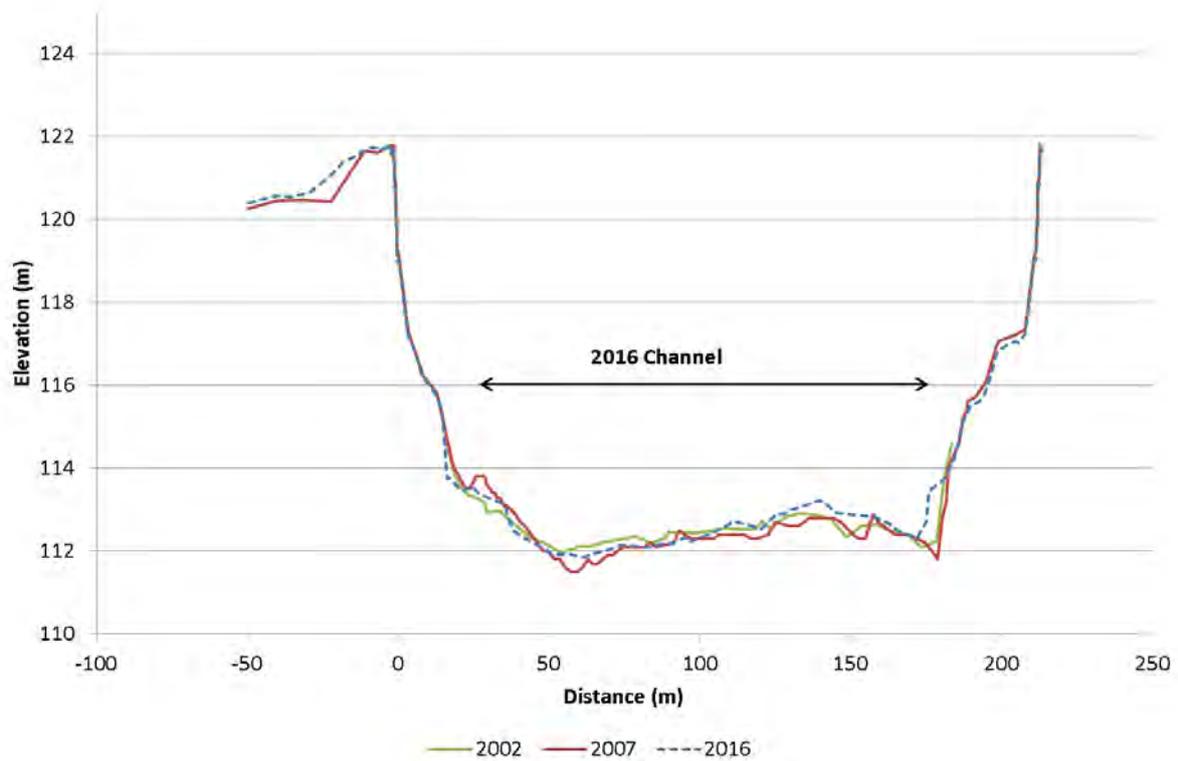
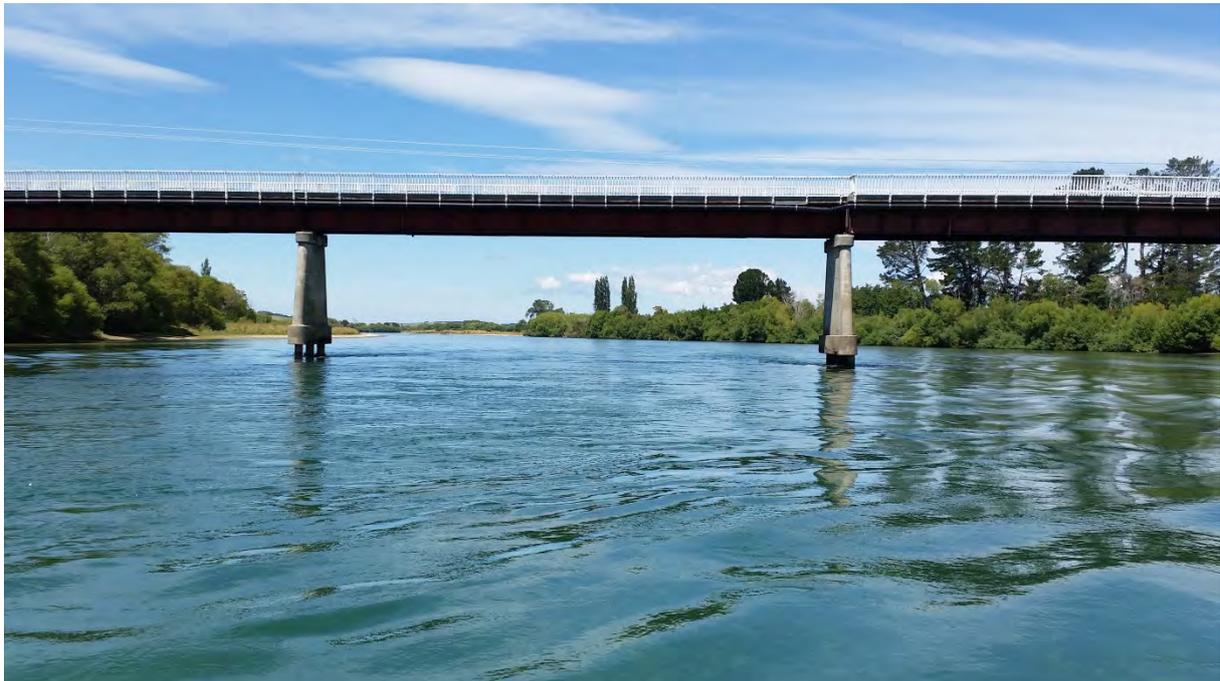
Figure 184. Clutha River/Mata-Au cross-section C22, looking downstream

Figure 185. Clutha River/Mata-Au cross-section C22, looking upstream

Cross-section C22 is located 26.7 km upstream of the Clutha River/Mata-Au bifurcation at Balclutha and is situated at the Allangrange Road bridge in Clydevale. The channel has mostly aggraded at this location with minor degradation occurring in the centre of the channel between 2007 and 2016.

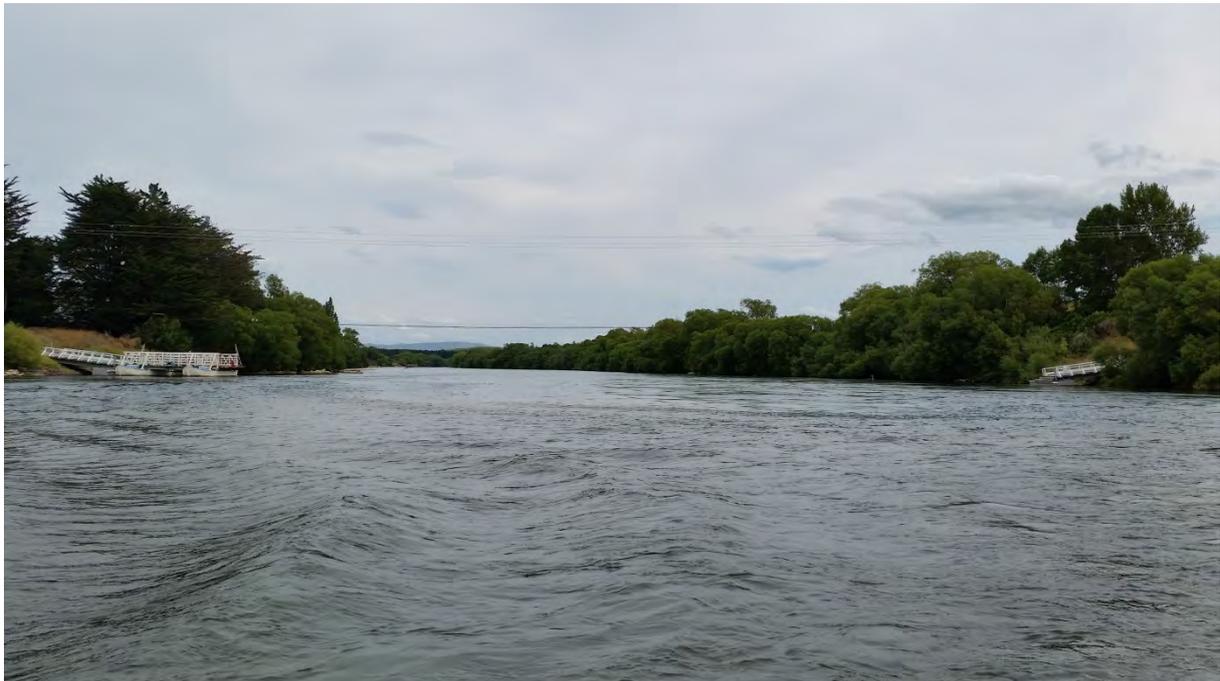
Figure 189. Clutha River/Mata-Au cross-section C24, looking downstream

Cross-section C24 is located 36.9 km upstream of the Clutha River/Mata-Au bifurcation at Balclutha and is situated at the Tuapeka Mouth ferry crossing. The true left of the channel has aggraded between 2007 and 2016 while the true right of the channel has degraded by about 2.8 m. The banks have remained in a similar position between 2007 and 2016.

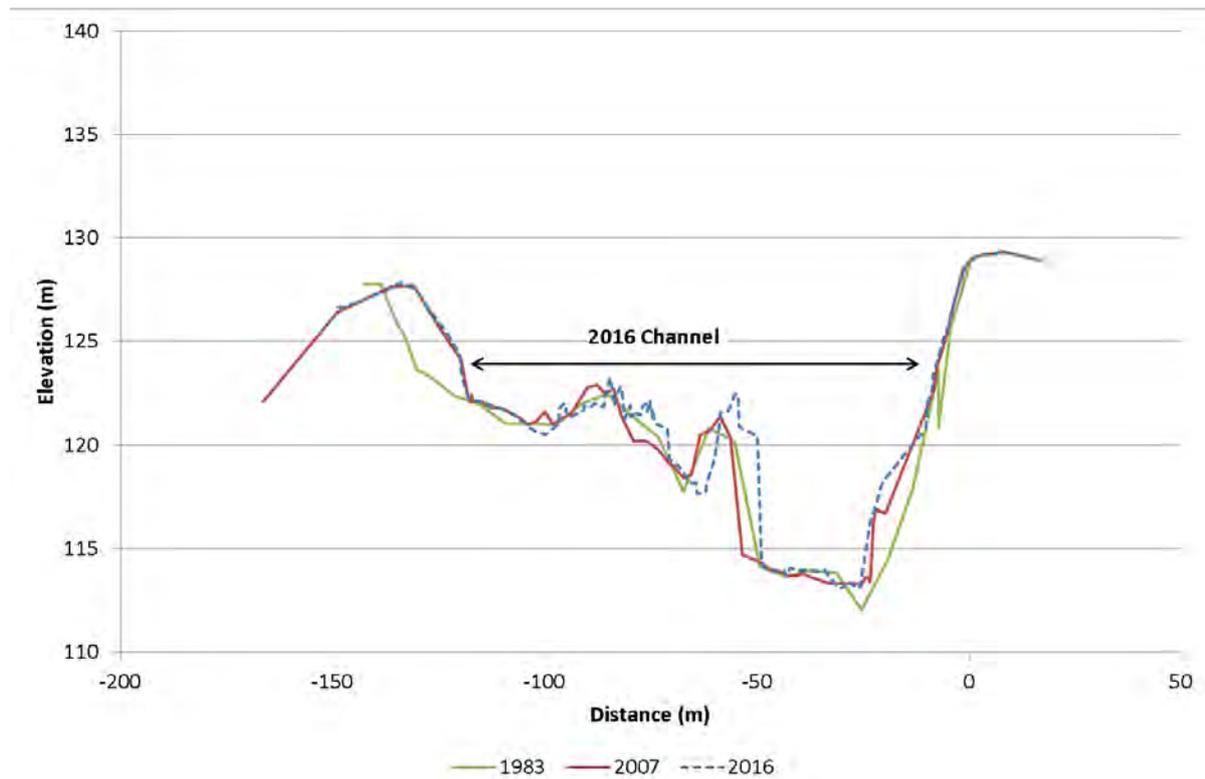
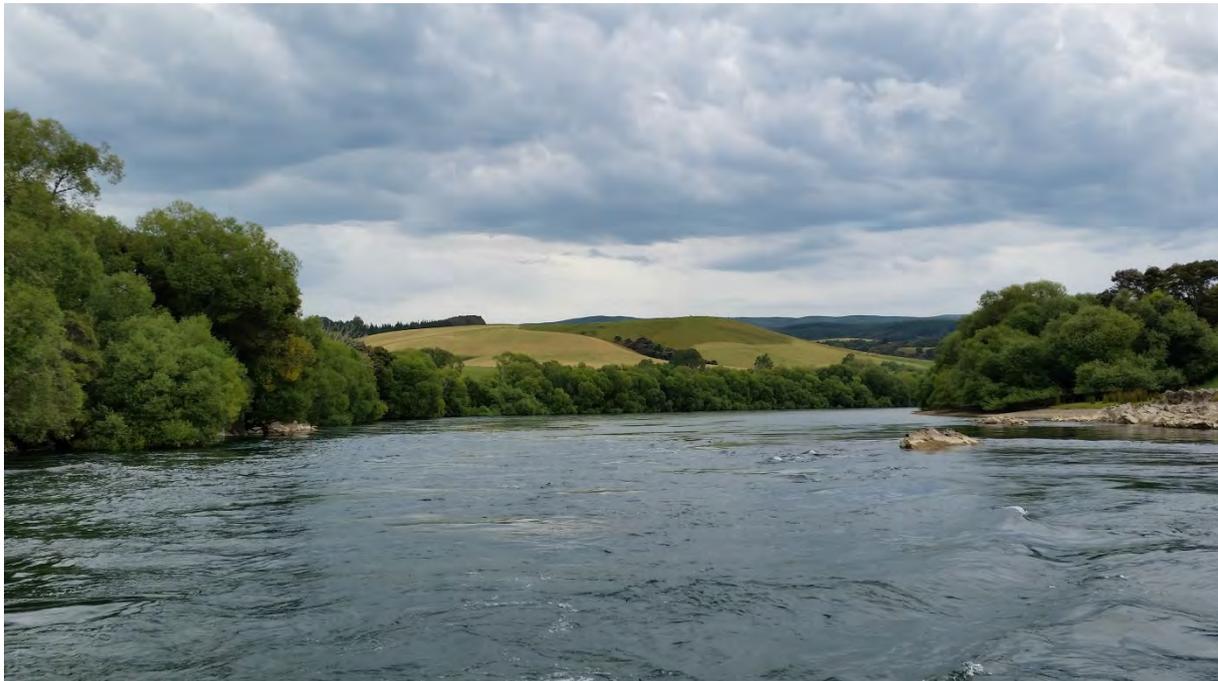
Figure 190. Clutha River/Mata-Au cross-section C25, looking downstream

Figure 191. Clutha River/Mata-Au cross-section C25, looking upstream

Cross-section C25 is located 41.2 km upstream of the Clutha River/Mata-Au bifurcation at Balclutha. Between 2007 and 2016 the true right of the channel became more confined with some minor aggradation and degradation on the true left. The thalweg has remained in the same horizontal and vertical position between 2007 and 2016.
