Natural hazards in the Cardrona Valley

Summary Report November 2011

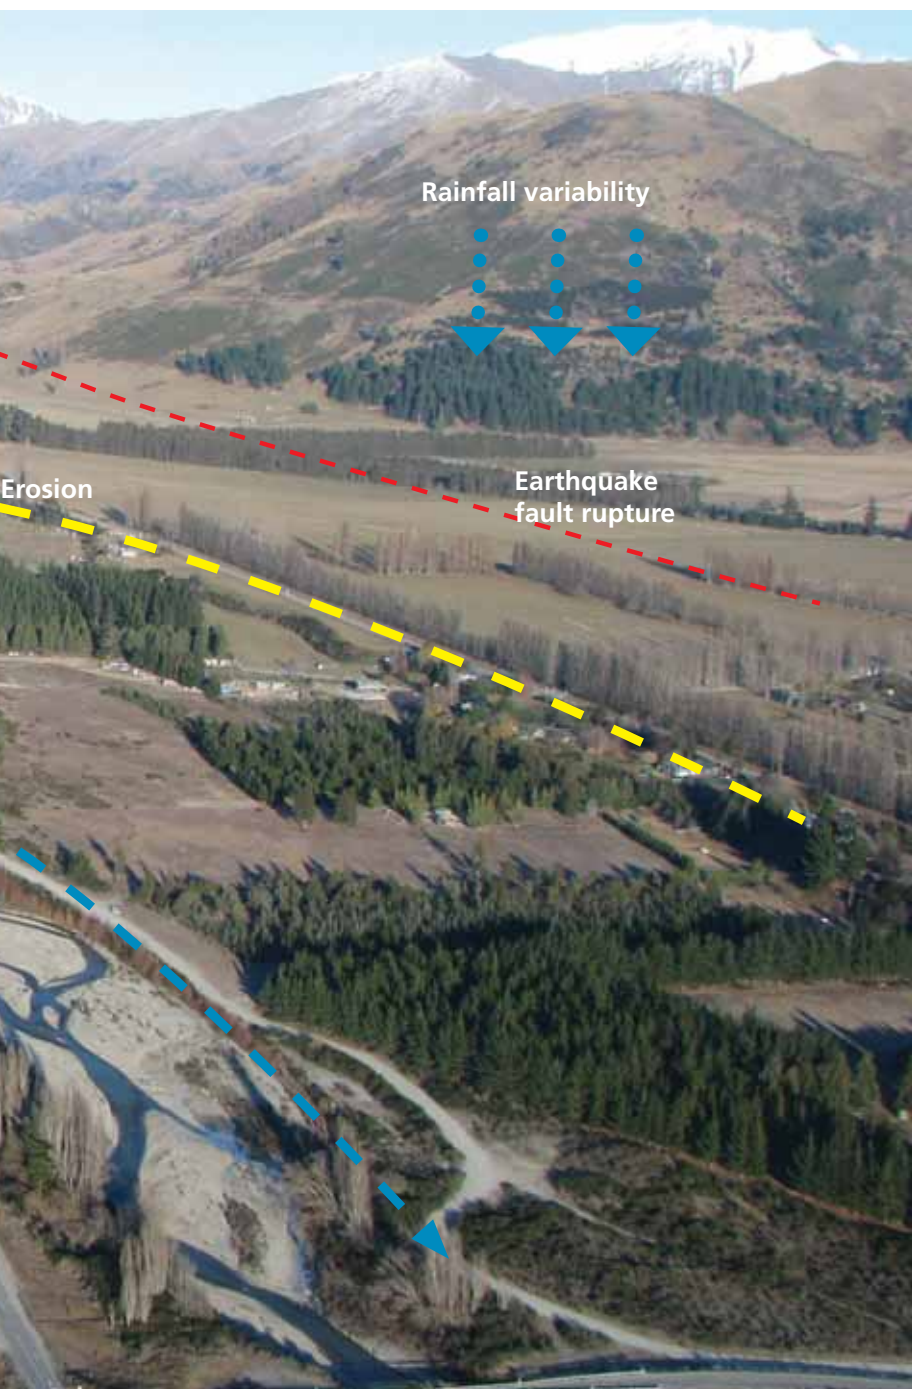
The Cardrona Valley has a complex hazard setting (Figure 2). Various parts of the valley are exposed to varying levels of flood hazard, alluvial fan hazard, debris flows, mass movement, and seismic hazards generated by earthquakes. Inundation, erosion, and sedimentation are all associated with flood hazard and can affect areas within the Cardrona River floodplain or its tributaries.

Figure 2. Natural hazards in the Lower Cardrona Valley. Photo taken looking upstream with the Ballantyne Rd bridge visible in the bottom right.

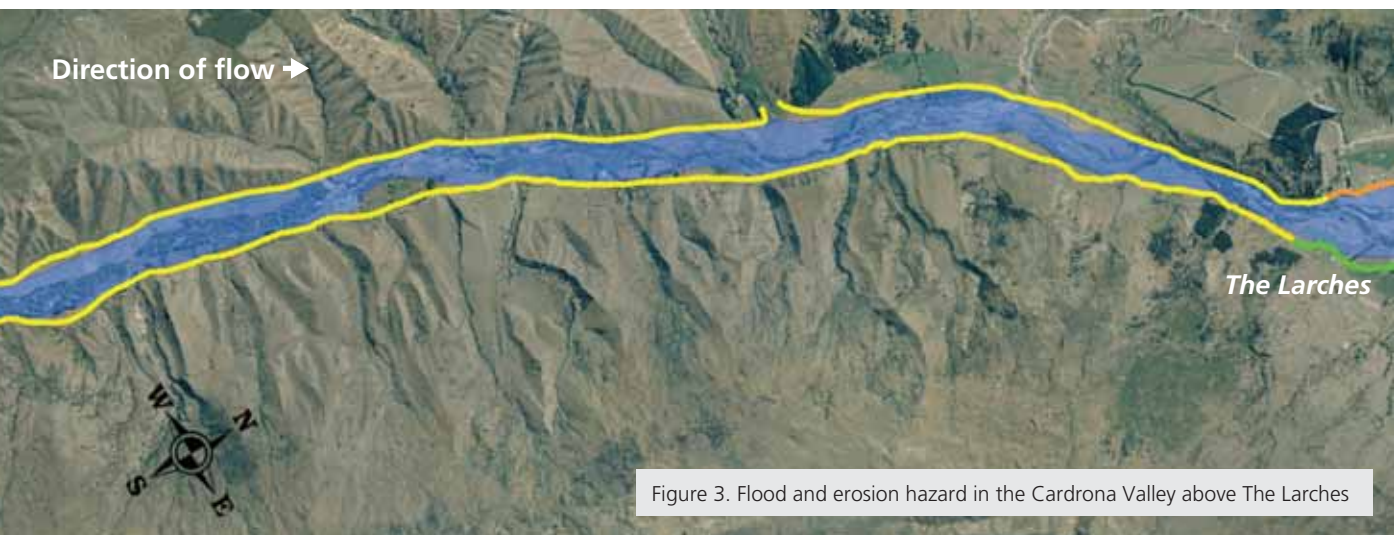
The area subject to flood hazard and erosion has been identified along the length of the Cardrona River and represents locations that may be subject to flood inundation, sedimentation, and erosion during a flood event (Figures 3 and 4).

Figure 3. Flood and erosion hazard in the Cardrona Valley above The Larches

Areas subject to erosion hazard adjacent to the Cardrona River are shown in Figures 3 and 4. Bank erosion has been categorised as high, moderate, and low based on channel morphology, on-site investigations and aerial photographs.

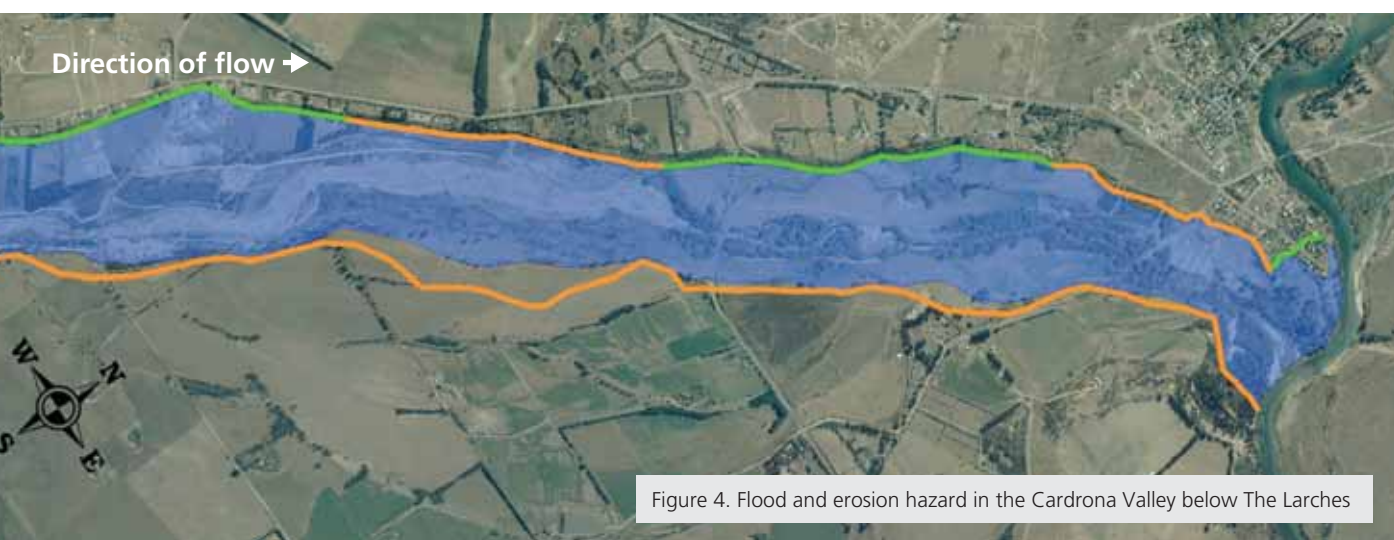
Figure 4. Flood and erosion hazard in the Cardrona Valley below The Larches

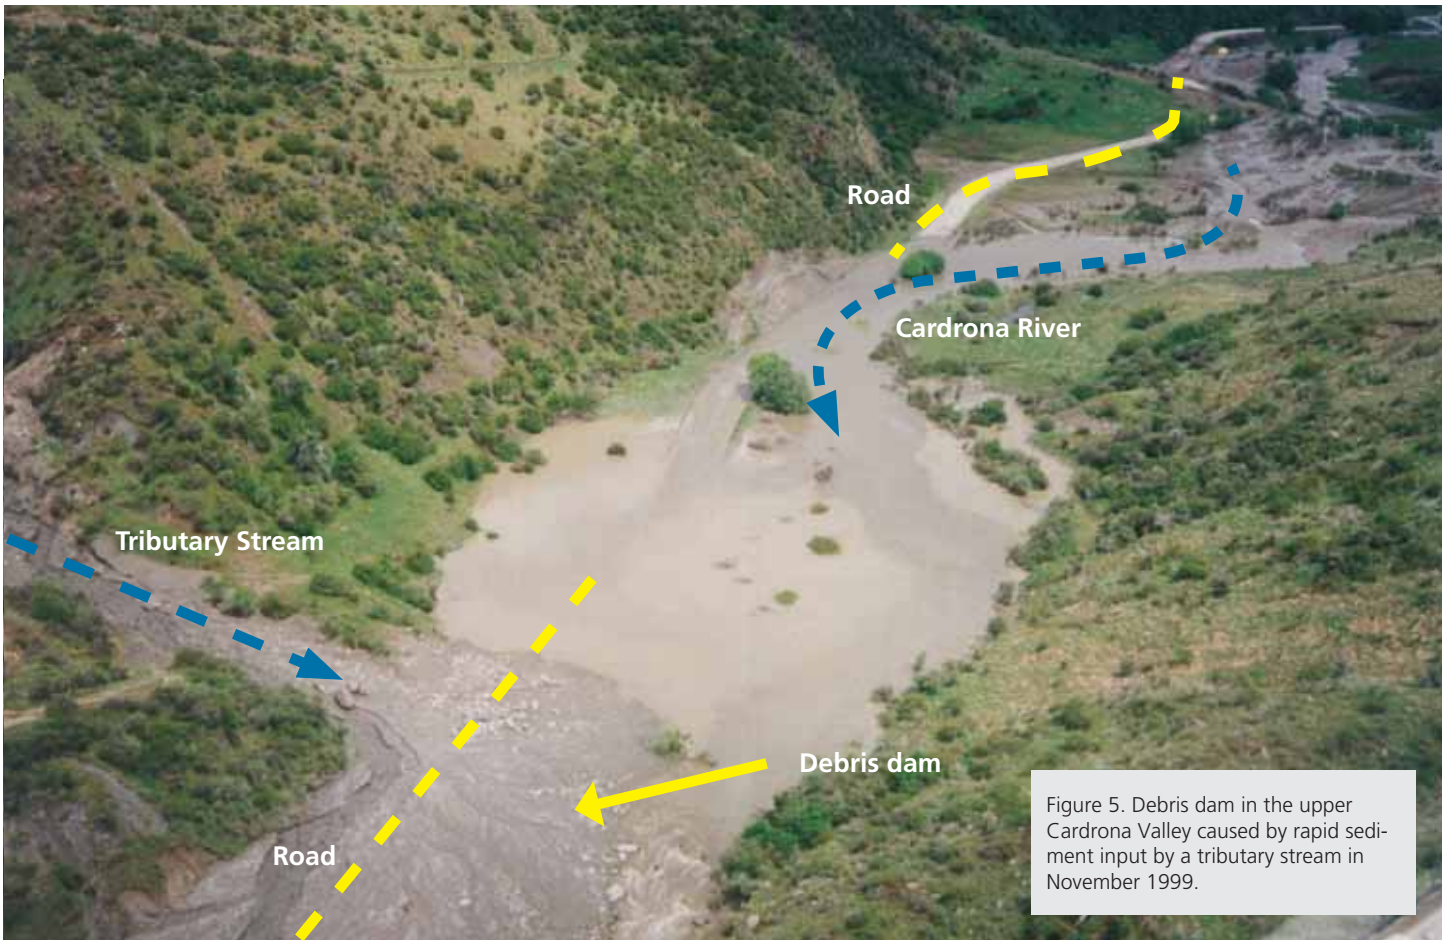
In the upper catchment above Cardrona village, the confined nature of the channel and rapid sedimentation from tributary streams

can result in channel blockage and debris dam formation (Figure 5).

Figure 5. Debris dam in the upper Cardrona Valley caused by rapid sediment input by a tributary stream in November 1999.

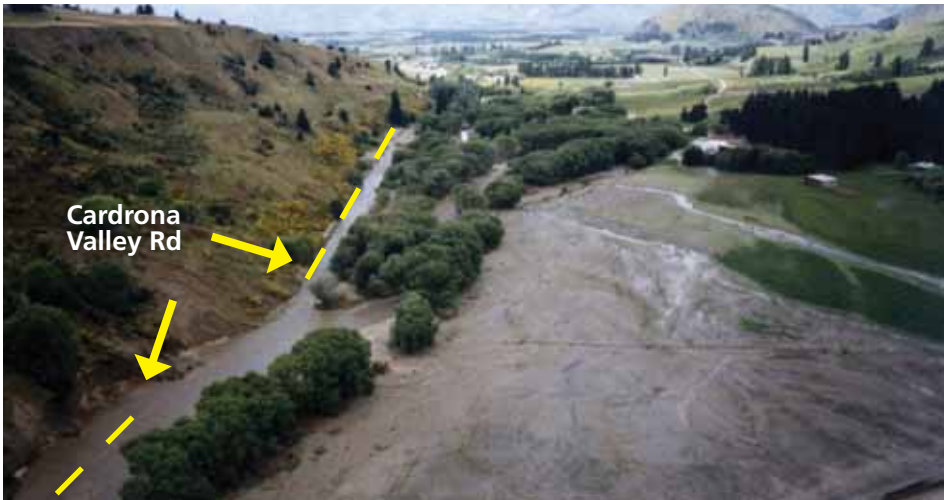
In the mid reaches of the river between the village and The Larches, the valley widens and has a lower gradient therefore flood flows can move unpredictably across the floodplain, depositing sediment and debris (Figure 6).

Figure 6. Flood flows and sedimentation across the floodplain in November 1999.

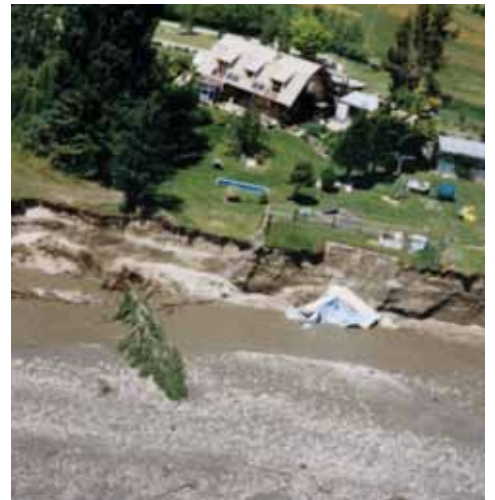
Downstream of The Larches the river form adopts a braided channel which moves easily across the floodplain, causing both sedimentation and bank erosion (Figure 7). The frequency and magnitude of flood events is directly related to the rainfall events which cause them.

Figure 7. Bank erosion on the east bank of the Cardrona River between The Larches and Ballantyne Rd (November 1999).

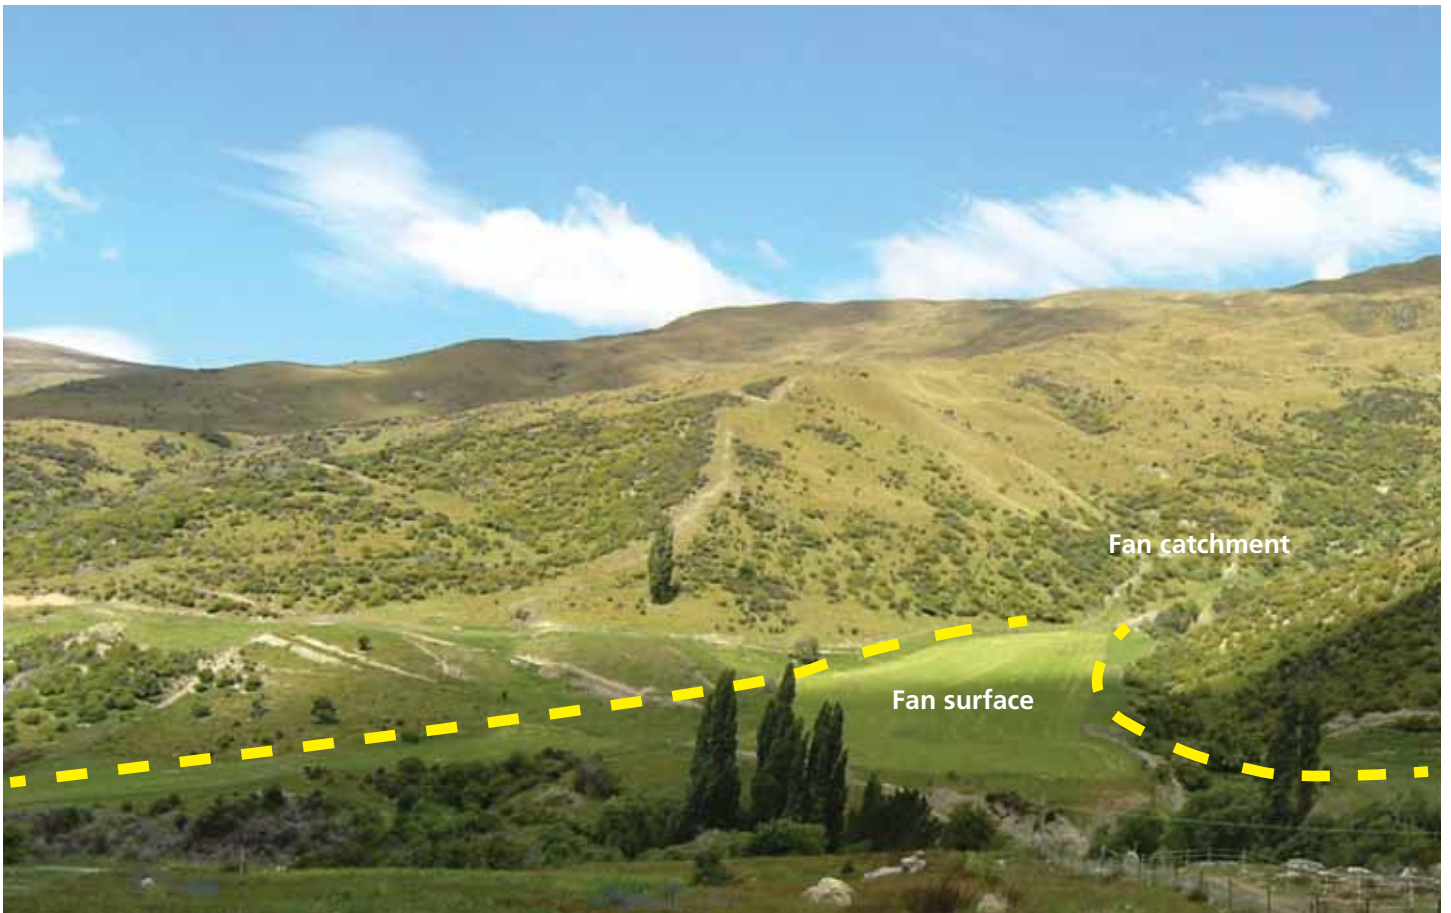
An alluvial fan is an accumulation of river (alluvial) sediments which typically forms in the shape of an open fan or cone. It occurs where a stream leaves the confines of a valley, loses energy, and deposits sediment (Figure 8). Alluvial fans are usually elevated above the valley floor and have good drainage. While this makes them attractive places for development people often fail to fully appreciate the potential alluvial fan hazard.

Figure 8. Alluvial fan in the lower Cardrona Valley

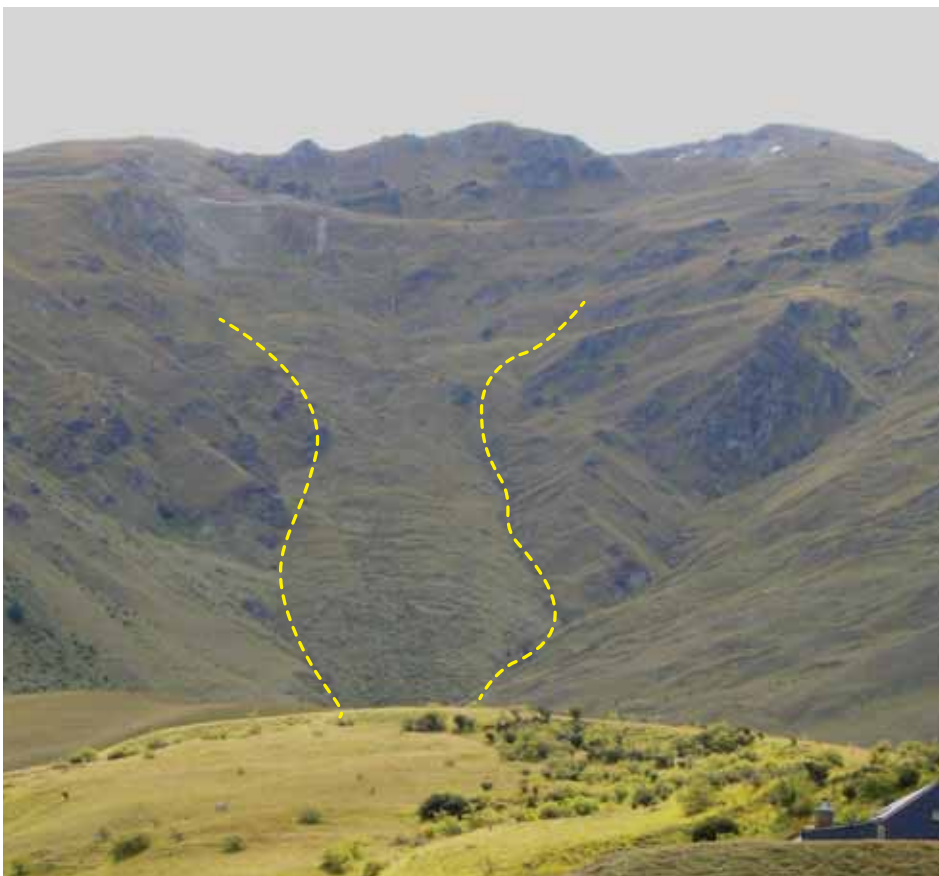
Figure 9. Large landslide deposit, formed by periodic failure and progressive erosion of active slopes in a tributary of the Cardrona River, Crown Range.

Mass movement is widespread throughout the valley. Large schist landslides flank the valley sides (Figure 9), which have been formed through geological activity and incision of the Cardrona River and its tributaries.

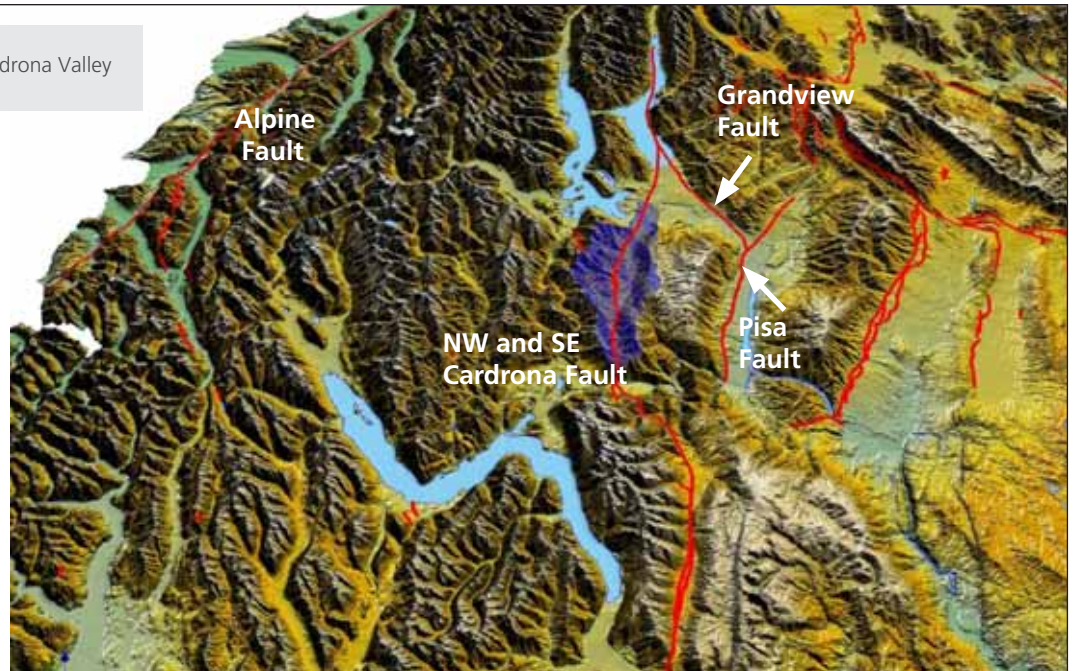
Figure 10. Active faults near the Cardrona Valley

Seismic activity affecting the valley is most likely to originate from the Alpine fault or the northwest and southeast Cardrona faults (Figure 10). The level of risk depends on the magnitude, location, depth, and type of earthquake as well as the underlying ground. Earthquake hazard includes fault surface rupture, landslides, liquefaction, ground shaking and rockfall.

The Alpine fault can produce large magnitude 8 earthquakes every 200-300 years. The NW and SE Cardrona faults have an estimated recurrence interval of about 7,500 years for magnitude 7.1 events. An event of this magnitude is estimated to cause up to 2m of displacement along the fault.
