Channel Morphology and Sedimentation in the Shag River, North Otago

Published November 2009

This report explores how the morphology and sedimentation of the Shag River has changed over the surveyed periods, while providing a synthesis of the study's results to guide river management into the future.

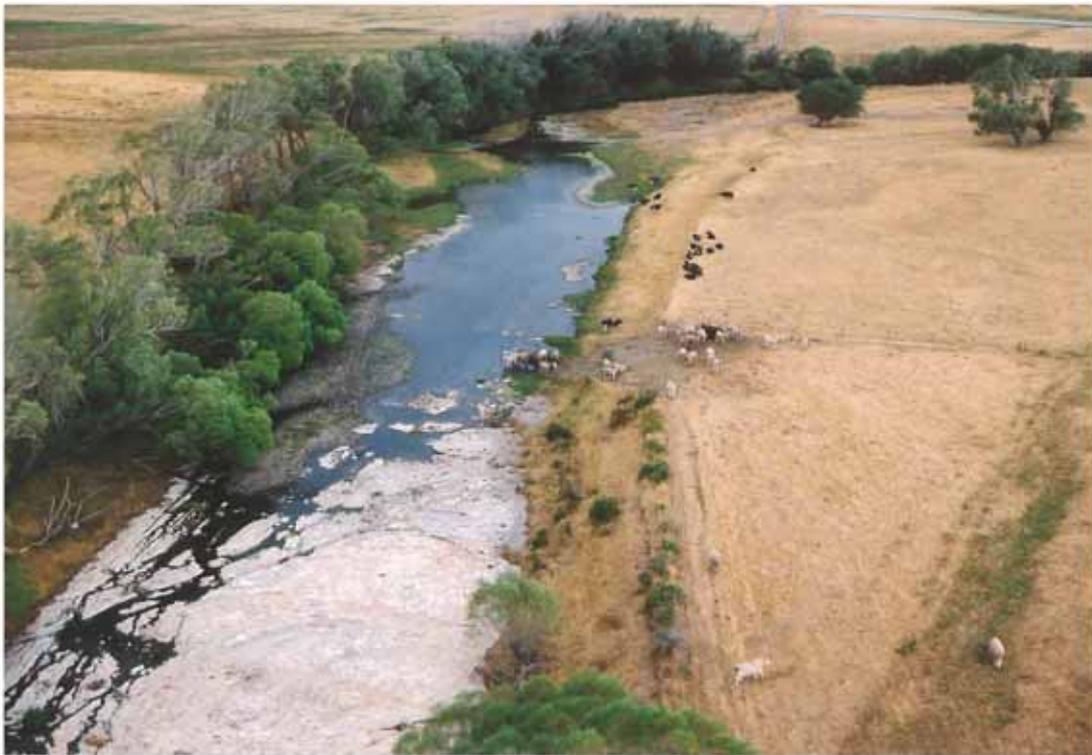
Channel morphology of the Shag River is indicative of an incising river system responding to uplift of the underlying geology. Floodplain incision is observed through much of the coastal lowlands and occurs as the river attempts to attain base level equilibrium with existing sea level. Figure 2.2 shows a reach of the Shag River during drought conditions in 2005. Incision of the floodplain is observed where a distinct terrace edge is evident on the right bank of the river. In some reaches of the river, as observed in the foreground of Figure 2.2, the river has incised down to bedrock.

Figure 2.2 The Shag River during drought conditions in 2005. Extensive areas of bedrock within the active channel margins are noted as well as significant channel incision into the floodplain

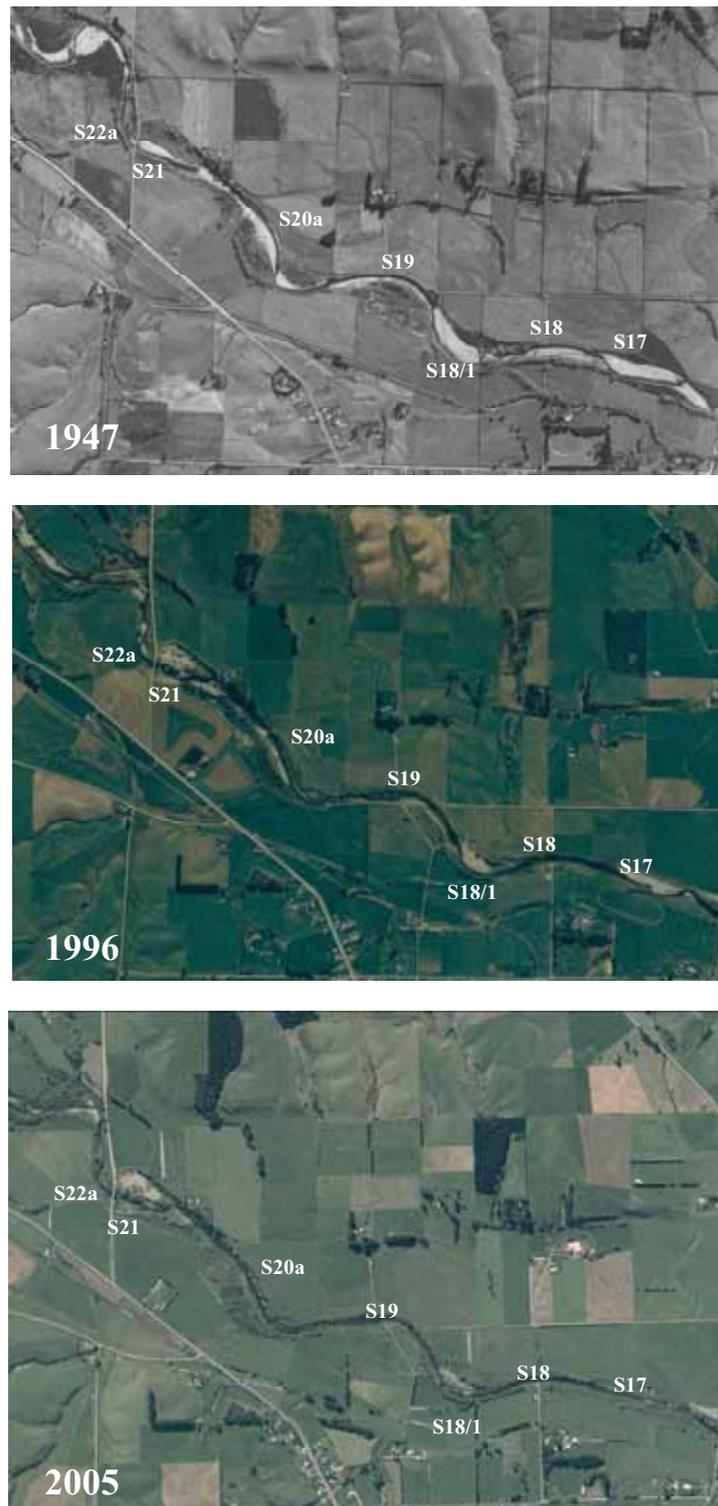
The 1947 aerial photography (Figures 2.4 – 2.7) clearly shows this contribution of excess sediment through an abundance of point and lateral bar formations¹ along the length of the Shag River main stem. By 2005 (Figures 2.4 – 2.7), the prominence of these features had diminished significantly where a more uniform confined channel form was evident. This depletion in active channel sediment storage indicates that bed levels previously observed within the Shag River have been significantly influenced by the contribution of mine tailing discharges. Black et al (2004) note that virtually all of the tailings have been removed from the Shag River system since gold mining ceased in 1946, indicating that the channel now exhibits a more natural form.

Figure 2.4 Aerial images of the Shag River in the vicinity of cross sections S17 – S22a for 1947, 1996 and 2005. These cross-sections are located just north of Palmerston and are between 9.2 and 11.6km upstream of the river mouth

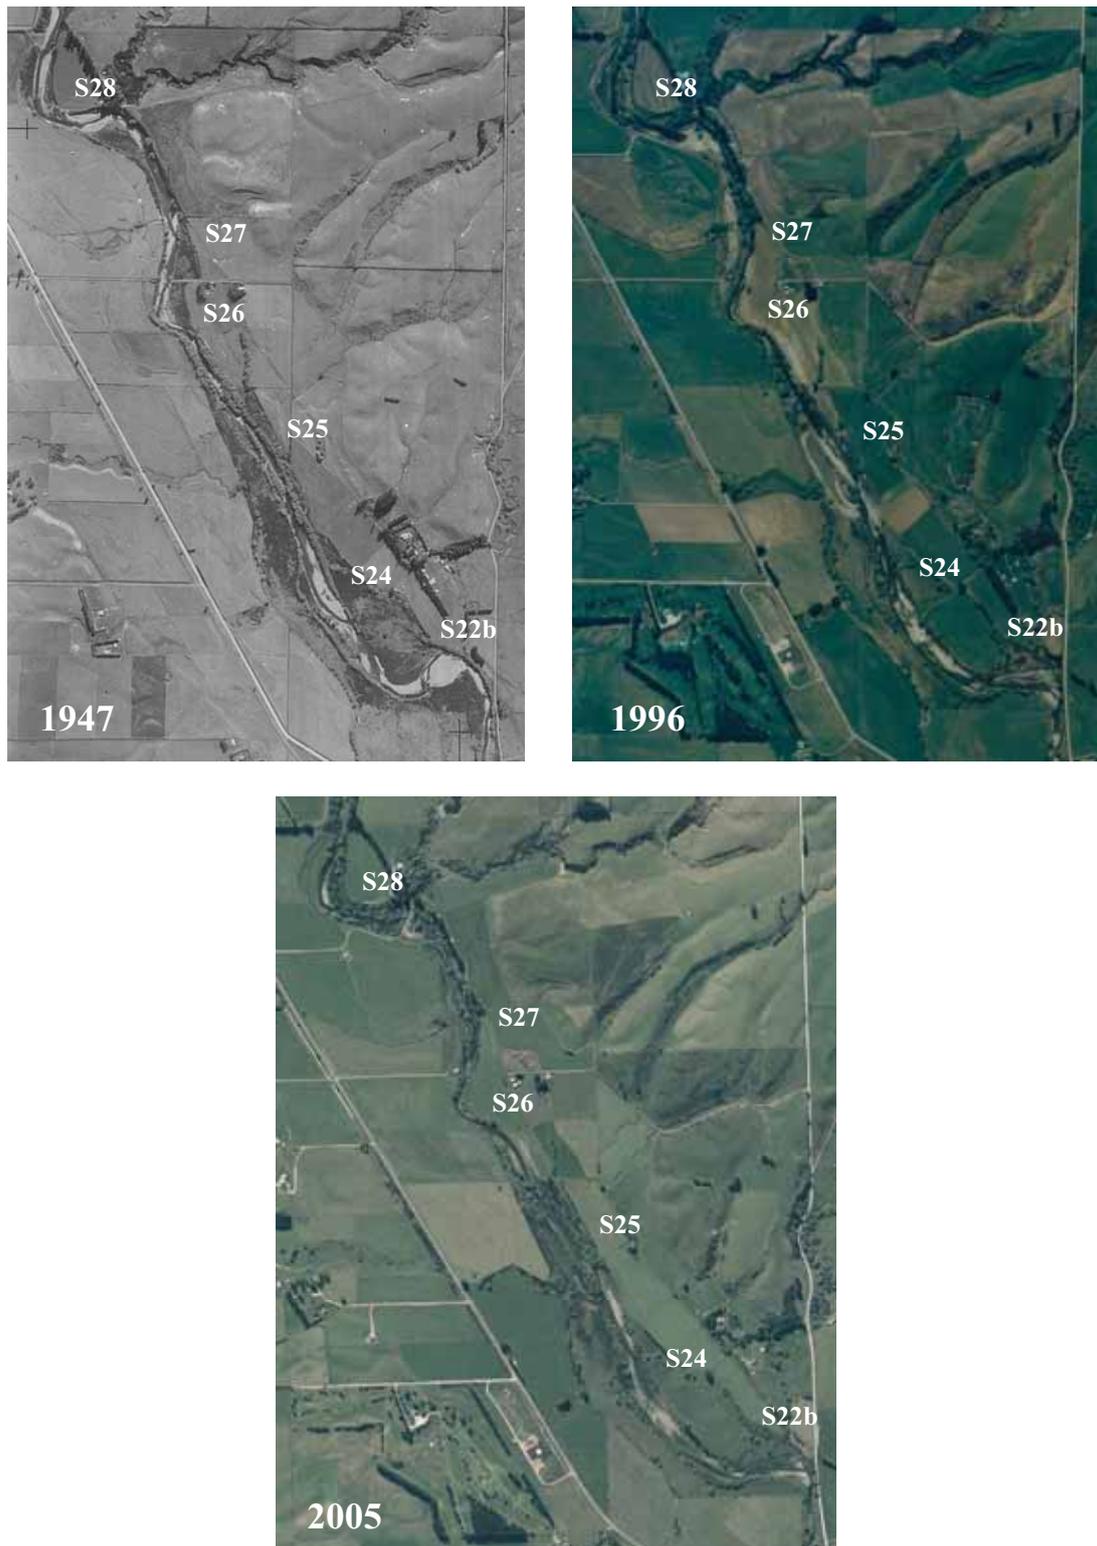
Figure 2.5 Aerial images of the Shag River in the vicinity of cross sections S22b – S28 for 1947, 1996 and 2005. These cross-sections are located just upstream of Switchback Road and are between 11.9 and 14.7km upstream of the river mouth

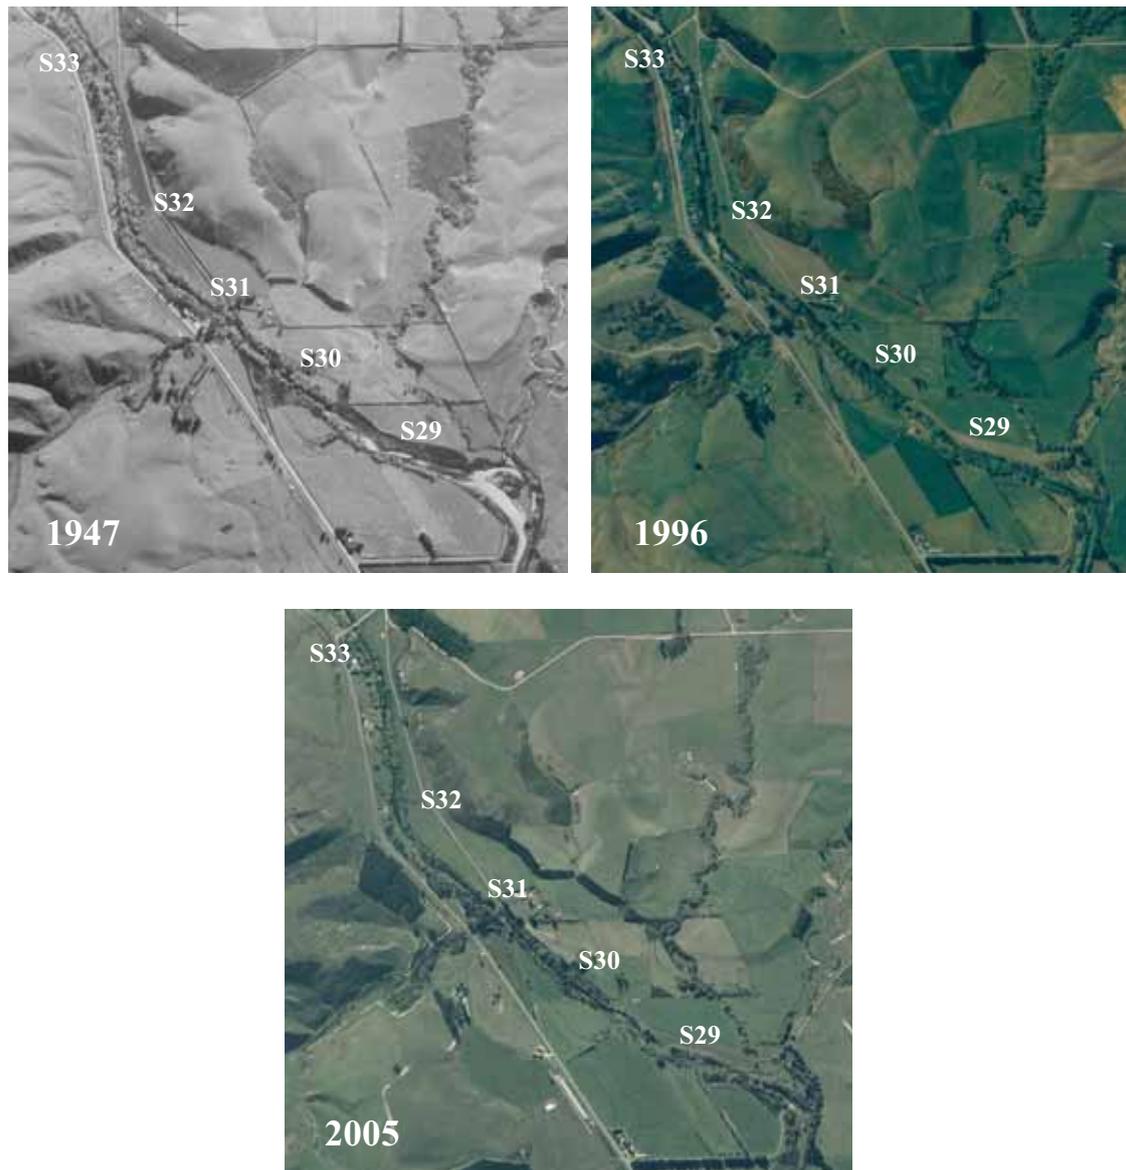
Figure 2.6 Aerial images of the Shag River in the vicinity of cross sections S29 – S33 for 1947, 1996 and 2005. These cross-sections are located downstream of Craig Road and between 15.6 and 17.4km upstream of the river mouth

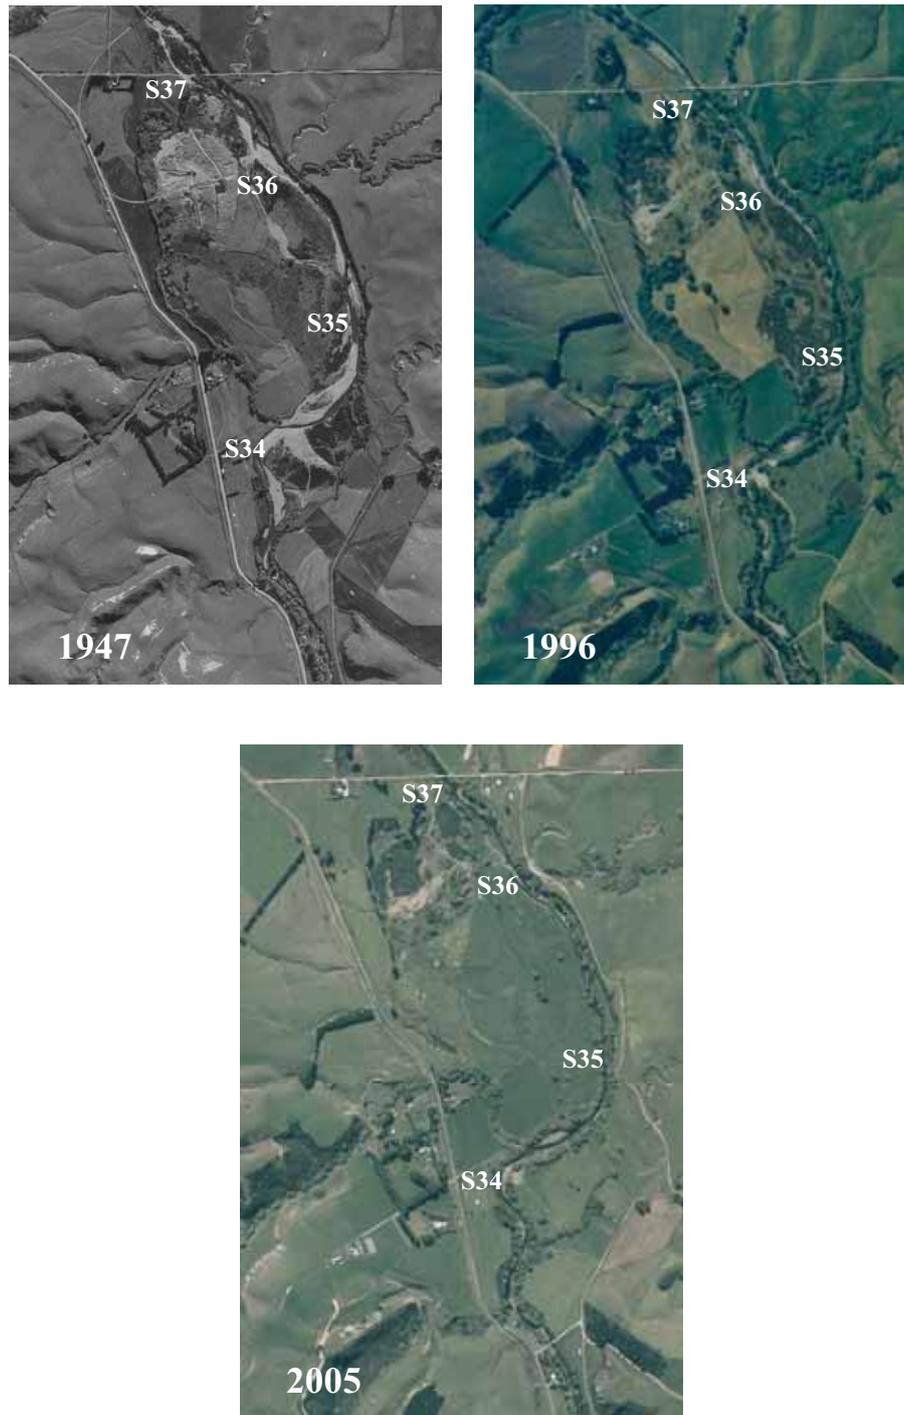
Figure 2.7 Aerial images of the Shag River in the vicinity of cross sections S34 – S37 for 1947, 1996 and 2005. These cross-sections are located downstream of McLew Road and between 18.0 and 19.8km upstream of the river mouth

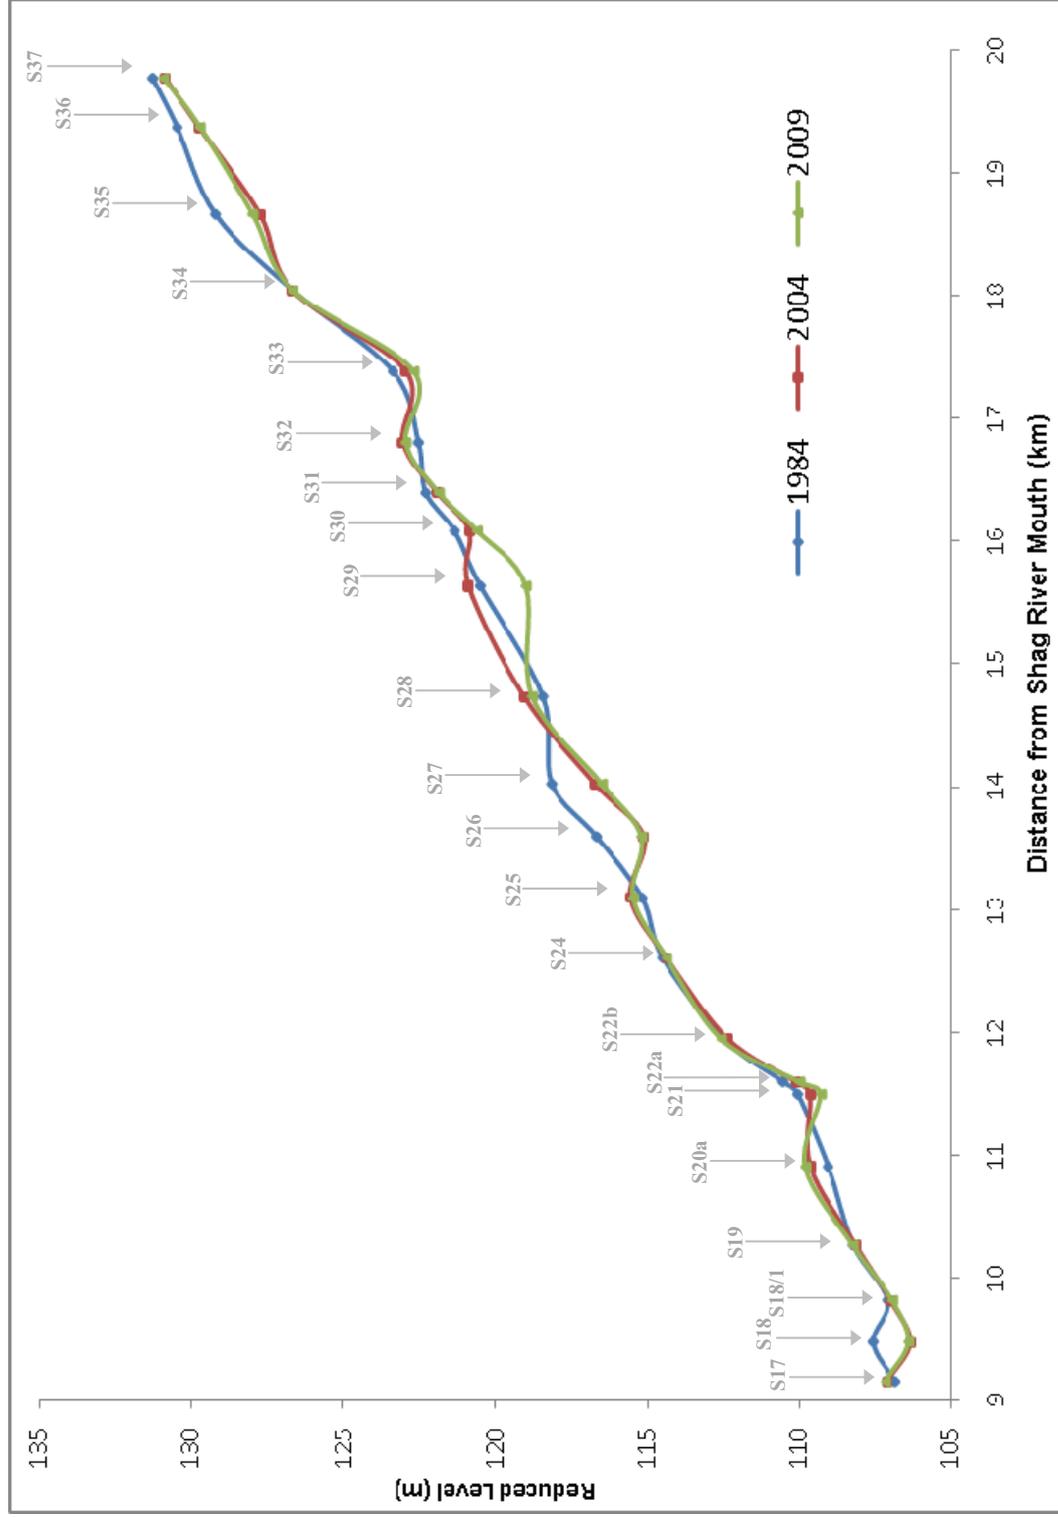
Figure 4.1 Longitudinal profile of the Shag River channel thalweg for 1984, 2004 and 2009

Figure 4.1 shows that the upper reach of the thalweg profile, cross-sections S37 to S34, experienced degradation between 1984 and 2004. The latest survey period, 2004 to 2009, shows that this section of the profile has remained relatively the same as 2004 levels, apart from a small amount of aggradation around S35 over this period. Thalweg levels at S34 have not changed significantly over the period 1984 to 2009.

Between cross-sections S34 and S33, the longitudinal profile indicates another degradational phase with the thalweg lowering between 1984 and 2004 followed by further degradation between 2004 and 2009. Downstream of cross-section S33, the 2004 and 2009 profiles start to increase in level again.

Figure 4.1 indicates that the 2009 thalweg level in the vicinity of cross-section S33 is higher than that surveyed in 1984. Between cross-sections S32 and S30 the 2009 profile remains at similar levels to 2004, with some degradation evident at S30. Thalweg levels over this reach are much lower than those surveyed in 1984.

Significant variability in the longitudinal profile is observed between S30 and S28. Within this reach, the 2004 thalweg level was higher than 1984 levels. However, significant degradation has occurred in this reach between 2004 and 2009. This degradation is reflected by deepening of the thalweg by 1.88m at cross-section S29. At cross-section S28, 2009 thalweg levels still lie slightly above 1984 levels but exhibited net degradation between 2004 and 2009.

The reach between cross-sections S28 and S25 experienced significant degradation between 1984 and 2004. Cross-section S27 experienced slight degradation between 2004 and 2009. At cross-section S25, the thalweg level has degraded slightly between 2004 and 2009 but still lies above levels surveyed in 1984.

Figure 4.1 indicates that thalweg levels remained relatively constant over all surveyed periods between cross-sections S25 to S22b. The channel at cross-sections S24 and S22b are incised to bedrock which contributes to this constant thalweg level. A significant change in gradient is noted between cross-sections S22b and S21 (Figure 4.2), with bed levels showing progressive degradation over surveyed periods. As the river gradient flattens, a reach exhibiting aggradation (cross-sections S21 and S19) is evident. The reach of cross-sections located farthest downstream have not changed significantly between 2004 and 2009. However, degradation at cross-section S18 is evident during this period.

The 2009 longitudinal profile exhibits a similar form to that surveyed in 2004 with some locations experiencing minor aggradation or degradation of the thalweg. One exception to this

trend is the reach S30 to S28 (Figure 4.1) which experienced significant lowering of the thalweg level over this time. Net degradation of this reach is reflected in lowering of the thalweg at cross-sections S30 and S28, although is best reflected by 1.88m of net degradation at cross-section S29. The longitudinal profile at some locations (S22b and S34) is constrained by bedrock channels and has therefore exhibited little net change between 1984 and 2009. In general, the 2009 longitudinal profile is much lower than the 1984 profile.

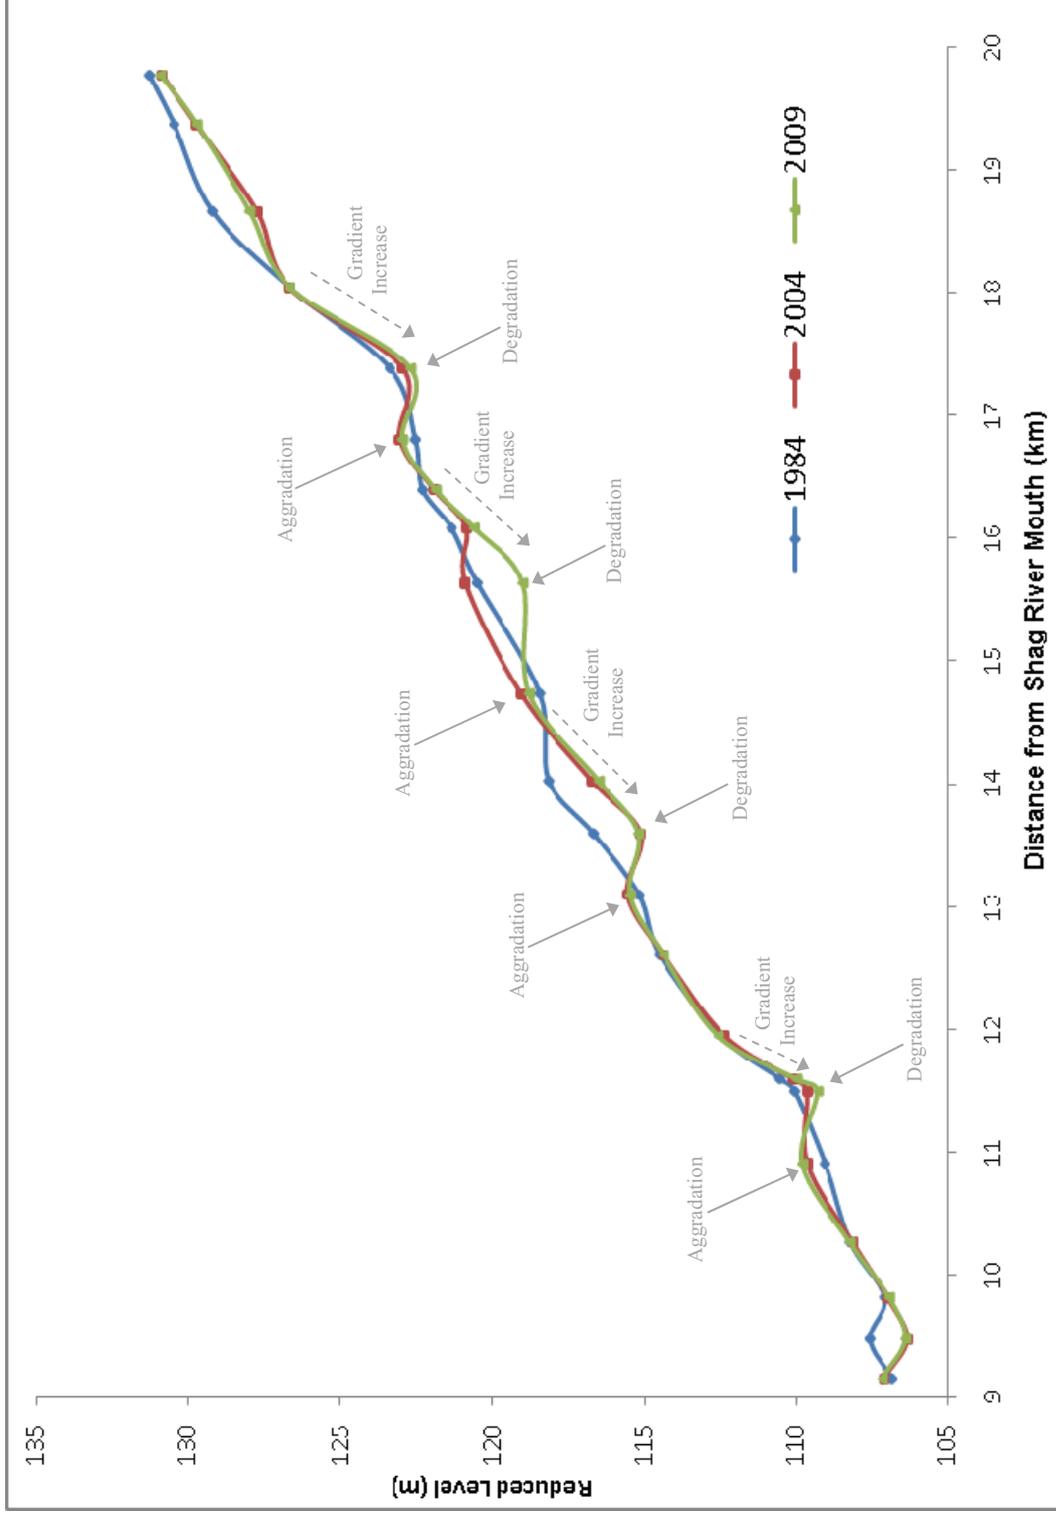
Figure 4.2 Longitudinal profile of the Shag River channel thalweg for 1984, 2004 and 2009 showing morphometric characteristics

Figure 4.2 shows an annotated plot of the longitudinal profile for 1984, 2004 and 2009. An interpretive analysis of the 2009 longitudinal profile indicates that the channel morphometry exhibits a cyclical sedimentation regime where periods of degradation and aggradation are identified following local increases in the channel gradient. Comparatively, the 1984 longitudinal profile exhibits a gentler morphometry with less variability along the length of the channel.

Observations of the longitudinal profile (Figures 4.1 and 4.2) indicate that the 2009 channel form exhibits a cyclical sedimentation regime where periods of degradation and aggradation are identified following local increases in the channel gradient. The morphometry of this profile is distinctly different from the 1984 channel form, indicating a significant change in the sedimentation characteristics along the surveyed reach.

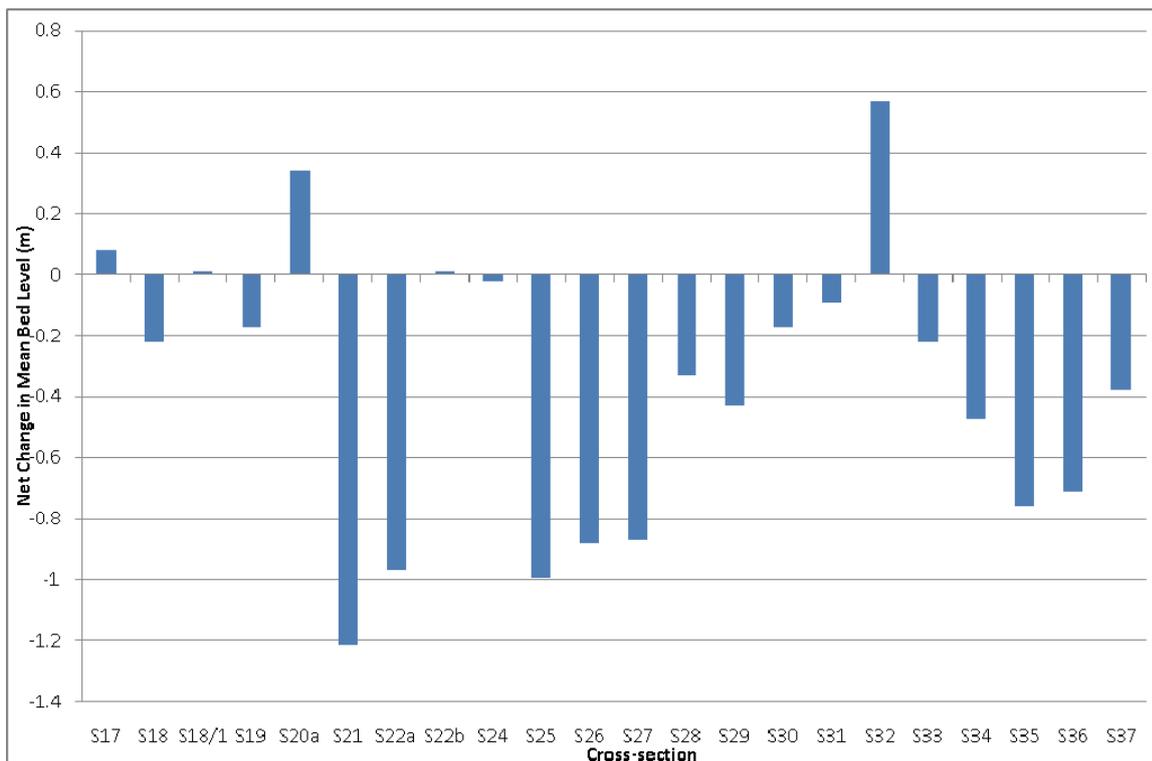
Figure 5.1 Graph showing net change in mean bed level across all survey periods for each cross-section

Cross-section analyses and interpretations have also exhibited trends which infer a decline in sediment supply to surveyed reaches. Figure 5.1 shows a graphical representation of the net change in mean bed levels quantified for each cross-section over each respective period of survey. A holistic interpretation of mean bed level results indicates that the general trend of bed level change is one of net degradation with some localised areas of aggradation. Of the 22 surveyed locations, only one cross-section location (S32) experienced net aggradation greater than 0.4m. Comparatively, nine cross-section locations experienced net degradation greater than 0.4m over surveyed periods. Cross-section S21 has experienced the most change in mean bed levels, experiencing 1.21m of degradation over the period 1977-2009 (Figure 5.1).

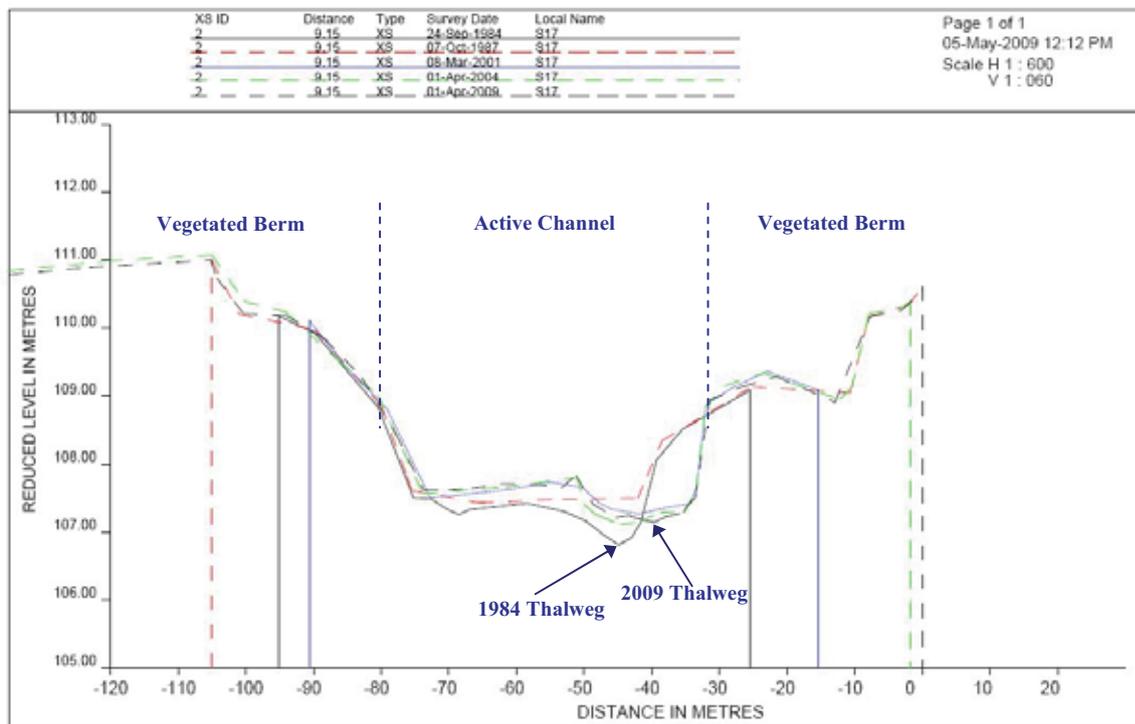
Figure 8.1 Cross-section S17, looking downstream

Aerial photography (Figure 2.4) indicates that the channel form at this location has changed from a sediment rich, unvegetated, low sinuosity channel in 1947 to a uniform straight channel with established vegetated banks in 2005.

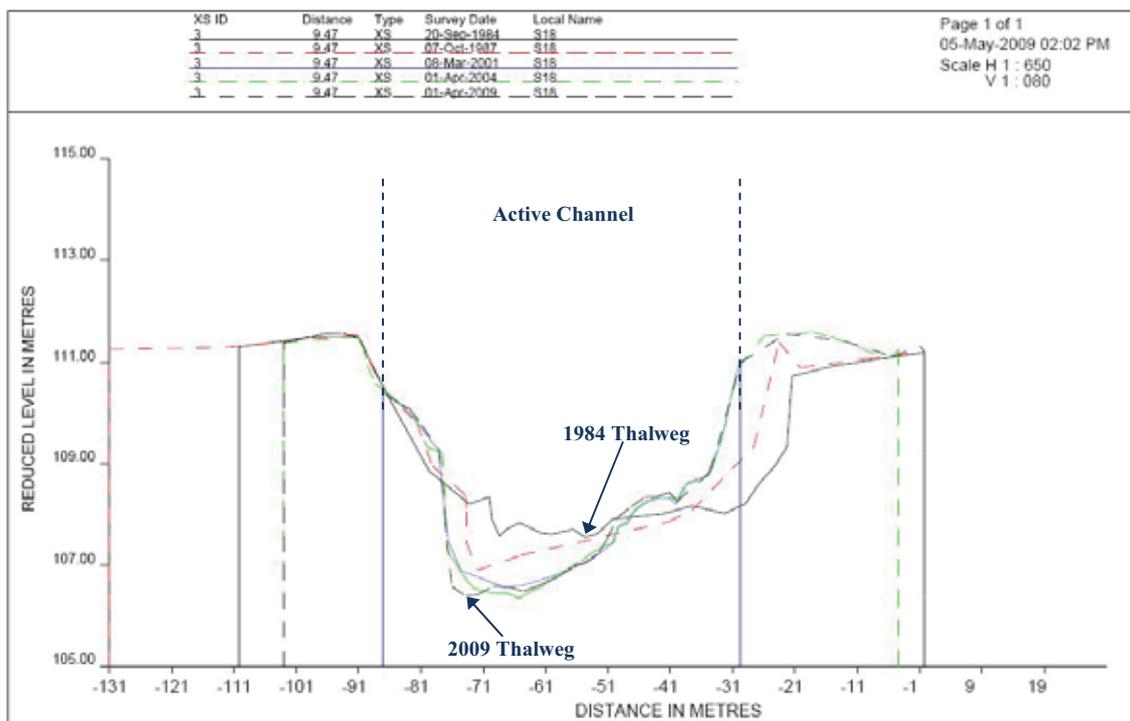
Figure 8.2 Cross-section S18, looking downstream

The active channel covers a surveyed width of 57.24m at this location. Mean bed level analysis shows net degradation of 0.22m over the active channel width between 1984 and 2009 (Table 3.2). This degradation is reflected by a true left shift and deepening of the thalweg by 1.16 (Figure 8.2). Additionally, the true right bank has accreted by approximately 20m which is inferred to be due to the construction of a river access, evident in Figure 2.2. No significant change in mean bed level (+0.01m) is evident between the 2004 and 2009 surveys at this location.

Aerial photography (Figure 2.4) indicates that changes in channel form at S18 are similar to cross-section S17. The 1947 photography shows the channel main stem occupying the true left of the active channel with dominant point and mid-channel bar features. Comparatively, by 2005, the active channel appears more confined with well-established vegetated banks. The removal of large willows on the true right bank is noted between 1947 and 1996 at this location.

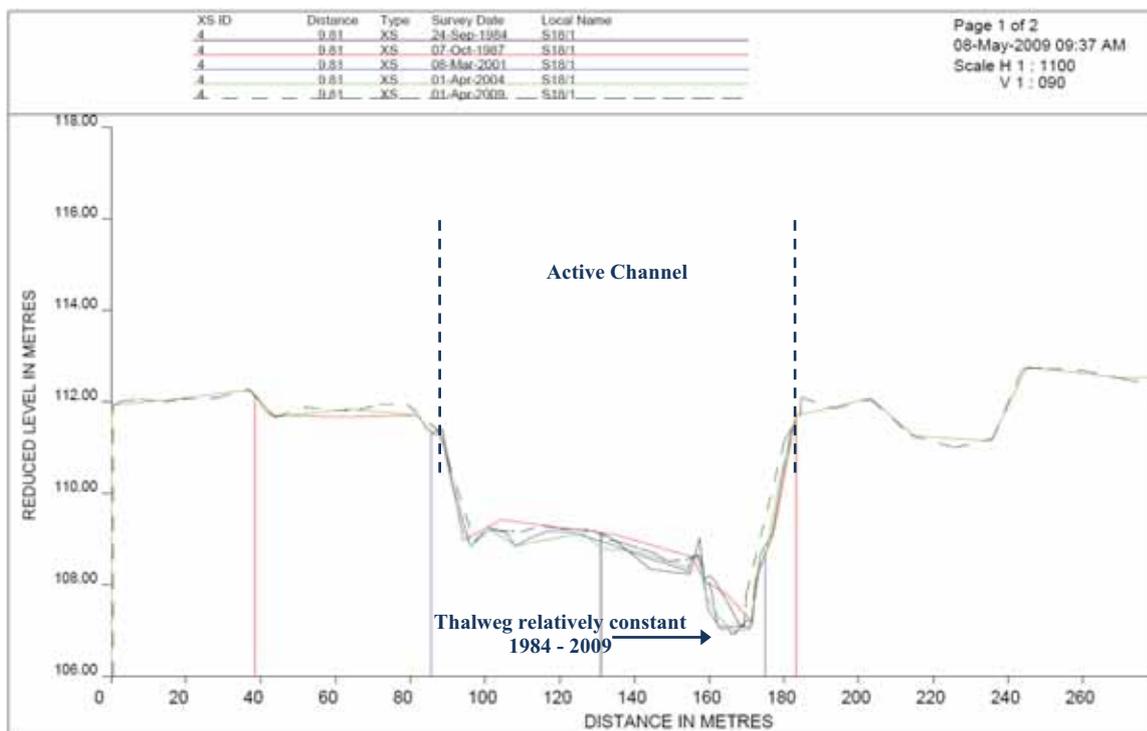
Figure 8.3 Cross-section S18/1, looking downstream

The active channel covers a surveyed width of 105.53m at this location. Mean bed level analysis shows net aggradation of 0.01m over the active channel width between 1987 and 2009 (Table 3.2). This analysis indicates that bed levels at this location are at similar levels to those surveyed in 1987. However, variation between survey periods is evident where net degradation of 0.34 metres was experienced between 1987 and 2001. Since this time, the active channel has aggraded by 0.35m with 0.21m of this aggradation occurring during the period 2004 to 2009. Both the channel banks and the thalweg⁴ location have remained relatively stable over all surveyed periods.

Aerial photography (Figure 2.4) indicates that the channel form has become more stable at this location since 1947. The establishment of the willow trees along much of the true right bank has contributed to this stabilisation. The 1947 photography shows a large active point bar feature dominating this cross-section area whereas this feature largely succumbed to vegetation by 2005.

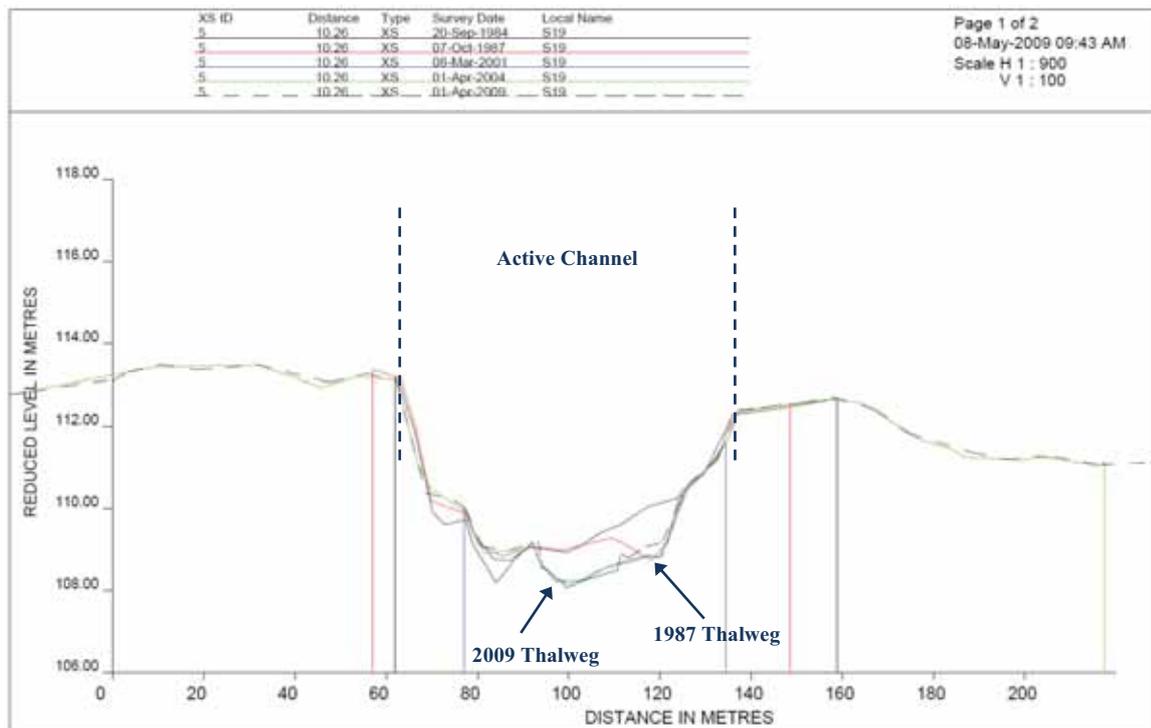
Figure 8.4 Cross-section S19, looking downstream

The active channel covers a surveyed width of 97.00m at this location. Mean bed level analysis shows net degradation of 0.17m over the active channel width between 1984 and 2009 (Table 3.2). Net degradation occurred over survey periods between 1984 and 2004 whereas the most recent survey period, 2004 to 2009, experienced net aggradation of 0.03m. At this location, channel banks have remained relatively stable while the thalweg location has varied across the active channel width.

Aerial photography (Figure 2.4) indicates that the channel form at this location has exhibited change similar to cross-sections S17 and S18. The 1947 photography shows the main channel stem occupying the true left of the active channel margin with fresh bar deposits located on the true right bank. Comparatively, the 2005 photography shows a uniform straight channel with established vegetated banks.

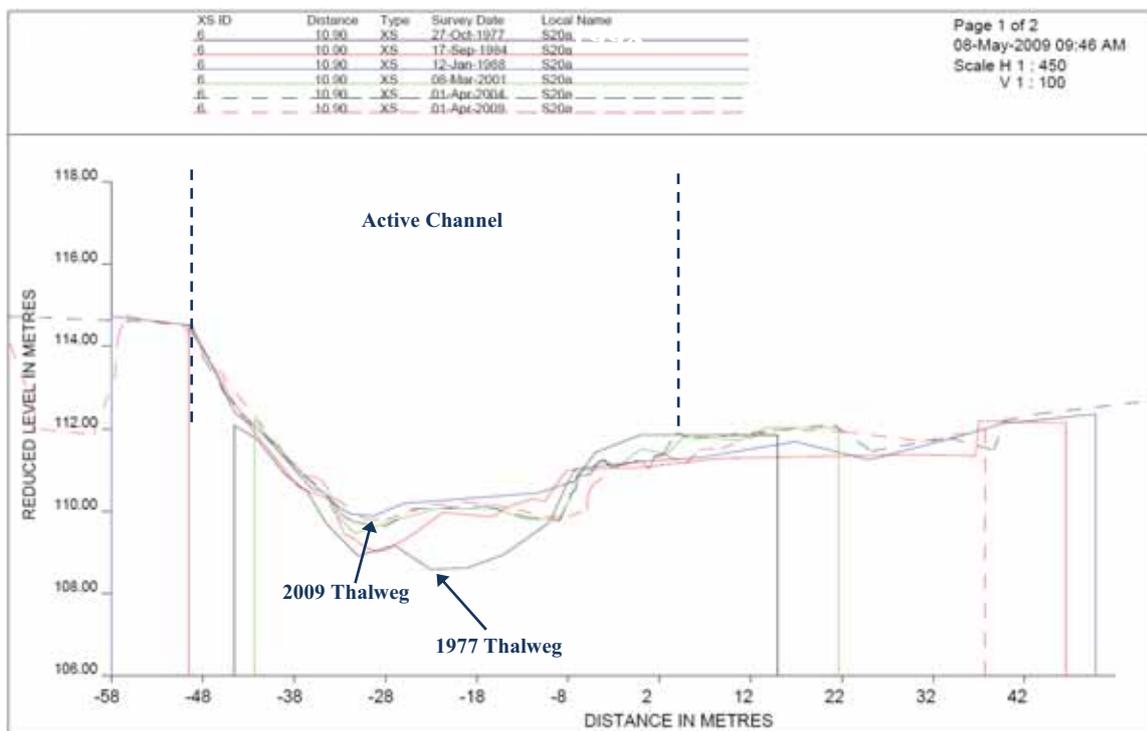
Figure 8.5 Cross-section S20a, looking downstream

Aerial photography (Figure 2.4) shows that the channel form in this reach has experienced similar stabilisation and vegetation to cross-section S19. The 1947 photography shows the main channel stem occupying the true left of the active channel margin with fresh bar deposits located on the true right bank. Comparatively, the 2005 photography shows a uniform straight channel with established vegetated banks.

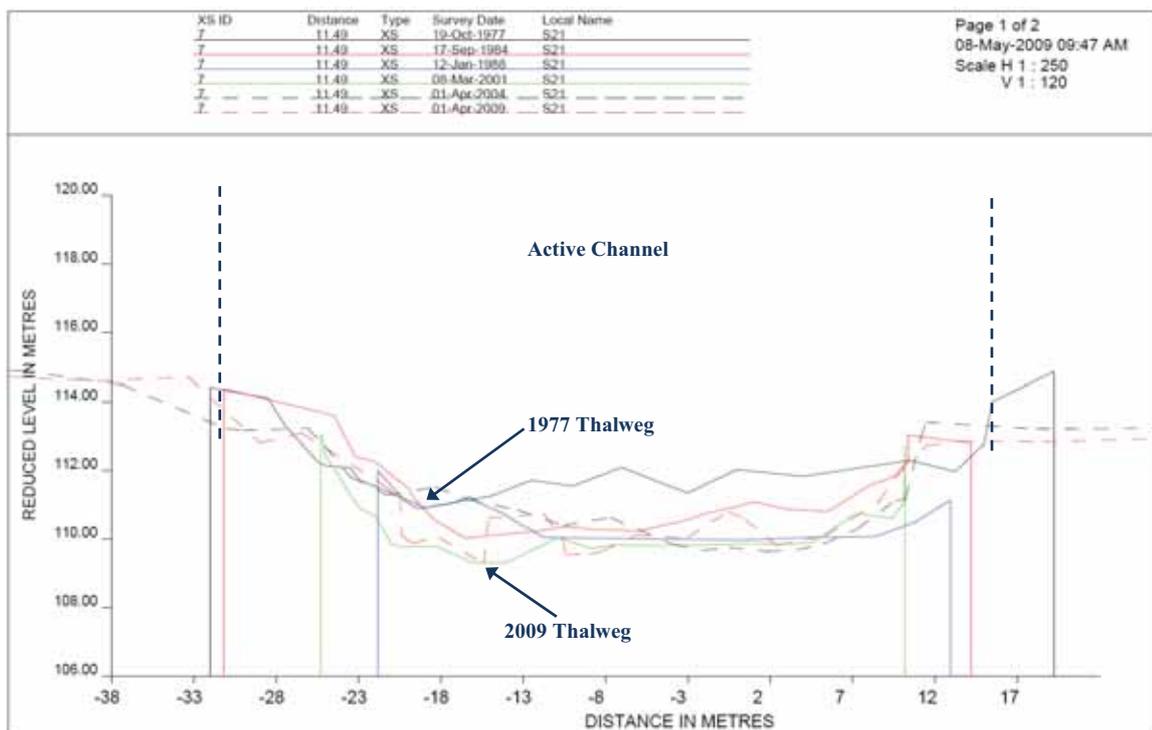
Figure 8.6 Cross-section S21, looking downstream

The active channel covers a surveyed width of 35.46m at this location. Mean bed level analysis shows net degradation of 1.21m over the active channel margin between 1977 and 2009 (Table 3.2). Most degradation, 1.64m, occurred during the period 1977 to 2001 followed by a period of aggradation, 0.55m, between 2001 and 2004. The most recent survey period, 2004 to 2009, has experienced degradation of 0.12m. This net degradational trend is also observed through lowering of the thalweg by 1.64m between 1977 and 2009 (Figure 8.6).

Aerial photography (Figure 2.4) indicates that the channel has become confined on the true left bank due to the establishment of willow trees between 1947 and 1996. The stabilisation of the left bank and subsequent narrowing of the channel may be a contributing factor to the observed level of degradation at this location. In addition, where the true right bank was occupied by willow trees in 1947, by 2005 this bank had become less vegetated and subsequently dissected by the main stem channel.

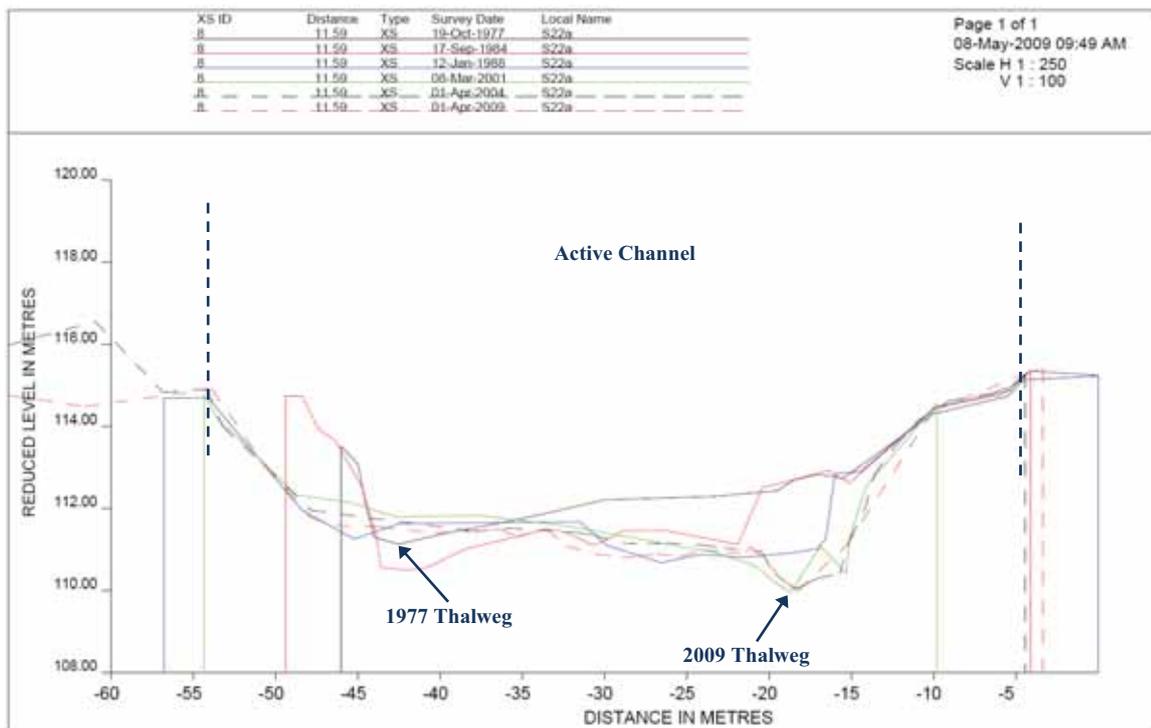
Figure 8.7 Cross-section S22a, looking downstream

The active channel covers a surveyed width of 36.00m at this location. Mean bed level analysis shows net degradation of 0.97m over the active channel width between 1977 and 2009 (Table 3.2). While the largest proportion of this degradation, 0.66m, occurred during the period 1977 to 1988, a consistent trend of degradation is evident for all surveyed periods at this cross-section. The most recent survey period, 2004 to 2009, shows net degradation of 0.17m. The net degradation trend is also reflected by a true right shift and deepening of the thalweg by 1.16m over the period 1977 to 2009 (Figure 8.7).

Aerial photography (Figure 2.4) indicates that the channel form in 1947 is not dissimilar from the 2005 channel form. This is most likely due to the presence of well-established vegetation on both banks that confine the active channel margin. Some bare lateral bar deposits are evident in the 1996 imagery.

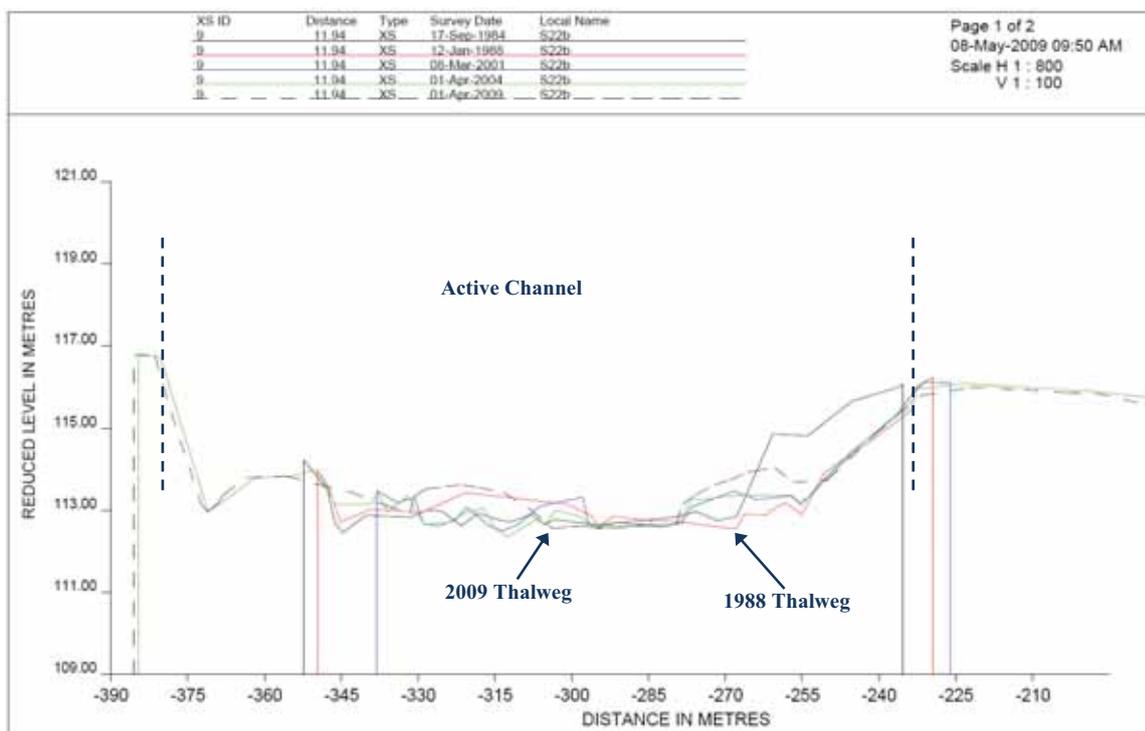
Figure 8.8 Cross-section S22b, looking downstream

The active channel covers a surveyed width of 117.00m at this location. Mean bed level analysis shows net aggradation of 0.01m over the active channel width between 1984 and 2009 (Table 3.2). This analysis indicates that bed levels at this location are at similar levels to those surveyed in 1984. However, variation between survey periods is evident where net degradation of 0.22m was experienced between 1984 and 1988. Comparatively, the survey period 2004 to 2009 experienced aggradation of 0.25m. Thalweg levels have remained relatively consistent across surveyed periods with some observed lateral movement (Figure 8.8). Of note is the erosion of approximately 15 to 20m of the true right bank between 1984 and 1988.

Aerial photography (Figure 2.5) shows a sinuous channel in 1947 with a large point deposit formed by the lateral accretion of sediment on the convex (true right) bank. Comparatively, the 1996 and 2005 photographs shows this point bar feature to be largely dissected by the main channel stem with a large proportion of the true left channel now succeeded by vegetation.

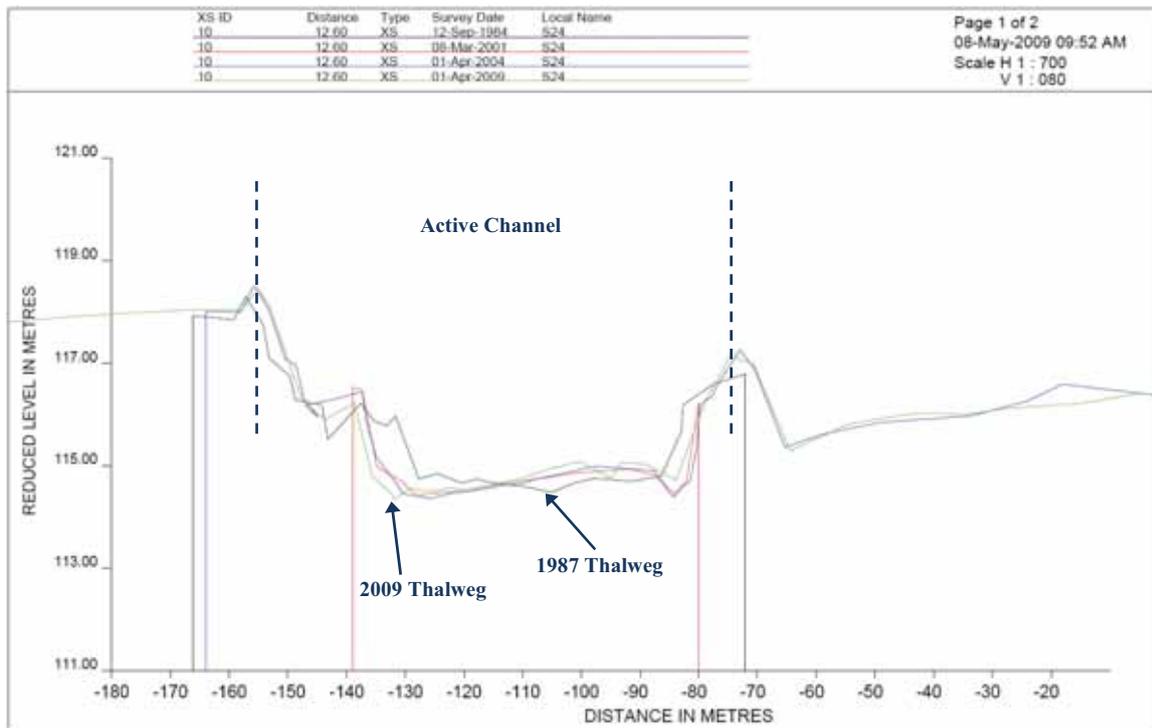
Figure 8.9 Cross-section S24, looking downstream

The active channel covers a surveyed width of 94.00m at this location. Mean bed level analysis shows net degradation of 0.02m over the active channel width between 1984 and 2009 (Table 3.2). This analysis indicates that 2009 bed levels at this location are at similar levels to those surveyed in 1984. In addition, little variation is evident within surveyed periods with only 0.01m of aggradation evident for the most recent, 2004 to 2009, survey period. Thalweg levels have remained relatively consistent across surveyed periods with some observed lateral movement (Figure 8.9).

Aerial photography (Figure 2.5) indicates that the channel form at this location has remained relatively similar to that in 1947. Some lateral bar formation is still evident at this location although replenishment rates do not appear to be as recurrent with the prevalence of succeeding vegetation evident in the 2005 photography.
