Channel Morphology and Sedimentation in the Shag River, North Otago

Published November 2009

This report explores how the morphology and sedimentation of the Shag River has changed over the surveyed periods, while providing a synthesis of the study's results to guide river management into the future.

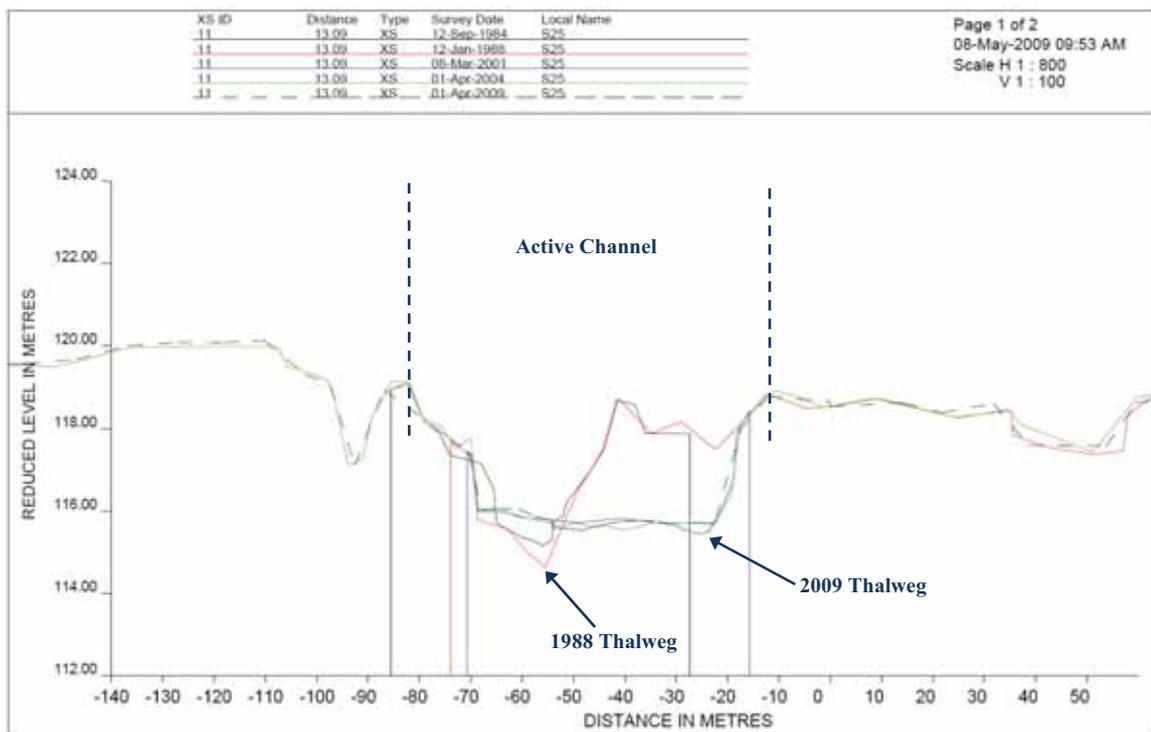
Figure 8.10 Cross-section S25, looking downstream

The active channel covers a surveyed width of 55.04m at this location. Mean bed level analysis shows net degradation of 0.99m over the active channel width between 1984 and 2009 (Table 3.2). Most degradation, 0.86m, occurred during the period 1988 to 2004, which is largely represented in Figure 3.11 as approximately 30m of true right bank erosion in the 1988 to 2001 survey period. In response to this erosion and widening of the channel, the thalweg level rose by 0.83m during the period 1988 to 2009 (Figure 8.10).

The right bank erosion is also evident on aerial photography (Figure 2.5), whereas in 1947 the channel form is uniform and straight with stable banks succeeded by willow trees. The 1996 and 2005 photography shows a section of trees removed in the vicinity of cross-section S25.

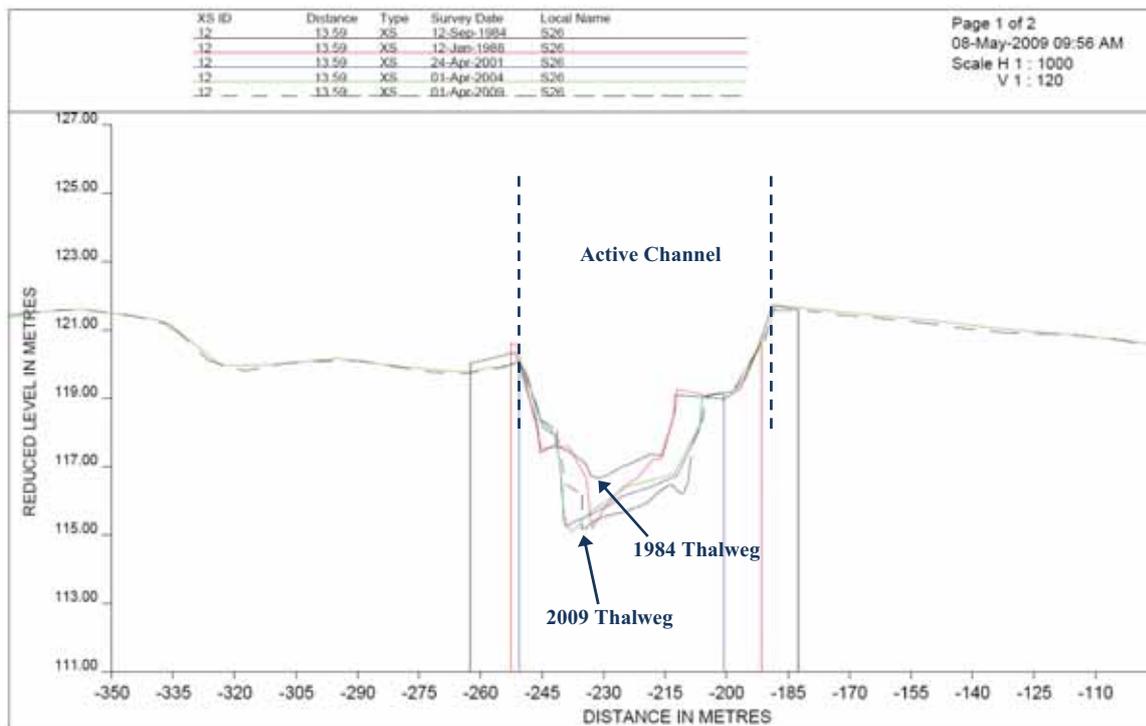
Figure 8.11 Cross-section S26, looking downstream

The active channel covers a surveyed width of 49.96m at this location. Mean bed level analysis shows net degradation of 0.88m over the active channel width between 1984 and 2009 (Table 3.2). Most degradation, 0.79m, occurred during the period 1984 to 2001, which is reflected in deepening of the thalweg by 1.41m. The most recent survey period, 2004 to 2009, experienced degradation of 0.17m. Changes in bank stability at this cross-section are similar to S25 with approximately 10m right bank erosion occurring during the period 1988 to 2001.

Aerial photography (Figure 2.5) indicates that S26 has a similar channel form to S25, whereas in 1947 a uniform, straight channel with stable willow bound banks is evident. This is compared to photography from 1996 and 2005 showing similar morphological changes to S25 with the removal of willows on the right bank and a widening of the channel.

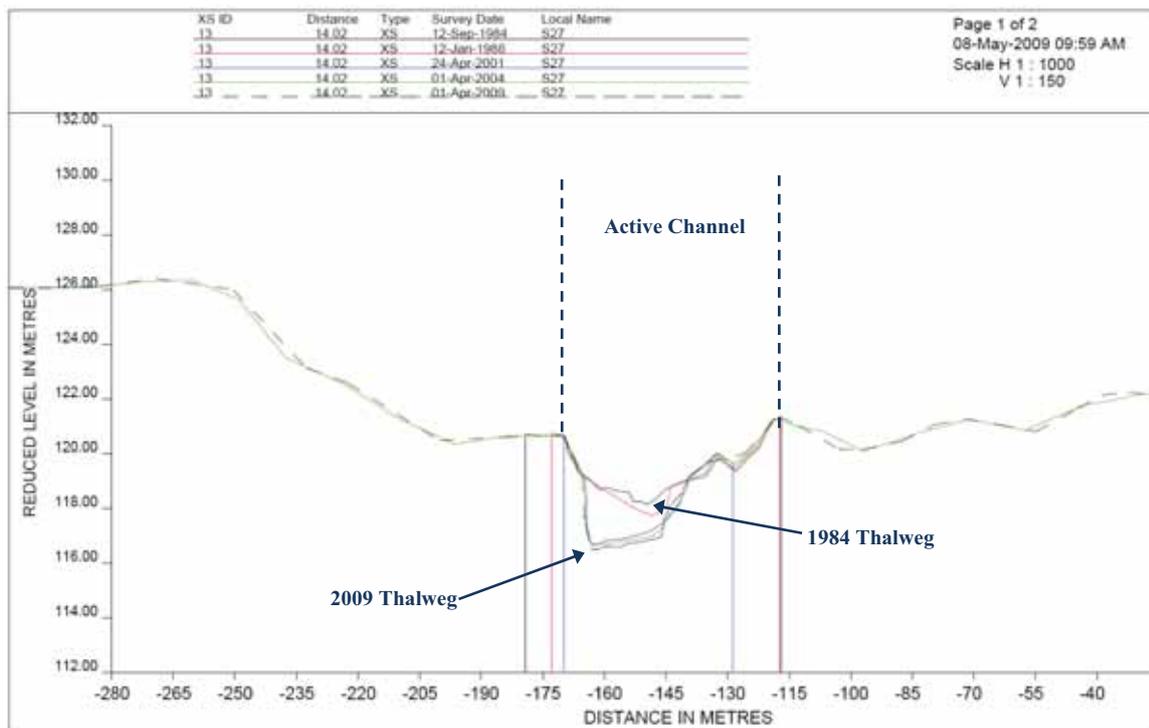
Figure 8.12 Cross-section S27, looking downstream

The active channel covers a surveyed width of 41.17m at this location. Mean bed level analysis shows net degradation of 0.87m over the active channel width between 1984 and 2009 (Table 3.2). While the largest proportion of this degradation, 0.64m, occurred during the period 1988 to 2001, a consistent trend of degradation is evident for all surveyed periods at this cross-section. The most recent survey period, 2004 to 2009, shows net degradation of 0.06m. The overall trend in net degradation is also reflected by a true left shift and deepening of the thalweg by 1.66m between 1984 and 2009 (Figure 8.12).

Aerial photography (Figure 2.5) indicates that the channel form in 1947 is not dissimilar from the 2005 channel form. This is most likely due to the presence of well-established vegetation on both banks that confine the active channel margin.

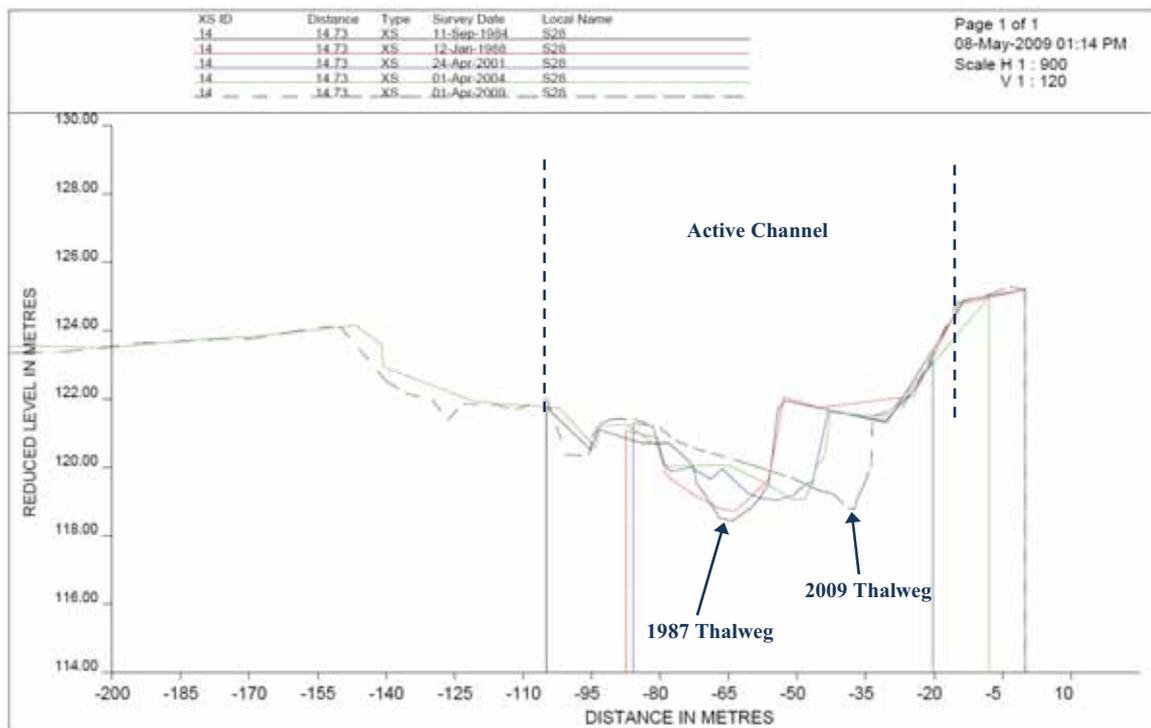
Figure 8.13 Cross-section S28, looking downstream

The active channel covers a surveyed width of 65.66m at this location. Mean bed level analysis shows net degradation of 0.33m over the active channel width between 1984 and 2009 (Table 3.2). Most degradation, 0.30m, occurred during the period 1988 to 2001, while the most recent survey period, 2004 to 2009, experienced 0.13m degradation. Figure 3.14 shows considerable right bank erosion of 9.7m in the period 1988 to 2001 followed by an additional 9.8m in the period 2004 to 2009. These periods of erosion, totalling near 20m, have been consistent with a lateral thalweg shift to the true right.

Aerial photography (Figure 2.5) indicates that the channel form at this location has changed from a sediment rich, active channel with relatively large point and lateral bar deposits in 1947, to a more confined channel with a singular point bar deposit in 2005.

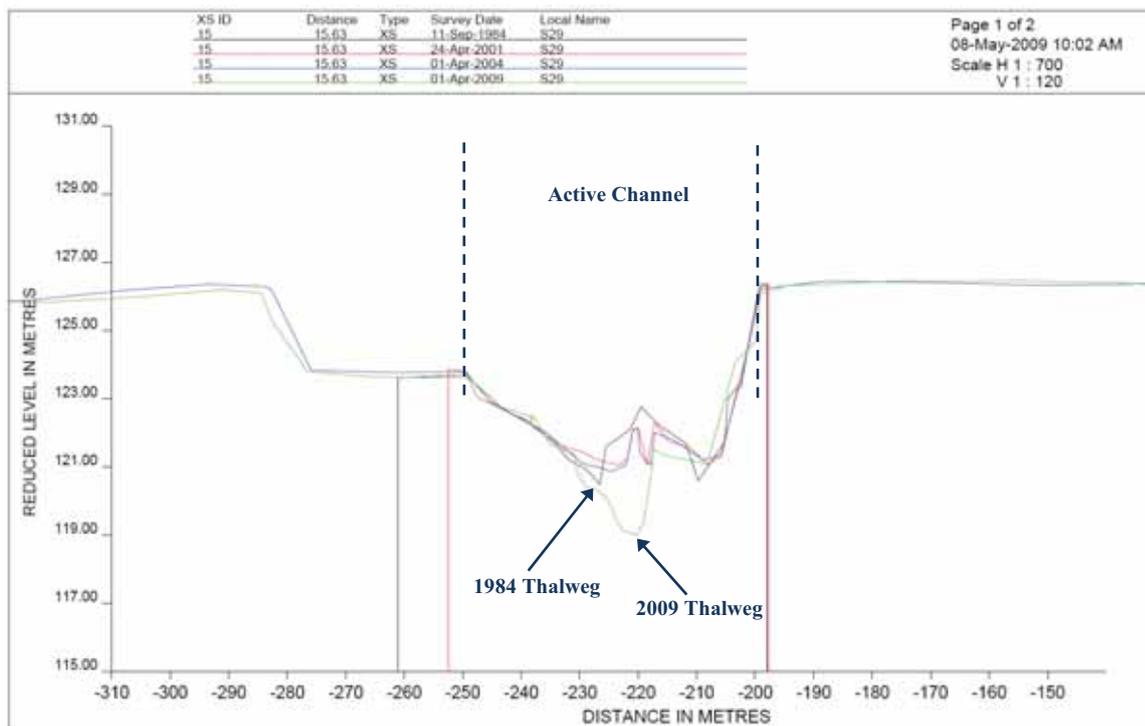
Figure 8.14 Cross-section S29, looking downstream

Aerial photography (Figure 2.6) indicates that the channel form in 1947 is not dissimilar from the 2005 channel form. The 1947 photography has a number of fresh lateral bar deposits at this location, whereas more recent photography indicates that sediment supply rates have declined. The 2005 photography shows that vegetation has become well-established along both banks at this location.

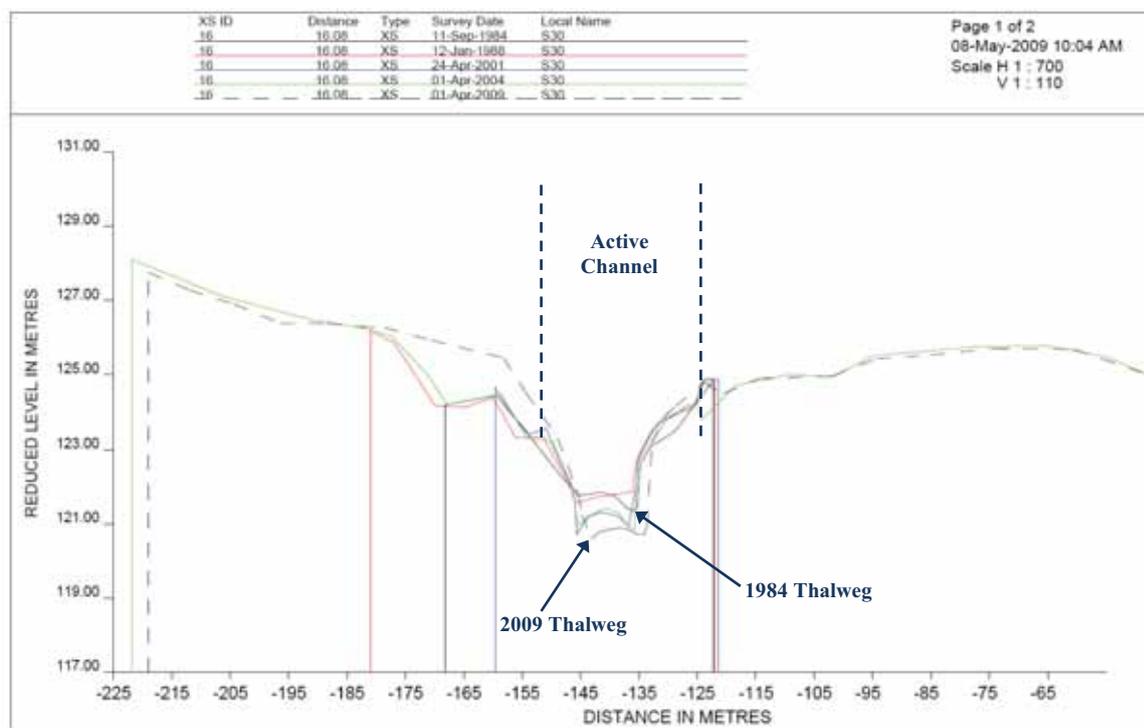
Figure 8.15 Cross-section S30, looking downstream

Aerial photography (Figure 2.6) indicates that the channel form in 1947 is not dissimilar from the 2005 channel form. This is most likely due to the presence of well-established vegetation on both banks that confine the active channel margin.

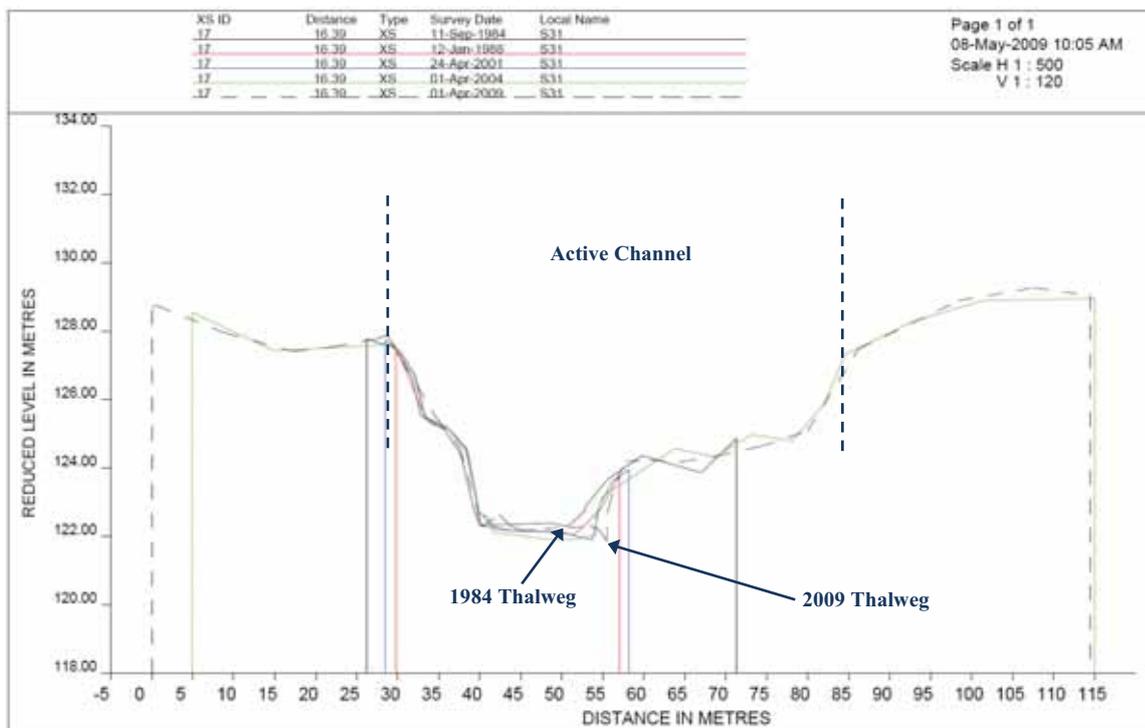
Figure 8.16 Cross-section S31, looking downstream

Aerial photography (Figure 2.6) indicates that the channel form in 1947 is not dissimilar from the 2005 channel form. This is most likely due to the presence of well-established vegetation on both banks that confine the active channel margin.

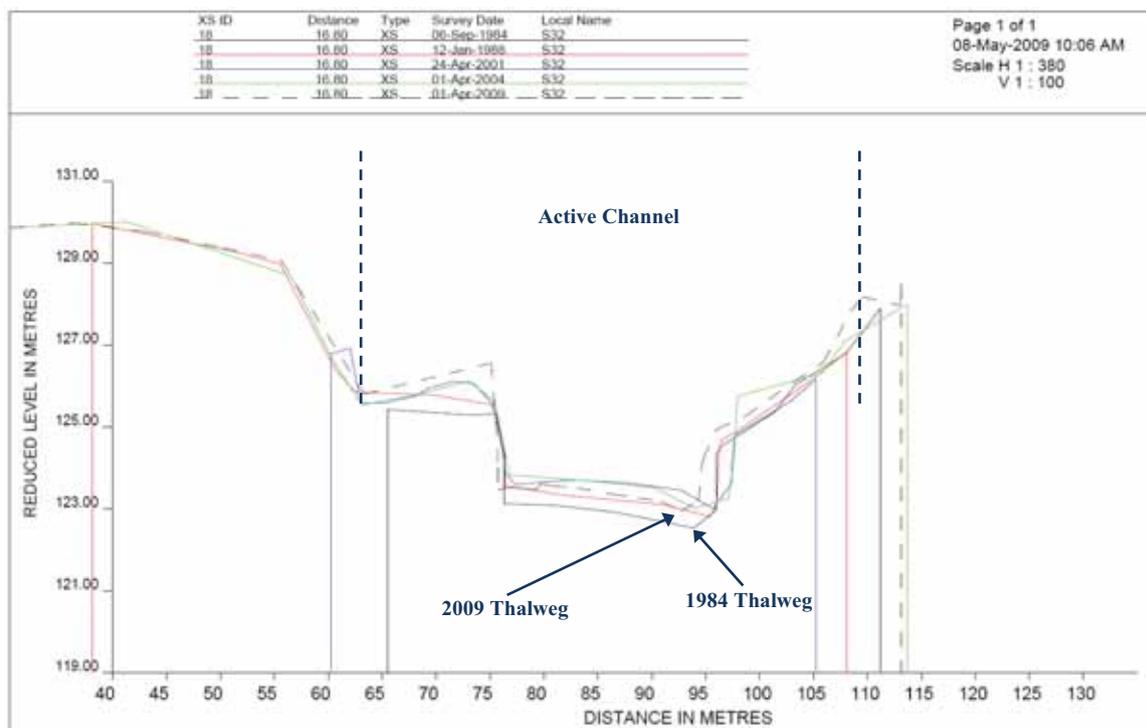
Figure 8.17 Cross-section S32, looking downstream

Aerial photography (Figure 2.6) indicates that the channel form in 1947 was largely influenced by dense vegetation encroaching on the active channel margins. Comparatively, the 2005 photography shows much less vegetation near the active channel.

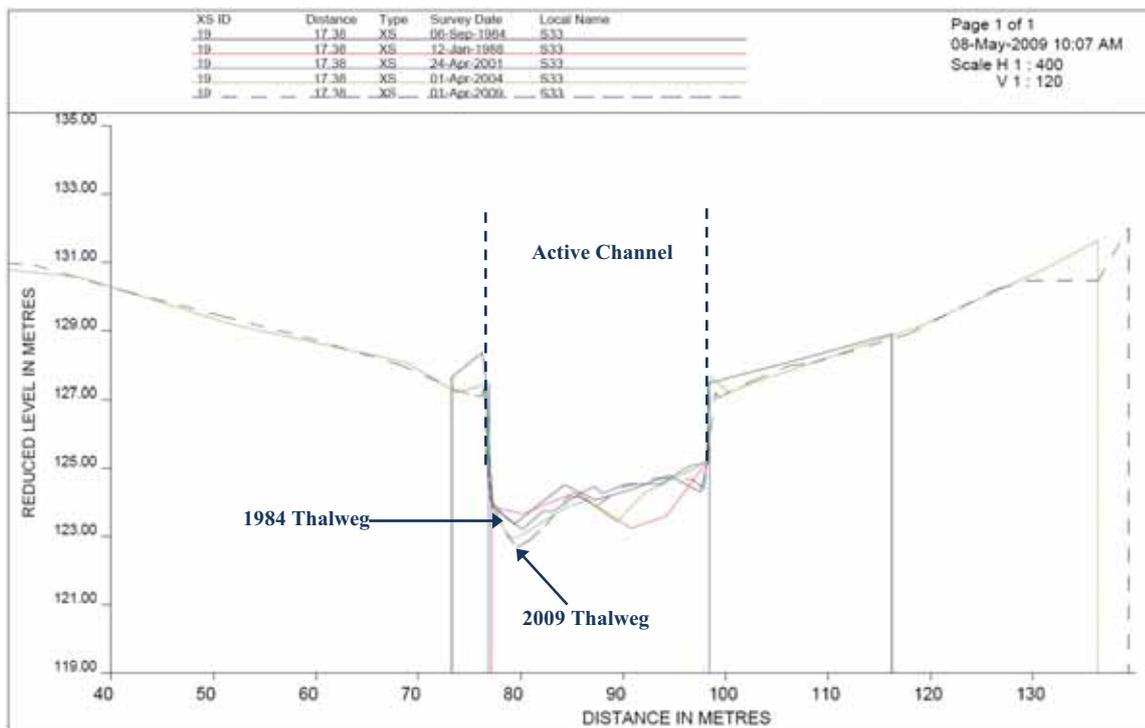
Figure 8.18 Cross-section S33, looking downstream

Aerial photography (Figure 2.6) indicates that the channel form in 1947 is not dissimilar from the 2005 channel form. It is noted that the Craig Road Bridge was not in place in 1947 but is visible in the 1996 photography.

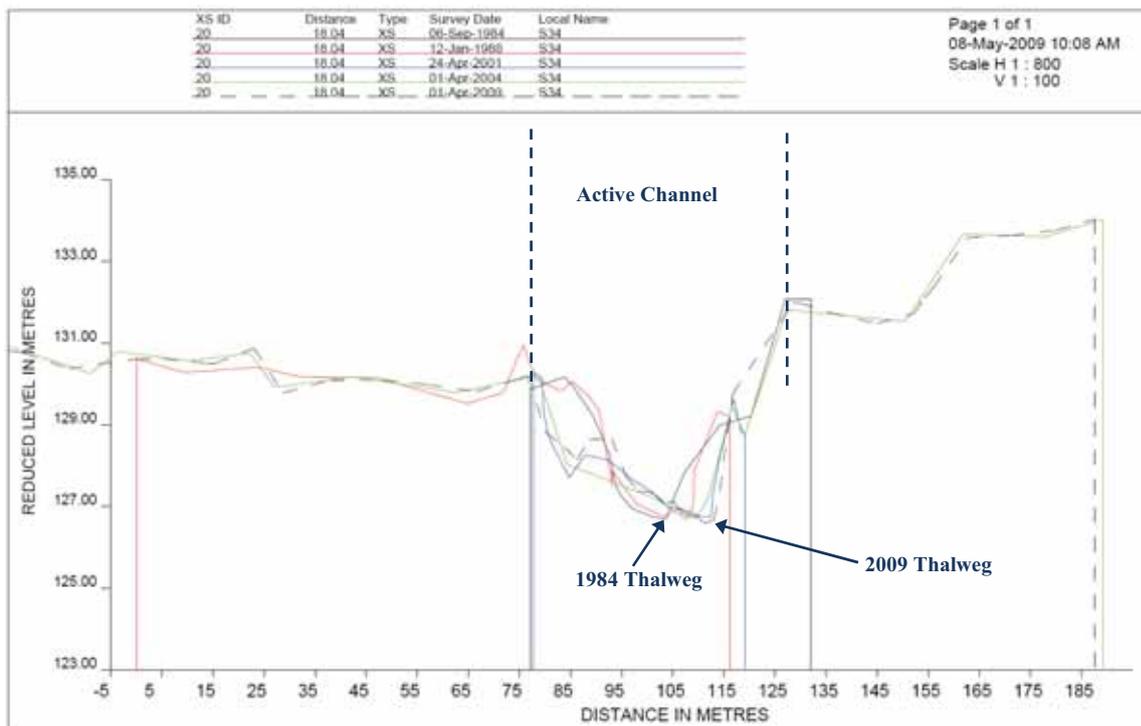
Figure 8.19 Cross-section S34, looking downstream

Aerial photography (Figure 2.7) indicates the active channel width at this location has been reduced significantly between 1947 and 2009. Some deposition on the main point bar feature at this location is evident in 2005 photography; however, observations note that sediment supply rates have diminished significantly since 1947.

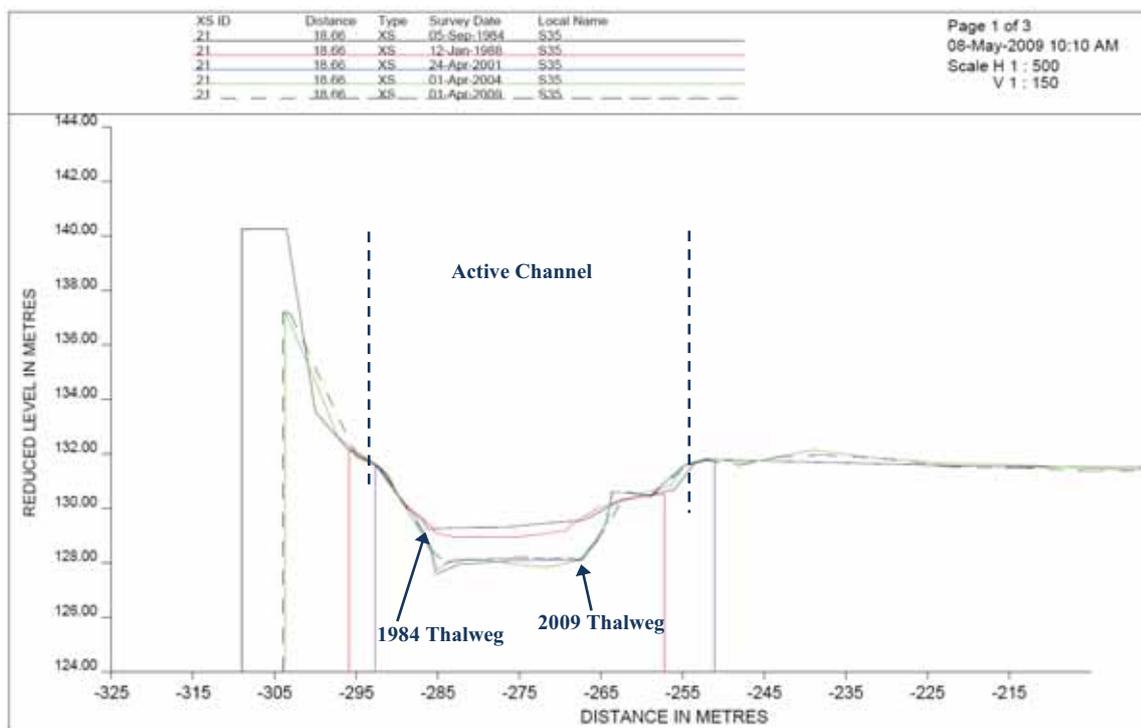
Figure 8.20 Cross-section S35, looking downstream

Aerial photography (Figure 2.7) indicates that the channel form at this location has changed significantly from a sediment-rich, semi-vegetated channel in 1947 to a uniform straight channel with established vegetated banks in 2005.

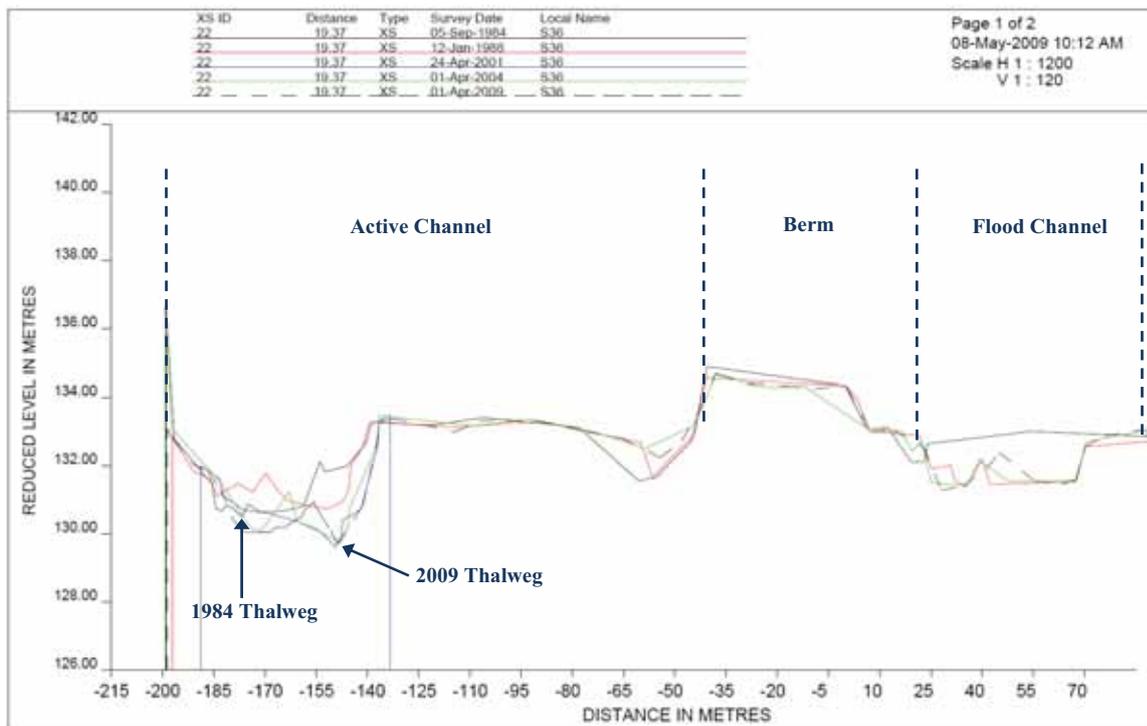
Figure 8.21 Cross-section S36, looking downstream

Aerial photography (Figure 2.7) indicates that the channel form at this location has changed significantly from a sediment-rich, semi-vegetated channel in 1947 to a more uniform straight channel in 2005. Secondary flood channels (Figure 8.21) are evident in the 1947 photography as bare gravel beaches whereas, in 2005, these appear as less active pastoral land.

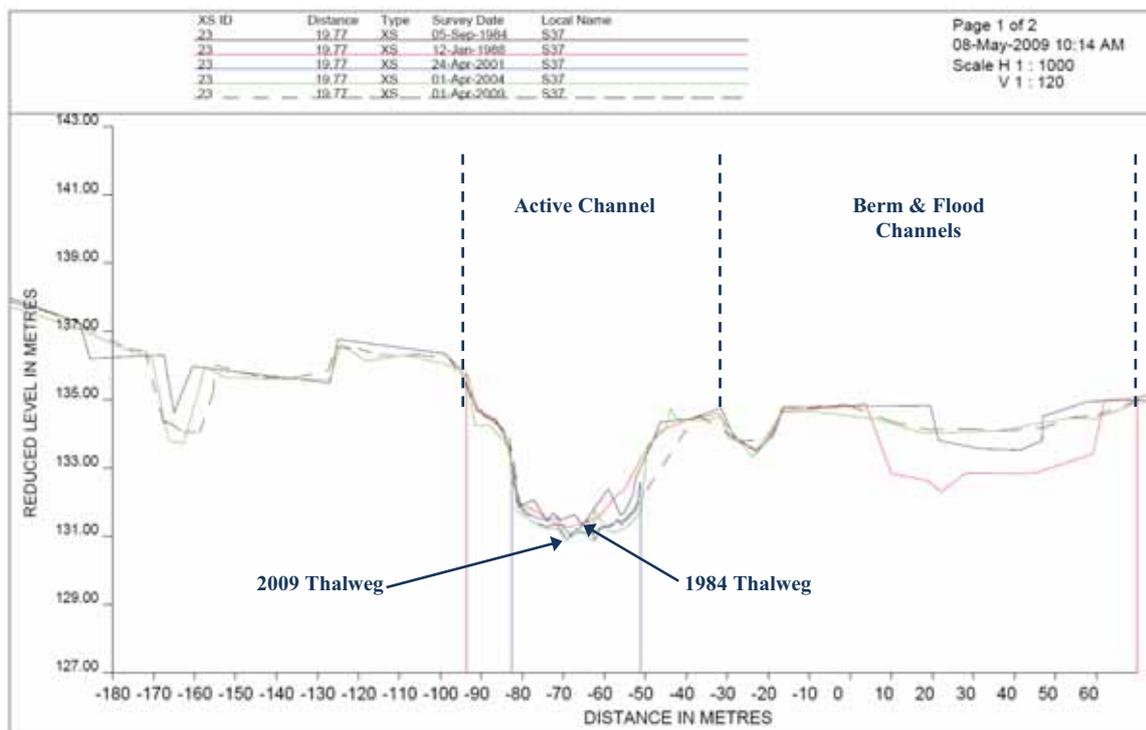
Figure 8.22 Cross-section S37, looking downstream

Aerial photography (Figure 2.7) indicates that the channel form at this location has changed significantly from a sediment rich, semi-vegetated channel in 1947 to a more uniform straight channel in 2005. Secondary flood channels (Figure 8.22) are evident in the 1947 photography as bare gravel beaches whereas, in 2005, these appear as less active pastoral land.
