Cardrona River Channel Morphology

May 2016

Otago Regional Council

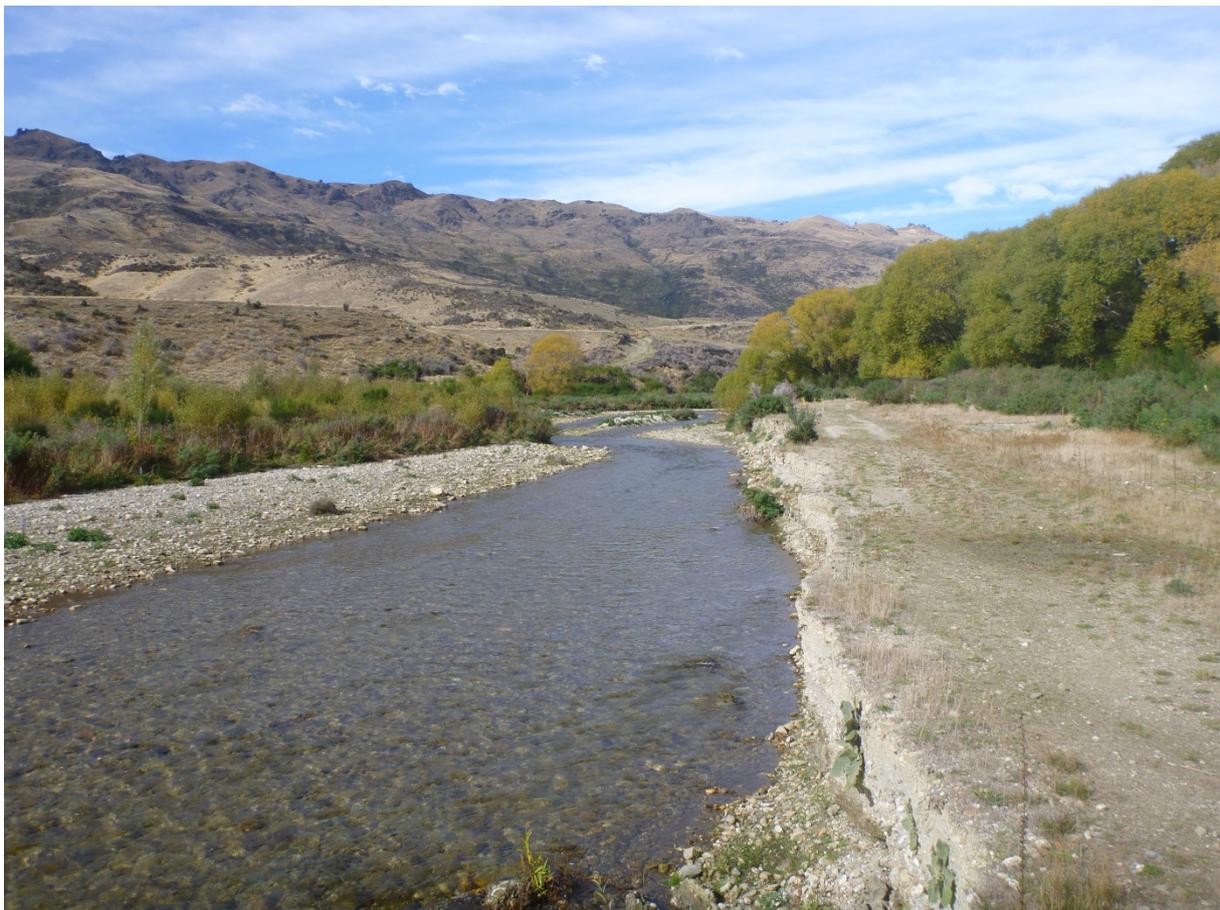
Bank erosion is considered to be the erosion of the margins of the active channel fairway and not the erosion of the low flow channel or channel braid migration. Bank erosion was observed at five of the forty two surveyed cross-sections. Other areas of bank erosion outside of the surveyed cross-sections were identified using aerial photography and site visits (Figure 4 to Figure 8). An example of bank erosion is shown in Figure 13.

Figure 13. Bank erosion of the true left bank downstream of cross-section CR11-1 (Figure 6)

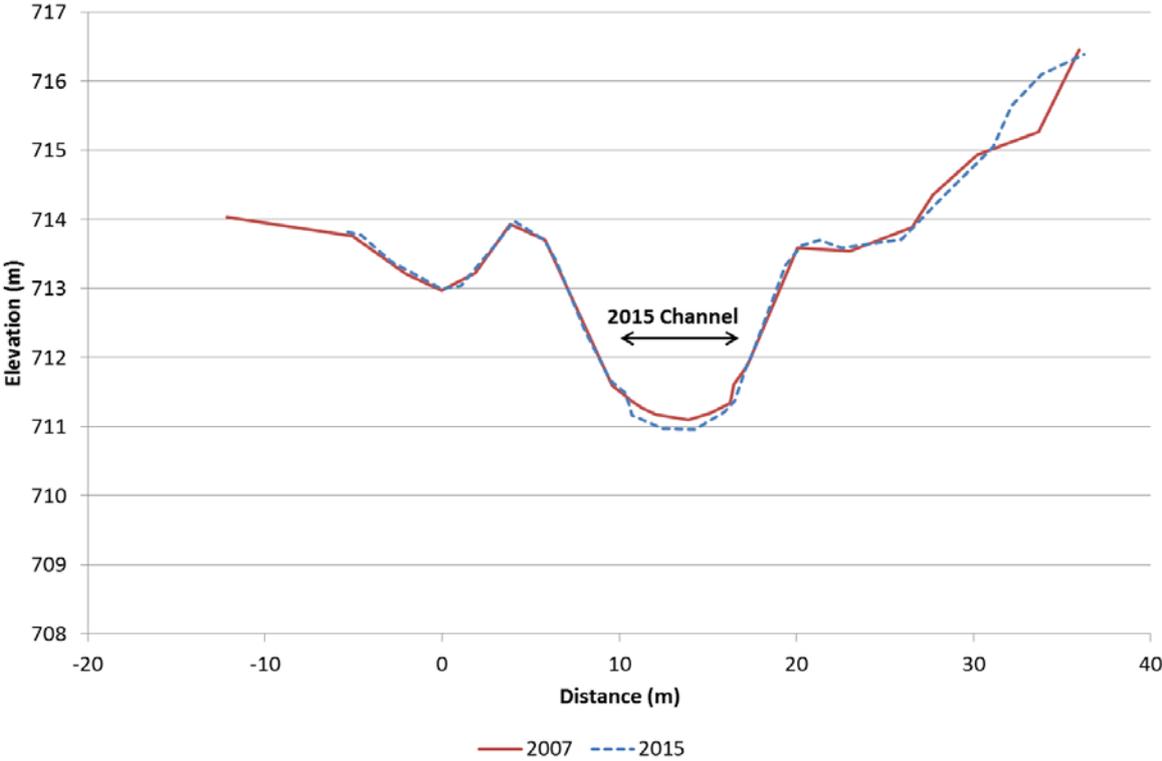
Cardrona River cross-section CR25-7

Figure 46. Cardrona River cross-section CR25-7, looking downstream refer to Figure 8 for location

Cross-section CR25-7 is located 31 km upstream of the confluence with the Clutha River/Mata-Au. The main channel has degraded at this location between 2007 and 2015 with minimal change across the wider of the floodplain.

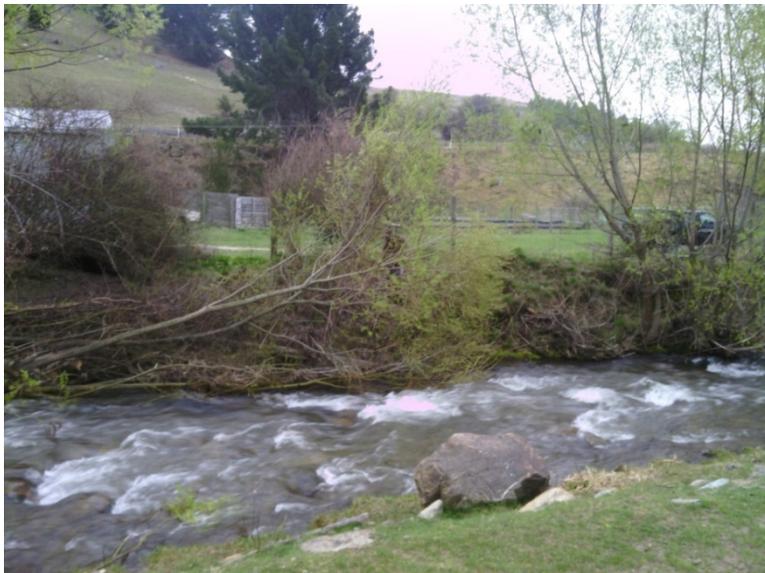
Figure 50. Cardrona River cross-section CR25-5, looking from true right to true left bank, November 2015

Cross-section CR25-5 is located 29.5 km upstream of the confluence with the Clutha River/Mata-Au. The channel has degraded between 2007 and 2015 with aggradation occurring on the true right bank.

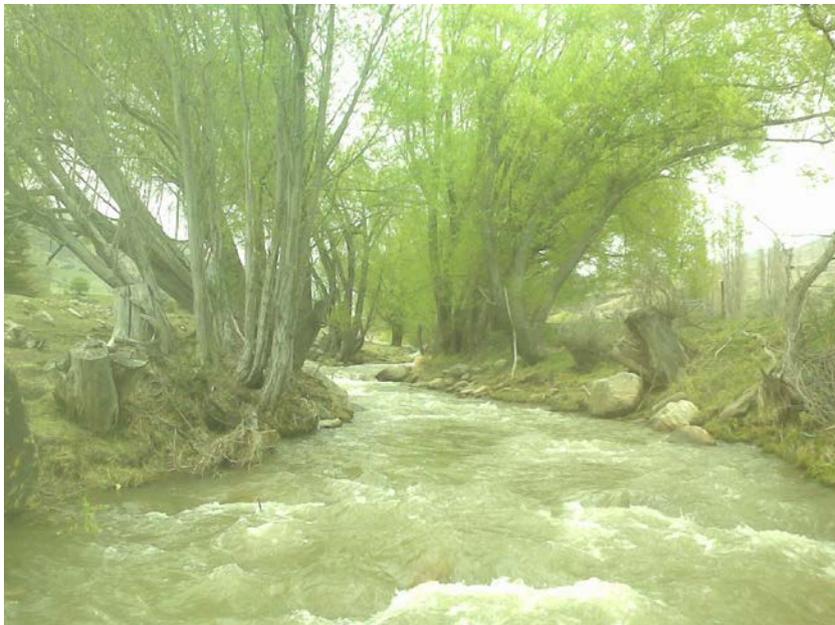
Figure 56. Cardrona River cross-section CR25-2, looking upstream, November 2015

Cross-section CR25-2 is located 27.1 km upstream of the confluence with the Clutha River/Mata-Au. The main channel has remained in a similar position between 2007 and 2015. The true left floodplain has both aggraded and degraded between 2007 and 2015.

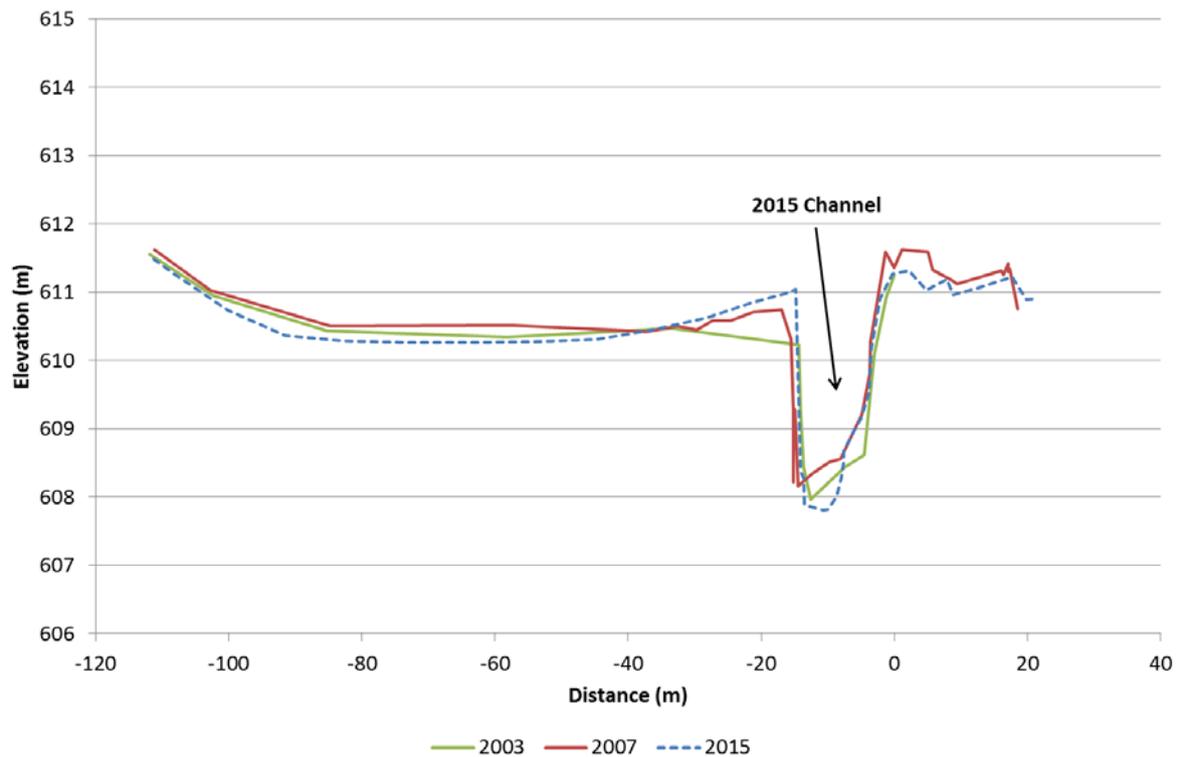
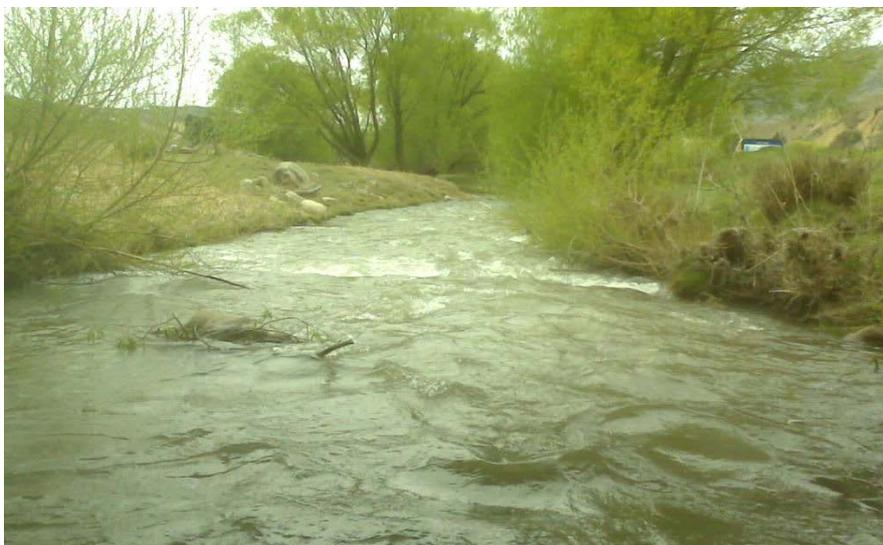
Cardrona River cross-section CR25-1

Figure 57. Cardrona River cross-section CR25-1, looking downstream refer to Figure 7 for location

Figure 58. Cardrona River cross-section CR25-1, looking downstream, November 2015

Cross-section CR25-1 is located 26.5 km upstream of the confluence with the Clutha River/Mata-Au. Between 2003 and 2015 the main channel has experienced degradation. Aggradation has occurred on the true left channel bank between 2003 and 2015 with degradation occurring on the wider true left and right bank floodplain between 2007 and 2015.

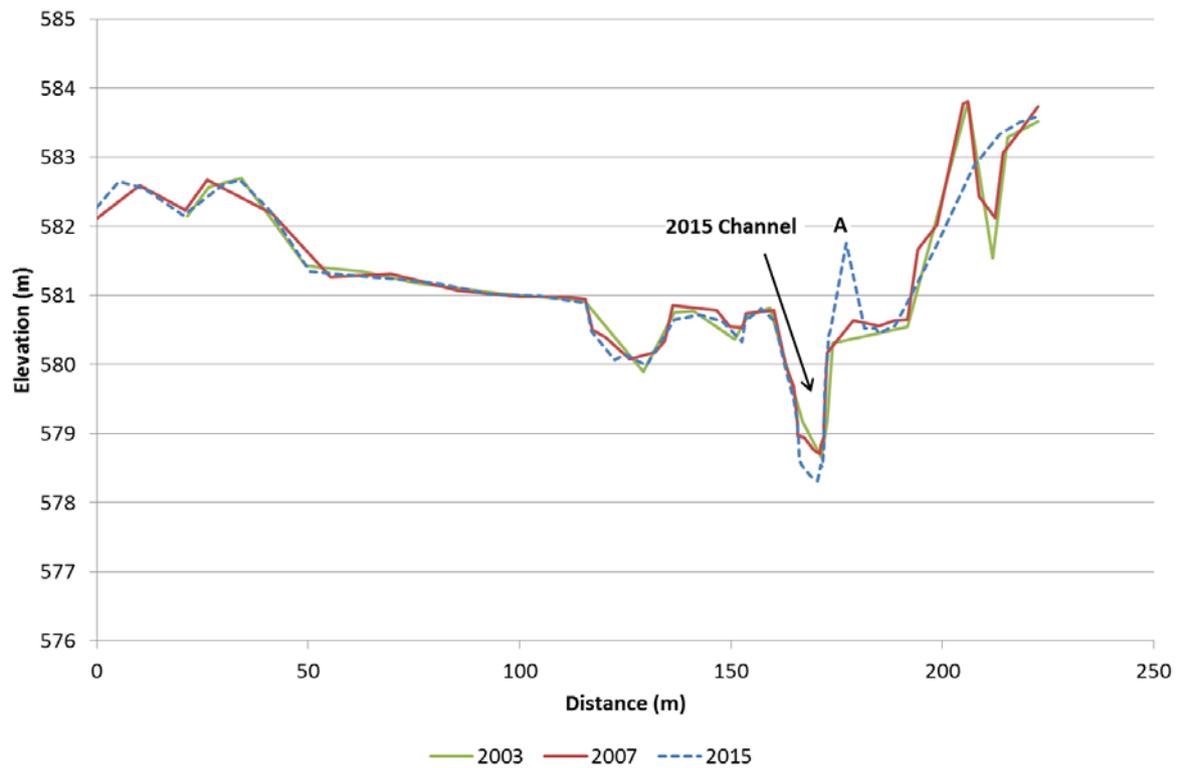
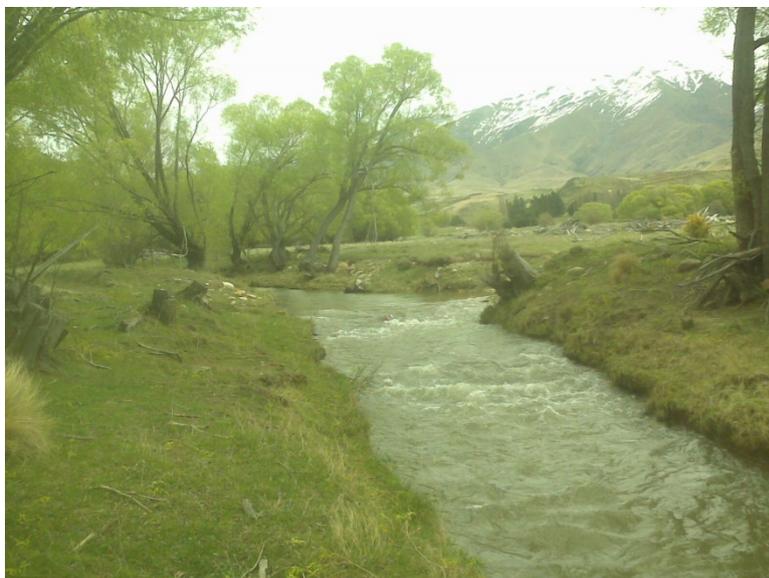
Cardrona River cross-section CR22

Figure 59. Cardrona River cross-section CR22, looking downstream refer to Figure 7 for location

Figure 60. Cardrona River cross-section CR22, looking upstream, November 2015

Cross-section CR22 is located 24.1 km upstream of the confluence with the Clutha River/Mata-Au. The main channel has degraded between 2003 and 2015 with the creation of a feature at the point labelled A. Bank erosion occurred on the true right bank between 2003 and 2015.

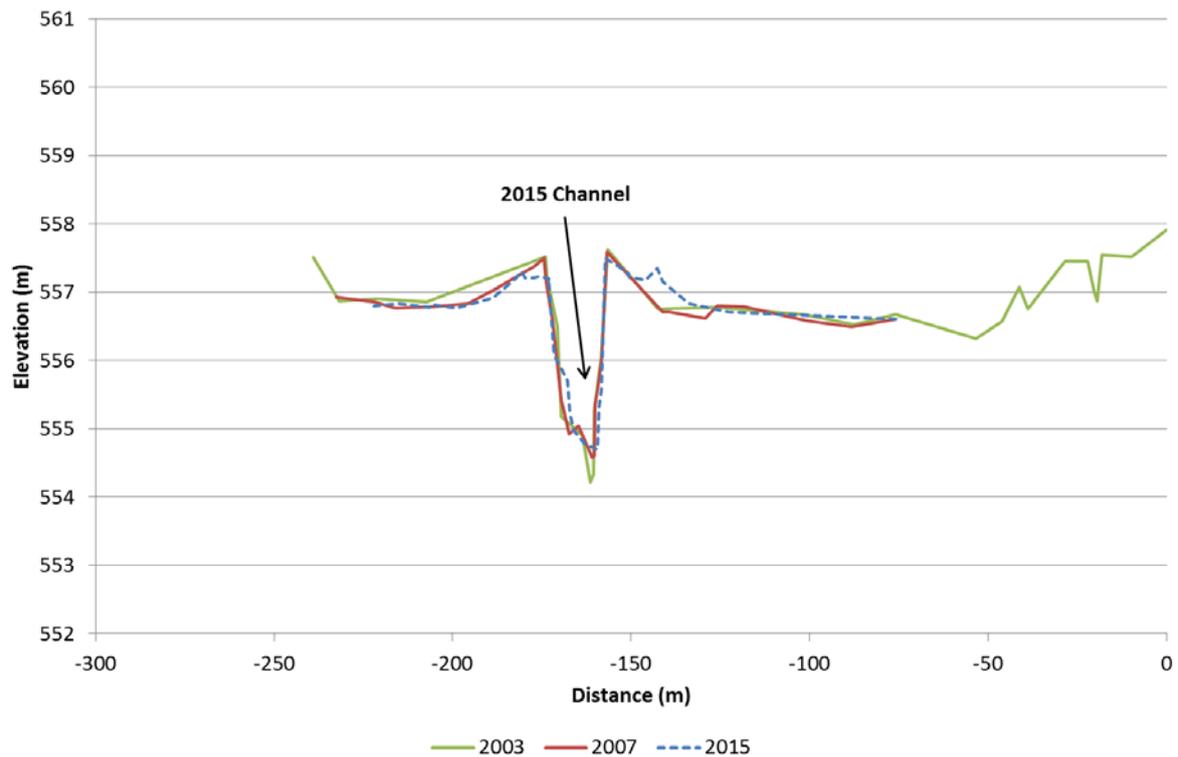
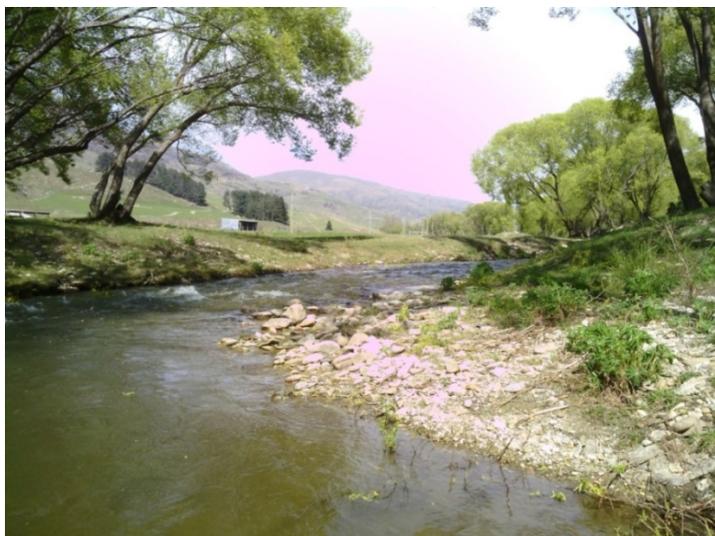
Cardrona River cross-section CR18-1

Figure 61. Cardrona River cross-section CR18-1, looking downstream refer to Figure 7 for location

Figure 62. Cardrona River cross-section CR18-1, looking upstream, November 2015

Cross-section CR18-1 is located 21.74 km upstream of the confluence with the Clutha River/Mata-Au. The channel has aggraded between 2003 and 2015 but has remained in a similar position between 2007 and 2015. The true right floodplain has aggraded between 2003 and 2015. The true left floodplain has degraded between 2003 and 2015 but has remained in a similar position between 2007 and 2015.

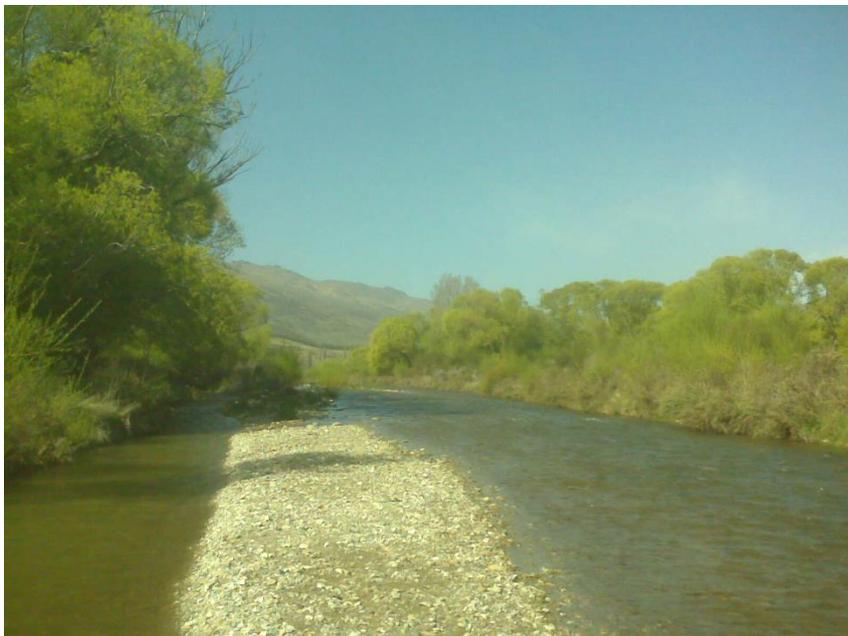
Figure 66. Cardrona River cross-section CR11-1, looking upstream, November 2015

Cross-section CR11-1 is located 17.5 km upstream of the confluence with the Clutha River/Mata-Au. Between 2003 and 2015 the main channel has degraded and become more confined. The true left floodplain has aggraded between 2007 and 2015.

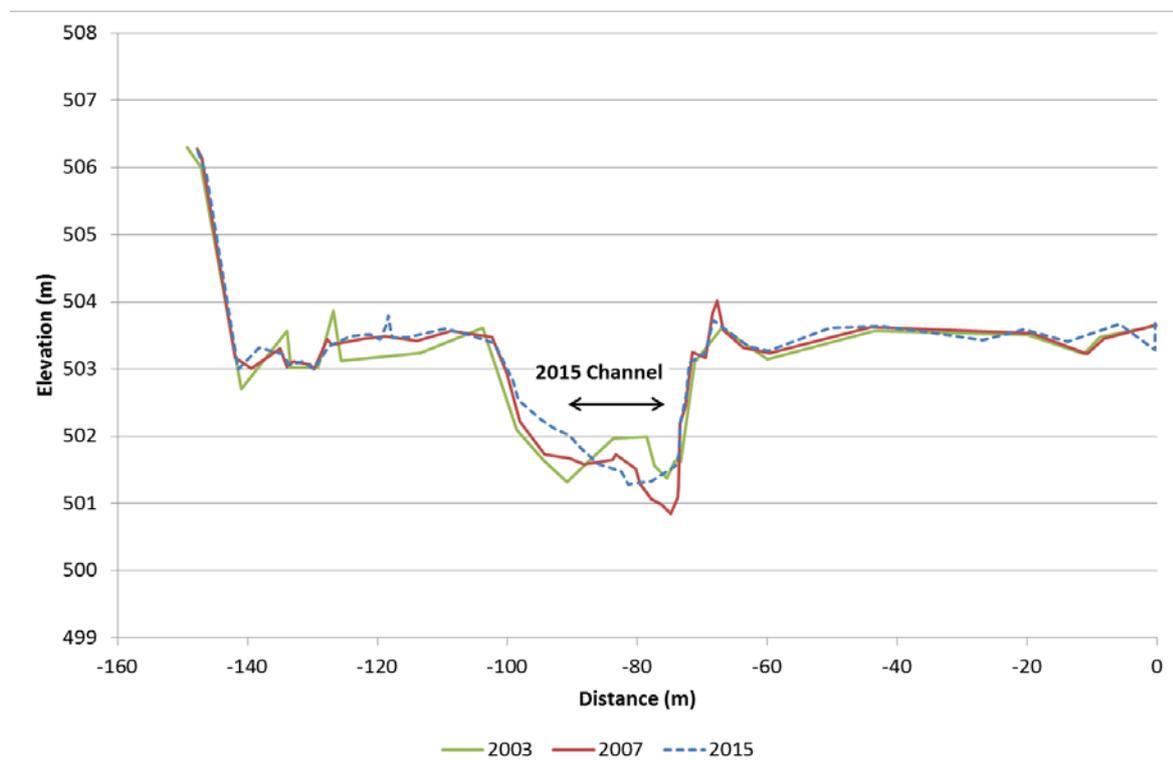
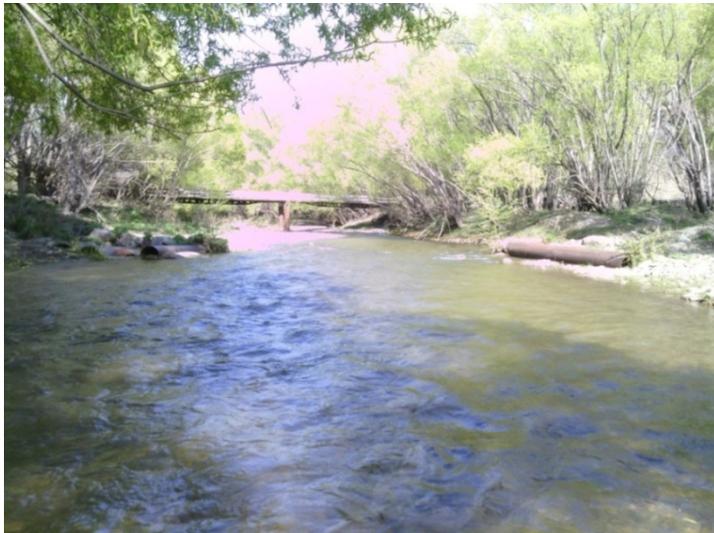
Cardrona River cross-section CR9

Figure 67. Cardrona River cross-section CR9, looking downstream refer to Figure 6 for location

Figure 68. Cardrona River cross-section CR9, looking upstream, November 2015

Cross-section CR9 is located 15.7 km upstream of the confluence with the Clutha River/Mata-Au. The main channel has aggraded on the true left and true right, but has degraded in the centre between 2007 and 2015 creating a more confined channel. The wider floodplain has remained similar between 2007 and 2015 but has experienced aggradation between 2003 and 2015.

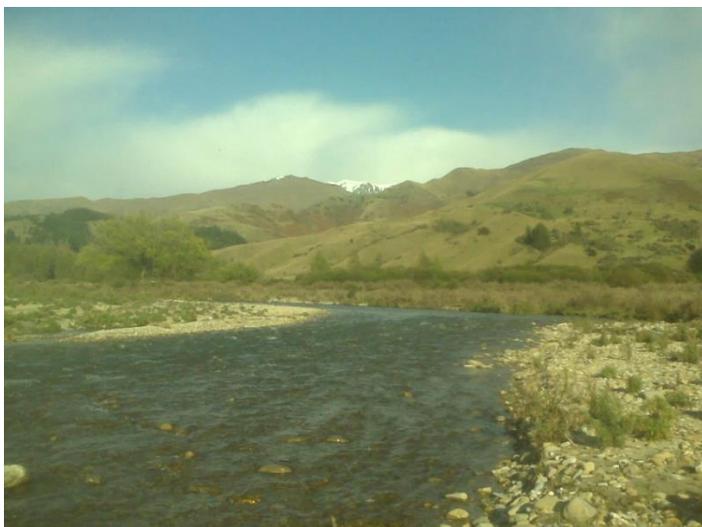
Figure 74. Cardrona River cross-section CR3, looking upstream, November 2015

Cross-section CR3 is located 11.7 km upstream of the confluence with the Clutha River/Mata-Au. The channel at this location is braided with one main channel in the centre of the active fairway and several low flow channels. These channels have both aggraded and degraded between 2003 and 2007. Aggradation of the true left bank terrace has occurred between 2007 and 2015.

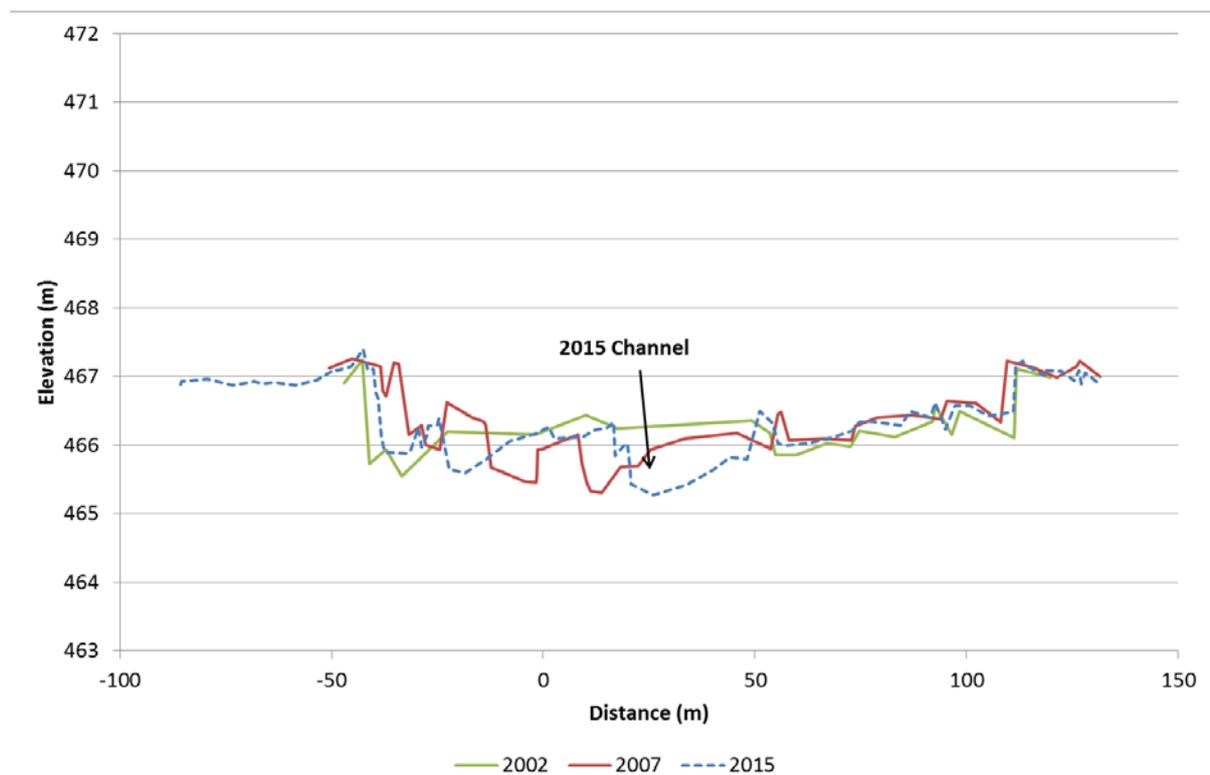
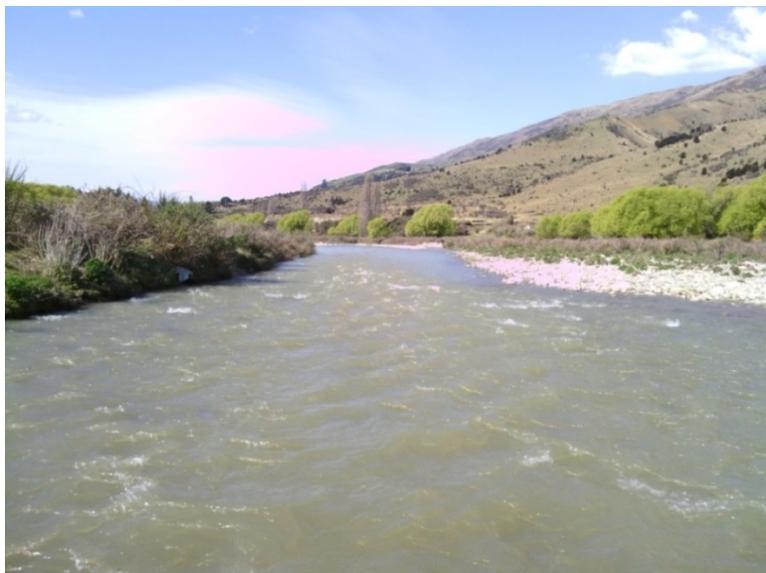
Cardrona River cross-section CR2B

Figure 75. Cardrona River cross-section CR2B, looking downstream refer to Figure 5 for location

Figure 76. Cardrona River cross-section CR2B, looking downstream, November 2015

Cross-section CR2B is located 11.4 km upstream of the confluence with the Clutha River/Mata-Au. The main channel has been migrating towards the true right bank between 2003 and 2015 with both aggradation and degradation occurring as previous channel became infilled. The true left bank floodplain has eroded between 2007 and 2015.

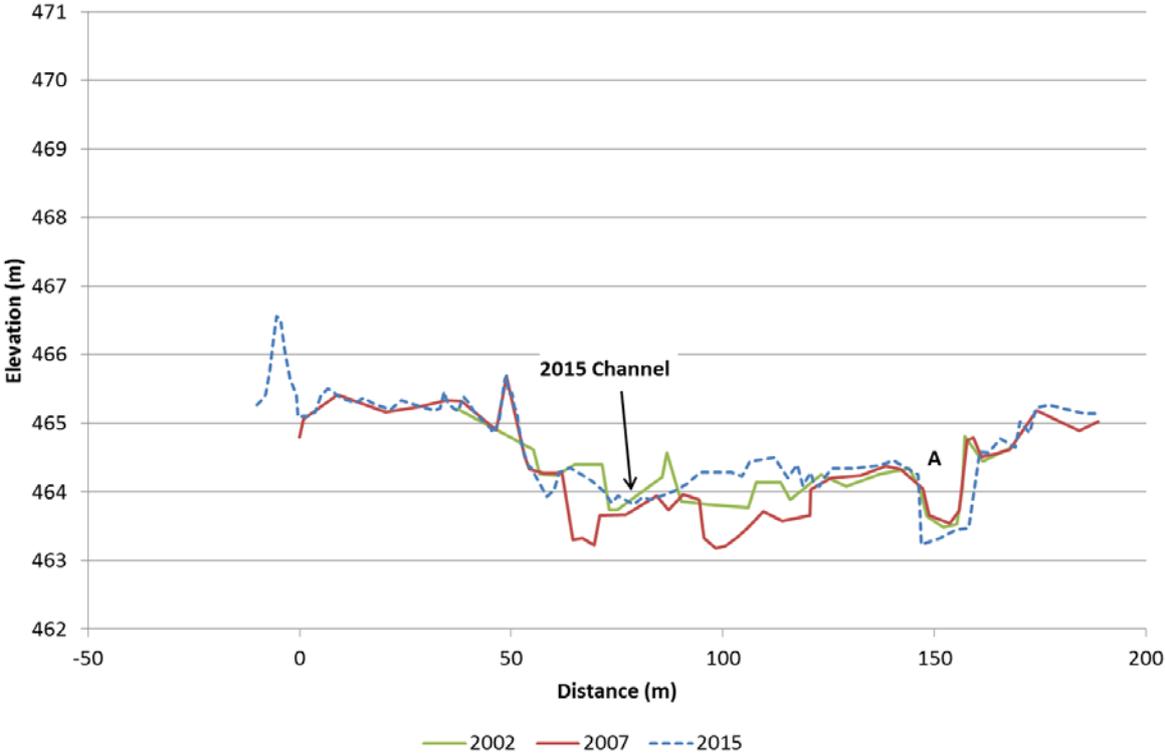
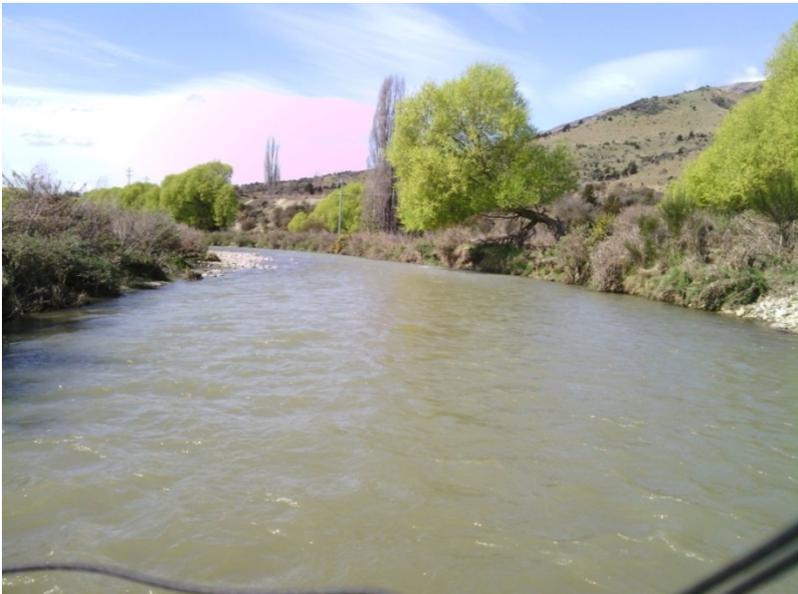
Cardrona River cross-section CR2

Figure 77. Cardrona River cross-section CR2, looking downstream refer to refer to Figure 5 for location

Figure 78. Cardrona River cross-section CR2, looking downstream, November 2015

Cross-section CR2 is located 11.2 km upstream of the confluence with the Clutha River/Mata-Au. The wider braid network has experienced aggradation between 2007 and 2015 with the exception of a secondary channel at the point labelled A, which has degraded between 2007 and 2015 as well as eroding the true right bank.

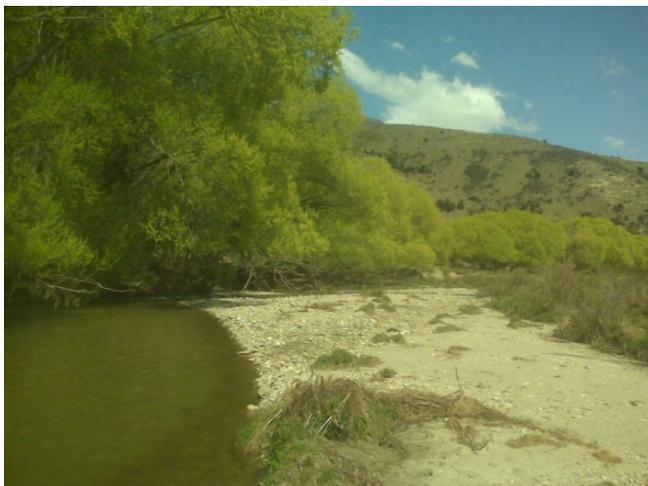
Figure 82. Cardrona River cross-section CR1B, looking upstream, November 2015

Cross-section CR1B is located 10.7 km upstream of the confluence with the Clutha River/Mata-Au. Aggradation has occurred on the true left of the fairway with degradation occurring on the true right between 2007 and 2015. The main channel has switched from the true left of the fairway in 2007 to the true right side of the fairway in 2015. Aggradation has occurred on the true right bank between 2007 and 2015.

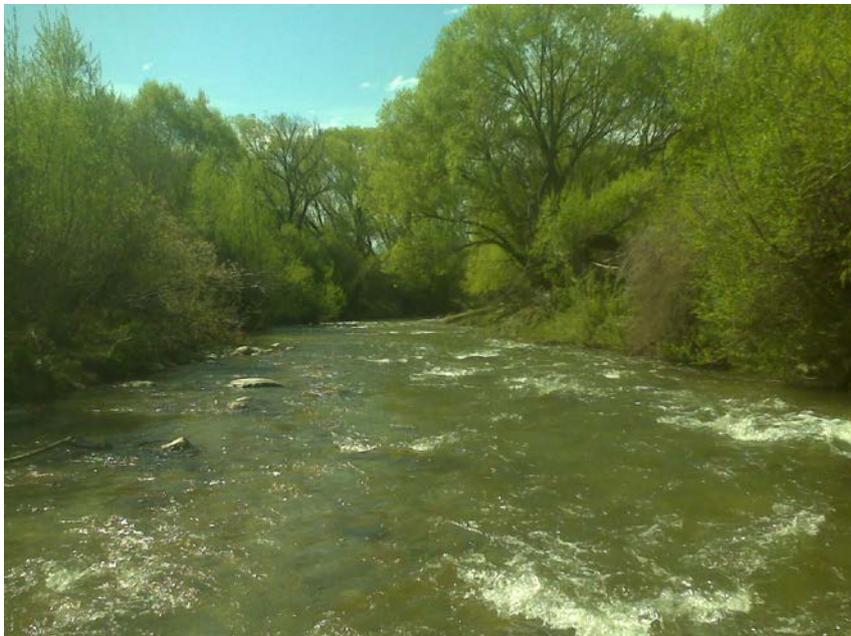
Figure 86. Cardrona River cross-section CR28-2, looking downstream, November 2015

Cross-section CR28-2 is located 10.18 km upstream of the confluence with the Clutha River/Mata-Au. The main channel has degraded between 2007 and 2015 with degradation occurring on the true left and right bank floodplain.

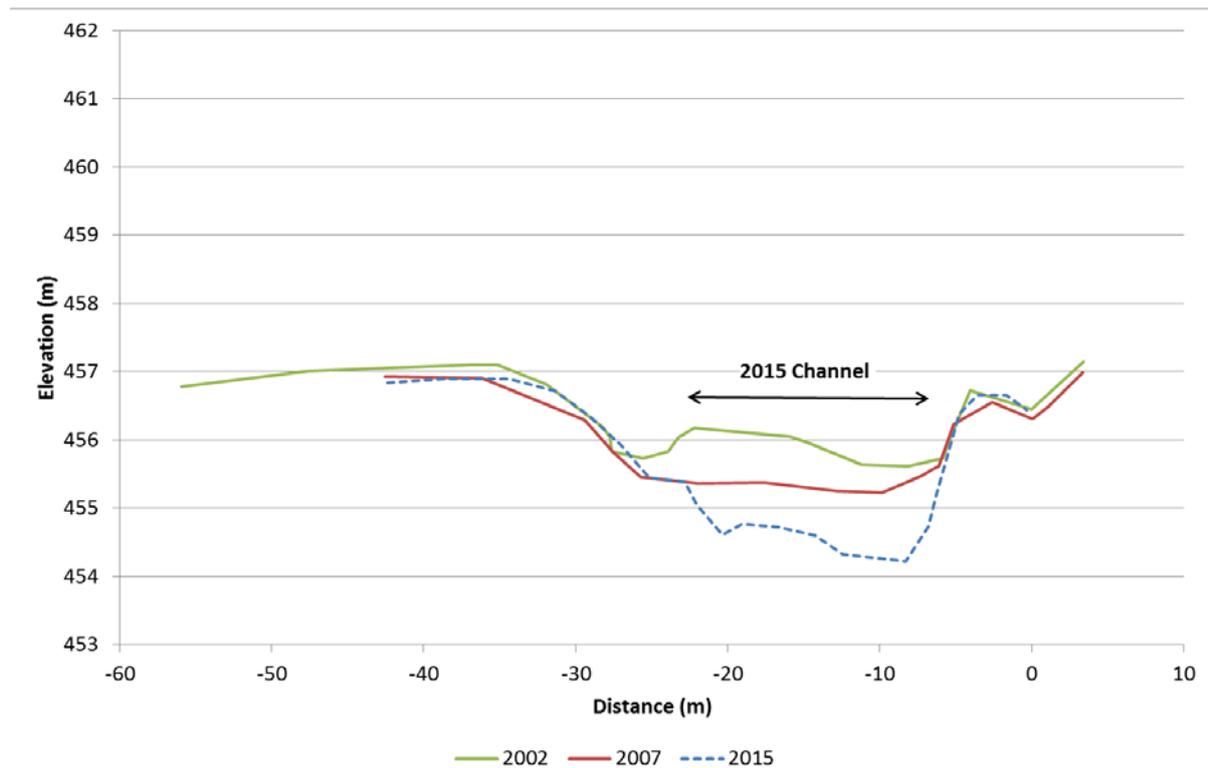
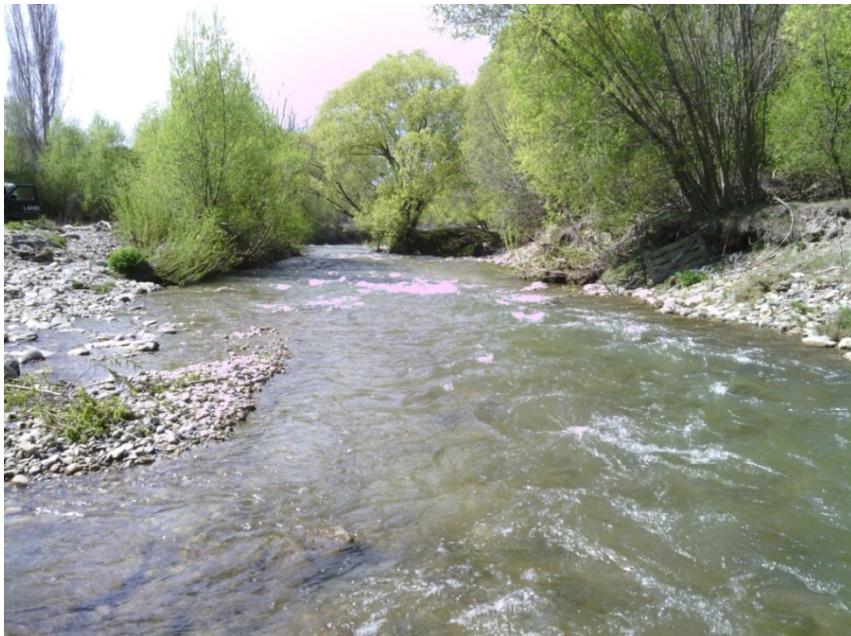
Cardrona River cross-section CR28-1

Figure 87. Cardrona River cross-section CR28-1, looking downstream refer to Figure 5 for location

Figure 88. Cardrona River cross-section CR28-1, looking downstream, November 2015

Cross-section CR28-1 is located 10 km upstream of the confluence with the Clutha River/Mata-Au. The main channel has degraded between 2002 and 2015 with minimal change occurring across the wider floodplain.

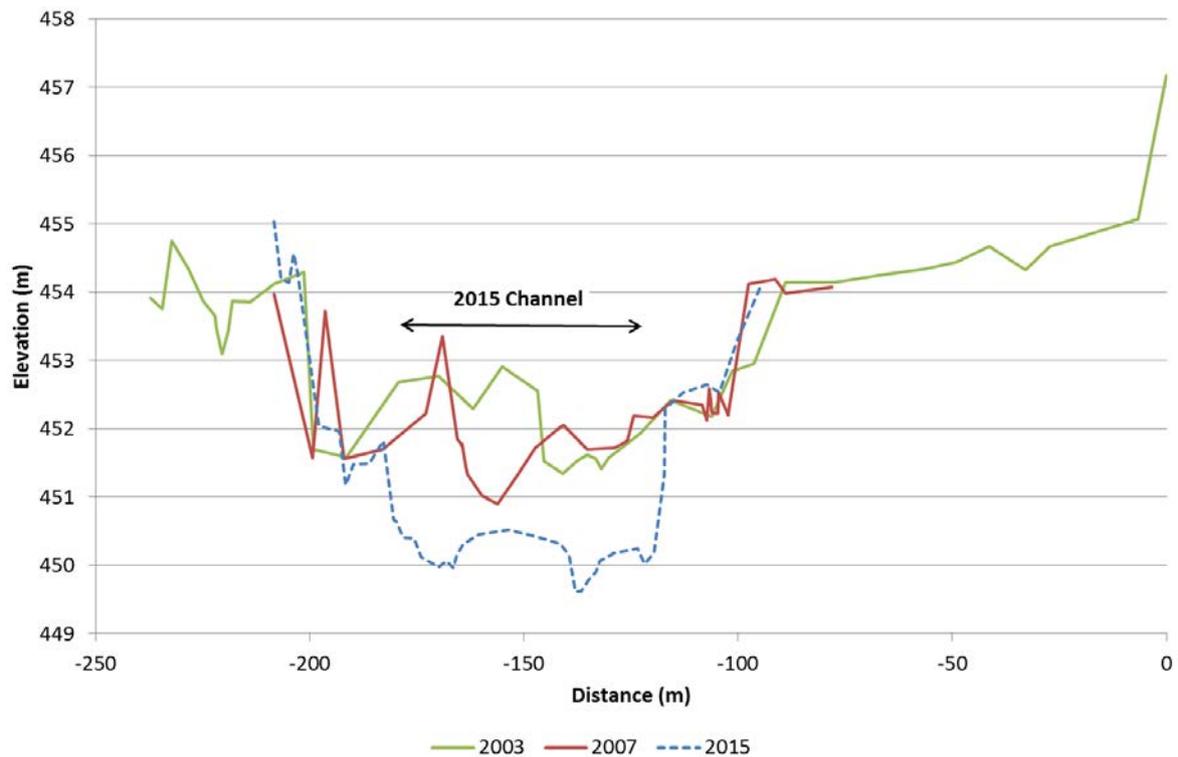
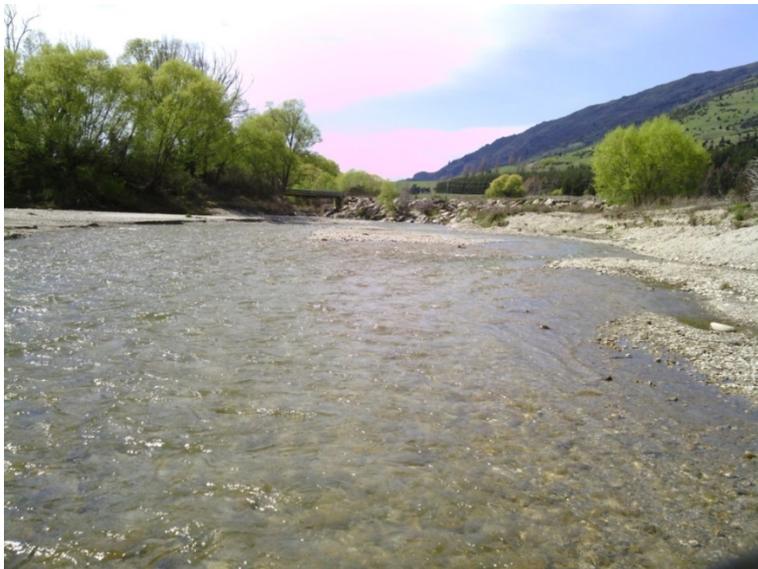
Cardrona River cross-section CR54-2

Figure 89. Cardrona River cross-section CR54-2, looking downstream refer to Figure 5 for location

Figure 90. Cardrona River cross-section CR54-2, looking downstream, November 2015

Cross-section CR54-2 is located 9.5 km upstream of the confluence with the Clutha River/Mata-Au. The main channel has degraded between 2007 and 2015 which has created a more confined channel.⁸

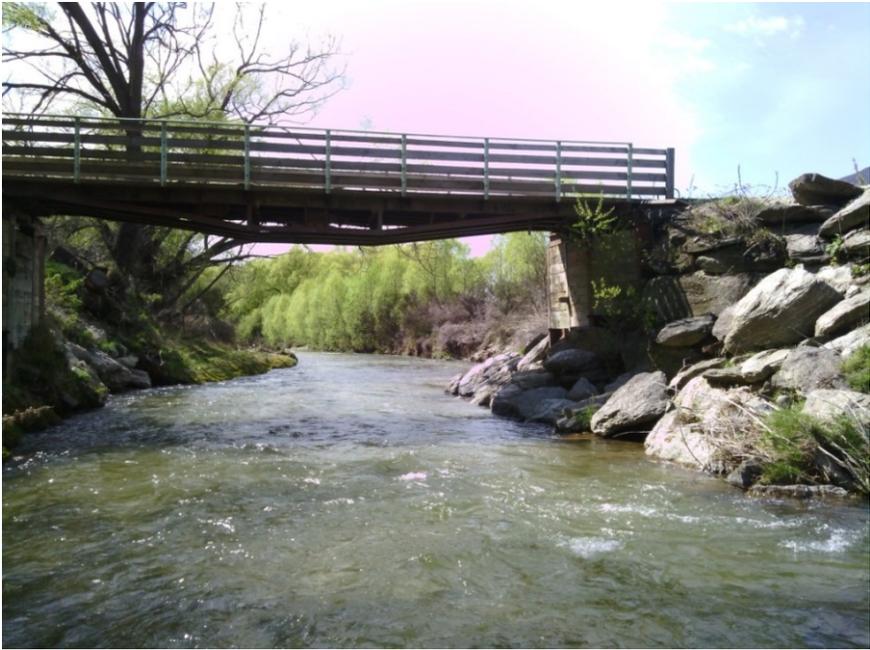
Figure 92. Cardrona River cross-section CR54-1, looking downstream, November 2015

Cross-section CR54-1 is located 9.4 km upstream of the confluence with the Clutha River/Mata-Au. The main channel has degraded between 2007 and 2015 with some degradation occurring on the true right bank floodplain.

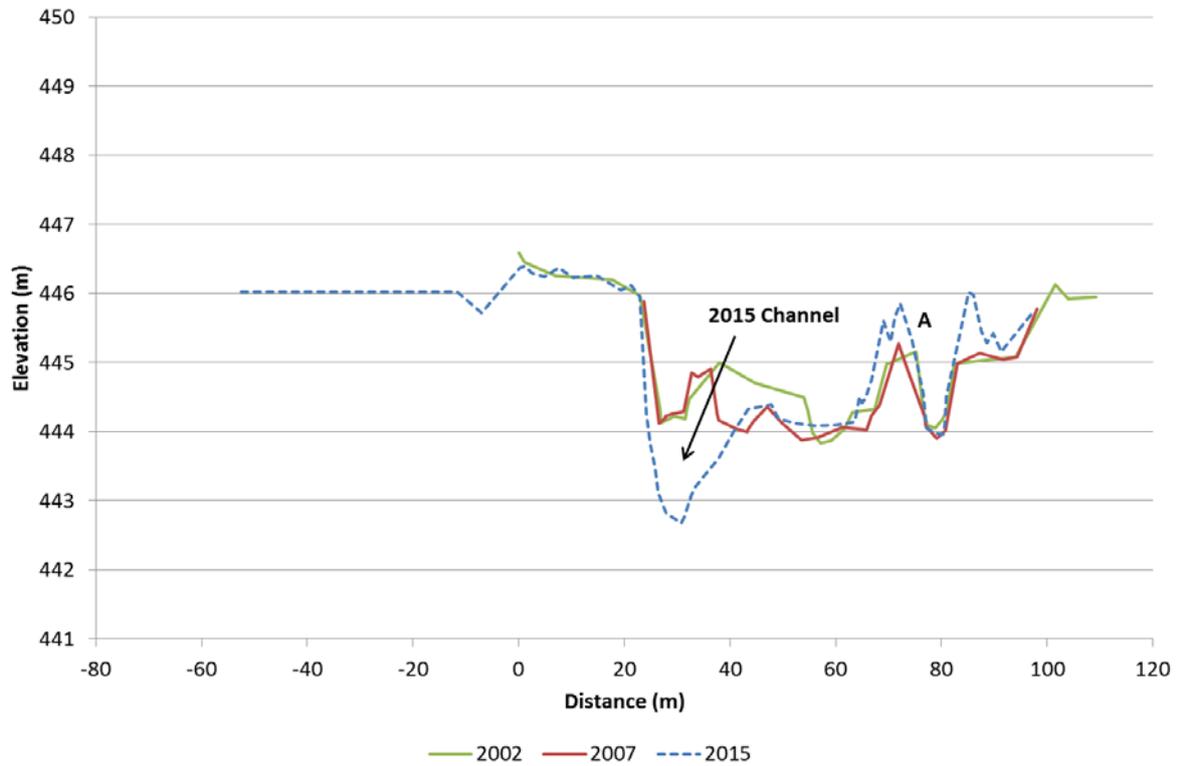
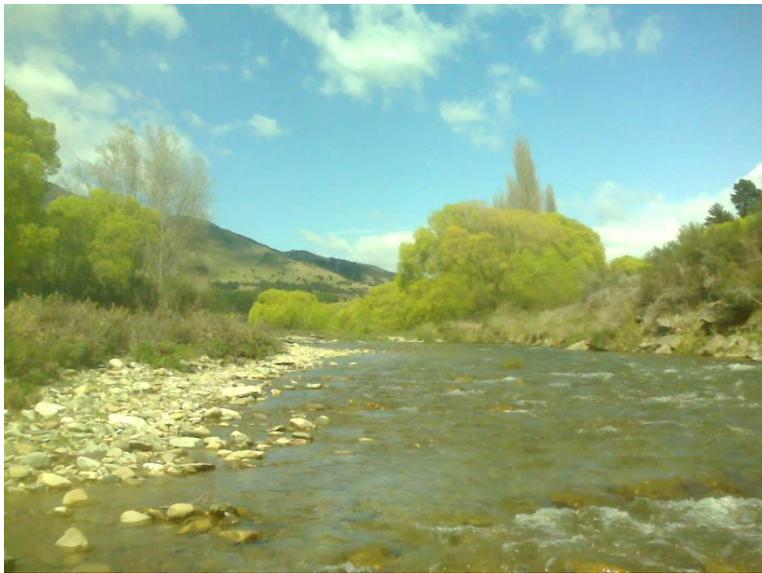
Cardrona River cross-section CR30-1

Figure 93. Cardrona River cross-section CR30-1, looking downstream refer to Figure 5 for location

Figure 94. Cardrona River cross-section CR30-1, looking upstream, November 2015

Cross-section CR30-1 is located 8.6 km upstream of the confluence with the Clutha River/Mata-Au. The main channel has shifted to the true left of the active fairway and degraded between 2007 and 2015 creating a more confined channel. The secondary channel at the point labelled A has become more confined between 2007 and 2015.

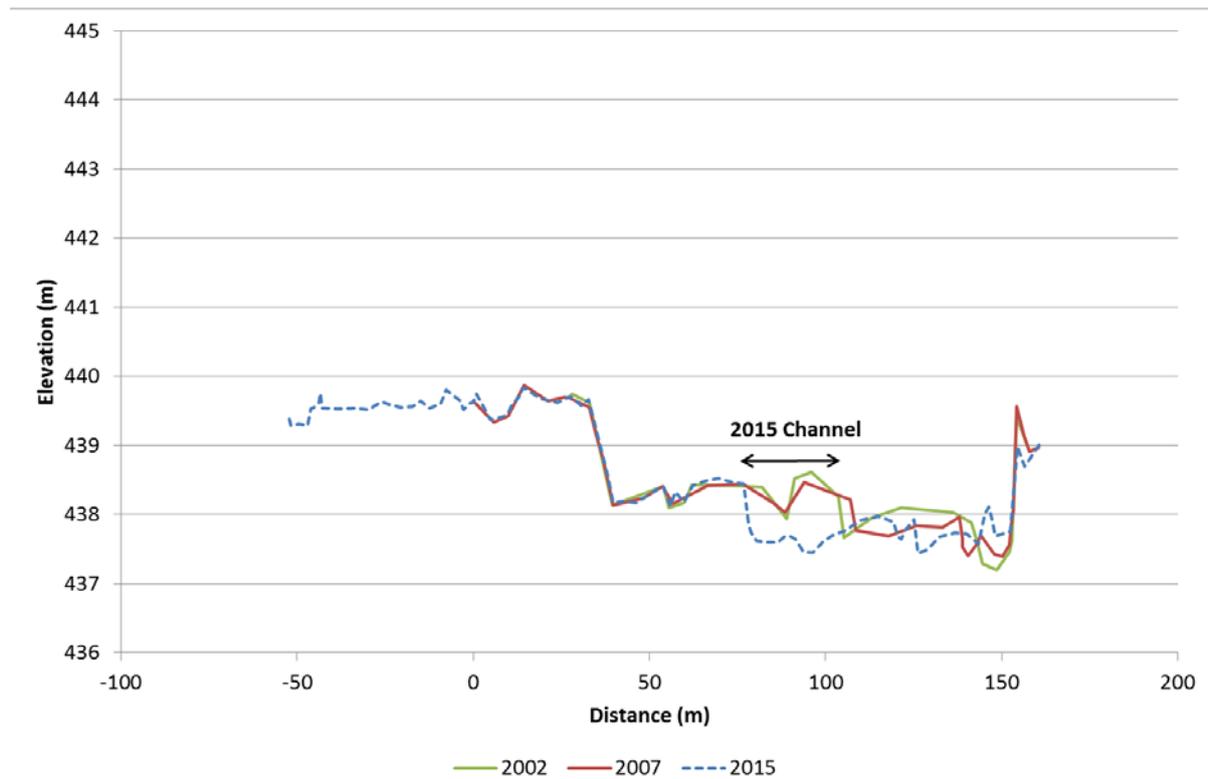
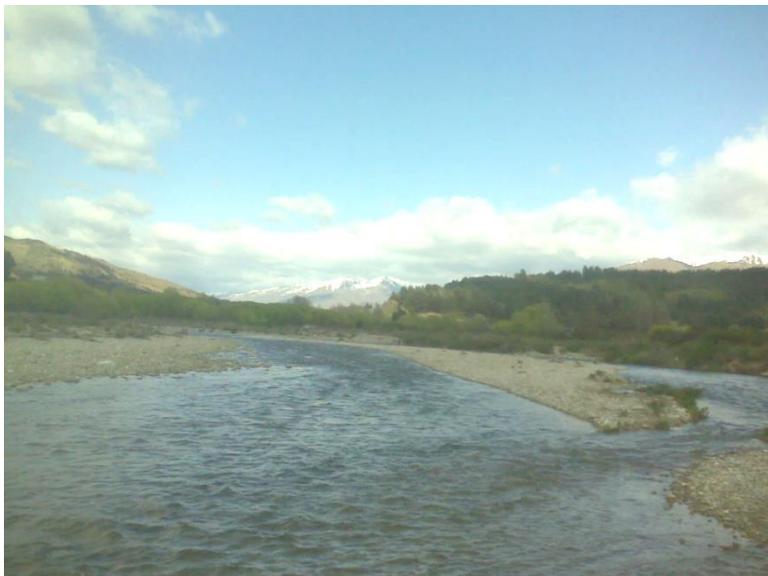
Cardrona River cross-section CR31-1

Figure 95. Cardrona River cross-section CR31-1, looking downstream refer to Figure 5 for location

Figure 96. Cardrona River cross-section CR31-1, looking upstream, November 2015

Cross-section CR31-1 is located 7.9 km upstream of the confluence with the Clutha River/Mata-Au. The main channel shifted to the true left of the active fairway between 2007 and 2015, the true right of the active fairway both aggraded and degraded between 2003 and 2015.

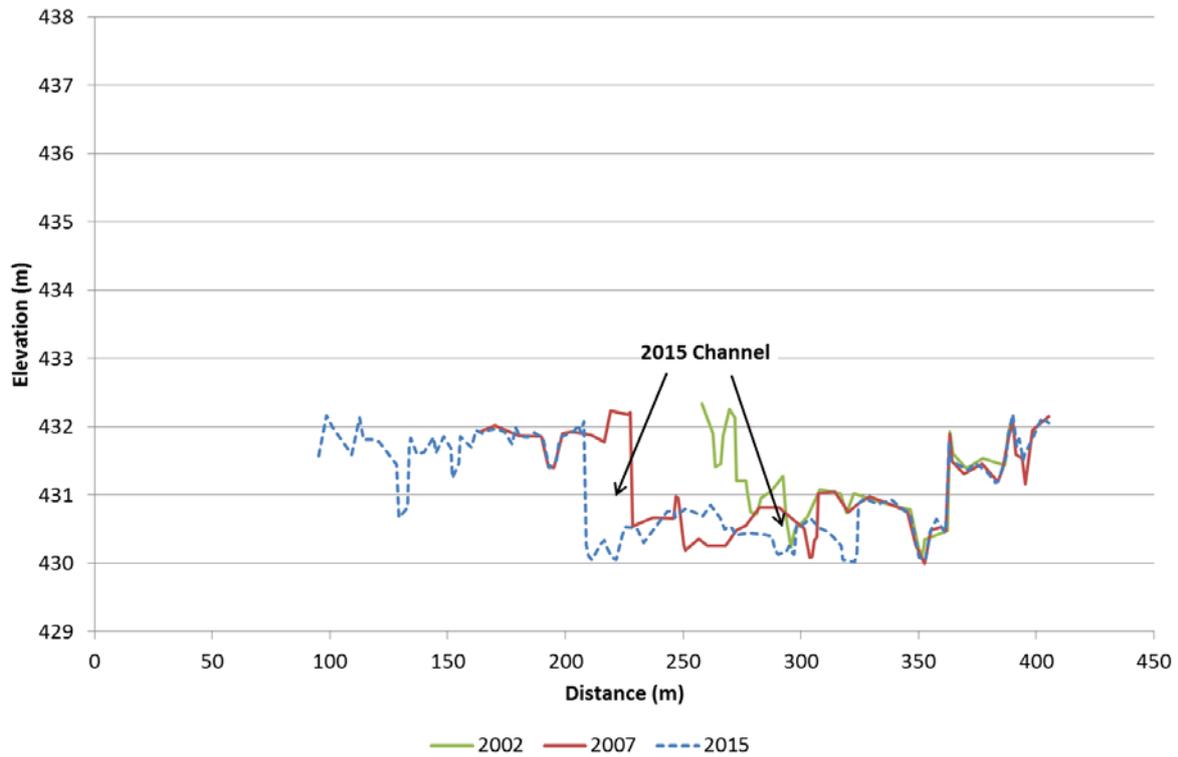
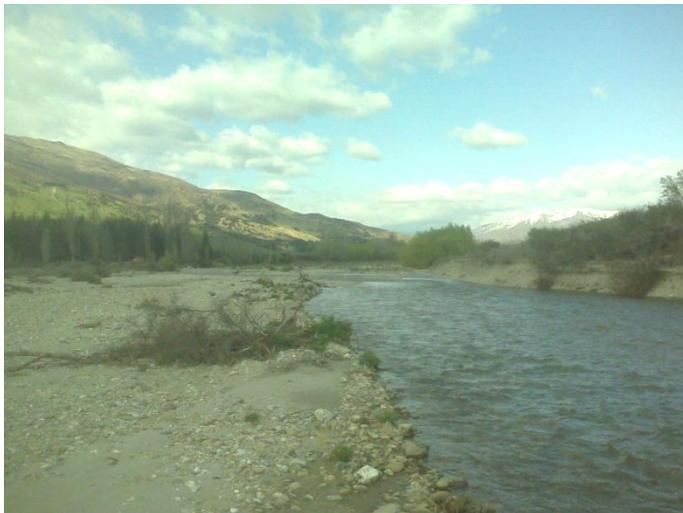
Cardrona River cross-section CR36-1

Figure 97. Cardrona River cross-section CR36-1, looking downstream refer to Figure 5 for location

Figure 98. Cardrona River cross-section CR36-1, looking downstream, November 2015

Cross-section CR36-1 is located 7.1 km upstream of the confluence with the Clutha River/Mata-Au. The true left and right banks of the active fairway have continued to erode between 2002 and 2015 creating a wider active fairway. Both aggradation and degradation has occurred between 2007 and 2015 in the active river fairway as the river braids migrate.⁹
