Cardrona River Channel Morphology

May 2016

Otago Regional Council

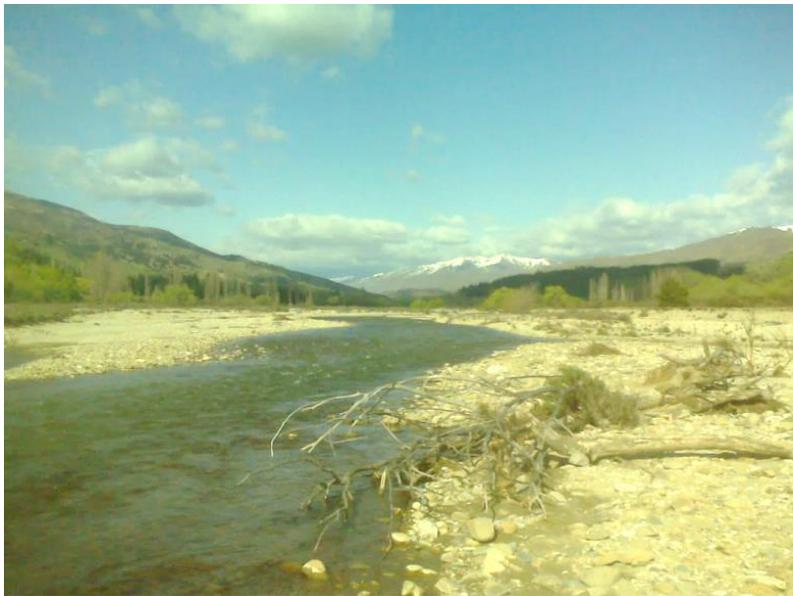
Figure 100. Cardrona River cross-section CR39, looking upstream, November 2015

Cross-section CR39 is located 6.6 km upstream of the confluence with the Clutha River/Mata-Au. The true left bank of the active fairway has eroded between 2007 and 2015. The active fairway has both aggraded and degraded between 2007 and 2015 as the river braids migrate across the river fairway.

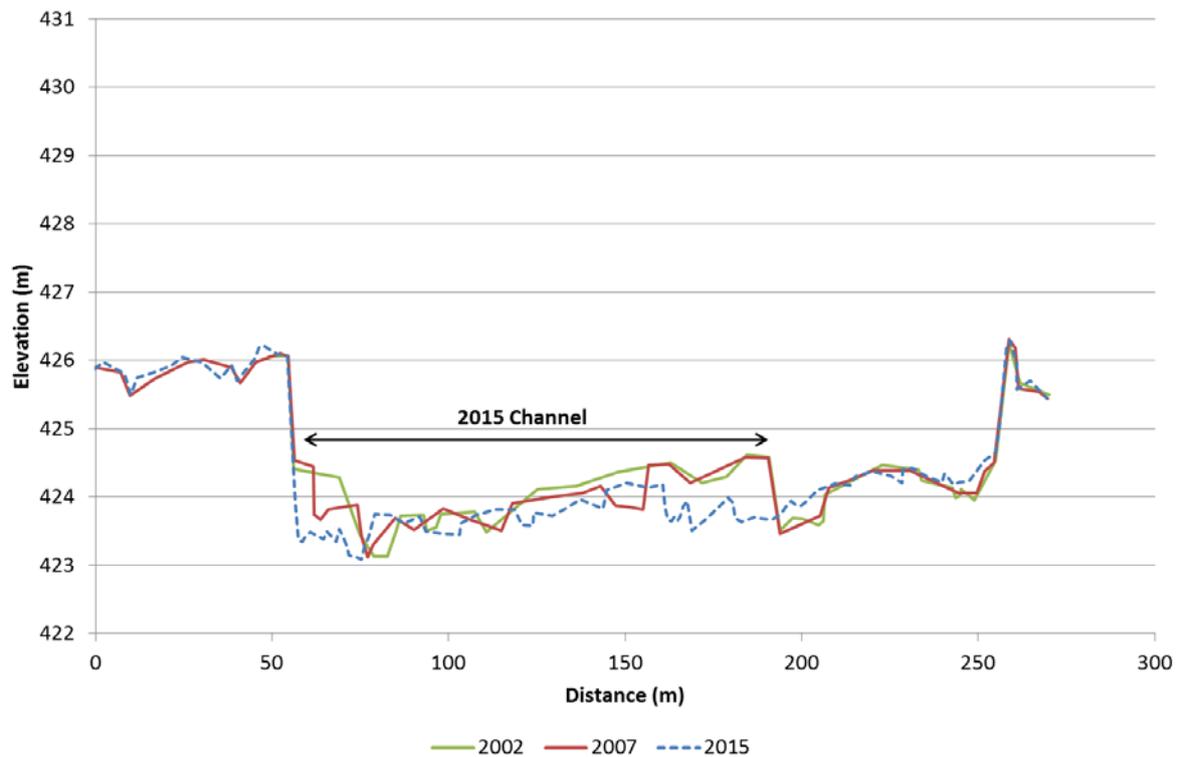
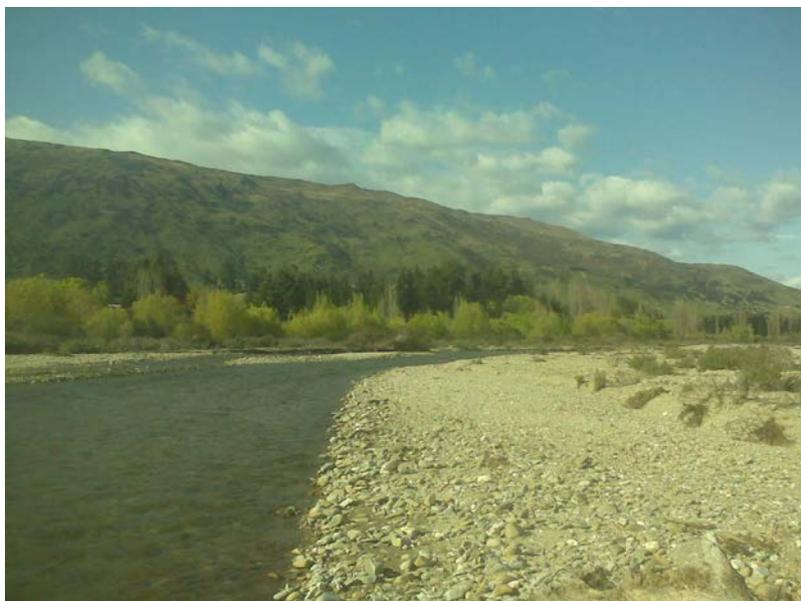
Cardrona River cross-section CR39-1

Figure 101. Cardrona River cross-section CR39-1, looking downstream refer to Figure 4 for location

Figure 102. Cardrona River cross-section CR39-1, looking upstream, November 2015

Cross-section CR39-1 is located 6.5 km upstream of the confluence with the Clutha River/Mata-Au. The active fairway has experienced mostly degradation between 2007 and 2015. Erosion of the true left bank of the active fairway has occurred between 2002 and 2015. The wider floodplain has remained similar between 2007 and 2015.

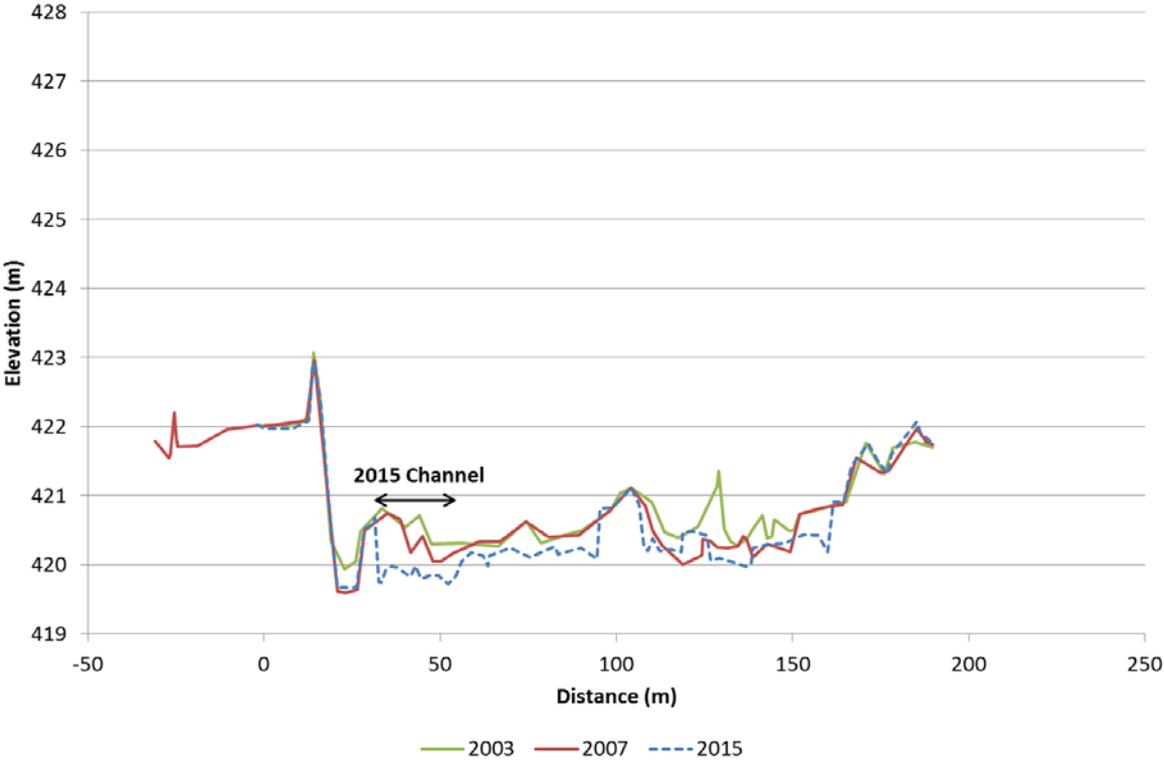
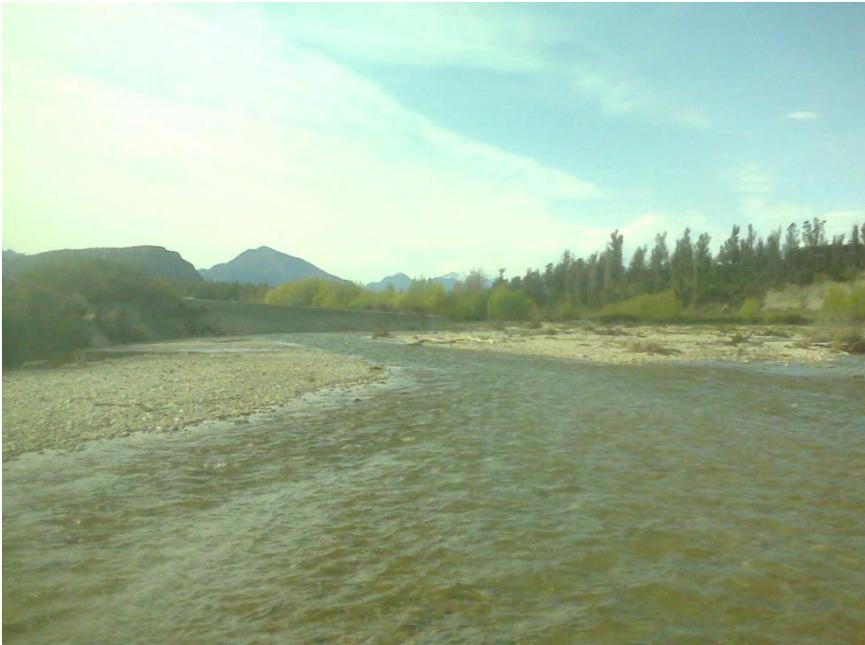
Cardrona River cross-section CR40-1

Figure 103. Cardrona River cross-section CR40-1, looking downstream refer to Figure 4 for location

Figure 104. Cardrona River cross-section CR40-1, looking downstream, November 2015

Cross-section CR40-1 is located 6 km upstream of the confluence with the Clutha River/Mata-Au. The active fairway has experienced mostly degradation between 2007 and 2015. There has been minimal change of the wider floodplain between 2007 and 2015.

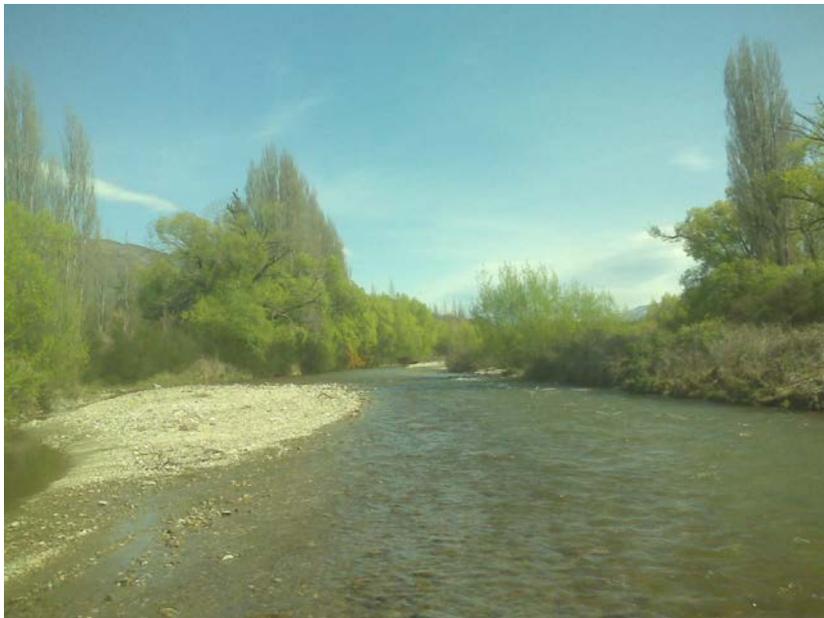
Figure 108. Cardrona River cross-section, looking upstream, November 2015

Cross-section CR42 is located 5.1 km upstream of the confluence with the Clutha River/Mata-Au at the Ballantyne Road bridge. The active channel at this location is confined by the presence of the bridge and has continued to degrade between 2002 and 2015.
