# **Channel morphology and sedimentation in the Cardrona River**

**January 2010**

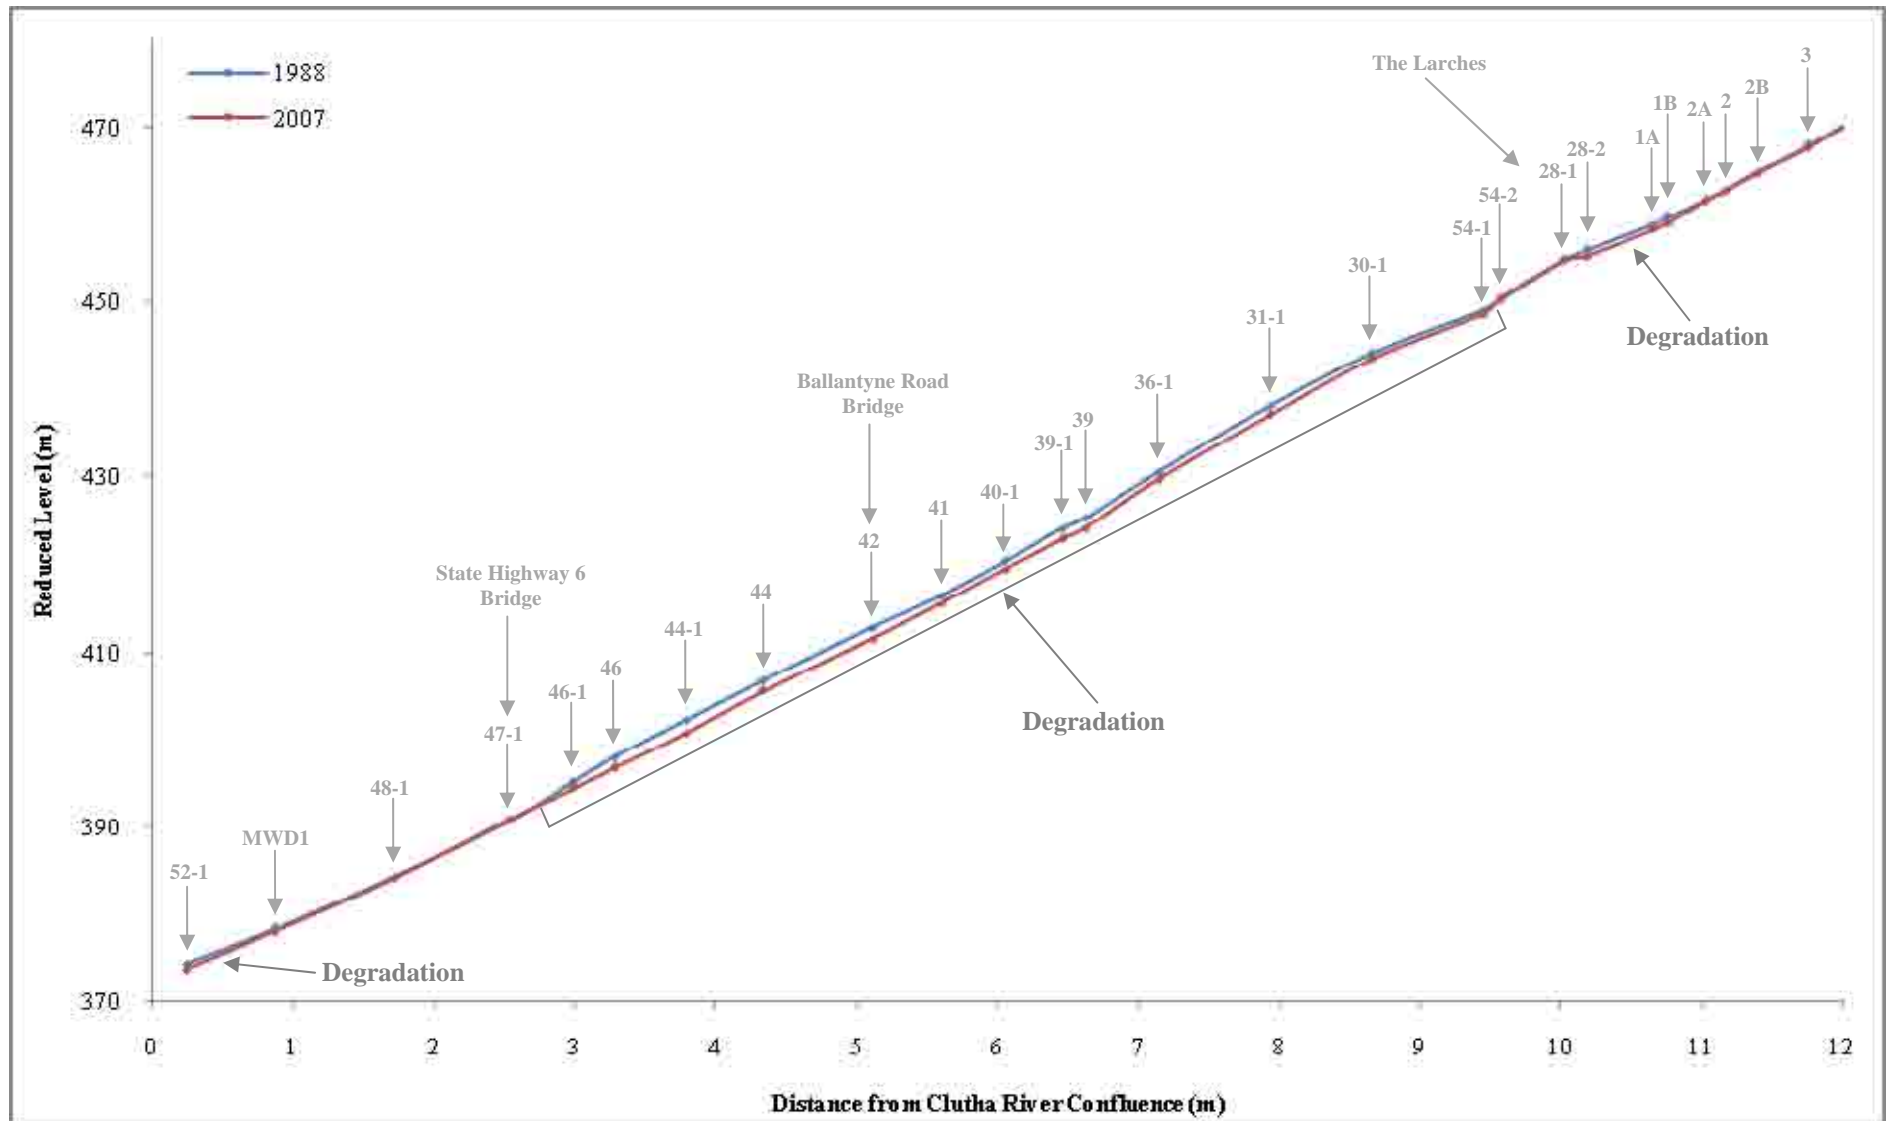
Figure 4.1 shows that the longitudinal profile just upstream of the Clutha River/Mata-Au confluence, from cross sections 52-1 to MWD1, has experienced degradation over the period 1988 to 2007. Upstream of cross section MWD1 to cross section 47-1, at the State Highway Bridge, thalweg levels have exhibited very little change between the two surveyed periods.

The most notable reach of thalweg degradation along the length of the Cardrona River is evident between cross sections 47-1 and 54-1 (Figure 4.1). Between 1988 and 2007, this 6.9km reach has degraded by greater than 0.7 m at every cross section location, including 1.51 m of thalweg degradation at cross section 44-1 (Table 8.1.3).

At The Larches, the longitudinal profile between cross sections 54-1 and 28-1 did not vary significantly during the period 1988 to 2007. Upstream of this location, further degradation of the channel thalweg is evident to cross section 2A, where little variation in the longitudinal profile becomes apparent. From cross section 2A to cross section 5, the profile has remained relatively unchanged over the period 1988 to 2007 (Figure 4.1).

The only notable reach of aggradation, along the length of the river, is located just upstream of Spotts Creek at cross section 8. The reach from cross section 8 to cross section 9 transitions back to exhibit further degradation. Upstream of cross section 9, the river profile did not exhibit significant change in thalweg levels during the period 1988 to 2007, apart from some degradation observed at cross section 16.

Figure 4.1 Longitudinal profile of the Cardrona River, lower to mid-reaches channel thalweg, for 1988 and 2007

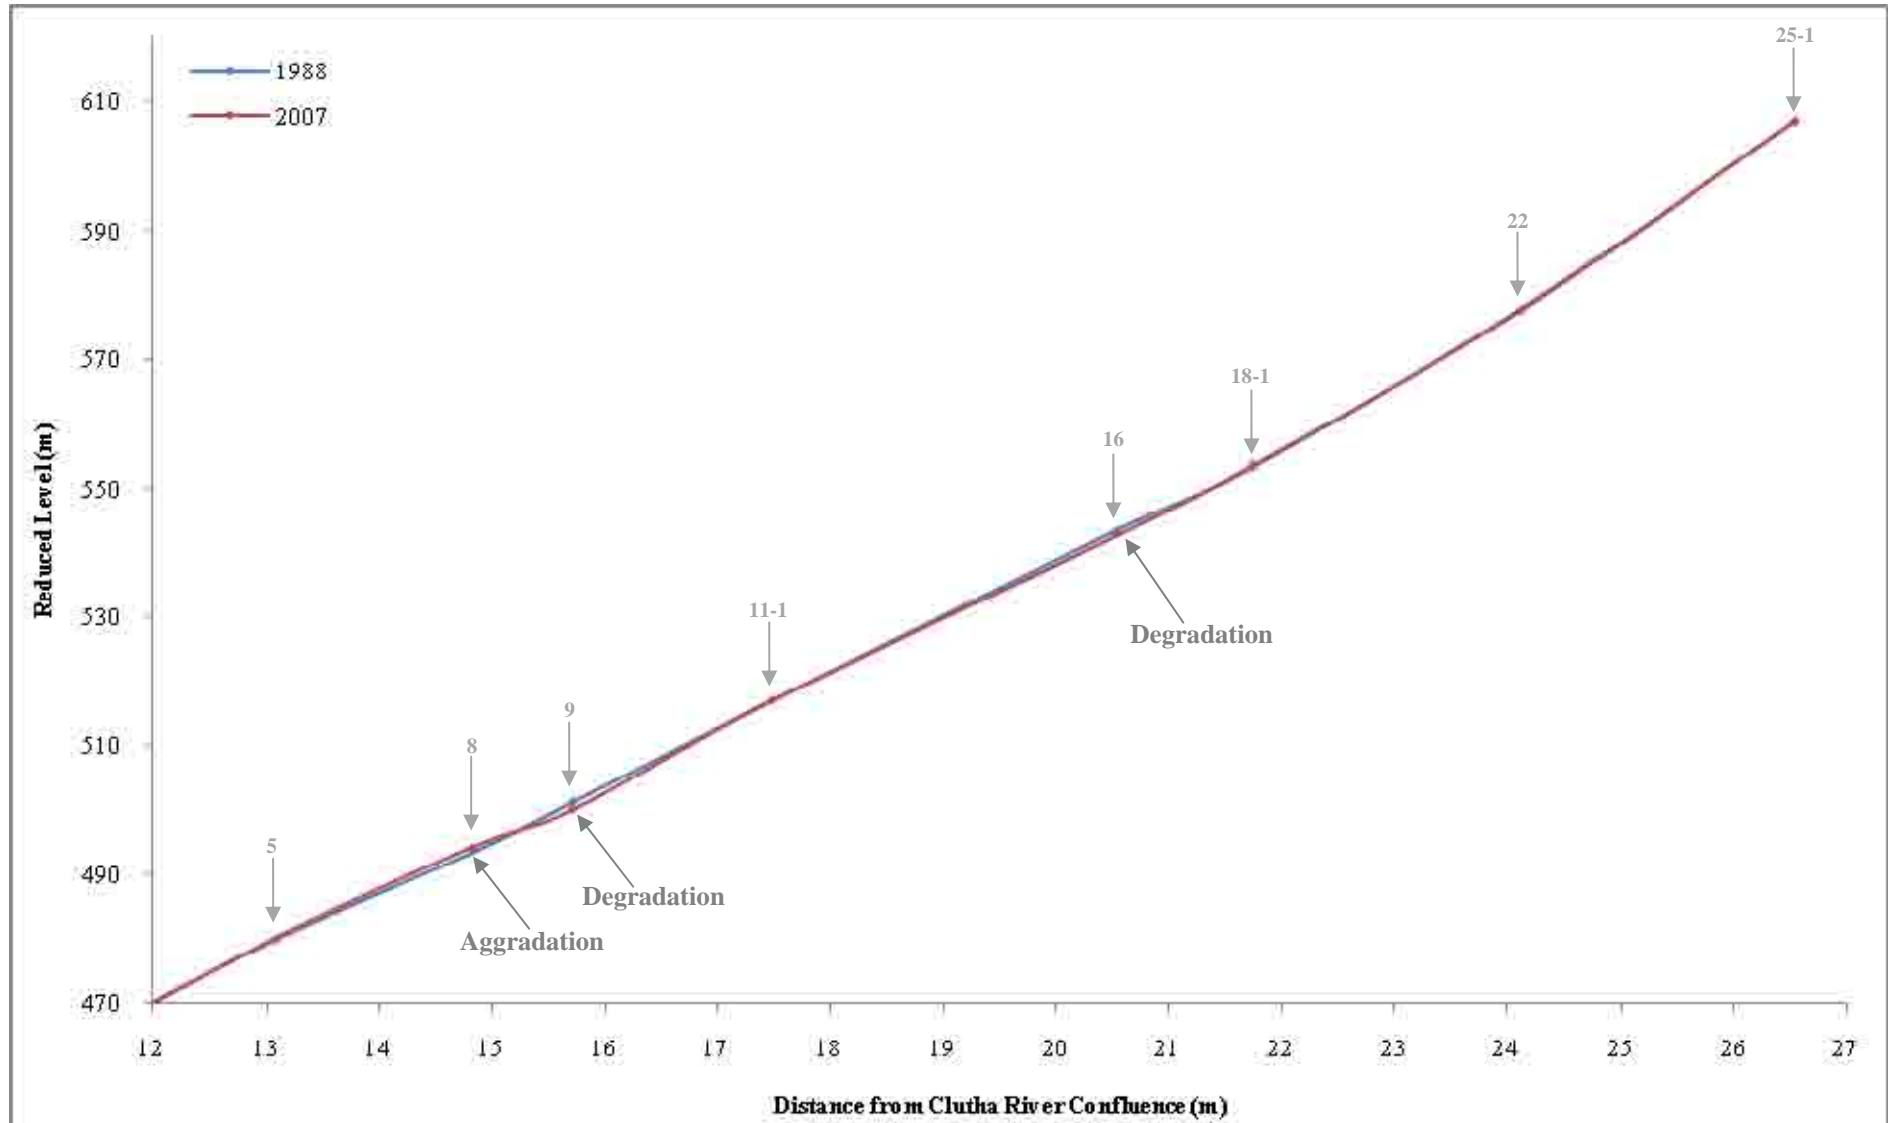
Figures 4.1 and 4.2 show that the Cardrona River longitudinal profile has been subject to presiding degradation of the channel thalweg over the period 1988 to 2007. Five reaches of notable degradation, compared to one reach of aggradation, were observed along the river's surveyed length. The presiding degradational trend indicates that the river profile has experienced significant change over this time. Of particular note is the 6.9km reach of degradation extending from the State Highway 6 Bridge to The Larches.

Figure 4.2 Longitudinal profile of the Cardrona River mid-to upper reaches channel thalweg for 1988 and 2007

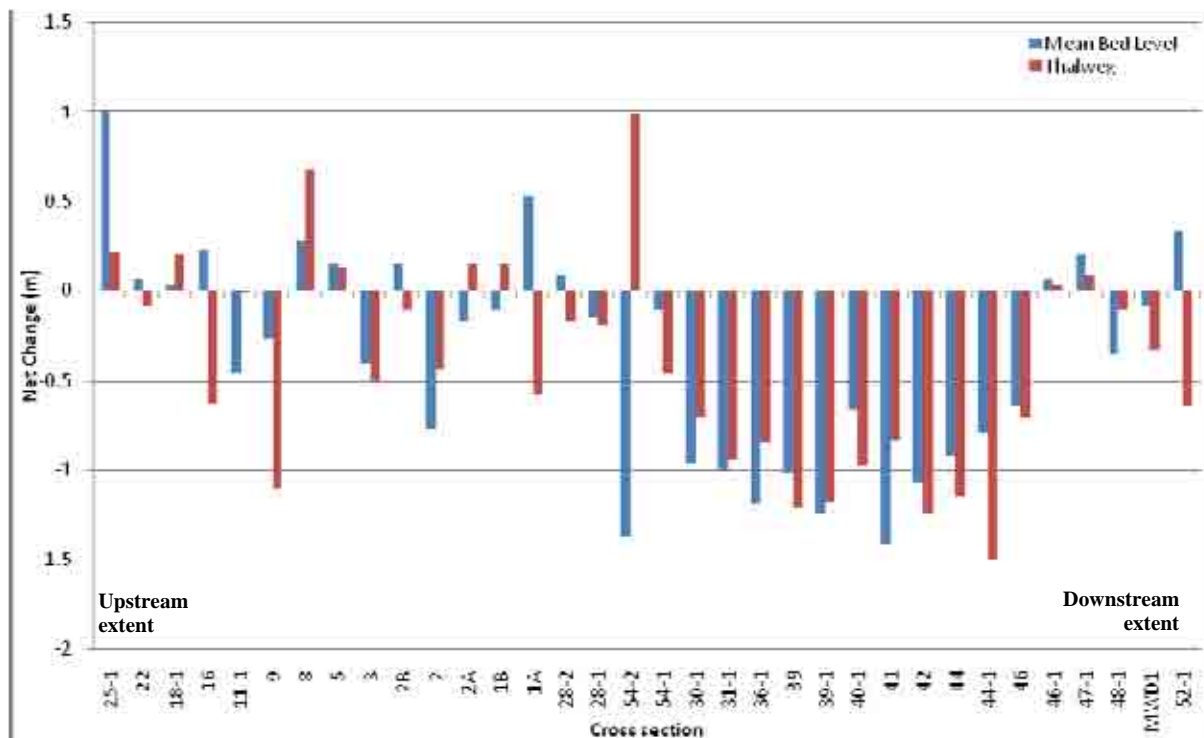
Figure 5.3 Graph showing net change in mean bed-level and thalweg level across all survey periods for each cross section

Figure 5.3 shows that, in general, thalweg levels reflect a similar trend to the respective mean bed-level change. However, some locations, such as cross section 54-2, experience net degradation of the mean bed-level and an increase in the channel thalweg. A few cross sections within the vicinity of The Larches experience these trends, which are primarily related to a significant change in channel form. This is best represented in Figure 8.3.18 where the channel form in 1988 exhibited a deep single-thread channel, which by 2007 had widened significantly, increasing the thalweg level, while lowering the mean bed-level of the cross section.

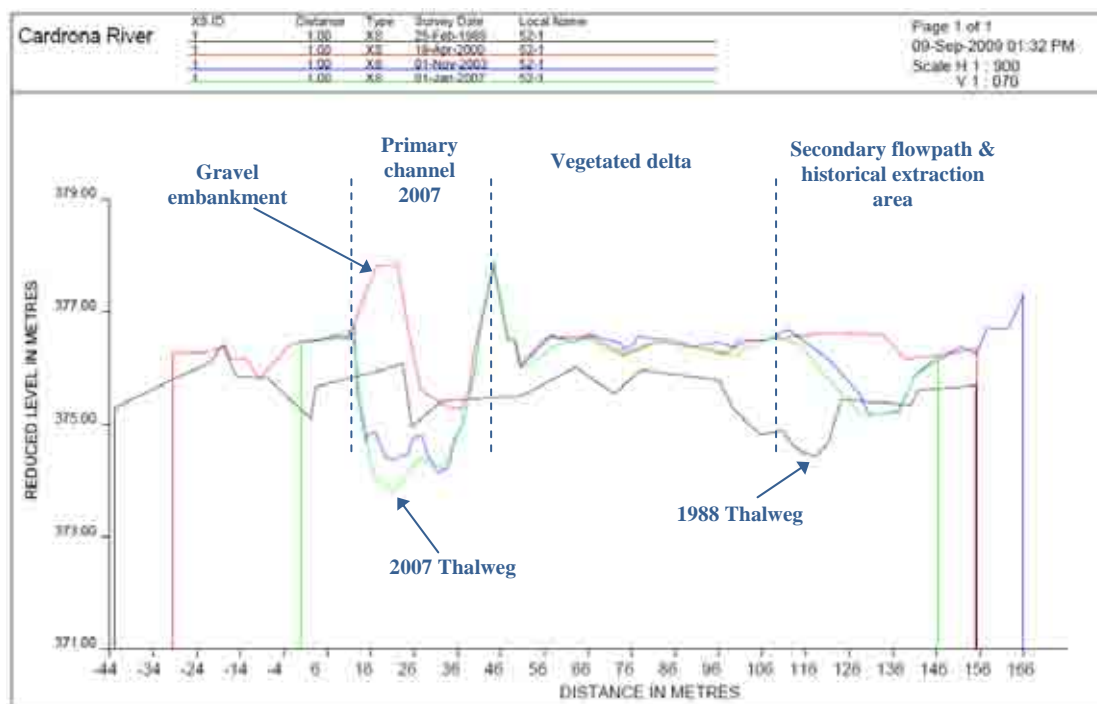
Figure 8.3.1 Cross section 52-1, looking downstream

Recent surveys, 2000 to 2007, indicate that the primary active channel margin has been located on the true left of the delta since channel re-establishment after the November 1999 flood. Mean bed-level analysis shows net aggradation of 0.33m during the period 1988 and 2007 (Table 8.1.2). Most aggradation occurred during the period February 1988 and April 2000, which could be indicative of sedimentation resulting from large flood events during the mid-1990s and in November 1999. However, since the April 2000 survey, a presiding trend of net degradation has become prevalent, with the most recent survey period, 2003 to 2007, experiencing net degradation of 0.19m. This degradational trend is further represented by a lowering of the channel thalweg by 0.64m over the period 1988 to 2007.

The gravel embankment shown on the April 2000 cross section is inferred to be a result of channel re-establishment after the November 1999 flood event.

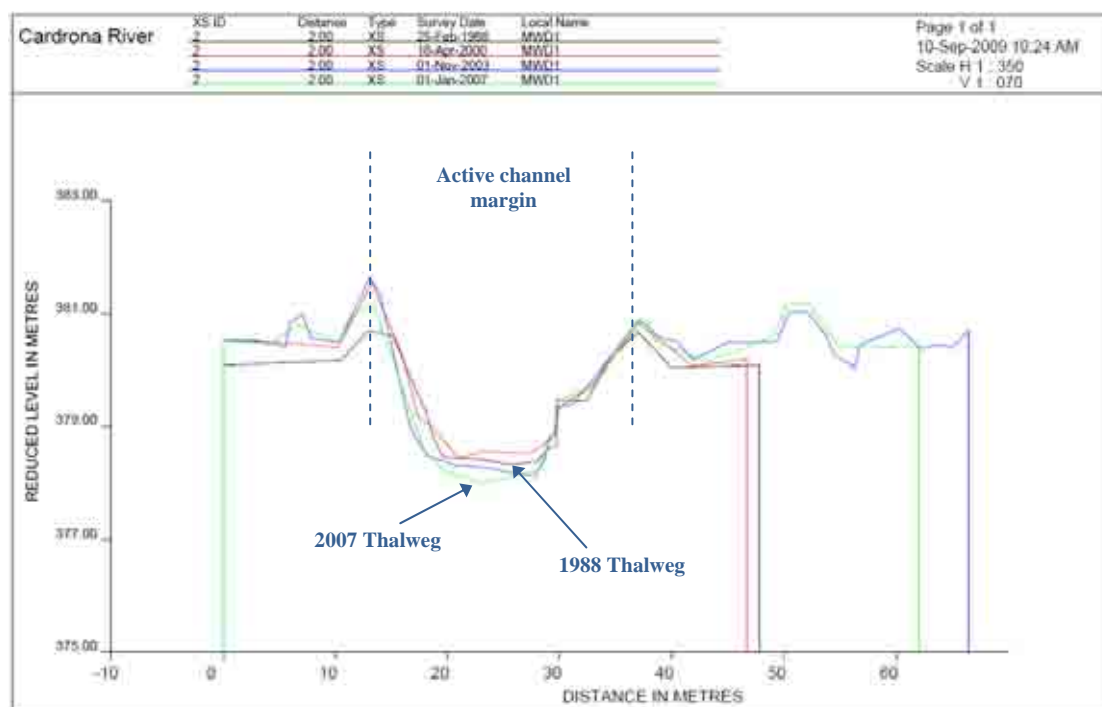
Figure 8.3.2 Cross section MWD1, looking downstream

The active channel covers a surveyed width of 24.5m at this location. Mean bed-level analysis shows net degradation of 0.08m over the active channel width during the period 1988 and 2007 (Table 8.1.2). Similar to cross section 52-1, this location experienced net aggradation between 1988 and 2000, with subsequent survey periods showing a degradational trend. This trend is also reflected by a lowering of the channel thalweg by 0.33m during the period 1988 to 2007 (Table 8.1.3).

The geomorphology of this location is indicative of the lower reaches of the river downstream of the State Highway 6 Bridge. Since 1958, willow growth, has led to a general decrease in the width of the active channel zone and contributed to a relatively stable active margin. This has likely increased sediment transport rates through this reach, by confining lower magnitude flows within a reduced width to depth ratio channel. The observed lowering of the channel thalweg and degradational trend in mean bed-levels may reflect the increased sediment transport rates at this location.

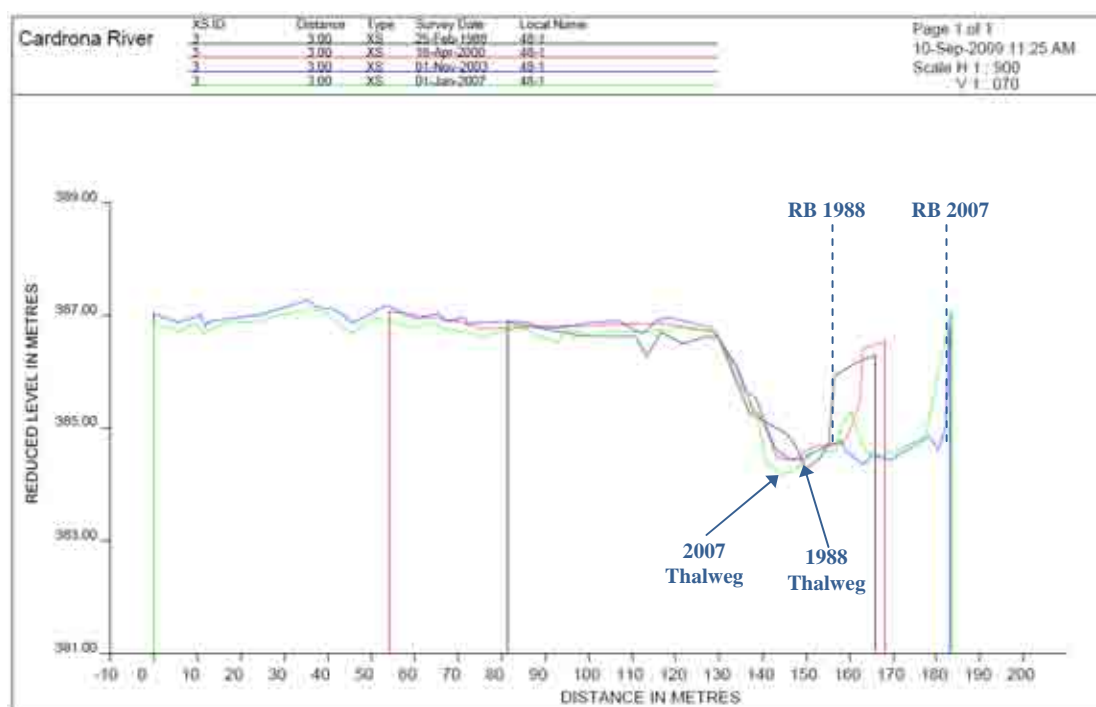
Figure 8.3.3 Cross section 48-1, looking downstream

The 1988 active channel margin covered a distance of 26.50m, which had increased to 53.61m by November 2003. Mean bed-level analysis shows net degradation of 0.36m over the active channel width during the period 1988 and 2007 (Table 8.1.2). The largest proportion of net degradation, 0.41m, occurred during the period 2000 to 2003, coinciding with some 27.1m of right bank erosion (Figure 8.3.3). At this location, bed levels have slightly recovered in the most recent survey period, 2003 to 2007, with net aggradation of 0.14m. During the period 1988 to 2007, the thalweg has lowered by 0.11m at this cross section.

The morphology of the channel at this cross section is similar to the single thread, confined nature observed downstream of the State Highway. The extent of right bank erosion at this cross section is difficult to attribute to any particular event. It is unclear whether the bank position represented in the April 2000 cross section is the true right bank or an embankment from channel re-alignment following November 1999.

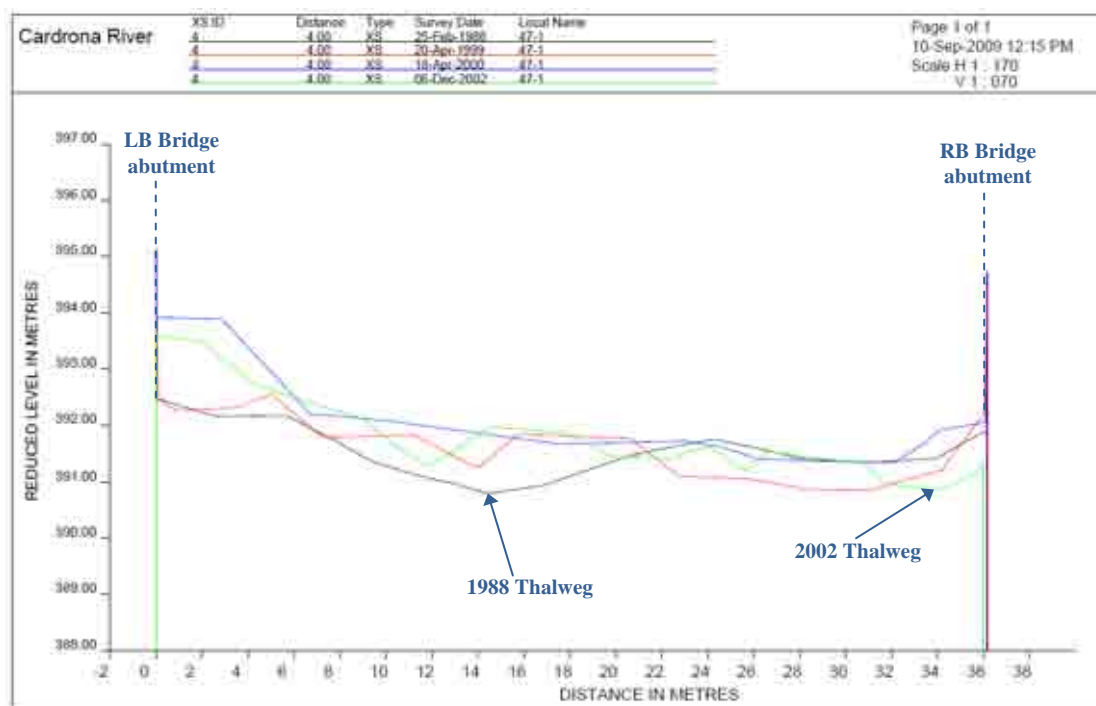
Figure 8.3.4 Cross section 47-1, looking downstream

The active channel covers a surveyed width of 36.1m and is confined by the State Highway bridge abutments at this location. Mean bed-level analysis shows net aggradation of 0.20m over the active channel width during the period 1988 to 2002. This cross section was not re-surveyed in January 2007; although net degradation of 0.32m was observed over the last survey period, April 2000 to December 2002. The level of the channel thalweg also reflects similar variation to bed levels, in that during the period 1988 to 2000, it had aggraded by 0.56m, but by 2002, it had lowered 0.47m.

The morphology of the channel at this cross section is largely dictated by the constraints of the bridge.

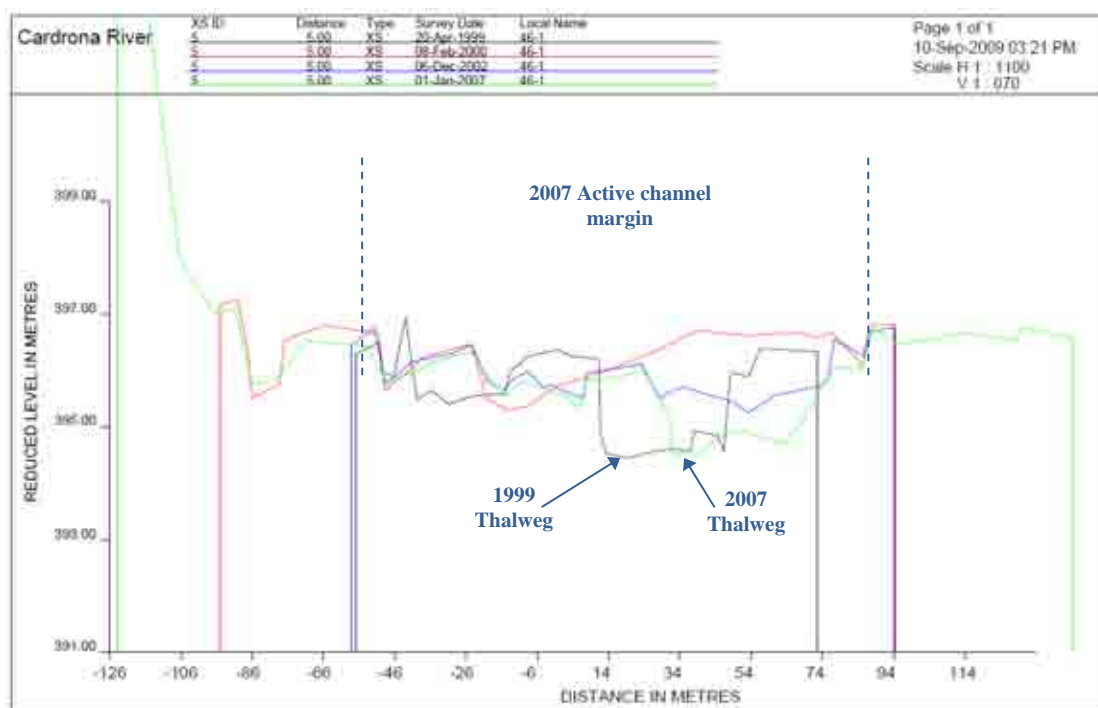
Figure 8.3.5 Cross section 46-1, looking downstream

The 2007 active channel covers a surveyed width of 142.8m at this location. Mean bed-level analysis shows net aggradation of 0.07m over the active channel width during the period 1999 to 2007. The largest proportion of aggradation, 0.61m, occurred during the period April 1999 to February 2000 and is largely attributable to the November 1999 flood event. The trend in net aggradation is also reflected, with minor aggradation of the channel thalweg by 0.03m for the period 1999 to 2007. Similar to cross sections downstream, a presiding trend of net degradation has prevailed since the February 2000 survey.

Upstream of the State Highway Bridge, the active channel margin widens considerably (Figure 8.3.5). This reach has been subject to a high degree of historical gravel extraction, which has reduced the complexity within the active channel zone. This is largely represented by a more defined thalweg (Figure 8.3.5), with secondary flowpaths becoming less prevalent.

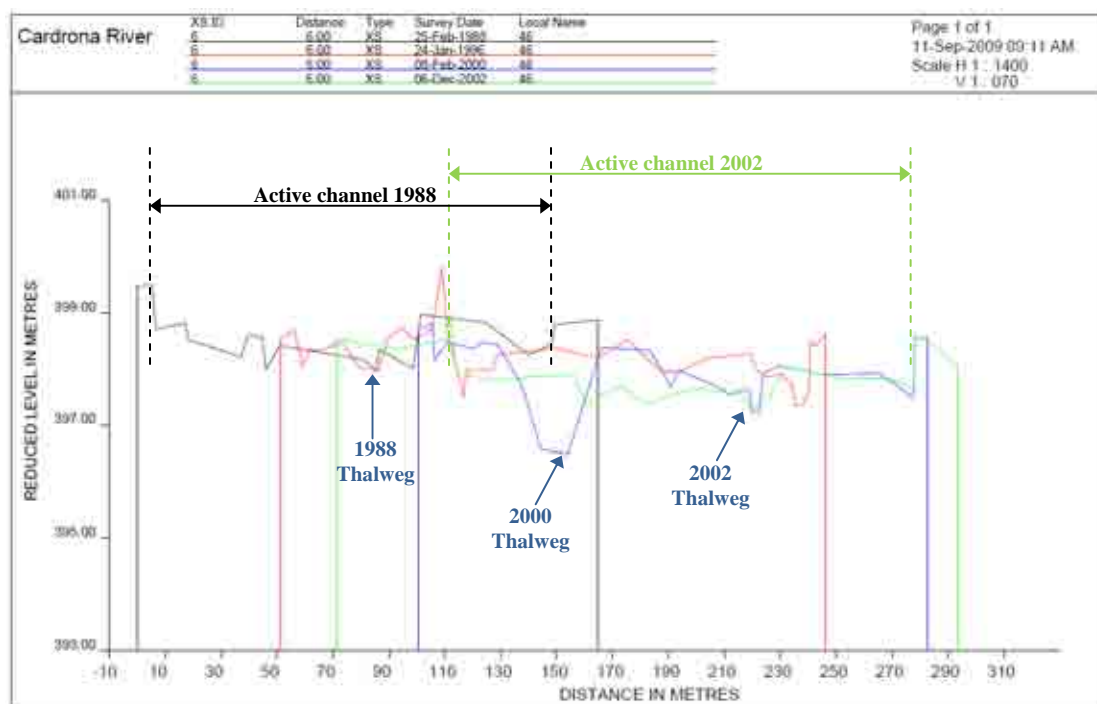
Figure 8.3.6 Cross section 46, looking downstream

The 1988 active channel margin covered a surveyed width of 143.2m compared to 171.4m in the 2002 survey. Mean bed-level analysis shows net degradation of 0.64m over the active channel width between 1988 and 2002. The largest proportion of net degradation, 0.71m, occurred during the period January 1996 to April 1999, while the period April 1999 to February 2000 experienced net aggradation of 0.31m. This period of aggradation is inferred to be a result of sedimentation from the November 1999 flood. The trend in net degradation is also reflected by a lowering of the channel thalweg by 0.70m over the period 1988 to 2002.

At this cross section location, the Cardrona River has a very mobile bed, which is reflected in Figure 8.3.6 by lateral movement of the active channel to the true right. Similar to cross section 46-1, this reach has been subject to a high degree of historical gravel extraction, which has reduced the complexity within the active channel zone.

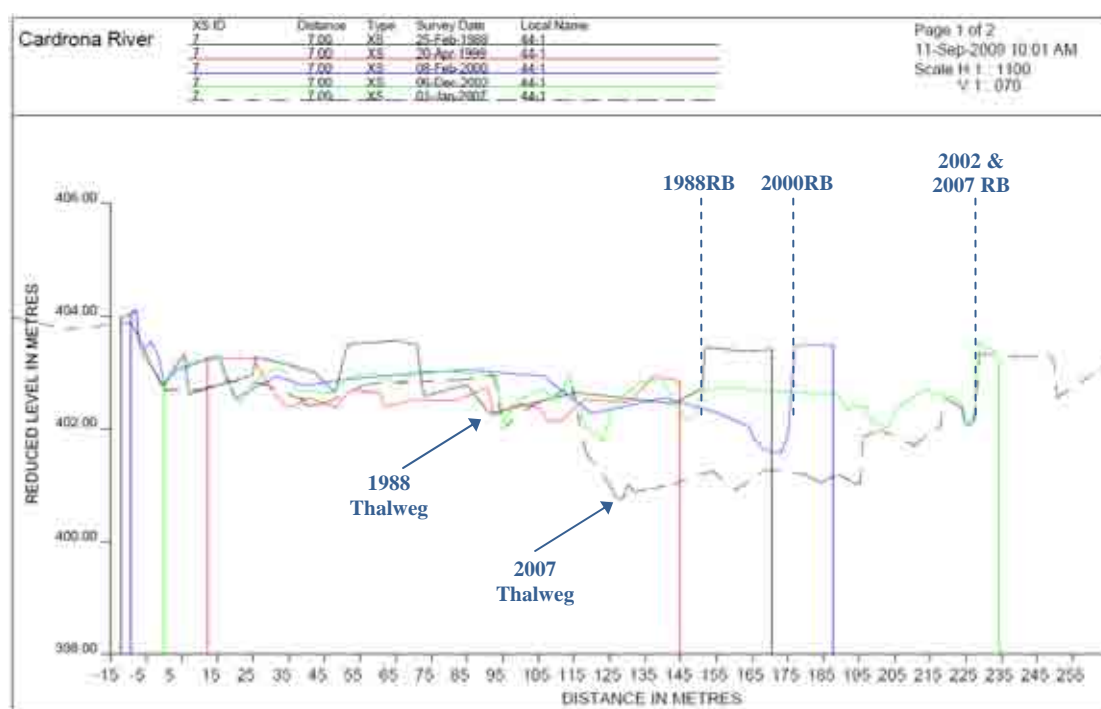
Figure 8.3.7 Cross section 44-1, looking downstream

The 1988 active channel margin covered a surveyed width of 158.7m, compared to 270.4m in the 2007 survey. Mean bed-level analysis shows net degradation of 0.80m over the active channel width during the period 1988 to 2007 (Table 8.1.2). Most surveyed periods experienced net degradation, apart from 1989 to 1996 and April 1999 to February 2000, which aggraded in response to flood-induced sedimentation. The greatest proportion of degradation, 0.64m, occurred in the most recent survey period, August 2003 to January 2007. The degradational trend at this location is further reflected by a lowering of the thalweg by 1.51m over the surveyed periods.

Similar to the cross sections immediately downstream, this reach of the river has been subjected to a high degree of the historical gravel extraction. In addition, erosion of the true right bank, 25.1m (1988 to 2000) and 51.5m (2000 to 2002), has contributed to widening of the active channel margin.

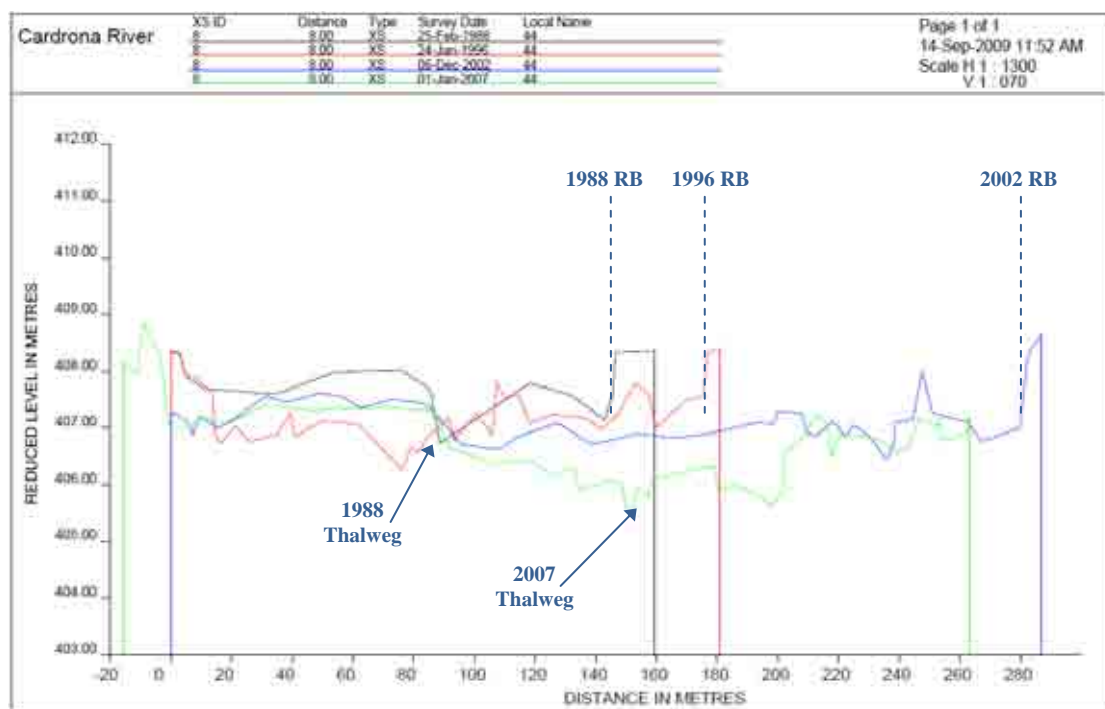
Figure 8.3.8 Cross section 44, looking downstream

The 1988 active channel margin covered a surveyed width of 143.6m, compared to 282.3m in the 2002 survey. Mean bed-level analysis shows net degradation of 0.93m over the active channel width during the period 1988 to 2007 (Table 8.1.2). The period February 1988 to April 1999 exhibited net degradation of 0.63m. Like cross section 44-1, the period April 1999 to December 2002 experienced net aggradation of 0.08m, which most probably can be attributed to sedimentation from the November 1999 flood event. The most recent period of survey, 2002 to 2007, has experienced further net degradation of 0.29m. This degradational trend is reflected in lowering of the channel thalweg by some 1.15m over the period 1988 to 2007.

Changes in channel morphology at cross section 44 are very similar to those observed downstream at cross section 44-1. Erosion of the true right bank is observed over surveyed periods with 30.2m (1988 to 1996) and 105.5m (1996 to 2002). This has widened the active channel margin significantly at this location.

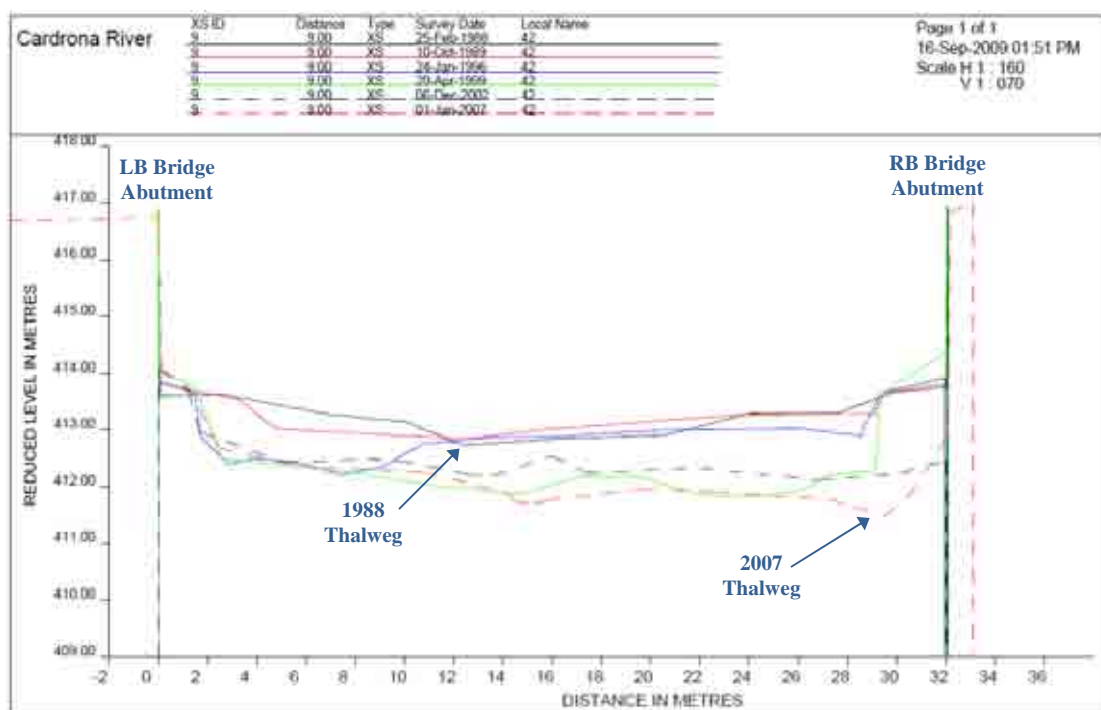
Figure 8.3.9 Cross section 42, looking downstream

The active channel covers a surveyed width of 32m and is confined by the bridge abutments at this location. Mean bed-level analysis shows net degradation of 1.07m over the active channel width during the period 1988 to 2007. Like cross section 44, the only survey period that experienced aggradation, 0.05m, was April 1999 to December 2002 where all other survey periods experienced net degradation. The latest survey period, 2002 to 2007, experienced net degradation of 0.29m at this location. This trend is also reflected by a lowering of the channel thalweg by 1.25m between the period 1988 to 2007 (Table 8.1.3).

The morphology of the channel at this cross section location is largely dictated by the constraints of the bridge. Where the bridge acts as an impediment to flow, flood flows are forced between this small cross sectional area.

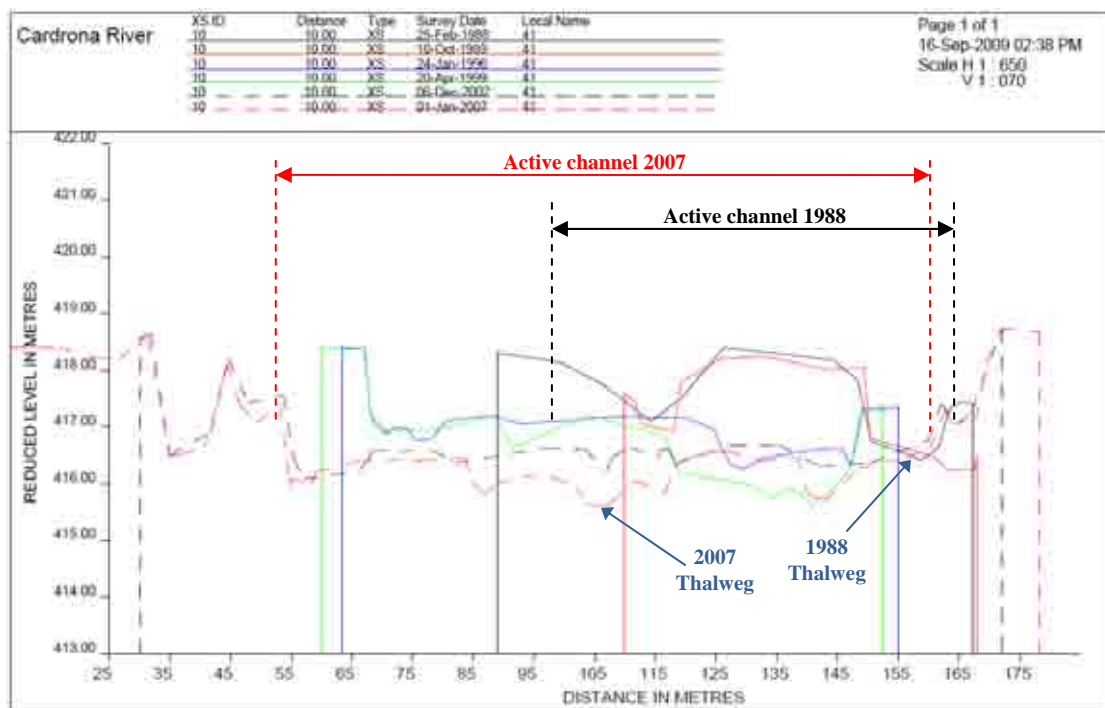
Figure 8.3.10 Cross section 41, looking downstream

The 1988 active channel margin covered a surveyed width of 64m, compared to 109.7m in the 2007 survey. Mean bed-level analysis shows net degradation of 1.41m over the active channel width during the period 1988 to 2007 (Table 8.1.2). All surveyed periods exhibited net degradation at this location, with the most recent survey period experiencing net degradation of 0.26m. This degradational trend is further reflected by a lowering of the channel thalweg by 0.83m during the period 1988 to 2007.

At this cross section location, the Cardrona River has a very mobile bed, which is reflected in Figure 8.3.10 by lateral movement and widening of the active channel margin. This reach has been subject to a high degree of historical gravel extraction, which has reduced the complexity within the active channel zone.

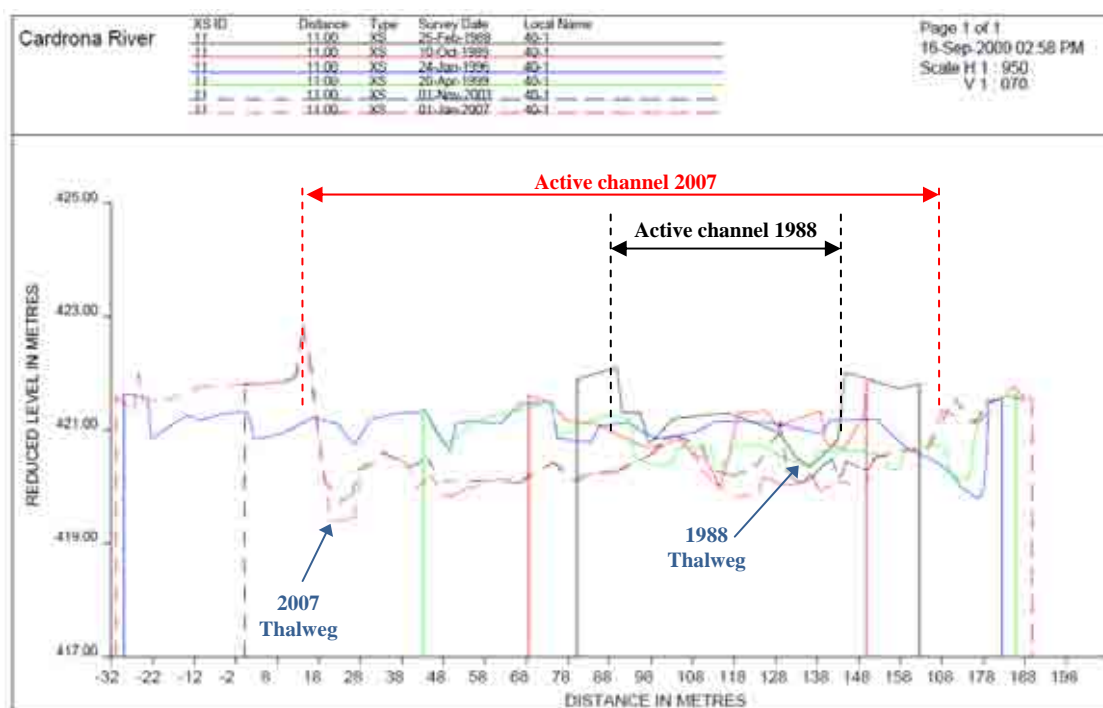
Figure 8.3.11 Cross section 40-1, looking downstream

The 1988 active channel margin covered a surveyed width of 55m, compared to 171m in the 2007 survey. Mean bed-level analysis shows net degradation of 0.67m over the active channel width during the period 1988 to 2007 (Table 8.1.2). Most surveyed periods experienced net degradation, apart from 1989 to 1996, which experienced net aggradation of 0.06m. The greatest proportion of degradation, 0.41m, occurred during the last two survey periods, April 1999 to 2007. The degradational trend at this location is further reflected by a lowering of the thalweg by 0.98m over the surveyed periods.

At this cross section location, the Cardrona River has a very mobile bed, which is reflected in Figure 8.3.11 by lateral movement and widening of the active channel margin. This reach has been subject to a high degree of historical gravel extraction, which has reduced the complexity within the active channel zone.

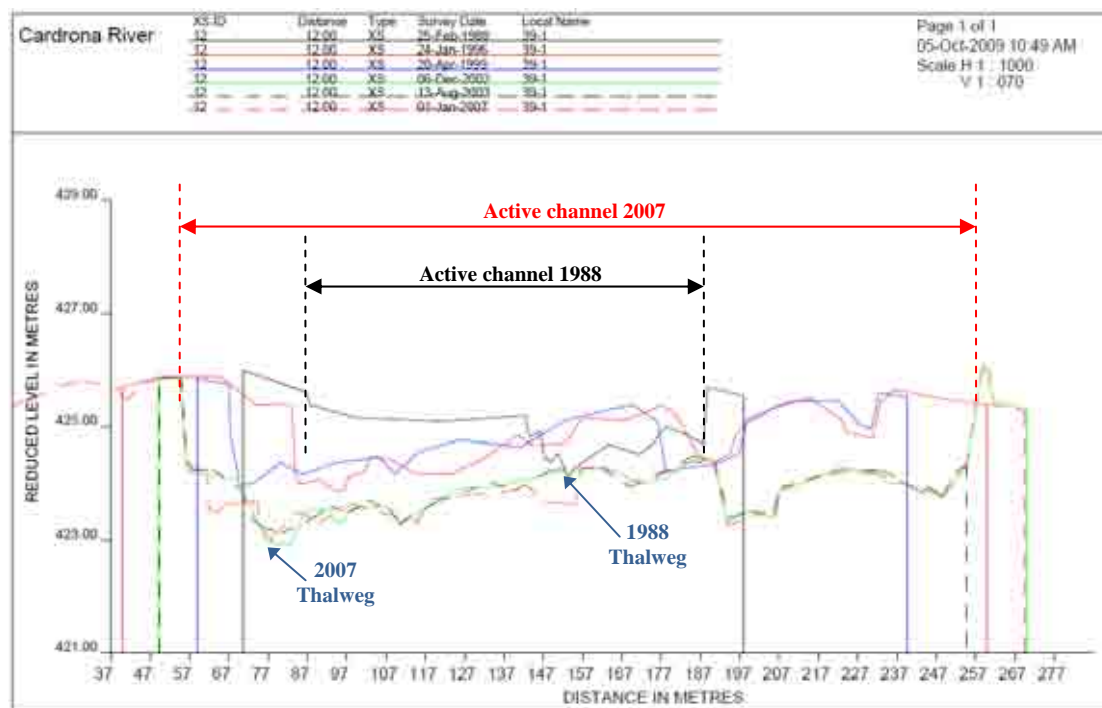
Figure 8.3.12 Cross section 39-1, looking downstream

The 1988 active channel margin covered a surveyed width of 101m, compared to 203m in the 2007 survey. Mean bed-level analysis shows net degradation of 1.24m over the active channel width during the period 1988 to 2007 (Table 8.1.2). All surveyed periods experienced net degradation with the greatest proportion, 0.85m, occurring during the period April 1999 to December 2002. The degradational trend at this location is further reflected by a lowering of the thalweg by 1.18m over the surveyed periods.

At this cross section location, the Cardrona River has a very mobile bed, which is reflected in Figure 8.3.12 by lateral movement and widening of the active channel margin. This reach has also been subject to a high degree of historical gravel extraction, which has reduced the complexity within the active channel zone.

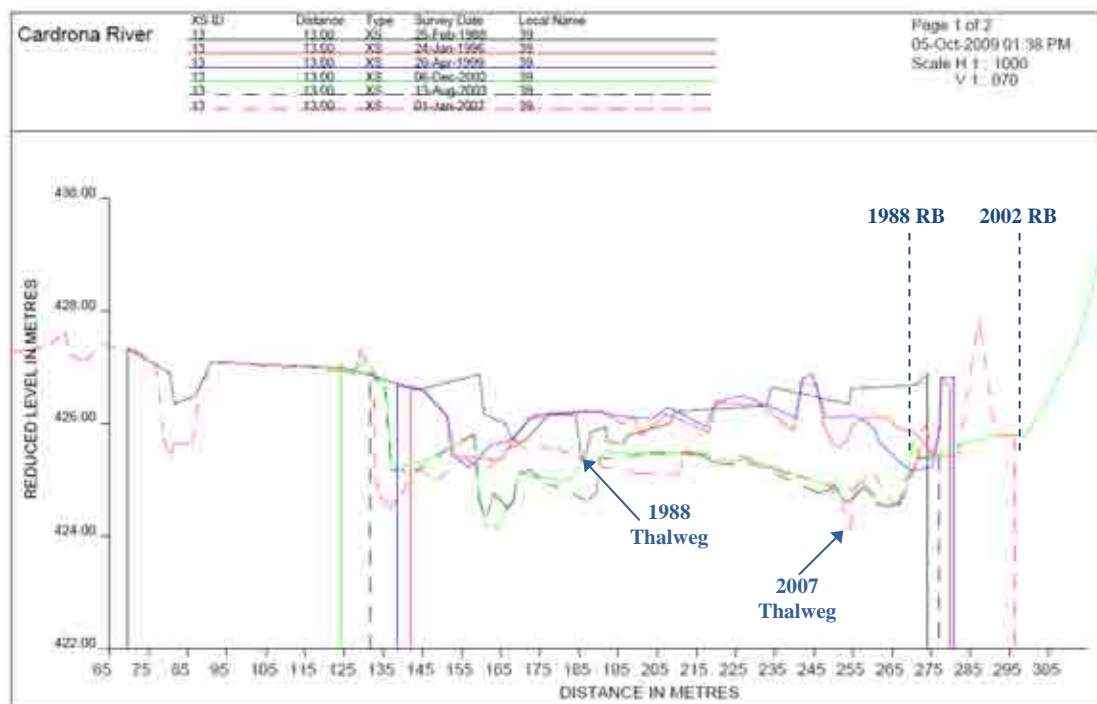
Figure 8.3.13 Cross section 39, looking downstream

The 1988 active channel margin covered a surveyed width of 114m, compared to 155m in the 2007 survey. Mean bed-level analysis shows net degradation of 1.02m over the active channel width during the period 1988 to 2007 (Table 8.1.2). The largest proportion of net degradation, 0.82m, occurred during the period April 1999 to December 2002. Periods of both net aggradation and degradation have occurred over surveyed periods, with the most recent survey period, August 2003 to January 2007, experiencing net aggradation of 0.08m. The net degradational trend at this location is further reflected by a lowering of the thalweg by 1.21m over the surveyed periods.

At this cross section location, the Cardrona River has a very mobile bed, which is reflected in Figure 8.3.13 by lateral movement and widening of the active channel margin. Lateral erosion of both banks has occurred over many surveyed periods, including 22m of true right bank erosion during the period April 1999 to December 2002 (Figure 8.3.13). This reach has also been subject to a high degree of historical gravel extraction, which has reduced the complexity within the active channel zone.

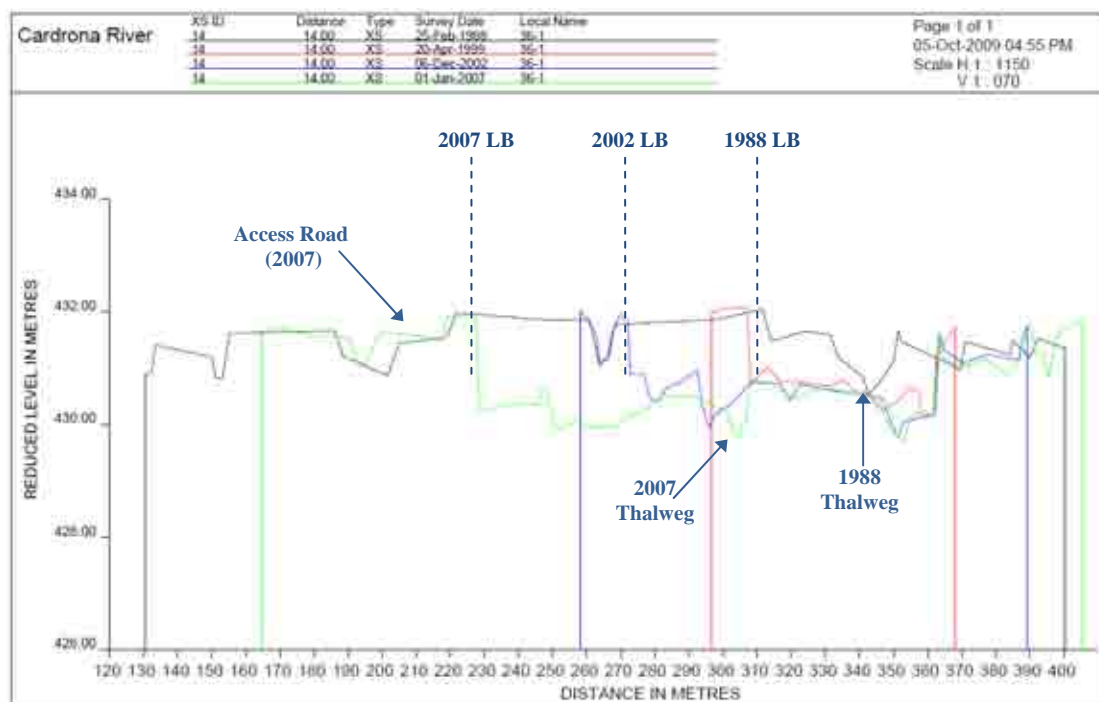
Figure 8.3.14 Cross section 36-1, looking downstream

The 1988 active channel margin covered a surveyed width of 88m compared to 136m in the 2007 survey. Mean bed-level analysis shows net degradation of 1.19m over the active channel width during the period 1988 to 2007 (Table 8.1.2). All surveyed periods experienced net degradation, with the greatest proportion, 0.72m, occurring during the period February 1988 to January 1996. The net degradational trend at this location is further reflected by a lowering of the thalweg by 0.85m over the surveyed periods.

At this cross section location, the Cardrona River has a very mobile bed, which is reflected in Figure 8.3.14 by lateral movement and widening of the active channel margin. Erosion of the true left bank has been observed at this cross section over many surveyed periods: 41.8m between 1988 and 2002 and 43.1m between 2002 and 2007. This reach has also been subject to a high degree of historical gravel extraction, which has reduced the complexity within the active channel zone.

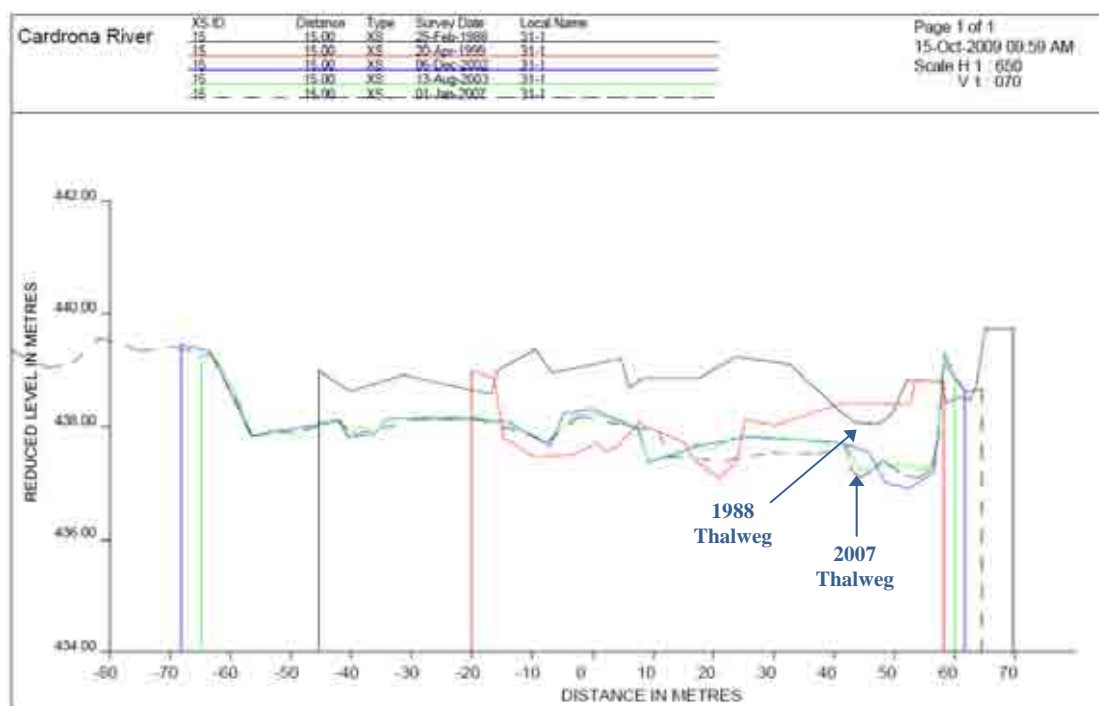
Figure 8.3.15 Cross section 31-1, looking downstream

Channel morphology at this location has lowered and widened significantly between April 1999 and December 2002 (Figure 8.3.15). Subsequent survey periods note the active channel margin has not significantly deviated since December 2002; rather, bed level variation on the true right of the channel has experienced variation.

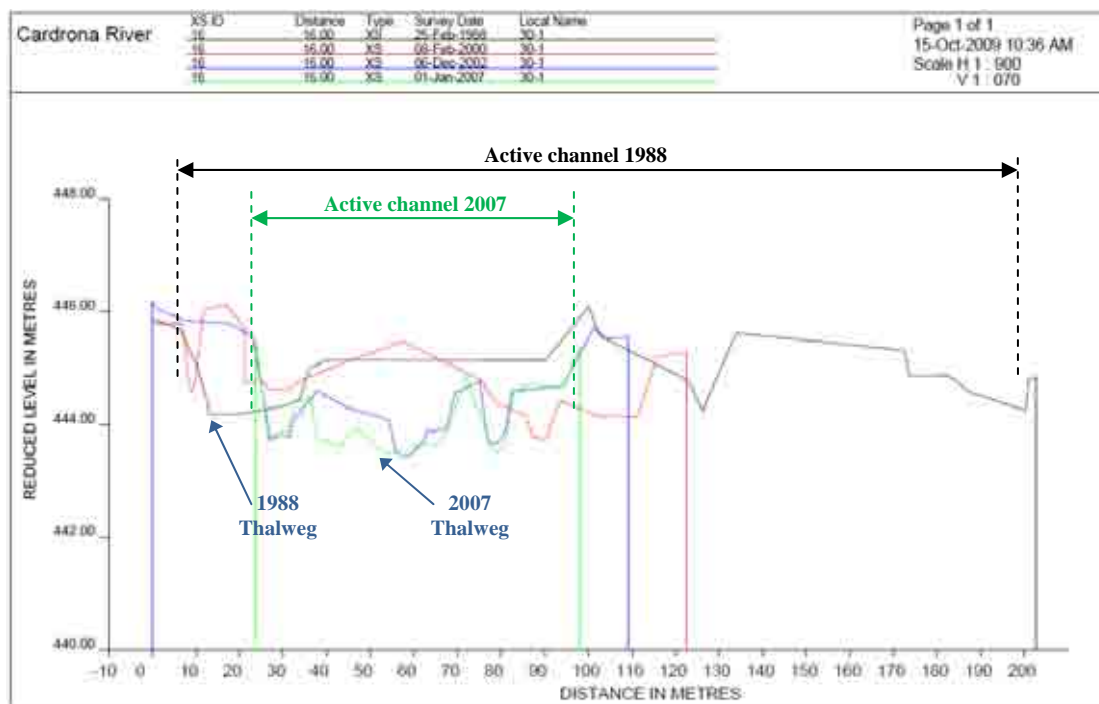
Figure 8.3.16 Cross section 30-1, looking downstream

Historical aerial photography and cross section extents indicate that the channel width at this location has become very confined, due to the establishment of willows on the true right bank. Stabilisation of the channel margins within the vicinity of The Larches is characteristic of cross sections within this reach.
