# **Channel morphology and sedimentation in the Cardrona River**

**January 2010**

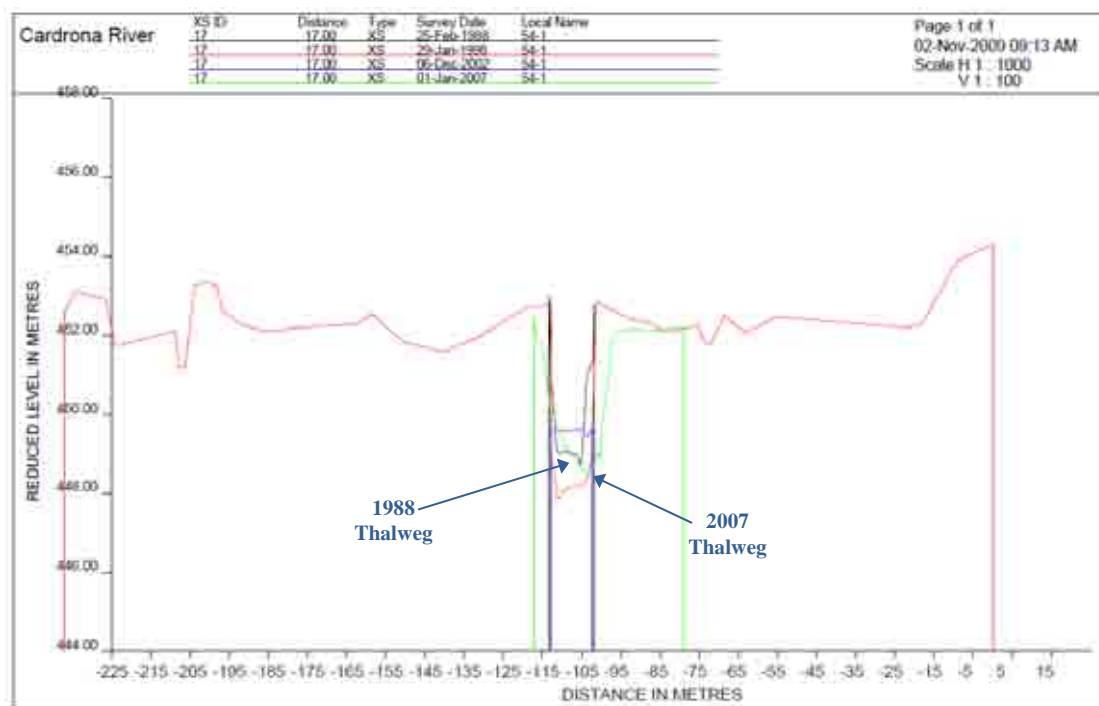
Figure 8.3.17 Cross section 54-1, looking downstream

Historical aerial photography and cross section extents indicate that the channel width at this location is confined, due to the establishment of willow plantings and vehicle tracks within the active channel margin. Under normal flow conditions, the channel remains within the confined 10m width; however, flood capacity is limited and the channel leaves the primary channel during flood flows.

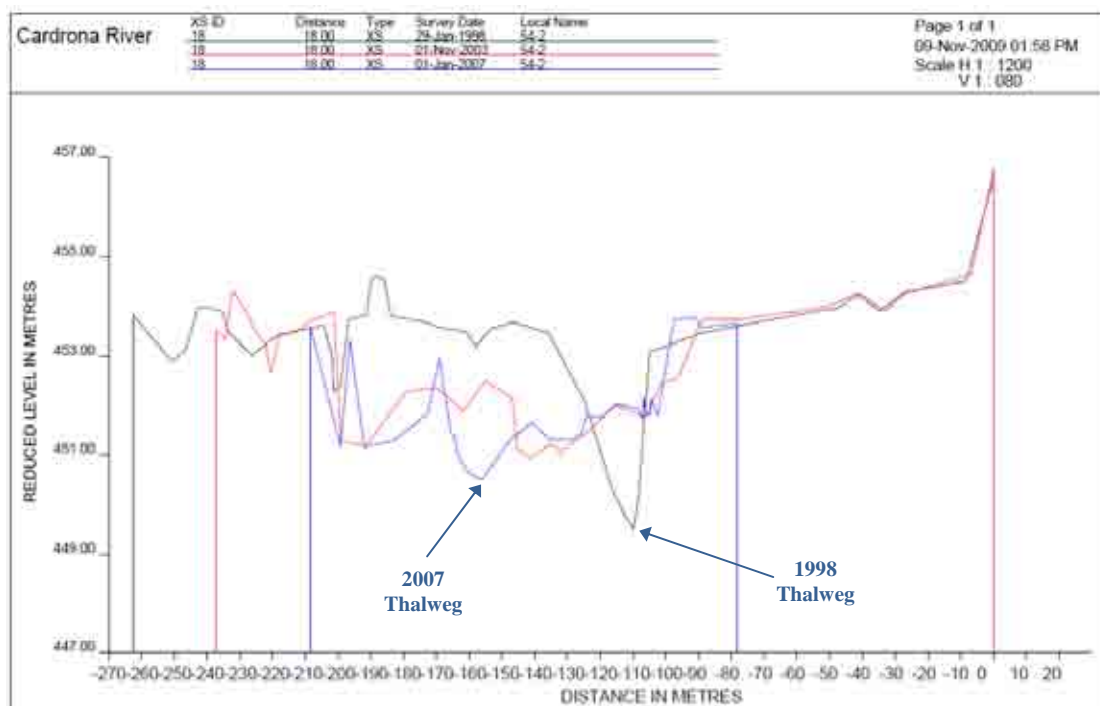
Figure 8.3.18 Cross section 54-2, looking downstream

The channel morphology has changed significantly over the surveyed periods. In the 1998 survey, the active channel was confined to an area on the true right of the current channel margins. The 2003 and 2007 surveys indicate that the channel margins have widened significantly at this location, presumably as a result of the 1999 flood event.

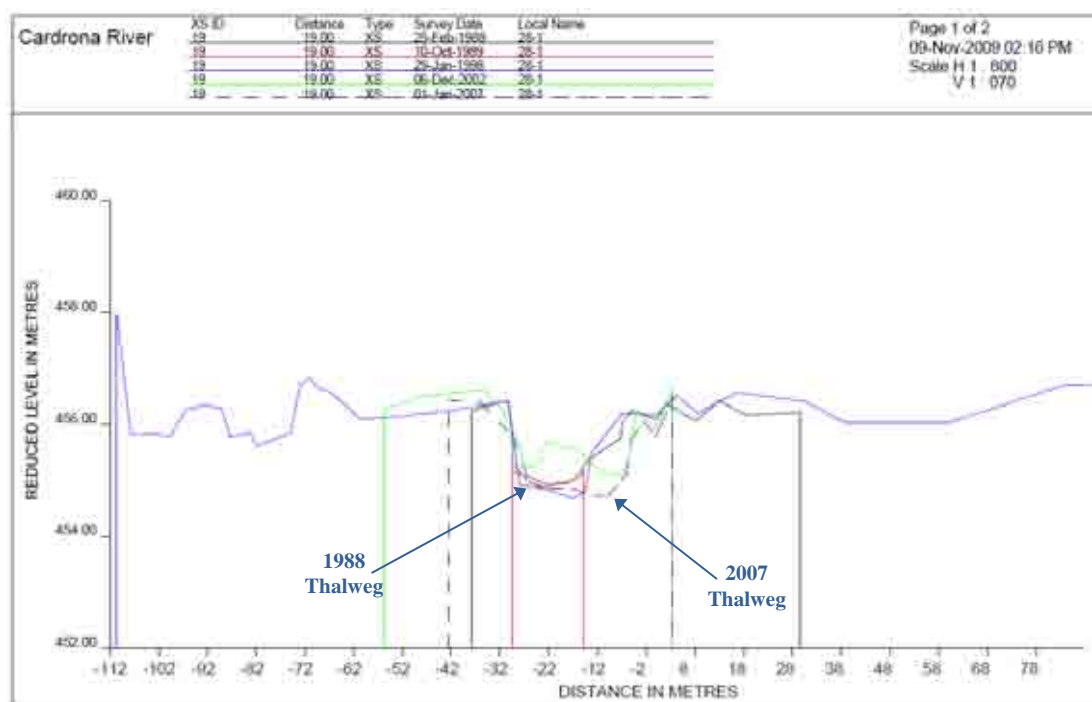
Figure 8.3.19 Cross section 28-1, looking downstream

The channel morphology at cross section 28-1 has remained relatively consistent over surveyed periods. While the channel has experienced periods of both aggradation and degradation, the channel margins have remained relatively stable between surveyed periods. This reach is very confined by willow growth, which may be the primary reason for channel confinement and stable nature.
