# TECHNICAL COMMITTEE AGENDA

## WEDNESDAY 21 MARCH 2018

### 11.1. Floodbank Structural Integrity Assessment

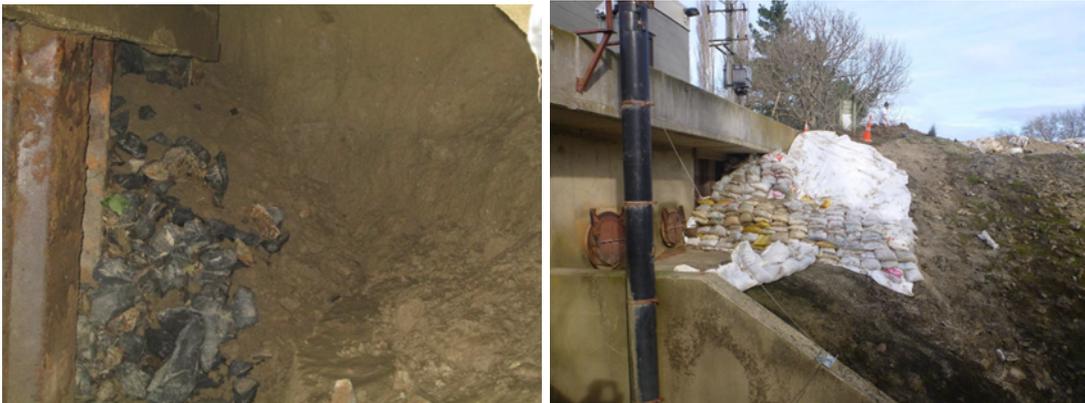
Seepage of floodwaters around the downstream interface of the Mill Creek pump station floodbank interface resulted in a piping failure starting from seepage past the soil sheetpile interface resulting in significant internal erosion of the floodbank fill (Figure 7). The failure occurred progressively over several hours on the morning of 22 July 2017. Failure of the Taieri River left bank floodbank in this location would result in

significant and catastrophic flooding of over 800ha of farmland and damage to infrastructure including the Mill Creek pump station itself.

**Figure 7 – Mill Creek Pump Station. Left Photo: Cavity scoured away within floodbank post July 2017 event. Right Photo: Sandbags installed during event to arrest seepage of floodwater through Taieri left bank floodbank.**

A temporary fix has been undertaken which includes an engineered fill material within the floodbank void and around the floodbank to sheetpile interface, along with heightened emergency preparedness including having materials readily available to mitigate any further seepage. A long-term design solution and construction thereof has been allowed for in the first year of the 2018/2028 Draft Long Term Plan. The solution will aim to be consistent with modern design standards and include provision for controlled internal drainage of any seepage water with adequate capture of fine materials.

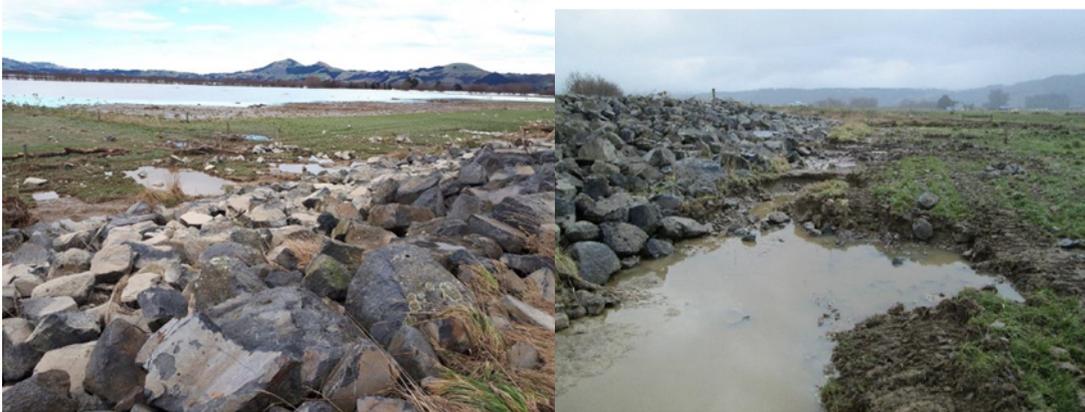
Tonkin and Taylor have raised concerns about the performance of the Riverside Road spillway structure at a design level event (Figure 8). Failure of the spillway would severely compromise the operation of the Lower Taieri Flood Protection Scheme in both East Taieri and West Taieri, as the peak flow attenuation would be compromised. It would also potentially cause sudden and catastrophic flooding of the East Taieri Upper Pond. Further review of performance and integrity have been recommended and strengthening works are likely required subject to the outcome of that assessment. Allowance has been made in the 2018/2028 Draft Long Term Plan for these

**Figure 8 – Riverside Road Spillway showing scour damage post July 2017 flood.**

assessments and future works. In the interim, repairs will be necessary following any significant future overtopping events. The extent of damage will be proportional to the magnitude and duration of overtopping.

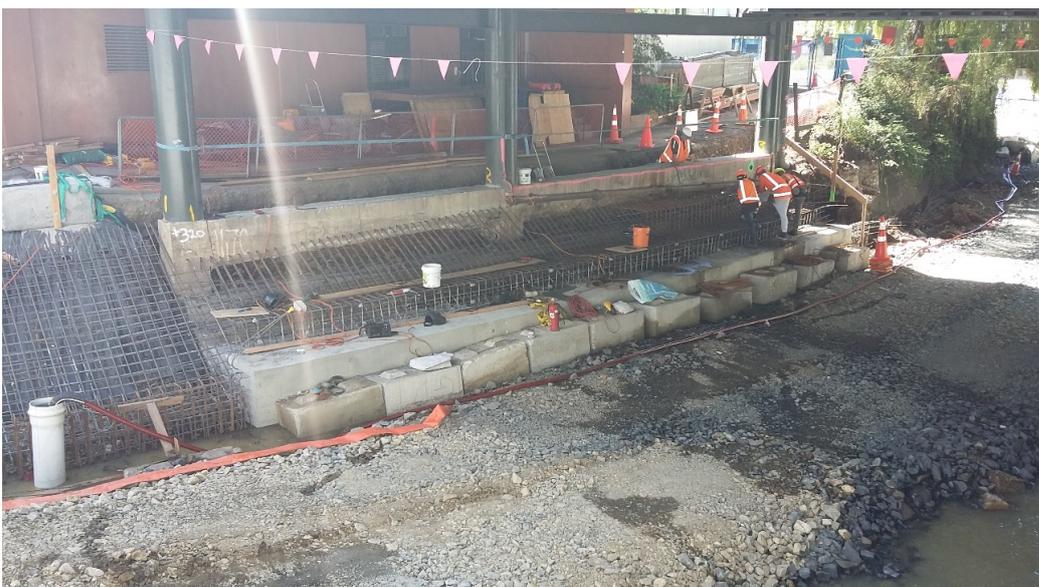
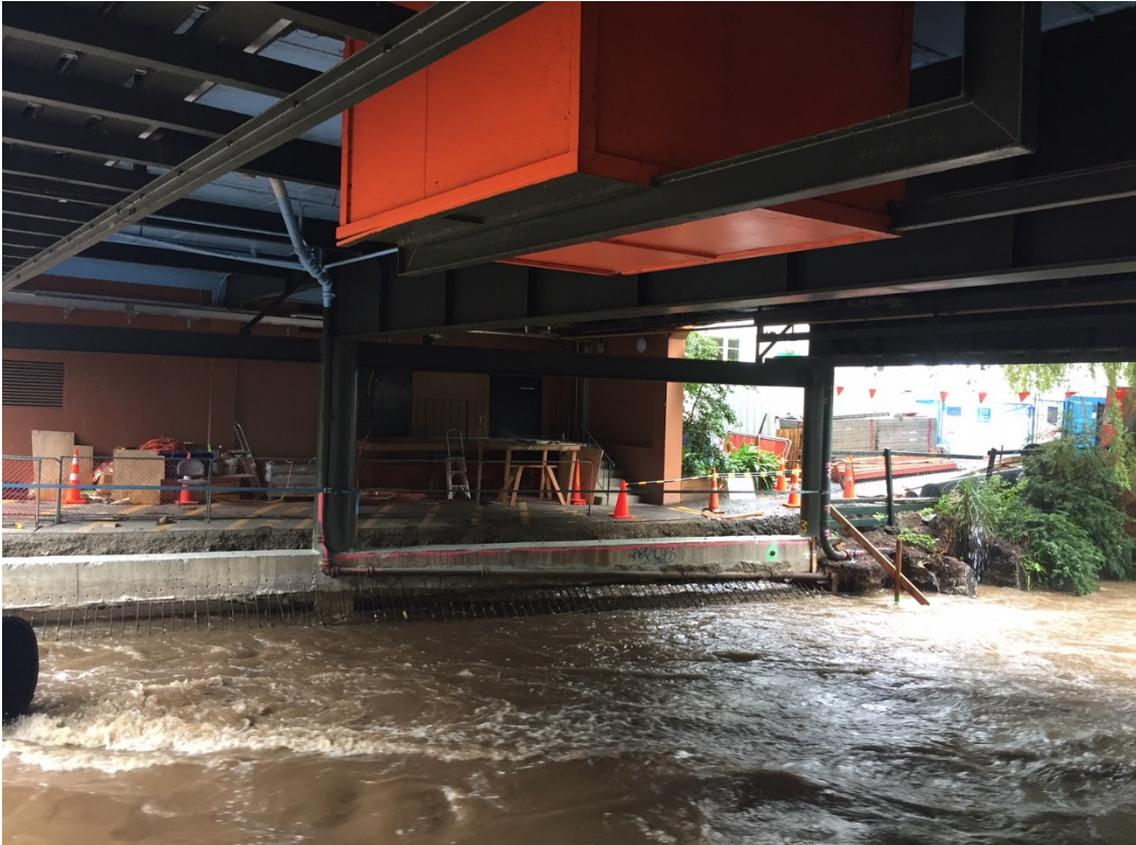
Two significant rain events in the last month have caused damage to temporary works resulting in additional costs and time delays (Figure 9, 10). A value engineering workshop has taken place with the main contractor (Downer New Zealand Ltd) to review the programme and work towards completion of the project by June 2018.

**Figure 9:** Leith Flood Protection Scheme works between Union Street and Leith Footbridge; this photograph was taken during low flows.

**Figure 10: Leith Flood Protection Scheme works between Union Street and Leith Footbridge. The photographs in Figures 9 and 10 are looking towards the left bank below the ITS building. This photograph was taken on 1 February 2018 at a flow of approximately  $48\text{m}^3/\text{s}$ ; peak flow during this event was  $61\text{m}^3/\text{s}$ . The Scheme design flow is  $171\text{m}^3/\text{s}$ .**
