# Management and Reduction of Debris Flow Risk in Roxburgh, Otago

Engineering Options Report (Conceptual Design)

#### **Otago Regional Council**

#### **Golder Associates (NZ) Limited**

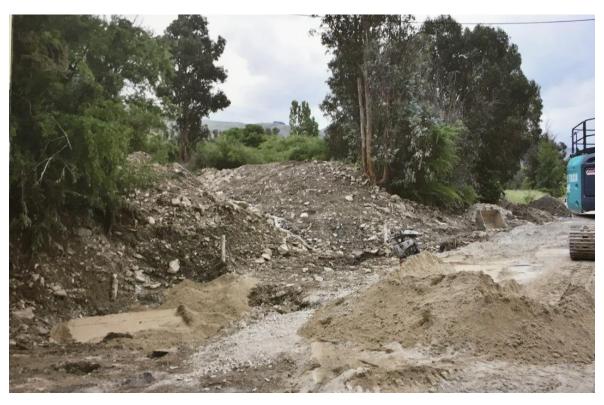
Figure 7: Pumpstation Creek – after 26 November 2017 event, looking upstream from SH8 (source: Withington, Teviot Valley Tempest, 2018).

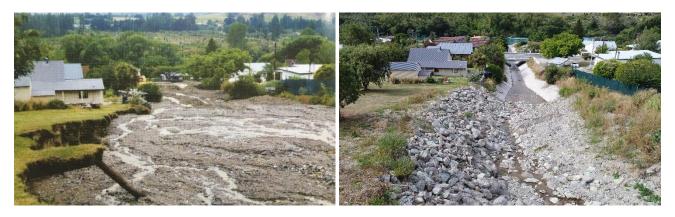
Figure 15: left: Aggradation of debris at entrance to concrete channel after 26 November 2017 event (source: Withington, Teviot Valley Tempest, 2018); right: Channel status 26 February 2019.

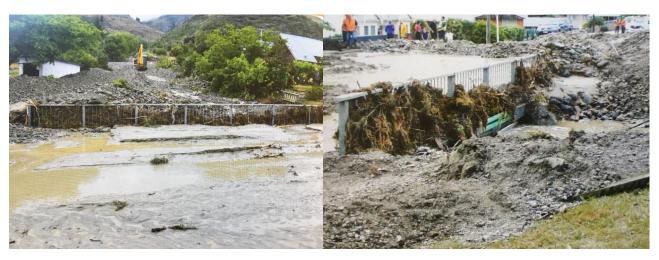
Figure 16: Aggradation of debris above SH8 crossing and avulsion of water and fine debris on 26 November 2017 (source: Withington, Teviot Valley Tempest, 2018).

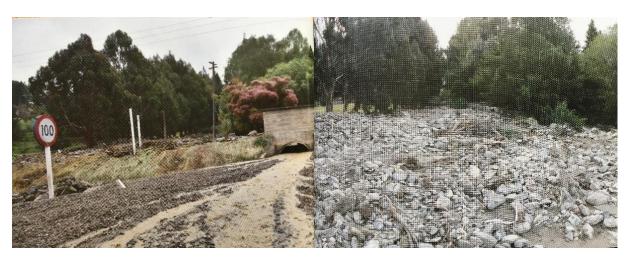
Figure 23: Golfcourse Creek - November 2017, left: looking from downstream at old road culvert; right: looking at channel upstream (source: Withington, Teviot Valley Tempest, 2018).

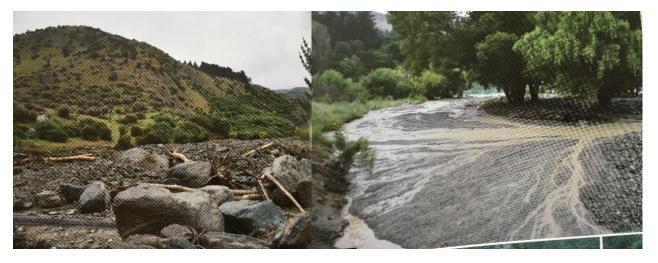
Figure 27: Black Jacks Creek - Nov 2017, left: view SH8 and upstream; right: view from SH8 downstream (source: Withington, Teviot Valley Tempest, 2018).

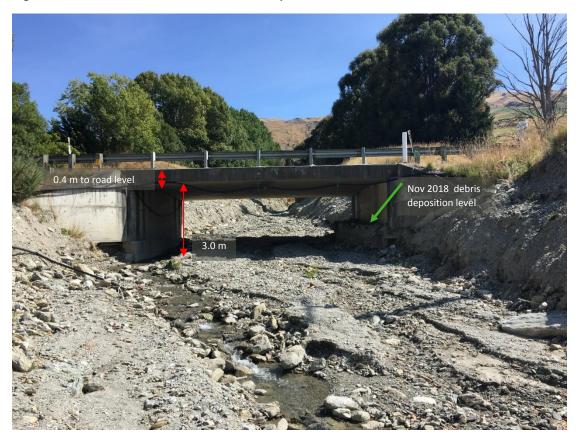
Figure 30: Stevensons Creek - SH8 crossing, view from downstream; channel recently cleared by heavy machinery.
