# REPORT Management and Reduction of Debris Flow Risk in Roxburgh, Otago

Geomorphological Assessment Report

18113634\_7407-003-R-Rev0

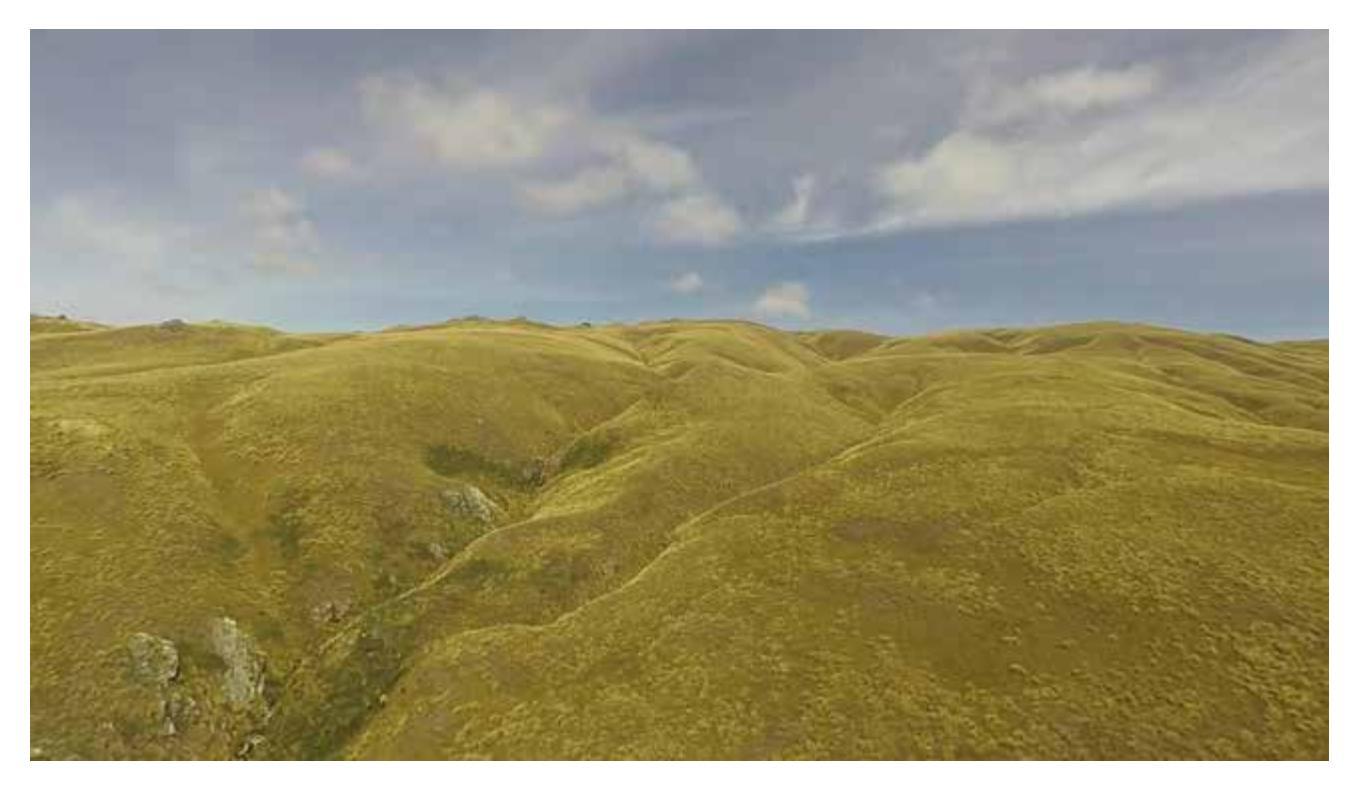
Figure 1: Pumpstation Creek - Upper catchment above 600 m asl, dominated by incised channels and tussock grass vegetation; bedrock is exposed along some sections of the creek; no recent erosion is visible in the upper reaches of the catchment.

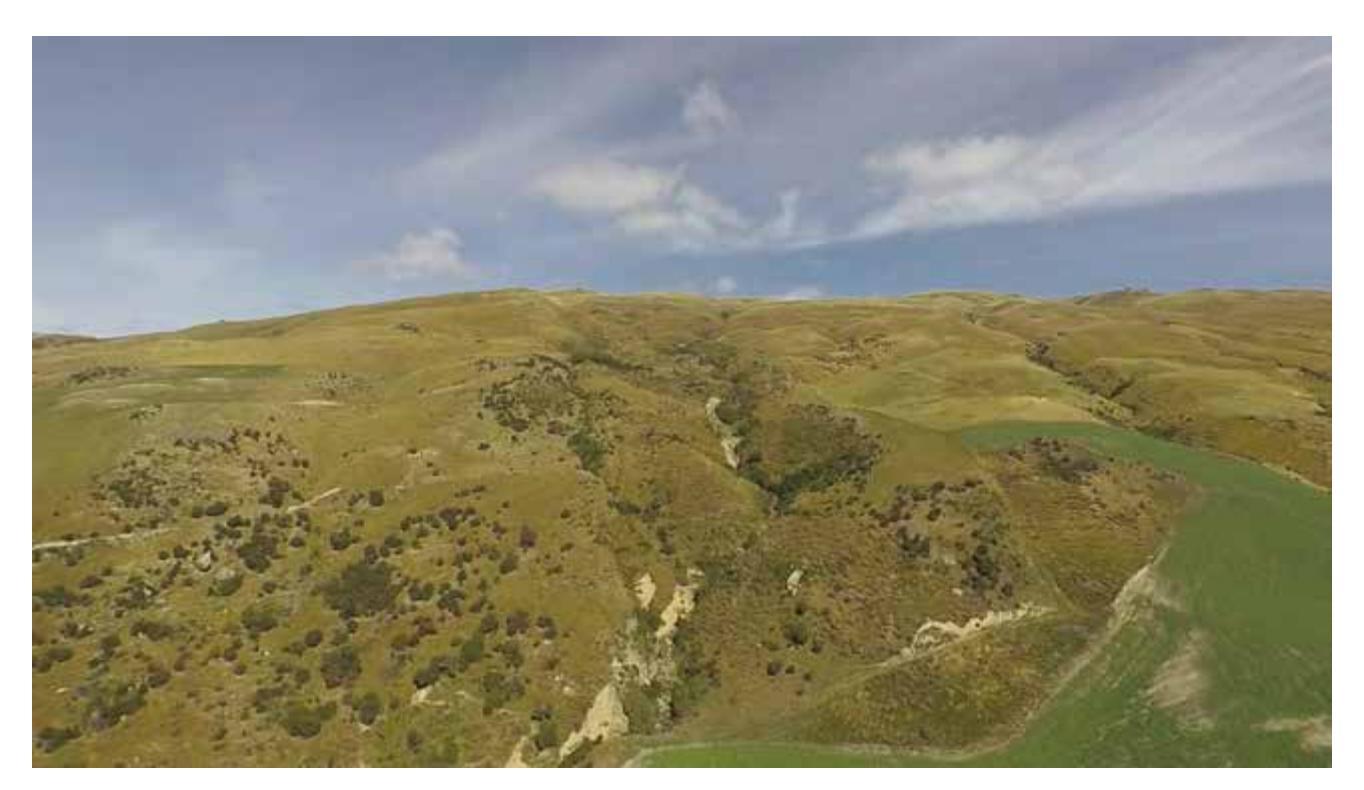
Figure 2: View of the catchment from about 450 m asl with visible active soil slips in colluvium along the true right slopes of the main channel. Slopes along the true left of the main channel are partially vegetated with shrubs and small trees.

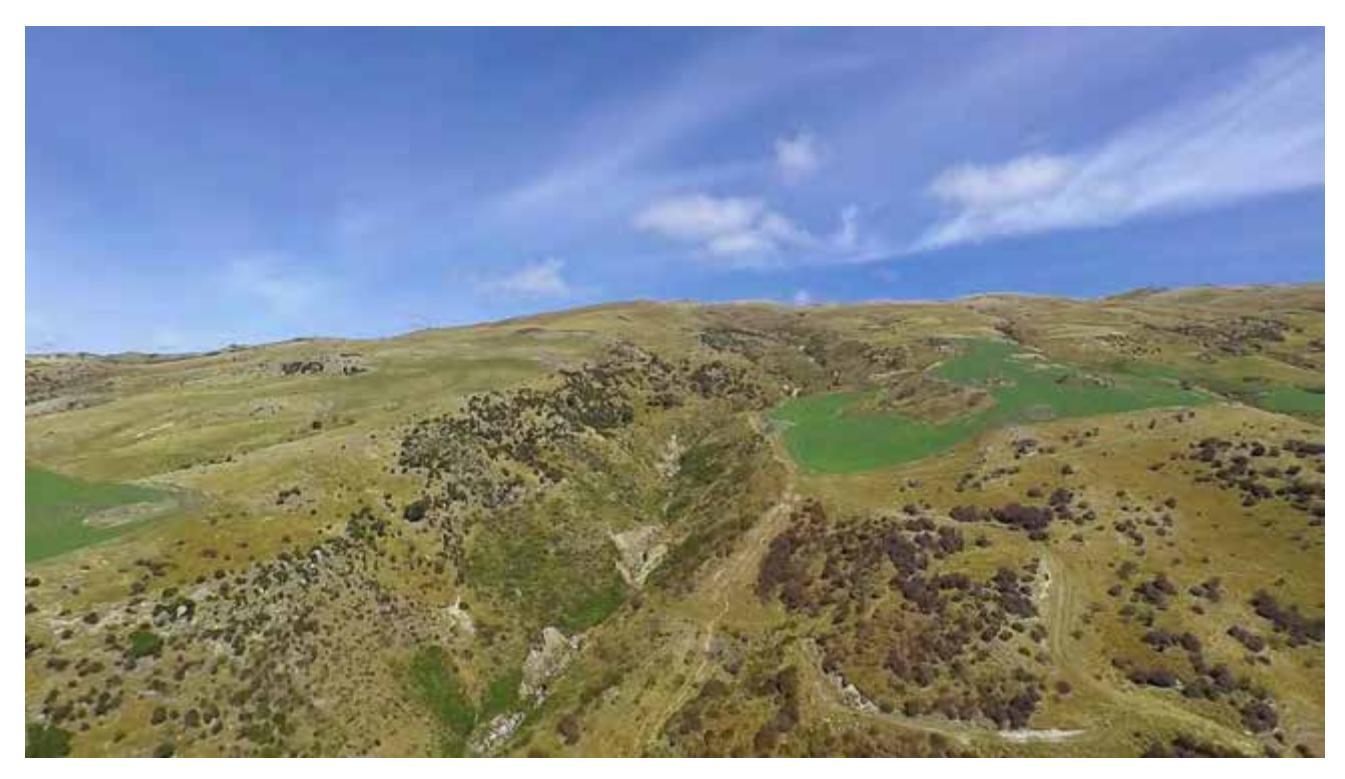
Figure 3: View of the catchment from about 300 m asl. Recent slips in colluvium visible along true right channel slopes. Slopes adjacent to the creek are generally vegetated by grasses and shrubs. Agriculture is present in this area of the catchment on both sides of the creek.

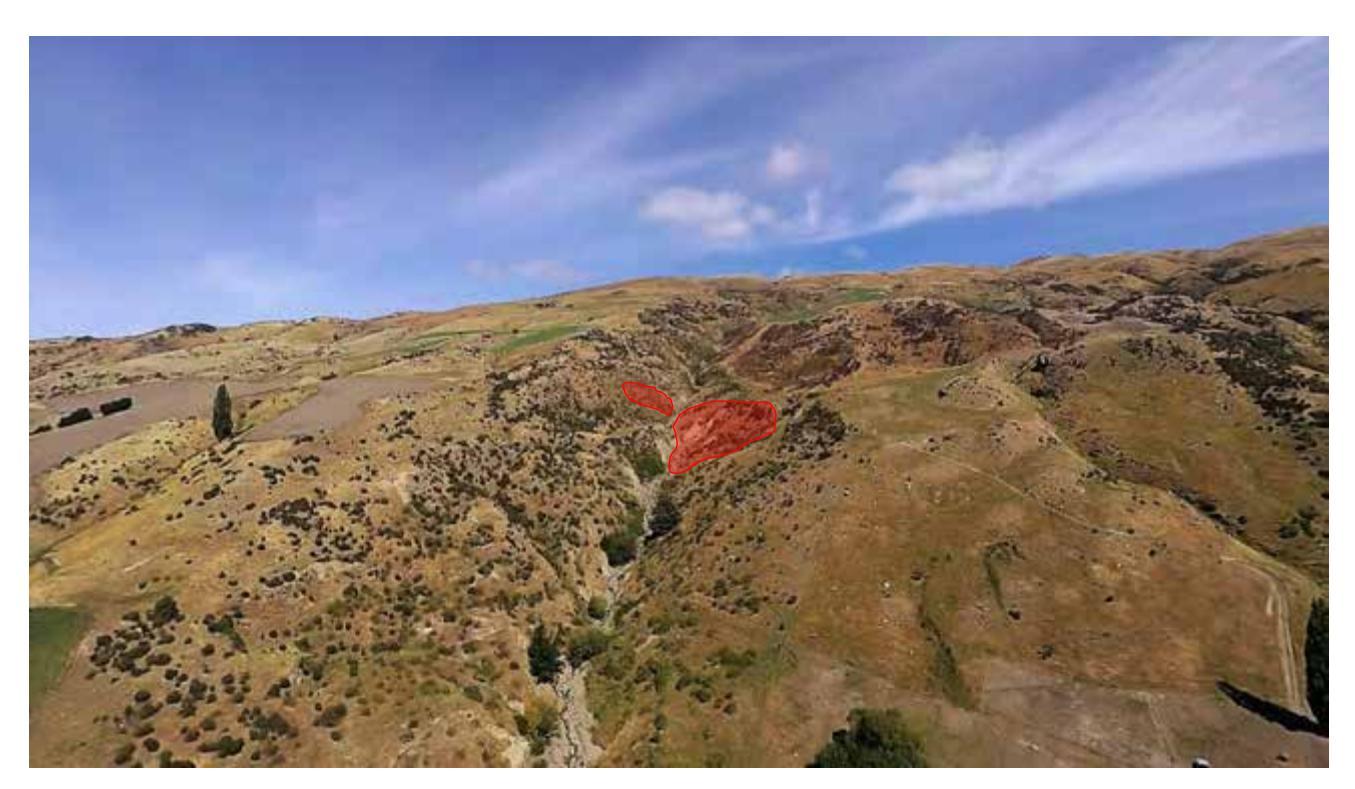
Figure 4: View of the catchment from about 200 m asl. The red shaded areas delineate areas of recently reactivated slope instabilities.

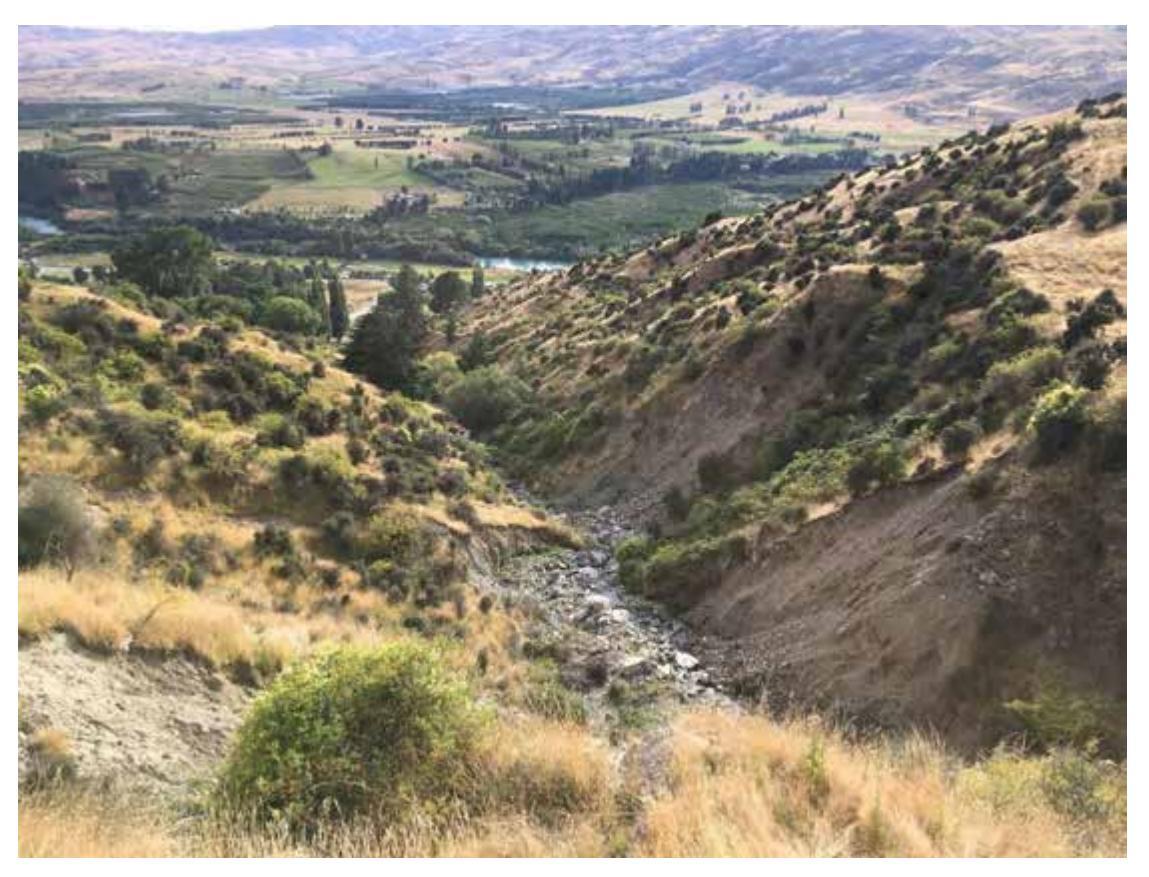
Figure 5: View from the landslide area at about 300 m asl towards the Clutha River showing recent bank erosion along both sides of the creek.

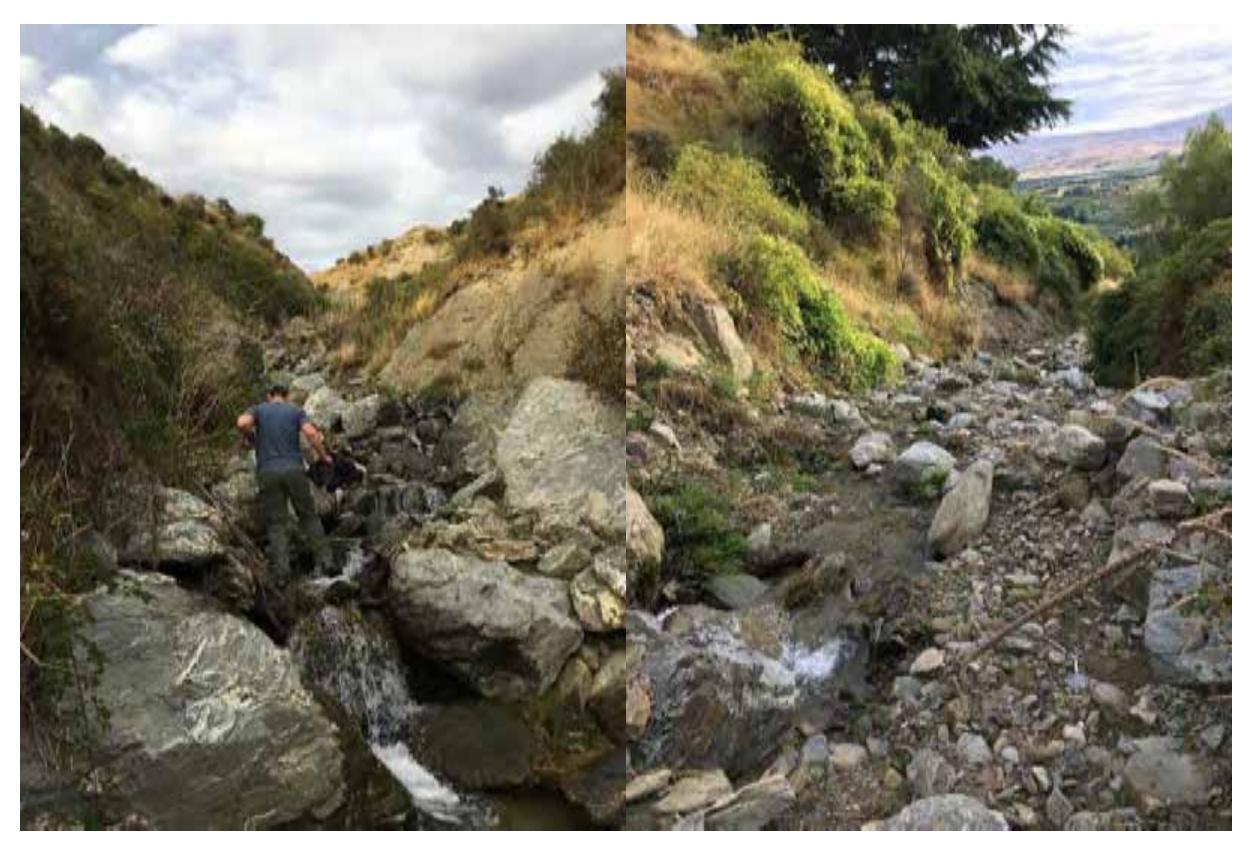
Figure 7: Channel at about 230 m asl looking upstream (left) and downstream (right). Bedload consists of bouldery material with individual boulders reaching diameters of up to 2 m.

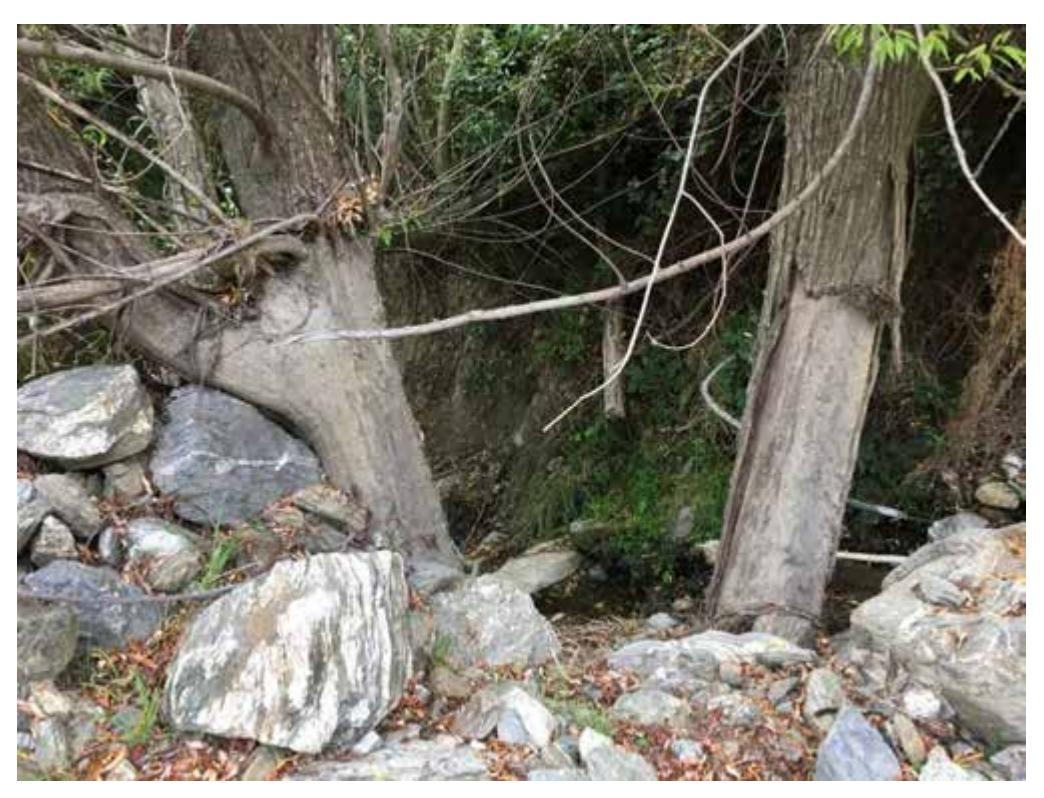
Figure 9: Damage marks on trees within creek channel (approx. 200 m asl.) extending to approx. 1.5 m above current creek bed level.

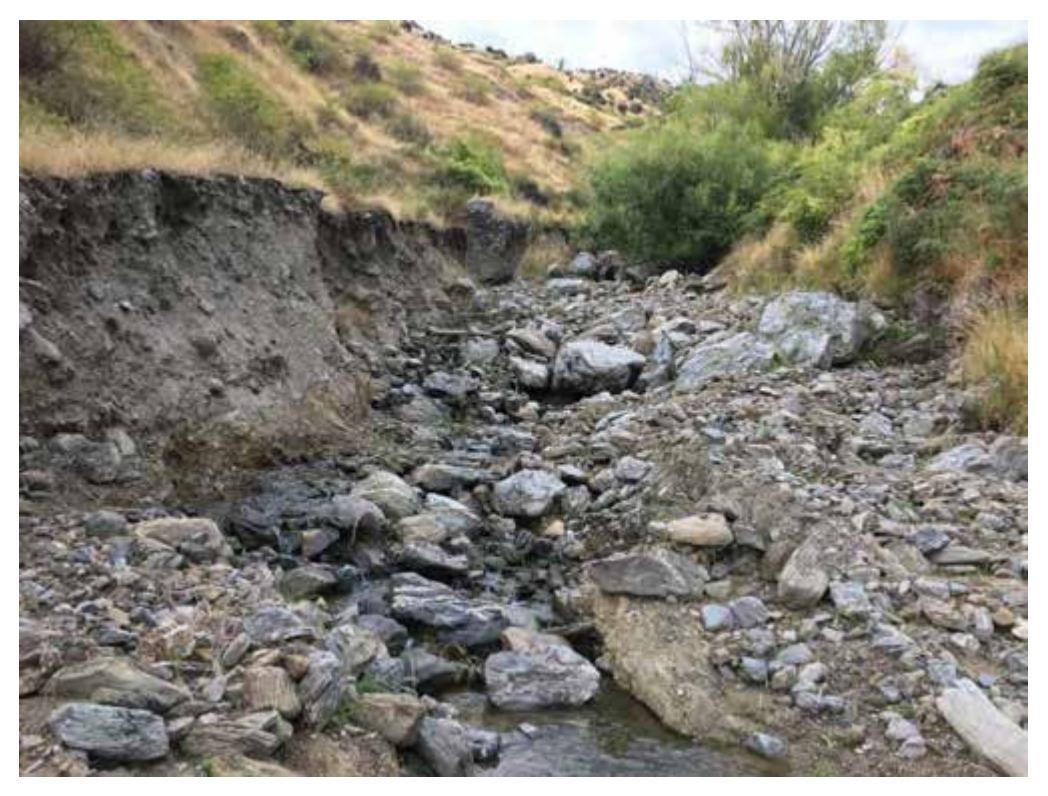
Figure 10: Channel bank erosion along the true right bank at about 180 m asl and deposition of boulders up to approx. 1.5 m in diameter; looking upstream.

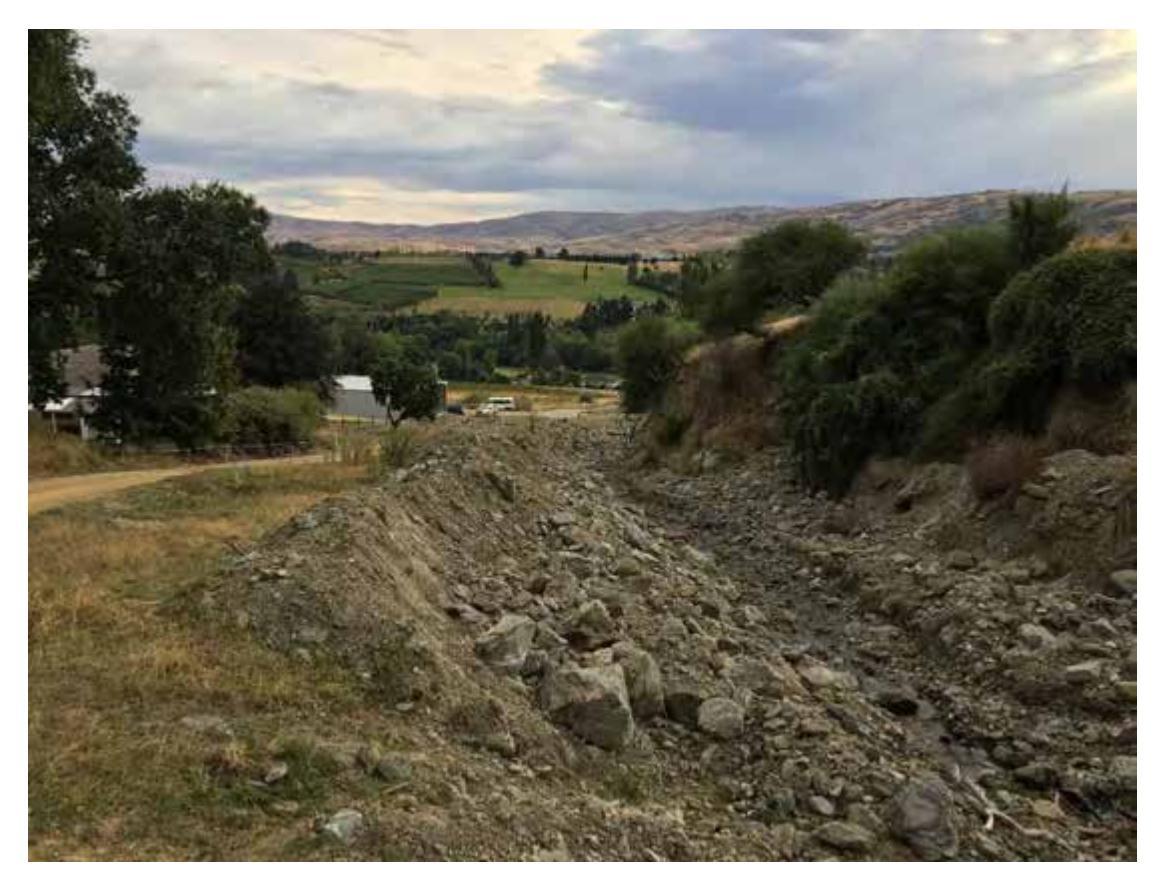
Figure 13: Looking downstream from fan apex area; about 150 m asl. Visible signs of erosion along the true right bank. Max boulder size are up to 0.7 m in diameter.

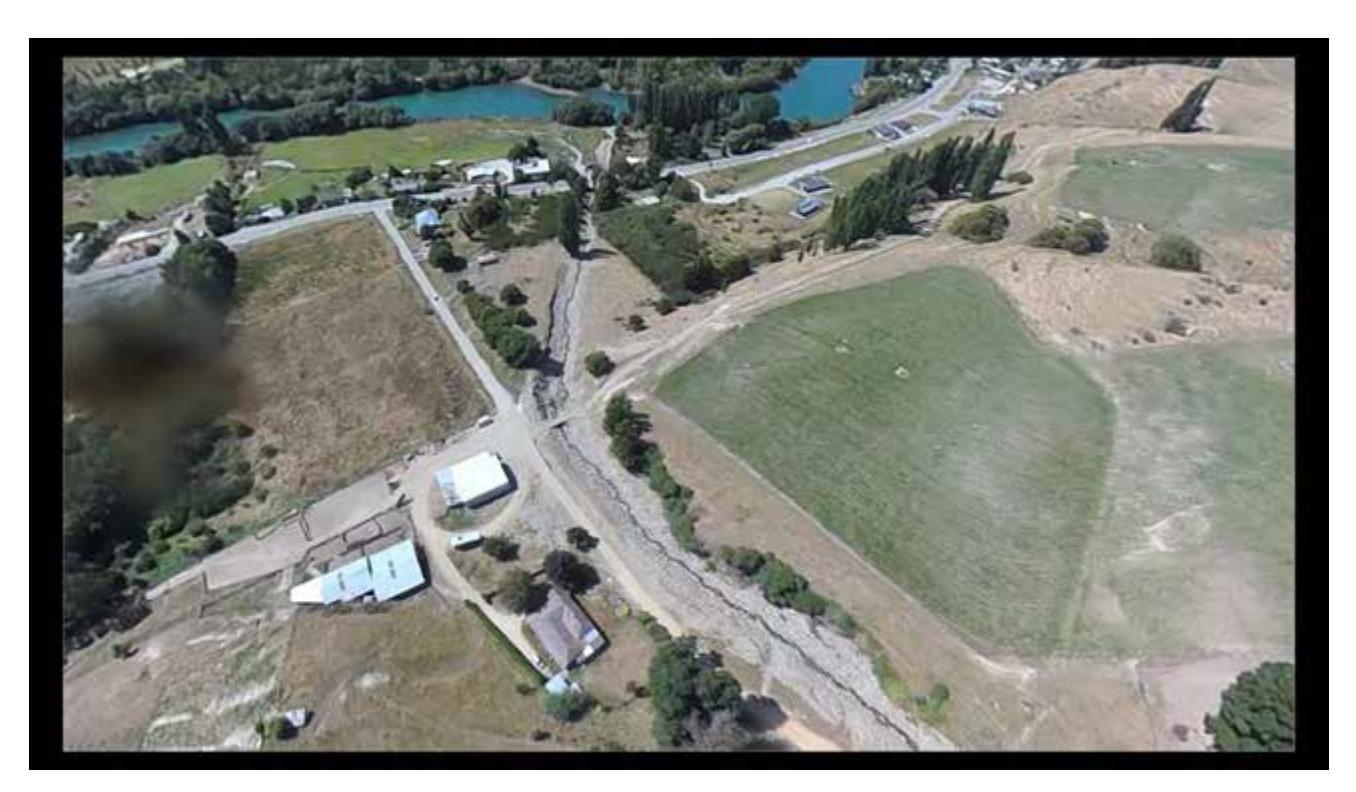
Figure 14: Aerial view of debris fan area with SH8 and Clutha River. Visible bank erosion and scour along the channel bed at the debris fan. The channel changes direction near the farm access track bridge in the center of the picture. In Nov 2017 avulsion occurred upstream of the farm bridge and damaged the farm shed (white roof).

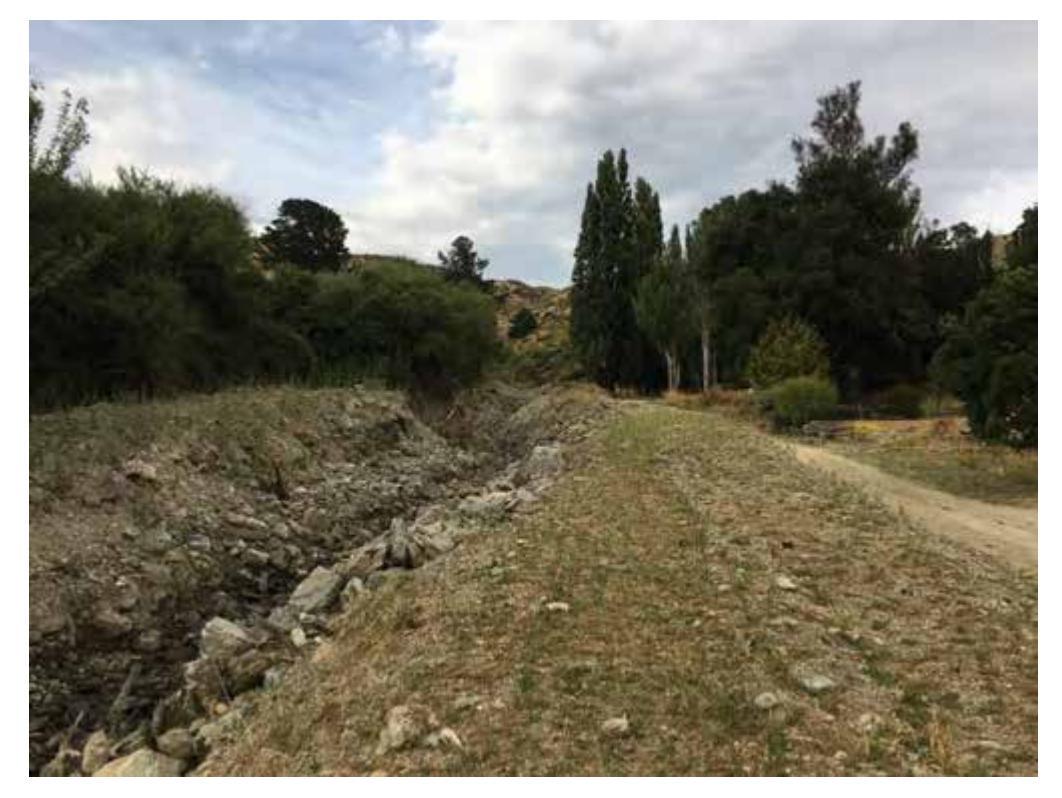
Figure 15: View from about 130 m asl upstream of farm access bridge towards fan apex showing steep banks and erosion along channel bed. This section of the channel towards the confluence with the Clutha river was cleared by heavy machinery out after the November 2017 event.

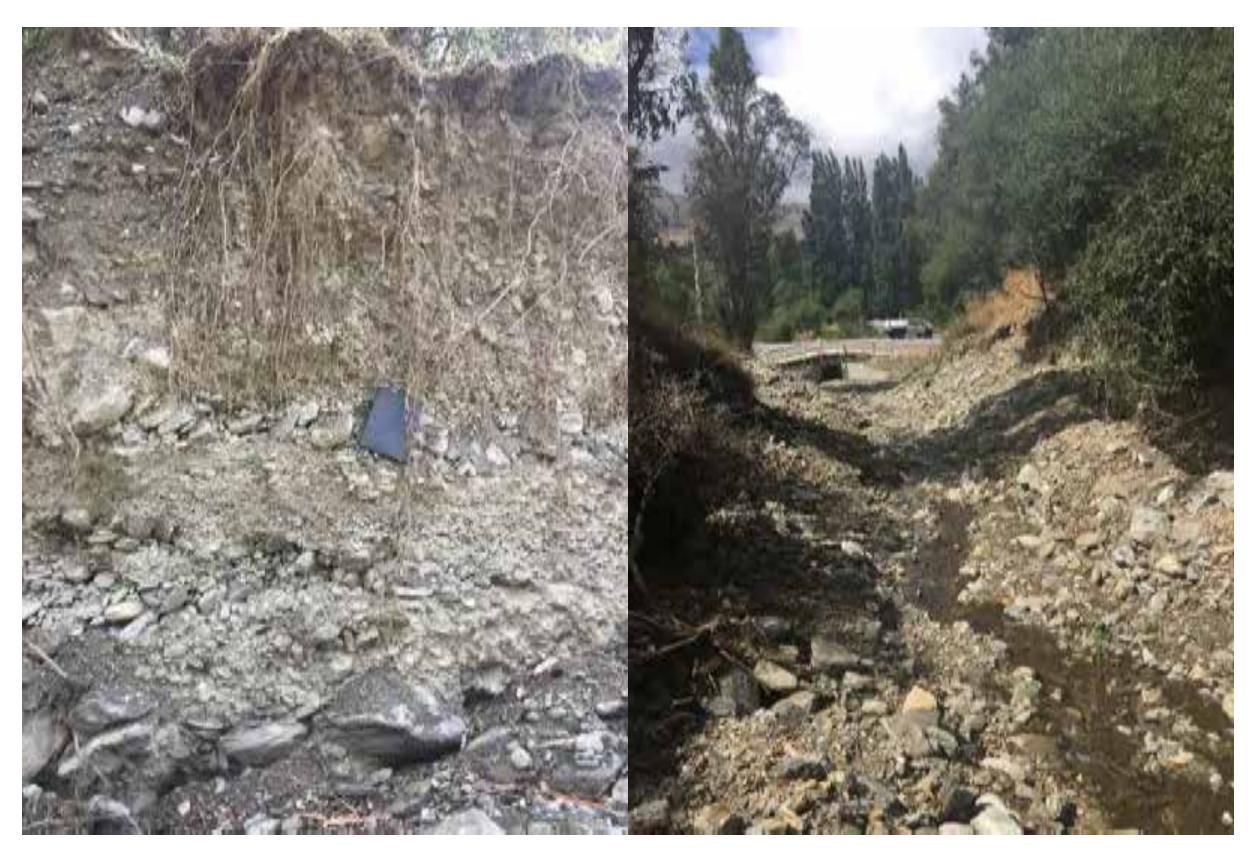
Figure 18: Exposed true left channel bank showing sequence of previous debris deposition structures (left); View just upstream of SH8 looking towards SH8 crossing from about 100 m asl.

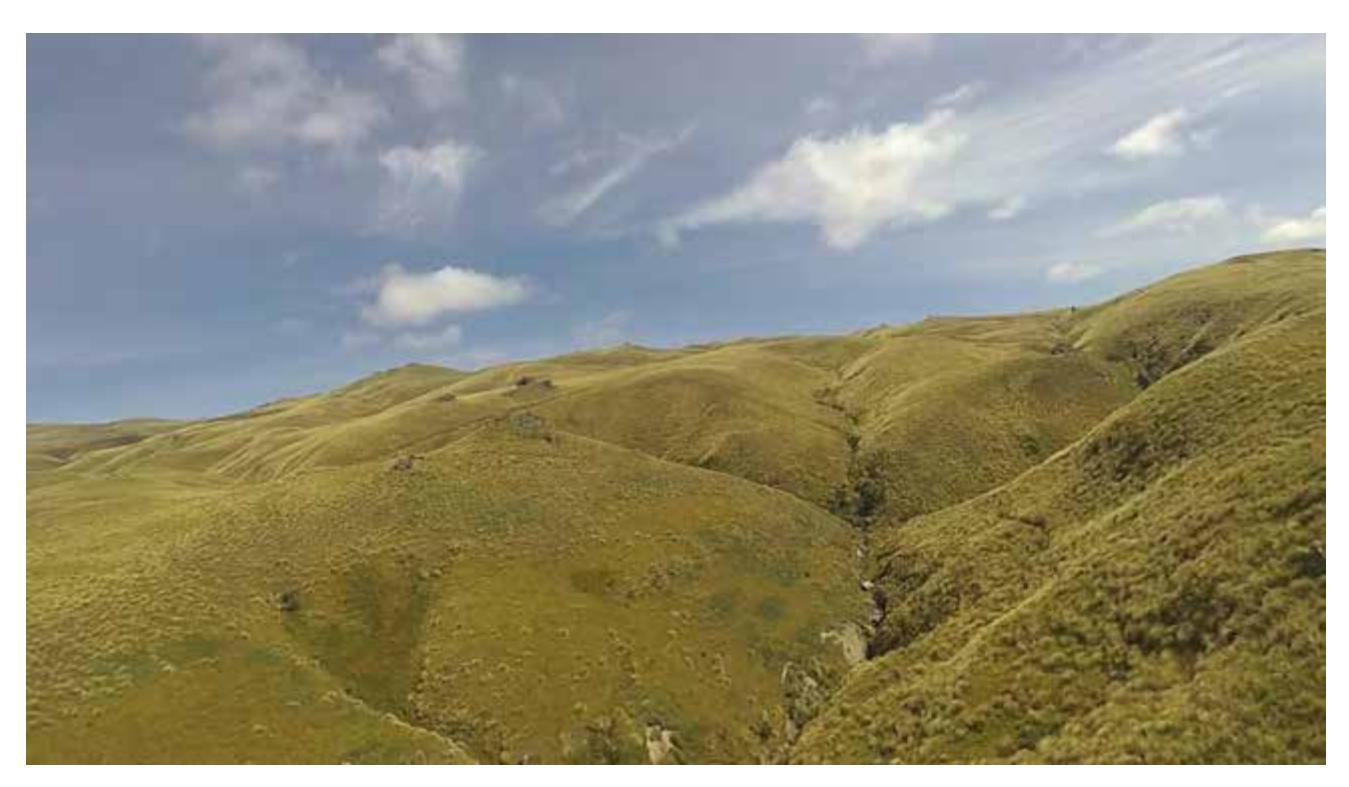
Figure 2: View of the upper reaches of the catchment at about 700 m asl. First evidence of recent bank erosion and soil slips along the true right bank.

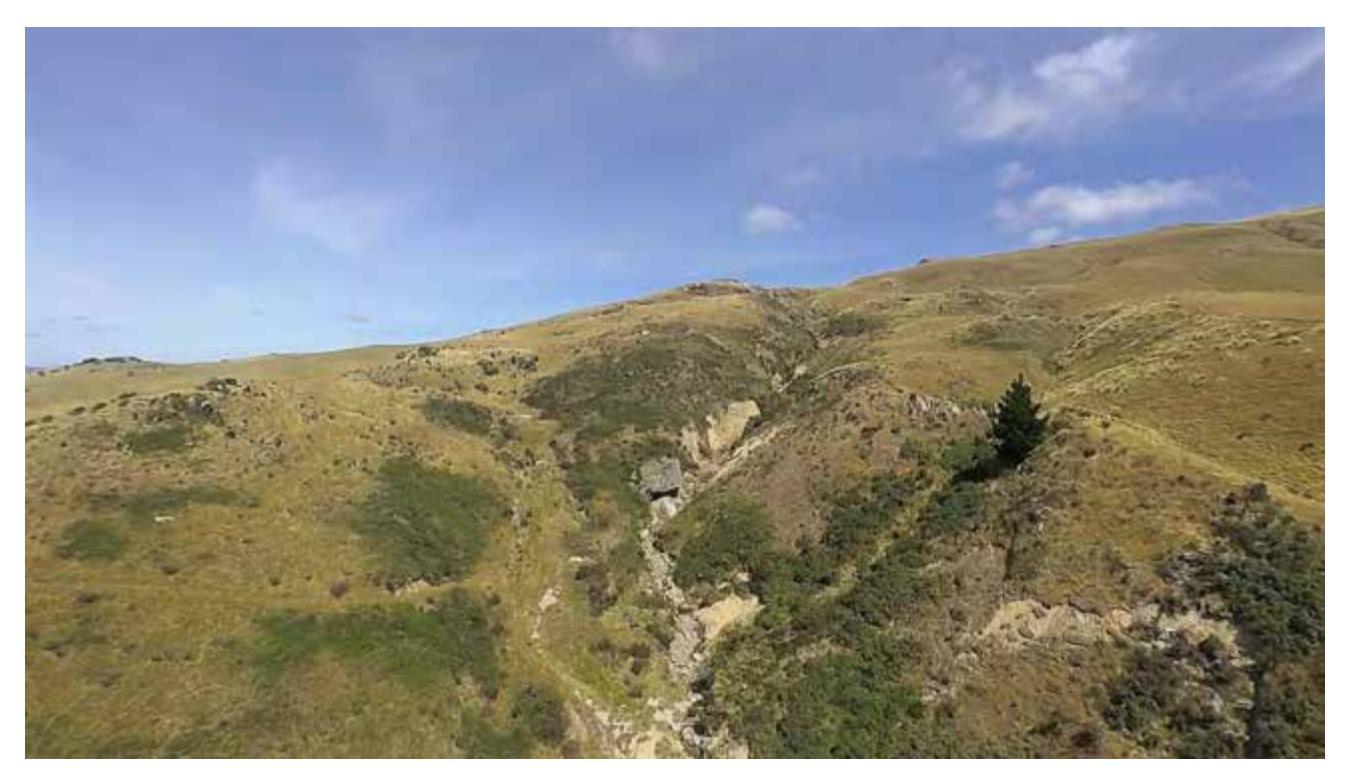
Figure 3: Channel section at about 500 m asl with evidence of recently active soil slips and shallow landslides along the adjacent slopes. Schist bedrock outcrops are visible along the creek and are a source for bouldery debris.

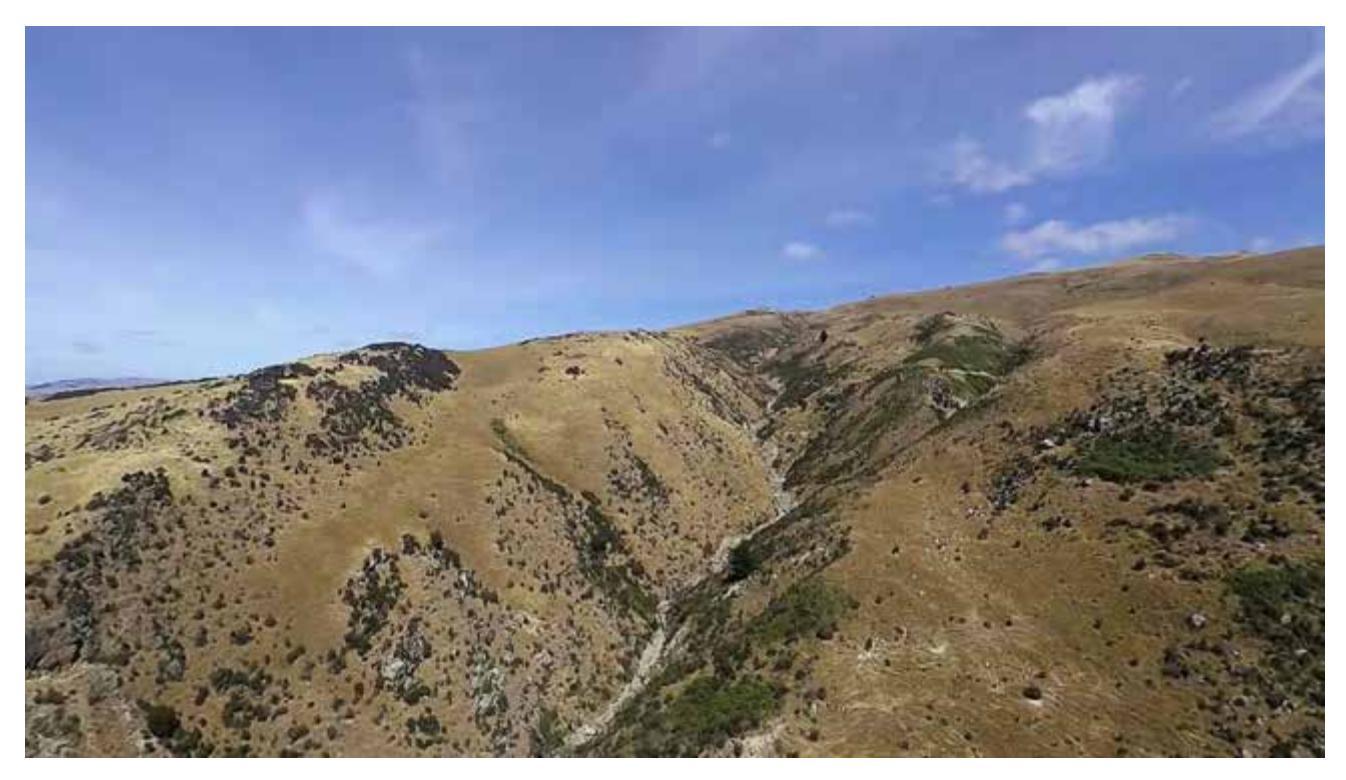
Figure 5: Aerial view of Reservoir Creek and adjacent slopes upslope from about 450 m asl. Partial vegetation with shrubs present along the true left slopes in this section of the channel. Recent erosion along channel banks are visible.

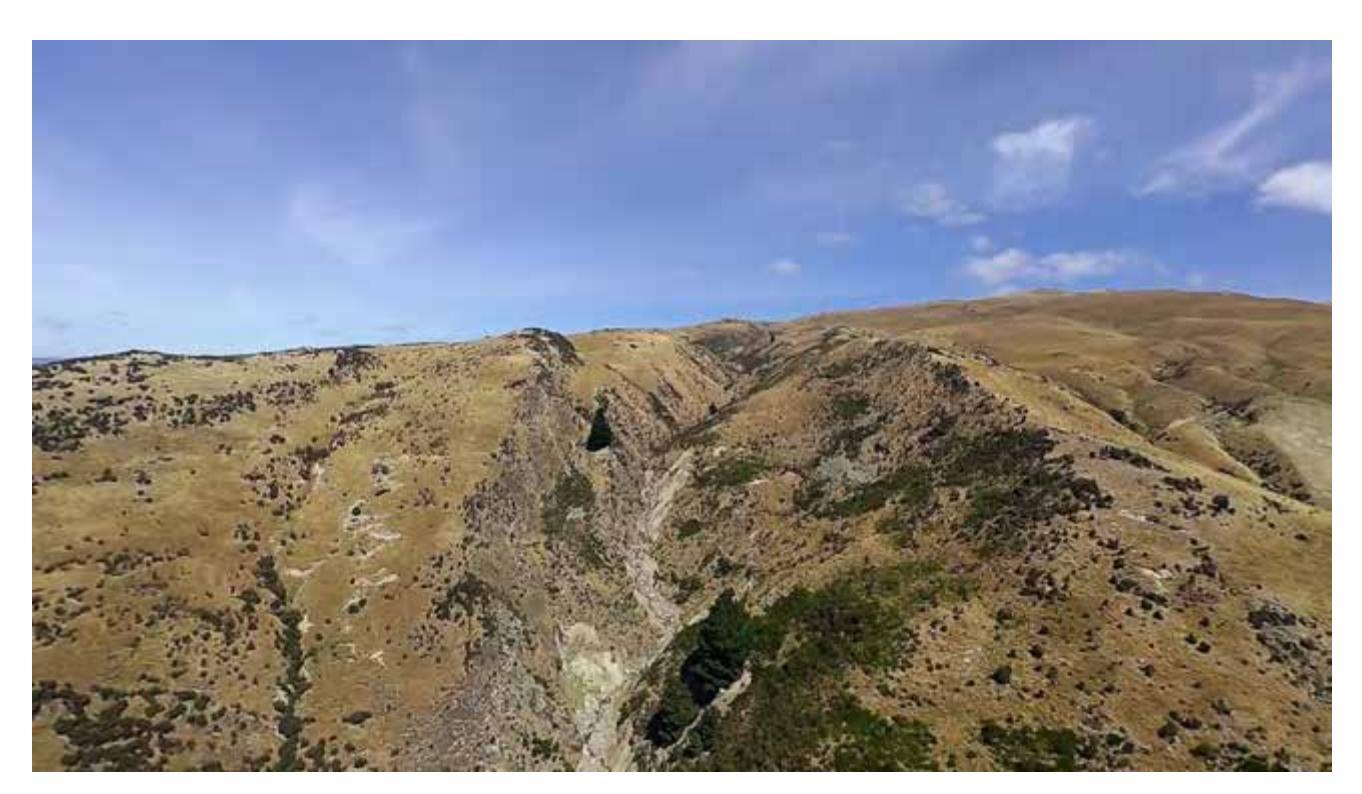
Figure 6: View from about 300 m asl upslope. The channel in this section shows evidence of erosion and deposition of material as the width increases. Slope instabilities are present along both sides of the creek.

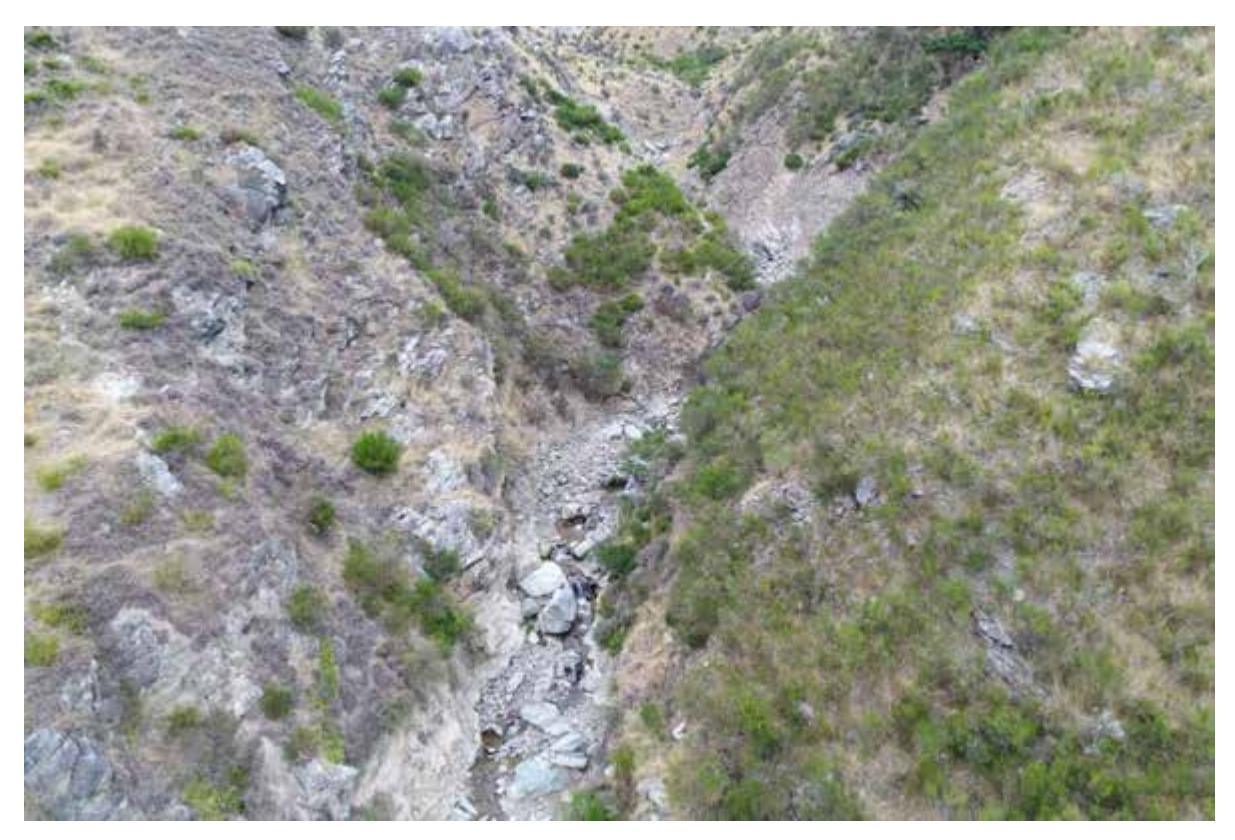
Figure 7: Channel at about 270 m asl, view upslope; boulders in creek bed up to 2-3 m in diameter. Schist bedrock visible along both channel banks.

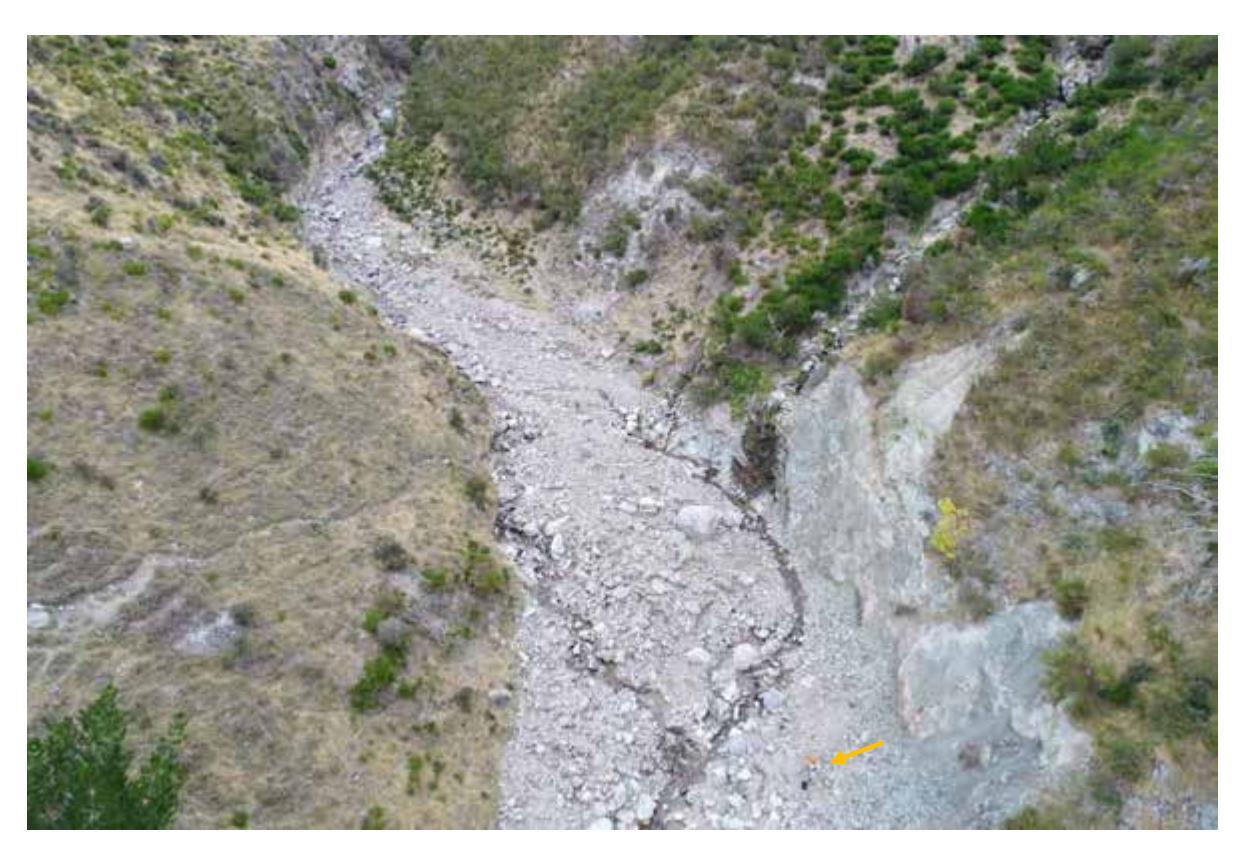
Figure 8: Widening of channel (up to 25 m in this area) and deposition of bouldery debris (up to 3 m in diameter) at about 250 m asl. Channel slope angle about 10 ° in this section; view in upslope direction. Orange arrow: Indicating position of drone operator for scale

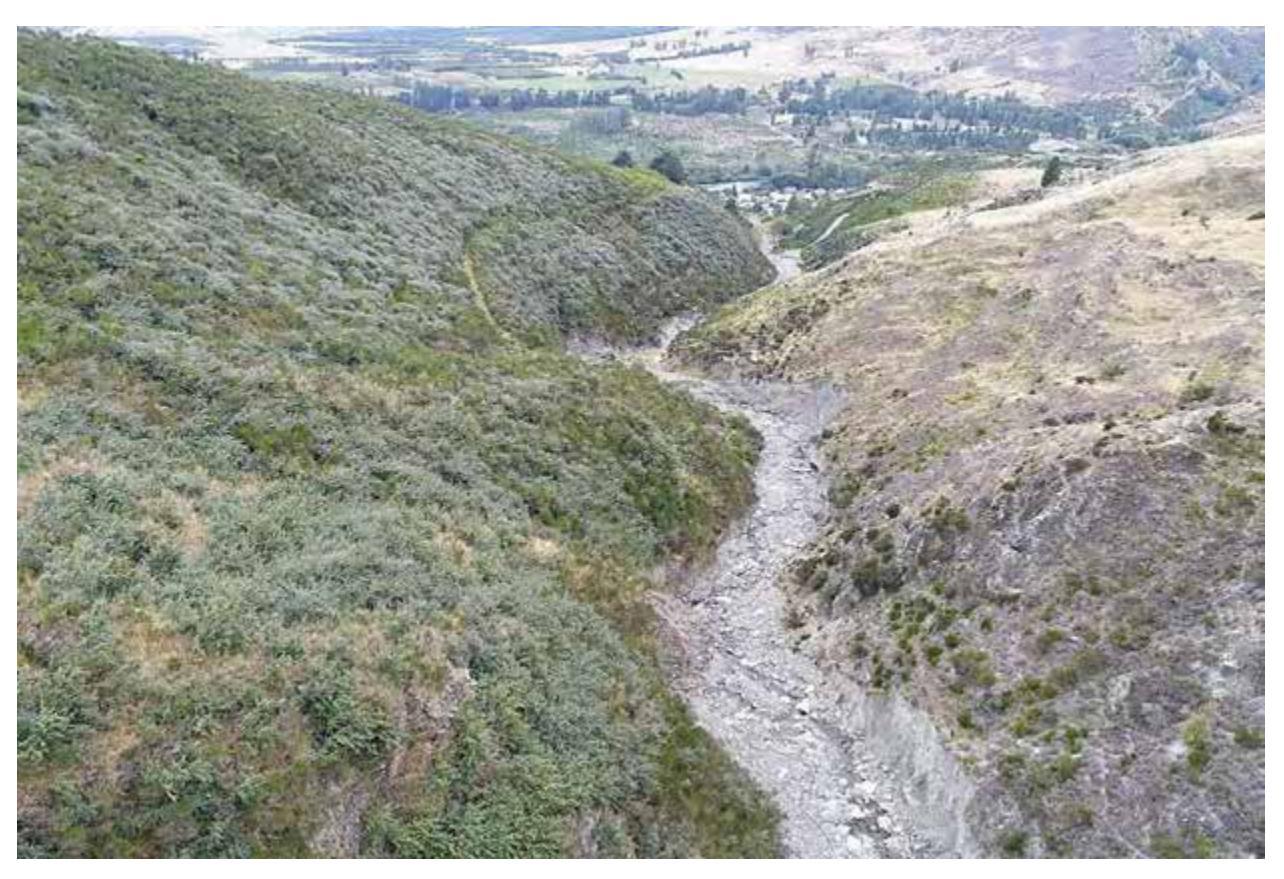
Figure 9: View downstream from about 230 m asl. Visible bank erosion in colluvium, predominantly along the true right of the channel. Deposition of bouldery debris present along this section. True left slopes are vegetated by shrubs and bushes. Schist bedrock along true left banks is present.

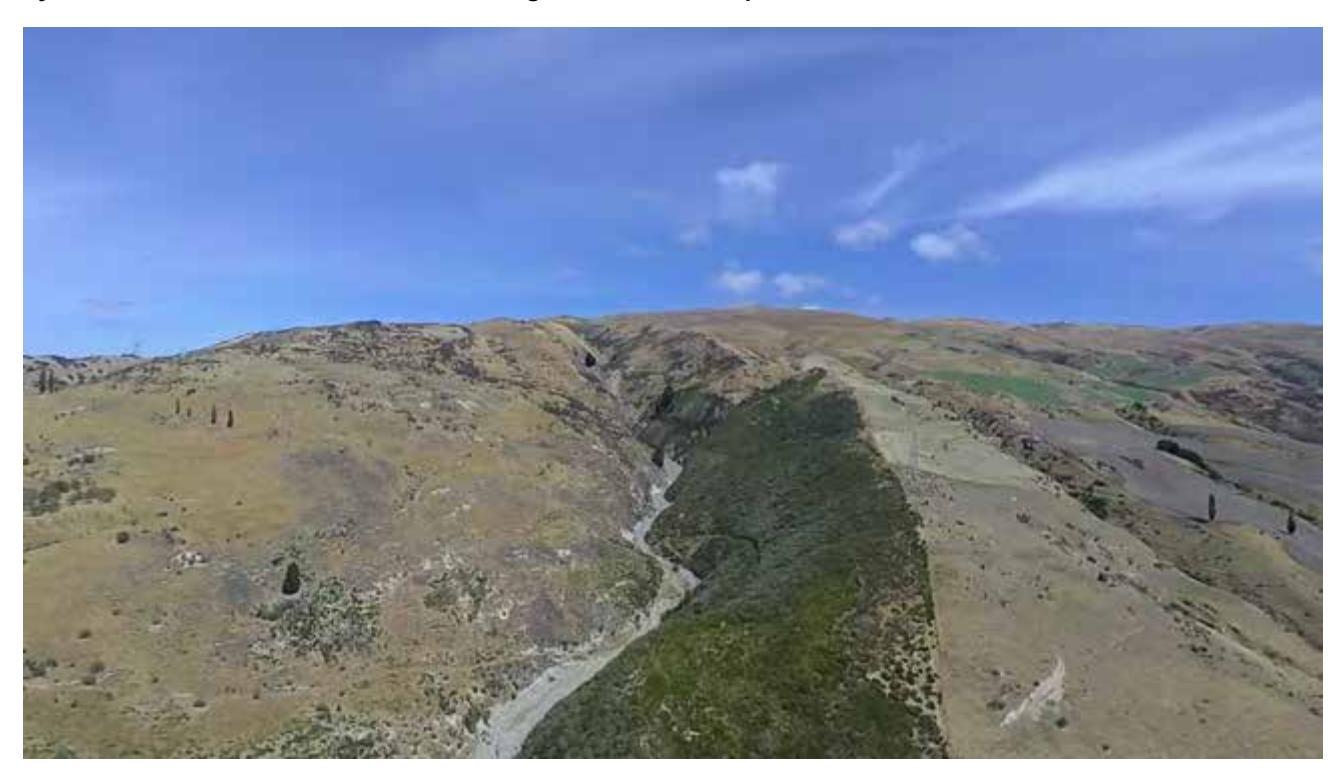
Figure 10: Aerial overview of channel section from about 150 m asl upwards. Vegetation mostly along true left slopes in this visible section of the creek channel. Depositional areas are present along this section of the channel.

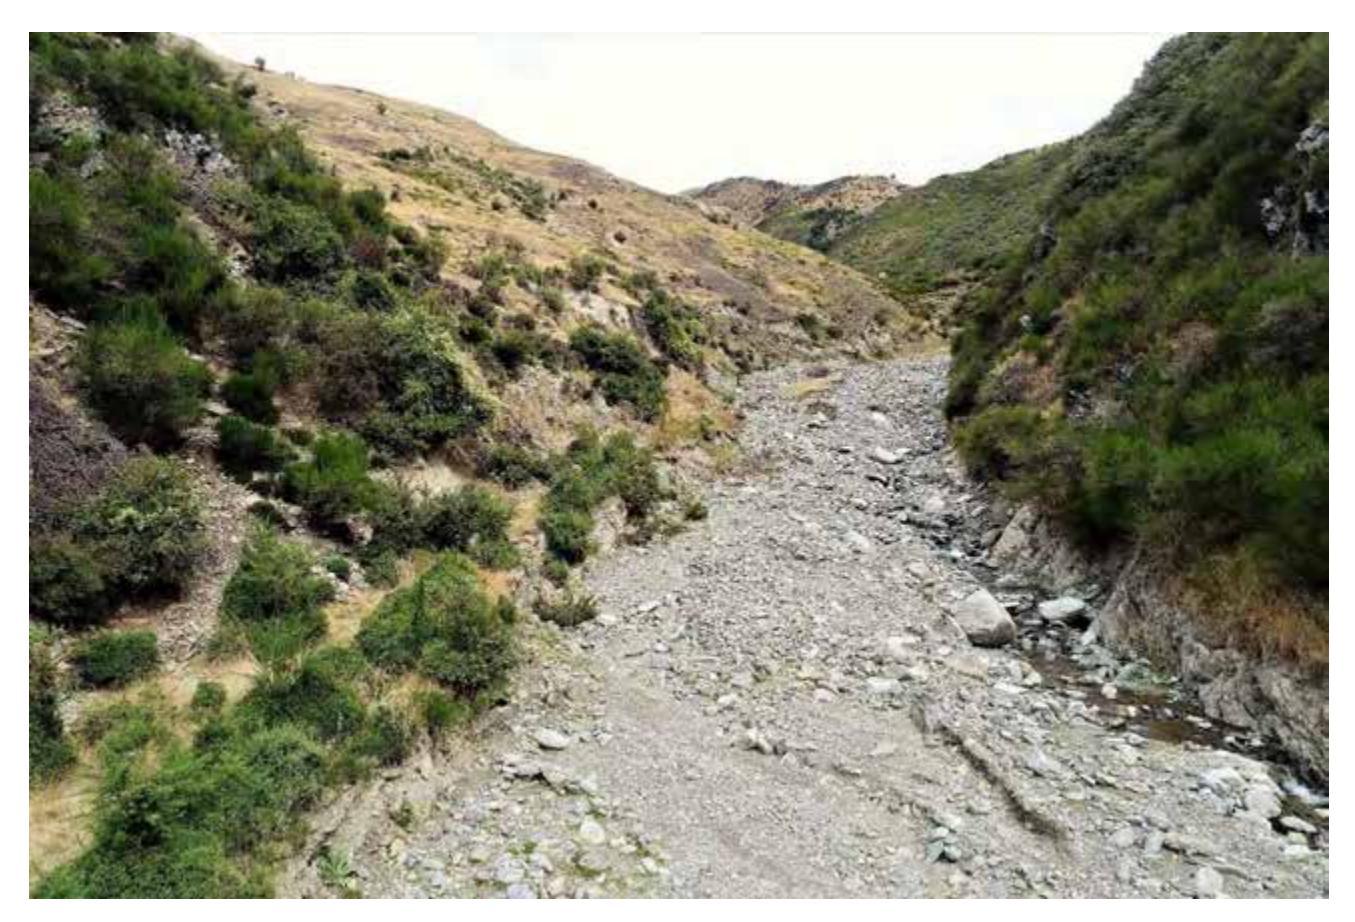
Figure 11: View of the creek channel at about 160 m asl in upslope direction. Boulder sizes up to 1.5 m in diameter; bedrock exposed along true left. Deposition of debris visible as channel widens in this section.
