# REPORT Management and Reduction of Debris Flow Risk in Roxburgh, Otago

Geomorphological Assessment Report

18113634\_7407-003-R-Rev0

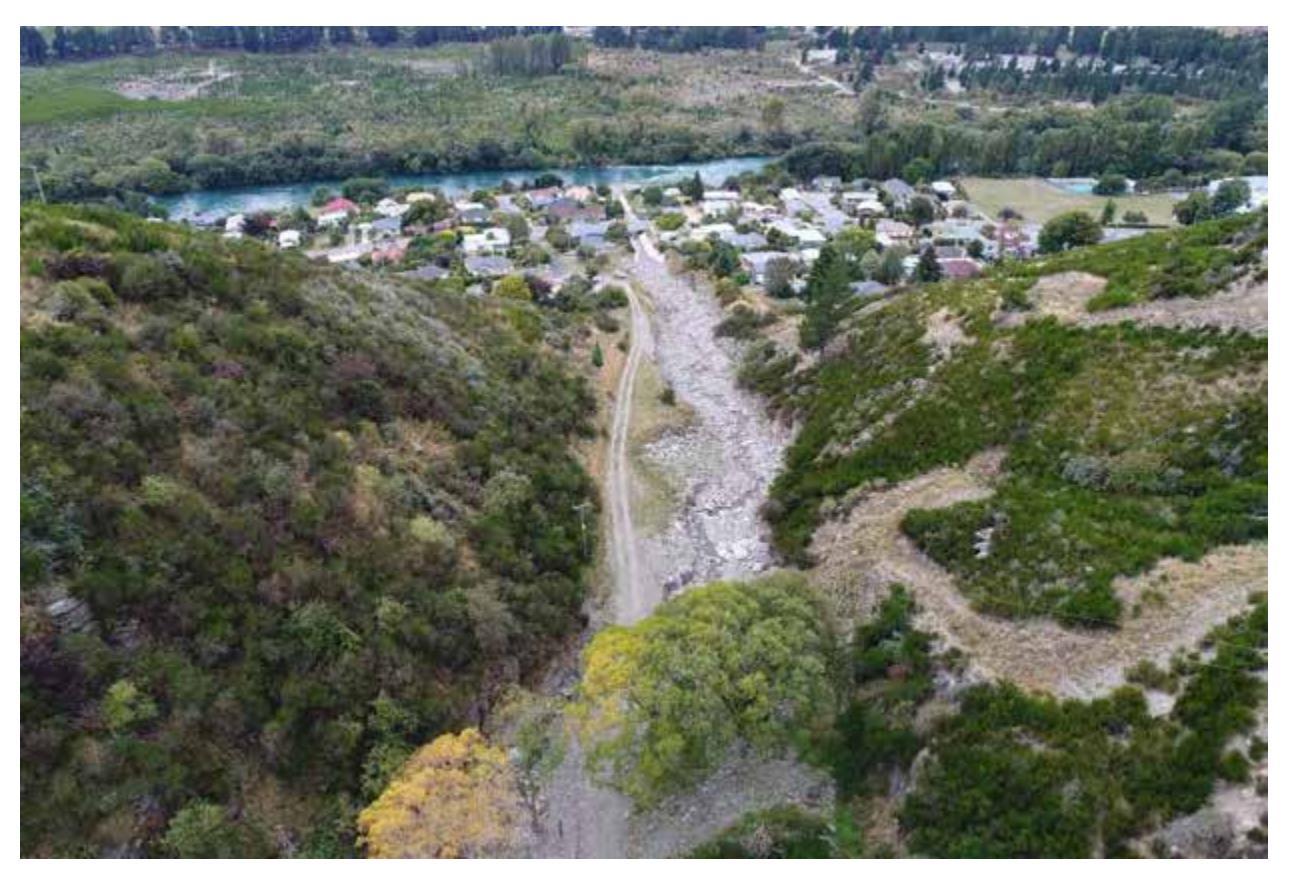
Figure 13: UAV image looking towards Roxburgh and top of the fan area from about 150 m asl. Undercutting and erosion of both banks is visible as a result of the November 2017 and February 2018 events.

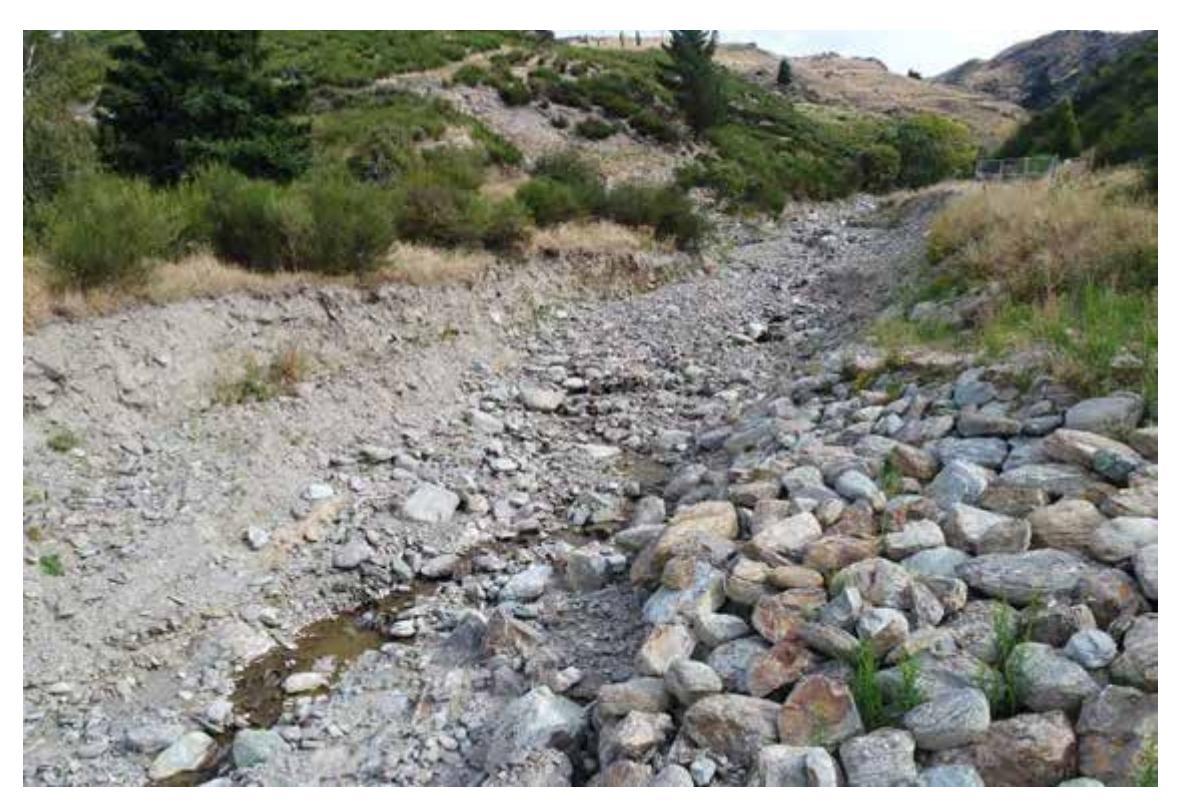
Figure 16: Looking upstream from about 110 m asl. Erosion along both banks of the creek along this section of the fan just upstream of the concrete channel. True left bank has been preliminary stabilised by placement of loose rock armour.

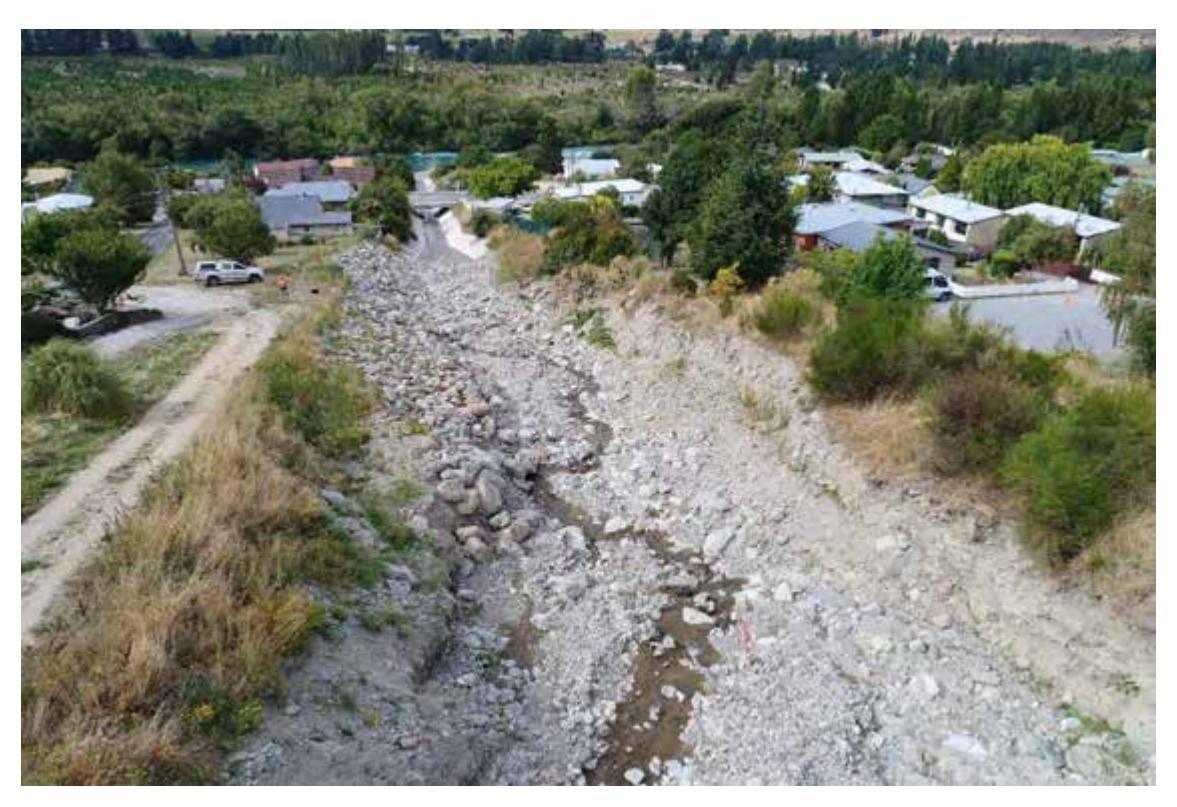
Figure 17: Looking downstream from the fan apex area at about 120 m asl towards the start of the concrete channel. Preliminary reinstatement of bank stability along true left banks with loose rock armour. Undercutting and erosion visible along true right bank.

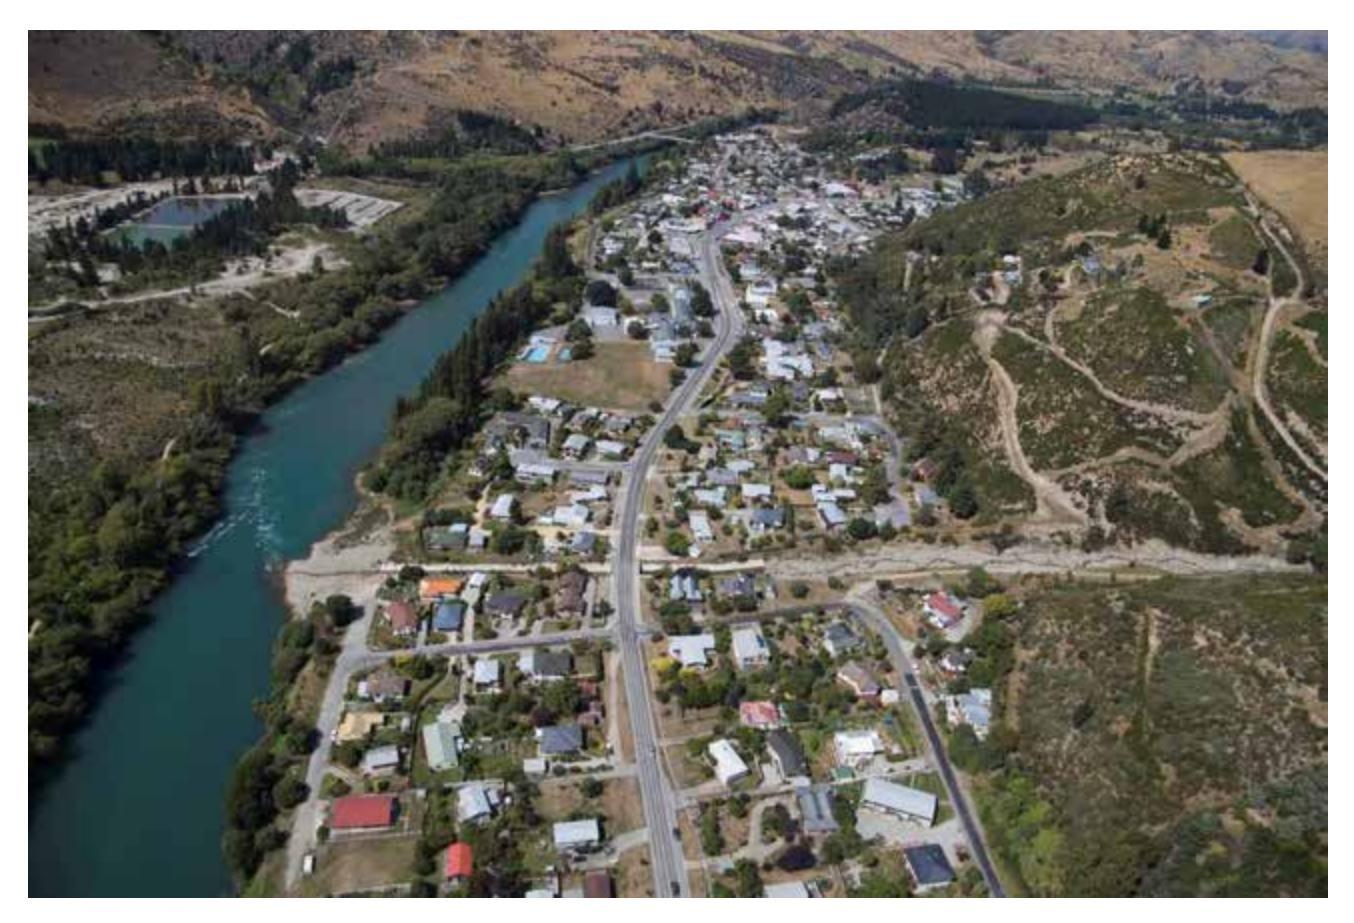
Figure 21: Aerial overview of Roxburgh and Reservoir Creek and the SH8 crossing in the center, looking south. Clearly visible is the debris fan at the confluence with the Clutha River that built up and extended itself into the Clutha River during the November 2017 event. Also visible are the widening of the channel bed and erosion of channel banks upstream of the concrete channel on the debris fan.

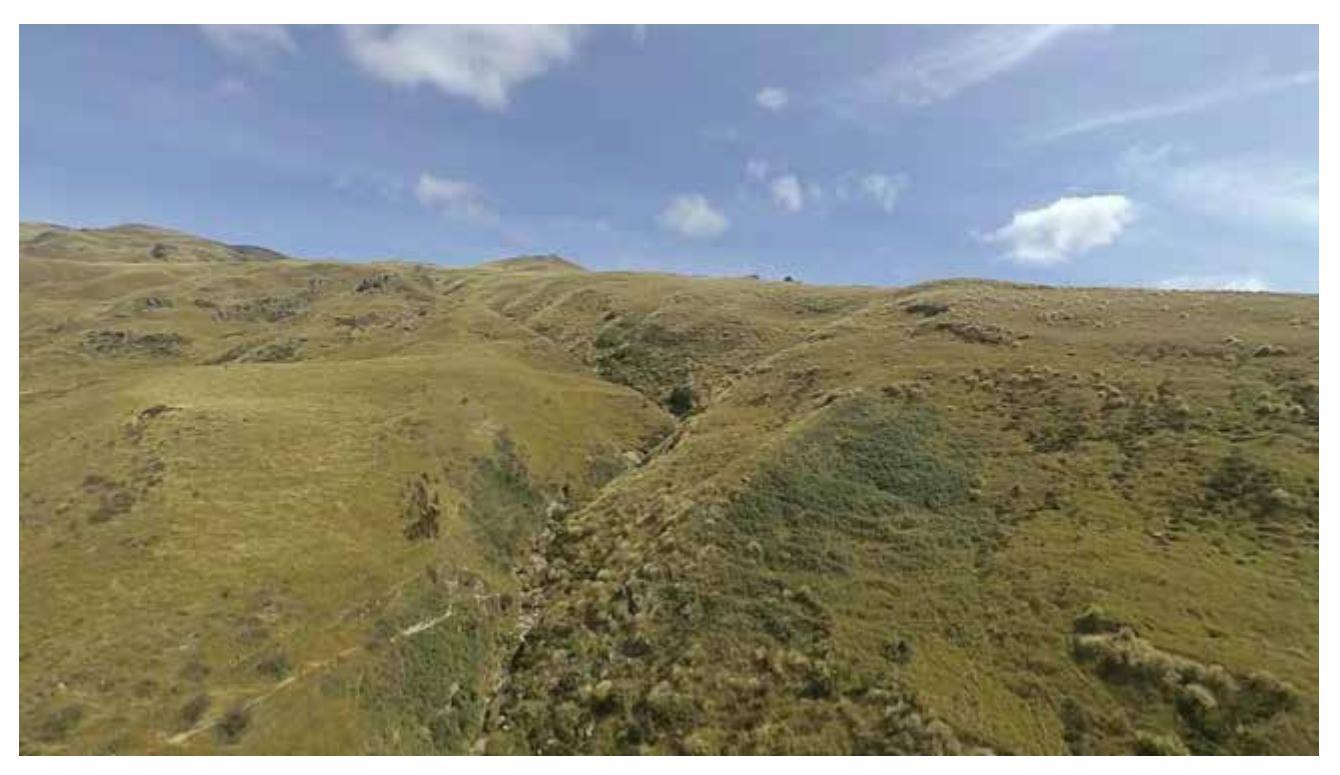
Figure 2: View of the upper reaches at about 600 m asl. Some evidence of recent erosion is visible within the creek channel and along the channel banks.

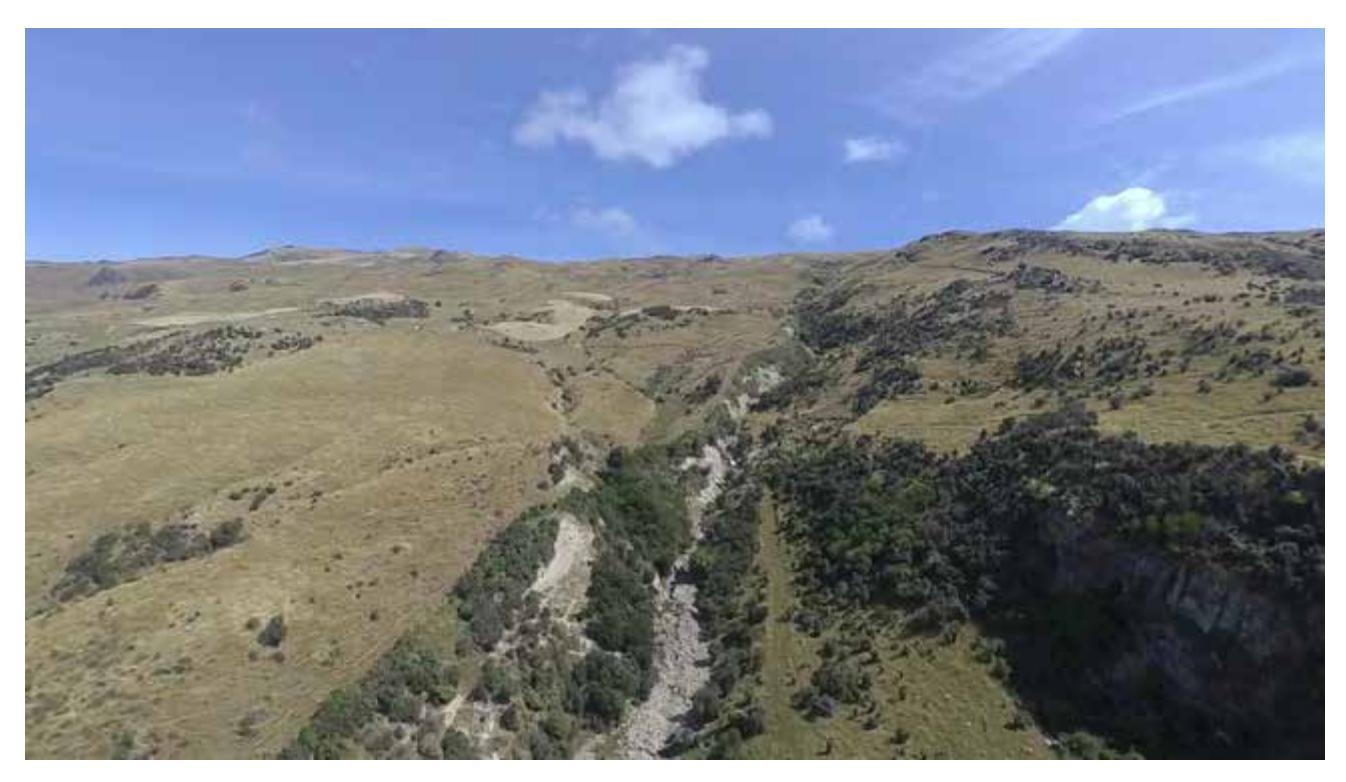
Figure 3: Visible erosion along channel banks - view at about 400 m asl. Also deposition of debris is present along this section of the channel.

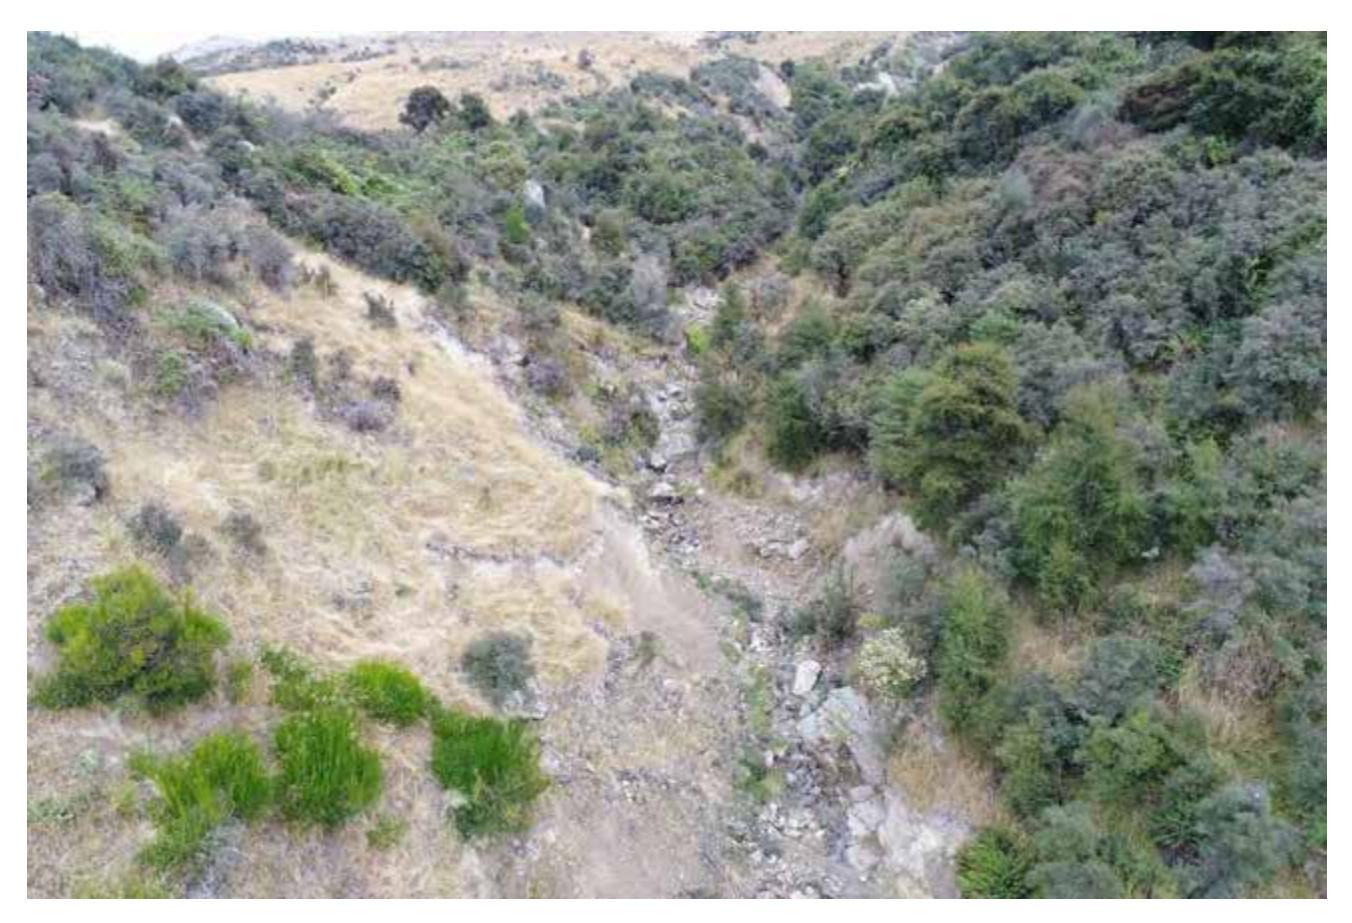
Figure 4: Narrow channel section in exposed schist bedrock at about 380 m asl and source area for bouldery debris. Recent bank erosion and soil slips are present along both sides of the channel.

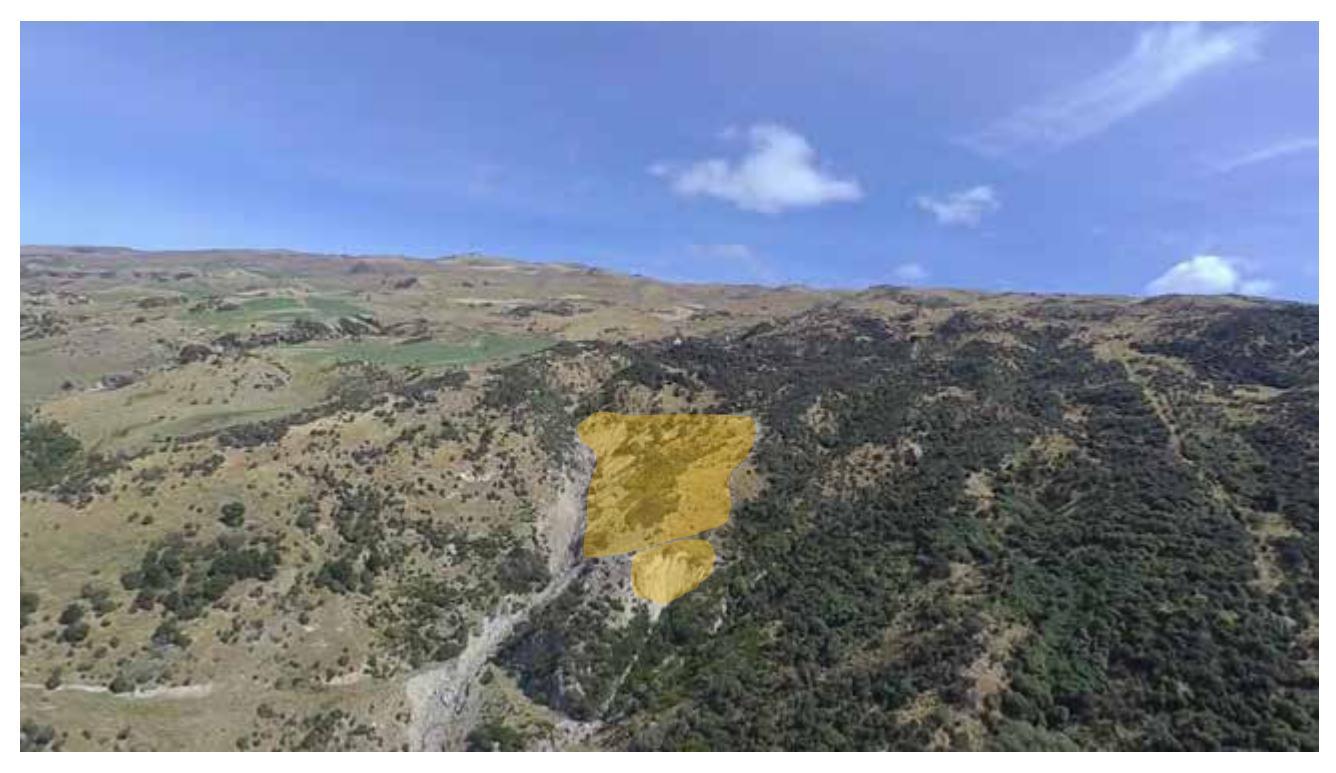
Figure 5: Overview of section along reactivated landslide in colluvium (highlighted area) at approx. 250 m asl.

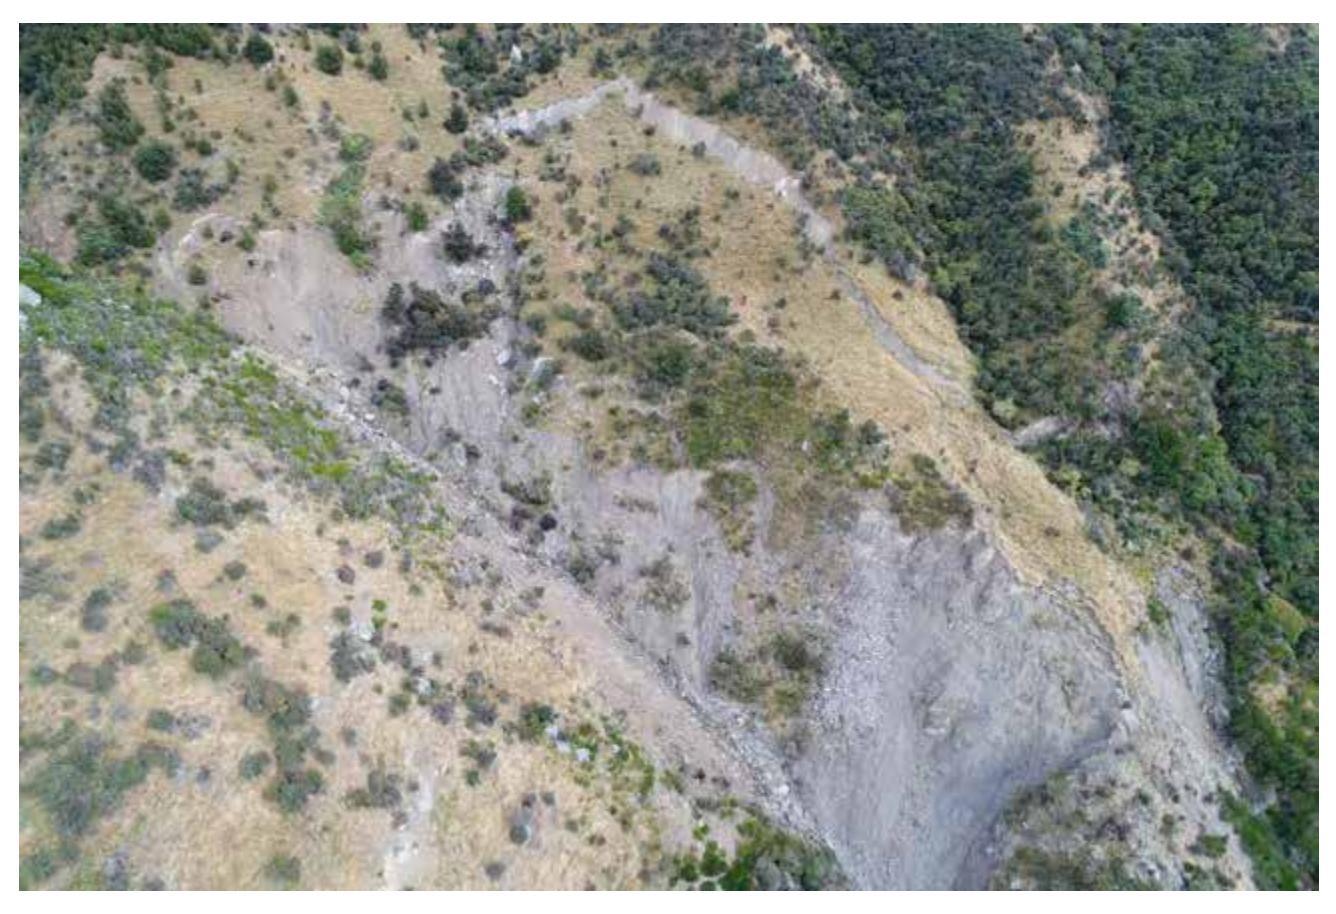
Figure 6: Oblique view from the south of the area of the reactivated landslide (head scarps were visible after a heavy rainfall in late November 2018) along the true left slope of the channel between about 220 - 330 m asl. Undercutting and entrainment of debris along the banks is a prominent erosional process in this area.

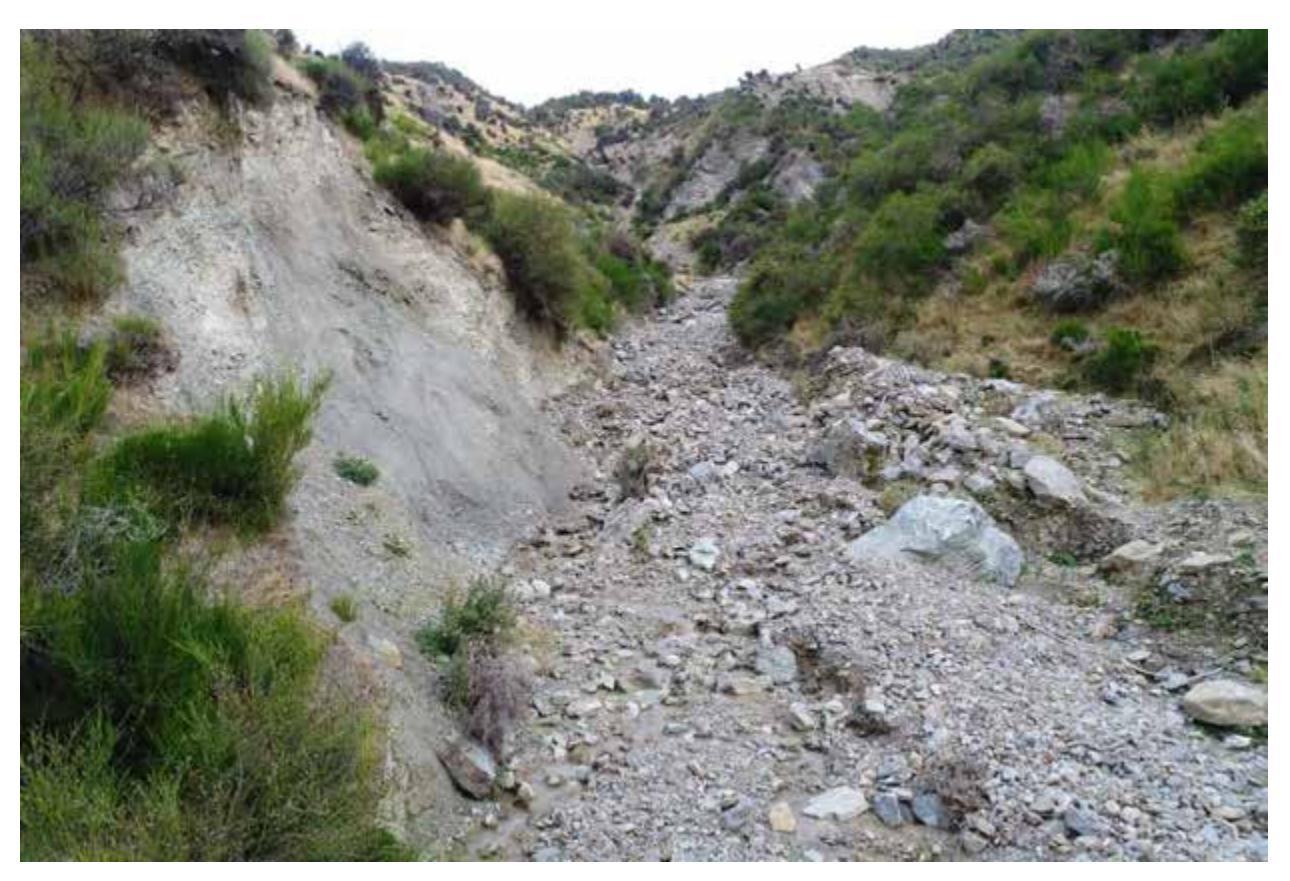
Figure 9: Channel at about 190 m asl looking upstream, showing evidence of bank erosion and deposition of boulders of up to 1,5 m in diameter.

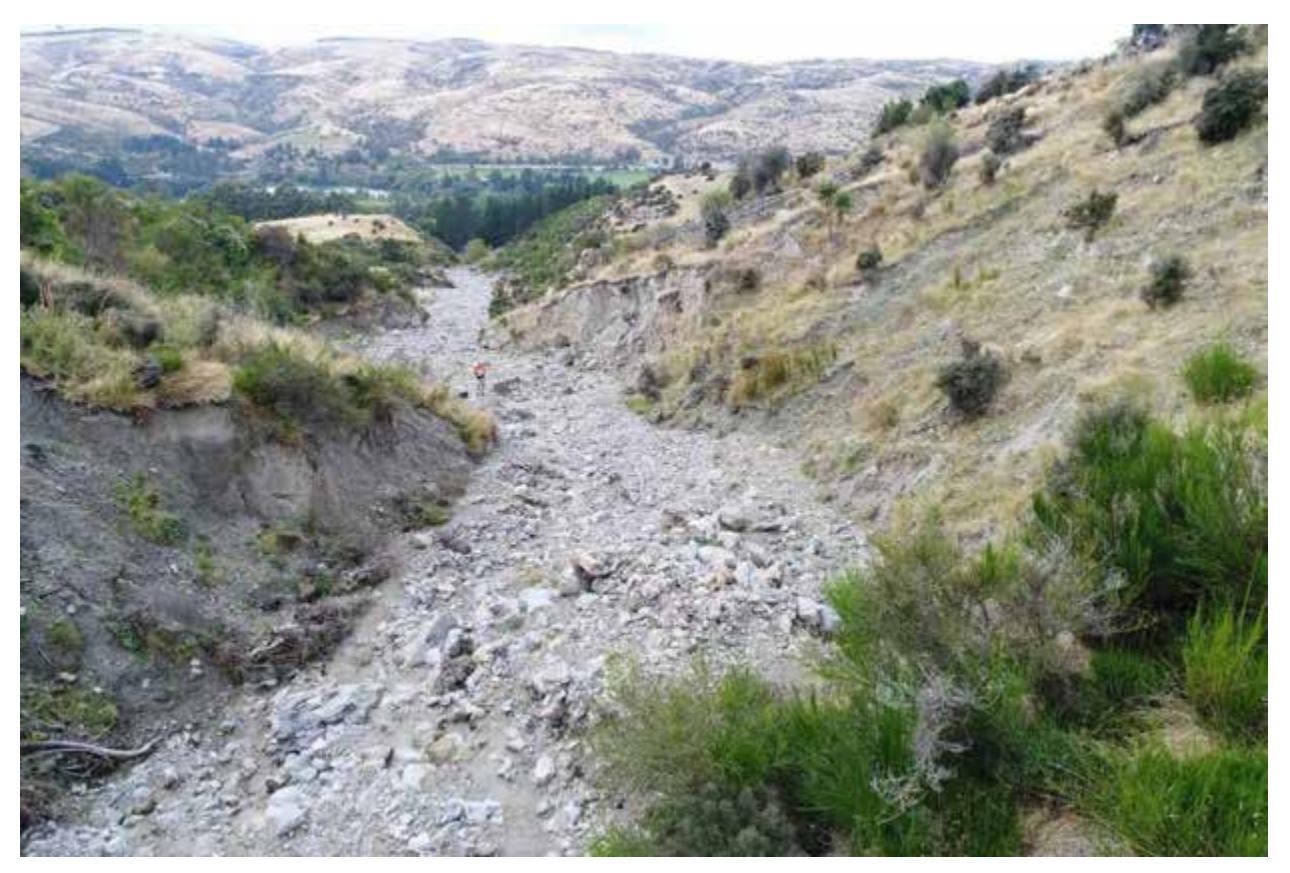
Figure 10: UAV image of channel at about 190 m asl, looking downstream along the start of a depositional area along the channel and sections of visible bank erosion and soil slip activity in colluvium.

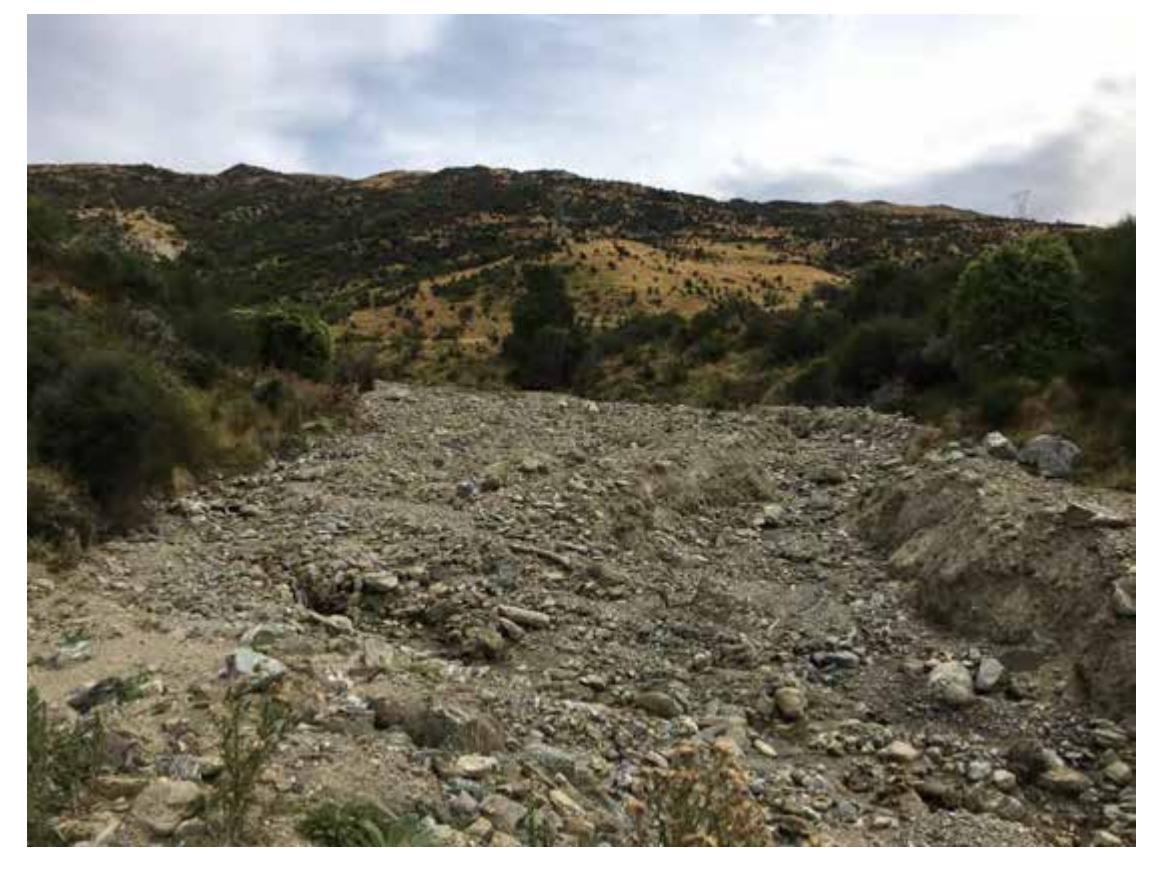
Figure 14: Channel at about 160 m asl, looking upstream. Channel bed erosion visible in debris deposits within the existing creek. Boulders are up to 1 m in diameter.

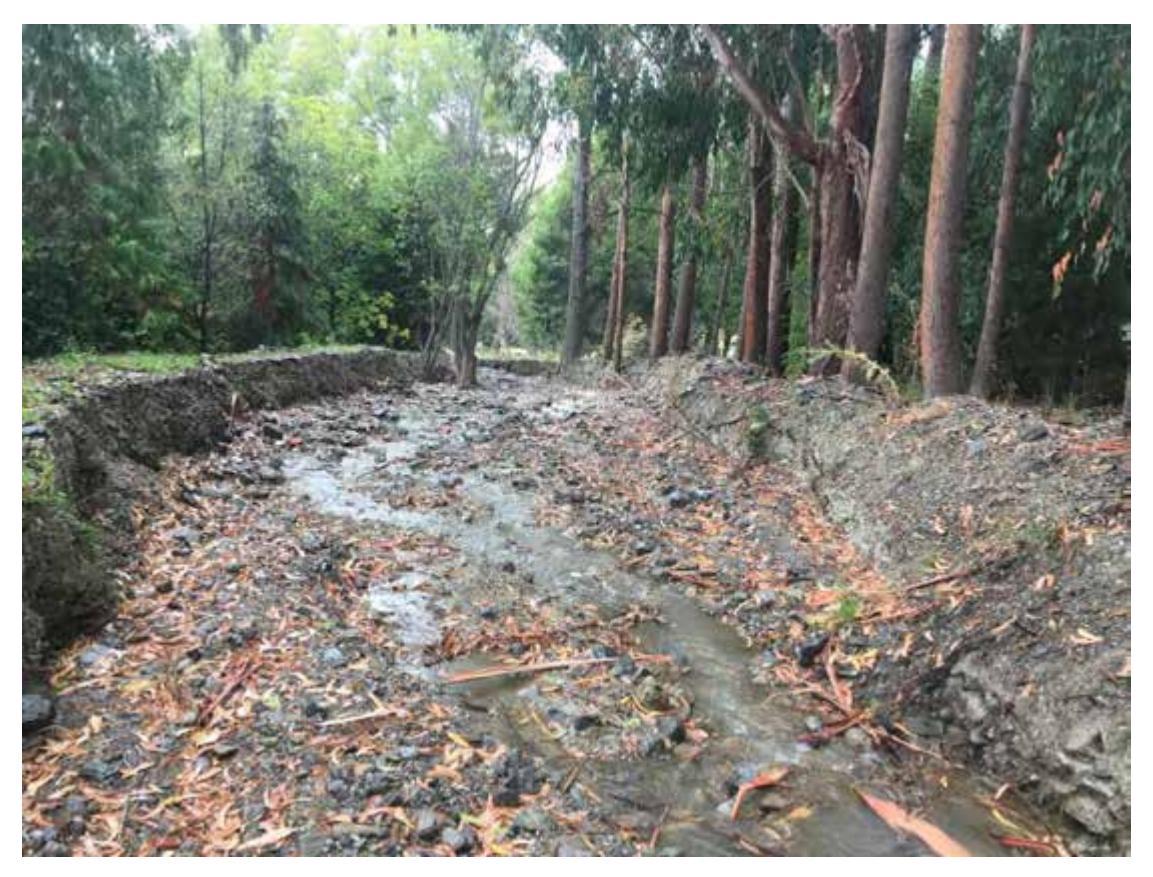
Figure 18: View downstream at about 130 m asl. Channel bank erosion is visible along both sides of the current creek bed.

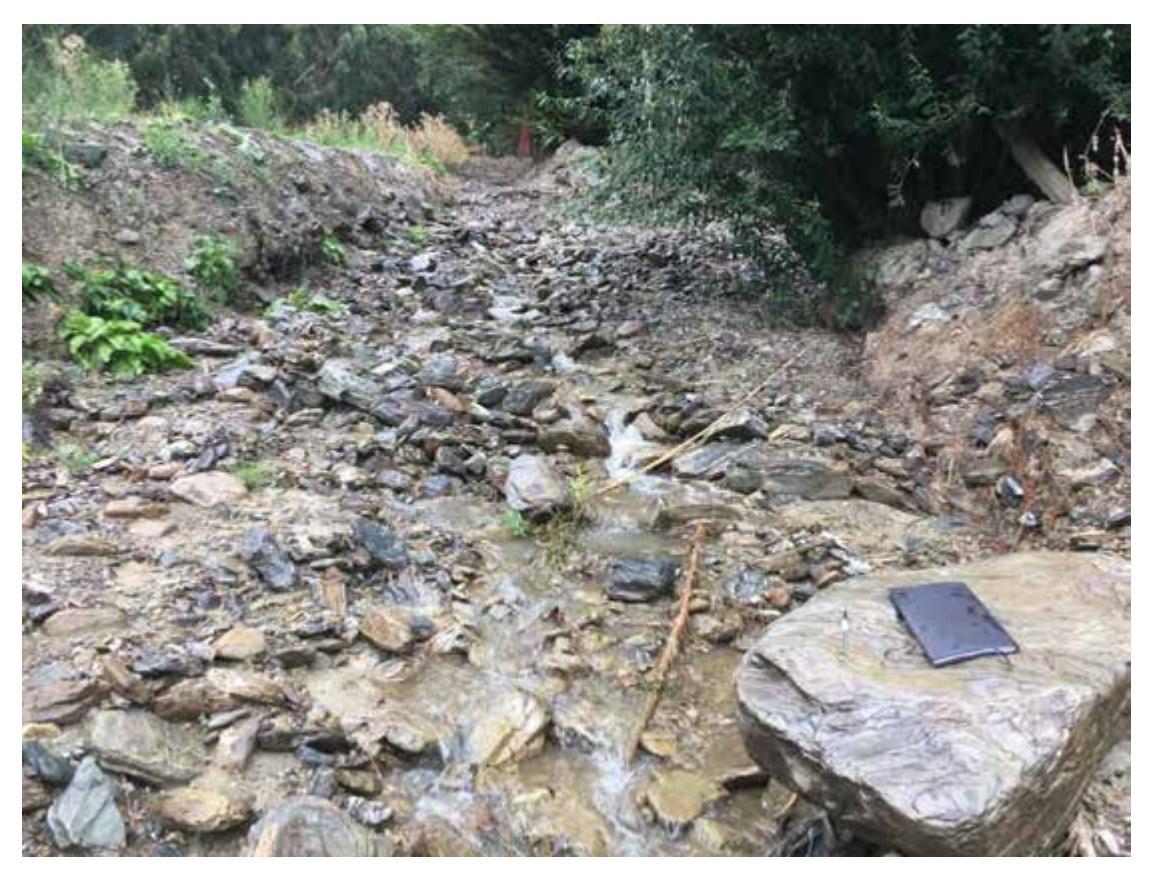
Figure 22: Channel above SH8 crossing, looking upstream from about 115 m asl. Current creek bed is about 1 m below the channel banks.

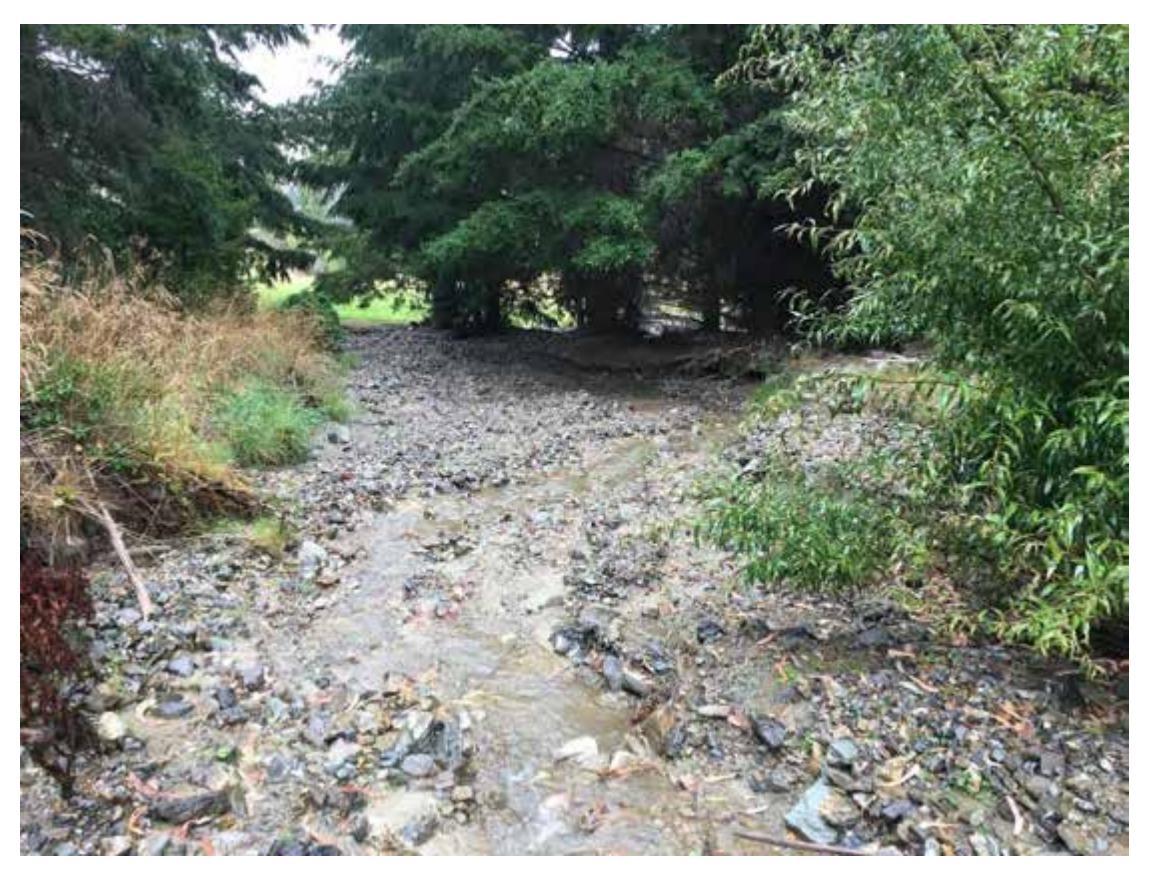
Figure 26: Golfcourse creek below SH8, looking downstream from about 104 m asl with recent deposition of gravel and cobbles.

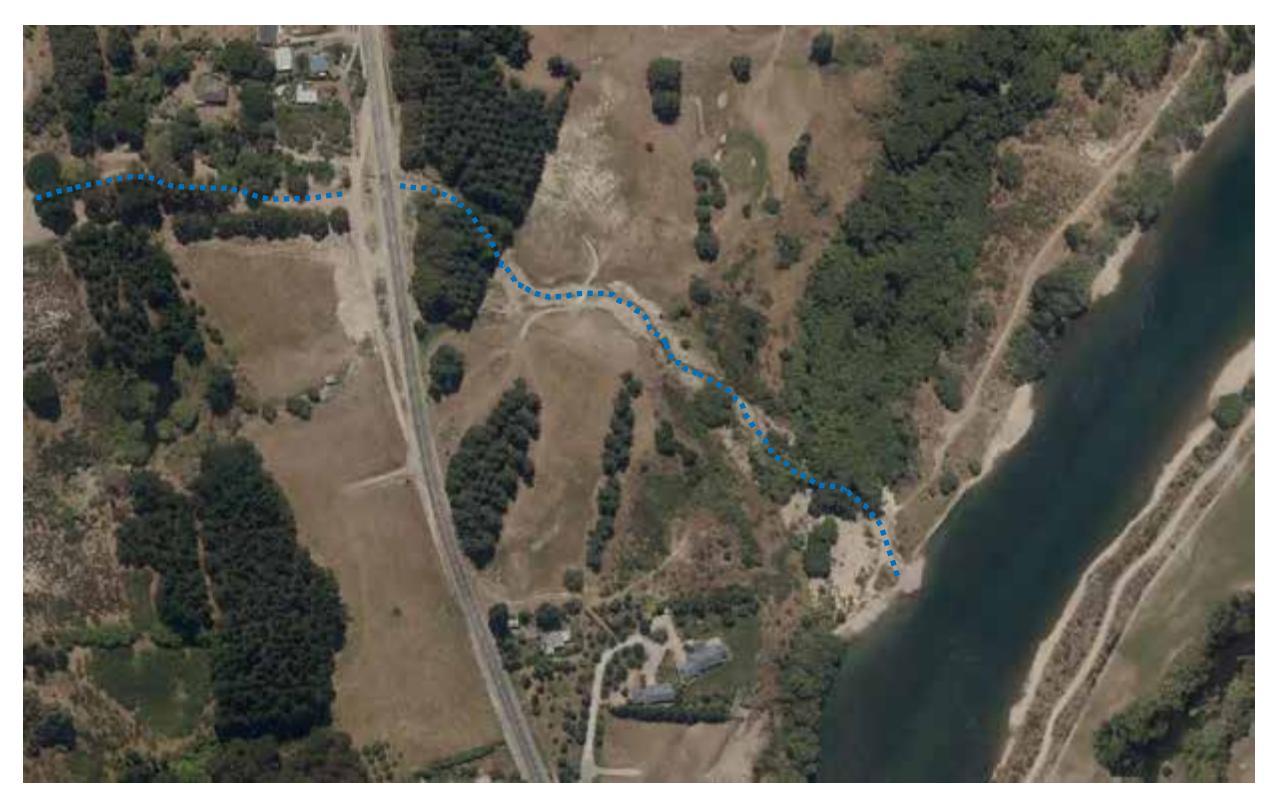
Figure 28: Aerial image (Jan 2018) showing the lower section of Golfcourse Creek (highlighted) from the debris fan to the confluence with the Clutha River (aerial image is courtesy of ORC). Recent erosion and deposition of debris along the channel is visible.

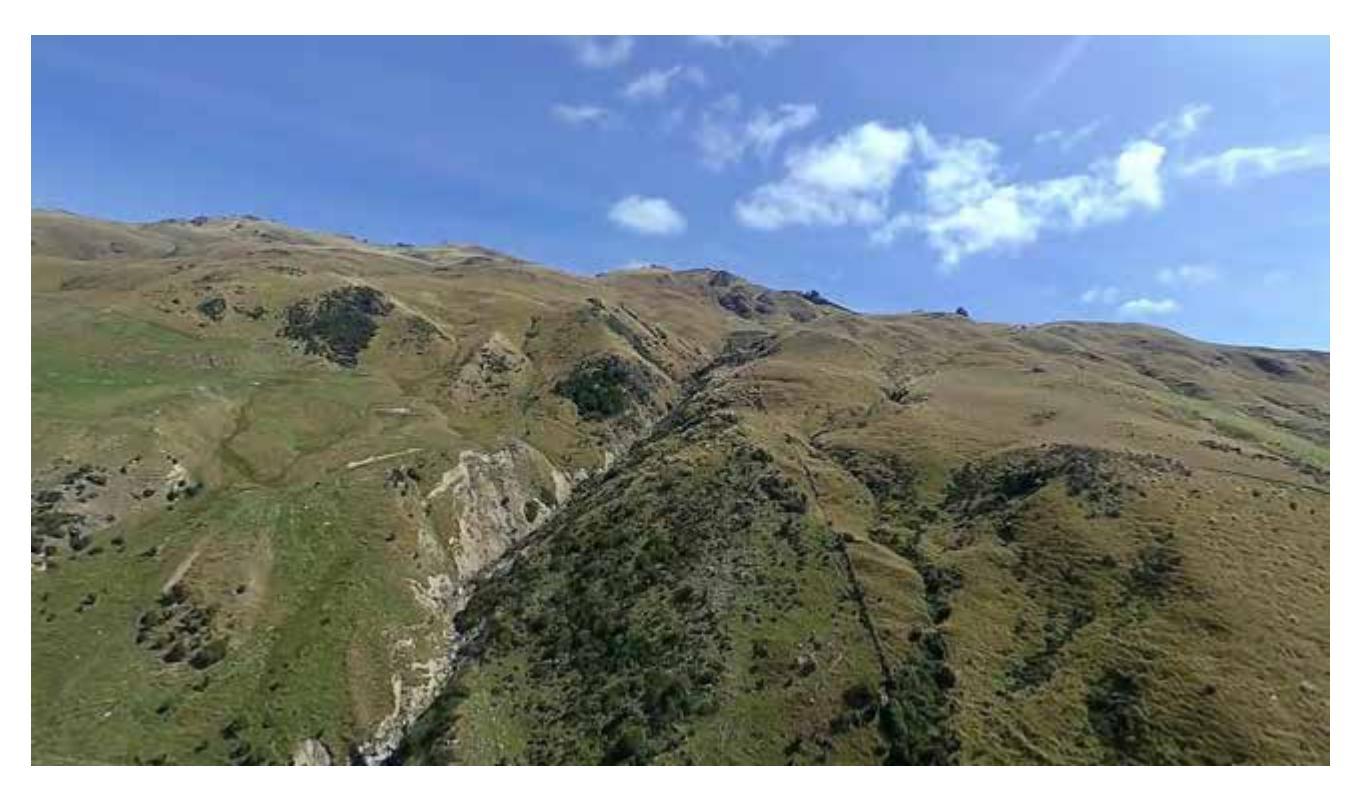
Figure 3: View from about 530 m asl, looking upstream. Undercutting and erosion is present along the true right banks of the channel. Channel slopes partially covered by shrub and bush vegetation, predominantly along the true left slopes.

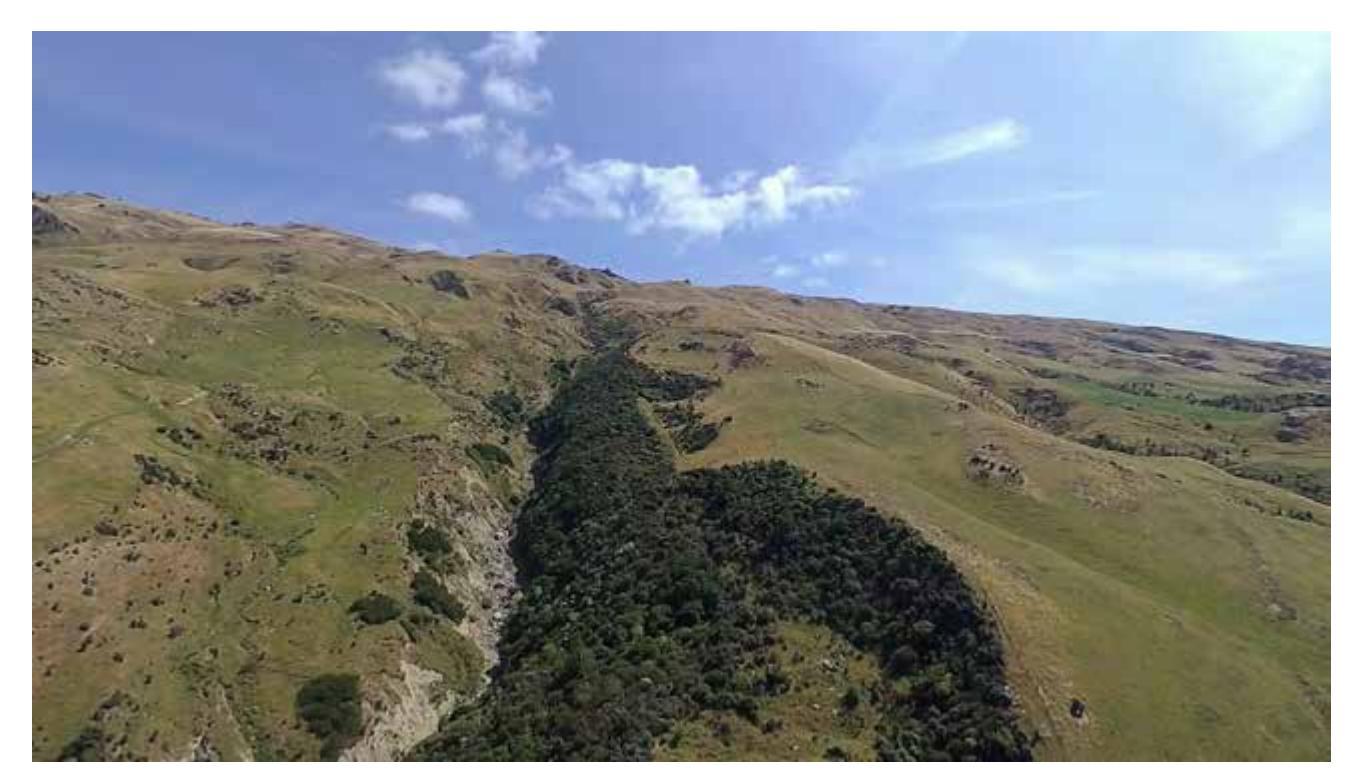
Figure 4: View of the catchment area above 350 m asl, looking upstream. Recent erosion is limited to the true right banks as the true left slopes are covered by vegetation.

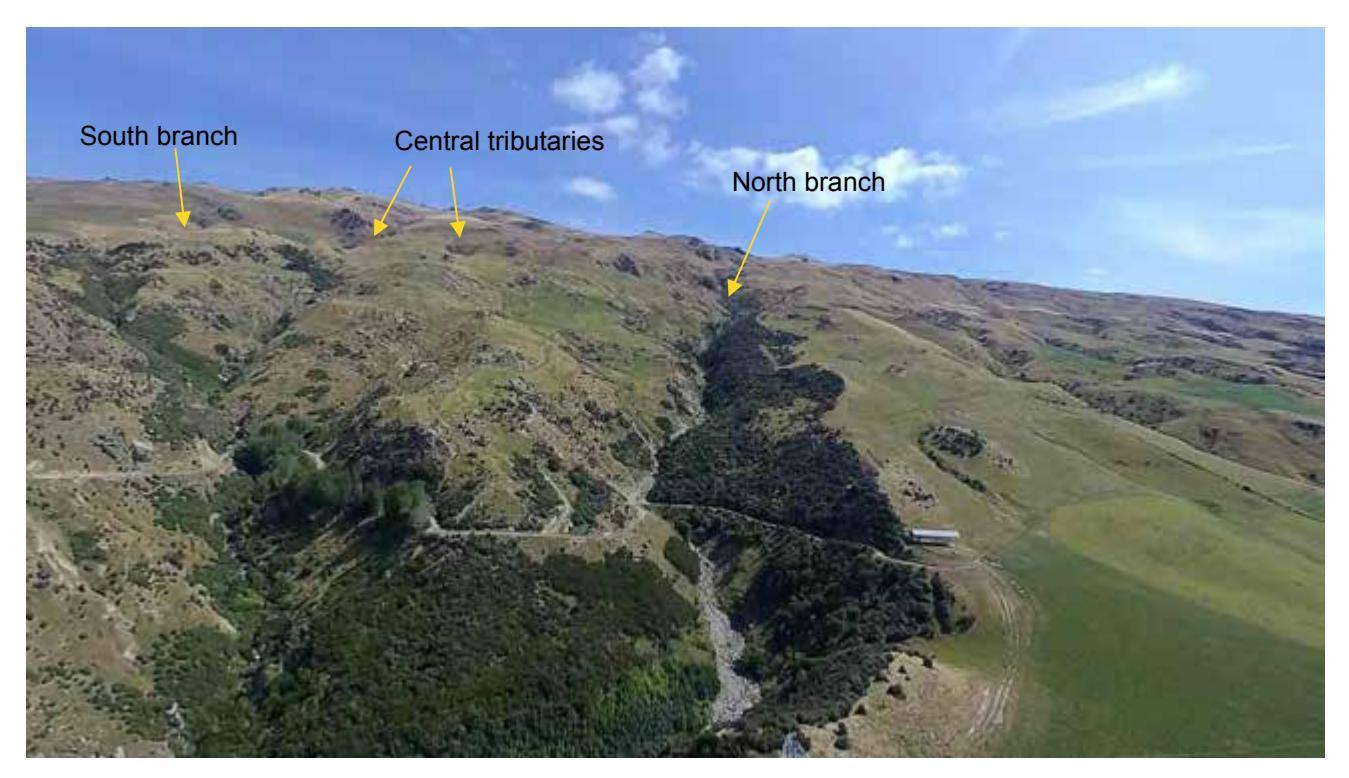
Figure 5: Overview of the area above about 200 m asl, looking upstream into the catchment areas of the north branch as well as the south branch and central tributaries. The main north branch shows areas were the channel widens and deposition of debris is present.

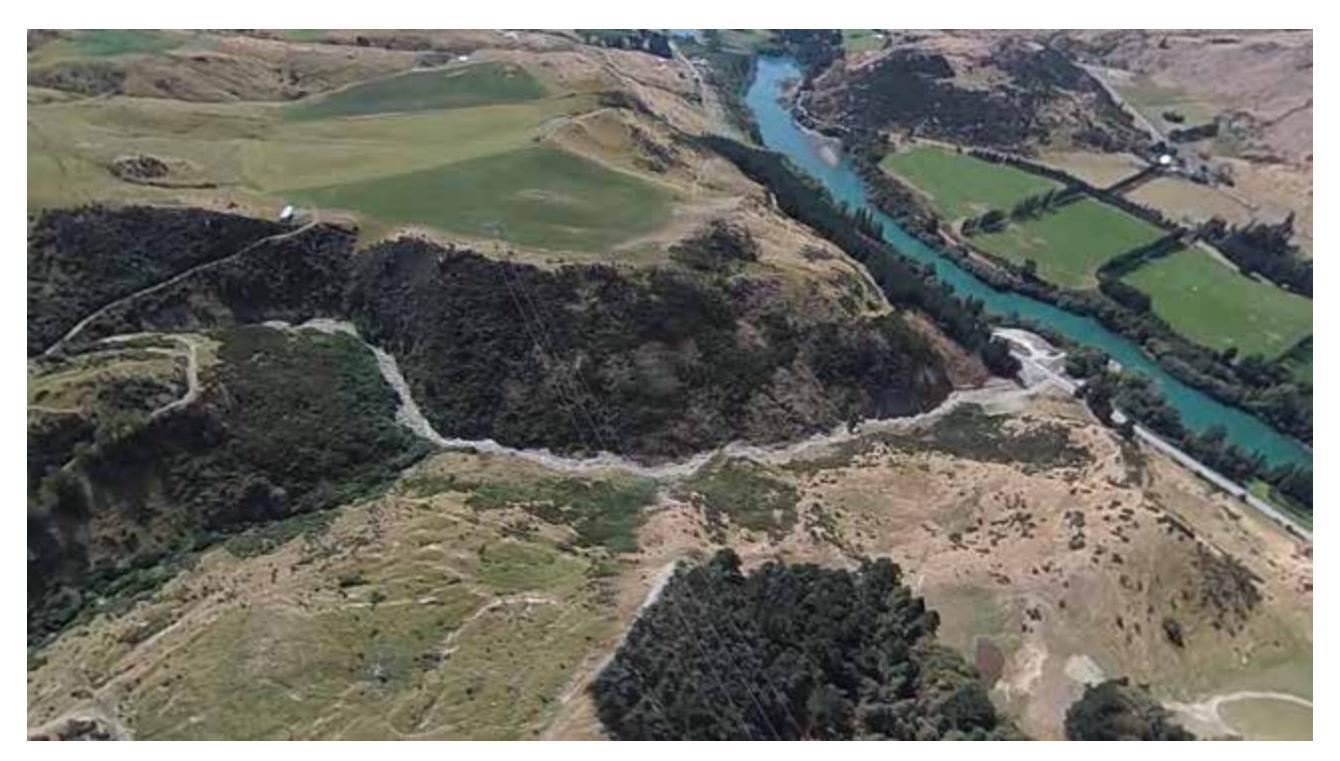
Figure 6: Overview of the lower reaches of the creek between about 230 m asl and the confluence with the Clutha River. Deposition of debris and erosion along the banks is visible along the main channel.
