# REPORT Management and Reduction of Debris Flow Risk in Roxburgh, Otago

Geomorphological Assessment Report

18113634\_7407-003-R-Rev0

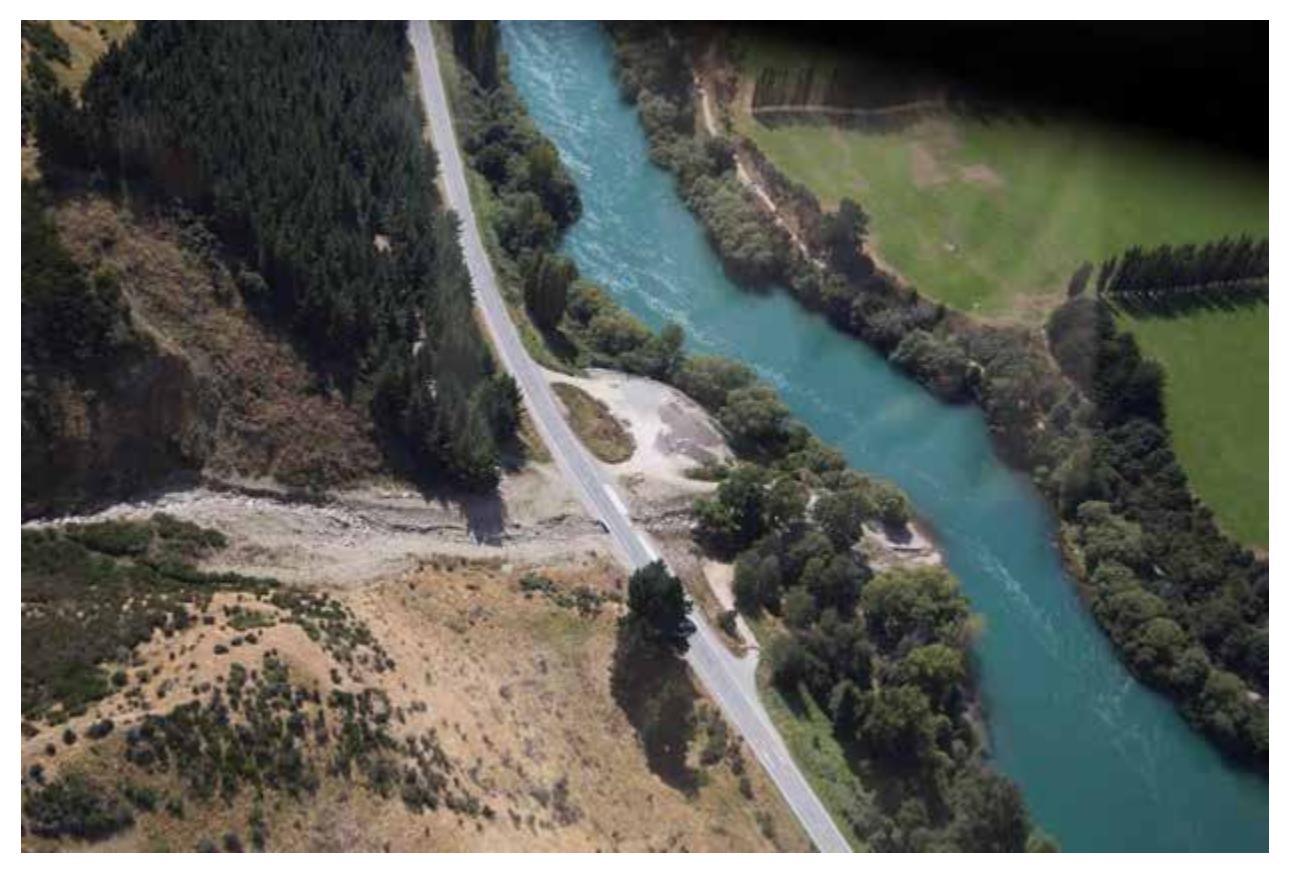
Figure 7: Aerial view of the debris fan area at the SH8 crossing and confluence with the Clutha River. Recent channel bed erosion and deposition along the channel is visible upstream and downstream of SH8.

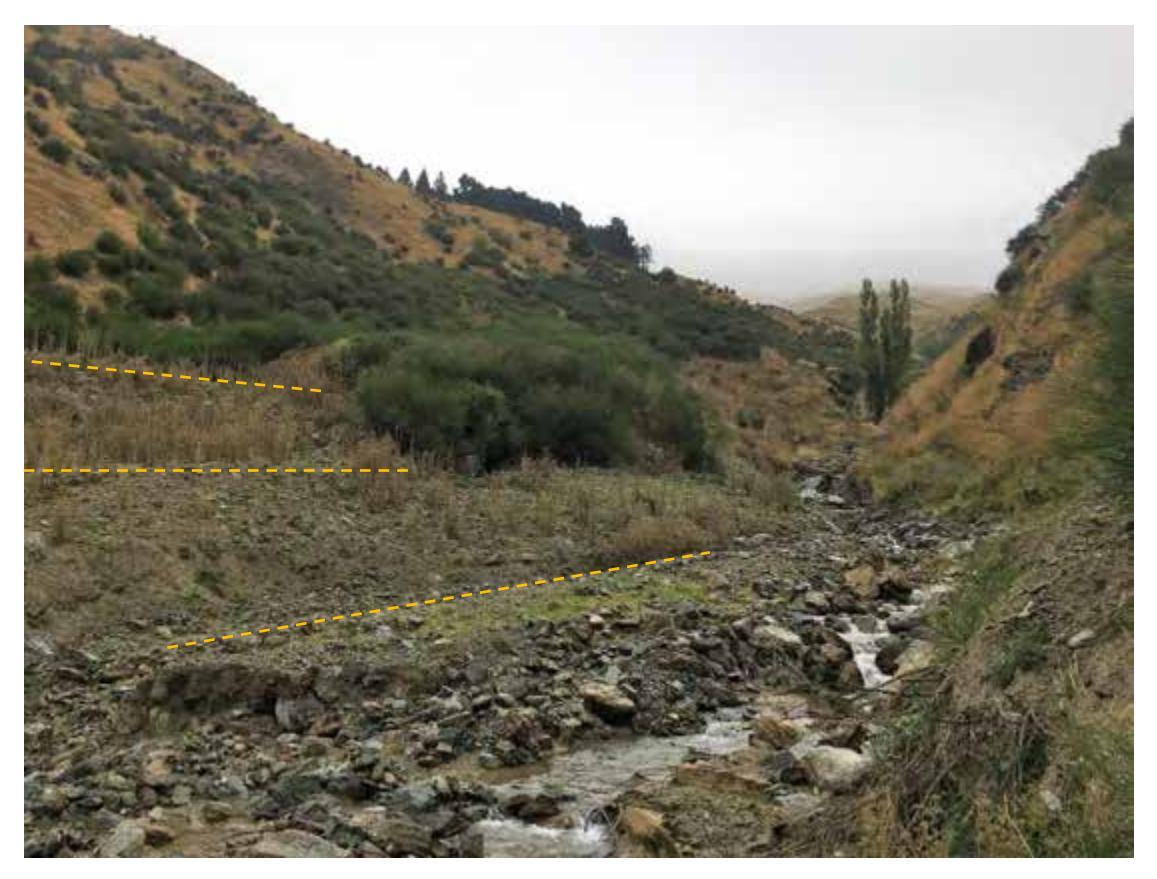
Figure 8: View of the fan apex area, looking upstream, at about 95 m asl. Terraced, partially reworked older debris deposits are visible in the background (marked lines) above current creek bed level along the fan.

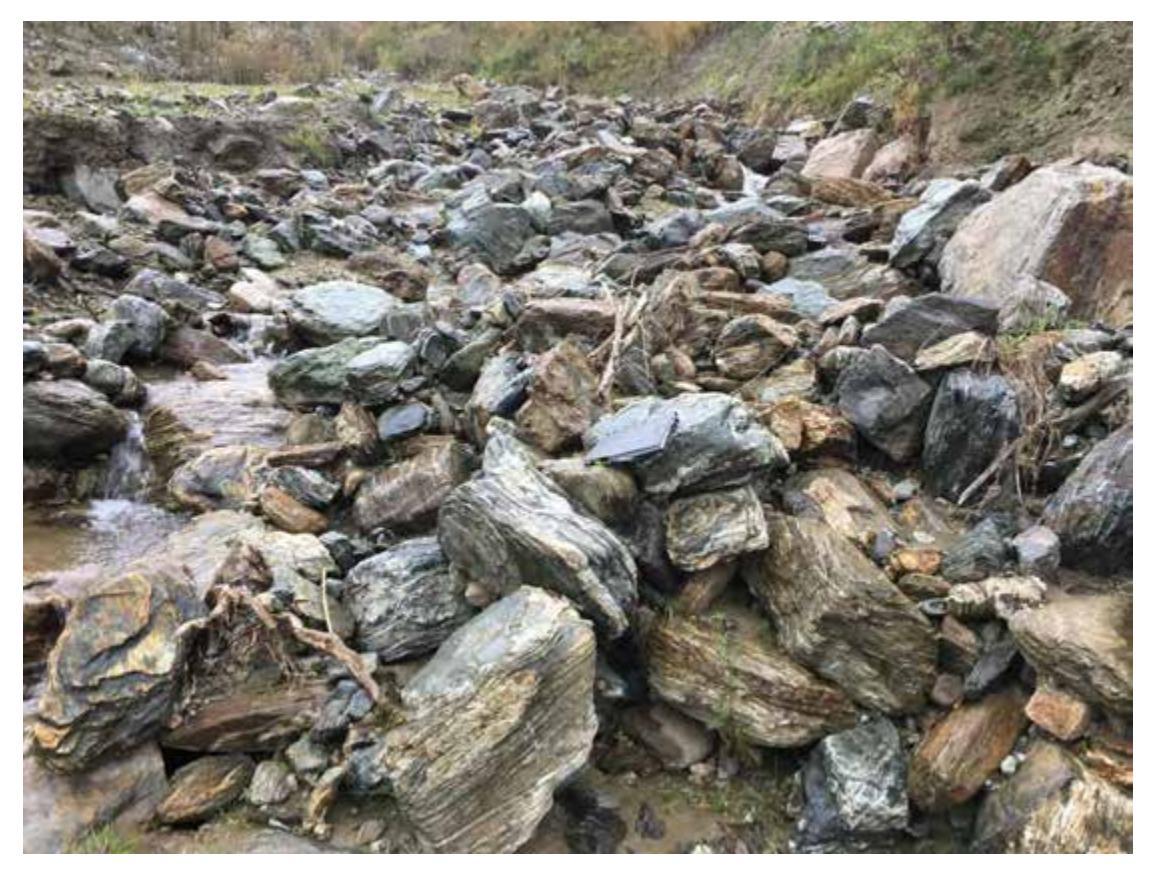
Figure 9: Bouldery bedload at fan apex area at about 100 m asl. Some boulder are up to 1.5 m in diameter.

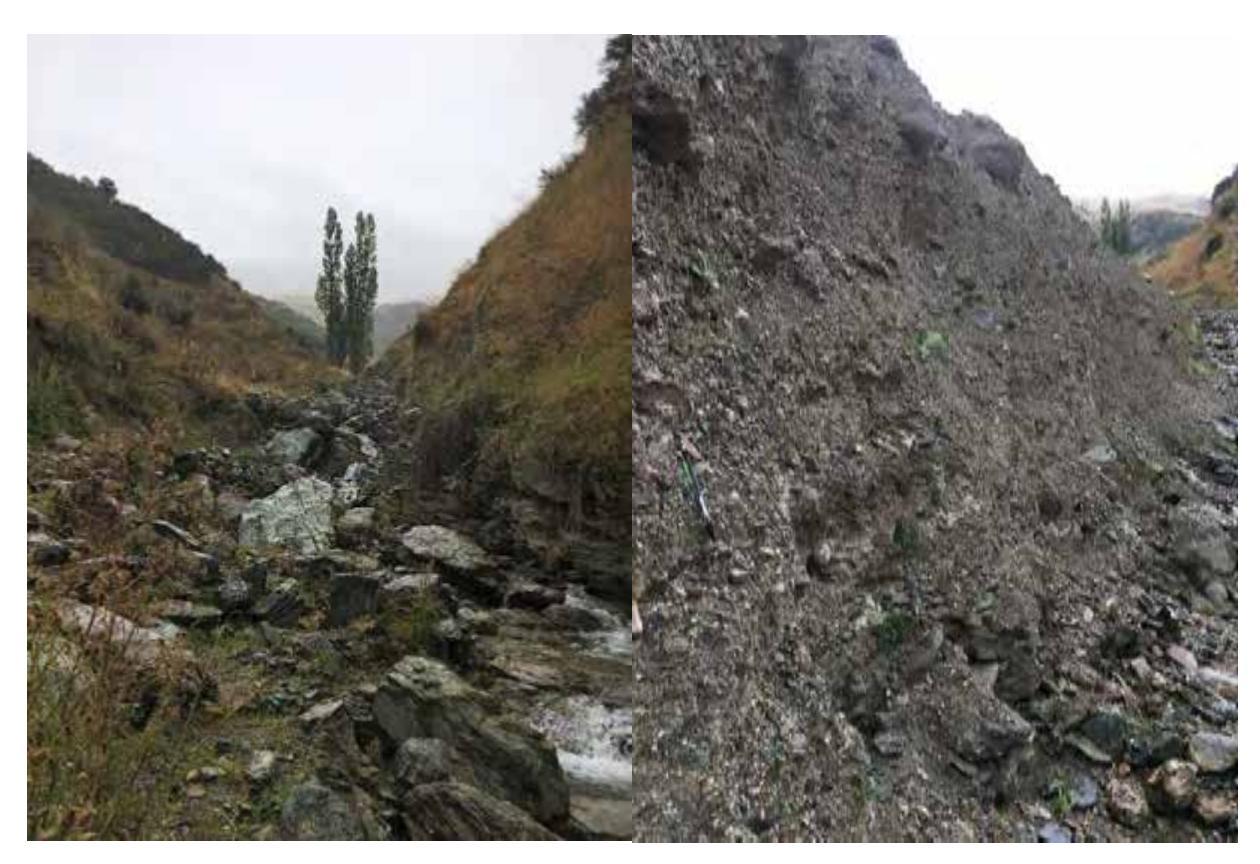
Figure 10: left: Bedload with boulders (up to 1.5 m in diameter) and insitu schist along the true left bank at about 100 m asl; right: profile through debris fan deposits along true right bank at about 95 m asl.

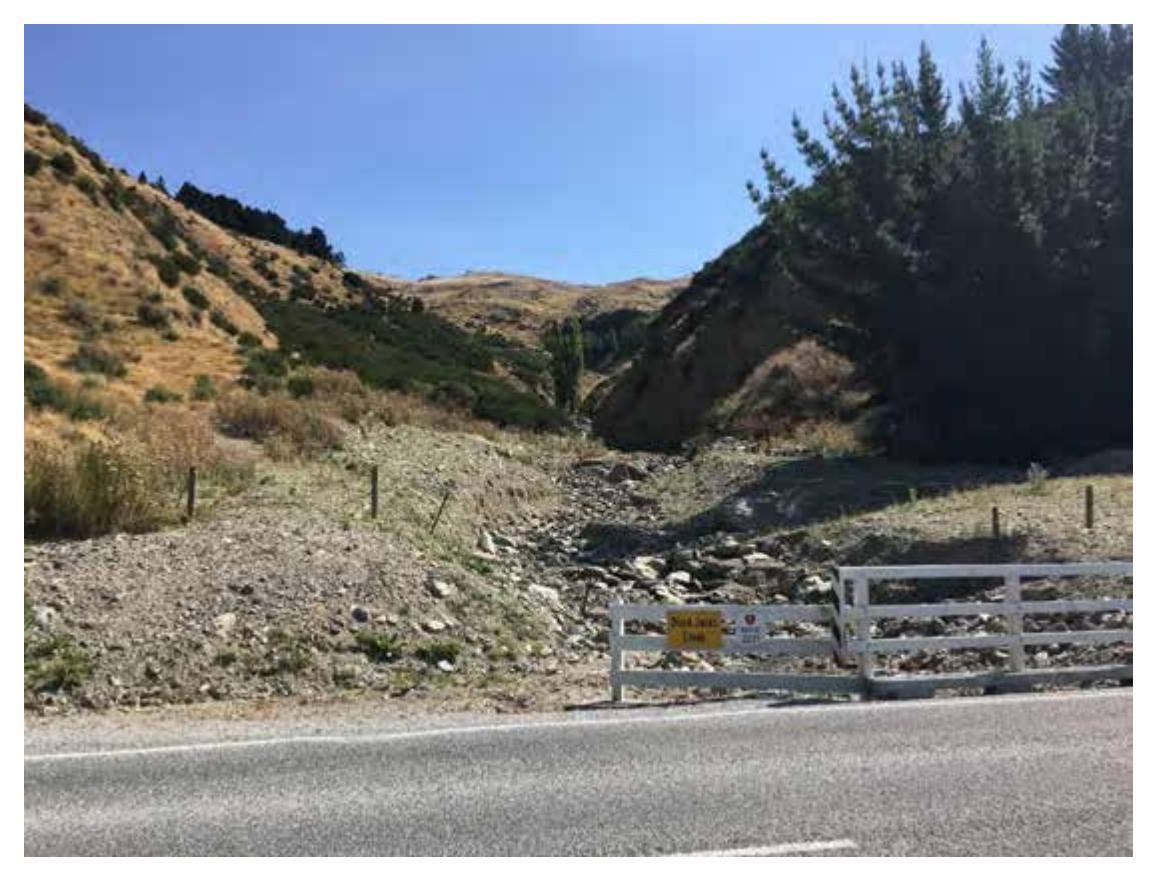
Figure 12: View from SH8 upstream to towards the fan apex and above. SH8 is located about 90 m from the fan apex. Multiple depositional surfaces are exposed along the true right banks of the current channel on the fan.

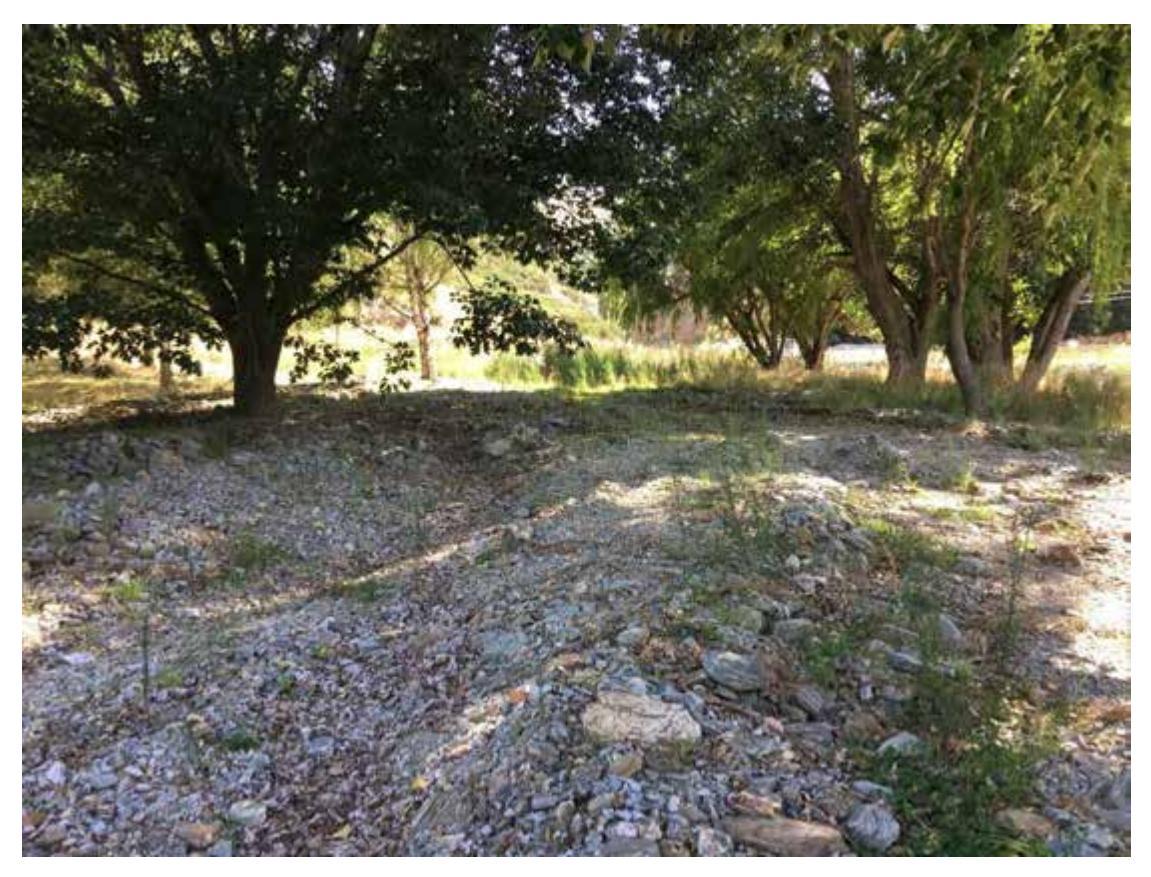
Figure 16: Inundation with debris at former rest area to the south below SH8 crossing. The area has been buried by debris as a result of avulsion of the creek after culvert blockage during the November 2017 event.

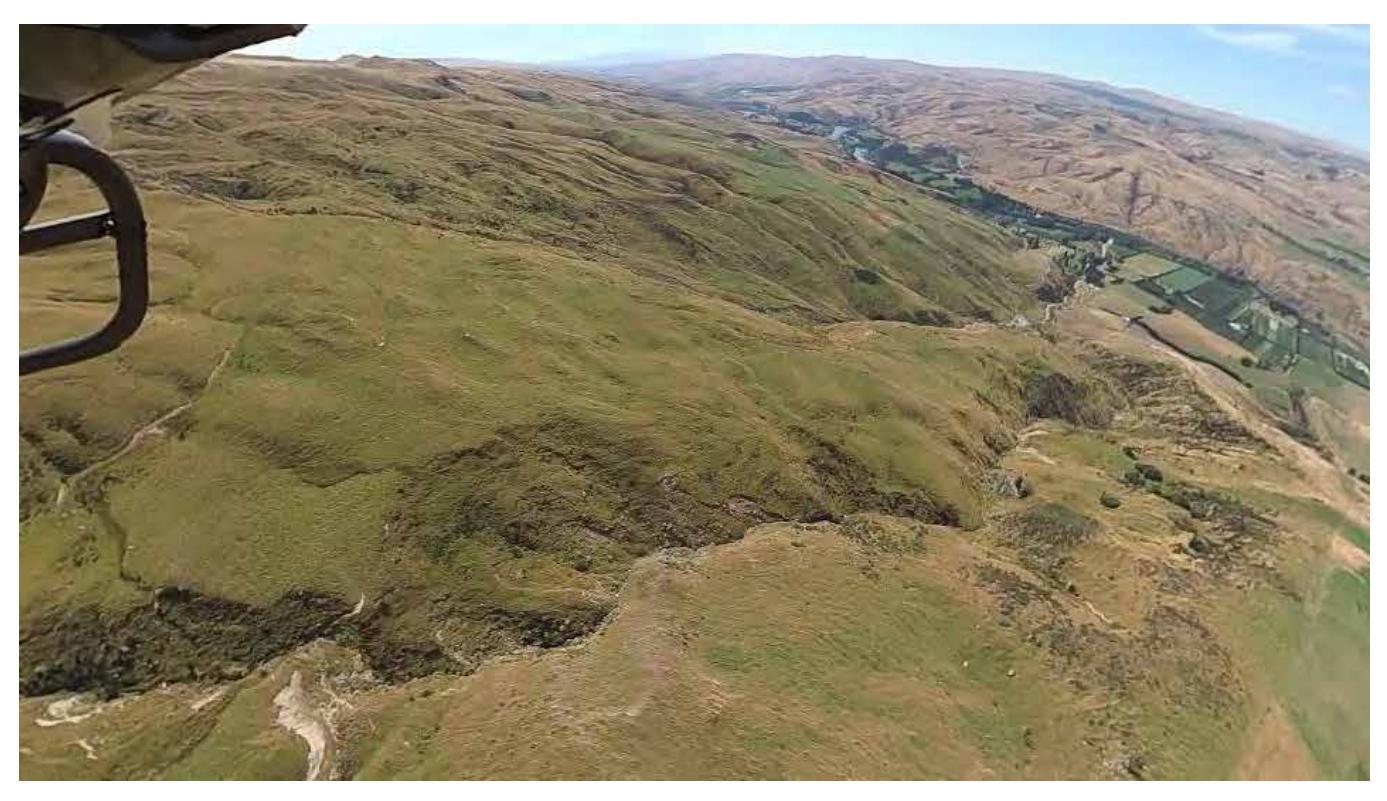
Figure 3: View downstream into the South branch from about 760 m asl; starting evidence of erosion and soil movement along the banks of the channel.
