Memorandum

To: Michelle Mifflin, Manager Engineering, **Otago Regional Council**
CC: Daniel King, Operations and Maintenance Lead, **Otago Regional Council**
From: Melanie Vermeulen, Greg Ryder, **Ryder Environmental Limited**
Date: 10 March 2021
Subject: **Otago Regional Council – Kaikorai Lagoon Investigation**

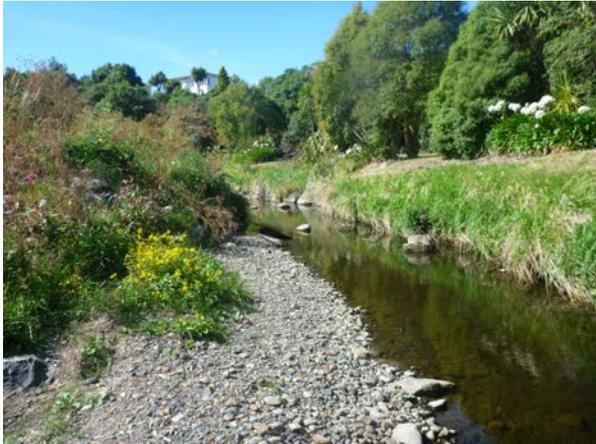
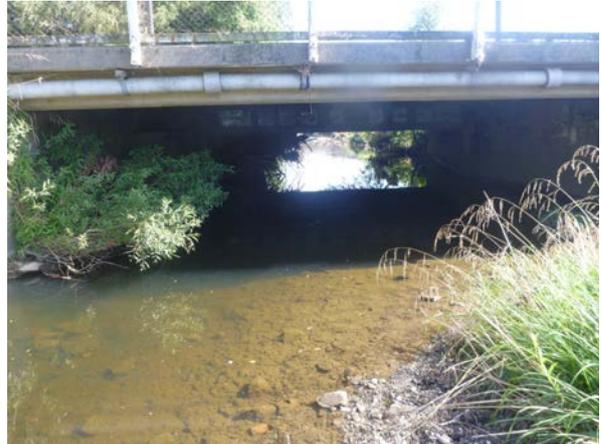
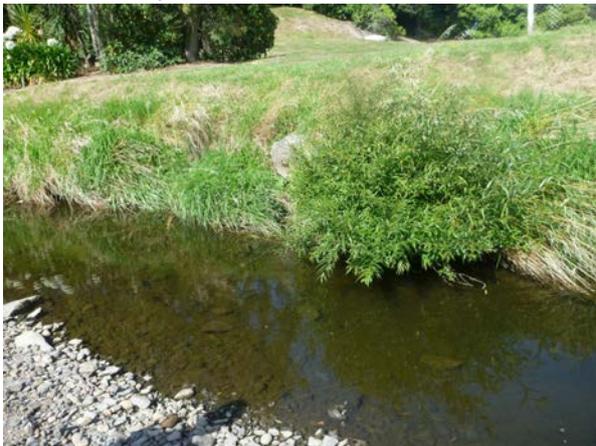
At the Brighton Road Bridge, the Kaikorai Stream is approximately 2 m wide, has a maximum depth of around 0.6 m and has a predominantly cobble substrate with no shading. The streambed was covered in thick mats of brown periphyton (~90% cover). The riparian zone comprised native and exotic shrubbery, exotic grasses, boulder riprap and cobbles/gravel. Some rubbish was seen on the banks and within the channel. The water was clear and did not have an odour. A bully was observed swimming in the area.

Plate 1: Upstream at Site 1 Kaikorai Stream

Plate 2: Downstream at Site 1 Kaikorai Stream

Plate 3: Midstream at Site 1 Kaikorai Stream

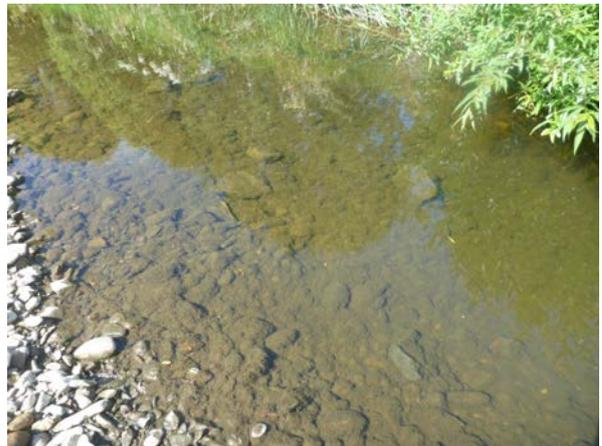
Plate 4: Instream at Site 1 Kaikorai Stream

The Australia and New Zealand Guidelines for Marine and Freshwater Quality (ANZG 2018) do not provide default guideline values (DGVs) for estuarine environments and so their use for this survey is very limited. For site 1 located on Kaikorai Stream, the River Environment Classification is Cool Dry Low-elevation and DGVs are provided by ANZG 2018 for conductivity and dissolved oxygen saturation. The conductivity at site 1 exceeds the 80th percentile DGV of 116 $\mu\text{S}/\text{cm}$ and is indicative of nutrient enrichment, not unexpected for a catchment dominated by urban and rural land uses. The dissolved oxygen saturation exceeds the 80th percentile DGV of 101% and is likely the result of high periphyton biomass, as observed (Plate 4).

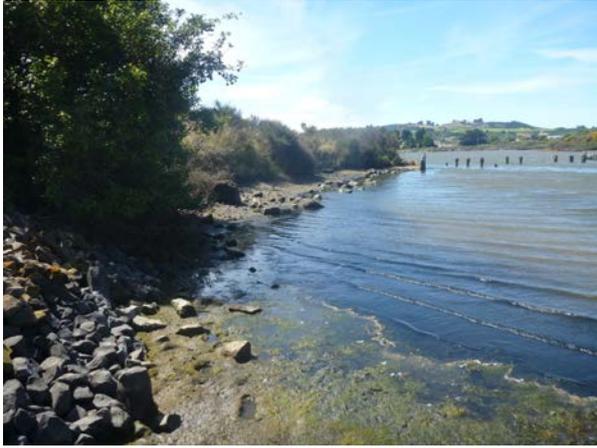
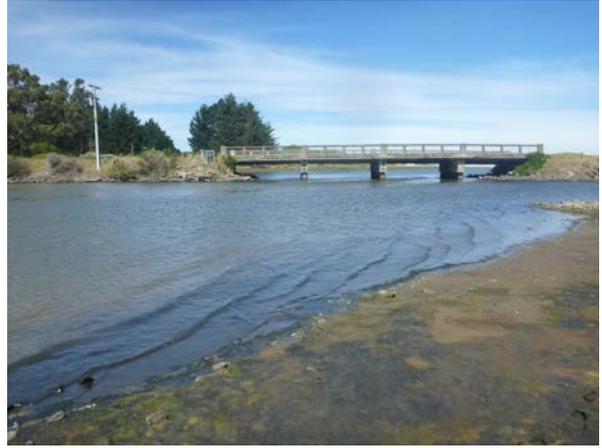
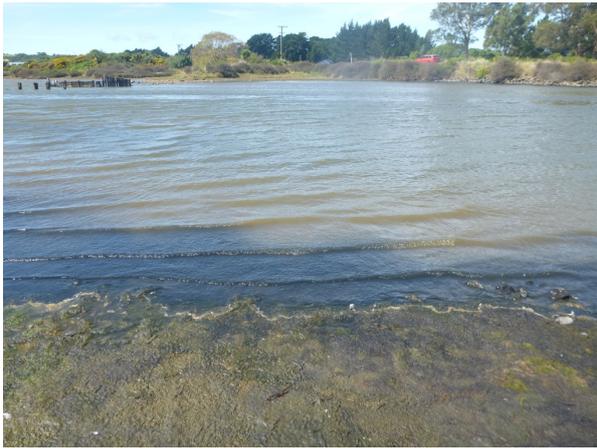
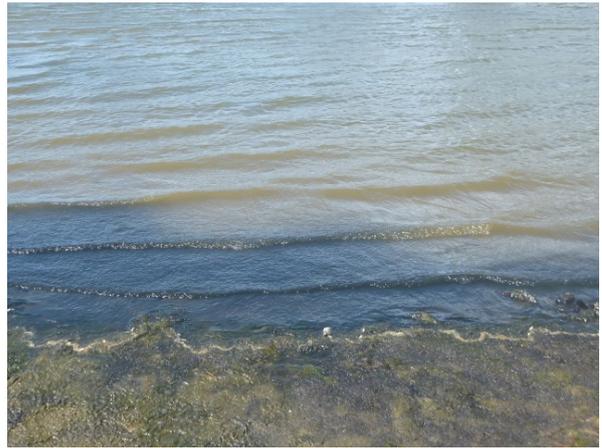
This site is located about 60 m upstream and west of the Brighton Road Bridge and about 30 m upstream of two large stormwater culverts and 40 m downstream of old piles on the true right side. The estuary is approximately 80 m wide to the opposite bank and the water was light brown with low clarity. The substrate was predominantly mud with a black anoxic edge that was approximately 1 m wide with a lot of suction when walked over. There was dead green algae and wind driven scum on the wetted edge and a slight marine odour. The riparian zone comprised a boulder and cobble wall with sparse vegetation.

Plate 5: Upstream at Site 2 Kaikorai Lagoon

Plate 6: Downstream at Site 2 Kaikorai Lagoon

Plate 7: Midstream at Site 2 Kaikorai Lagoon

Plate 8: Instream at Site 2 Kaikorai Lagoon

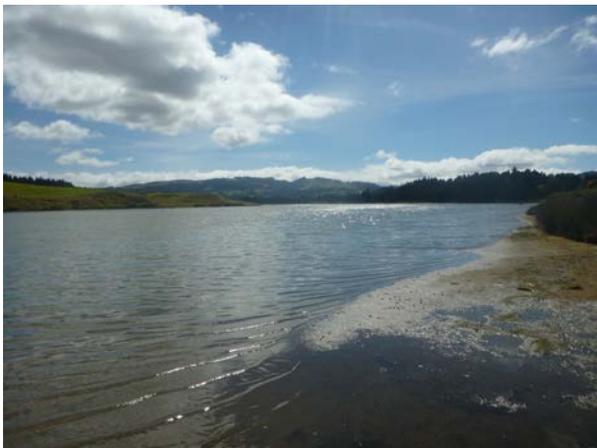
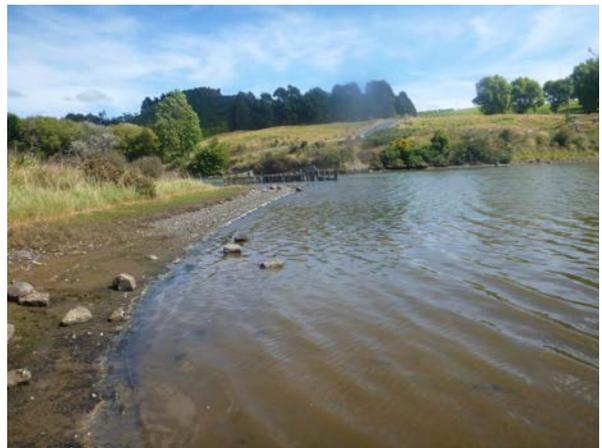
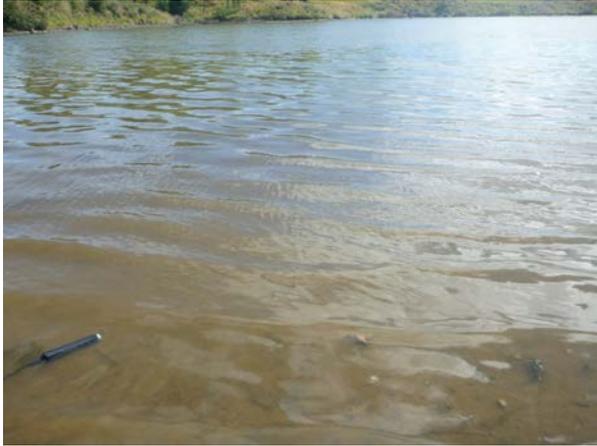
This site is located about 30 m upstream and east of the Brighton Road Bridge on the true left side. The estuary is approximately 90 m wide to the opposite bank and the water was light brown with low clarity. The substrate was predominantly mud with a black anoxic edge that was approximately 0.3 m wide with a lot of suction when walked over. There was dead green algae and wind driven scum on the wetted edge. The riparian zone comprised reeds, salt meadows and shrubbery.

Plate 9: Upstream at Site 3 Kaikorai Lagoon

Plate 10: Downstream at Site 3 Kaikorai Lagoon

Plate 11: Midstream at Site 3 Kaikorai Lagoon

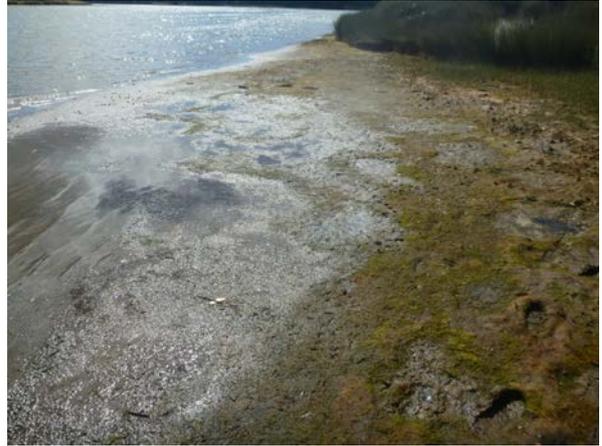
Plate 12: Anoxic mudflats at Site 3 Kaikorai Lagoon

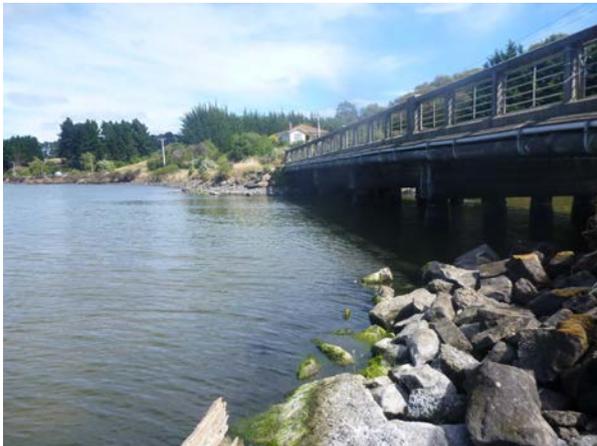
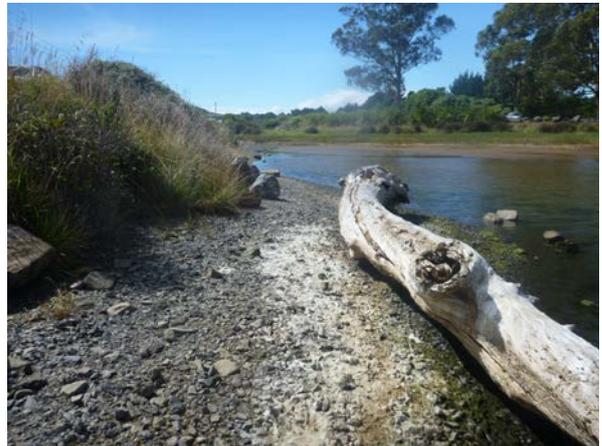
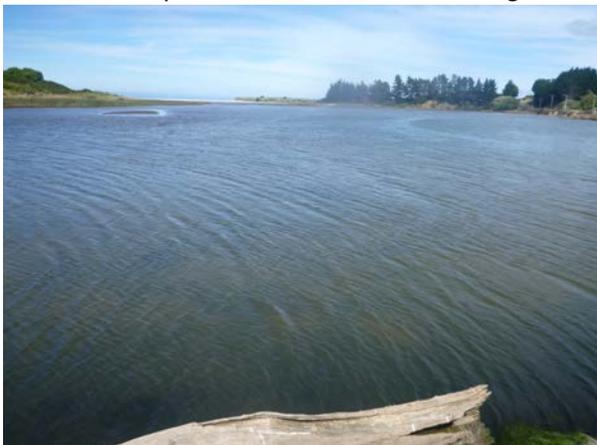
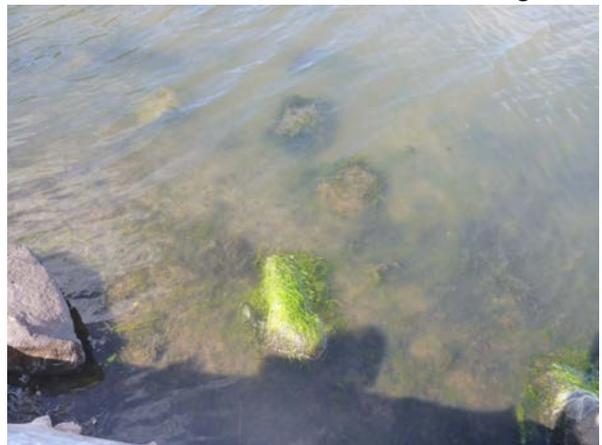
This site is located about 30 m downstream and east of the Brighton Road Bridge on the true left side. The estuary is approximately 130 m wide to the opposite bank and the water was light brown with low clarity. The substrate was a mixture of sand and mud and there was dead green algae on the wetted edge. The riparian zone comprised mainly grasses and shrubbery.

Plate 13: Upstream at Site 4 Kaikorai Lagoon

Plate 14: Downstream at Site 4 Kaikorai Lagoon

Plate 15: Midstream at Site 4 Kaikorai Lagoon

Plate 16: Instream at Site 4 Kaikorai Lagoon

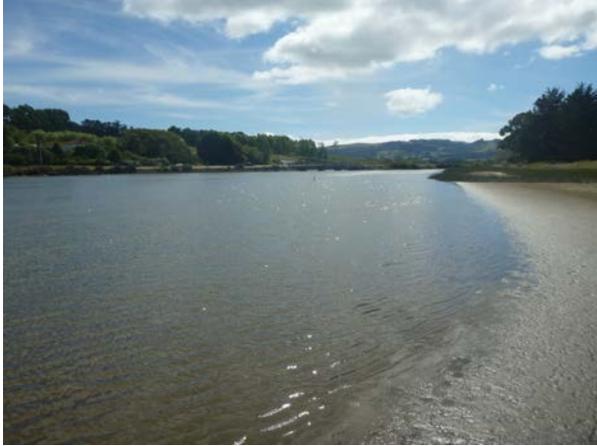
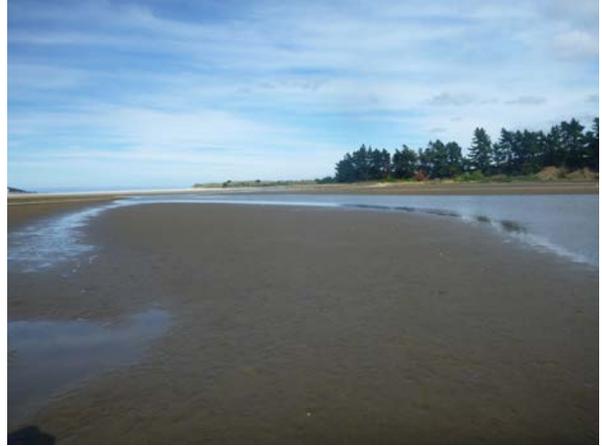
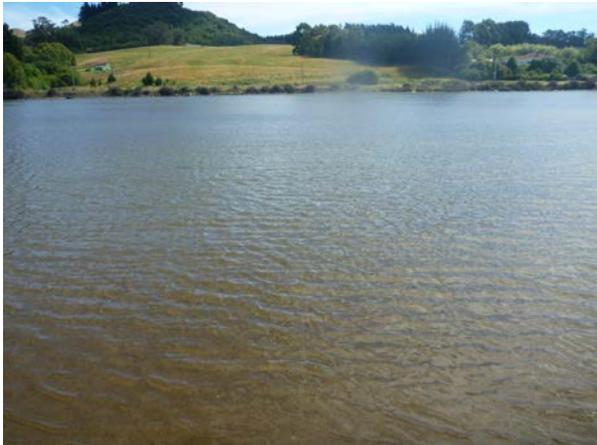
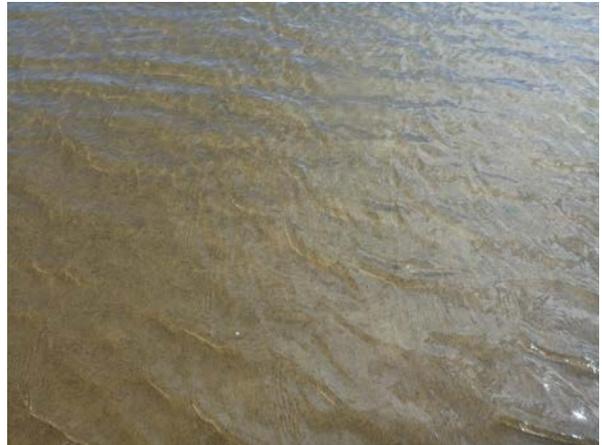
This site is located about 250 m downstream and east of the Brighton Road Bridge on the true left side. The estuary is approximately 220 m wide to the opposite bank and the water was clear with high clarity. As the tide was low-ish, extensive sand flats were exposed and the wetted channel was narrow. The substrate was predominantly sand and with no vegetation in the vicinity.

Plate 17: Upstream at Site 5 Kaikorai Lagoon

Plate 18: Downstream at Site 5 Kaikorai Lagoon

Plate 19: Midstream at Site 5 Kaikorai Lagoon

Plate 20: Instream at Site 5 Kaikorai Lagoon

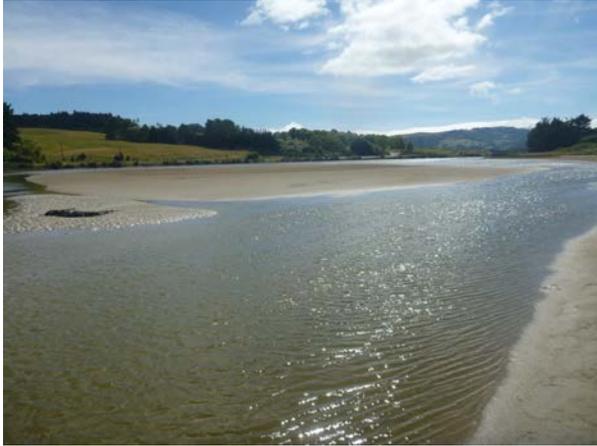
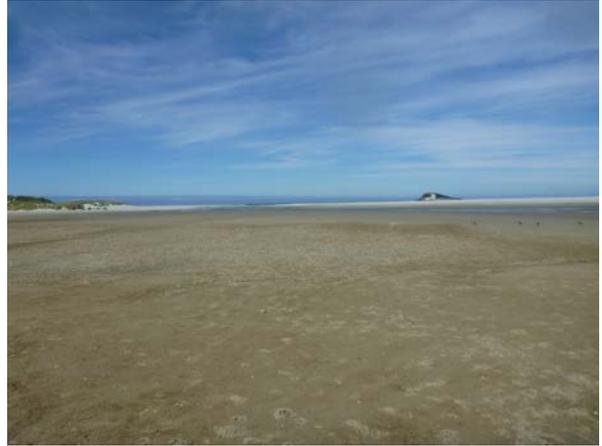
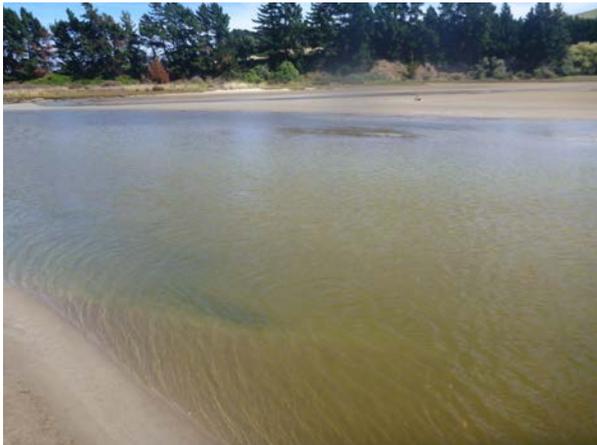
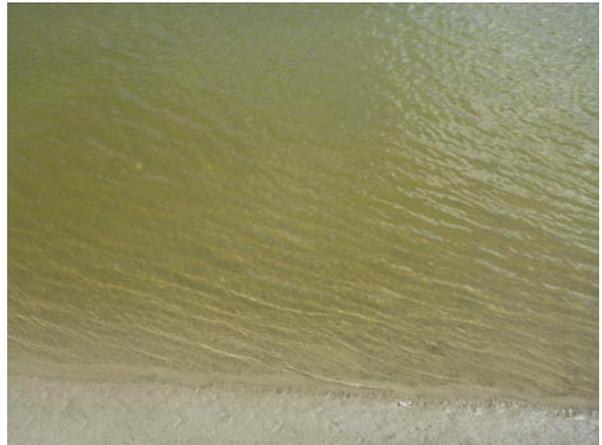
This site is located about 430 m downstream and east of the Brighton Road Bridge on the true left side. The estuary is approximately 300 m wide to the opposite bank and the water was clear with medium clarity. As the tide was relatively low, extensive sand flats were exposed and the wetted channel was narrow. The substrate was predominantly sand and with no vegetation in the vicinity. A small flock of pied oystercatcher were spotted on the sandflats.

Plate 21: Upstream at Site 6 Kaikorai Lagoon

Plate 22: Downstream at Site 6 Kaikorai Lagoon

Plate 23: Midstream at Site 6 Kaikorai Lagoon

Plate 24: Instream at Site 6 Kaikorai Lagoon

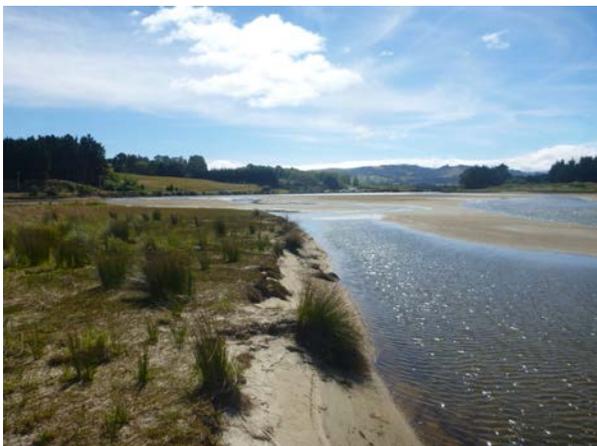
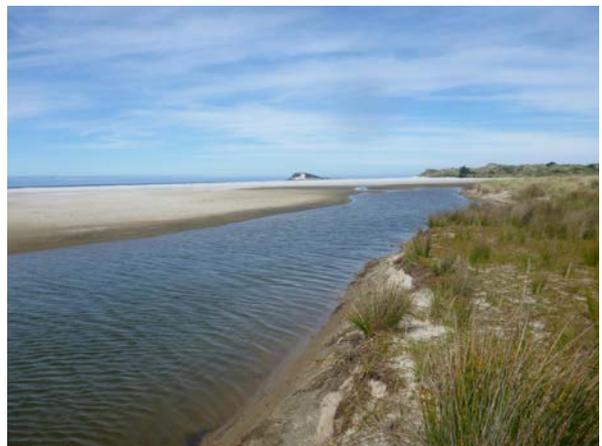
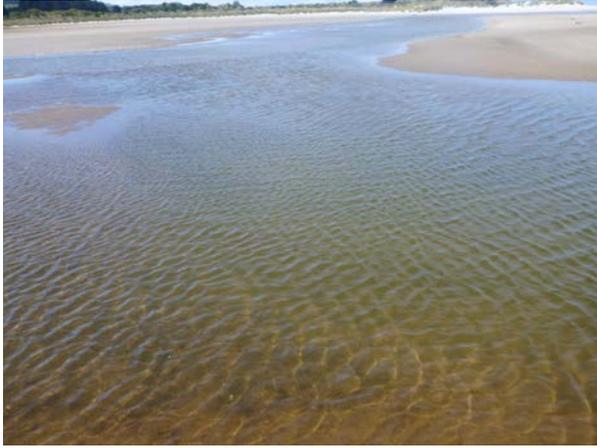
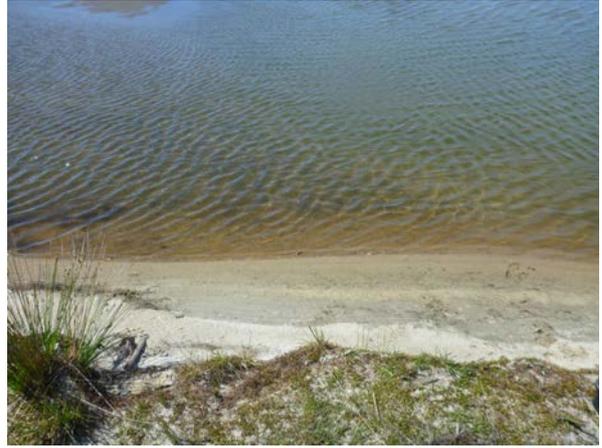
This site is located about 500 m downstream and west of the Brighton Road Bridge on the true right side. The estuary is approximately 280 m wide to the opposite bank and the water was clear with medium clarity. The substrate was predominantly sand and the riparian zone comprised salt meadows and rushes.

Plate 25: Upstream at Site 7 Kaikorai Lagoon

Plate 26: Downstream at Site 7 Kaikorai Lagoon

Plate 27: Midstream at Site 7 Kaikorai Lagoon

Plate 28: Instream at Site 7 Kaikorai Lagoon

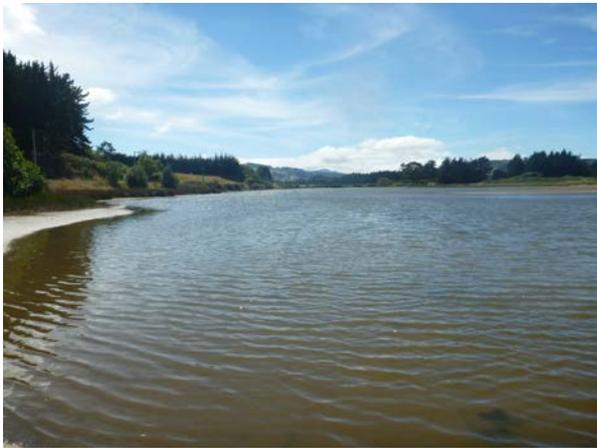
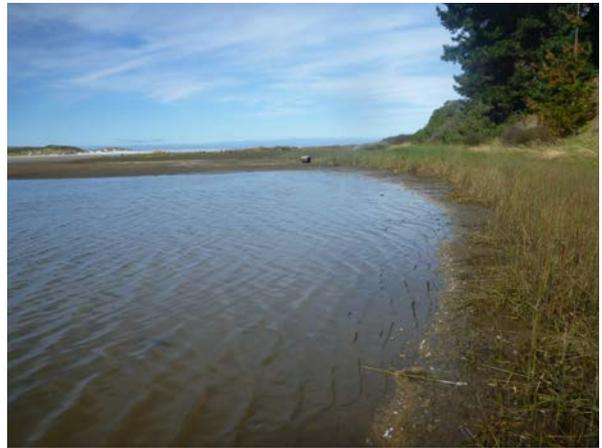
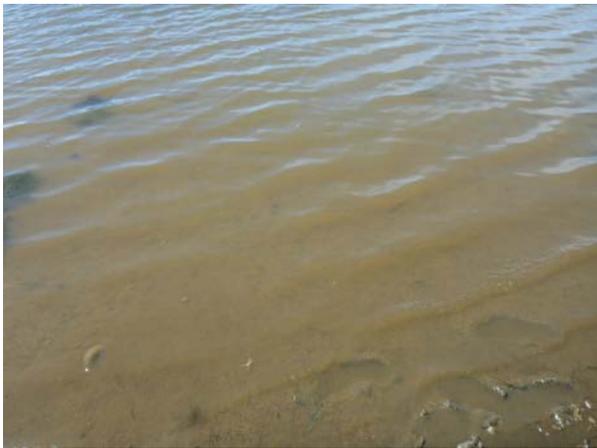
This site is located about 430 m downstream and west of the Brighton Road Bridge on the true right side. The estuary is approximately 315 m wide to the opposite bank and the water was light brown with low clarity. The substrate was predominantly mud with a black anoxic subsurface layer that was exposed when walked on. The riparian zone comprised salt reeds and shrubbery.

Plate 29: Upstream at Site 8 Kaikorai Lagoon

Plate 30: Downstream at Site 8 Kaikorai Lagoon

Plate 31: Instream at Site 8 Kaikorai Lagoon

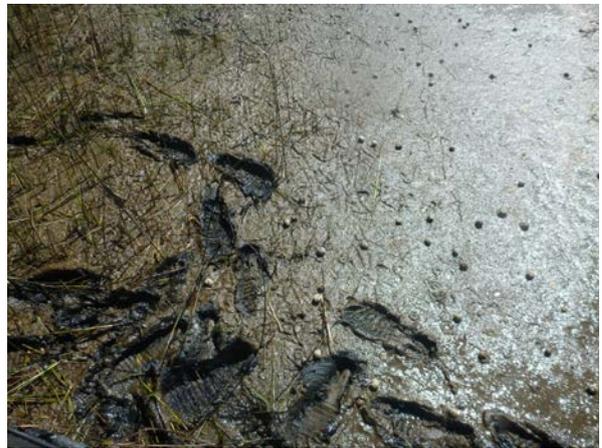
Plate 32: Anoxic mudflats at Site 8 Kaikorai Lagoon

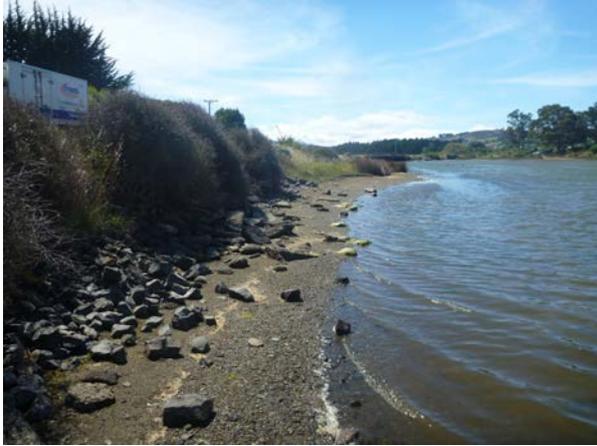
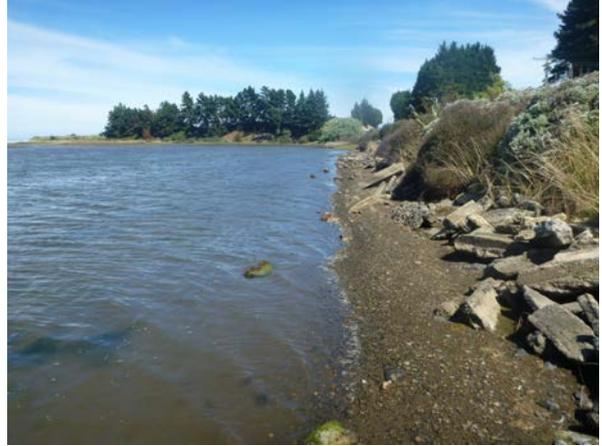
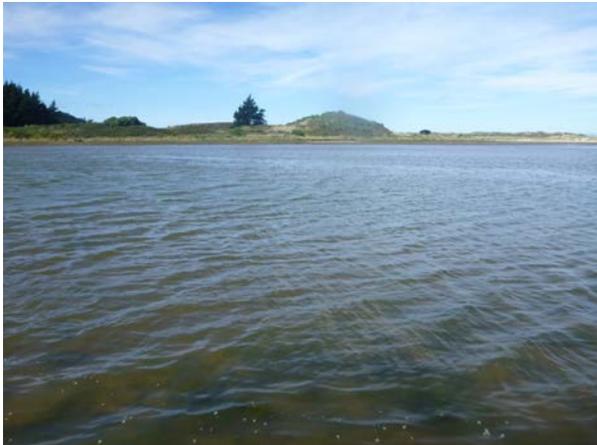
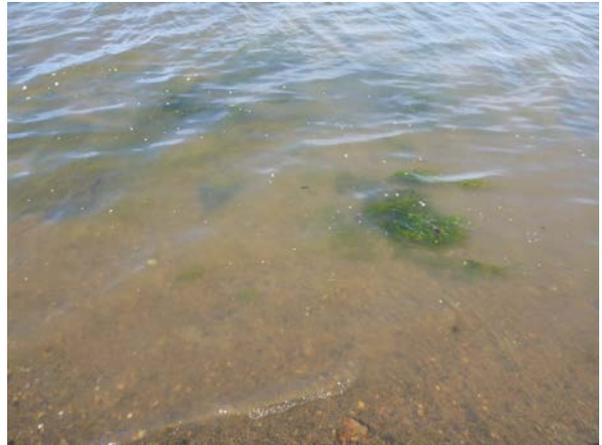
This site is located about 180 m downstream and west of the Brighton Road Bridge on the true right side. The estuary is approximately 170 m wide to the opposite bank and the water was light brown with low clarity. The substrate was predominantly coarse sand with occasional green seaweed. The riparian zone comprised a narrow stony beach, rock and concrete block wall and shrubbery.

Plate 33: Upstream at Site 9 Kaikorai Lagoon

Plate 34: Downstream at Site 9 Kaikorai Lagoon

Plate 35: Midstream at Site 9 Kaikorai Lagoon

Plate 36: Instream at Site 9 Kaikorai Lagoon

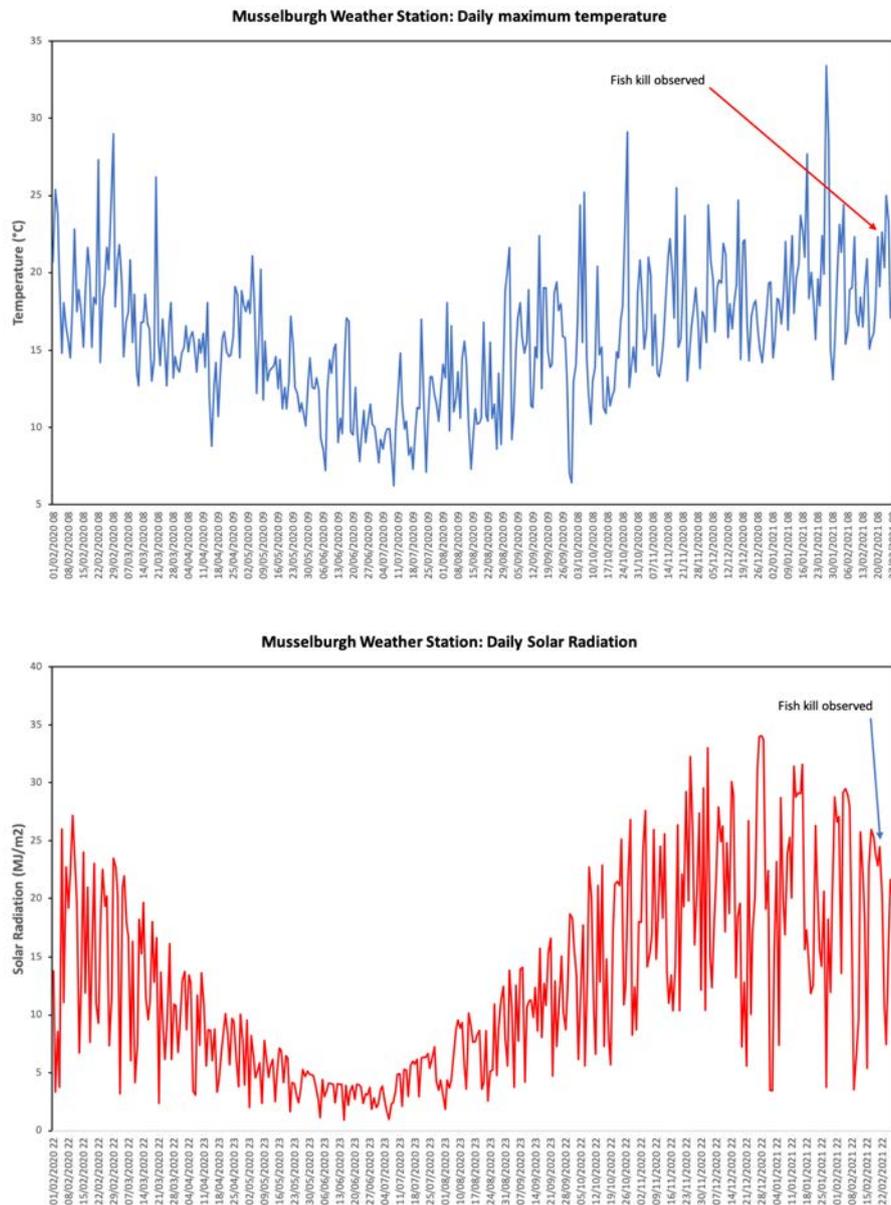
The Kaikorai Lagoon fish kill observed on February 20 2021 included smelt, flounder, giant bullies, trout and inanga. Fish & Game Otago staff visited the site at 4 pm and reported that the “water was very warm to the touch and any remaining fish appeared stressed” (Otago Daily Times, 22 February 2021). However, meteorological data downloaded from the Musselburgh weather station (located approximately 9.5km east of Kaikorai Lagoon) indicates that ambient air temperature and daily global radiation were not particularly high (for summer) on that day or in the days leading up to February

20 2021 (Figure 2). This data suggests that climate conditions were not extreme for this time of the year and so may not have exacerbated water quality conditions in the lagoon at the time.

Figure 2. Top: Daily maximum air temperature recorded at the Musselburgh weather station. Bottom: Daily solar radiation recorded at the Musselburgh weather station.

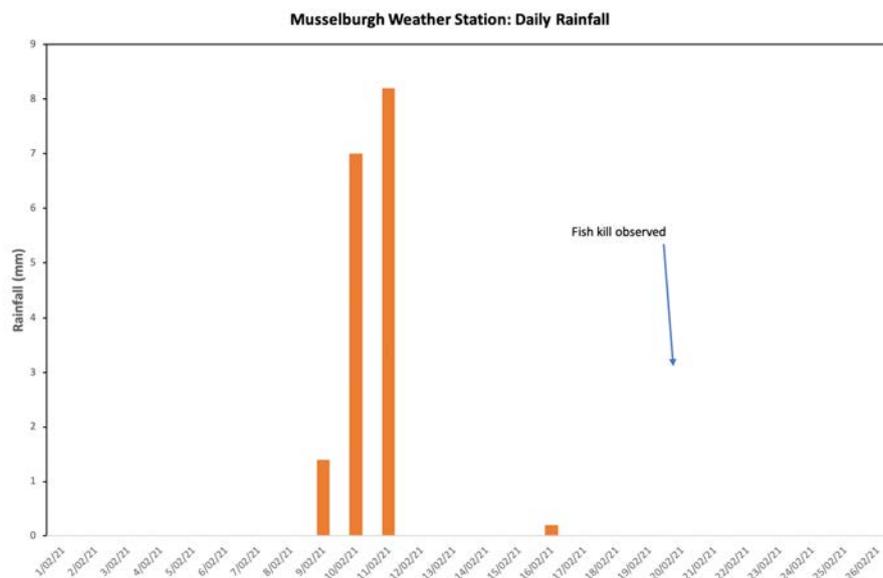
There are a number of potential sources of contaminants to the lagoon, including landfill leachate from the two landfills located in the upper reaches of the lagoon, the Green Island Wastewater Treatment Plant, and stormwater and overland flow from urban, industrial and rural areas. Our understanding is that the DCC Green Island landfill has a contained leachate collection system, and the Green Island Wastewater Treatment Plant is a contained system also, therefore contamination from these sources seems unlikely unless there was some failure associated with the containment system. To our knowledge, no accidental or deliberate discharges of contaminants to Kaikorai Stream or Abbotts Creek, or from the surrounding catchment of the lagoon, were reported at time, or prior to when, the fish kill was reported. If a significant discharge were to have occurred from any of these locations, it is likely that dead fish would have been observed in areas further upstream of the Brighton Road Bridge. It is also worth noting that there was no significant rain in the Dunedin area in the eight days leading up to when dead fish were reported (Figure 3).

Figure 3. Daily rainfall recorded at the Musselburgh weather station.
