This letter provides a further response to Minute 3 - Directions of the Commissioner.

I request the applicant to provide a further concise document (at their earliest convenience) containing only photographs (not videos) that clearly identifies the relevance of the photographs, the locations in the Royal Burn (or new Chums Creek) where they were taken and the expert evidence that they are intended to support.

All of the photos and videos were taken on the North Branch and main stem of the Royal Burn, and were referenced in paragraphs 39, 91 and 95 of my evidence. The date of each recording is provided in the folder title. A plan showing where they were taken was provided, and is attached again to this letter for convenience.

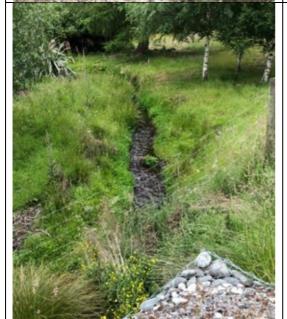
Location 4 - main stem of the Royal Burn at @ Crown Range Rd

High flow

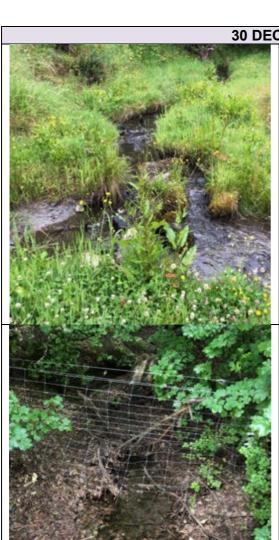
Location 1 - lower point of take on RBNB

Approx. 80% of flow remains in RBNB

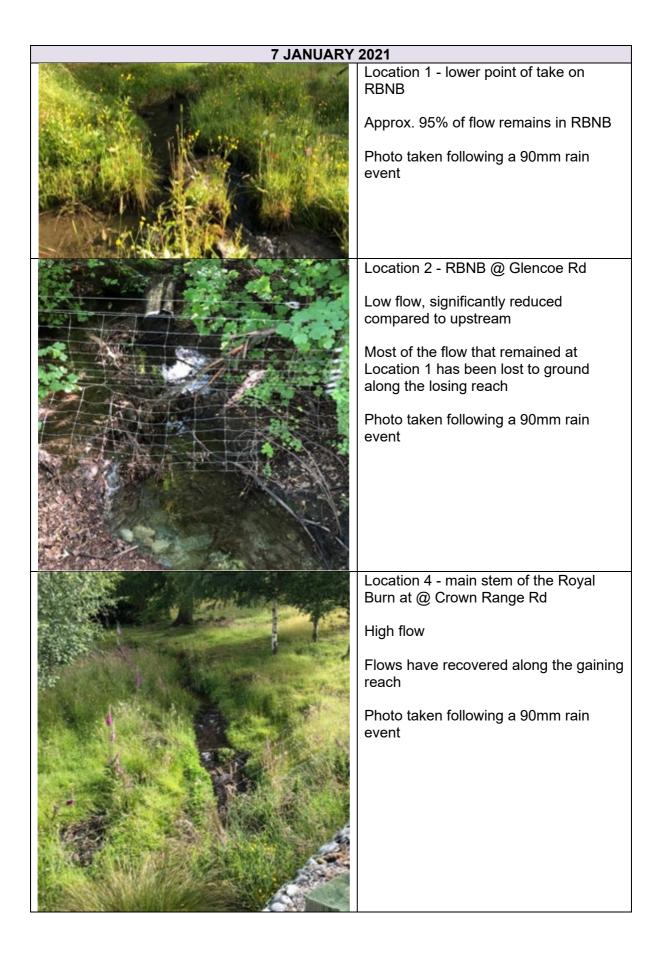
Location 2 - RBNB @ Glencoe Rd

No flow, standing water only

Flow that remained at Location 1 has been lost to ground along the losing reach

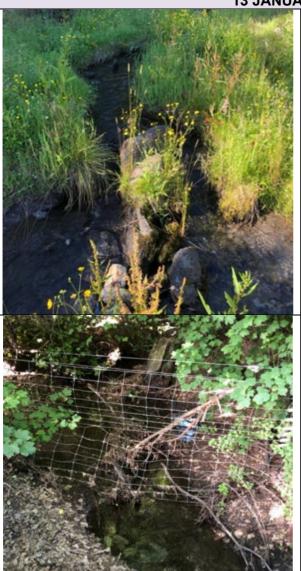
Location 1 - lower point of take on RBNB

Approx. 90% of flow remains in RBNB

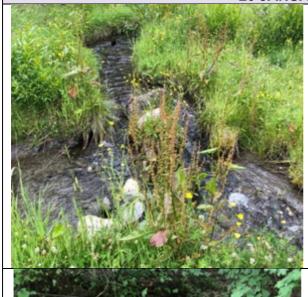
Location 1 - lower point of take on RBNB

Approx. 60% of flow remains in RBNB

Photo taken following a rain event

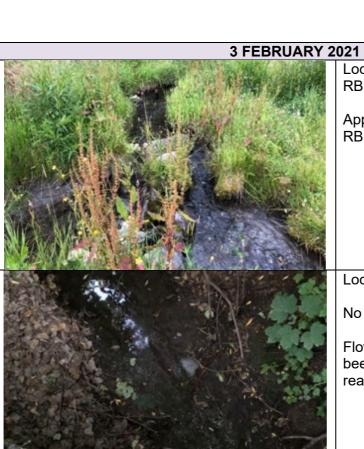
Location 1 - lower point of take on RBNB

Approx. 60% of flow remains in RBNB

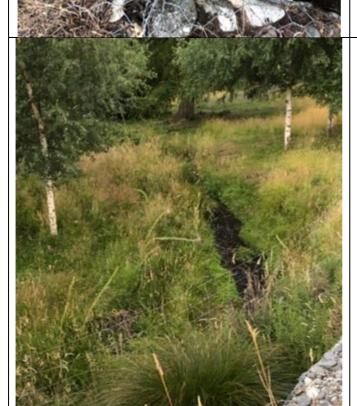
Location 4 - main stem of the Royal Burn at @ Crown Range Rd

High flow

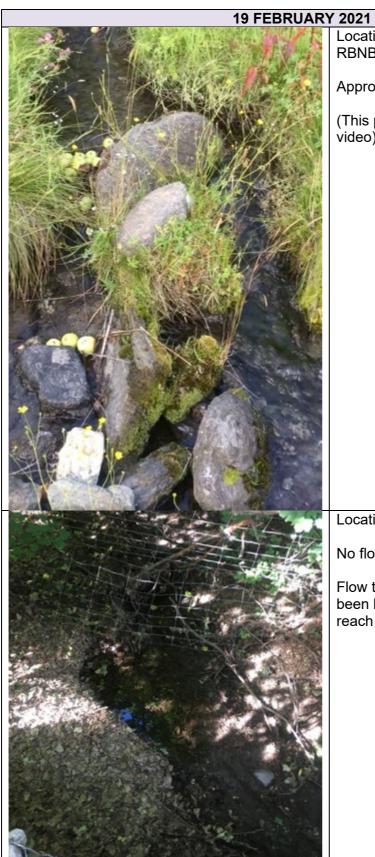
Location 1 - lower point of take on RBNB

Approx. 90% of flow remains in RBNB

(This photo is a still taken from the video)

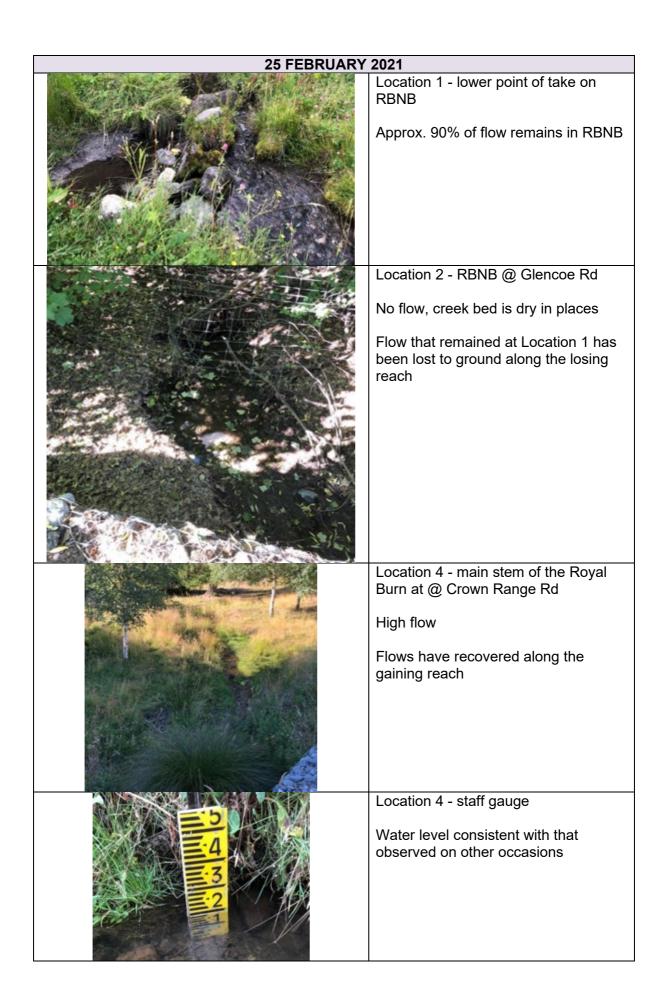
Location 2 - RBNB @ Glencoe Rd

No flow, creek bed is dry in places

Flow that remained at Location 1 has been lost to ground along the losing reach

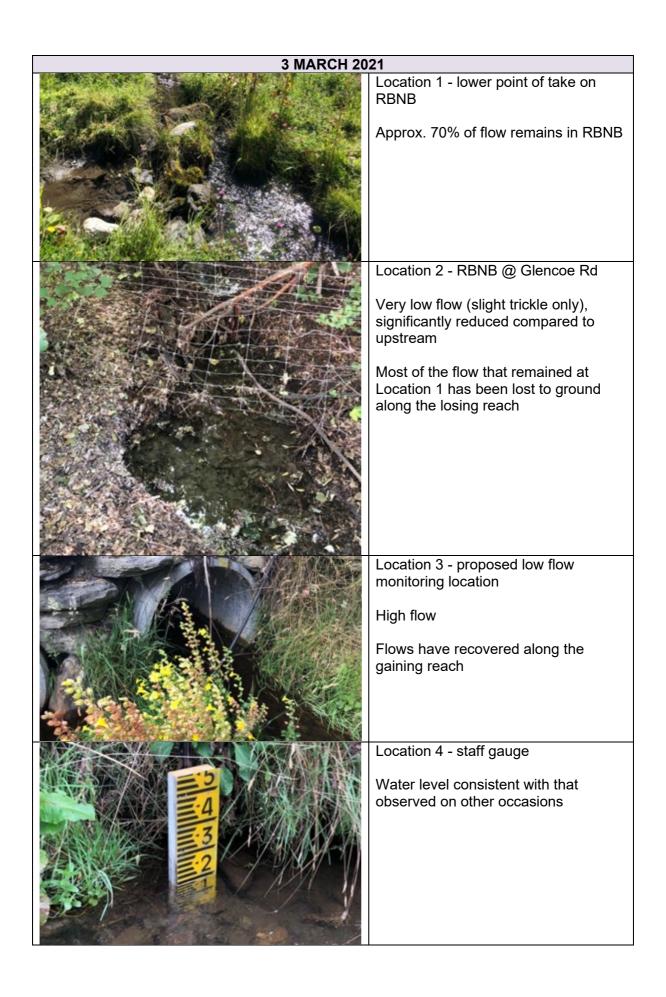
Location 1 - lower point of take on RBNB

Approx. 80% of flow remains in RBNB

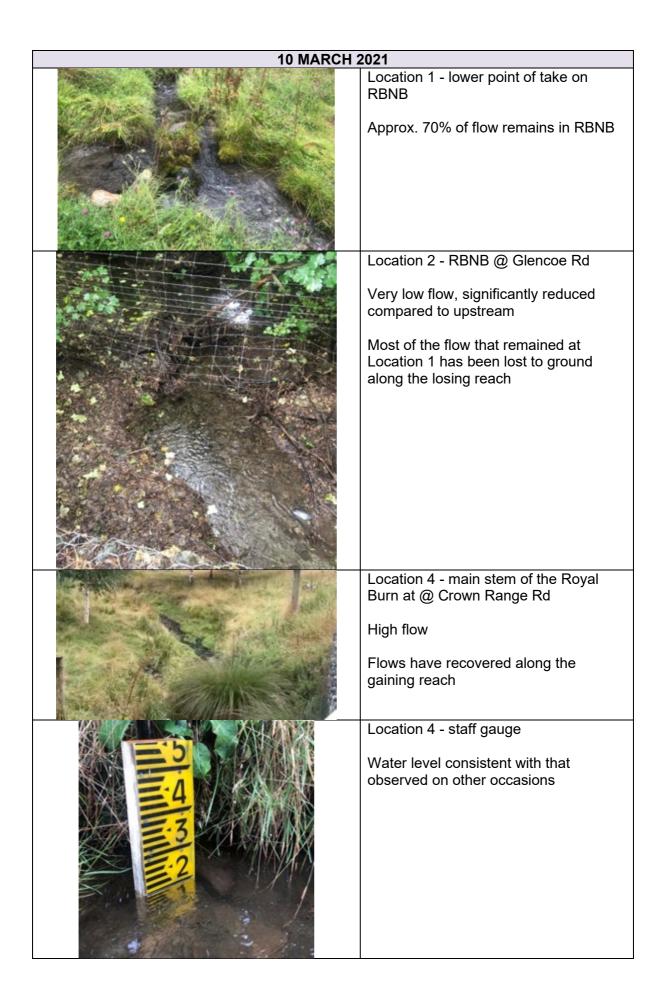
Location 2 - RBNB @ Glencoe Rd

No flow, creek bed is dry in places

Flow that remained at Location 1 has been lost to ground along the losing reach

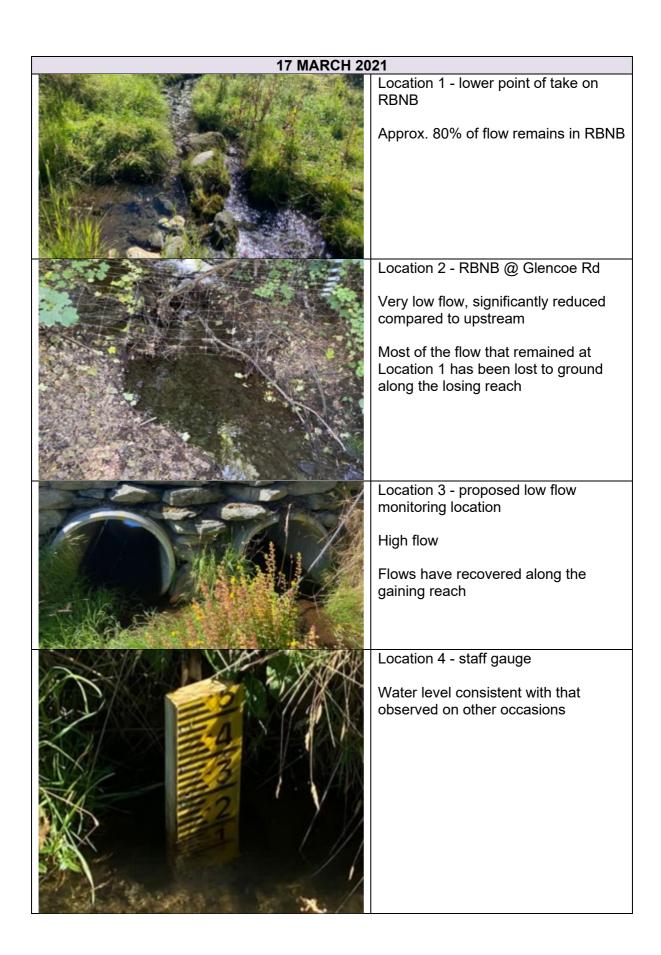
Location 3 - proposed low flow monitoring location

High flow

Flows have recovered along the gaining reach

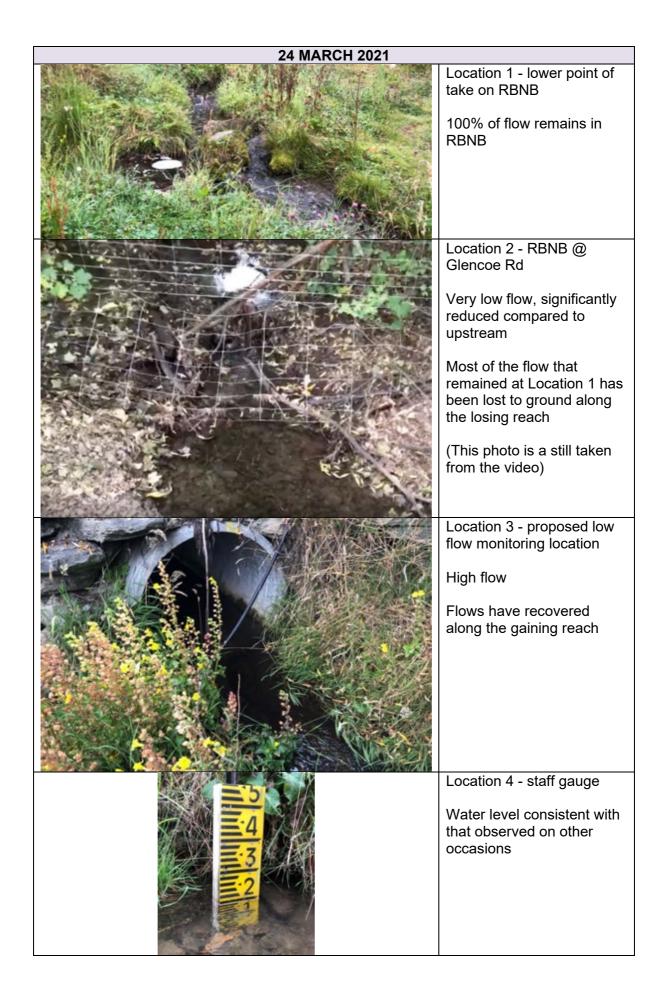
Location 4 - staff gauge

Water level consistent with that observed on other occasions
