**General distribution and characteristics of active faults and folds in the Clutha and Dunedin City districts, Otago**

**GNS Science Consultancy Report 2020/88**  
**April 2021**

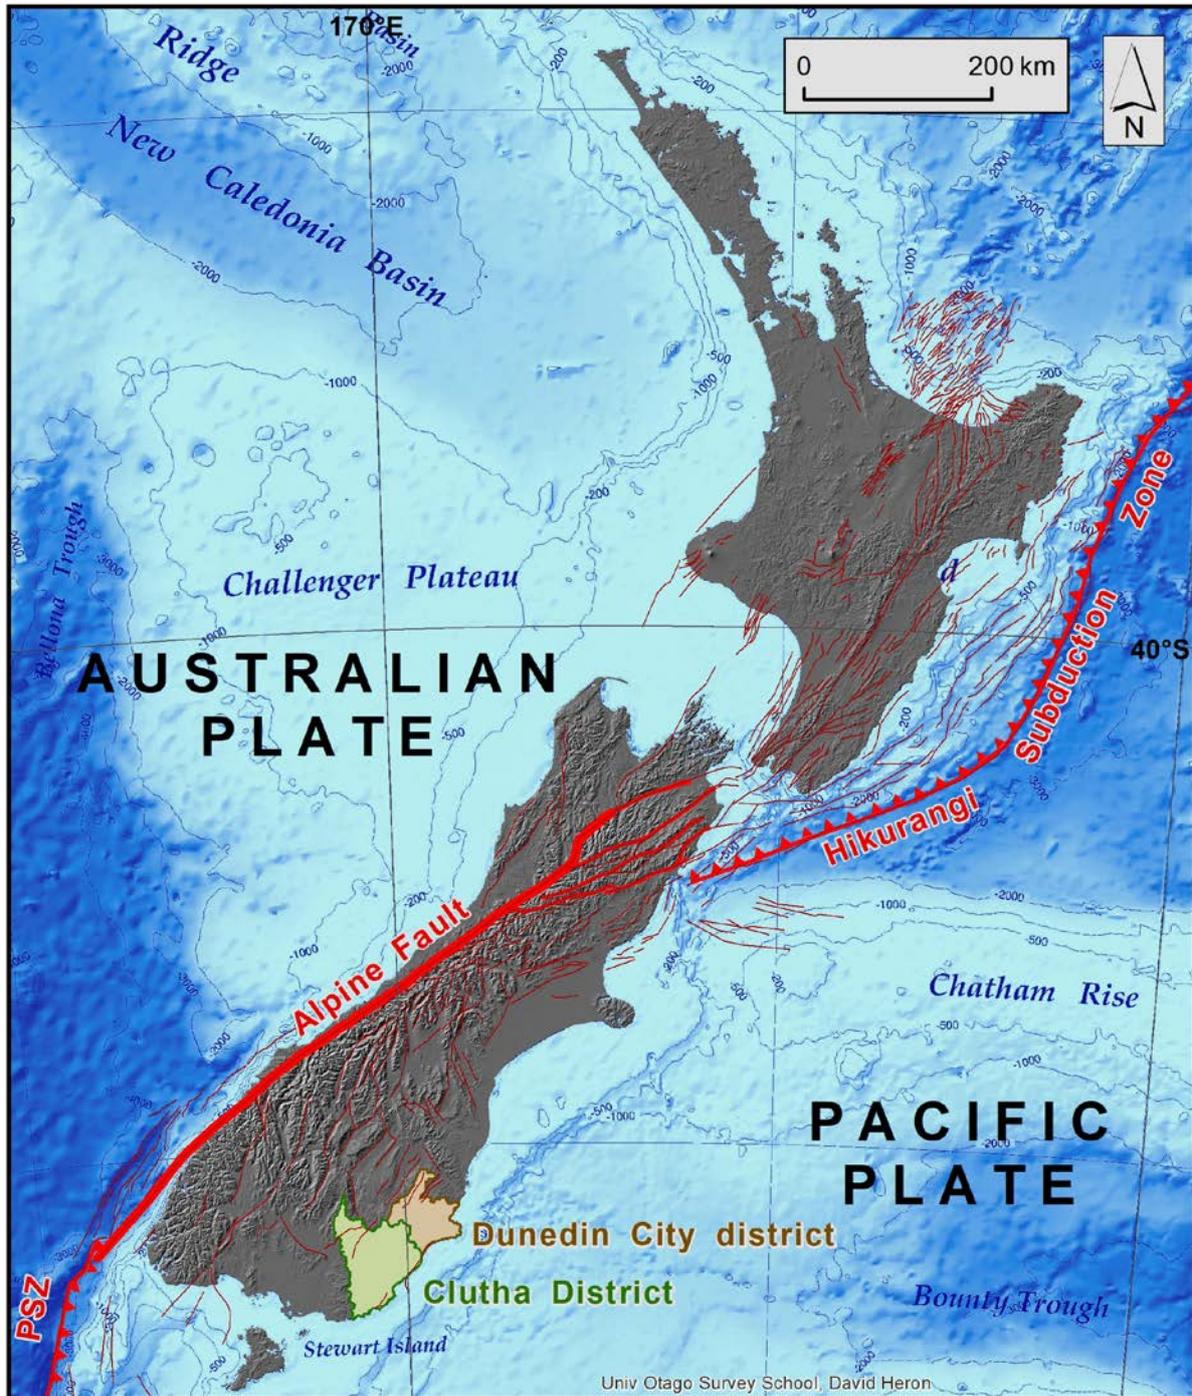
Figure 1.1 The tectonic setting of the Clutha and Dunedin City districts. The junction between the Australian and Pacific plates of the Earth's crust passes through New Zealand. The Pacific Plate pushes westward against, and under, the Australian Plate at the Hikurangi Subduction Zone while, at the Puysegur Subduction Zone (PSZ), the Australian Plate is being pushed down alongside the southwestern South Island. The Alpine Fault (thick red line) and the Marlborough Fault System (medium thickness red lines) transfer most of the plate motion between the two subduction zones, with the remainder accommodated across a wider zone of deformation marked by other active faults (thin dark red lines; from Litchfield et al. 2014). The offshore image is the New Zealand Continent map (GNS Science), showing shallower water in light blue and deeper water in darker blue. Bathymetric contours are in metres below sea level.

The geologically active nature of New Zealand reflects our position astride the active boundary between two large slabs (plates) of the Earth's crust (Figure 1.1). The forces involved in plate movement (tectonic forces) are immense and cause the rock of the Earth's crust to buckle (fold) and fracture (fault) in the general vicinity of the boundary between the plates. The plate boundary through the South Island is marked, at the ground surface, by a sideways tear, the Alpine Fault and, in the northern South Island, by a companion set of tears, the Marlborough Fault System. Although these large faults accommodate most of the plate motion, the remainder is distributed over a wider zone across much of the South Island. The Clutha and Dunedin City districts lie within this wider zone of tectonic deformation.

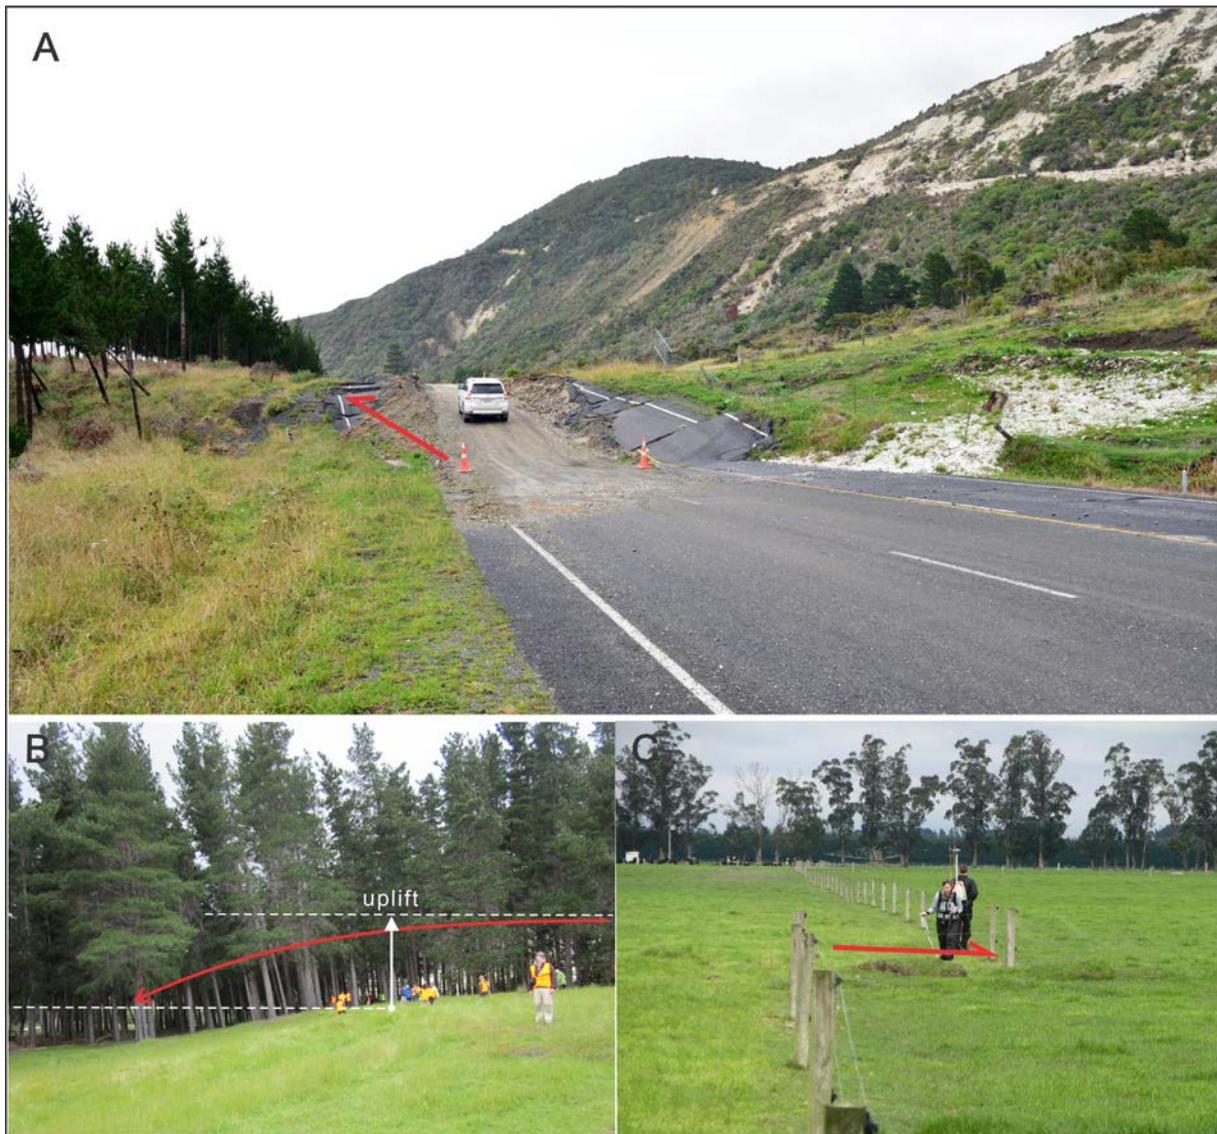
Figure 1.2 Illustrations of recent historical fault rupture deformation of the ground surface in New Zealand. A: Offset of State Highway 1 across the Papatea Fault, north of Kaikōura, that occurred during the 2016 Kaikōura Earthquake. The movement included several metres of upthrow and also several metres of sideways shift to the left, as indicated by the red half-arrow. Photo: GNS Science, VML ID: 210453; DB Townsend. B: Monoclinal fold associated with the Papatea Fault rupture during the Kaikōura Earthquake, illustrated well by the tilting of the pine trees. The ground here was flat prior to the earthquake. The white lines indicate the amount of uplift, and the red arrow shows the breadth and curvature of the monocline. Photo: GNS Science; DJA Barrell. C: A fence offset sideways by ~4.5 m of strike-slip rupture on the Greendale Fault during the 2010 Darfield Earthquake. Photo: GNS Science, VML ID: 137457; NJ Litchfield. The red half-arrow shows the amount of relative displacement, which here involved a shift to the right.

Although the movement along the plate boundary is continuous over geological time and can be measured by ground and satellite (GPS) surveying, rock of the Earth's crust is remarkably elastic and can accommodate a lot of bending before letting go and breaking suddenly (rupturing) along a fault, causing an earthquake. On large faults, the break may be big and extend up to the Earth's surface, causing sudden offset and breakage (faulting) and/or buckling and warping (folding) of the ground surface, accompanied by a large earthquake. The 2010 Darfield and 2016 Kaikōura earthquakes provided good examples of the nature and effects of large, ground-surface-rupturing earthquakes on geological faults (e.g. Barrell et al. 2011; Litchfield et al. 2018; Figure 1.2).

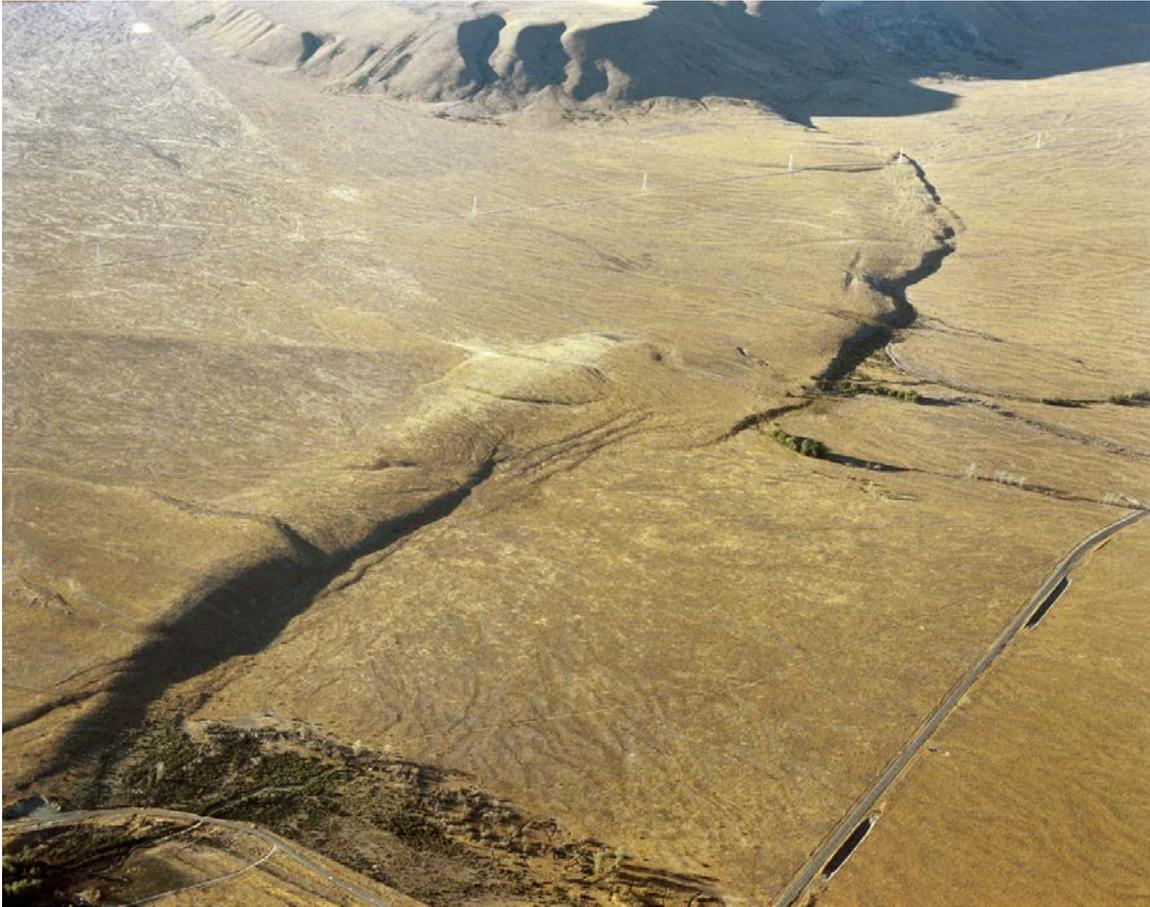
Figure 1.3 A northward oblique aerial view of ground-surface deformation across the Ostler Fault Zone, in the Waitaki District in the Canterbury region, about 12 km southwest of Twizel. The fault zone runs from lower left to upper right and has offset and buckled a ~22,000-year-old glacial meltwater outwash plain with well-preserved relict braided channels. This location is one of the best expressed examples of fault deformation in New Zealand because it is entirely across old landforms. This view shows complicated elements of main and subsidiary fault offsets and folds across a zone that is several hundreds of metres wide. All of these elements form part of a single entity, the Ostler Fault Zone. This figure is taken from Barrell (2016), where a more detailed description of the features in this view is provided. Photo: GNS Science, CN576/B and VML ID: 5151. DL Homer, taken 1995.

The fault and fold styles illustrated in Figure 3.1 are idealised examples. They do not show the range of variations and complexity that may exist (e.g. see Figure 1.3). To find such simple examples in nature as displayed in Figure 3.1 would be an exception rather than a rule. The steepness of inclination (dip) of the fault may vary considerably (Figure 3.1). Where a fault has a gentle dip (i.e. is closer to horizontal than vertical), each successive movement commonly results in the upthrown side 'bulldozing' outward, over-riding the ground and encroaching over anything in its immediate vicinity. The destroyed building in the upper diagram of the lower panel of Figure 3.1 attempts to convey an impression of a bulldozer effect.

There is rarely an exact distinction between a fault and a monocline at the ground surface. Fault scarps are commonly associated with some buckling of the ground and near-surface layers, particularly on the upthrown side of a reverse fault scarp (Figure 3.1; also see Figure 1.3). In some cases, part of the fault movement may have broken out on a series of smaller subsidiary faults near the main fault. In the case of monoclines or anticlines, subsidiary faults may also occur over buried faults that underlie these folds, resulting in small ground surface offsets. An important message is that, on any active fault or fold, there are commonly elements of both faulting and folding close to the ground surface (Figure 3.2). The amount of deformation due to faulting, relative to the amount expressed as folding, may vary over short distances (Figure 1.3).

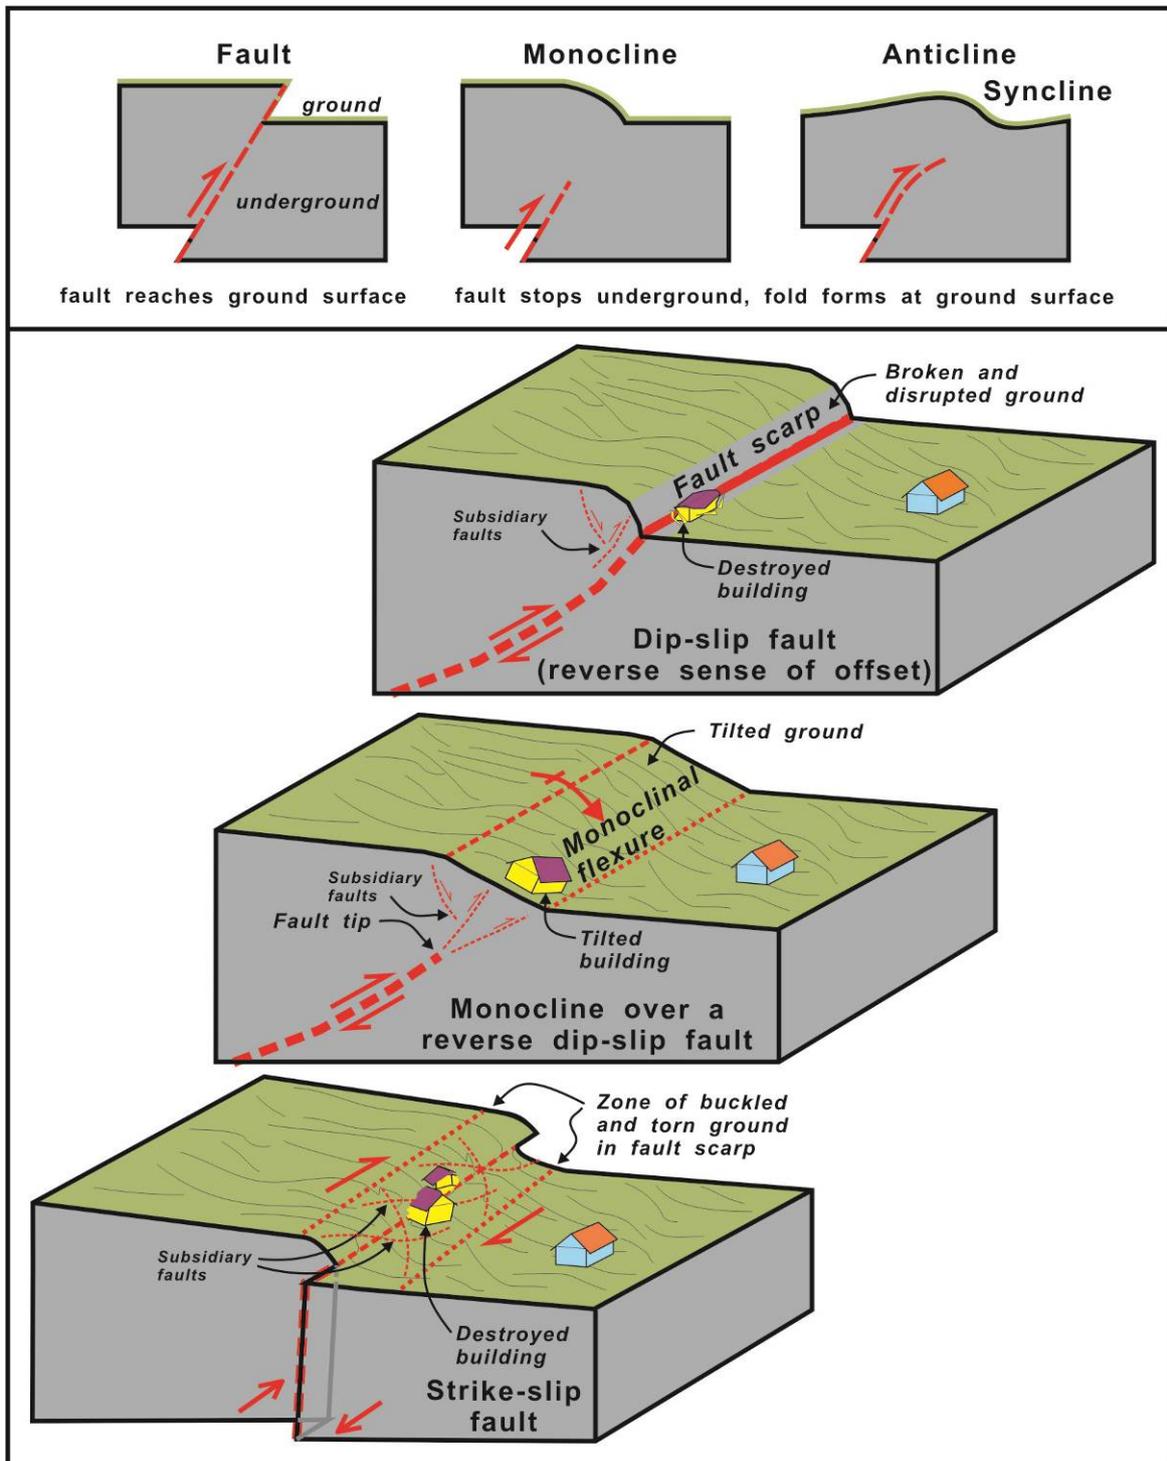
Figure 3.1 Diagrams illustrating styles of active faults and folds. The diagrams show general concepts rather than actual details and are not drawn to an exact scale. Upper panel: Cross-section (vertical slice) diagrams illustrating an active fault, active monocline and active anticline and syncline. Most folds are, as shown here, thought to have formed over faults whose ruptures have not made it all the way to the ground surface. Lower panel: perspective block diagrams showing typical ground-surface expressions of faults and monoclines. The diagrams include hypothetical examples of effects on buildings of a fault rupture or monocline growth event.

In practice, where the zone of ground deformation is quite narrow, it is interpreted as a fault, and, where it is broad, it is interpreted as a fold (e.g. monocline; see Figure 3.1). The only way to determine the accuracy of this interpretation is to excavate a trench across the deformed zone to see whether, or to what extents, the near-surface deposits have been offset or merely folded (Figure 3.2). Sometimes, natural exposures in stream banks provide the necessary information. This highlights a key issue; without detailed work involving examination of what lies within the first few metres beneath the ground surface, we can at best only make informed guesses about the exact locations, form and likely future consequences of fault or fold activity.

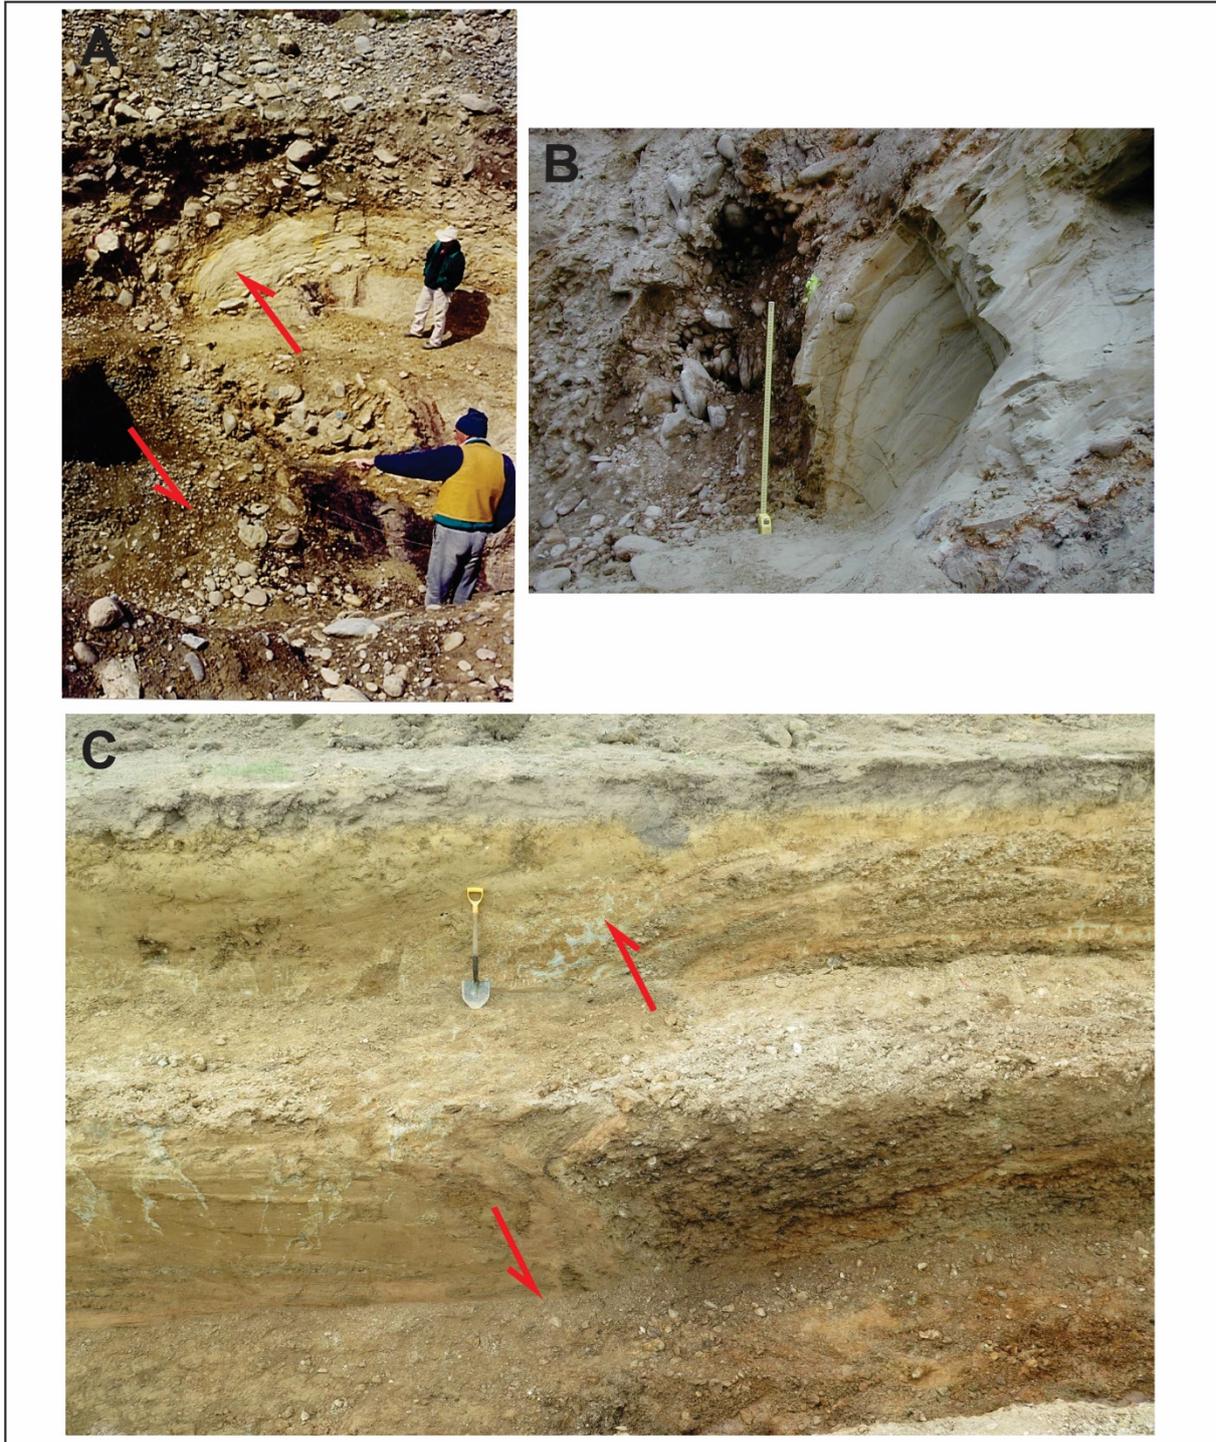
Figure 3.2 Illustrations of faults exposed in investigation trenches. Red half-arrows indicate the relative sense of fault displacement. A and B: The Waitangi Fault exposed in 1999 in a trench 700 m downstream of Aviemore Dam, Waitaki District of Canterbury (Barrell et al. 2009). A: the fault runs upper left to lower right, and a bed of yellow sand has been pushed up and buckled over against river gravel to the left. B: detail of the fault contact after further excavation and cleaning. The yellow tape measure (extended 1 m) provides scale. Layering in the sand has been dragged down nearly vertical against the fault, while elongate river stones immediately left of the sand bed have been dragged up into vertical alignments. C: A view of the wall of a trench excavated across the Titri Fault near Milton in coastal Otago, Clutha District, in 2016. Yellow-brown stream gravel (right of centre) has been thrust up and buckled over against yellow-brown silt (loess) to the left. Detailed examination and mapping of the materials, and dating of the sediments, provides evidence for at least two separate rupture events here within the past ~38,000 years. The 1-m-long shovel illustrates scale. Photos: GNS Science, DJA Barrell.

An important message is that, while landforms provide important clues as to the general location of active faults or folds, many details of these features that may be relevant to land use, development and hazard mitigation cannot be obtained without more detailed site-specific investigations (e.g. Figure 3.2).

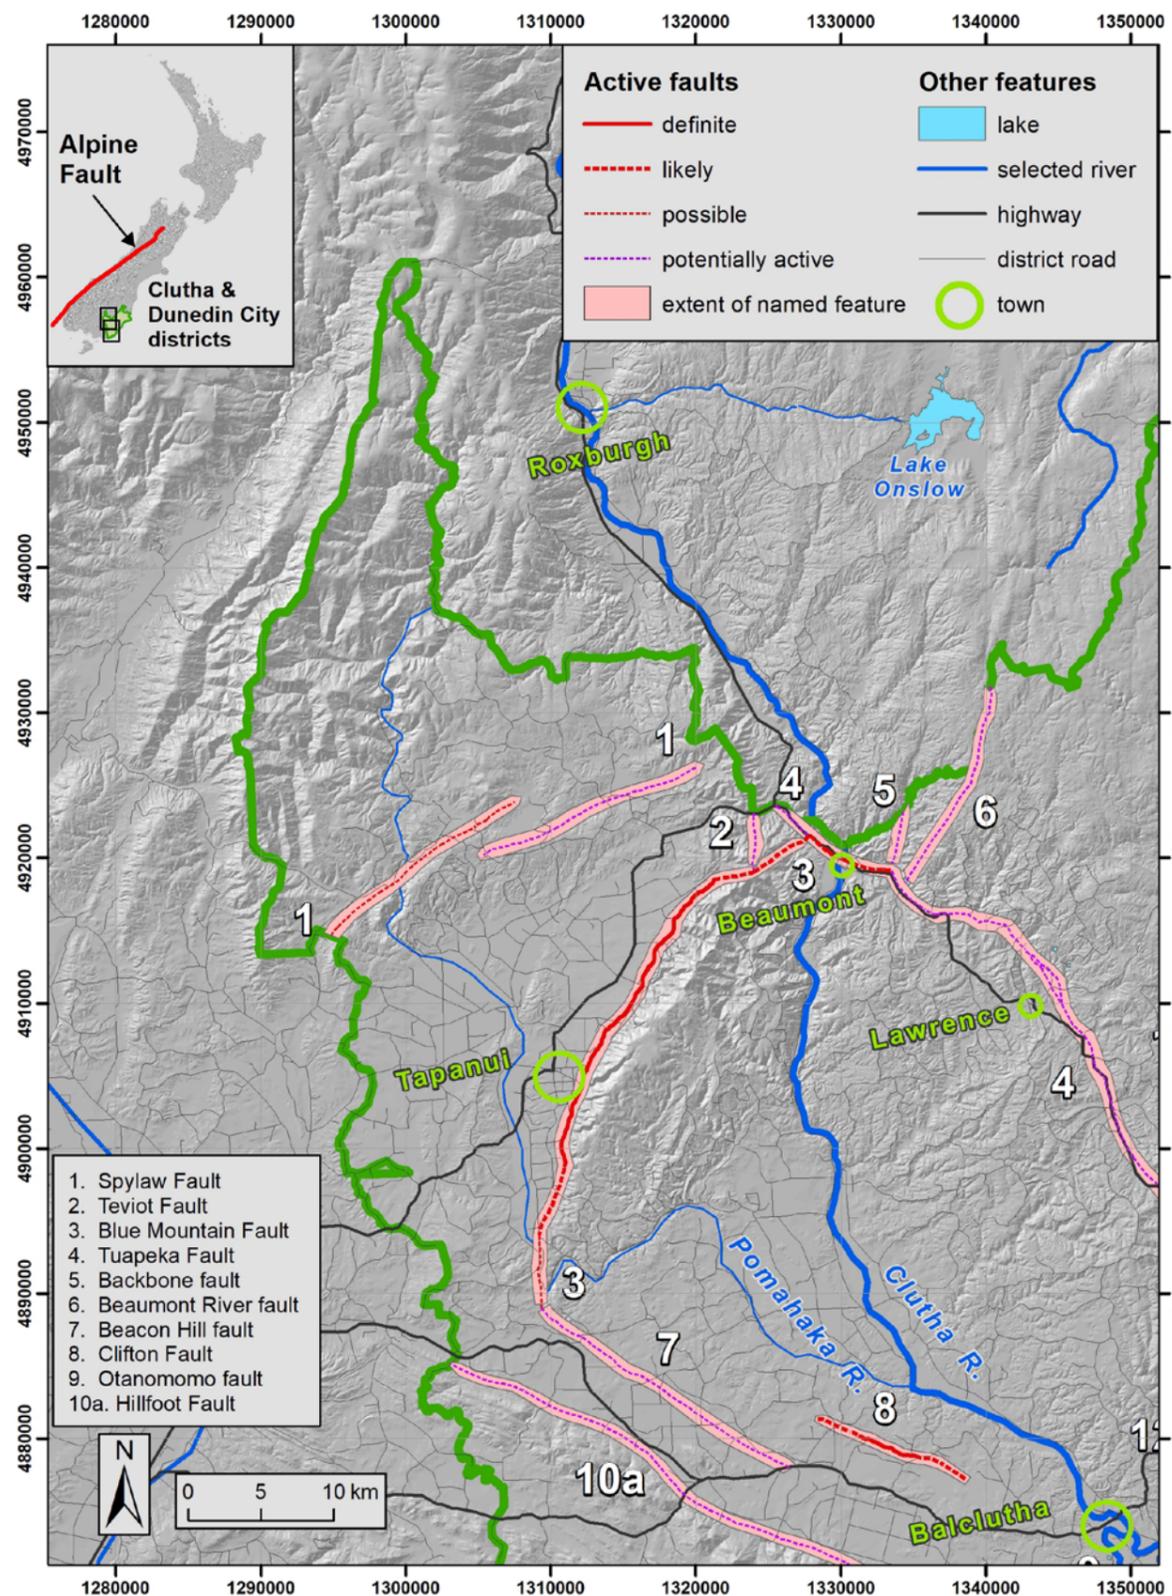
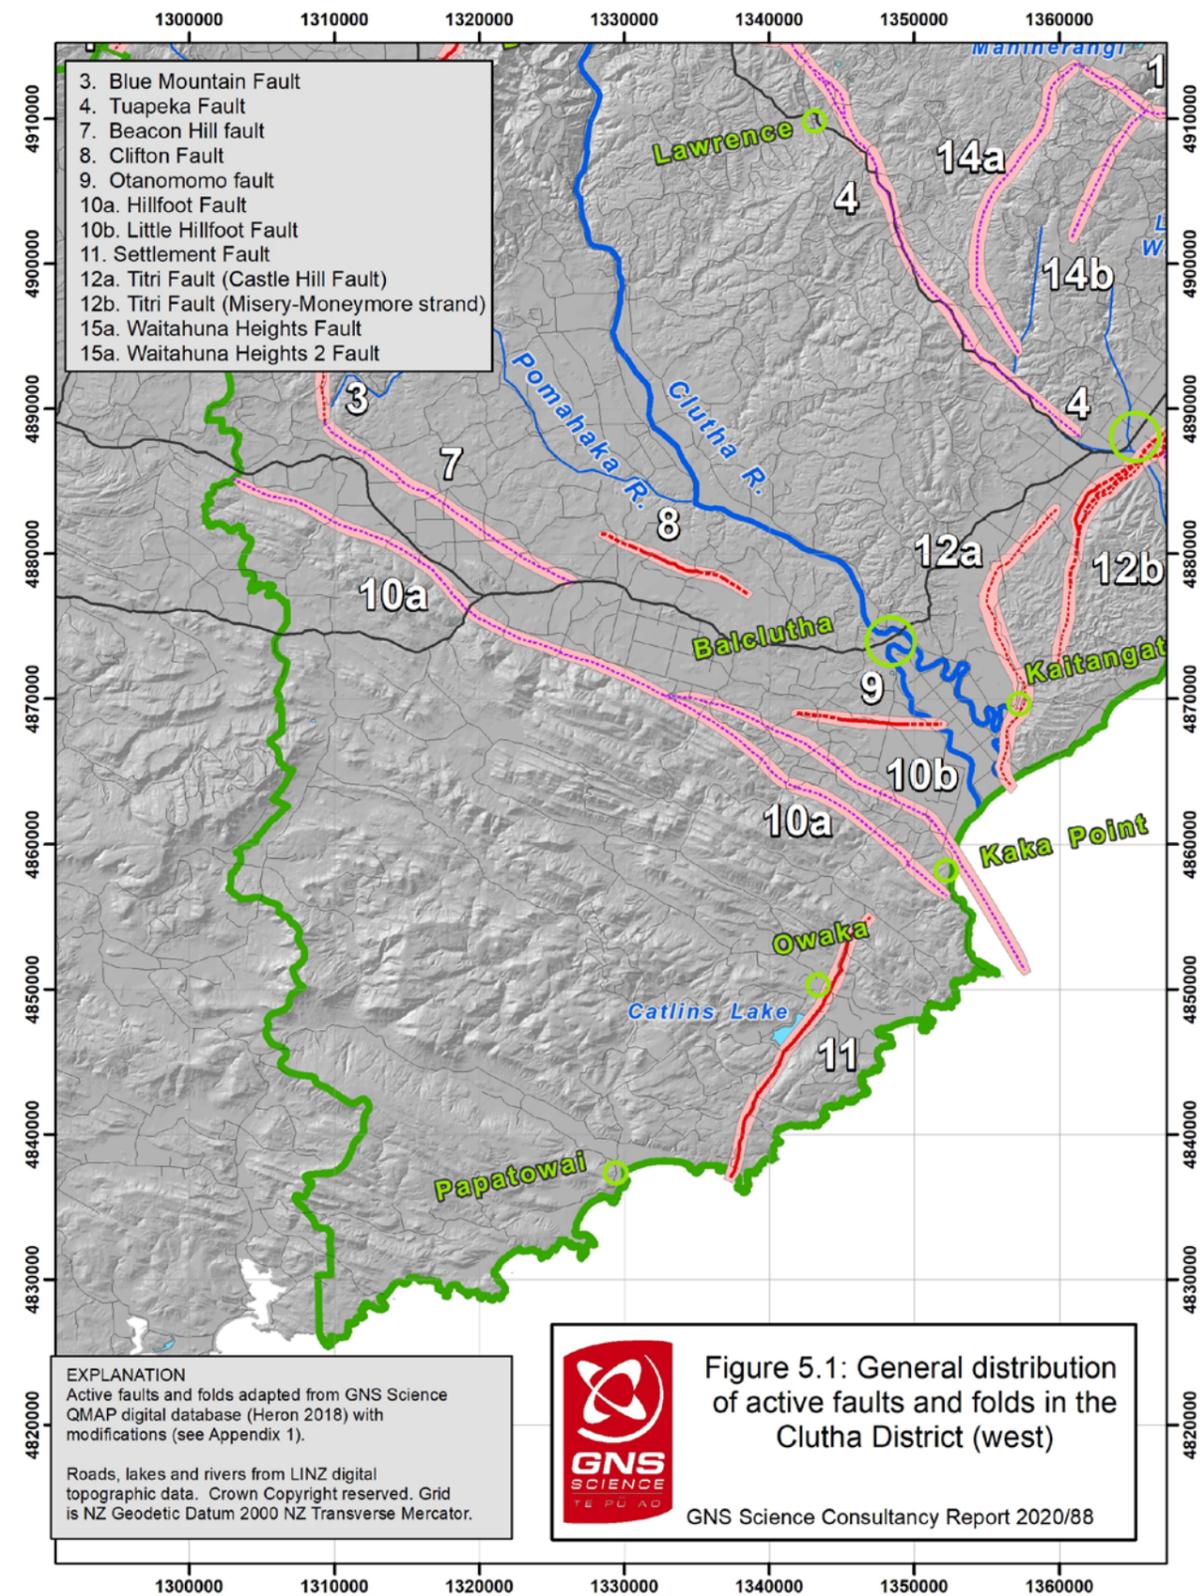
Figure 5.1 General distribution of active faults and folds in the western part of the Clutha District. The pink areas indicate groupings of fault or fold strands that collectively form part of a single numbered active fault. The pink areas are purely illustrative and do not imply anything about the location or extent of fault-related ground deformation. Each fault that intersects the outer boundary of the combined districts (thick green line) extends into a neighbouring district. The location of the overlapping map panels is shown in the inset at top left.

The present project has delineated 26 active and potentially active faults thought to be potentially capable of generating ground-surface-rupturing earthquakes, noting that the total of 34 named fault features in Figures 5.1–5.2 and Table 5.2 includes several regarded as only able to rupture together with other faults. In comparison, the 2010 NSHM identifies a total of seven active fault earthquake sources partly or entirely within the limits of the combined Clutha and Dunedin City districts, and the same seven active fault features are delineated in the NZAFM. The NZAFD, which in the assessment area is based largely on interpreted active fault scarps from the QMAP dataset, mostly shows scattered, disconnected, active fault strands rather than entire active fault structures, as are portrayed in the NZAFM, for example. The active fault dataset described in this report provides a full update of information on active faults in the combined Clutha and Dunedin City districts. The information on active faults in this report is more comprehensive than the current version (August 2020) of the NZAFD.

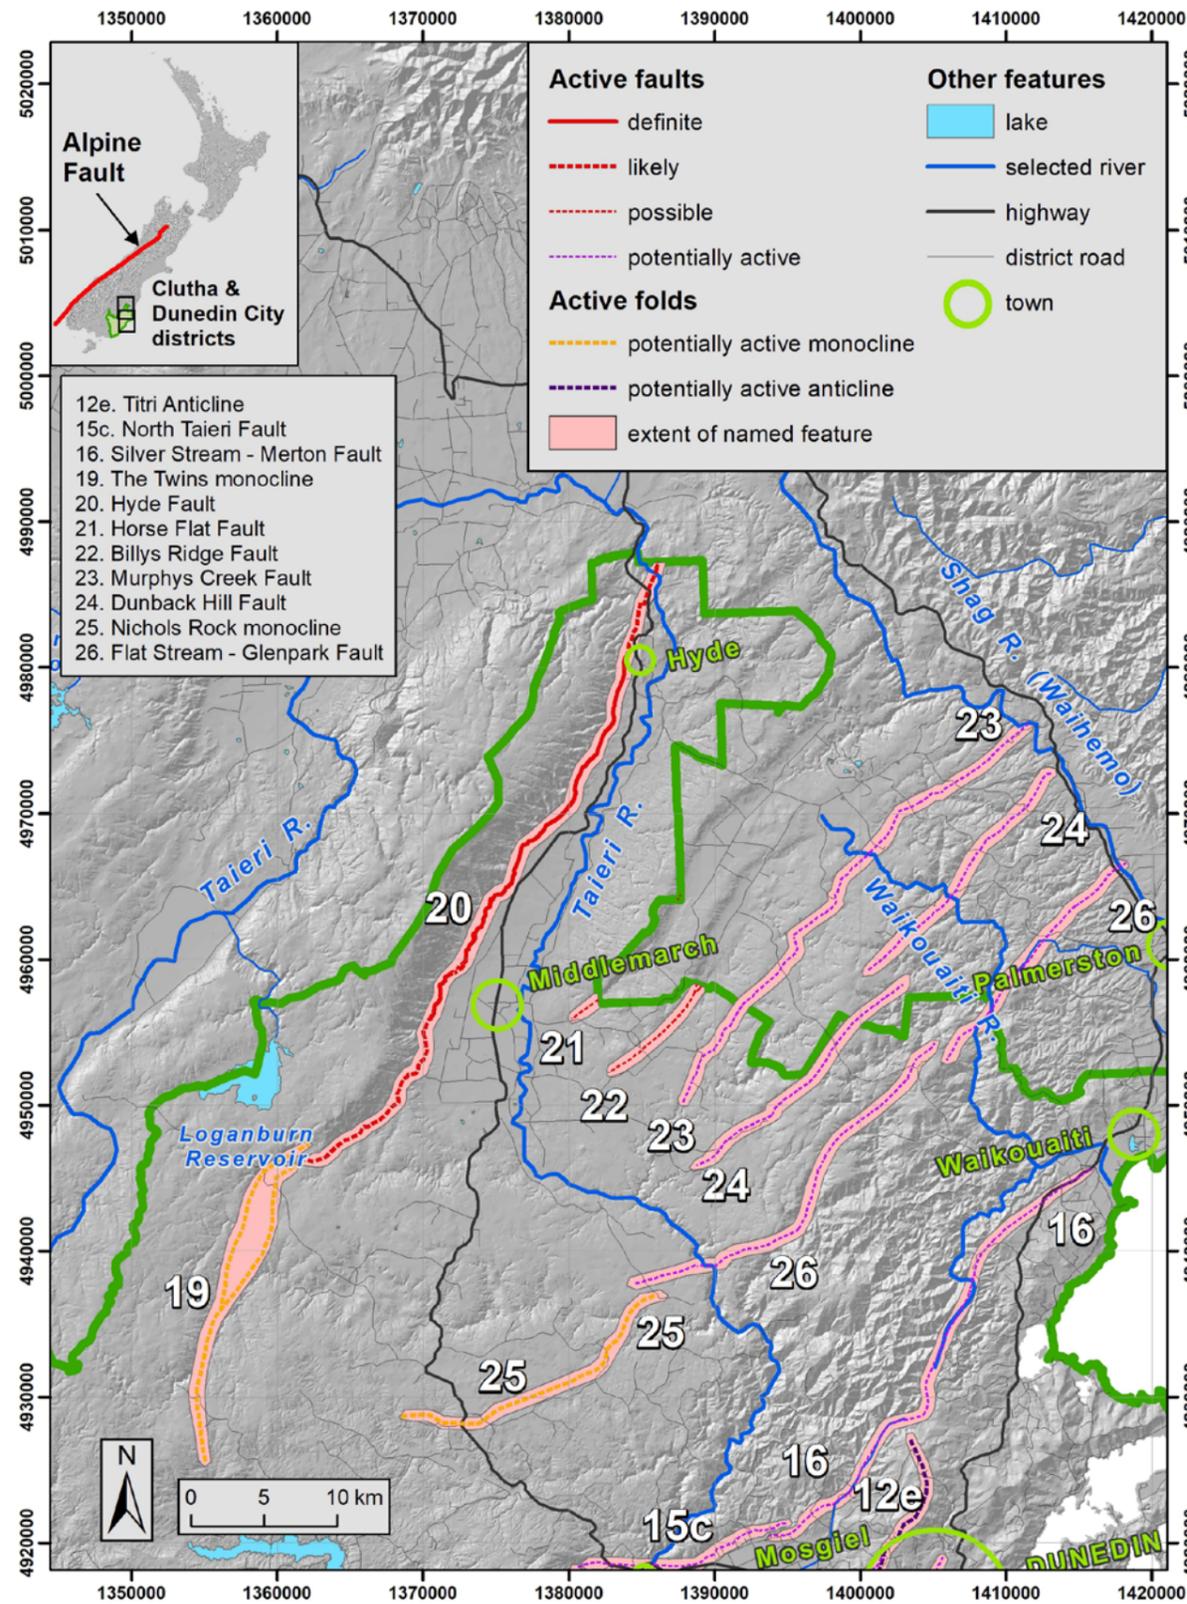
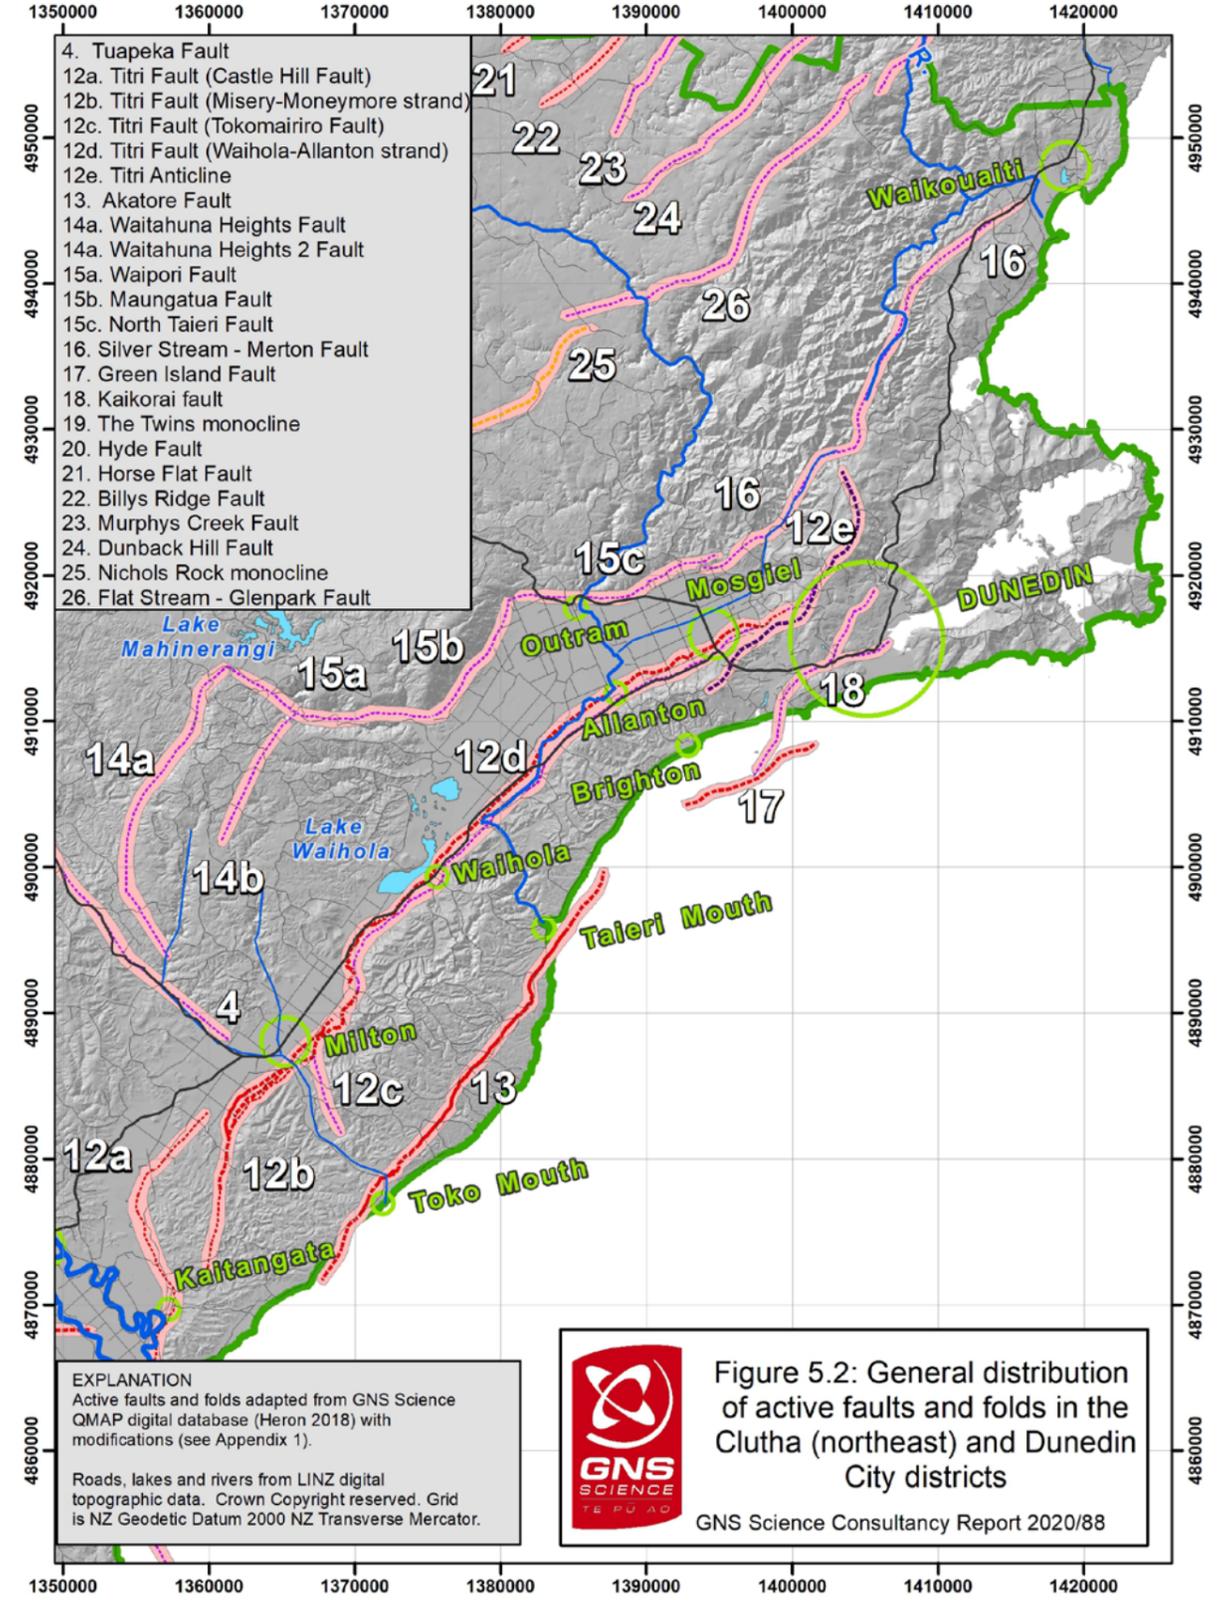
Figure 5.2 General distribution of active faults and folds in the eastern part of the Clutha District and the Dunedin City district. The pink areas indicate groupings of fault or fold strands that collectively form part of a single numbered active fault. The pink areas are purely illustrative and do not imply anything about the location or extent of fault-related ground deformation. Each fault that intersects the outer boundary of the combined districts (thick green line) extends into a neighbouring district. The location of the overlapping map panels is shown in the inset at top left.

In the active fault assessment for the Waitaki District (Barrell 2016), the focus was on faults designated as active in the NSHM and NZAFM. Subsequently, in the southern Waitaki District, Villamor et al. (2018) delineated several more faults assessed as potentially active. All extend into the Dunedin City district, and, in the dataset described in this report, the full extent of those faults across both districts is included. The additional faults are the Murphys Creek, the Dunback Hill and the Flat Stream – Glenpark faults (Figure 5.2).

In the northern part of the Dunedin City district (Figure 5.2; left panel), the small population centres of Middlemarch and Hyde lie within 4 km and 1 km, respectively, of the Hyde Fault. The Hyde Fault has an estimated recurrence interval of ~14,000 years, with the most recent surface rupture ~10,000 years ago. Similarly to southwestern Otago, the recognition of several potentially active faults only minimally increases the chance of fault rupture and related hazards occurring due to a local-source earthquake in the northern part of the Dunedin City district, because their rates of activity (if any) are very low.

The Tokomairaro and Taieri basins, and the coastal range of hills, are occupied by the main population centres of the assessment area (Figure 5.2; right panel). The most prominent feature is the Titri Fault, whose movement over time has been responsible for uplift that has raised the coastal hills. The fault has complexity of surface expressions, with step-overs from one fault strand to another and, in places, curved to sinuous surface break-up scarps (Figures 5.3–5.5). In several places, notably near Milton, Henley and Mosgiel, the exact location of the most recent fault break-outs are uncertain because stream action has removed or buried the fault-diagnostic landforms. In the south, there is a good geological and topographic basis for positioning the Titri Fault (Castle Hill Fault component) along the foot of the hills on the eastern edge of Kaitangata township, rather than farther west under the Inch Clutha plain as previously mapped. Further north, Milton lies about 2 km northwest of the Titri Fault, which is mapped as passing along the foot of higher ground immediately southeast of its Tokoiti suburb.

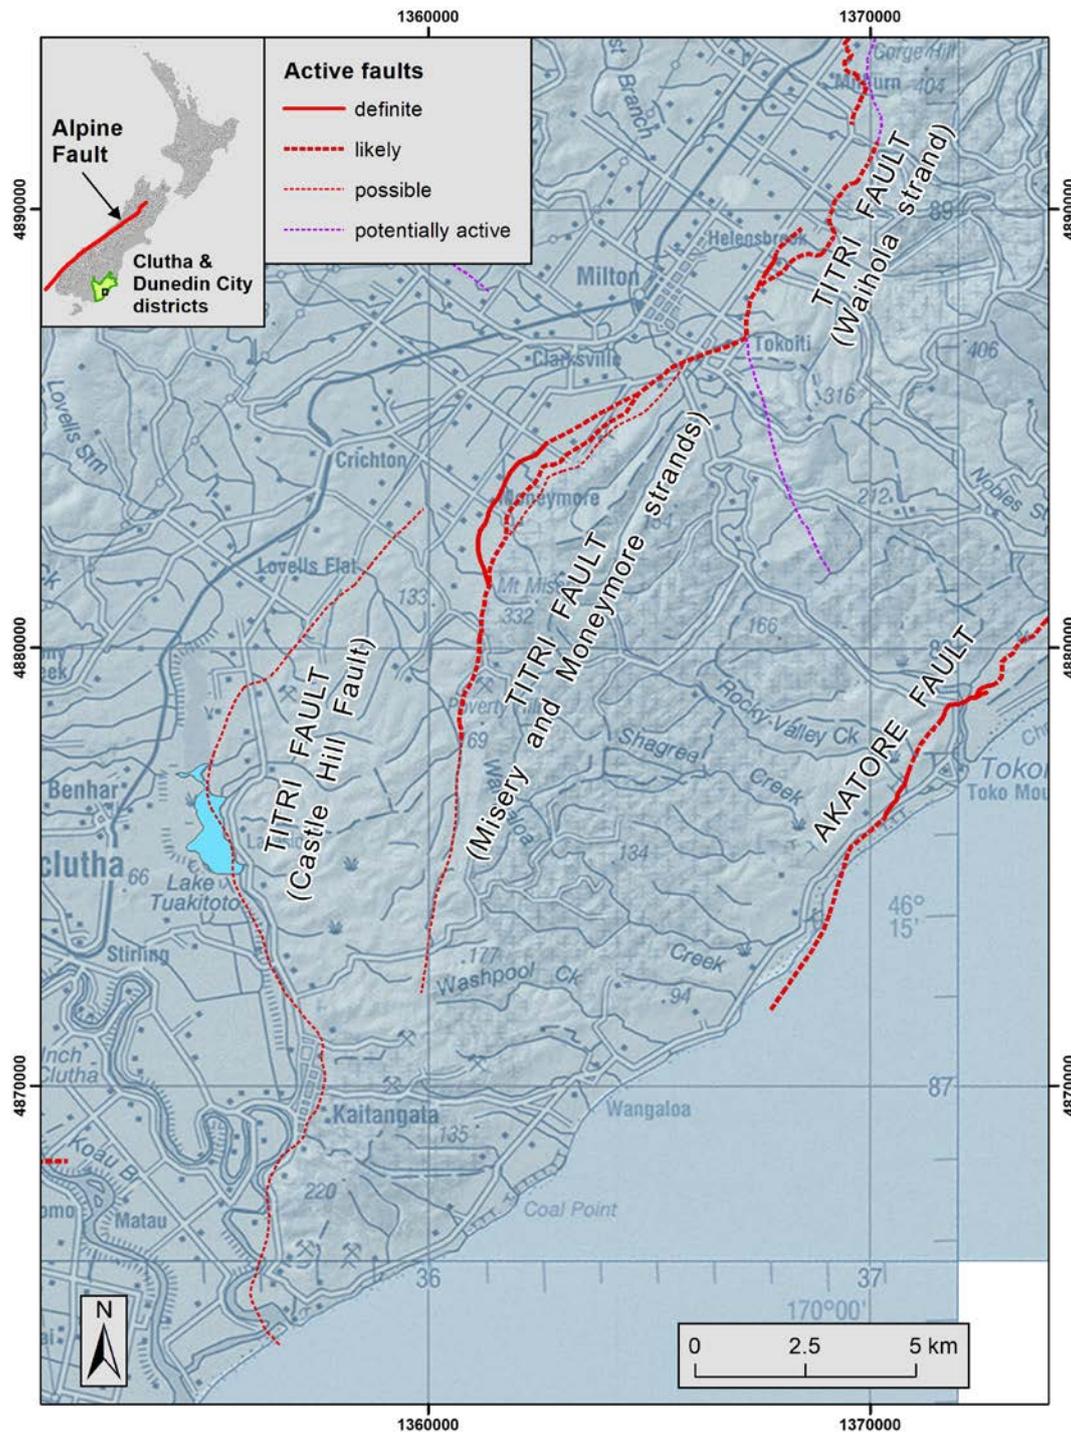
Figure 5.3 Active faults in the southwestern sector of the coastal hills. The background is the Topo 250 topographic map draped transparently over a hillshade digital elevation model. The location of the map panel is shown in the inset at top left.

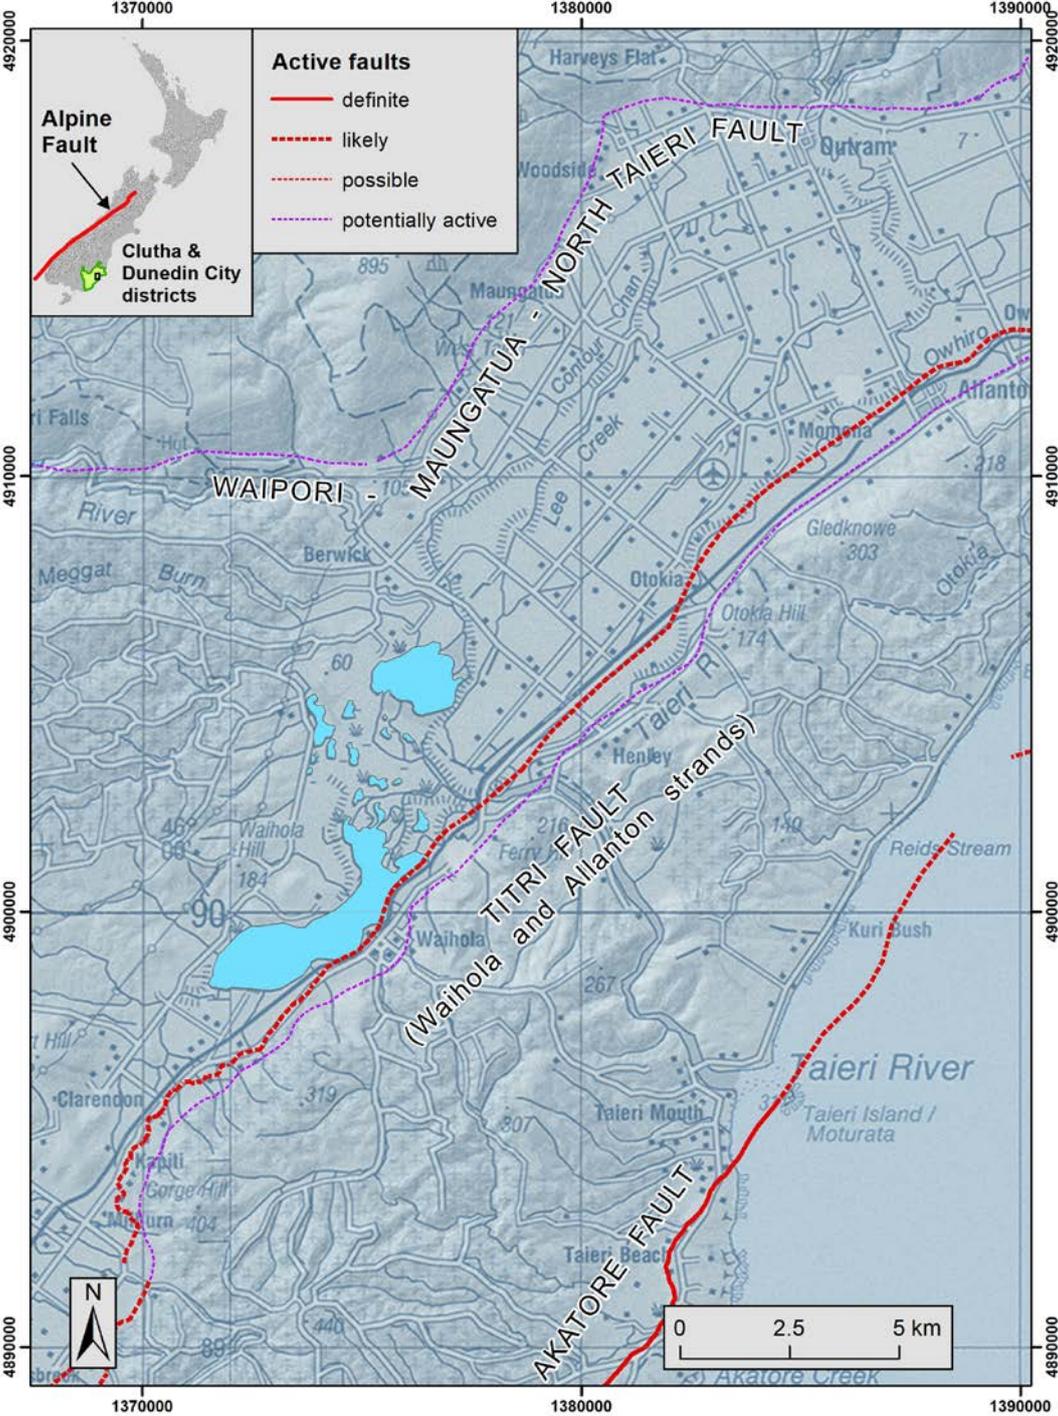
Figure 5.4 Active faults in the central sector of the coastal hills and the Taieri Plain. The background is the Topo 250 topographic map draped transparently over a hillshade digital elevation model. The location of the map panel is shown in the inset at top left.
