**General distribution and characteristics of active faults and folds in the Clutha and Dunedin City districts, Otago**

**GNS Science Consultancy Report 2020/88**  
**April 2021**

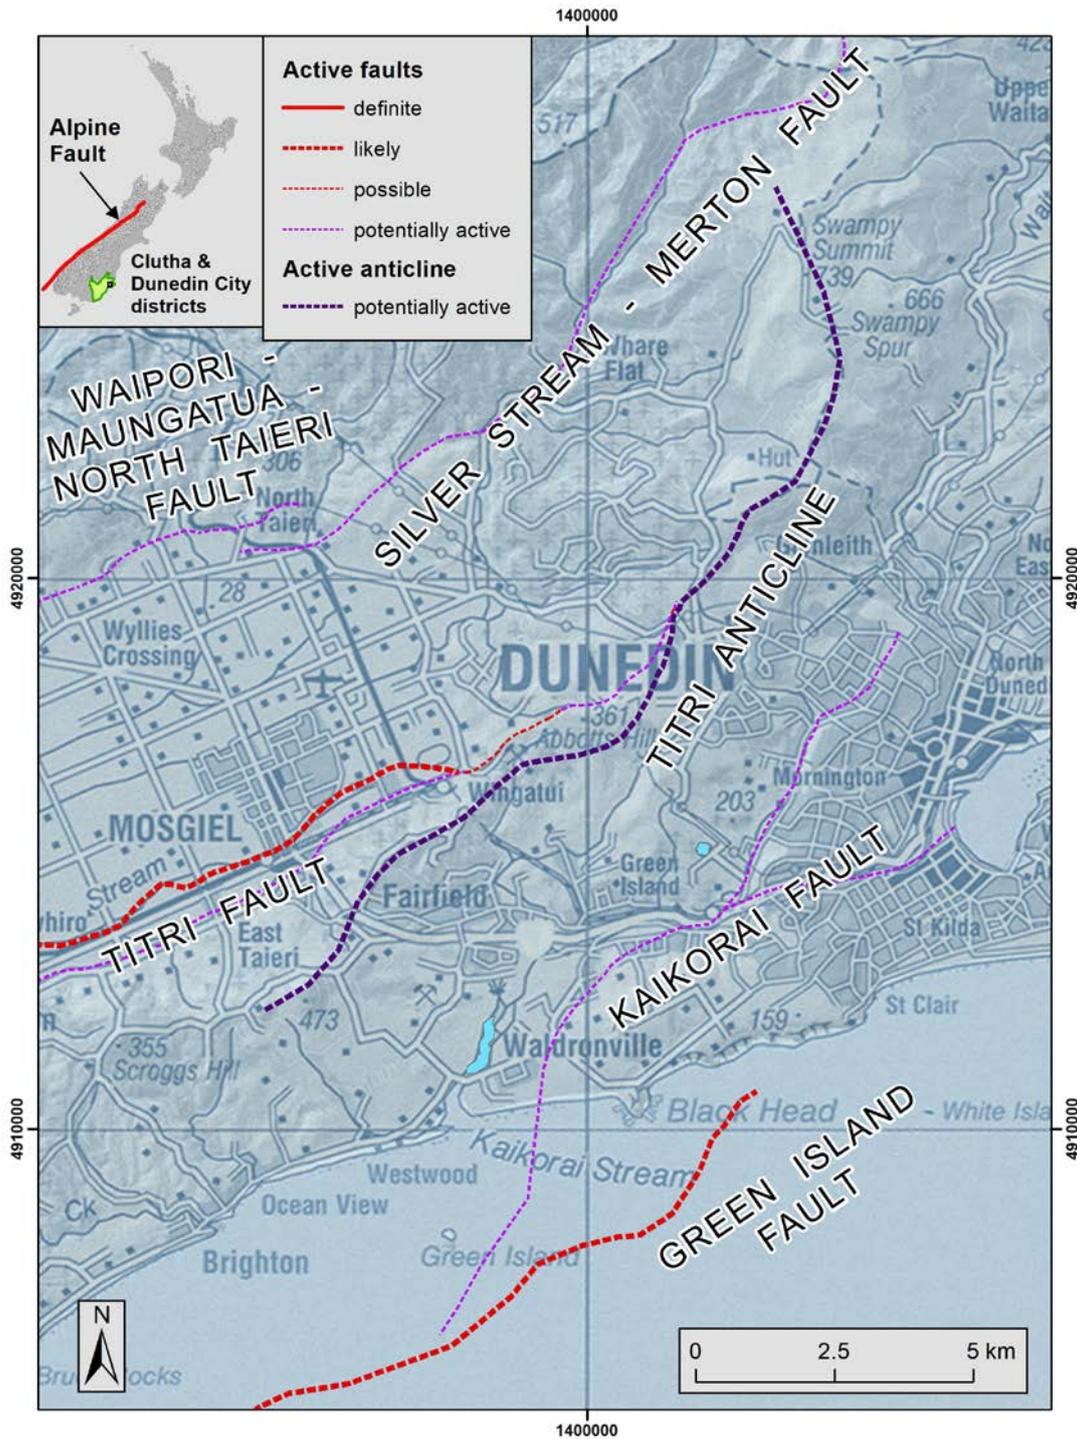
Figure 5.5 Active faults in the northern sectors of the coastal hills and Taieri Plain. The background is the Topo 250 topographic map draped transparently over a hillshade digital elevation model. The location of the map panel is shown in the inset at top left.

The northwestern side of the Taieri Plain is marked by the Waipori – Maungatua – North Taieri Fault, which has, over time, uplifted the hills on that side of the plains (Figures 5.4–5.5). The village of Outram lies within ~1 km southeast of the inferred mapped line of the fault, but none of the built-up area lies directly on the mapped position. Previously, sections of the fault had been interpreted as having had geologically recent activity, based on landform evidence. However, as part of the present assessment, that interpretation has been revised, and those landform features are now interpreted as being unrelated to fault activity. This fault is interpreted as potentially active with an assessed recurrence interval of ~50,000 years. It is not known when it last ruptured.
