Appendix 19: Preliminary Site Investigation

Dunedin City Council

Waste Futures Phase 2 - Smooth Hill Landfill Preliminary Site Investigation

May 2021

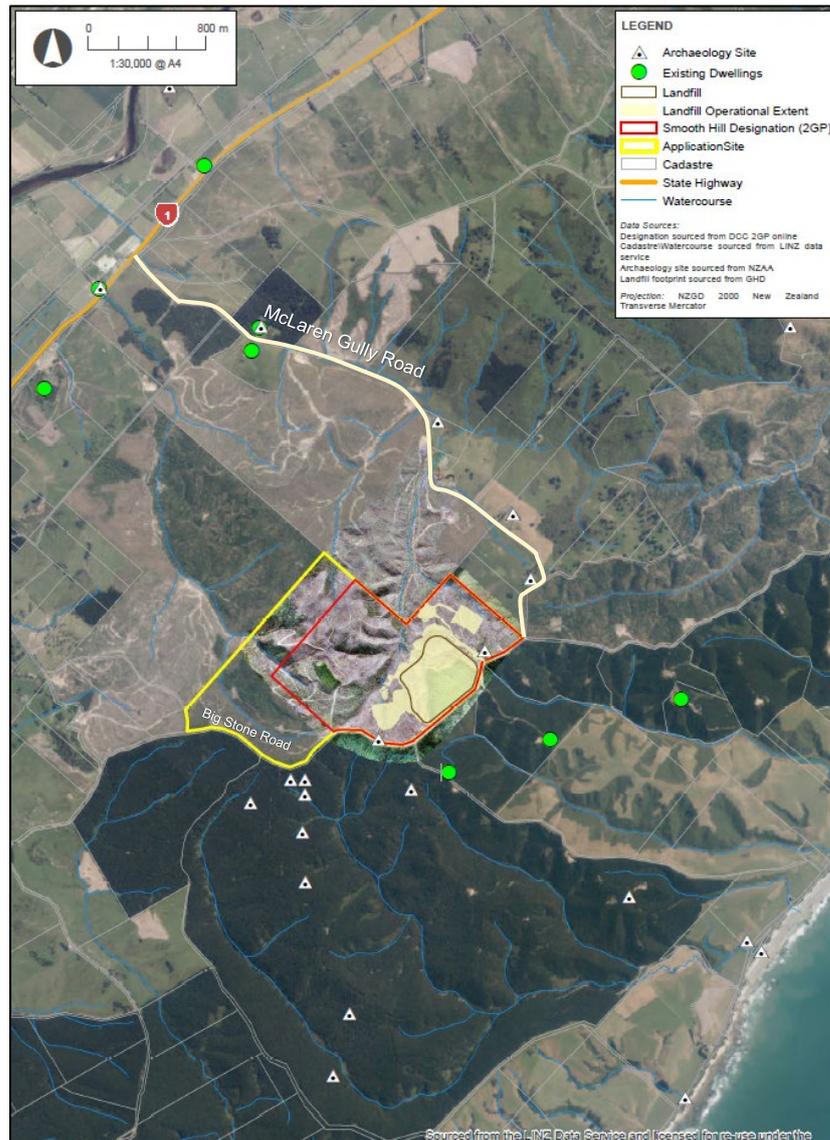
Figure 1 Proposed Smooth Hill landfill general locality features

The site is located approximately 28 km south-west of central Dunedin in the hills between State Highway 1 (SH1) and the coast. For the purposes of this assessment, we have assessed the entire application site, as outlined in yellow in Figure 1. Earthworks will also be required for the upgrade of access roads from SH1 to the site – namely via McLaren Gully Road and Big Stone Road to the south-eastern boundary of the site. This review also assessed both roads. Both roads are currently unsealed but will be widened, re-aligned and sealed as part of these works. The site is bounded to the north and west by forestry land (pine plantations) and to the north-east by pastoral farmland (Figure 1). Within the site, access is via a series of forestry roads and tracks. Most of the site has been logged and re-planted in the past 5 years, although minor areas of remnant native vegetation occur in the gully bottoms.

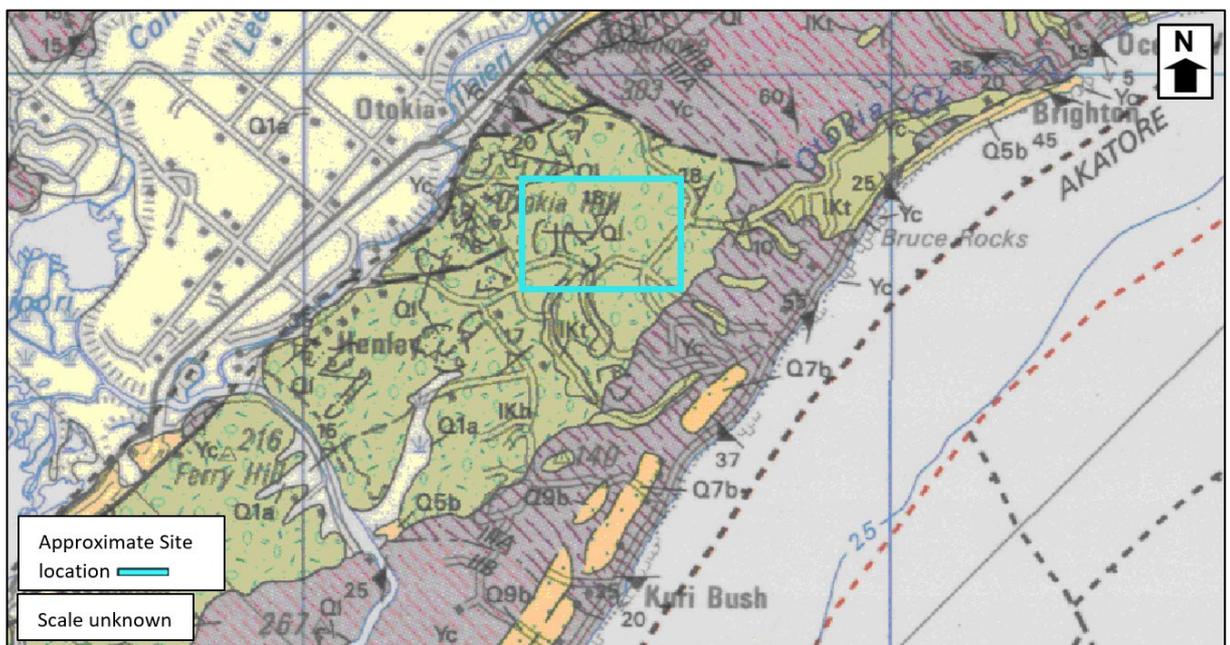
Figure 2 Site Geology

The Institute of Geological & Nuclear Sciences geological map for Dunedin⁶ (Figure 2) shows that the Site and roads are underlain by Henley Breccia. Henley Breccia is composed of non-marine schist and semischist breccia and conglomerate, minor sandstone and coal.

Although not shown on the geological map, geotechnical investigations⁷ have shown the Henley Breccia is overlain by up to 5 m of topsoil, colluvium and loess; and the presence of alluvium deposits within gullies.

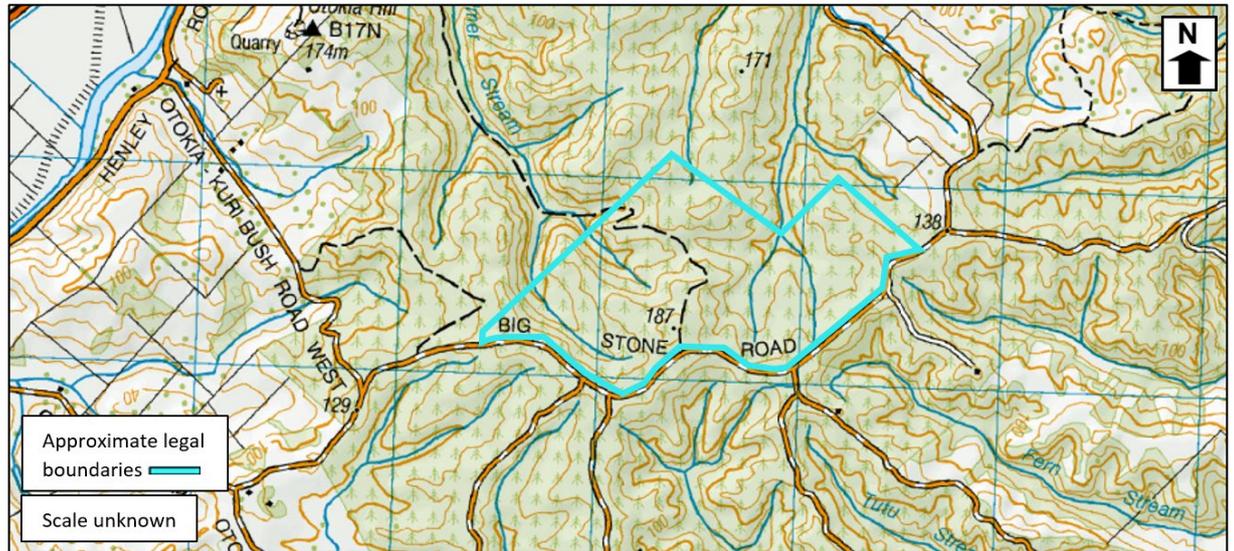
Figure 3 Site topography

The landfill site lies within in a natural “amphitheatre”, bisected by a larger central ridge and a smaller ridge in the south-west, which are both aligned and fall from south to north within the basin of the site. The site typically has side slopes of 20%. A south to north system of gullies passes through the site, which are ephemeral and flow only after rainfall. The gullies merge into a single gully near the northern edge of the site and join a sequence of wetlands connected by a semi-permanent stream to the north of the site. During dry periods surface water flow ceases as far downstream as at least the culvert under McLaren Gully Rd and surface water retreats to a series of disconnected wetlands. Further downstream from the McLaren Gully Road culvert, the stream joins the Otokia Creek that ultimately flows to the coast near Brighton, approximately 10 km north-east of the landfill site.

Big Stone Road runs along a ridge on the south-eastern edge of the site and is the catchment divide. To the south of Big Stone Road the land drains directly to the Pacific Ocean via a series of gullies and streams (from north to south Graybrook Stream, Fern Stream, Tutu Stream and Flax Stream).

McLaren Gully Road runs from a junction with Big Stone Road just to the northeast of the site in a northwest direction towards SH1. The road crosses a number of streams and galleys before joining SH1 on the edge of the Taieri Plains.

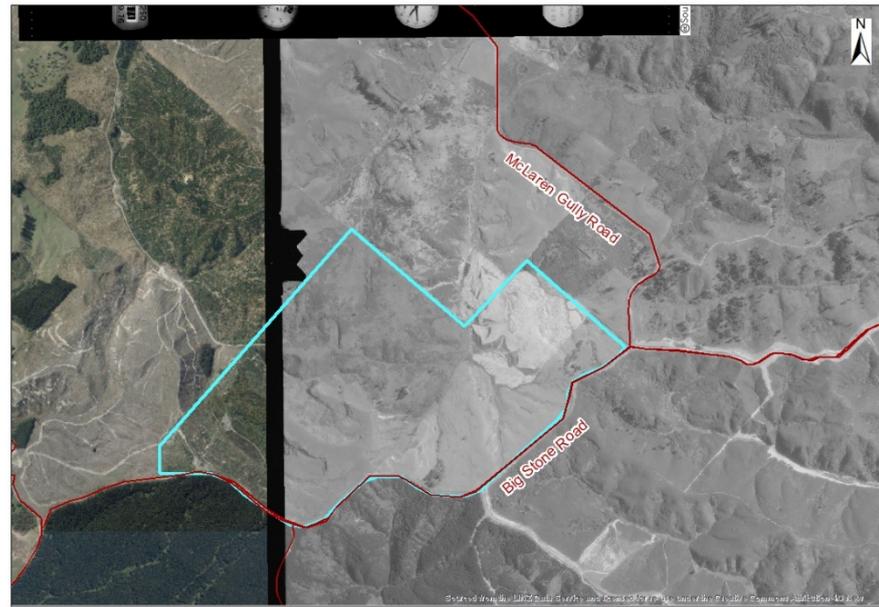
As a part of this PSI, GHD completed a historical aerial image review of the Site and the works required for the upgrade of the roads. The images used for the historical aerial review were sourced from Land Information New Zealand (LINZ), Retrolens Historical Image Resource and Google Earth. Limited aeriels were available for review. Aerial photographs from 1958 to 2019 were reviewed and are provided in **Appendix A**. The review found that the Site has been used for forestry purposes from 1958 to today. No evidence of HAIL activities were identified in the aerial review.
