5.1. Head of Lake Wakatipu flooding and liquefaction hazard investigations

Prepared for: Data and Information Committee
Report No. HAZ2202
Activity: Safety & Hazards - Natural Hazards
Author: Tim van Woerden, Natural Hazards Analyst
Jean-Luc Payan, Manager Natural Hazards
Endorsed by: Gavin Palmer, General Manager Operations
Date: 9 June 2022

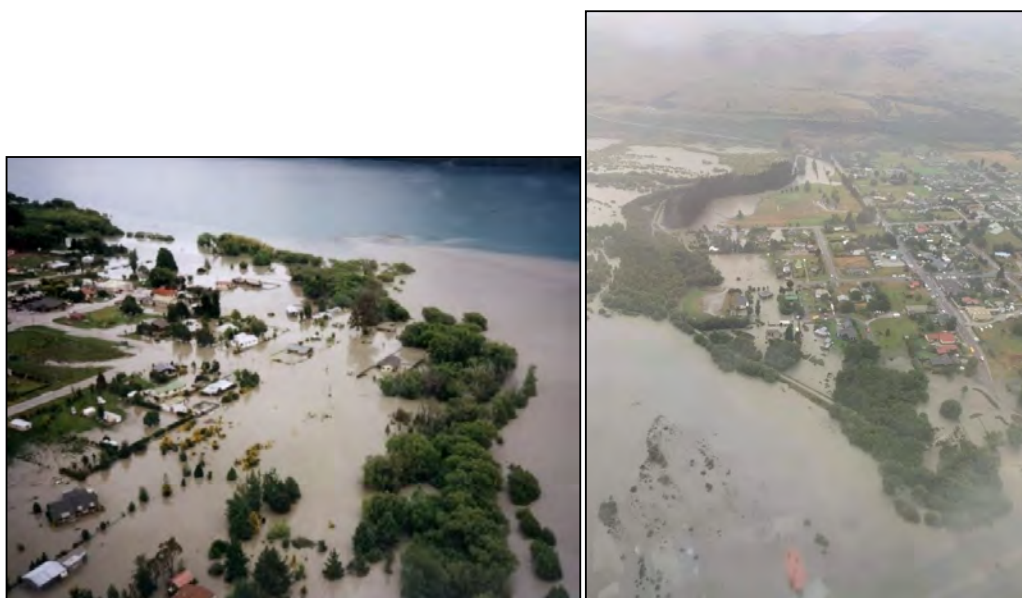
Figure 2: Flooding in Glenorchy township in November 1999 (a, left) and February 2020 (b, right). (photo of 2020 event provided by Luke Hunter).

- [22] The flooding hazard at Glenorchy township is known from observations of several flooding events in recent decades. Flooding most recently impacted on the residential area of the township in February 2020 (Figure 2b). Previous recent floods include that November 1999 (Figure 2a).

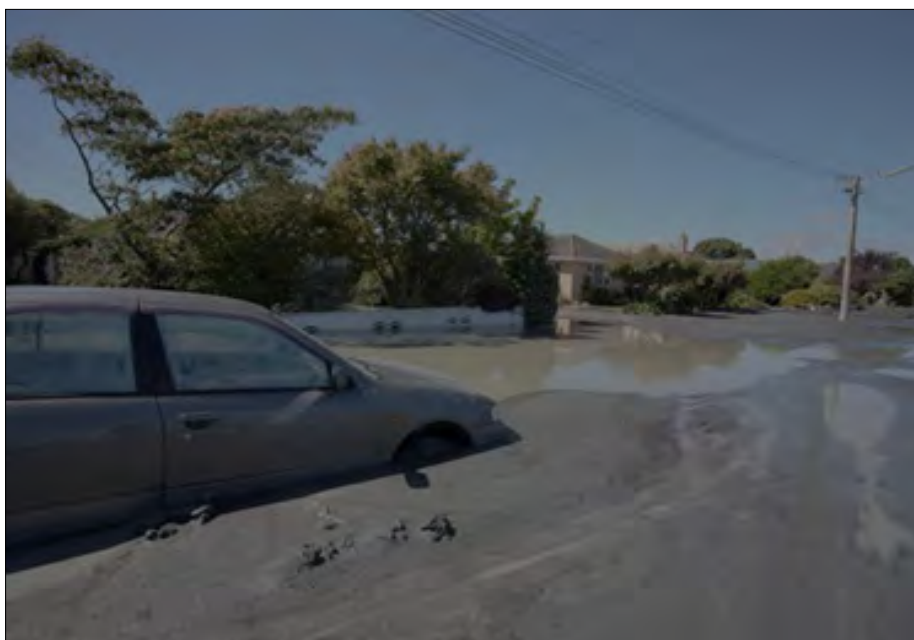
Figure 7: Example of liquefaction following the 2011 Christchurch earthquake, showing the type of liquefaction land damage expected where the LSN is 25 or greater.

- [47] The T+T report shows examples from the 2011 Christchurch earthquake of the type of liquefaction land damage expected where the LSN is 25 or greater. These examples are Figures B10, B11 and B12 of Appendix B, with one of these shown as Figure 7.

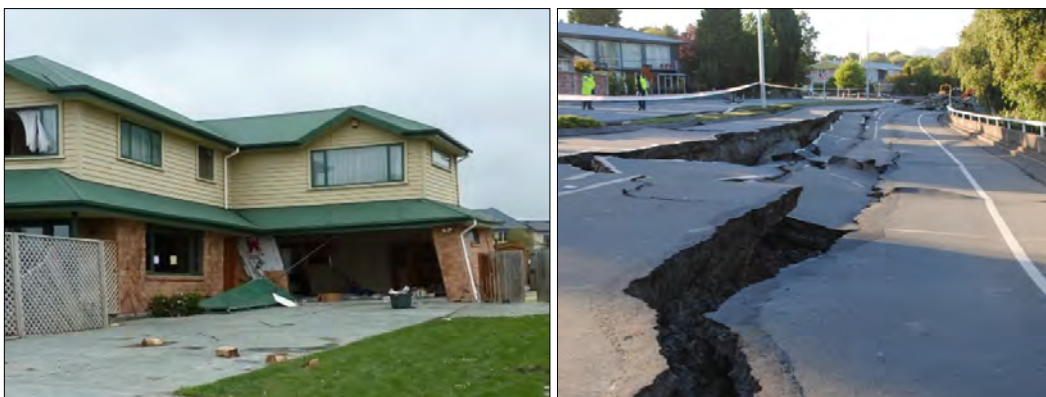
Figure 9: Example of lateral spreading damages following the 2010 Darfield and 2011 Christchurch earthquake, showing the type of damage to buildings or roads expected where lateral spreading is in the range of 1-3 metres.

- [52] The T+T report shows examples from the 2010 Darfield and 2011 Christchurch earthquakes of the type of lateral spreading damage expected where lateral spread is in the order of 1m to 3m. These are Figures B4 to B9 of Appendix B, with two of these examples shown as Figure 9.

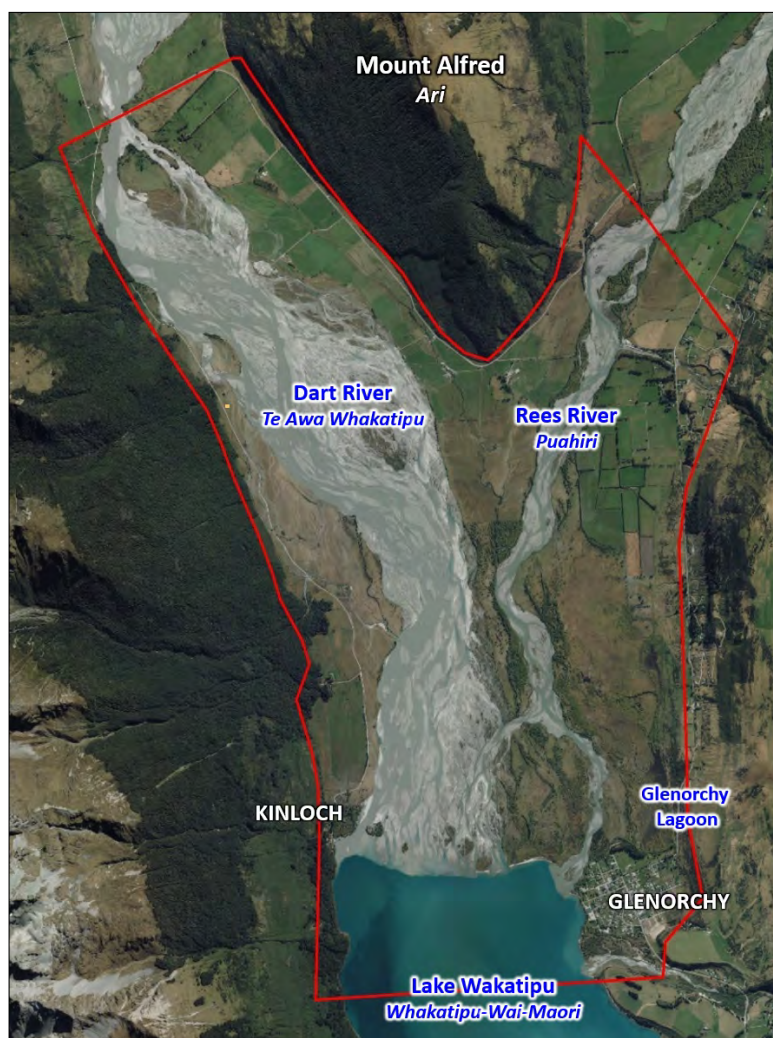
Figure 12: Overview of the lower Dart and Rees Rivers systems, showing the extent of hydraulic modelling and flood hazard assessment (red outline).

- [61] Hydraulic modelling and flood hazard assessment was undertaken for the Dart-Rees floodplain and delta for the extent shown in Figure 12.
- [62] Numerical hydraulic modelling for flood event scenarios was completed using MIKE21, an industry-standard 2D hydraulic modelling software.
- [63] Model topography is based on a 2019 LiDAR dataset, with channel bathymetry interpolated based on surveyed cross-section data.

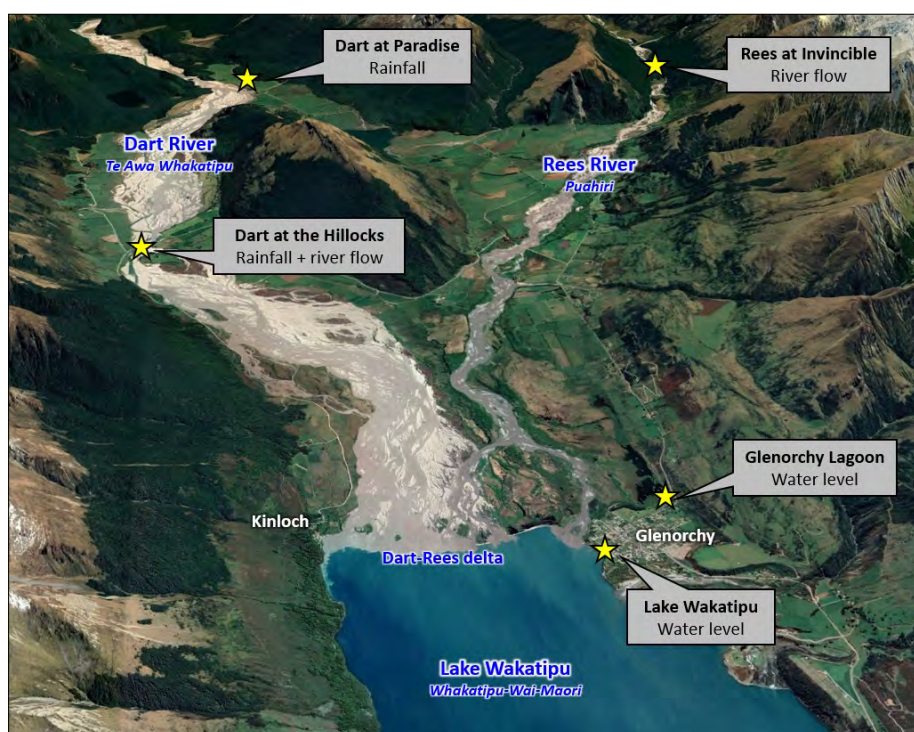
Figure 19: ORC environmental monitoring stations in the head of Lake Wakatipu area.

- [93] These three recently installed environmental monitoring stations were suggested by community members as actions to improve awareness of flood hazard following the February 2020 flooding event.
- [94] Following these additions to ORC's previously established monitoring stations at the Hillocks (since 1996) and at Paradise (since 2003), the current environmental monitoring network provides greatly improved monitoring coverage and understanding of hydrological responses to major weather events. ORC's current environmental monitoring stations in the head of Lake Wakatipu area are shown in Figure 19.

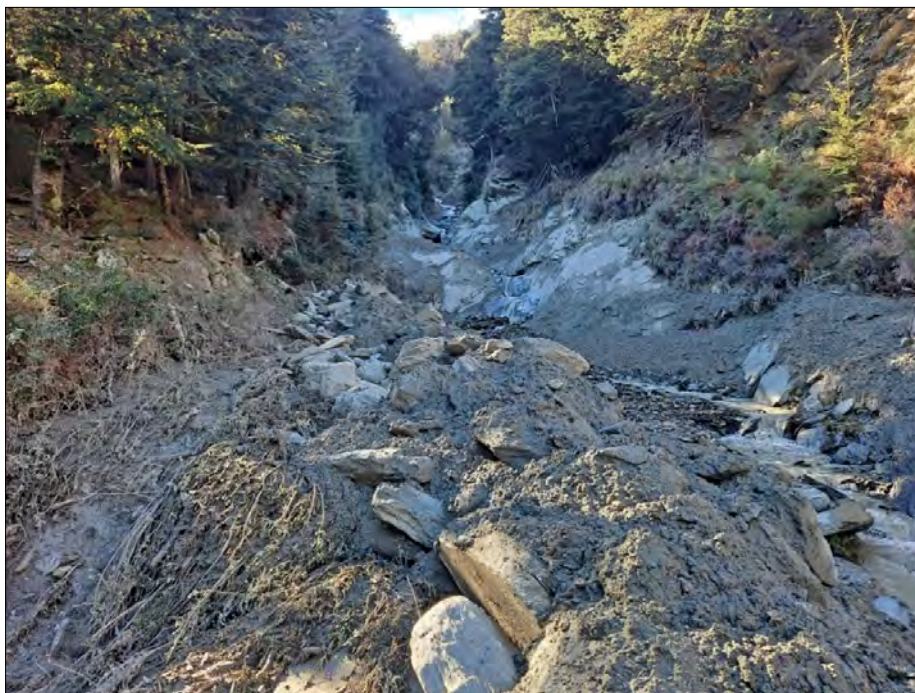
Figure 21: A lower section of Shepherd's Hut Creek following the 21 April 2022 event, showing freshly deposited debris including large boulders (photo by Scott Liddell, ORC).
