Submitter Evidence - Kim Fogelberg

**on application for resource consents
for Suction Dredge Mining on Clutha
River / Mata-Au**

Reginald Hall Evidence
7/11/2023

Clutha River/Mata-Au CGC mining dredge.

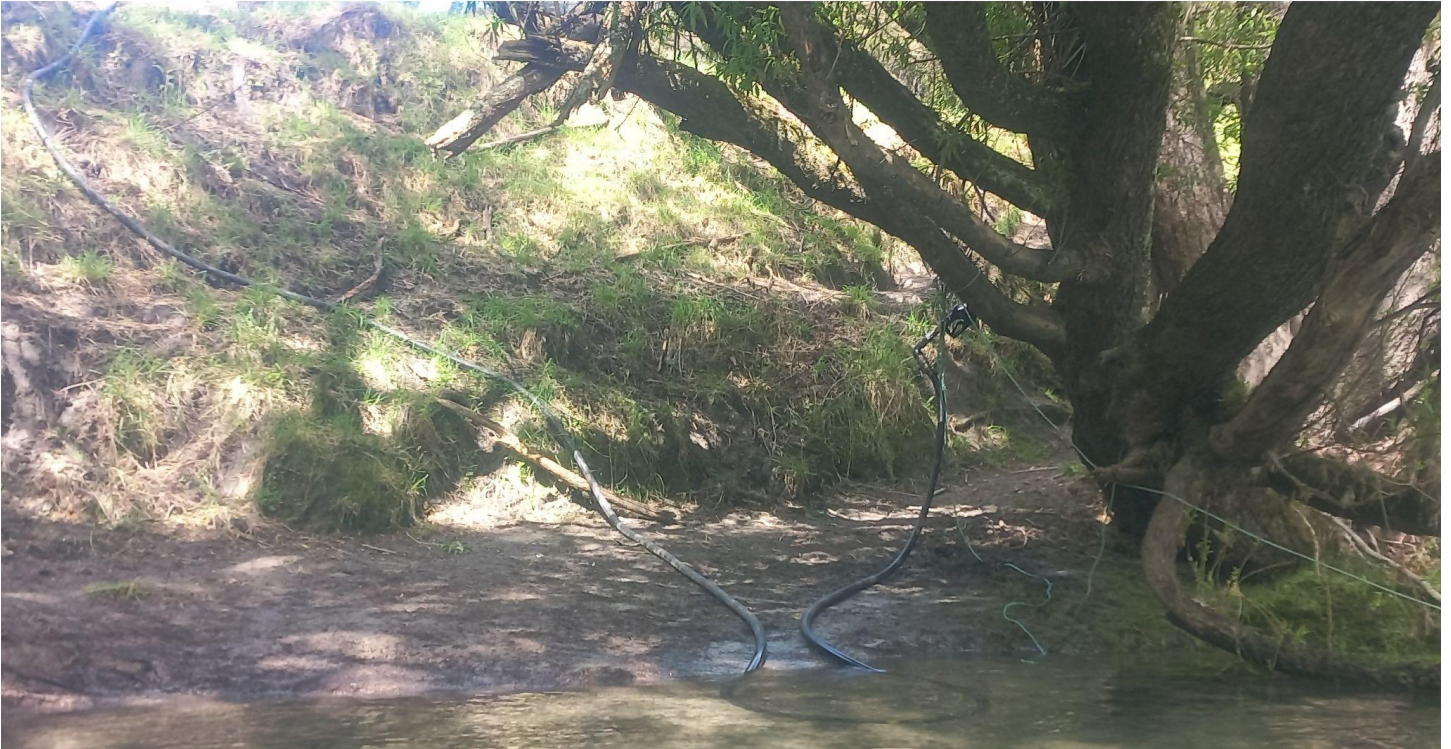
Appendix A.

Please refer to the recent photo of the CGC1 river bank fuel transfer station. Note the fuel hose hanging in a willow over the river. (Appendix A.)

Fuel transfer site on the Clutha River for CGC1 taken on 28/10/2023

This has been referred to the ORC pollution hotline.
