Salt Ecology Short Report 022. Prepared by Barrie Forrest for Otago Regional Council, March 2023

OVERVIEW

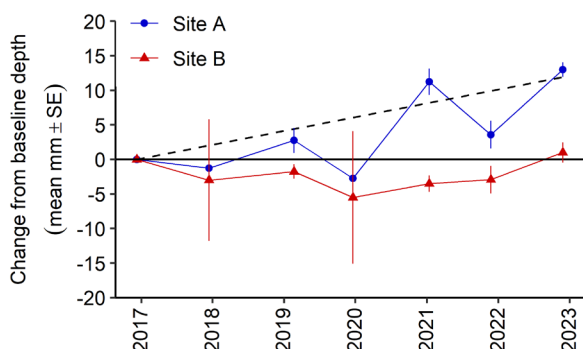
The cumulative change in sediment depth over plates at each site is shown in Fig. 2. The mean sedimentation rate over the past 5 years at Site A has exceeded the national guideline value of 2mm/yr, corresponding to a condition rating of ‘poor’. Long-term sedimentation has been relatively low at Site B. However, at both sites sediment accrual was observed between November 2021 and November 2022, with the annual sedimentation rate at both sites exceeding 2mm/yr (rated ‘poor’, Table 3). The temporal variance in erosion and accretion at the monitoring sites, illustrated by Fig. 2, likely reflects the river-dominated hydrological setting, periodic restriction of the estuary

Fig. 2. Temporal change in mean sediment depth over buried plates (\pm SE) relative to the Dec-2016 baseline. The diagonal black dashed line represents accretion since the baseline at the national guideline value of 2mm/yr.

The sedimentation rate over the past 6 years has been highly variable, but the average has exceeded the 2mm/yr national guideline value at Site A. The November 2022 results show that fine sediment deposition has occurred in the past year and that the estuary flats remain under pressure from muddy sediments. These findings reinforce previous recommendations (e.g. Robertson et al. 2017) to monitor and manage catchment sediment sources.

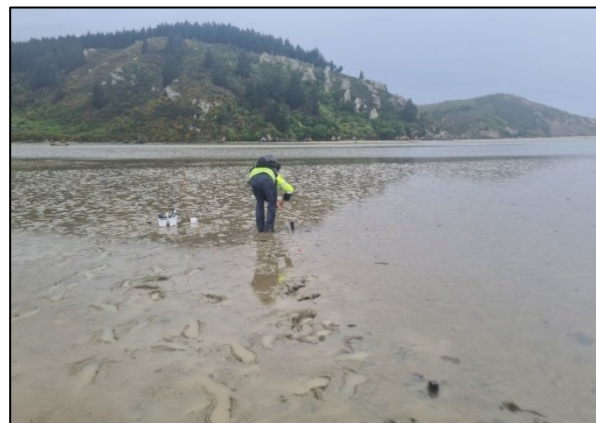
Sediment mud content at both sites was slightly higher than in the previous survey, and was rated as 'poor', as it exceeded the biologically relevant threshold of 25% (Table 3).

Muddy surface sediments at Site A in November 2022

Continue annual monitoring of sedimentation rate, sediment grain size and aRPD depth, and report results annually via a summary report. Comprehensive reporting should be undertaken 5-yearly as part of 'fine scale' ecological and sediment monitoring (next due in the summer of 2023/24).
