Flood hazard on the Taieri Plain

Review of Dunedin City District Plan:
Natural hazards

First revision: August 2015

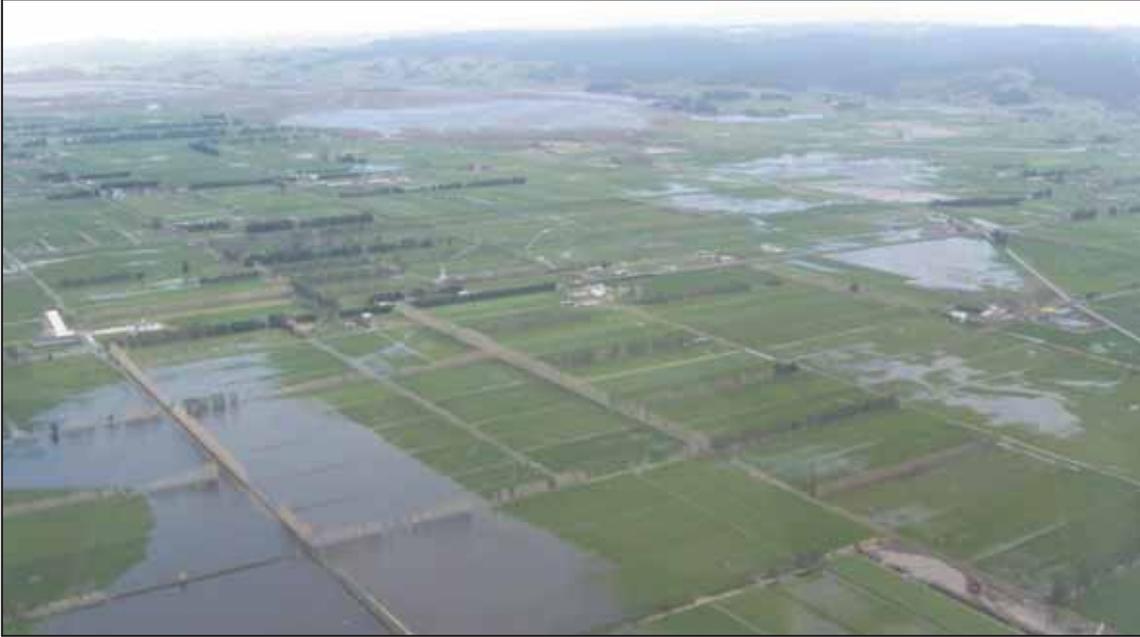
Figure 4. Aerial view of ponding on the West Taieri Plain, resulting from internal runoff from areas 1A and 1B during heavy rainfall in June 2013 (195mm over eight days at the Riccarton Road rain gauge). Lakes Waipori and Waihola can be seen in the distance.

Flood-hazard characteristics and effects: Extensive ponding is the main type of hazard in this area, with depths ranging from less than 0.5m on the margins, to more than 3m in some places (Figure 3). Sources of flooding include the Taieri River to the south, Waipori River to the west, Maungatua Range to the north and internal runoff from areas 1A, 1B and 1C. The flood hazard associated with these waterways can be significant (ORC, 2013). The natural tendency of waterways to inundate Area 1A is mitigated to some extent by flood-protection and drainage schemes. As a result, flood hazard in this area is generally limited to ponding of a moderate depth and duration and low-velocity flows (see Scenario 1 and Figure 4 below).

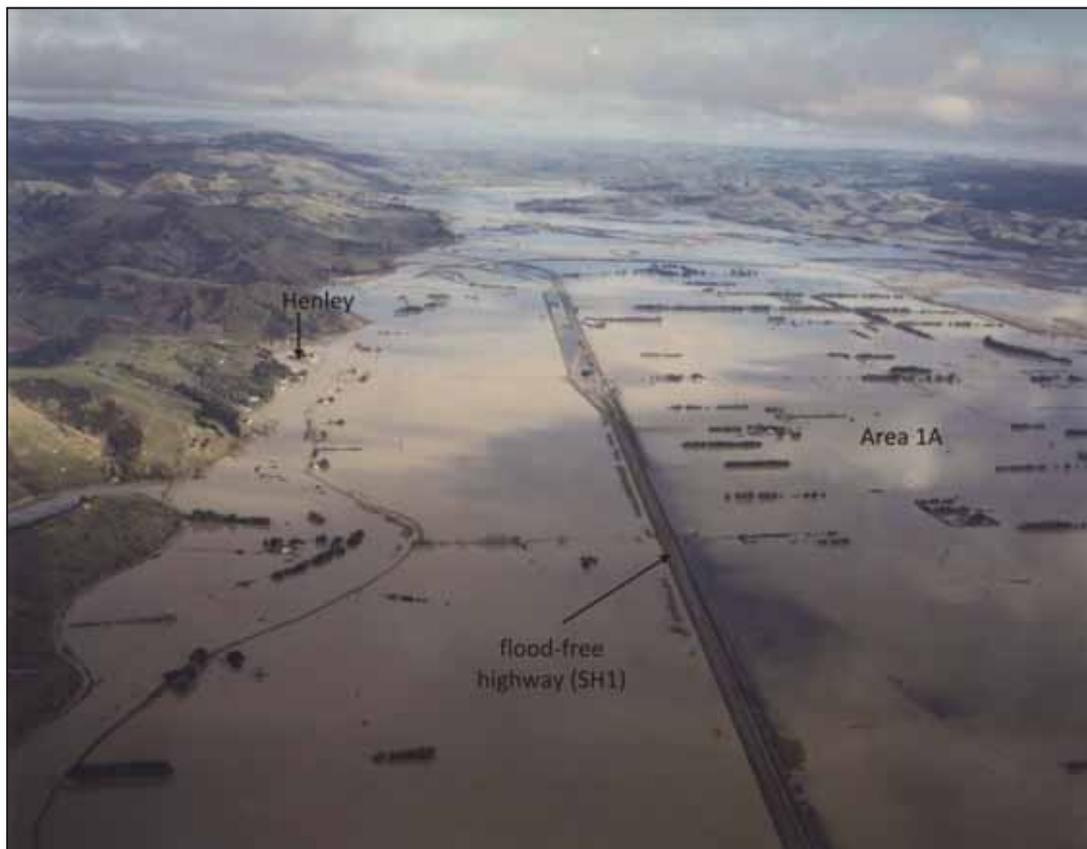
Figure 5. Aerial view (looking south) of flooding on the West Taieri, following the June 1980 flood event. Area 1A is to the right (west) of the 'flood-free' highway, while Areas 9, 10 and 11 are to the left.

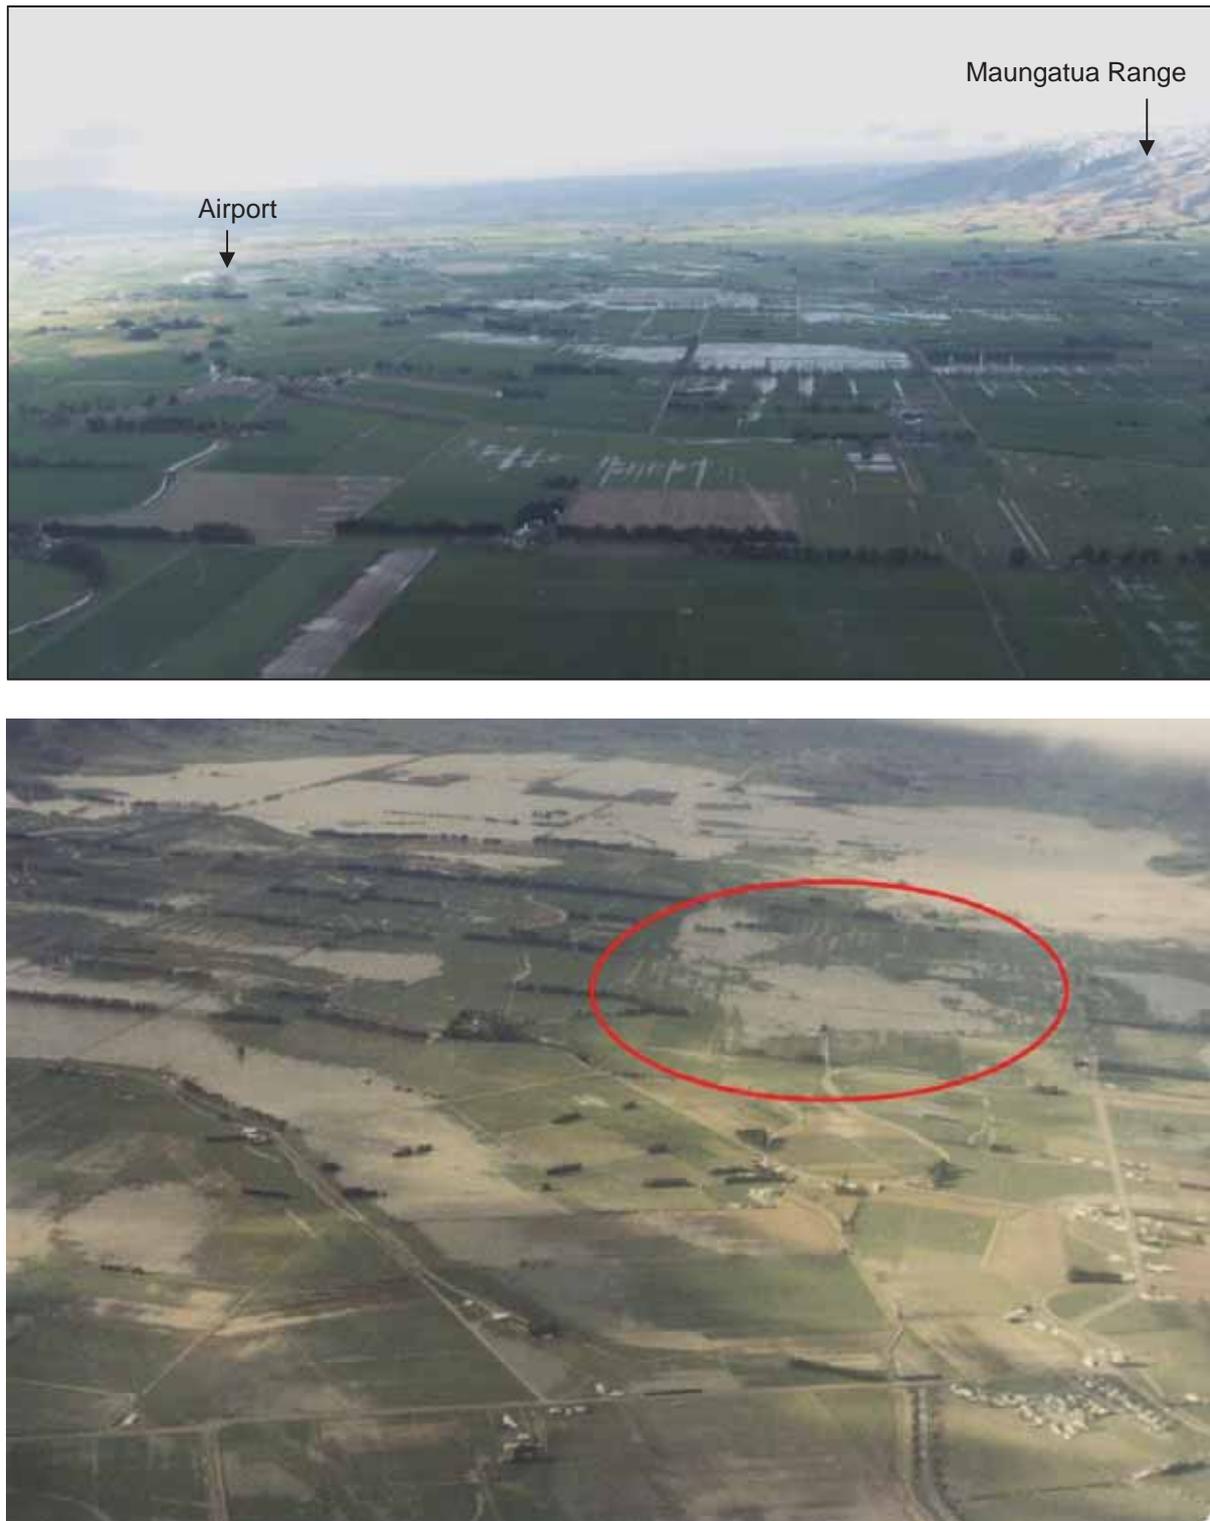
Figure 7. Top: Aerial view of ponding on the West Taieri Plain (looking south), resulting from internal runoff during heavy rainfall in June 2013 (195mm over 8 days at the Riccarton Road rain gauge). Bottom: Looking northeast across Area 1B, with the lowest-lying part (labelled X in Figure 6) circled in red, August 1978. The ponding areas can be seen in the distance.

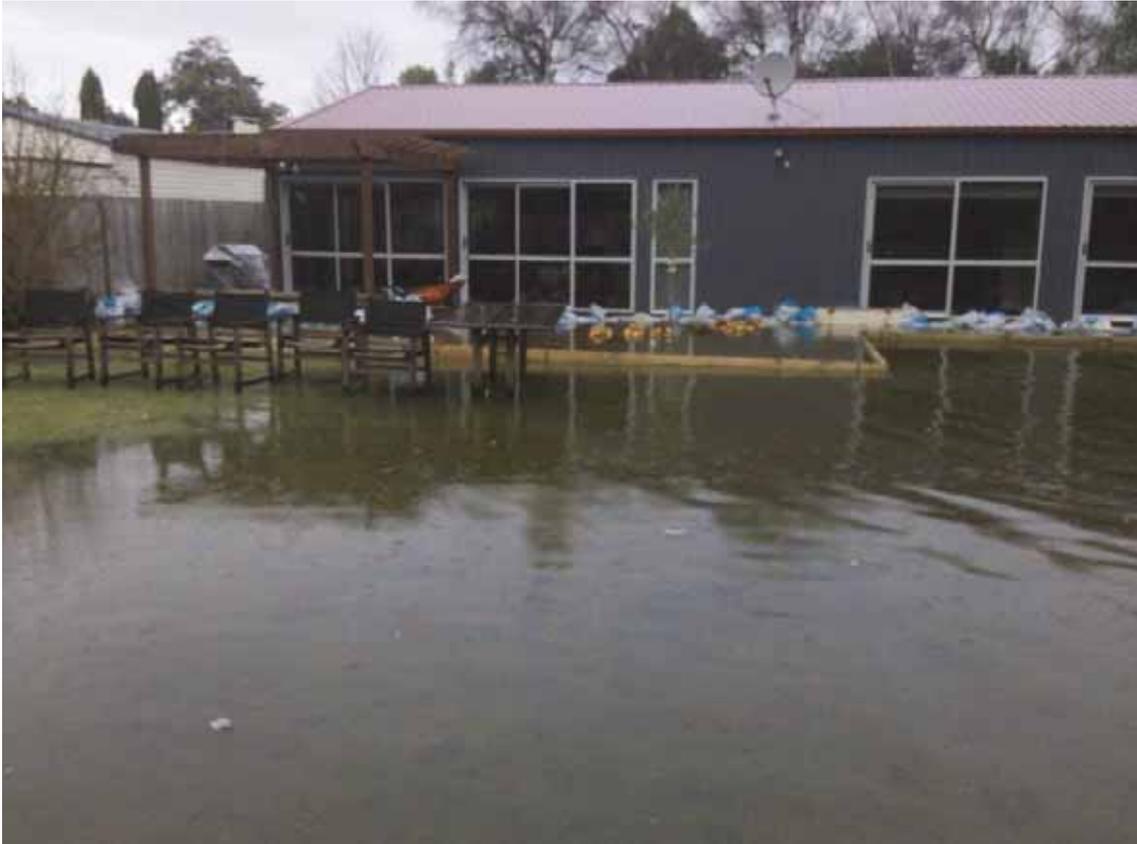
Figure 10. Water ponding around a residential property located within Area 1C, in July 2013

The depth of water in these features ranges from reasonably shallow (<0.5m) (Figure 10) to more than 2m in the larger and more defined features (Figure 9). Similarly, the velocity of floodwater can vary from relatively slow to fast (more than 1m/s) in the major drains. Where the flow path is not currently impeded, the duration of flooding may be limited to a few hours during the time of peak-rainfall intensity. However, where there is no clear outlet, or where obstructions, such as road embankments, impede the drainage of water, the duration of flooding may be much longer, and in some cases require pumping to remove floodwater.

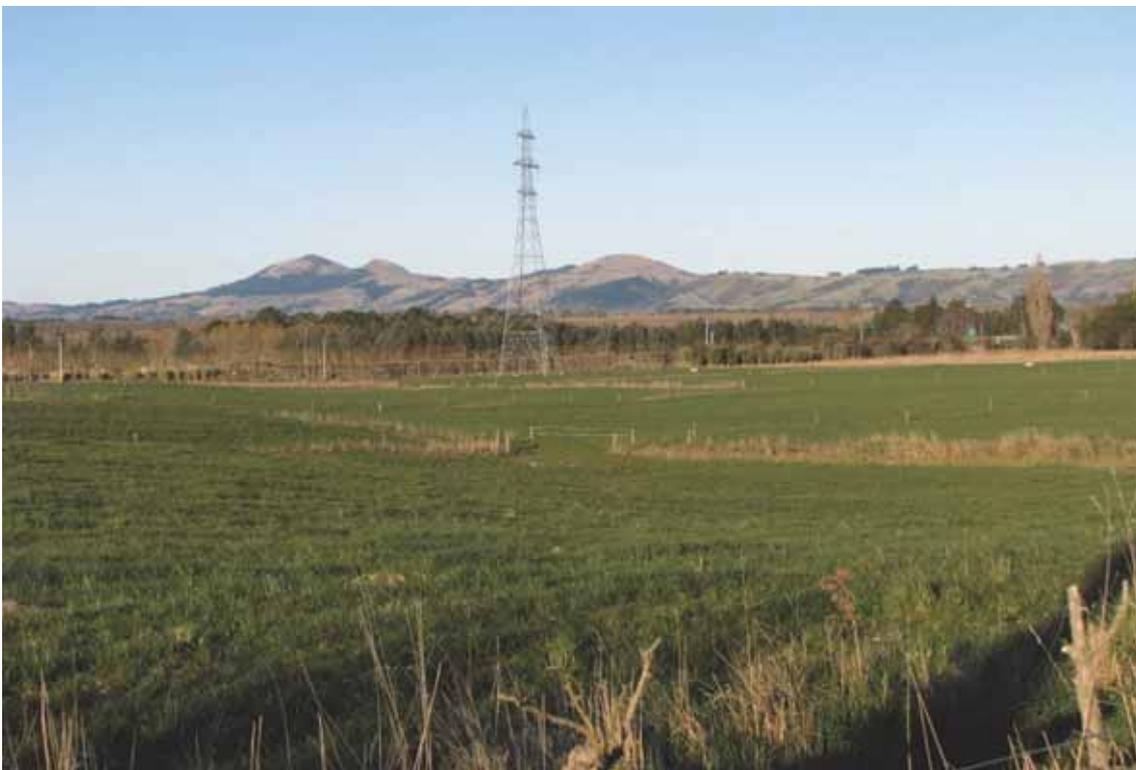
Figure 12. Looking east across the lower reaches of an active flood-water-dominant alluvial fan that drains from the Maungatua Range

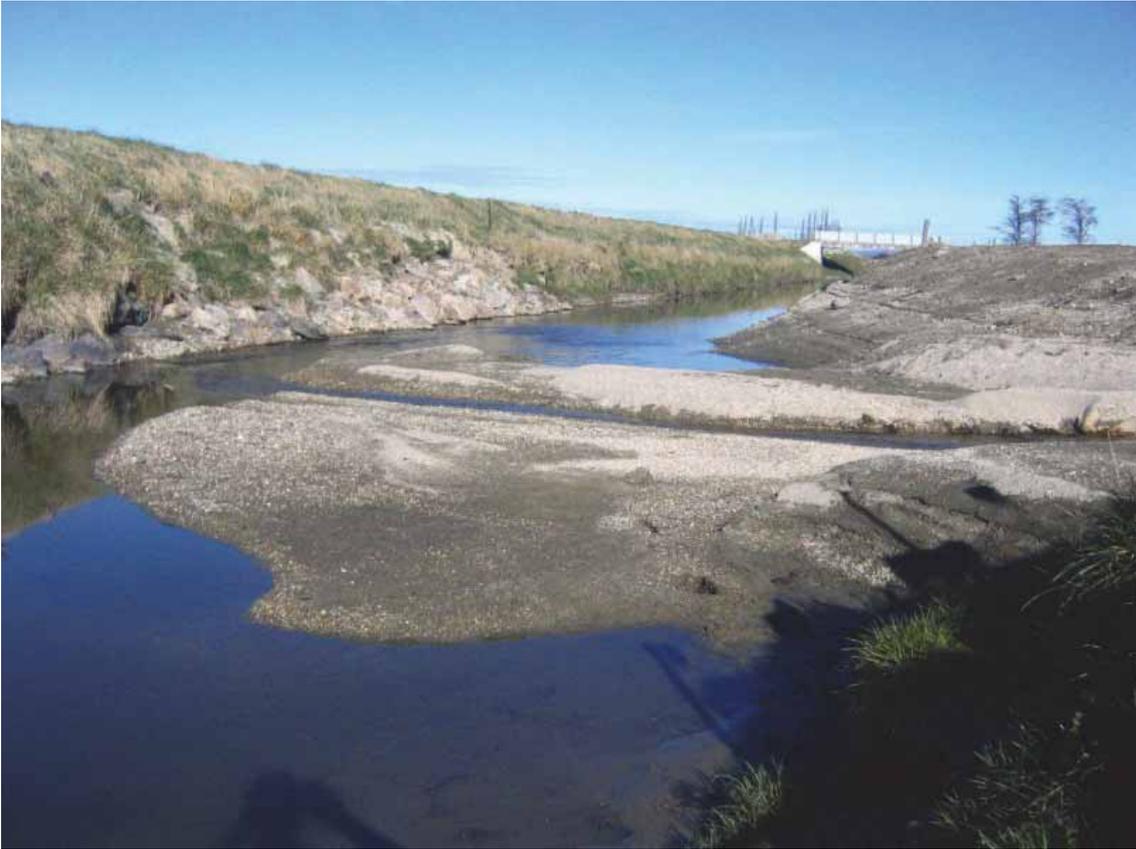
Figure 13. Deposition of gravel in the Contour Channel from a tributary hill stream

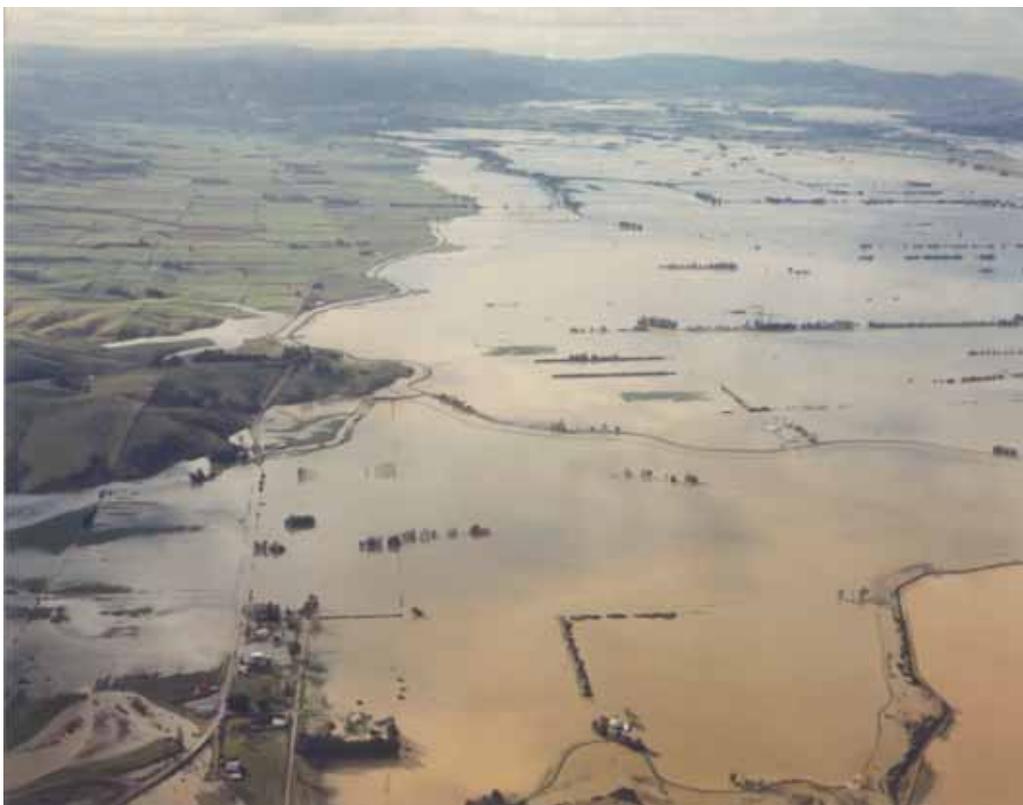
Figure 15. West Taieri Plain, looking north, with Berwick in the left foreground, June 1980. The photo was not taken at the maximum extent of flooding.

This area was extensively inundated in the floods of 1868, 1923 and 1980 (ORC, 2013) (Figure 15). Floodbanks that are part of the Lower Taieri Flood Protection Scheme provide a low level of protection during flood events. The ability of floodwater to drain from this area is affected by the level of Lake Waipori, which in turn can be affected by conditions at the mouth of the Taieri River.

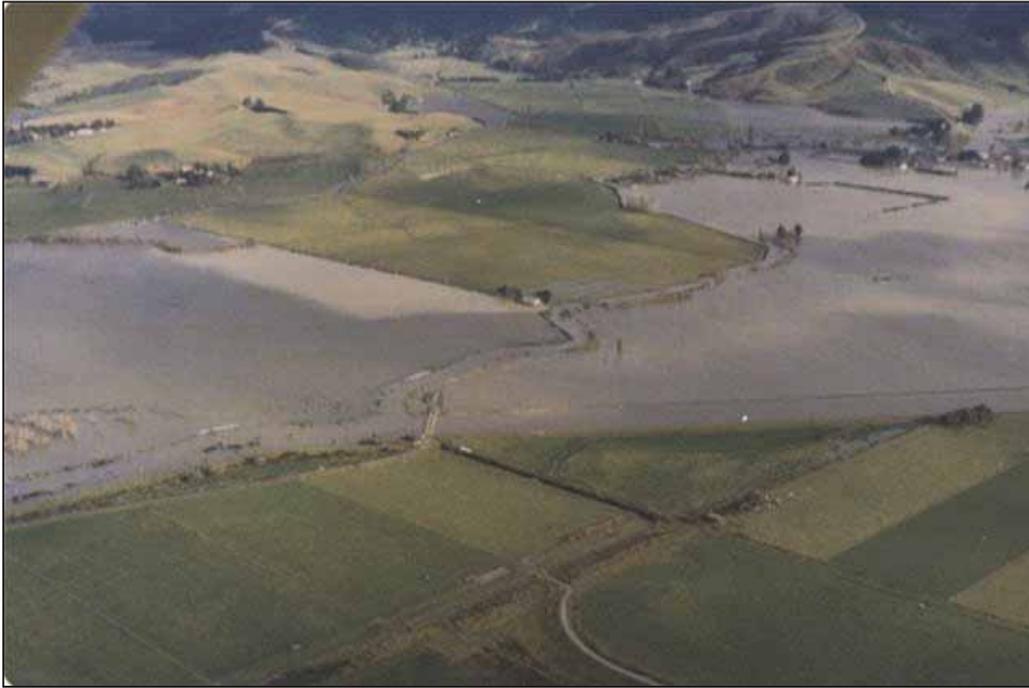
Figure 16. Aerial view of Waipori River No. 1 contour channel bridge, looking towards Berwick, May 1977. The photo was not necessarily taken at the peak of the flood.

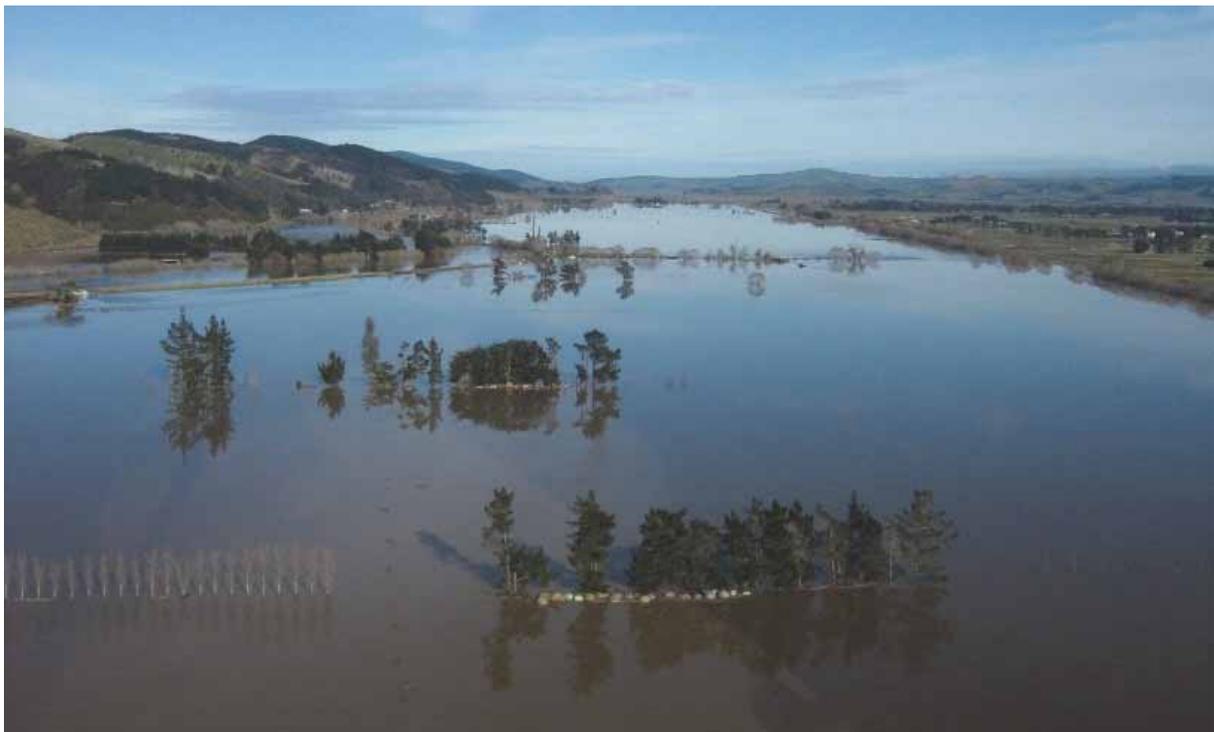
Figure 25. Lower Taieri floodway, looking downstream to Henley, 31 July 2007. Several rows of trees and balage lie perpendicular to the direction of flow.

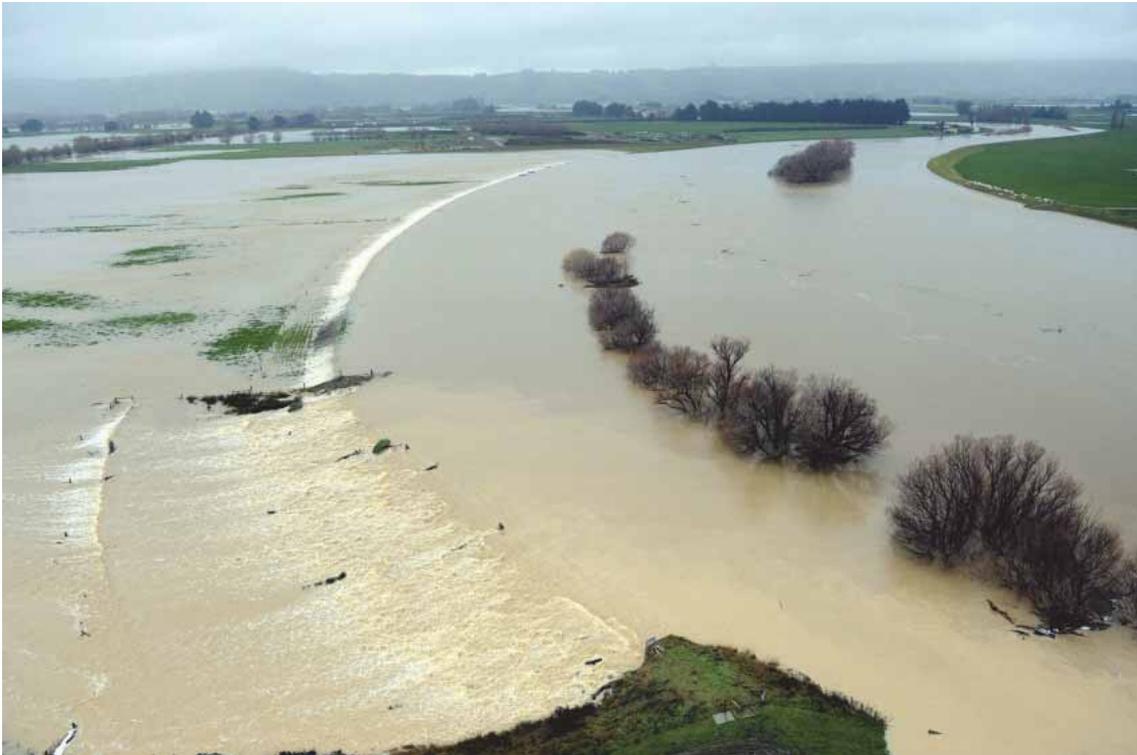
Figure 30. Taieri River flows spilling into Area 12 on 29 May 2010. (Photo courtesy of Otago Daily Times)

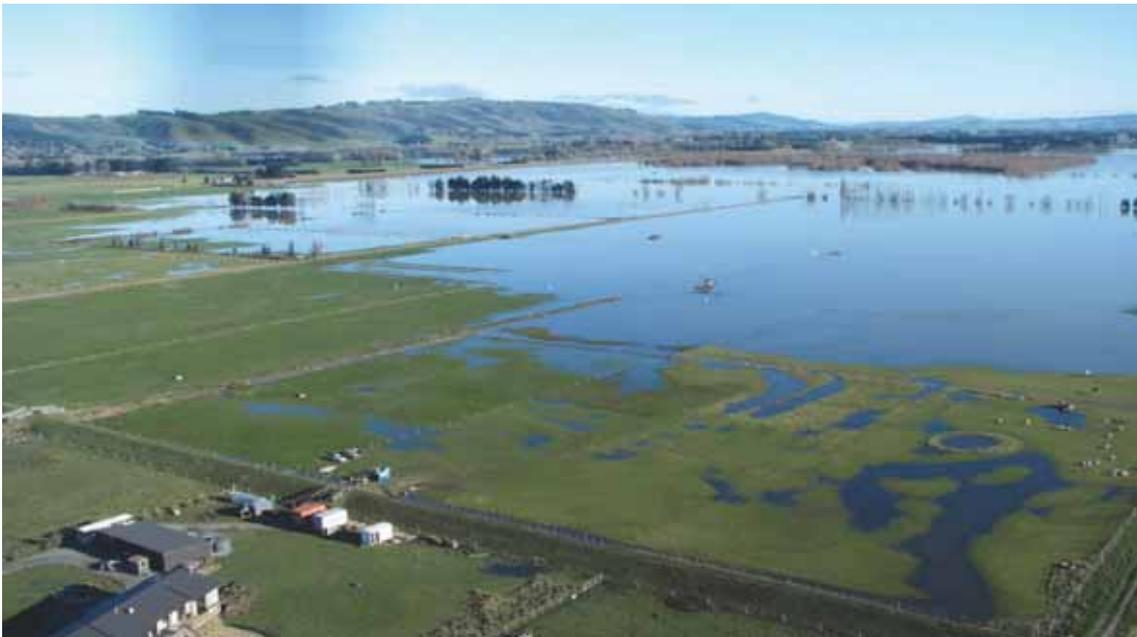
Figure 31. Water ponding in Area 12 on 31 May 2010. The Upper Pond cut-off bank is at the bottom of the image.

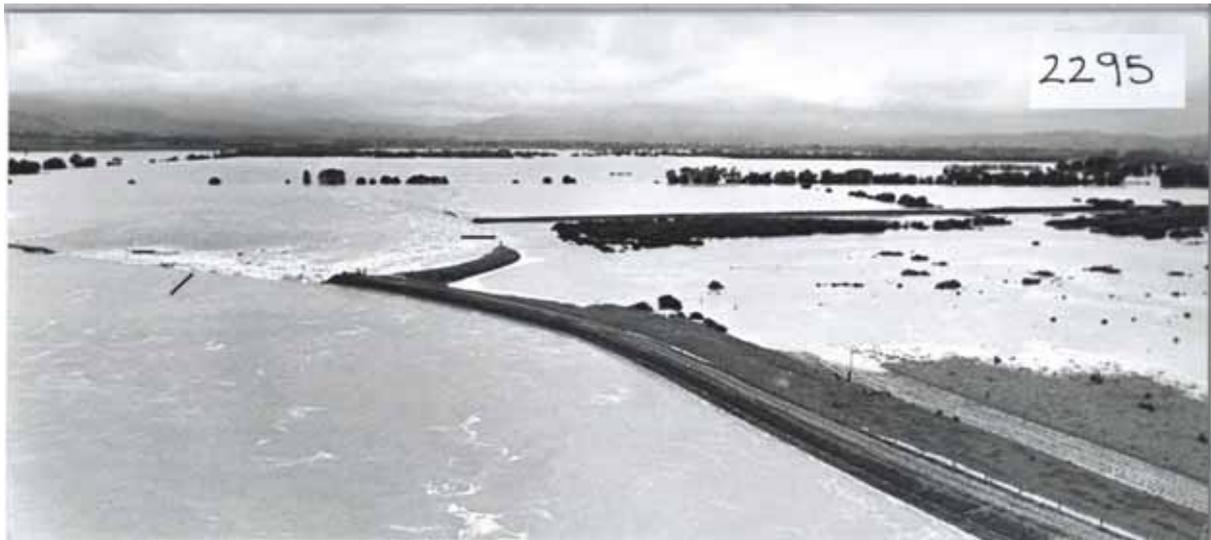
Figure 36. Breach of the northern section of the Area 13B ring bank during the December 1993 flood event. The location and direction of this photo are shown in Figure 33.

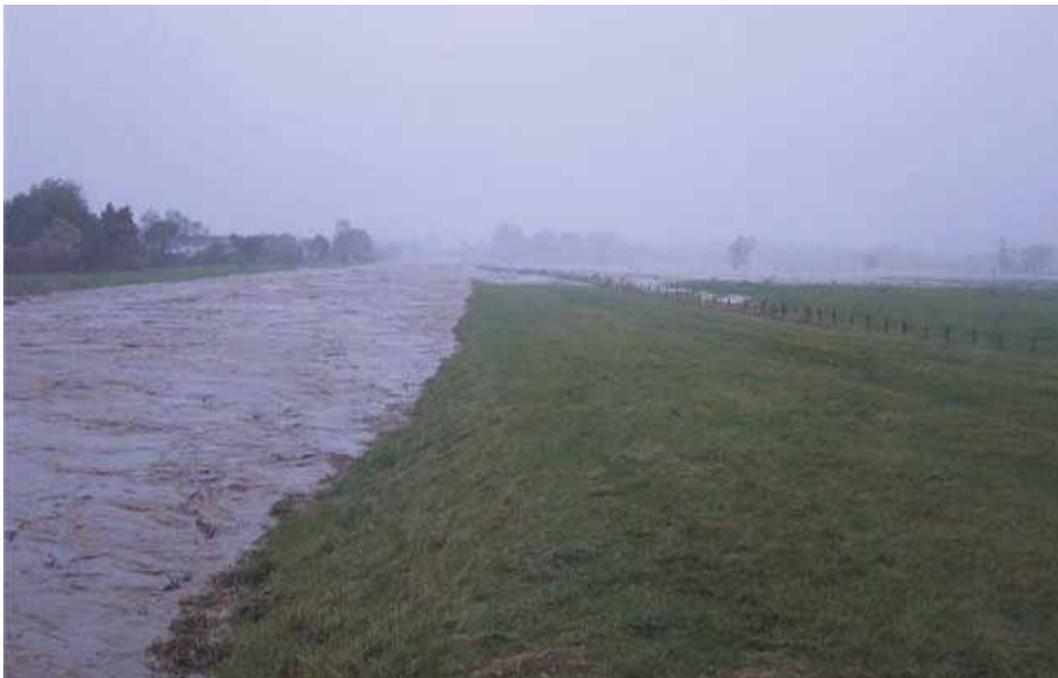
Figure 38. Silver Stream flows spilling over the Gordon Road spillway (April 2006)

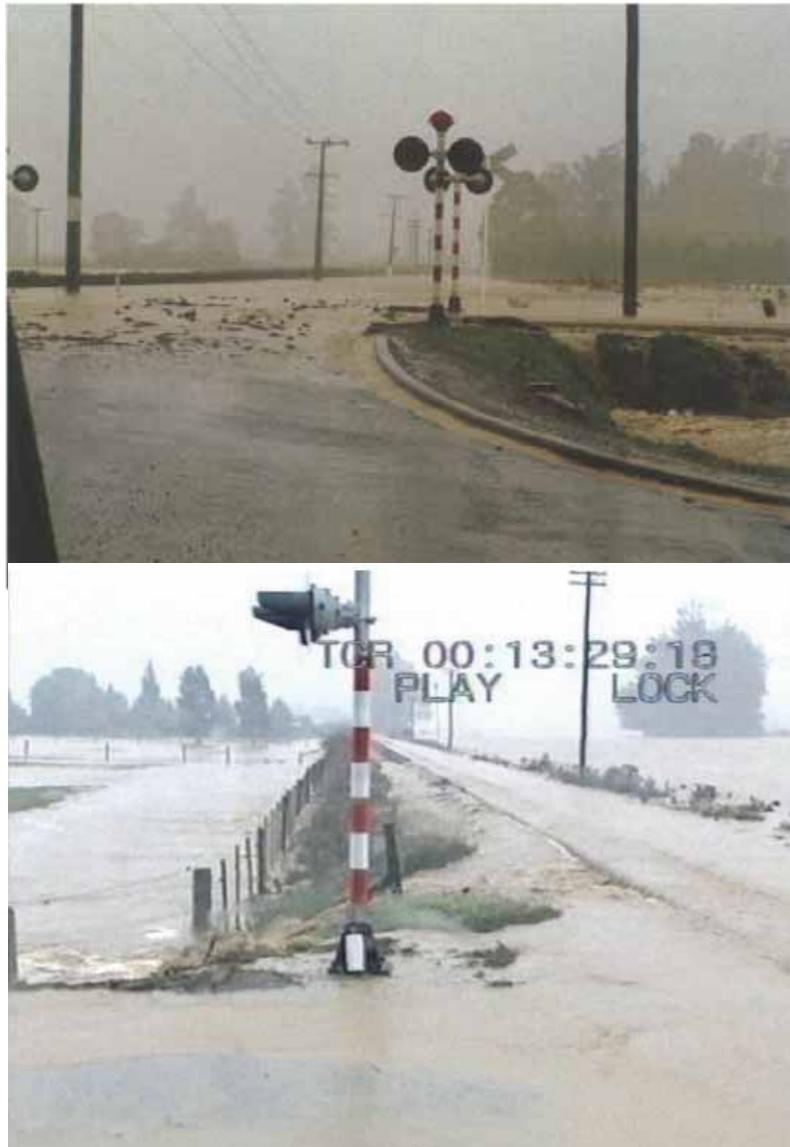
Figure 40. Water ponding behind the Taieri Gorge Railway, 26 April 2006

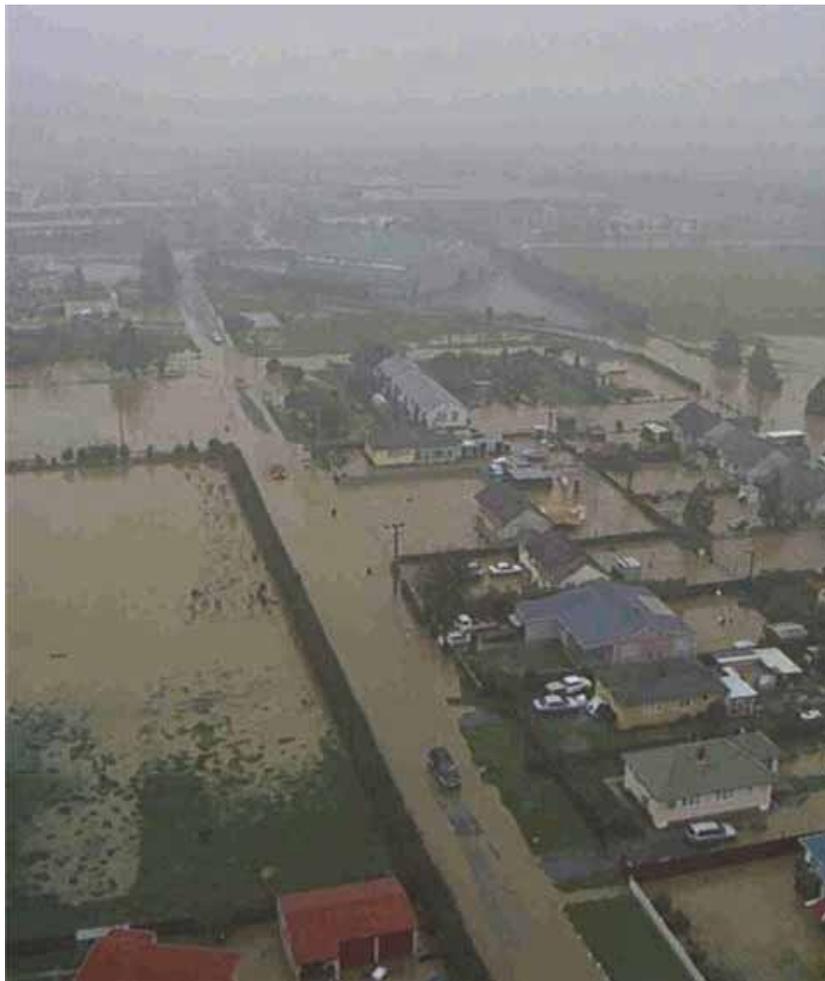
Figure 46. Flooding of residential properties within Area 14D (looking down Hazlett Road to Dukes Road north (April 2006))

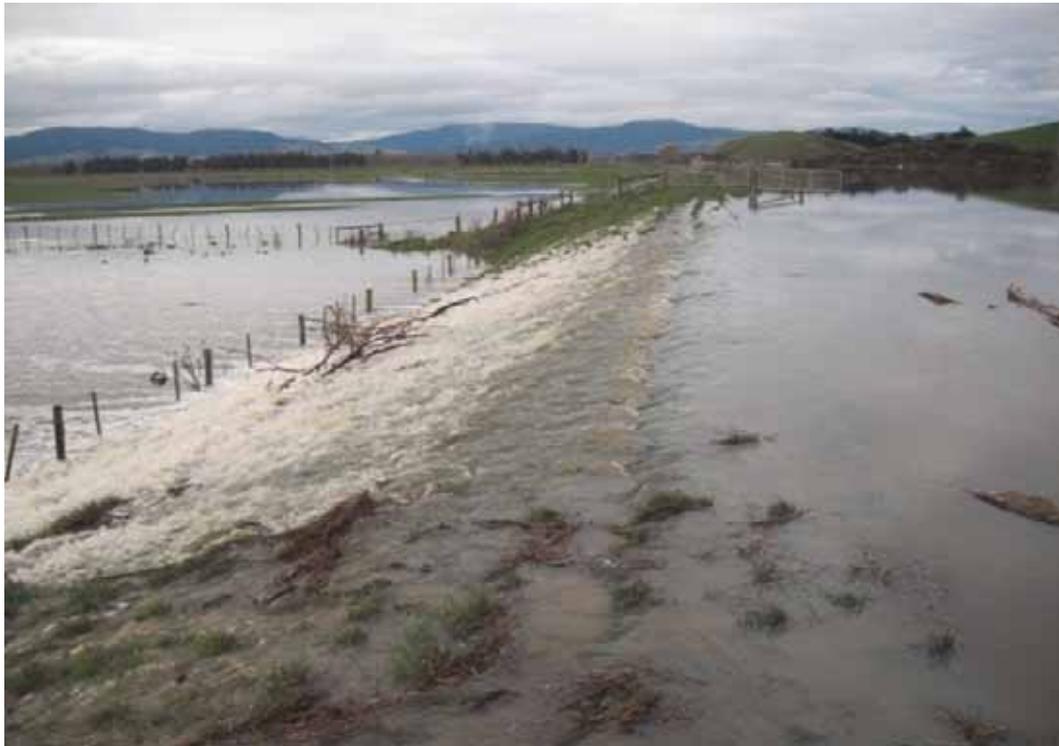
Figure 47. Overtopping of the Owhiro Stream into Area 17 (August 2012)

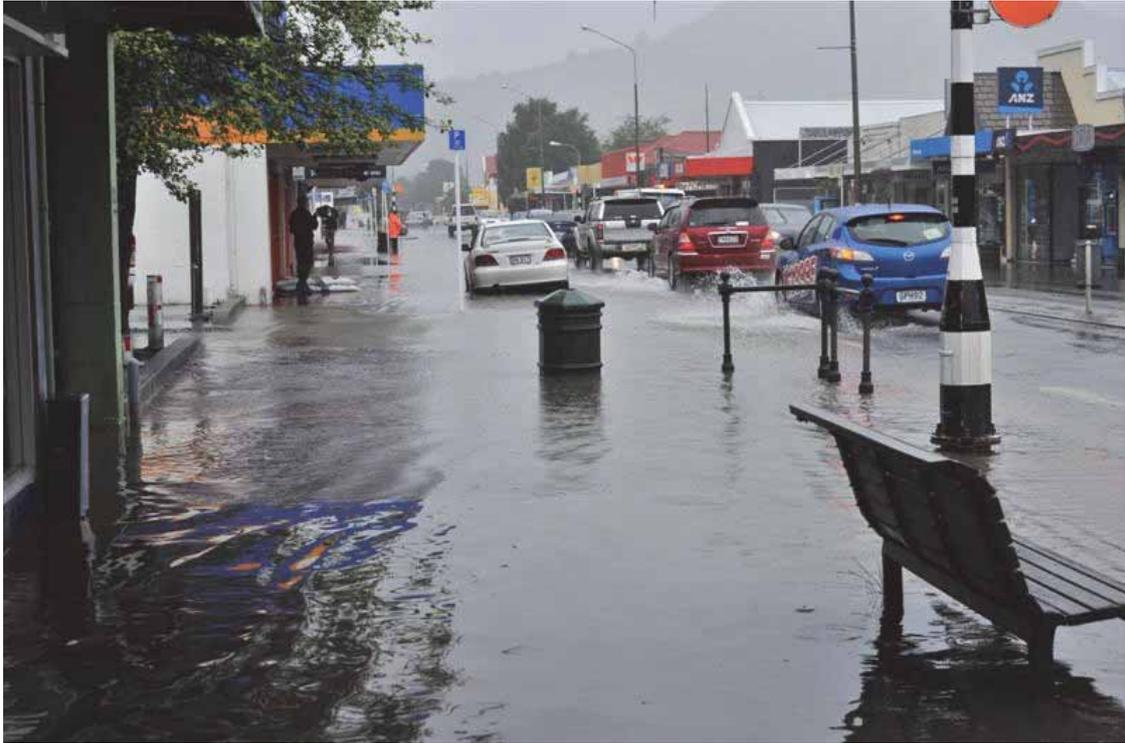
Figure 51. Surface flooding on Gordon Road, November 2012. (Source: Otago Daily Times)

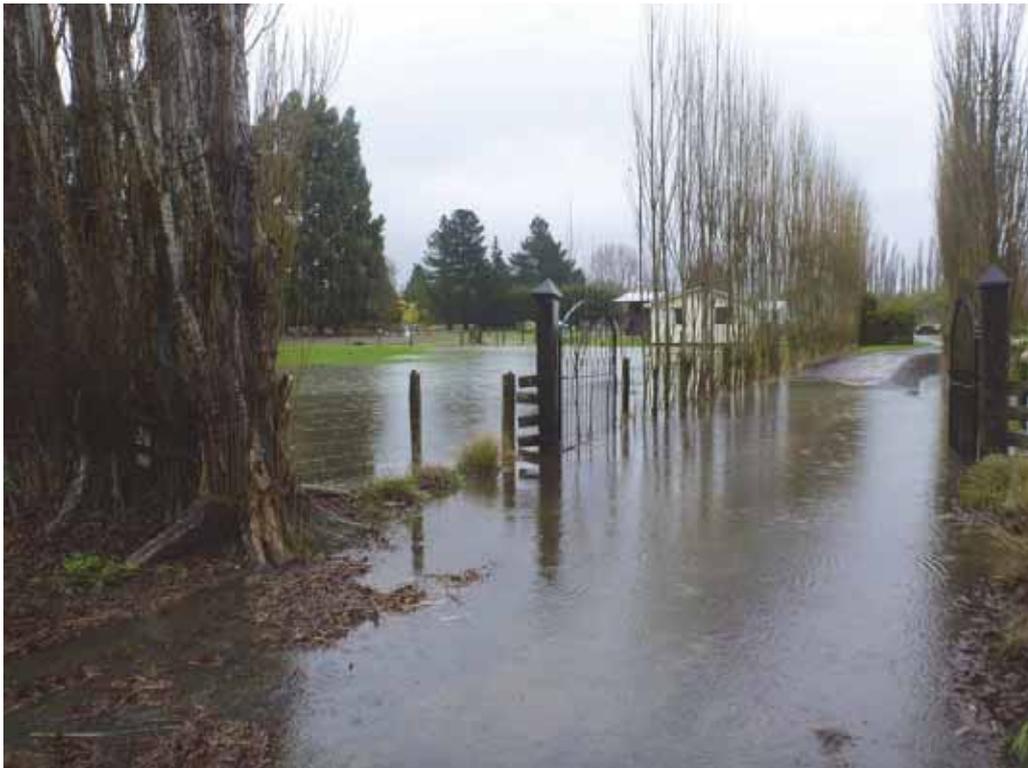
Figure 54. Overland flow, which has drained from the adjacent hill catchment, ponding near Puddle Alley, at the northern end of Area 21 (June 2013)

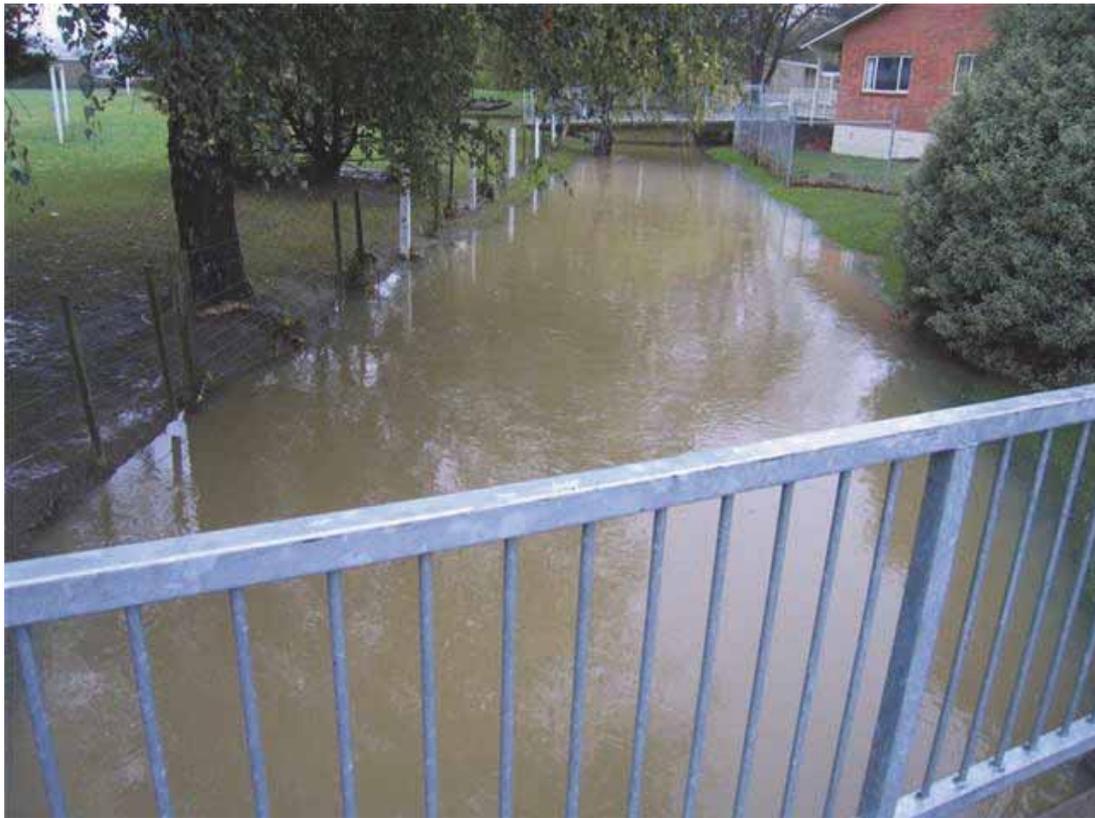
Figure 57. Quarry Creek at Cemetery Rd Bridge, April 2006. Photo not taken at the time of peak flow.

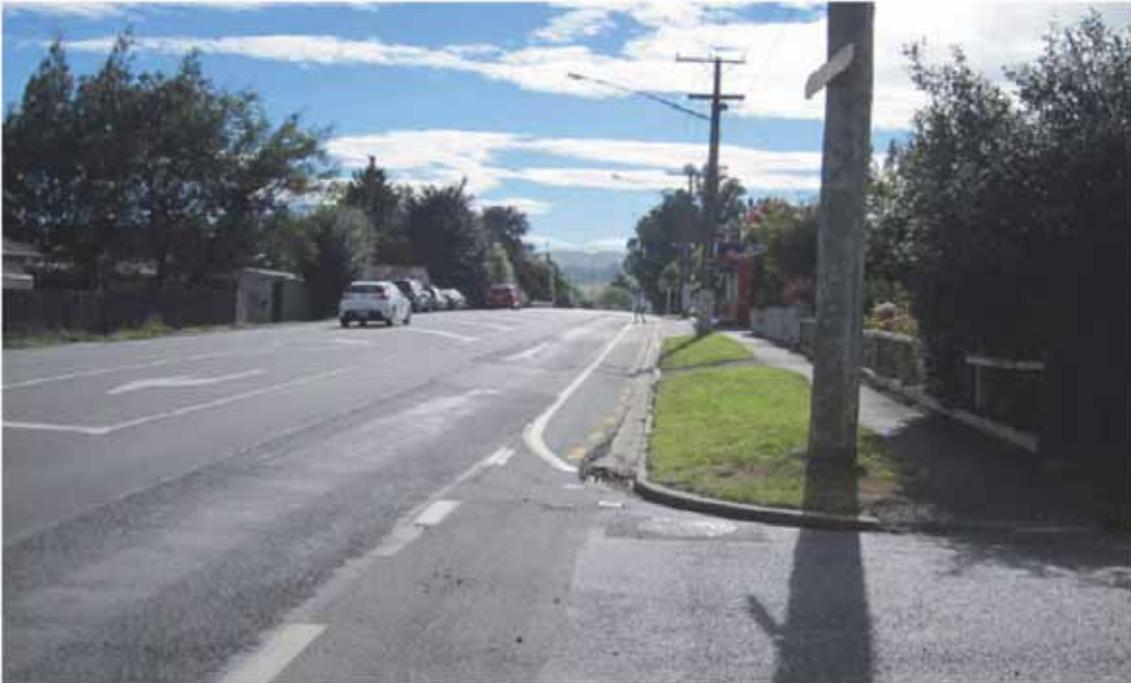
Figure 61. A view northeast along SH1 at East Taieri township, showing the fan of Jaffray Stream. The road rises over the fan axis, and Jaffray Stream is conveyed in a culvert at the point where the road goes out of sight. If the culvert were to become blocked by debris during a major rainstorm, there is potential for flooding and sedimentation on the fan surface. (Photo: D. Barrell, 17 February 2014, GNS Science.)

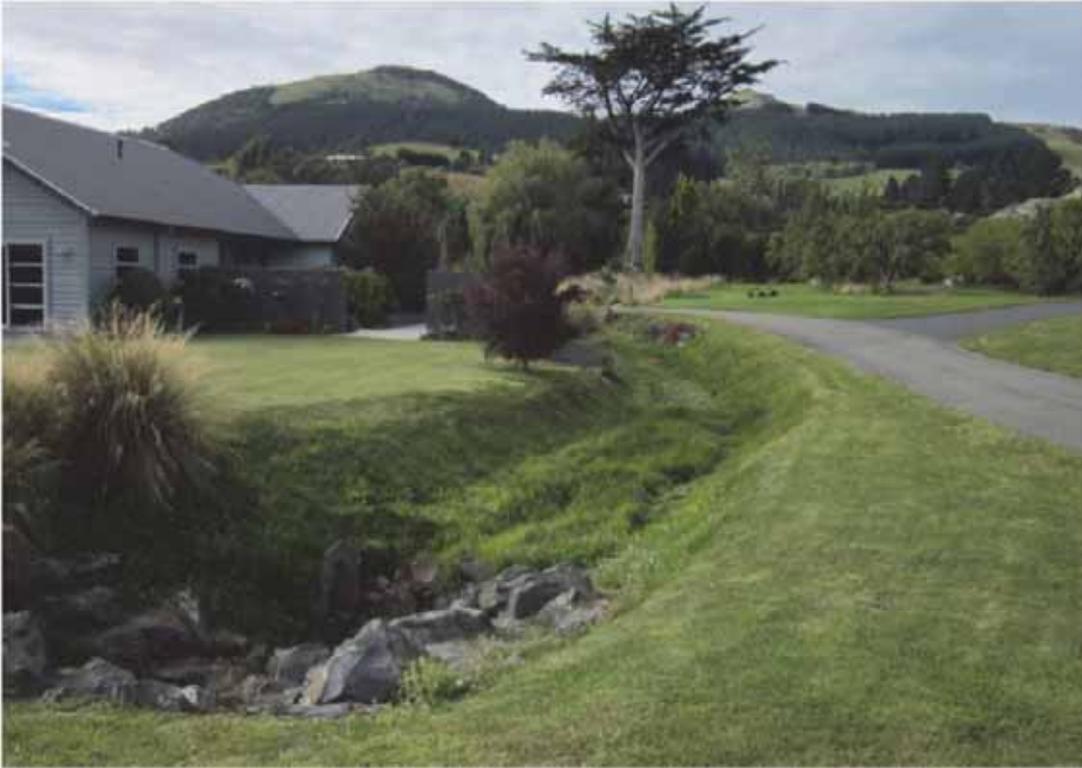
Figure 62. The engineered channel of Jaffray Stream at Orchard Grove, East Taieri. The head of its approximately 70ha catchment extends between Saddle Hill (left) and Jaffray Hill (right). (Photo: D. Barrell, 17 February 2014, GNS Science.)

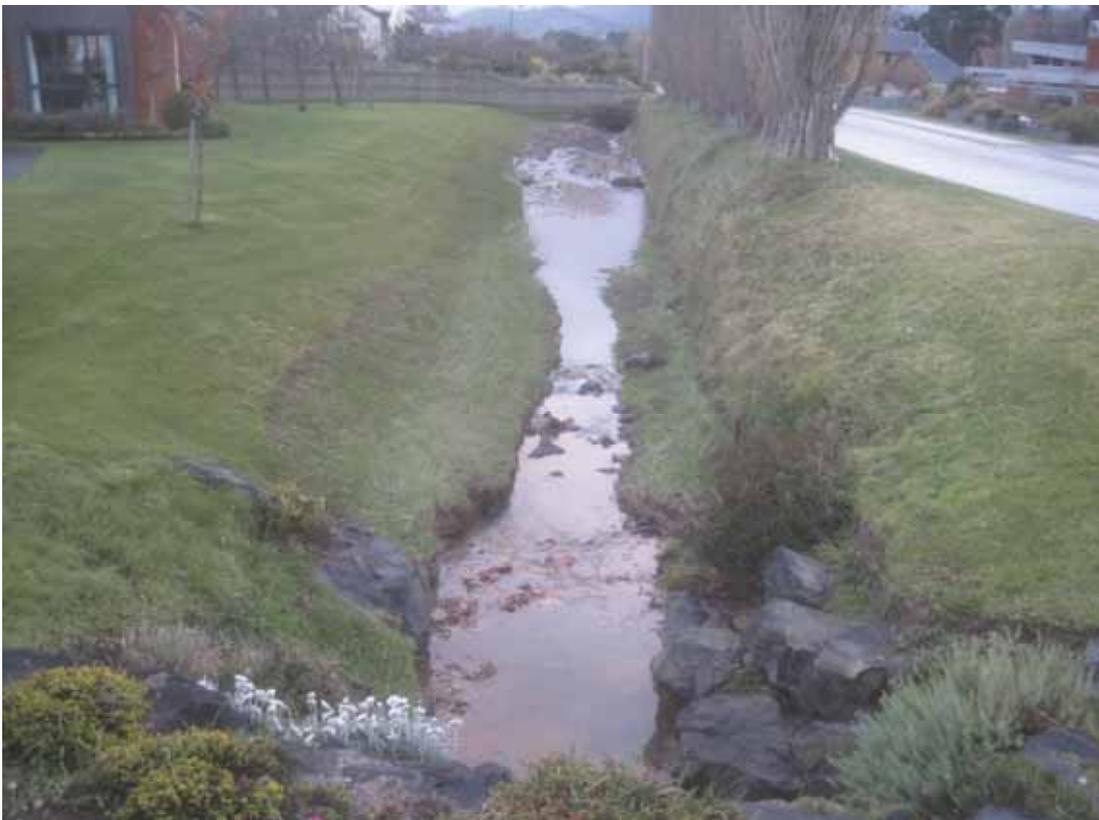
Figure 63. Debris marks and channel aggradation in Jaffrays Stream, following a heavy rainfall event on 3 June 2015

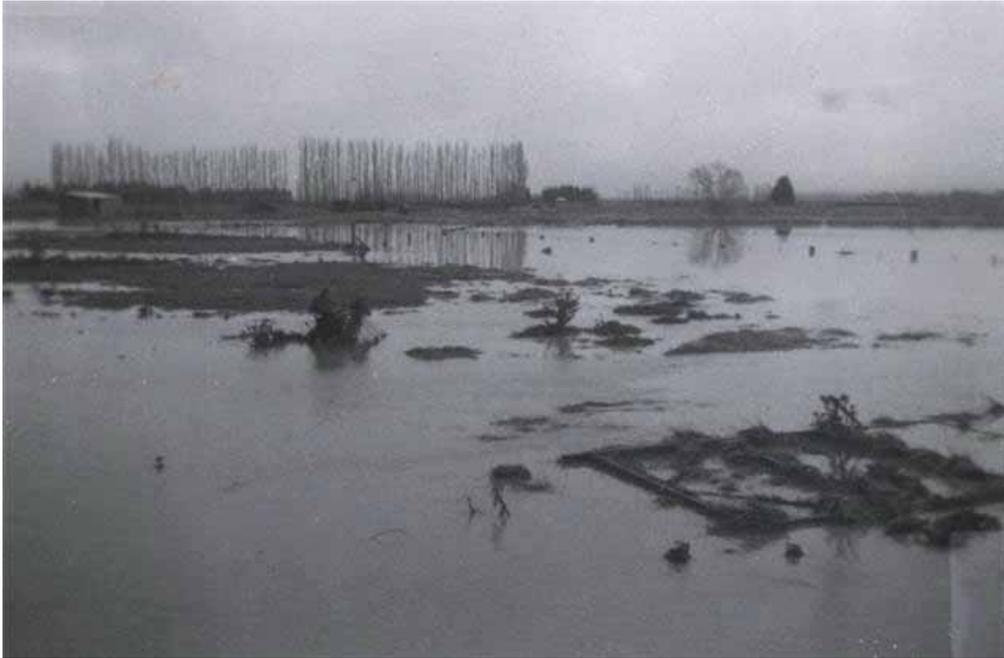
Figure 66 Inundation of rural land near Creamery Creek (Middlemarch) following the May 1957 flood. Note the lines of fence posts just visible above the water level.

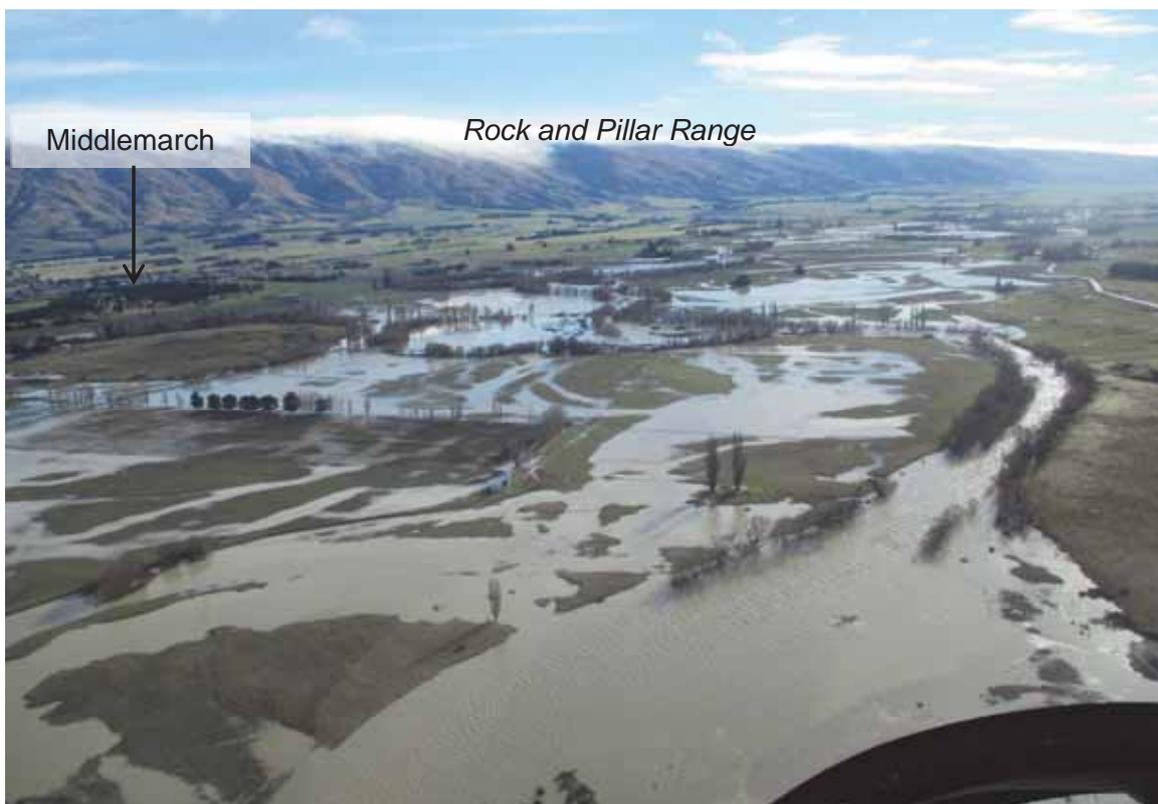
Figure 67 Inundation of rural land on the margins of the Taieri River on 18 June 2013, following a prolonged period of heavy rainfall. This photo was taken six hours after the flood peak, when flow in the Taieri River at Sutton had dropped from 354m³/s to 326m³/sec. The ORC natural hazards database (www.orc.govt.nz) contains other photos of the Strath Taieri taken on this day.

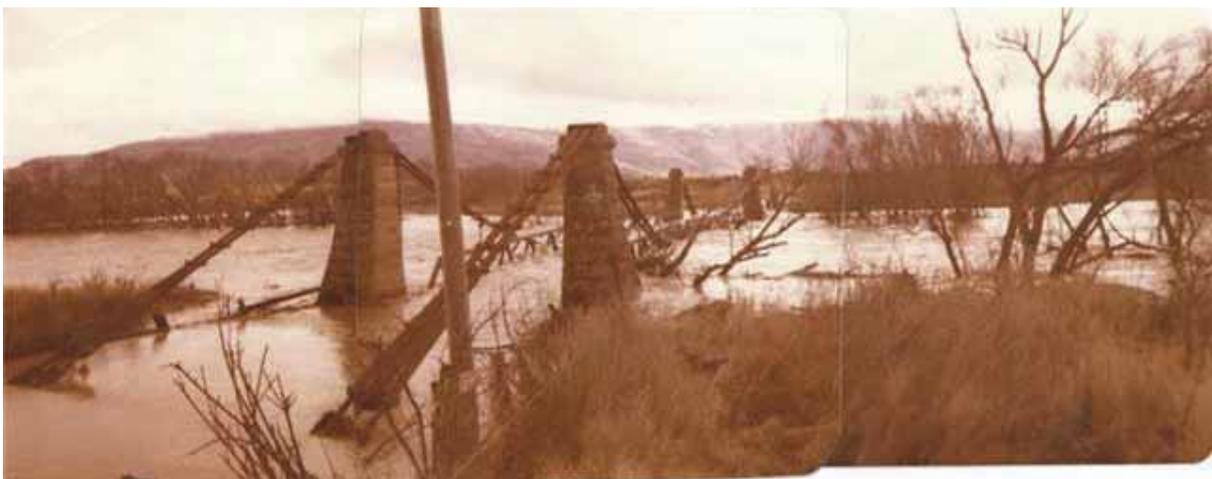
Figure 68 Taieri River at Sutton Bridge, during the June 1980 flood
