# Review of Dunedin City District Plan—Natural Hazards

Flood Hazard of Dunedin's urban streams

Published June 2014

Prepared by: Michael Goldsmith, Manager Natural Hazards  
Jacob Williams, Natural Hazards Analyst  
Jean-Luc Payan, Investigations Engineer  
Hank Stocker (GeoSolve Ltd)

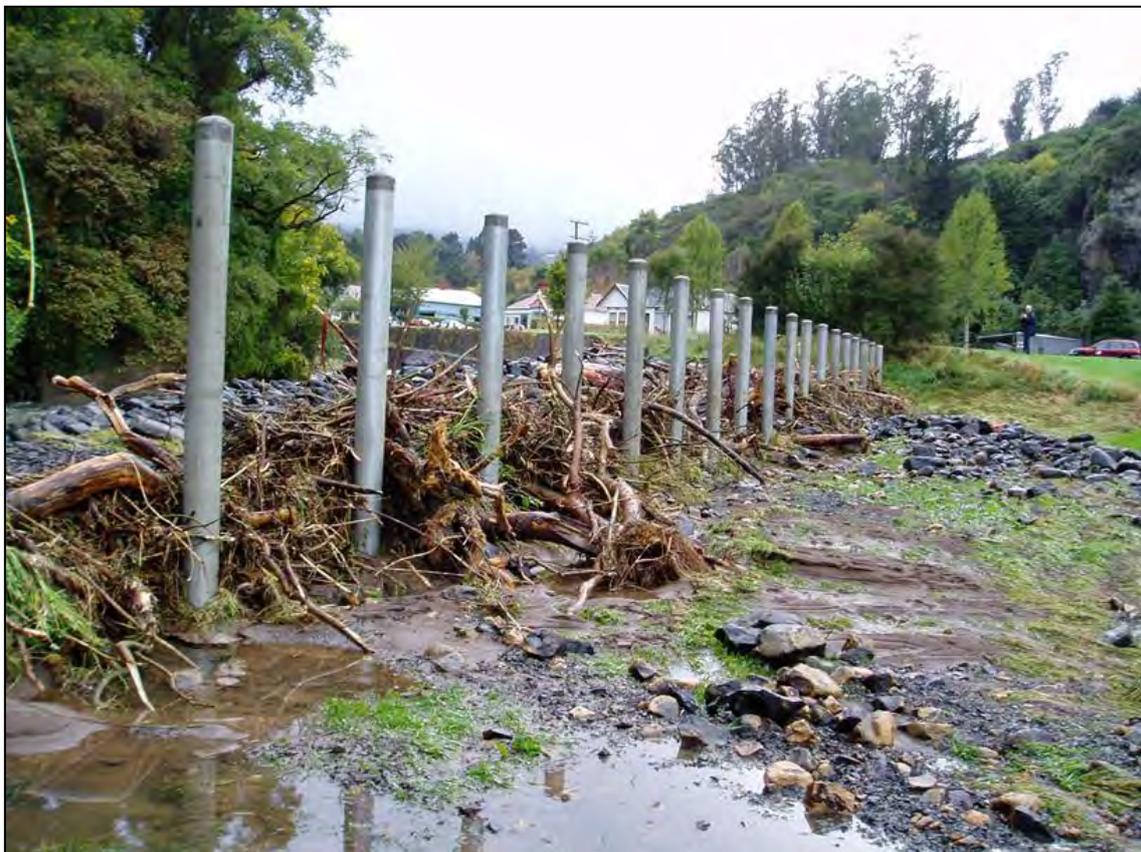
**Figure 2** Debris trap, Malvern Street Park, Water of Leith, April 2006

Physical works have been undertaken over many decades, and to varying standards to mitigate the effects of high flows and debris (examples are shown in Figure 2 and Figure 3).<sup>1</sup> Physical works have improved channel capacity in some reaches and eliminated or reduced the potential for some of the historically recorded flooding. However these works are not continuous and potential still exists for out-of-channel flooding, particularly if the channel becomes blocked with alluvial or landslide debris or the flood event is of an extreme magnitude. Therefore, a residual risk still exists in regards to flood events which overtop the

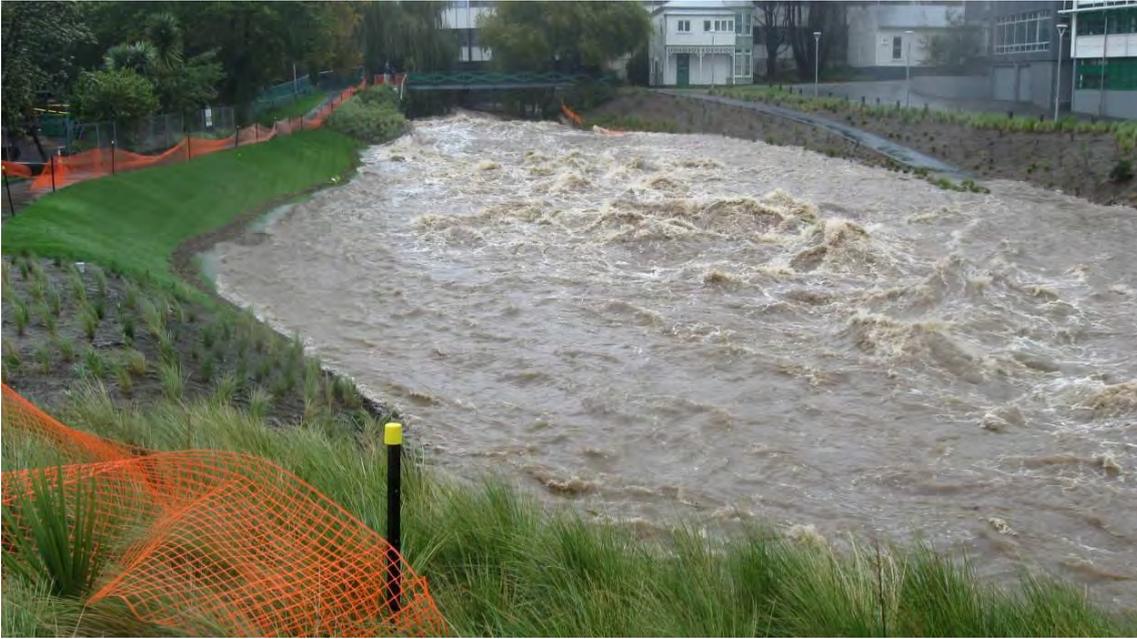
**Figure 3** The Water of Leith channel, downstream of Leith Street, at approximately midday on 18 April 2014 (taken close to the peak flow on that day of 71m<sup>3</sup>/s – see Figure 9). Works to improve the capacity of this reach commenced in 2011. Photo source: Jeff King.

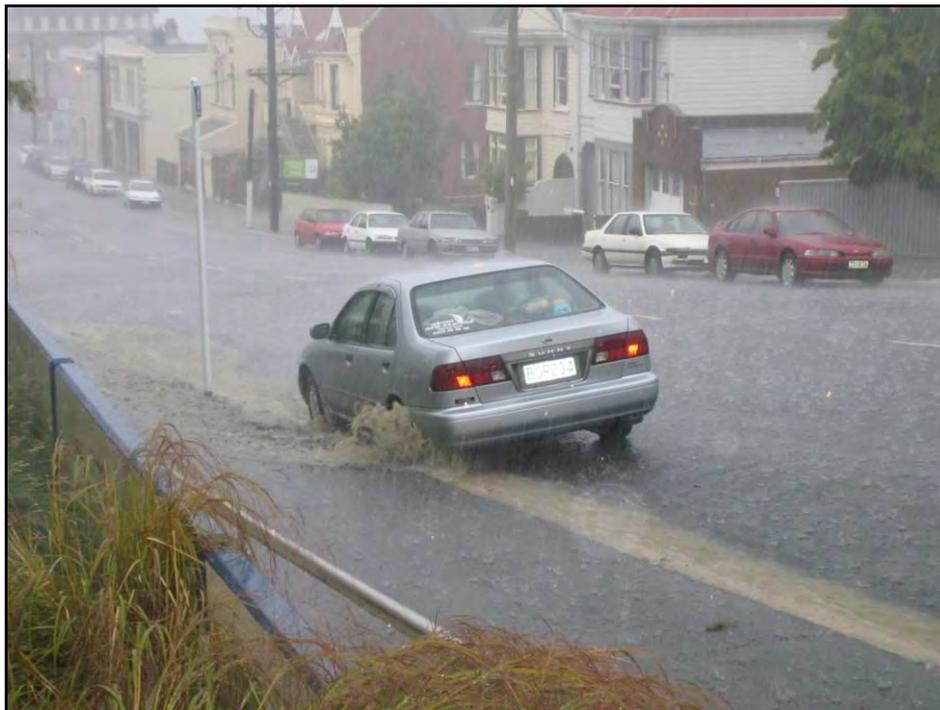
**Figure 4** Stormwater runoff on Stafford Street during a period of intense rainfall, February 2005

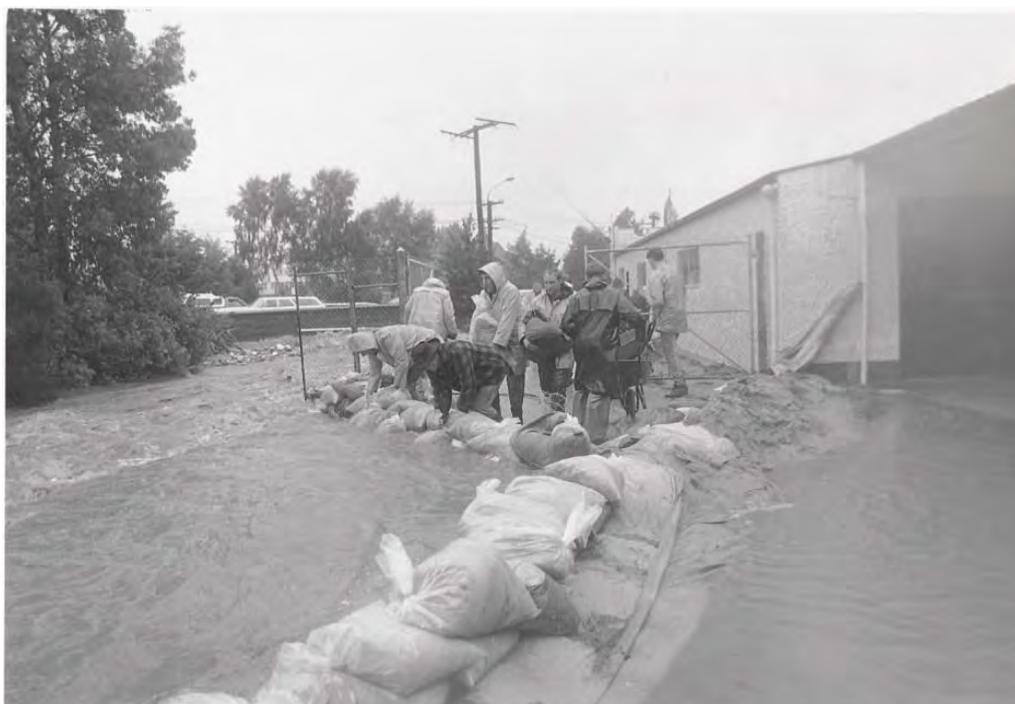
**Figure 5** Kaikorai Stream flooding, Green Island, looking downstream towards the Main South Road Bridge, March 1994. The location of this photo is shown on Figure 27. Photo source Otago Daily Times.

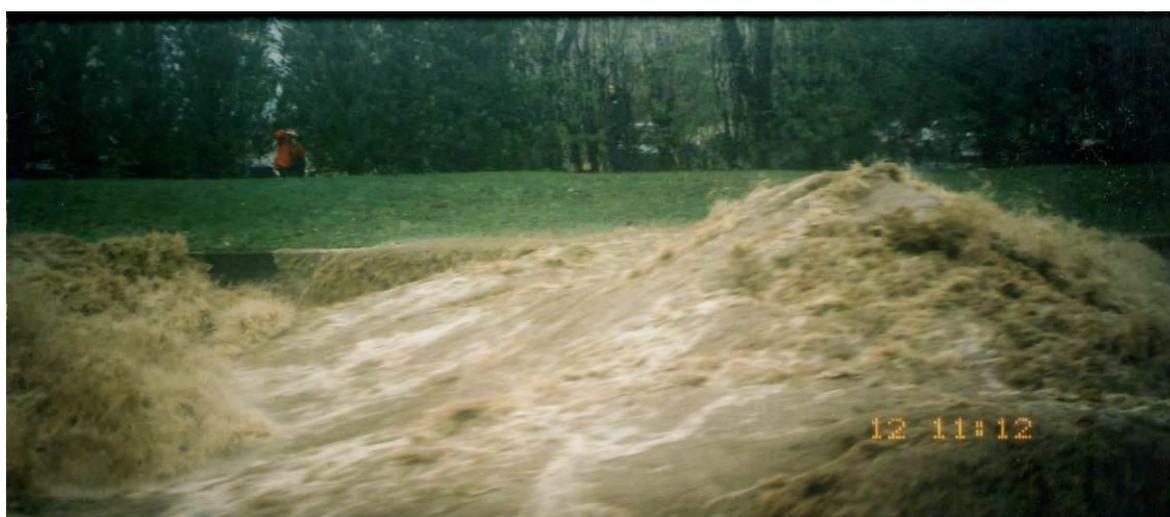
Figure 7 Standing wave in the Water of Leith during the April 2006 flood event

The upper section of the catchment and its tributaries are characterised by steep slopes and fast flows. The lower reaches are still relatively steep hydraulically, with a fall of 25m between the George Street and Dundas Street bridges. These characteristics result in the Water of Leith having the potential to behave in times of flood as a mountain torrent, as evidenced by the large alluvial boulders visible in the channel even in the lower reaches. The Water of Leith is hydraulically steep with flood flows moving at up to 3m/s in some reaches (Opus, 2004c). The water surface under flood conditions is likely to be highly turbulent throughout most reaches (Opus, 2004c) with large standing waves being observed in some locations (Figure 7).

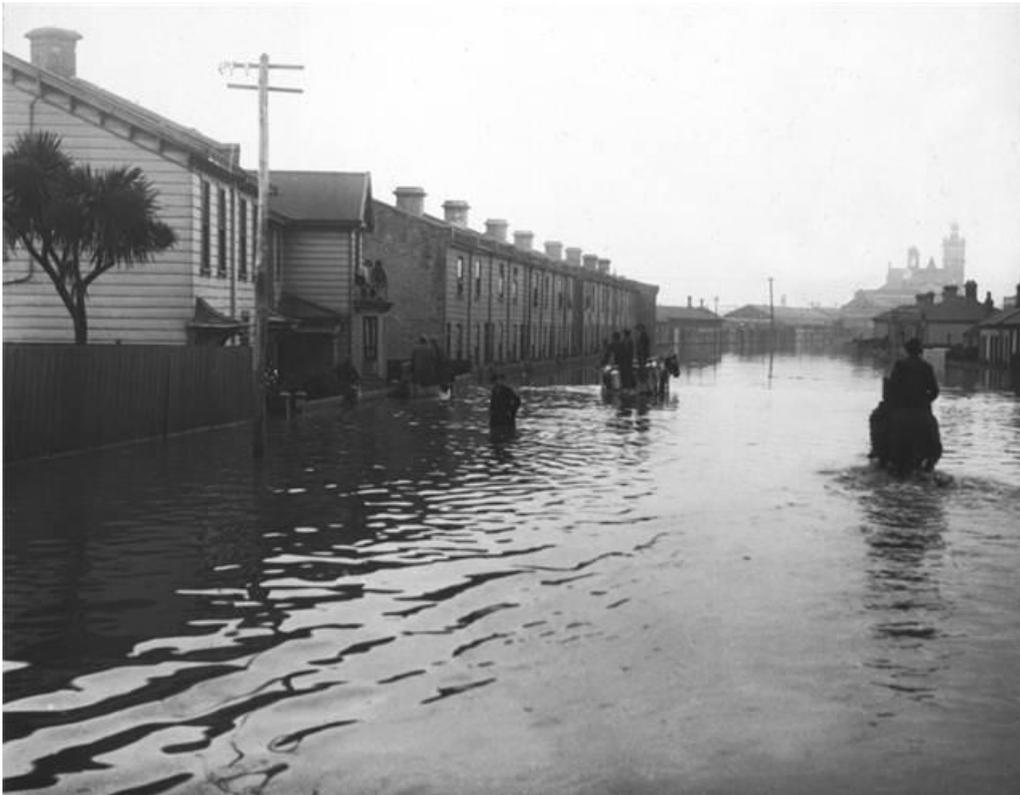
**Figure 10** Floodwater from the Water of Leith ponding in Harrow Street (looking south towards the Railway Station), April 1923. The approximate location of this photo is shown in Figure 32.

Damaging floods in the Leith were a frequent occurrence from the time of first settlement; being recorded in 1868, 1877, 1911, 1923 (Figure 10 and Figure 11), and 1929. The 1929 event was the most severe on record, with floodwaters sweeping away and damaging bridges and other channel structures, affecting numerous houses, and flowing along the streets beyond lower Rattray Street. Observed flood extents and anecdotal evidence from previous events show that inundation of 1m or more can occur in some places. During the 1929 event, flood water from the Water of Leith flooded approximately 500 houses in the north end of Dunedin City to a depth of up to 1.2m (MacLean *et al*, 1931). Since 1929 there have been a number of significant floods in the Water of Leith (the largest in 1991); but none comparable to the 1929 event (Figure 9). River control works have progressively been undertaken within the catchment with a formal flood protection scheme in place. The

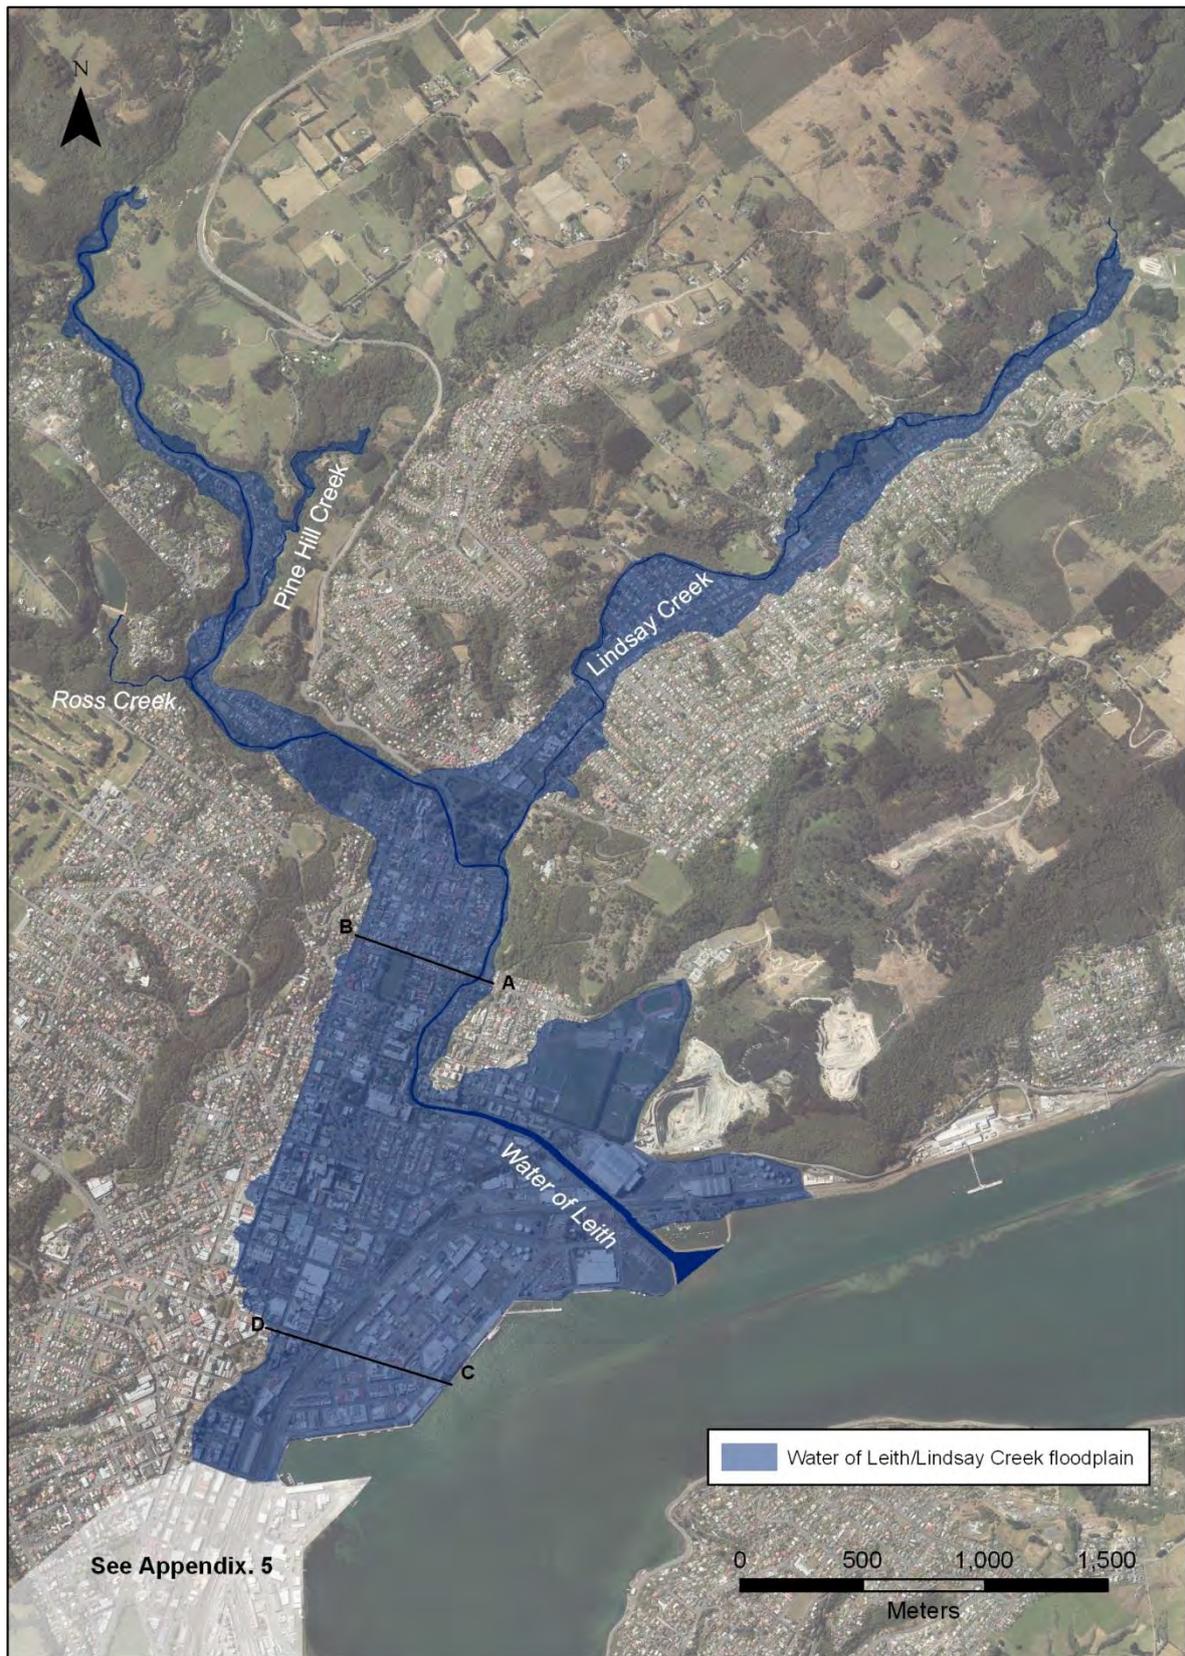
**Figure 12** Water of Leith and Lindsay Creek mapped floodplain area. The location of the cross sections shown in Figure 13 and Figure 14 is also shown. The topography of the area to the south of Jetty Street (shaded white) is shown in Appendix 5.

The mapped floodplain extends from Nicol's Creek downstream to Otago Harbour (Figure 12). More detailed maps of the upper, mid and lower reaches of the Water of Leith catchment are shown in Appendix 2.

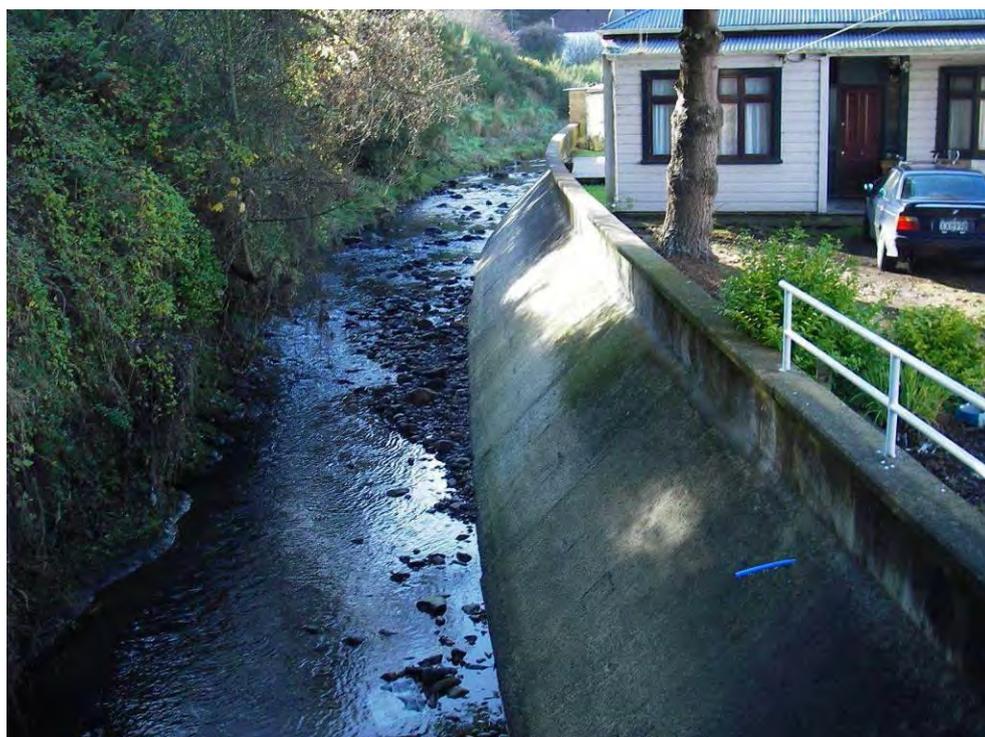
Figure 15 House located immediately next to the main channel of Lindsay Creek

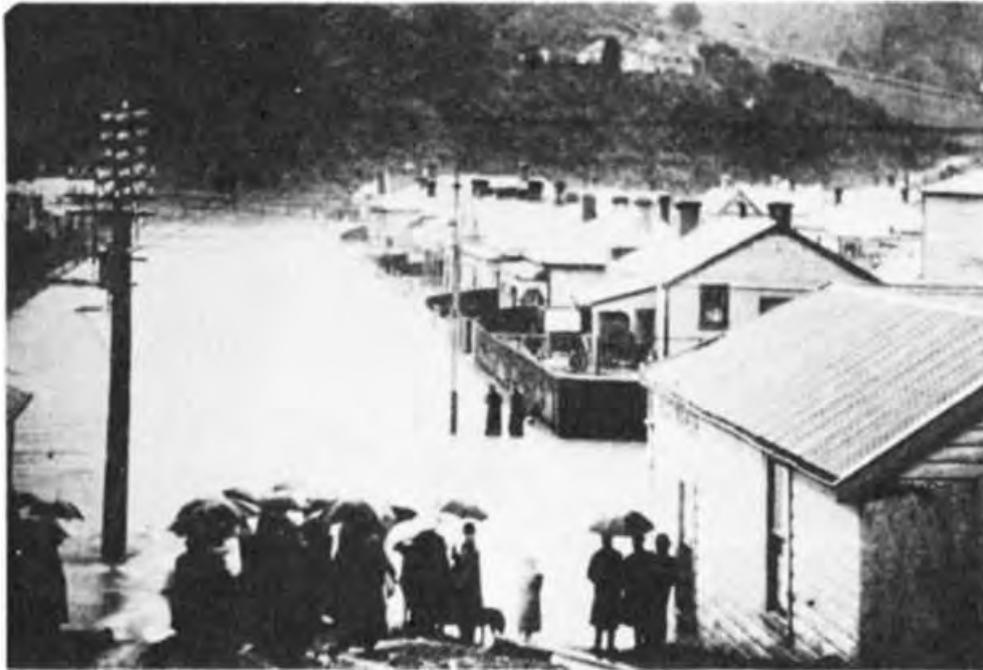
**Figure 16** View from Blacks Road across the North East Valley floodplain, during an event in 1912 (above), and approximately the same view today (below)

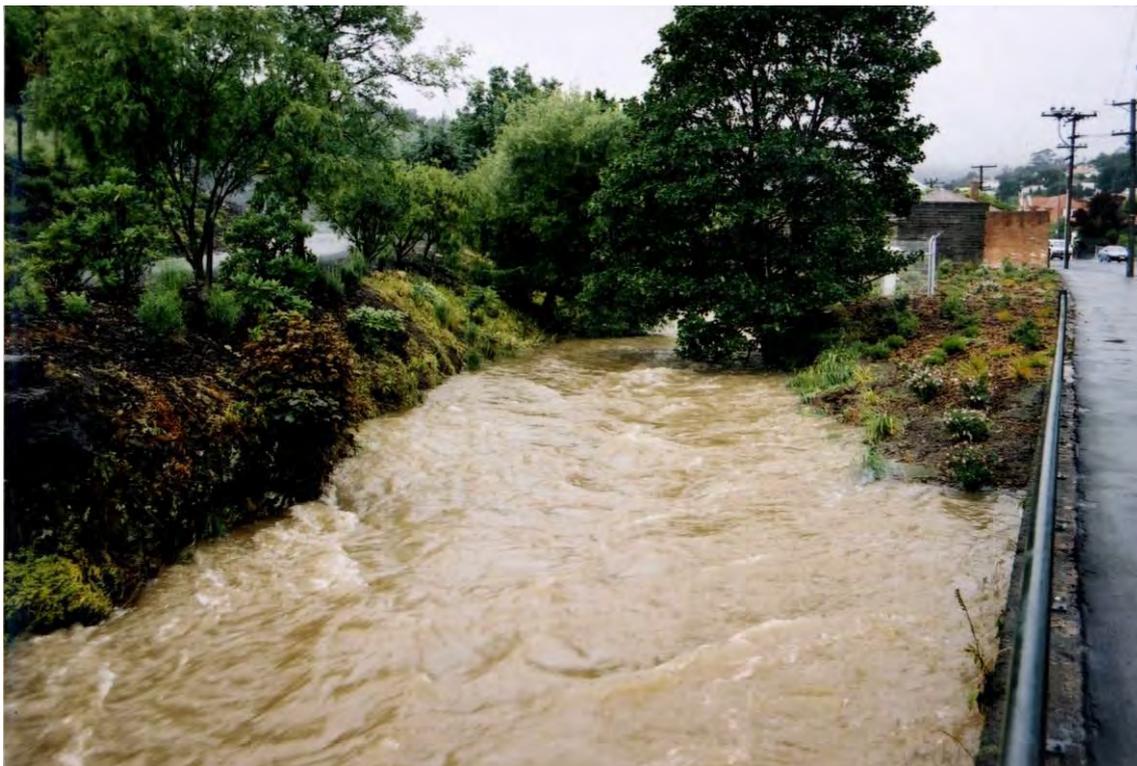
**Figure 18** Lindsay Creek at Palmers Quarry Bridge, April 2006 (looking upstream). This photo was not taken at the peak of the flood.

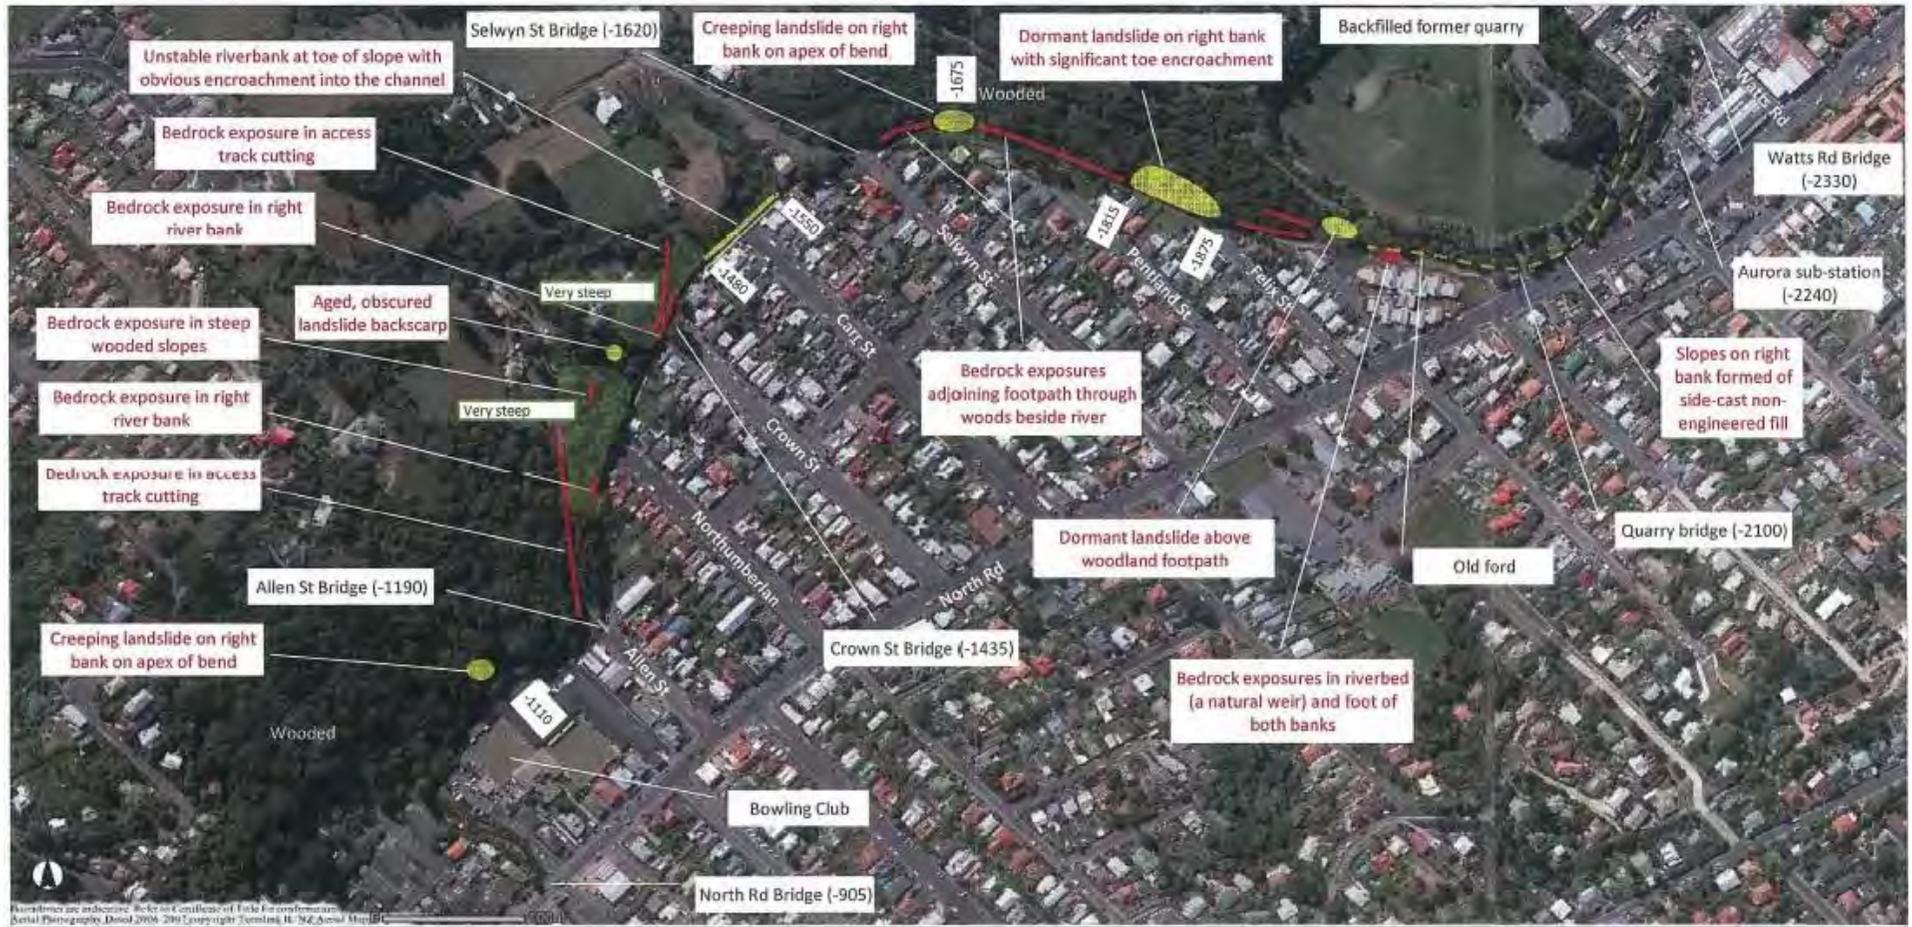
Figure 21 Geological summary map of Lindsay Creek between Watts Road and North Road Bridge, as prepared by Coffey (2010)

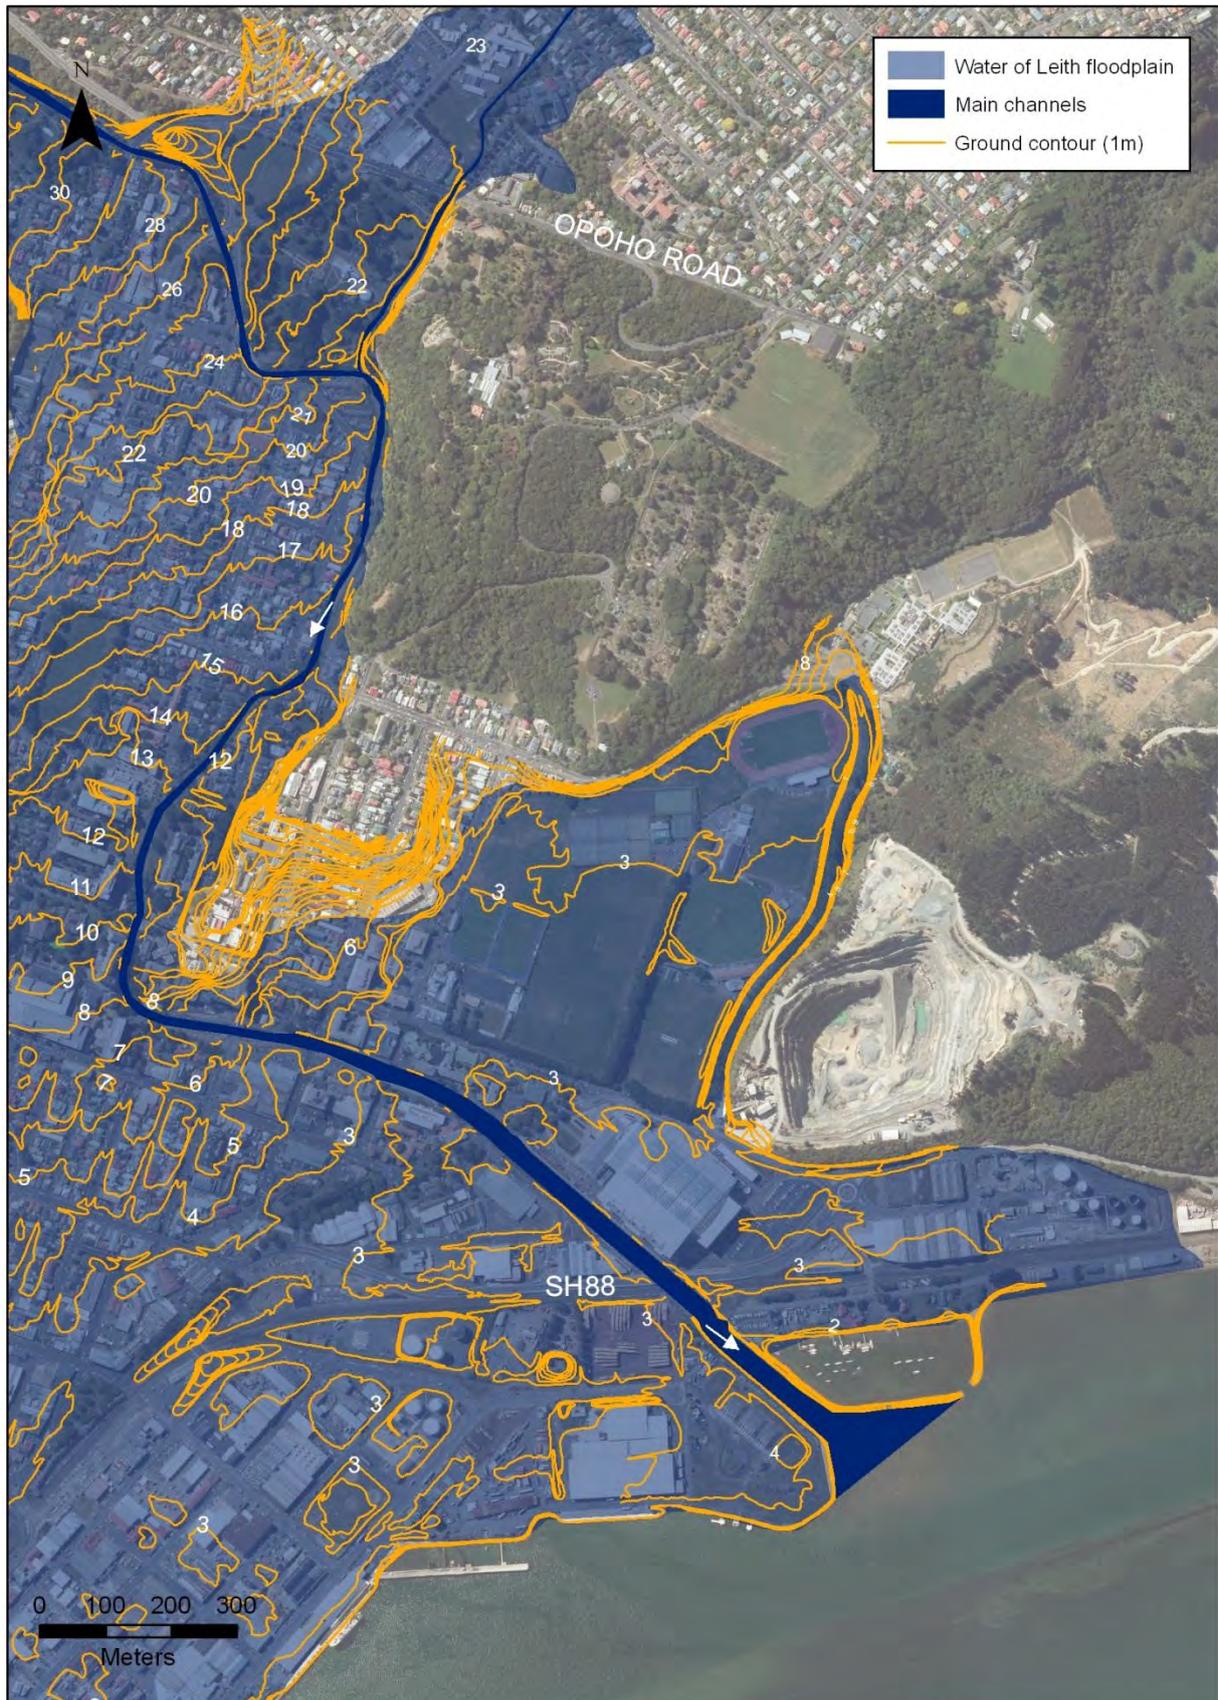
Figure 31 Mapped floodplain area in the mid Water of Leith catchment

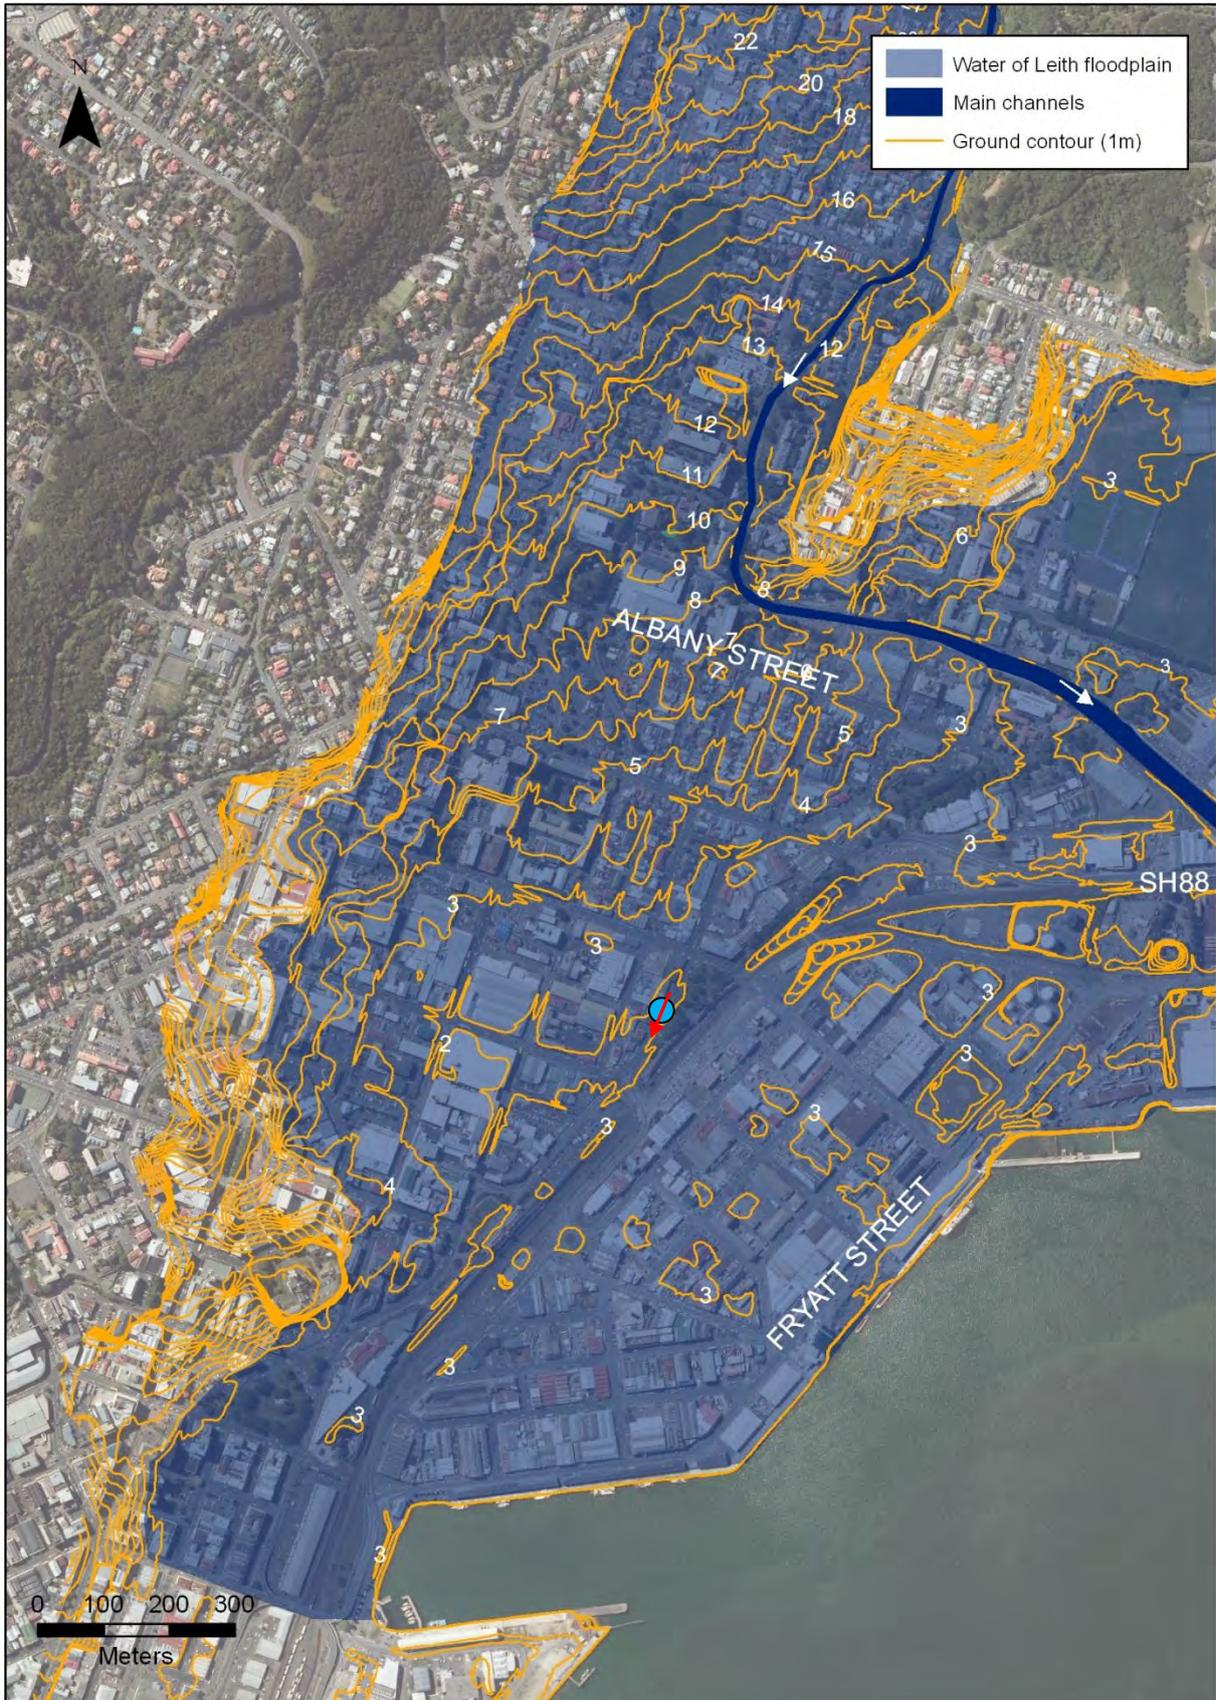
**Figure 32** Water of Leith – CBD reach floodplain area. The approximate direction and location of the photo in Figure 10 is also shown. The topography of the area to the south of Jetty Street is shown in Appendix 5.

Due to the general southward slope of this part of the floodplain, overland flows may reach as far as Queens Gardens (Figure 32) before exiting to the Otago Harbour between Fryatt and Birch Streets. This is consistent with the tentative conclusion of MWH (1999). The land continues to slope to the south from this point. It is therefore possible that overflow from the Water of Leith which was not contained within the Queens Gardens area could continue to drain towards the Oval, and beyond. Due to the very flat relief of this area, and the potential effects of buildings, roads and the stormwater system, the floodplain has not been defined beyond Jetty Street. Land which lies at the same level, or downslope of the floodplain at this point is shown in Appendix 5.

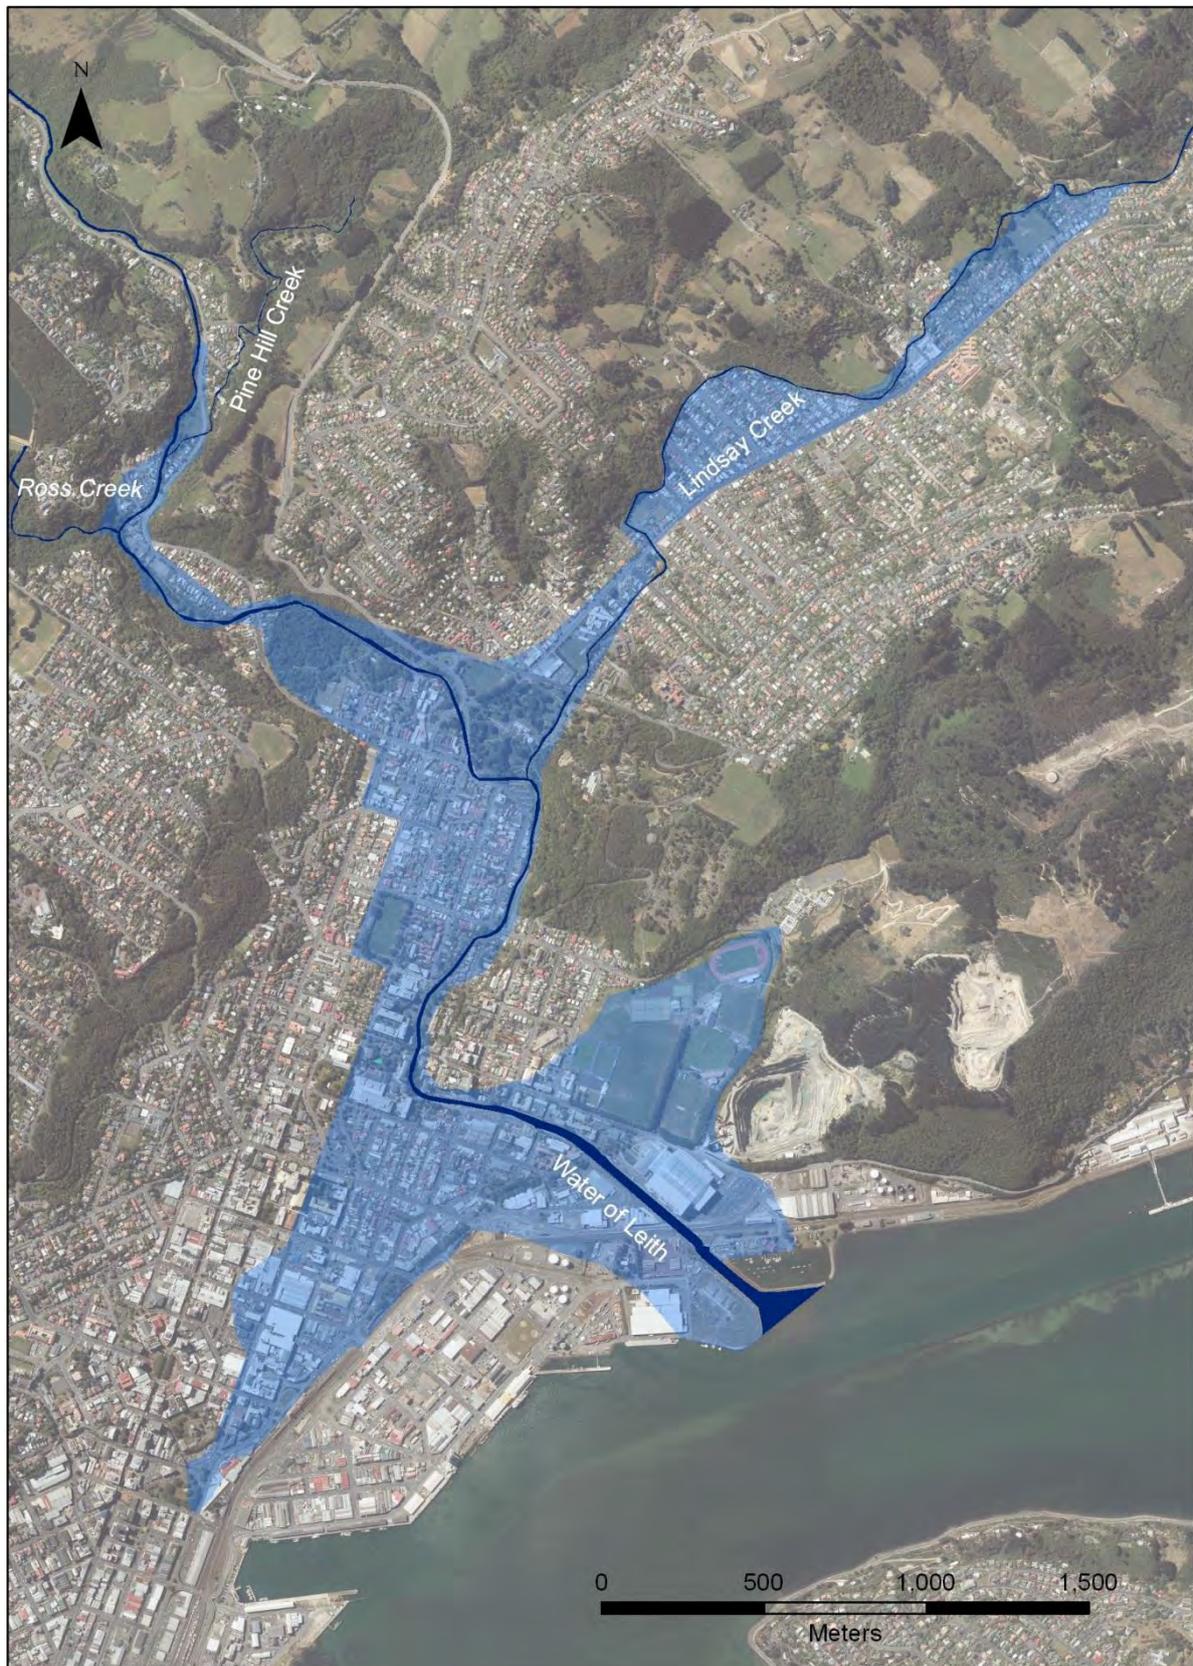
**Figure 36** Previously mapped flood hazard area in the Water of Leith and Lindsay Creek catchments.
