# **Review of Dunedin City District Plan—Natural Hazards**

**Flood Hazard on the Taieri Plain and Strath Taieri**

Report writers:       Jean-Luc Payan, Investigations Engineer  
                              Michael Goldsmith, Manager Natural Hazards

Published June 2014

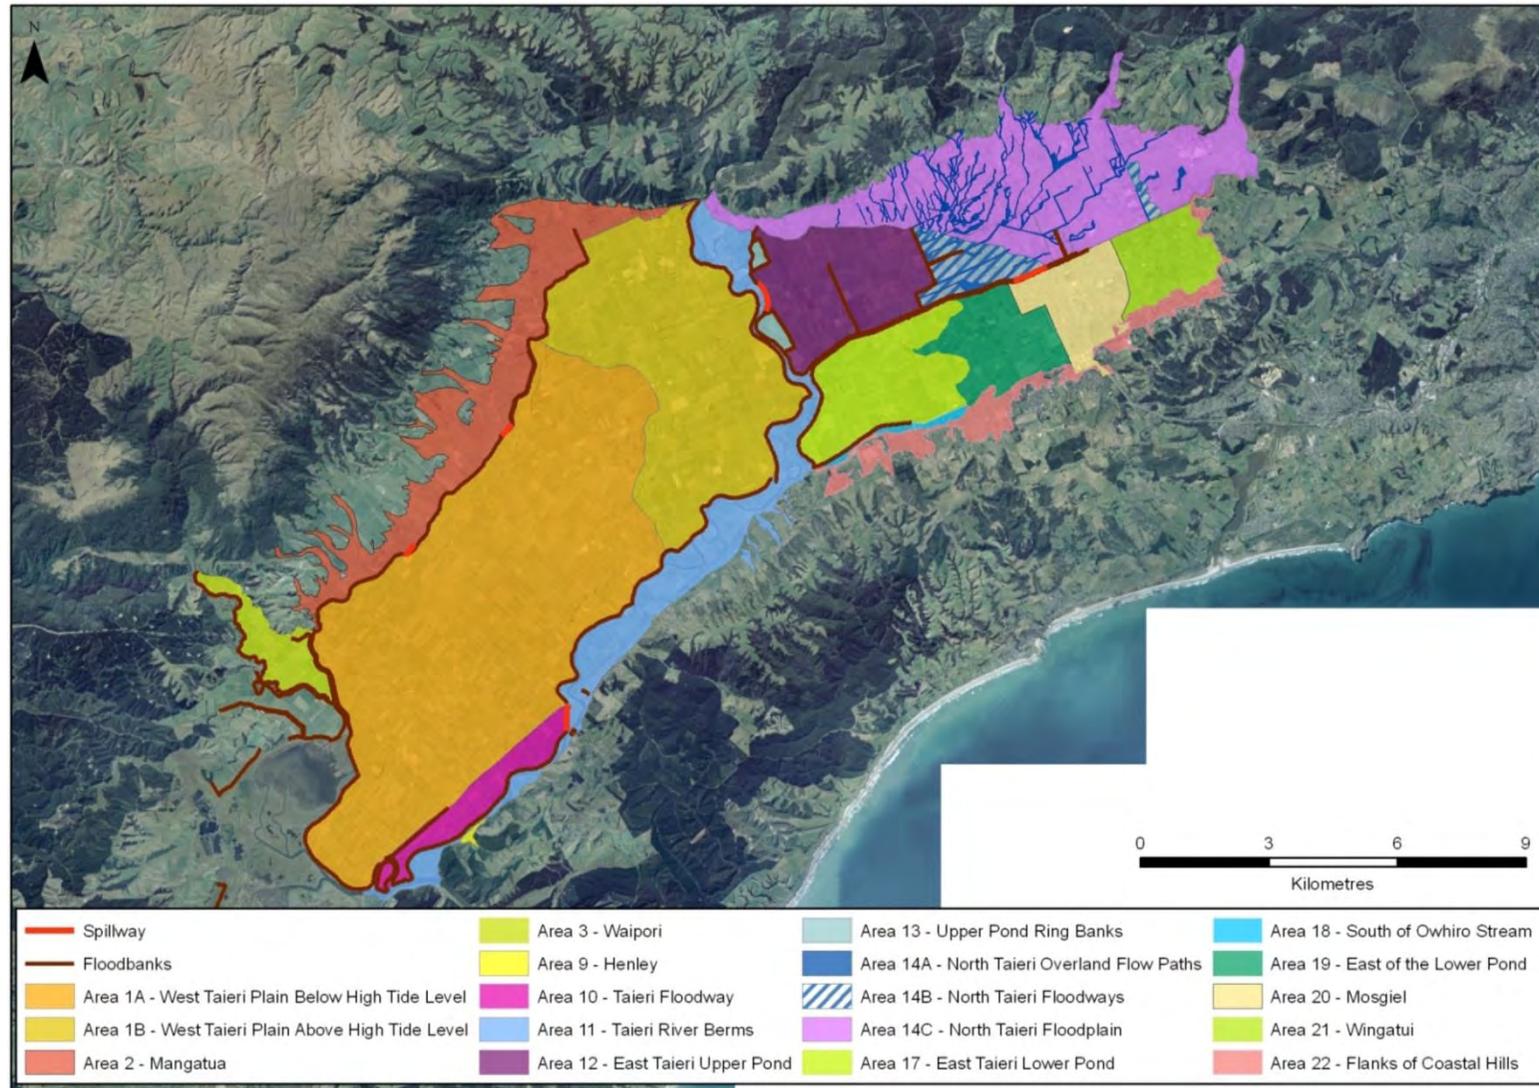
Figure 2 Flood hazard areas on the Taieri Plain. Area 1, and Areas 14-16 (as defined by ORC, 2013) have been further refined, as described above.

The revised flood hazard areas, as described in this report, are shown in Figure 2. It is noted that flood hazard within each area is not necessarily uniform, as it is influenced by localised topographical features and flood management structures.

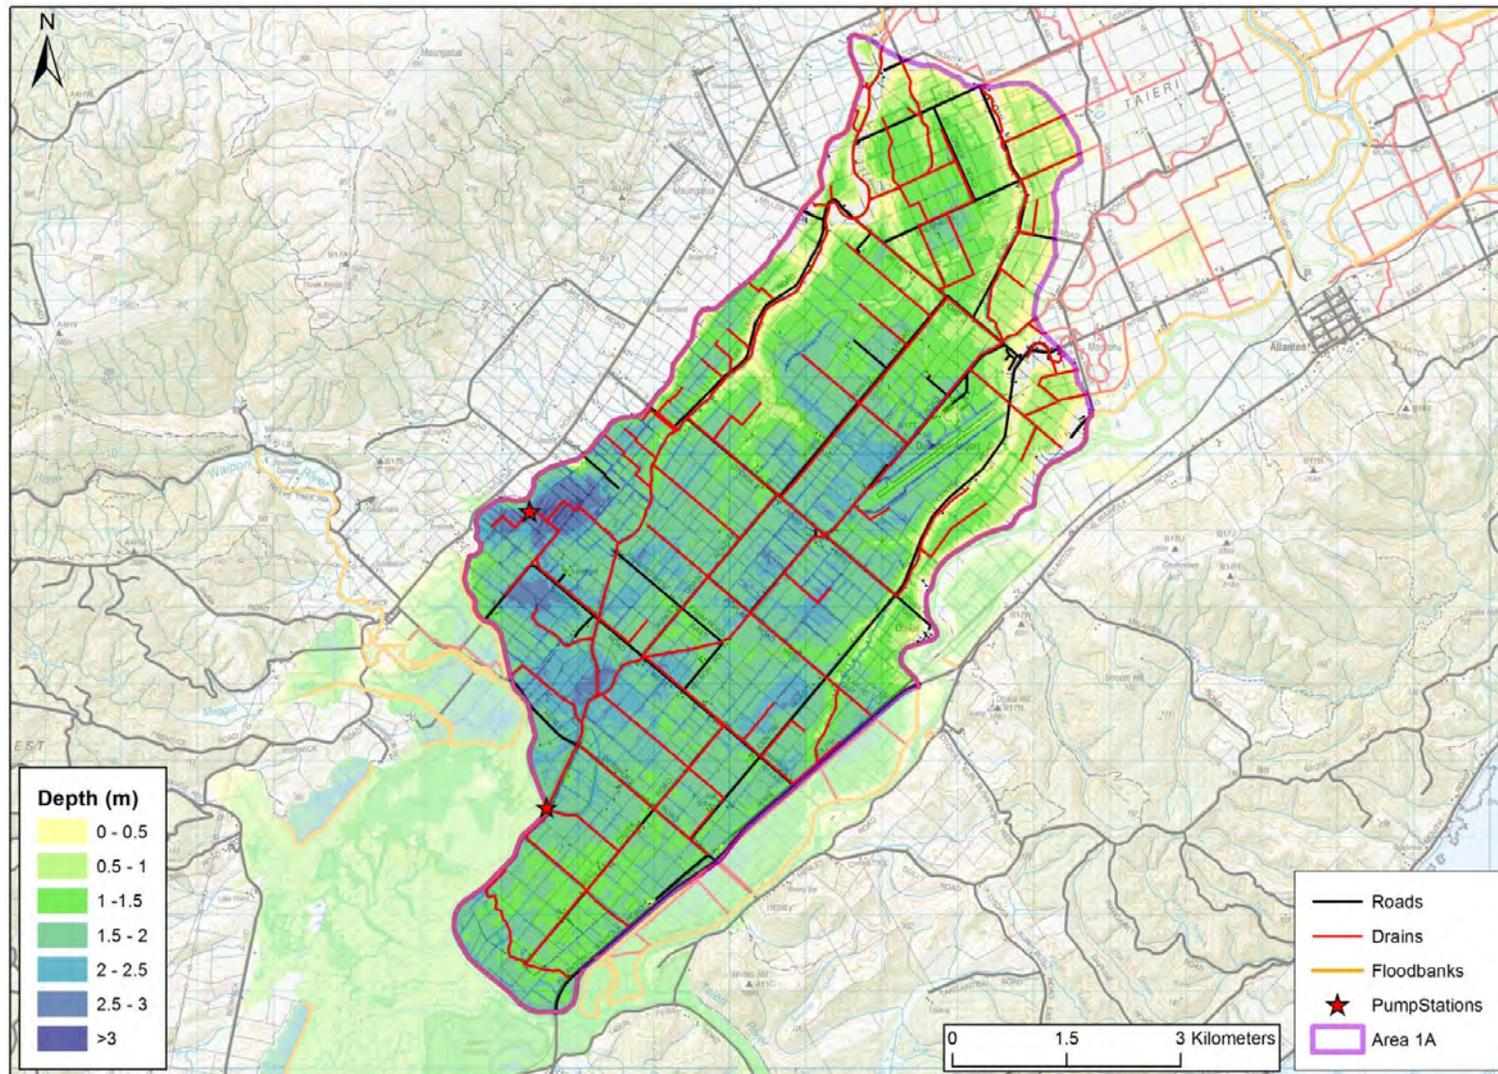
**Figure 3** Depth of inundation on the lower West Taieri Plain (Area 1A) at a water level of 1.5m above msl (the estimated level of the June 1980 flood)

**Flood hazard characteristics and effects:** Extensive ponding is the predominant type of hazard in this area, to depths of more than 3m in some places (Figure 3). Sources of flooding include the Taieri River to the south, Waipori River to the west, Maungatua Range to the north, and internal runoff from Areas 1A and 1B. The flood hazard associated with these waterways can be significant (ORC, 2013). The natural tendency of waterways to inundate Area 1A is mitigated to some extent by flood protection and drainage schemes. As a result, flood hazard in this area is generally limited to ponding of a moderate depth and duration, and low velocity flows (see Scenario 1 and Figure 4 below).

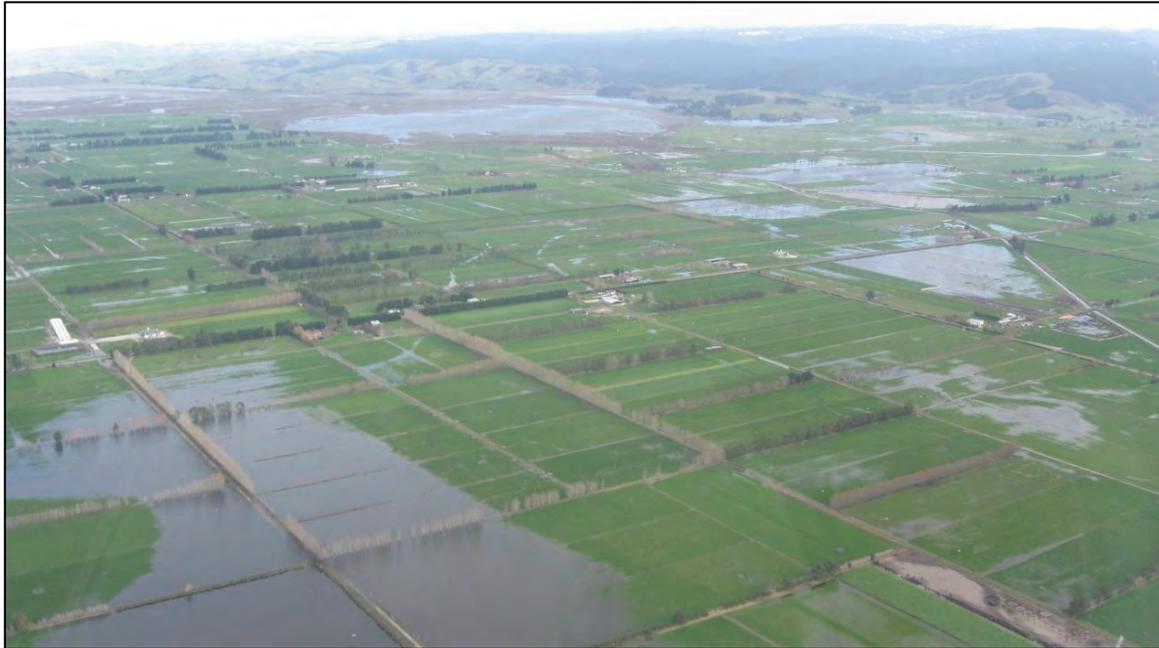
**Figure 4** Aerial view of ponding on the West Taieri Plain, resulting from internal runoff from Area 1A and 1B during heavy rainfall in June 2013 (195mm over 8 days at the Riccarton Road rain gauge). Lakes Waipori and Waihola can be seen in the distance.

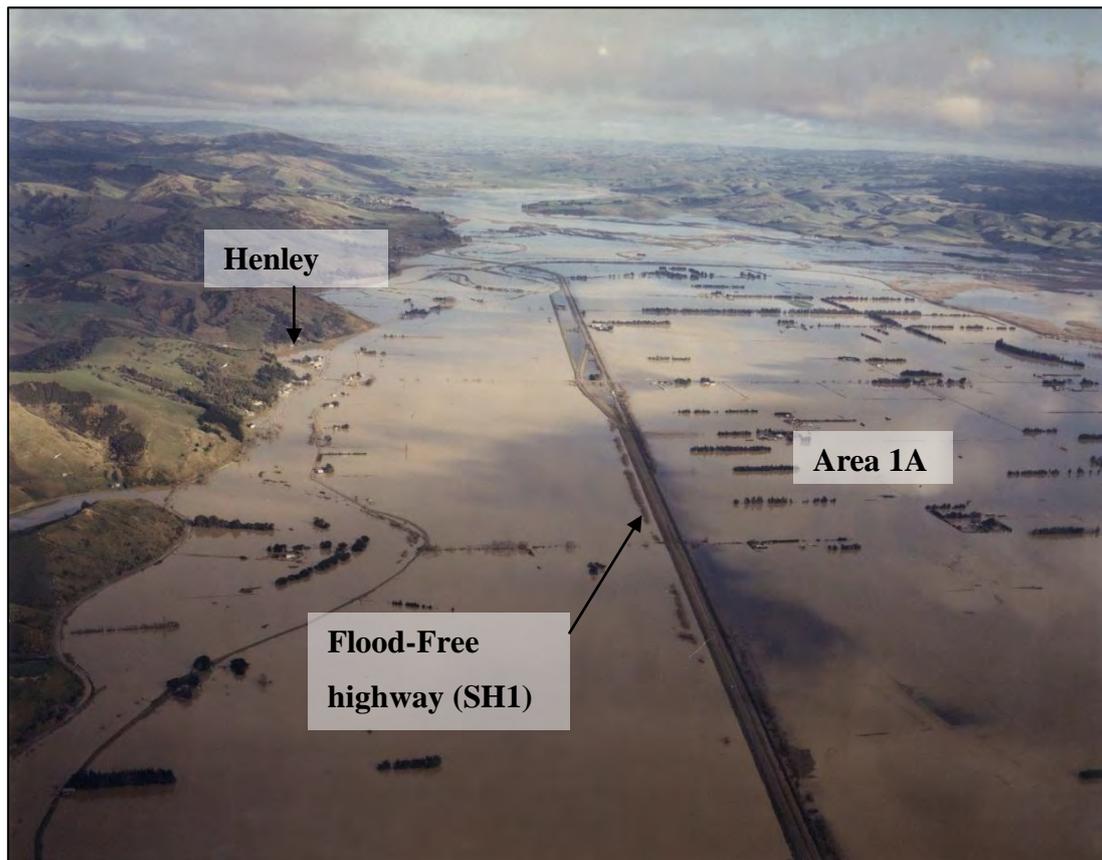
**Figure 5** Aerial view (looking south) of flooding on the West Taieri following the June 1980 flood event. Area 1A is to the right (west) of the 'Flood-Free' highway.

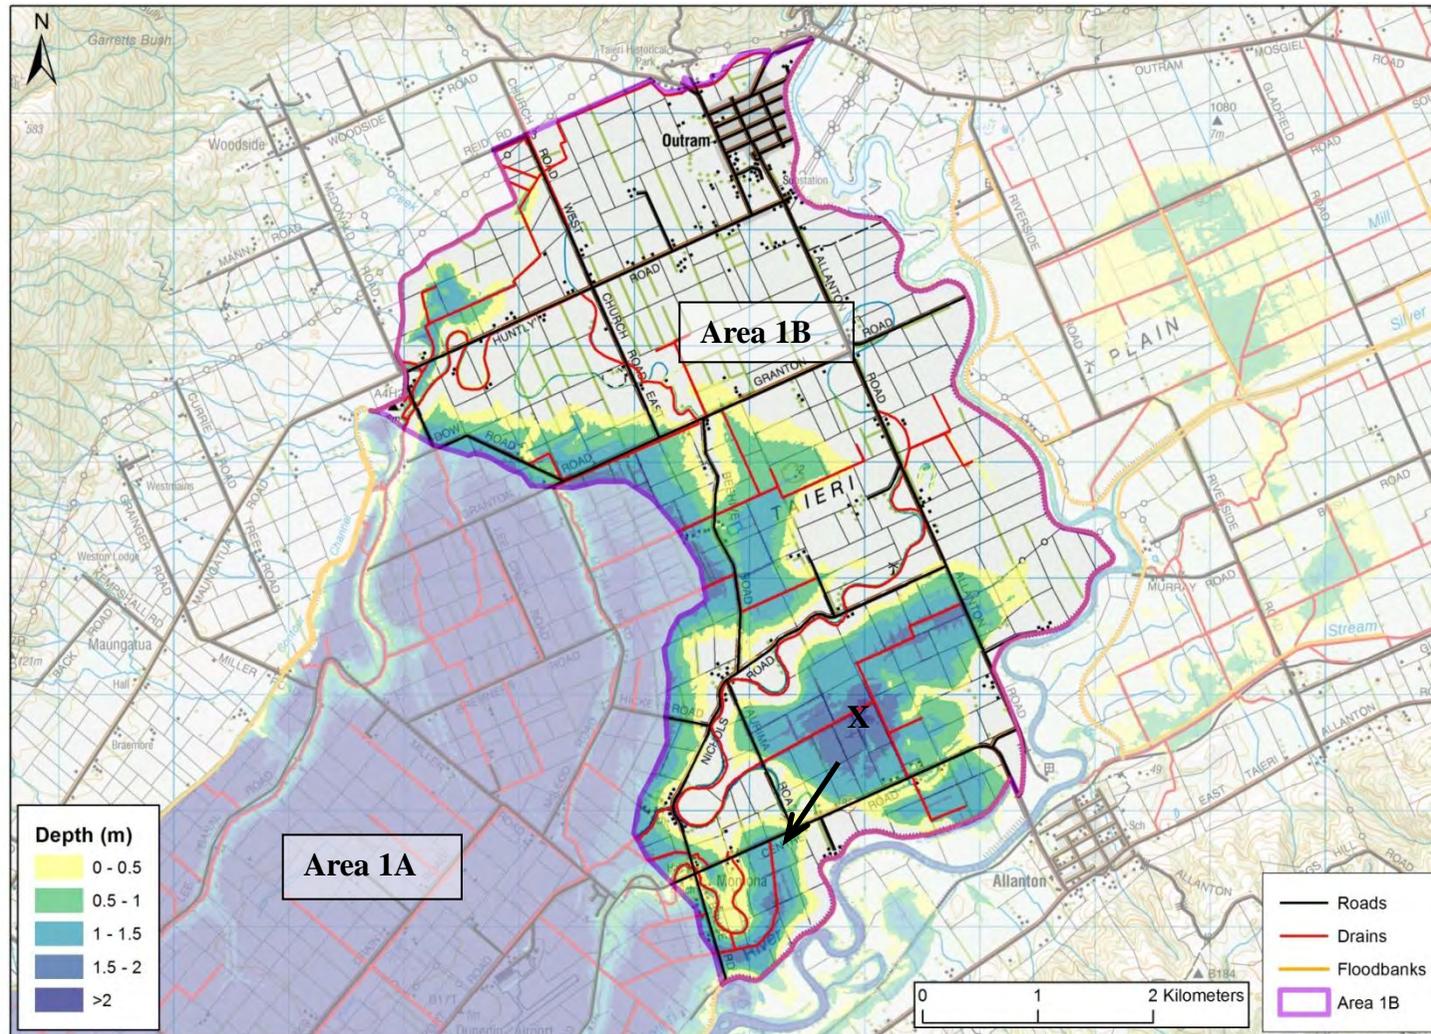
**Figure 6** Depth of inundation in the lowest-lying part of Area 1B if water was at a level where it began to overtop the ponding area labelled X (3.1m above msl). The black arrow shows the approximate location where water would initially overtop from 'X' and flow downslope to the southwest.

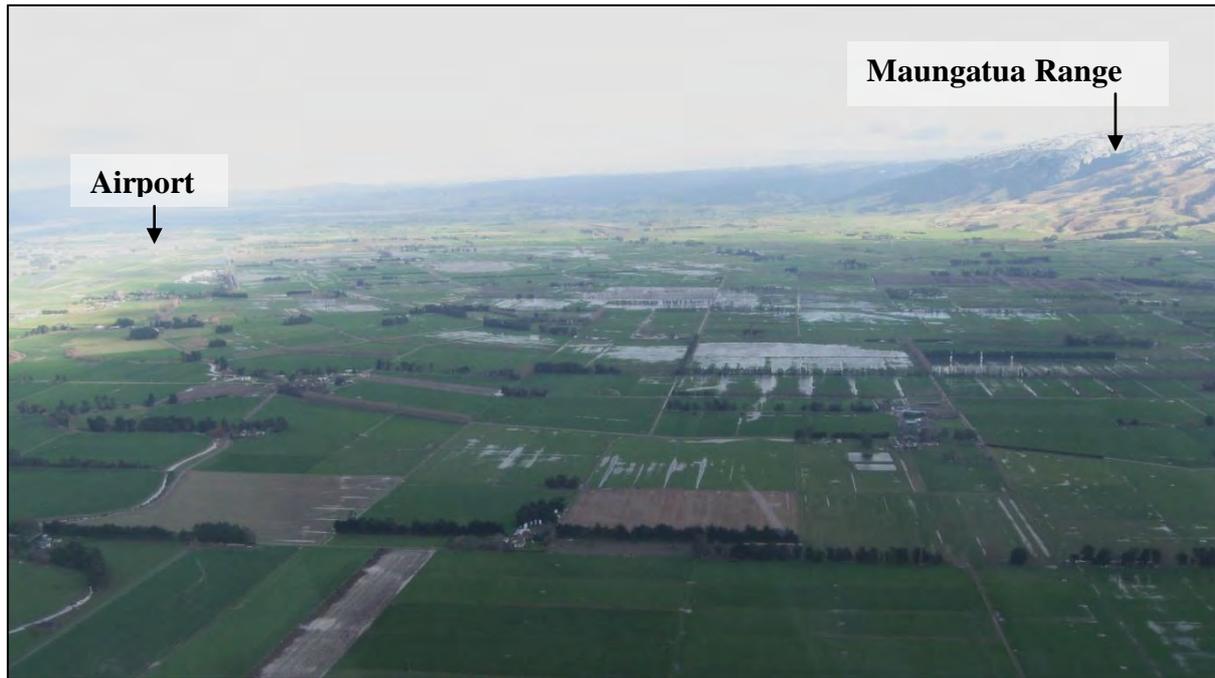
**Figure 7** Aerial view of ponding on the West Taieri Plain (looking south), resulting from internal runoff from Area 1B during heavy rainfall in June 2013 (195mm over 8 days at the Riccarton Road rain gauge)

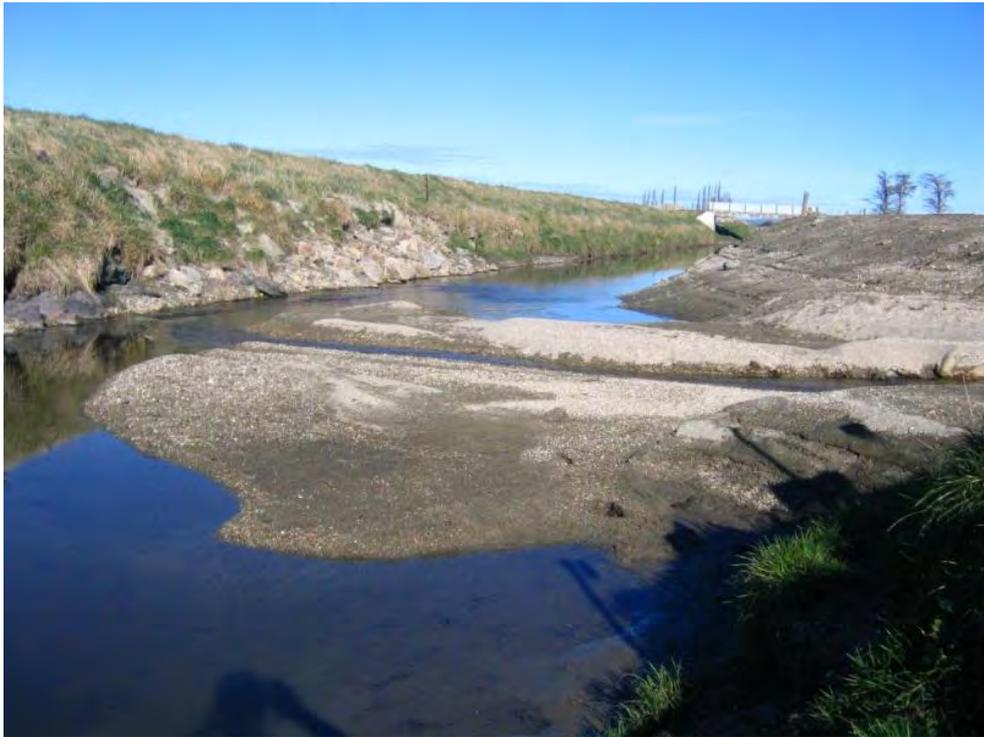
Figure 9 Deposition of gravel in the Contour Channel from a tributary hill stream

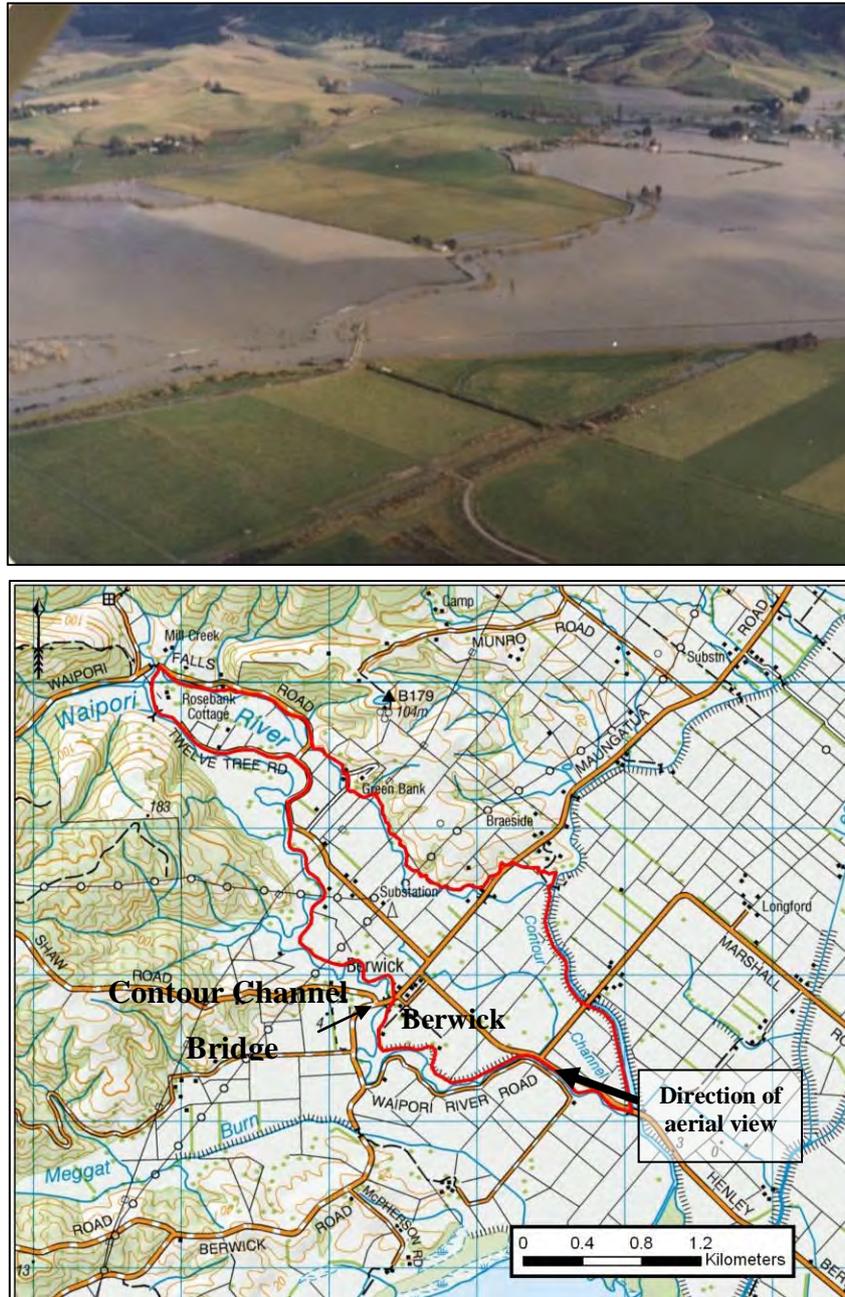
Figure 10 Top: Aerial view of Waipori River No. 1 Contour Channel Bridge, looking towards Berwick (May 1977). Bottom: Map of the same area (with Area 3 outlined in red).

**Flood hazard characteristics and effects:** Extensive ponding is the predominant type of flood hazard in this area, although surface runoff and peak river flows can also create a hazard (Figure 10). Inundation depths of up to 2m are possible, with velocities ranging from slow (in ponding areas) to fast where surface runoff occurs. It is exposed to flood hazard from the Waipori River, the streams along the Maungatua Range (via the Contour Channel),<sup>4</sup> and Lake Waipori. Flood hazard effects are likely to be exacerbated by changes in climate or sea level.

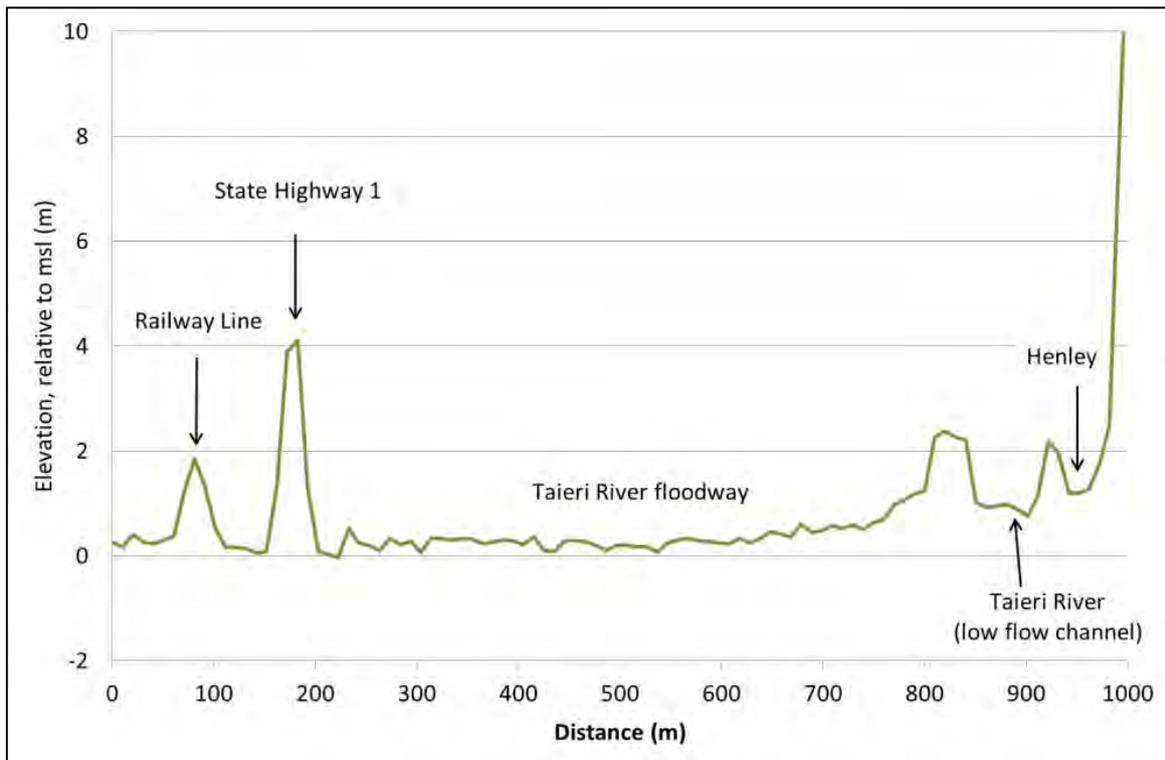
Figure 11 Cross-section from the West Taieri Plain to Henley, just upstream of Henley-Berwick Road

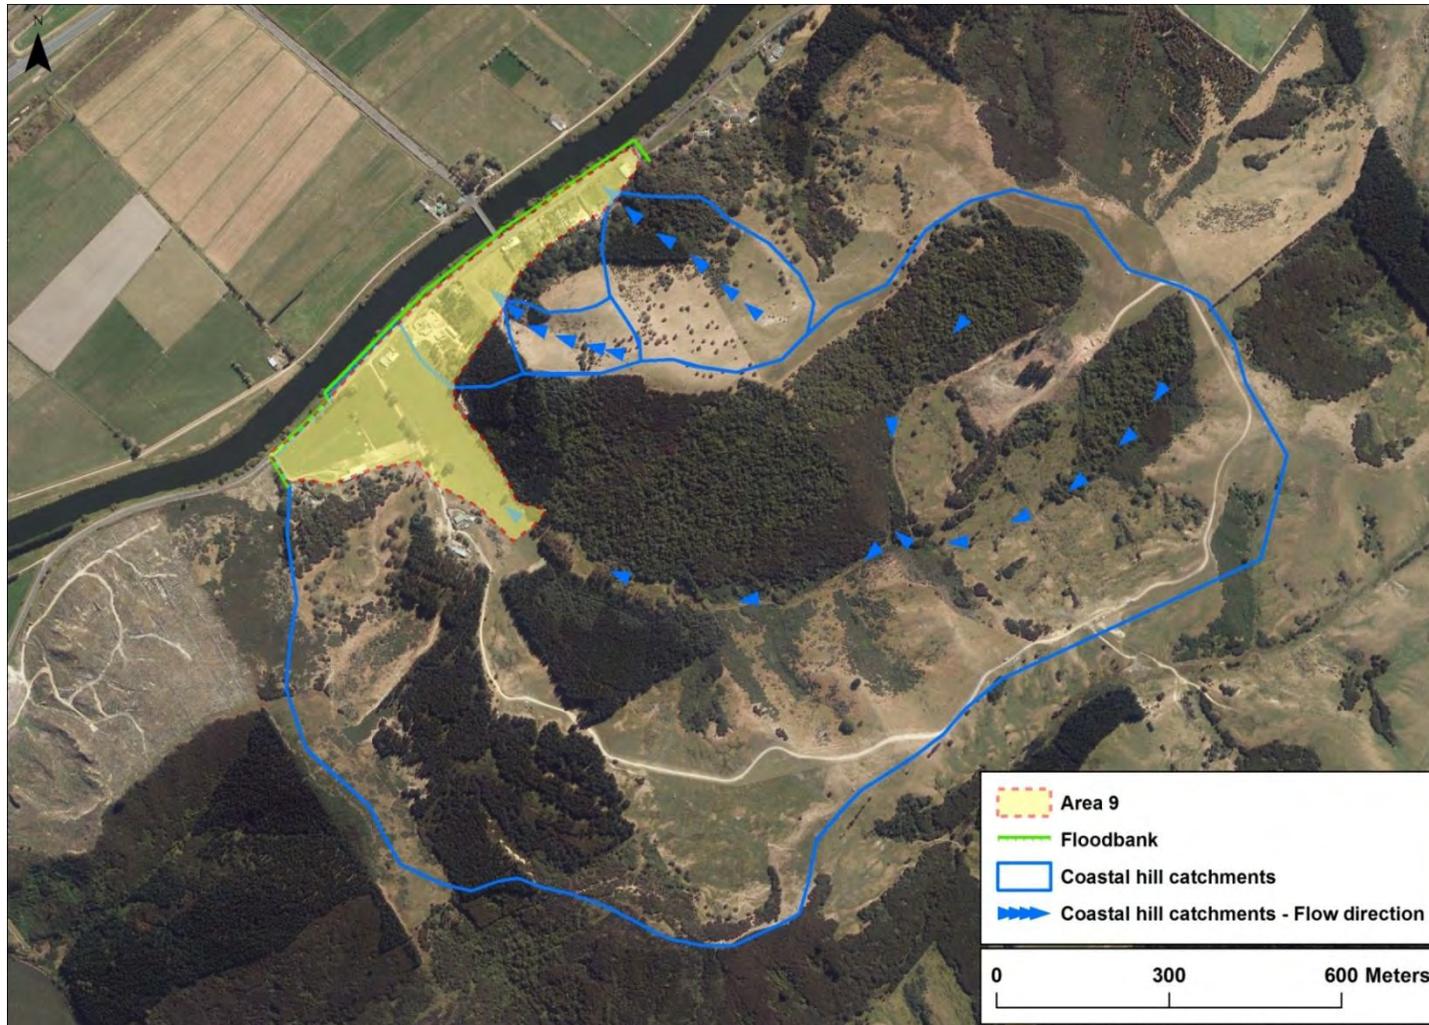
Figure 14 Coastal hill catchments behind Henley, and general flow direction

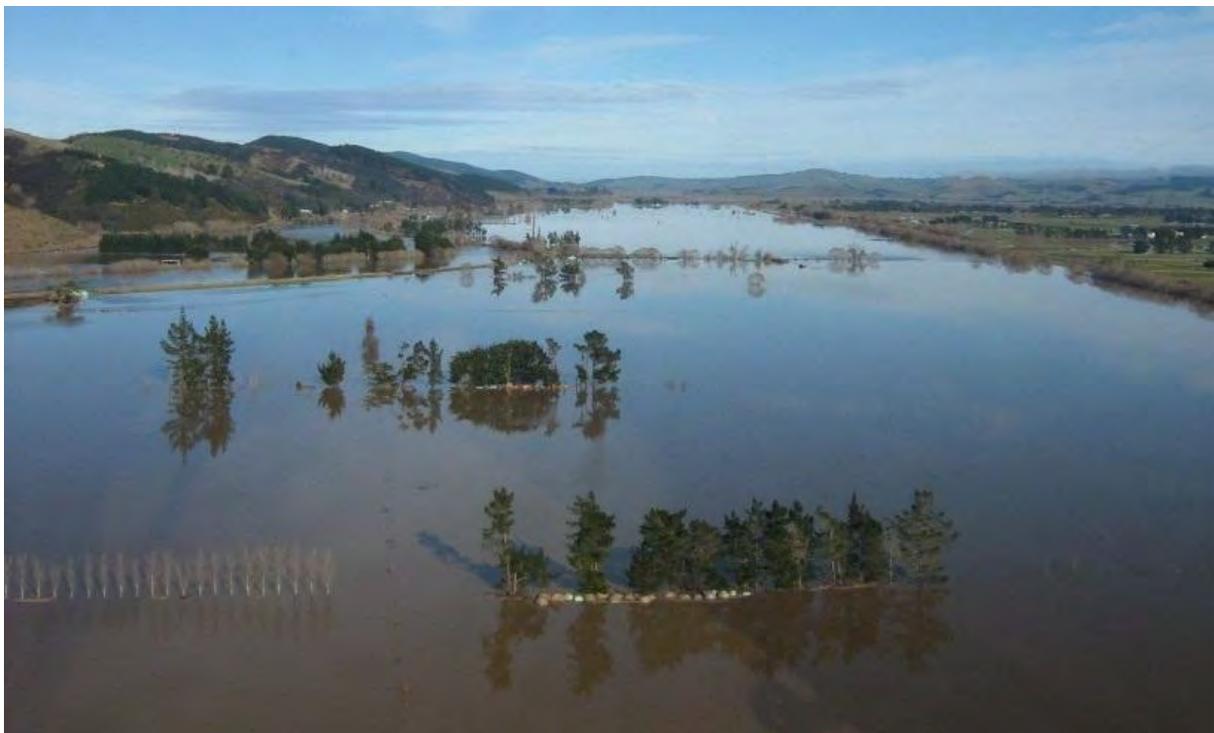
**Figure 15** Lower Taieri Floodway, looking downstream to Henley, 31 July 2007. Several rows of trees and balage lie perpendicular to the direction of flow

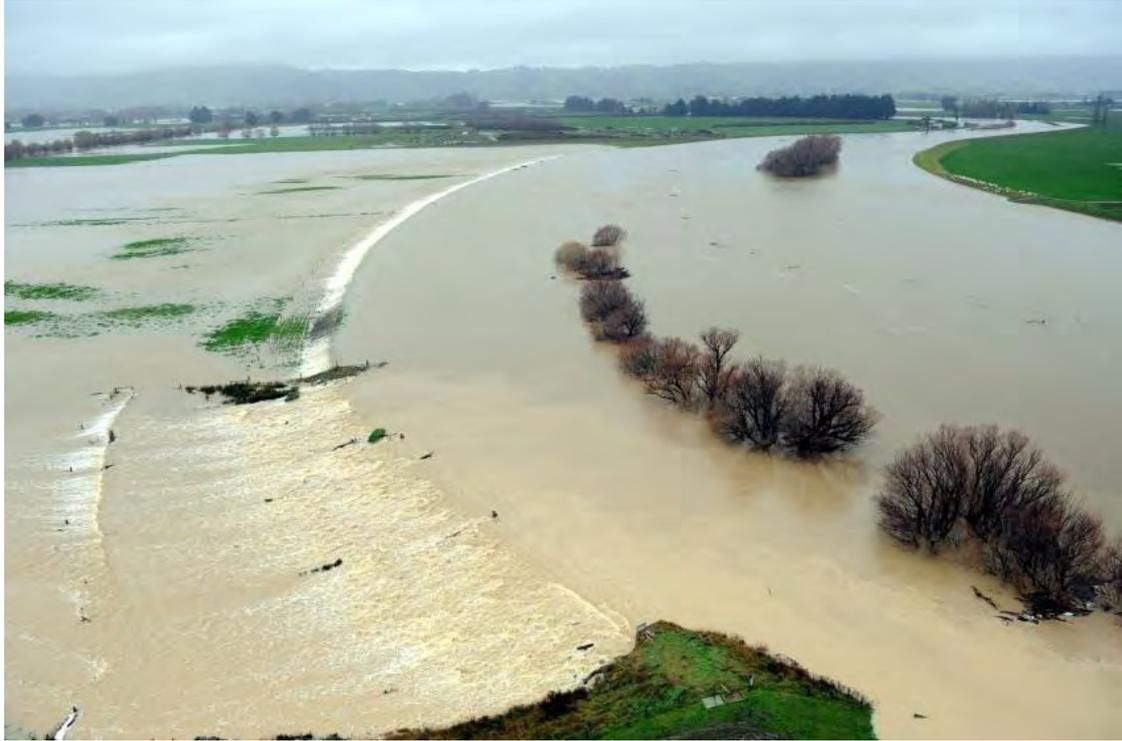
**Figure 16** Taieri River flows spilling into Area 12 on 29 May 2010 (Photo courtesy of Otago Daily Times)

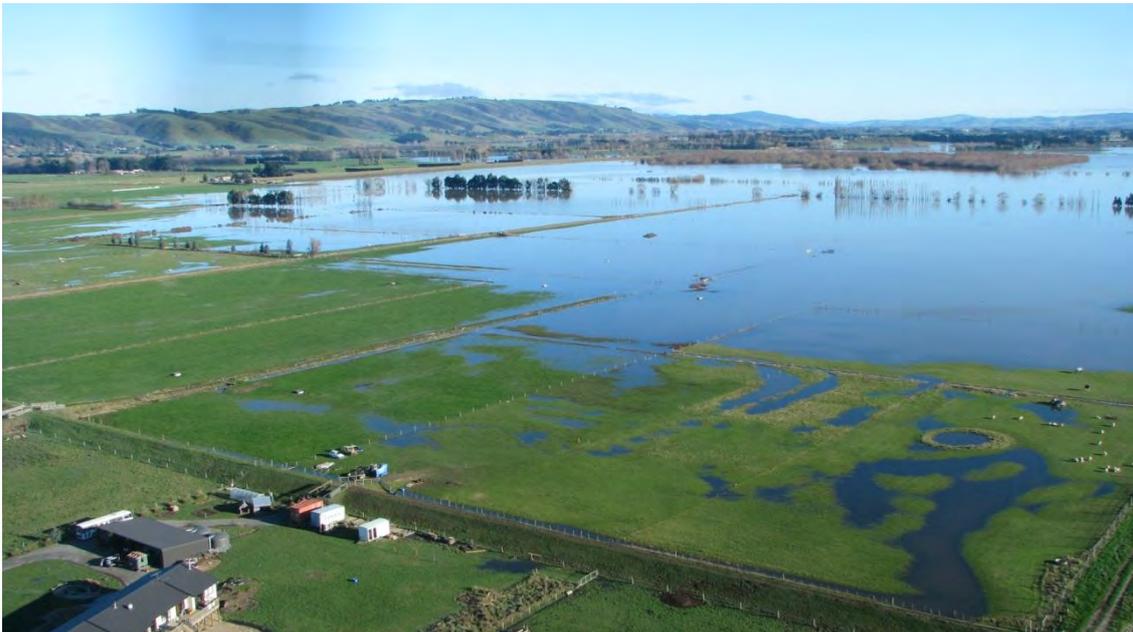
**Figure 17** Water ponding in Area 12 on 31 May 2010. The upper pond cut-off bank is at the bottom of the image.

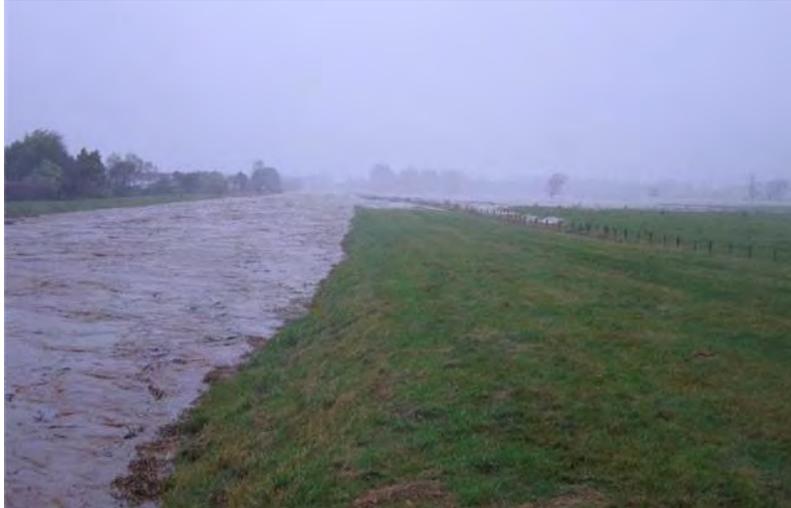
Figure 21 Silver Stream flows spilling over the Gordon Road Spillway (April 2006)

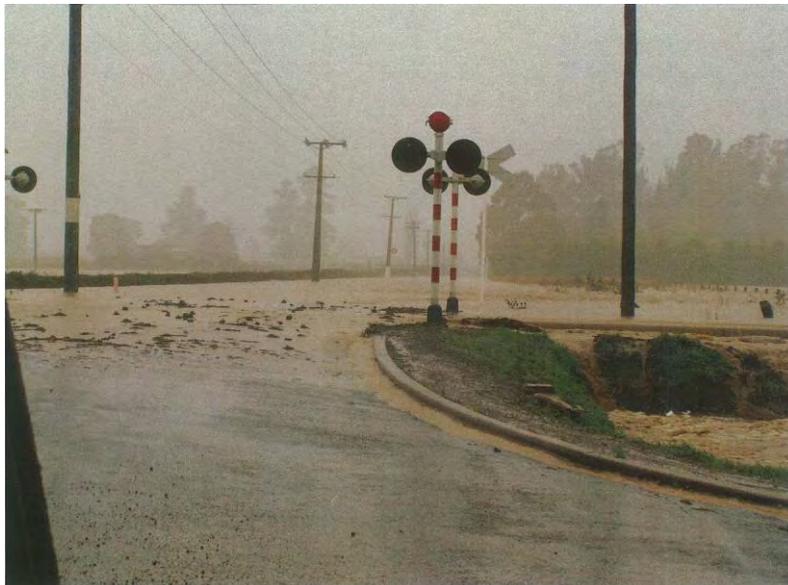
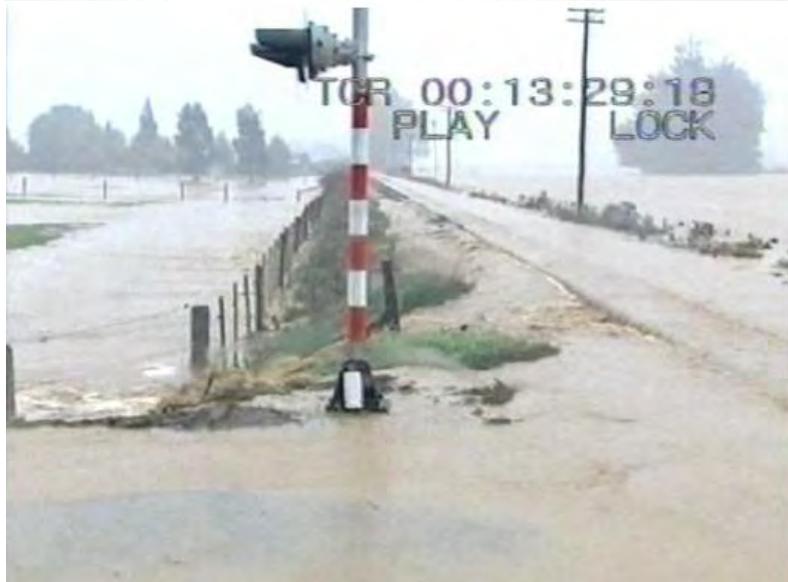
Figure 22 Water ponding behind the Taieri Gorge Railway, 26 April 2006

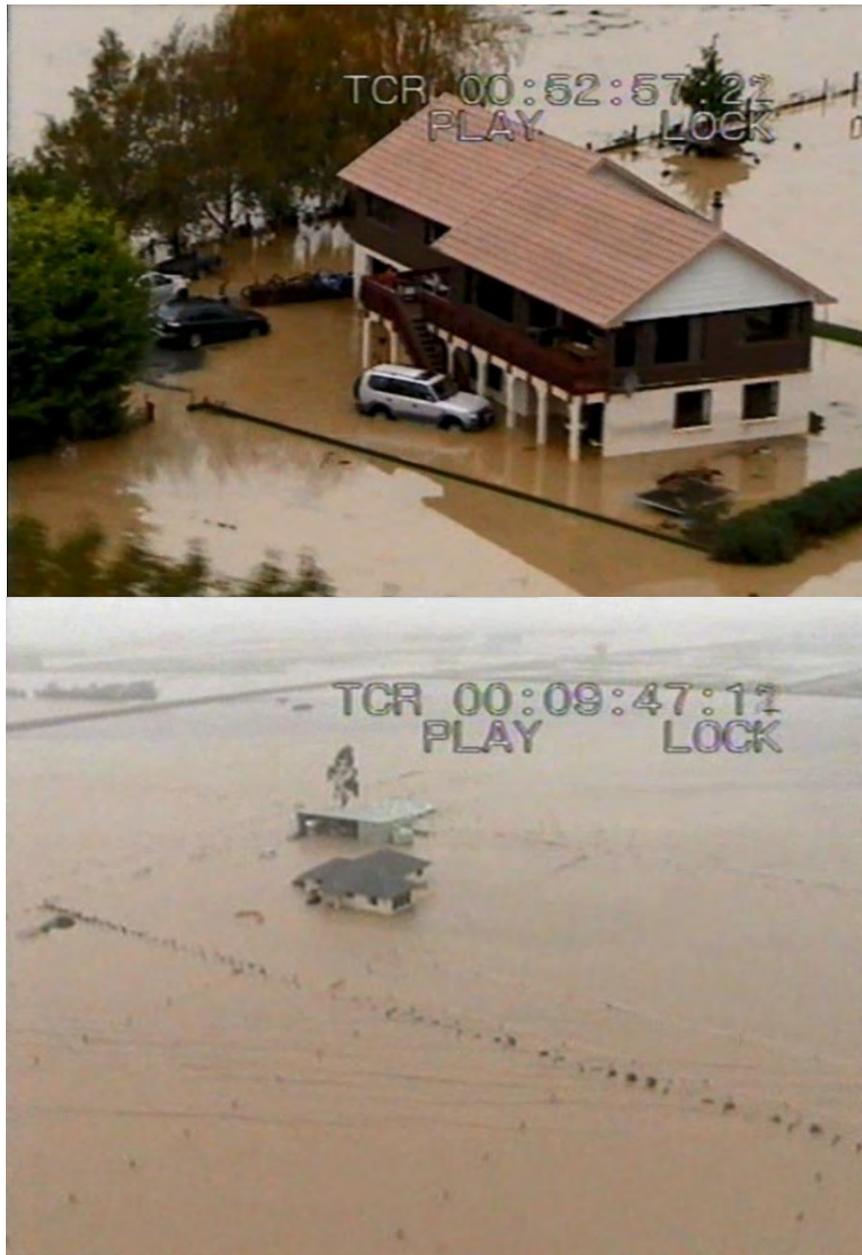
Figure 23 Flooding behind the Upper Pond Cut-off bank, April 2006. A flood mark is visible on the house in the upper image (Source: TVNZ).

The deepest and swiftest flows in this area would be associated with a failure of the upper pond cut-off bank, which could produce flows 2.5-3m deep, with a high velocity, as water drained rapidly from the Upper Pond (Area 12). The ability of this bank to contain water for a prolonged period and to a depth of up to three metres has not been tested in a flood event since it was built in the 1990"s. The lower part of Area 14B can also be affected by water ponding behind the upper pond cut-off bank to a depth of 3m, over a period of several hours (Figure 23).

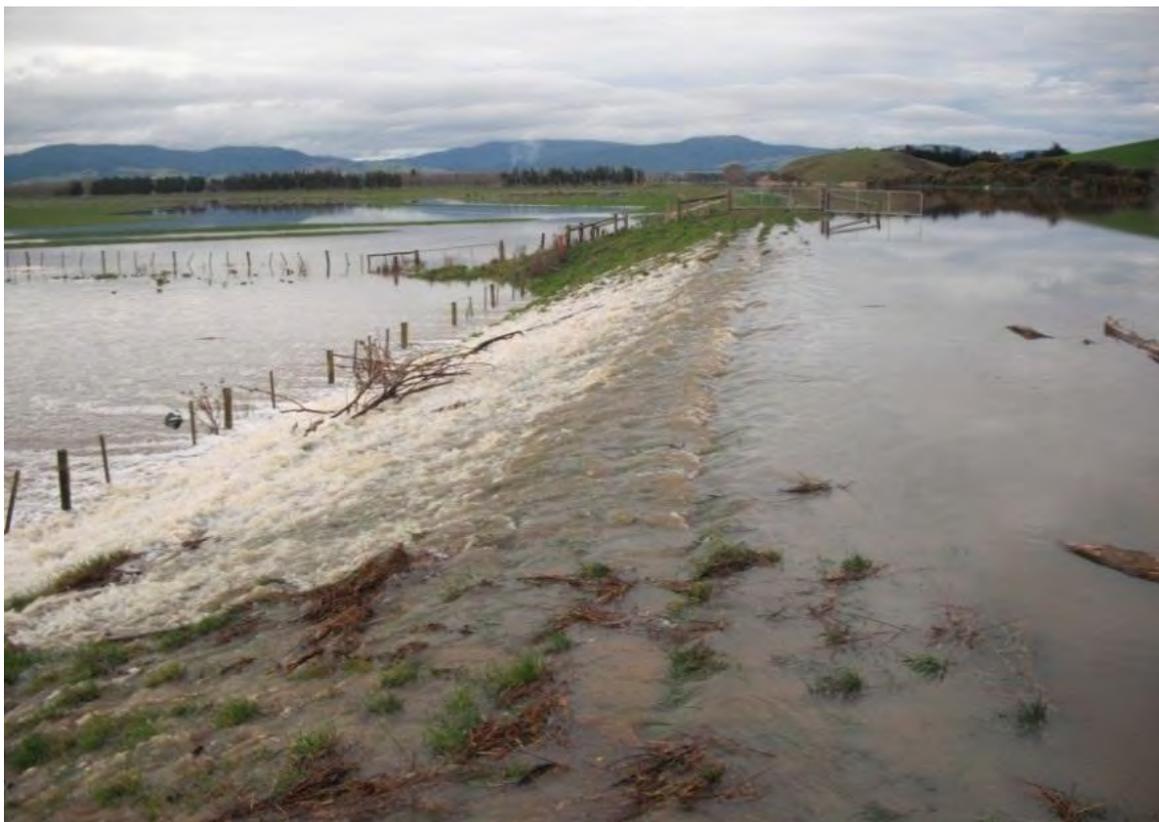
Figure 25 Overtopping of the Owhiro Stream into Area 17 (August 2012)

**Flood hazard characteristics and effects:** Flood hazard relates to the Taieri River, and also to the Silver Stream, Owhiro Stream (Figure 25) and the hill catchments to the south. Ponding can reach depths of over five metres if water was to reach the minimum crest level of the Taieri River true left floodbank (Figure 26), and can last for several weeks. The extent, depth and duration of ponding during each flood event depend on the flood's duration and size. If any of the surrounding flood banks were to fail, then the effects of flooding may also include water travelling at medium to high velocities, particularly in close proximity to that failure. A significant volume of water could pond in Area 17 (particularly if there were inflows from the Taieri River), and land could therefore be flooded for a prolonged period.

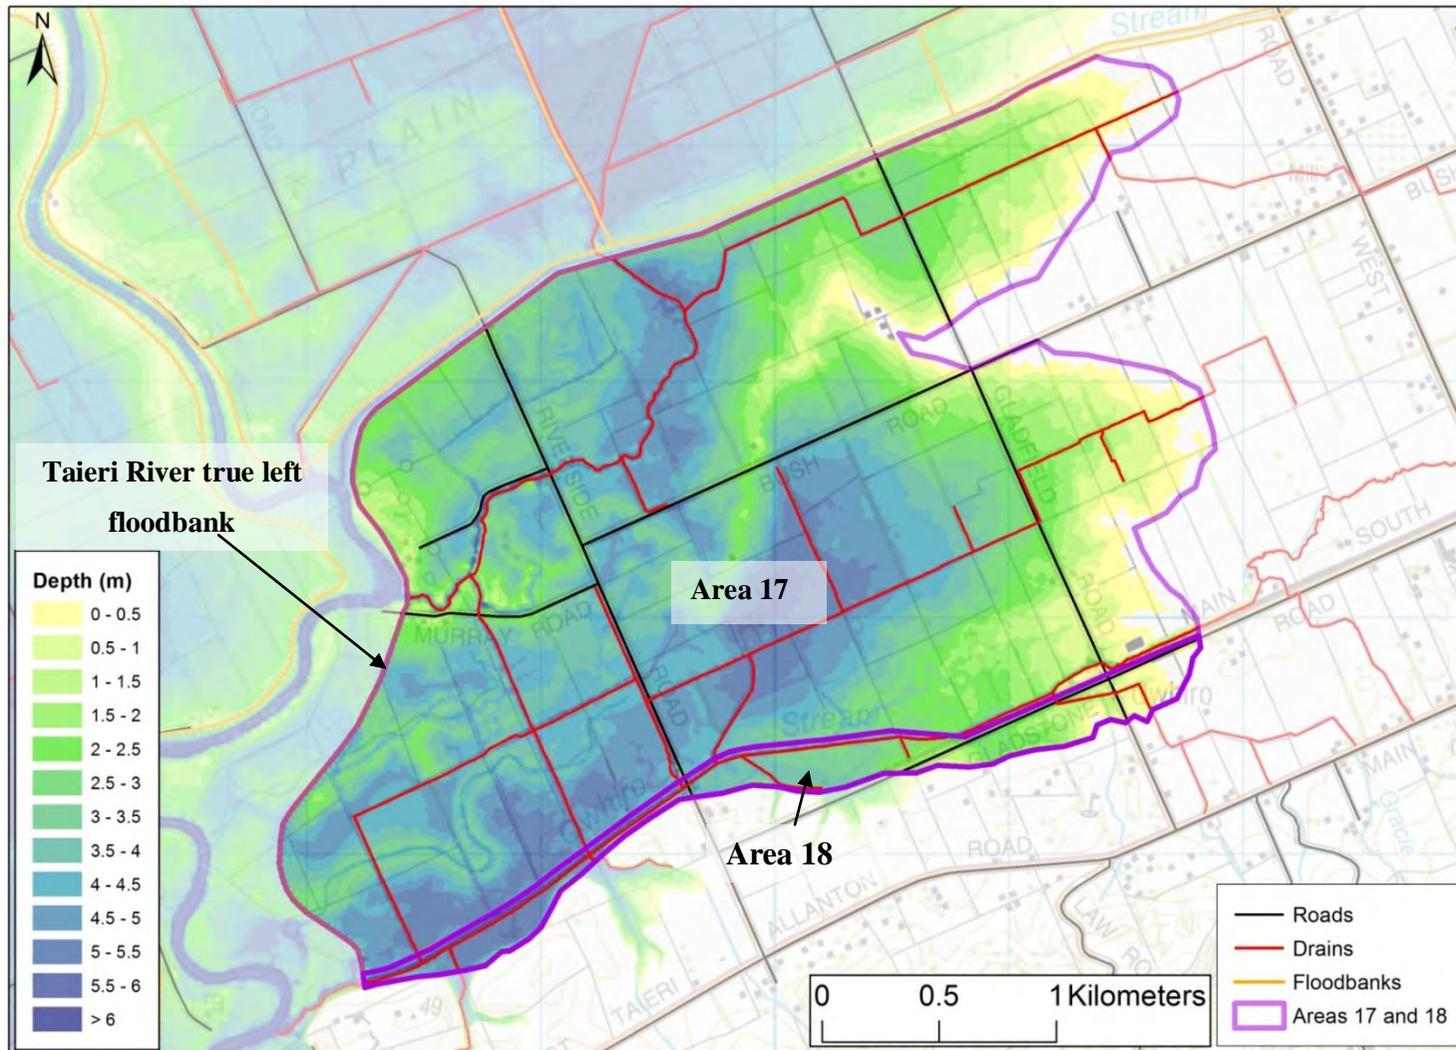
Figure 26 Depth of inundation in Area 17 and Area 18 if water was to reach the crest of the Taieri River true left floodbank

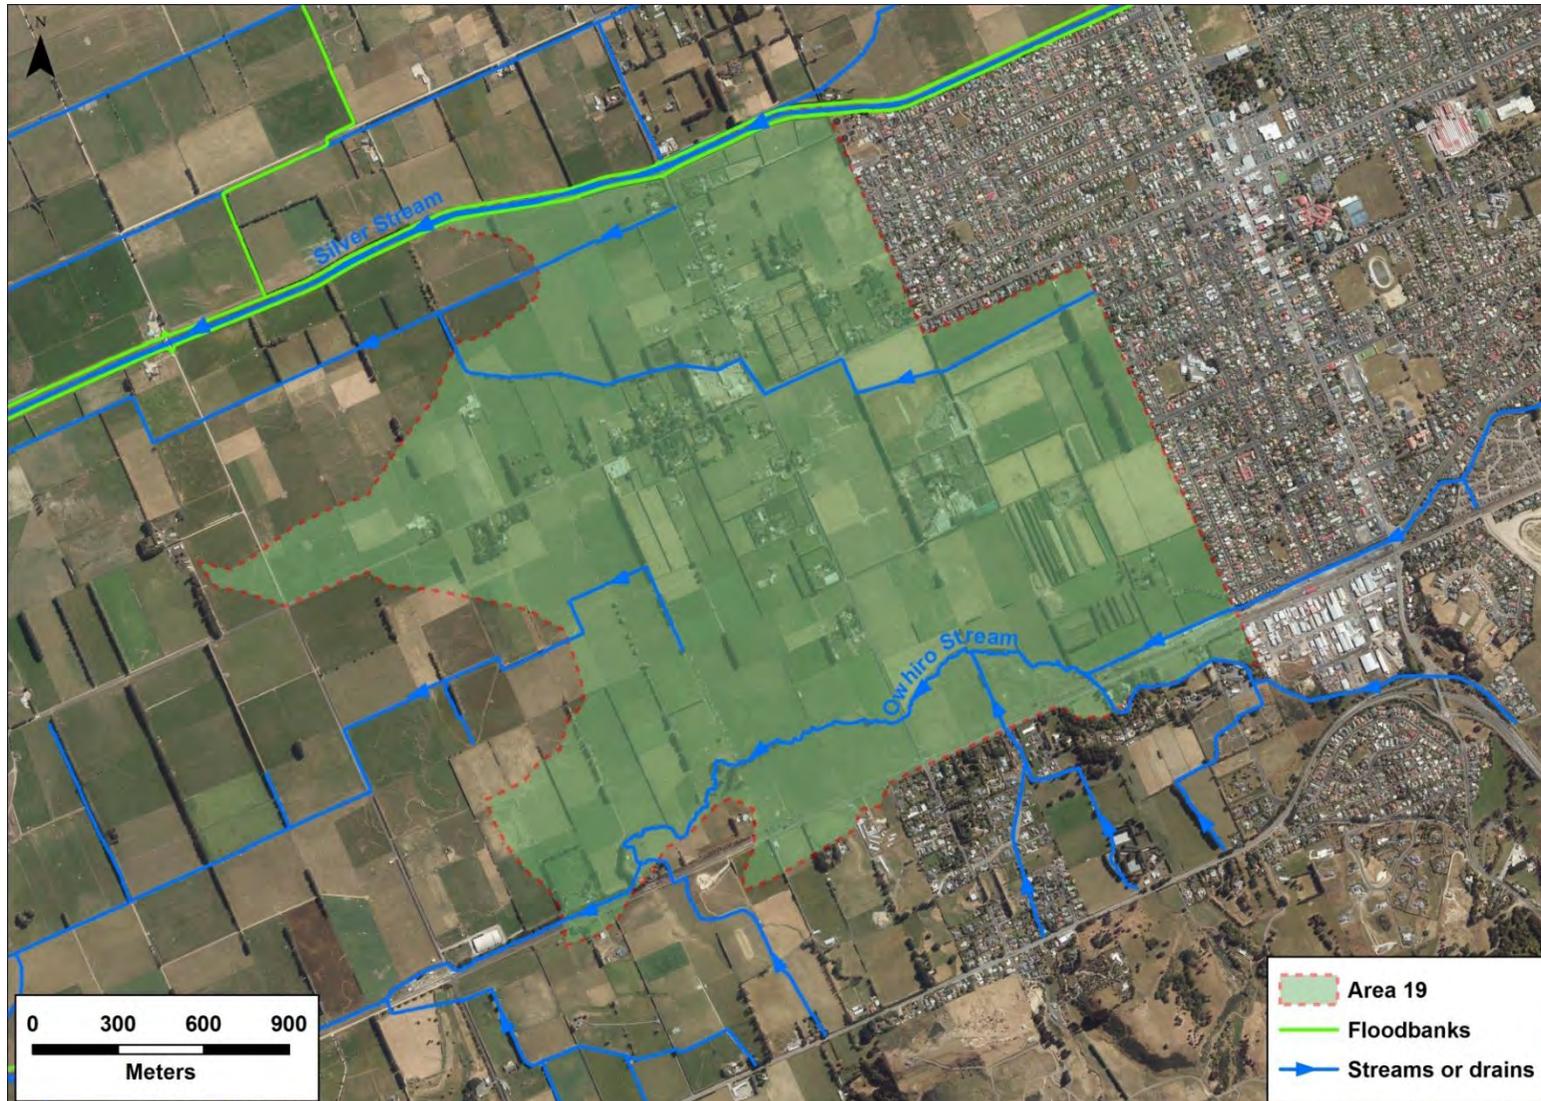
Figure 27 Area 19 – Streams and drains and general direction of flows in Area 19

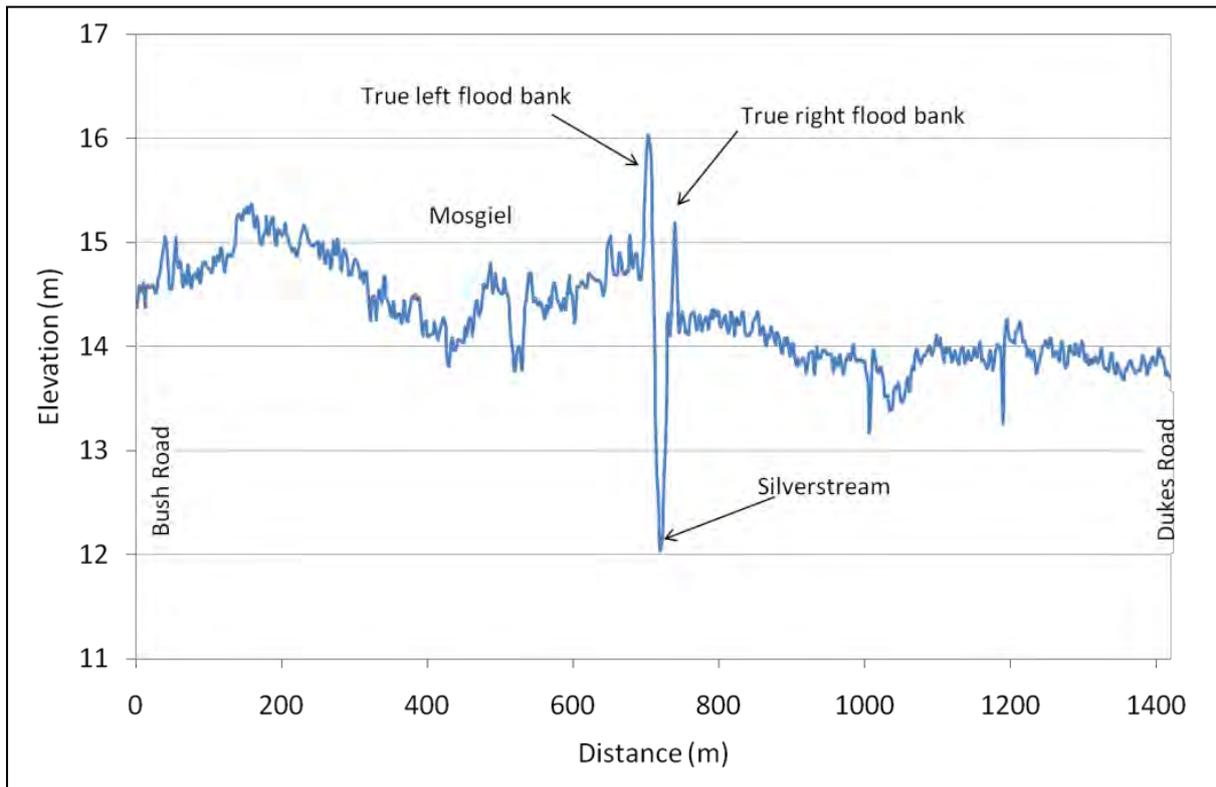
**Figure 28** Cross section through the Silver Stream (from Bush Road in Mosgiel to Dukes Road in Area 14), looking downstream

**Setting:** Most of the Mosgiel urban area is elevated slightly above the land on the northern side of the Silver Stream (Figure 28) and the land to the south alongside the Owhiro Stream. As such, it has limited exposure to flood hazard from the Silver Stream, Owhiro Stream, Quarry Creek, internal runoff from within Area 20, and downslope runoff from Area 21 (Figure 34). The flood banks along the southern (true left) side of the Silver Stream are designed to contain flows which have an assessed return period of approximately 100 years.
