# **Review of Dunedin City District Plan—Natural Hazards**

**Flood Hazard on the Taieri Plain and Strath Taieri**

Report writers:       Jean-Luc Payan, Investigations Engineer  
                              Michael Goldsmith, Manager Natural Hazards

Published June 2014

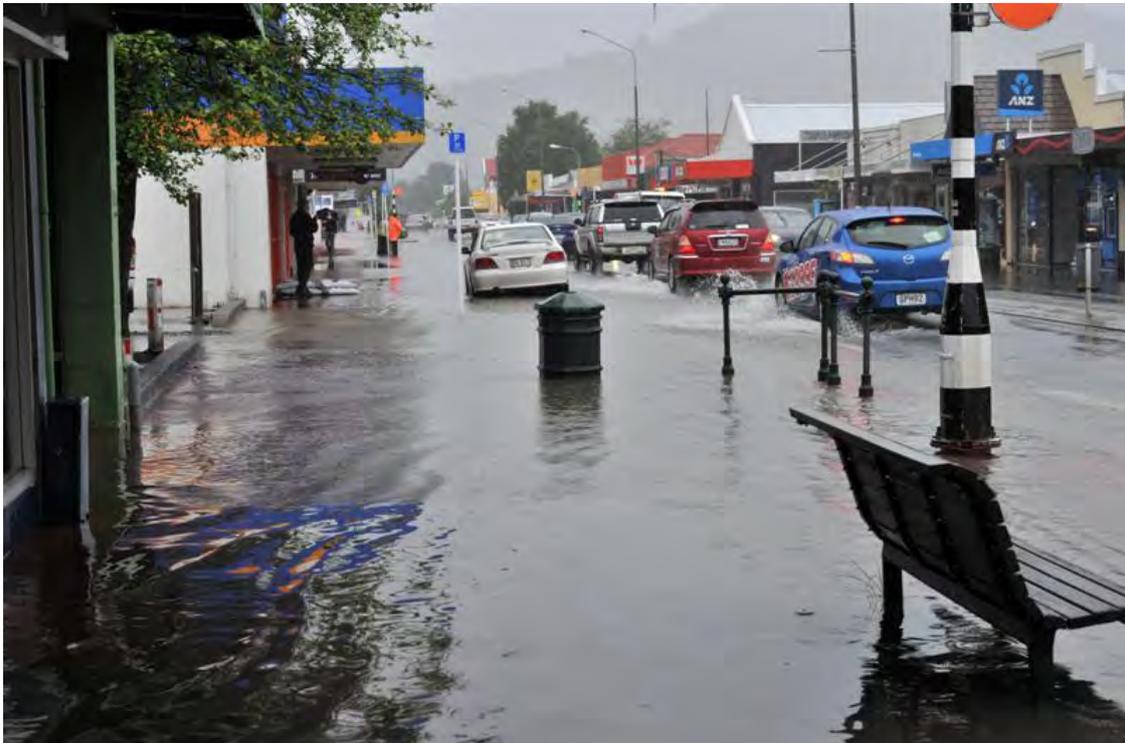
Figure 29 Surface flooding on Gordon Road, November 2012 (Source: Otago Daily Times)

The characteristics of flood hazard (including depth, duration and velocity) within urban Mosgiel are determined in part by the capacity of the drainage network, and most of Area 20 is serviced by an urban standard stormwater network. Heavy rainfall events which exceed the design capability of this network can result in internal runoff and ponding of floodwater (Figure 29).

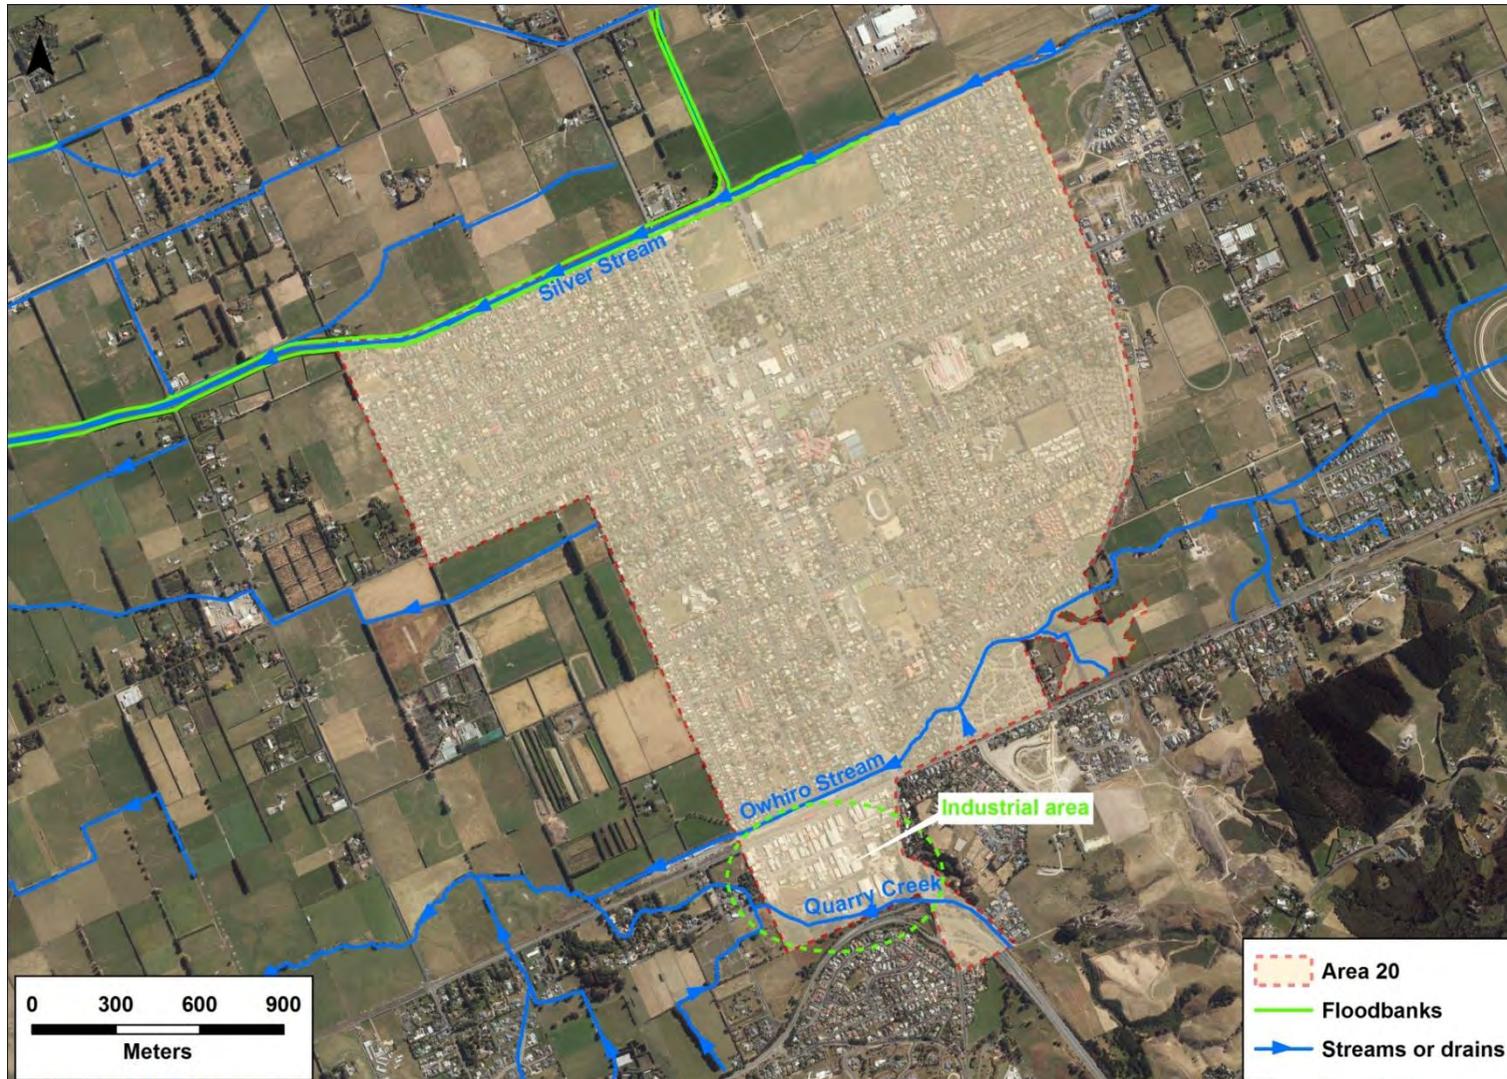
Figure 30

Area 20 – Streams and drains, and the location of the industrial area at the southern end of Area 20

During periods of heavy rainfall, surface flooding and runoff from the eastern hills can cause localised ponding, especially in the industrial, southern part of the urban area, near Quarry Creek (ORC, 2013) (Figure 30). The flooding in the industrial area is not directly caused by Quarry Creek overtopping its true right bank but is the result of an undersized stormwater network (Figure 31). The flooding is exacerbated by the location of the stormwater network outlets discharging in Quarry Creek: when the

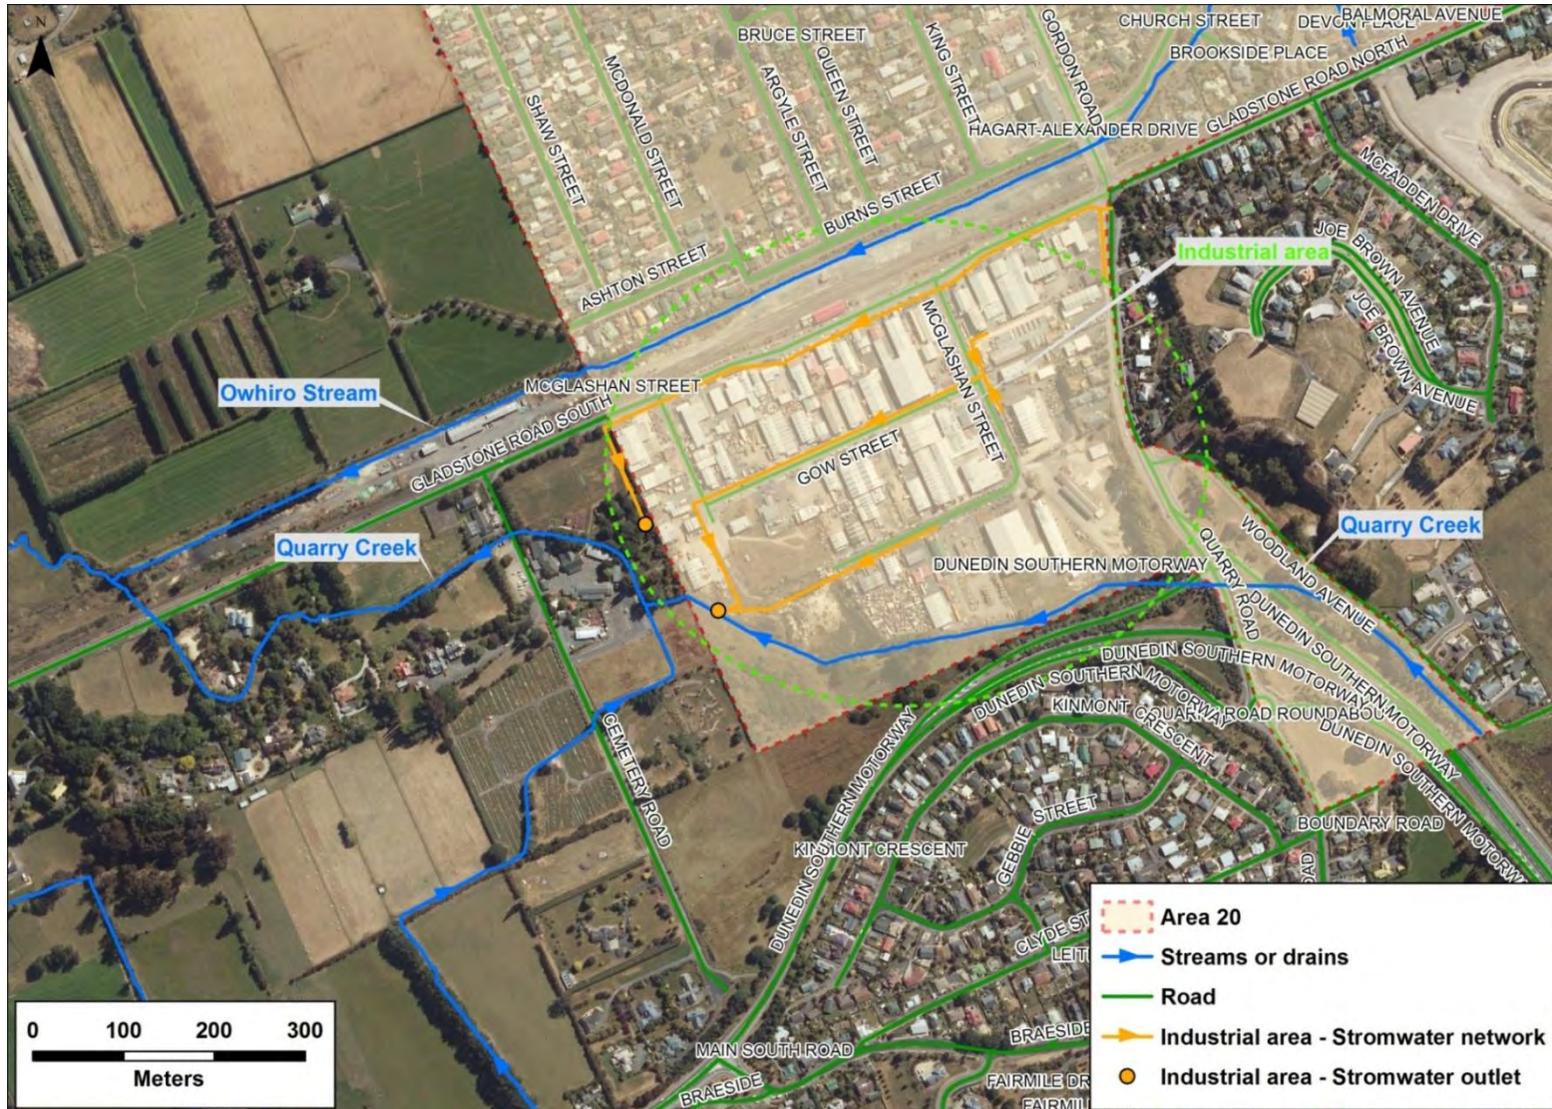
Figure 31 Area 20 – Industrial area and location of the stormwater network and outlets

water level in the creek is high flood water can impede the stormwater discharge and water can back up through the stormwater network causing flooding in the industrial area.

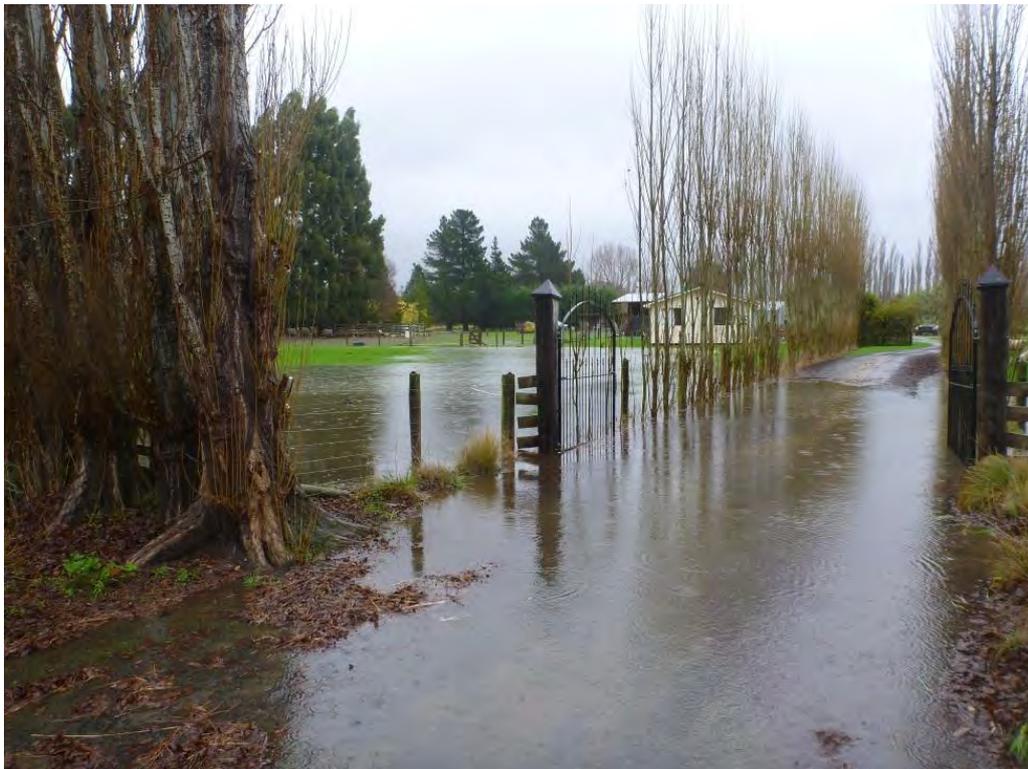
**Figure 32** Overland flow which has drained from the adjacent hill catchment, ponding near Puddle Alley, at the northern end of Area 21 (June 2013)

**Setting:** The Wingatui area is exposed to flood hazard from internal runoff, the hill catchments to the east and south, the Owhiro Stream, and to a lesser extent, the Silver Stream<sup>8</sup> (ORC, 2013). A series of active floodwater-dominated alluvial fans emerge from the adjacent hill catchments (Abbotts Hill (360m) to the east; and the Chain Hills (approximately 150m) to the south) (GNS, 2014c). These fans grade into an extensive alluvial plain, with a corresponding change in elevation from about 40m down to 25m near Mosgiel. Surface runoff and ponding resulting from heavy rainfall can occur in this area with little warning, due to the short, steep upstream catchments which discharge onto this eastern part of the Taieri Plain (Figure 32).

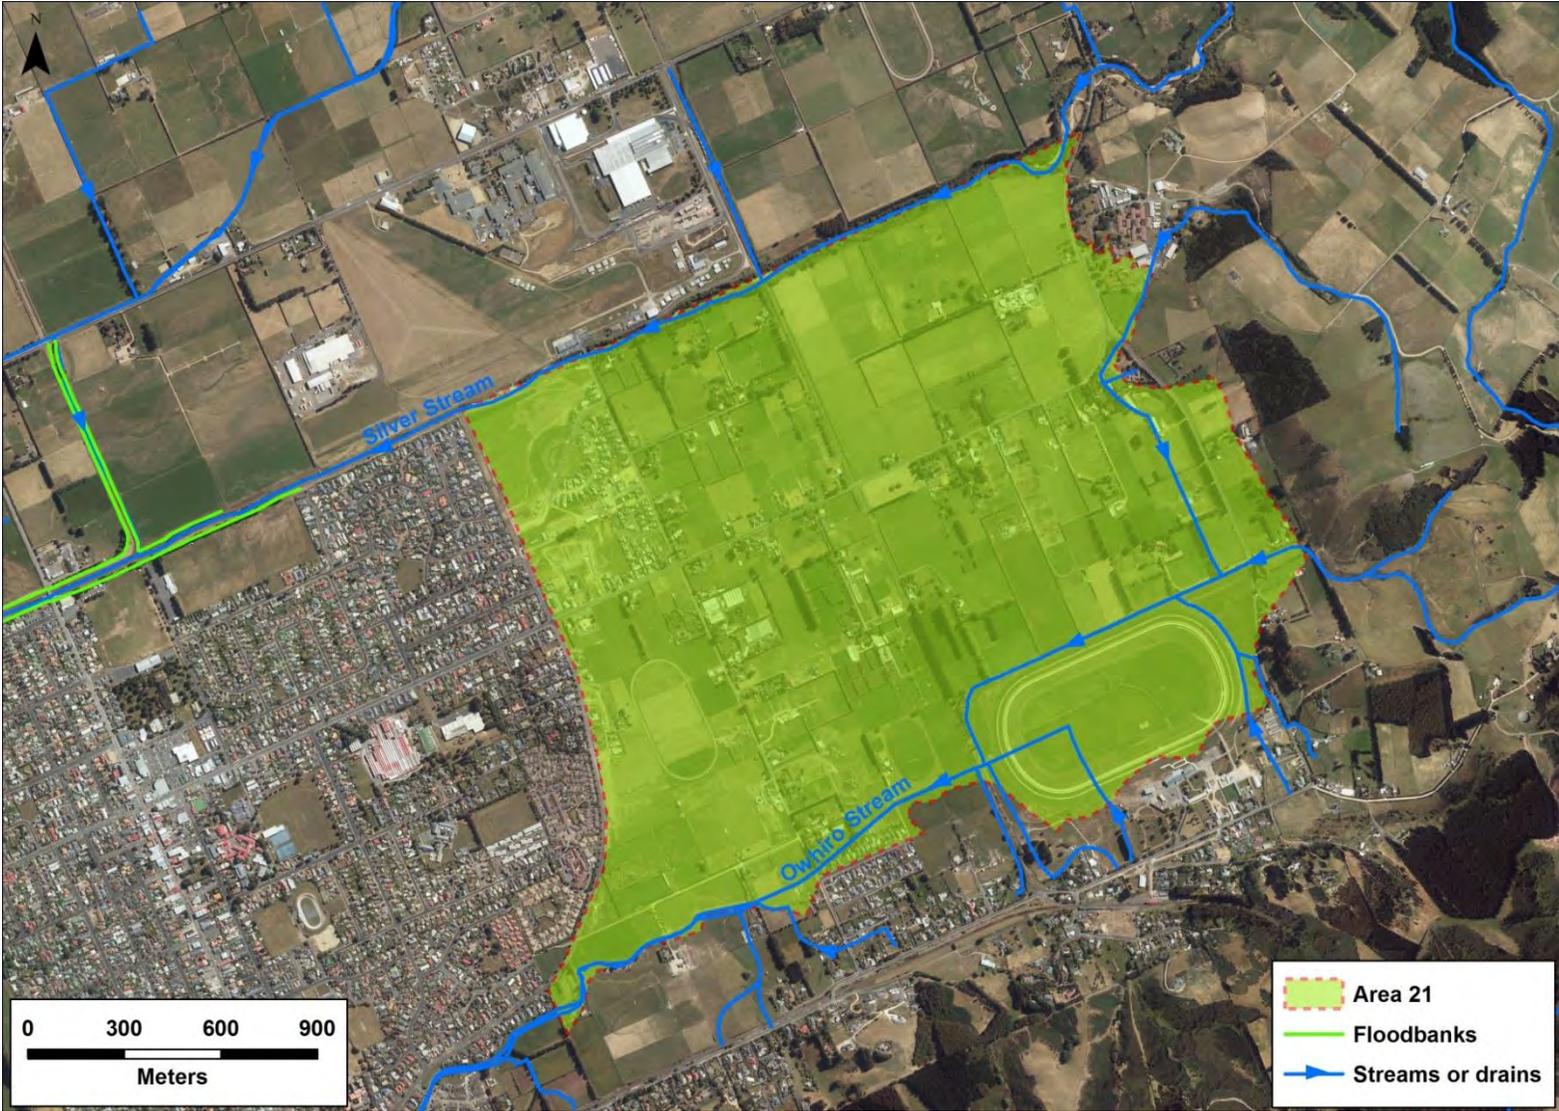
Figure 33 Area 21 – Streams and drains and general direction of flows in Area 21

There are a limited number of formal drains which cross Area 21, and the location of these is shown in Figure 33. These drains carry much of the overland flow which flows towards the southwest during heavy rainfall events. Because of the generally subtle topography (as shown in Figure 34), the depth and extent of flooding can also be influenced by local features such as embankments, fences, shelterbelts and buildings, which can impede natural downslope drainage. The area lies within the East Taieri Drainage Scheme, which provides land drainage to a rural standard, and Figure 33 shows the location of scheduled drains (as defined in ORC, 2012).

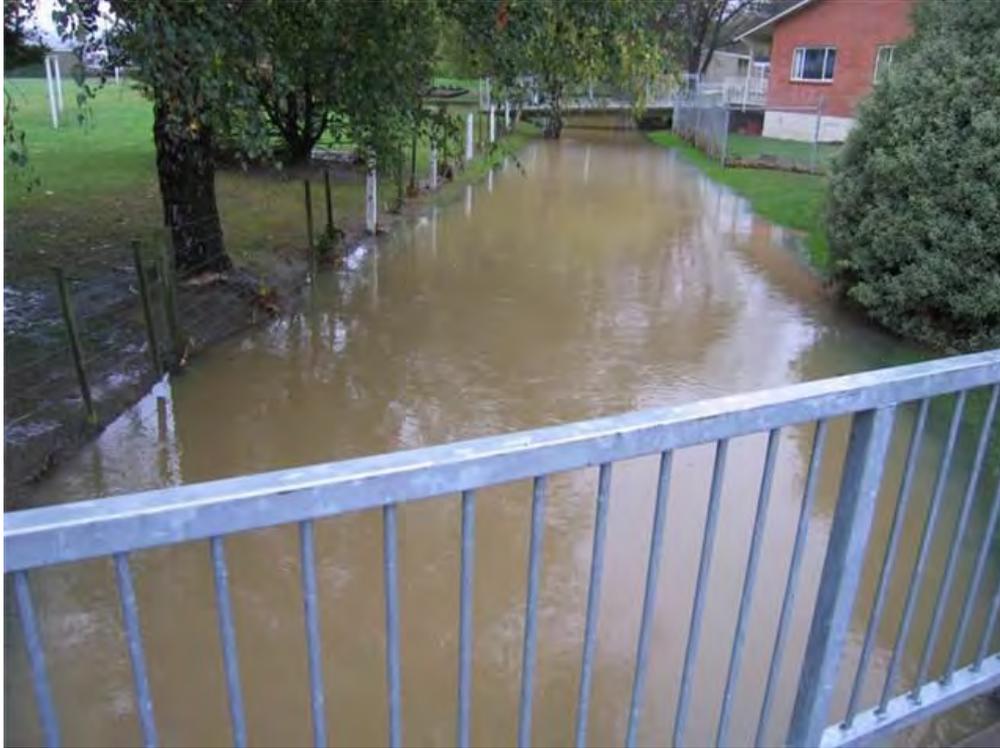
**Figure 35** Quarry Creek at Cemetery Rd Bridge, April 2006. Photo was not necessarily taken at the time of peak flow.

Quarry Creek is a short watercourse (approx. 3.5km) which drains the North facing slopes of Saddle Hill. It has a catchment area of approximately 3.5km<sup>2</sup>. The creek passes through a culvert under State Highway 1 adjacent to Kinmont Park and flows through Area 20 (see Area 20 description and Figure 31) and the East Taieri School grounds before joining the Owhiro Stream about 400m below Cemetery Road (Figure 37). The area adjacent to the creek between the culvert under State Highway 1 and Cemetery Road Bridge is low-lying (Figure 37). During periods of heavy or extended rainfall the creek can cause flooding of these low-lying areas, in particular the car park of the East Taieri School and parts of the school grounds. The school car park area and part of the East Taieri School grounds are located at a relatively low level adjacent to a breakout point (Figure 37). Given the topography of the area (flat and low-lying), the flood hazard is significantly influenced by the backwater effect from the Owhiro Stream. High water levels in Quarry Creek can also cause the bridge on Cemetery Road to flood.

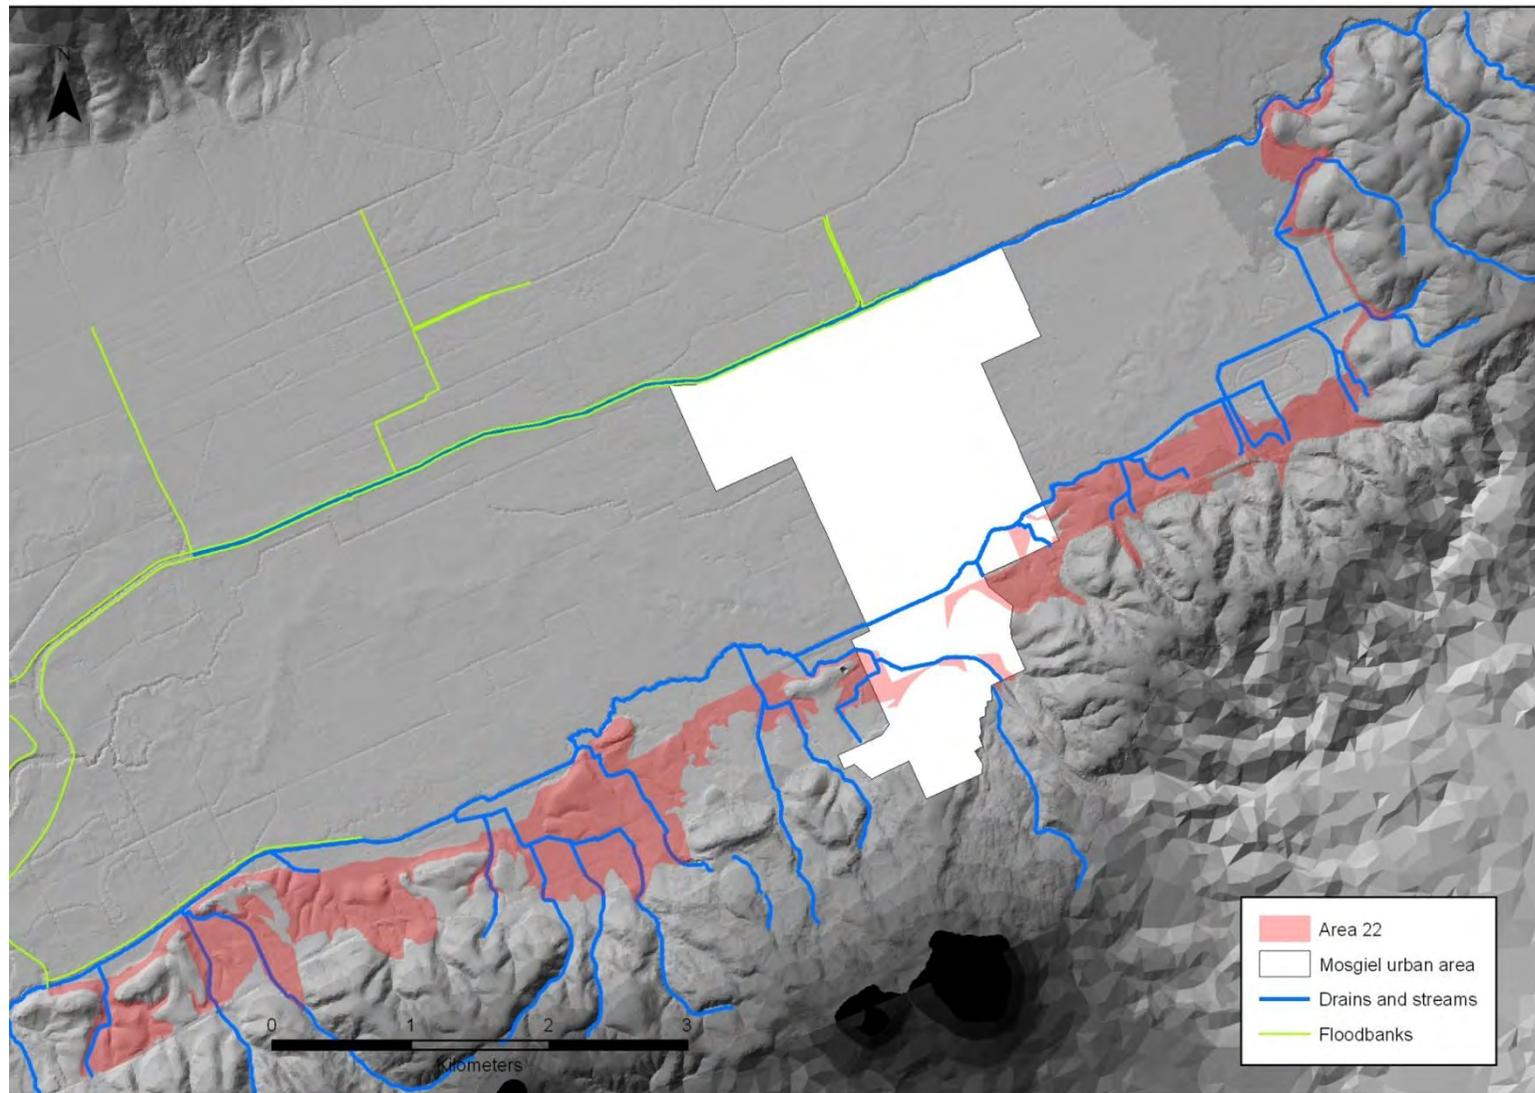
Figure 36 Coastal hill catchments which traverse Area 22

**Setting:** This area is sufficiently elevated not to be affected by the Taieri River or the Silver Stream. Flood hazard is derived from Quarry Creek (Figure 35), Owhiro Stream, and the hill tributaries to the south and east (Figure 36). Flood hazard is mainly associated with overland flow and, in some places, the presence of floodwater-dominant alluvial fans (Opus, 2009). High stream flows, surface runoff, and ponding resulting from heavy rainfall can occur in this area with little warning, due to the short, steep upstream catchments which discharge onto the Taieri Plain. The depth of flooding can range from less than 0.25m through to about 2m in the deeper drains. The velocity of runoff is generally slow to medium, and runoff generally does not last more than a few hours, during the period of peak rainfall intensity.

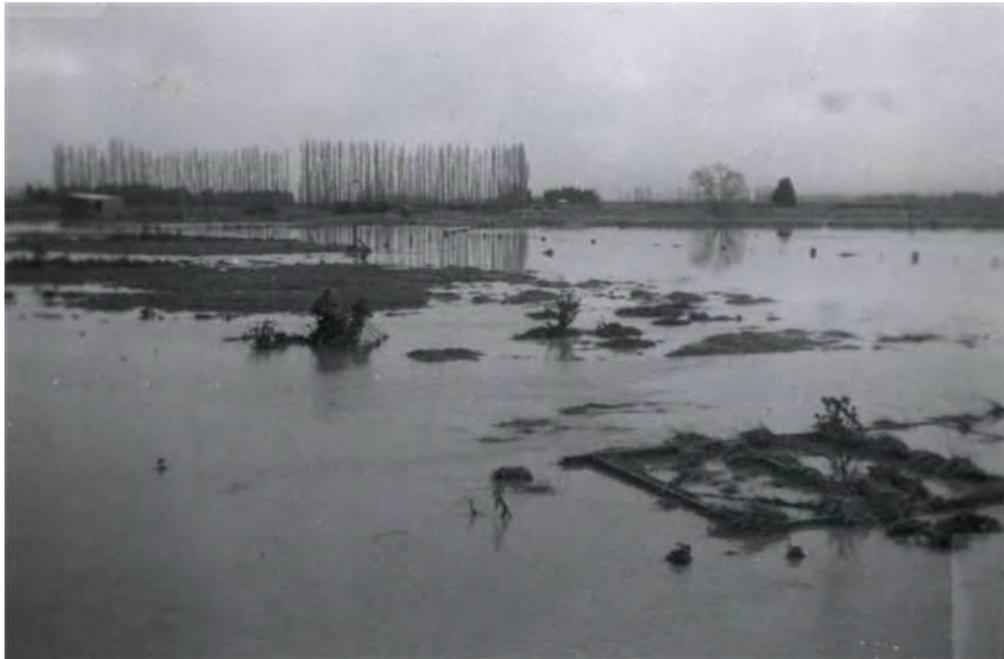
**Figure 40** Inundation of rural land near Creamery Creek (Middlemarch) following the May 1957 flood. Note the lines of fence posts just visible above the water level.

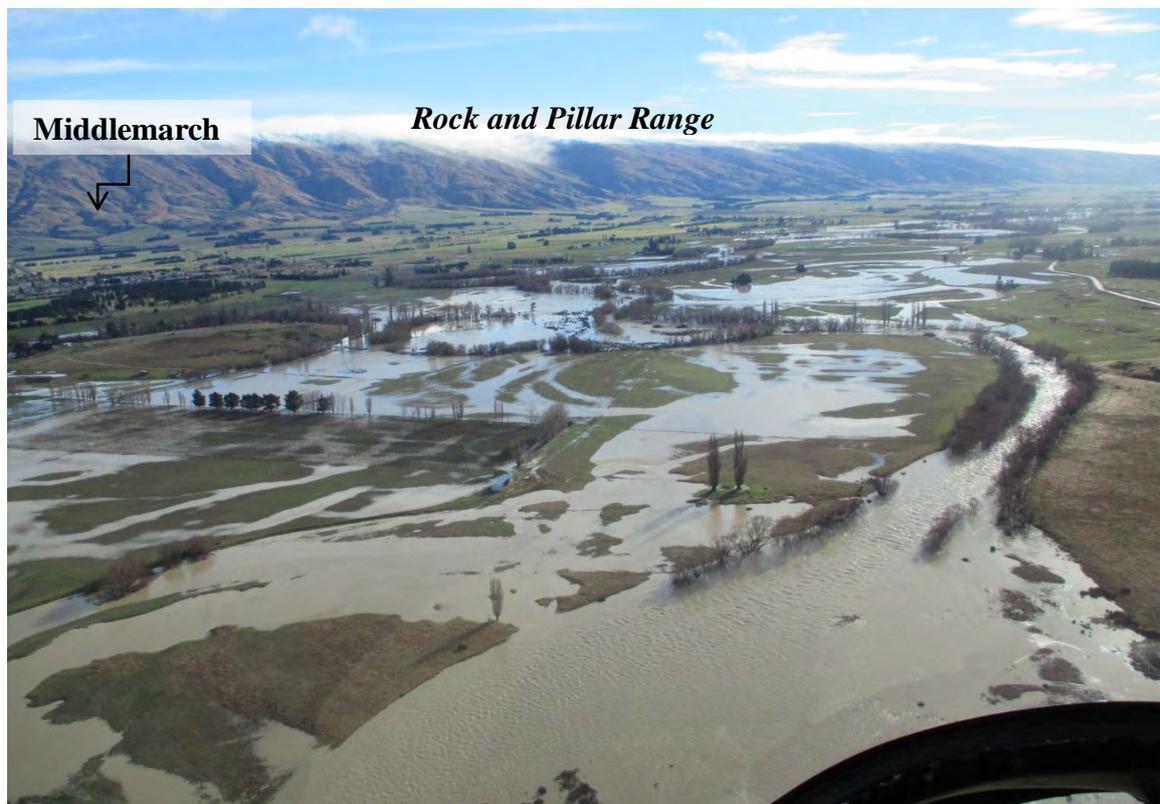
**Figure 41** Inundation of rural land on the margins of the Taieri River on 18 June 2013, following a prolonged period of heavy rainfall. This photo was taken 6 hours after the flood peak, when flow in the Taieri River at Sutton had dropped from

354m<sup>3</sup>/s to 326m<sup>3</sup>/sec. The ORC Natural Hazards Database ([www.orc.govt.nz](http://www.orc.govt.nz)) contains a series of photos of the Strath Taieri taken on this day.

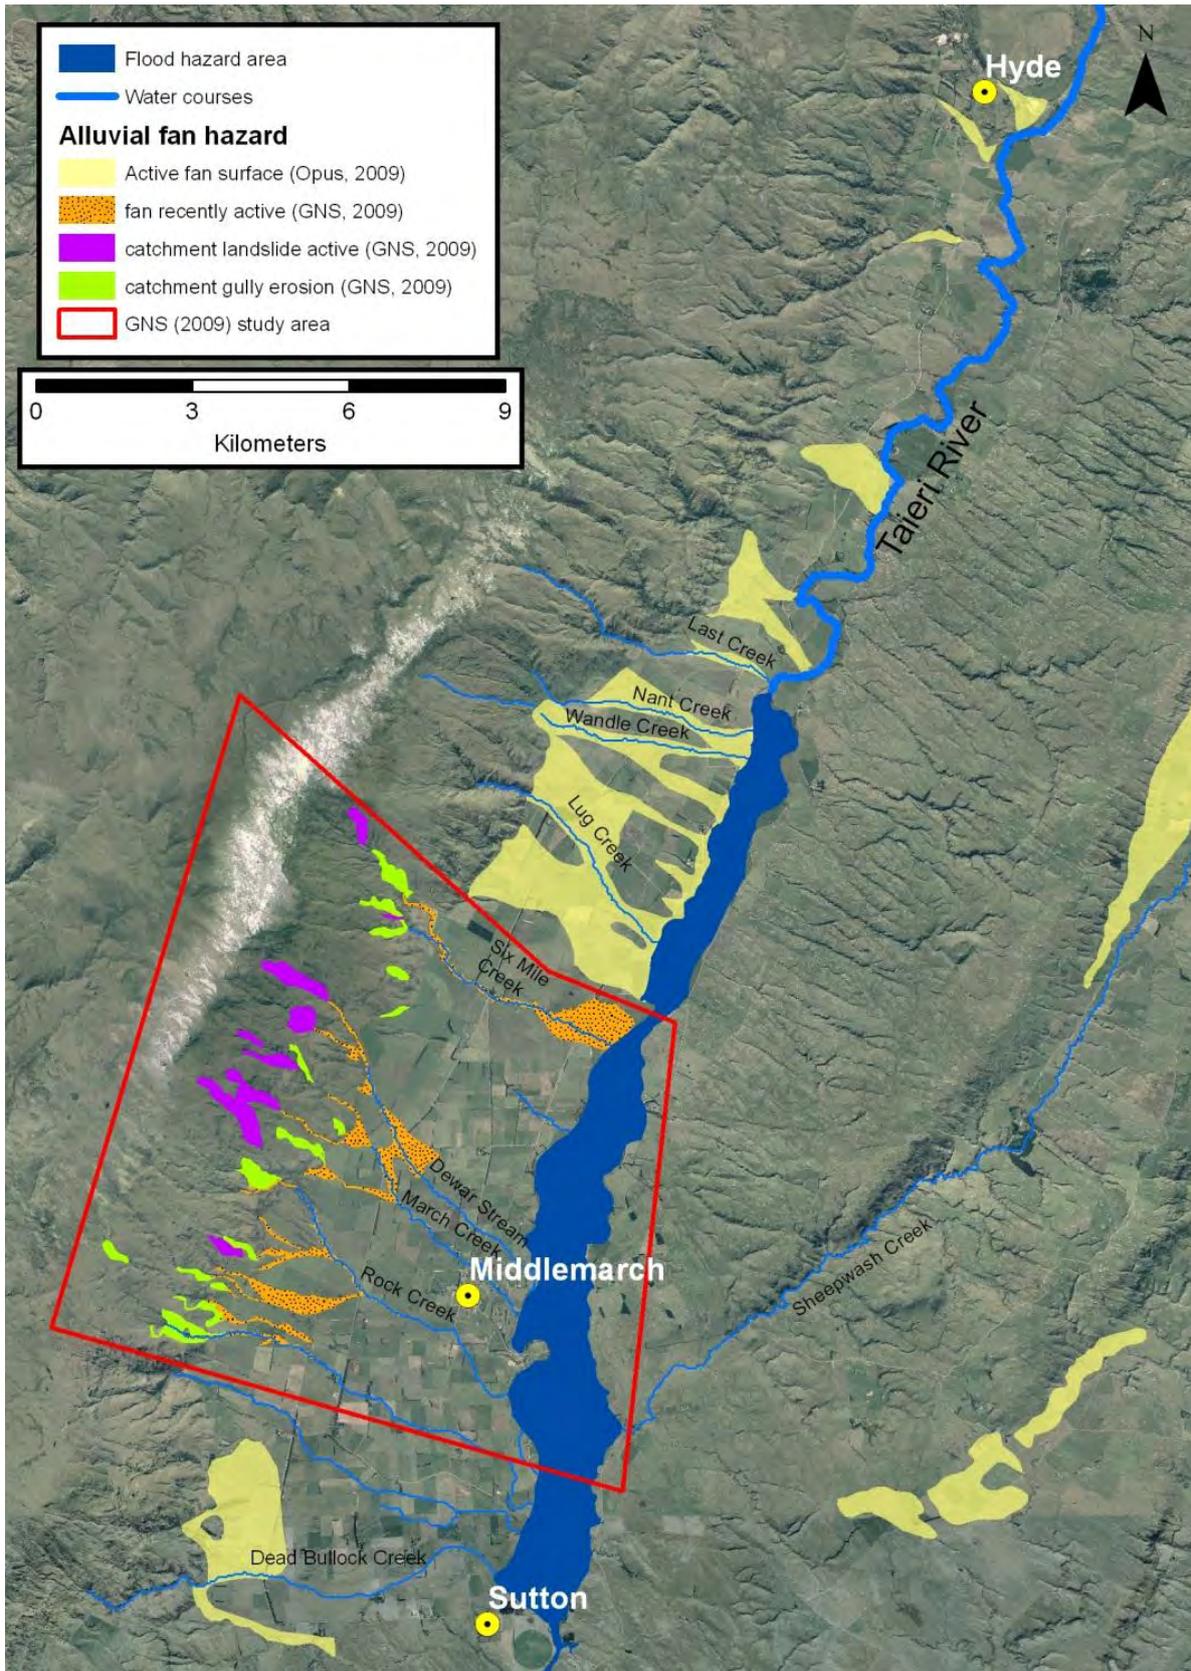
Figure 43 Strath Taieri flood hazard area (ORC, 1993), and active alluvial fan surfaces (GNS, 2009 and Opus, 2009)

The Taieri River flood hazard area (as shown on Figure 43) has been mapped primarily using information from flood events in June 1980 and December 1993. These are the two largest floods since records began in 1960. The flood hazard area extends 20km from the confluence of Last Creek with the Taieri River in the north, to Sutton in the south. It covers an area of 85km<sup>2</sup> and is almost 2km across at its widest point. There have been relatively few large flood events since the mid 1990's, and the peak flow at Sutton during the June 2013 flood was considerably smaller than during previous events. Recent experience of flood events may therefore not represent the full spectrum of risk associated with flood hazard. However, Figure 39 shows that there have been occasions when several large floods have occurred within 12 months or less (March 1986 to March 1987, and December 1993 to July 1994).
