### 9.1. Roxburgh Natural Hazards Management

**Prepared for:** Safety and Resilience Comm  
**Report No.** HAZ2404  
**Activity:** Governance Report  
**Author:** Julion Wright, Natural Hazards Analyst  
Tim van Woerden, Acting Manager Natural Hazards  
**Endorsed by:** Tom Dyer, General Manager Science and Resilience  
**Date:** 7 November 2024

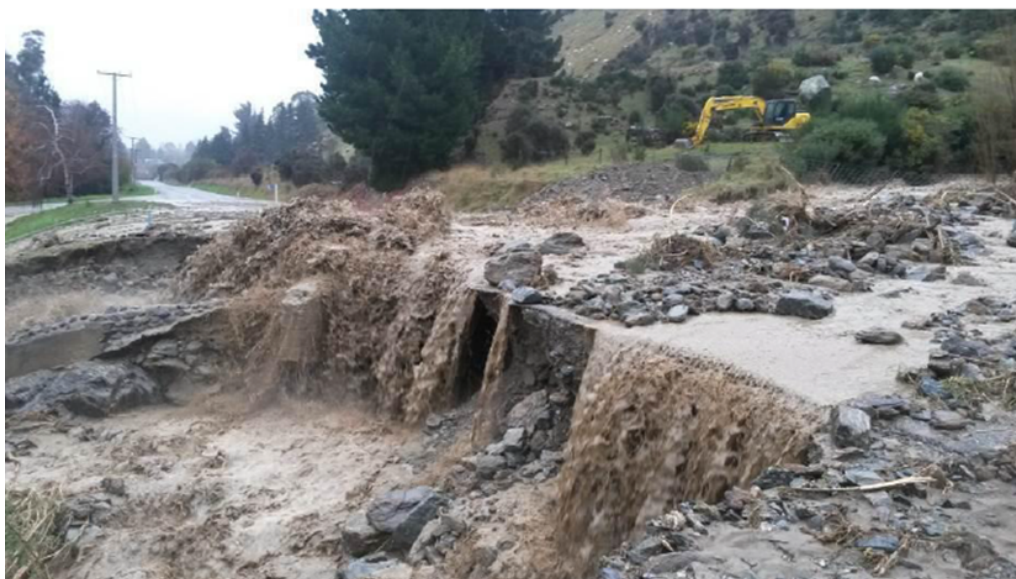
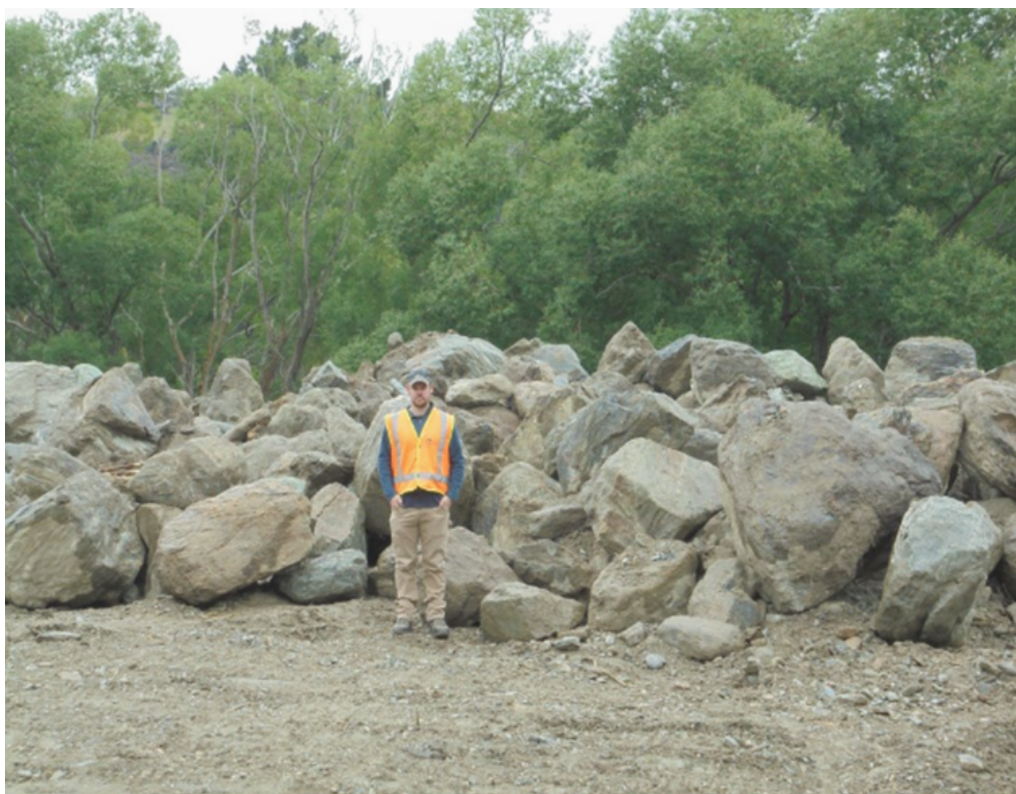
**Figure 4: Examples of debris flow deposits from Roxburgh events: top, debris flow at Blackjacks Creek in 2015, and bottom, boulders removed from a debris flow deposit at Blackjacks Creek after the November 2017 events.**

high sediment concentration and are very dense relative to clear water, they also contain coarse sediments (i.e., boulders) (e.g., Figure 4).

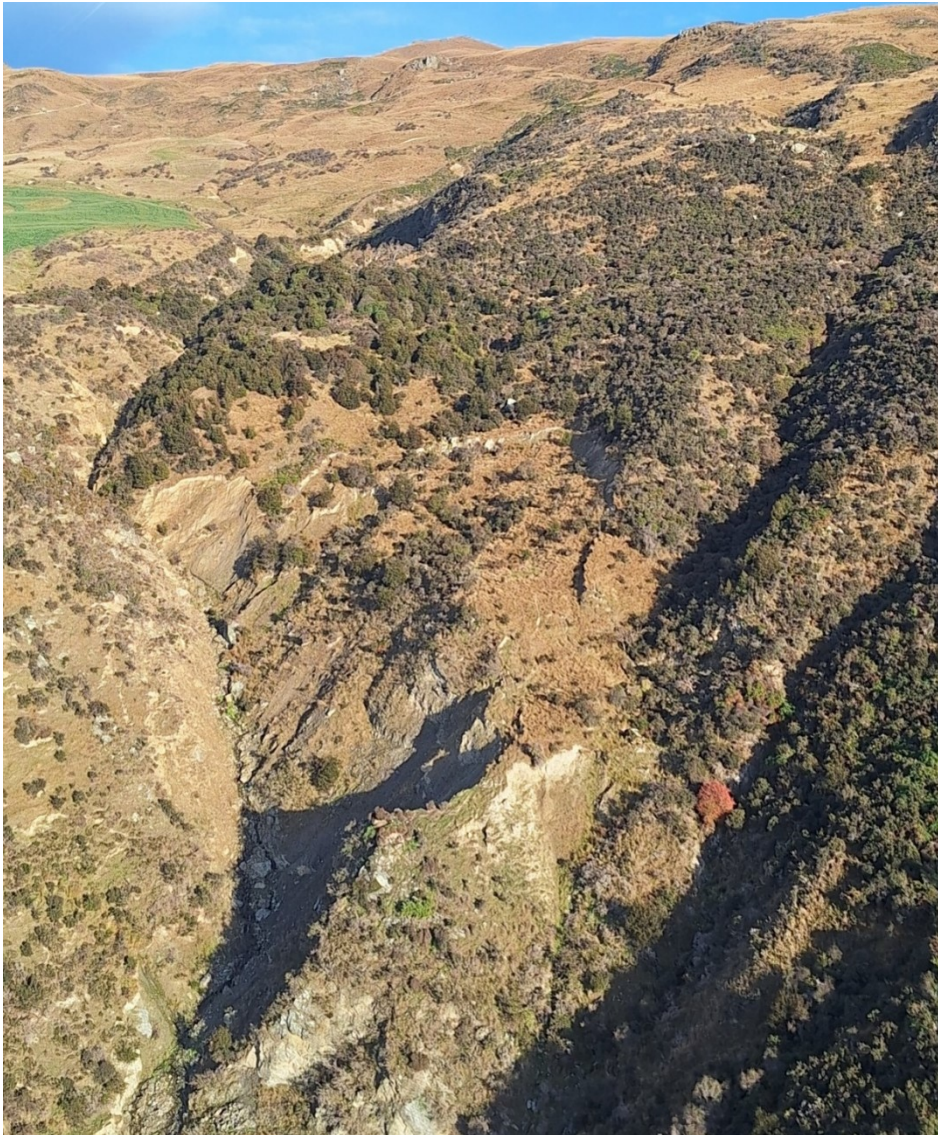
**Figure 5: Example of a large active landslide in Golfcourse Creek, currently being undercut and eroded by the channel, which likely supplies sediment to a debris flow during an event. This is a typical situation in these catchments.**

- [16] The geomorphic and geological characteristics of the Old Man Range and the Roxburgh area, west of the Clutha River, are the primary drivers for the debris flow susceptibility in the Roxburgh area. Key factors include the high sediment yields of the Creeks that drain the eastern flanks of the Old Man Range, and the relatively small, steep nature of the catchments themselves (Figures 3 and 5).

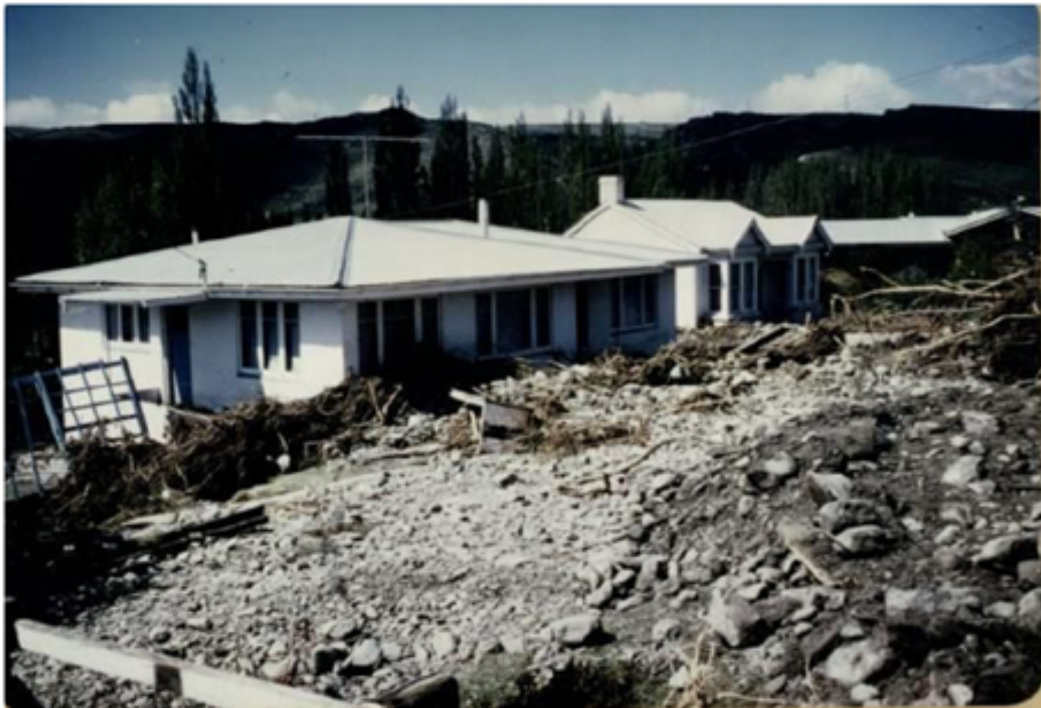
**Figure 6: Direct impact of a debris flow at Reservoir Creek, 1978, showing extensive debris deposition, and direct impact to dwellings adjacent to the stream channel.**

- [18] Following the 1978 event (Figure 6), in the early 1980's, the Otago Catchment Board (OCB) excavated the channel and constructed a concrete-lined channel in the downstream section of Reservoir Creek (from where it exits the valley). The channel structure is designed to rapidly convey floodwaters and debris across the alluvial fan and into the Clutha River. The concrete channel is 200 metres long, 3 metres wide at the base, 9 metres wide at the top, and 2 metres deep (Figure 7).

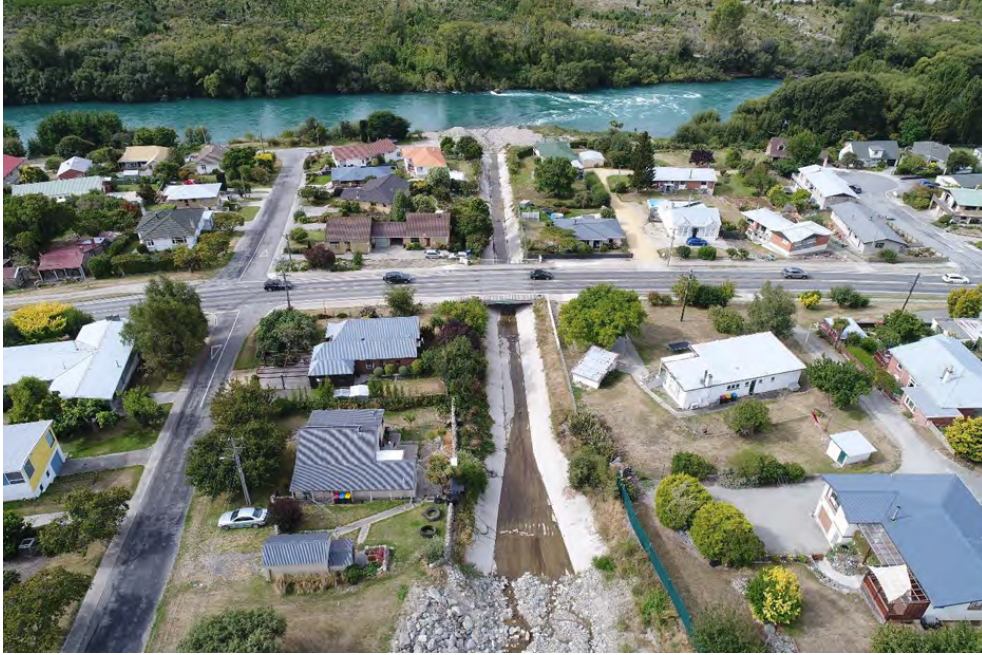
**Figure 7: The Reservoir Creek concrete chute, constructed in the early 1980s.**

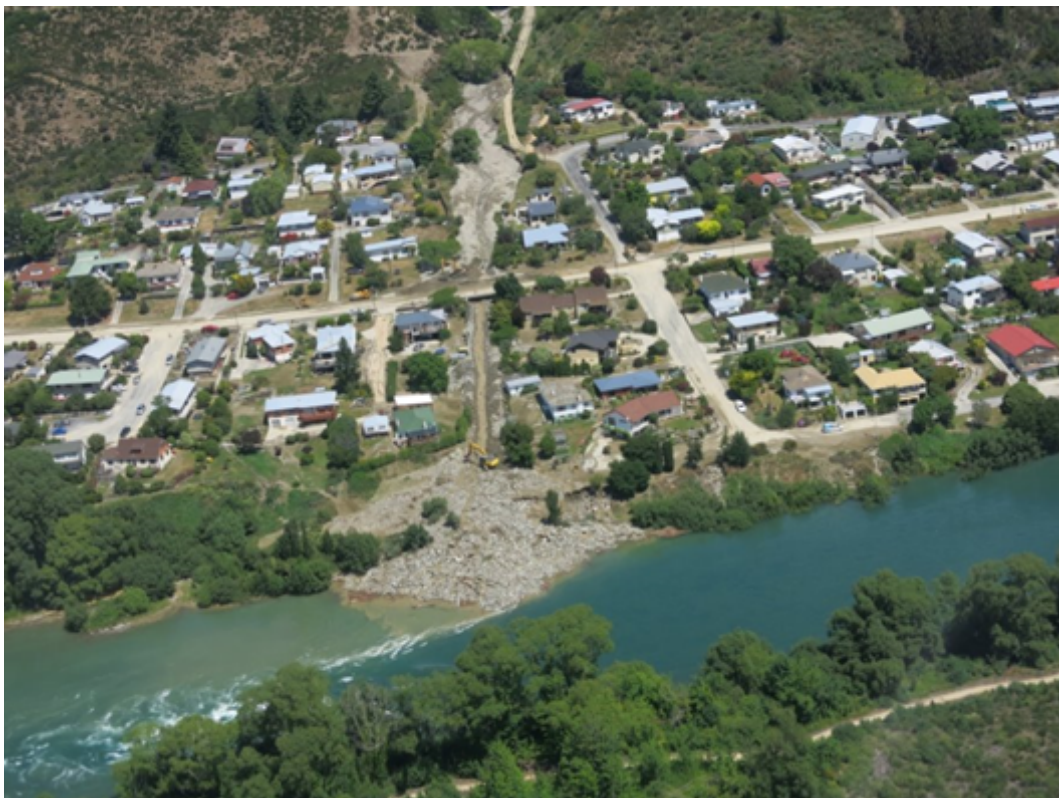
**Figure 8: Impacts of the November 2017 debris flow event at Reservoir Creek, showing the extensive deposition of sediment debris at the confluence with the Clutha River.**

Date	Catchments	Key Impacts
1938	Slaughterhouse Creek and several others adjacent	9 m high debris flow. 2.4 km section of SH8 inundated and orchards severely damaged
1978	Reservoir Creek, Blackjacks Creek, Pumpstation Creek, and Slaughterhouse Creek at least	Direct debris flow impact to dwellings, extensive property damage at Reservoir Creek (Figure 6). Impact to SH8 likely. Prompted the construction of the concrete chute.
1993	Slaughterhouse Creek and Pumpstation Creek at least	Substantial damage to property, orchards, SH8 network (30-ton boulder deposited in middle of road), and power supply cut at Pumpstation Creek
2015	Blackjacks Creek	SH8 inundated with debris (Figure 3).
November 2017	Pumpstation, Reservoir, Golfcourse, Blackjacks, and Stevensons Creek (no direct impact)	Damage to water and power supply, extensive inundation of SH8, property damage by debris and flooding associated with the debris flows (Figures 8-10).

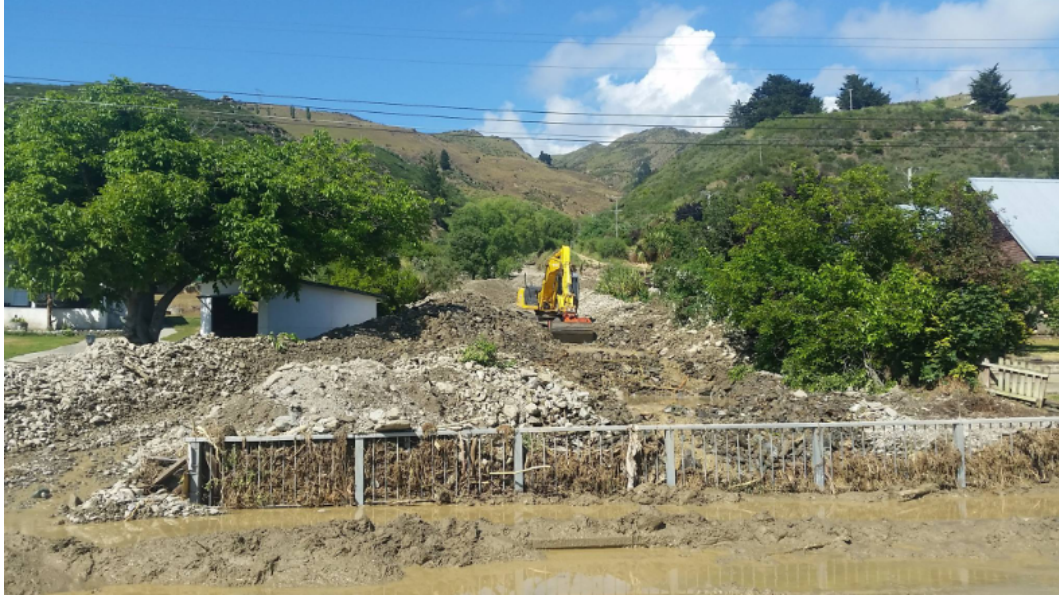
**Figure 9: Impacts of the November 2017 events at Reservoir Creek, looking upstream of the SH8 bridge.**

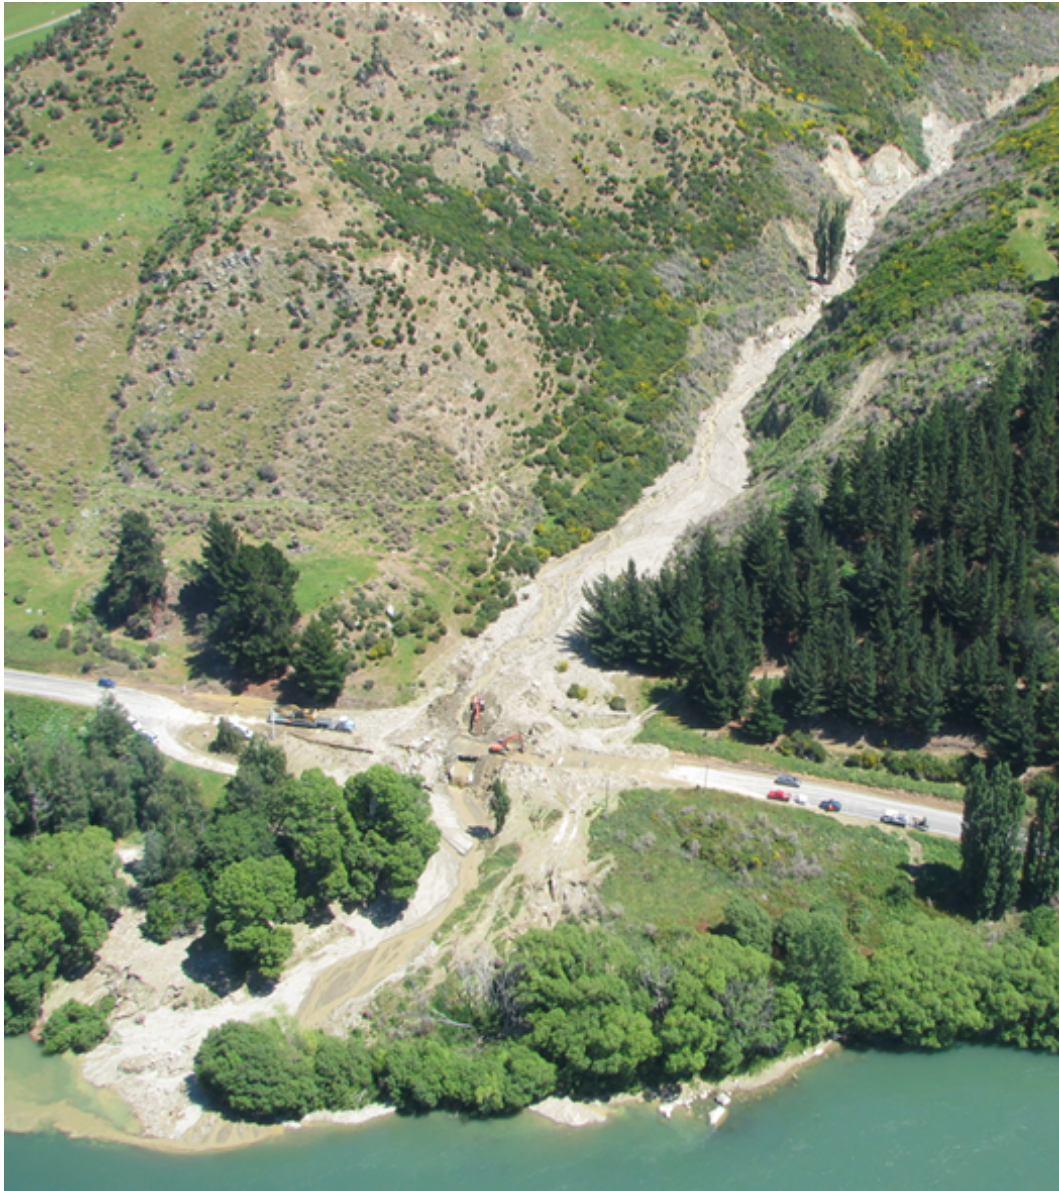
**Figure 10: Impacts of the November 2017 debris flow event at Blackjacks Creek, showing the extensive deposition of sediment debris over State Highway 8.**
