Channel morphology of the Shag River, North Otago

Technical summary

Changes in the channel morphology of the Shag River/Waihemo have been assessed using visual inspections, aerial and ground photography, and cross-section data collected in April 2009 and October 2013. This assessment provides an update on changes in channel morphology that have occurred since the last catchment wide analysis of long term trends in 2009. This report describes the nature of those changes where they have been significant and is intended to inform decisions relating to the management of the Shag River/Waihemo, including gravel extraction, floodwater conveyance, and asset management.

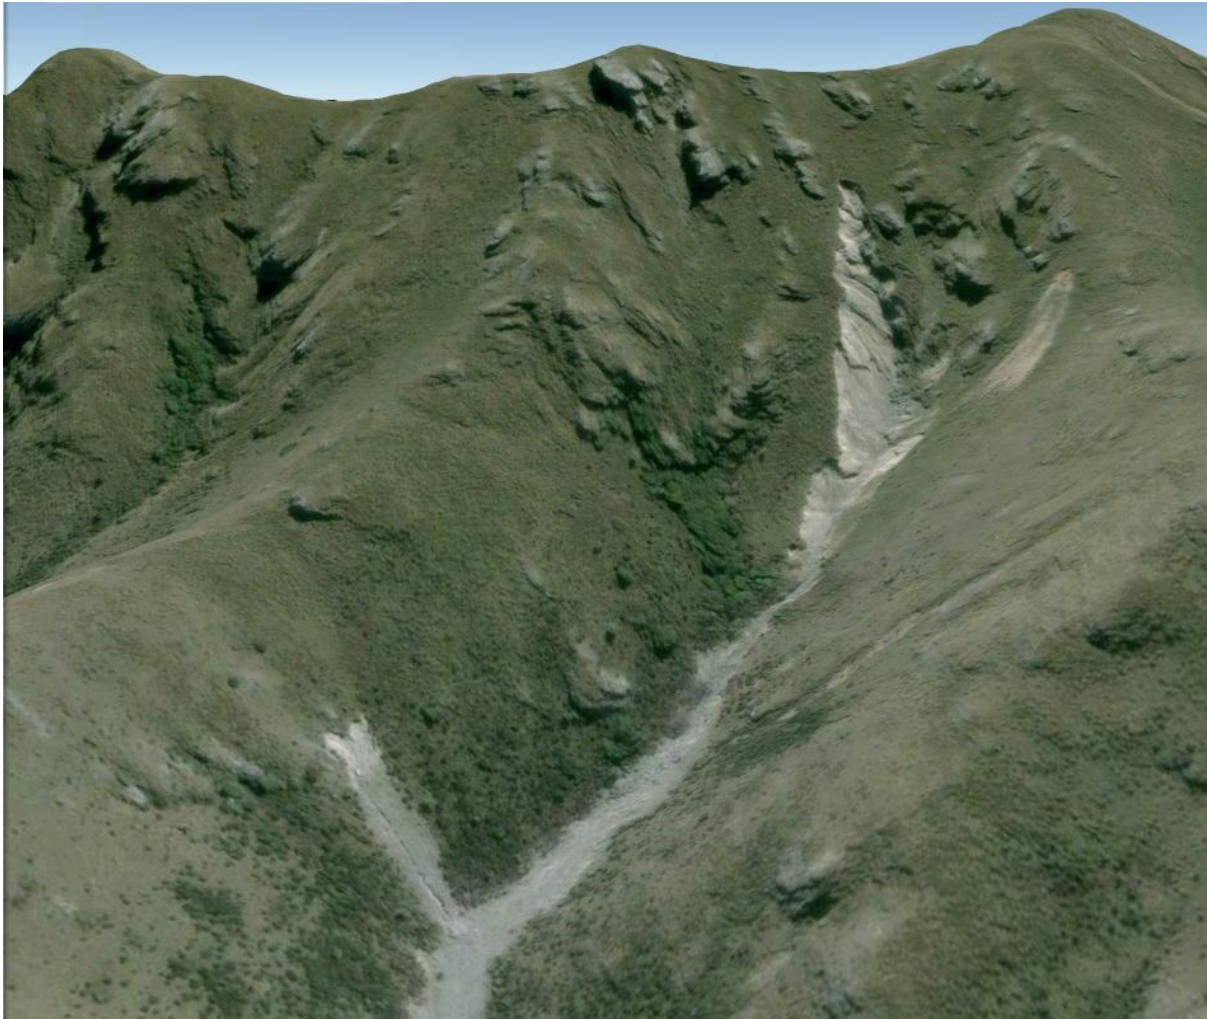
Figure 2. Evidence of land instability in an unnamed tributary of the Shag River (red circle on Figure 1), imagery date: April 2007 (Google Earth)

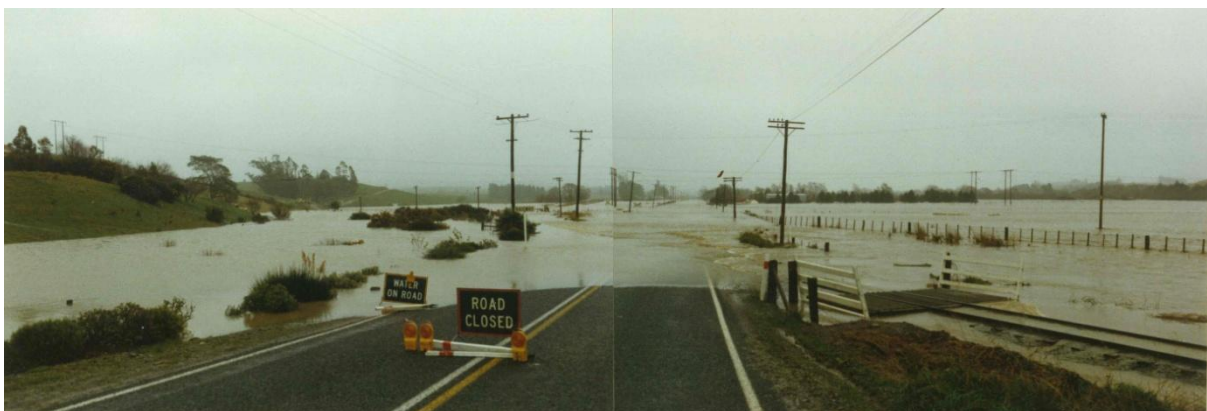
Figure 3. Flooding of the Shag River/Waihemo at SH85 near Palmerston on 5 June 1980

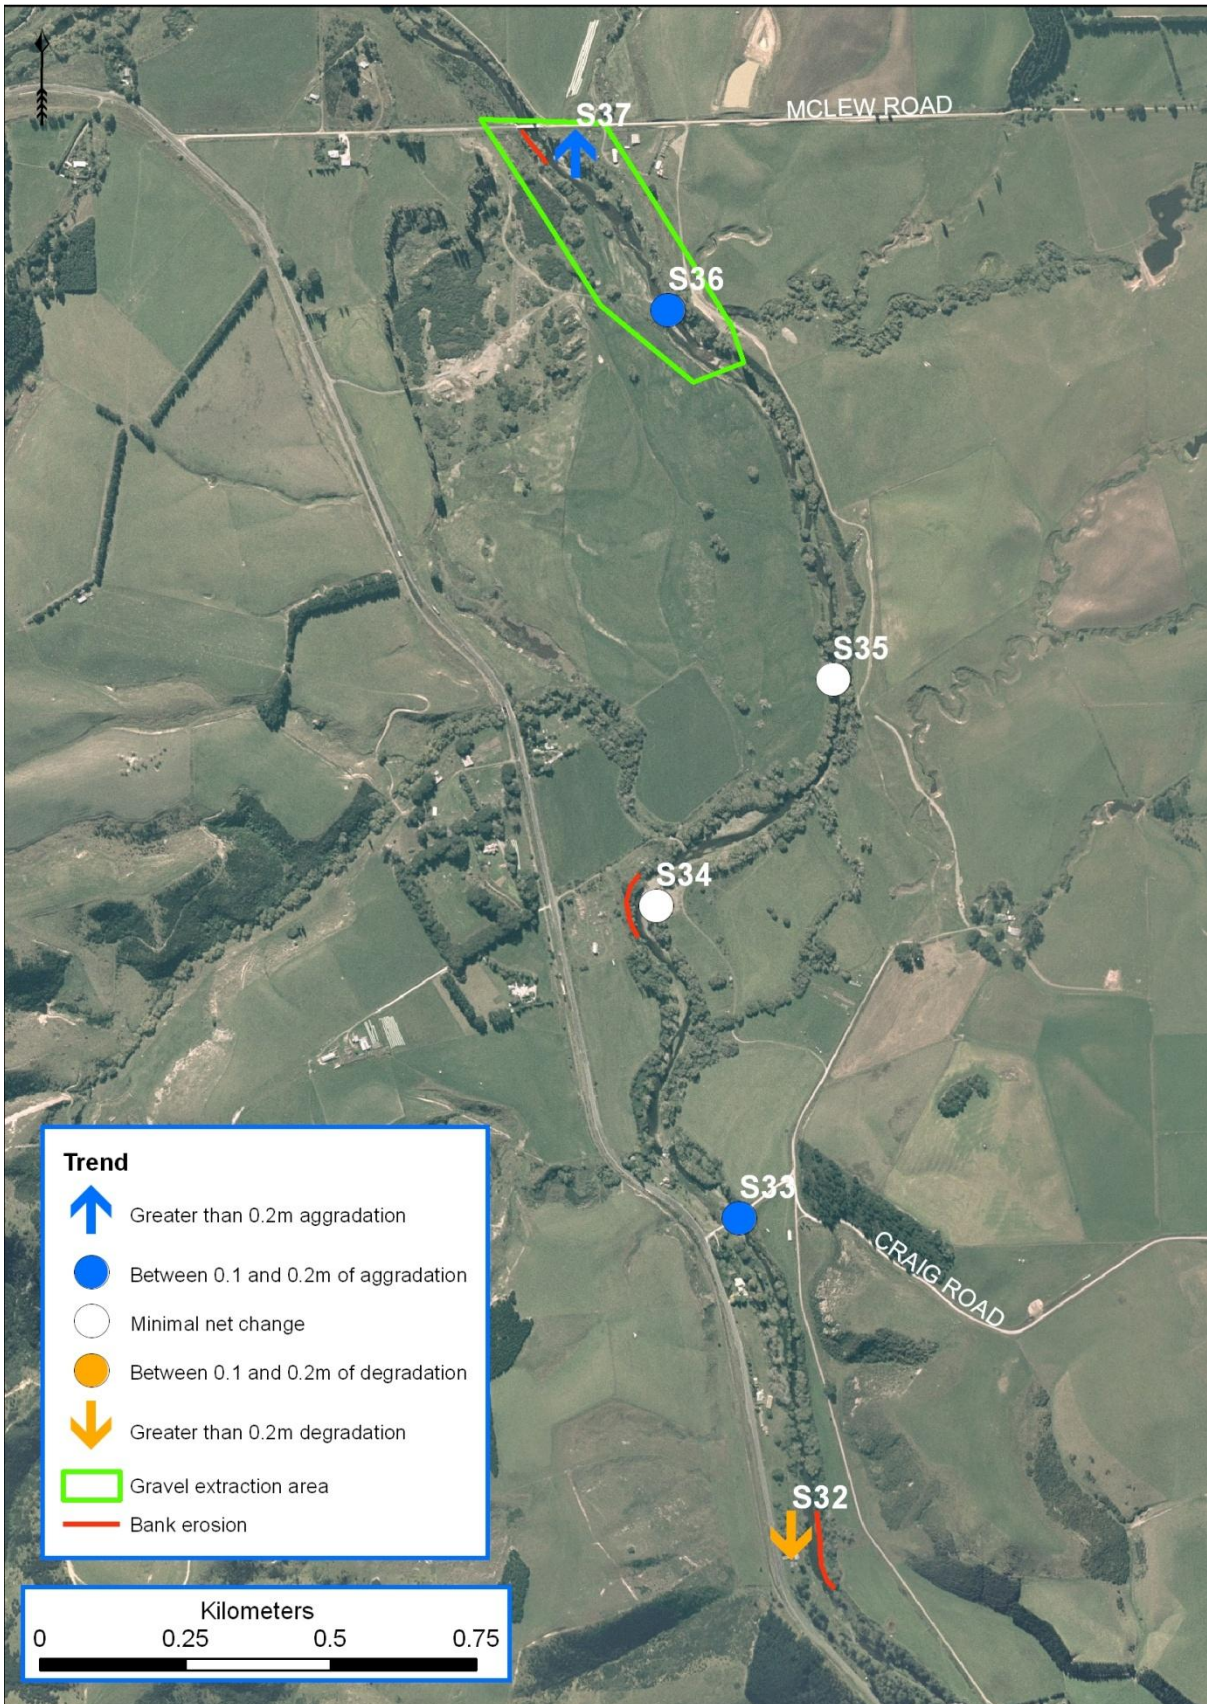
Figure 7. The location of cross-sections S37 to S32 on the Shag River/Waihemo. The white, orange, and blue symbols show the magnitude of MBL change at each cross-section between April 2009 and October 2013. Locations where significant bank erosion (>1m) was observed during this period are shown as red lines. Locations of historic gravel extraction are outlined in green.

Cross-sections in the upper part of the surveyed reach (between S37 and S32) generally show an increase in MBL between April 2009 and October 2013 (Figure 7). This increase is expressed either as aggradation of sediment in the channel bed, or as an increase in the level of the wider floodplain. Cross-section S32 was the only site in this reach to display a decrease in MBL during this period (2009 to 2013). During the previous survey period (April 2004 to April 2009) four of the six sites displayed aggradation. ORC (2009) stated that the overall long-term (1977-2009) trend observed in this reach was one of degradation. The general increase in MBL between 2004 and 2009 and 2009 and 2013 may indicate that the trend of this reach (in the short term) has changed from degradation to one of aggradation / stability.

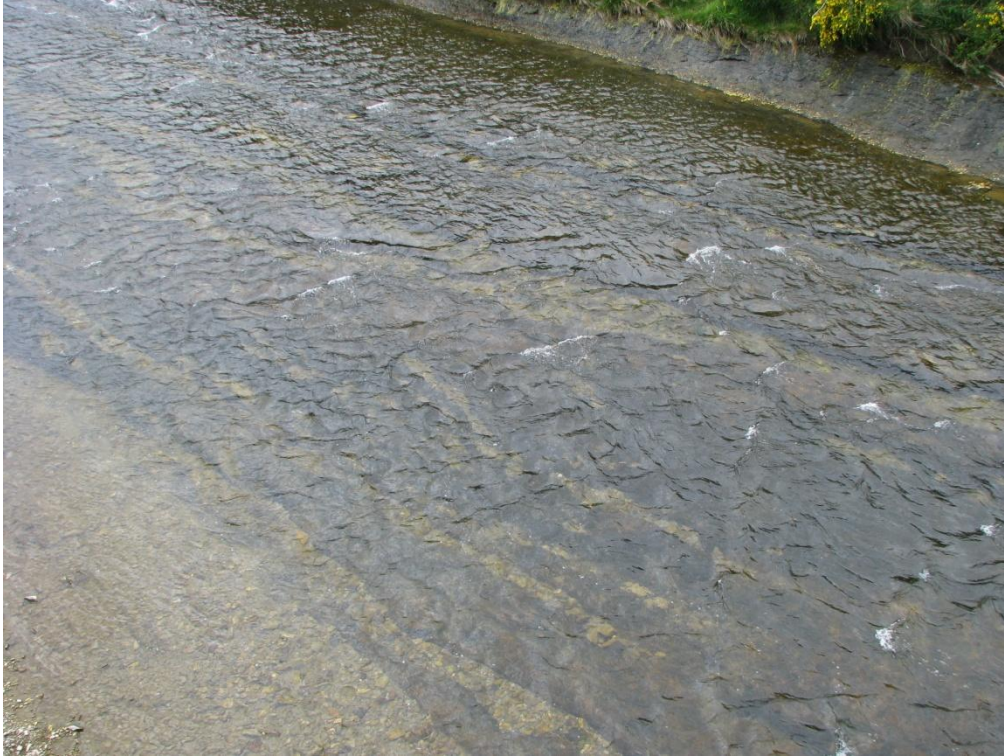
ORC (2004)⁶ identified that bedrock was exposed in the Shag River/Waihemo channel upstream and downstream of McLew Road, bedrock was also exposed at this location in October 2013 (Figure 10). Bedrock was also exposed at Craig Road Bridge in October 2013. Bedrock channels form where the supply of sediment to the channel is insufficient to keep the channel mantled with an alluvial cover and can represent a limited sediment supply (Howard, 2013).⁷

Figure 10. Exposed bedrock upstream of McLew Road Bridge

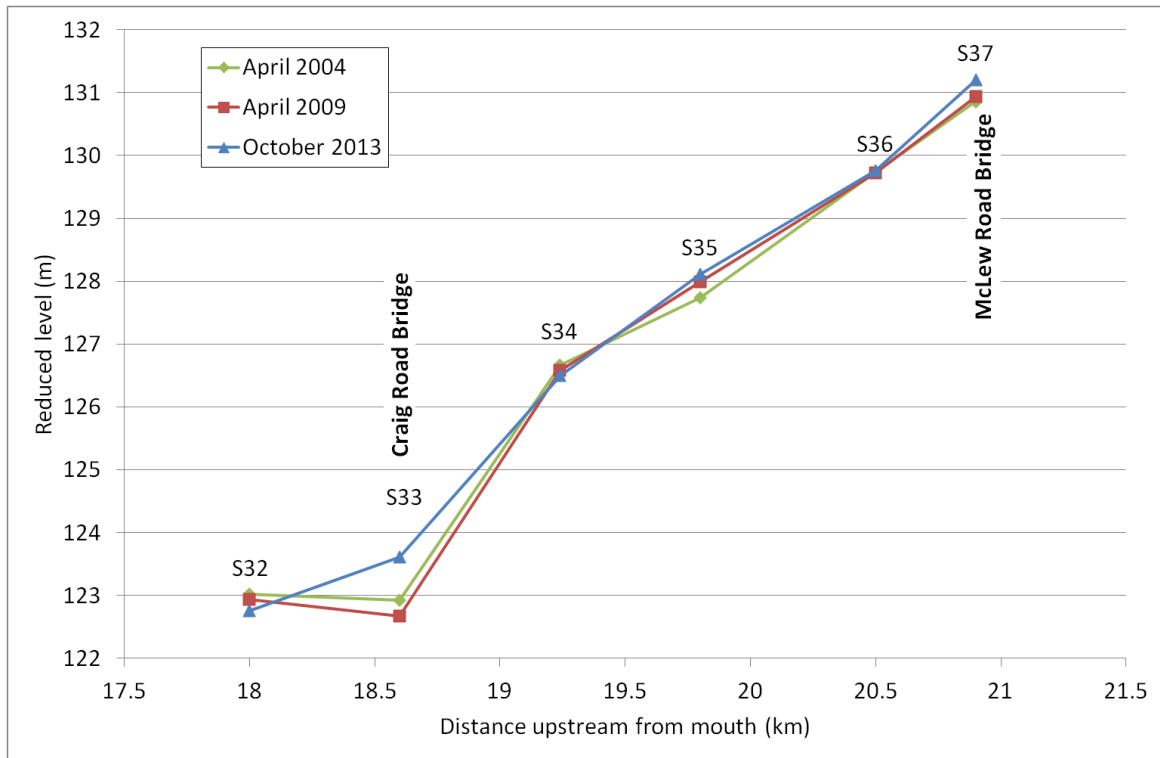
Figure 11. Longitudinal profile showing the thalweg level at cross-sections in the upper reach (as shown in Figure 9) of the Shag River/Waihemo

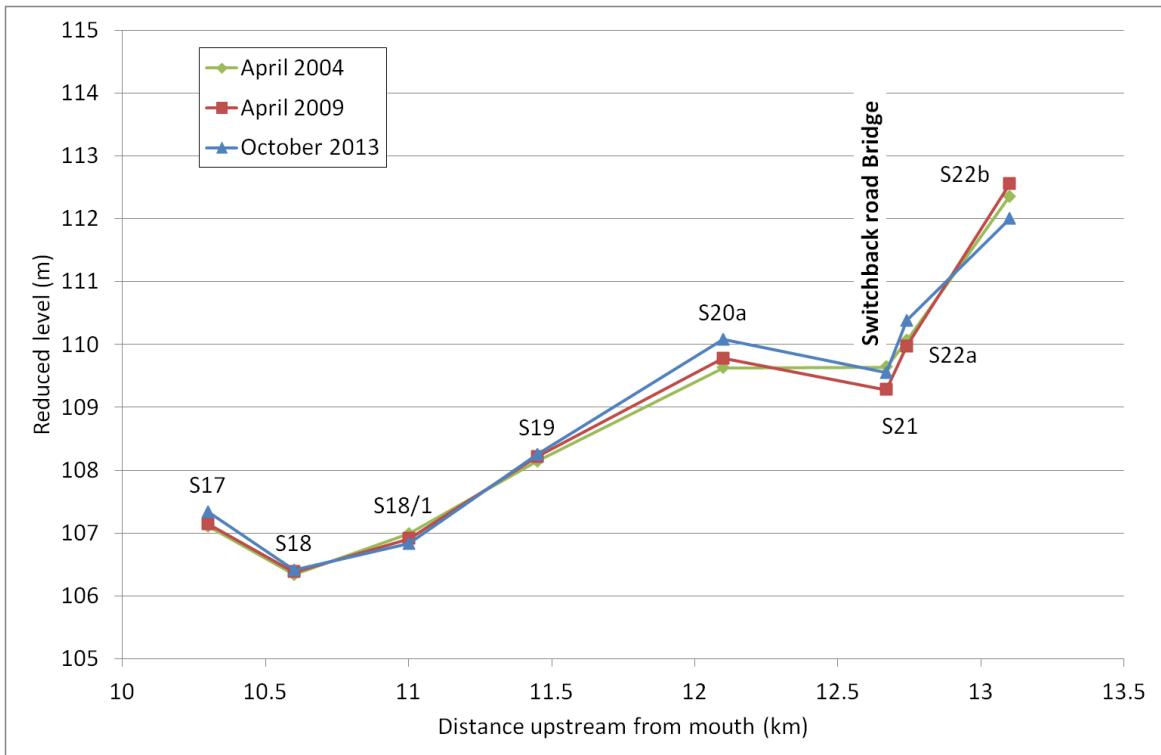
Figure 13. Longitudinal profile showing the thalweg level at cross-sections in the lower reach (as shown in Figure 9) of the Shag River/Waihemo

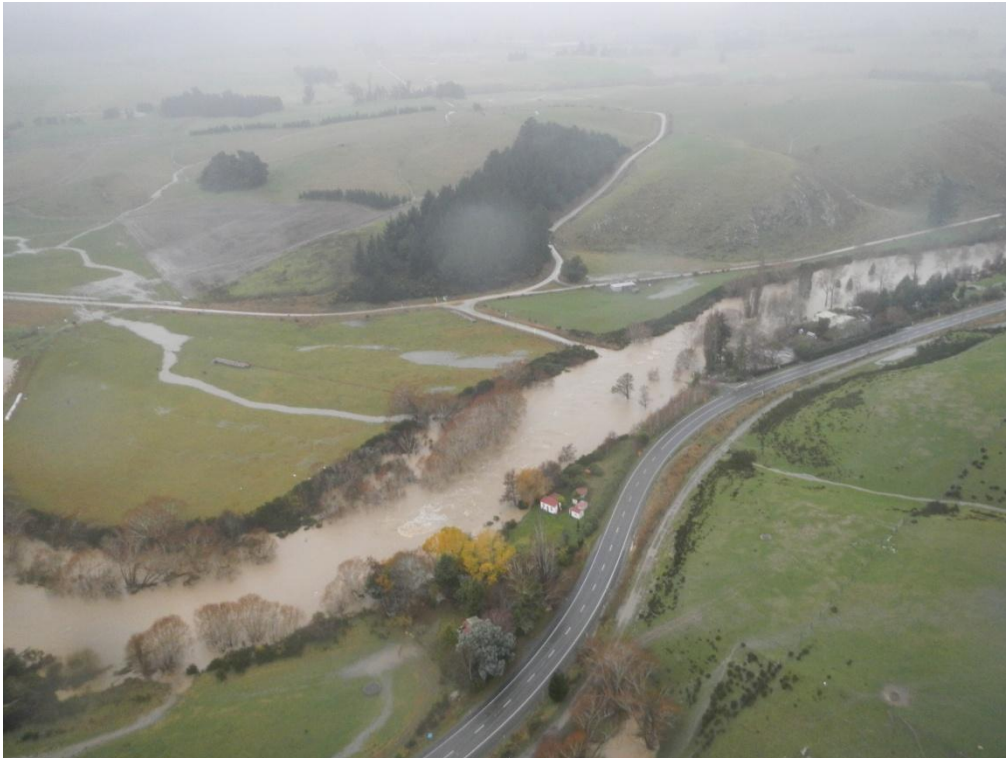
Figure 20. 17 June 2013, flooding, Shag River/Waihemo, looking downstream to the junction of Craig Road and SH85

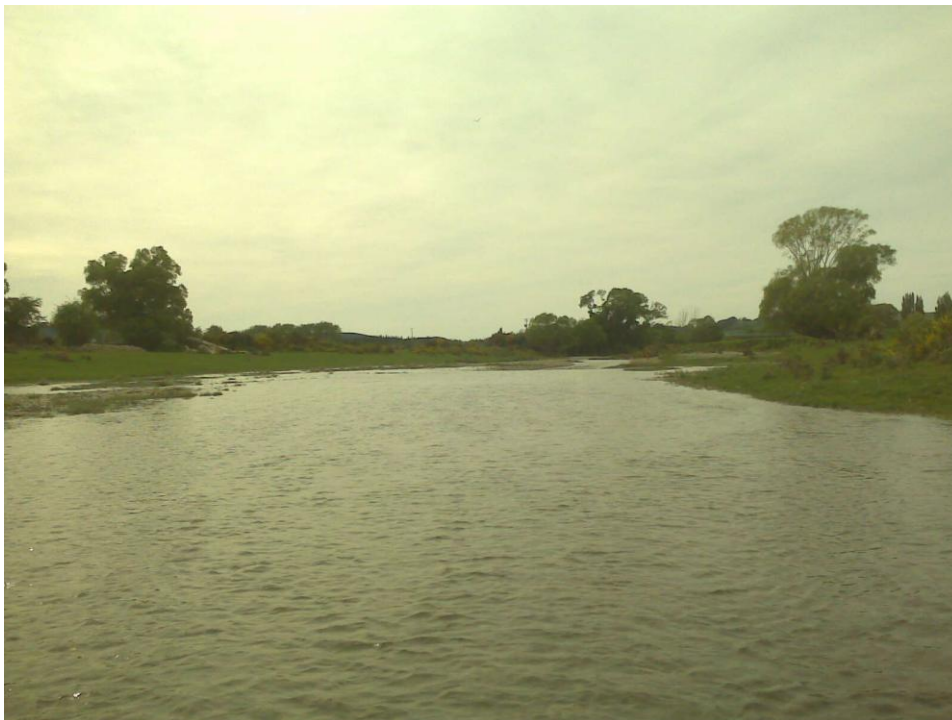
Shag River/Waihemo : S17

Figure 22. Cross-section S17, looking downstream

Figure 23. Cross-section S17, looking downstream October 2013, October 2013

Cross-section S17 is located 10.3km upstream of the Shag River/Waihemo mouth and 0.4km downstream of Horse Range Road Bridge. The channel bed remained similar between April 2004 and April 2009. Between April 2009-October 2013 the channel bed aggraded approximately 0.25-0.5m with minimal change in the over bank deposits. The thalweg level increased by 0.2m between 2009-2013.

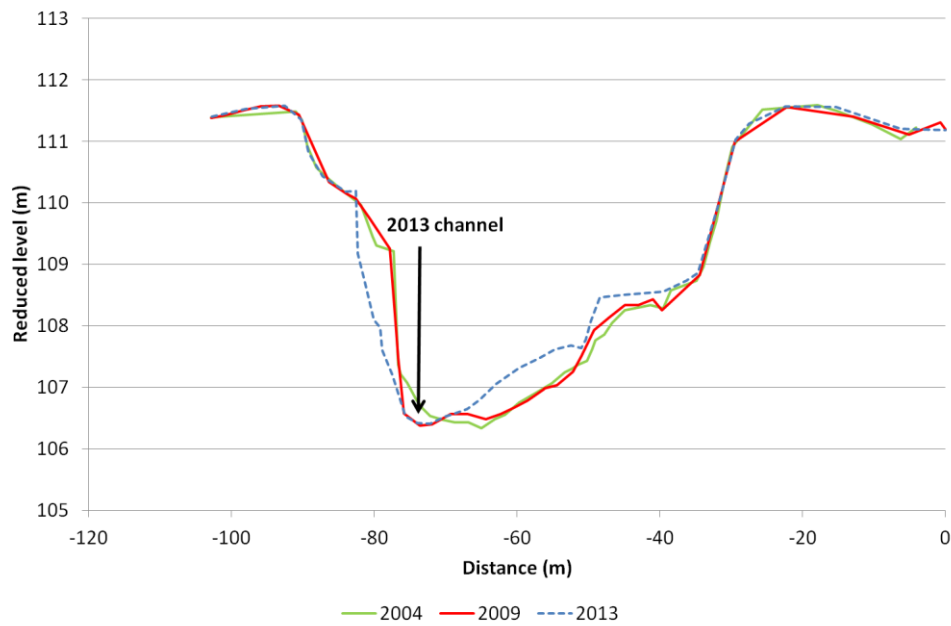
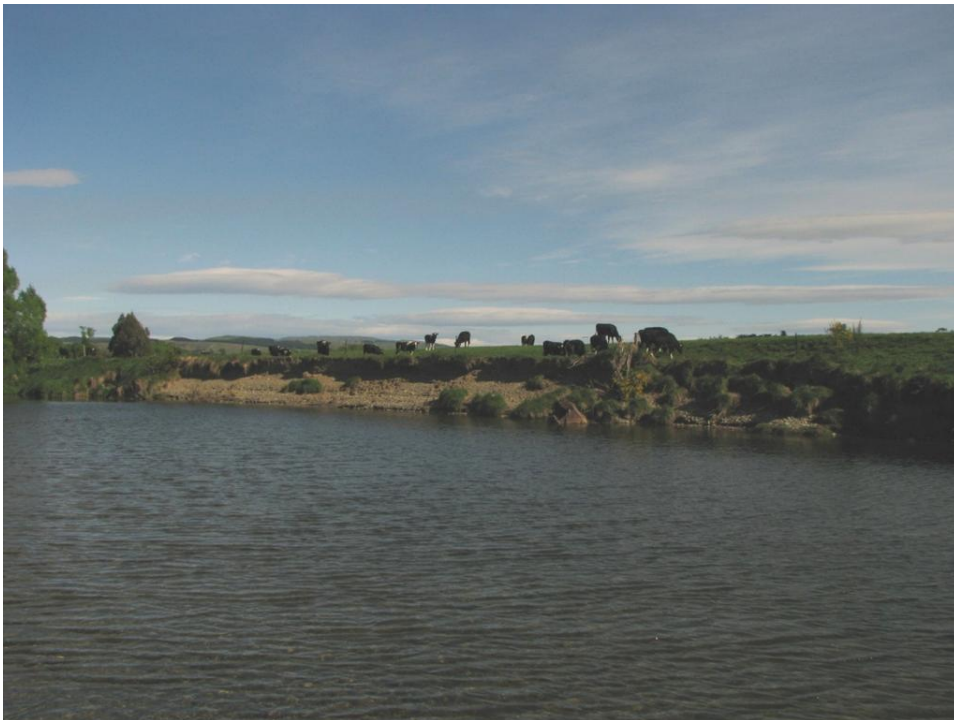
Shag River/Waihemo : S18

Figure 24. Cross-section S18, looking downstream

Figure 25. Cross-section S18, looking from true right to true left, October 2013

Cross-section S18 is located 10.6km upstream of the Shag River/Waihemo mouth and 0.75km upstream of Horse Range Road Bridge. The channel bed remained similar between April 2004-April 2009 with a small amount of degradation occurring on the left of the channel bed and the right bank. Between April 2009-October 2013 the channel bed and right bank aggraded approximately 0.5m, and the left bank has eroded by approximately 5m. The thalweg remained in the same position between 2009-2013.

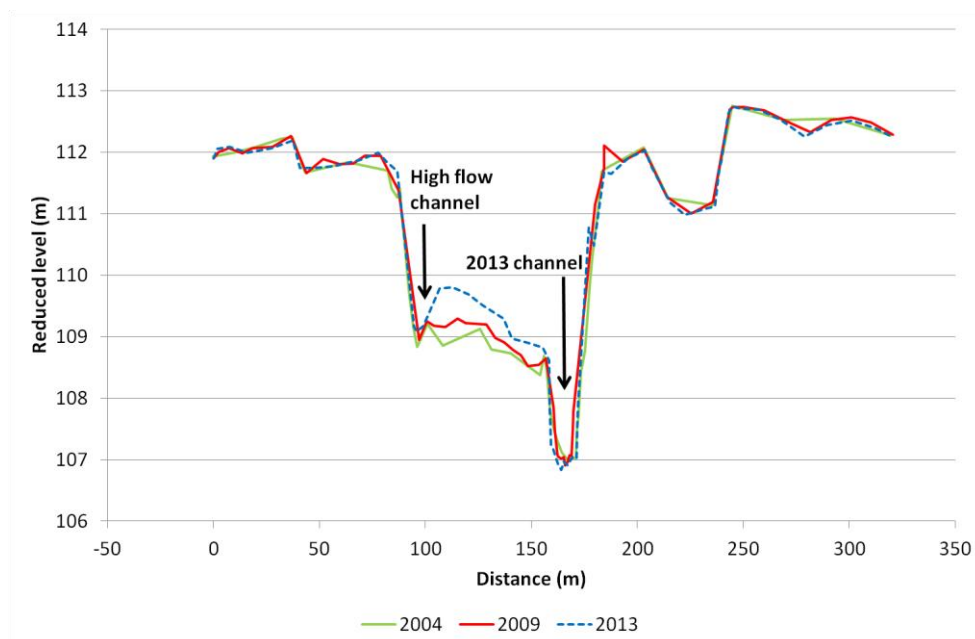
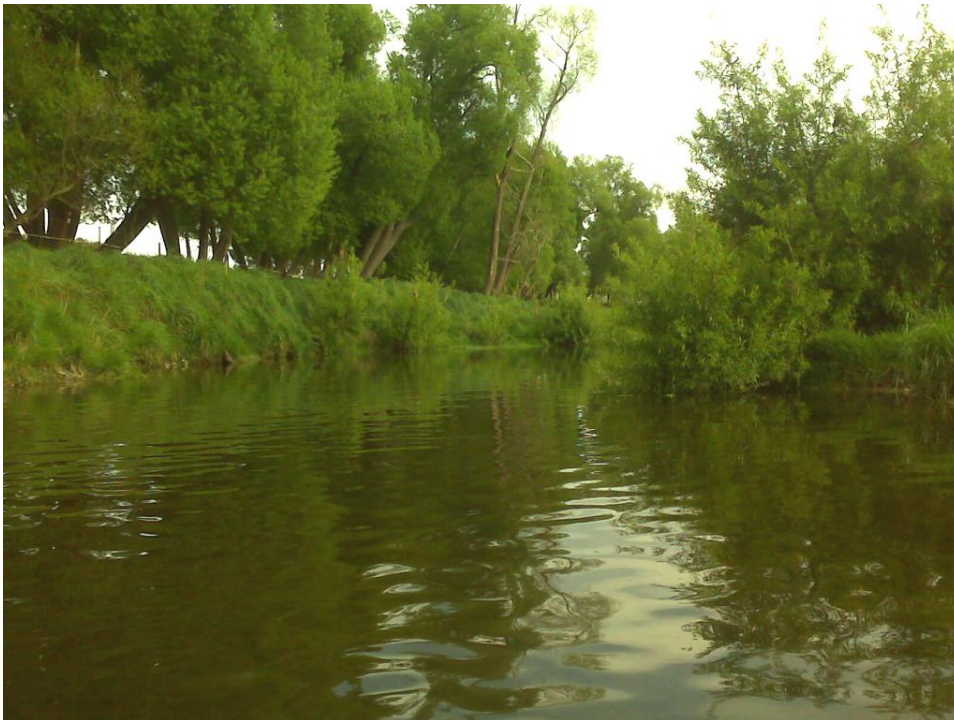
Shag River/Waihemo : S18/1

Figure 26. Cross-section S18/1, looking downstream

Figure 27. Cross-section S18/1, looking upstream, October 2013

Cross-section S18/1 is located 11km upstream of the Shag River/Waihemo mouth and 1km upstream of Horse Range Road Bridge. The main channel bed remained similar between April 2004-April 2009 with a small amount of aggradation occurring on the left bank of the high flow channel. Between April 2009-October 2013 the main channel bed degraded approximately 0.1m, and the left bank of the high flow channel aggraded by approximately 0.5m. The thalweg remained in the same position between 2004-2013.

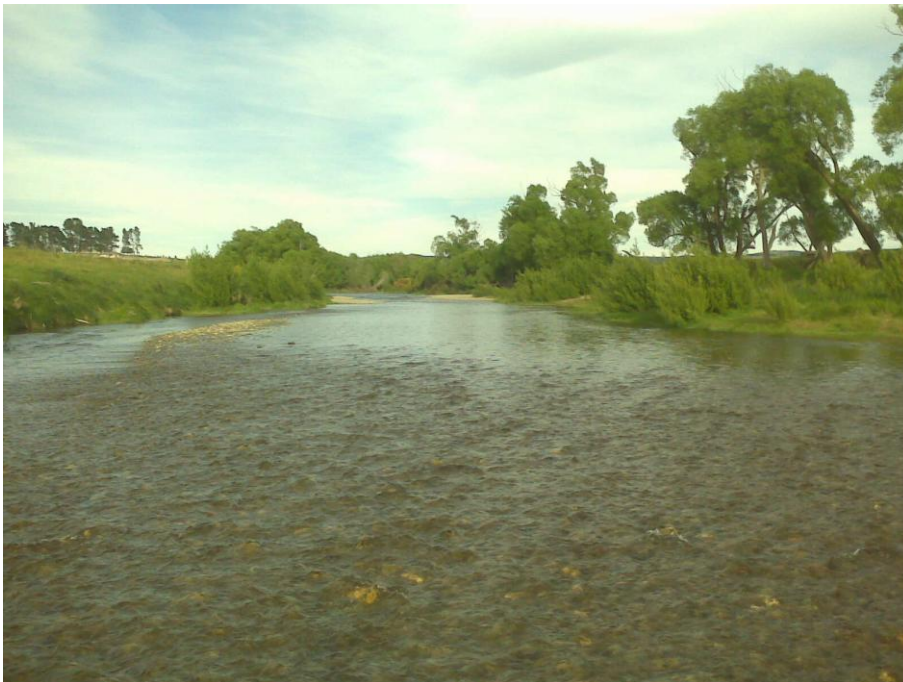
Shag River/Waihemo : S19

Figure 28. Cross-section S19, looking downstream

Figure 29. Cross-section S19, looking upstream, October 2013

Cross-section S19 is located 11.45km upstream of the Shag River/Waihemo mouth and 1.5km upstream of Horse Range Road Bridge. The main channel bed remained similar between April 2004-April 2009 with a small amount of aggradation occurring on the left and right banks of the main channel. Between April 2009- October 2013 the main channel bed aggraded approximately 0.05m, and the left bank of the high flow channel aggraded by approximately 0.5m. The wider floodplain shows minimal change between 2004-2013. The thalweg remained in a similar position between 2004-2013.

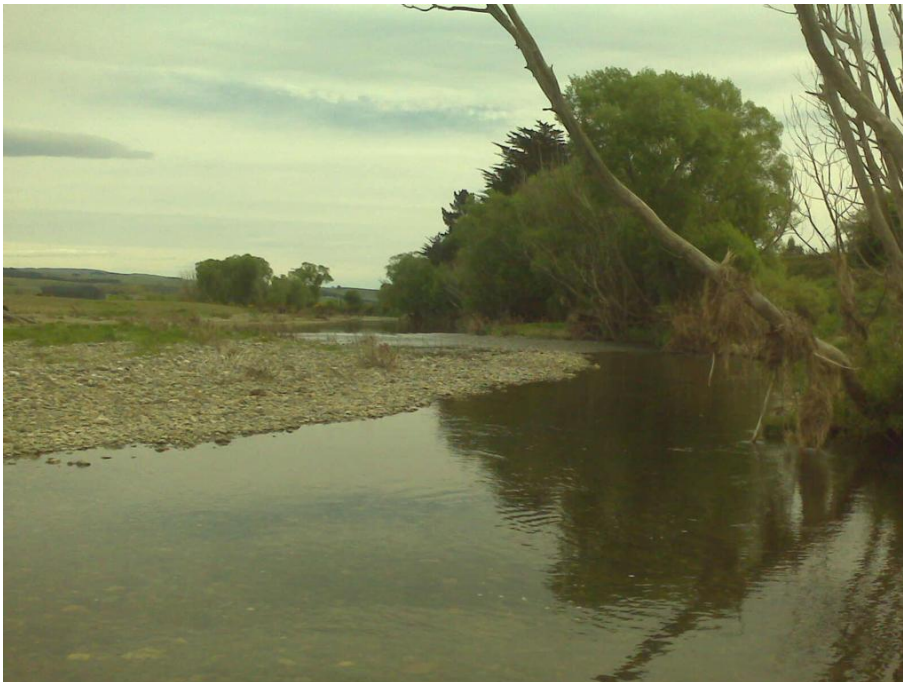
Shag River/Waihemo : S20a

Figure 17. Cross-section S20a, looking downstream

Figure 30. Cross-section S20a, looking downstream

Figure 31. Cross-section S20a, looking upstream, October 2013

Cross-section S20a is located 12.1km upstream of the Shag River/Waihemo mouth and 0.6km downstream of Switchback Road Bridge. The main channel bed remained similar between April 2004-April 2009 with the creation of a secondary channel occurring on the left bank and a small amount of degradation on the right bank. Between April 2009-October 2013 the main channel bed aggraded approximately 0.5m on the right, and approximately 0.5m on the left. The wider floodplain shows minimal change between 2004-2013. The thalweg remained in a similar position between 2004-2013.

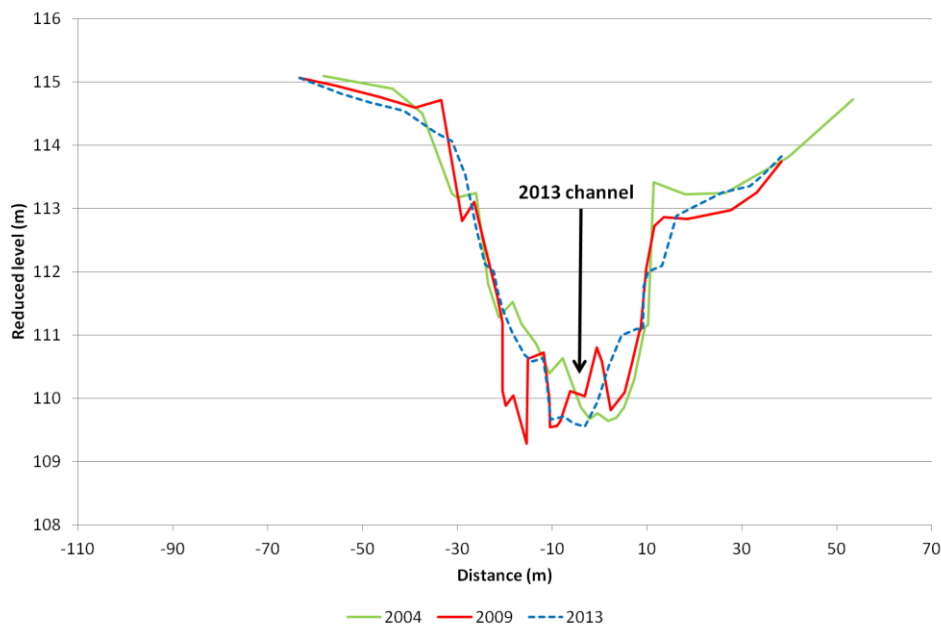
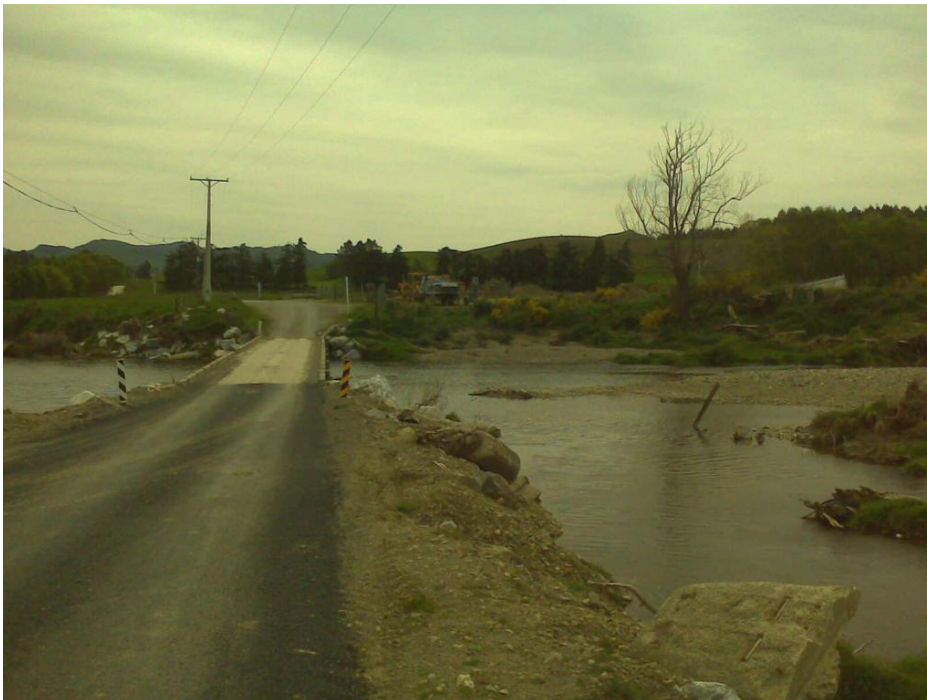
Shag River/Waihemo : S21

Figure 32. Cross-section S21, looking downstream

Figure 33. Cross-section S21, looking from true right to true left, October 2013

Cross-section S21 is located 12.67km upstream of the Shag River/Waihemo mouth at Switchback Road bridge. The main channel bed and the top of the right bank degraded between April 2004-April 2009 with the creation of three low flow channels. Between April 2009-October 2013 the bed aggraded approximately 1m on the left and right side of the main channel. Aggradation and degradation occurred on the left and right banks between 2009-2013. The thalweg aggraded 0.38m between 2009-2013 and is located in a similar position (horizontally) to 2004.

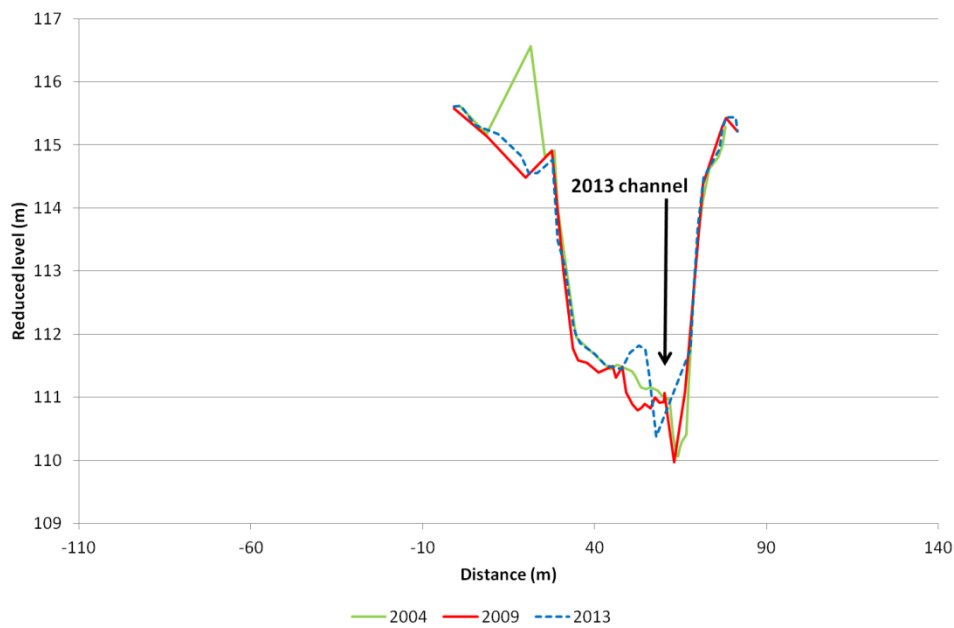
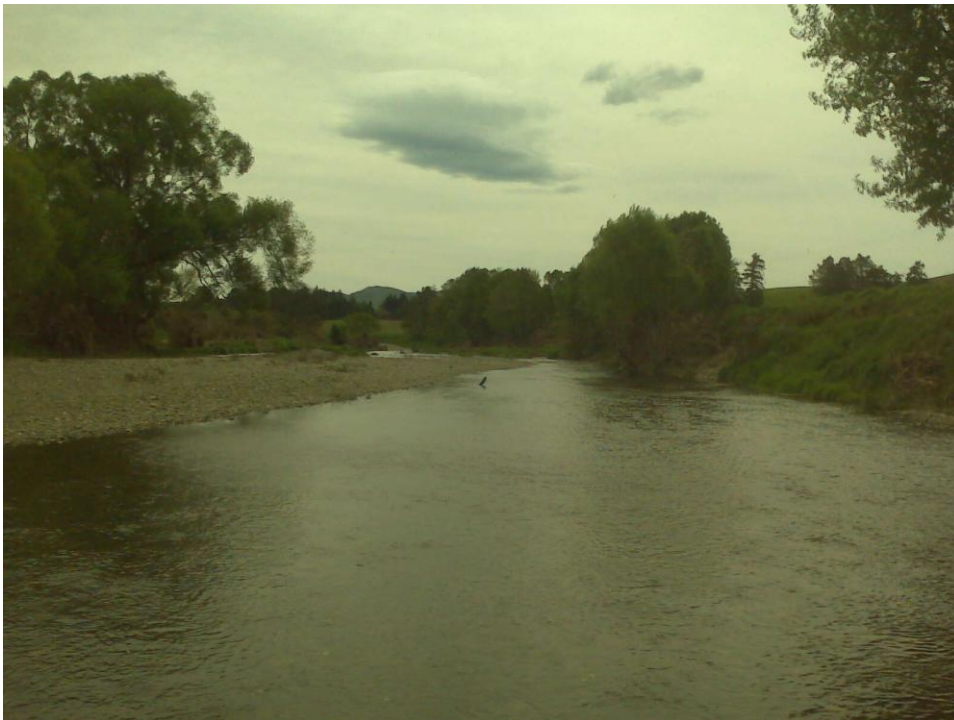
Shag River/Waihemo : S22a

Figure 34. Cross-section S22a, looking downstream

Figure 35. Cross-section S22a, looking upstream, October 2013

Cross-section S22a is located 12.74km upstream of the Shag River/Waihemo mouth and 0.1km upstream of Switchback Road bridge. The main channel bed degraded on the left bank between April 2004-April 2009 as well as the top of the left bank losing approximately 1m of material. Between April 2009-October 2013 the main channel bed aggraded approximately 1m and moved towards the left bank. The wider floodplain shows minimal change between 2009-2013. The thalweg aggraded 0.41m between 2009-2013.

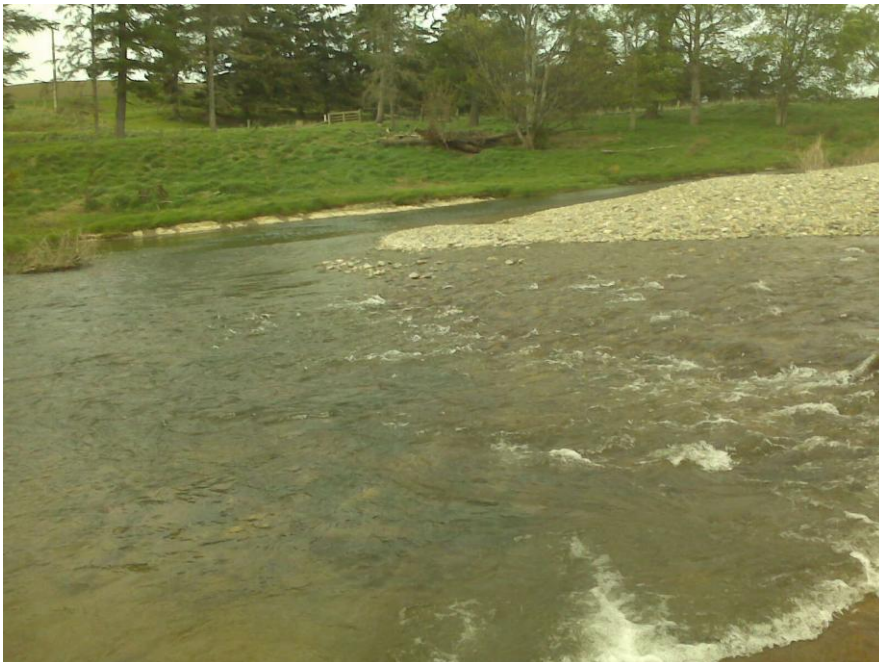
Shag River/Waihemo : S22b

Figure 36. Cross-section S22b, looking downstream

Figure 37. Cross-section S22b, looking downstream, October 2013

Cross-section S22b is located 13.1km upstream of the Shag River/Waihemo mouth and 0.42km upstream of Switchback Road bridge. The main channel bed aggraded between April 2004-April 2009 creating a smoother channel form as well as the right bank floodplain experienced aggradation of approximately 1m (at the point labelled A) and degradation of approximately 1.5m (at the point labelled B). Between April 2009-October 2013 the main channel degraded approximately 1m with the right bank continuing to aggrade and erosion of the left bank. The wider floodplain shows minimal change between 2009-2013. The thalweg degraded 0.53m between 2009-2013.

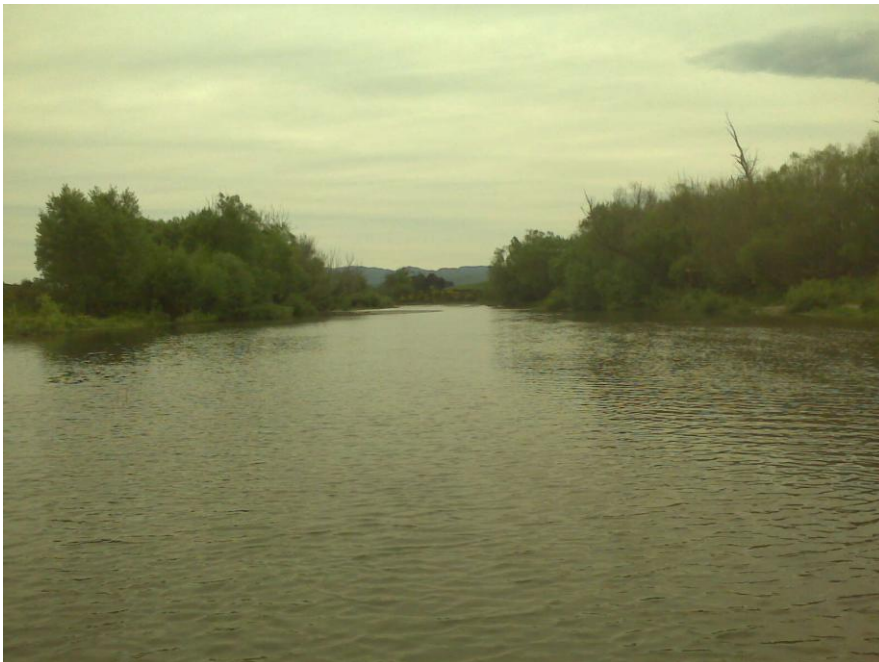
Shag River/Waihemo : S24

Figure 38. Cross-section S24, looking downstream

Figure 39. Cross-section S24, looking upstream, October 2013

Cross-section S24 is located 13.77km upstream of the Shag River/Waihemo mouth and 1.1km upstream of Switchback Road bridge. The main channel bed remained in a similar position between April 2004-April 2009 with a small amount of bed aggradation occurring. The right bank floodplain experienced degradation of approximately 0.4m. Between April 2009-October 2013 the main channel degraded approximately 1m with aggradation of the left of the main channel. The wider floodplain shows a general lowering of the left bank and both degradation and aggradation of the right bank between 2009-2013. The thalweg degraded 0.57m between 2009-2013.

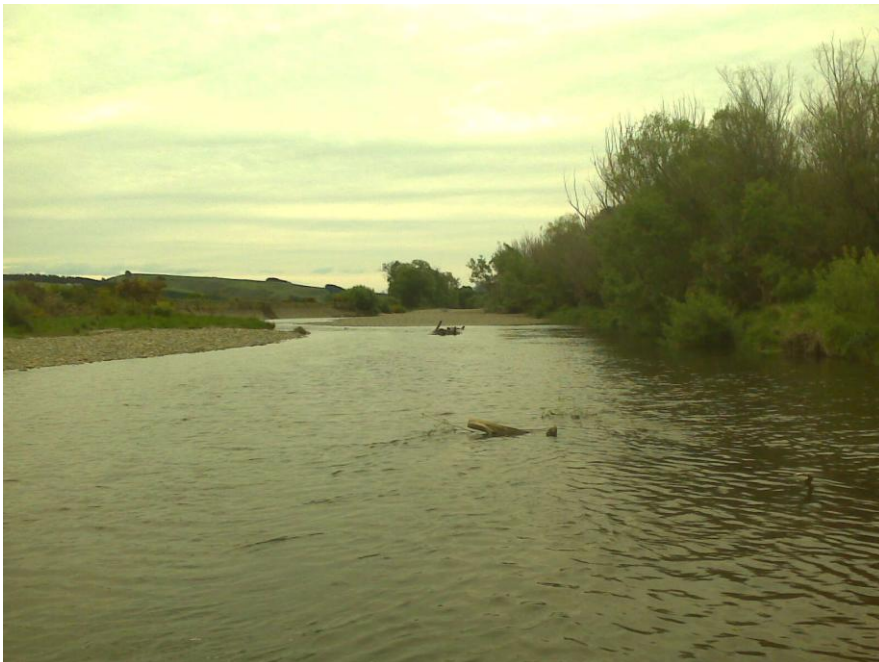
Shag River/Waihemo : S25

Figure 40. Cross-section S25, looking downstream

Figure 41. Cross-section S25, looking upstream, October 2013

Cross-section S25 is located 14.25km upstream of the Shag River/Waihemo mouth and 1.6km upstream of Switchback Road bridge. The main channel bed remained in a similar position between April 2004-April 2009 with a small amount of bed aggradation and degradation occurring. The left bank experienced minor degradation and the right bank secondary flow channel widened. Between April 2009-October 2013 the main channel degraded approximately 0.5m with aggradation on the left of the main channel. The wider floodplain remained in a similar position between 2009-2013 with minor aggradation of the left bank occurring. The thalweg degraded 0.53m between 2009-2013.

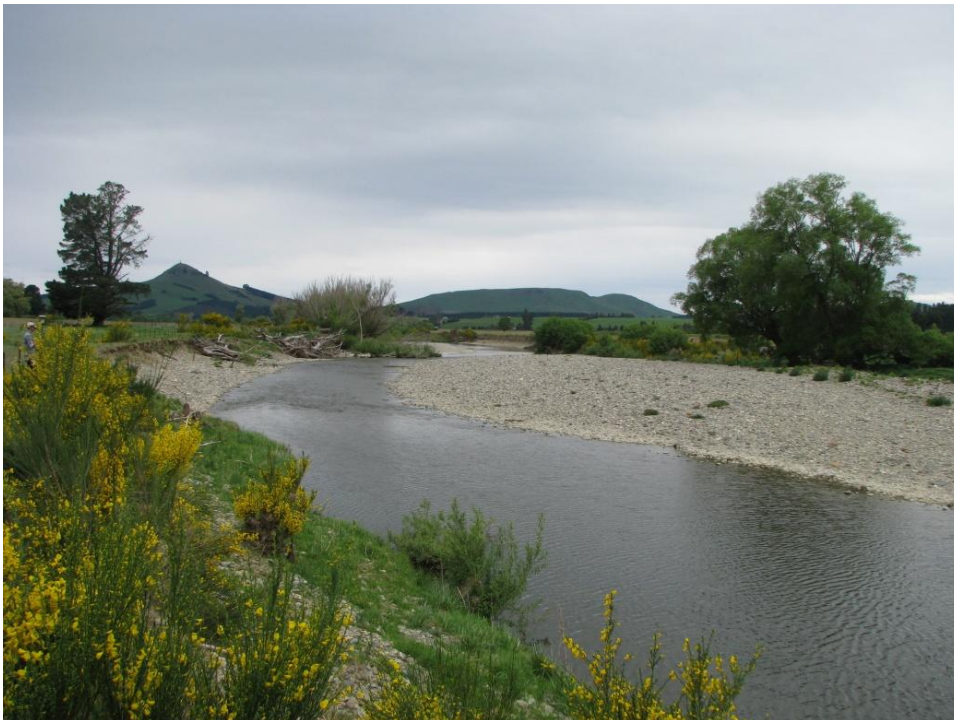
Shag River/Waihemo : S26

Figure 42. Cross-section S26, looking downstream

Figure 43. Cross-section S26, looking downstream, October 2013

Cross-section S26 is located 14.76km upstream of the Shag River/Waihemo mouth and 2.1km upstream of Switchback Road bridge. The right bank of the main channel eroded between April 2004-April 2009 with the rest of the floodplain remaining similar. Between April 2009-October 2013 the main channel divided into two low flow channels separated by a gravel bar. A build up of material on the left bank created a 1m high bank. The wider floodplain remained in a similar position between 2009-2013. The thalweg degraded 0.2m between 2009-2013.

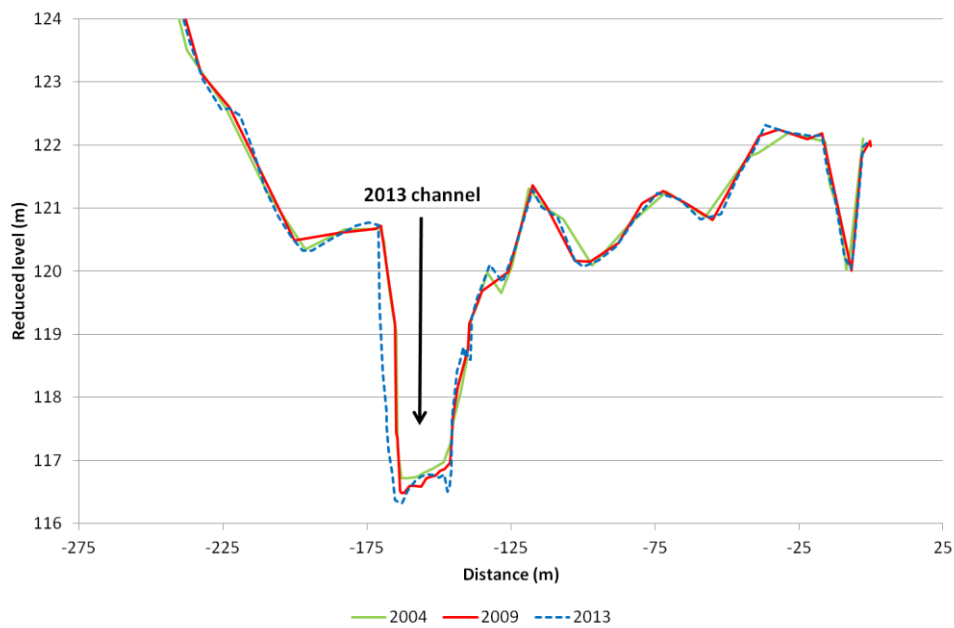
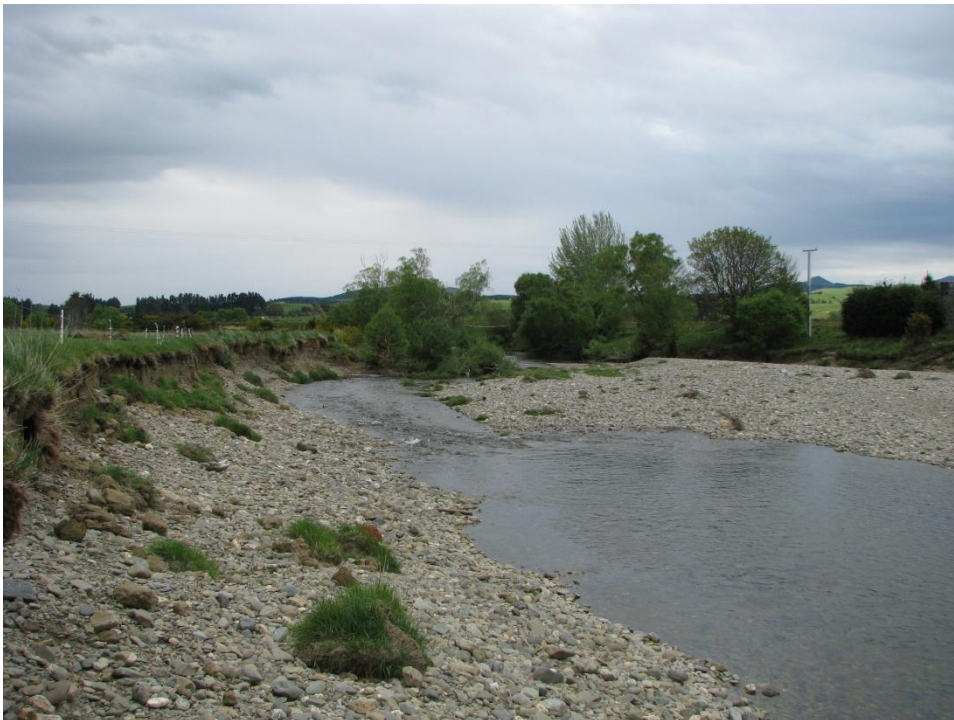
Shag River/Waihemo : S27

Figure 14. Cross-section S27, looking downstream

Figure 44. Cross-section S27, looking downstream

Figure 45. Cross-section S27, looking downstream, October 2013

Cross-section S27 is located 15.2km upstream of the Shag River/Waihemo mouth and 2.55km upstream of Switchback Road bridge. The main channel bed degraded between April 2004-April 2009 with a small amount of degradation and aggradation occurring in the wider floodplain. The main channel bed continued to degrade between April 2009-October 2013 with erosion of the left bank by approximately 5m. The wider floodplain remained in a similar position between 2009-2013. The thalweg degraded 0.05m between 2009-2013.

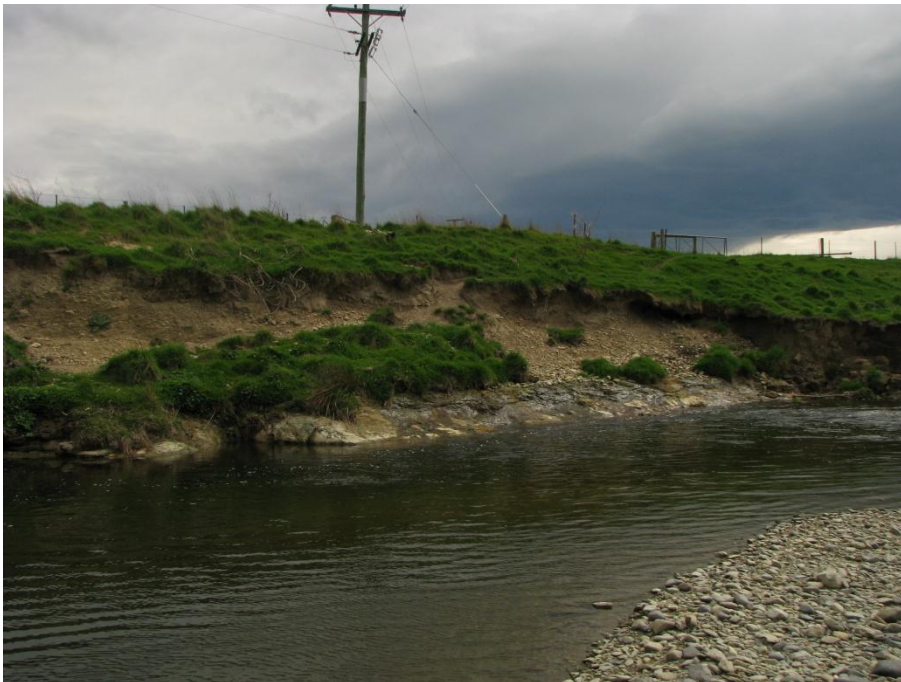
Shag River/Waihemo : S28

Figure 15. Cross-section S28, looking downstream

Figure 46. Cross-section S28, looking downstream

Figure 47. Cross-section S28, looking from true left to true right, October 2013

Cross-section S28 is located 15.95km upstream of the Shag River/Waihemo mouth and 3.3km upstream of Switchback Road bridge. The main channel bed degraded and moved towards the right bank between April 2004-April 2009 with predominantly degradation occurring across the wider floodplain. The main channel bed continued to degrade and move towards the right bank between April 2009-October 2013 with erosion of the right bank occurring by approximately 10m. The wider floodplain shows predominantly degradation between 2009-2013. The thalweg degraded 0.63m between 2009-2013.

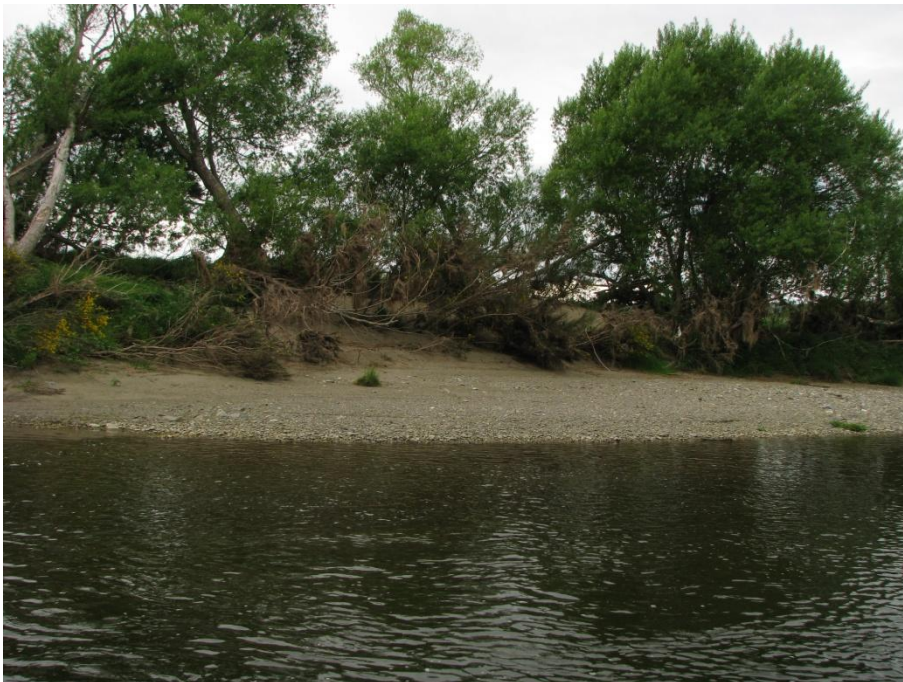
Shag River/Waihemo : S29

Figure 48. Cross-section S29, looking downstream

Figure 49. Cross-section S29, looking from true right to true left, October 2013

Cross-section S29 is located 16.8km upstream of the Shag River/Waihemo mouth and 4.2km upstream of Switchback Road bridge. The main channel bed degraded by approximately 1.75m between April 2004-April 2009 with a small amount of degradation occurring on the left terrace and wider left floodplain. The main channel bed aggraded between April 2009-October 2013, however it is still lower than the 2004 channel bed level. Aggradation occurred on the left bank terrace and wider left floodplain between 2009-2013 with levels predominantly being higher than those in 2004. The thalweg aggraded 1.2m between 2009-2013.
