Channel morphology of the Shag River, North Otago

Technical summary

Changes in the channel morphology of the Shag River/Waihemo have been assessed using visual inspections, aerial and ground photography, and cross-section data collected in April 2009 and October 2013. This assessment provides an update on changes in channel morphology that have occurred since the last catchment wide analysis of long term trends in 2009. This report describes the nature of those changes where they have been significant and is intended to inform decisions relating to the management of the Shag River/Waihemo, including gravel extraction, floodwater conveyance, and asset management.

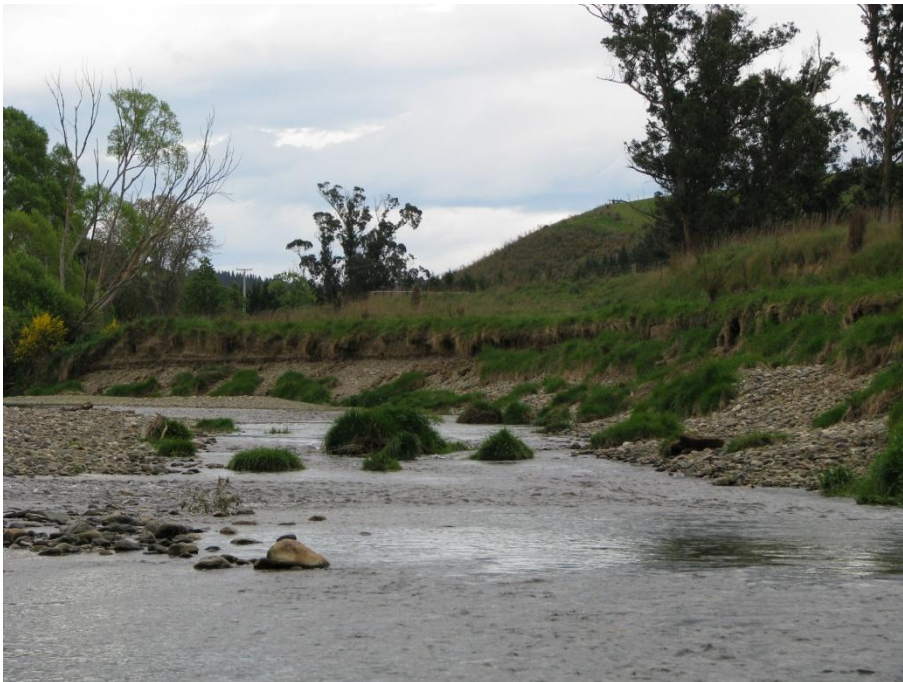
Shag River/Waihemo : S30

Figure 50. Cross-section S30, looking downstream

Figure 51. Cross-section S30, looking downstream, October 2013

Cross-section S30 is located 17.27km upstream of the Shag River/Waihemo mouth and 4.6km upstream of Switchback Road bridge. The main channel bed degraded between April 2004-April 2009 with erosion of the left bank by approximately 13m occurring. The main channel bed aggraded and widened between April 2009-October 2013, eroding the right bank by approximately 10m. The top of the left bank shows aggradation and the creation of two natural levees (at the point labelled A), the wider floodplain remained similar between 2009-2013. The thalweg aggraded 1m between 2009-2013.

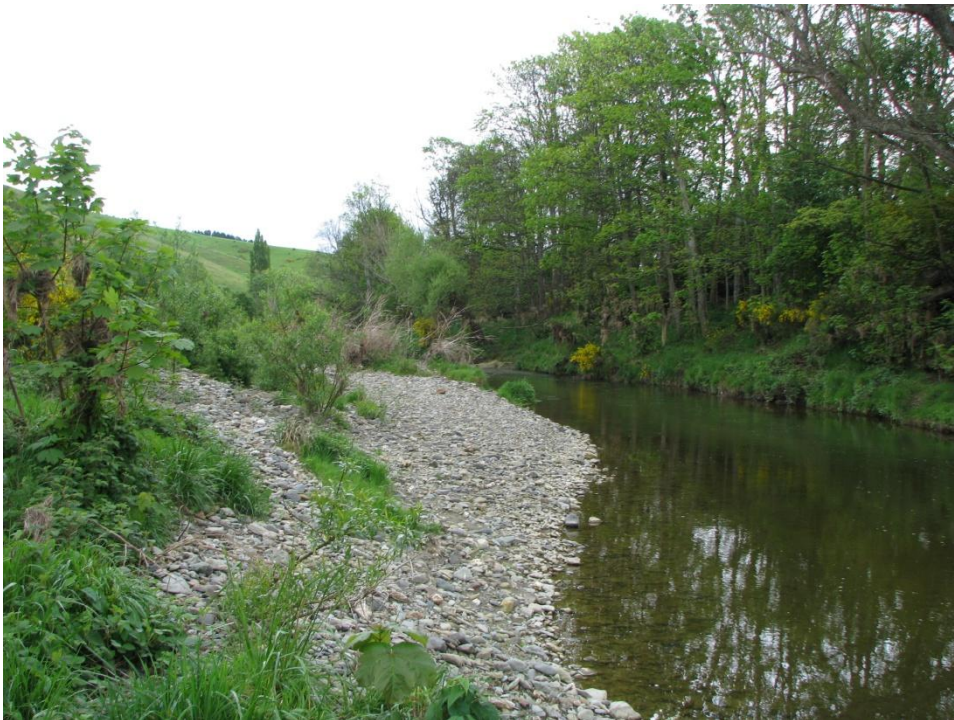
Shag River/Waihemo : S31

Figure 52. Cross-section S31, looking downstream

Figure 53. Cross-section S31, looking upstream, October 2013

Cross-section S31 is located 17.6km upstream of the Shag River/Waihemo mouth and 1km downstream of Craig Road bridge. The main channel bed aggraded between April 2004-April 2009 with erosion of the right bank and both aggradation and degradation of the wider floodplain. The main channel bed both aggraded, degraded and widened between April 2009-October 2013. The wider floodplain remained similar between 2009-2013. The thalweg aggraded 0.15m between 2009-2013.

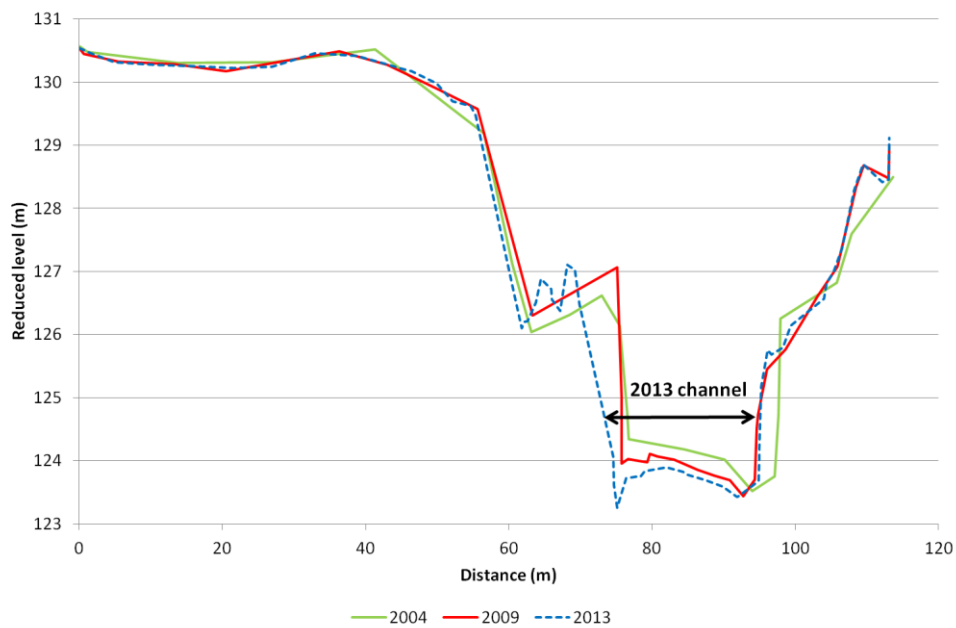
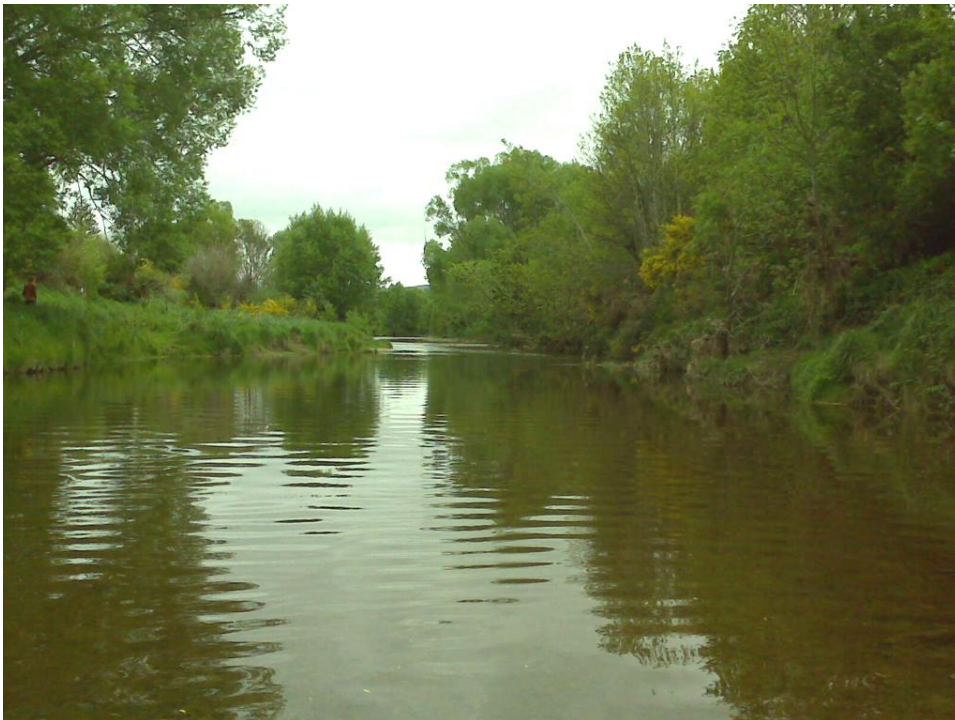
Shag River/Waihemo : S32

Figure 54. Cross-section S32, looking downstream

Figure 55. Cross-section S32, looking upstream, October 2013

Cross-section S32 is located 18km upstream of the Shag River/Waihemo mouth and 0.57km downstream of Craig Road bridge. The main channel bed degraded and narrowed between April 2004-April 2009 with aggradation of the left and right banks. The main channel bed degraded between April 2009-October 2013 with erosion of the left bank by approximately 6m occurring. The wider floodplain remained similar between 2009-2013. The thalweg degraded 0.3m between 2009-2013 and is now located on the left of the main channel.

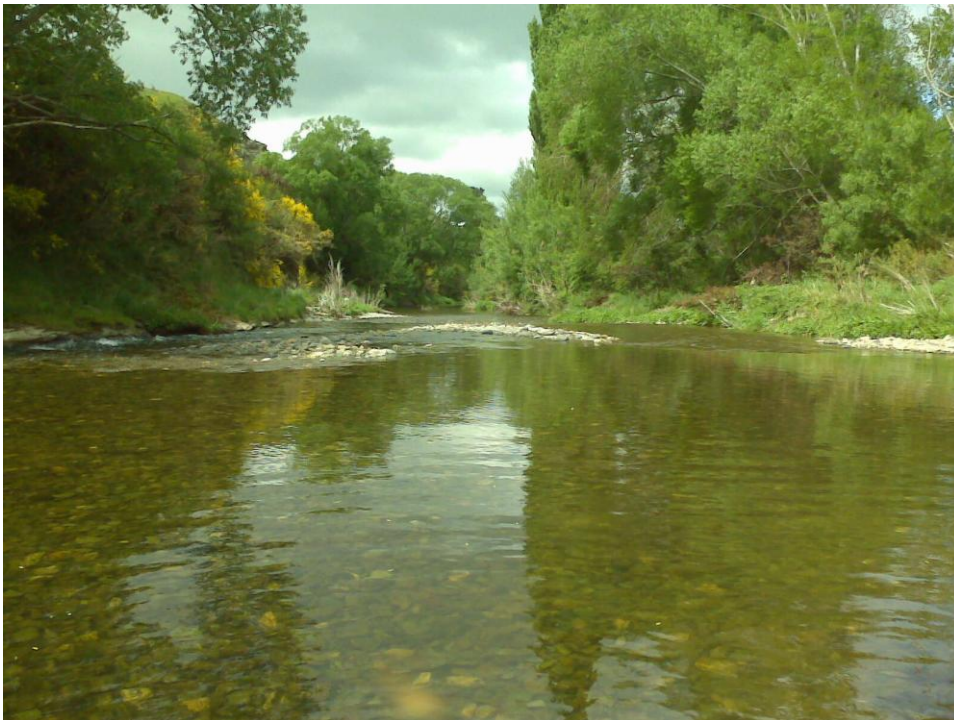
Shag River/Waihemo : S33

Figure 56. Cross-section S33, looking downstream

Figure 57. Cross-section S33, looking downstream, October 2013

Cross-section S33 is located 18.6km upstream of the Shag River/Waihemo mouth at Craig Road bridge. The main channel bed aggraded on the right and degraded on the left causing the thalweg level to decrease between April 2004-April 2009. The main channel bed aggraded by 1m between April 2009-October 2013 causing the low flow channel to narrow. The wider floodplain remained similar between 2009-2013. The thalweg aggraded 0.93m between 2009-2013.

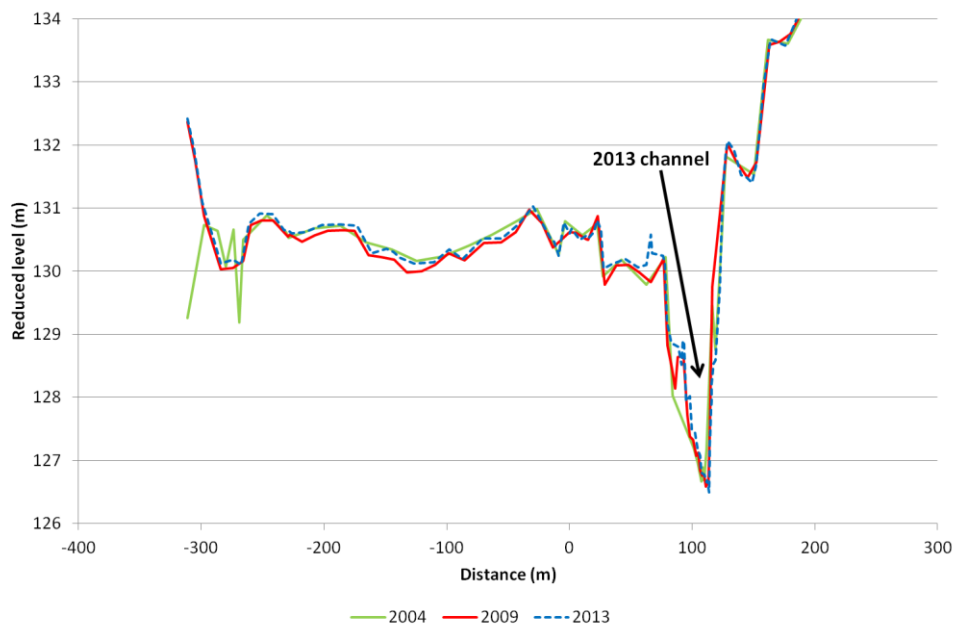
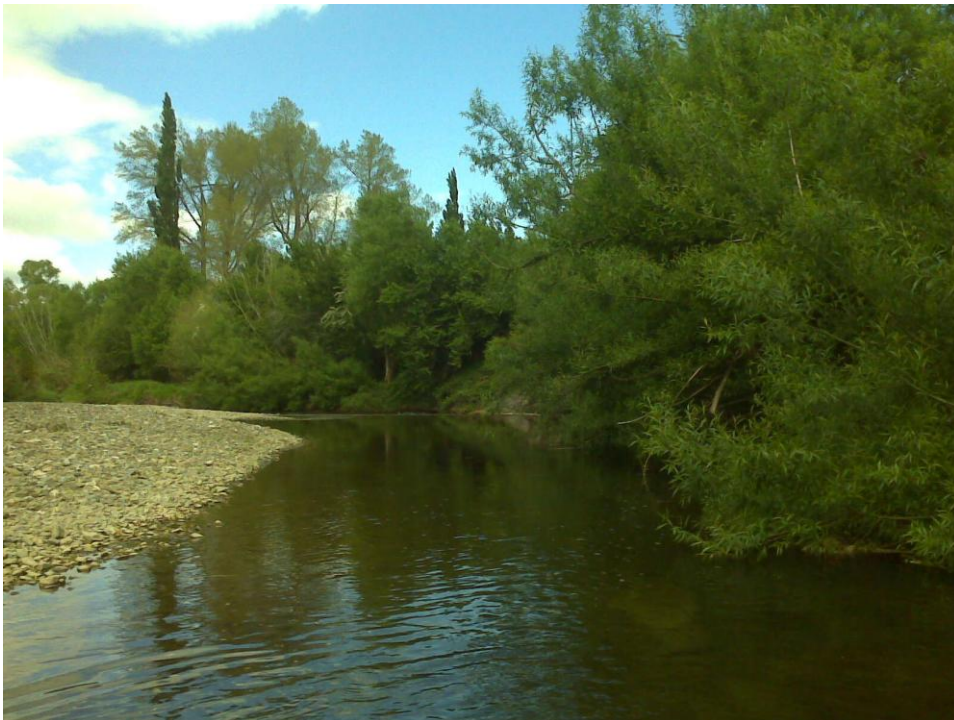
Shag River/Waihemo : S34

Figure 58. Cross-section S34, looking downstream

Figure 59. Cross-section S34, looking downstream, October 2013

Cross-section S34 is located 19.24km upstream of the Shag River/Waihemo mouth and 0.65km upstream of Craig Road bridge. The main channel bed aggraded on the left bank narrowing the channel, the left side floodplain showed degradation or limited change between April 2004-April 2009. The main channel bed in October 2013 remained similar to the 2009 bed with a small amount of aggradation on the left bank. The left side floodplain aggraded between 2009-2013. The thalweg stayed in the same position between 2009-2013.

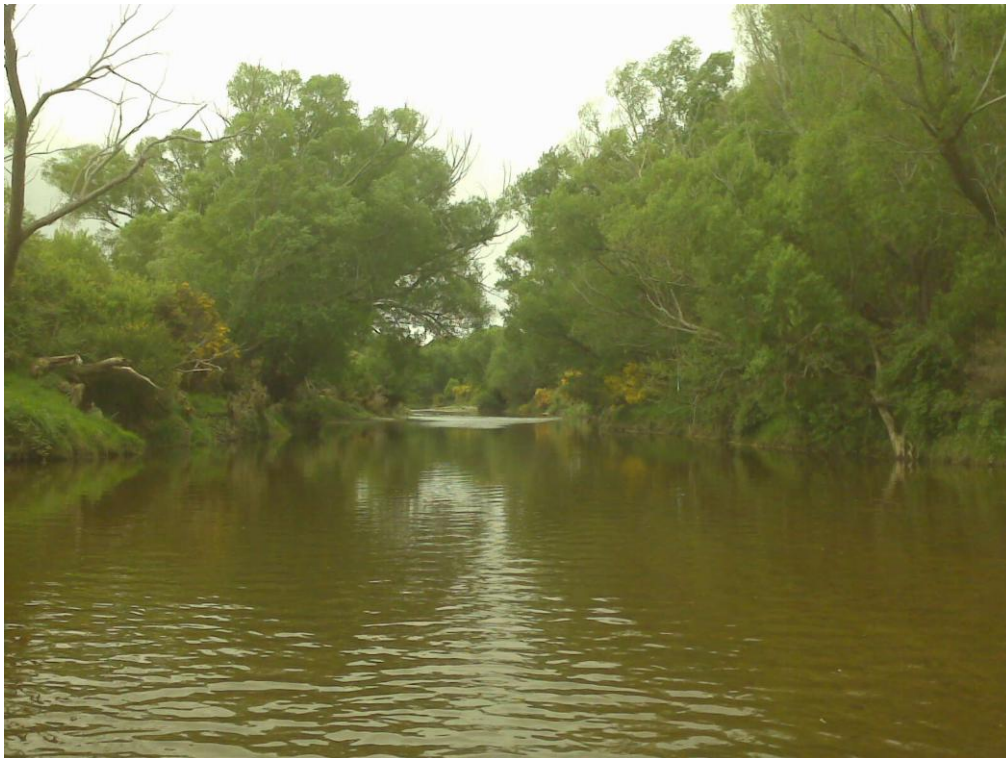
Shag River/Waihemo : S35

Figure 60. Cross-section S35, looking downstream

Figure 61. Cross-section 35, looking upstream, October 2013

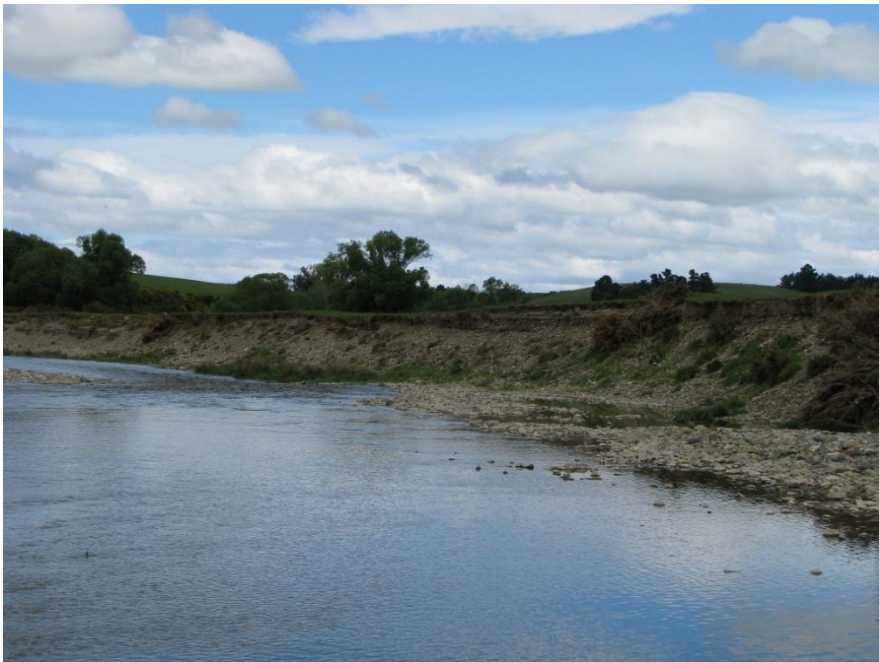
Shag River/Waihemo : S36

Figure 62. Cross-section S36, looking downstream

Figure 63. Cross-section S36, looking downstream, October 2013

Cross-section S36 is located 20.5km upstream of the Shag River/Waihemo mouth and 0.39km downstream of McLew Road bridge. The main channel bed is divided into two low flow channels. Between April 2004-April 2009 the left channel widened with the right channel narrowing, the right side floodplain both aggraded and degraded. Between April 2009-October 2013 the left channel became narrower and deeper with the right channel aggrading approximately 1m. The right side floodplain remained similar between 2009-2013 with some minor aggradation and degradation occurring. The thalweg remained in a similar position between 2004-2013.

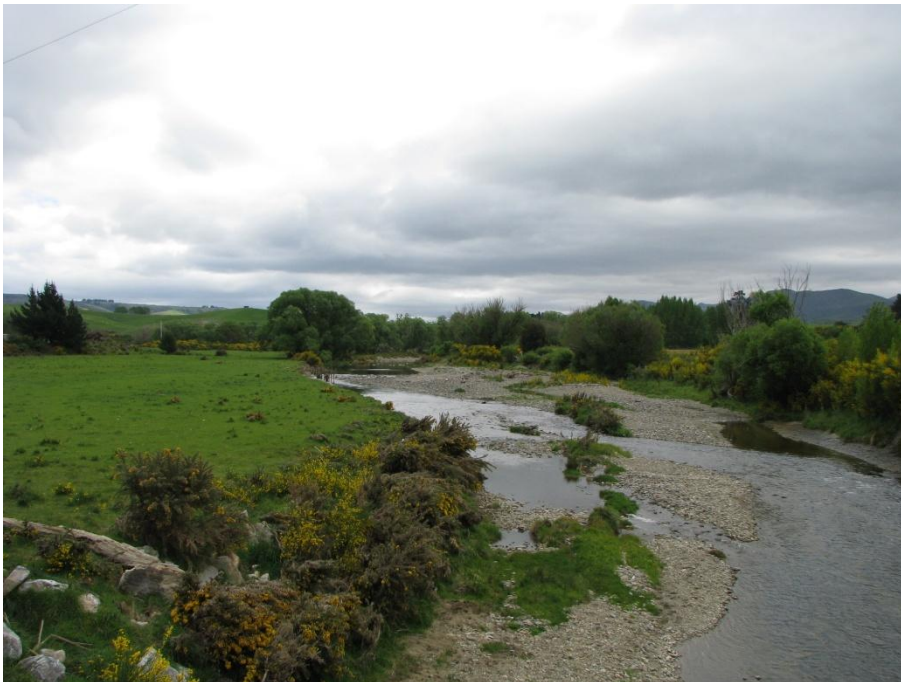
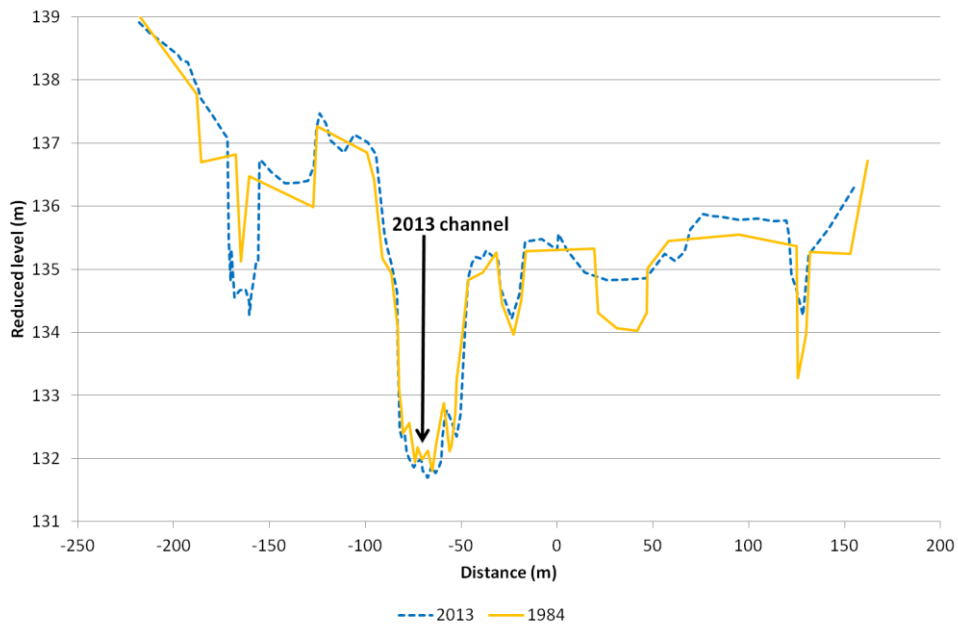
Shag River/Waihemo : S37

Figure 16. Cross-section S37, looking downstream

Figure 64. Cross-section S37, looking downstream

Figure 65. Cross-section S37, looking upstream, October 2013

Cross-section S37 is located 20.9km upstream of the Shag River/Waihemo mouth at McLew Road bridge. The main channel bed both aggraded and degraded but has become smoother between April-2004-April-2009. The right bank eroded approximately 6m with both aggradation and degradation occurring across the wider floodplain between April 2004- April 2009. The main channel bed and right bank aggraded between April 2009-October 2013 with predominantly aggradation occurring across the wider floodplain. The thalweg aggraded 0.4m between 2009-2013.
