# Flood hazard on the Taieri Plain

## **Review of Dunedin City District Plan: Natural hazards**

1<sup>st</sup> revision: June 2015

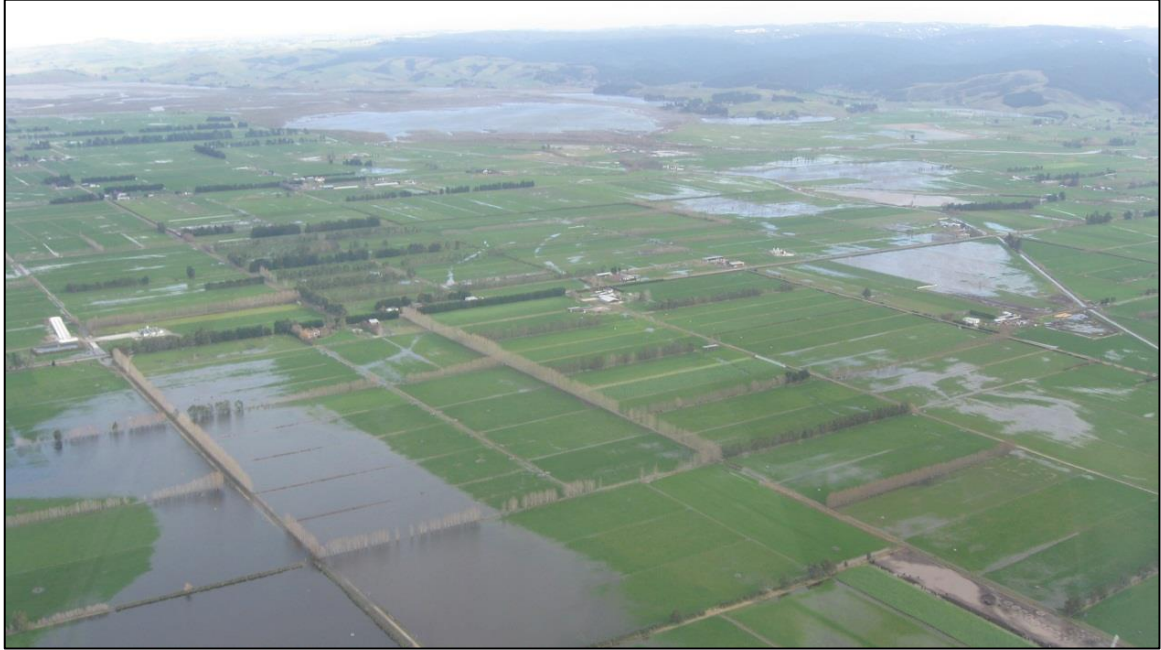
**Figure 4.** Aerial view of ponding on the West Taieri Plain, resulting from internal runoff from areas 1A and 1B during heavy rainfall in June 2013 (195mm over eight days at the Riccarton Road rain gauge). Lakes Waipori and Waihola can be seen in the distance.

**Flood hazard characteristics and effects:** Extensive ponding is the main type of hazard in this area, with depths ranging from less than 0.5m on the margins, to more than 3m in some places (Figure 3). Sources of flooding include the Taieri River to the south, Waipori River to the west, Maungatua Range to the north and internal runoff from areas 1A, 1B and 1C. The flood hazard associated with these waterways can be significant (ORC, 2013). The natural tendency of waterways to inundate Area 1A is mitigated to some extent by flood protection and drainage schemes. As a result, flood hazard in this area is generally limited to ponding of a moderate depth and duration and low-velocity flows (see Scenario 1 and Figure 4 below).

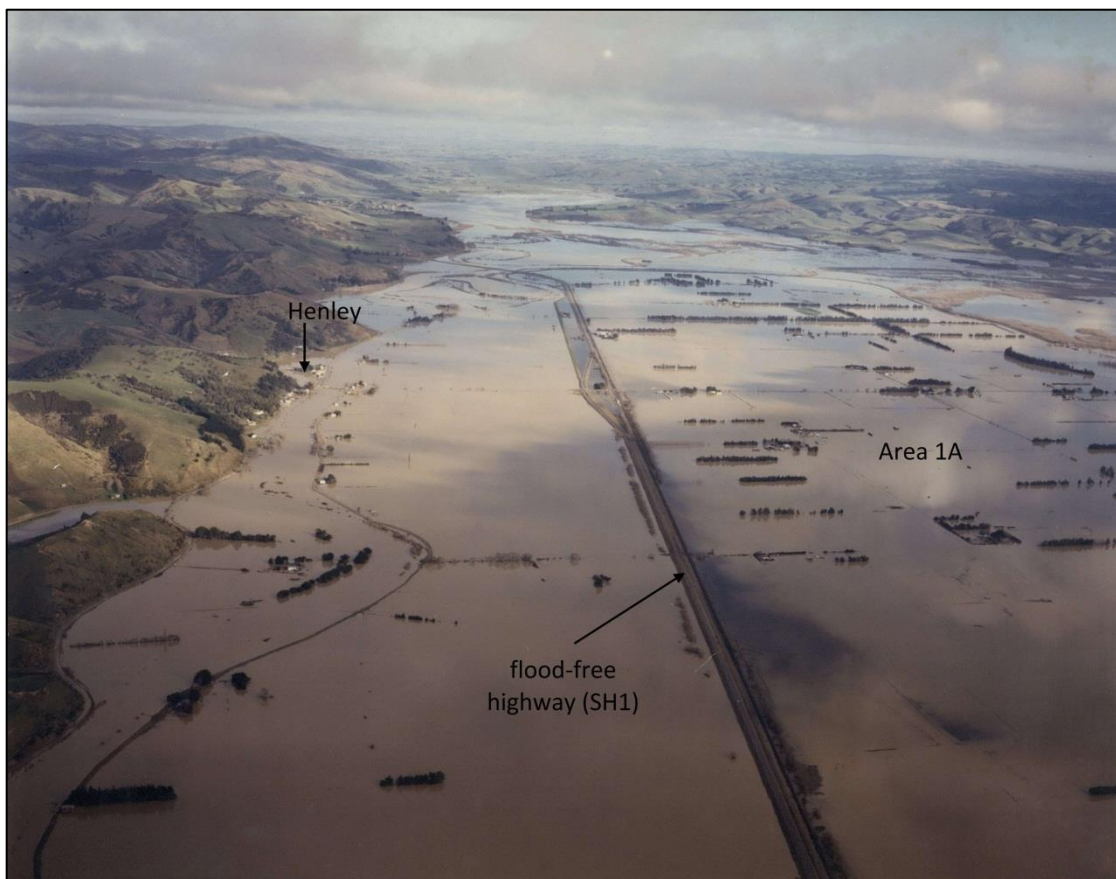
**Figure 5.** Aerial view (looking south) of flooding on the West Taieri following the June 1980 flood event. Area 1A is to the right (west) of the 'flood-free' highway while Areas 9, 10 and 11 are to the left.

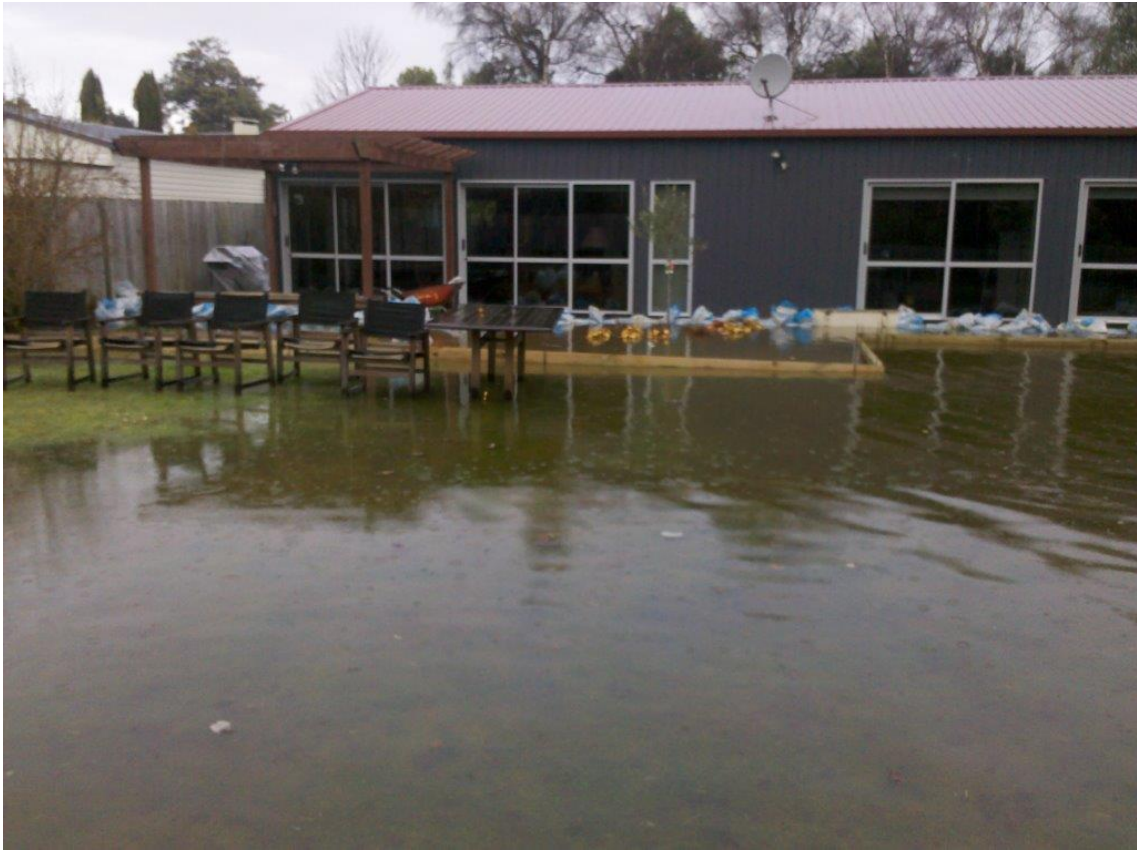
**Figure 10. Water ponding around a residential property located within Area 1C, in July 2013**

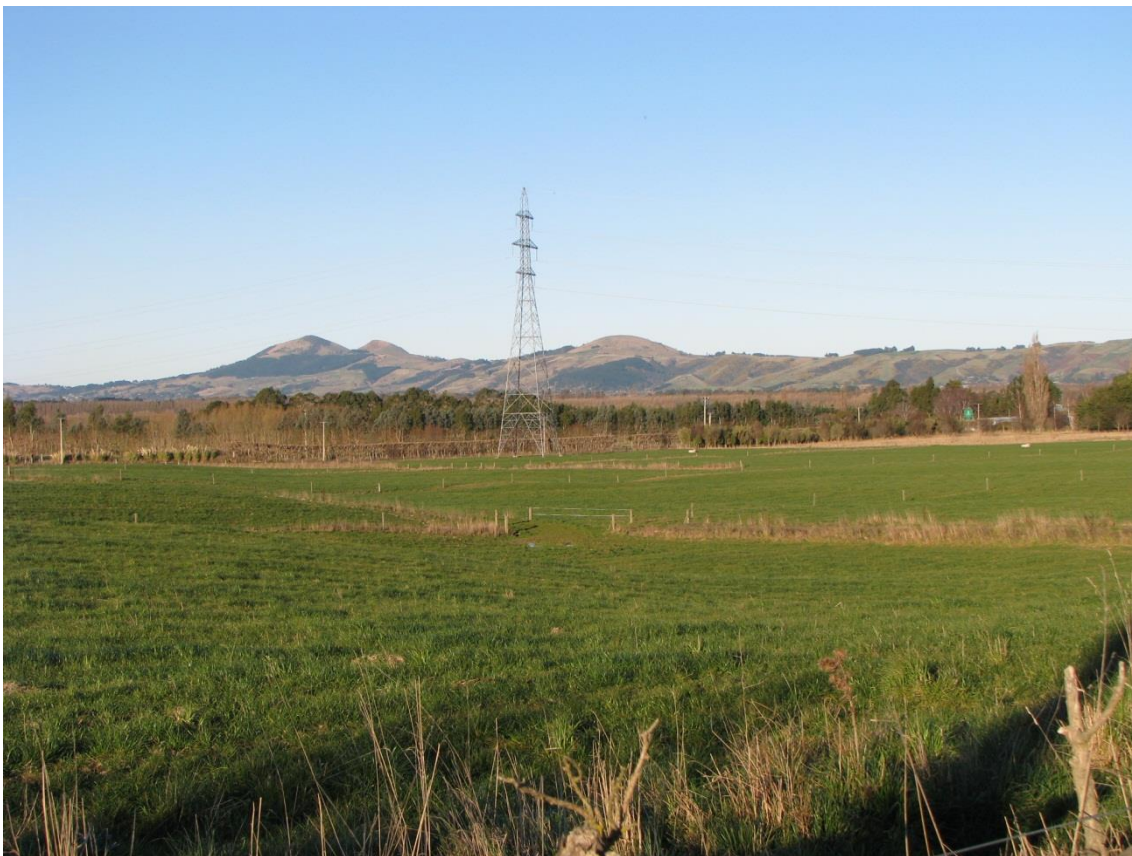
Figure 12. Looking east across the lower reaches of an active flood-water dominant alluvial fan that drains from the Maungatua Range

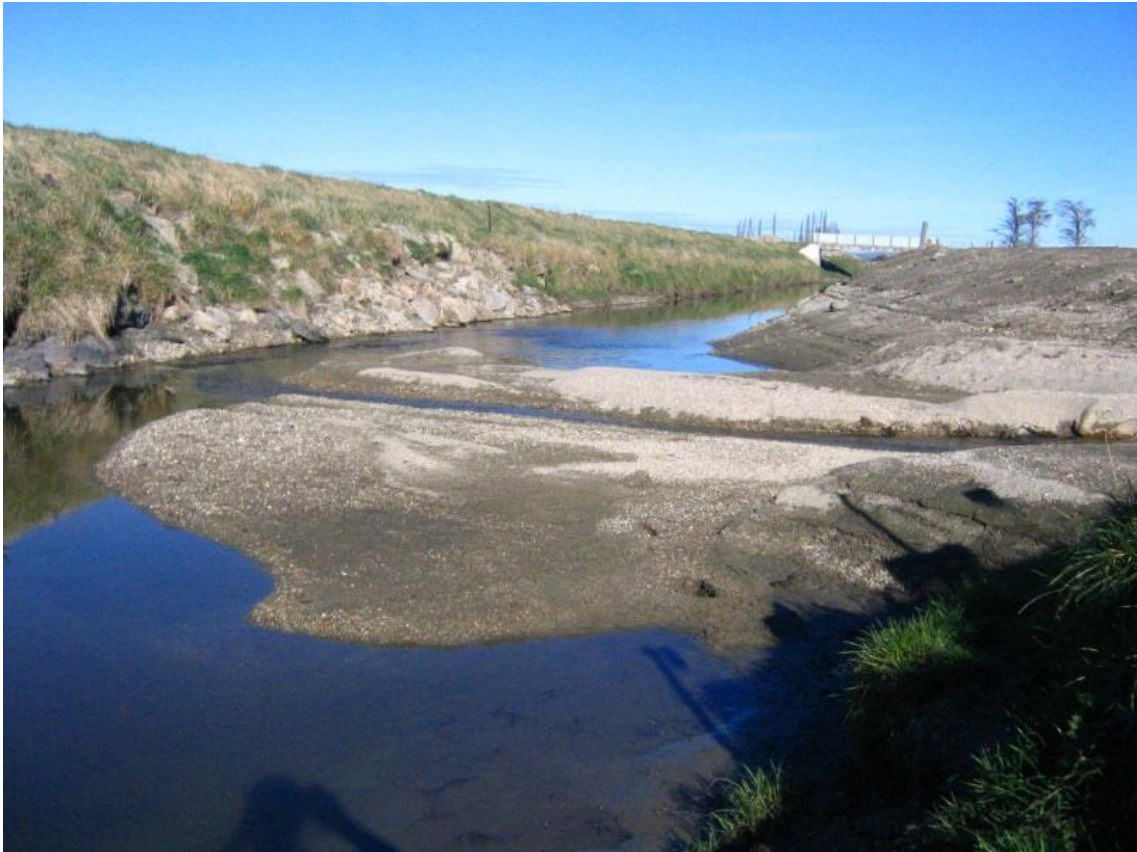
**Figure 13. Deposition of gravel in the Contour Channel from a tributary hill stream**

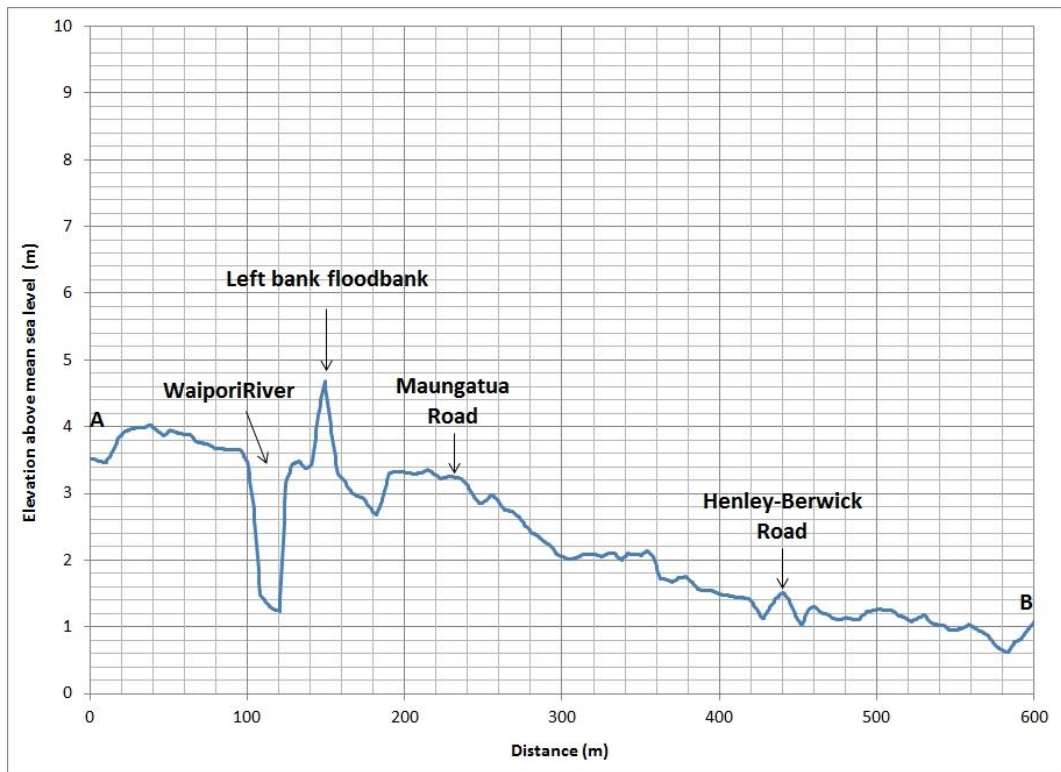
Figure 14. Cross section A-B through Berwick, showing the low-lying elevation of the settlement relative to the Waipori River main channel and berm areas, and to the Waipori River true left floodbank. The location of the cross-section is shown in Figure 18.

The reliance on earth floodbanks for flood protection in Area 3 means there is some residual risk<sup>11</sup> exposure (failure before the design capacity is reached). This is of particular relevance to the settlement of Berwick given the topography and its close proximity to the Waipori River true left bank floodbank (Figure 14).

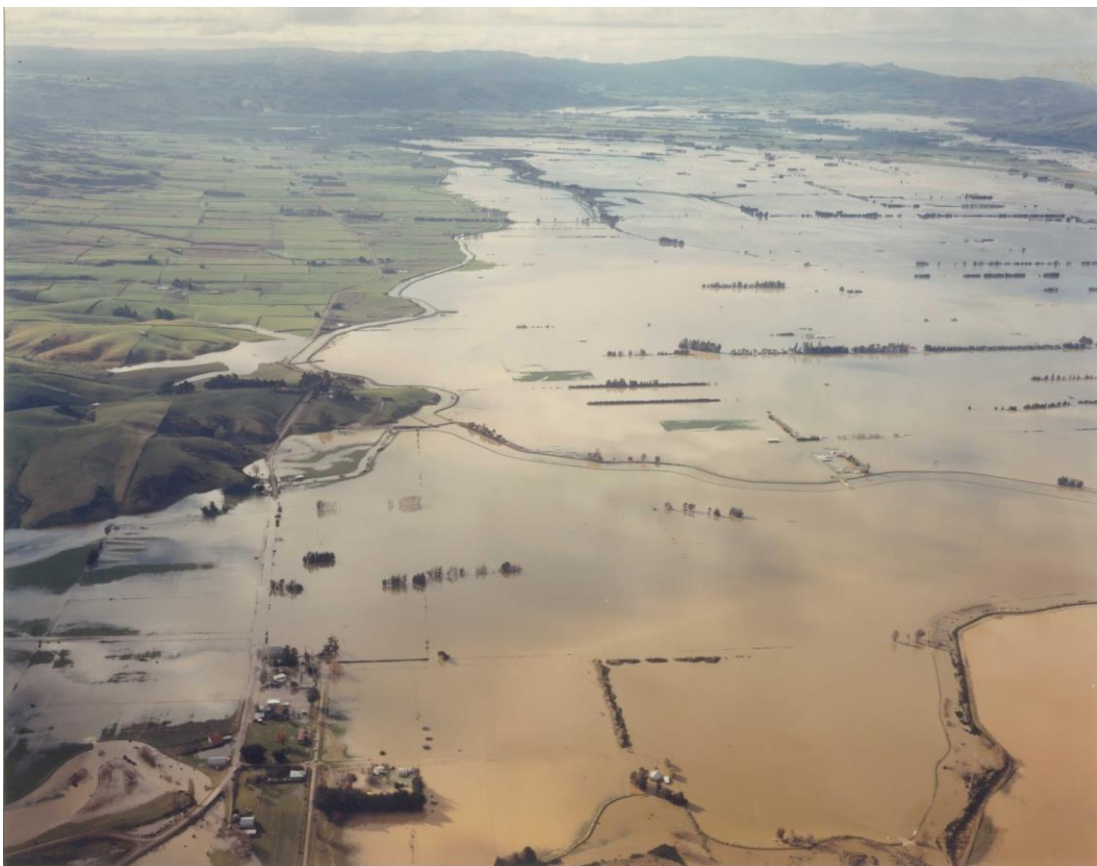
Figure 15. West Taieri Plain, looking North, with Berwick in the left foreground - June 1980. The photo was not taken at the maximum extent of flooding.

This area was extensively inundated in the floods of 1868, 1923 and 1980 (ORC, 2013) (Figure 15). Floodbanks that are part of the Lower Taieri Flood Protection Scheme provide a low level of protection during flood events. The ability of floodwater to drain from this area is affected by the level of Lake Waipori, which in turn can be affected by conditions at the mouth of the Taieri River.

Observations of previous flood events (eg, Figure 15) and LiDAR<sup>12</sup> elevation data (Figure 19) show that much of this area has been, or is likely to be, affected by flooding. While some historical flood events may not have inundated all of Berwick, large events are likely to inundate much of the settlement. Figure 18 and Figure 19 show that there are small pockets of land within Area 3 which are elevated slightly above surrounding lower-lying areas. However, large flood events or floodbank failure can result in situations where these areas are isolated for extended periods, and/or be affected by low level inundation.

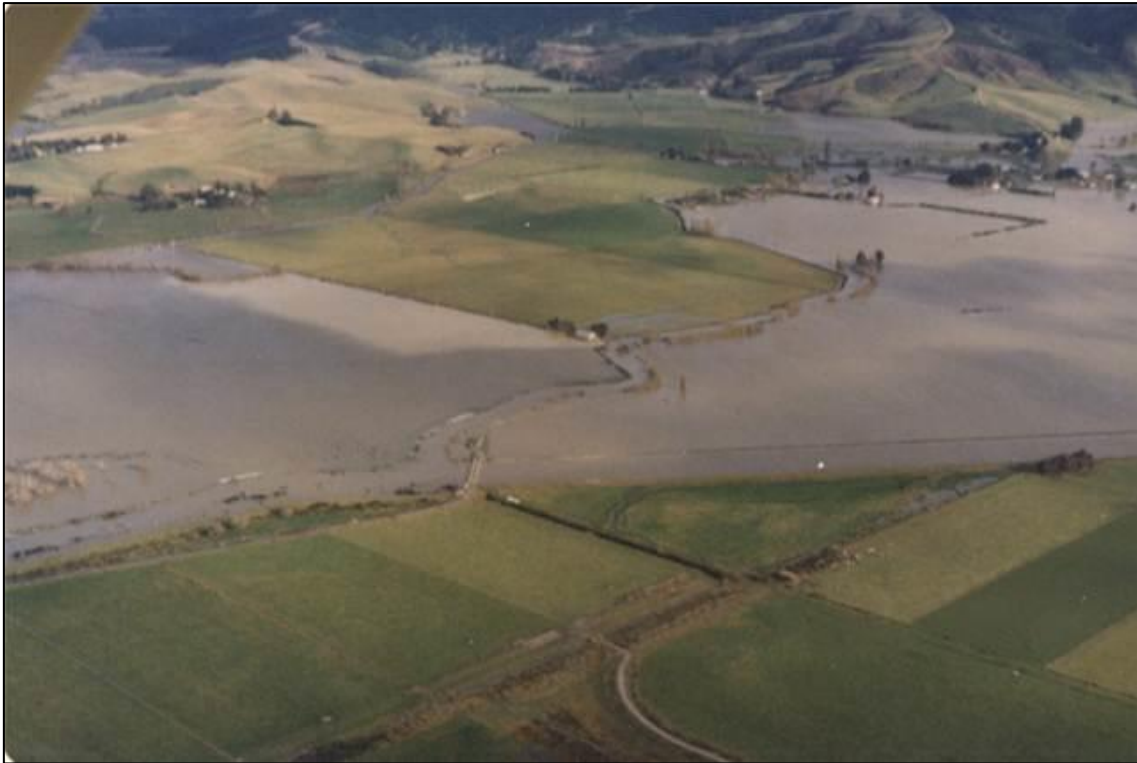
Figure 16. Aerial view of Waipori River No. 1 contour channel bridge, looking towards Berwick - May 1977. The photo was not necessarily taken at the peak of the flood.

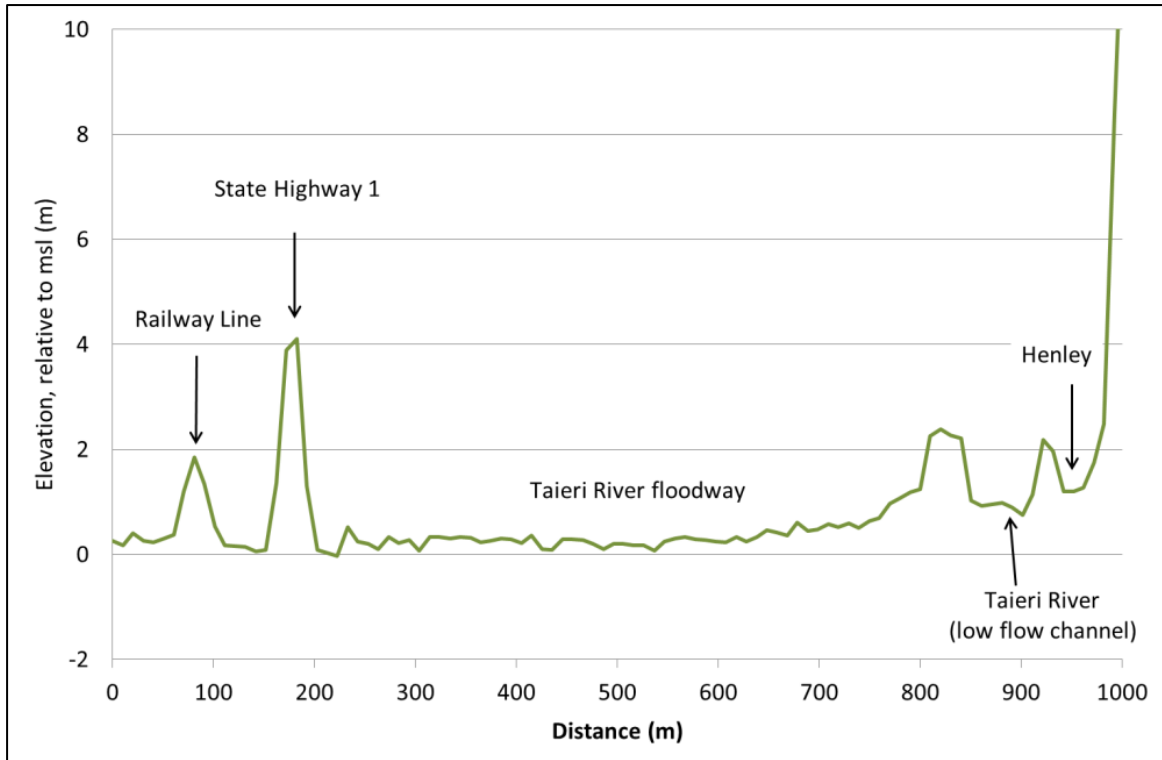
**Figure 21. Cross-section from the West Taieri Plain to Henley, just upstream of Henley-Berwick Road**

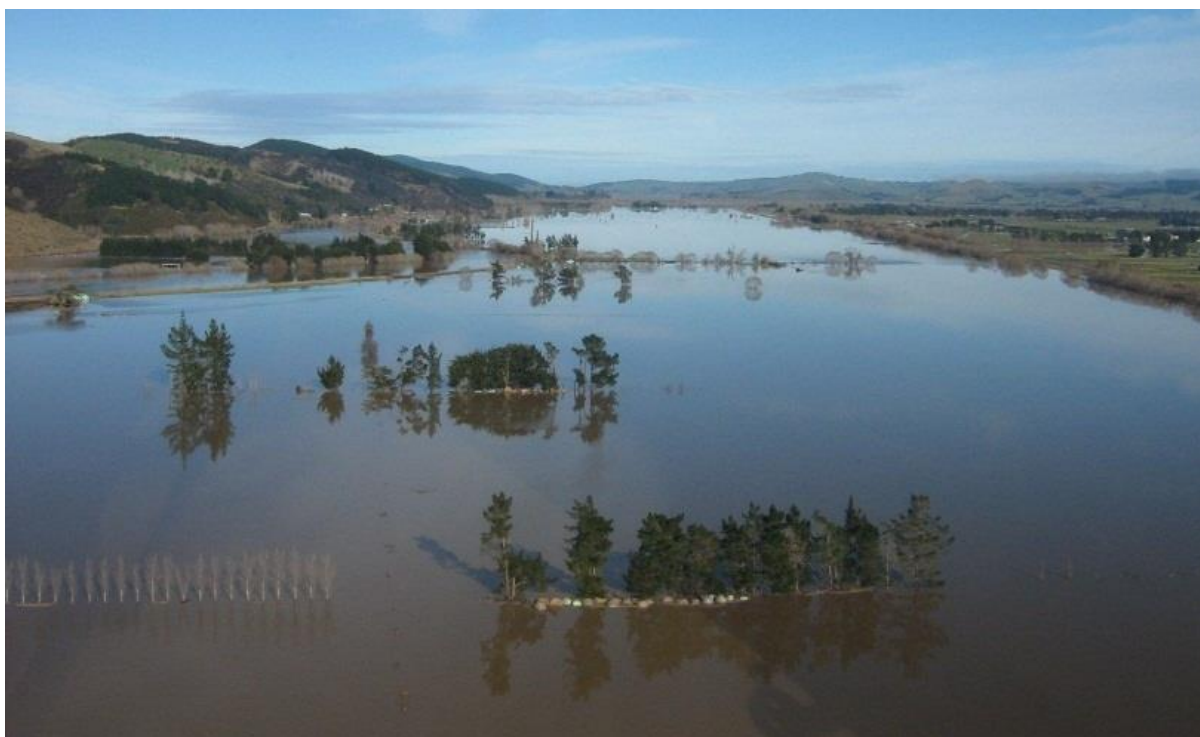
**Figure 25. Lower Taieri Floodway, looking downstream to Henley, 31 July 2007. Several rows of trees and balage lie perpendicular to the direction of flow.**

**Setting:** These areas consist of the berms which lie between the Taieri River flood banks; or, downstream of Allanton, between the foothills on the true left bank and the Taieri River floodbank on the true right bank (Figure 25). They are exposed to flooding from the Taieri River, and to a lesser degree, the Silver Stream and Owhiro Stream. They play a crucial role in the conveyance and temporary storage of floodwater and hence the mitigation of flood hazard for other parts of the Taieri Plain. Area 10 is generally lower-lying than Area 11, and therefore has less ability to drain by gravity. Tidal effects are observed as far upstream as Allanton, although these are largely drowned out and have little effect on river levels during floods. Low-lying parts of Allanton are situated within Area 11, and some were flooded in June 1980 (ORC, 2013), although there are very few residential dwellings in this area.

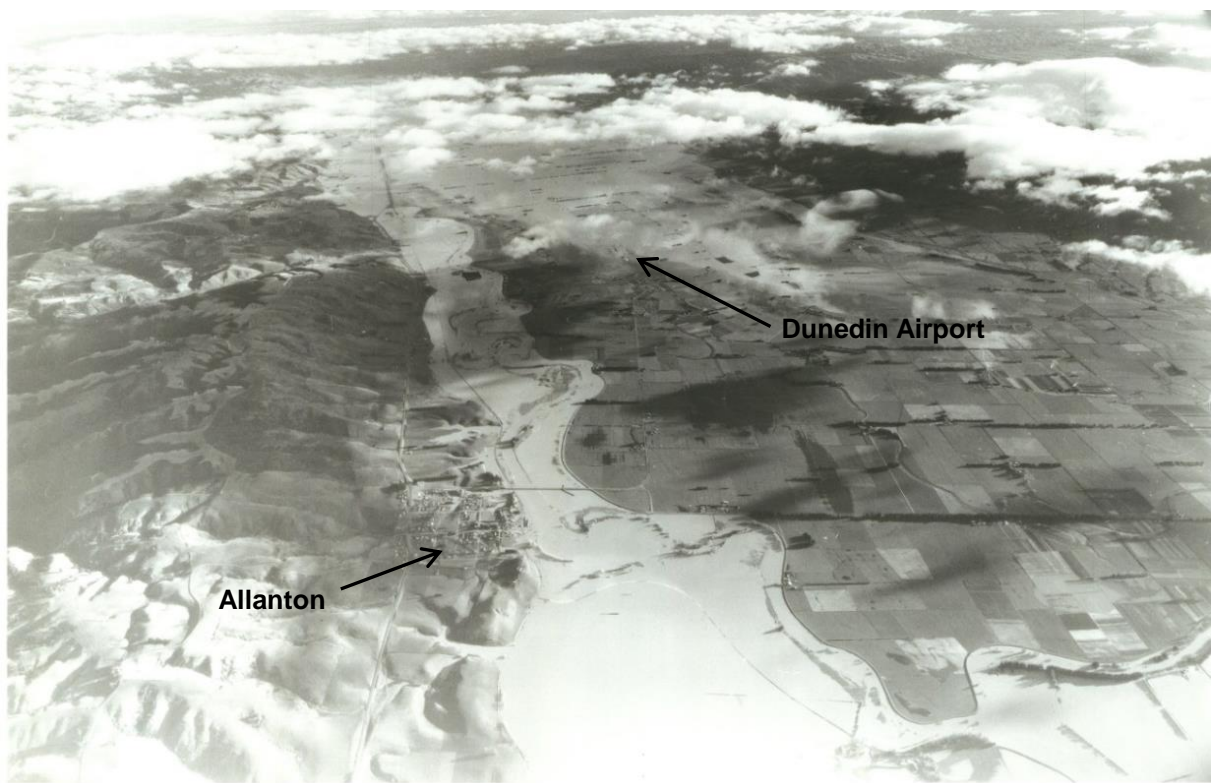
Figure 26. Aerial view (towards the southwest) of Areas 10 and 11 following the 1980 flood

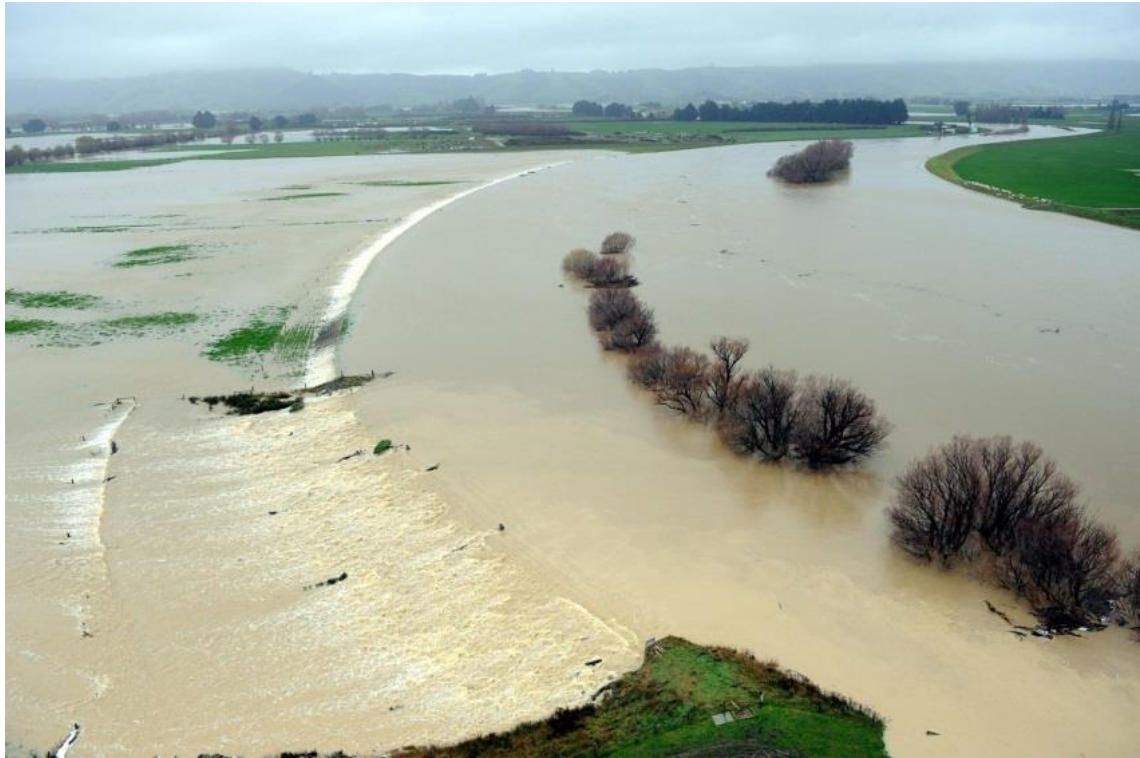
**Figure 30. Taieri River flows spilling into Area 12 on 29 May 2010 (Photo courtesy of Otago Daily Times)**

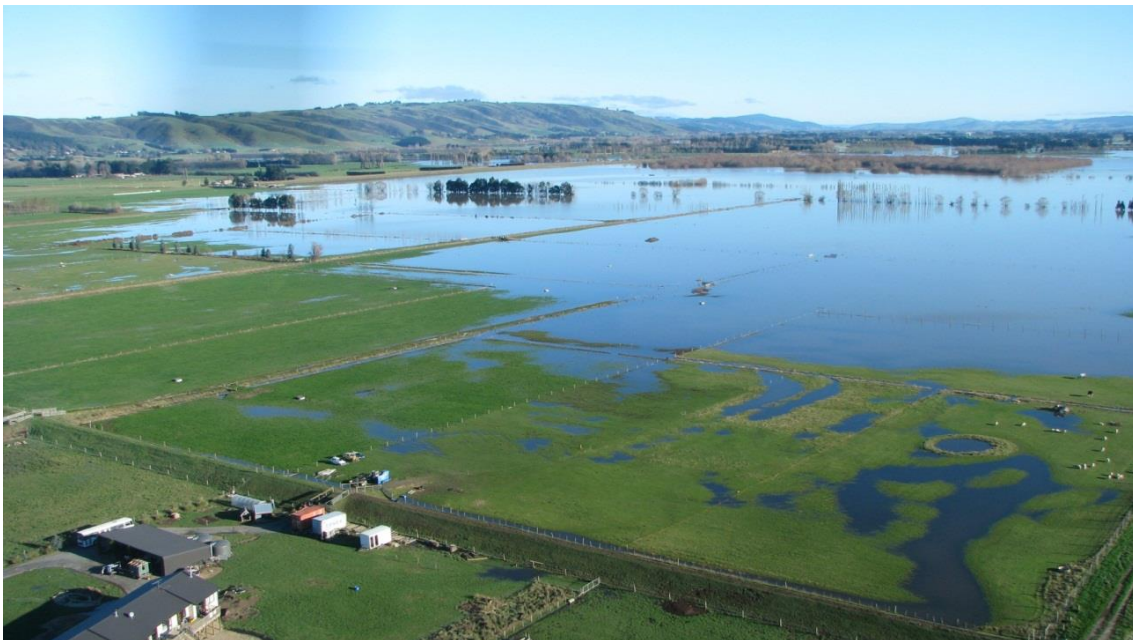
**Figure 31. Water ponding in Area 12 on 31 May 2010. The upper pond cut-off bank is at the bottom of the image.**

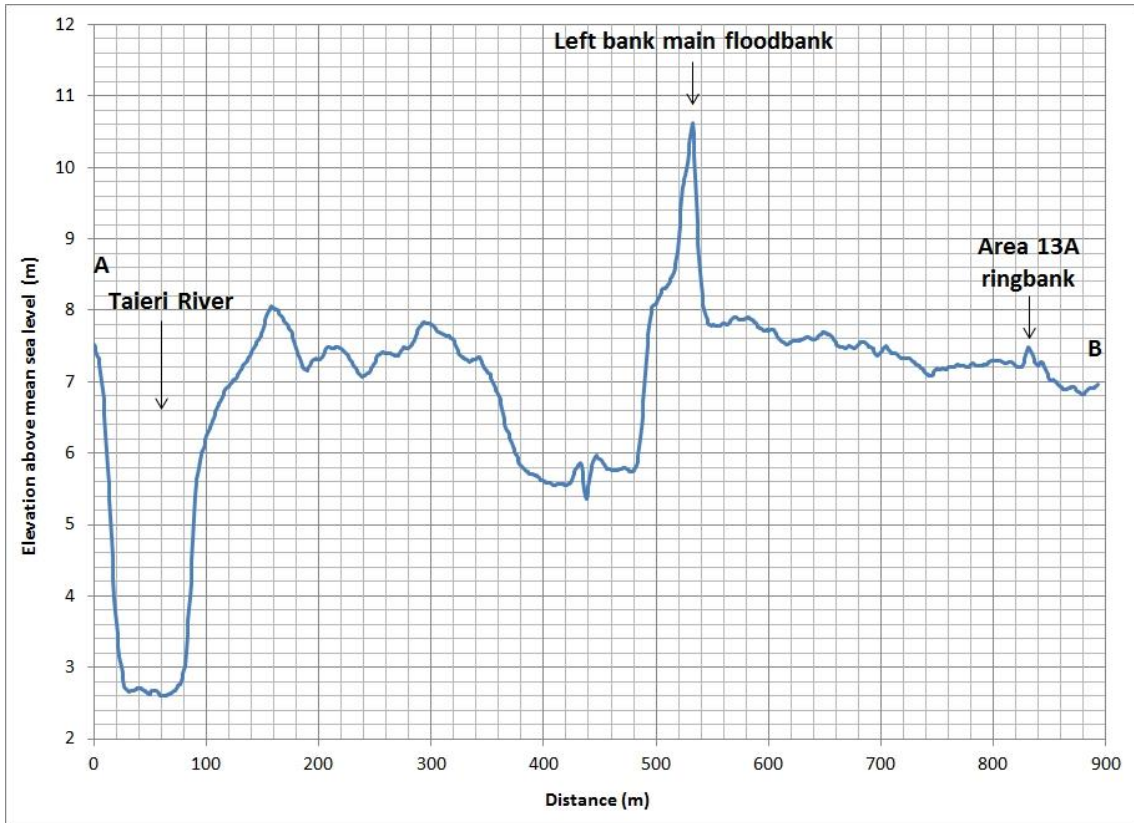
Figure 34. Cross section A-B, through Area 13A

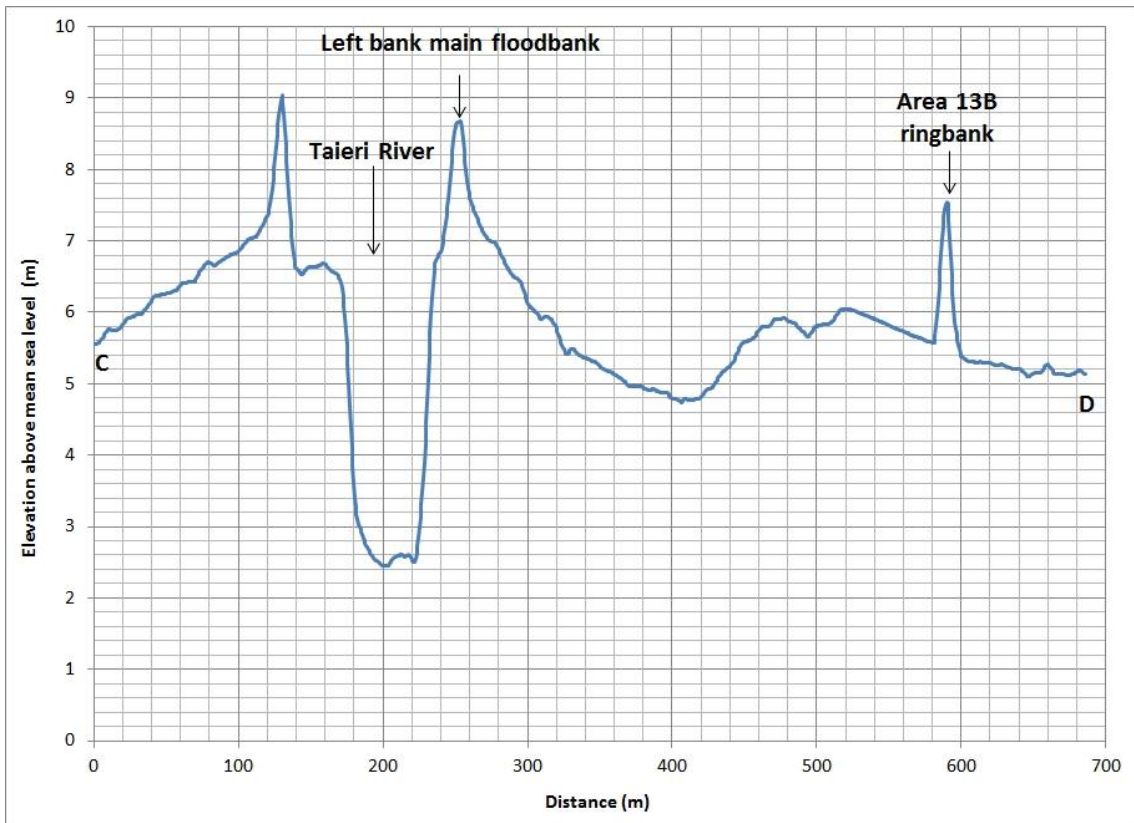
Figure 35. Cross-section C-D, through Area 13B

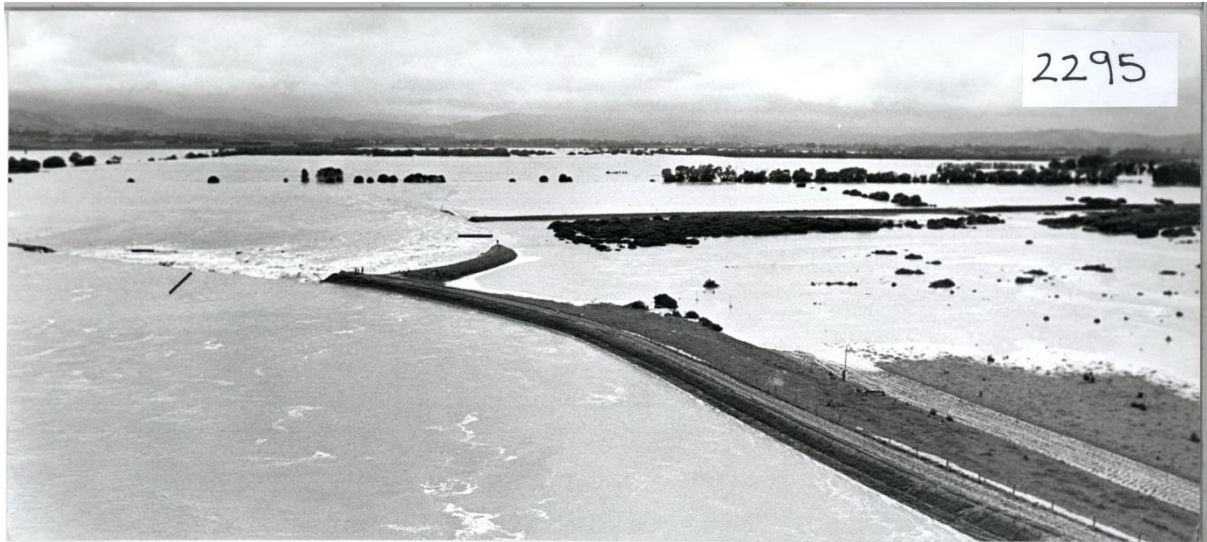
**Figure 36. Breach of the northern section of the Area 13B ring bank during the December 1993 flood event. The location and direction of this photo is shown in Figure 33.**

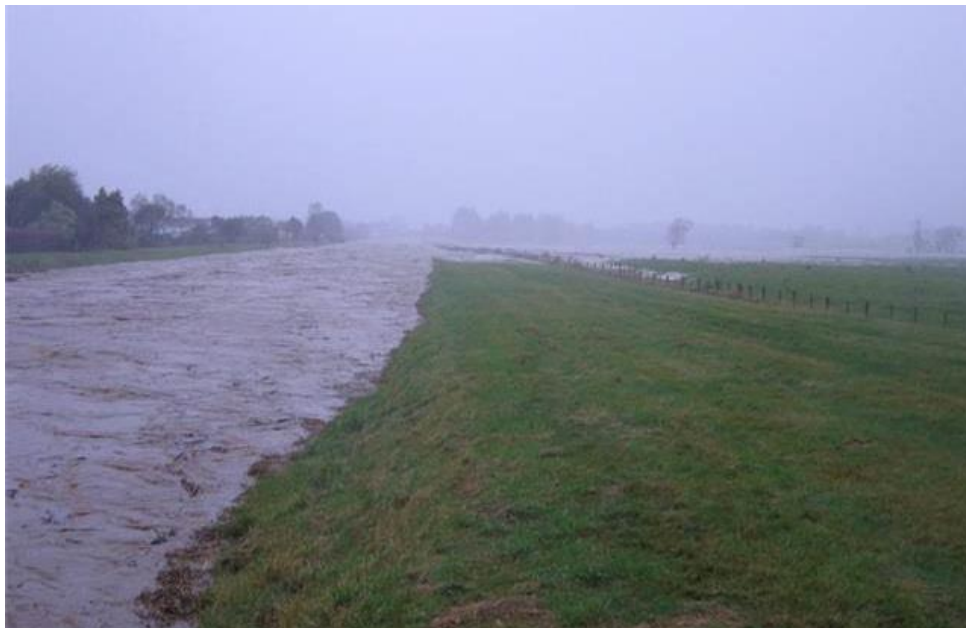
Figure 38. Silver Stream flows spilling over the Gordon Road spillway (April 2006)

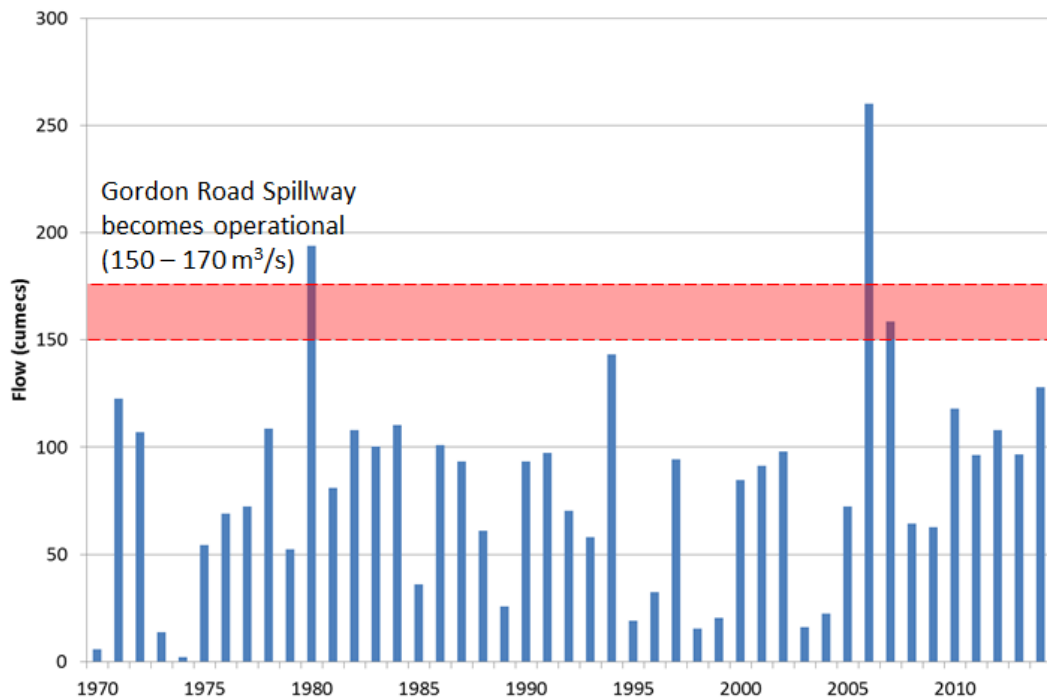
**Figure 39. Silver Stream observed flood peaks, 1970 - 2014**

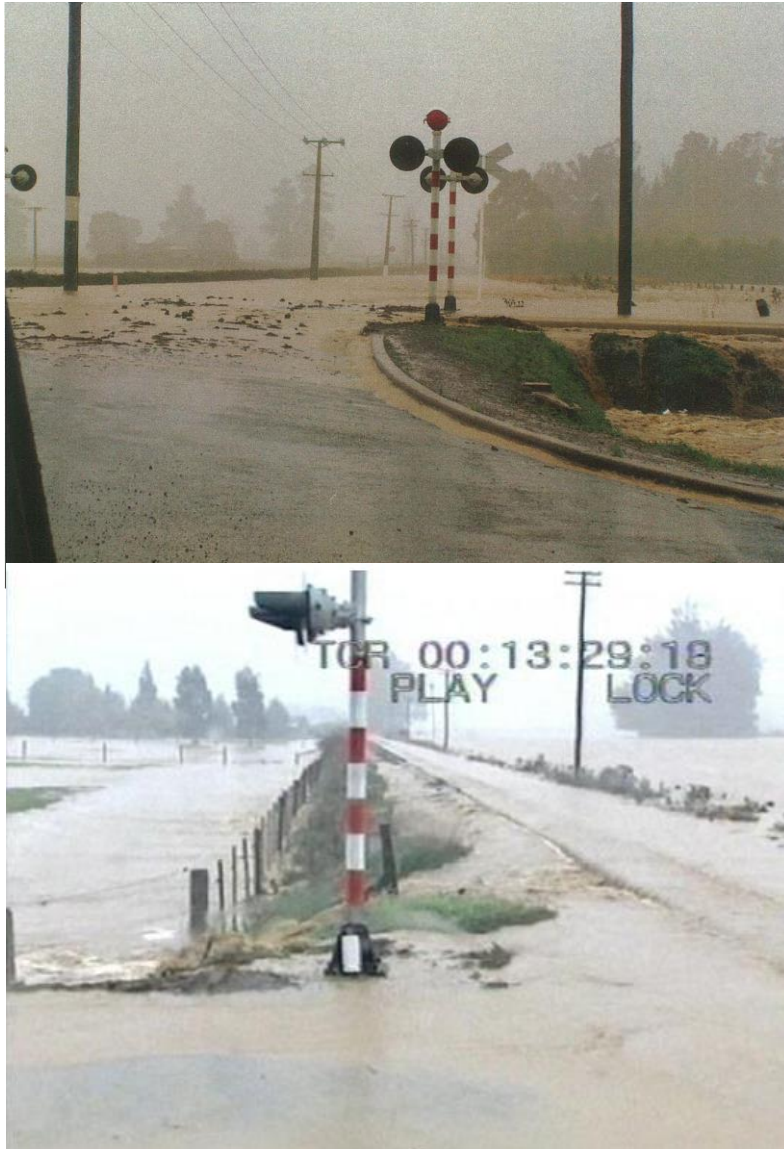
**Figure 40. Water ponding behind the Taiari Gorge Railway, 26 April 2006**

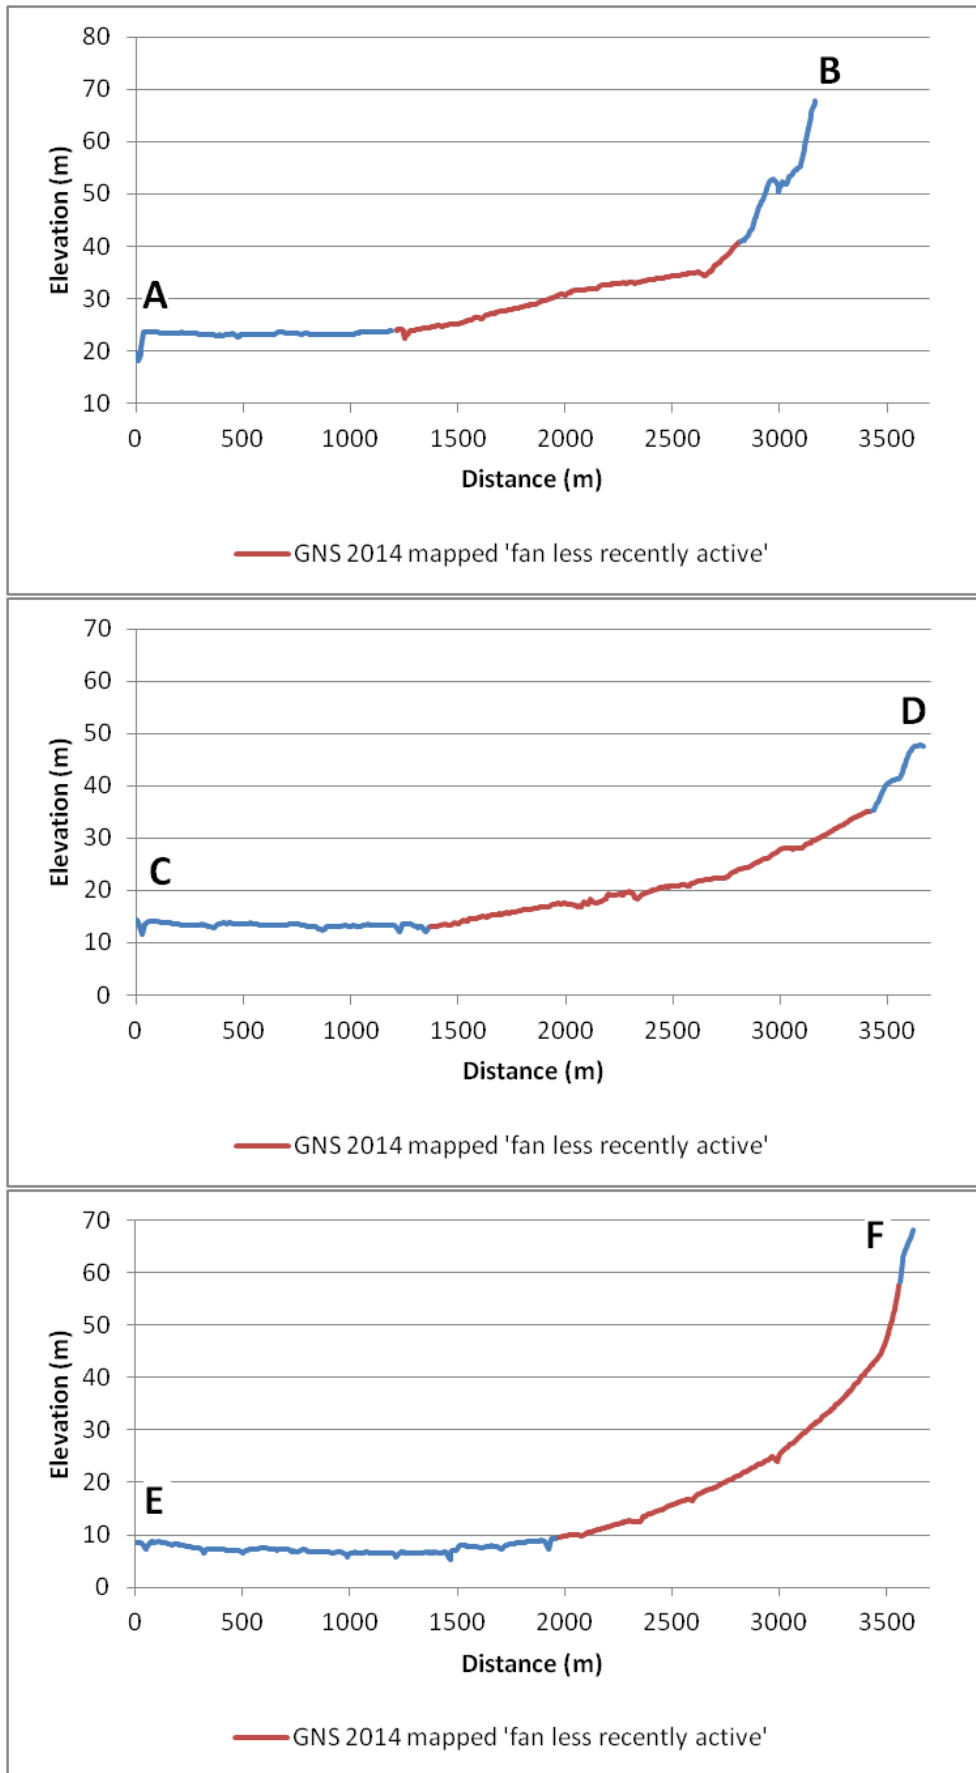
Figure 44. Elevation profiles A-B (top), C-D (middle) and E-F (bottom), as shown on Figure 43

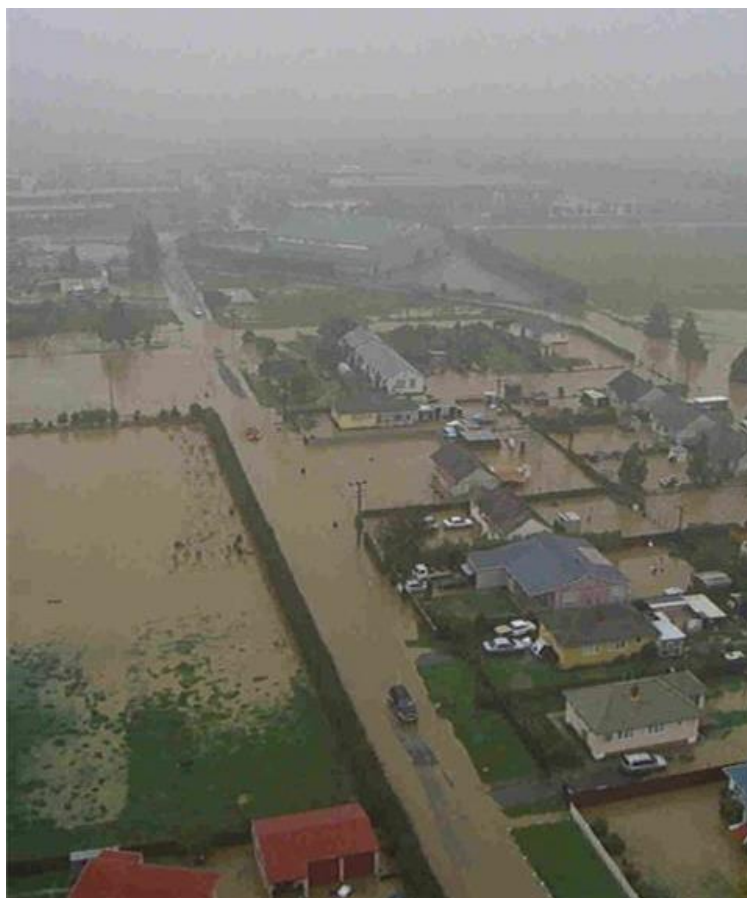
**Figure 46. Flooding of residential properties within Area 14D (looking down Hazlett Road to Dukes Road north (April 2006)**

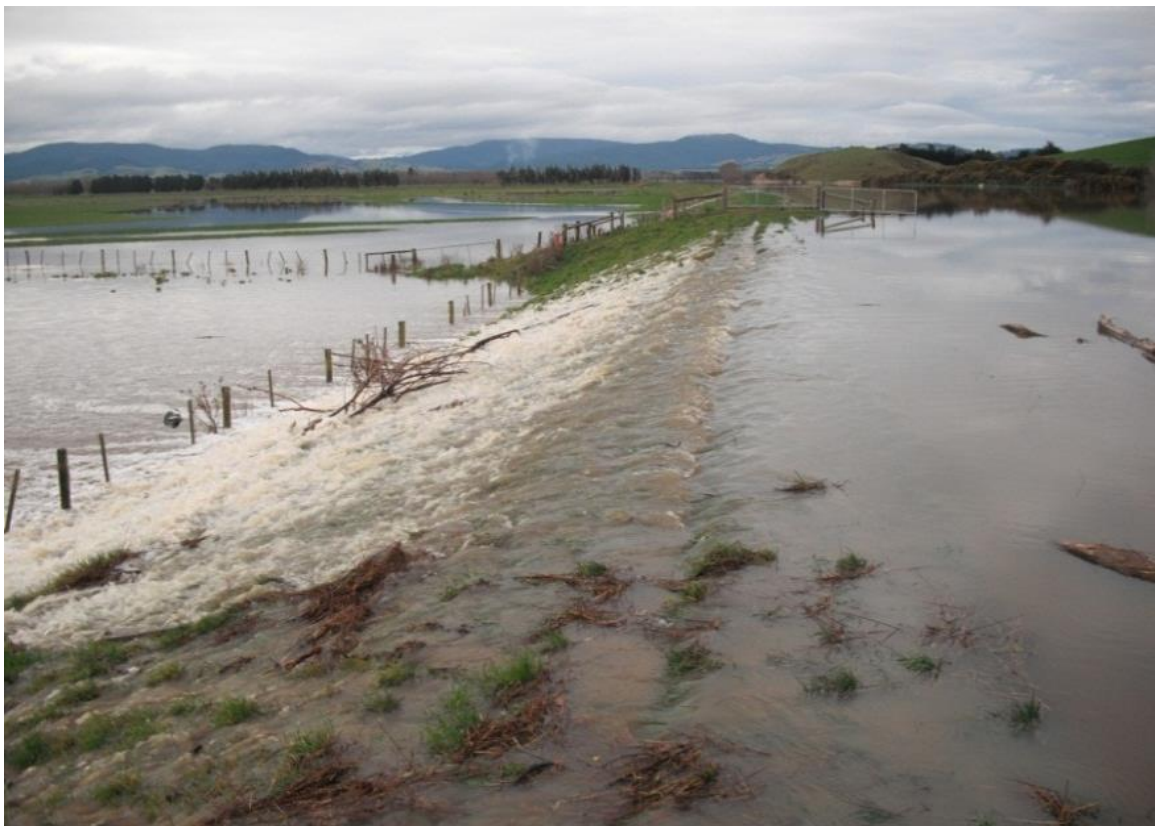
**Figure 47. Overtopping of the Owhiro Stream into Area 17 (August 2012)**

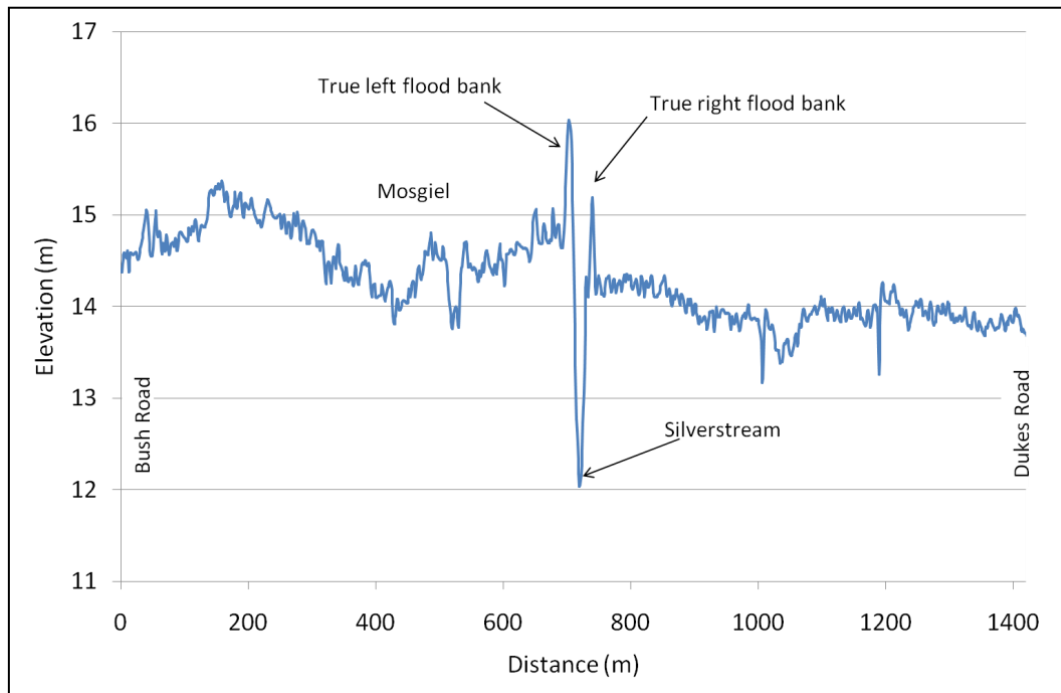
**Figure 50. Cross section through the Silver Stream (from Bush Road in Mosgiel to Dukes Road in Area 14), looking downstream**

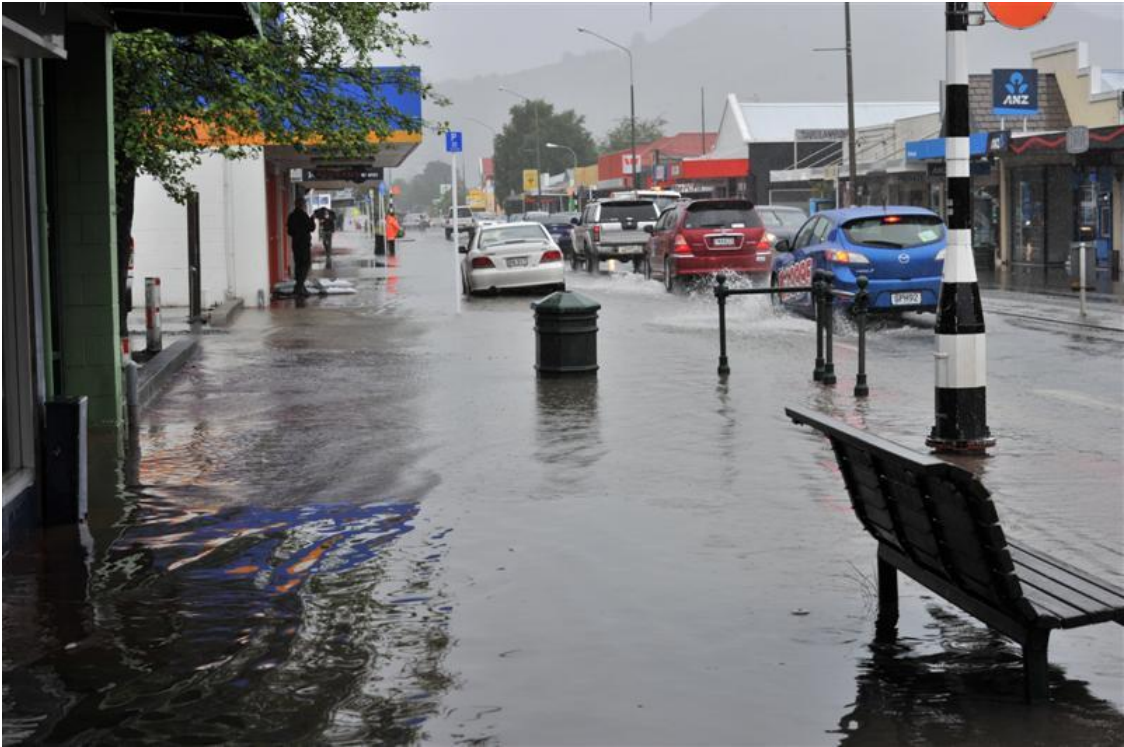
**Figure 51. Surface flooding on Gordon Road, November 2012 (Source: Otago Daily Times)**
