# Flood hazard on the Taieri Plain

## **Review of Dunedin City District Plan: Natural hazards**

1<sup>st</sup> revision: June 2015

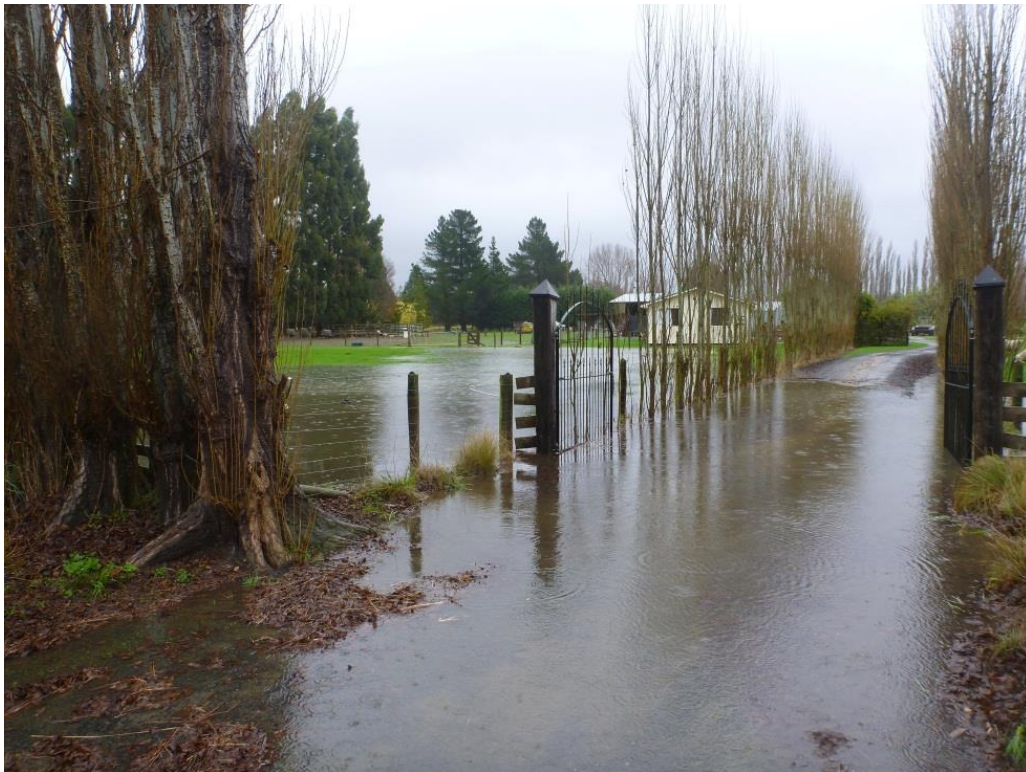
**Figure 54. Overland flow which has drained from the adjacent hill catchment, ponding near Puddle Alley, at the northern end of Area 21 (June 2013)**

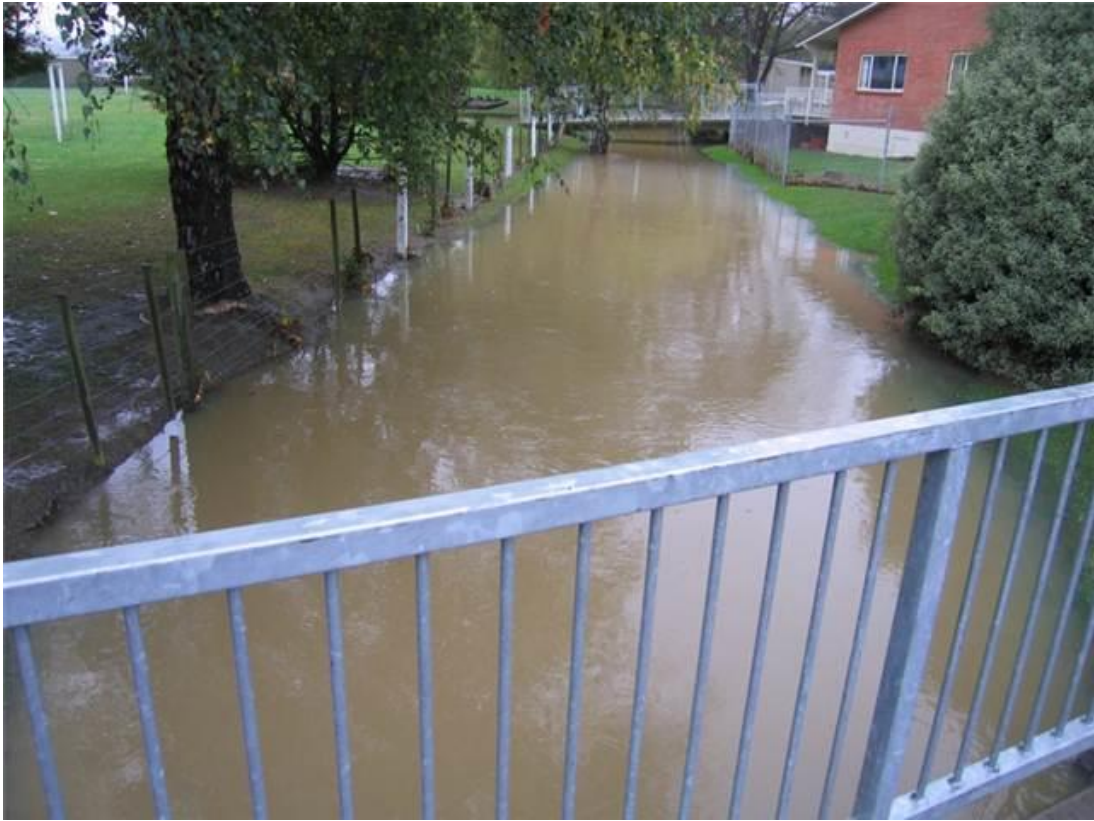
**Figure 57. Quarry Creek at Cemetery Rd Bridge, April 2006. Photo not taken at the time of peak flow.**

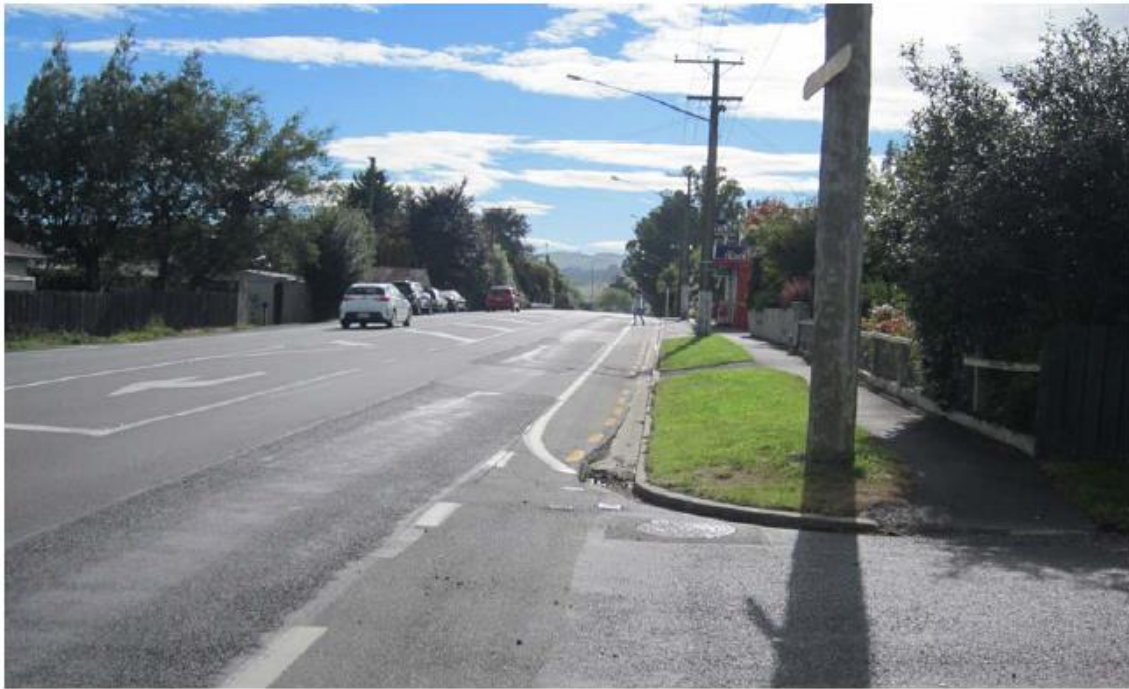
**Figure 61. A view northeast along State Highway 1 at East Taieri township, showing the fan of Jaffray Stream. The road rises over the fan axis, and Jaffray Stream is conveyed in a culvert at the point where the road goes out of sight. If the culvert were to become blocked by debris during a major rainstorm, there is potential for flooding and sedimentation on the fan surface. Photo: D. Barrell, 17 February 2014, GNS Science.**

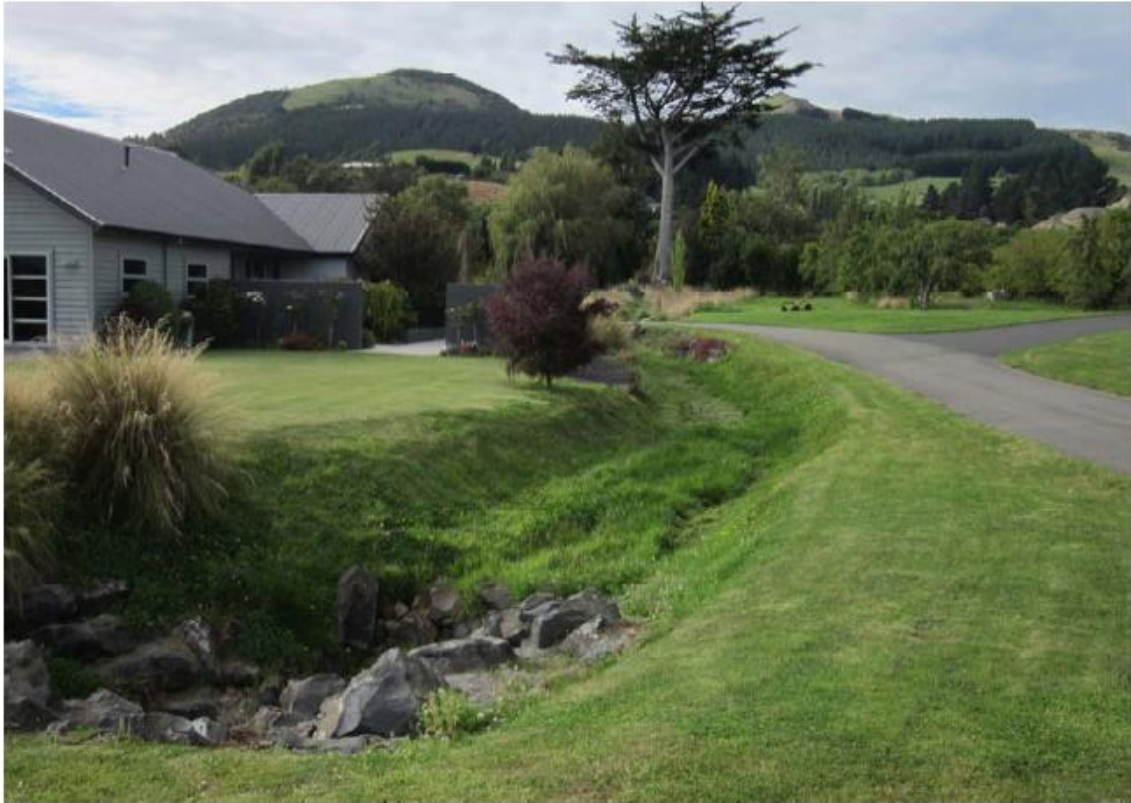
**Figure 62. The engineered channel of Jaffray Stream at Orchard Grove, East Taieri. The head of its approximately 70ha catchment extends between Saddle Hill (left) and Jaffray Hill (right). D. Barrell, 17 February 2014, GNS Science.**
