Seismic Hazard in Queenstown Lakes District

August 2015

Report writer: Ben Mackey, Natural Hazard Analyst
Reviewed by: Michael Goldsmith, Manager, Natural Hazards

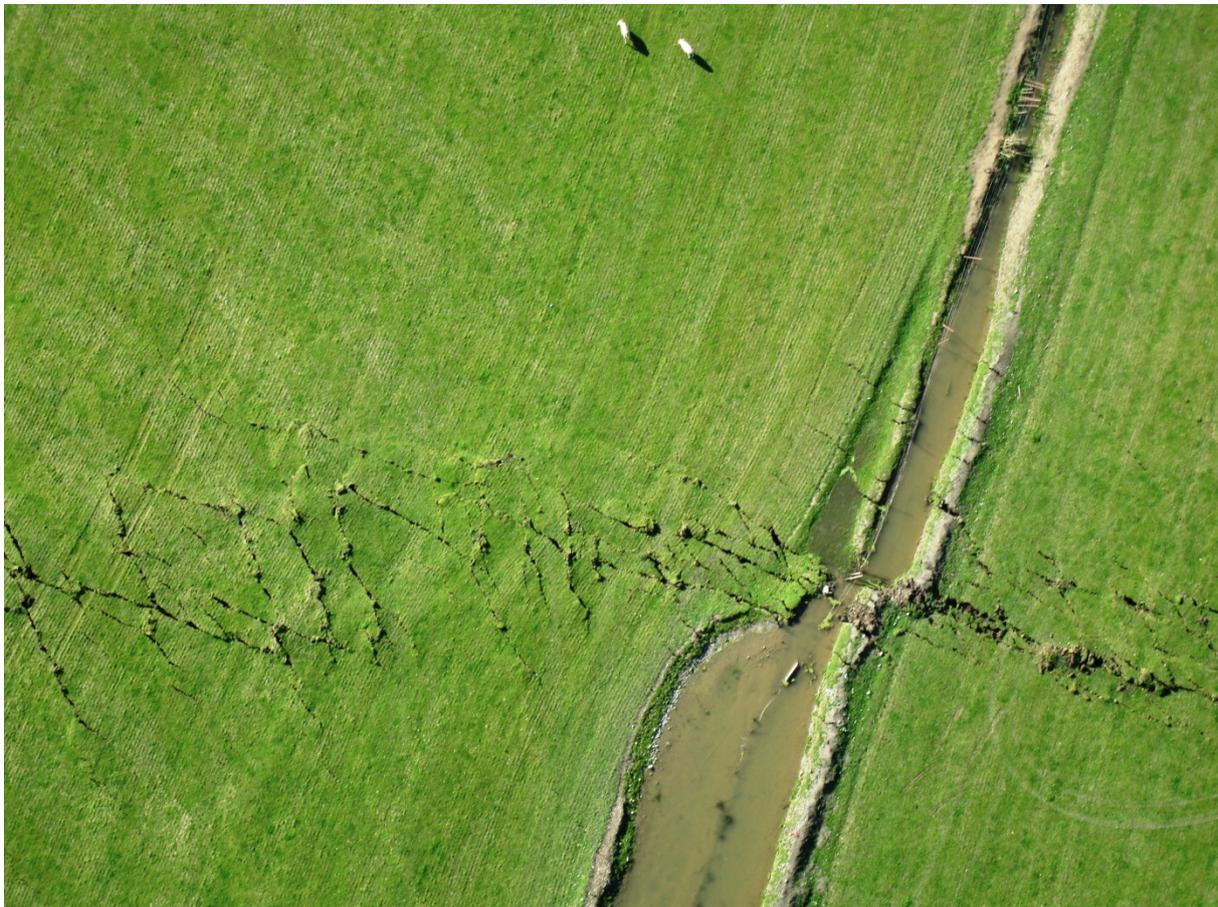
Figure 1. The surface trace of the Greendale Fault rupture cut across paddocks in the Canterbury Plains in September 2010. (Photo courtesy M. Quigley). The ground moved up to 5.3 m laterally, but was expressed at the surface as a zone of distributed deformation up to 300 m wide, seen in the network of shear structures (Quigley et al., 2012).

A fault rupture at the ground surface is one of the most dramatic signs of an earthquake (Figure 1). The ground can be displaced laterally on a strike slip fault, or vertically on a thrust or normal fault (Figure 2).

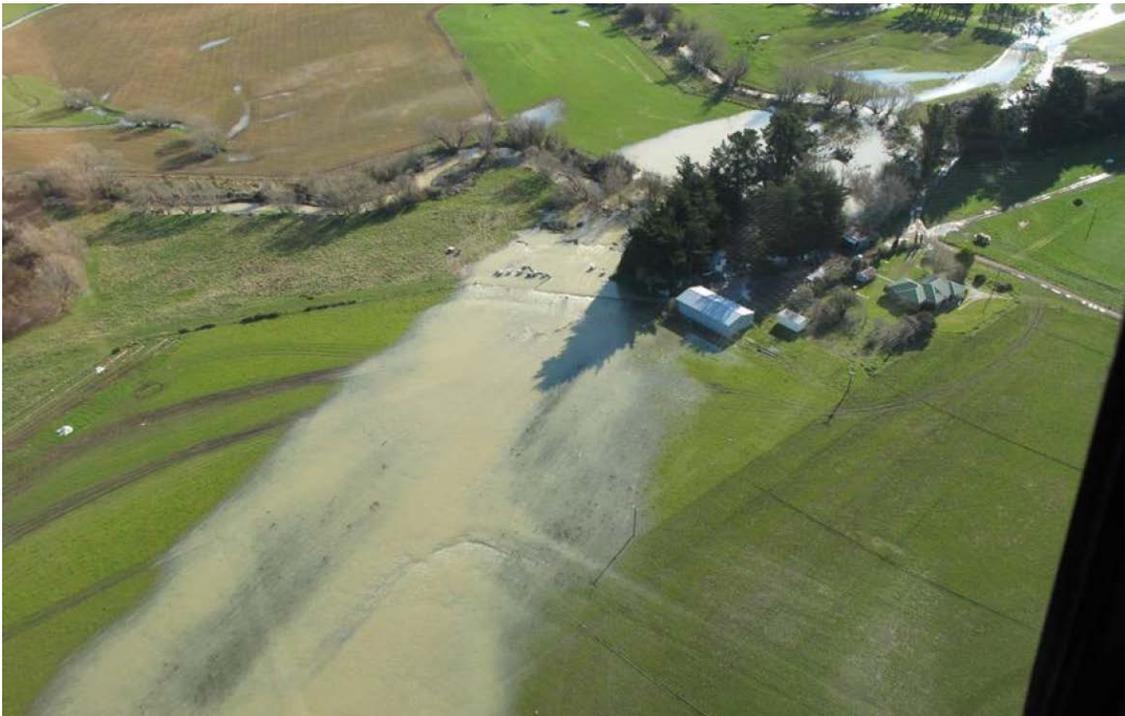
Figure 4. Avulsion of the Hororata River following fault movement during the September 2010 Darfield Earthquake (Photo courtesy D. Barrell, GNS Science).

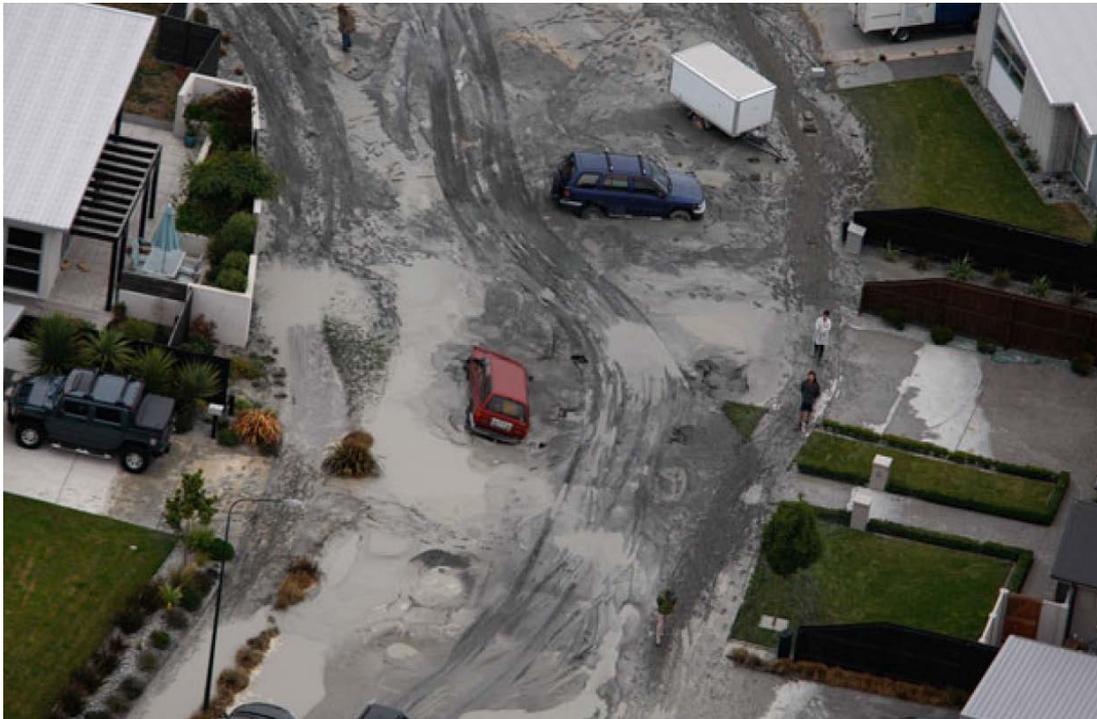
Figure 6. Liquefaction following the Christchurch 2011 Earthquake (Photo courtesy A. King, GNS Science)

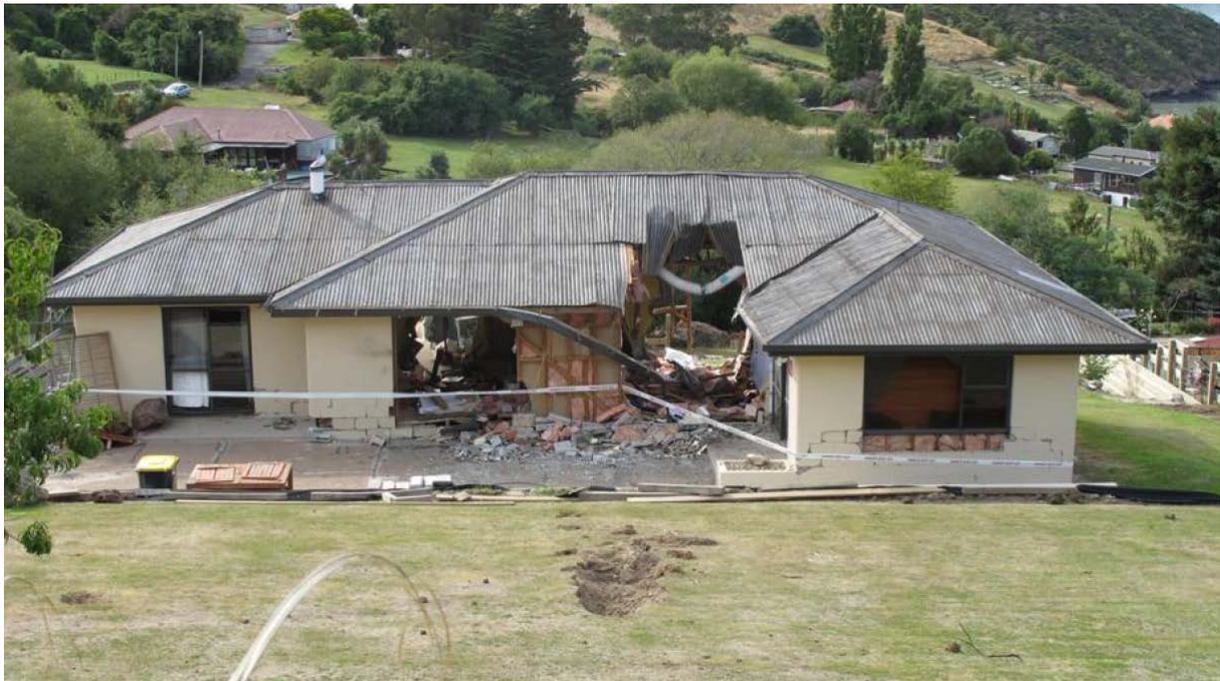
Figure 8. Rockfall damage to dwelling at Rapaki, Christchurch, during Feb 22nd 2011 earthquake. The gouge in the foreground is an impact divot from a boulder, which then impacted the house (Photo courtesy D. Barrell, GNS Science).

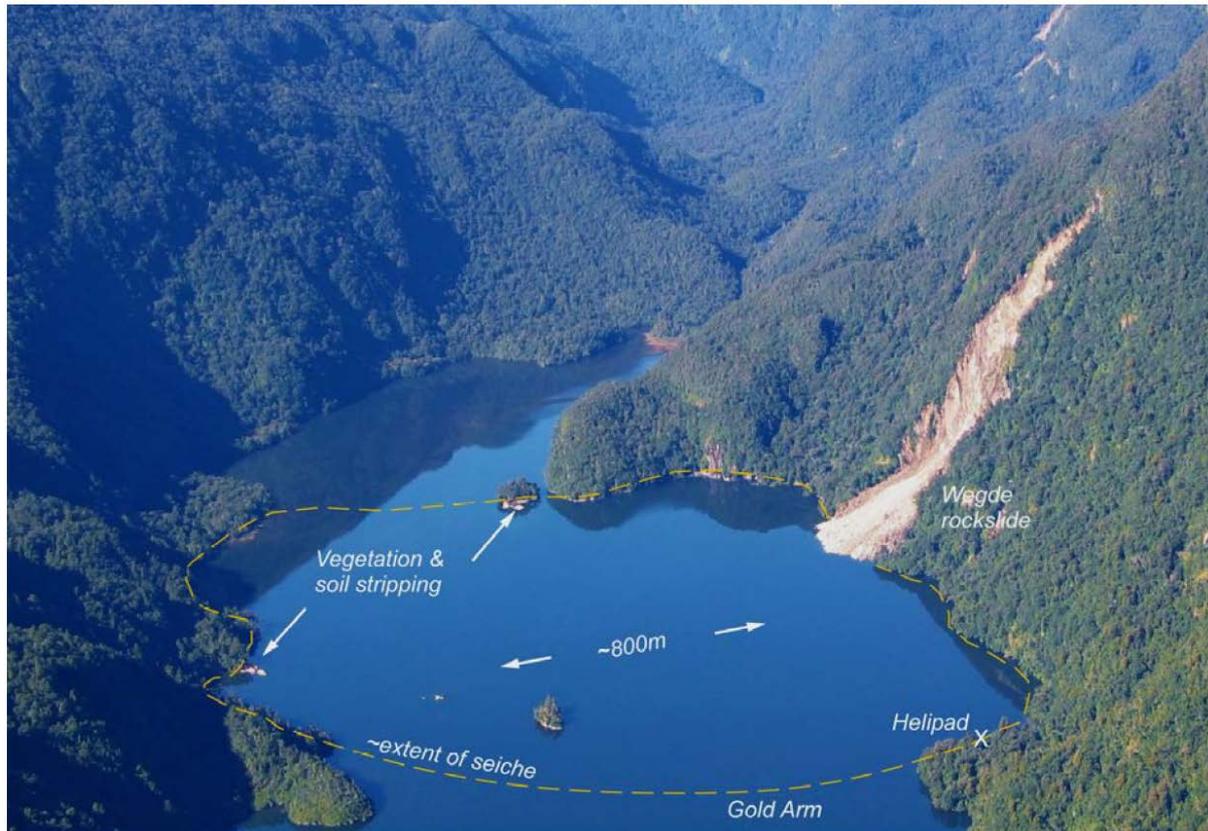
Figure 9. The 2003 Fiordland earthquake caused a 200,000 m³ rockslide into Charles Sound. The landslide caused a small tsunami which ran 4-5 m up the other side of the sound, approximately 800 m away. (Hancox et al., 2003).

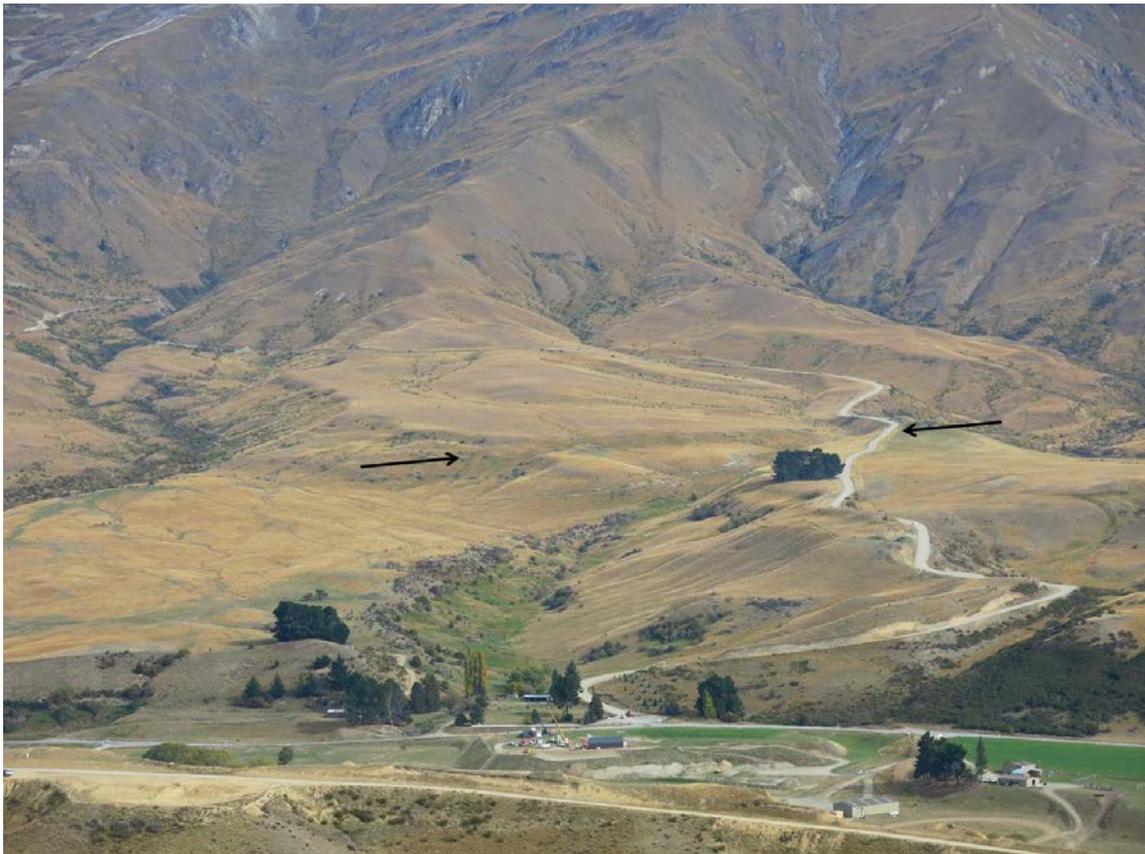
Figure 22. View towards the west across the Cardrona Valley. The Cardrona Skifield access road runs lower right to upper left across the ridge. A visible, active trace of the NW Cardrona Fault is highlighted between the two arrows (Photo April 2015).

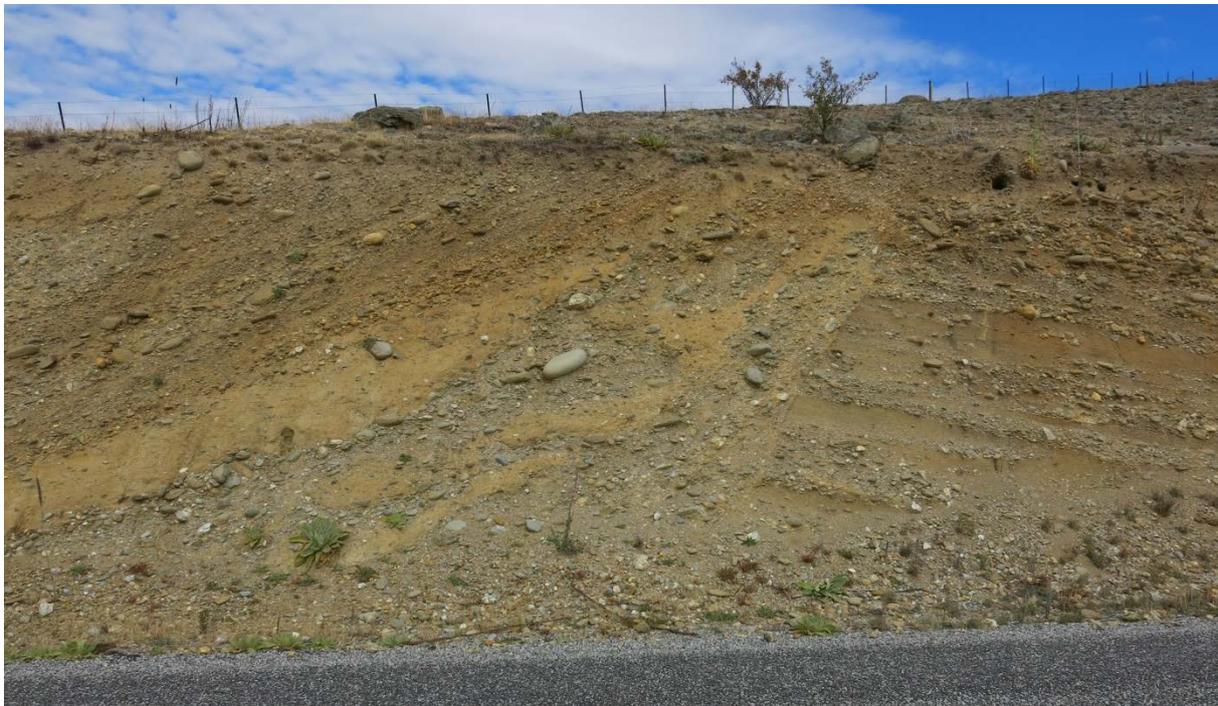
Figure 23. Road cut along Mt Pisa Road showing faulted alluvium and glacial till units along the Pisa Fault Zone. The gravels, assessed as outwash deposits, are associated with the Lindis glacial advance (~430,000 years old).

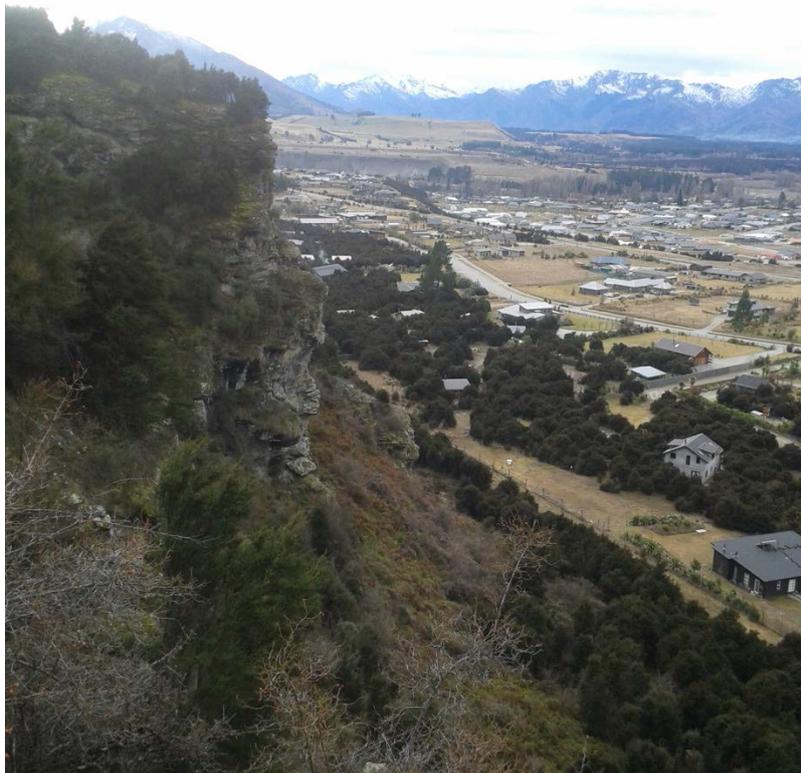
Figure 26. View of the east side of Mt Iron. Steep to subvertical schist cliffs on the eastern and southern sides of the hill provide source areas for rockfall boulders to roll downslope (July 2015).

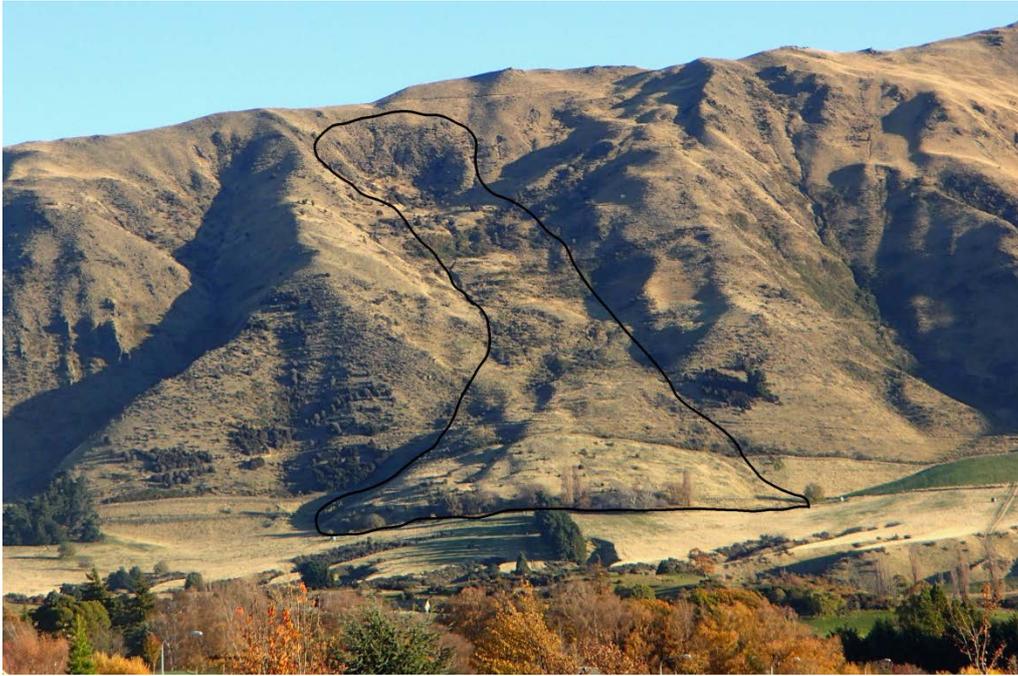
Figure 27. Rock avalanche deposit south of Wanaka township (Photo courtesy of G. Halliday). Approximate extent of rock avalanche outlined in black.

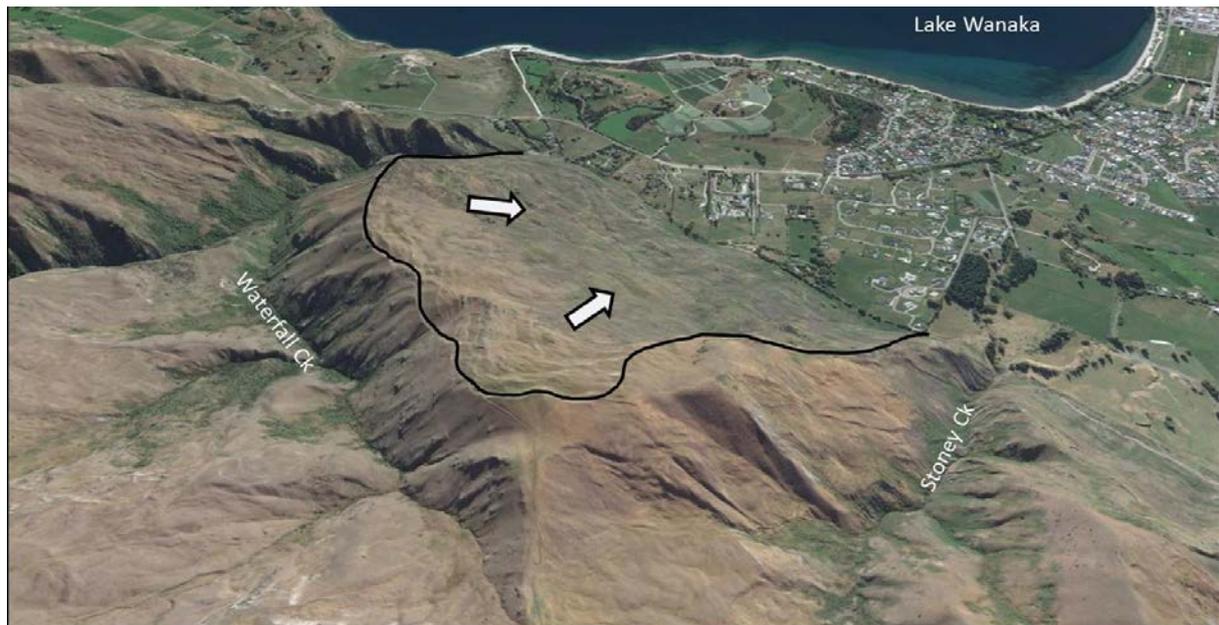
Figure 28. Oblique view towards the north, with downtown Wanaka visible in top right of image. A large deep-seated schist landslide south of Wanaka is outlined in black. Ridgeline relaxation can be seen at the top of the landslide.

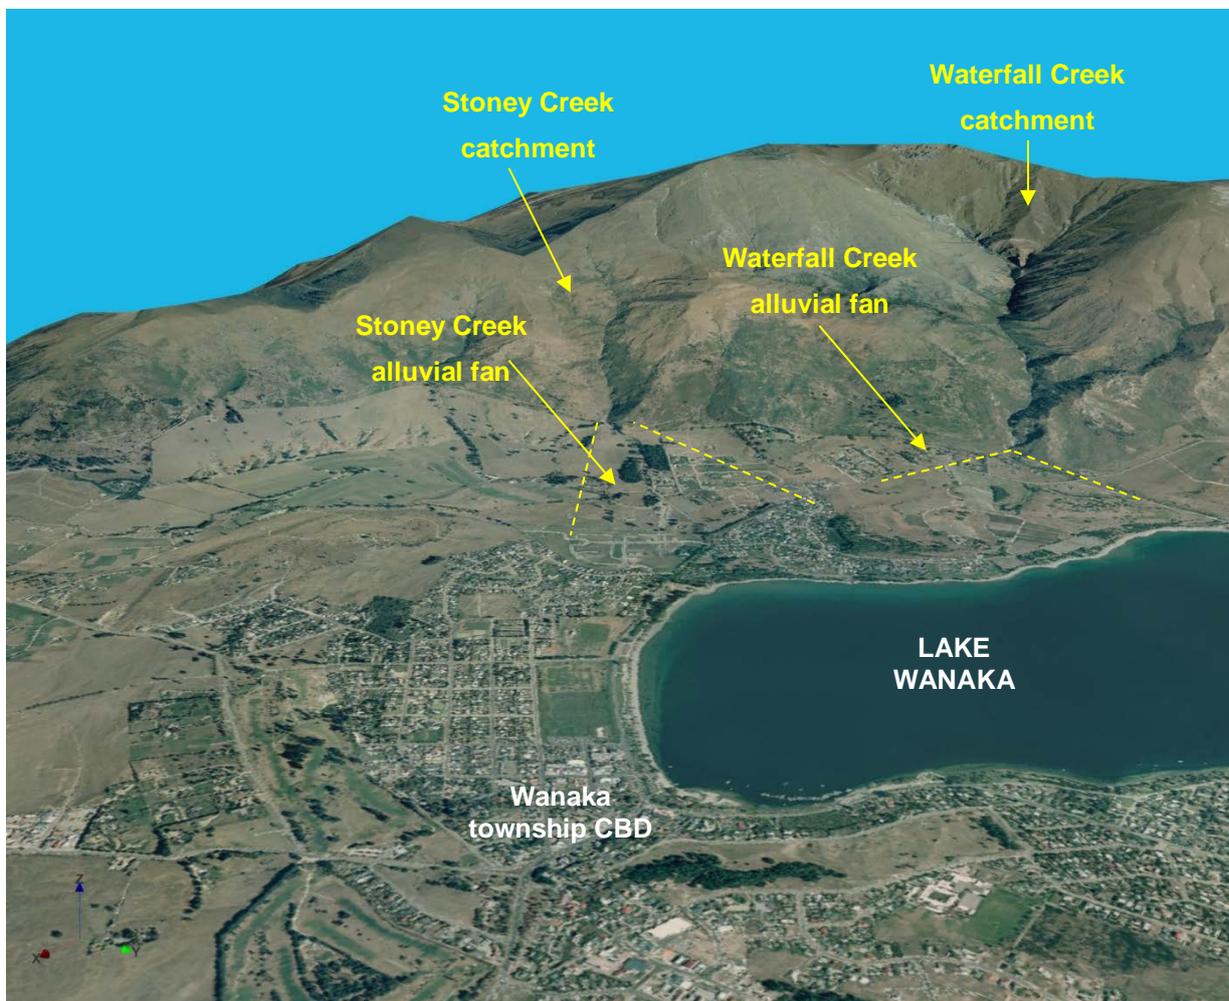
Figure 29. Oblique view towards south of Stoney Creek and Waterfall Creek Catchments, and their associated alluvial fans in southern Wanaka (Modified from Woods, 2011)

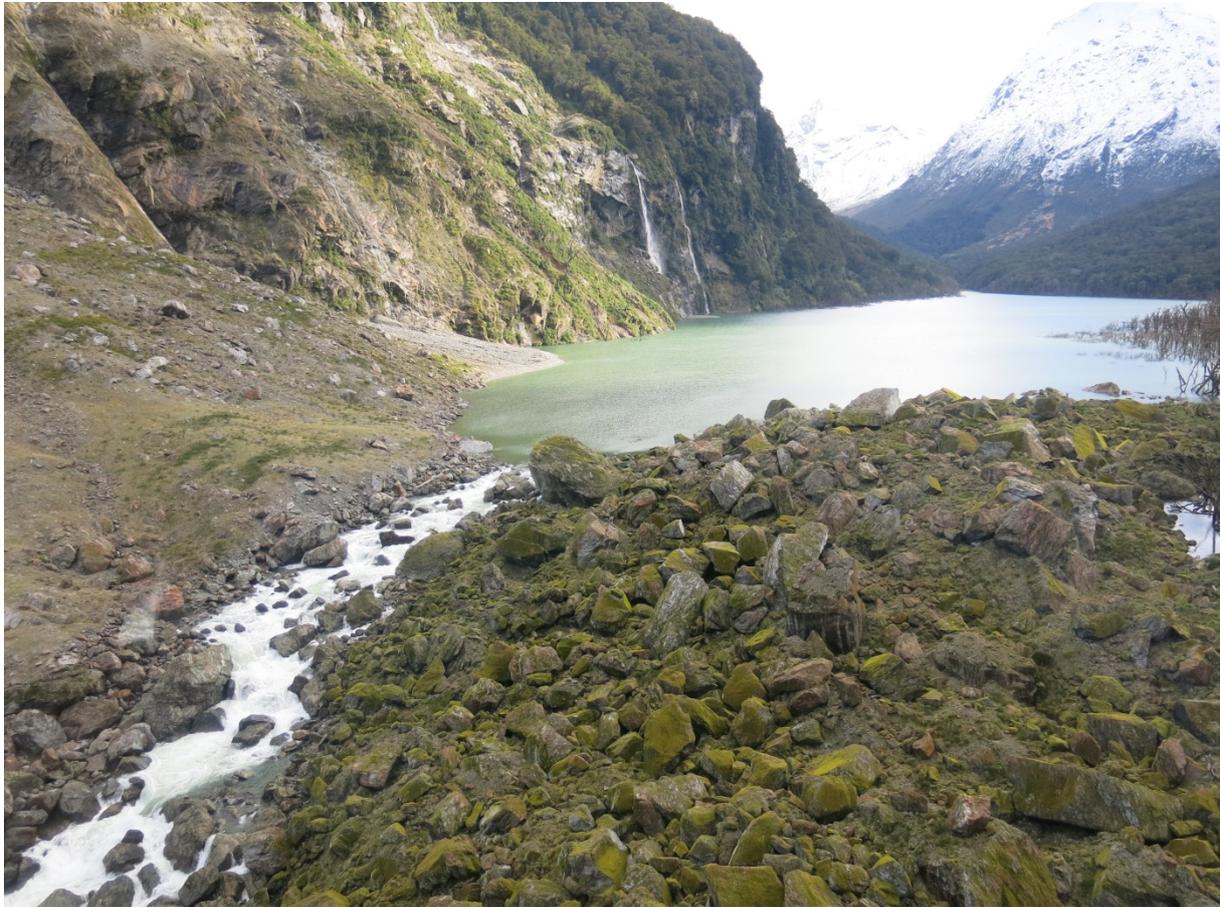
Figure 31. View of the Young River Landslide Dam. A landslide in August 2007 dammed the Young River to a height of 70m, and formed a ~1.5 km long lake. (May 2015)

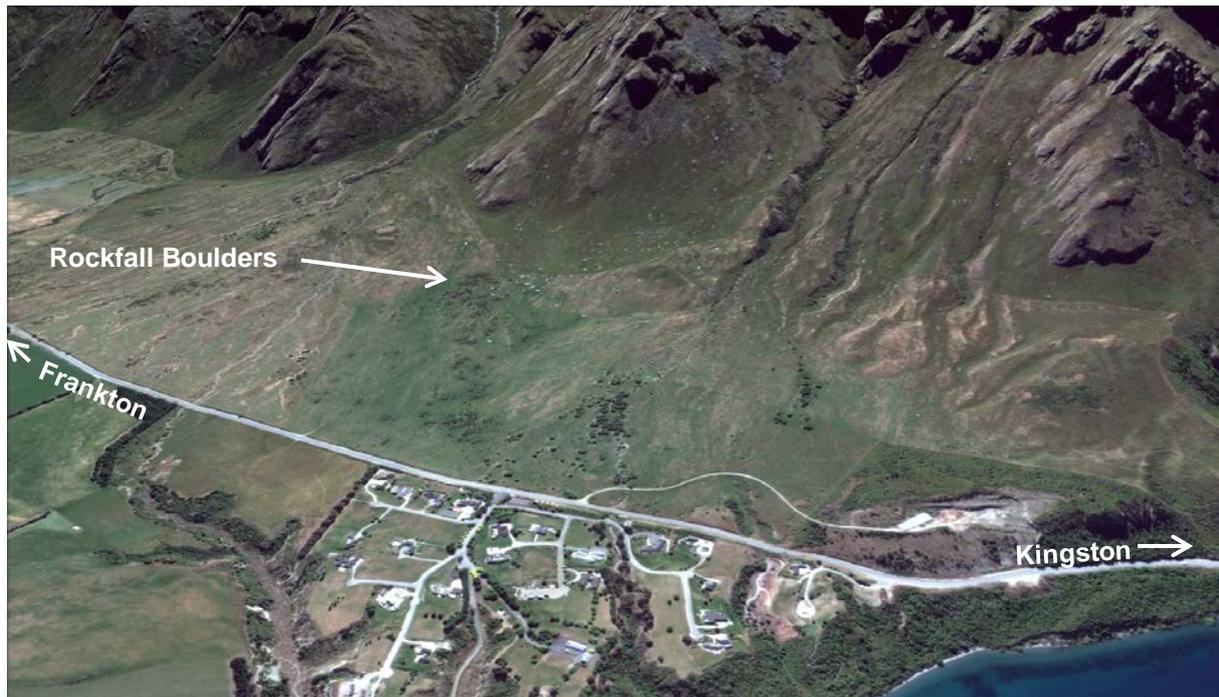
Figure 42. Oblique view towards the foothills of the southern Remarkables Range. SH6 runs across the lower view, with Lake Wakatipu lower right. Large boulders, likely from a rockfall, can be seen on the slopes below the rocky cliffs in the middle of the view (white dots). Active alluvial fans drain the catchments (view from Google Earth).

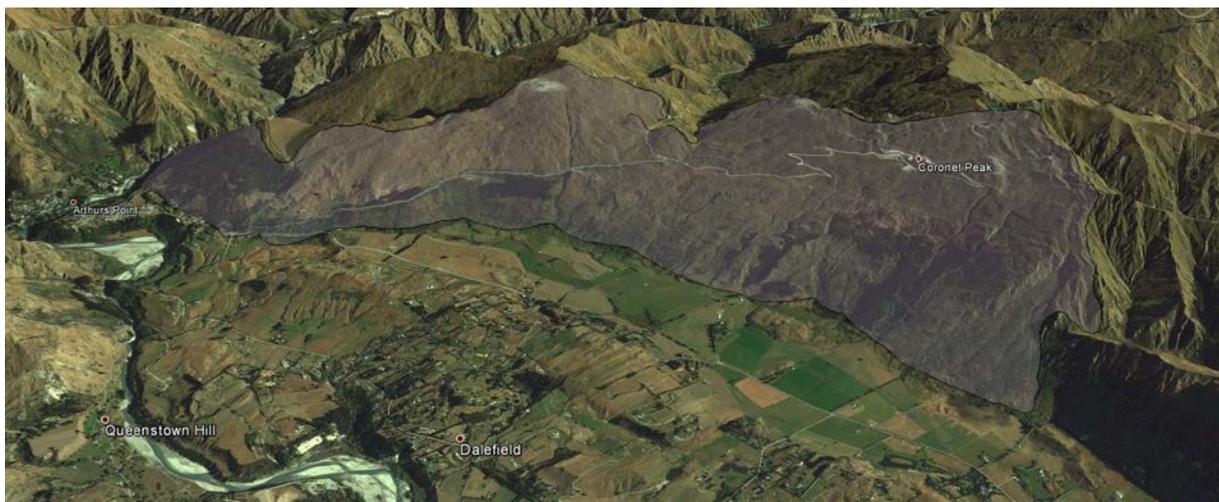
Figure 43. Oblique view showing outline of the Coronet Peak landslide, a large deep-seated schist landslide. The Shotover River runs along the left side of the image. (Google Earth).

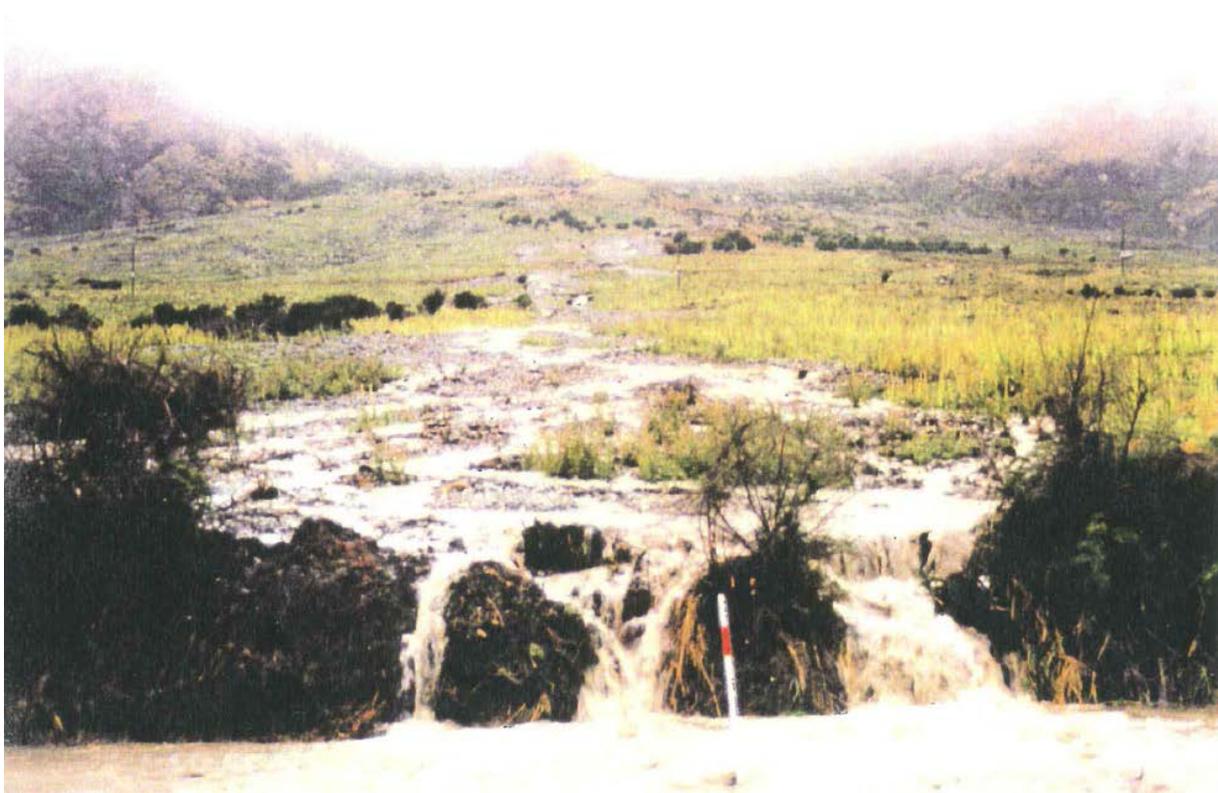
Figure 44. Active alluvial fan and debris deposition in February 1994 as seen from SH6 looking towards the Remarkables. Gravel was deposited across SH6. These fans have potential to become more active if the headwaters are inundated with sediment following an earthquake. Photo from Cunningham (1994).

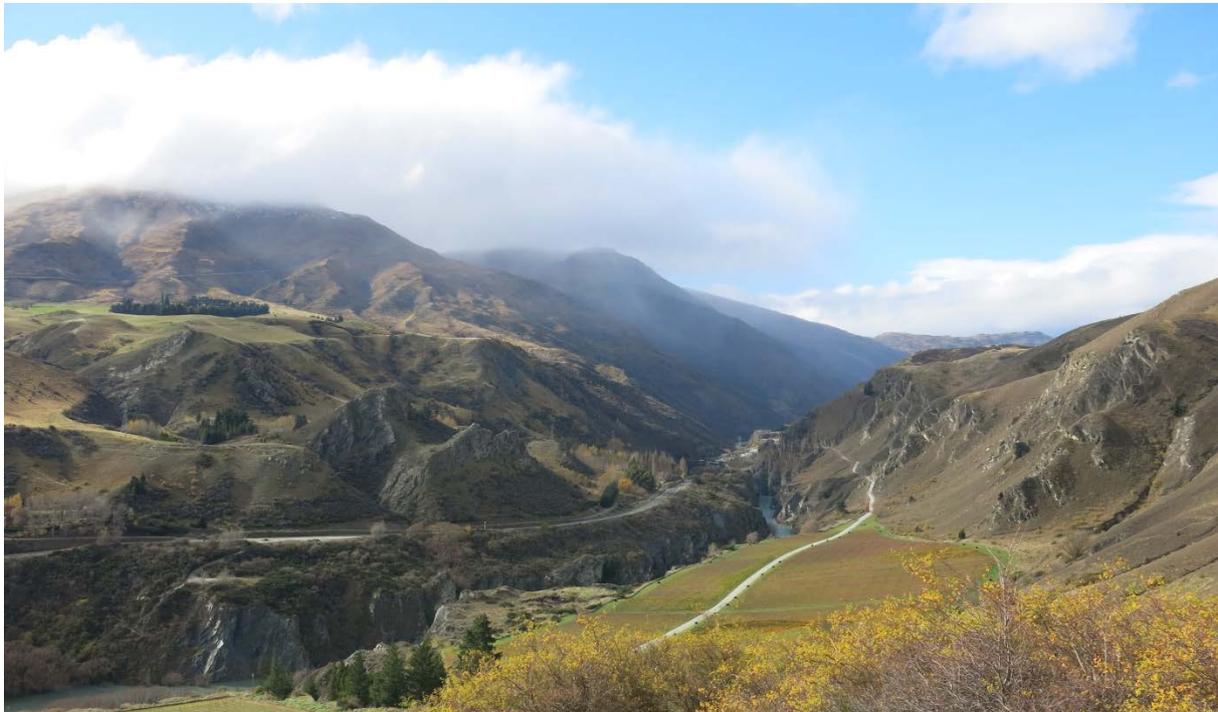
Figure 46. View down the Kawarau Gorge from Chard Farm Winery. The deep narrow gorge along this section of the river, which drains the Wakatipu Basin, has the potential to be blocked by a large landslide from the side slopes. (May 2015)
