# Natural Hazards on the Clutha Delta, Otago

May 2016

## Executive summary

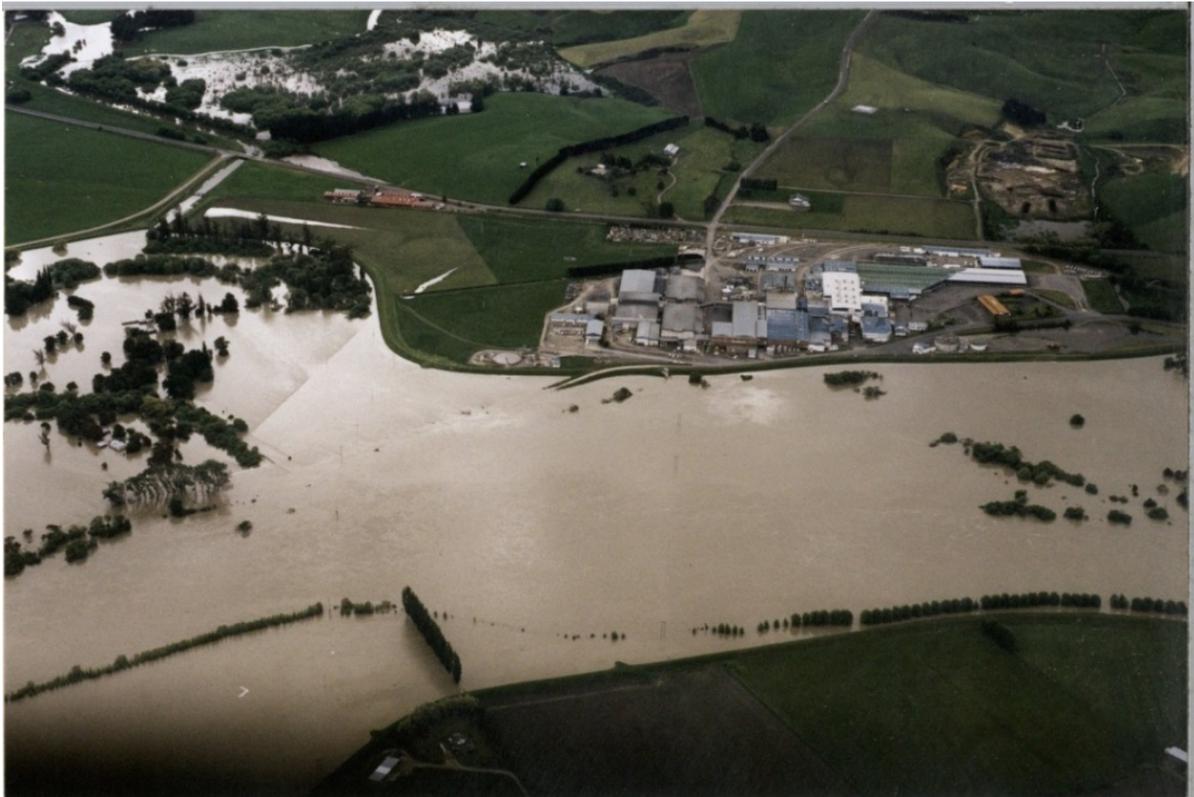
**Figure 2.6** Silver Fern Farms Finegand Plant located on the true right bank of the Koau Branch, during the November 1999 flood event (see Figure 2.4 for location).

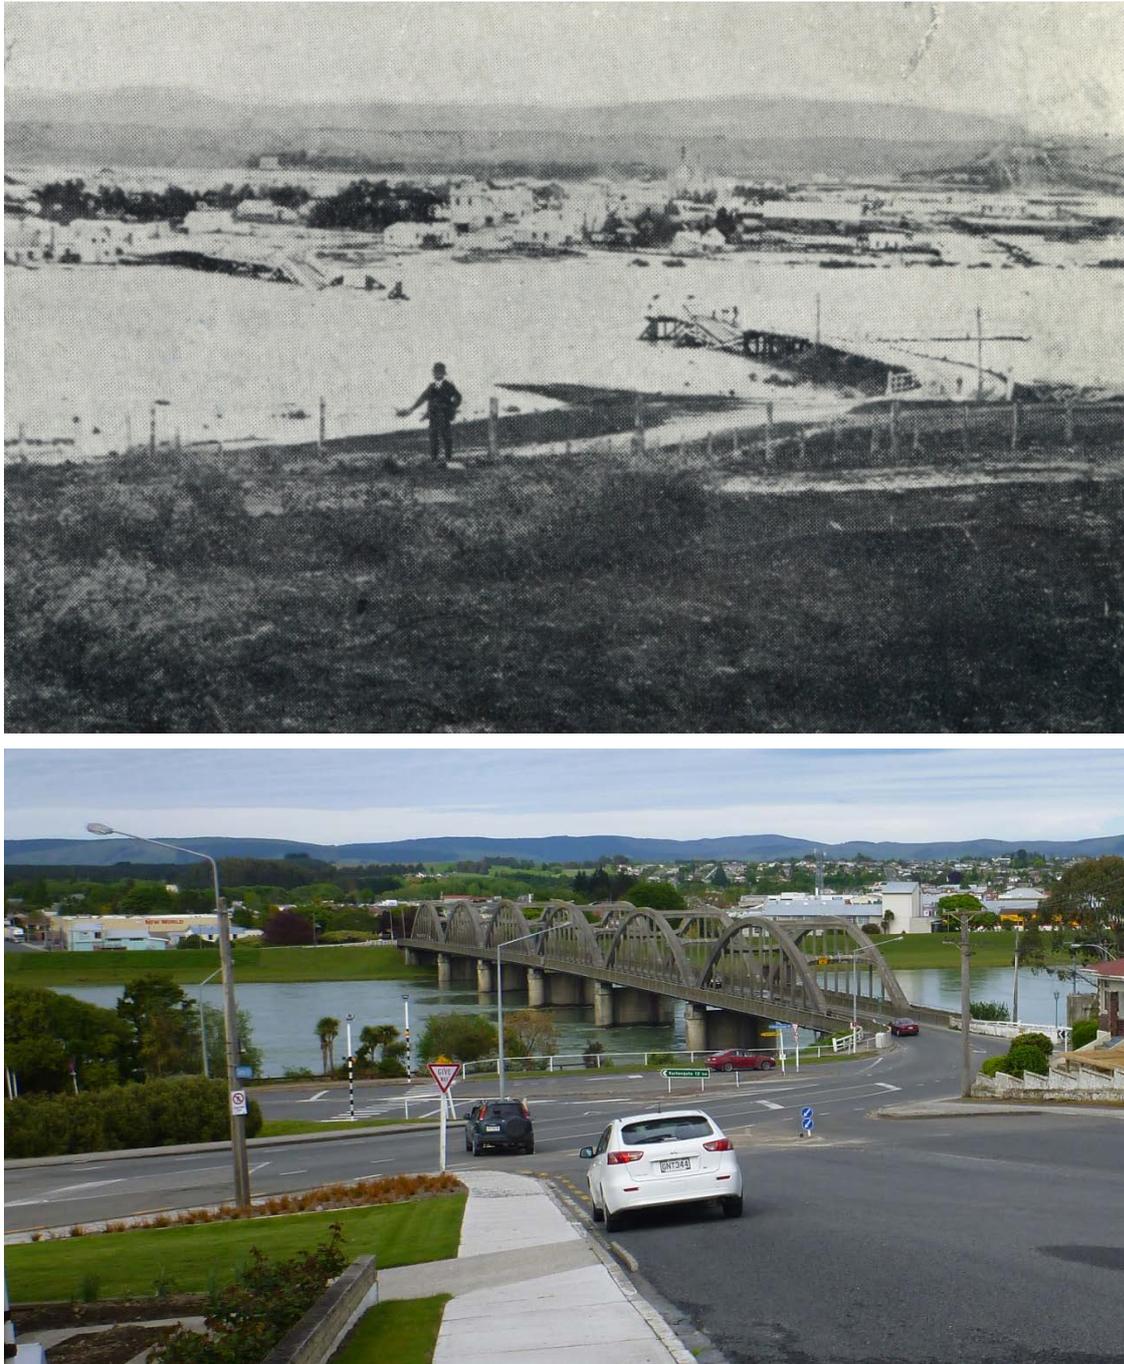
**Figure 2.7** Top: Balclutha Bridge following the October 1878 flood event. The largely wooden bridge structure was washed away on 14<sup>th</sup> October 1878 and was not rebuilt until 1881. Bottom: The modern SH1 bridge in approximately the same location, during moderately high summer flows (2014).

State Highway 1 (SH1) connects Dunedin City with Invercargill City and the smaller communities between, and passes through the town centre of Balclutha (Figure 2.5). Traffic volumes on the SH1 Balclutha Bridge (the main route across the Clutha River) average 11,820 vehicles per day, significantly reducing to 4,630 vehicles per day north and 3,280 vehicles per day to the south (NZTA, 2016). The larger traffic volumes around Balclutha reflect the urban characteristic of this township. The original Balclutha Bridge was opened in 1868 and was subsequently washed away in the flood of 1878 (Figure 2.7).

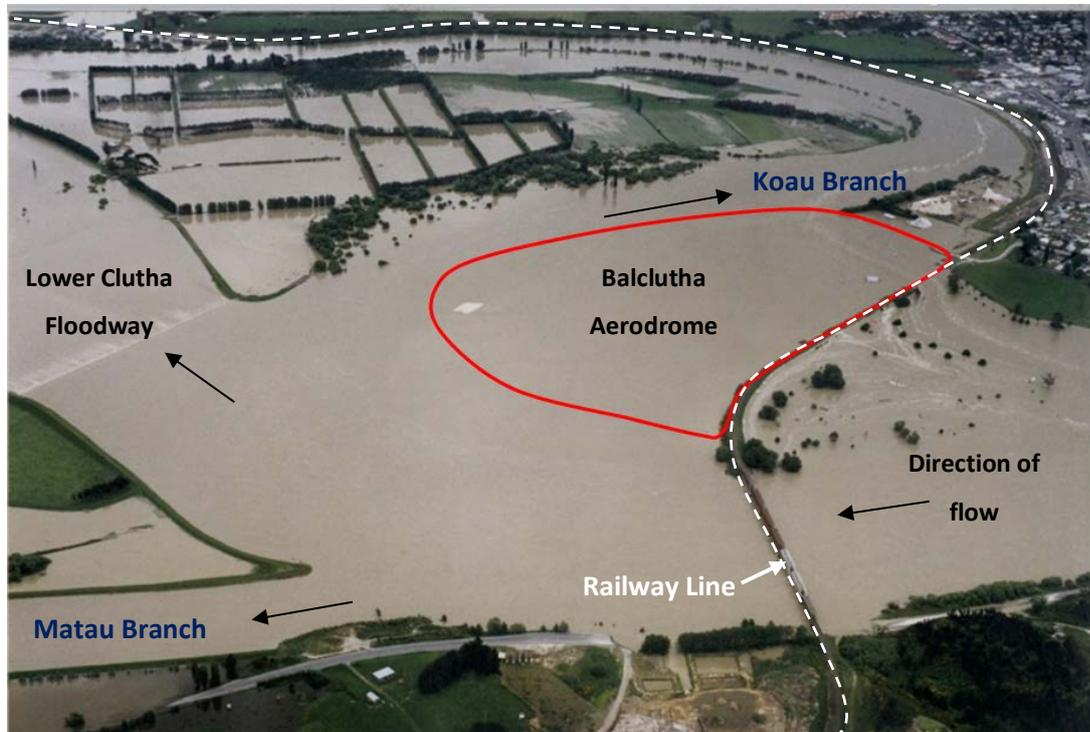
**Figure 2.8** South Island Main Trunk Railway (highlighted with white dashed line), during the November 1999 flood on the lower Clutha Delta. The Balclutha Aerodrome is completely underwater (approximate location outlined in red).

Silver Fern Farms Meat Processing Plant with direct access to the railway network. The railway is generally built on an embankment elevated above the surrounding delta, but can be overtopped by floodwater at several locations (Figure 2.8).

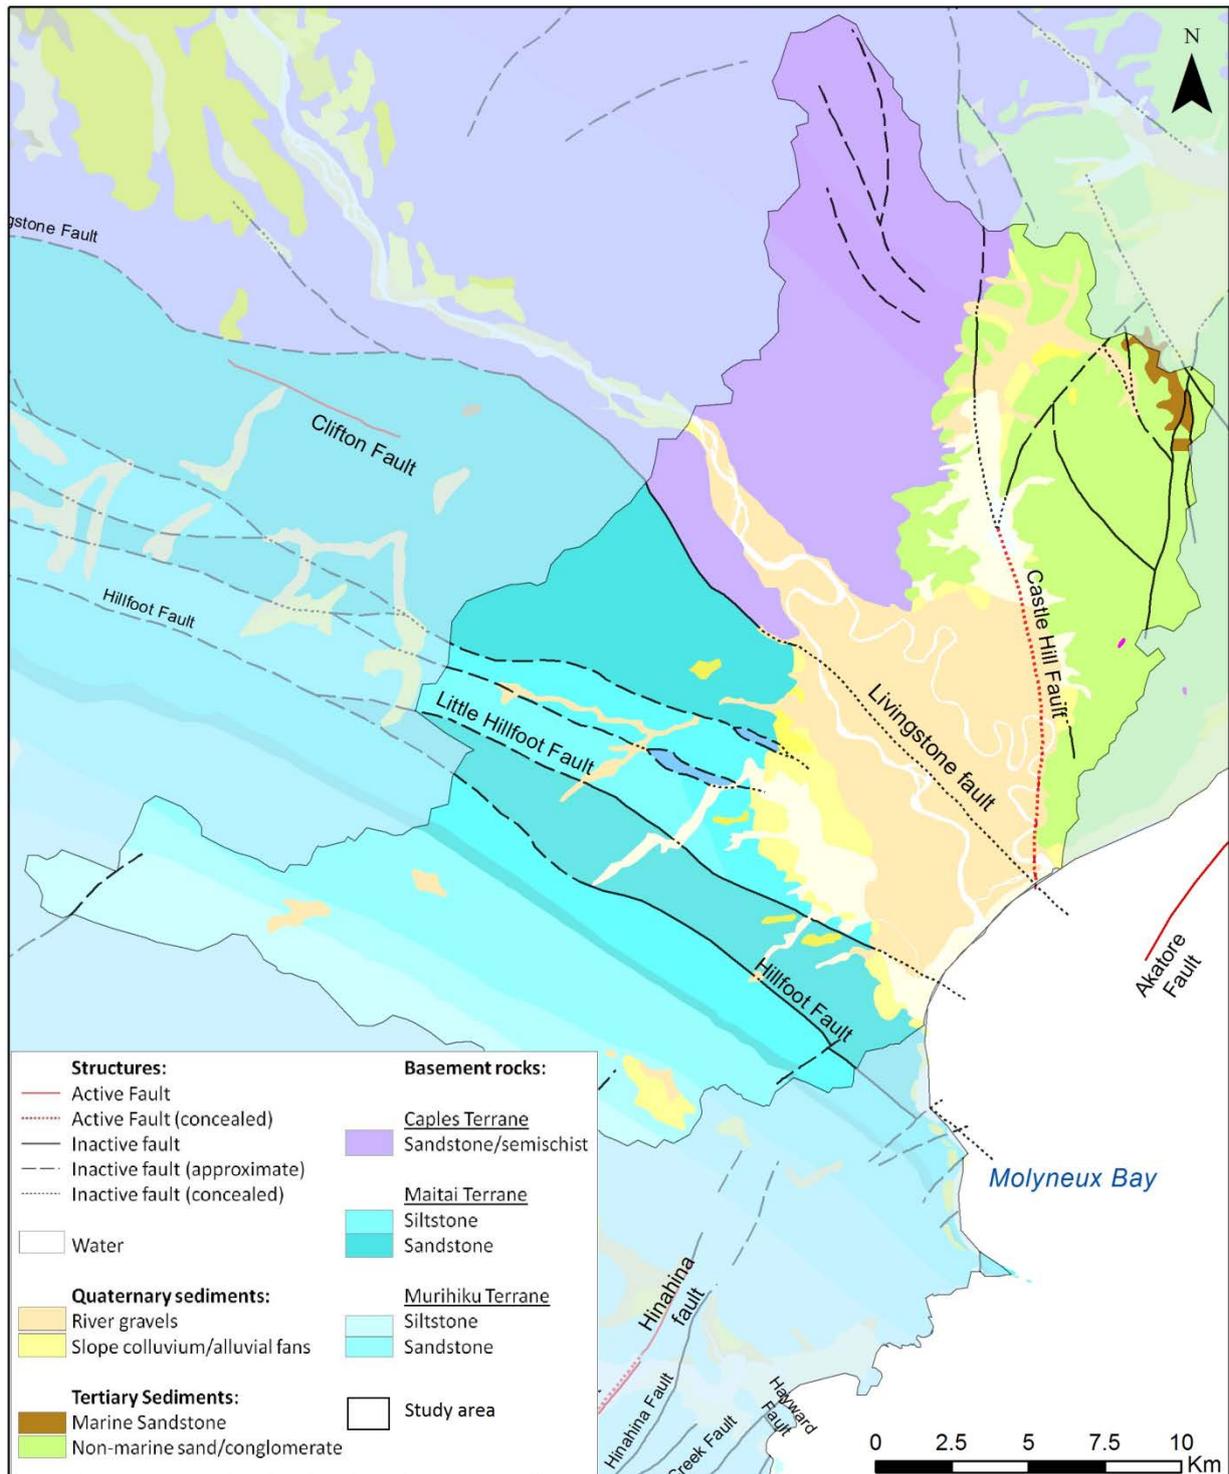
Figure 3.1 Geology of Lower Clutha Catchment (Adapted from Bishop & Turnbull, 1996).

The Clutha Delta sits astride the Livingstone Fault which marks the boundary between the ancient basement rocks of the Caples and Maitai Terranes. These formations of folded and altered sandstones and siltstones outcrop to the northwest of the Clutha Delta (Irricon, 1998; Tonkin and Taylor, 2005) (Figure 3.1). To the east in the Kaitangata district, younger Tertiary-age sediments of both marine and terrestrial origin overly the Caples terrane and these host several large, high quality coal seams. These younger rocks are uplifted relative to the Clutha Delta by the active Castle Hill Fault and associated tectonic activity in the seaward range. In the south and southwest of the Clutha Delta catchment an enormous fold in the ancient rocks of the Murihiku Terrane<sup>1</sup>, known as the Southland Syncline, marks the south eastern boundary of the study catchment. Alternating layers of harder sandstone and softer mudstone have been eroded to form long, parallel strike ridges (Figure 3.1) (Bishop and Turnbull, 1996; Irricon 1998; Turnbull & Allibone, 2003).

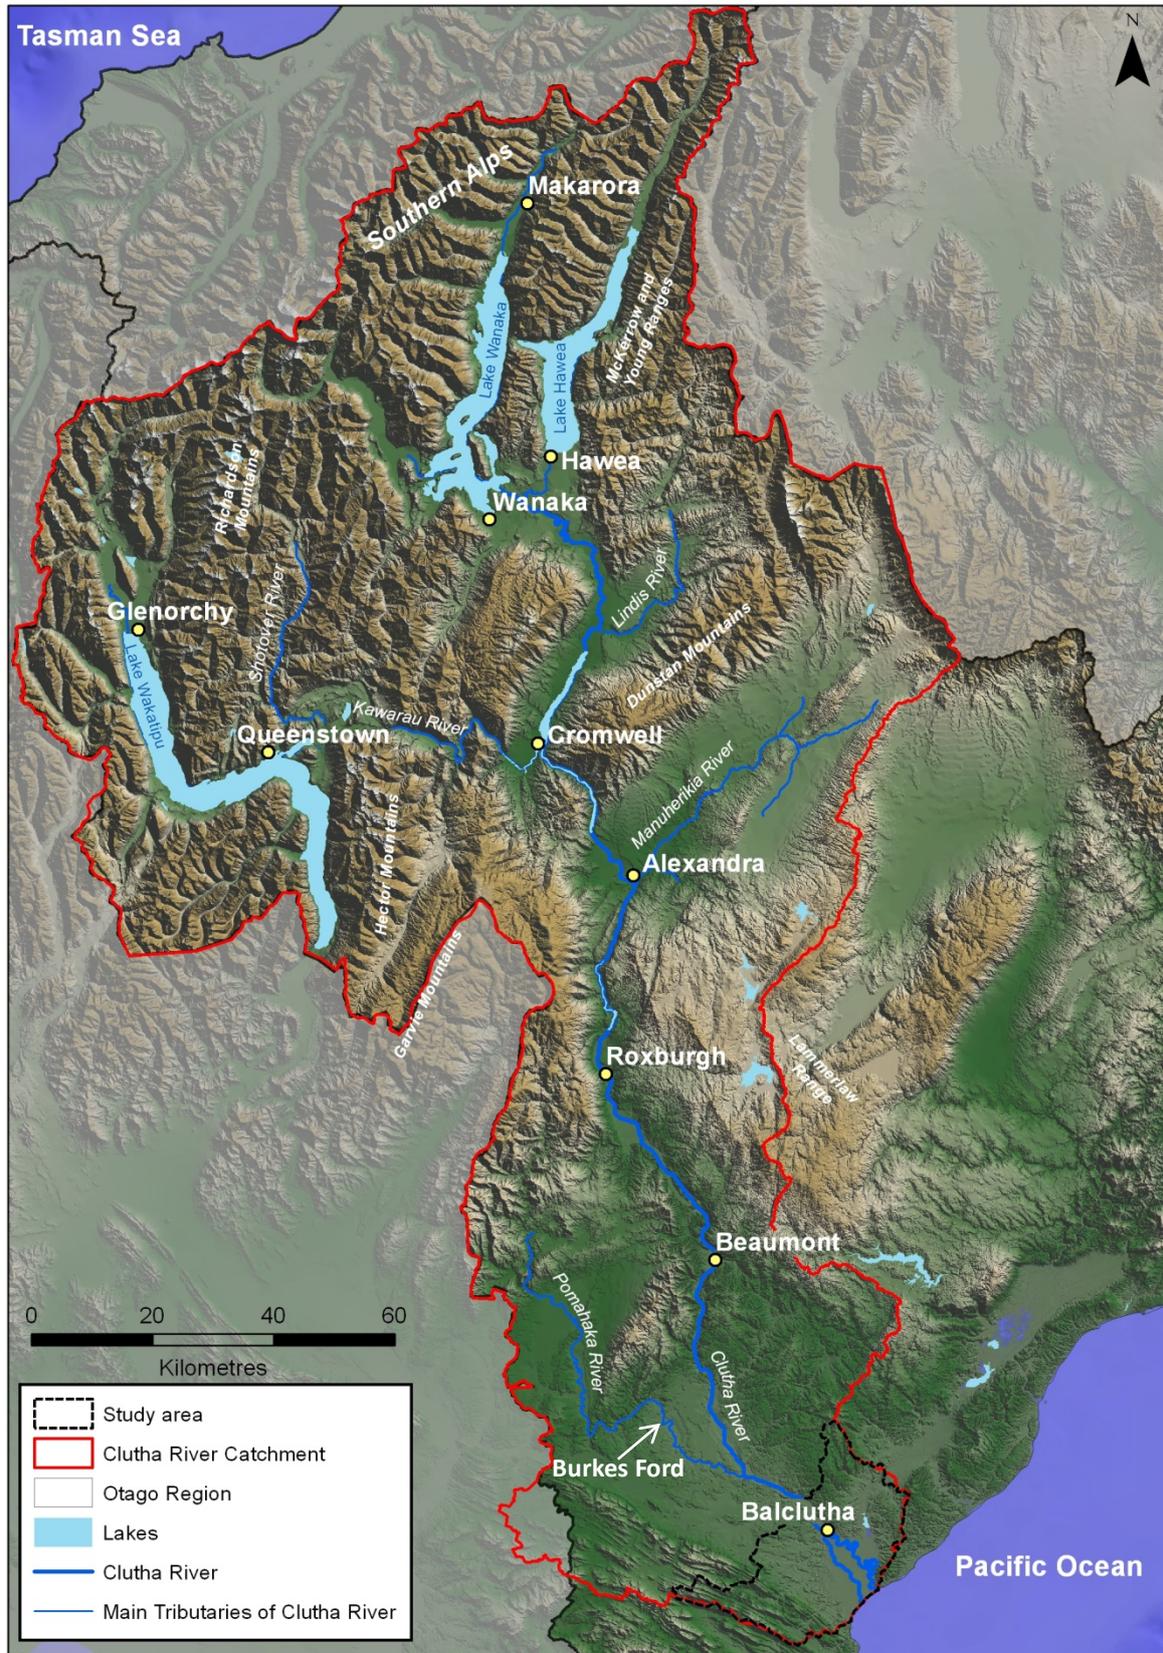
Figure 3.2 Topography of the Clutha River catchment.

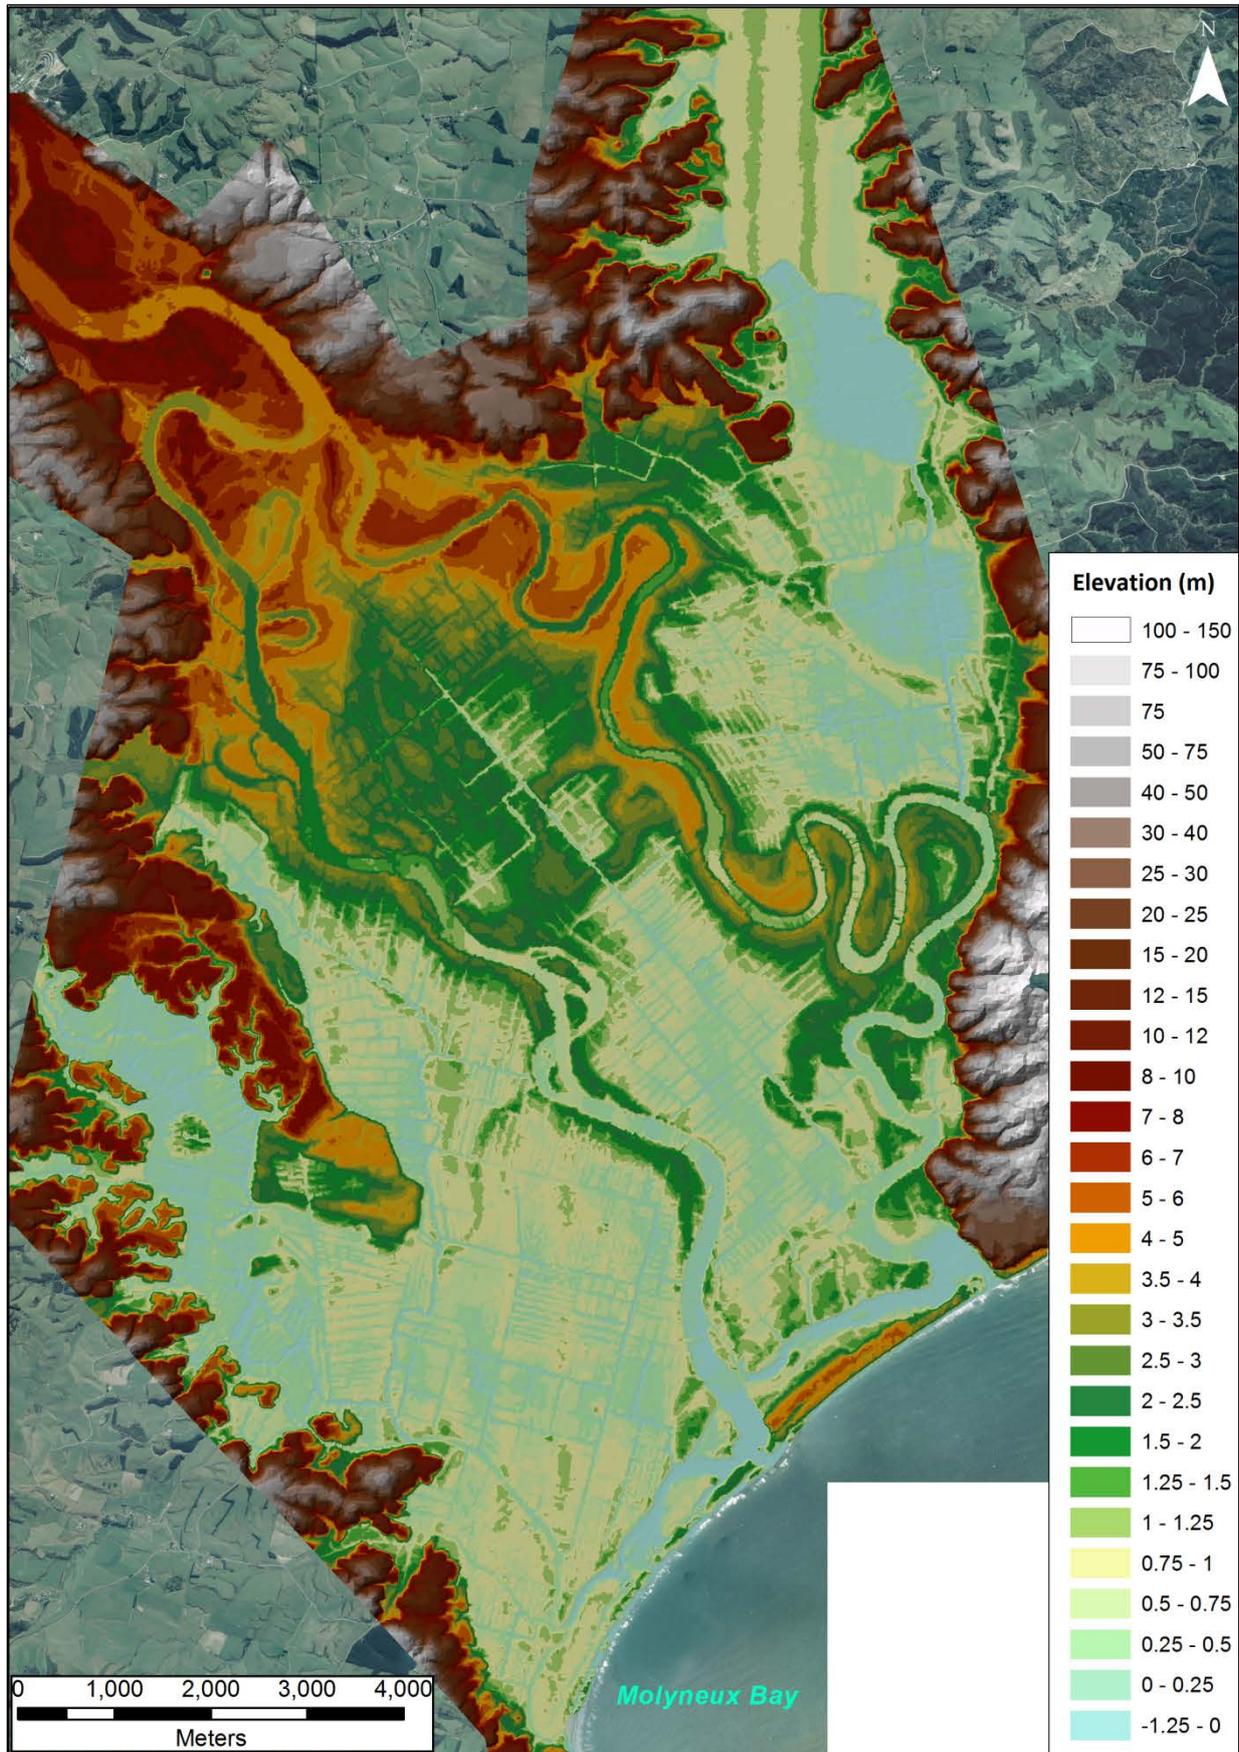
Figure 3.3 Elevation of the Clutha Delta. Land elevation is in metres, relative to msl.

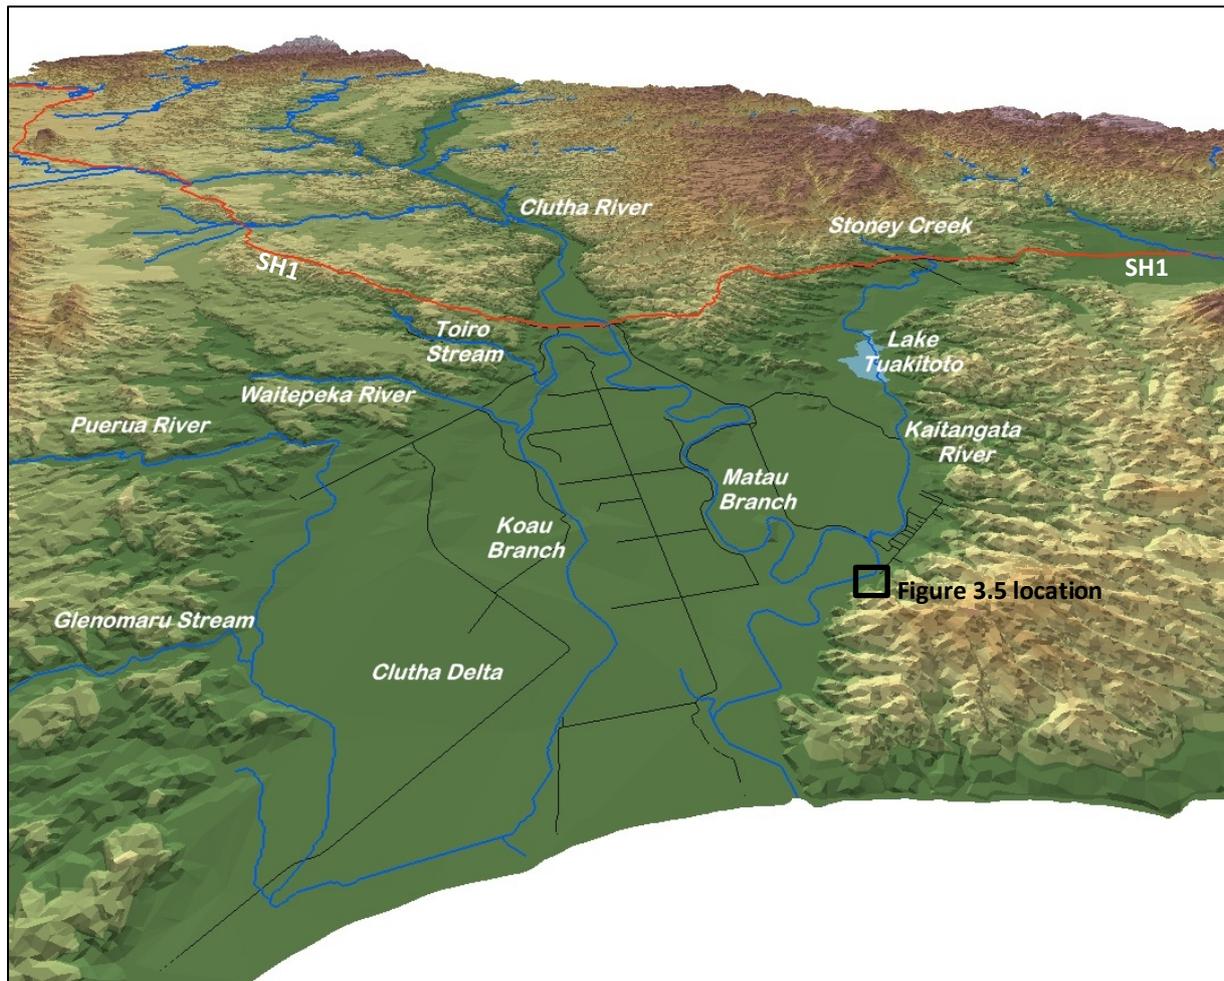
**Figure 3.4** Digital Elevation Model (DEM) of the Lower Clutha and Delta. View towards northwest, with 3 times vertical exaggeration.

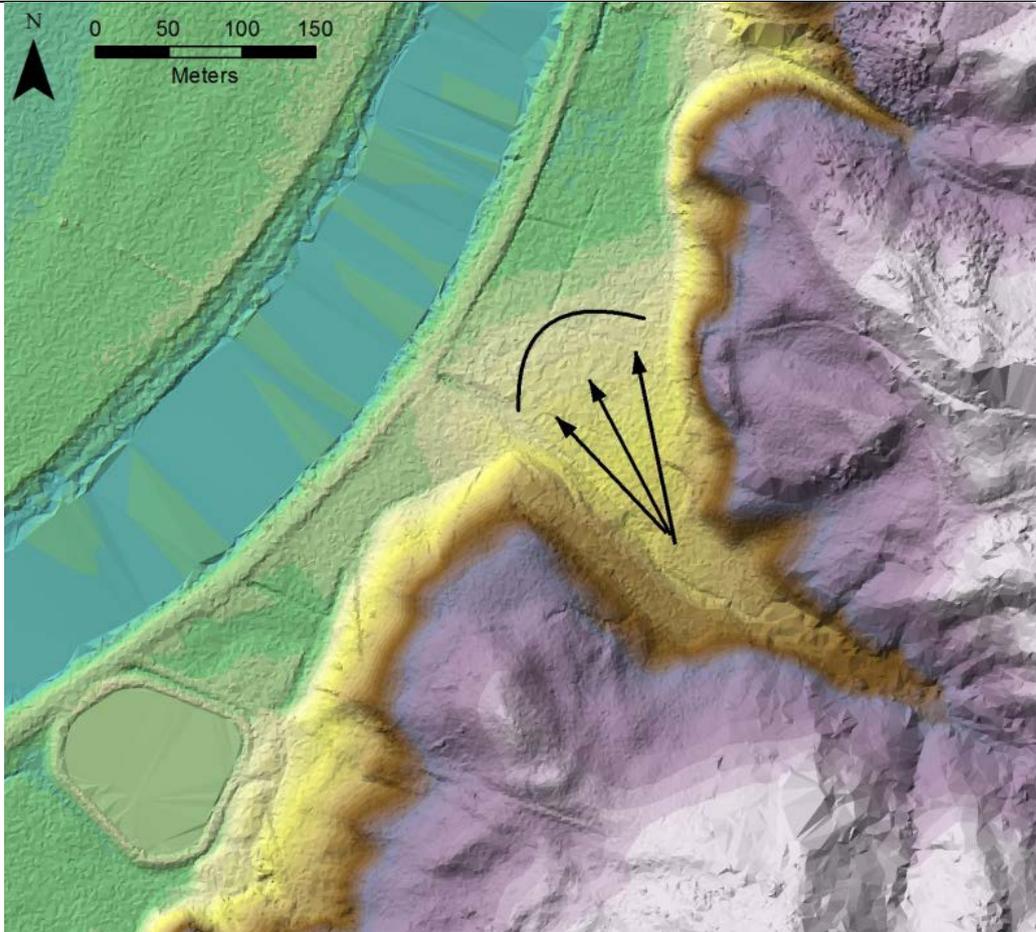
**Figure 3.5** Looking south east across the upper reaches of an alluvial fan near Kaitangata. LiDAR of the area shows a distinct fan shape as the flows of the ephemeral stream exit the confines of the gully.

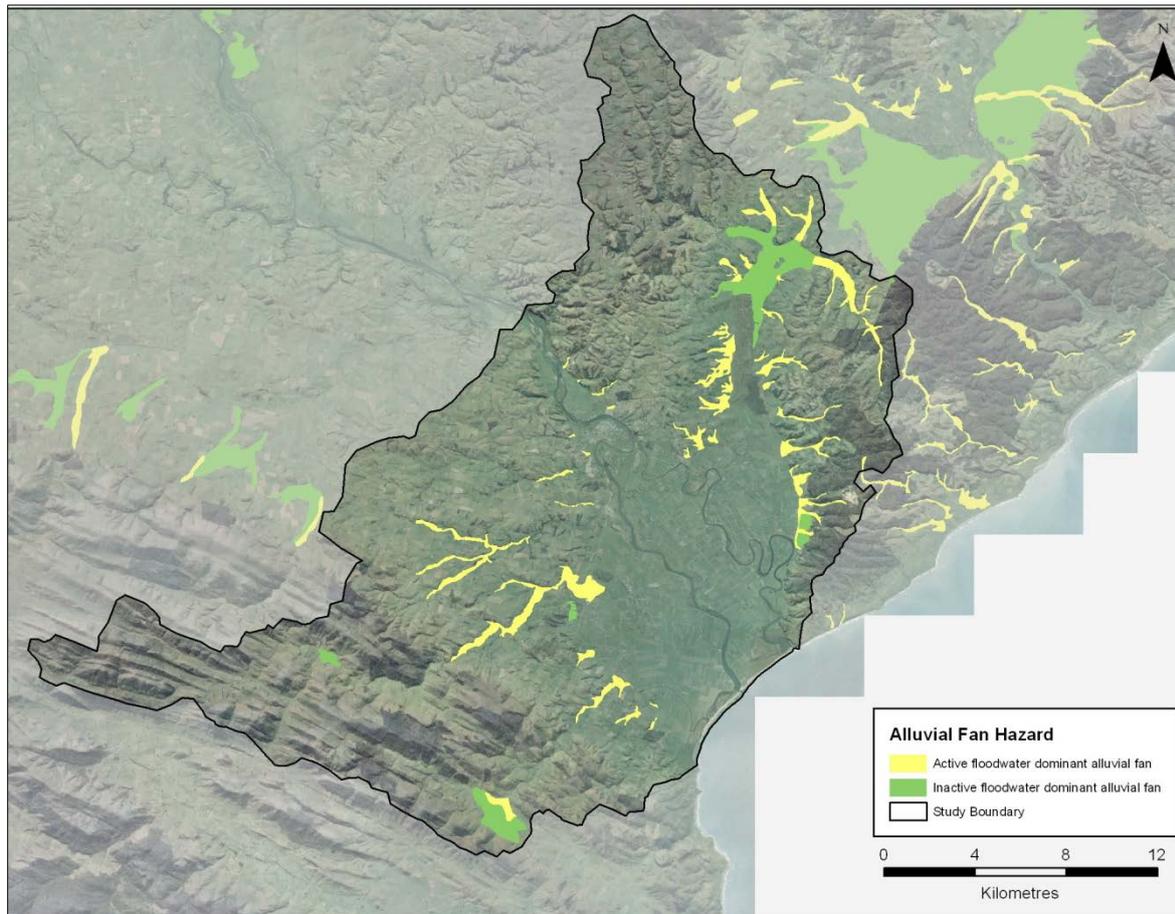
Figure 3.6 Alluvial-fan deposits greater than 0.5km<sup>2</sup> in and around the Clutha Delta (Opus 2009).

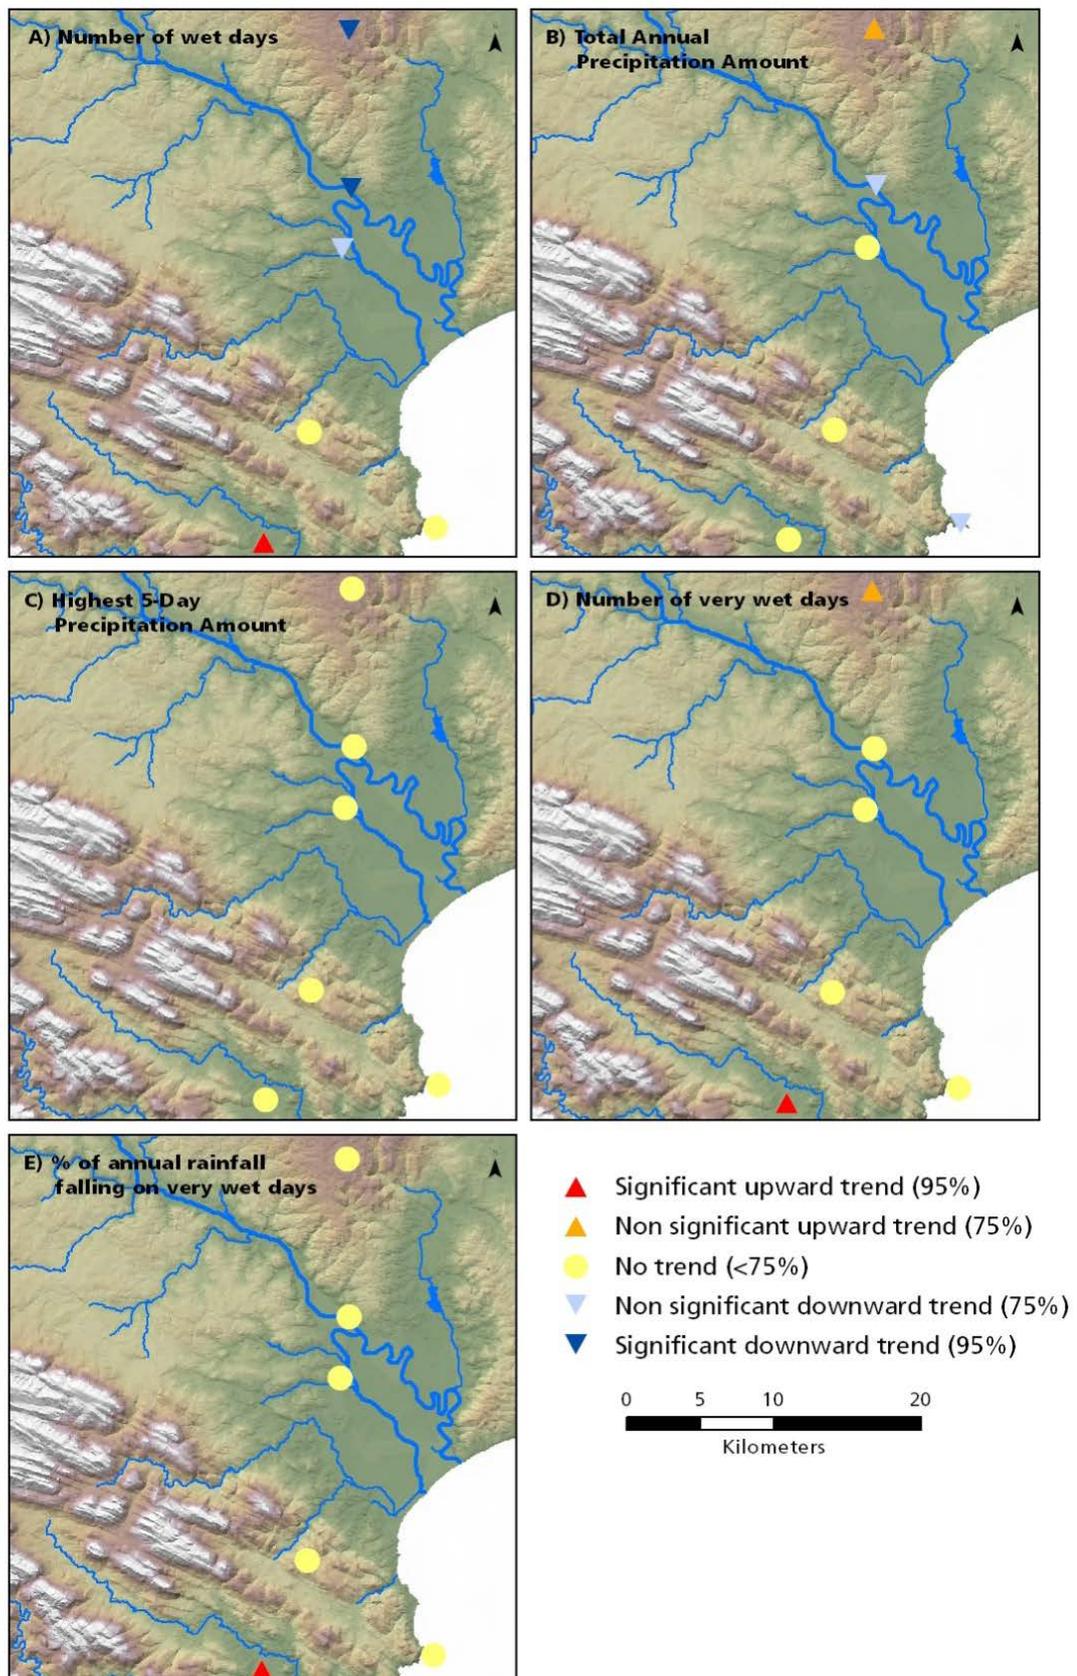
**Figure 3.8** Spatial variability of extreme precipitation trends on the Clutha Delta and surrounding hills. The trends shown are for the full length of record, until the end of 2012. See Figure 3.7 for rainfall station names.

Figure 3.8 gives an updated analysis of precipitation extremes for the full length of continuous record up to December 2012 at stations within the Lower Clutha Delta catchment. The figure shows changes over time (since records began) for the following parameters: (a) the highest 5-day precipitation amount (b) total annual precipitation (c) the number of wet days<sup>7</sup> (d) the average intensity of rainfall (e) the number of very wet days and (f) the percentage of annual rainfall falling on very wet days.

Figure 3.8 shows that only one of the six trends investigated shows a statistically significant trend. This was demonstrated at the Balclutha and Lovells Creek (at Hillend Road) rainfall stations where a significant downward trend in the number of wet days was observed. There were no other statistically significant trends observed in the Lower Clutha Delta Catchment.<sup>8</sup> A significant upward trend in the number of wet days, very wet days and percentage of annual rainfall falling on very wet days was observed in Owaka, however this rainfall station is located beyond the boundary of the study area.

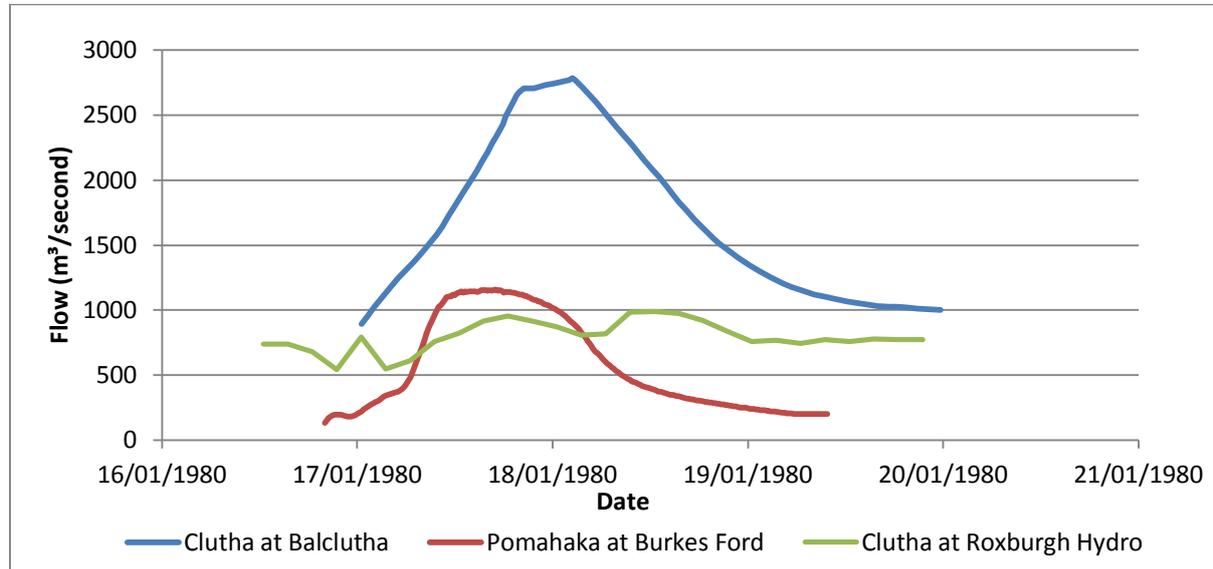
**Figure 3.9** Hydrograph demonstrating the approximate travel time between high flows in the Pomahaka River and high flows in the Clutha River/Mata-au at Balclutha, during January 1980 easterly storm event.

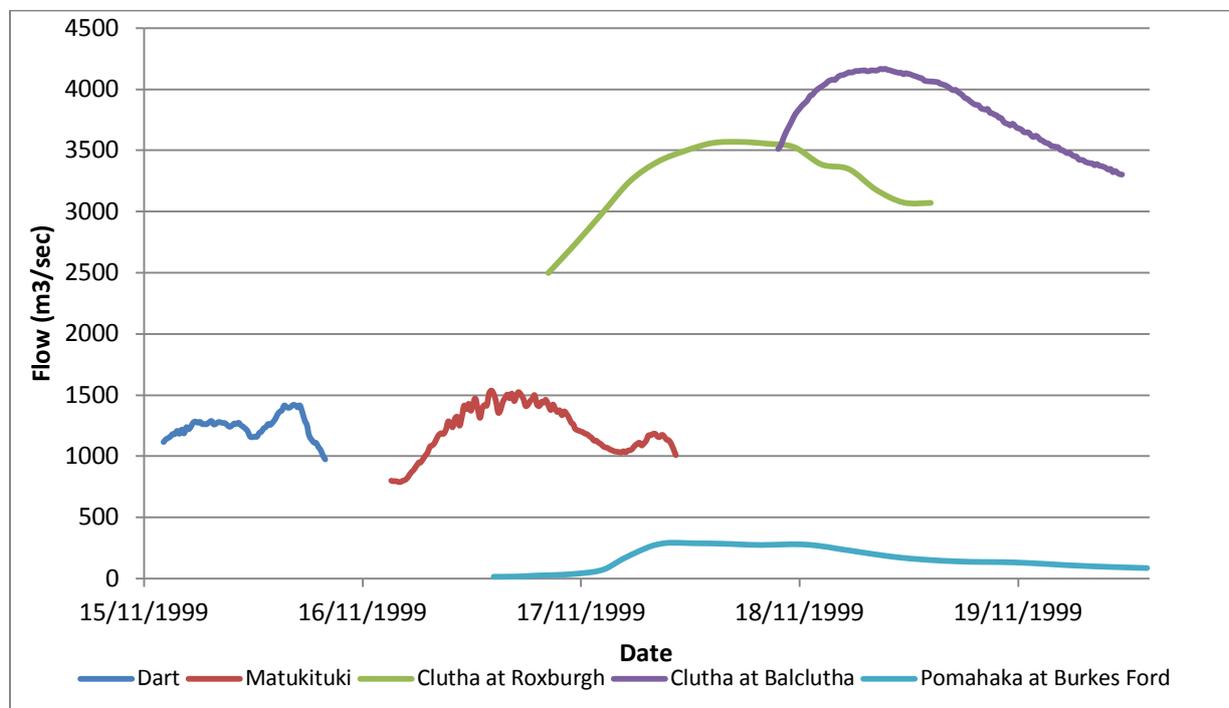
**Figure 3.10** Hydrograph demonstrating the approximate travel time between flows in the headwaters of the Clutha River/Mata-au catchment and high flows in the Clutha River/Mata-au at Balclutha for the November 1999 flood event.

The third, and most critical flood producing event is one where significant rain falls in both the upper and lower catchments, with flows arriving simultaneously at Balclutha (Figure 3.10). The flood of September 1878, and more recently November 1999 are examples of such flooding, with heavy rainfalls recorded for several days initially in the headwaters and subsequently over the whole catchment. Major flooding was experienced over the entire catchment, however destructive and widespread flooding occurred on the Lower Clutha Delta as a result of peak flows from the upper catchment coinciding with the peak flows from the Pomahaka catchment at Balclutha. The flood of October 1878 is still today the largest flood since records began in this catchment.

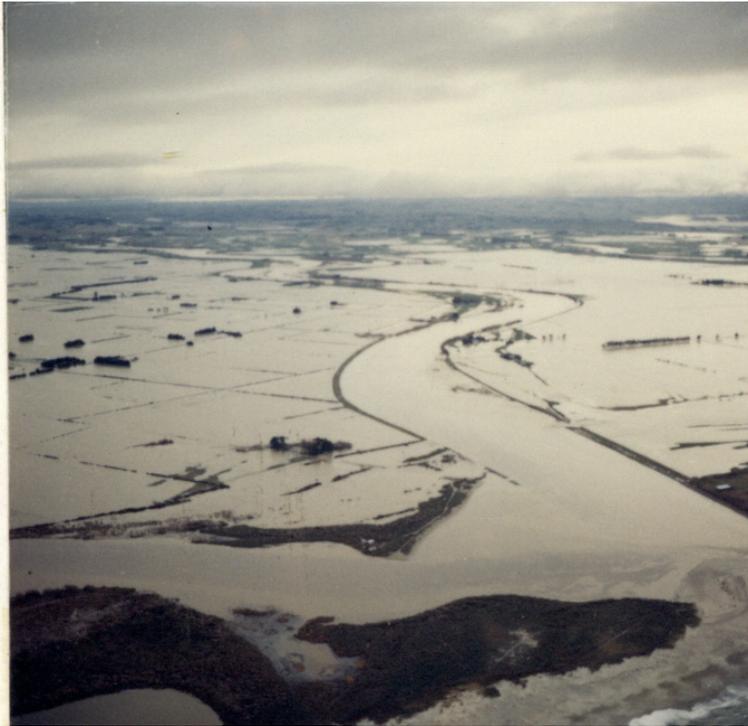
**Figure 3.11** Flooding of the lower Paretai area during the June 1972 flood event.

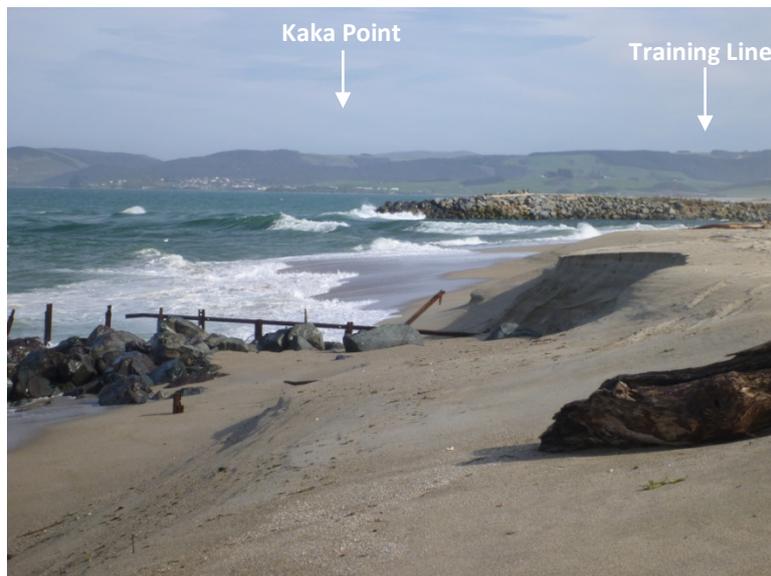
**Figure 3.12** Training line at the Koau Mouth of the Clutha River/Mata-au in August 2012.

Flooding on the Lower Clutha Delta can also be amplified by blockages at either or both of the Clutha River mouths. Offsetting or blockages of the river mouths can reduce the efficiency in which the Clutha River/Mata-au discharges flows into Molyneux Bay. This results in river levels being higher than would ordinarily be expected near the river mouths and immediately upstream (Scarf, 1997). In the June 1972 flood event the water level at the Koau Mouth was approximately 1.6m above the expected flood level due to offsetting of the mouth. What should have been a flood that was safely contained within the floodbank system, overtopped the Paretai floodbanks inundating a large area (Figure 3.8). Works completed at both mouths since the 1980s, including the construction of rock training walls at each mouth, has substantially reduced the potential for the mouths to move and offset (Figures 3.12 and 3.13). This is discussed further in Section 6.3.

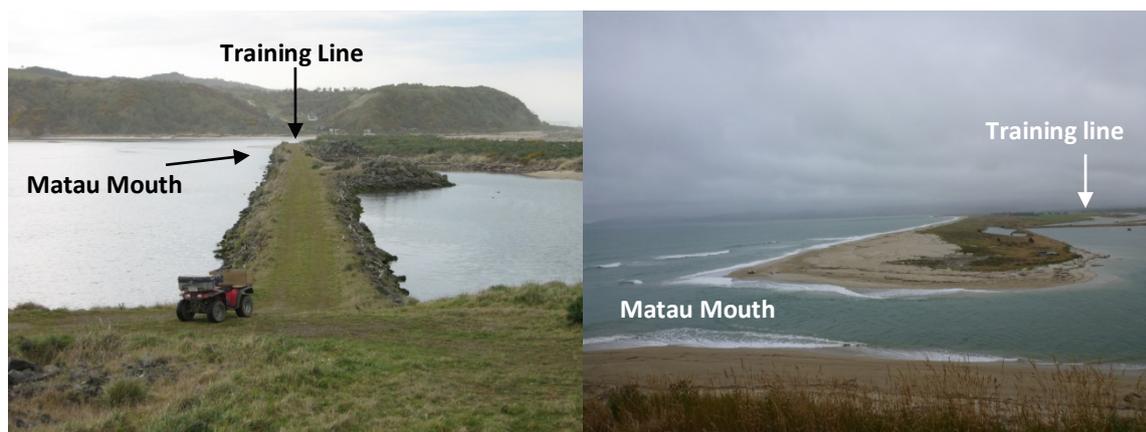
**Figure 3.13** Training line on the true right of the Matau Mouth of the Clutha River/Mata-au. Left image is looking eastwards, towards the Matau Mouth (September 2006), right image is looking westward towards Molyneux Bay (March 2013).

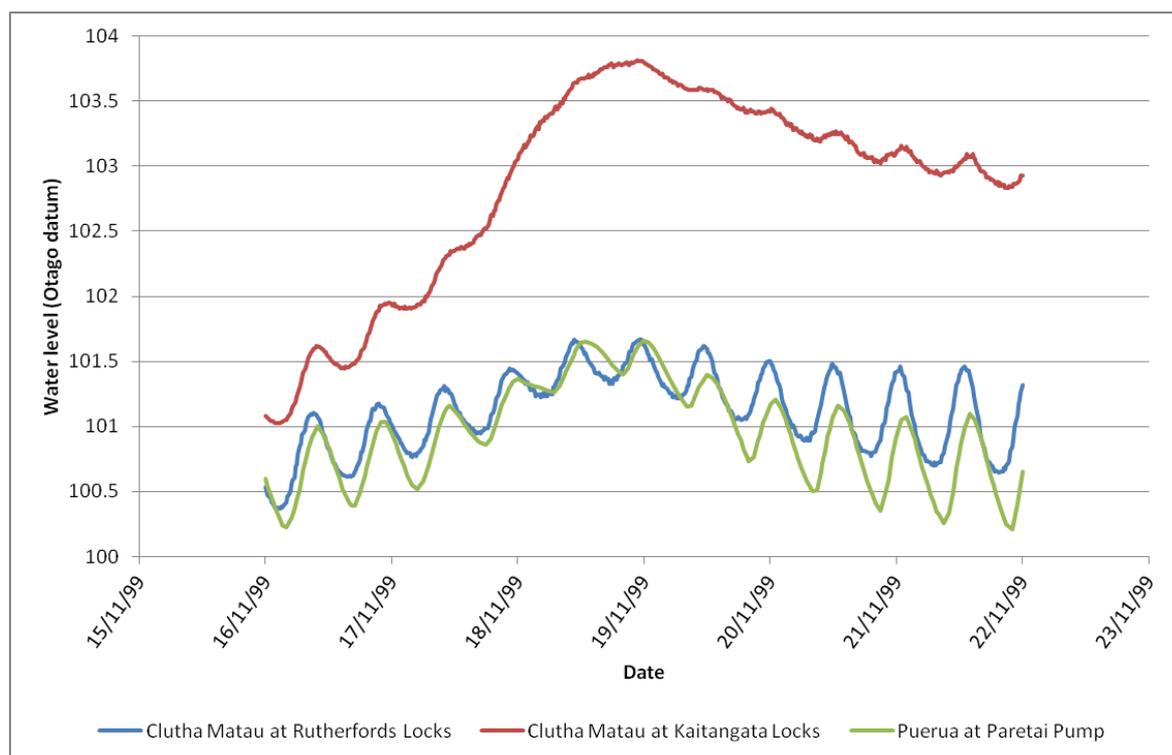
**Figure 3.14** Water levels in the Clutha River/Mata-au at Rutherford Locks and Kaitangata Locks, and the Puerua River at Paretai Pump during the November 1999 flood. The distinct tidal fluctuations become less apparent during the peak of the flood on 18 November 1999.

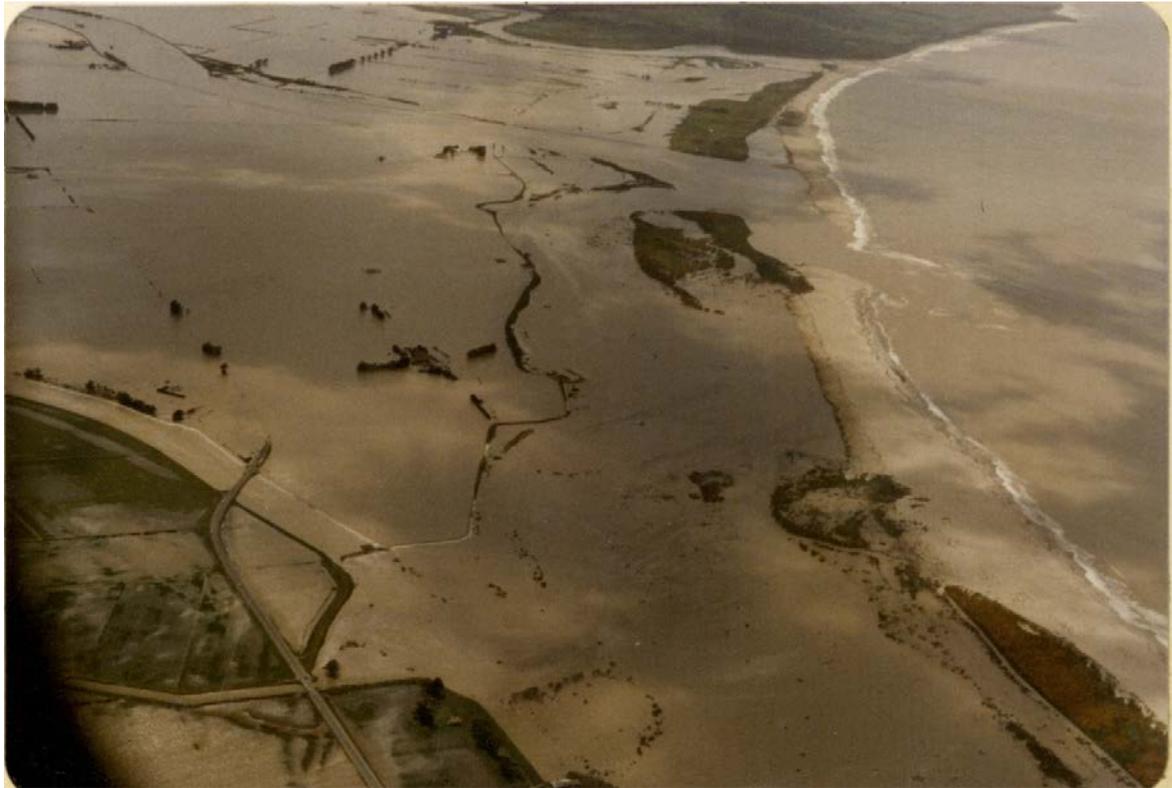
**Figure 4.1** Flooding of the coastal Clutha Delta during the October 1978 event.

Figure 4.1 shows the extent of the flooding that occurred during that event (Paretai area in foreground) including the off-set position of the Koau mouth. The Barnego Flats and the land on the true left bank of the Matau Branch, between Stirling and Kaitangata (known as the Matau District) were all extensively flooded by the river; in addition to the lower parts of Inch Clutha, and the Paretai and Otanomomo areas that are also shown in Figure 4.1. Refer also to Figure 4.2 for the full extent of the flooding for the October 1978 flood event.
