# Natural Hazards on the Clutha Delta, Otago

May 2016

## Executive summary

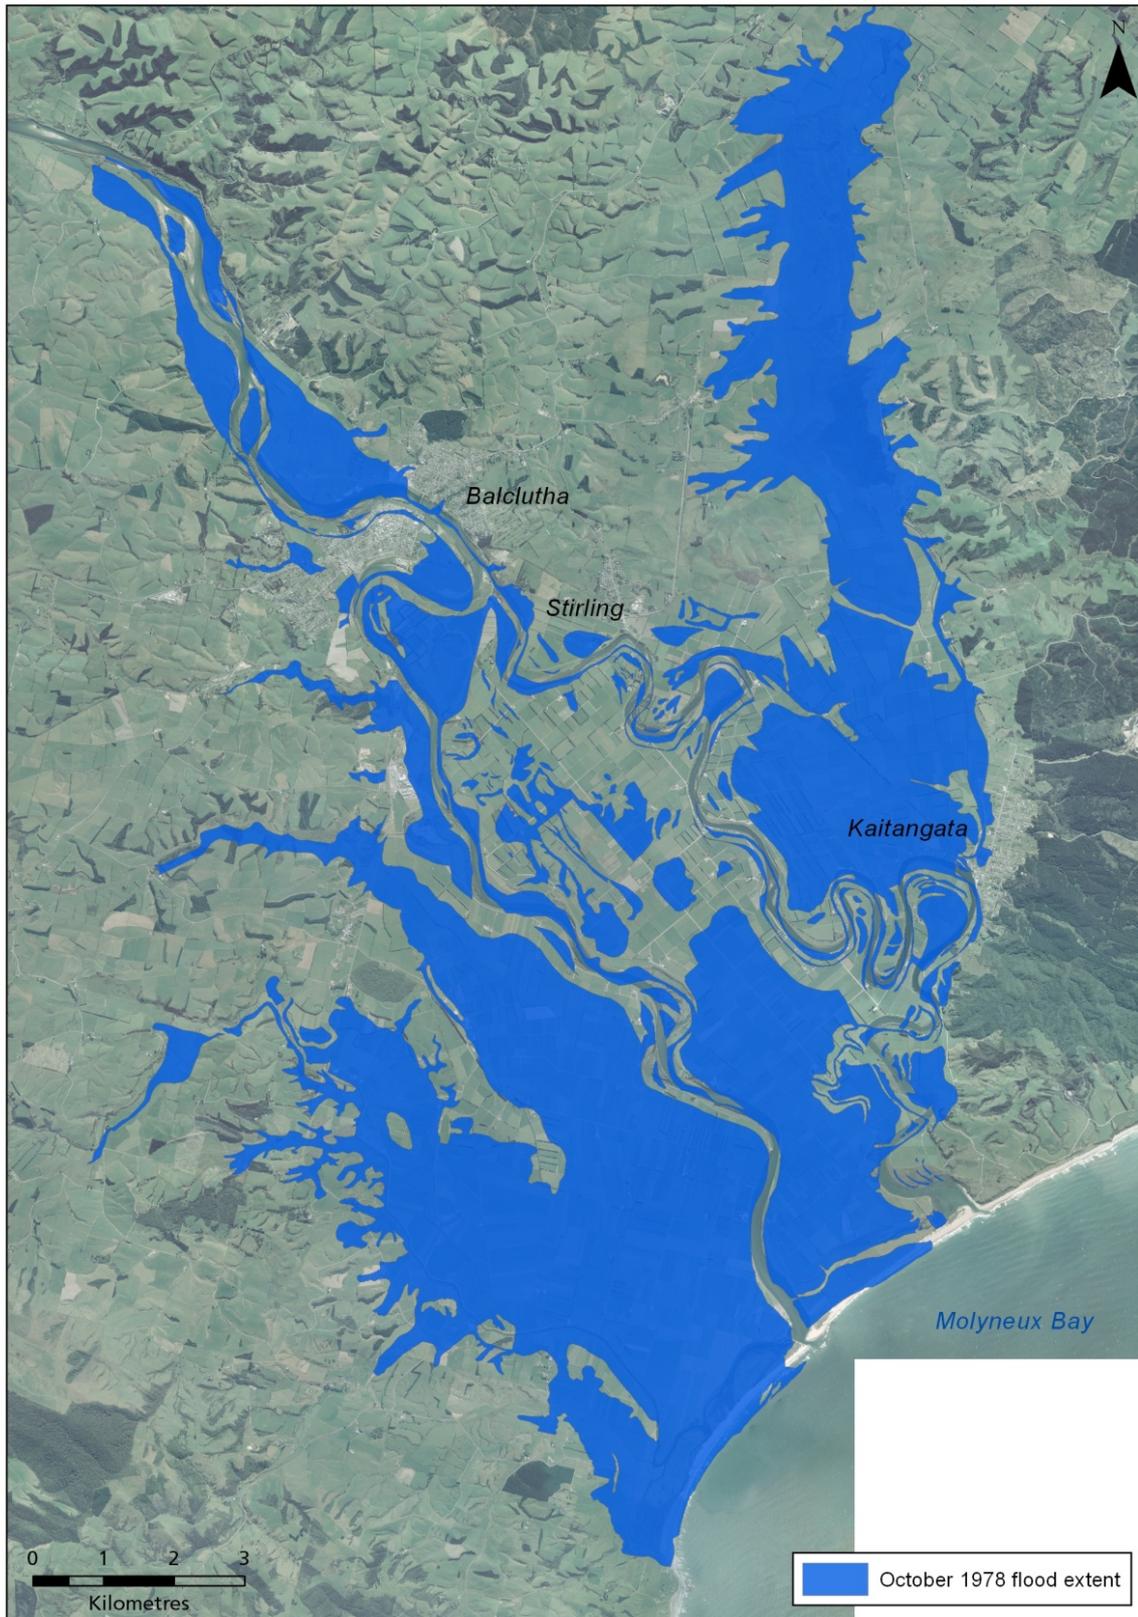
**Figure 4.2** Mapped inundation extents during the October 1978 flood.

Figure 4.1 shows the extent of the flooding that occurred during that event (Paretai area in foreground) including the off-set position of the Koau mouth. The Barnego Flats and the land on the true left bank of the Matau Branch, between Stirling and Kaitangata (known as the Matau District) were all extensively flooded by the river; in addition to the lower parts of Inch Clutha, and the Paretai and Otanomomo areas that are also shown in Figure 4.1. Refer also to Figure 4.2 for the full extent of the flooding for the October 1978 flood event.

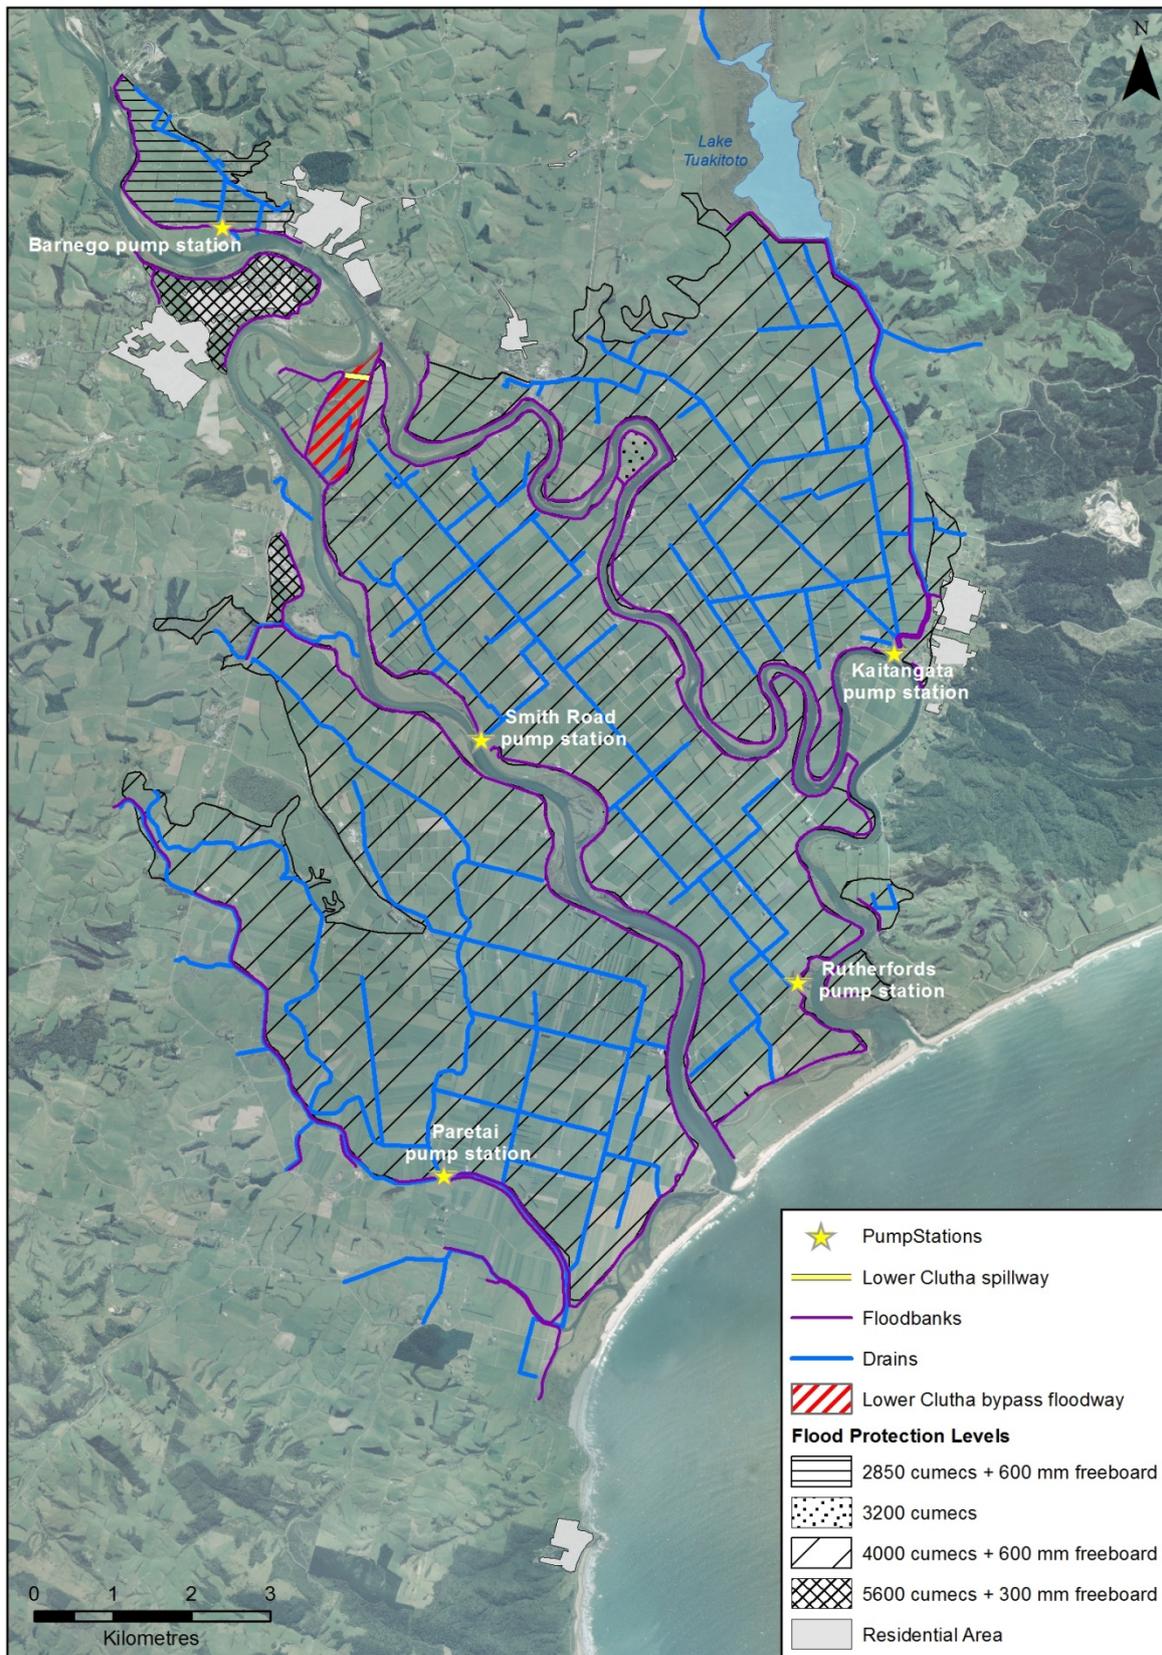
Figure 4.3 Lower Clutha Flood Protection and Drainage Scheme (engineered features of the scheme that modify the flood hazard).

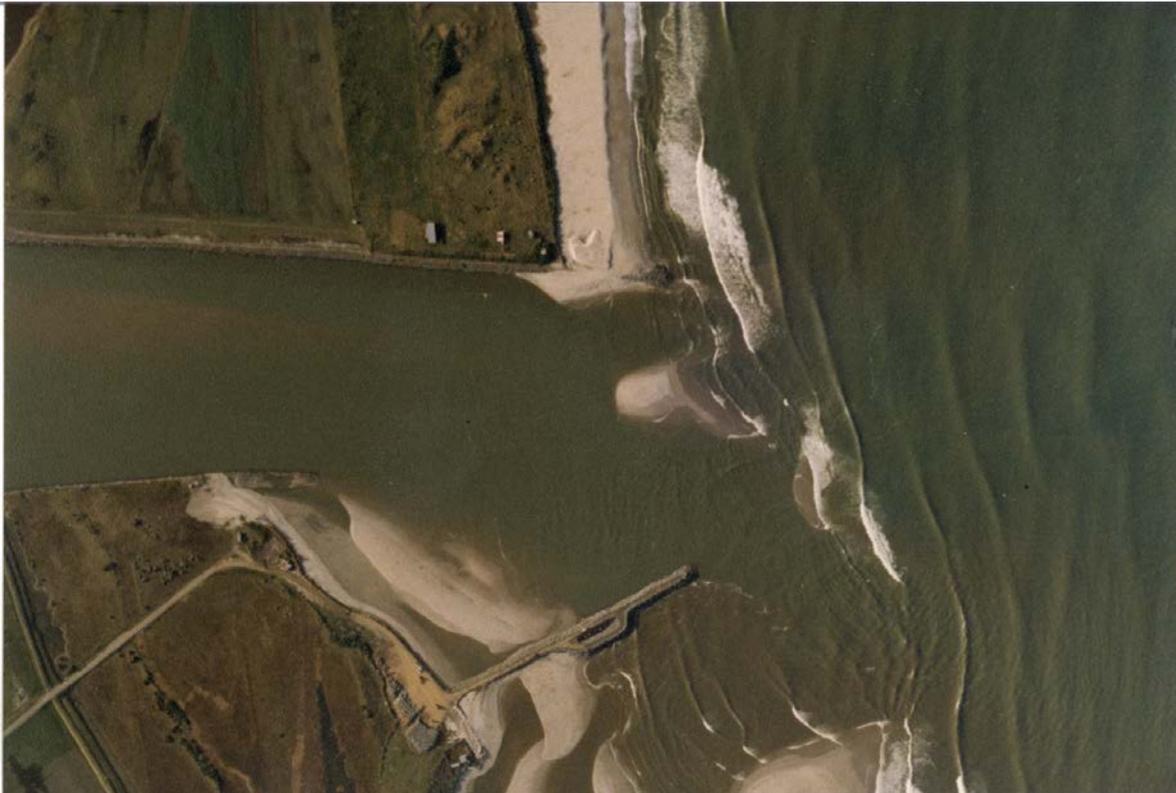
**Figure 4.4** Koau Mouth works- June 1983 (during construction).

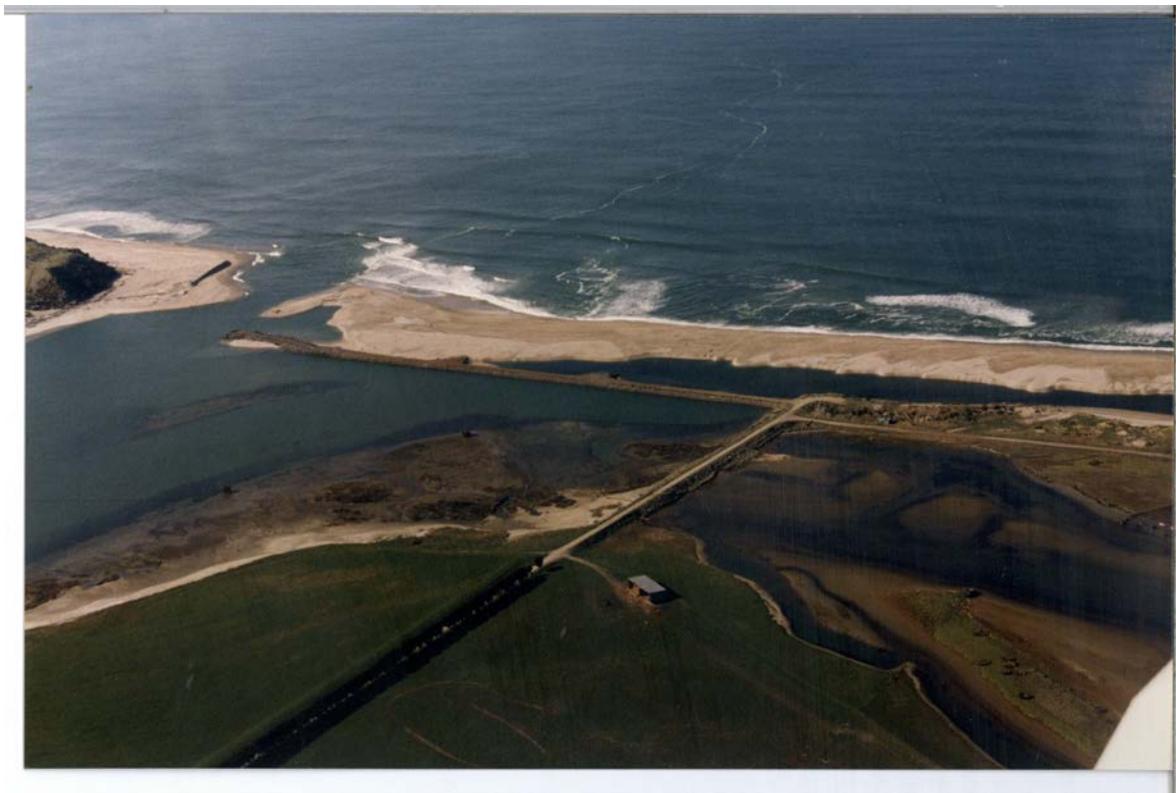
**Figure 4.5** Matau Mouth works - September 1993

The Matau Mouth control works have included:

- The construction of a low level protective rock banks both adjacent and parallel to the narrow sandbank that separates the southern estuarine area from the sea, to prevent a southward migration of the mouth; and
- The construction of a short groyne on the northern side of the mouth to prevent the establishment of a northern blockage.

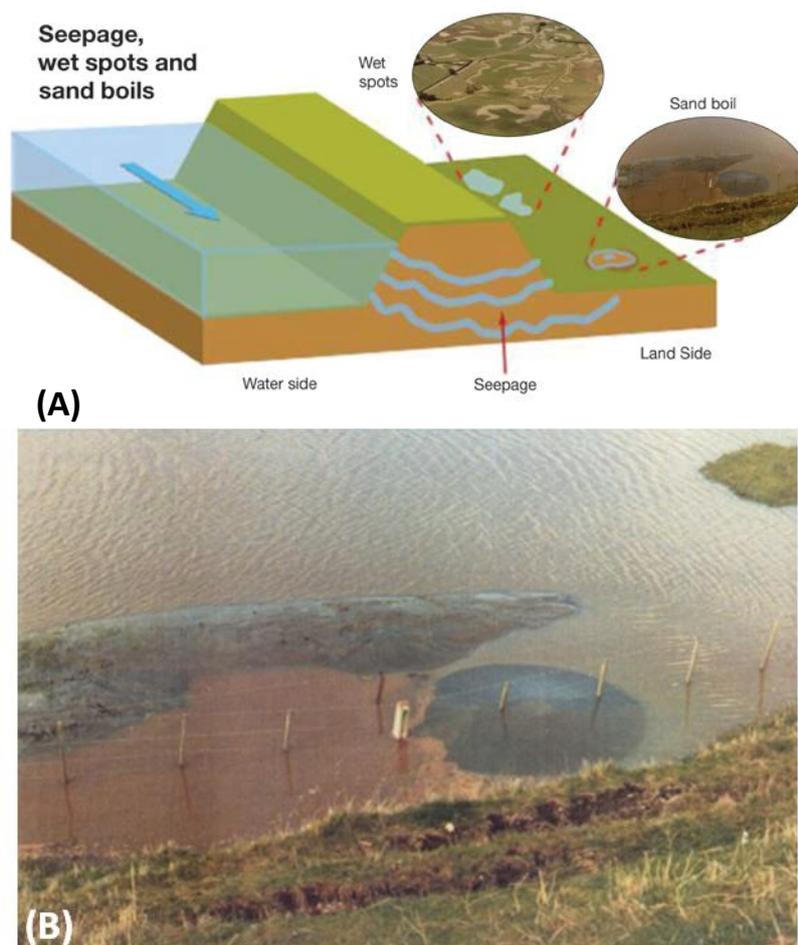
**Figure 4.6 a)** Illustration of floodbank failure by seepage under the floodbank. **b)** Example of sand boils in Inch Clutha during the October 1978 flood.

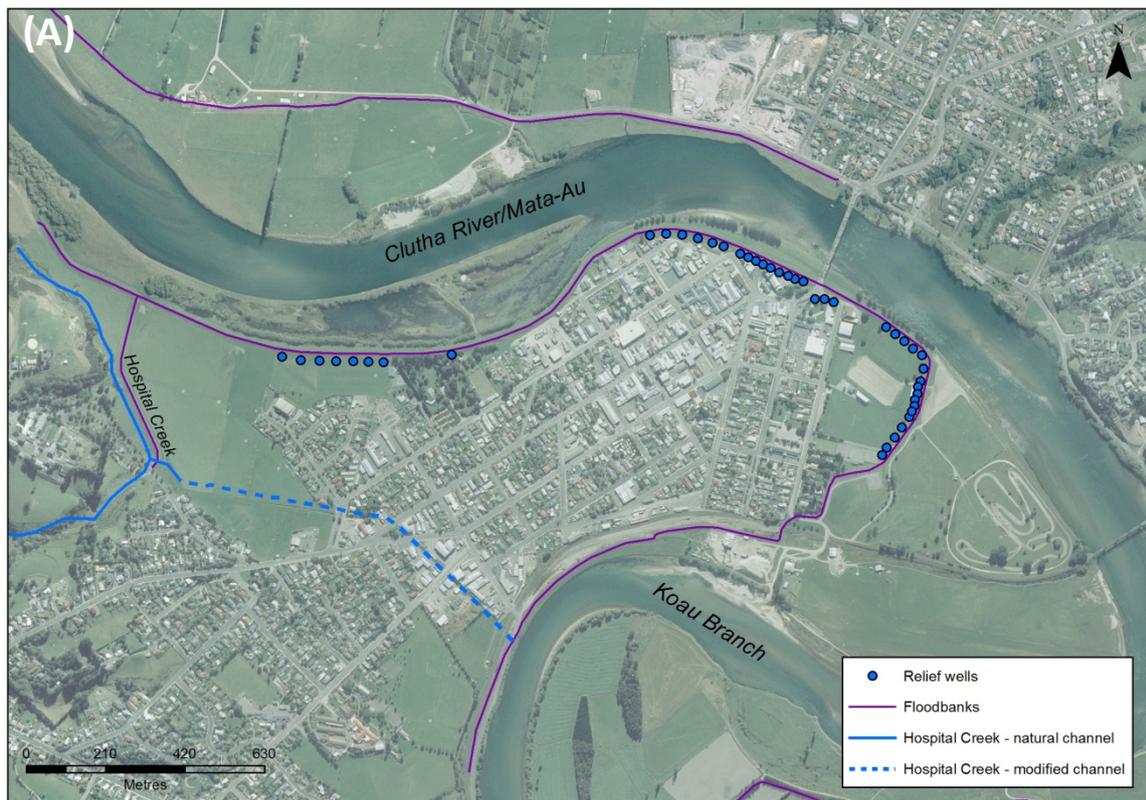
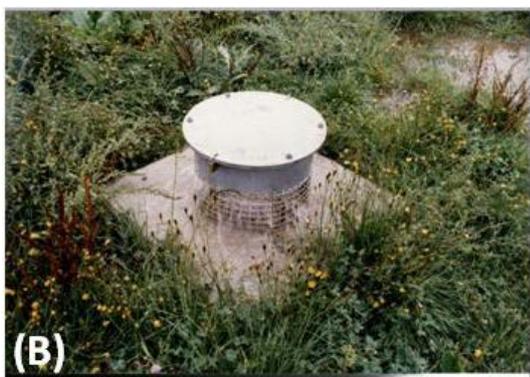
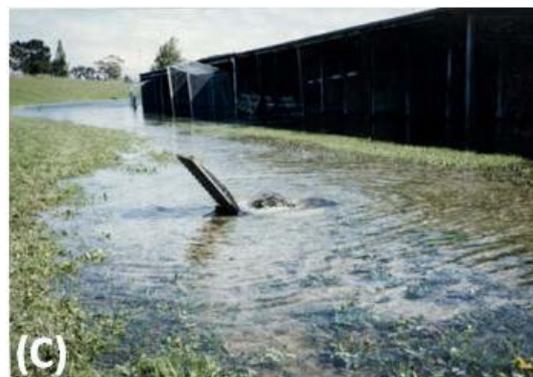
**Figure 4.7** Location of the 43 relief wells in Balclutha **a)** and photos of the emerging part of two types of relief wells operating in the March 1987 flood event (**b** and **c**, below).

The relief wells connect the pervious gravel layer to the surface, thus allowing the seepage water to escape without taking the fine soil material with it, and so relieve the upward

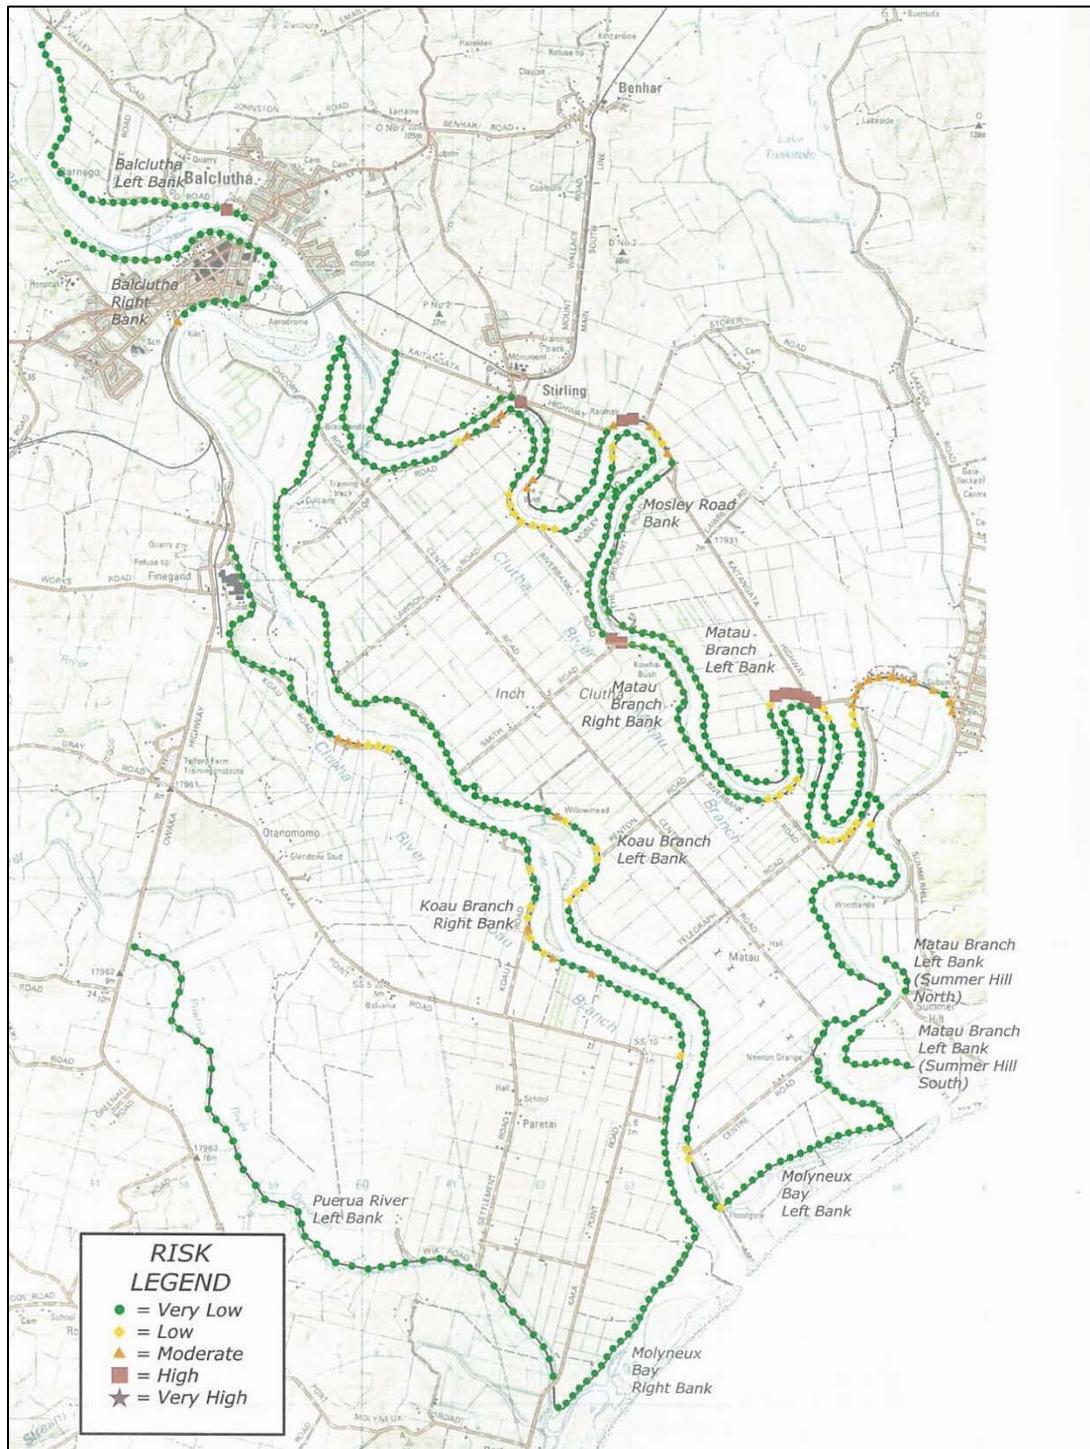
**Figure 4.8** Assessed risk of piping failure of the Lower Clutha Flood Protection Scheme floodbank foundations (Tonkin & Taylor Ltd, 2005).

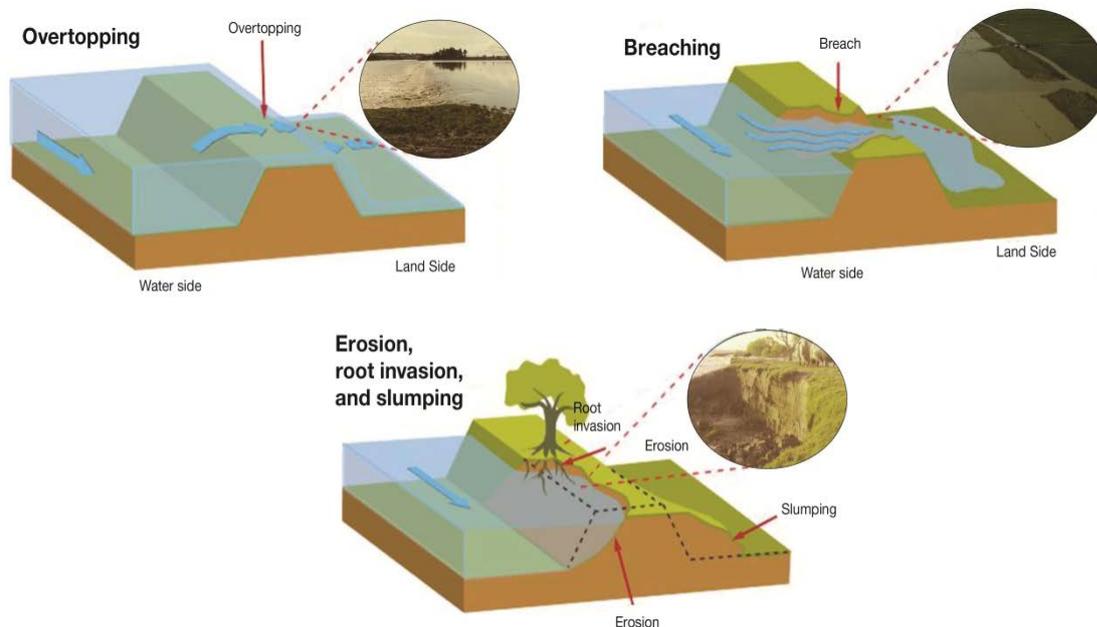
**Figure 4.9** Floodbank failure mechanisms, other than piping.

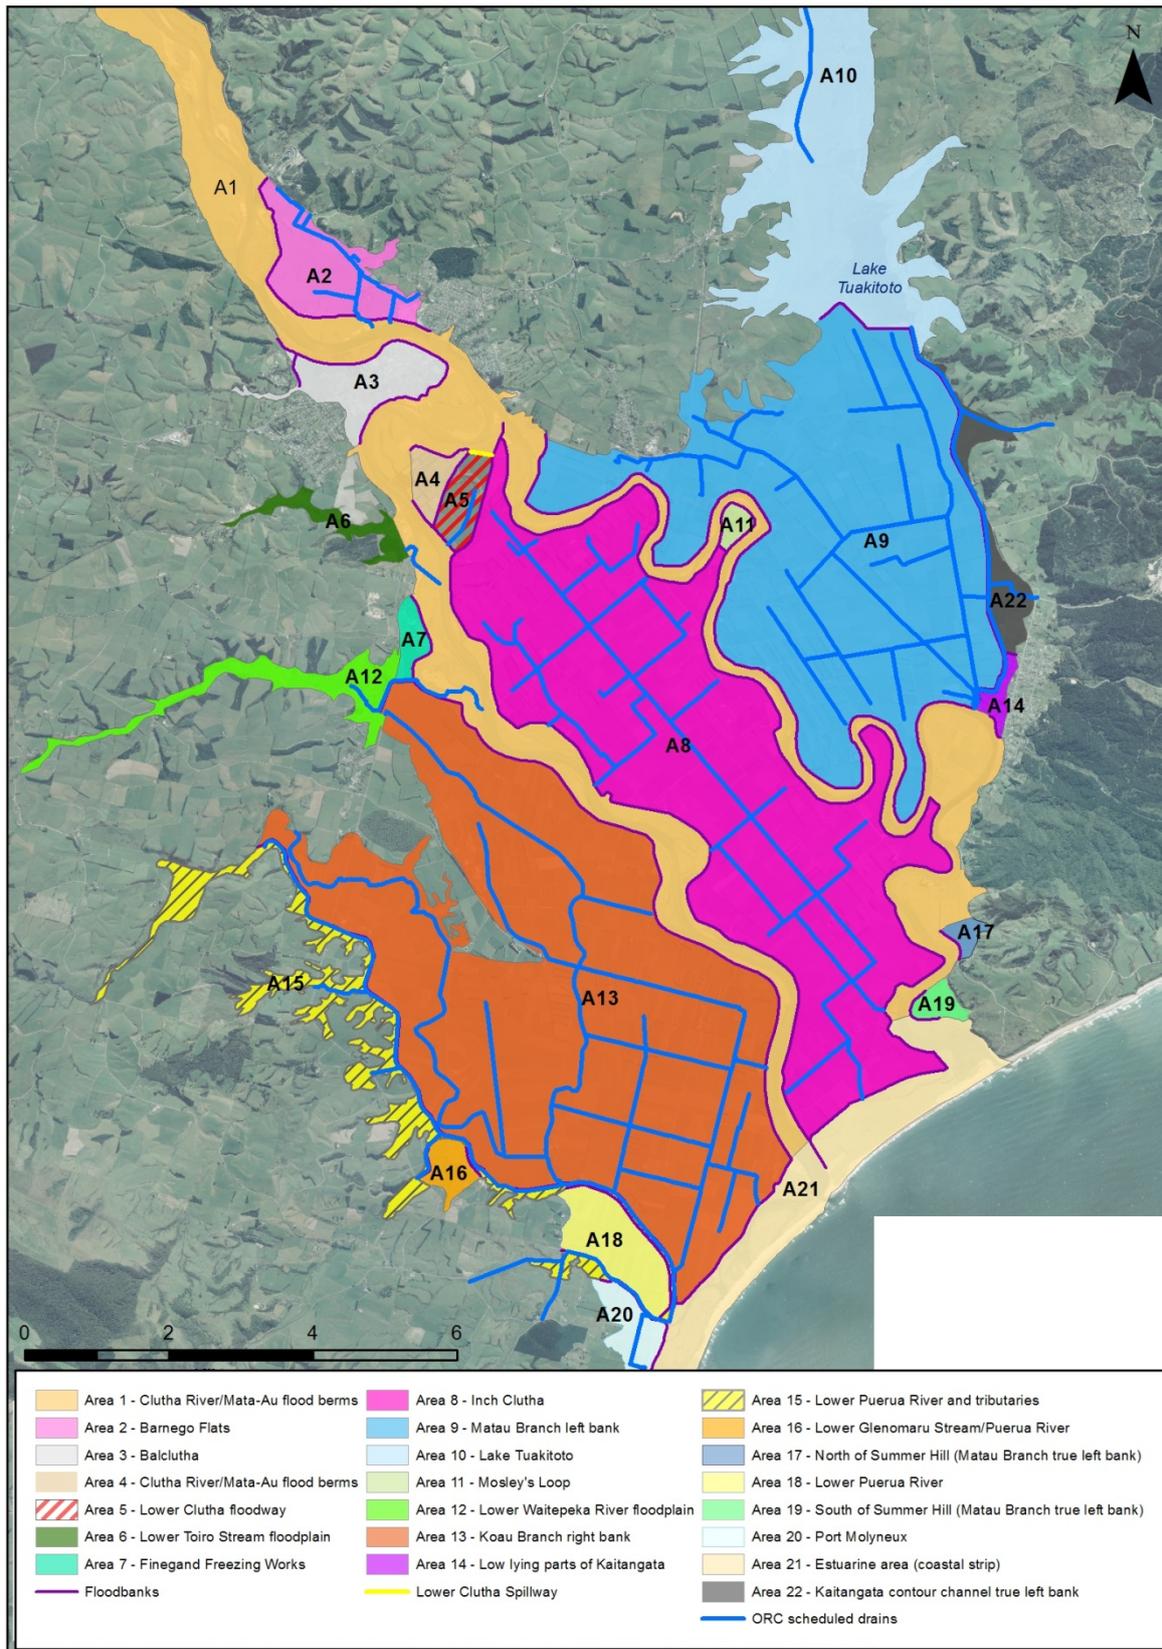
**Figure 4.10** Flood-hazard areas on the Clutha Delta. Note that the flood hazard within each area is not uniform. Localised topographical features will also influence the flood hazard within each of those areas.

Inundation depths and flow velocities derived from the 2005/2006 NIWA investigation are used in this report to describe some of the flood hazard characteristics for each of the areas shown on Figure 4.10. Figure 4.11 shows the flood extent (shaded blue) for a 1:100-year flood event (peaking at 5200 m<sup>3</sup>/s at Balclutha) for the present mean sea level scenario, and with a breach on the Matau Branch (true left floodbank, at Mosley's Loop). It also shows the potential flood hazard (expressed as a combination of the depth of inundation and the water velocity) for this flood flow and breach scenario - where the areas shaded purple (as overlaid on the blue flood extent) represent a high potential hazard from flooding to people and buildings. As already noted, the flood hazard characteristics for a particular area (and flood magnitude) are very sensitive to the assumed location for a breach in the floodbank network; so those characteristics could be very different for a particular area if a different breach scenario was to be considered. Also, the flood extent shown on Figure 4.11 does not include the contribution from the local hill catchments or internal run-off.

The flood-hazard characteristics each area shown on Figure 4.10 are described below:

Modelling has also demonstrated that, during a 1:100-year flood (peaking at 5200 m<sup>3</sup>/s), flooding (from both branches) would be widespread over Area 8 (Figure 4.10). The depth of water could reach up to 1.5 m in low-lying areas, with the water velocity not exceeding 1 m/s (Figures 4.12 and 4.13) (NIWA, 2005). Modelling of the 1:200-year flood event (peaking at 5800 m<sup>3</sup>/s, at Balclutha) indicates that the depth of water in this area could exceed 2 m in low-lying areas (see Figure 4.14) (NIWA, 2005). The potential hazard to people and buildings in parts of this area is therefore considered to be very high.

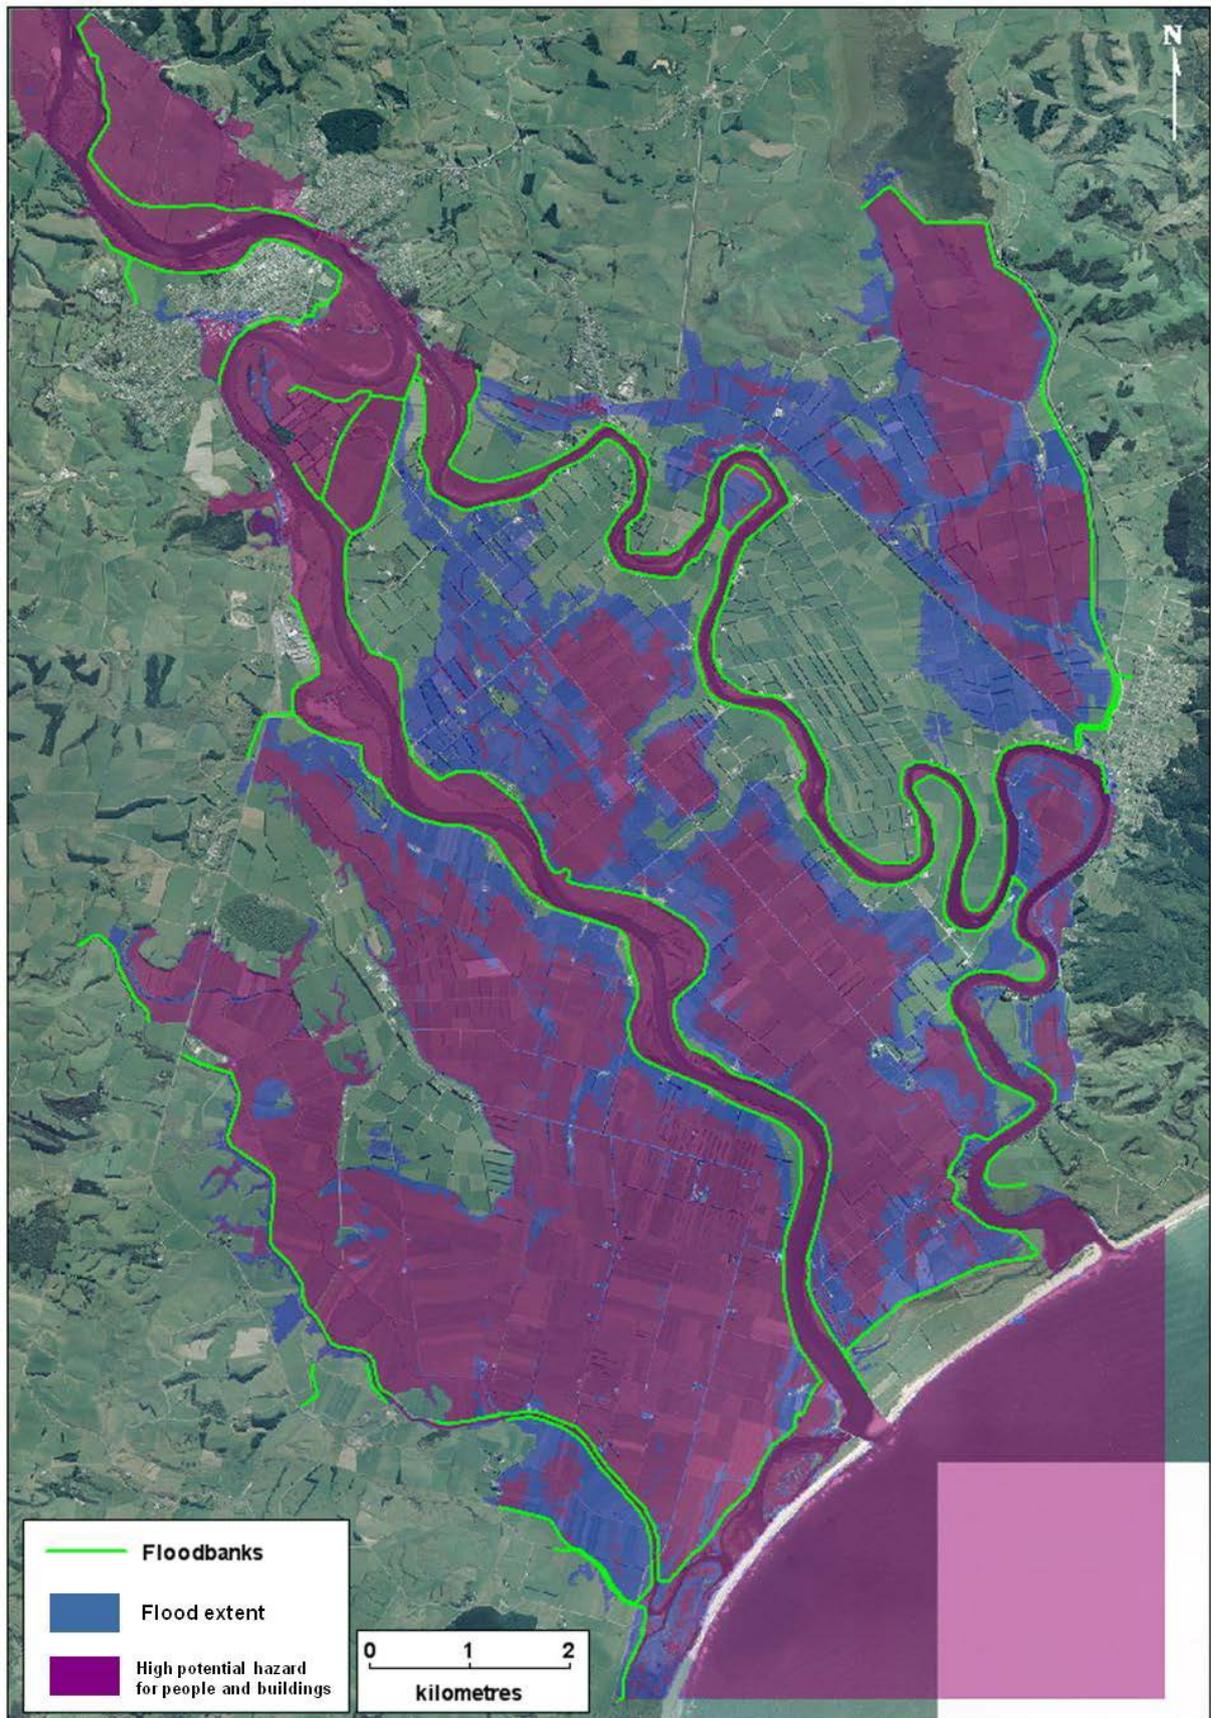
**Figure 4.11** Flood extent (shaded blue) and areas with high potential hazard (overlaid in purple) for people and buildings, in a 1:100-year flood event (peaking at 5200 m<sup>3</sup>/s at Balclutha) with a floodbank breach on the Matau Branch, at present mean sea level.

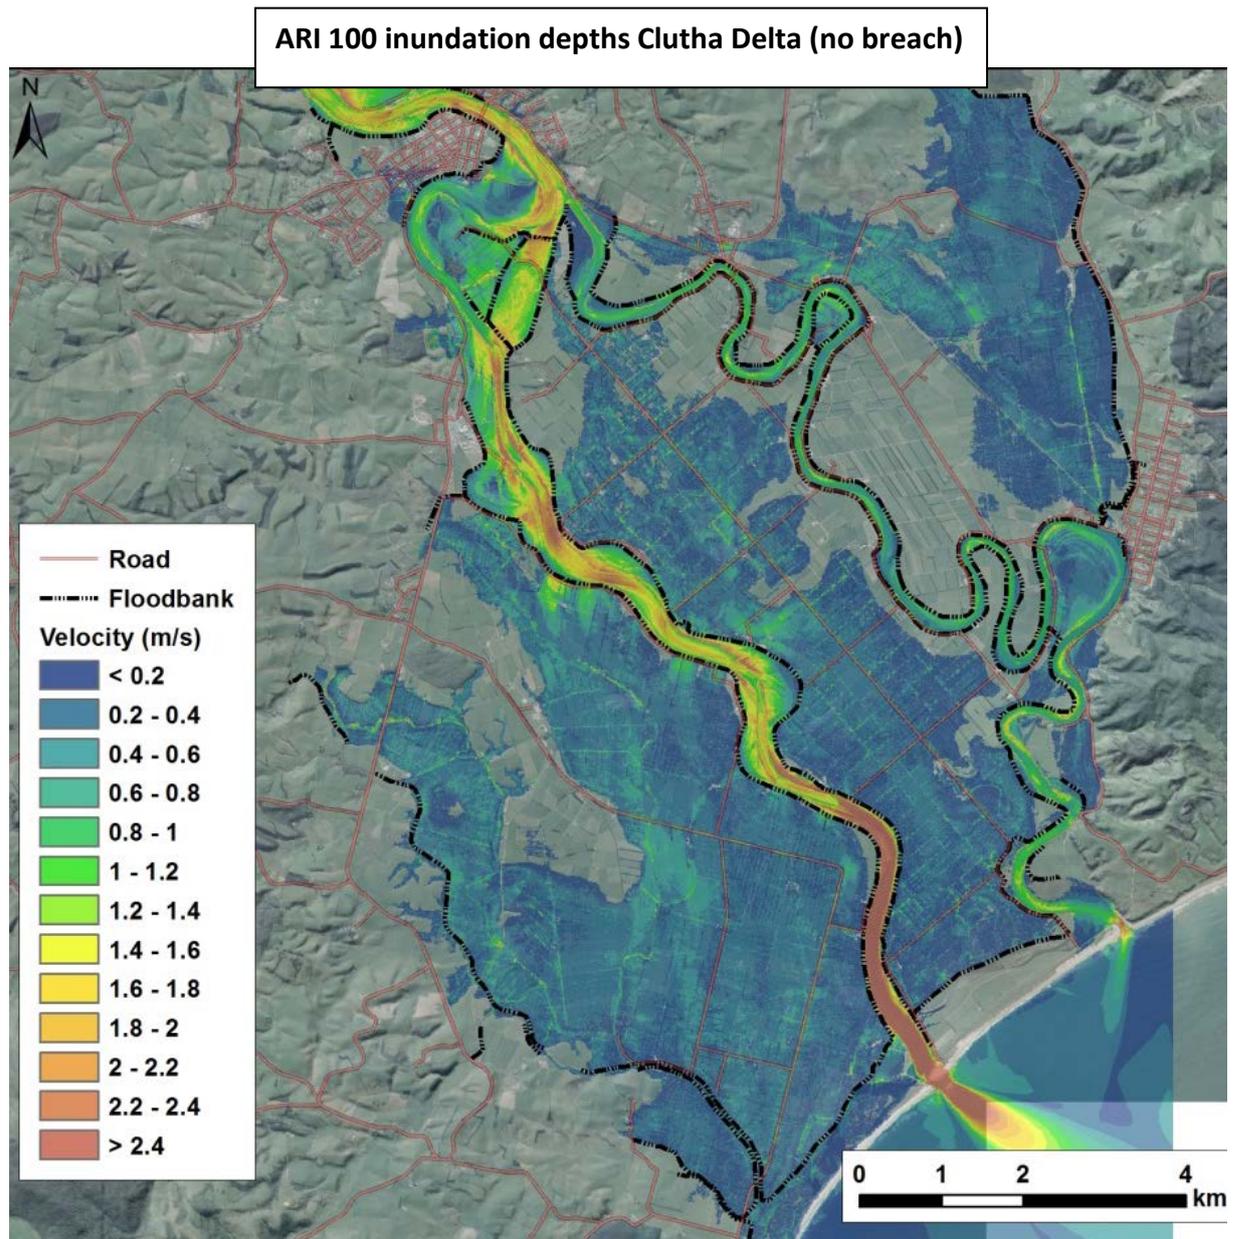
**Figure 4.12** Inundation depths across the Clutha Delta at the peak of a 100-year flood event (peaking at 5200 m<sup>3</sup>/s at Balclutha) at present mean sea level, but with no floodbank breaches.

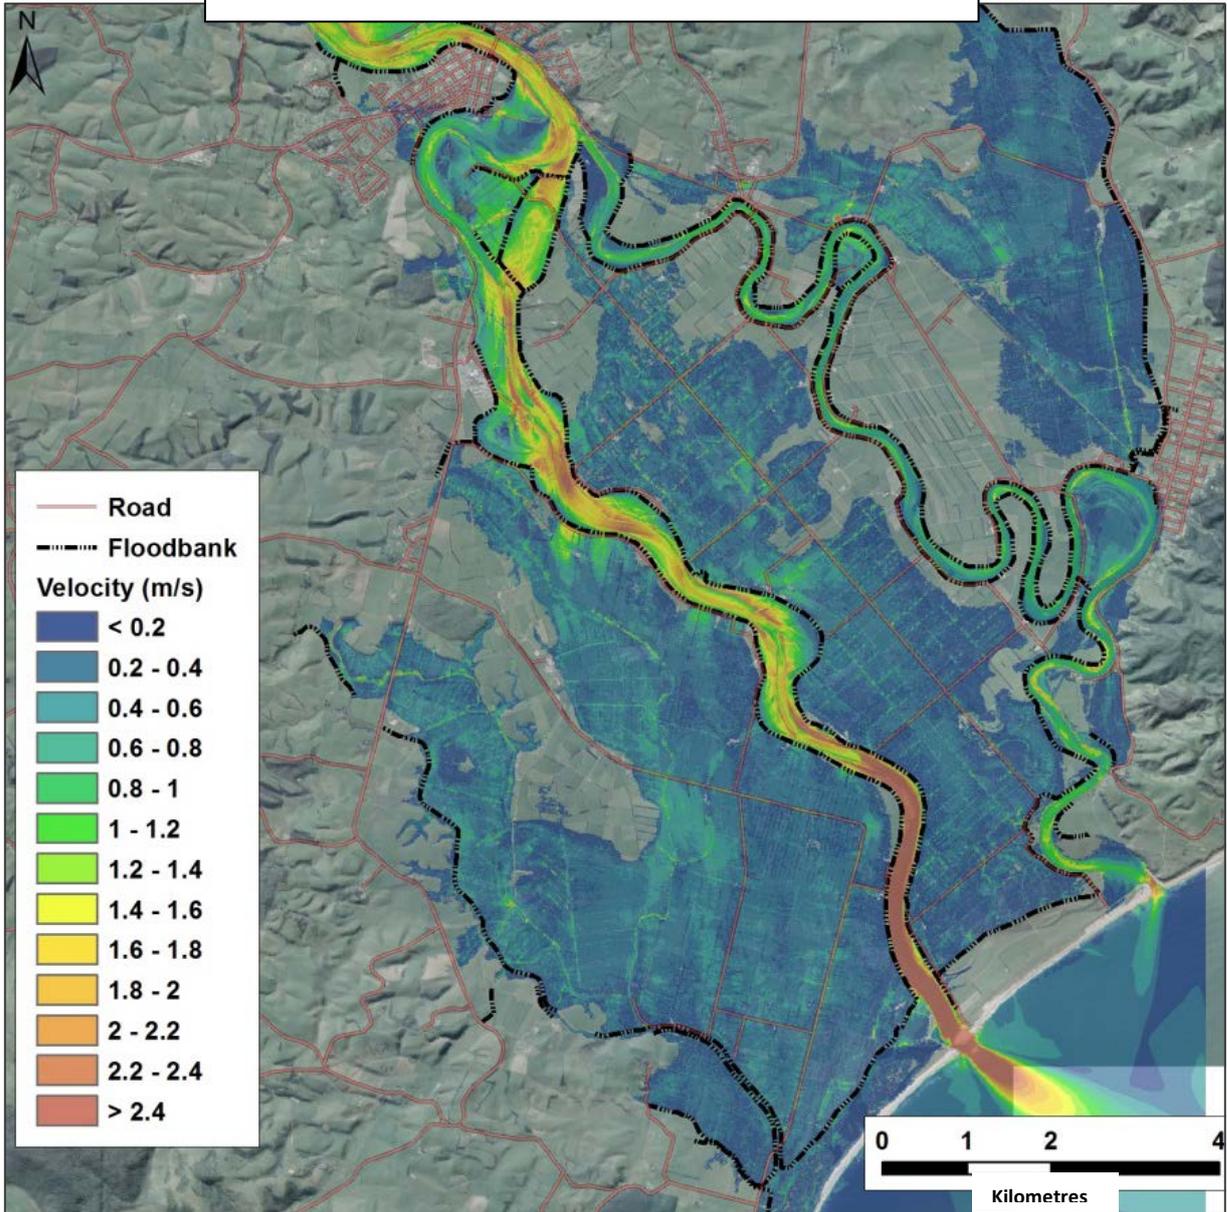
**Figure 4.13** Floodwater velocities on the Clutha Delta at the peak of a 100-yr flood event (peaking at  $5200 \text{ m}^3/\text{s}$  at Balclutha) at present mean sea level, but with no floodbank breaches.

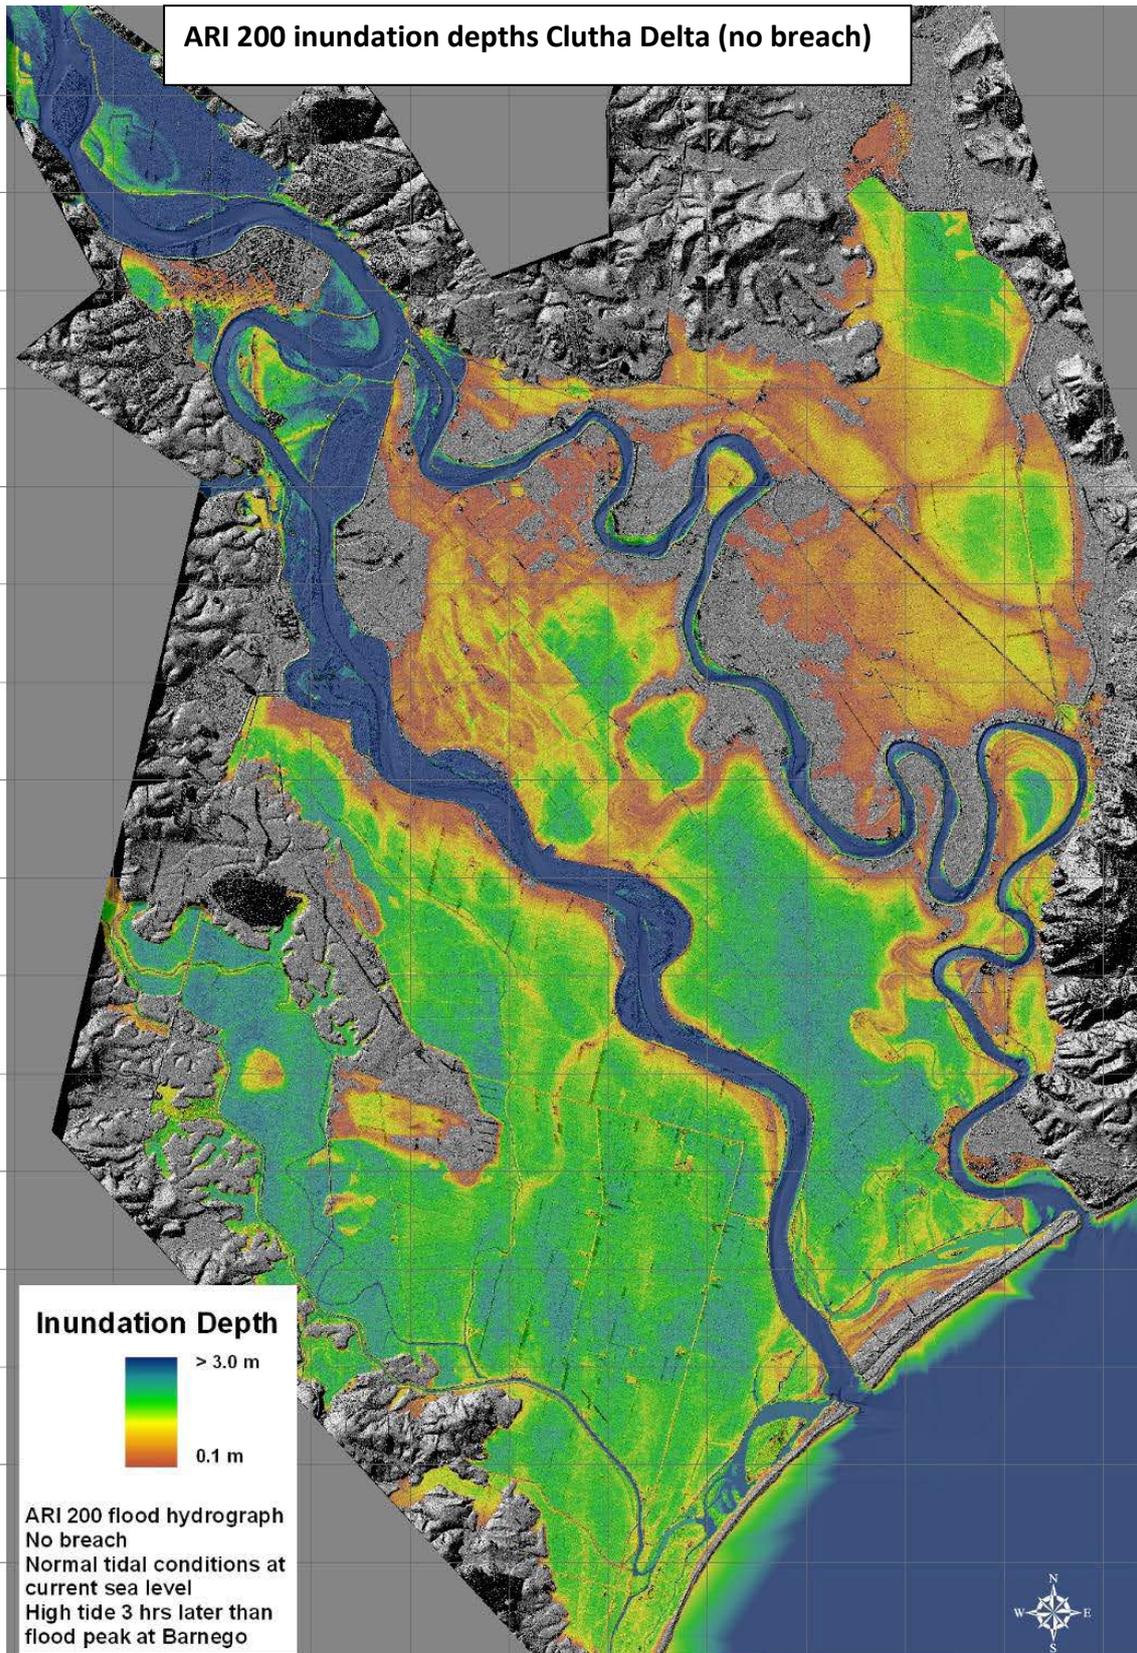
**Figure 4.14** Inundation depths across the Clutha Delta at the peak of a 200-year flood event (peaking at 5800 m<sup>3</sup>/s at Balclutha) at present mean sea level, but with no floodbank breaches.

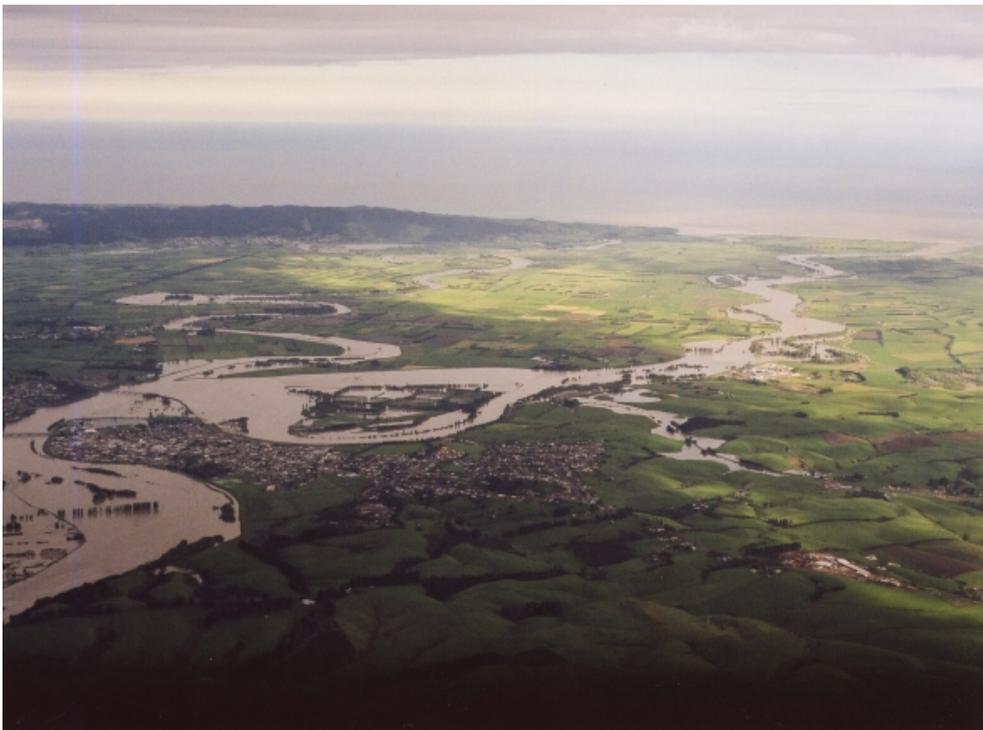
**Figure 4.15** Flooding in Area 1 during the November 1999 flood event, looking downstream to Molyneux Bay across Balclutha. Photo not necessarily taken at the peak of the flood.

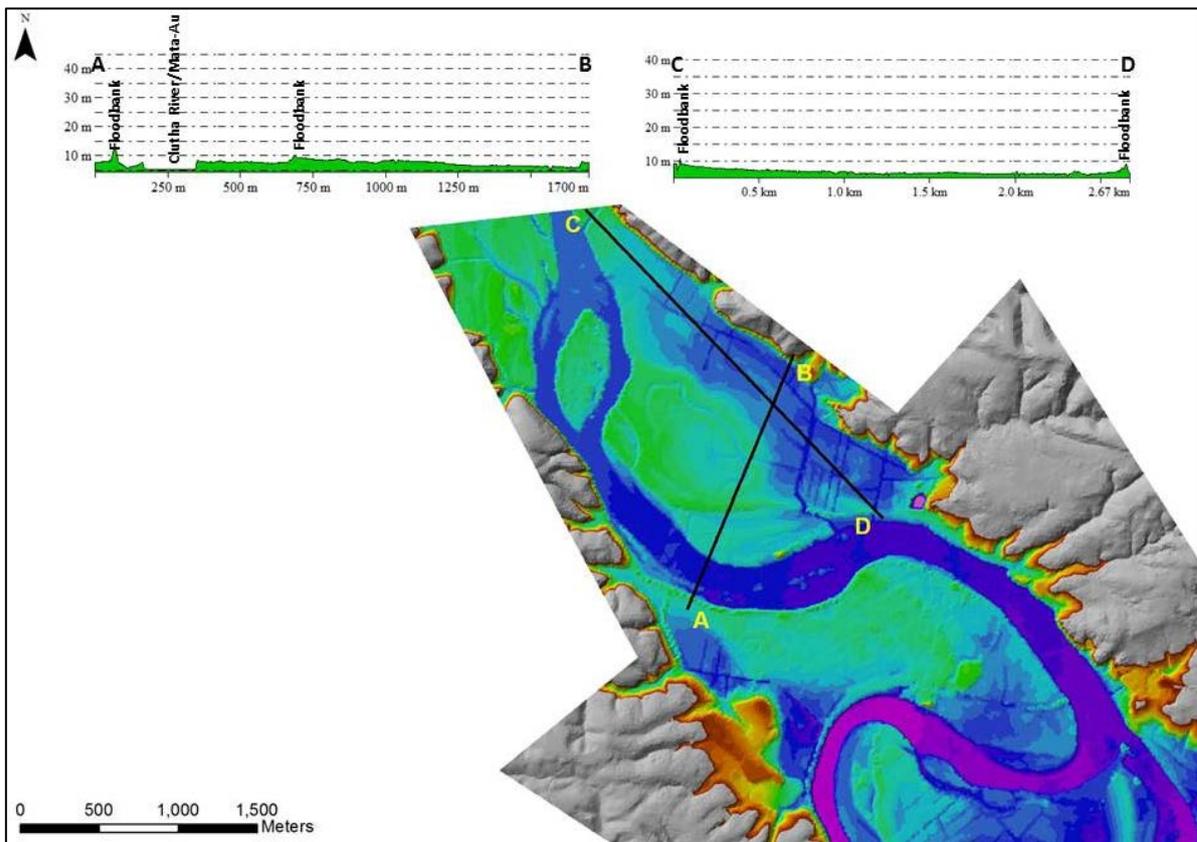
**Figure 4.16** Elevation of Area 2 derived from LiDAR data. Land elevation is in meters relative to mean sea level.

This area comprises the protected part of the Clutha River/Mata-Au floodplain immediately upstream of Balclutha on the true left bank. The land within Area 2 is exposed to flooding from the Clutha River/Mata-Au and, to a lesser degree, from the minor tributaries that flow from the hill catchments on the northern and eastern sides of the area. The land in this area is relatively flat (elevation generally ranging between 5 m to 10 m above msl) and falls away from the river to the toe of the hills, thus forming a natural, shallow bowl shape (Figure 4.16).
