# Natural Hazards on the Clutha Delta, Otago

May 2016

## Executive summary

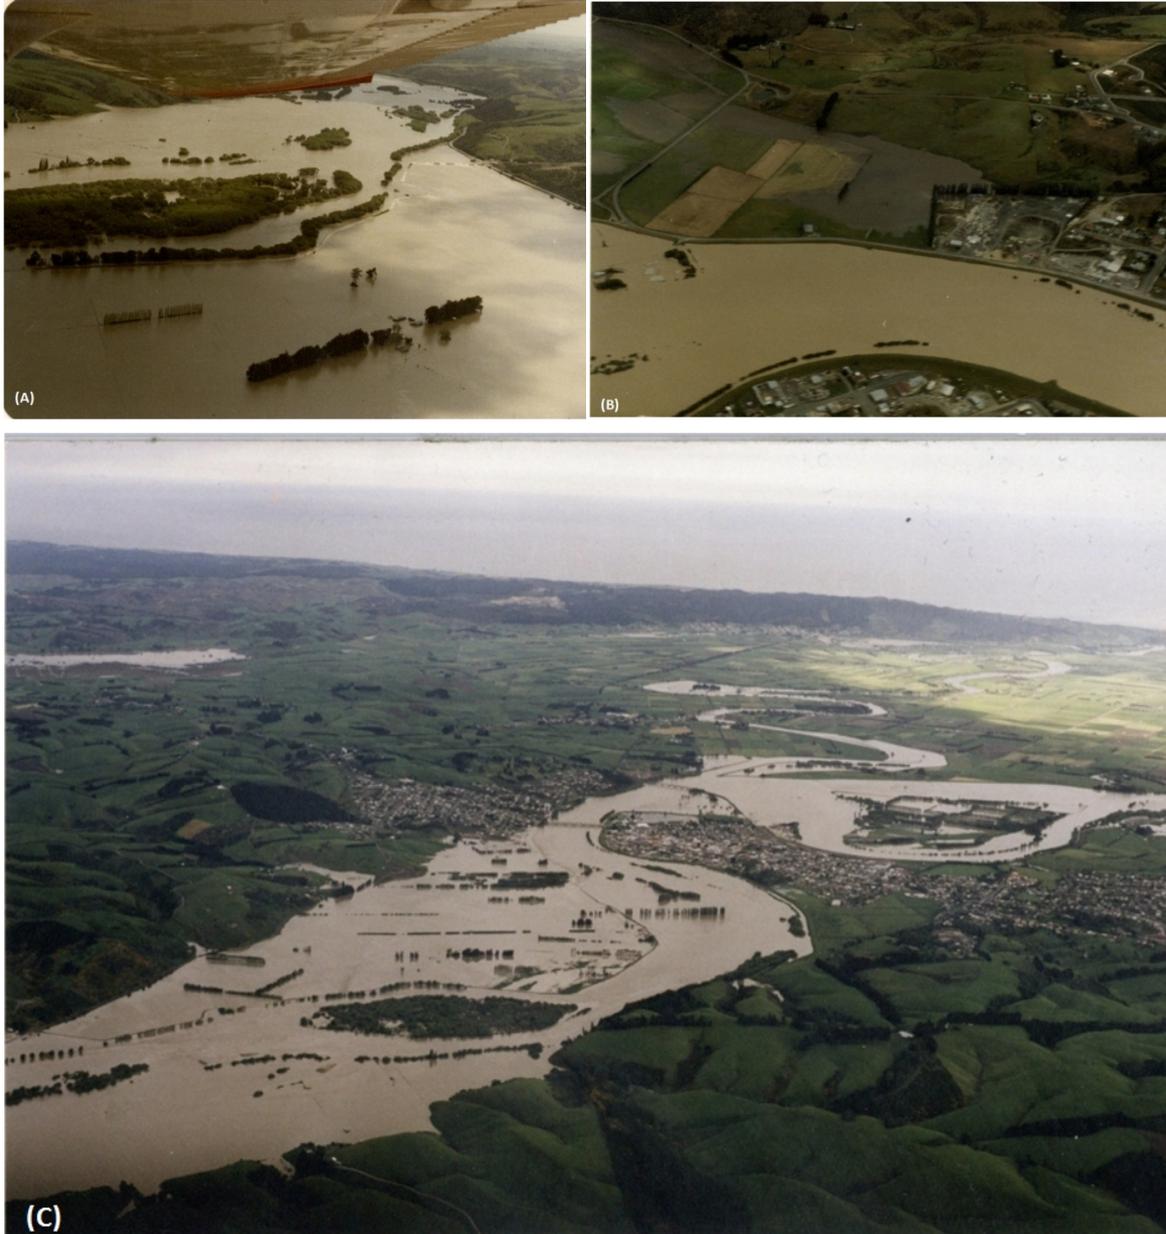
**Figure 4.17** Flooding in Area 2 during the October 1978 flood event, with Barnego Flats in the foreground (A), January 1980 (B) and November 1999, with Barnego Flats in the foreground (C).

Area 2 was inundated during the October 1978 and November 1999 floods (Figure 4.17) and there was also flooding in January 1980, though that was most likely a result of localised rainfall accumulation and drainage network overtopping.

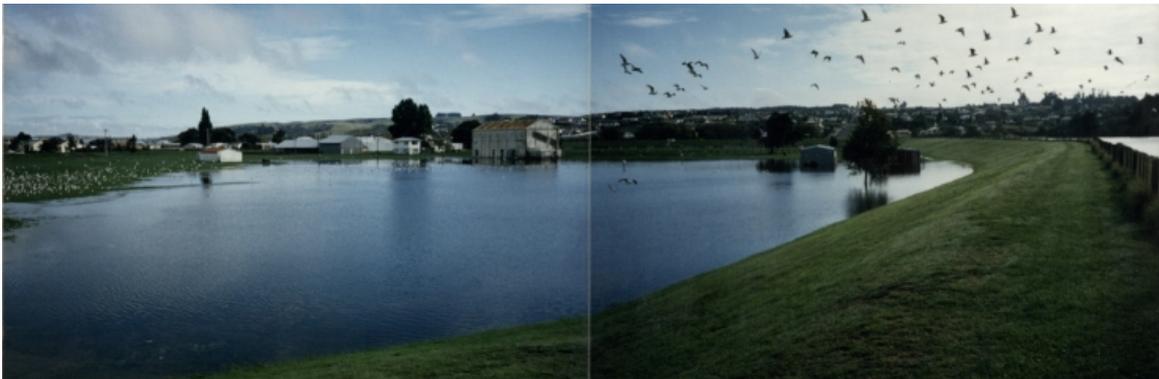
**Figure 4.18** Localised ponding due to seepage coming from the relief wells on the landward side of the floodbank at the Balclutha Showgrounds during the March 1987 flood event ( $2300 \text{ m}^3/\text{s}$  at Balclutha).

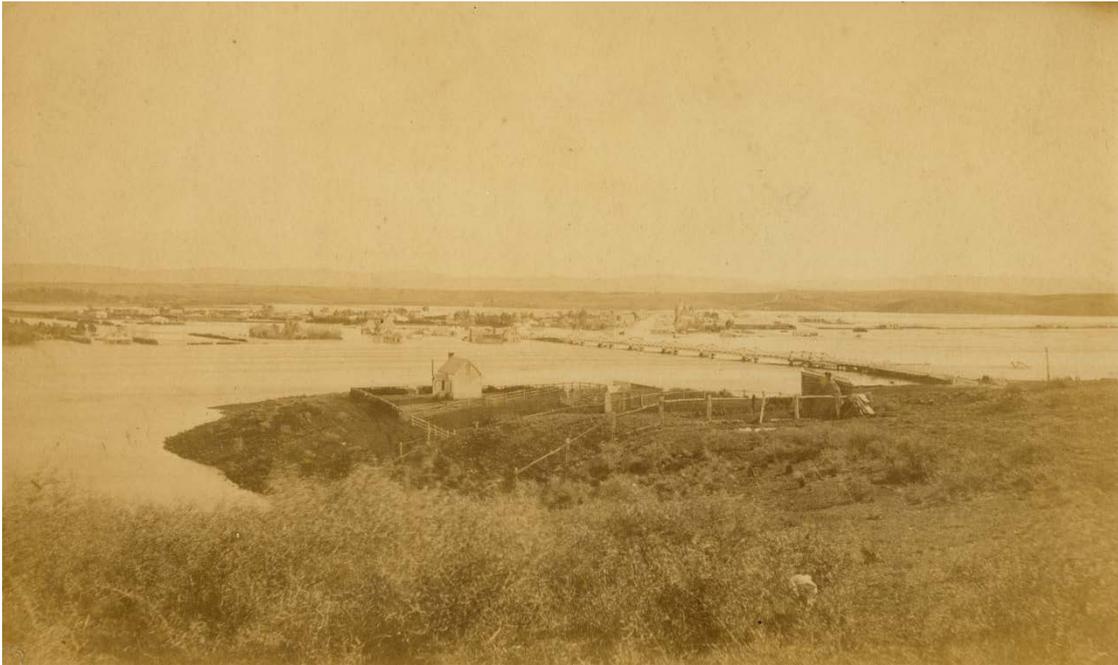
**Figure 4.19** Flooding in Balclutha during the September 1878 flood event (estimated peak flow of 5600 m<sup>3</sup>/s at Balclutha) (Photograph taken by C Nicholas, courtesy of the Hocken Library). Also note Figure 2.7 from the same event. The photos were not necessarily taken at the peak of the flood.

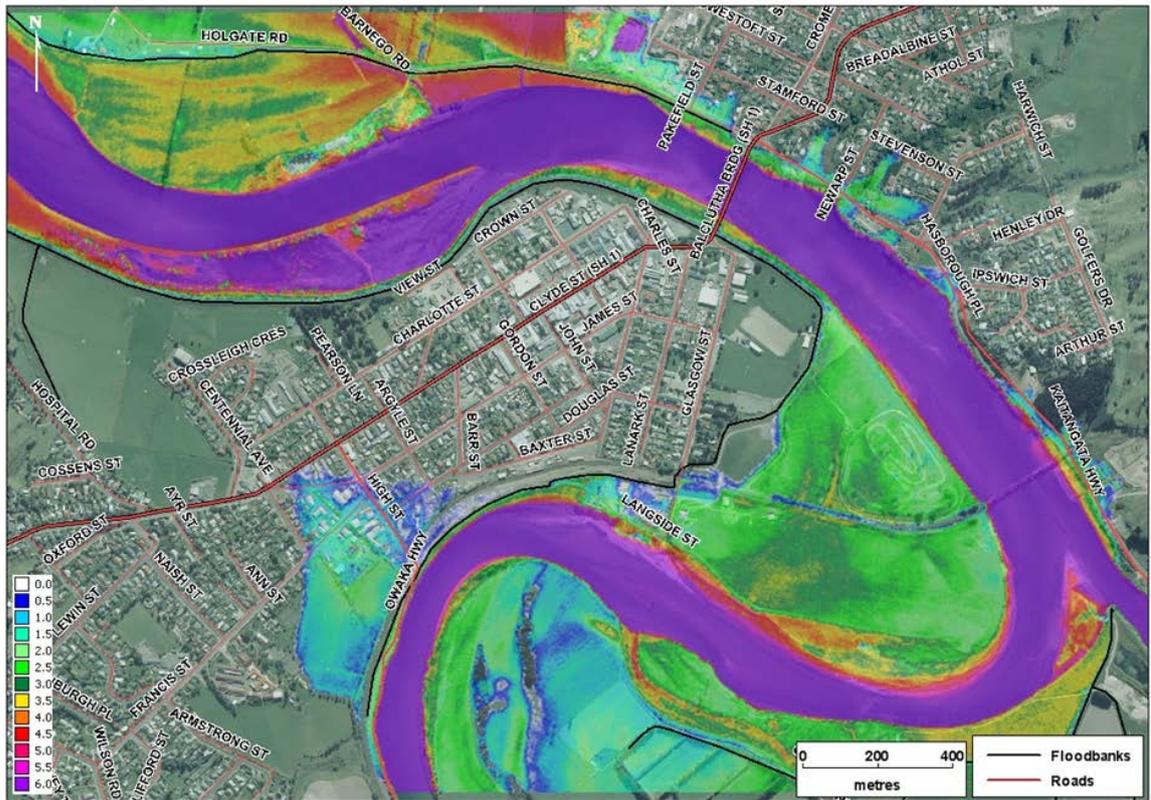
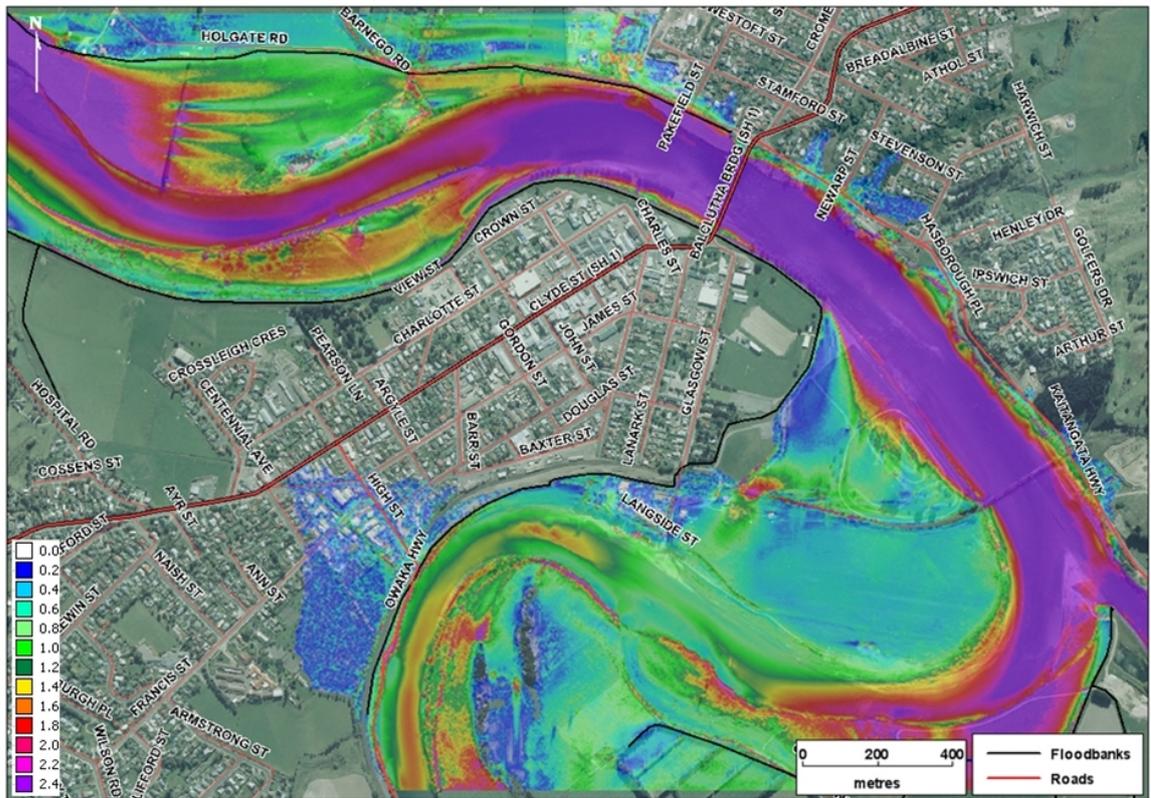
**Figure 4.20** Estimated flood depth (A) and velocities (B) in Balclutha associated with a 1:100-year flood (peaking at 5200 m<sup>3</sup>/s at Balclutha). Depth is in meters, relative to msl and velocity is in m/sec.

Flood modelling carried out by NIWA in 2005 indicates that during a 1:100-year flood (peaking at 5200 m<sup>3</sup>/s at Balclutha), the extent of inundation resulting from overtopping of the floodbank at the southern end of the township would be limited to that end of the town only – that is, to the vicinity of High Street and Francis Street (Figure 4.20). The depth of the overtopping floodwaters could reach up to 2 m - 2.5 m in lower areas (southern end of Balclutha) with the water velocity not exceeding 1 m/s (NIWA, 2005).

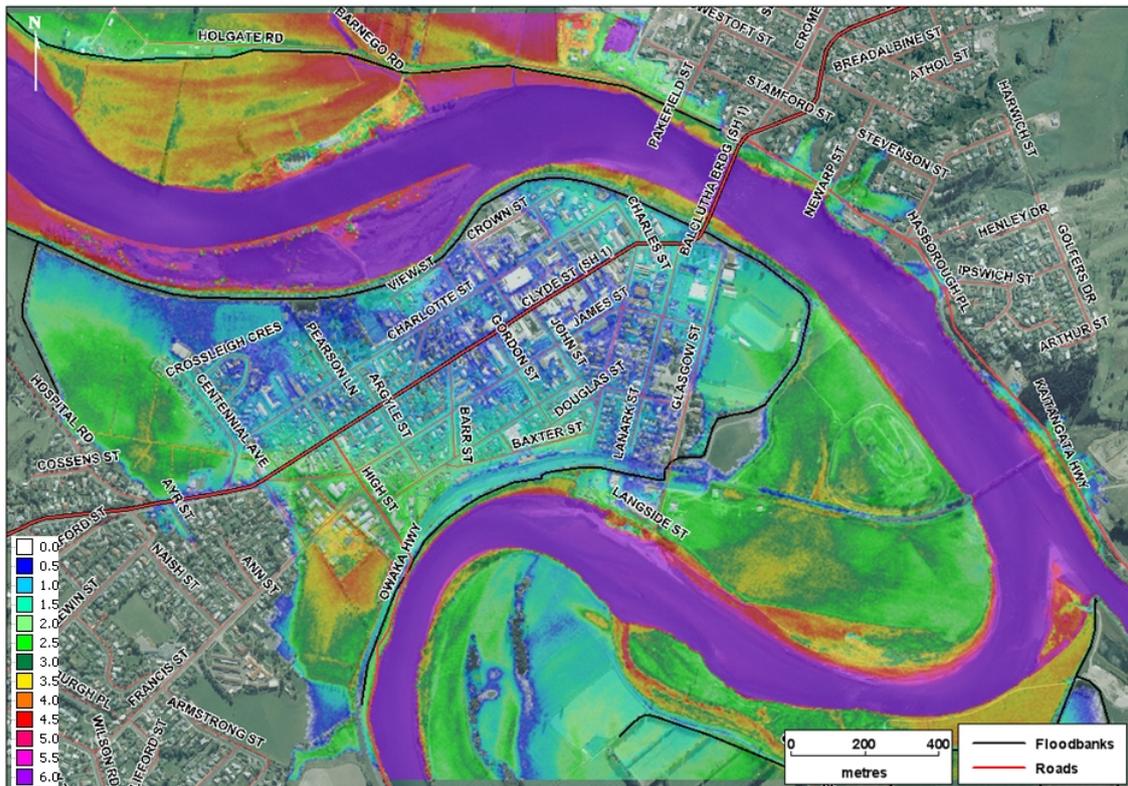
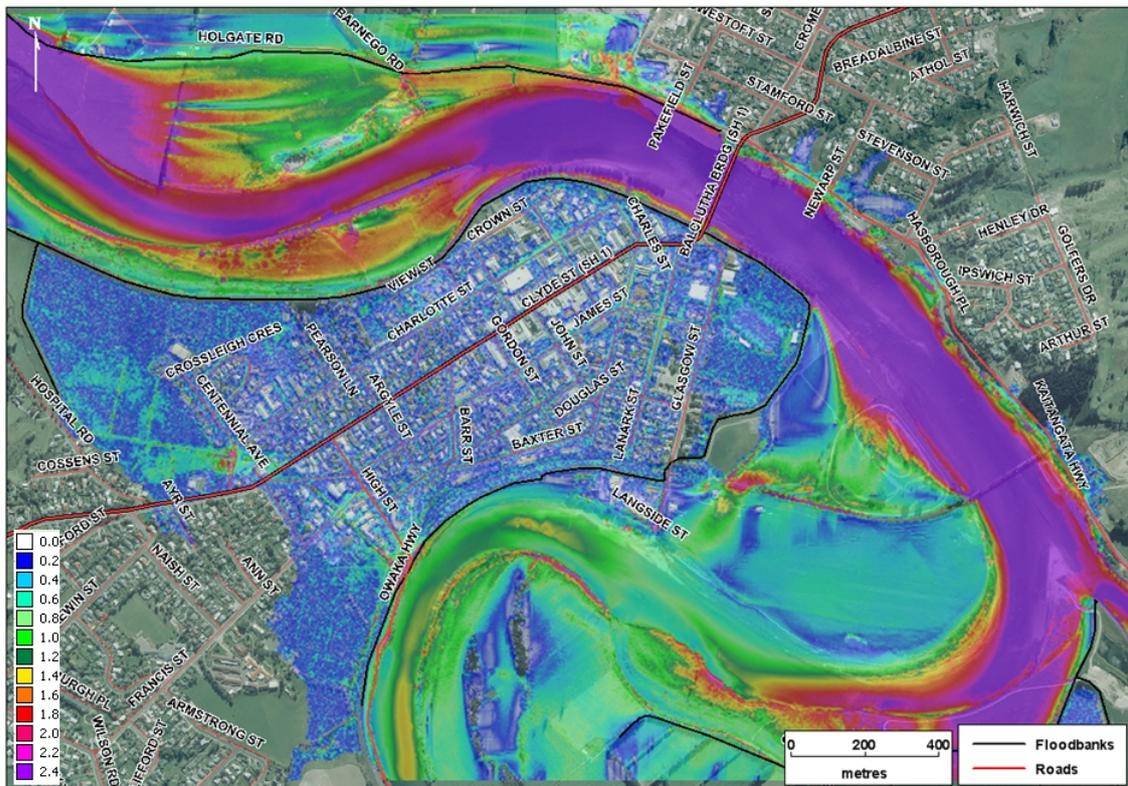
**Figure 4.21** Estimated flood depth (A) and velocities (B) in Balclutha associated with a 1:200-year flood (peaking at 5800 m<sup>3</sup>/s at Balclutha). Depth is in meters relative to msl and velocity is in m/sec.

Modelling of a 1:200-year flood event (peaking at 5800 m<sup>3</sup>/s at Balclutha) indicates that overtopping of the floodbank at the southern end of the town would result in widespread flooding of Balclutha township (Figure 4.21) with the depth of water reaching up to 1 m - 1.5 m, and possibly exceeding a depth of 3 m in the very low parts of the town. Water velocities would generally be less than 1 m/s, but could reach up to 2 m/s in the vicinity of High Street (NIWA, 2005).

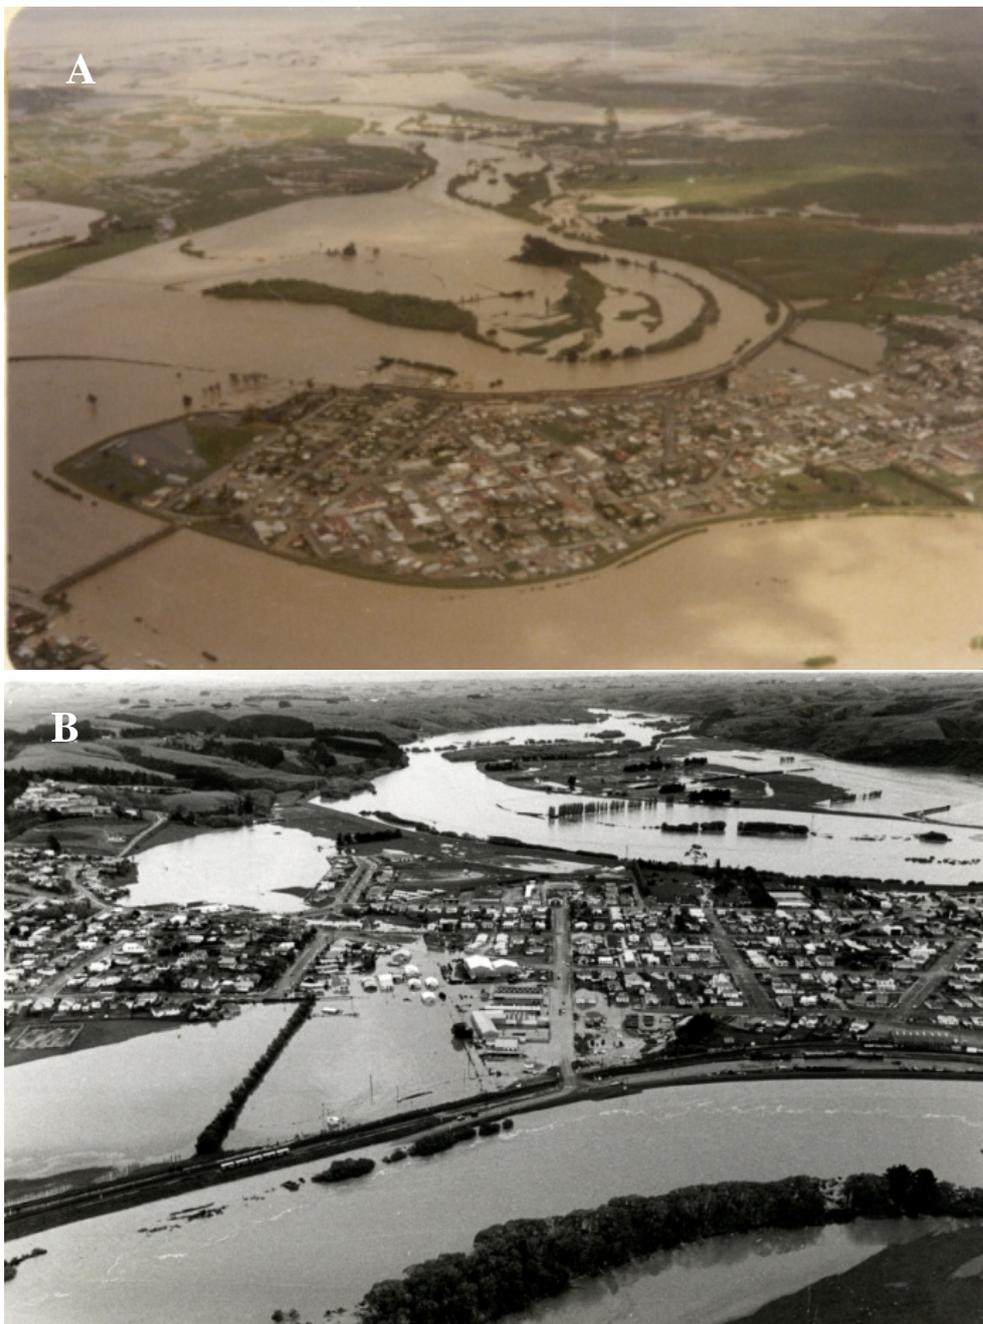
**Figure 4.22** Flooding in Balclutha during the October 1978 flood event (estimated peak flow of 4580  $\text{m}^3/\text{s}$  at Balclutha) (a) looking south. Note ponding behind the floodbank within Area 3. (b) Looking north. Note ponding from Hospital Creek and/or rainfall accumulation (not shown in a).

The Clutha River/Mata-Au flooded Area 3 extensively in the September 1878 flood (before any floodbanks had been constructed) and it was reported that the streets were covered by deep and fast flowing water with several houses having been swept away (Soil Conservation and Rivers Control Council, 1957). The low-lying ground to the south and west of the town flooded in October 1978, but probably due to the accumulation of localised rainfall and run-off from Hospital Creek (Figure 4.22).

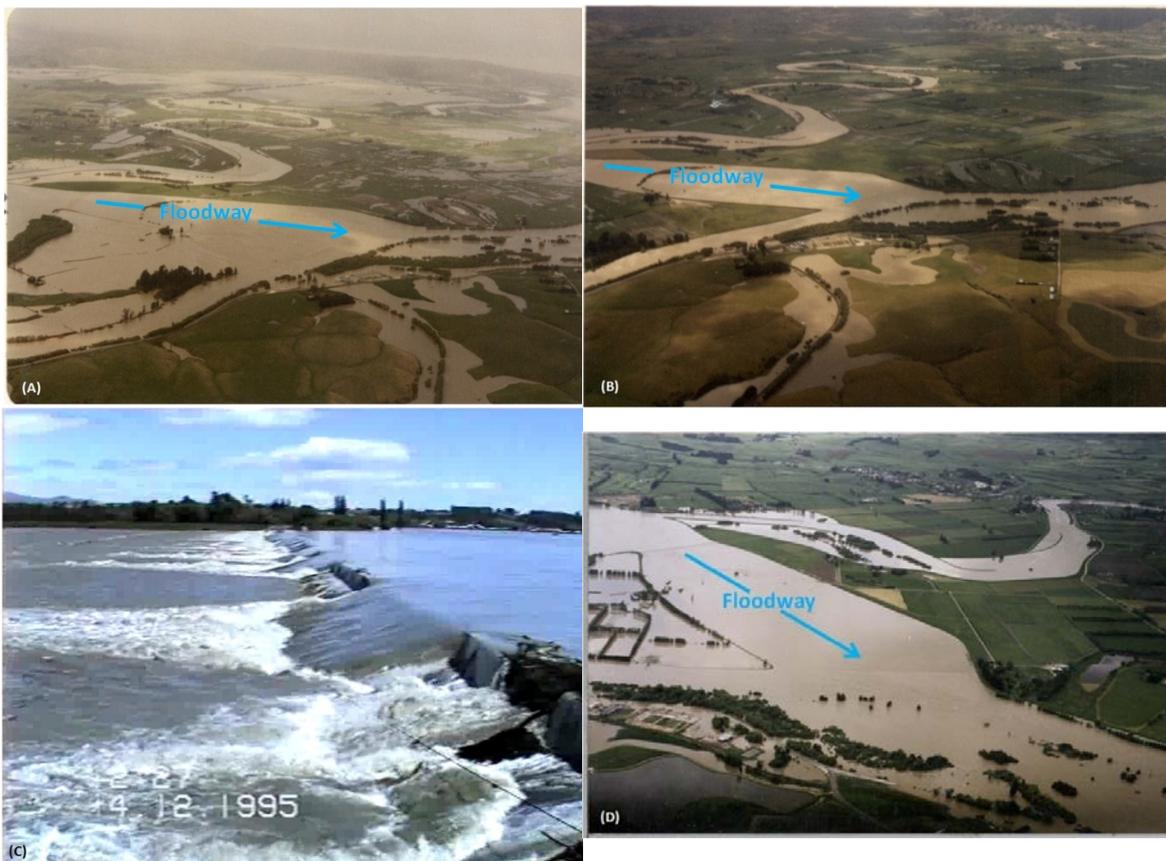
**Figure 4.23** The Lower Clutha Floodway operating during October 1978 (a), January 1980 (b), December 1995 showing the floodway gates partially dropped (c) and November 1999 (d) flood events.

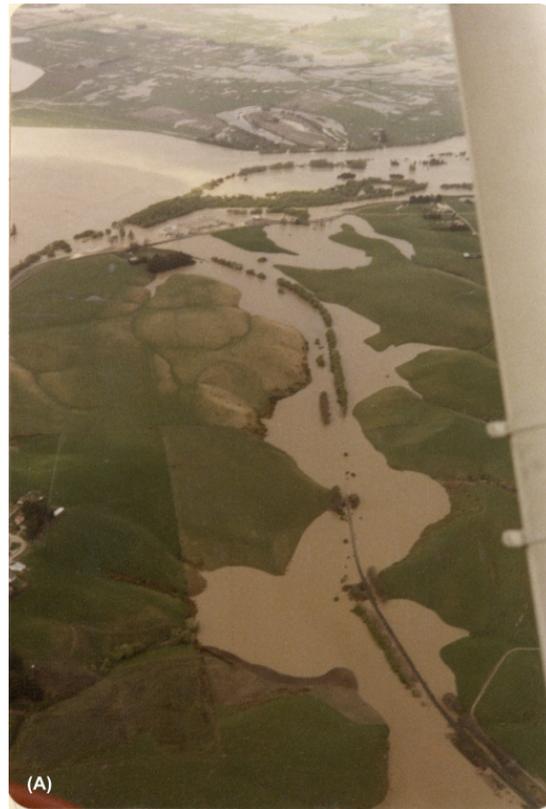
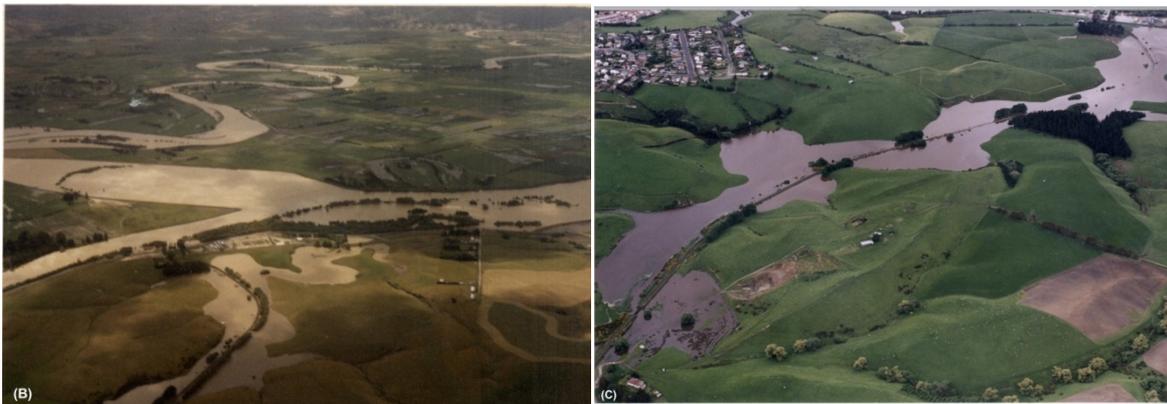
**Figure 4.24** Area 6 during the October 1978 (a), January 1980 (b) and November 1999 (c) flood events. The photos were not necessarily taken at the peak of the flooding.

Area 6 consists of the well-defined floodplain of the Toiro Stream between the toe of the hills and its confluence with the Koau Branch. Land-use within Area 6 involves mainly agricultural activities, including forestry. The upstream part of the Toiro Stream catchment (total area of 35 km<sup>2</sup>) is generally grassed rolling hills and the lower part is relatively flat with elevations ranging between 5 and 6 m above Mean Sea Level. The area closest to the Koau Branch is swampy. The Main South Railway Line embankment, set approximately 2 m above ground level, runs through Area 6 but is not considered to be a detrimental barrier to flood waters (see Figure 4.24). Area 6 is exposed to flooding from Toiro Stream and its tributaries and from localised rainfall accumulation. High water levels in the Koau Branch may exacerbate the flooding by impeding the stream discharge into the river. Floodwaters would then pond on the floodplain until the water level in the Koau Branch has dropped sufficiently to allow gravity drainage to resume. Although the Toiro Stream has been realigned in a number of locations with the last 800 m of the channel forming part of the Lower Clutha Drainage Scheme (ORC scheduled drain) there are no specific flood protection works to mitigate the flood hazard from the stream in this area. This area flooded in October 1978 (4580 m<sup>3</sup>/s at Balclutha), January 1980, (2770 m<sup>3</sup>/s) and November 1999 (4160 m<sup>3</sup>/s) flood events (Figure 4.24).

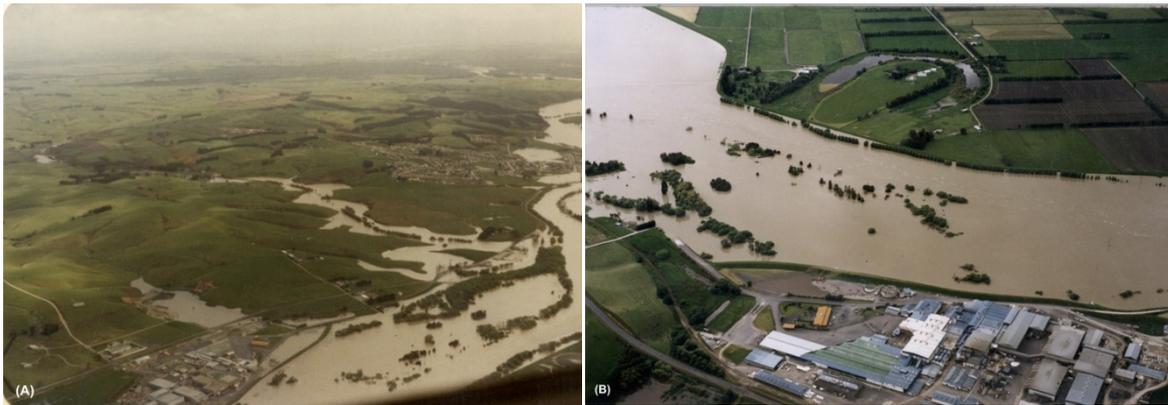
**Figure 4.25** Area 7 during the October 1978 (A, freezing works in the foreground), and November 1999 (B, freezing works in the foreground) flood events. The photos were not necessarily taken at the peak of the flood.

The low-lying parts of this area had very limited flooding in October 1978 ( $4580 \text{ m}^3/\text{s}$  at Balclutha), January 1980 ( $2770 \text{ m}^3/\text{s}$ ), and November 1999 ( $4160 \text{ m}^3/\text{s}$ ) that was due mainly to localised rainfall accumulation and overtopping of the drainage network (Figure 4.25).

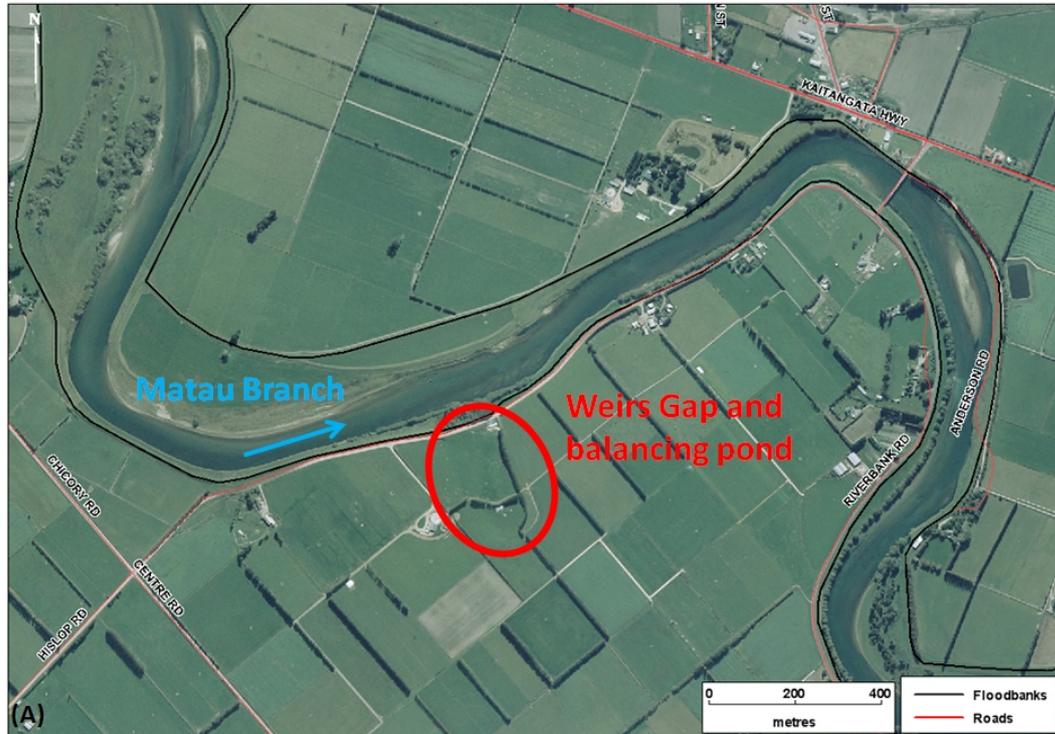
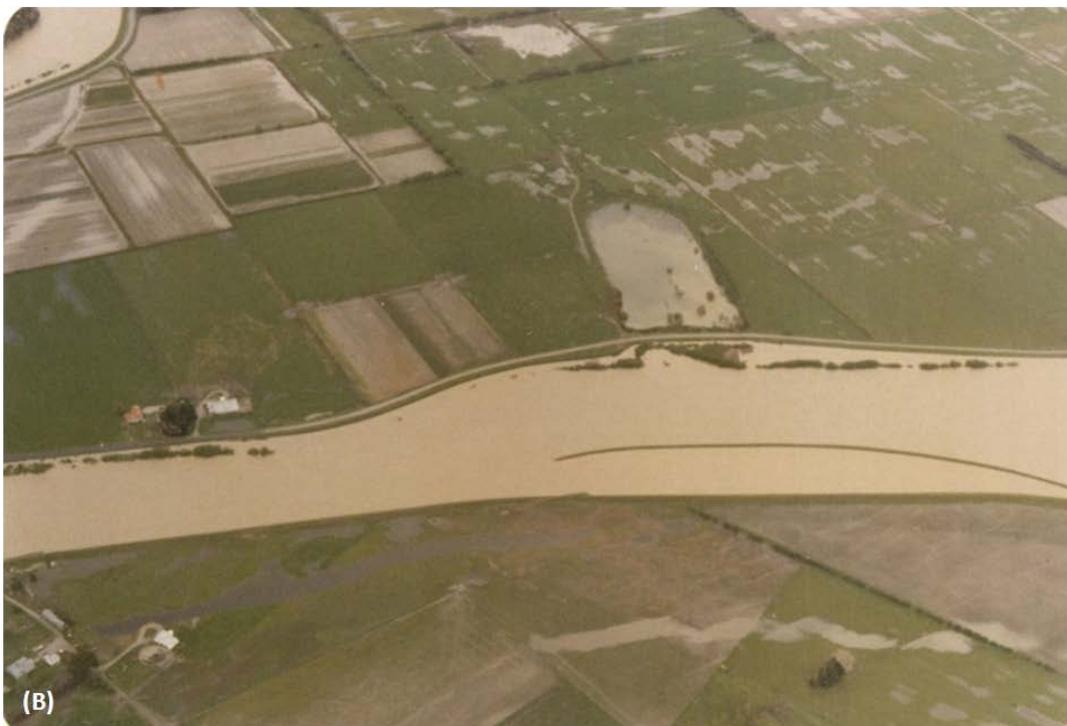
**Figure 4.25** Location of Weirs Gap (A) and Weirs Gap during the October 1978 flood event (B). Note the water from seepage under the floodbank ponding on the landward side of the floodbank in the balancing pond.

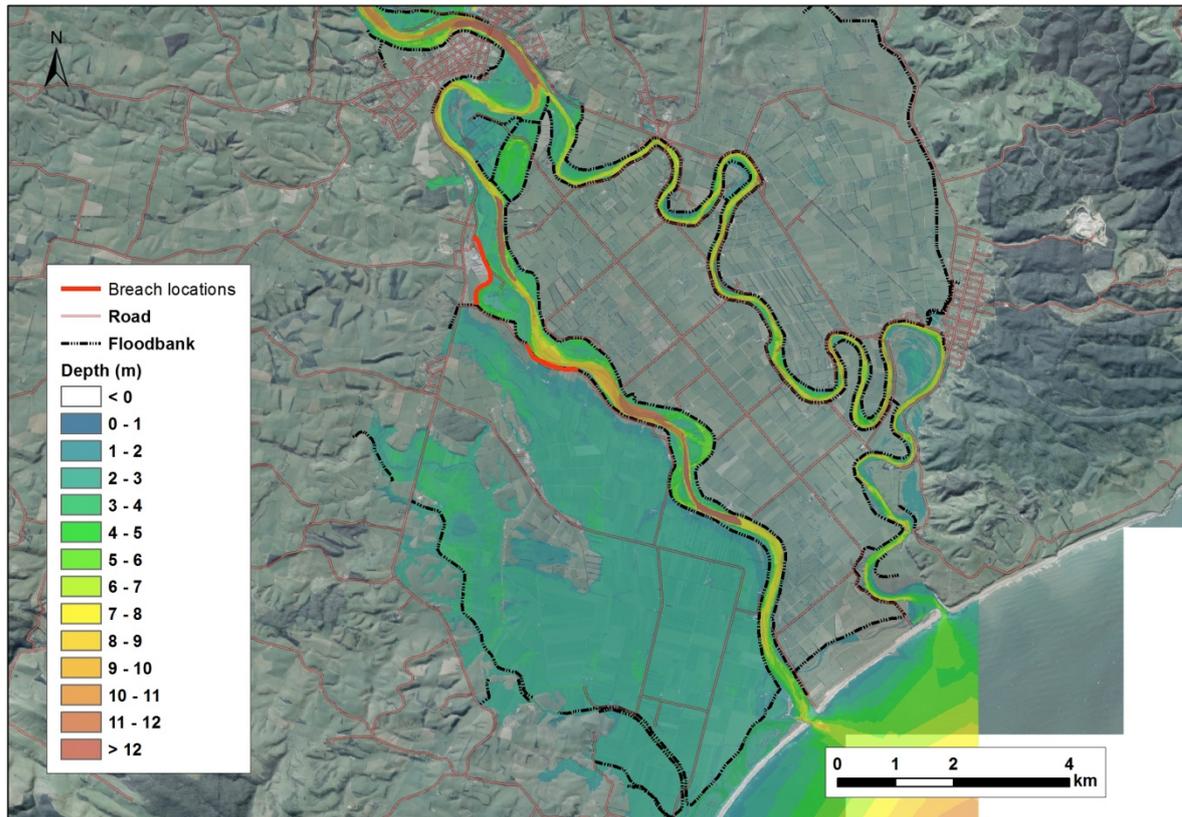
**Figure 4.26** Estimated flood depth in Inch Clutha associated with a flood peaking at  $5200 \text{ m}^3/\text{s}$  at Balclutha (1:100 year-flood) and with two Koau floodbank breaches. Depth is in meters relative to msl.

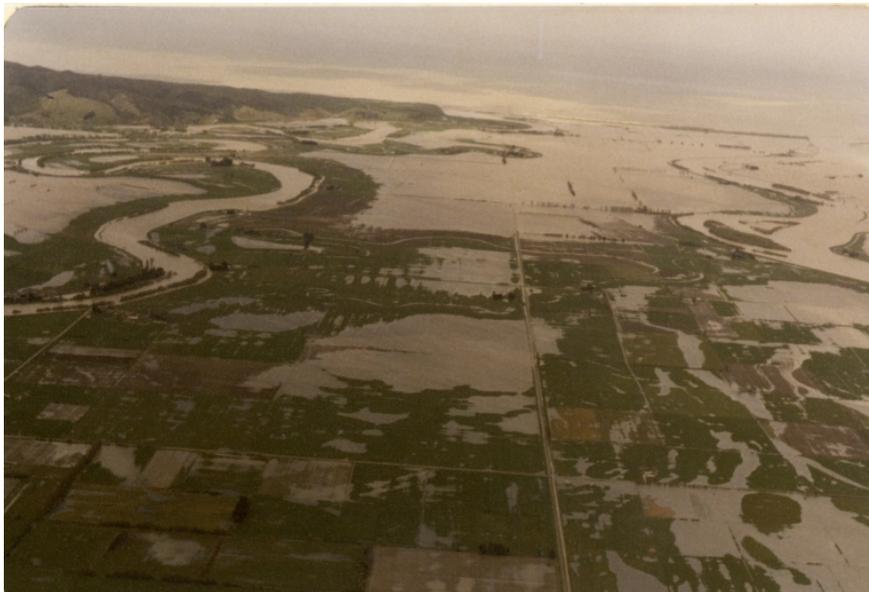
**Figure 4.27** Area 8 during the October 1978 flood event. Looking toward the sea with lower Inch Clutha in the foreground, Matau Branch on the left and Koau Branch on the right. The photos were not necessarily taken at the peak of the flood.

Area 8 has an extensive drainage network complemented by two pump stations (Smith Road, on the Koau Branch, and Rutherfords, on the Matau Branch). The pumps are used when high river levels prevent gravity drainage. The parts of Area 8 close to the sea were extensively flooded in October 1978 (4500 m<sup>3</sup>/s at Balclutha) due to overtopping of the lower section of the Koau true left floodbank and due to the uncompleted floodbanks on the Matau Branch (Figure 4.28). The flood protection scheme was not fully operative during that flood event and the overtopping was also aggravated by the Koau Mouth being offset (OCB, 1979).

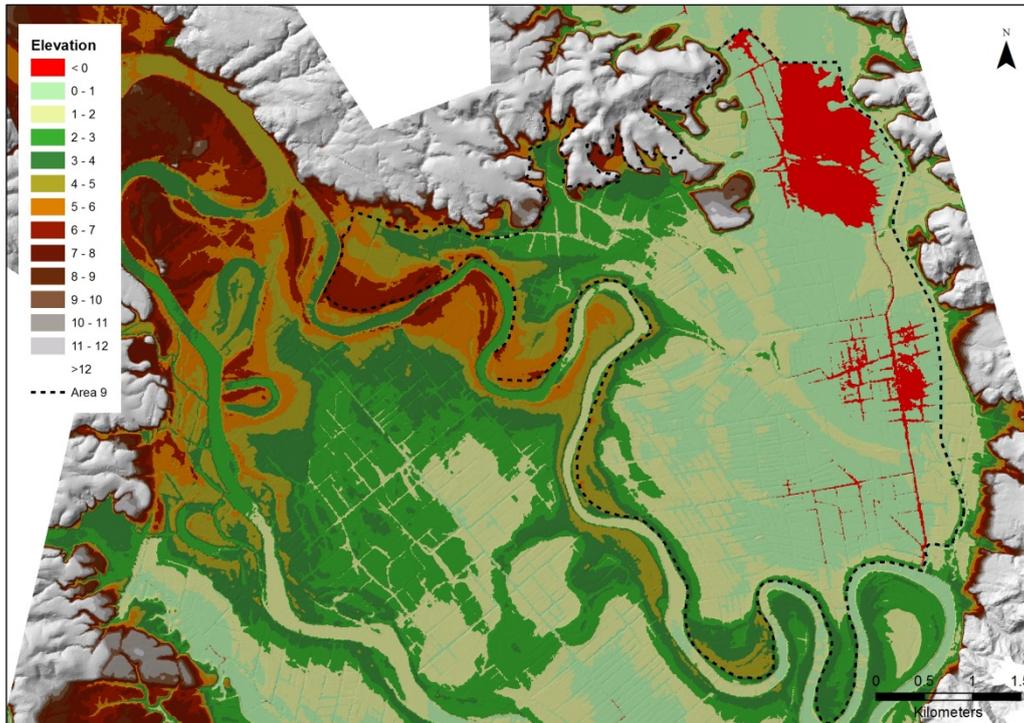
**Figure 4.28** Land elevation of Area 9 derived from LiDAR data. Land elevation is in meters relative to msl.

events that overload the drainage network. The land in this area generally falls away from the Matau Branch to the toe of the hills (Figure 4.29) with a minimal gradient and elevations ranging from between 3 m to 6 m on the western side, to between 3 m to less than sea level for the rest of the area. The land below sea level (shown in red on Figure 4.29) corresponds to the land that has been reclaimed from Lake Kaitangata (now completely drained) and of parts of Lake Tuakitoto.

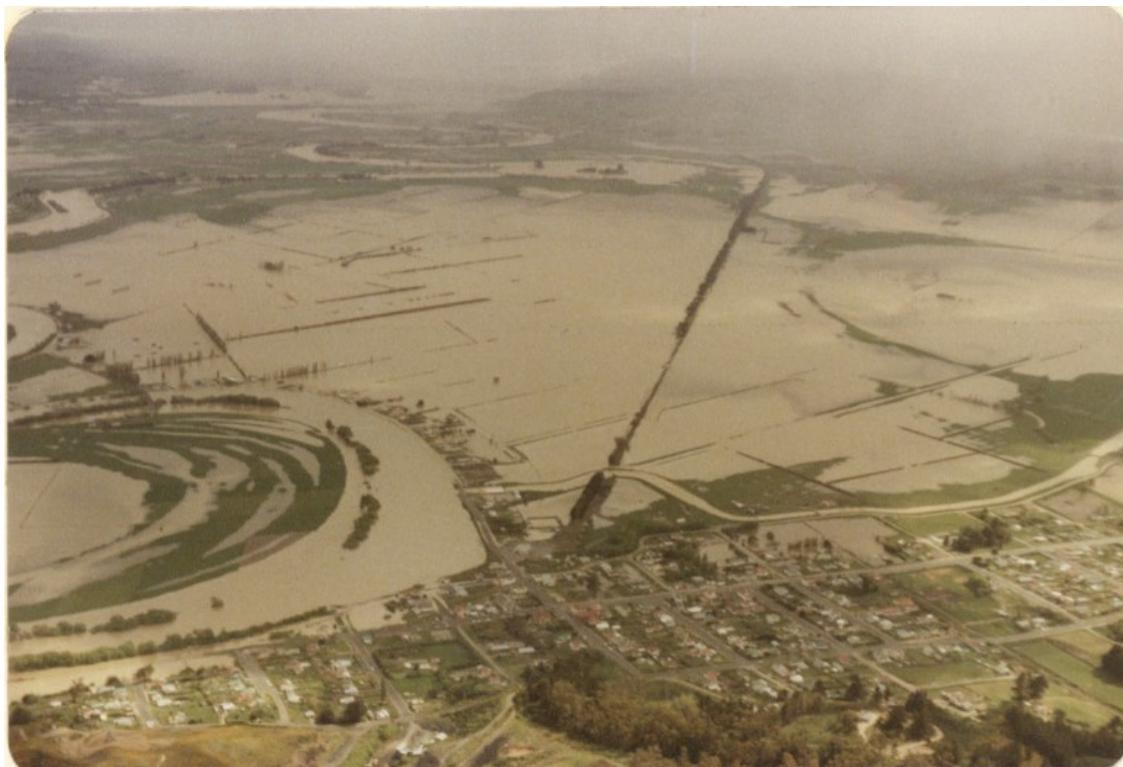
**Figure 4.29** Area 9 during the October 1978 flood event (looking towards Stirling) Matau Branch on the left, Old Kaitangata Railway and Kaitangata Contour Channel in the foreground). The photo was not necessarily taken at the peak of the flood.

Breaches of the true right floodbanks on the Matau Branch, or of the Koau Branch floodbanks, could result in significantly reduced inundation depths in Area 9. This area was extensively flooded in October 1978 (4580 m<sup>3</sup>/s at Balclutha) (Figure 4.30). In November 1999 (4160 m<sup>3</sup>/s at Balclutha) no water from the Matau Branch entered the area, although, low-lying parts were inundated, most likely due to localised rainfall accumulation and overloading of the drainage network.

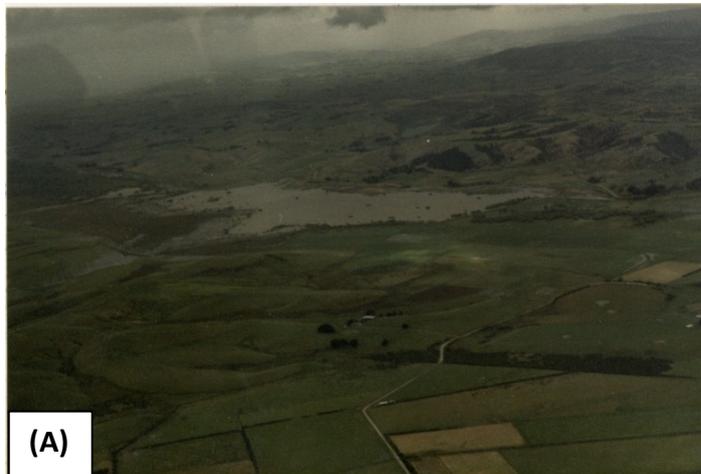
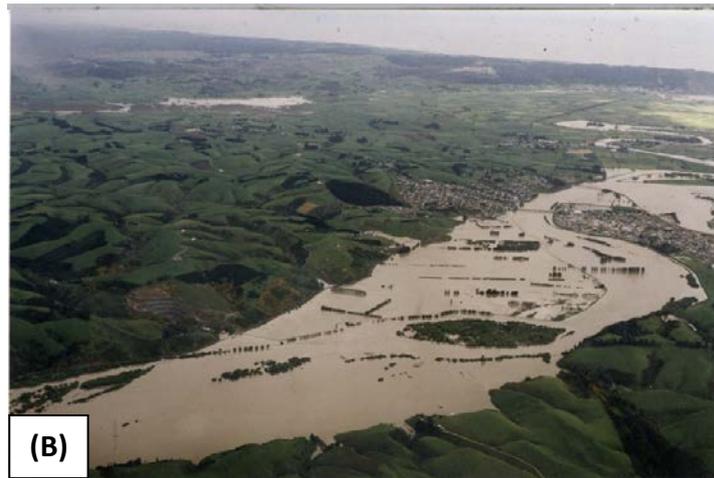
**Figure 4.30** Area 10 during the January 1980 (A) and November 1999 (B) flood events. Area 10 left background in B.

Limited flood protection and drainage works provide some mitigation against the flood hazard from the hill catchment streams in this area. Those works mainly comprise privately owned and maintained contour channels and drains designed to intercept and divert hill catchment flows away from the low-lying areas. A diversion channel situated at the north-western edge of the wetland complex diverts Stony Creek and Lovells Stream directly into the main body of Lake Tuakitoto. Much of the flat land on either side of Frasers Stream is subject to inundation (Otago Regional Council, 1999), including buildings on Station Road, and several roads including parts of SH1. Parts of Area 10 were flooded in October 1978 (4580 m<sup>3</sup>/s at Balclutha), January 1980, (2770 m<sup>3</sup>/s) and November 1999 (4160 m<sup>3</sup>/s) flood events (Figure 4.31).

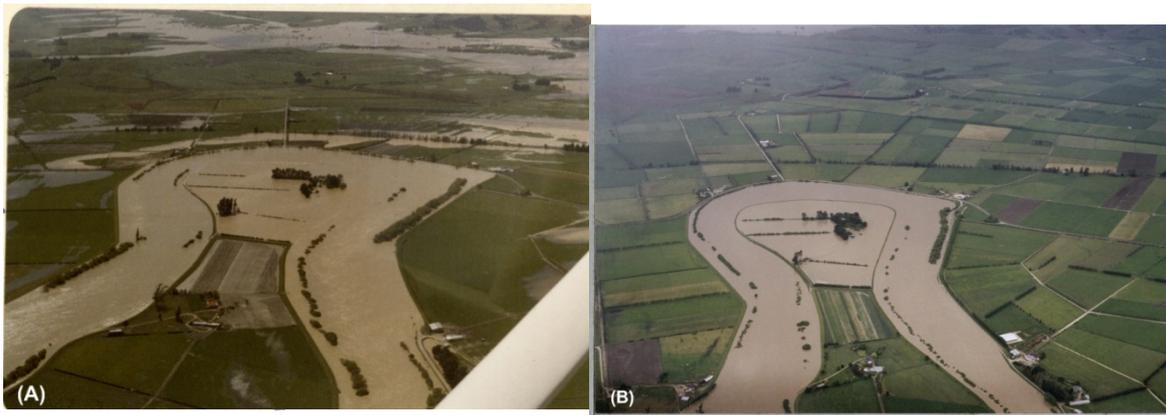
**Figure 4.32** Area 11 during the October 1978 (A) and November 1999 (B) flood events. The photos were not necessarily taken at the peak of the flood.

It is estimated that, during a 1:50-year flood (4300 m<sup>3</sup>/s, at Balclutha), flooding would be widespread over Area 11, where the depth of water could reach 1 m, with a velocity not exceeding 1 m/s (NIWA, 2005). During a 1:100-year flood, the depth of water in this area could reach up to 1.5 m, in low-lying parts, with a velocity of just over 1 m/s (NIWA, 2005). This area was flooded in the October 1978 (4580 m<sup>3</sup>/s at Balclutha) and November 1999 (4160 m<sup>3</sup>/s at Balclutha) flood events (Figure 4.32).

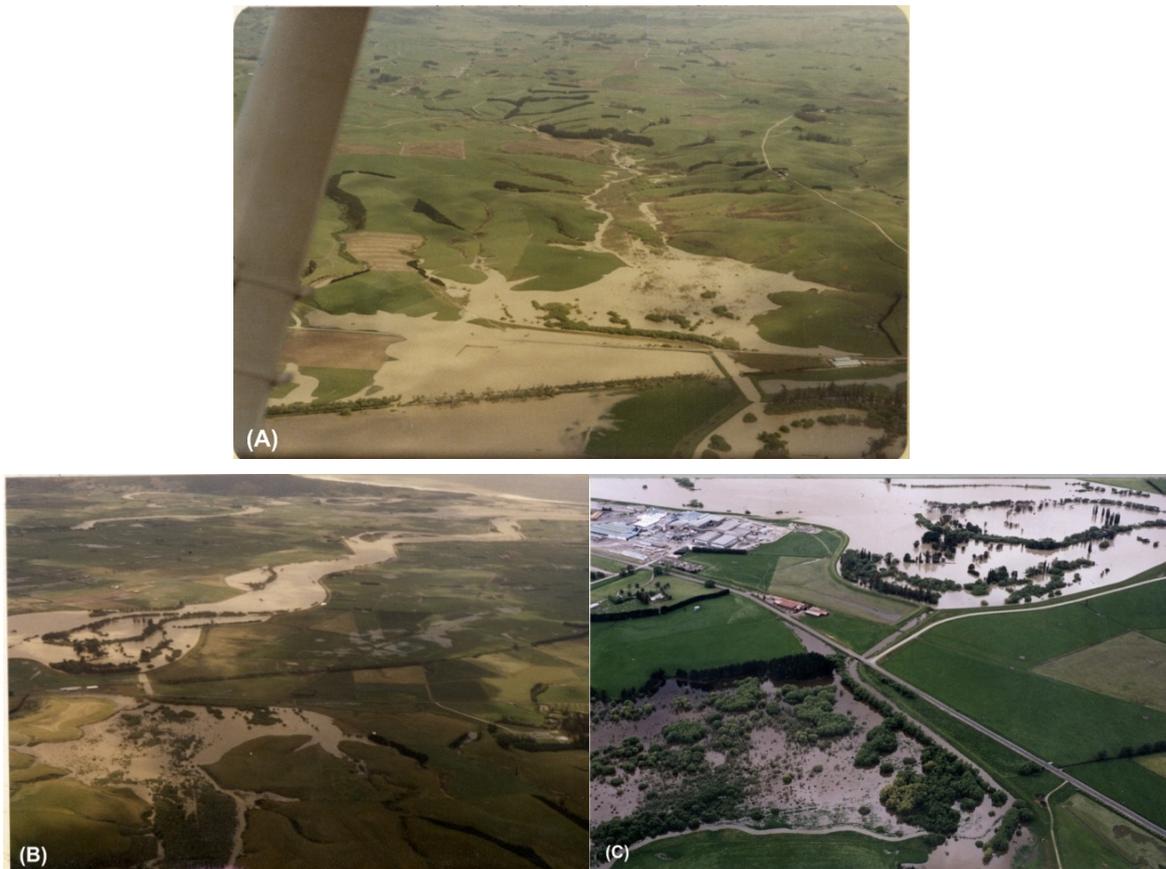
**Figure 4.33** Area 12 during the October 1978 (A) January 1980 (B) and November 1999 (C) flood events. The photos were not necessarily taken at the peak of the floods.

flooded in October 1978 (4580 m<sup>3</sup>/s at Balclutha), January 1980, (2770 m<sup>3</sup>/s) and November 1999 (4160 m<sup>3</sup>/s) flood events (Figure 4.33)

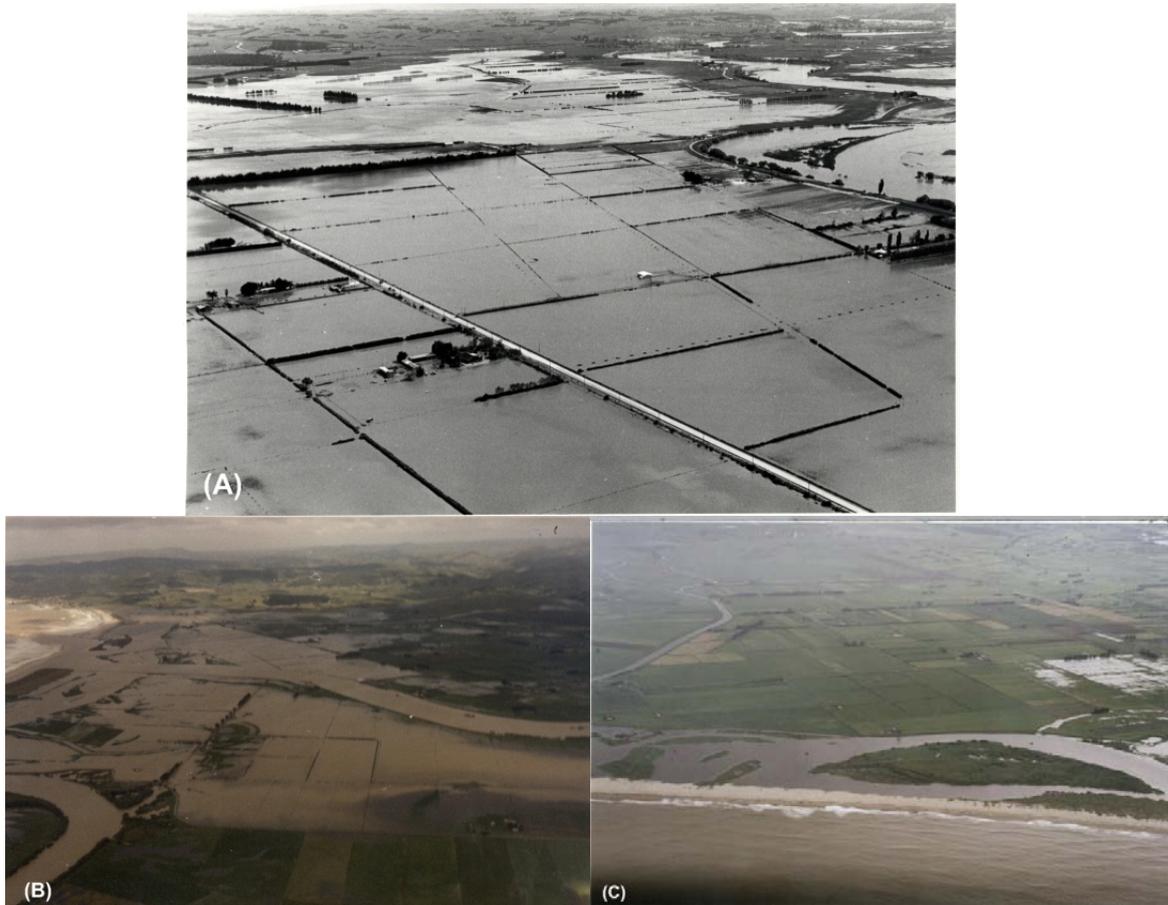
**Figure 4.34** Area 13 during the flood events of: (A) October 1978, Koau Branch on the right looking upstream; (B) January 1980, Inch Clutha in the foreground and Paretai in the background; and (C) November 1999, the Puerua River Contour Channel on the left. The photos were not necessarily taken at the peak of those floods.

Area 13 was extensively flooded in October 1978 (4580 m<sup>3</sup>/s at Balclutha) due to large breaches in the floodbank at McNutt's Break (opposite Telegraph Road, Inch Clutha) and at Botting's Bend (opposite Renton Road, Inch Clutha). Flooding was also observed in January 1980 (2770 m<sup>3</sup>/s at Balclutha). In February 1991 (2570 m<sup>3</sup>/s at Balclutha), floodwaters overtopped the Puerua Contour Channel and flowed into the area, but no water from the Koau Branch entered the area in that event. Also, in November 1999 (4160 m<sup>3</sup>/s at Balclutha), no water from the Koau Branch entered Area 13 but low-lying parts were inundated, probably from localised rainfall accumulation and drainage

network overloading (Figure 4.34). Under-seepage has been observed in the Factory Road ponds (Paretai) in previous floods indicating a potential risk of piping failure.

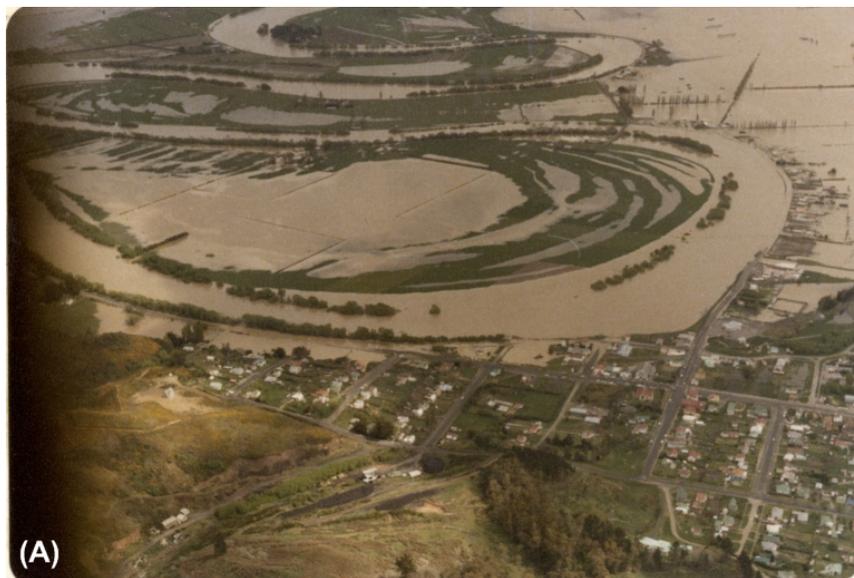
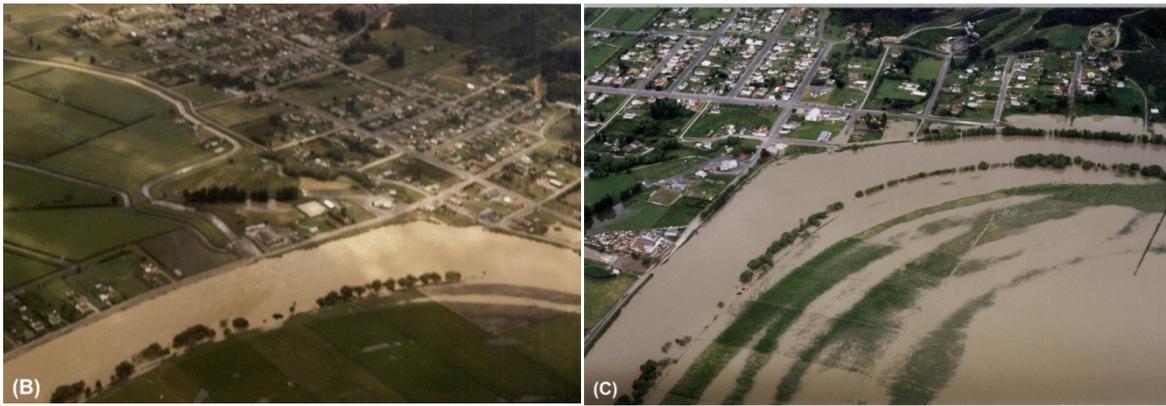
**Figure 4.35** Area 14 during the (A) October 1978; (B) January 1980 and (C) November 1999 flood events. The photos were not necessarily taken at the peak of the flood

This area was flooded in October 1978 (4580 m<sup>3</sup>/s at Balclutha), January 1980 (2770 m<sup>3</sup>/s) and November 1999 (4160 m<sup>3</sup>/s). However, that flooding was most likely caused by local rainfall accumulation and water from the small hill catchments to the east (Figure 4.35).

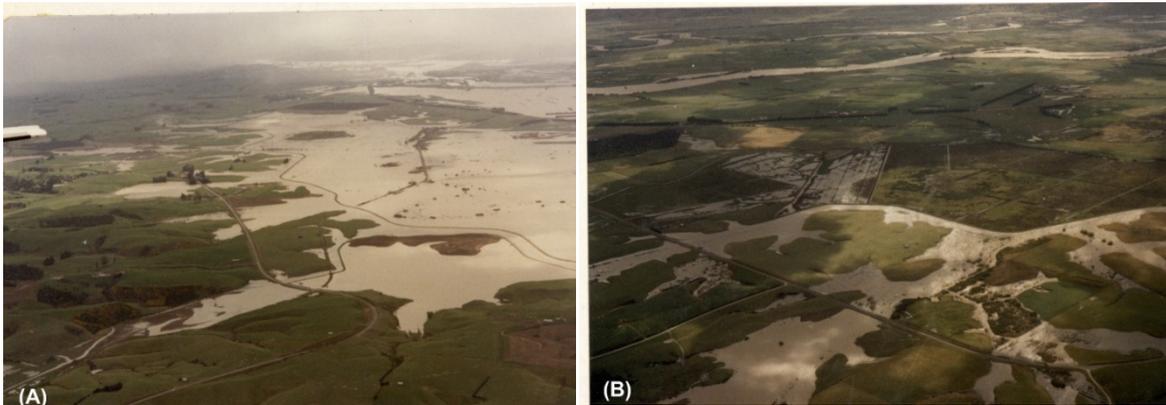
**Figure 4.36** Areas 15, 16, 18 and 20 during (A) the October 1978 and (B) January 1980 flood events. The photos were not necessarily taken at the peak of the floods.

Parts of these areas flooded in October 1978 (4580 m<sup>3</sup>/s at Balclutha), January 1980 and, to a limited extent, in November 1999 (Figure 4.36) where the flooding was probably caused by local rainfall accumulation. In October 1978 water from the Koau Branch impeded the outlet of the Puerua Contour Channel and flood water back-flowed up the Puerua Contour Channel and flooded these areas.
