# Natural Hazards on the Clutha Delta, Otago

May 2016

## Executive summary

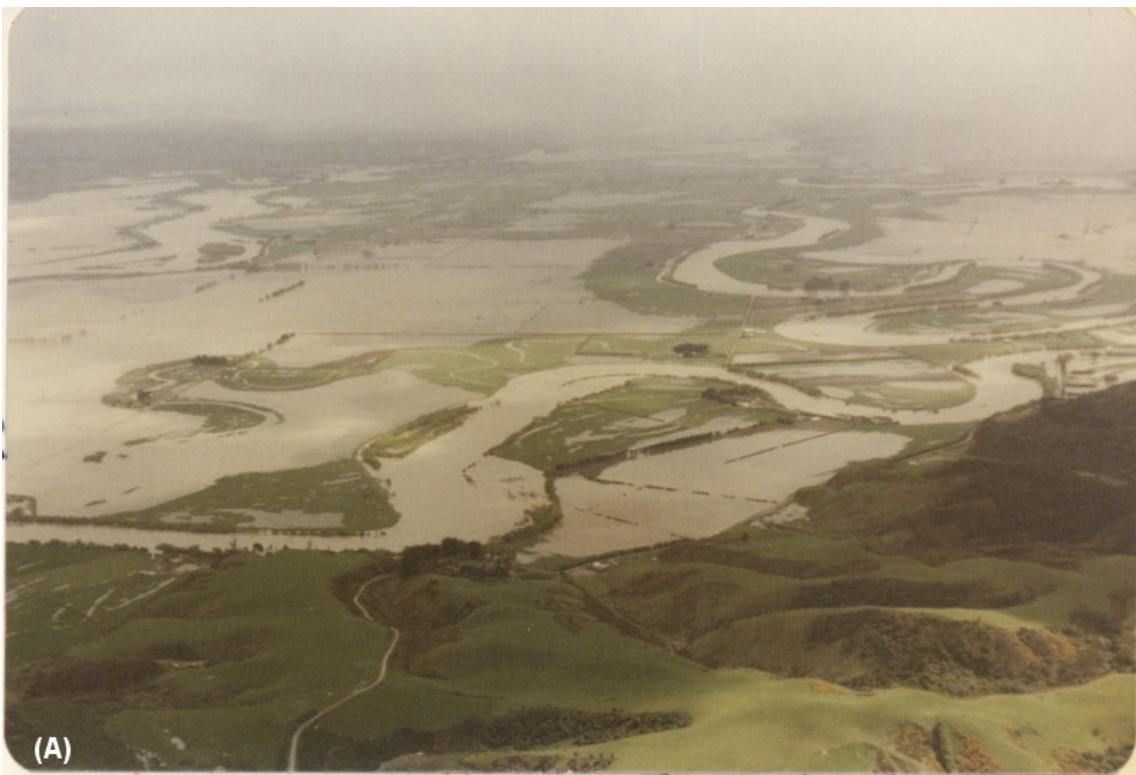
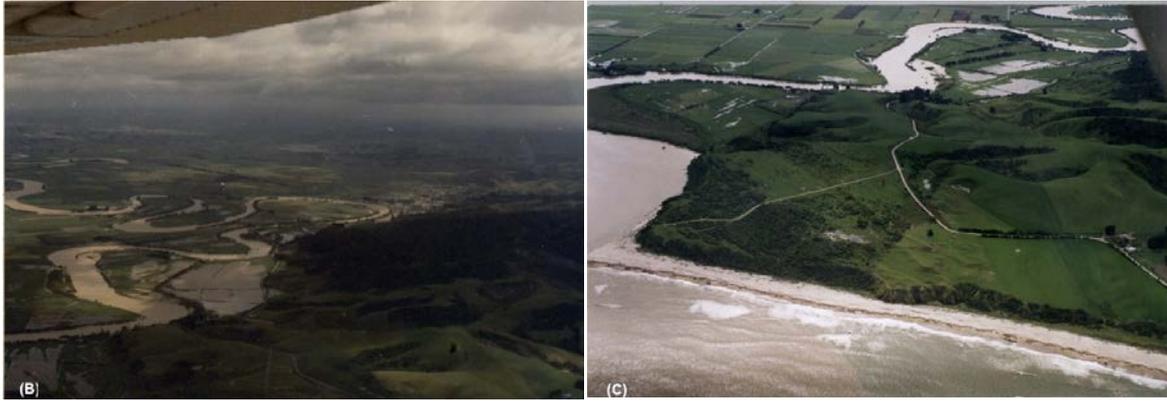
**Figure 4.37** Area 17 during the (A) October 1978; (B) January 1980 and (C) November 1999 flood events. The photos were not necessarily taken at the peak of the flood.

Area 17 was extensively flooded in October 1978 (4580 m<sup>3</sup>/s at Balclutha), and to a lesser extent in November 1999 (4160 m<sup>3</sup>/s at Balclutha) (Figure 4.37). The flooding observed in January 1980 (2770 m<sup>3</sup>/s) was probably from water overtopping the Matau Branch (true left bank) upstream of Area 17. Area 19 was also flooded during these events, but to a lesser degree, and probably mainly due to rainfall accumulation in the lower-lying areas.

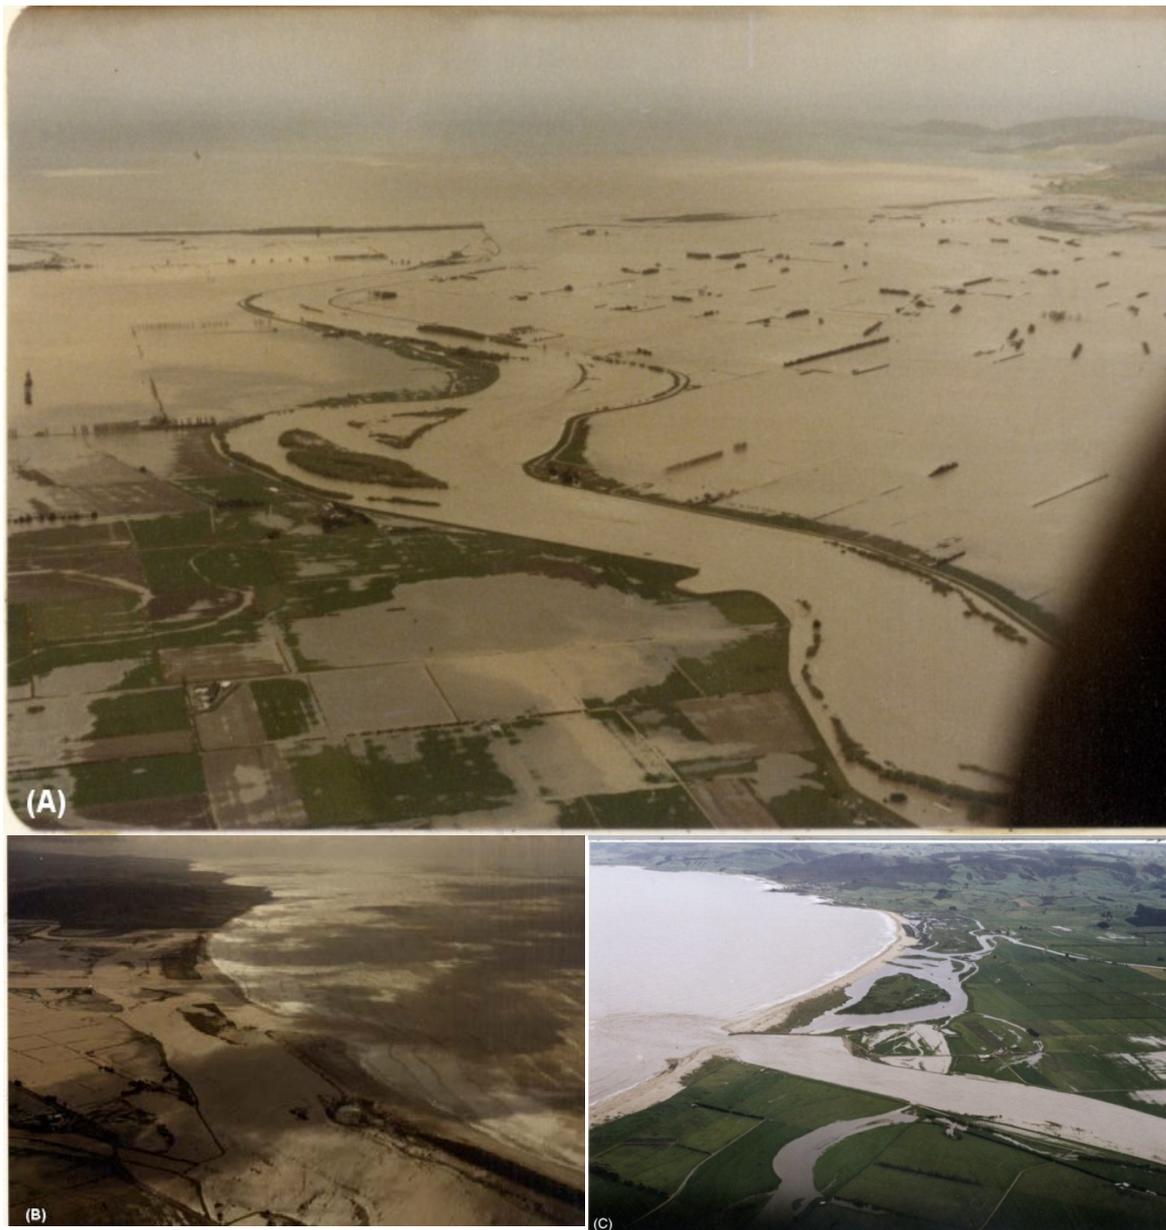
**Figure 4.38** Area 21 during (A) October 1978, Area 21 is in the background; (B) January 1980; (C) November 1999 flood events. The photos were not necessary taken at the peak of the flood.

The main sources of the river flood hazard for Area 21 are the Clutha River/Mata-Au (both branches) and the Puerua River (including the Puerua River Contour Channel). But, the area is also exposed to inundation from elevated sea levels - tides, storm surges and tsunamis (refer to Section 6 and ORC, 2012 for more details). There is no specific protection provided against these flood hazards, so the area is frequently inundated (Figure 4.38). However, the sand dunes provide some protection against elevated sea levels.

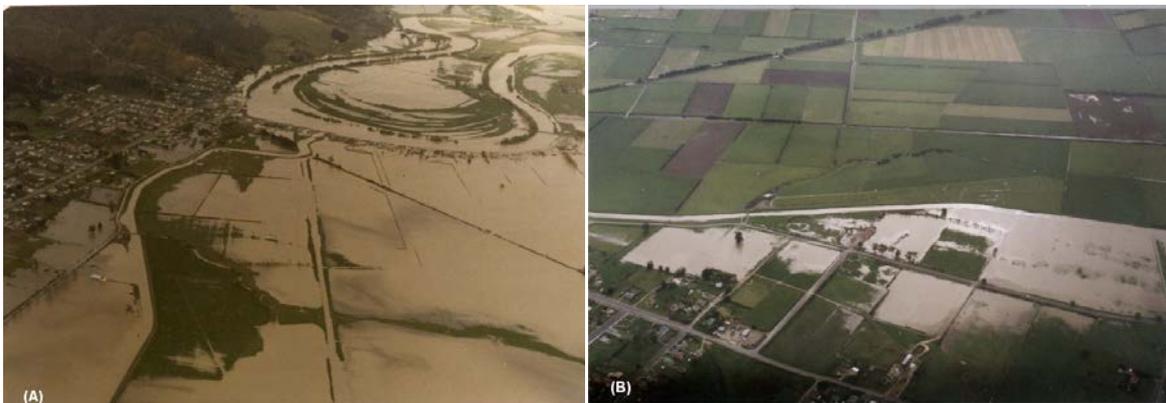
**Figure 4.39** Area 22 during (A) the October 1978 flood, with Area 22 to the left foreground; (B) the November 1999 flood. The photos were not necessarily taken at the peak of those flood events.

The area has no specific flood protection measures in place and it was extensively flooded in October 1978 and in November 1999 (Figure 4.39).

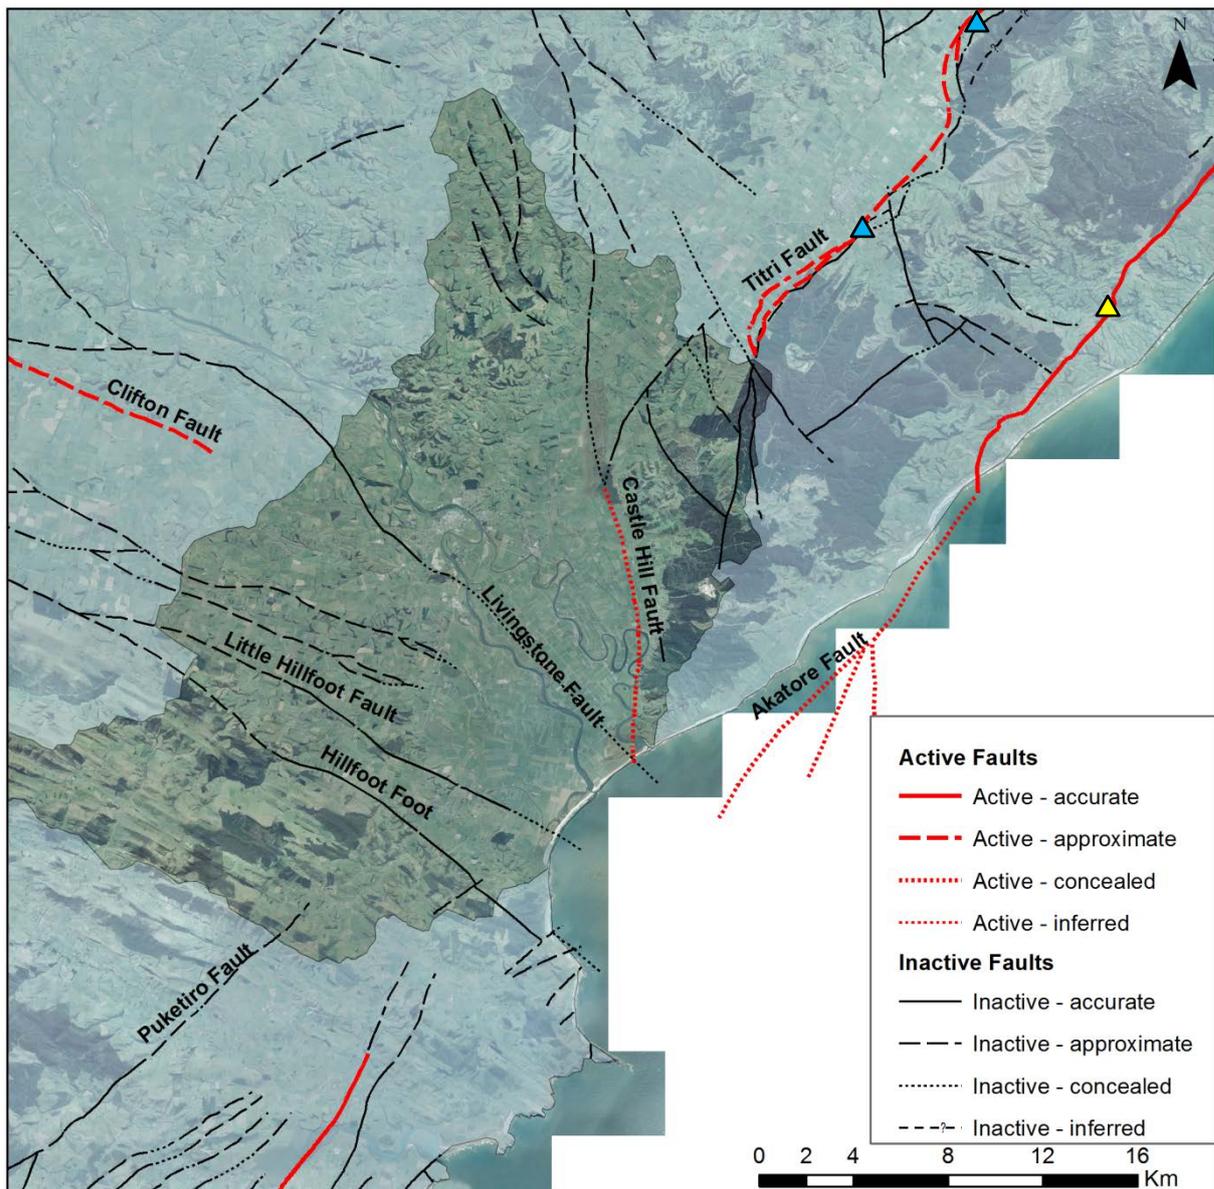
**Figure 5.1** Faults in the vicinity of the Clutha Delta (GNS Science, 2012; GNS Science 1996). Active faults are shown in red and are defined as faults that have experienced a major rupture in the past 100,000 years. Triangles show location of paleoseismic trenching studies carried out in 2016, funded by EQC grants.

The Clutha Delta is surrounded by a number of active and inactive fault systems (Figure 5.1). The northwest-southeast trending Livingstone, Castle Hill and Hillfoot Faults traverse across the wider Clutha Delta Catchment. The Clifton Fault is also located to the immediate north west of this area. Of these locally situated faults, only the Clifton and Castle Hill faults are considered active<sup>11</sup>.

The Livingstone Fault dissects the centre of the Clutha Delta and marks the boundary between the Dun Mountain-Maitai and Caples terranes<sup>12</sup> (Bishop and Turnbull, 1996) (see Figure 3.1 for geological terrane boundaries). While shown as inactive in Figure 5.1, any possible evidence of Quaternary movement is concealed beneath the Inch Clutha floodplain (Barrell *et al.*, 1998).

Deep and shallow surveys of the Akatore Fault system have identified a number of faults running parallel with it. Like the Akatore Fault, these faults strike northeast-southwest and dip south-eastward (Litchfield and Norris, 2000).<sup>15</sup> A series of faults splinter from the Akatore Fault, just south of Toko Mouth. These can be seen to the east in Figure 5.1.

The Titri Fault system<sup>17</sup> is located to the east of the Lower Clutha Delta study boundary (Figure 5.1). The south-east dipping reverse fault has a recurrence interval of between 70-80,000 years and last ruptured about 40-70,000 years ago (Opus, 2005; Norris and Nicolls, 2004). The alluvial fans located along the Titri Fault scarp provide clues to the historical movements of this fault. Deformation of older fans and fan deposits suggest that Quaternary movement has occurred along this fault. The absence of any deformation of the youngest alluvial fans, as well as a continuous profile of Waiholo sand/silt across the master fault (on the lower Taieri Plains) further suggests that no Holocene<sup>18</sup> activity has occurred along the fault.

EQC has funded two paleoseismic trenching investigations on the Titri Fault that aim to identify the timing of recent events on the fault (green triangles in Figure 5.1 show trench locations). Results of this study are due out in 2017. For Dunedin City (located approximately 70 km northeast of the Clutha Delta), the Titri Fault has been described as a less likely earthquake source than the Akatore and Alpine faults (Glassey et al., 2003).

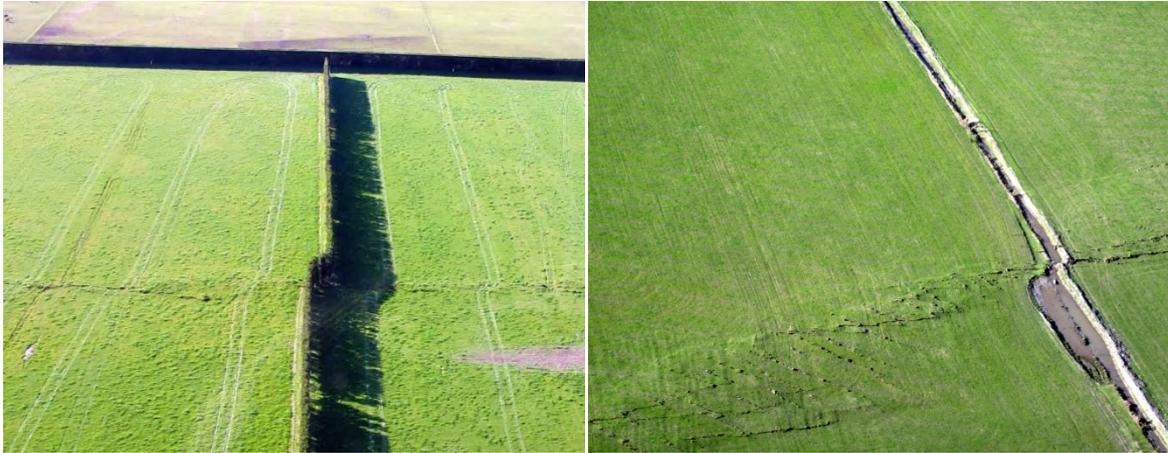
**Figure 5.2** Example of surface-fault rupture on the Canterbury Plains after the  $M_w$  7.1 Darfield earthquake, in September 2010. An average horizontal displacement of 2.5m was recorded along this fault (Quigley, *et al.*, 2011). (Photograph source, GNS Science).

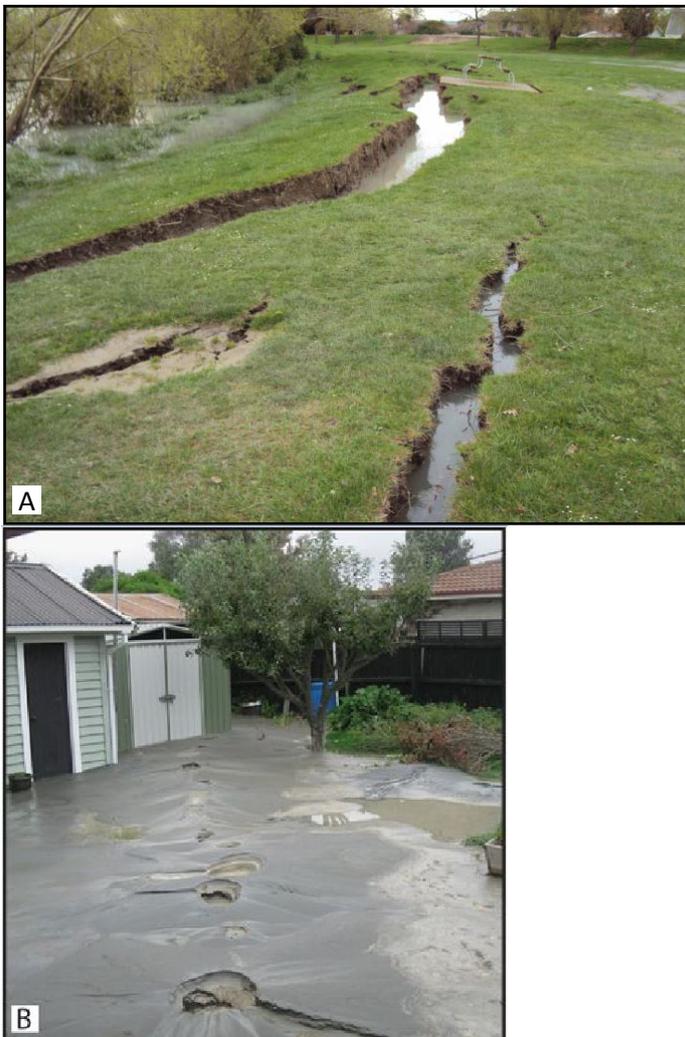
**Figure 5.3** a) Lateral spreading on the true-left bank of the Kaiapoi River, after the Christchurch magnitude 6.3 earthquake. b) Sand boils in Avonside after the Christchurch earthquake in February 2011 (after Quigley *et al.*, 2013).

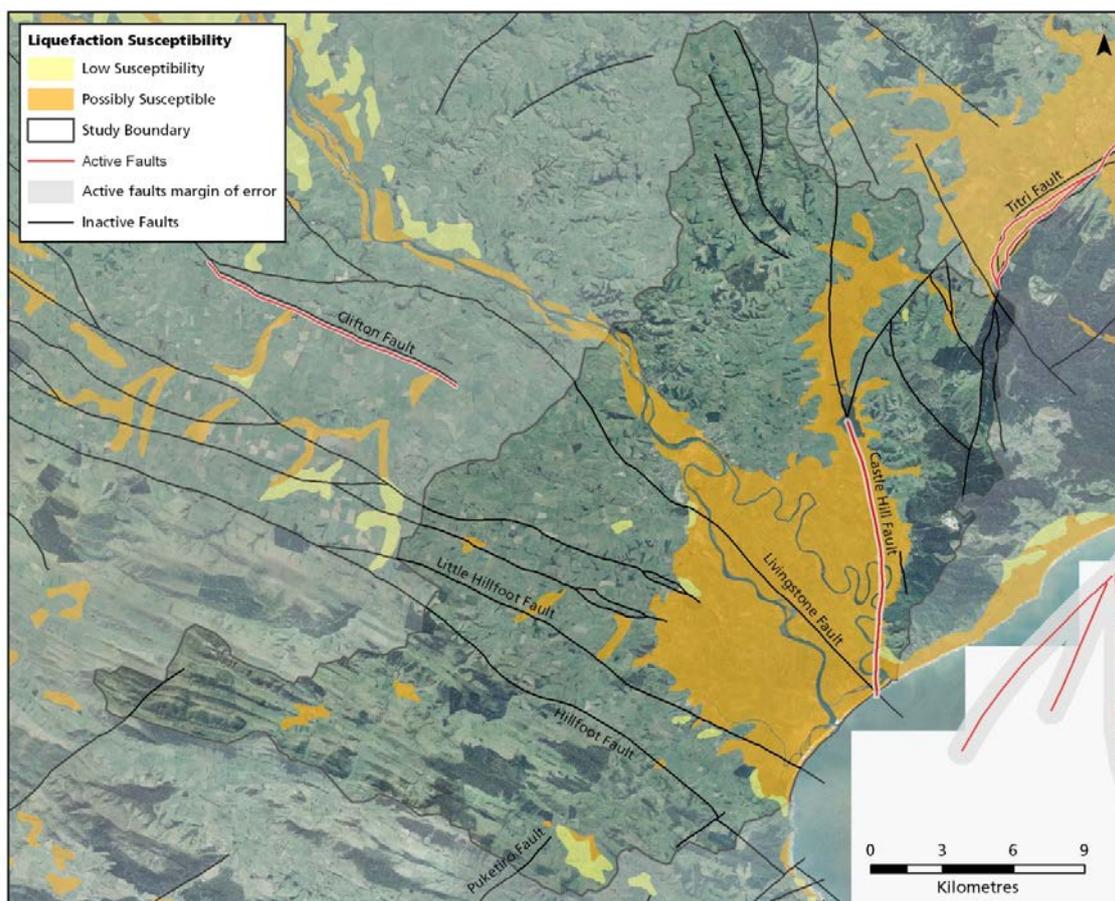
**Figure 5.4** Susceptibility to liquefaction hazard on the Clutha Delta (Opus, 2005; GNS Science, 2012).

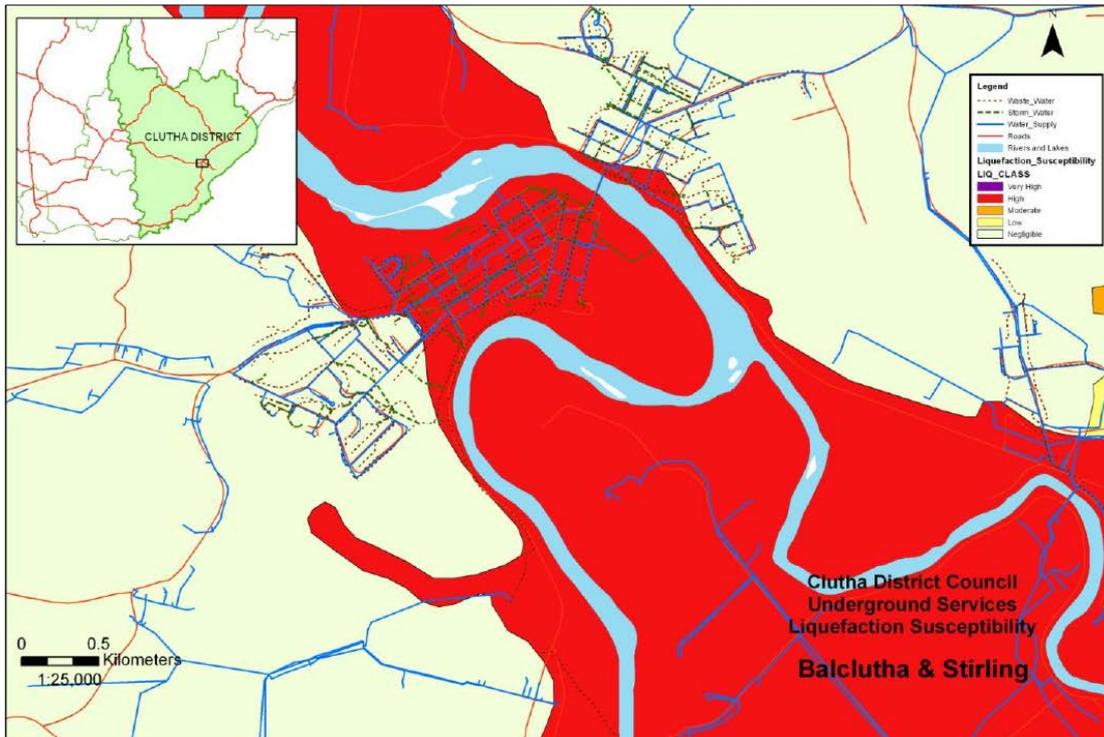
**Figure 5.5** Clutha District Council, Balclutha and Stirling, liquefaction susceptibility (after Pondard *et al.*, 2012).

Recent investigations completed by GNS Science have further refined the susceptibility of the Clutha District to liquefaction (Pondard, *et al.*, 2012). This report identifies that although 65% of Clutha District Council’s underground assets and infrastructure (e.g. water supply and stormwater) are located on land not likely to suffer significant damage, at least a quarter of asset value is located in areas exposed to high liquefaction hazard. Figure 5.5 shows an example from this report of Balclutha’s liquefaction susceptibility.

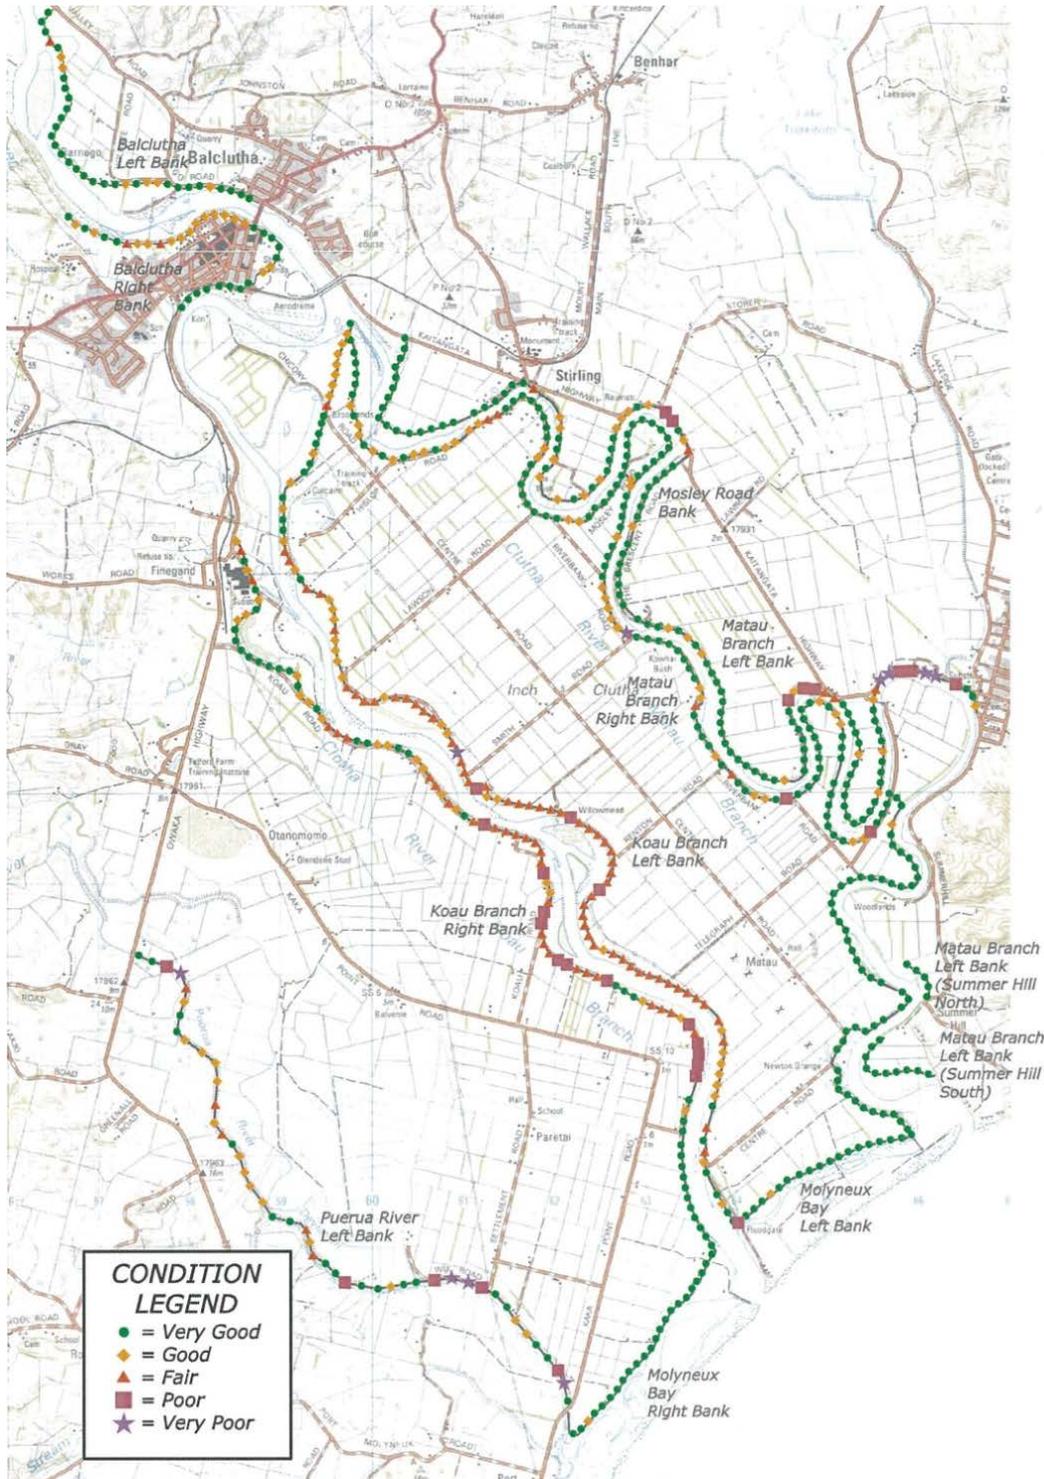
Figure 5.6 Seismic Performance Index of floodbanks on the Lower Clutha Delta Flood Protection Scheme (Tonkin & Taylor, 2005).

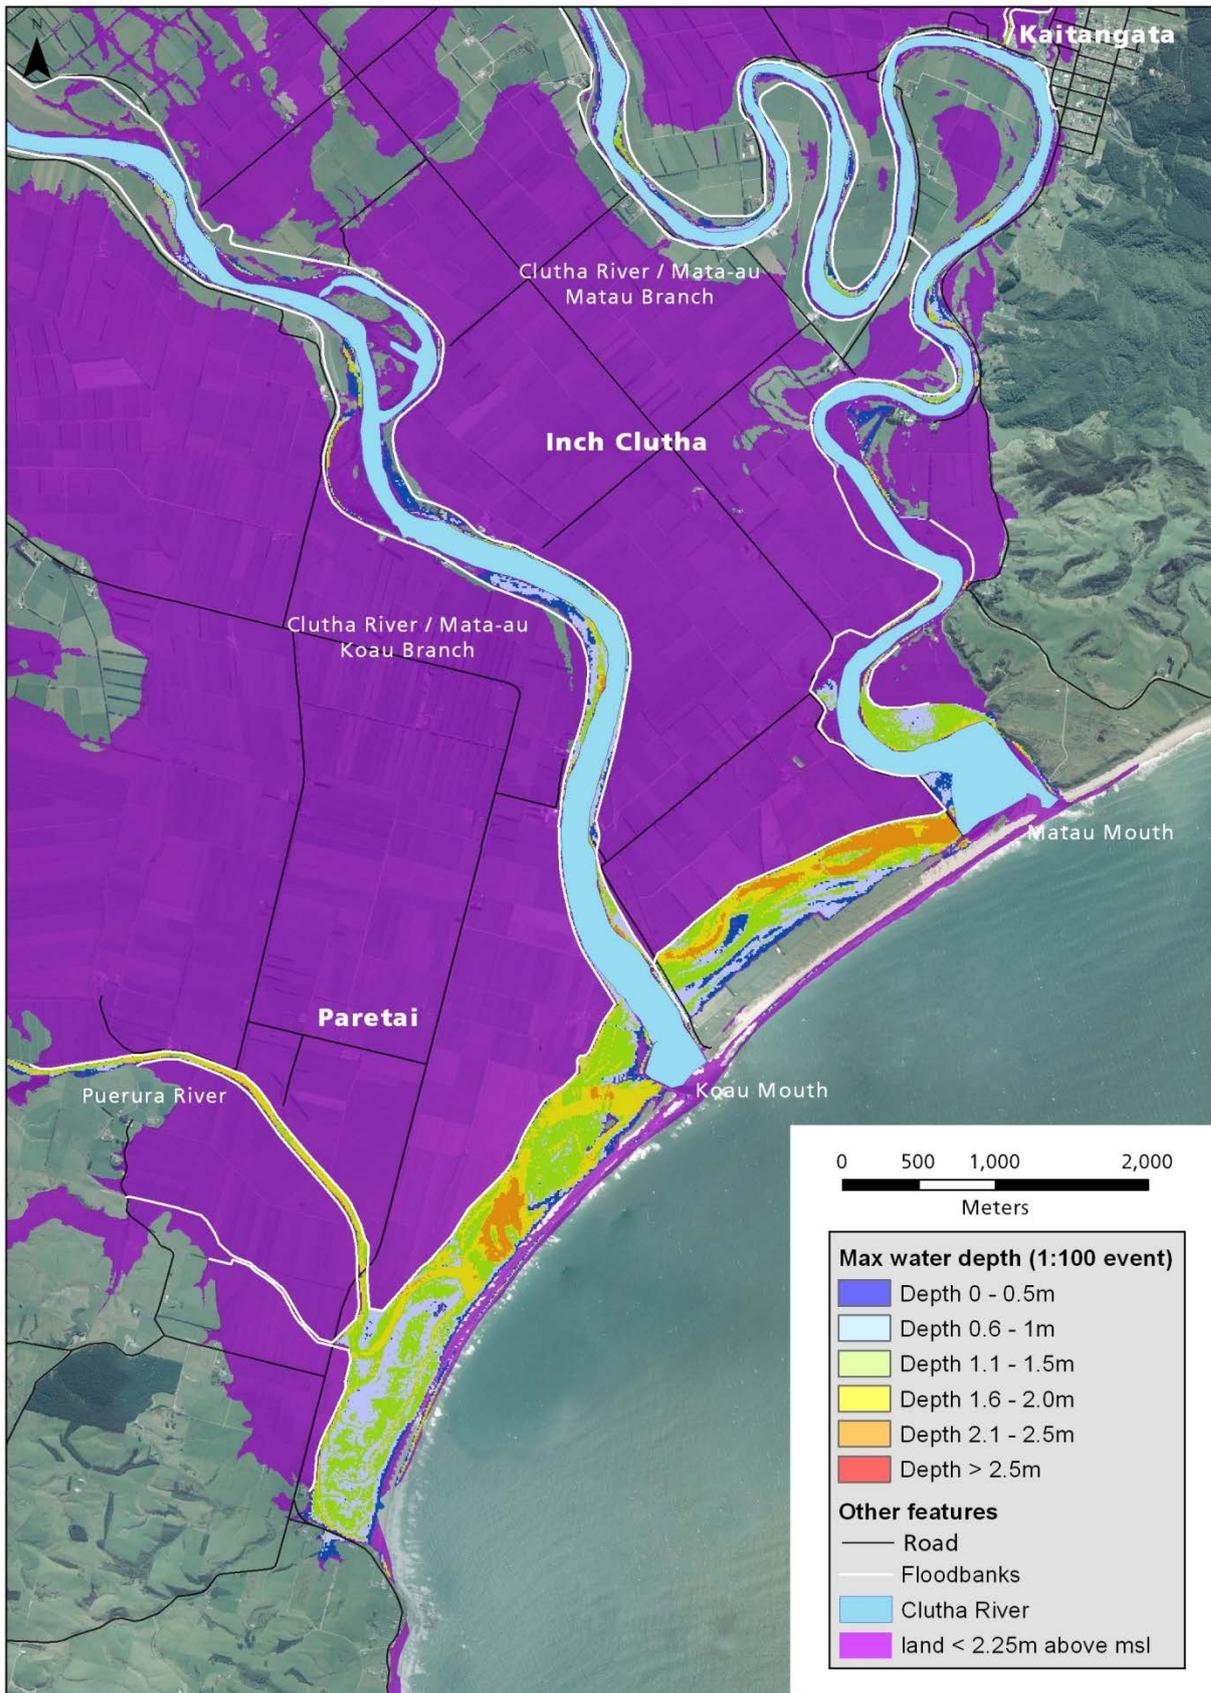
**Figure 6.1** Maximum water depth for inundated land along the Molyneux Bay coastline during a 1:100 year elevated sea level event at current mean sea level, as modelled by NIWA (2008). Parts of the lower Clutha Delta which are below the 1:100 year level (but not shown to be inundated by NIWA’s modelling) are shaded in purple.

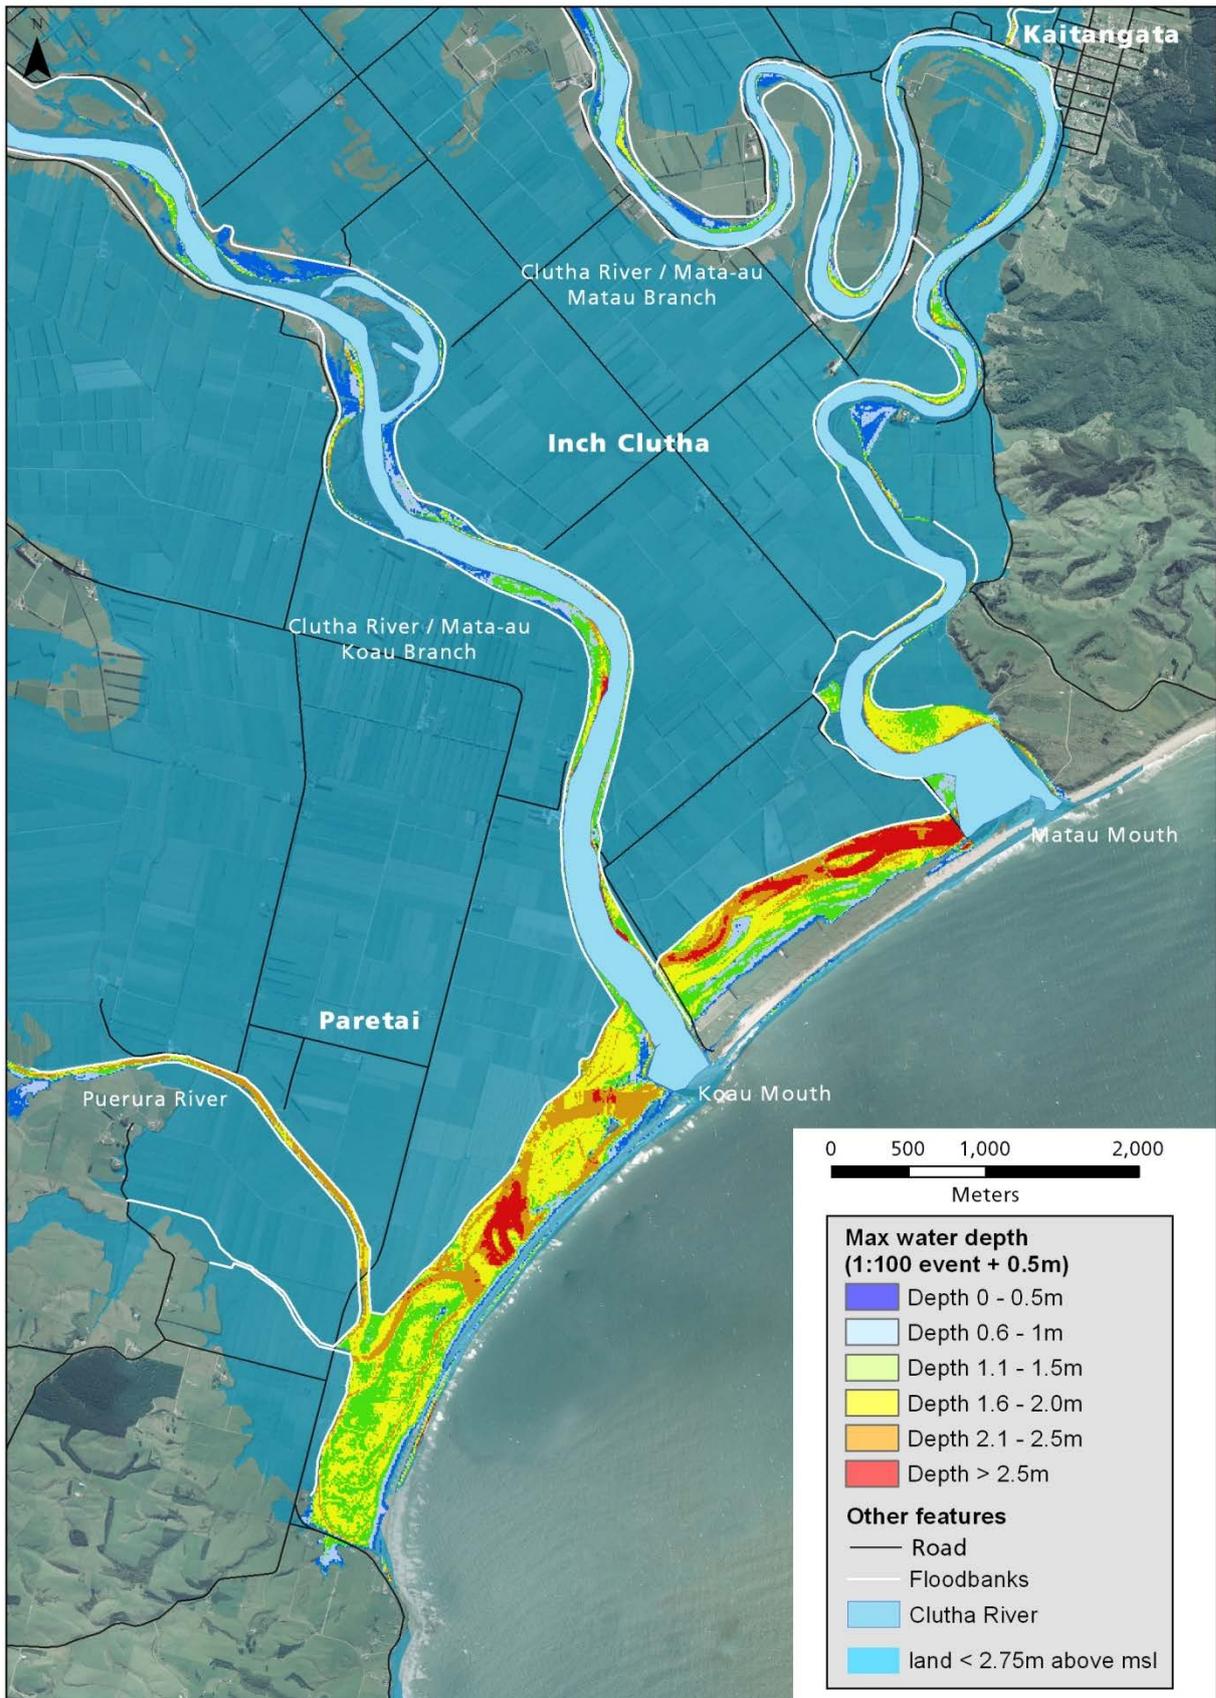
**Figure 6.2** Maximum water depth for inundated land along the Molyneux Bay coastline during a 1:100 year elevated sea level event with 0.5 m of sea-level rise, as modelled by NIWA (2008). Parts of the lower Clutha Delta which are below the 1:100 year +0.5 m level (but not shown to be inundated by NIWA’s modelling) are shaded in blue.

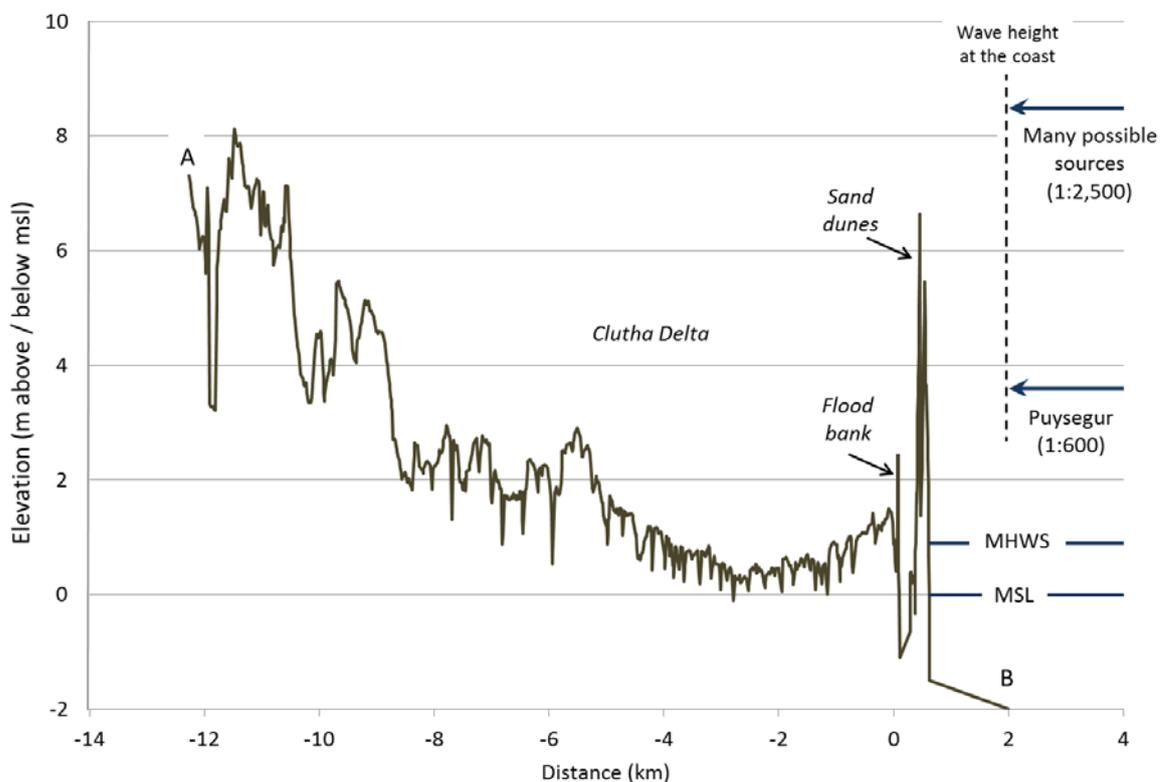
**Figure 6.3** Cross section A-B through the Clutha Delta, showing the tsunami wave height (at the coast) for a Puysegur Trench event (1:600 year return period), and an event with a 1:2500 year return period.

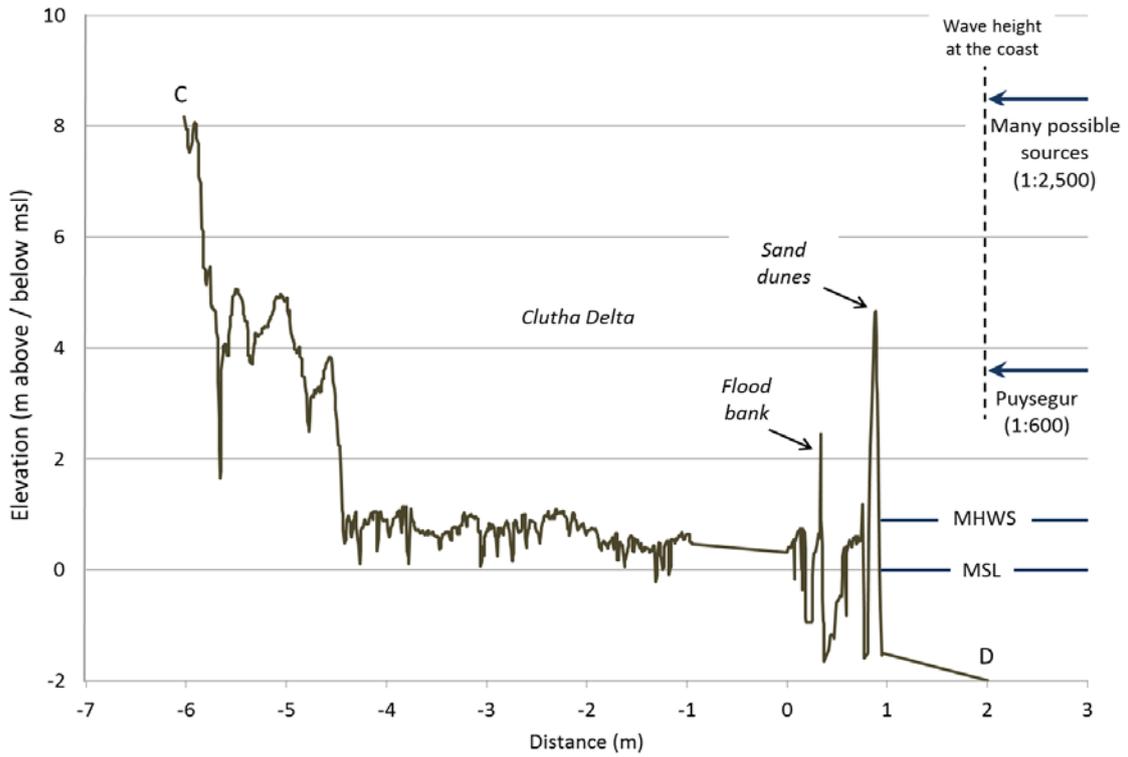
Figure 6.4 Cross section C-D through the Clutha Delta, indicating the tsunami wave height (at the coast) for a Puysegur Trench event (1:600 year return period), and an event with a 1:2500 year return period.

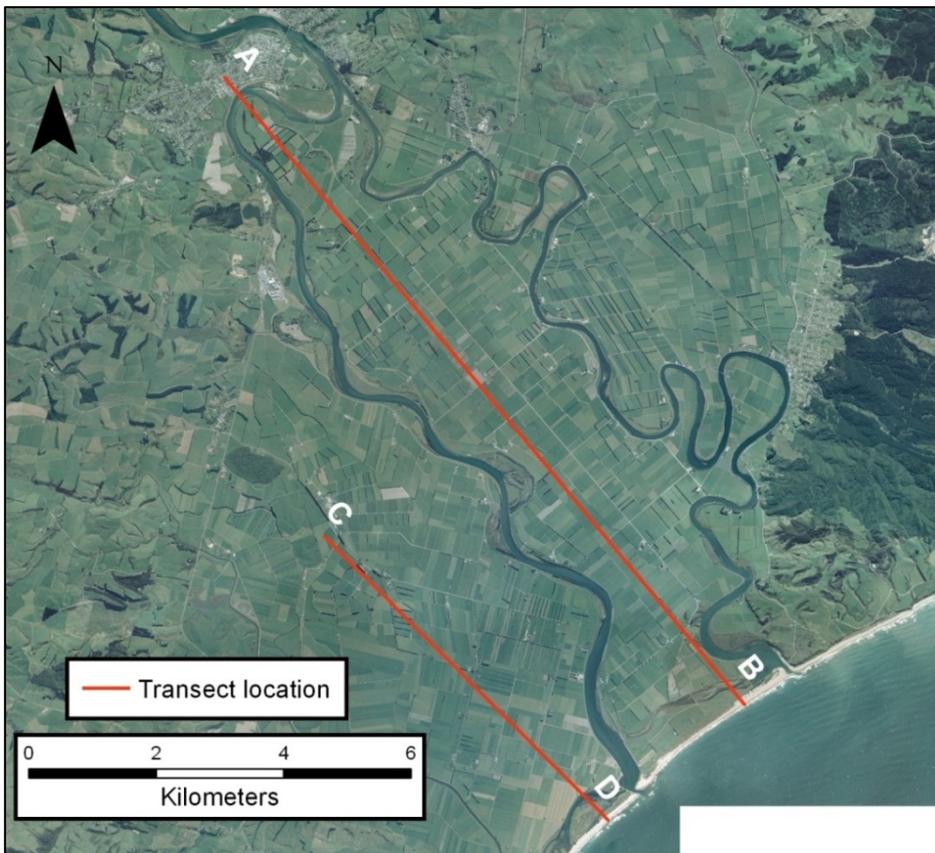
Figure 6.5 Location of Cross-sections A-B and C-D, as shown above.

Figures 6.3 and 6.4 show cross-sections through the Clutha Delta, from the coast to Balclutha and Otanomomo respectively. Figure 6.5 shows the location of these two cross-sections. These sections combine surveyed transects (collected in April 2013) across the beach and dunes with LiDAR data (collected in 2004) further inland. The

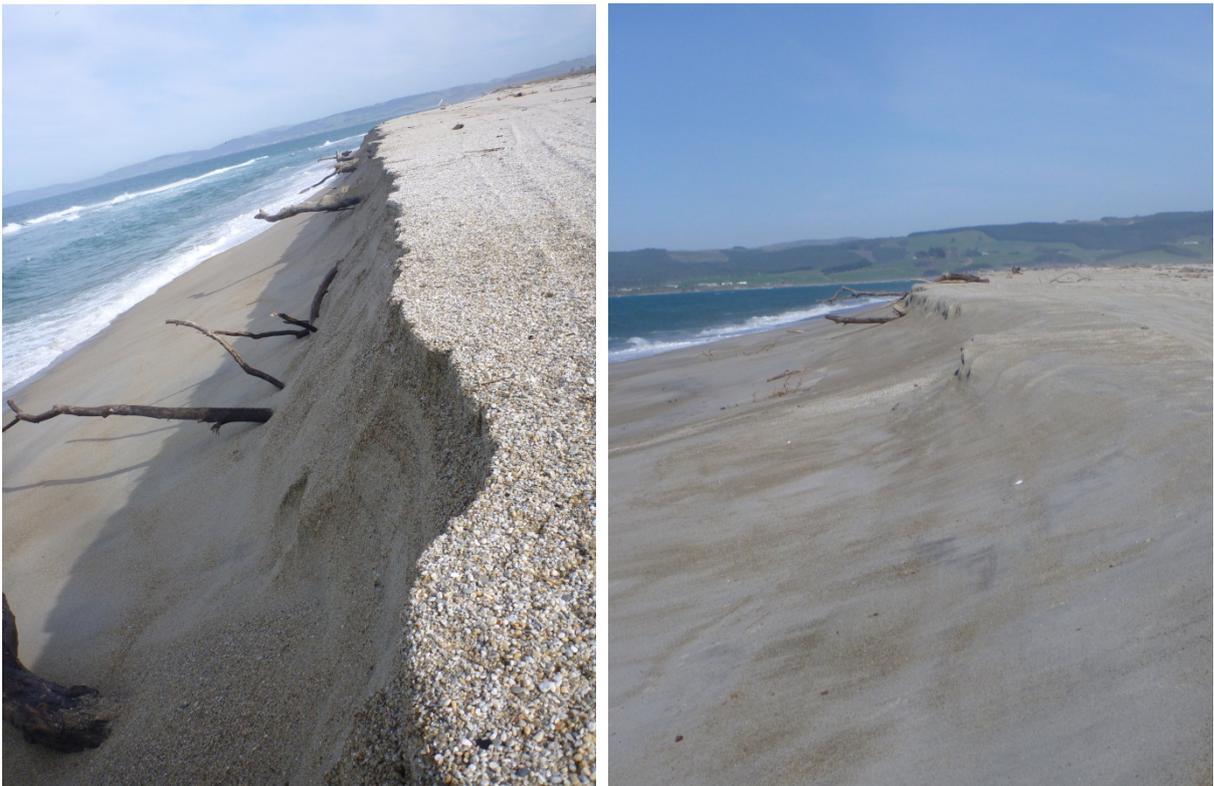
**Figure 6.6** Evidence of the sediment accumulation (1 m+ of sand over previously deposited driftwood) and subsequent erosion which can occur on the Molyneux Bay shoreline. Left: looking south from near the Matau Mouth. Right: looking south from near the Koau Mouth. Photos taken September 2012.

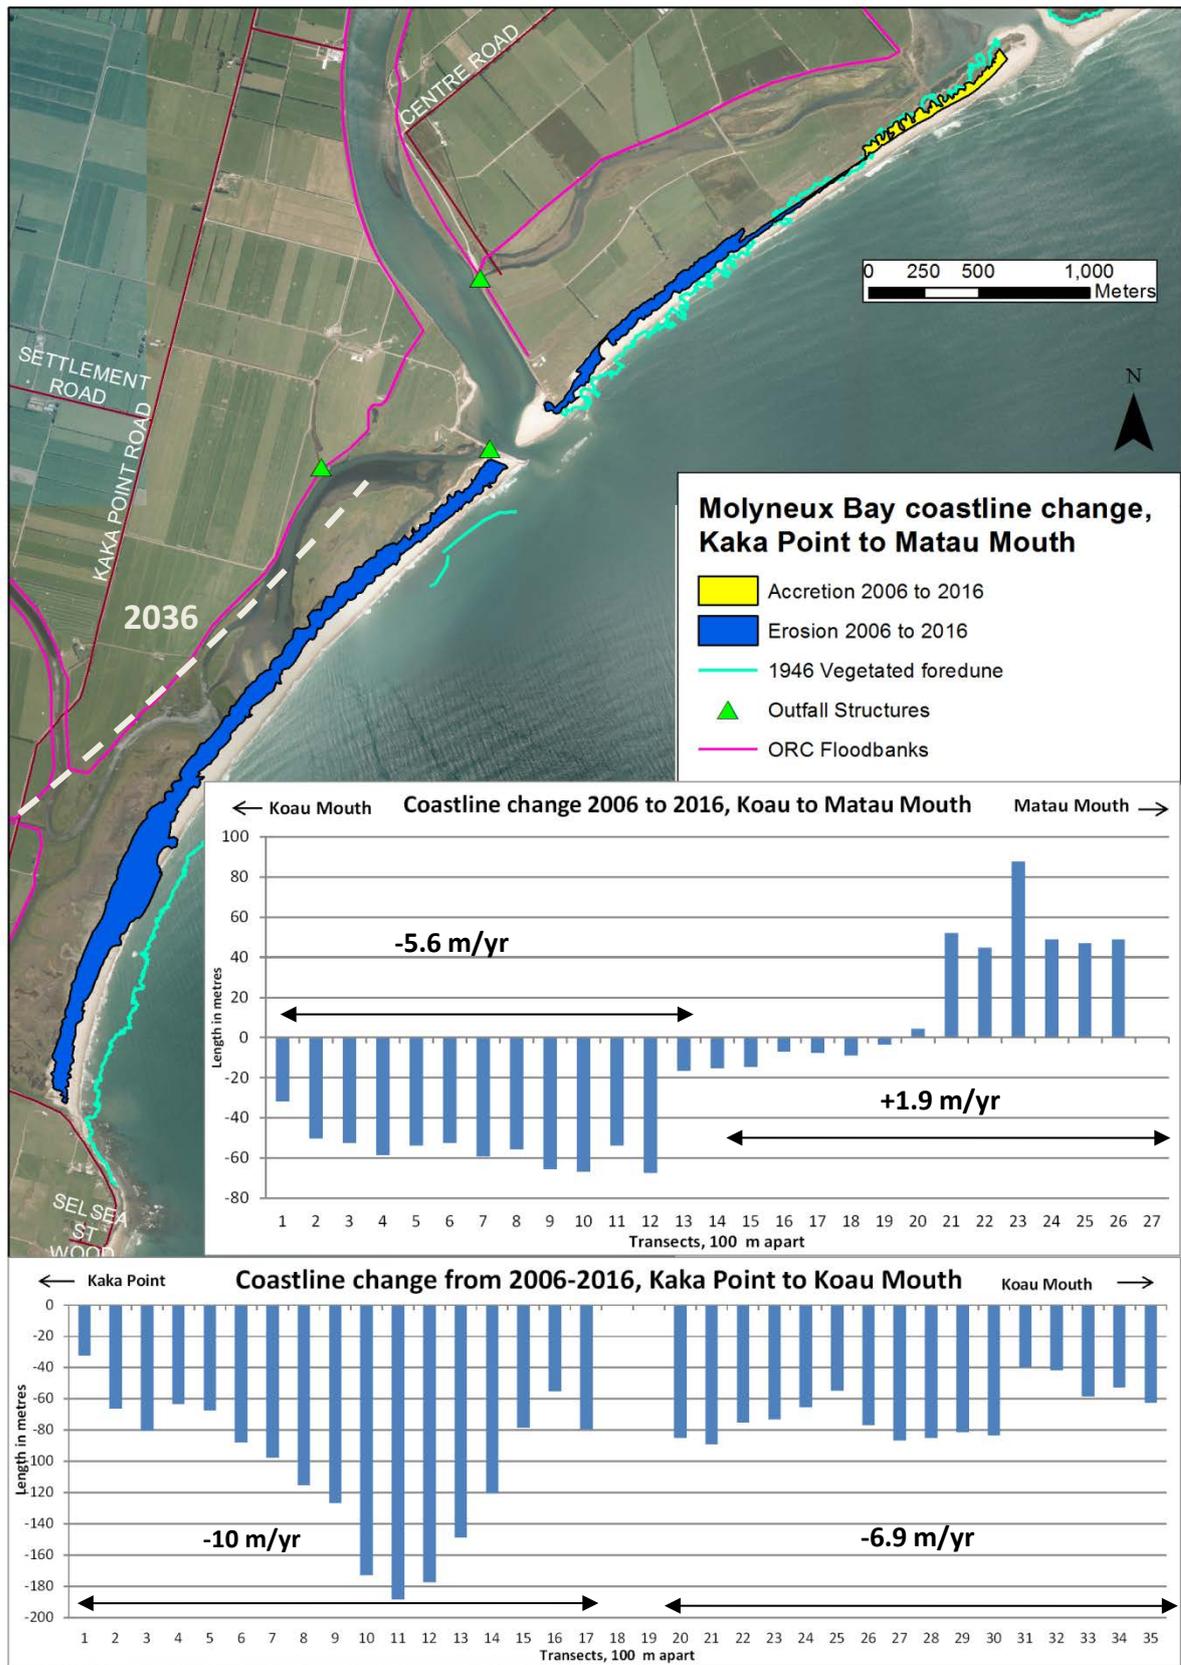
**Figure 6.8** Shoreline change for Molyneux Bay from Kaka Point (southern end of map) to Matau Mouth of the Clutha River. Background is 2013 imagery. Dashed white line labelled 2036 is estimated landward extent of shoreline if the present 10-year-average retreat rate continues.

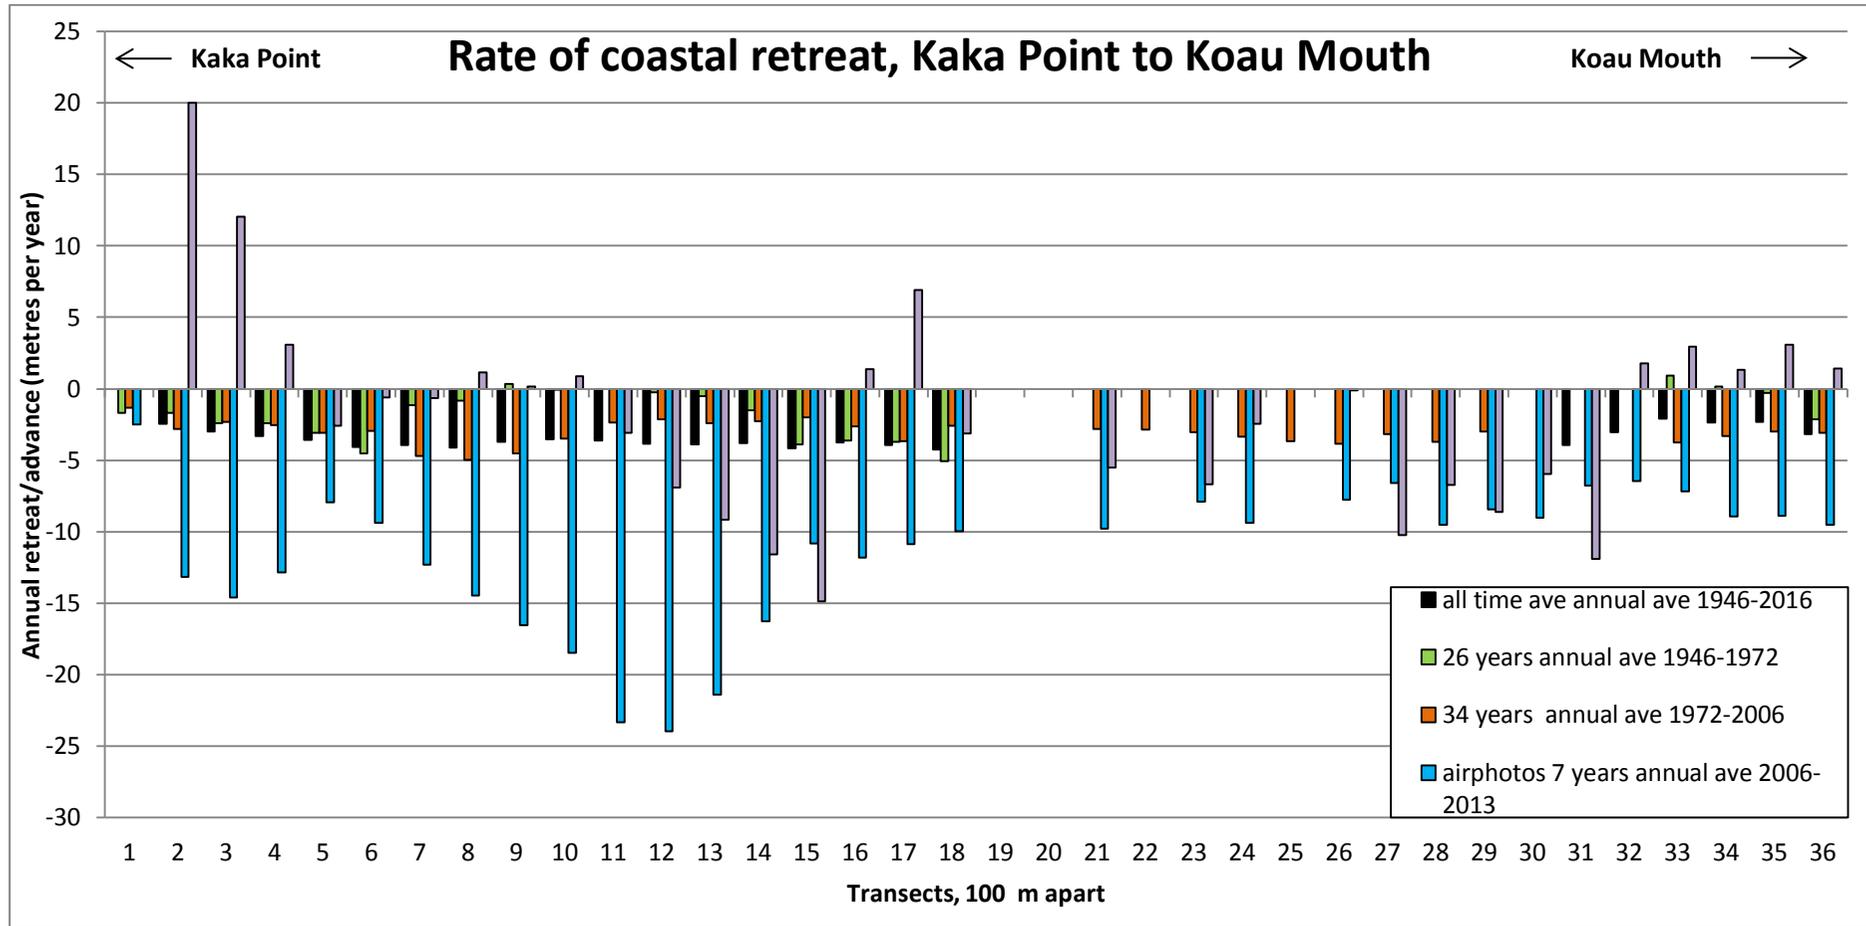
**Figure 6.9** Rates of coastal retreat and accretion from Kaka Point to Koau Mouth of the Clutha River. Transects were taken 100 m apart, perpendicular to shoreline.
