# Natural Hazards on the Clutha Delta, Otago

May 2016

## Executive summary

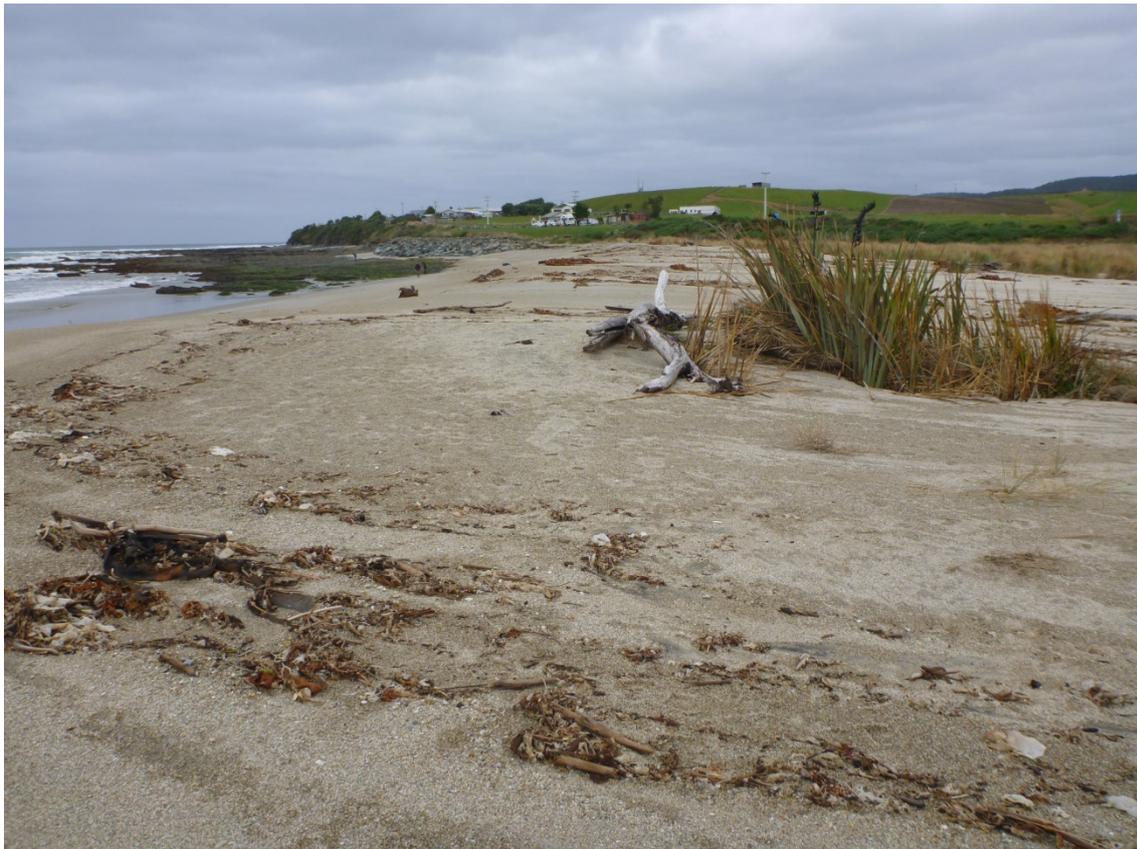
**Figure 6.11** Landward-advancing foredune at south end of Molyneux Bay. Flax bush has recently been buried by  $\sim 0.5$  m of sand and now occupies the new high-tide line.

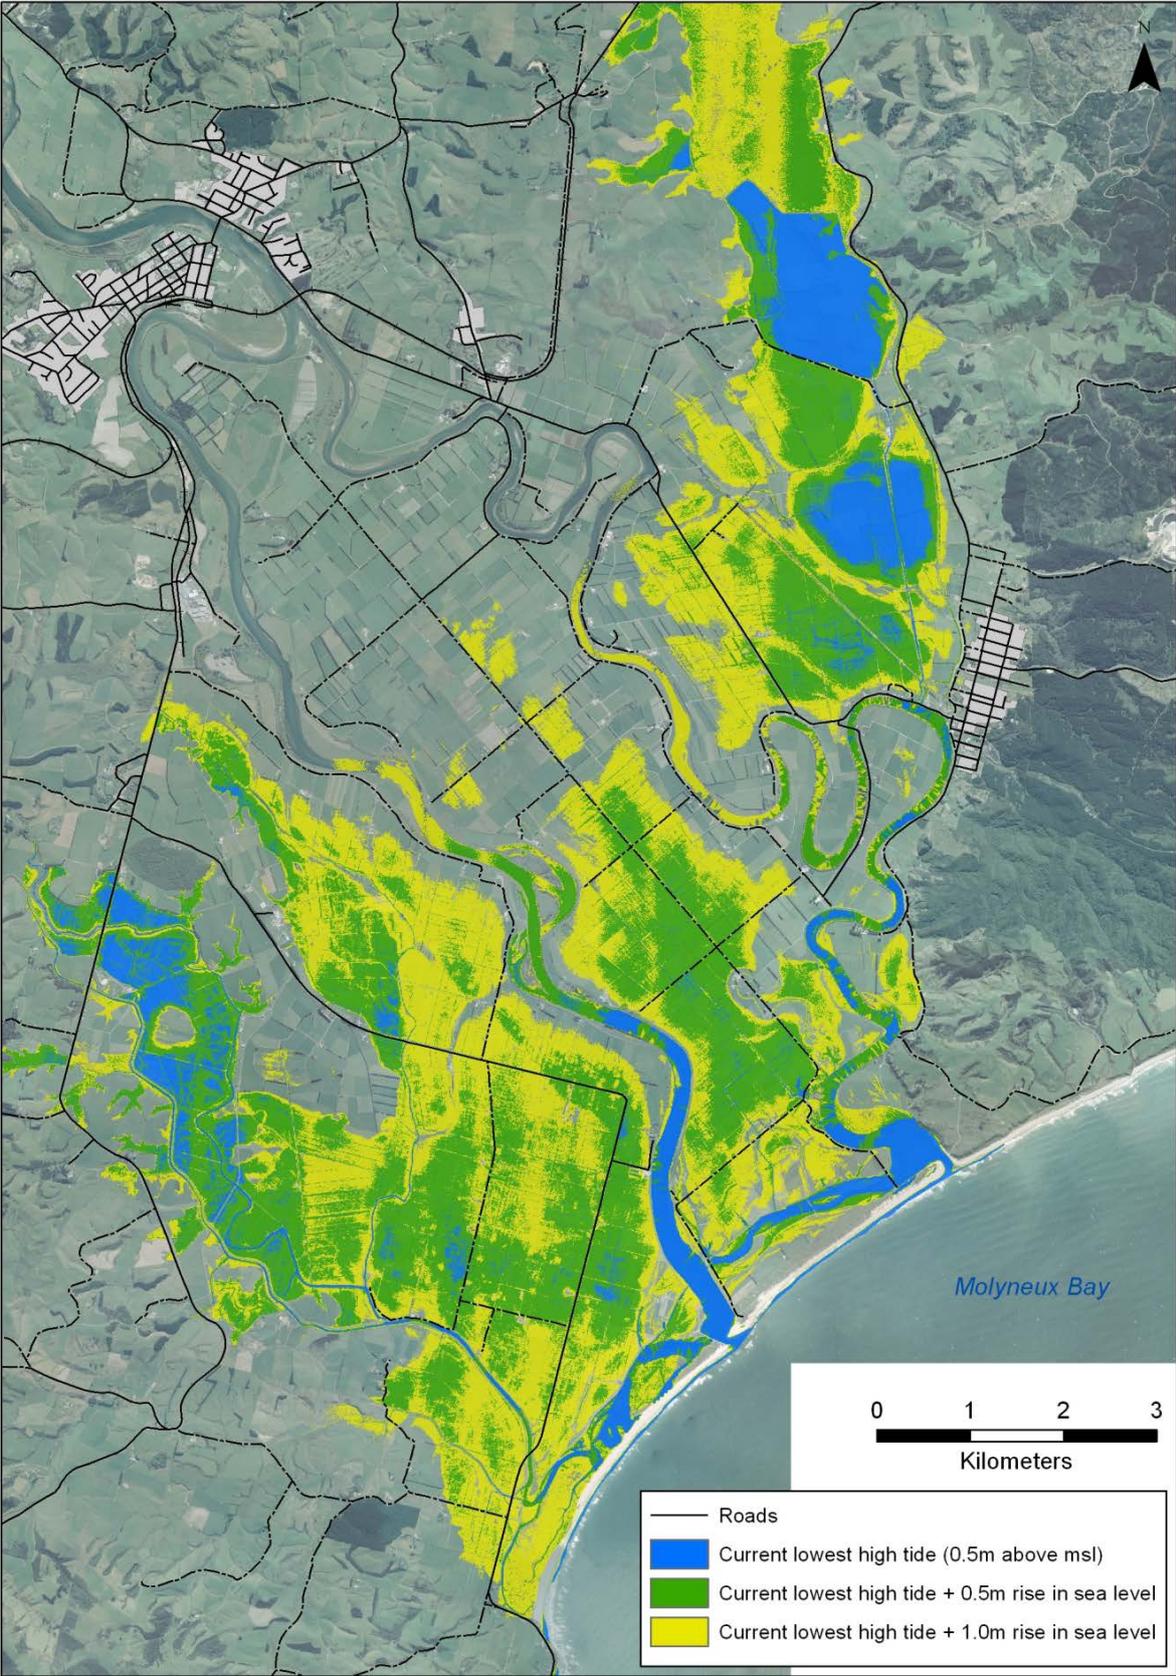
**Figure 6.12** Potential landward extent of inundation during a 'flood banks down' scenario without the additional protection of sand dunes in Molyneux Bay.

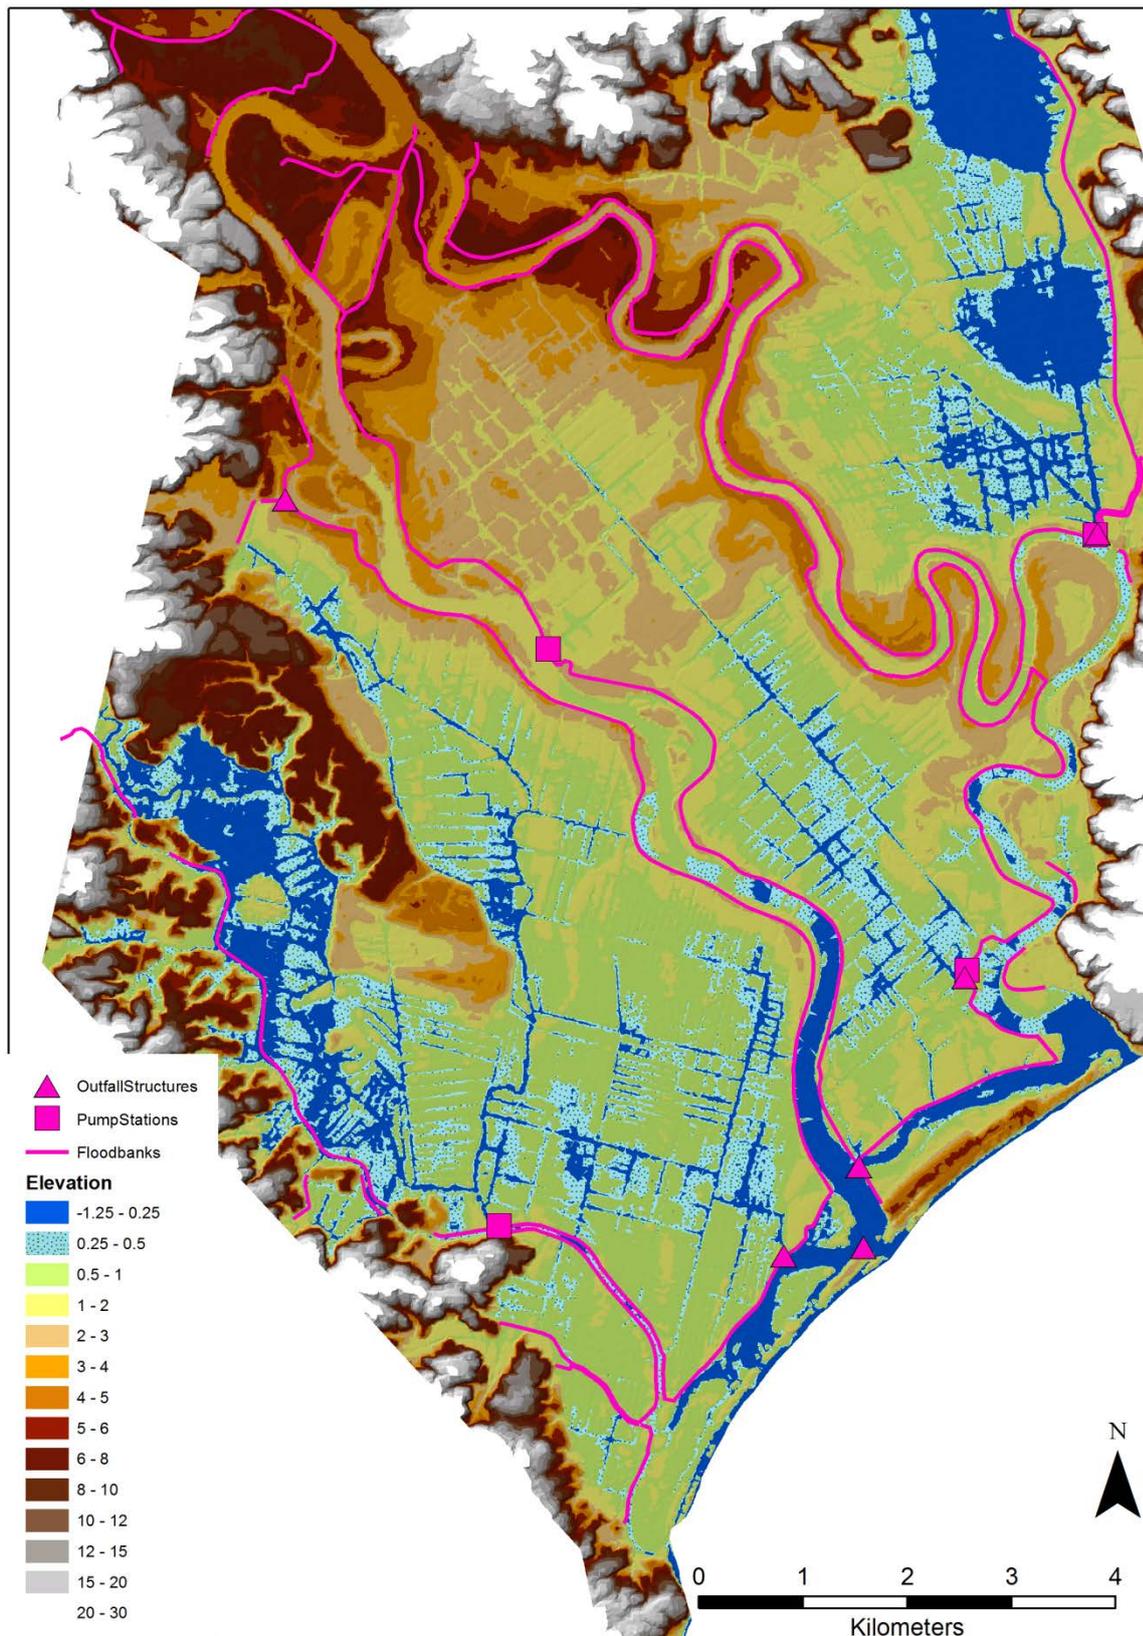
**Figure 6.13.** Elevation of land on the Clutha Delta. Land expected to be at risk of groundwater ponding as sea level rises by ~20 cm in the coming decades are highlighted in dark blue (<25 cm above MSL), with light blue showing areas likely to be similarly at risk (<50 cm above MSL). The southernmost outfall structures will also be negatively impacted as the hydraulic base level changes with projected sea-level rise (see Figure 6.14).

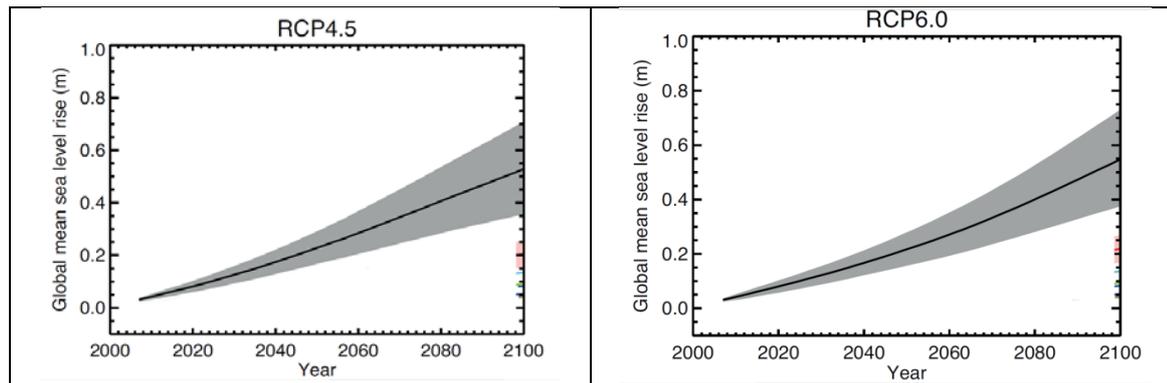
**Figure 6.14** Projections of global mean sea level rise, relative to 1986-2005, for IPCC mid-range scenarios (RCP 4.5 and 6.0). The grey band represents the range within which actual sea-level is predicted to increase, under each scenario.

Projections provided by the IPCC are that global mean sea level will increase by between 0.26 and 0.82m by the end of the 21<sup>st</sup> century, compared with 1986-2005. The efficiency of pump stations at lowest elevation will decrease in the coming decades as sea levels and associated groundwater levels rise in relation to the land which the drains, outfall structures and pump stations are designed to protect from flooding. Figure 6.13 shows a map of the Lower Clutha Delta with areas of ground below 25 cm indicated in dark blue, and ground below 0.5 m in light blue. Much of this area could require continuous pumping in order to remain dry by approximately the 2050s, even in low-river conditions. This is due to the hydraulic fall of the water table from groundwater to sea- and river-level. Operation of the pumps to effectively drain the area would be required more frequently and for less severe events as sea-level rises by an expected ~20 cm in the next 3-4 decades (Figure 6.14).
