Otago Alluvial Fans: High Hazard Fan Investigation

June 2011

Otago Regional Council

Prepared by Richard Woods, Natural Hazards Analyst, Otago Regional Council

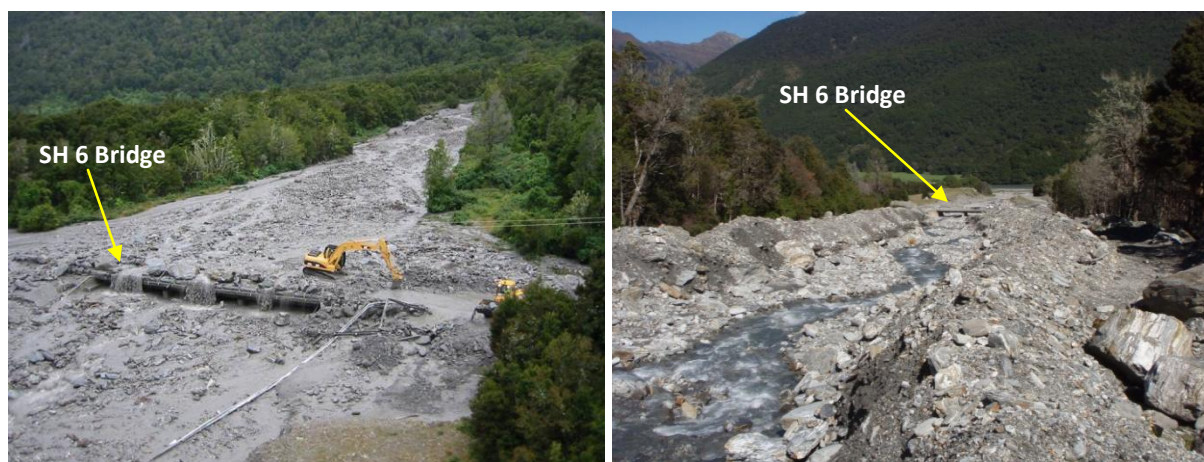
Figure 1.2 Pipson Creek in March 2004 (left), looking upstream, and November 2008 (right), looking downstream. In the left image, the creek has aggraded, so that the channels are migrating laterally outside of the channels low-flow banks; the hydrographic apex is located upstream and out of sight. In the right image, excavation and channel contouring has confined the channel to a single-thread channel, far beyond the state highway; the hydrographic apex is located near the confluence with Makarora River in this image.

The topographic and hydrographic apices of each fan have been identified on the respective alluvial-fan maps. The ‘topographic apex’ is the point, commonly where the fan head is located, where the creek or stream leaves the confines of the valley (Figure 1). This point is static and corresponds with the foothills of the source catchment. Comparatively, the ‘hydrographic apex’ is the point on the fan surface where the channel no longer becomes incised into the surface and therefore may migrate or adopt a braided form. The hydrographic apex is not static and may move within the channel, depending on the nature of the fan surface, channel and catchment-sediment supply. Often during storm events, the channel may aggrade and cause the hydrographic apex to move upstream quickly, promoting channel breakout or avulsion. An example of this phenomenon is shown in Figure 1.2.

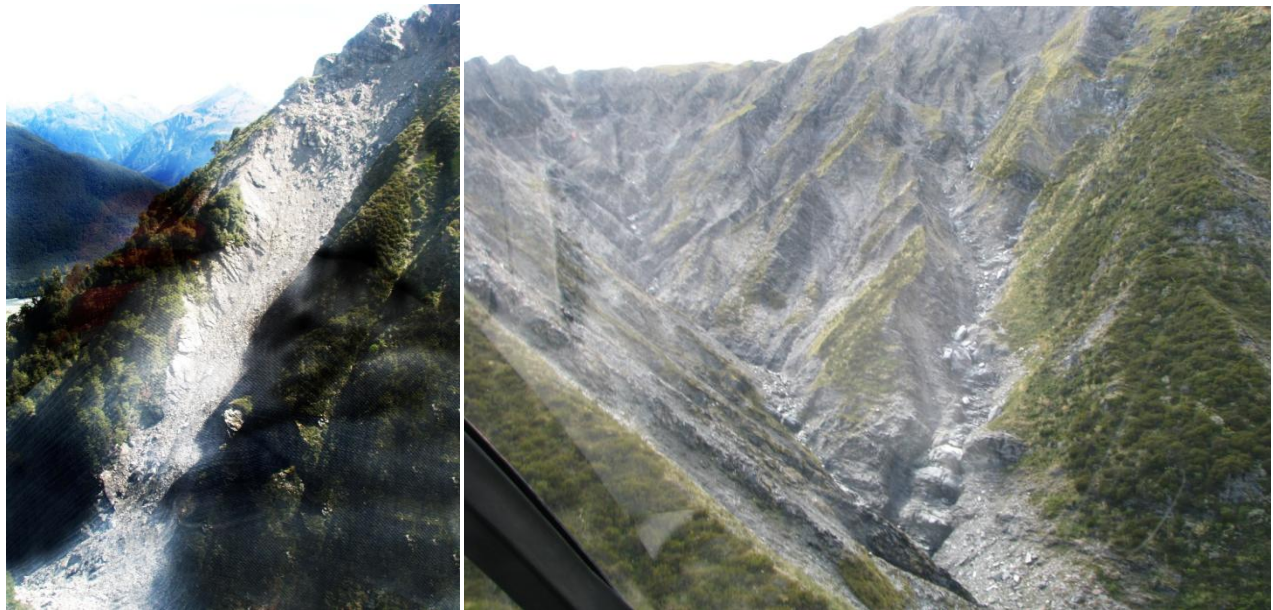
Figure 2.3 Photo C1 (left) and Photo C2 (right), showing recent mass movement in the upper catchment of Pipson Creek on 7 March 2011

Figure 2.3 also shows *Photo C2* (Figure 2.2) of the upper catchment slopes on 7 March 2011. Steep fresh, gullying of bedrock in the head of the catchment shows that large clasts of material are being actively supplied to the Pipson Creek channel throughout the upper catchment.

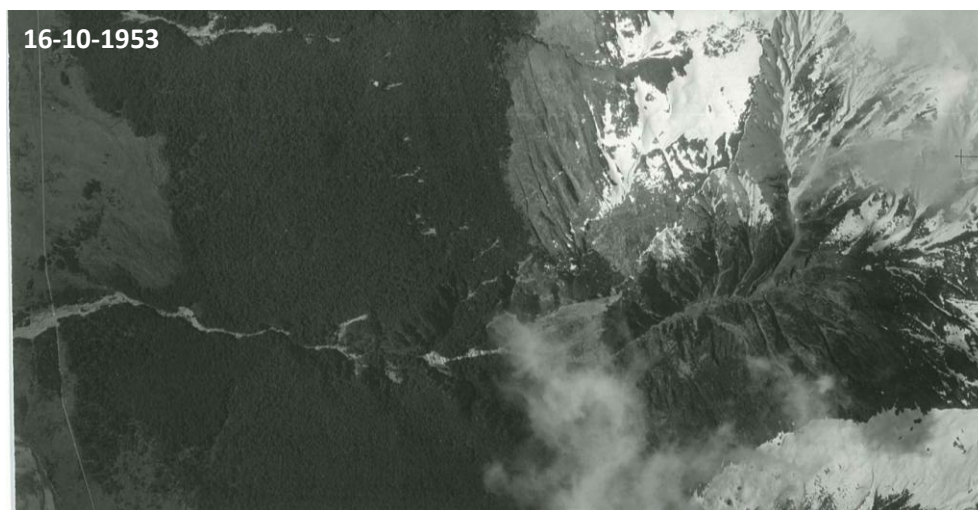
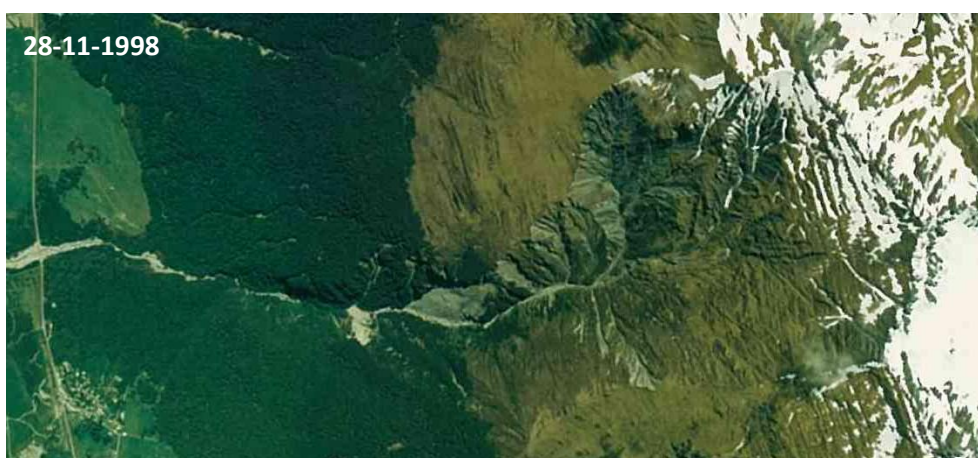
Historic Aerial Photographs Pipson Creek, Makarora

It is noted that a level of risk exists for the Makarora West community from debris flow derived from Pipson Creek. Should a large sediment input cause the channel to aggrade considerably at the head of the alluvial fan, there is potential for Pipson Creek to avulse and re-occupy or form new channels in the direction of the Makarora West community. In addition, flows that avulse from the channel further down the fan may also re-occupy palaeo-channels towards parts of the community.

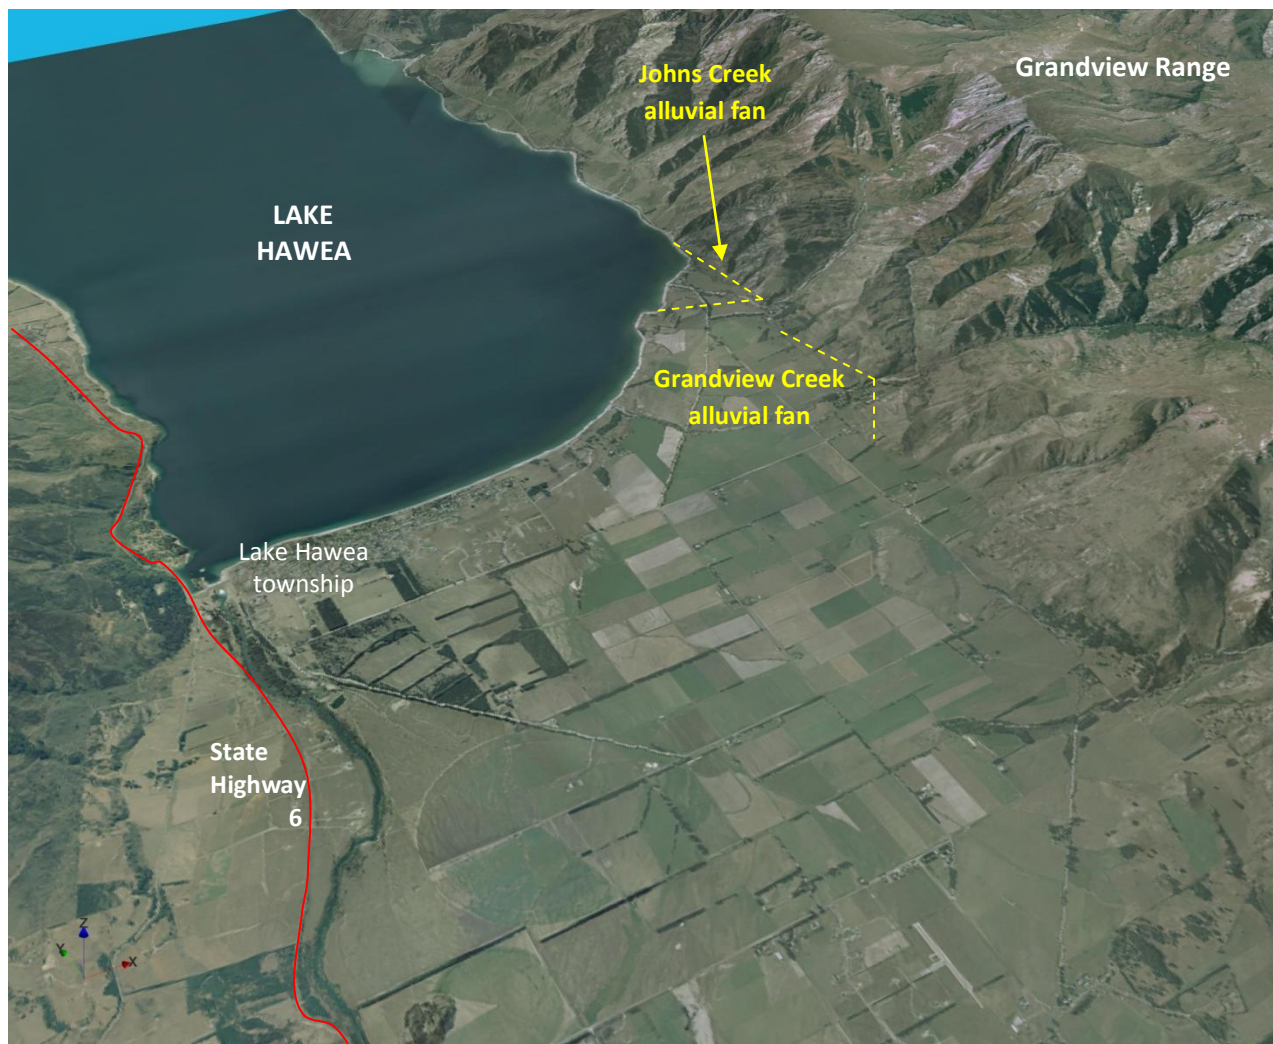
Figure 4.1 Image showing the location of the Johns Creek alluvial fan in the Lake Hawea Basin

Located at the southern end of Lake Hawea, the Hawea Basin (Figure 4.1) is a geologically young landscape, having been occupied by glaciers during the last glacial period, as discussed in Section 1.2. Incised into the western flank of the Grandview Range, the Johns creek catchment flows east to west, from an elevation of 1456m at Breast Peak, to around 420m, where the channel leaves the confines of the valley. Most of the fan surface is dominated by pastoral farmland, with some farm and ancillary buildings near the head of the fan. On the fan's lower margins, the creek is bound on both banks by a small community at Gladstone. Just upstream of the community, Gladstone Road crosses Johns Creek by way of a ford.

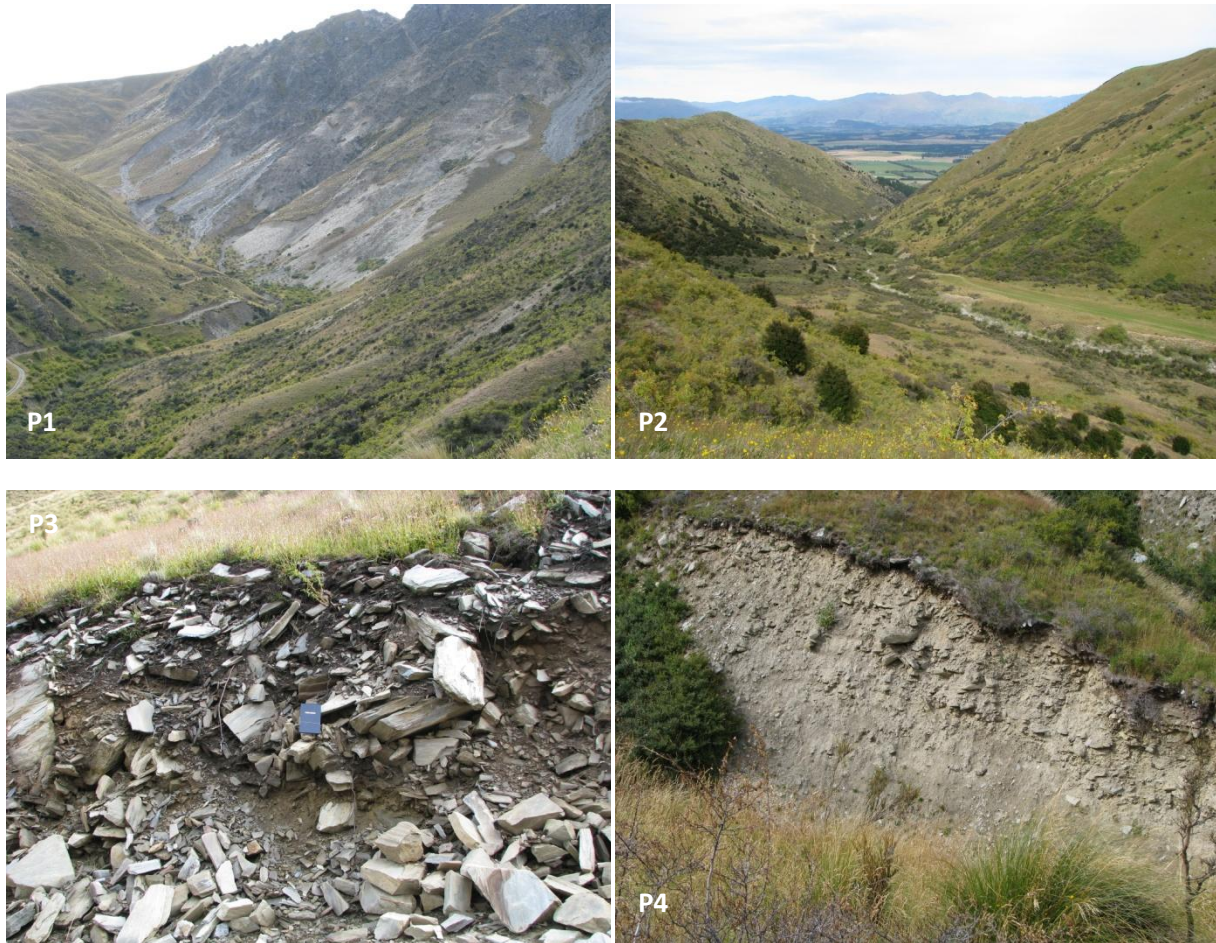
Figure 4.3 Photographs relating to the points of interest identified in Figure 4.2. P1 shows persistent mass movement on northern-facing slopes at the head of the Johns Creek catchment. P2 shows the wide valley setting of the Johns Creek catchment and incised channel into mid-catchment fan deposits. P3 shows chaotic landslide debris on the catchment's true right, where these deposits are being actively eroded by the creek. P4 shows a close-up of incision in the channel mid-catchment.

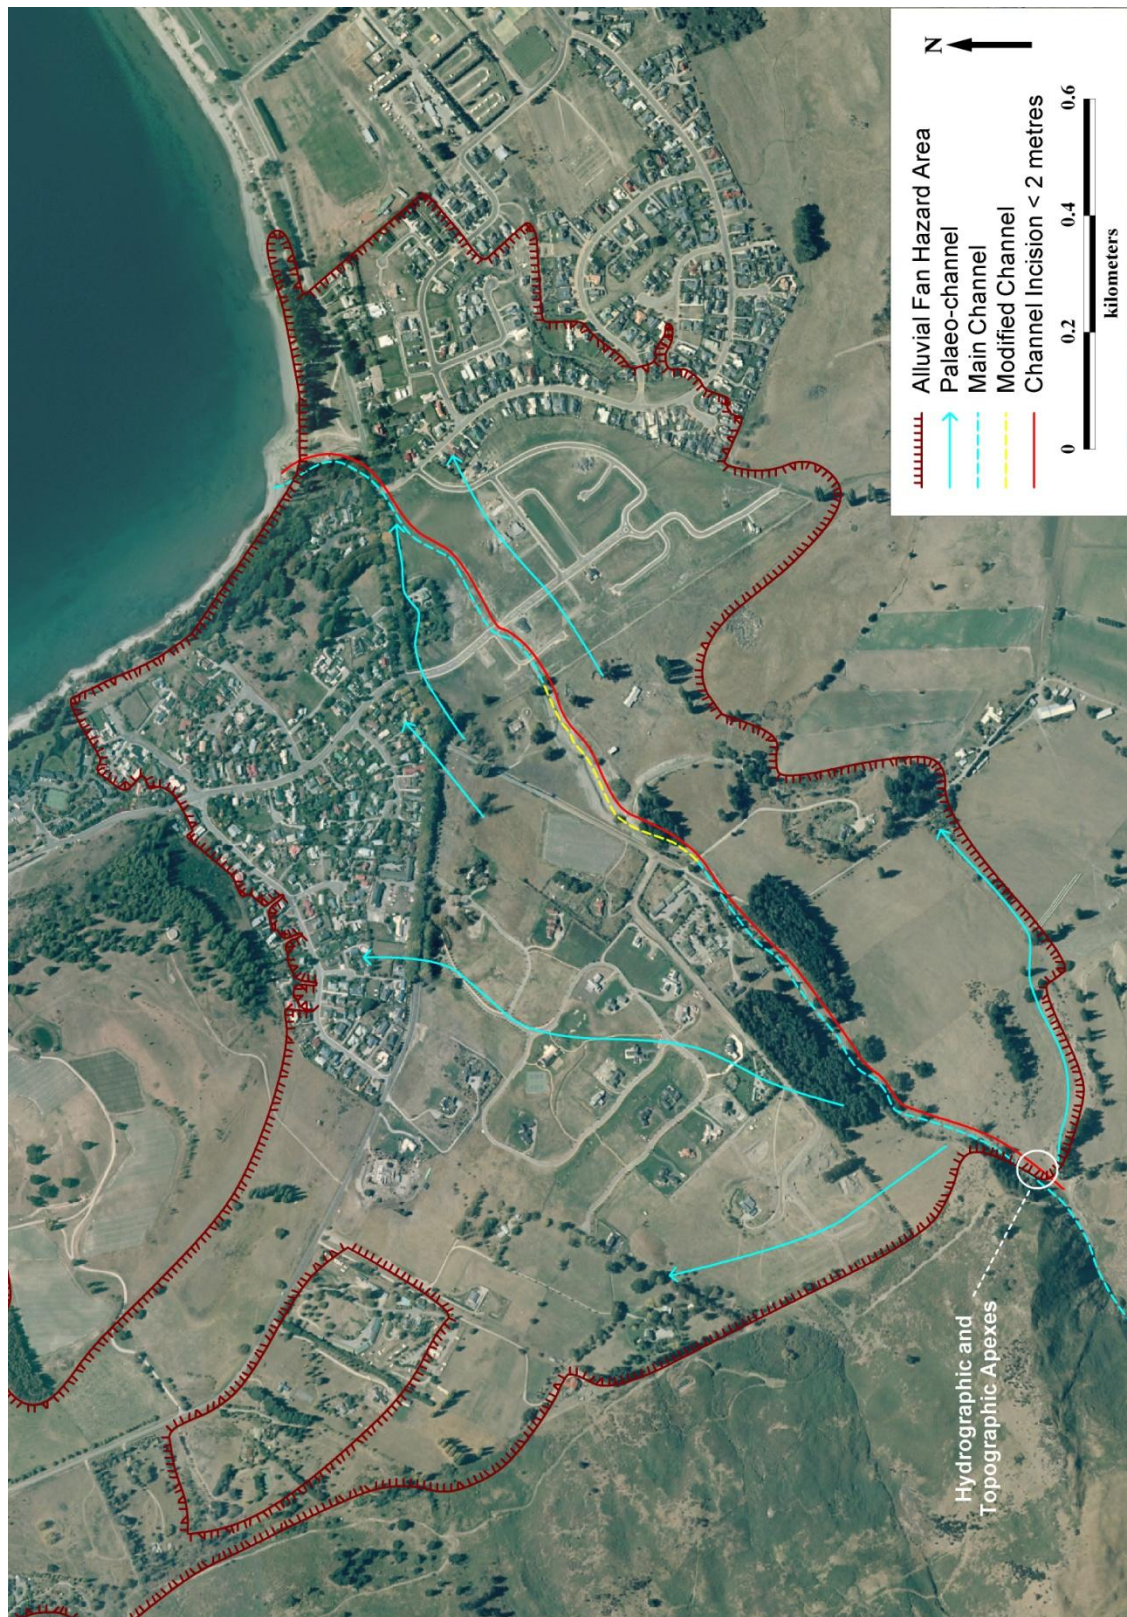
Figure 5.5 The Stoney Creek alluvial fan, noting the identified hazard area and other key features; aerial photo taken in March 2006

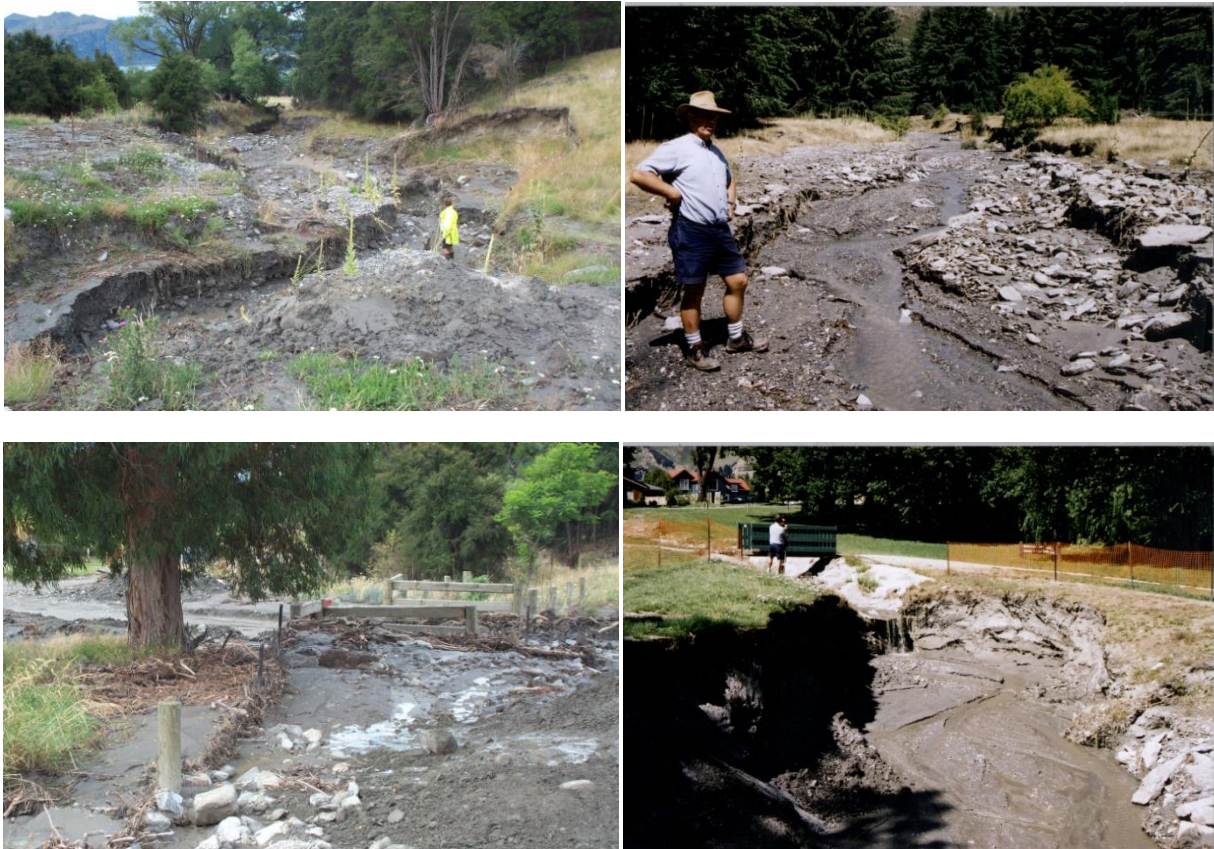
Figure 5.6 The effects of debris and flood floods derived from Stoney Creek in January 2004. Top left: Channel and bank erosion and overbank-debris deposition near the head of the alluvial fan. Top right: Channel aggradation and debris deposition in the Stoney Creek channel. Bottom left: Channel aggradation near Studholme Road resulting in channel avulsion and a build-up of sediment against adjacent fencing. Bottom right: Channel and bank erosion near the Stoney creek outlet at Lake Wanaka

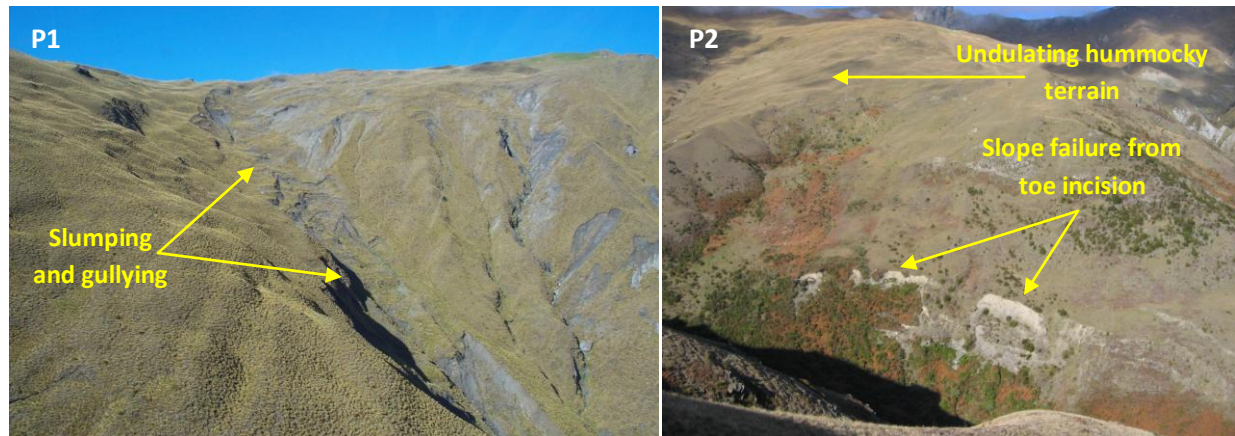
Figure 6.3 Mass-movement processes in the form of slumping and gullyng in the upper Waterfall Creek catchment (left); photograph taken 09 February 2004. Slope failure, induced by toe incision by Waterfall Creek, can be seen on the right.

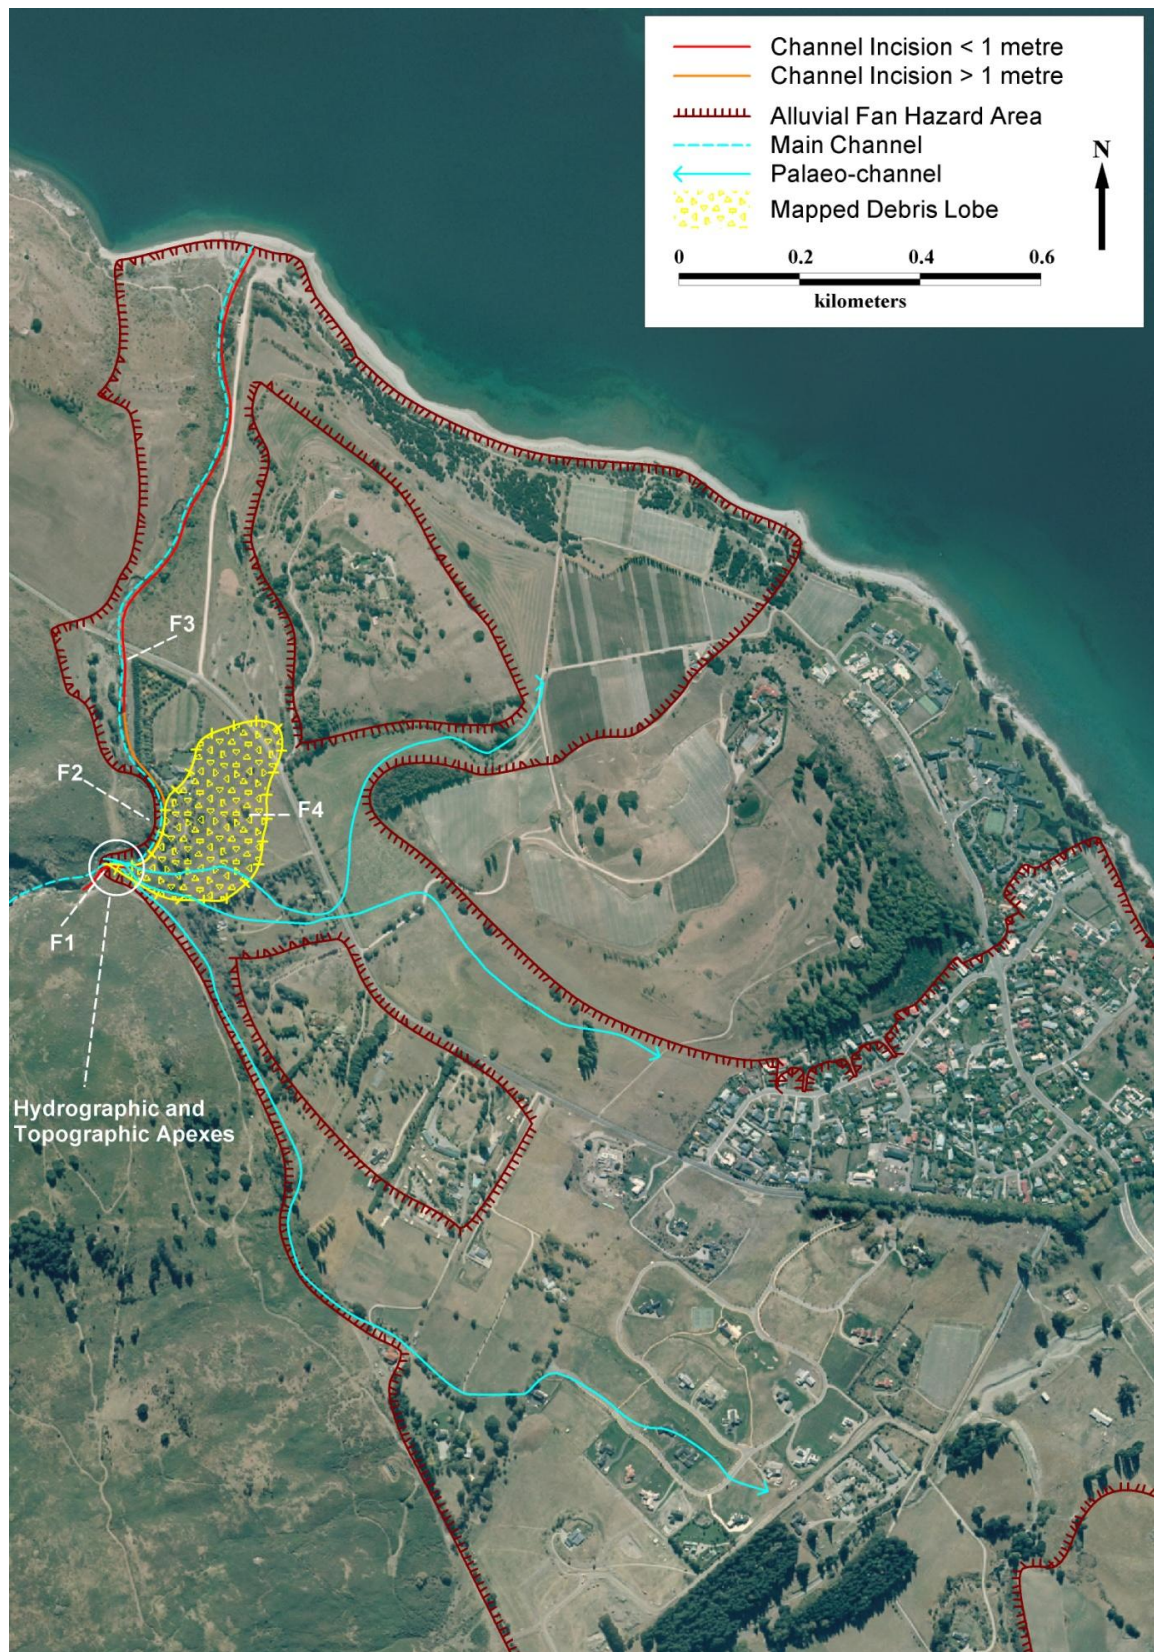
Figure 6.5 Waterfall Creek alluvial fan, noting some key alluvial-fan features; aerial photo taken in March 2006

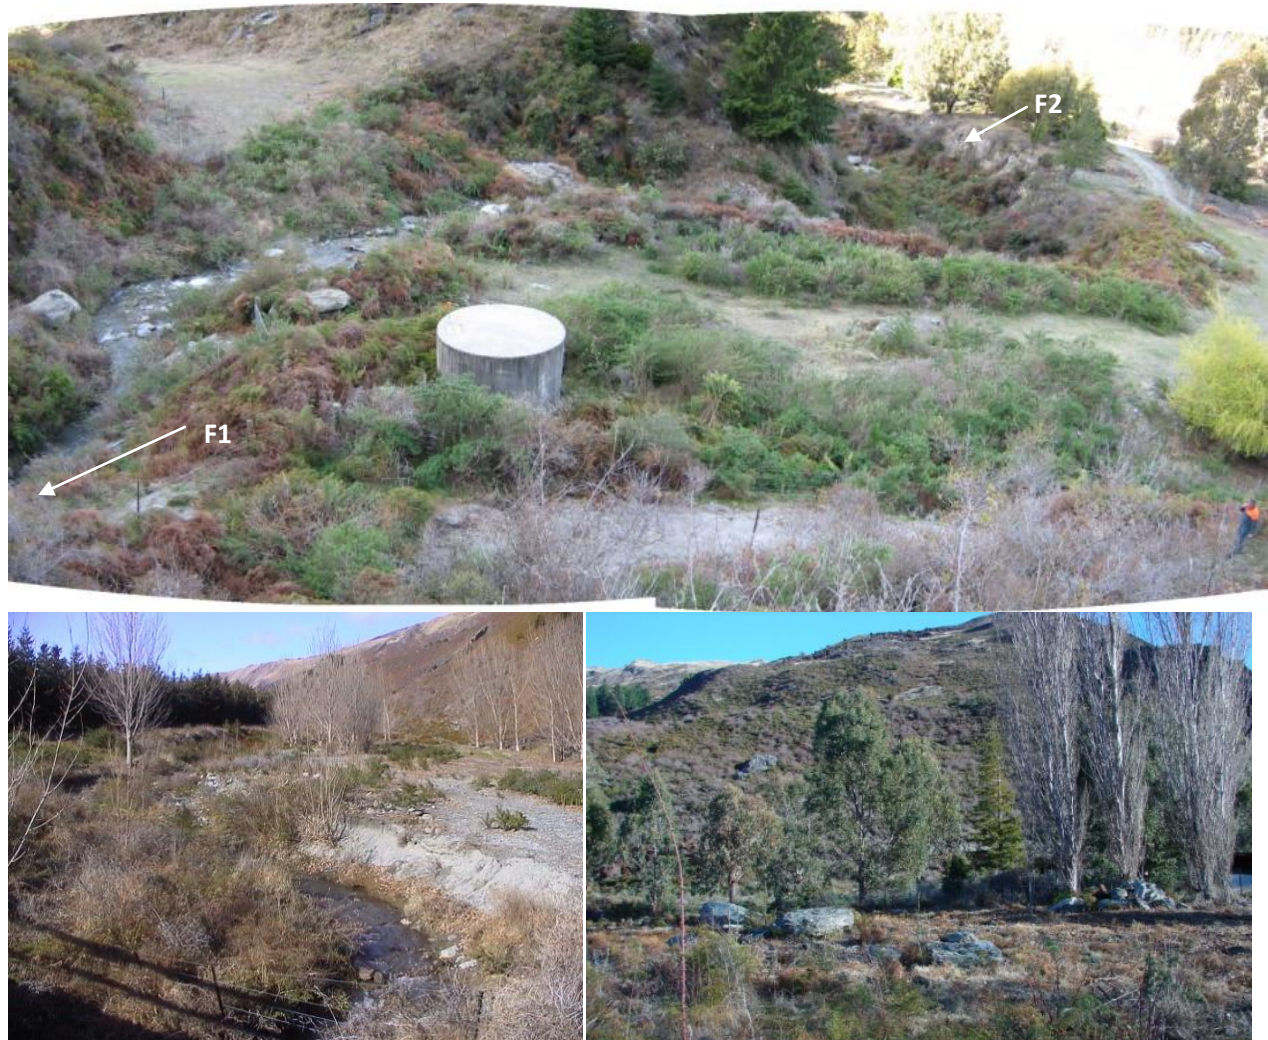
Figure 6.6 Photographs that relate to the points of interest in Figure 6.5. Top: Head of Waterfall Creek fan, showing less than 1m incision (F1) and becoming much more incised further downstream (F2). Bottom left: Waterfall Creek, looking upstream from Wanaka-Mount Aspiring Road (F3). Bottom right: Debris lobe on the Waterfall Creek fan, showing large boulders on the fan surface (F4)

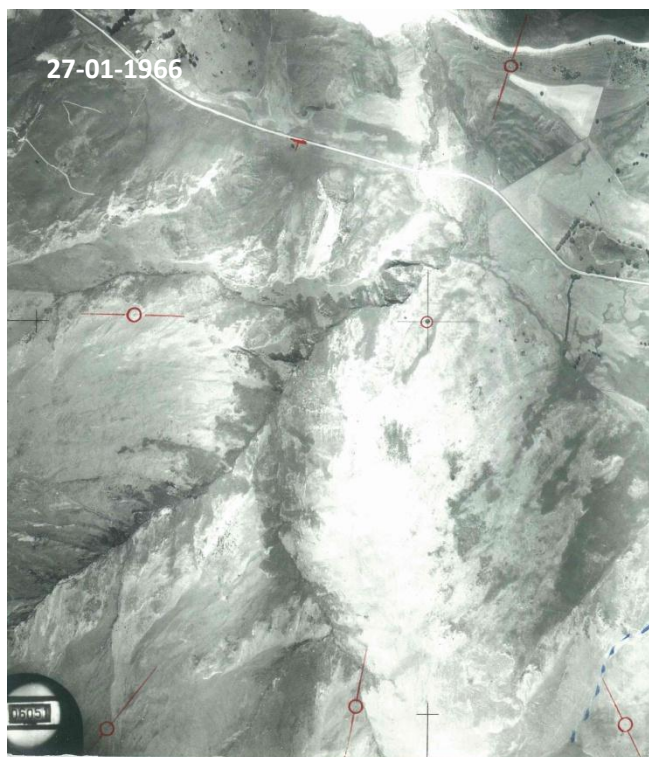
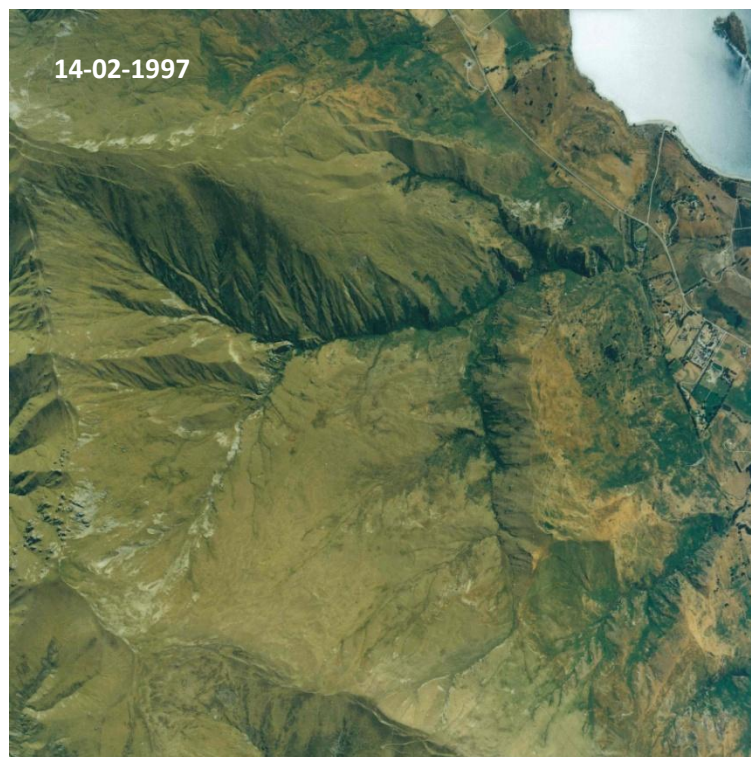
Historic Aerial Photographs Waterfall Creek, Wanaka

Evaluation of slope stability, vegetation dynamics and geomorphic evidence in the Waterfall Creek catchment suggests that there is potential for a landslide-debris dam to form. This scenario is most likely to be triggered by a large seismic and/or high-intensity storm event, which may result in complete or partial slope failures impounding the channel. The effects of a sudden landslide-dam failure in the catchment would include rapid aggradation on the alluvial fan, particularly in the vicinity of the fan head, debris and/or debris-flood deposits spreading across the wider fan surface, erosion of the fan surface and reoccupation of historic palaeo-channels. The slides identified in Figure 6.4-P4 are active, and if sudden failure and channel impoundment were to occur, their location in the catchment means that approximately 7.2km² of catchment may be impounded and subject to subsequent failure.

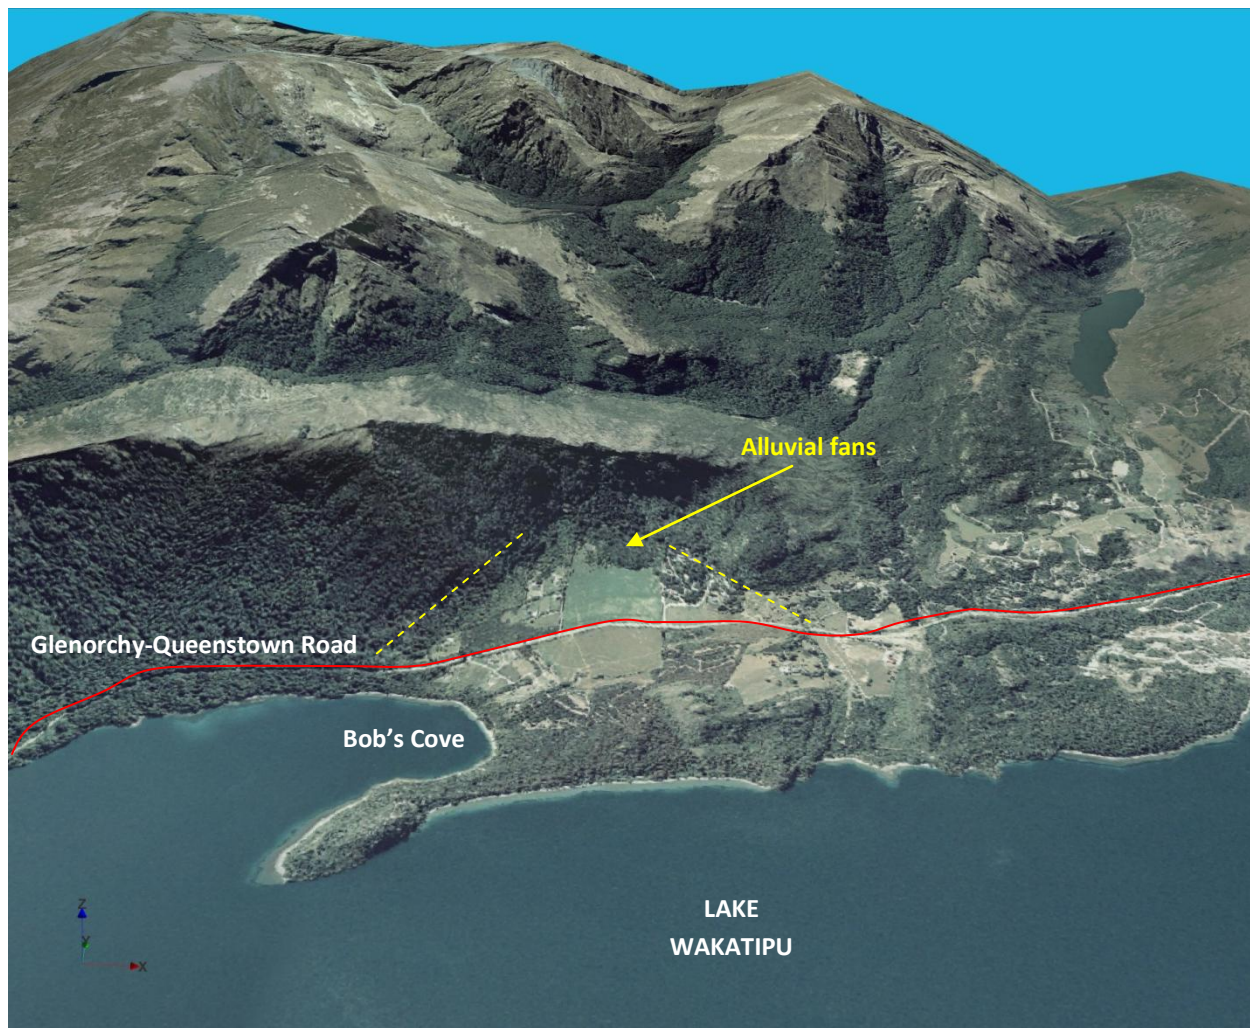
Figure 7.1 Image showing the Bob's Cove alluvial-fan complex, with respect to the surrounding environment

Located on the shores of Lake Wakatipu, the Bob's Cove area is a geologically young landscape, having been scoured by glaciers during the last glacial period, as discussed in Section 1.2. Bob's Cove is located approximately 12km west of Queenstown on the only access road to the Glenorchy township. The complex of alluvial fans in this area is known as Cove Flat and has historically been dominated by pastoral farming. Increasing urban development of these flats has occurred in recent decades, with much of the higher aspects of the alluvial fans being developed into subdivided allotments.

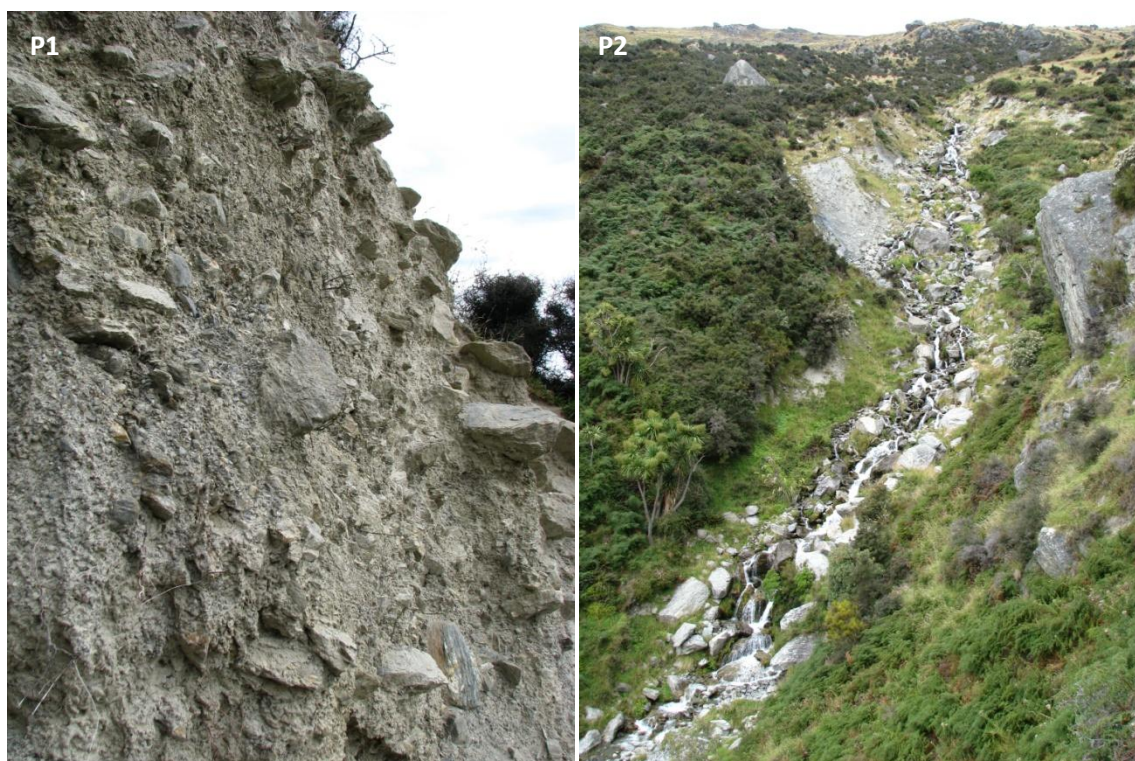
Figure 9.3 Left: Large landslide deposits flank the slopes of the Kingston Creek catchment on the channel's true left. Right: Kingston Creek, as it descends from the flatter-grade upper catchment; the creek is actively eroding landslide material in this reach of the catchment.

Where the catchment steepens, the creek is eroding into post-glacial landslide deposits that flank the slopes of the Hector Mountains. These deposits were formed following the recession of the buttressing glaciers during the last glacial period. Subsequent to slope relaxation, mechanical-weathering and mass-movement processes have contributed to the widespread development of unconsolidated landslide deposits on these slopes (Figure 9.3-P1). Slope instability is common in this reach of the catchment, with the greatest volume of sediment being derived from the sediment-source area on the true right of the creek (Figure 9.3-P2).

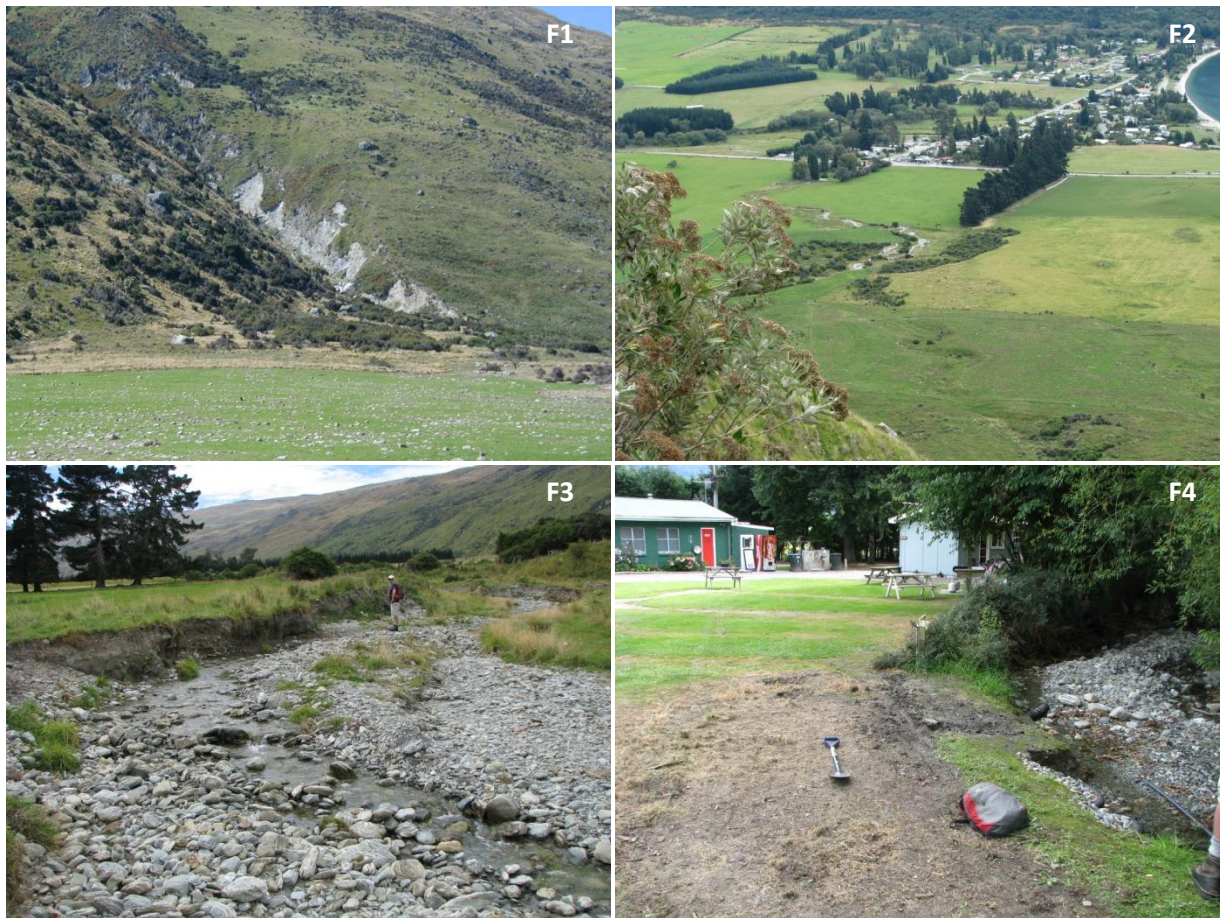
Figure 9.5 Photographs that relate to points of interest depicted on Figure 9.4. Top left: The upper Kingston Creek alluvial fan showing a large clast boulder field at the fan head and recently overturned debris deposits in the foreground. Top right: Large palaeo-channels traverse the Kingston creek alluvial-fan surface. Bottom left: The Kingston Creek channel above SH 6 is incised less than one metre for much of its length. Bottom right: Downstream of the state highway, the creek has almost no incision through the Kingston camping ground.

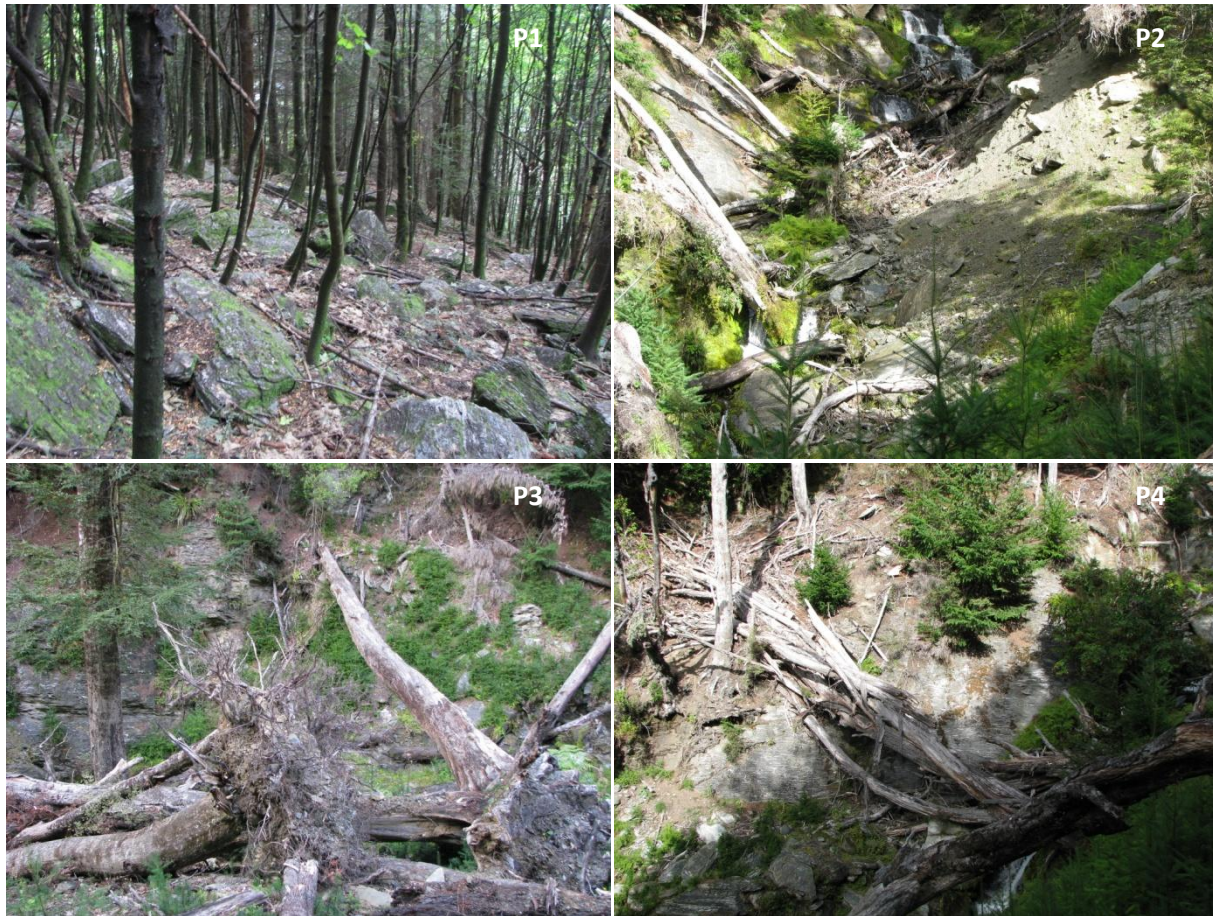
Figure 10.3 Photographs that relate to points of interest depicted in Figure 10.2. Top left: Large rock-fall boulders strewn across the Brewery Creek's left bank; this location has been succeeded by younger trees. Top right: Brewery Creek, looking upstream, colluvial landslide deposits are being eroded on the true left (image right), and the creek is bound by bedrock on the true right (image left). Bottom left: Large toppled trees lie on slopes next to the incised Brewery Creek channel. Bottom right: Log-jam dam formed in the Brewery Creek channel

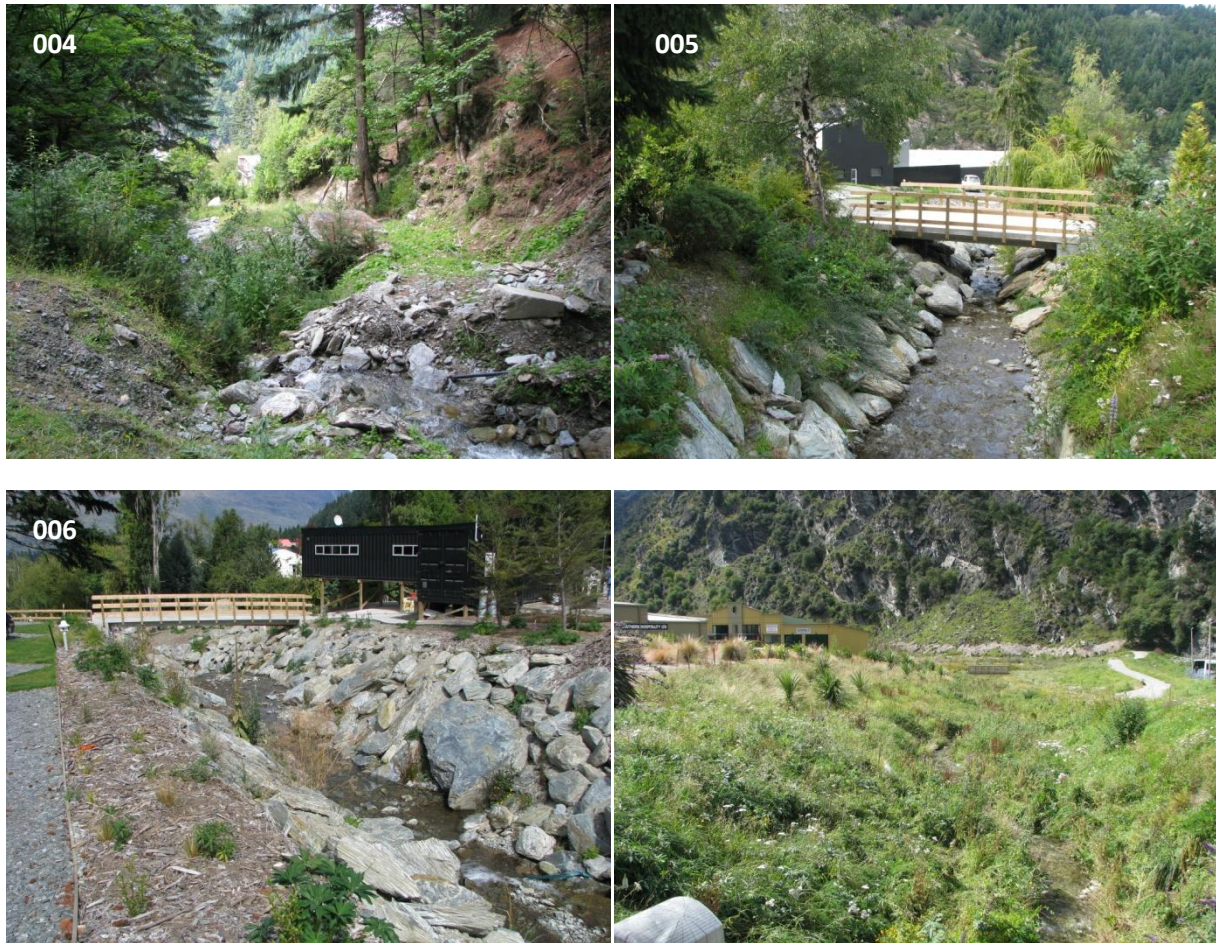
Figure 10.5 Top left: The U-shaped valley near the topographic apex of Brewery Creek. Top right: Modified Brewery Creek channel downstream of the topographic apex. Bottom left: Brewery Creek's modified channel in the mid-fan area, with visitor accommodation complex in the background. Bottom right: Brewery Creek's unconfined channel below Gorge Road

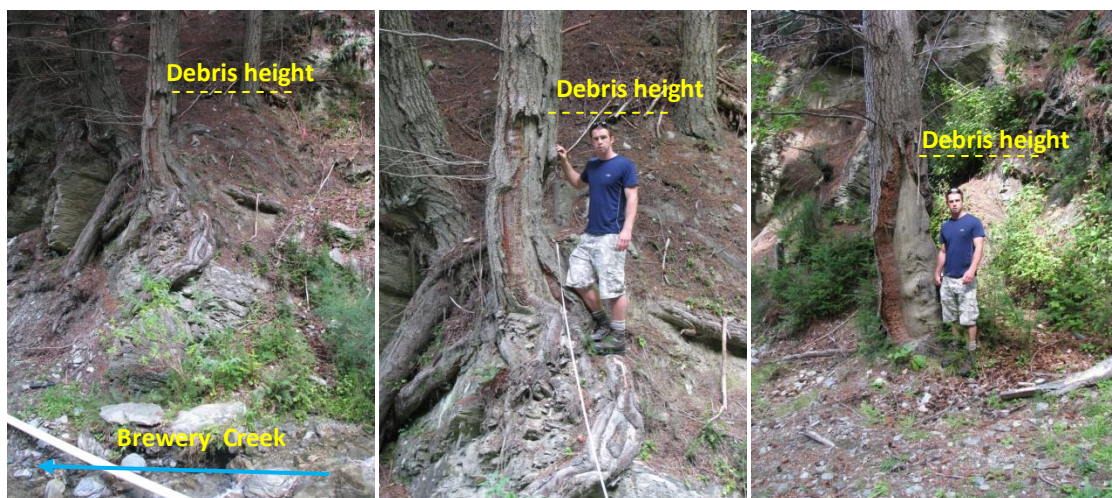
Figure 10.6 Debris-impact scars on mature trees near Brewery Creek's topographic apex. Left: Debris mark at 003 (Figure 10.4), showing height with respect to ground level. Centre: Same tree as left image, with figure for scale. Right: Similar tree just downstream of mark 003

During a debris-flow event, trees on the lateral margins of the flow often have bark and superficial layers removed from the trunk due to the flow's erosive power. Figure 10.4 shows a number of locations where historic-debris-flow heights have been measured from scars on mature trees with respect to the existing modified-channel invert and respective ground level; examples of these marks are depicted in figures 10.6 and 10.7.

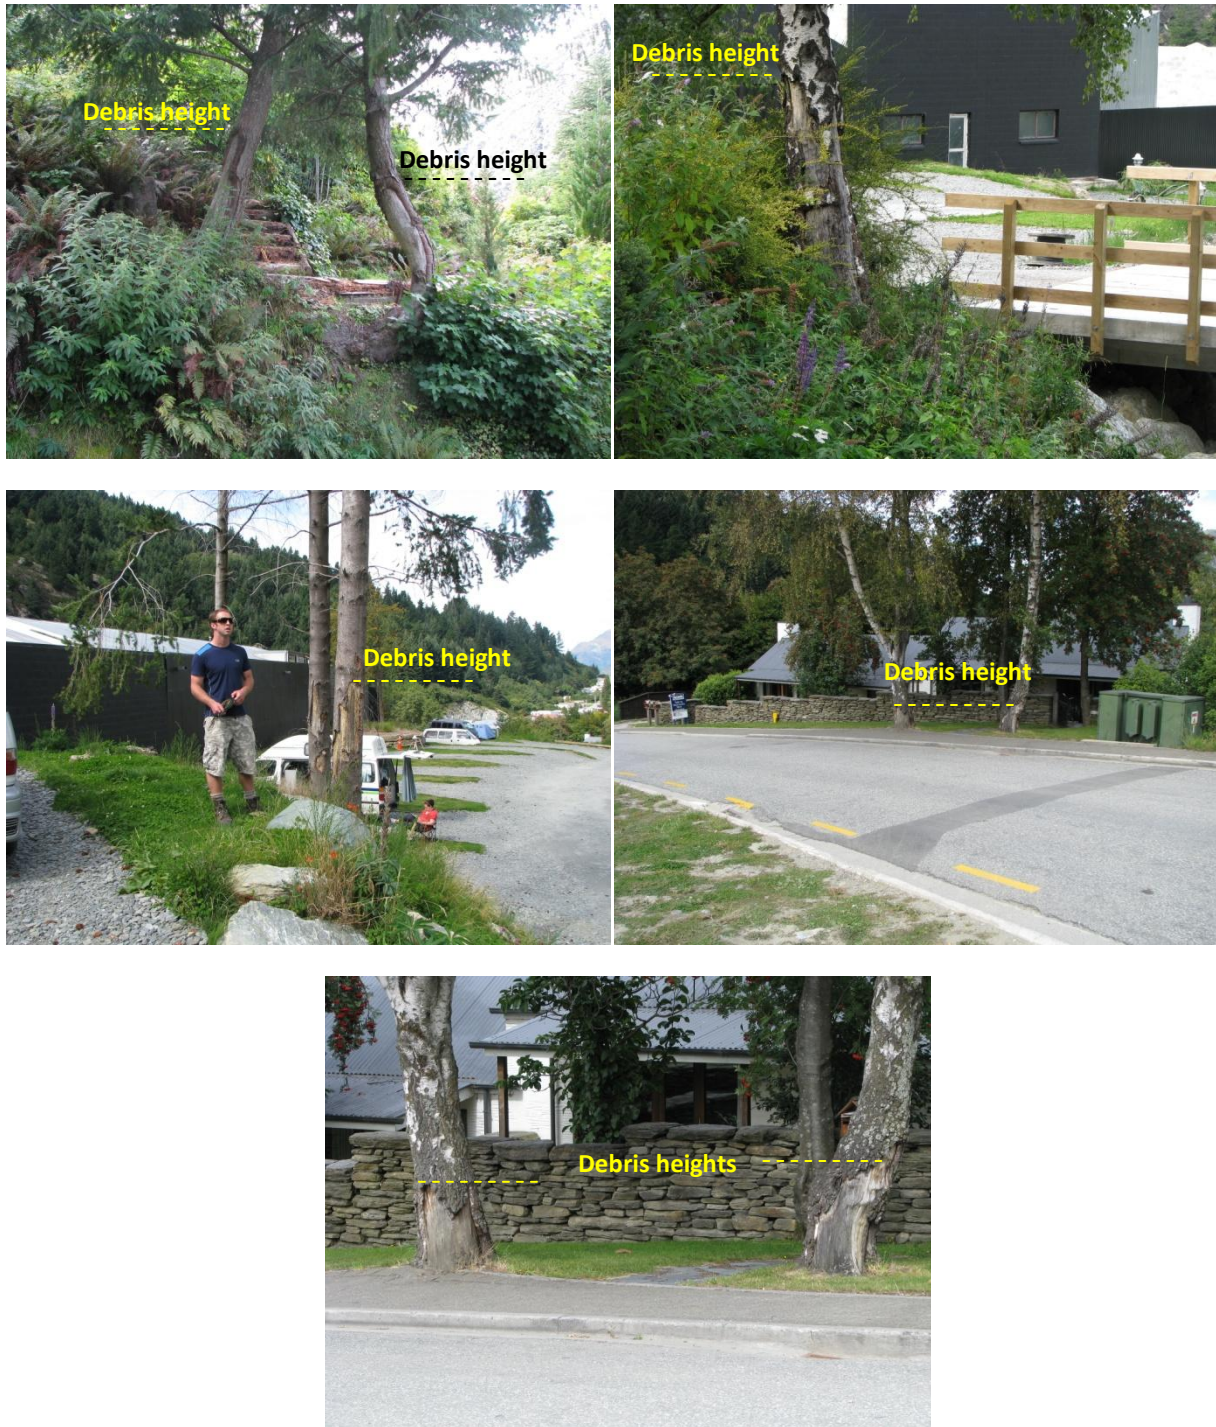
Figure 10.7 Debris-impact scars on mature trees on the Brewery Creek alluvial fan. Top left: Debris scars on left-bank trees just upstream of point 005 (Figure 10.4). Top right: Debris scar on true-left tree at point 005. Mid-left: Debris scars on trees at point 006 with figure for scale. Mid-right: Looking across Bowen Street towards trees at point 008. Lower image: Trees on far side of Bowen Street at 008
