Otago Alluvial Fans: High Hazard Fan Investigation

June 2011

Otago Regional Council

Prepared by Richard Woods, Natural Hazards Analyst, Otago Regional Council

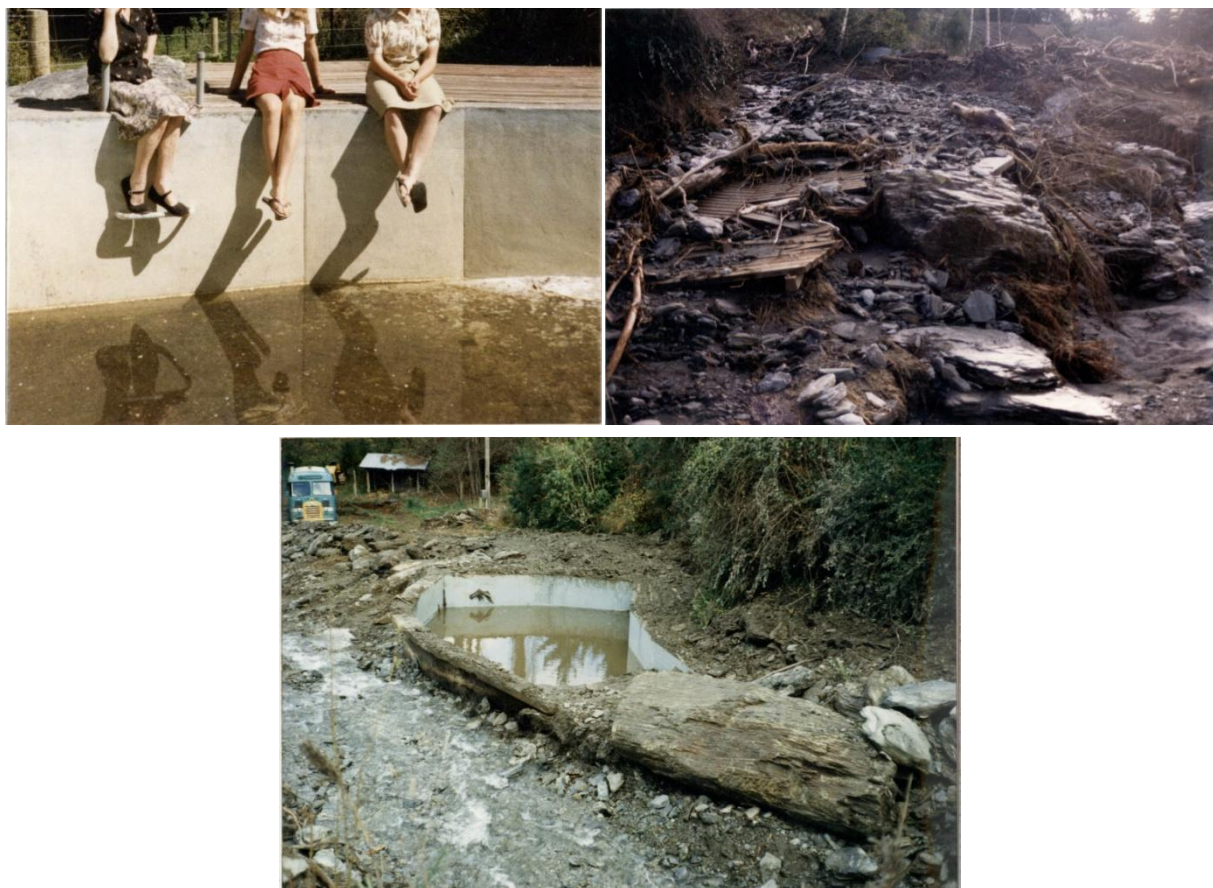
Figure 10.8 Photographs of a swimming pool on the Brewery Creek alluvial fan. Top left: Pool before May 1986, showing depth with respect to figures. Top Right: Pool filled with debris, following the storm event of May 1986. Bottom: Excavated pool after the May 1986 flood event; Brewery Creek flows to the immediate left of the pool.

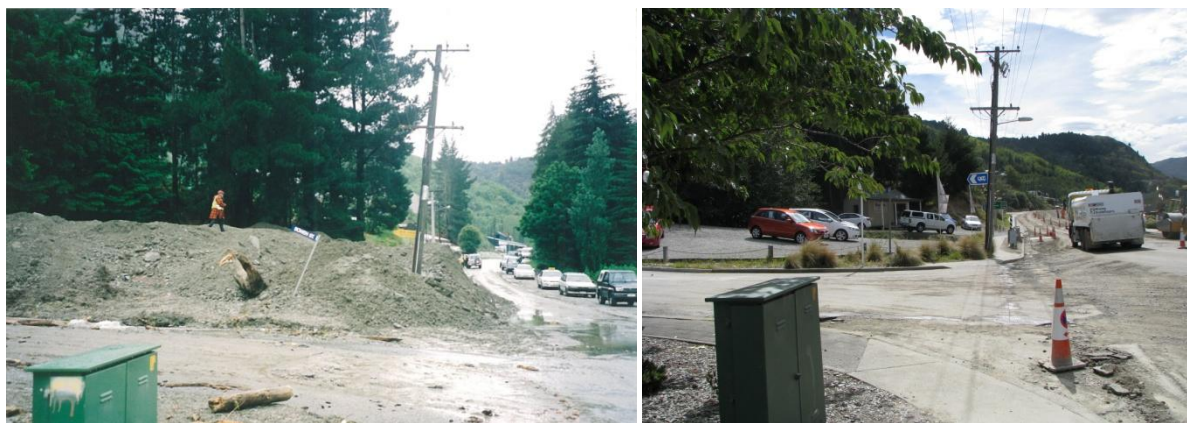
Figure 10.9 The intersection of Bowen Street and Gorge Road, following the November 1999 flood event (left), compared to the same view March 2011 (right). Brewery Creek flows down the centre of the road in the left image.

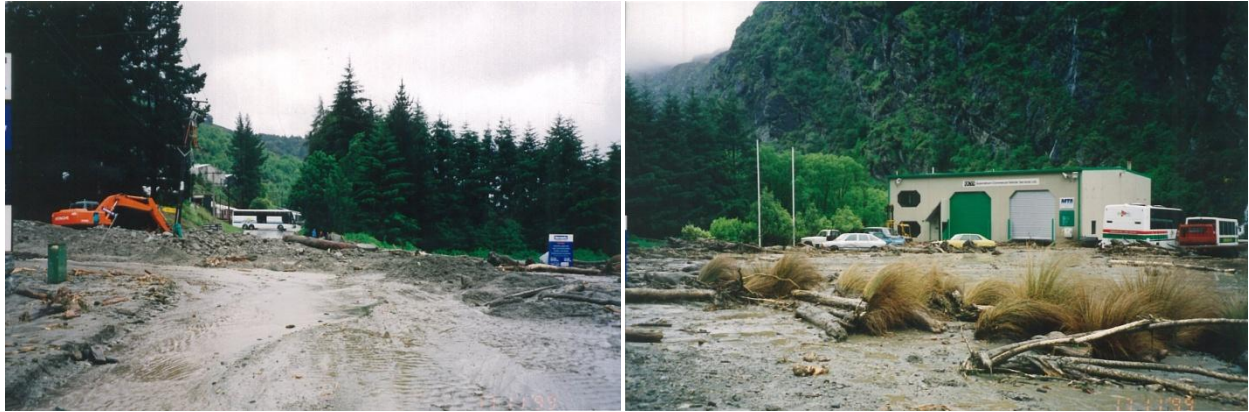
Figure 10.10 Brewery Creek, following the November 1999 storm event. Left: Looking north up Gorge Road on the corner with Bowen Street. Right: Sediment and tree debris carried by Brewery Creek on the downstream side of Gorge Road, 17 November 1999

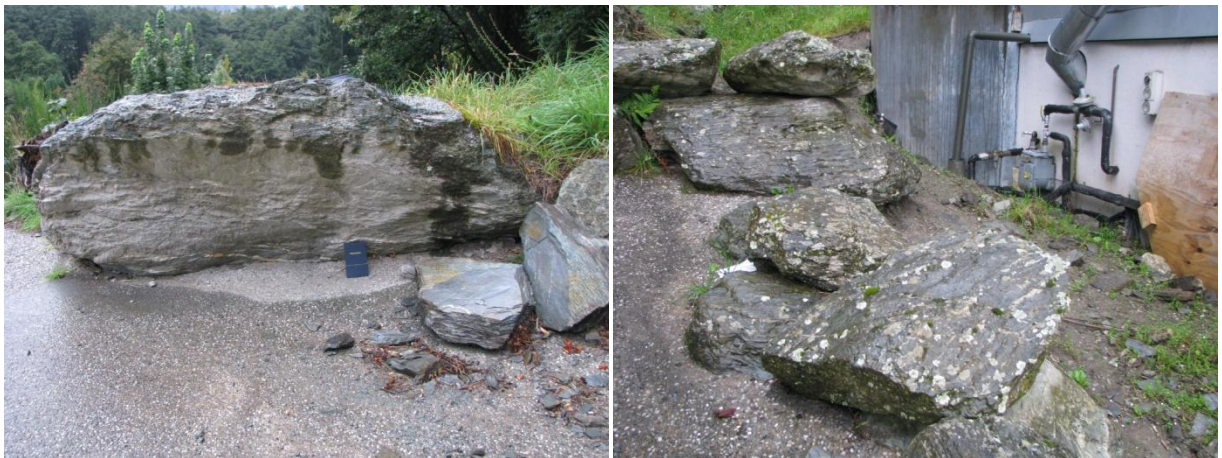
Figure 11.4 Large boulders and clasts of schist just down slope of the topographic apex of the Reavers Lane alluvial fan. While not *in situ*, it can be inferred that these boulders were derived from the alluvial-fan surface.

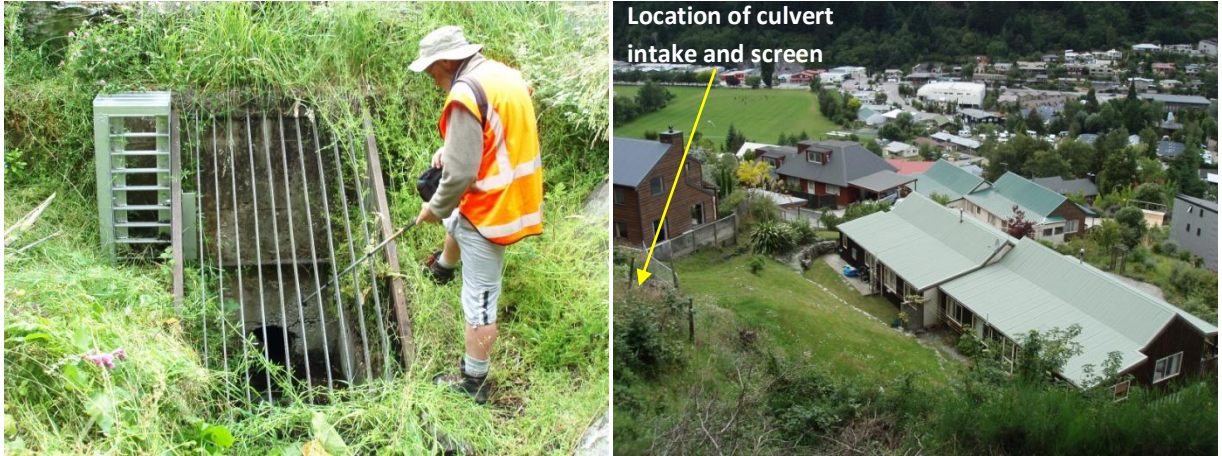
Figure 11.5 Reavers Lane alluvial-fan stormwater screen and culvert entrance (left). Residential properties at the head of the alluvial fan with respect to location of this structure (right)

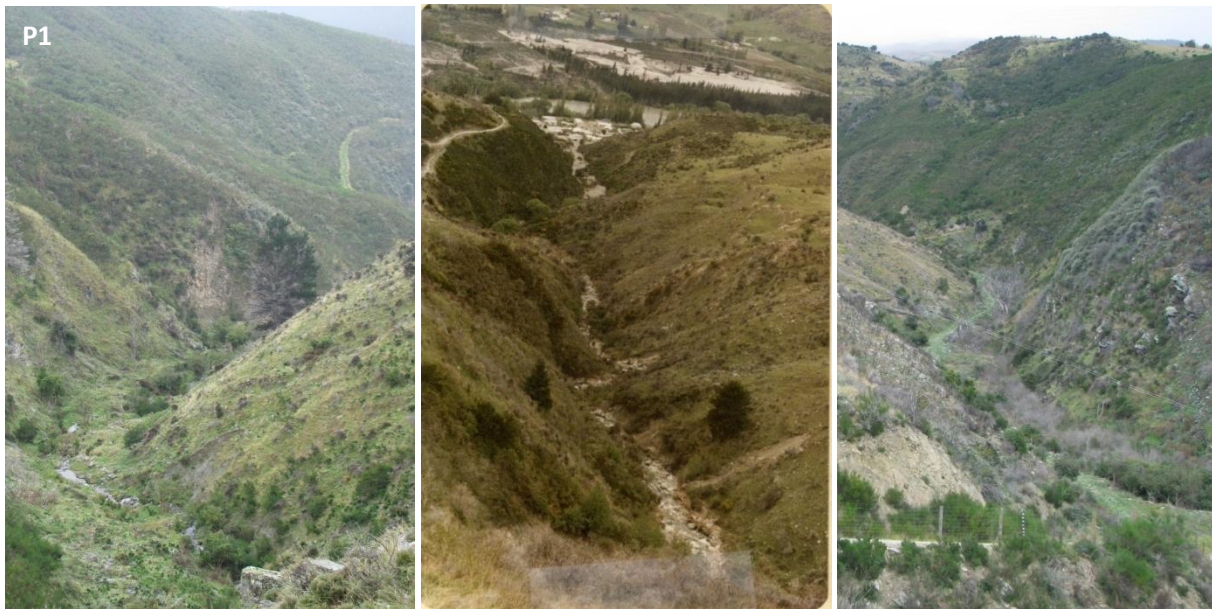
Figure 12.3 The Reservoir Creek catchment. Left: Incision into the base of the adjacent slopes contributes sediment and debris to the channel. Centre: Lower catchment on 17 October 1978, looking downstream; fresh debris deposits are evident along the length of the channel. Right: The same stretch of lower catchment as centre image, taken in March 2011, looking upstream. Debris deposits are now vegetated in this reach and have been subsequently incised by the active channel.

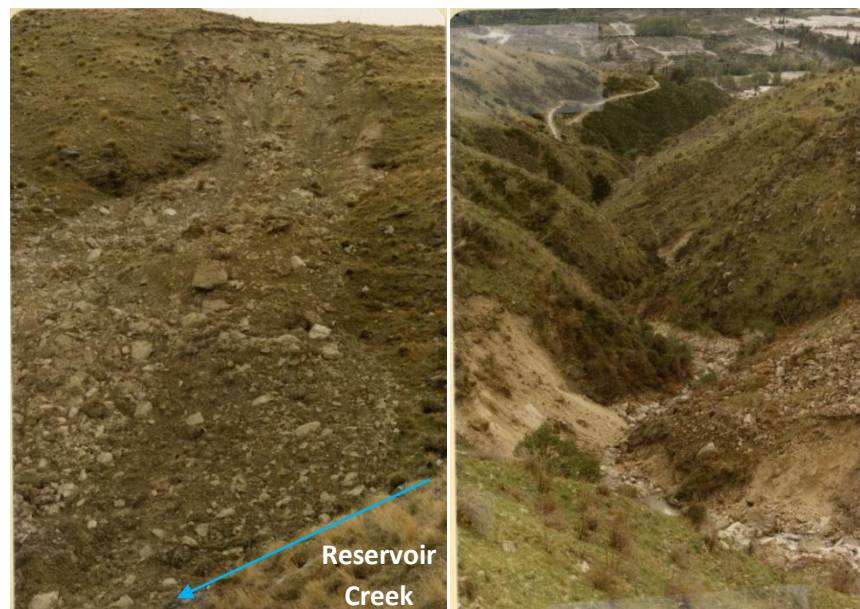
Figure 12.4 Left: Upper catchment debris slide almost impounding the Reservoir Creek channel, 17 October 1978. Right: Channel incision and erosion directly supply debris to the channel, 17 October 1978.

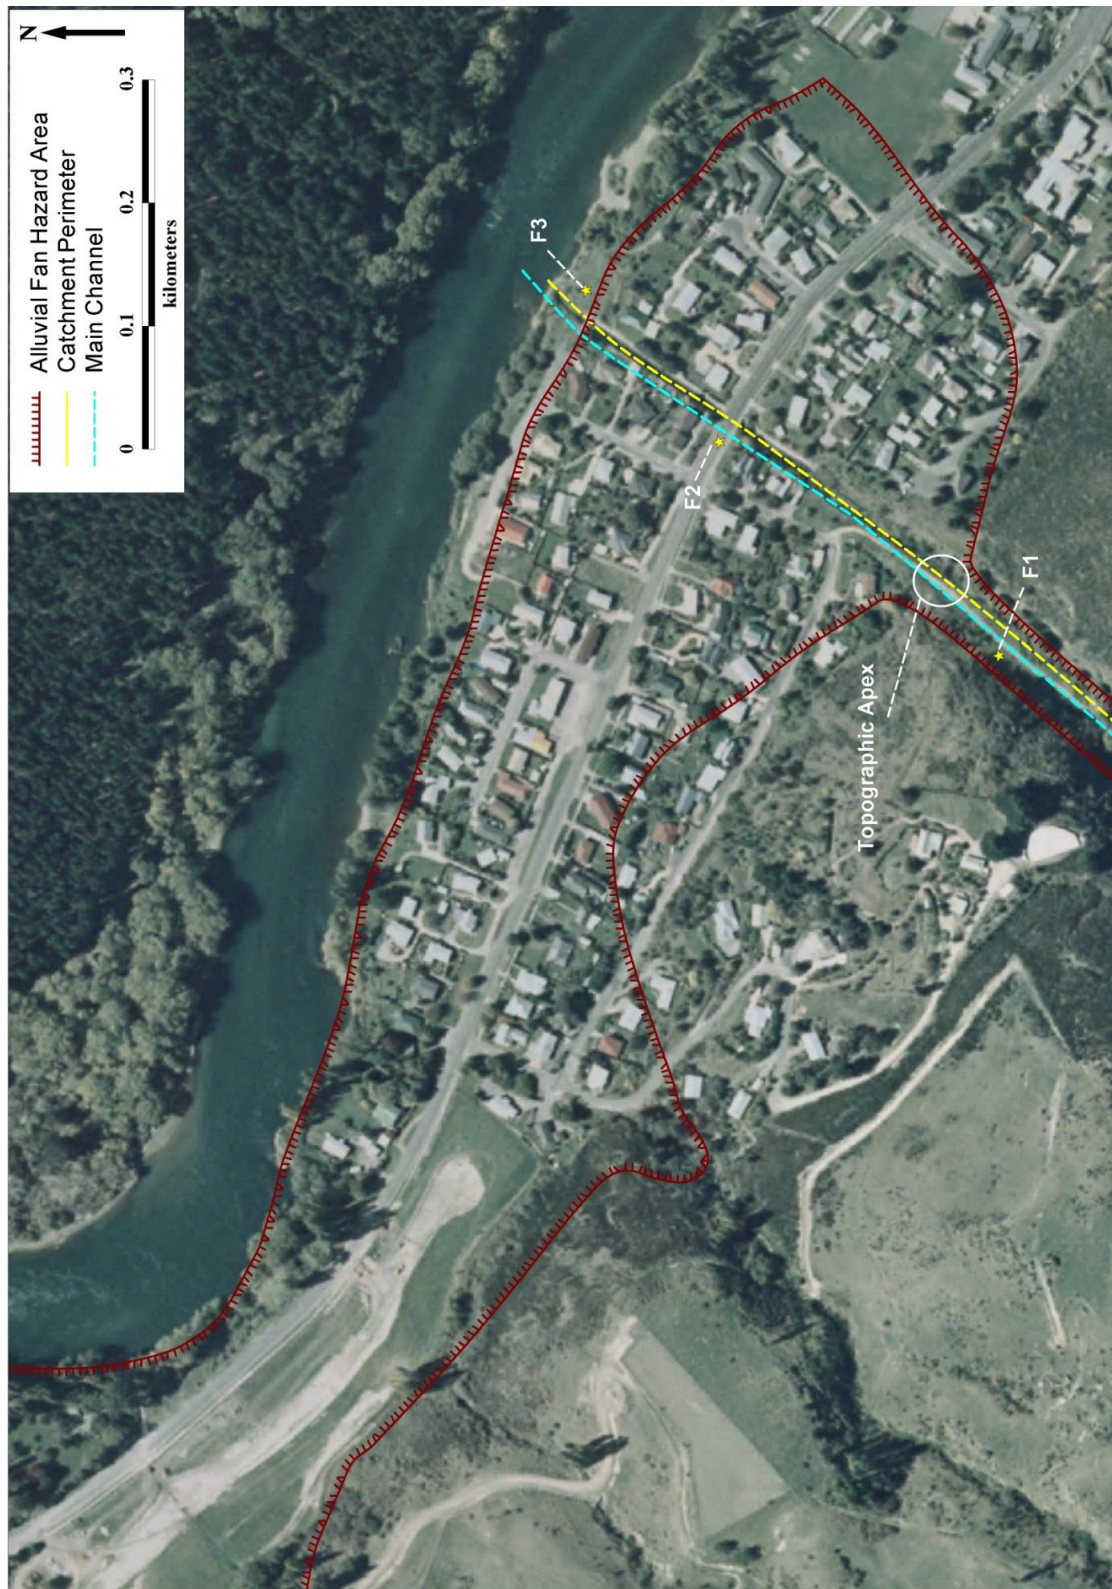
Figure 12.5 Reservoir Creek alluvial fan noting key features; aerial photo dated March 2006

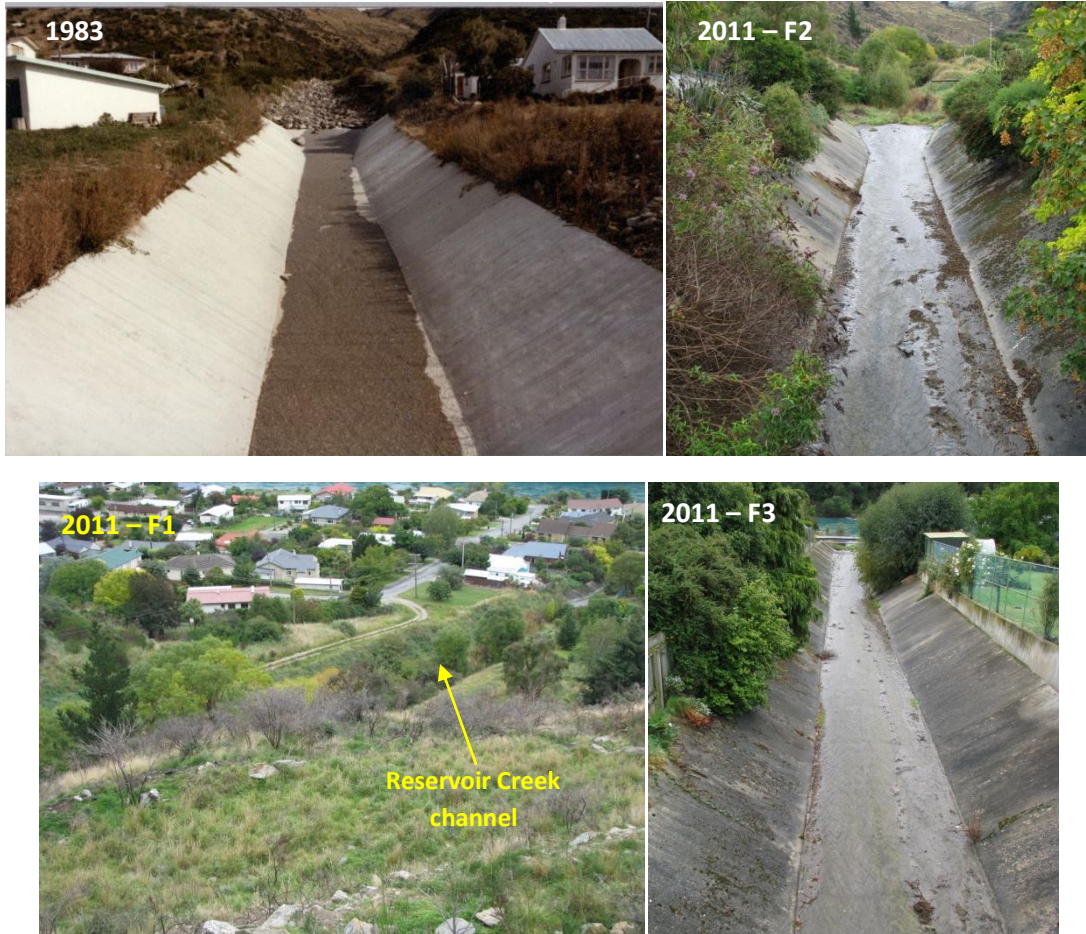
Figure 12.6 Reservoir Creek concrete-lined channel, upstream of SH 8 in March 1983 (top left), and in March 2011 (top right), looking upstream. Bottom left: Reservoir Creek channel upstream of concrete-lined channel. Bottom right: Reservoir Creek concrete-lined channel below SH 8

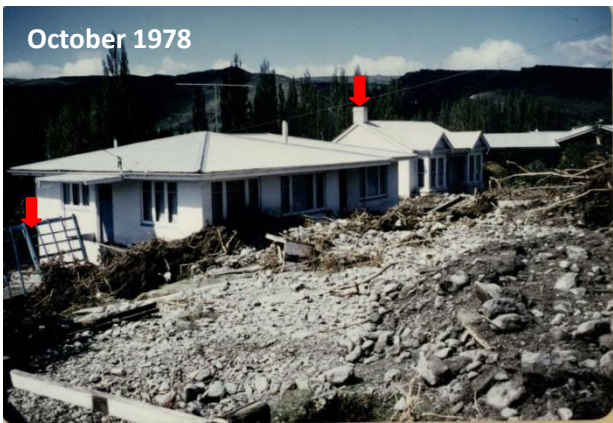
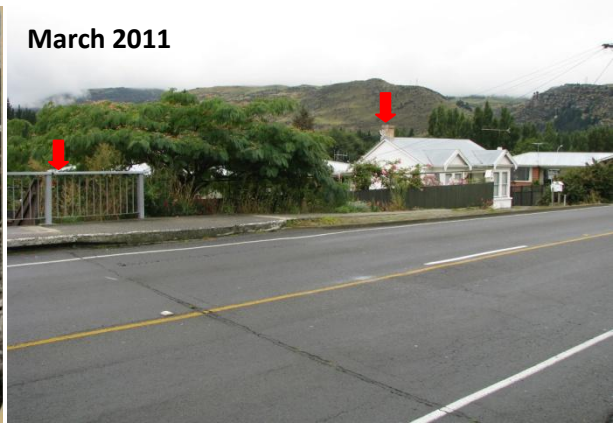
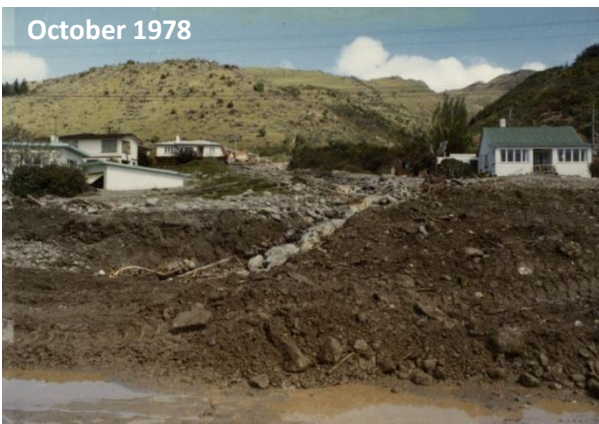
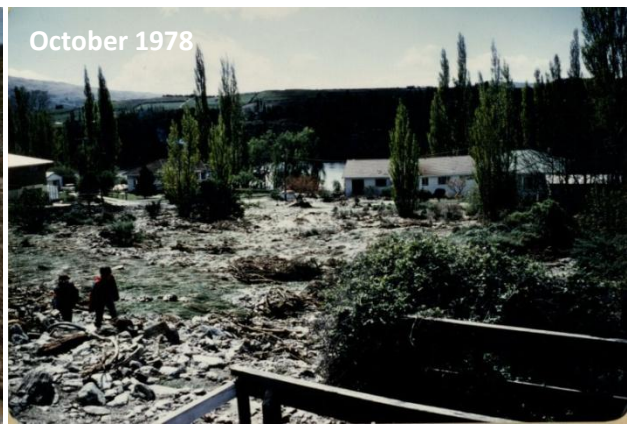
Figure 12.7 Top: Reservoir Creek at SH 8 after the October 1978 storm event, compared to March 2011. Large volumes of debris blocked the state highway in 1978 and impacted residential property. Bottom: Reservoir Creek, looking upstream (left) and downstream (right) of SH 8 in October 1978. Large volumes of debris are evident in both images.
