## **Technical report**

# **Methods used to define flood risk management areas**

**Otago Regional Council Natural Hazards team**

**July 2012**

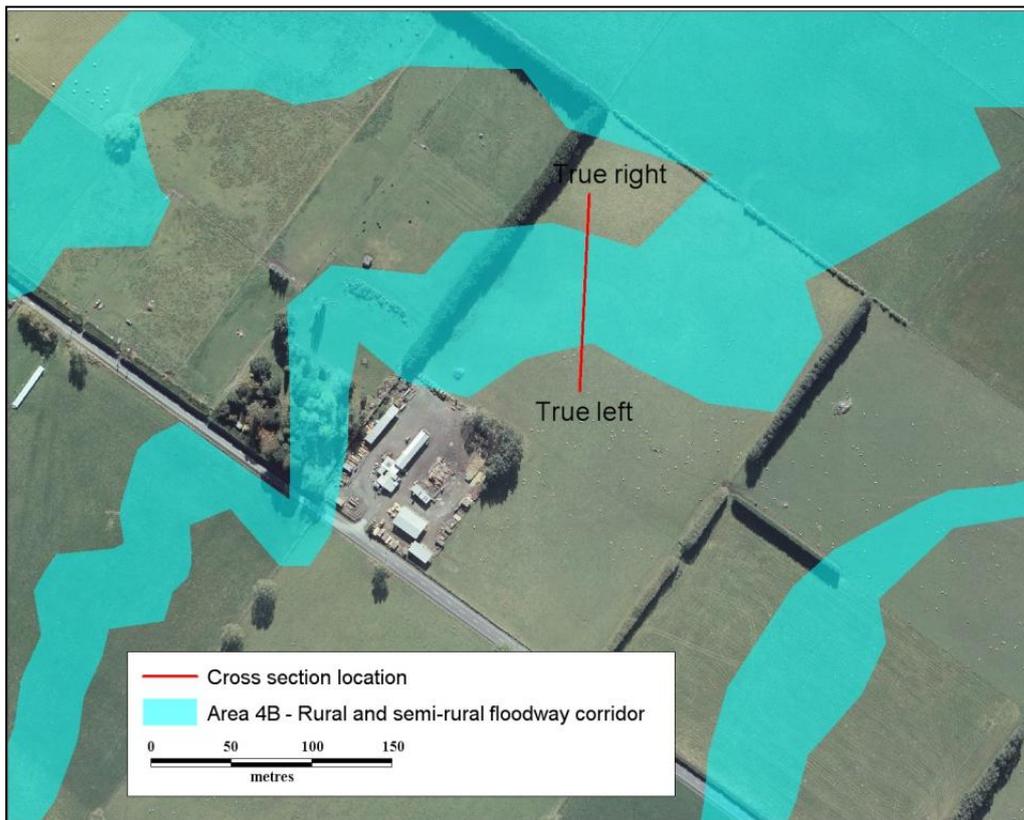
Figure 9. Location map of the cross section shown in Figure 8.

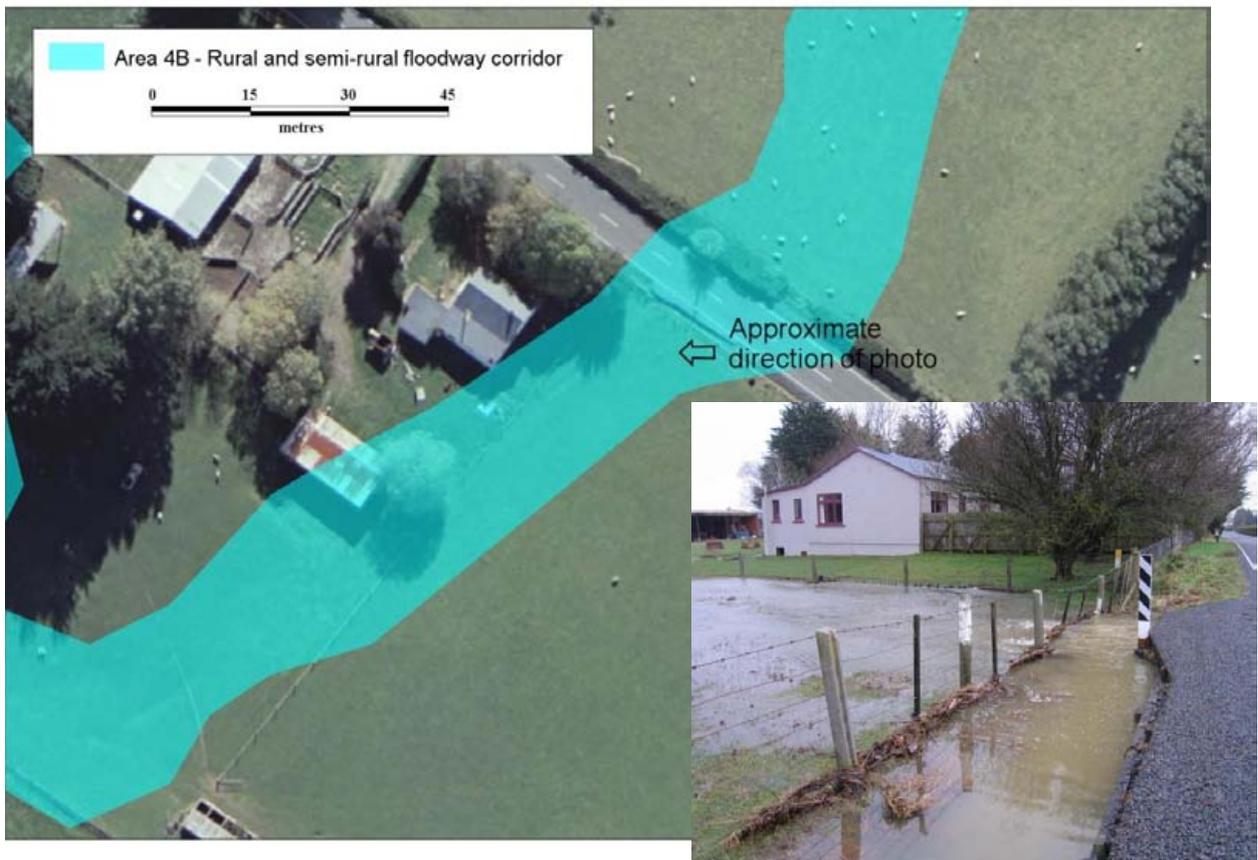
Figure 10. Example of a floodway crossing Springfield Road. The location and direction of the photo (inset) taken during a rainfall event in July 2008 is also marked on the image. The photo does not show floodwater covering the full extent of the floodway corridor, although the July 2008 event was a reasonably small magnitude event (an analysis using flow record from 1981 to 2012 at the Tokomairiro at the west branch bBridge site shows this event was slightly larger than an annual flood).

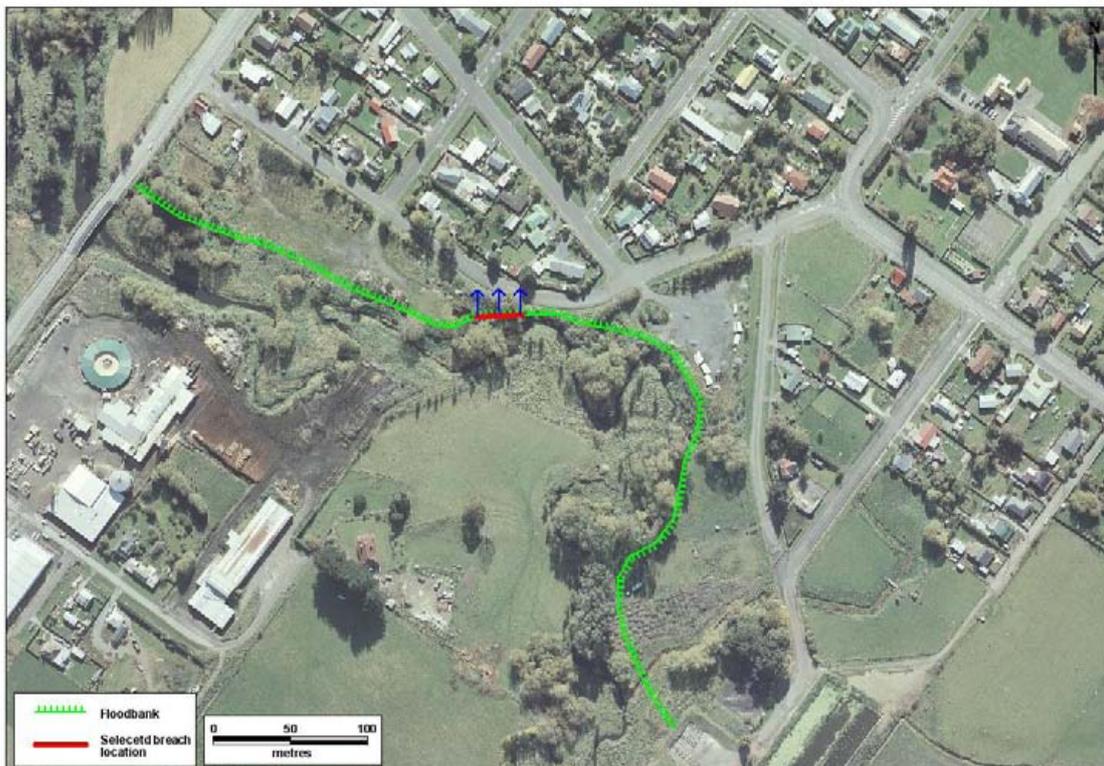
Figure 12. Floodbank breach location for the selected breach scenario.

- The breach characteristics are based on a scenario assuming the breach in the floodbank will occur adjacent to the sharp bend (higher velocities) in the North Branch channel upstream of the concrete retaining wall (upstream of the of the pump station) (Figure 12). At this location there is a 30m long section where the land was relatively lower than the surrounding before the construction of the floodbank (based on LiDAR data). It was assumed that the breach is 30m long and 0.7m deep (the estimated maximum depth of water over the natural ground at the 30m failed section of floodbank during a 100 year ARI flood);
