A 'rock ramp' fish ladder added to the ford at Brooklands Road in the lower reaches of Te Hakapupu / Pleasant River has substantially improved fish passage to the rest of the catchment. It serves as a lighthouse project to show what is possible.

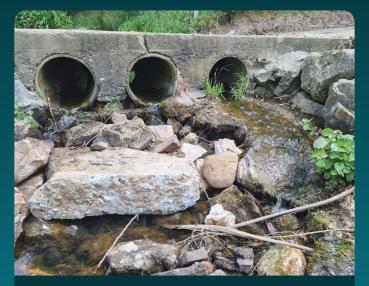
Figure 2. The downstream end of the Brooklands Road ford showing poor fish passage characteristics before construction of the rock ramp. © Matt Dale, Waterscape Connections

Barriers to fish passage were assessed and prioritised for remedial work. The Brooklands Road ford was an important barrier because it is close to the mouth of Te Hakapupu / Pleasant River (Figure 1). Being so close to the river mouth, it blocks access to most of the catchment's waterways for fish migrating from the sea (Figure 2).

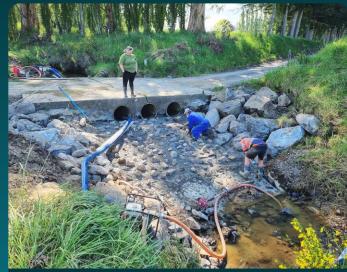
Figure 3. Construction of the rock ramp, showing the lowgradient ramp and rocks placed to reduce water velocity and provide resting areas for fish. © Matt Dale, Waterscape Connections

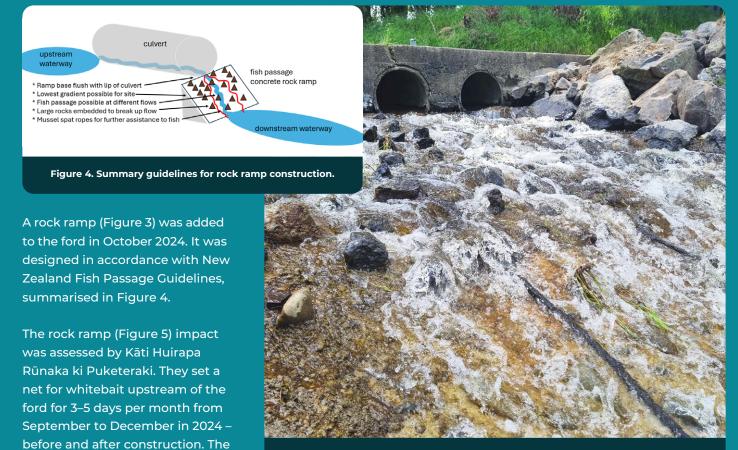
Figure 5. High flow levels showing pathways to assist with fish passage through the ramp and culvert. © Matt Dale, Waterscape Connections

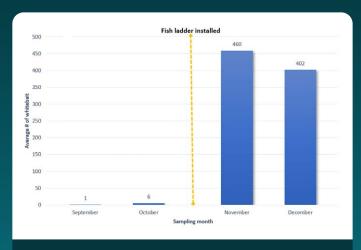
Figure 6. Average number of whitebait caught over a single tidal cycle upstream of the Brooklands Road ford between September and December 2024.

The rock ramp has made a huge difference to fish passage (Figure 6). Before construction, the average catch was less than ten whitebait in each tidal cycle. After construction, it was over 400!
