# Clutha River morphology trends at Balclutha

*Prepared for Otago Regional Council*

NIWA CLIENT REPORT No: 2025057CH  
Report date: March 2025  
NIWA Project: ORC25501

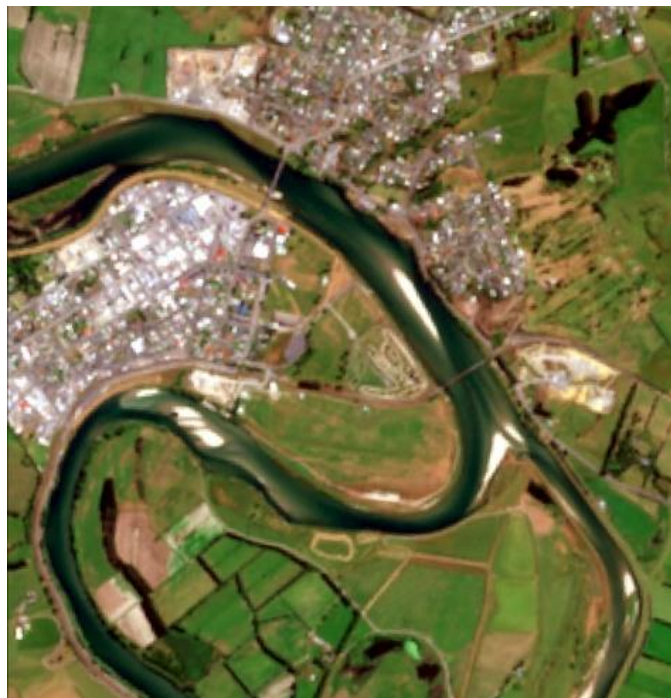
*Cover photo: Sentinel-2 satellite imagery of the Clutha River captured on 27<sup>th</sup> January 2025 showing the position of gravel bars.*

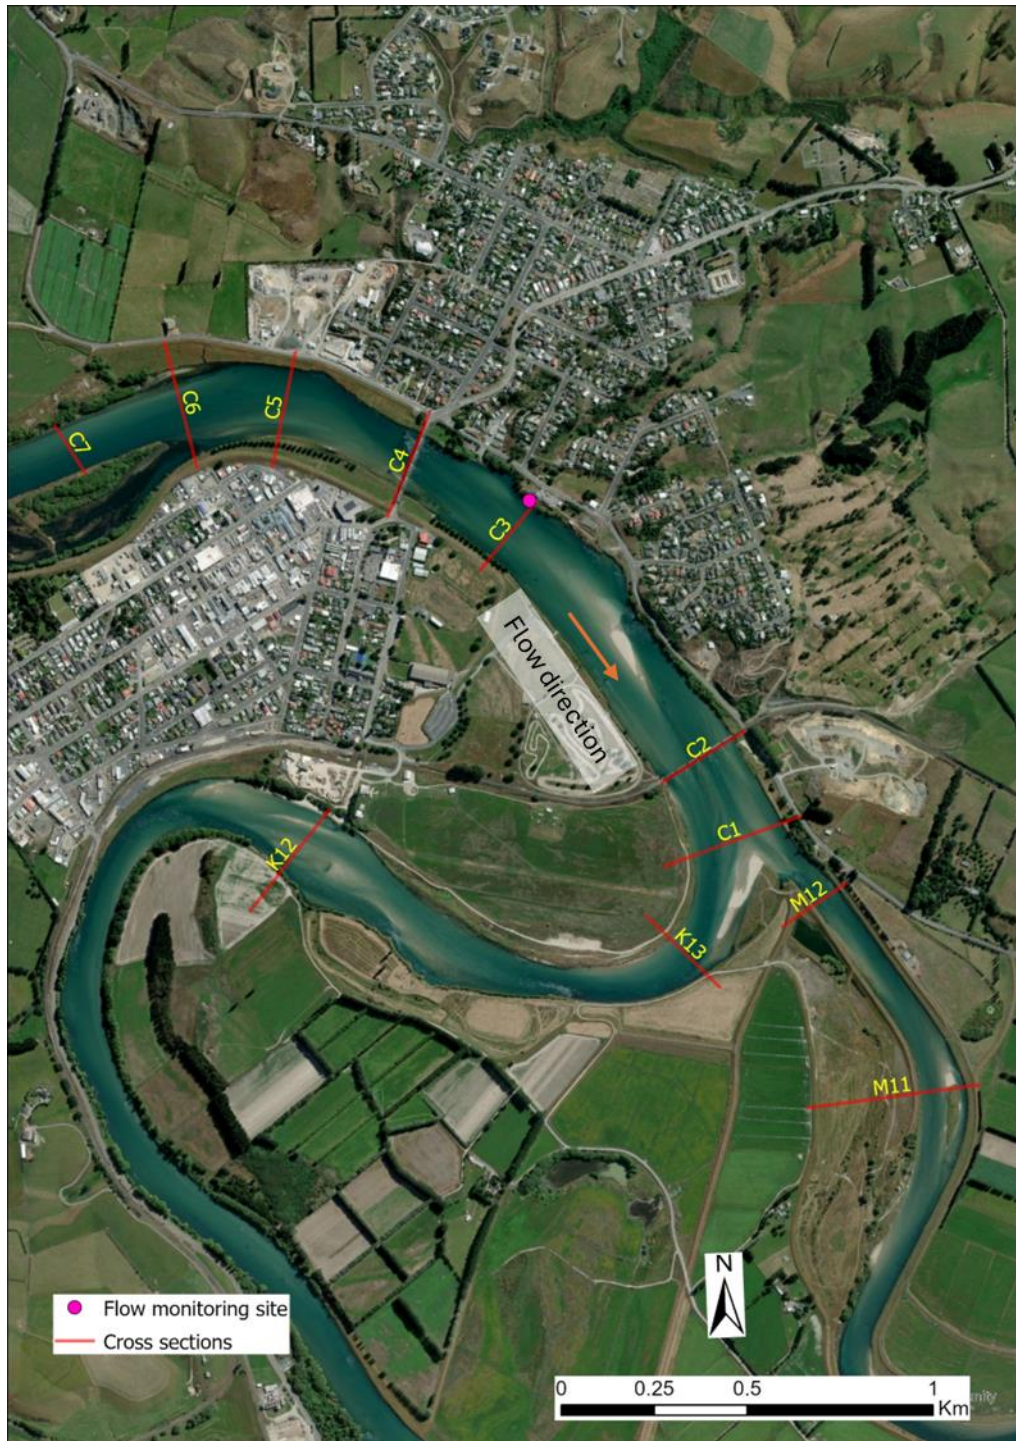
**Figure 2-1: The location of cross section surveys on the Clutha River at Balclutha together with the flow monitoring site. The flow monitoring site is “Clutha at Balclutha”.**

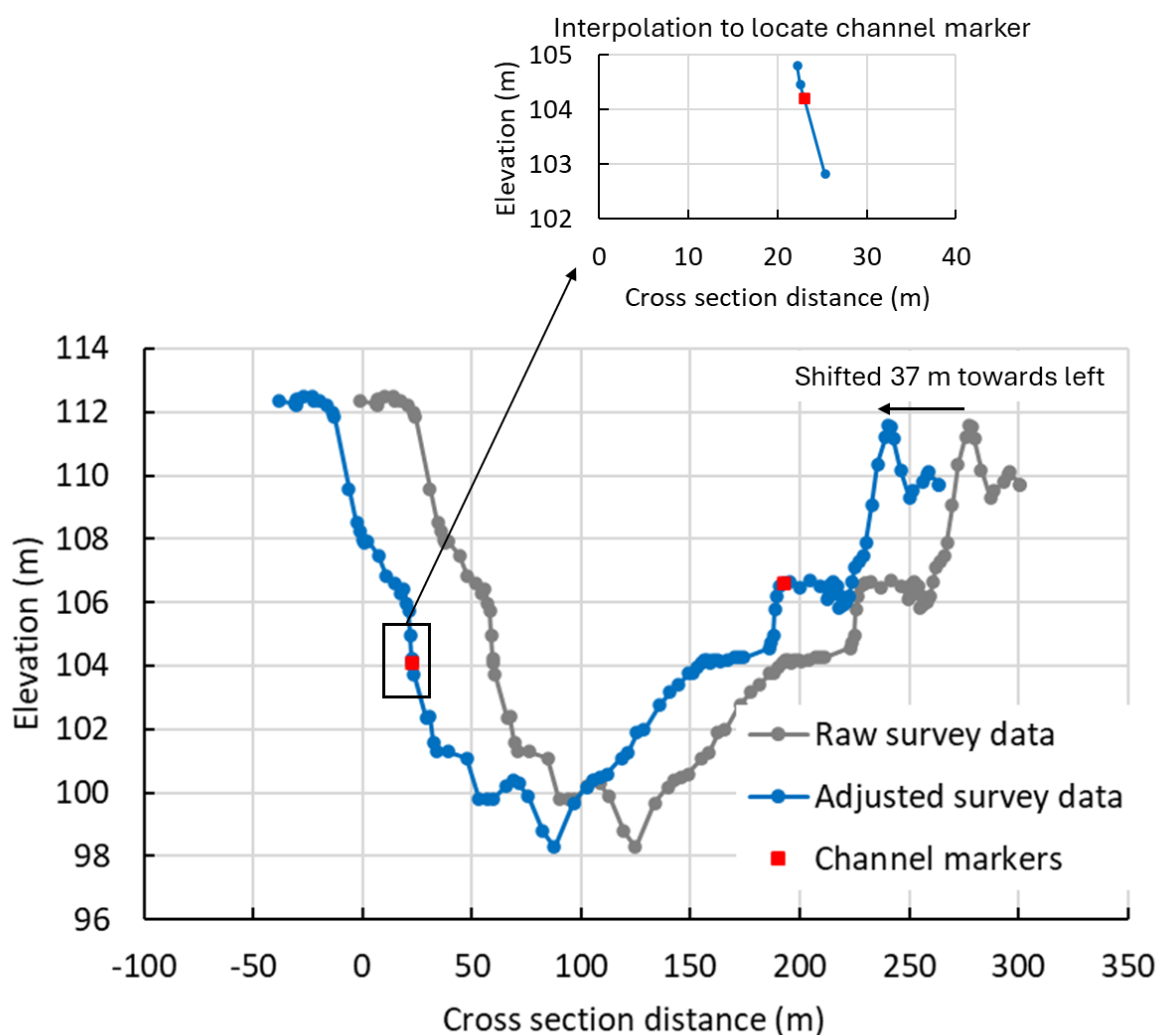
**Figure 2-2: Example of cross section data correction and interpolation between the measured points to find consistent start and end point for all surveyed years. Data shown are for cross section C4 in 2020.**

comparison of bed level changes, corrections have been made to surveys having obvious offset errors. These corrections were identified by overlaying consecutive surveys and measuring the horizontal offsets. These offsets are listed in Appendix A (Table A-1).

To ensure comparability of cross-section analyses, consistent start and end points were selected for each cross-section. These points were selected to encompass measurements from all surveyed years, allowing for a reliable comparison of changes over time. For surveys conducted in years where selected end points lacked measured elevation data, elevations were estimated using linear interpolation between the closest measured points. In cases where the surveys did not fully cover the start and end points, extrapolation was used to estimate the missing elevations (Figure 2-2). Table 2-2 summarizes the end point offsets and riverbed width used in the analysis of cross section data.

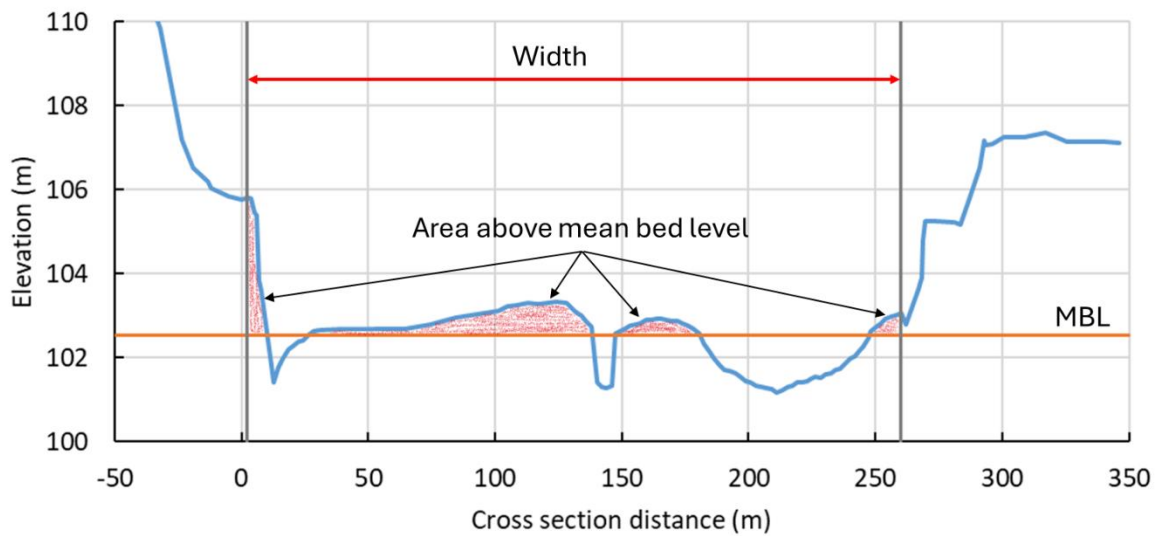
**Figure 2-4: Illustration of area above mean bed level for cross section C1 in 2024.**

Figure 2-4 shows the approach used to calculate this term for cross section C1 in 2024. The area above mean bed level was divided by the total width (as listed in Table 2-2) to give a consistent comparison between cross sections. The resulting average-height-above-mean-bed-level parameter helps quantify changes in morphological features across the river cross section. An increase in this parameter through time, means increased variation in bed levels across a cross section, which can indicate features such as sand or gravel bars or deeper channels forming.

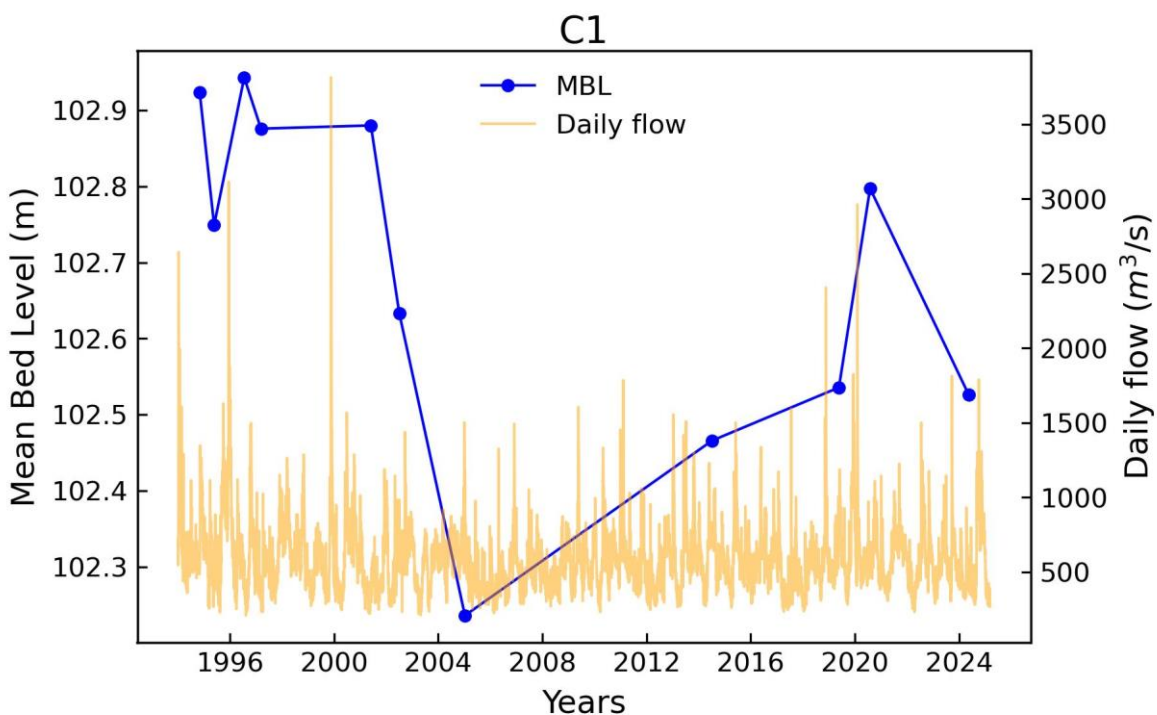
**Figure 5-4: Evolution of mean bed levels with time and daily mean river flow at section C1 and section C6.**

Changes in mean bed level over time were compared with mean annual flow and maximum annual flow. Examples are shown in Figure 5-4 for C1 and C6 with the remainder in Appendix C. There appears to be a tendency for the mean bed to rise when the flow rises but this not apparent at all cross sections and, at some sections, a reverse trend is evident, particularly after year 2020.

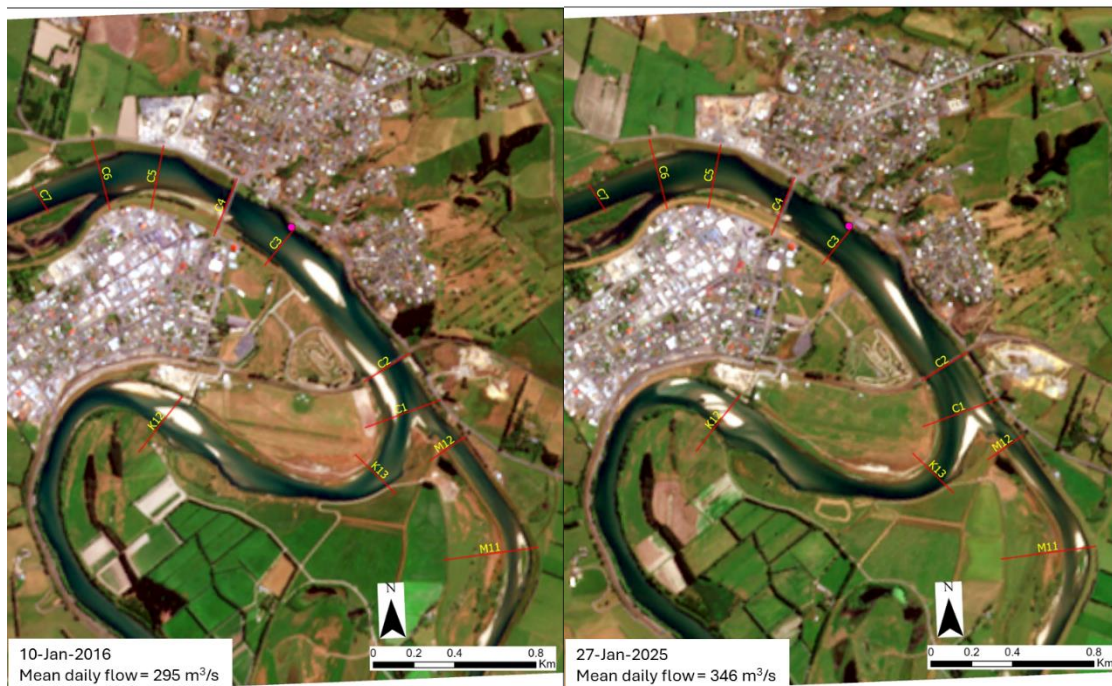
**Figure 5-9: Satellite imagery of the Clutha River at Balclutha on two dates: January 10, 2016 (left) and January 27, 2025 (right).** Imagery from Sentinel-2 satellite data. Red lines indicate the cross section locations. The flow monitoring site is shown with a magenta dot.

Due to variations in river flow at the time of satellite captures, it is not possible to measure quantitative temporal changes in the size of the bars, on the basis of the imagery. Bar size is also discussed in Section 6-2.

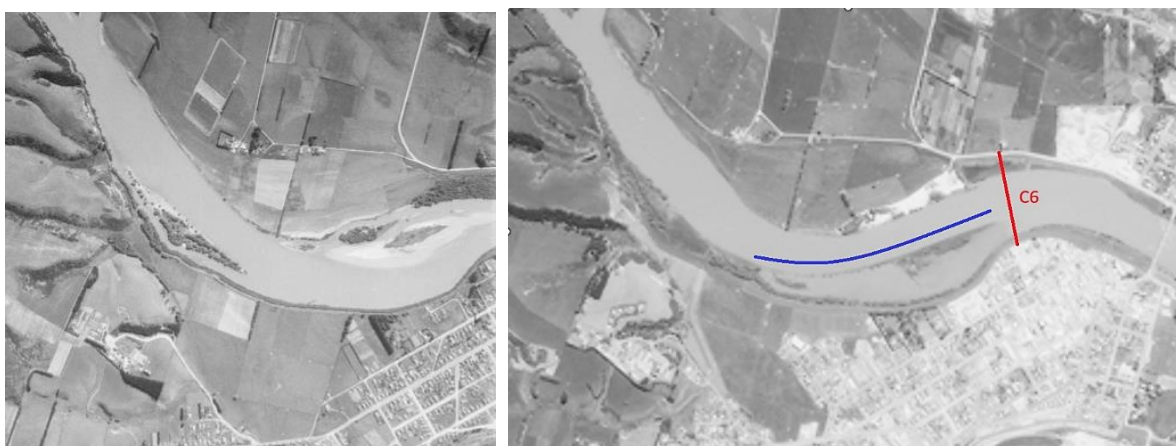
**Figure 6-1: Aerial photographs from 1946 (left) and in 1995 (right). Blue line indicates the mid-channel river training works upstream of cross section C6.**

In general, observed changes correspond to the expected long-term, morphological change following a severe reduction in sediment input (i.e., Roxburgh Dam construction). Bed levels and water levels have initially fallen and the rate of degradation appears to have tailed off with time. Recent reports that gravel bars are more evident at Balclutha may be due to the bar movement noted above and the fact that a stable bar can become more visible and appear to be higher if the river level falls alongside the bar. There has been a clear change in shape at section C6 (Appendix B). The deepest point (thalweg) used to be in the channel on the true right but is now in the centre. Historic aerial imagery below Figure 6-1) shows that between 1946 and 1995, mid-channel river training works narrowed and re-directed the channel upstream of C6. These works are likely to be the explanation for the thalweg movement at C6. There were also river training works to re-narrow the entrance to the Matau branch in the early 1970's [Retrolens.co.nz: air photos of 27/2/1968 and 28/2/1975].

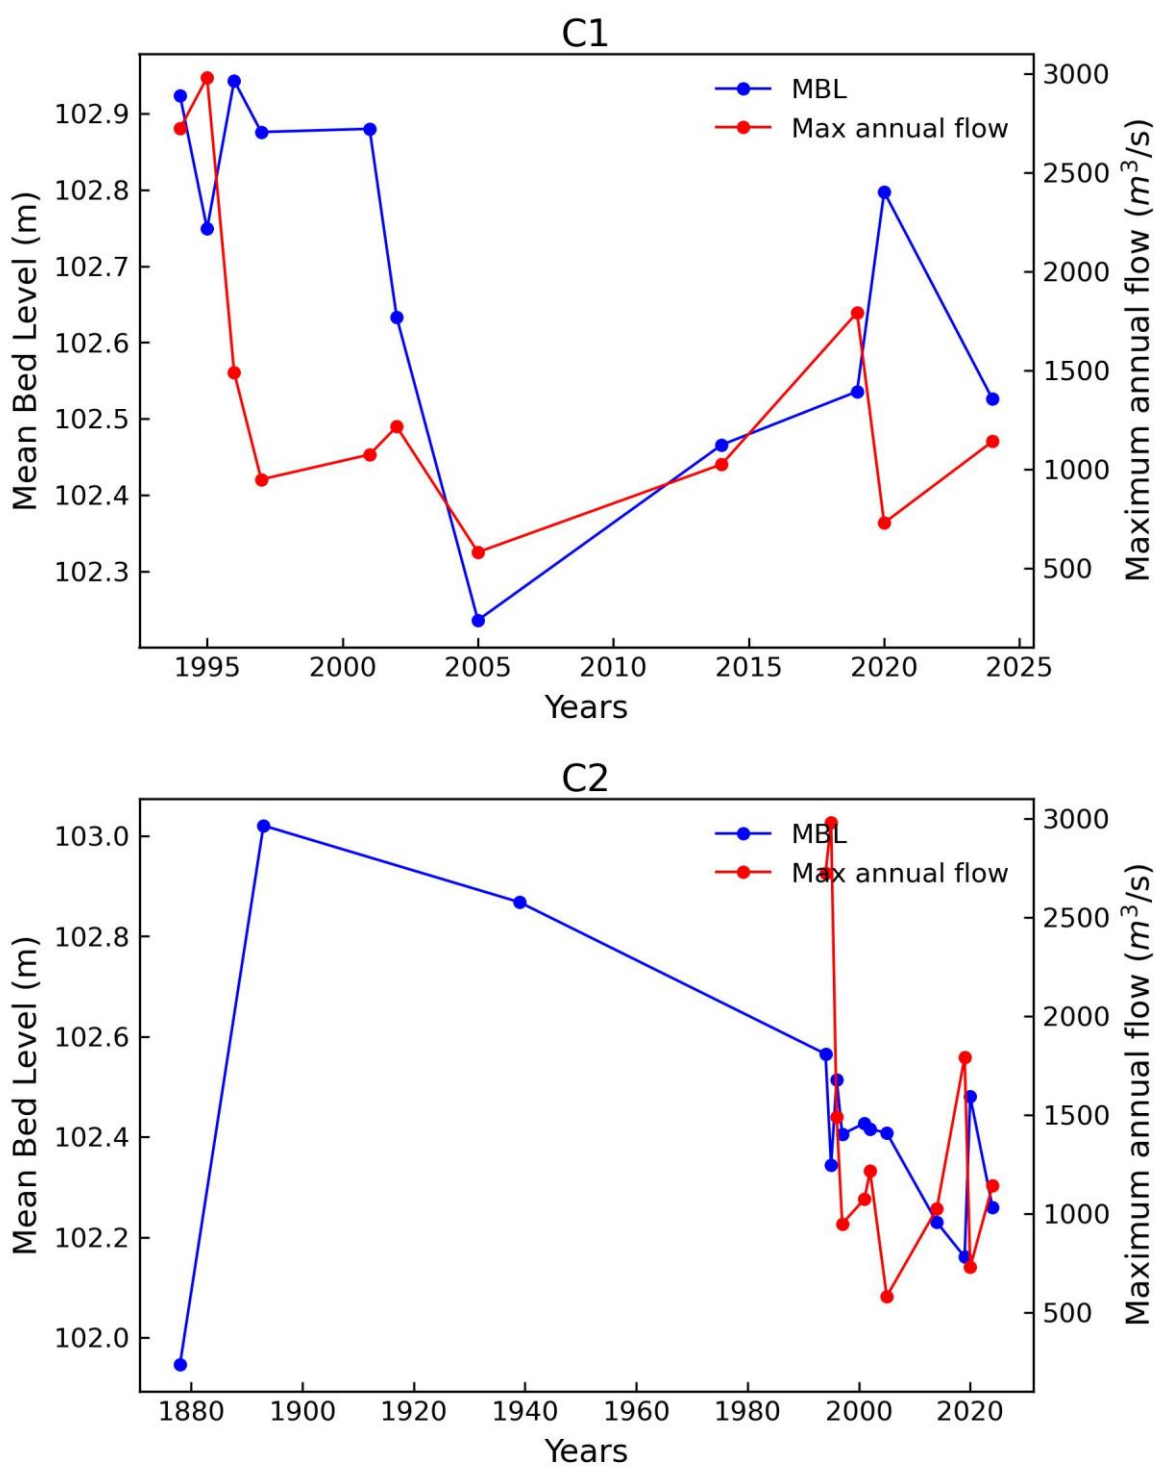
## Appendix C Maximum annual flow and mean annual flow vs. mean bed level for different survey years at each cross section

Note that axis scales differ on the plots.

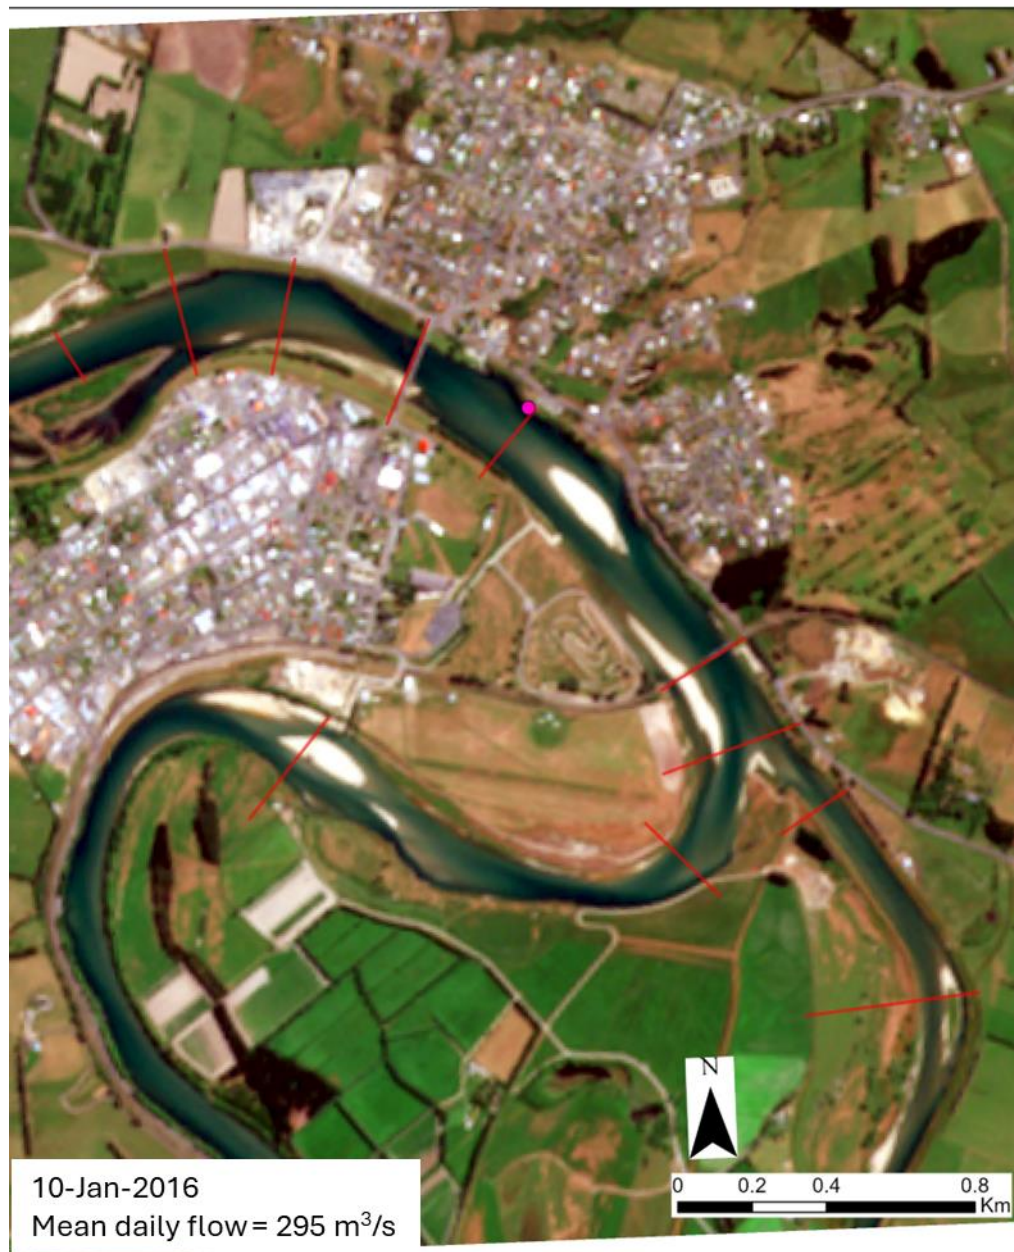
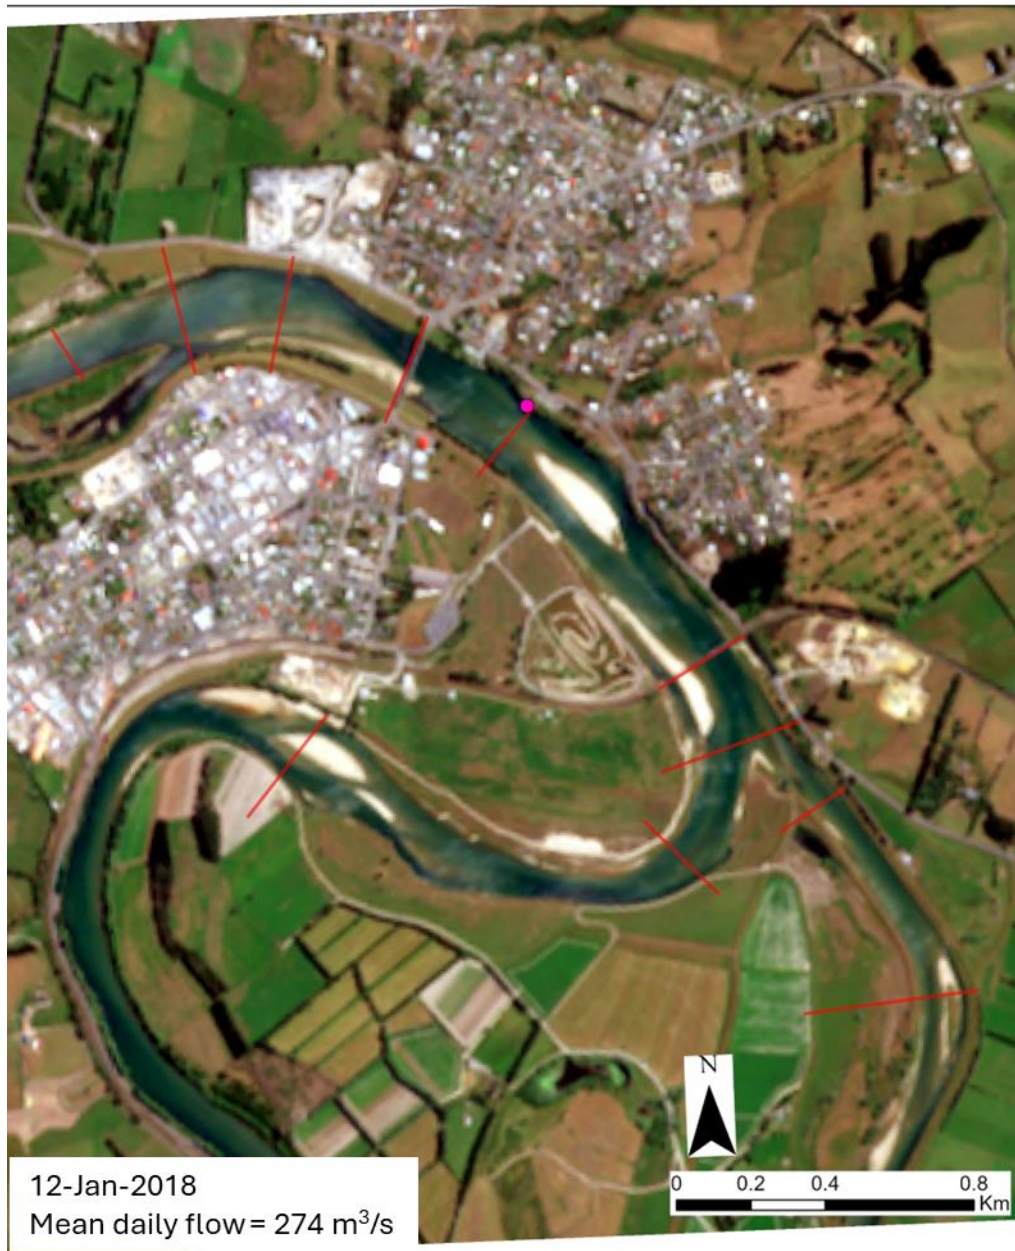
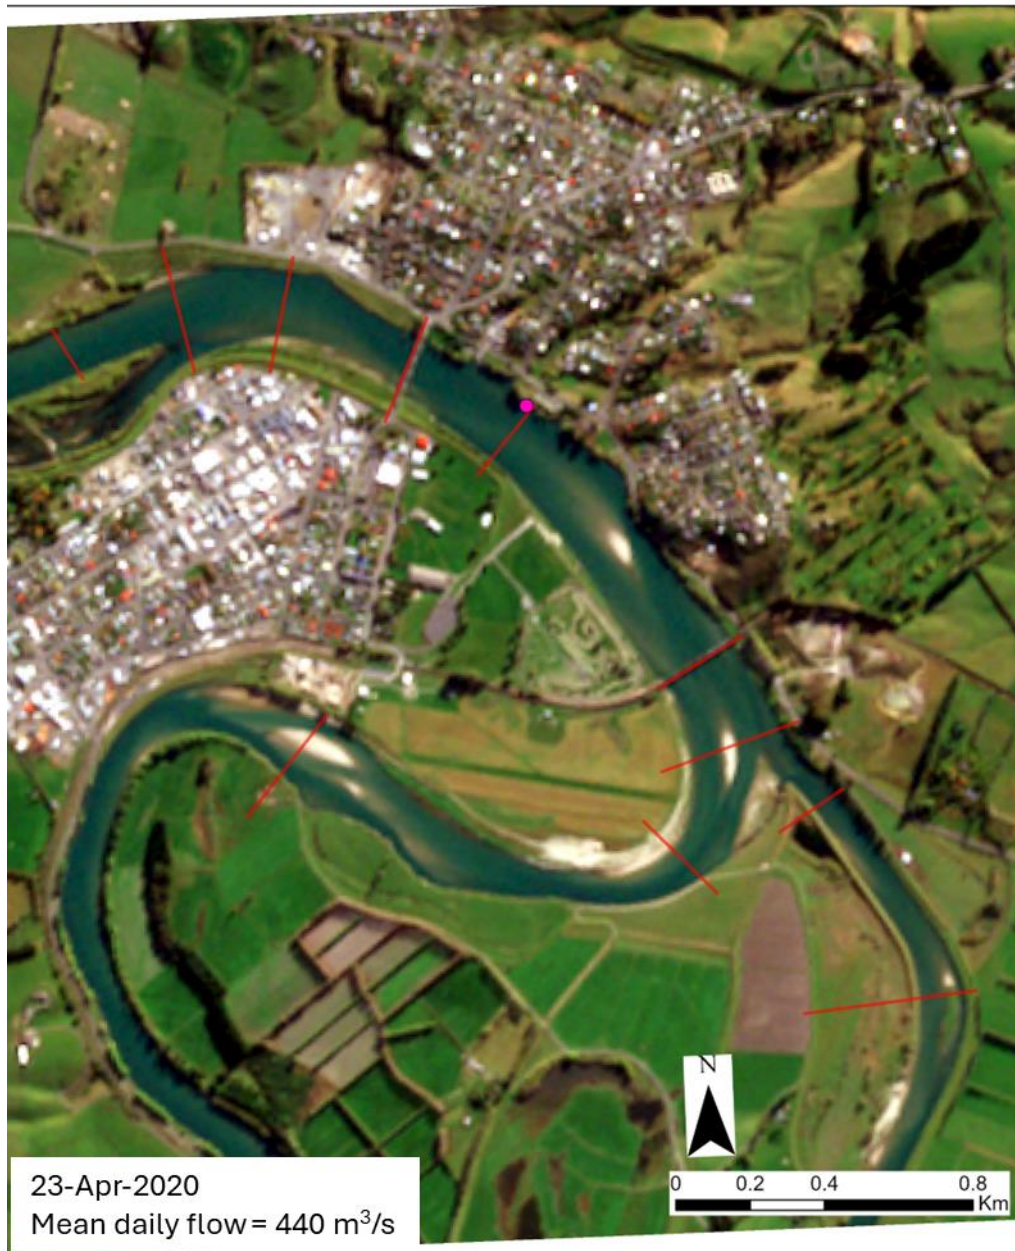
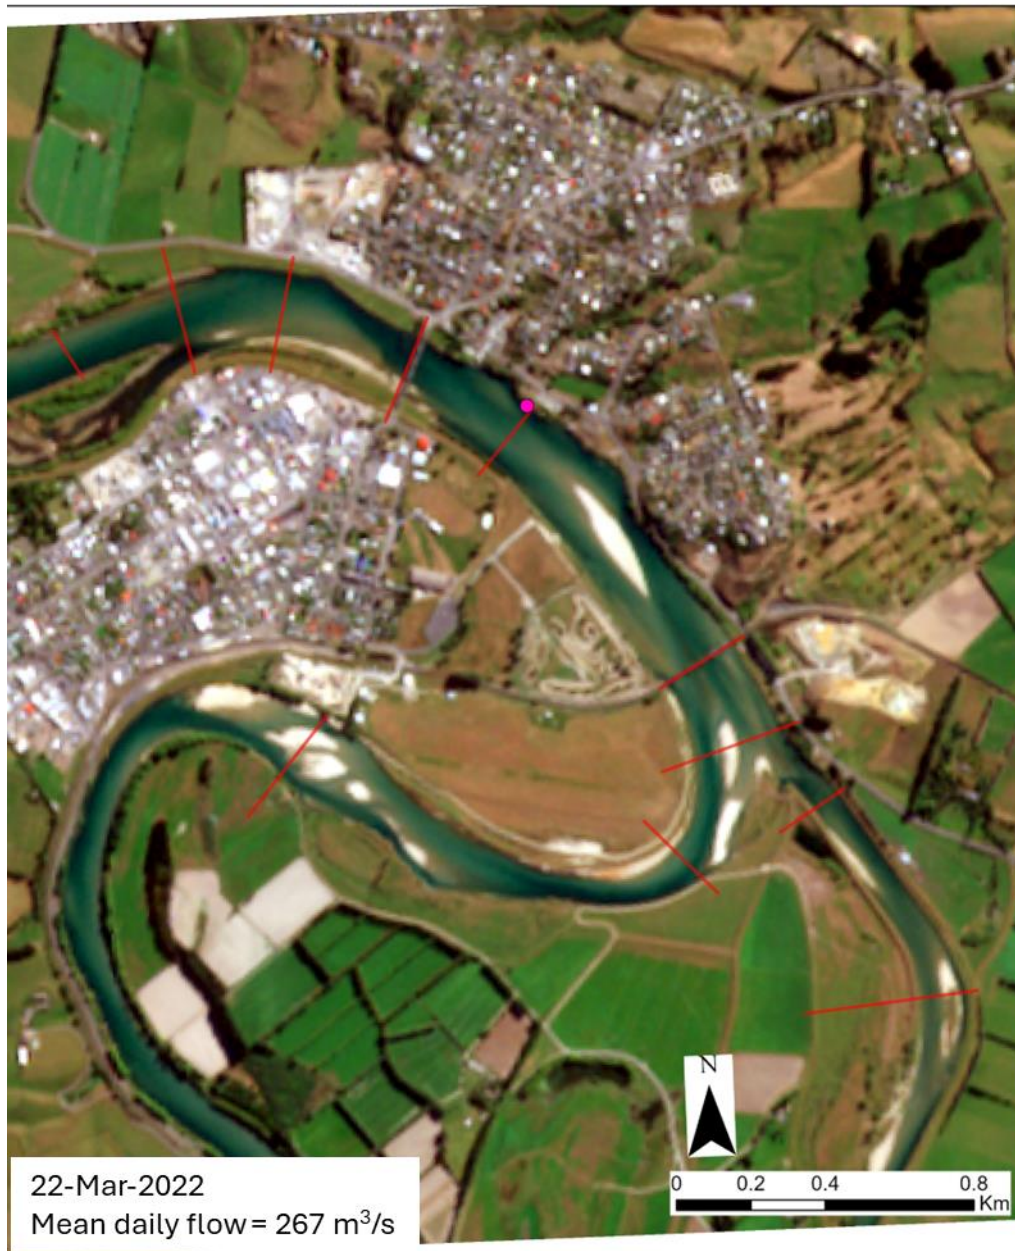
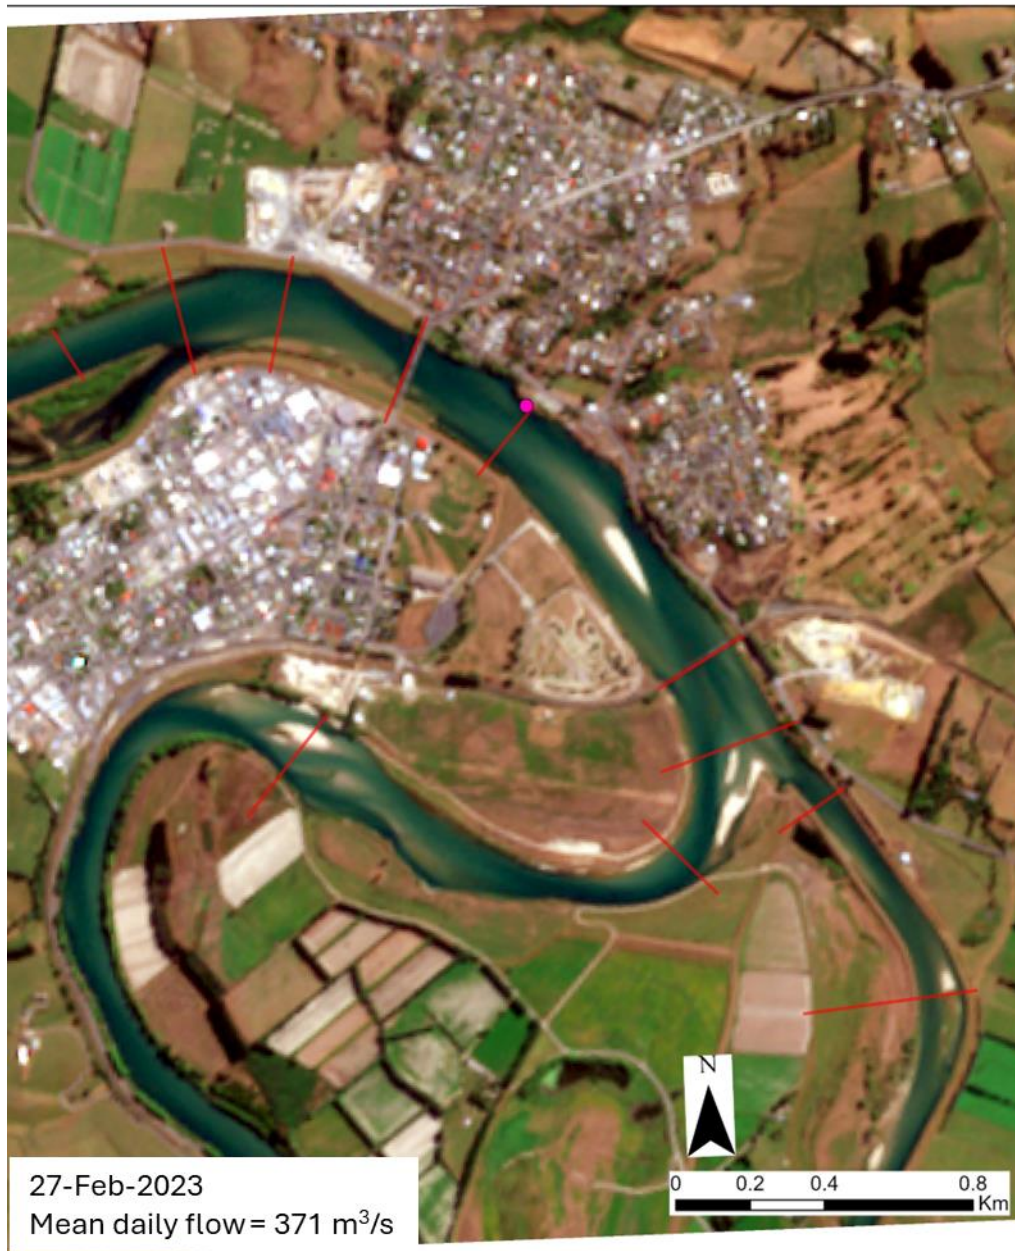
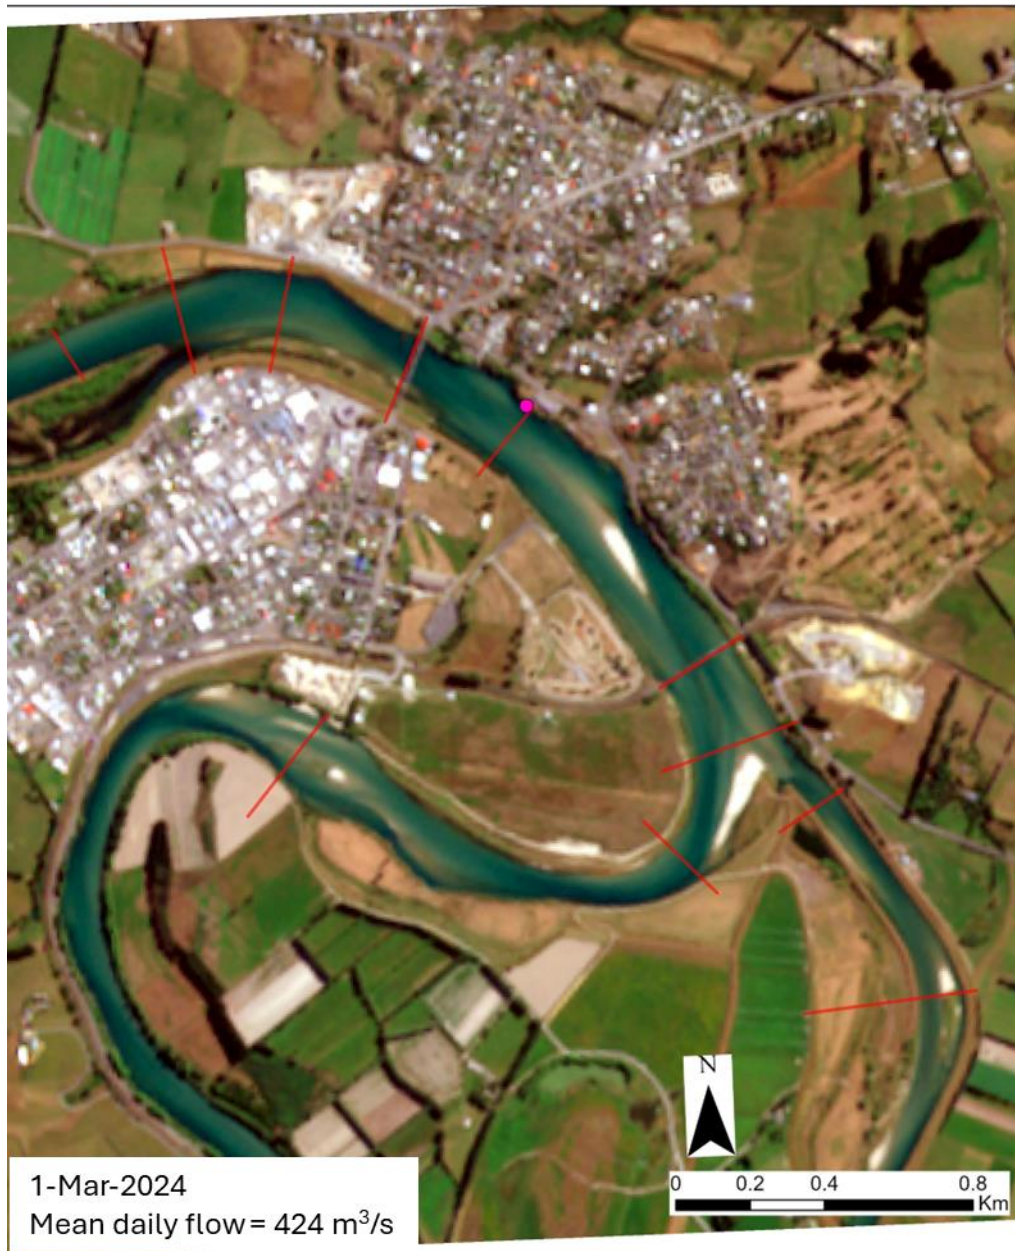
**Figure D-1: Satellite imagery of the Clutha River at Balclutha for seven years between 2016 and 2025.** The exact date of the satellite capture and mean daily flow values are inserted in bottom left of each image. Red lines indicate cross section locations.
